# THE KUMAMOTO JAPAN EARTHQUAKES OF 14 AND 16 APRIL 2016

# A FIELD REPORT BY EEFIT

Dr. Katsu Goda, *University of Bristol* (Team Leader and Editor) Dr. Grace Campbell, *Arup* Ms. Laura Hulme, *Arup* Mr. Bashar Ismael, *University of Manchester* Dr. Lin Ke, *Willis Re Japan* Ms. Rebekah Marsh, *Mott MacDonald* Prof. Peter Sammonds, *University College London* Dr. Emily So, *University of Cambridge*

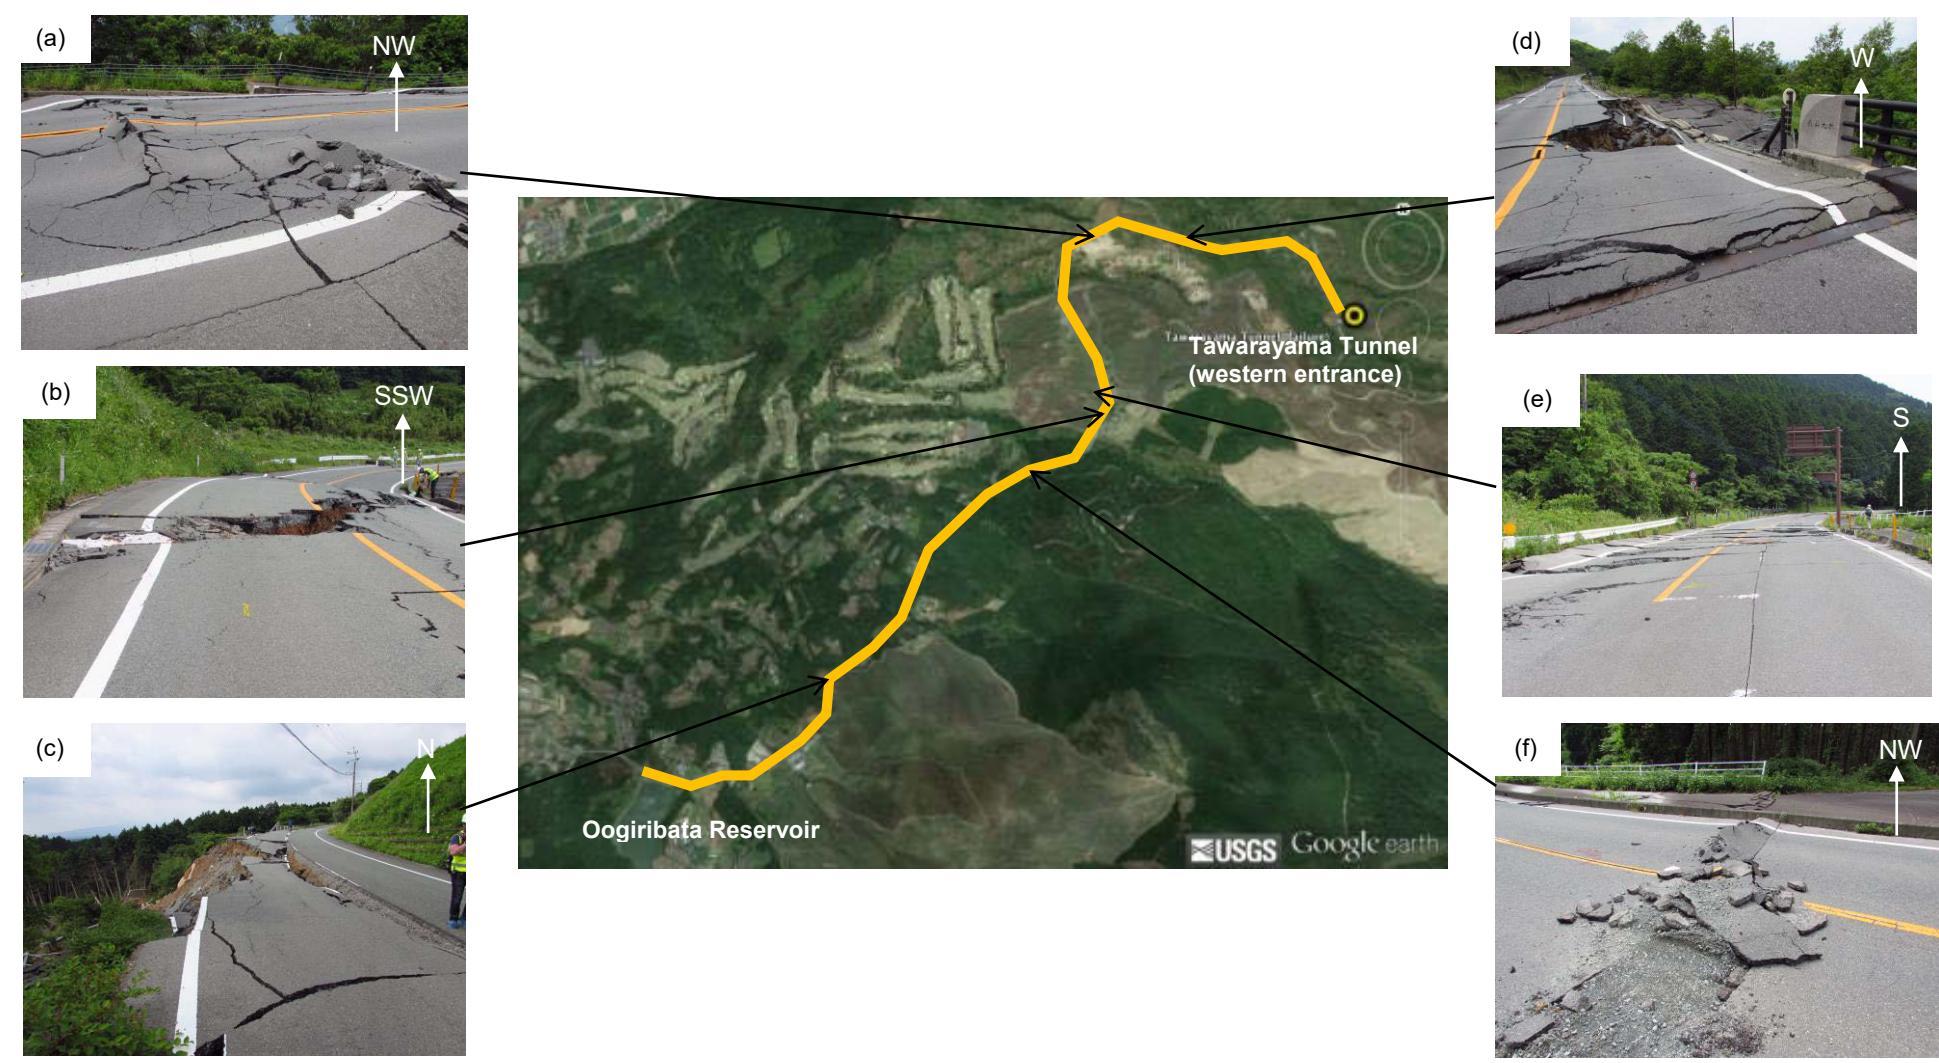
Figure 5.10 Road damage along Road 28: (a) compression features on the road surface, (b) bulking at the road bend, either caused by compressional fault movement or bulging at the toe of a slope failure, (c) cracking and collapse of the road at the crest of a slope failure, (d) compression features at road-bridge connection and sinkhole, (e) shearing seen on the road surface trending roughly NE-SW, and (f) compression features on the road surface in E-W direction and signs of vertical ground shaking revealed as displaced tarmac cover (image source: United States Geological Survey and Google Earth).

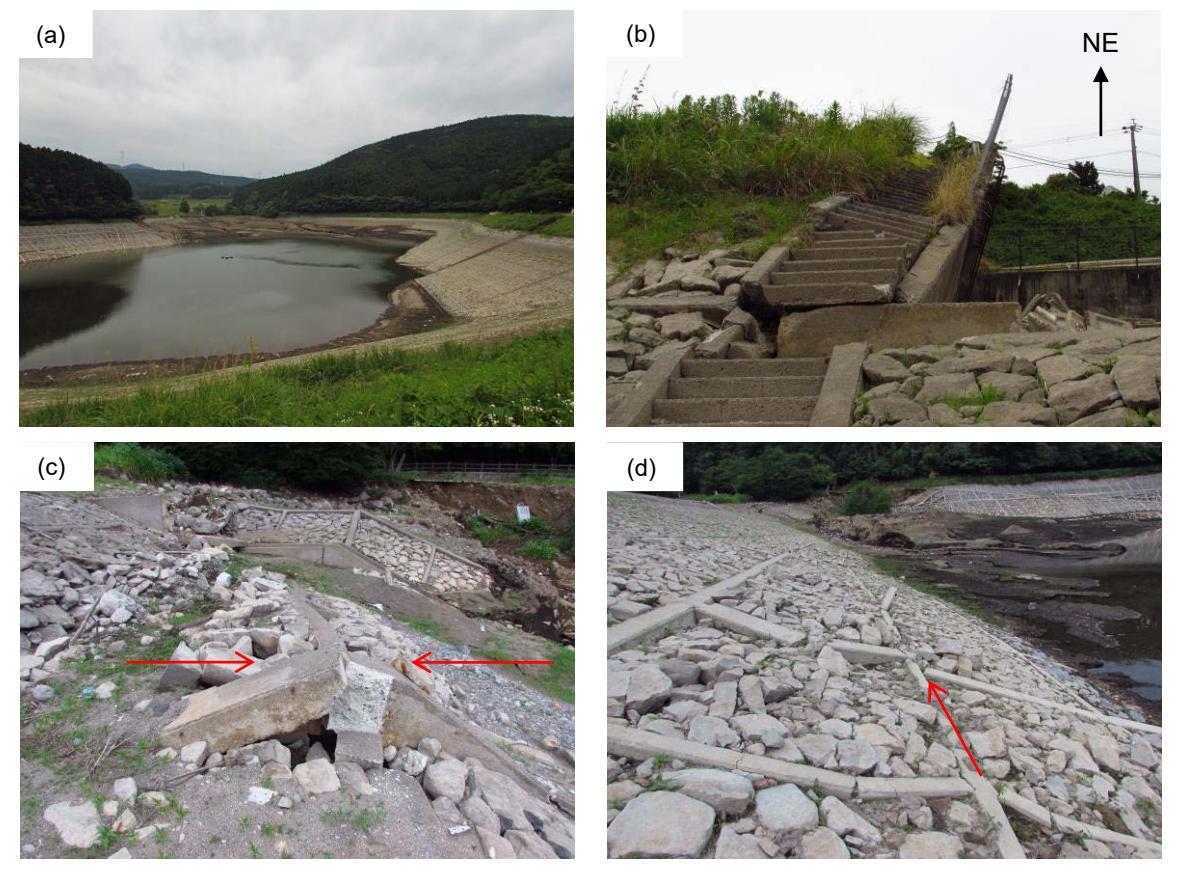
**Figure 5.11** Damage of the Oogiribata Dam: (a) reservoir, (b) failure of the retaining walls at the spillway, (c) compression features in the dam wall showing a NS compression, and (d) shearing features in the dam wall.

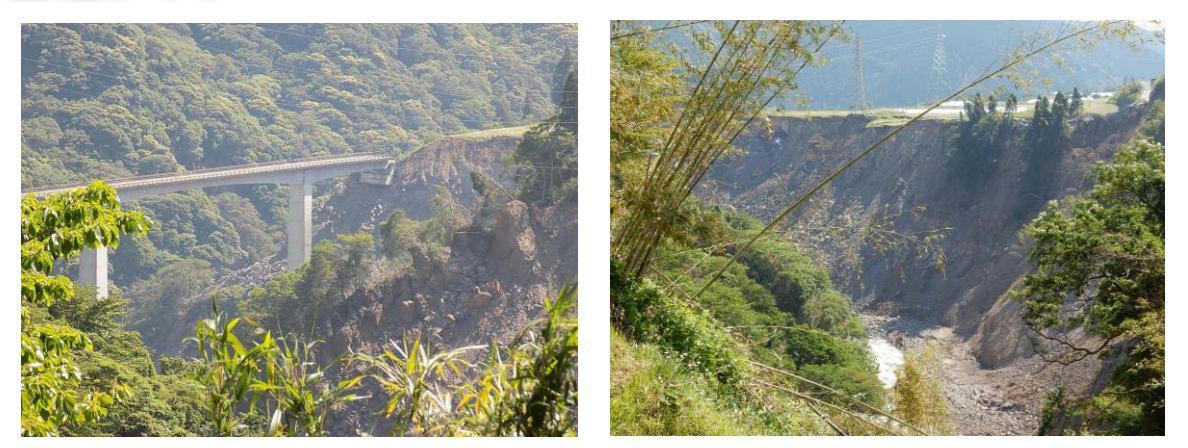
Figure 5.17 Debris flow near the Choyo Bridge.

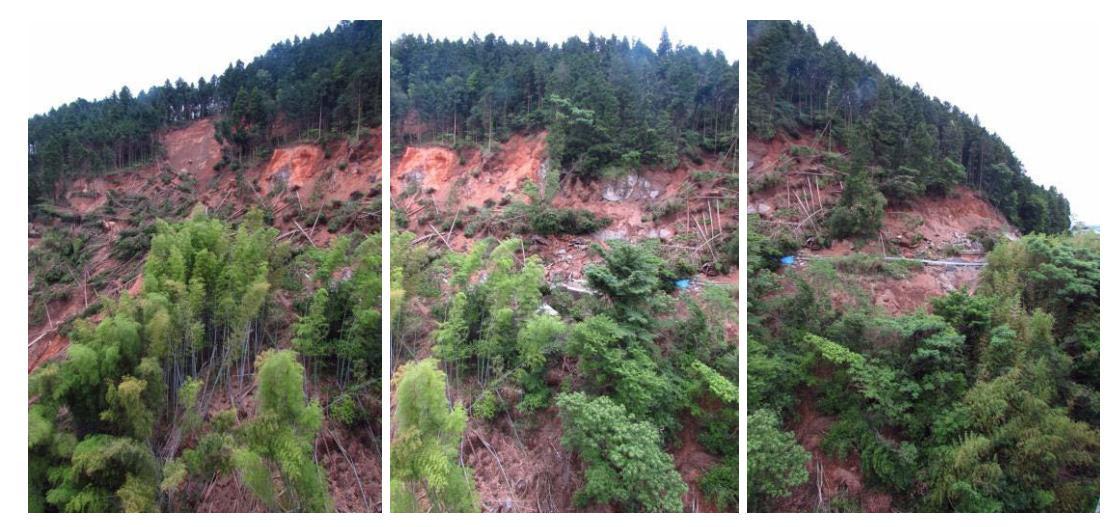
Figure 5.18 Landslide at the Oogiribata Bridge looking south at the failure from the bridge deck.

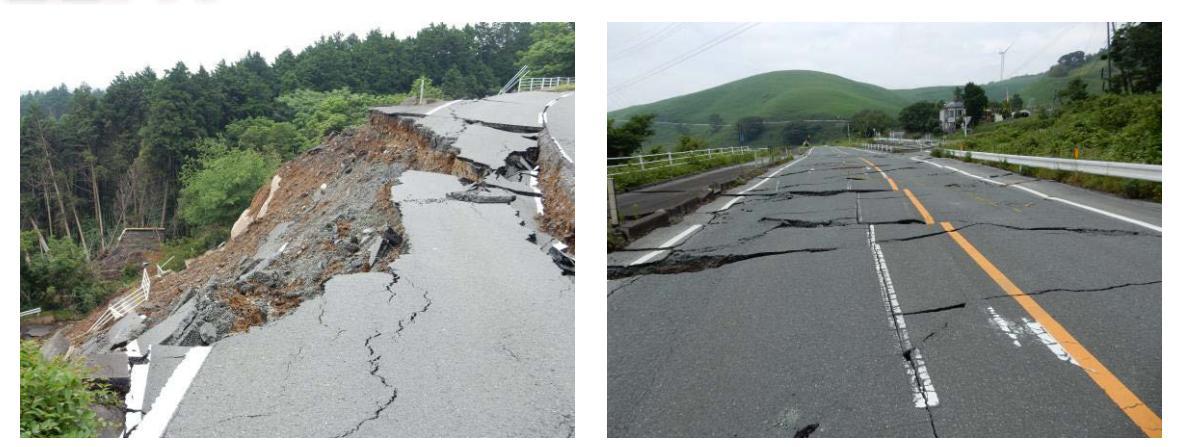
Figure 5.19 Extensive cracking of roads.

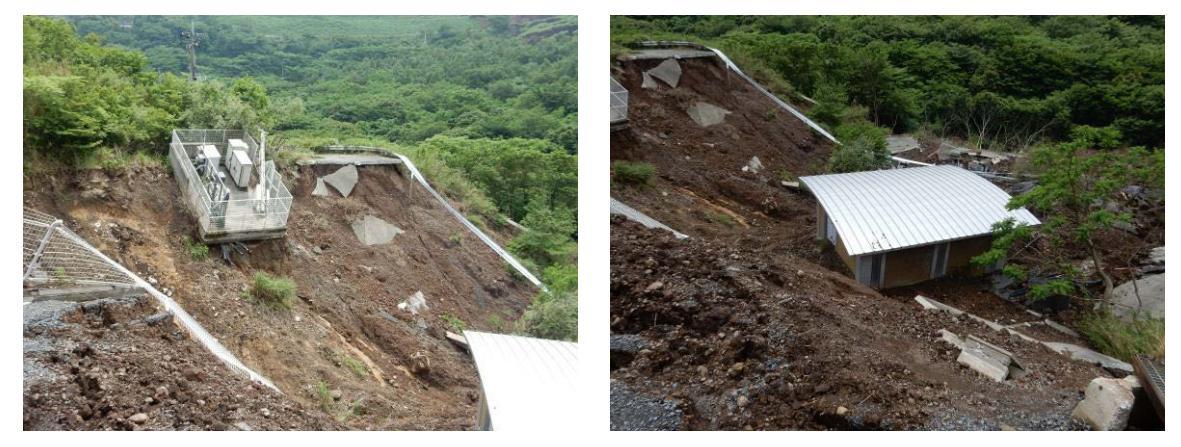
Figure 5.20 Damage to infrastructure facilities near the entrance of the Tawarayama Tunnel.

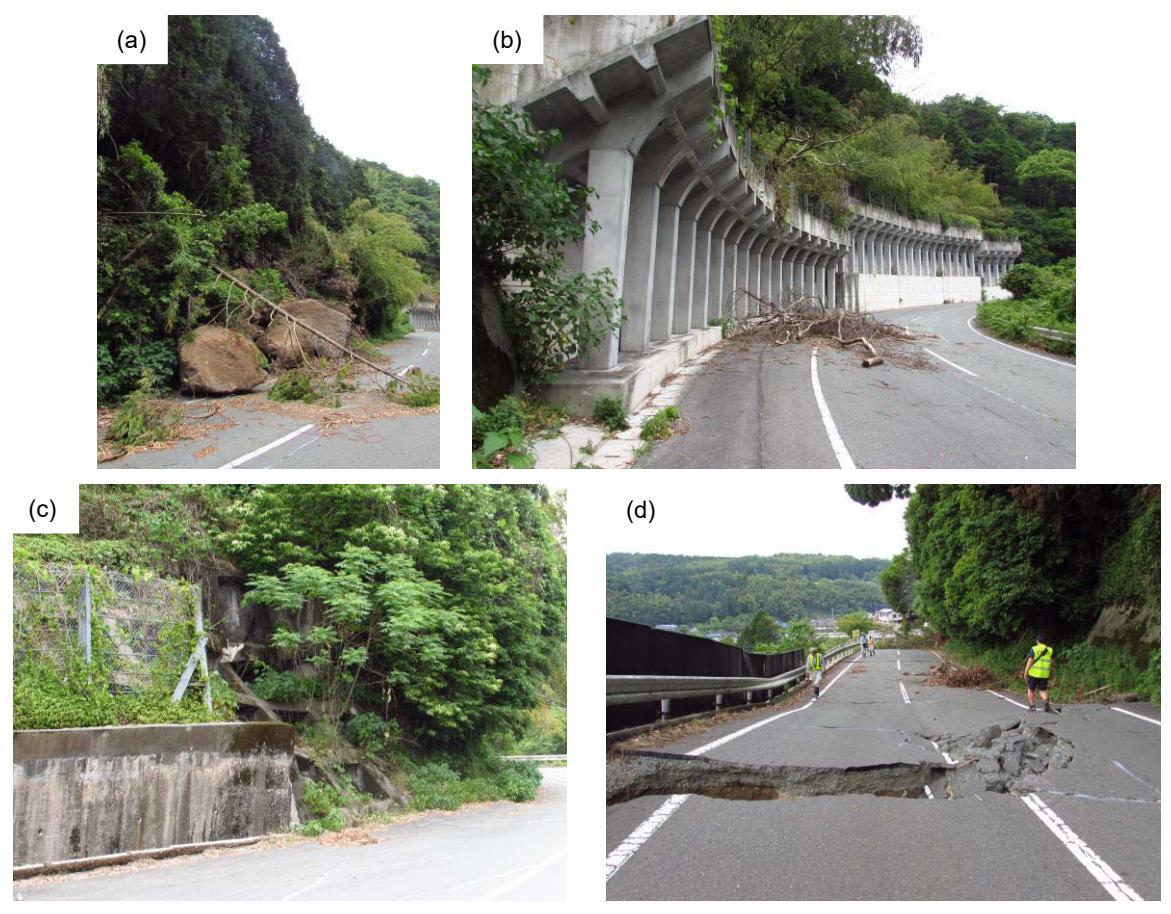
**Figure 5.21** Slope stability measures along Road 28 at the westerly road blockage: (a) rock bolts and wire mesh supporting boulders and other fallen debris from the slope failed, (b) giant concrete retaining wall remained standing although large amounts of debris have fallen behind the structure, (c) deformed retaining wall with vertical and horizontal struts, and (d) cracking on the road at the crest of a slope failure downslope from the road.

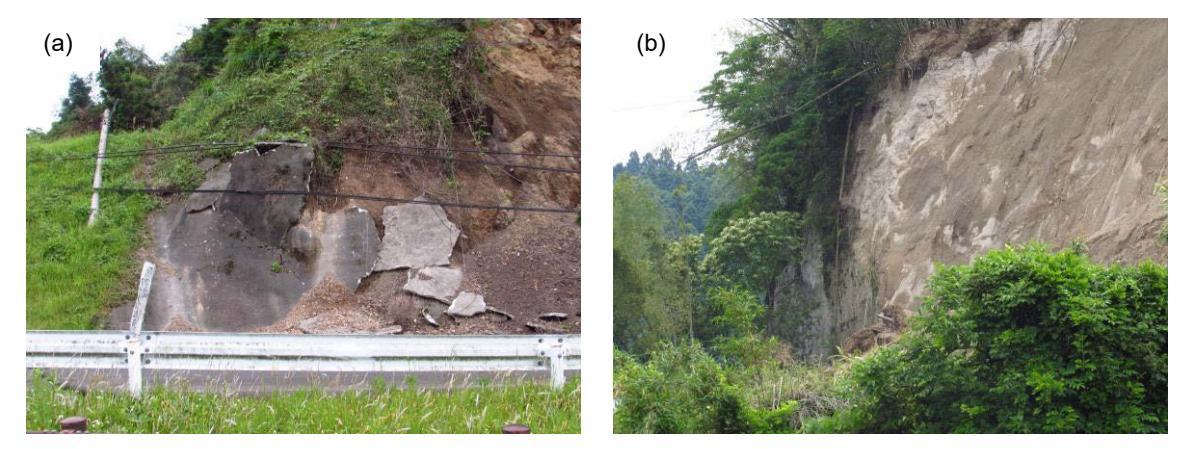
**Figure 5.22** Failure of sprayed shotcrete during slope failure: (a) eastern edge of the giant landslide at the Oogiribata Bridge and (b) near-vertical slope with shotcrete; the shotcrete has fallen but there has been minor failure of the soil.

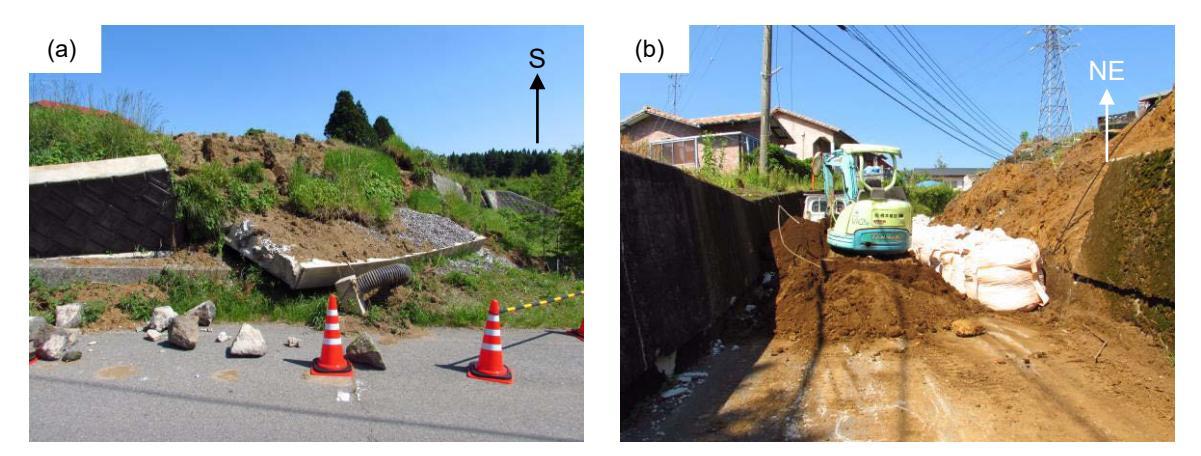
Figure 5.23 Retaining wall failures in the Kawayo district of Minami Aso Village.

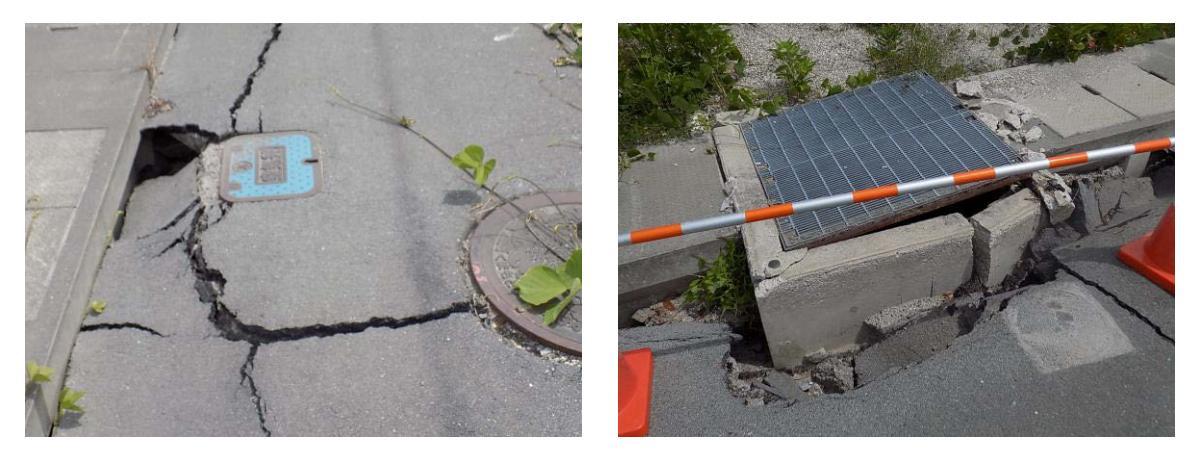
Figure 5.28 Liquefaction-induced failures at the Kumamoto Port.

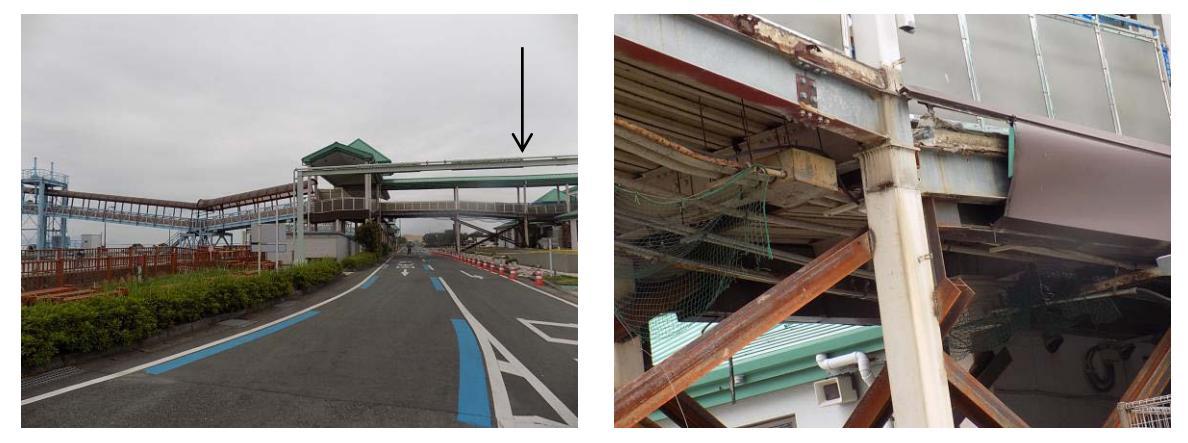
Figure 5.30 Damage to the steel overpass bridge at the ferry terminal due to liquefaction-induced settlement.

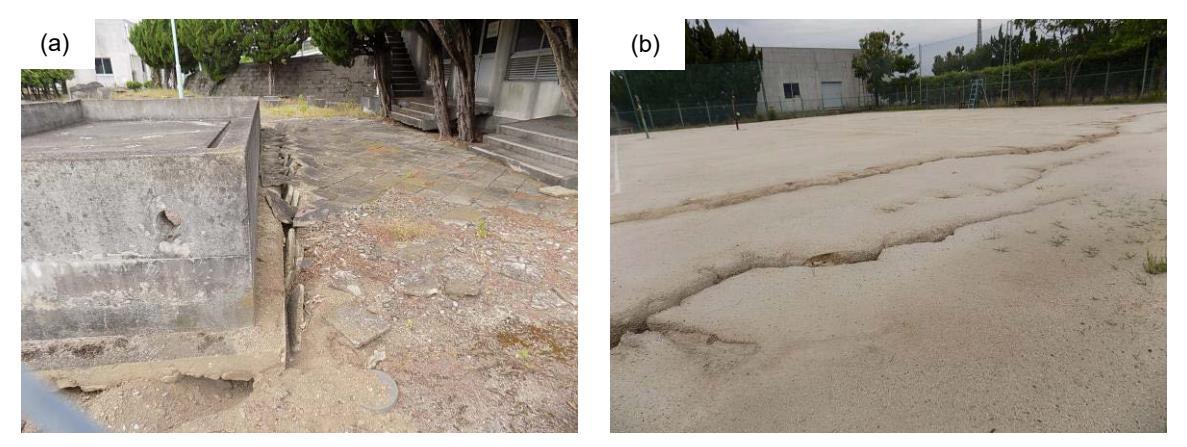
Figure 5.32 Widespread of liquefaction at: (a) bottom of a foundation and (b) a tennis court.

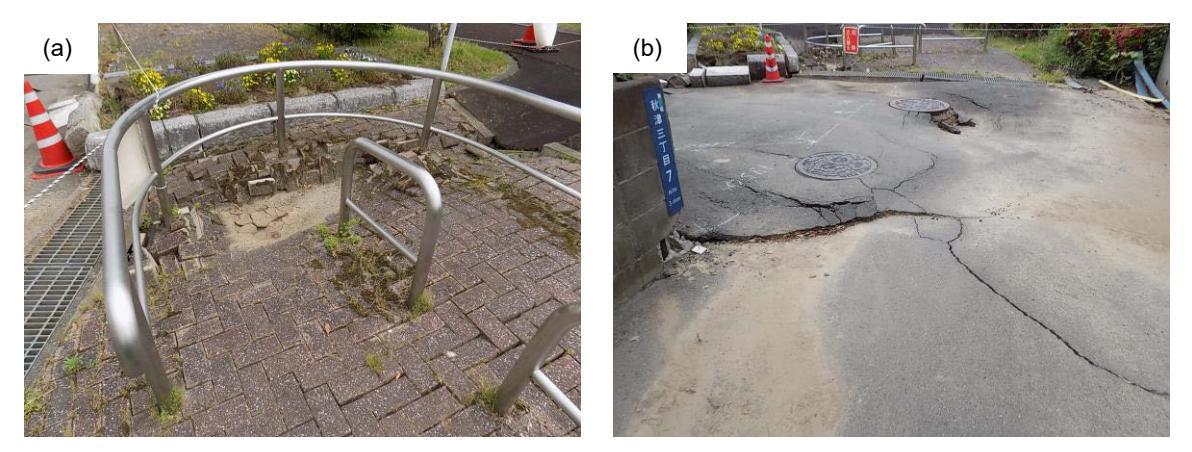
Figure 5.33 Ground failures due to liquefaction: (a) ground settlement and (b) tension cracks.

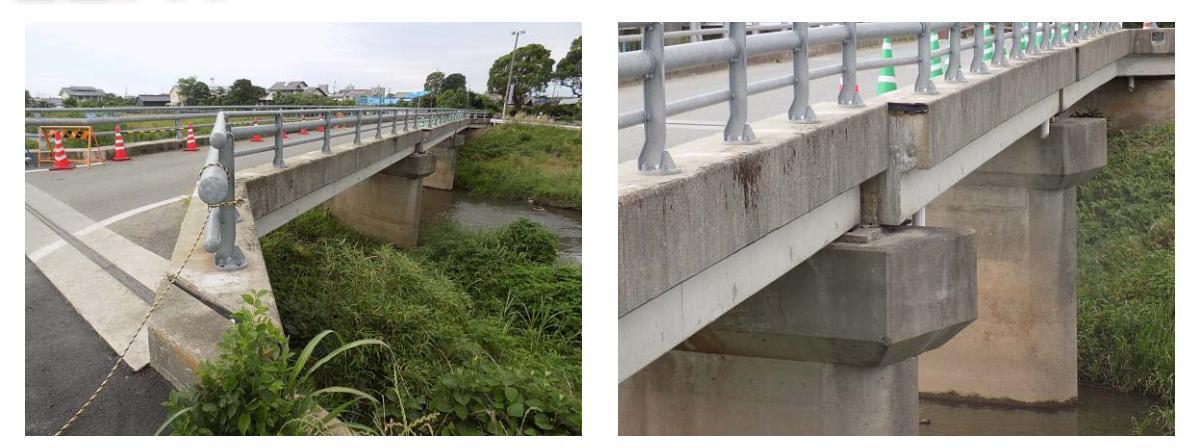
Figure 5.34 Lateral displacement of a bridge along the Akitsu River.

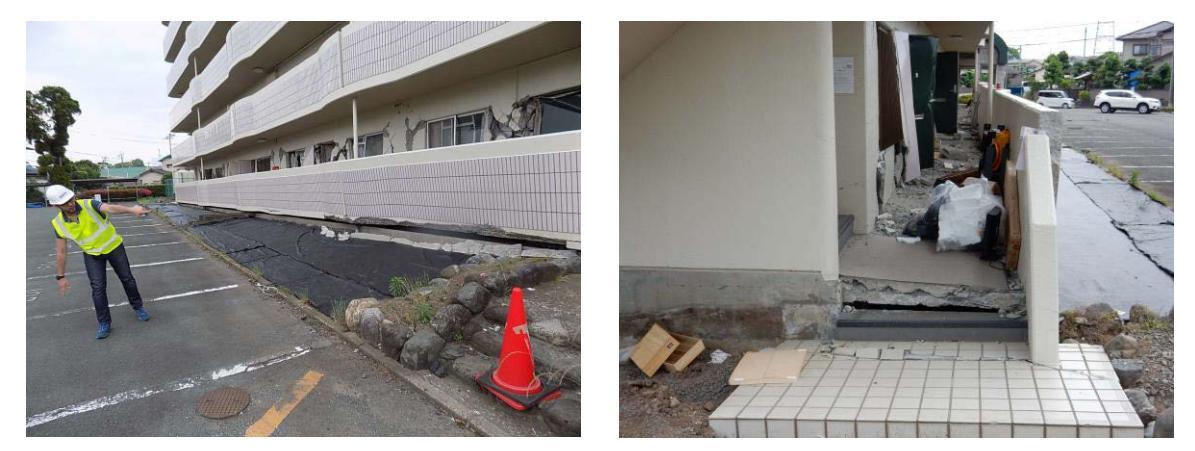
Figure 5.35 Bearing failure of an apartment building near the Akitsu River.

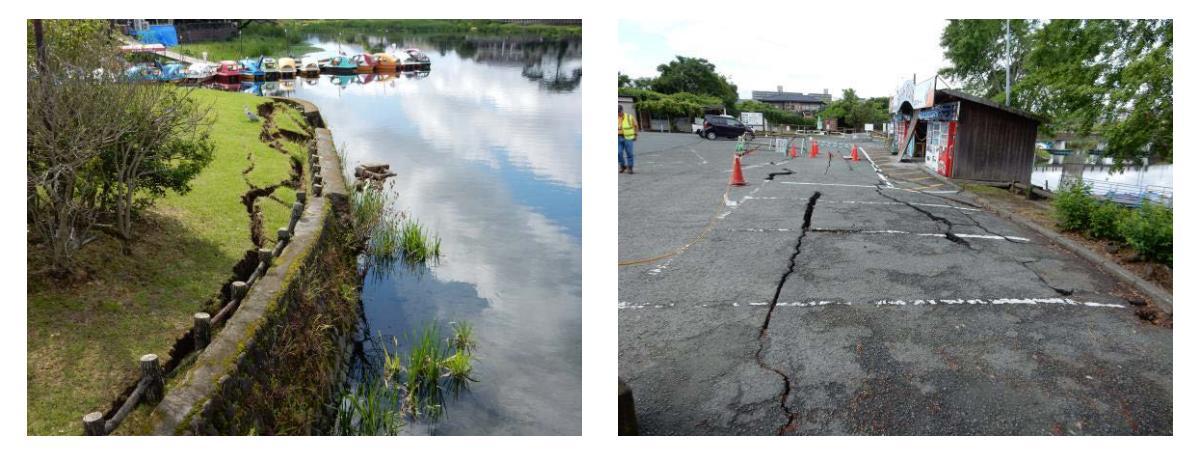
Figure 5.36 Liquefaction-induced lateral spreading at the Kamiezu Lake.
