# Lessons from history – the steel box girder story

Ian Firth, BSc, MSc, DIC, CEng, FStructE, FICE, FConsE

Presented at the Institution of Structural Engineers, 25 February 2010

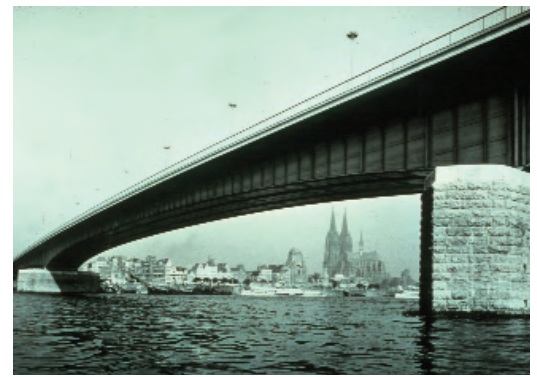
2 The Cologne-Deutz Bridge (1948)

it is generally considered that the first was the Cologne-Duetz Bridge (1948) designed by Leonhardt<sup>1</sup>. With a main span of 185m, this three span steel box girder replaced an earlier plate girder suspension bridge which had been bombed during the war. The girder had a depth over the piers of 7.8m (span/24) and 3.3m at midspan (span/56), and although it had a stiffened steel top flange, it had a concrete slab added on top as the wearing road surface (Fig 2). Interestingly, the plates were connected by rivetting.

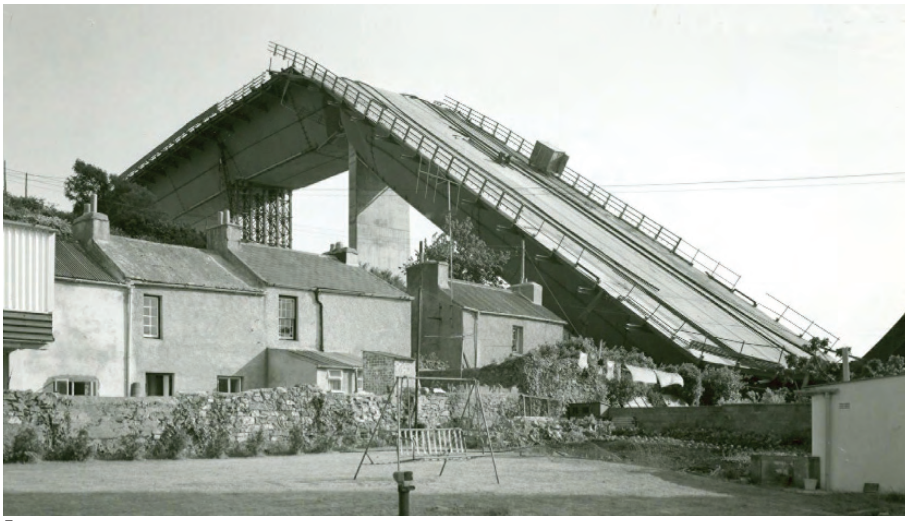
- 5 Collapse of the Cleddau Bridge, Milford Haven (1970)
- 6 Collapse of the Rhine Bridge, near Koblenz (1971)
- 7 Typical internal web stiffening adjacent to a pier diaphragm (Erskine)

On 2 June 1970, the steel box girder bridge under construction in Milford Haven, South West Wales, collapsed suddenly during construction killing four people (Fig 5). The cause of failure turned out to be an inadequately stiffened diaphragm over one of the piers, exacerbated by excessive eccentricity at the knuckle bearing. The diaphragm buckled during cantilevering of the girder, triggering buckling of the adjacent webs and flanges. The detailing of the stiffener splice joints was also called into question after the

capacity at a position where stresses would be low in the finished bridge. The failure occurred at a box splice joint position, aggravated by poor detailing of the longitudinal stiffener splices to accommodate the erector's chosen welding machine.
