Reinforcement of Concrete Beams with Continuous Glass Fibre Ropes

Michael Imber

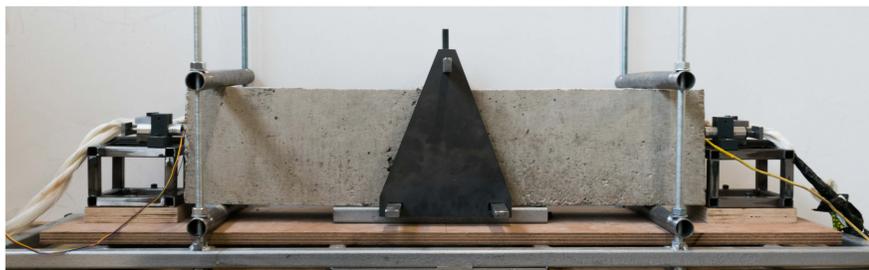
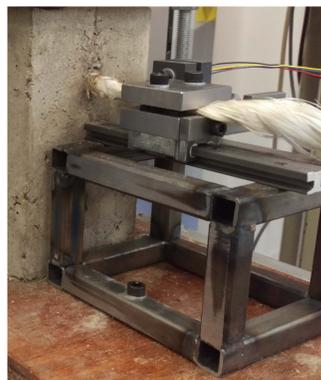
- An operational steel test rig was designed and developed for use in examining the force- and stress-slip response of continuous glass fibre ropes bonded with concrete.
- A rope clamping system was developed for slip measurement which gripped the rope and provided a means for slip measurement via an LVDT contact plate.
- A linear guide rail and carriage allowed for the transfer of rope slip during loading to the LVDTs positioned on the outer faces of beam (shown here).
