## ASTOR VALLEY EARTHQUAKE, NORTHERN AREAS PAKISTAN A FIELD ASSESSMENT, 1 APRIL 2003

*Richard Hughes, Consultant, Aga Khan Cultural Services.*

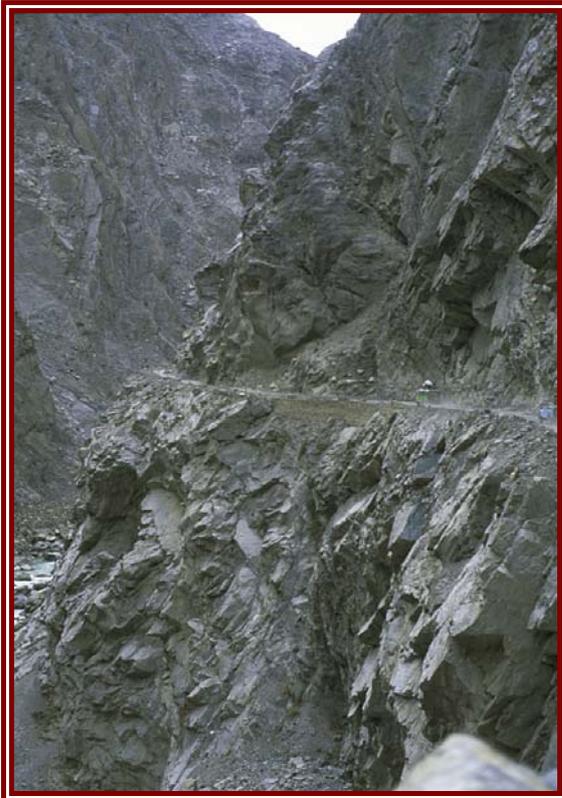
From the Indus Valley to Astor, some 40km, 90% of the mountain road has failed. A lot of the significant collapses and burial points are in the usual places of cliff and soil moraine instability. At the

**Figure 2: Clearing away rock falls along the main road into Astor Valley**

- The rock cliffs appear to be mostly biotite mica schists and gneisses that have highly sheared and consistently dip to the gorge. These are interspersed with what appears to be micro granodiorites and these forming more the vertical cliffs. Fractures are epidemically open here and not just the result of blasting! Rock detritus looked very sandy and micaceous, with no evidence for strata of fine silts and clays – the absence is as one would expect from the hydrological/rock/glacier character.

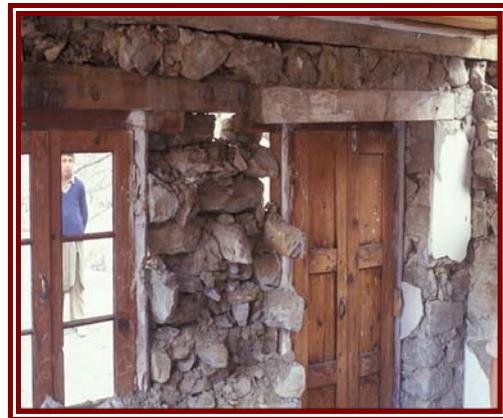
Figure 5: Internal damage to non-load bearing cross walls built in rubble masonry

- Moderately to severe damage shows corner wedge failure, outer or inner face skin (more on outside) splitting with collapse mostly mid wall, local failure under front beam, shattering of internal plaster.
