THE AEGEAN EARTHQUAKE and TSUNAMI OF 30 OCTOBER 2020

A FIELD REPORT BY EEFIT

The earthquake hit during the global COVID pandemic. This mission therefore adopted an unconventional strategy, and combined field and remote survey methods for assessing damage to buildings, critical infrastructure, and geotechnical structures. This hybrid strategy was achieved through a large remote team supported by two local field crews in Turkey and Greece. One of the main objectives of this mission was to assess this hybrid model's usability for future missions and investigate the extent in which other data sources can be used for remote reconnaissance in support of field work.

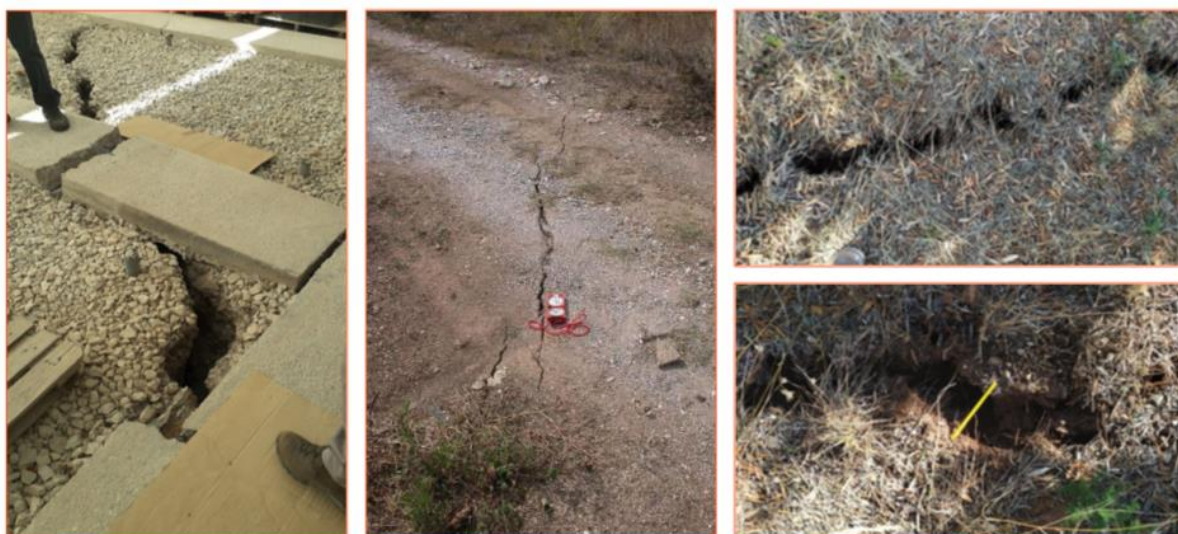
Due to the high magnitude and shallow nature of the 30th October 2020 earthquake, the island of Samos and area SW of Izmir displayed the full effects of the high ground motions produced. One of the first observations was coseismic surface rupturing which was documented across the Island of Samos and along the Eastern coast of Chios island, Greece. Our EFFIT field team located some metre-scale ruptures in northern Samos (Latitude: 37.803591° / Longitude: 26.724584°) as well as some structural ground cracking with offsets of < 30cm. The ruptures are continuous for up to ~10 m and strike ~60° NE as expected, as this is parallel with the main strain direction and active faulting in the area, especially the >10 km long Karlovasi fault (Pavlidis et al., 2009). Lekkas et al. (2020) also report many metre-scale surface ruptures with centimetre-scale offsets in the nearby Agios Nikolaos, Agios Elias and Kontakaeika villages in NW Samos. The ruptures in the area of Agios Nikolaos strike 40-70° NE, consistent with our findings. The ruptures were semi-continuous for lengths < 1 km and caused vertical and horizontal offsets between 5 – 8 cm (see **Figure 11**).

Figure 11: Photographs from Lekkas et al. (2020) illustrating surface rupturing in the Agios Nikolaos area in NW Samos.

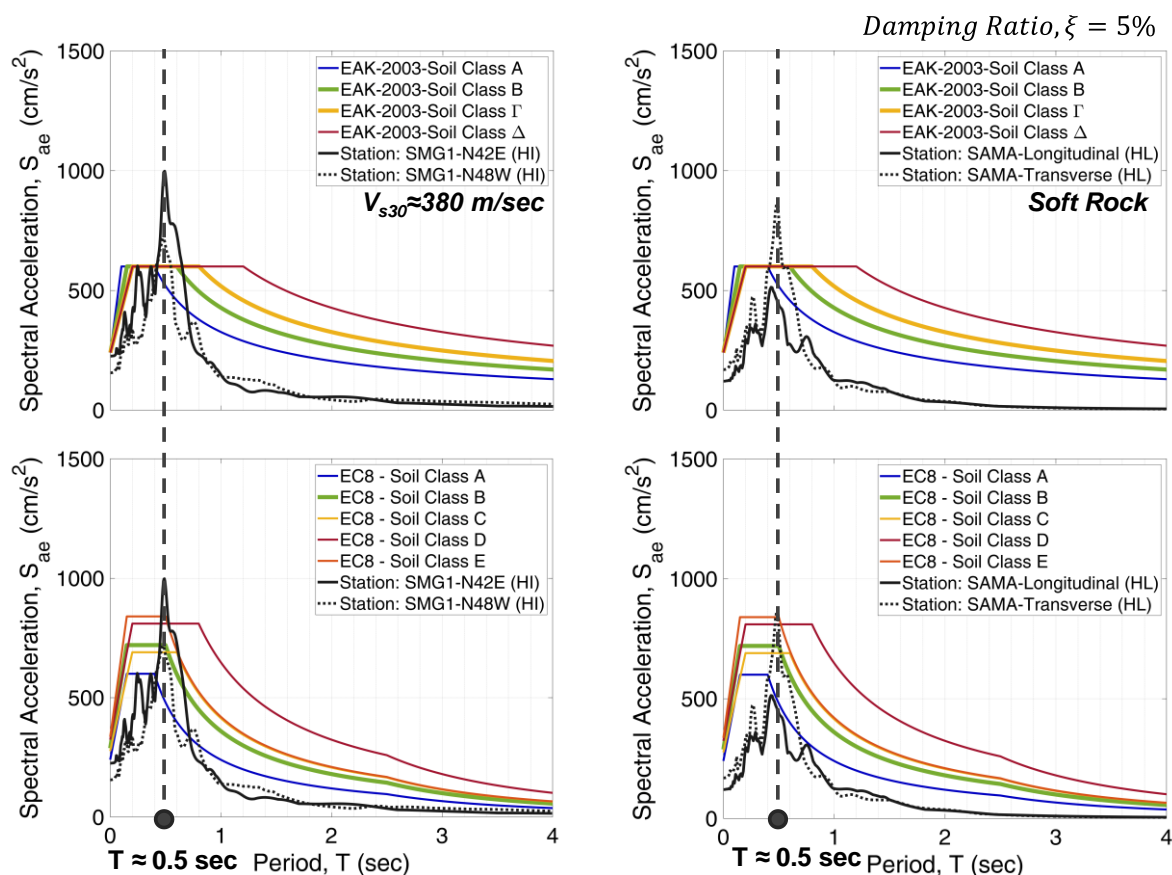
Figure 29: Comparison of the elastic acceleration response spectra of the recorded ground motions at the two stations in Samos Island against the design spectra recommended in EAK2003 and EC8 (Dashed line refers to the peak spectral accelerations).

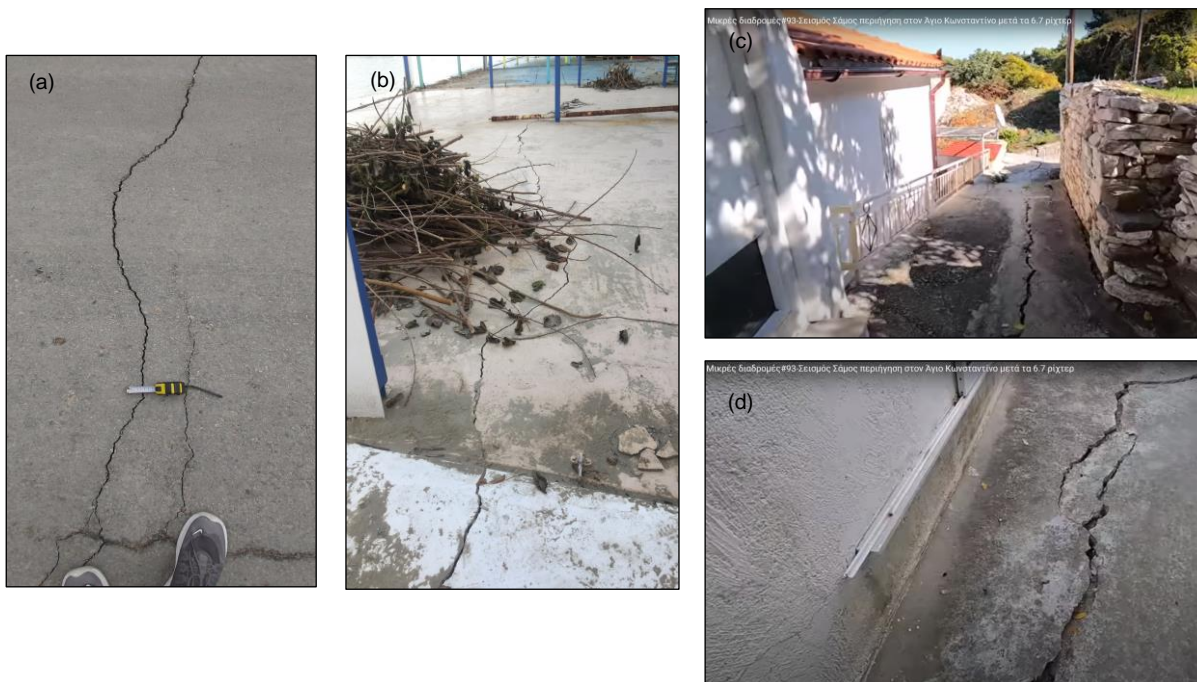
Figure 34: The observed ground cracks in a) Karlovasi, b) Kokkari and c) and d) at the village of Agios Konstantinos (source: <https://www.youtube.com/watch?v=E5lv20MwagI&t=1s>)

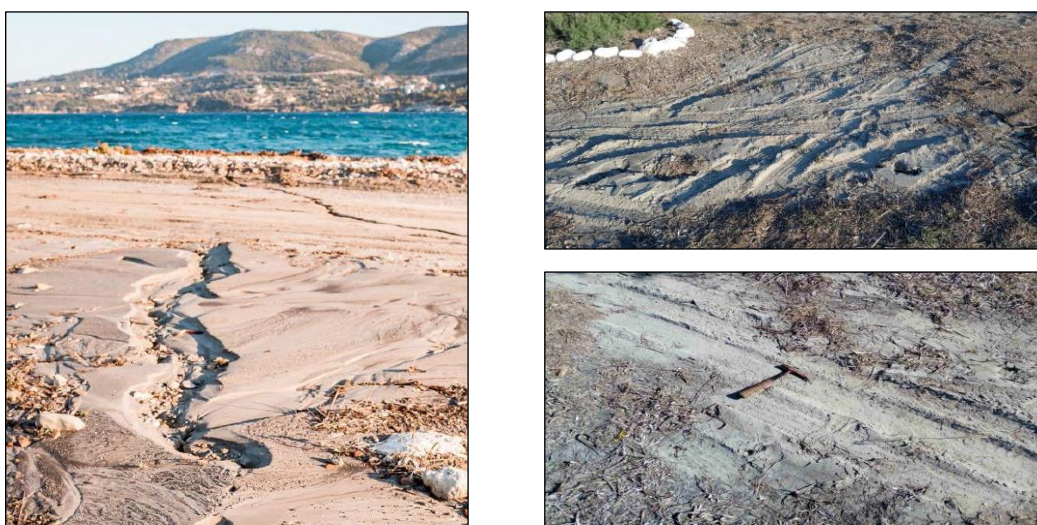
Figure 40: Soil liquefaction in the form of sand boils in Malagari (source: photo on the left after Lekkas et al. 2020) and photos on the courtesy of Dr. A. Ganas)

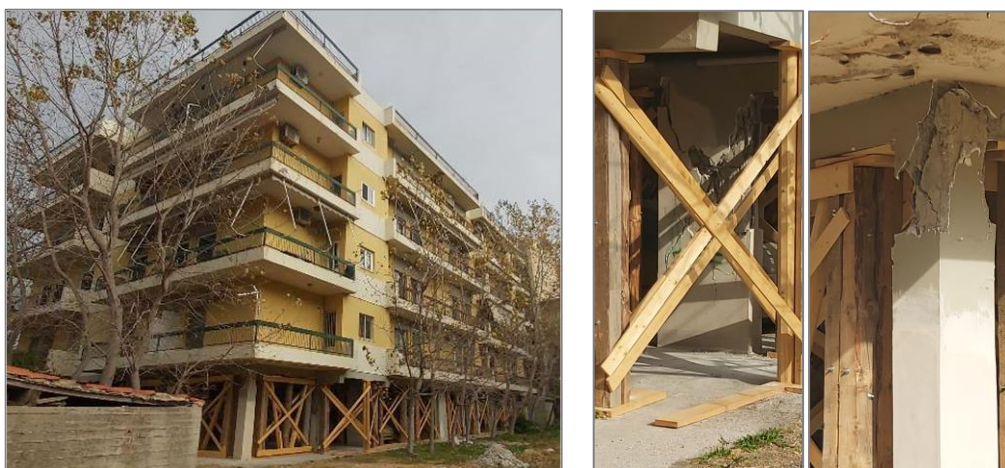
Figure 61: Five-storey building with soft first storey (pilotis) failure at the ground level in Karlovasi (Samos)

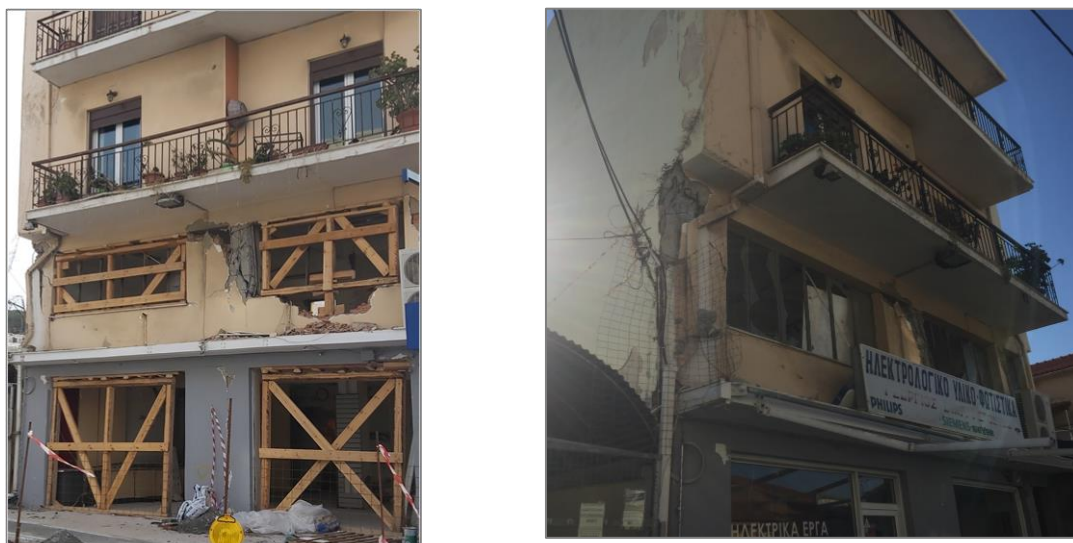
Figure 62: Four-storey building with short column failure in Samos

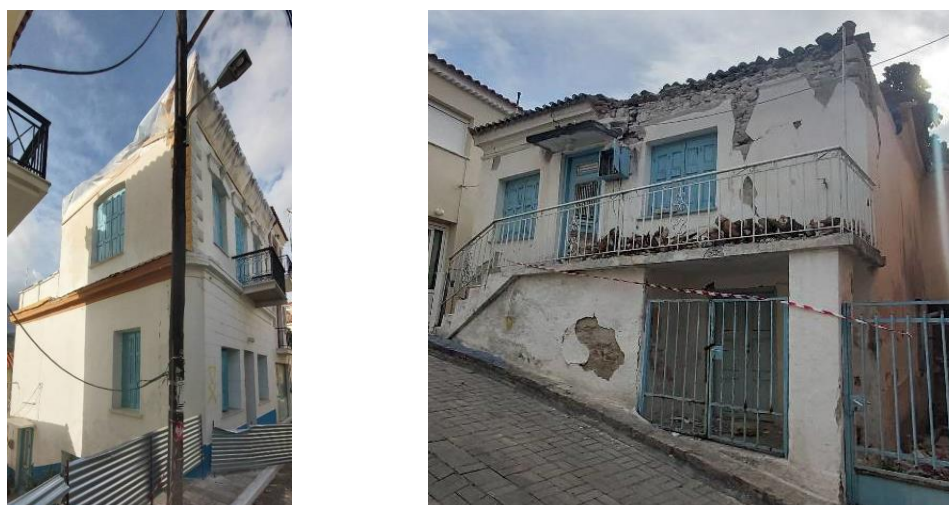
Figure 65: Roof damage to masonry buildings in Samos.

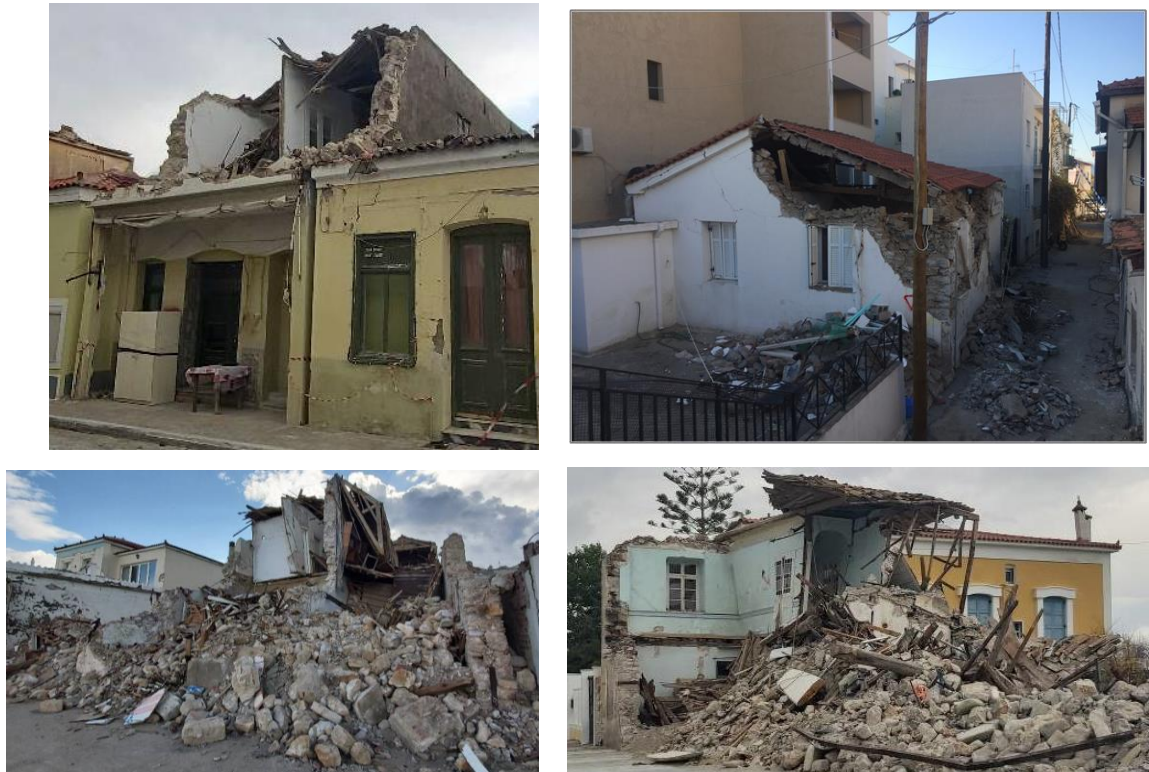
Figure 68: Partially and totally collapsed buildings in rural localities and Samos town.

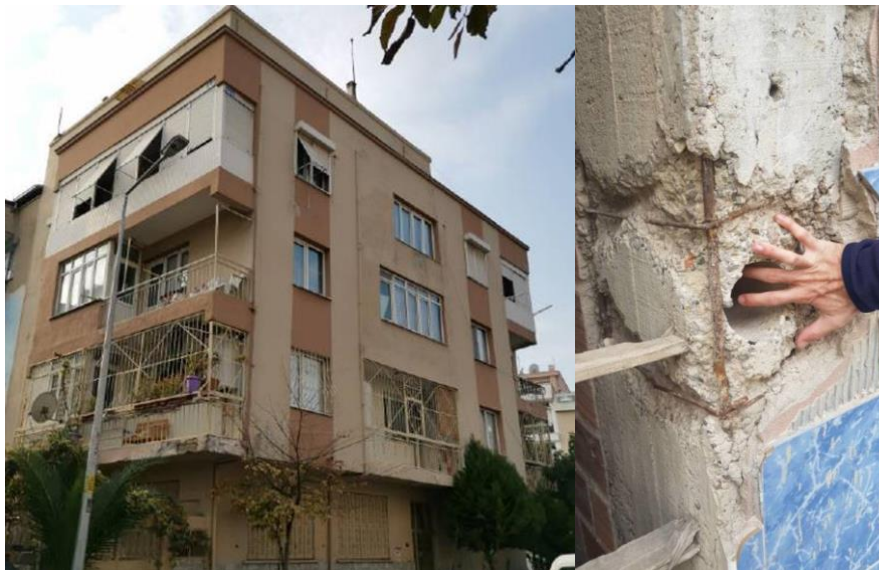
Figure 81: Degradation in structural material and poor detailing in an RC element

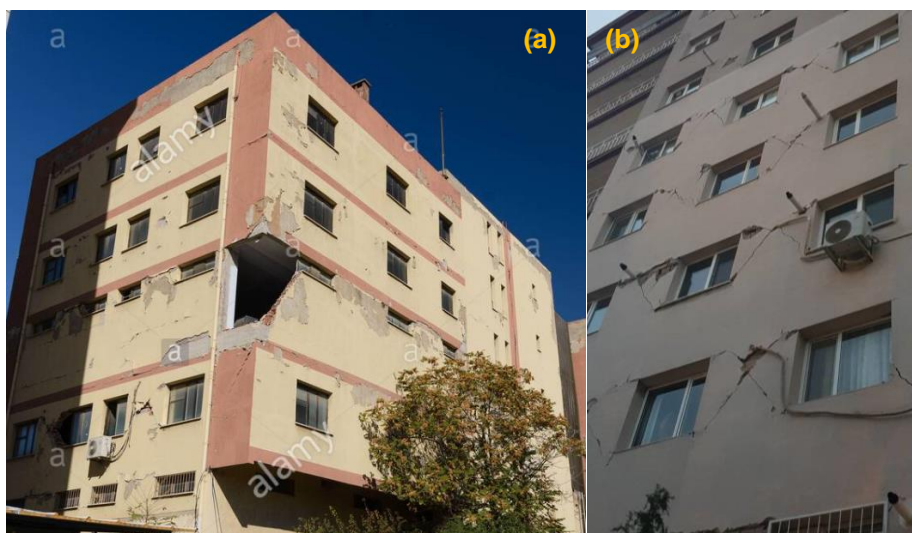
Figure 82: Infill walls damage in RC frames: (a) out of plane (Arda Savaşcioğulları / Alamy Stock Photo) and (b) in-plane failure

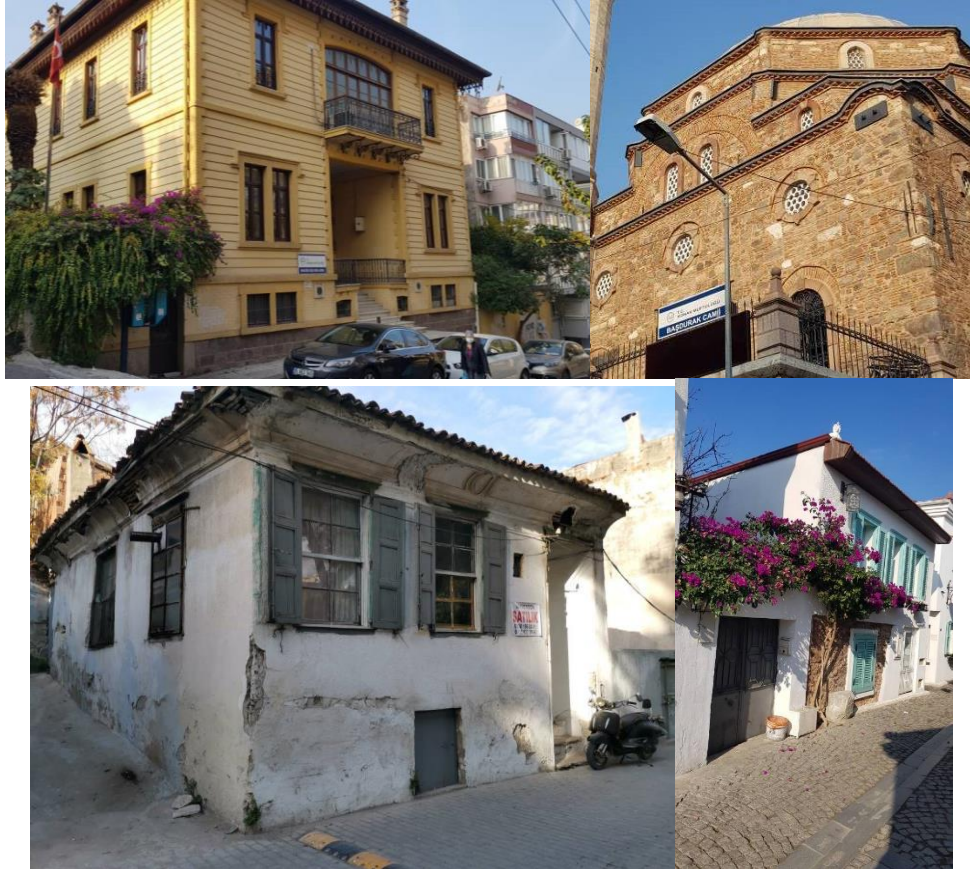
Figure 89: Good response of masonry buildings: (top row) monumental examples in central Izmir; (bottom row) vernacular typologies in Seferihisar

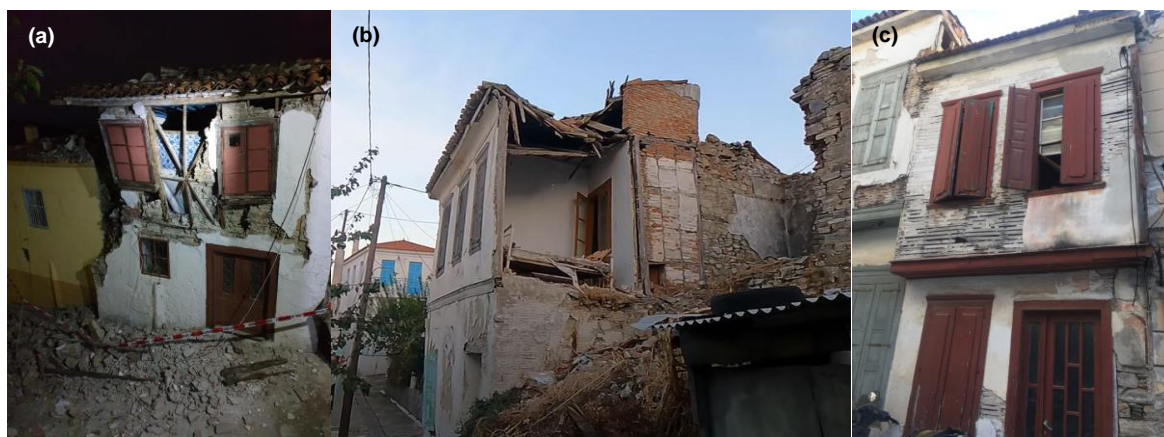
Figure 94: Examples to damage in *hımiş* structures

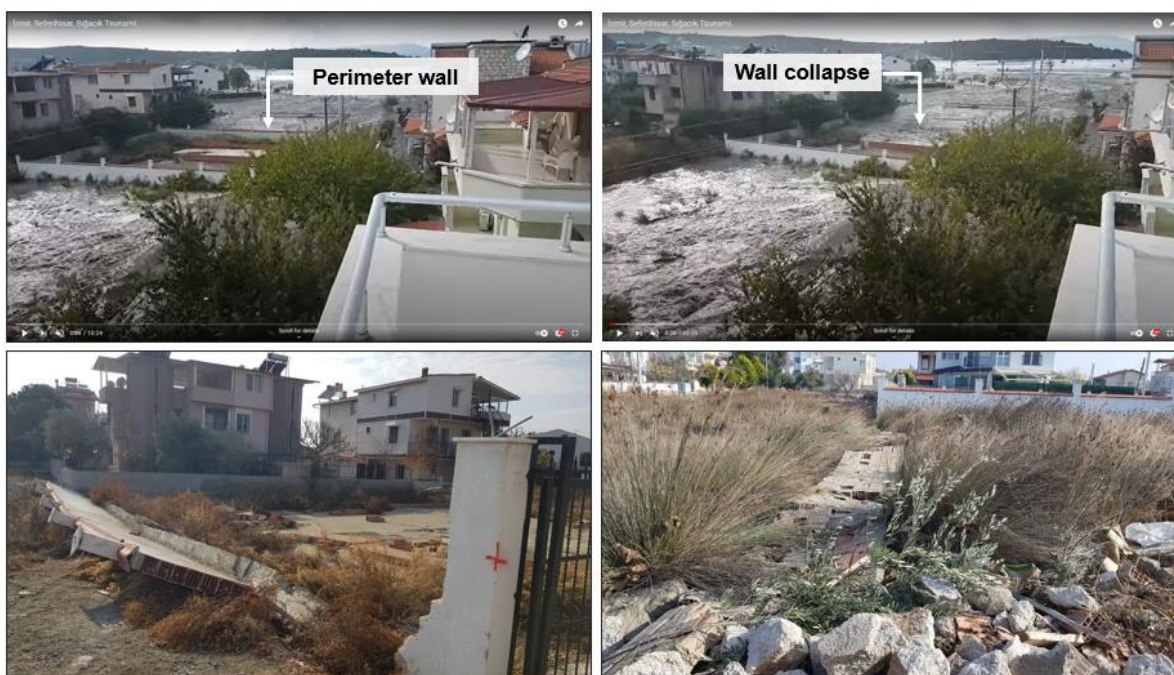
Figure 106: Perimeter wall overturning due to tsunami hydrodynamic effects in Sığacık (coordinates: 38.1982930, 26.7902697). Video frames (on top) from YouTube video: <https://youtu.be/n93puRYKhs0>

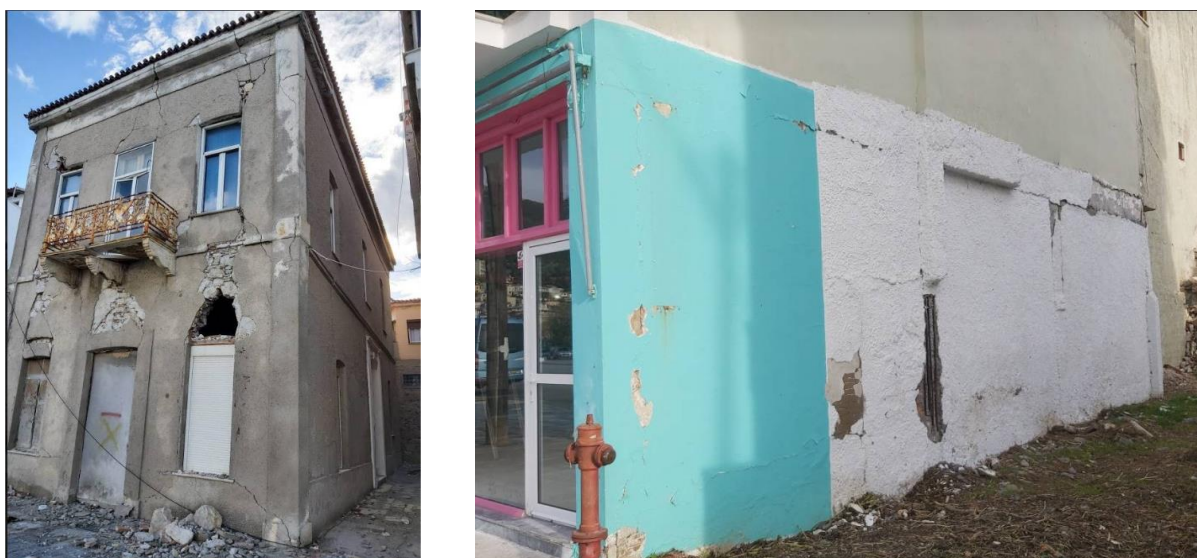
Figure 108: Buildings affected by earthquake and tsunami: Karlovasi (coordinates: 37.800145, 26.704959) and Vathy (coordinates: 37.751835, 26.976584).
