EEFIT Research Grant 2023 Report – Quantifying Masonry Construction Quality and Damage Using 3D Reality Capture Data

Sinan Acikgoz, University of Oxford

Use of post-earthquake point cloud data for forensic evaluation of failures in masonry structures

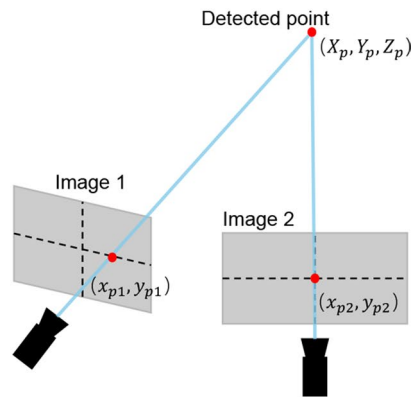
(a) TLS, image from Wu et al (2022).

(b) Photogrammetry.

Fig. 1 Schematics of TLS and photogrammetry, demonstrating how the world coordinates of a detected point are determined

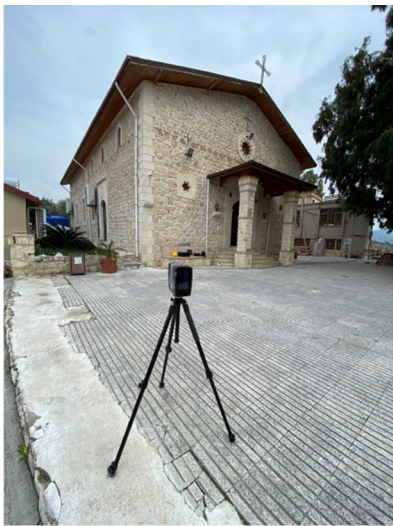
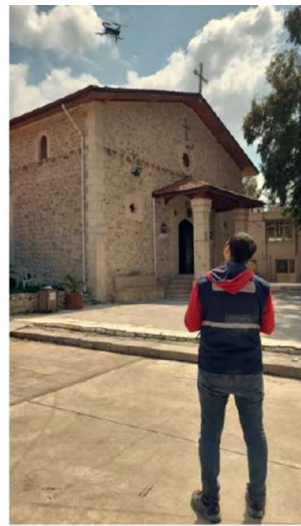
(a) TLS.

(b) Aerial photography.

Fig. 2 Photographs showing different modalities of data acquisition

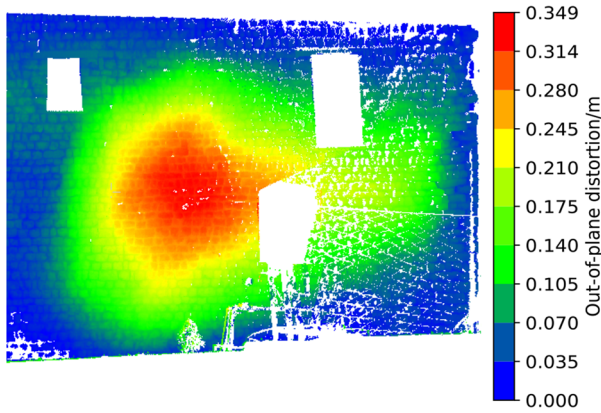
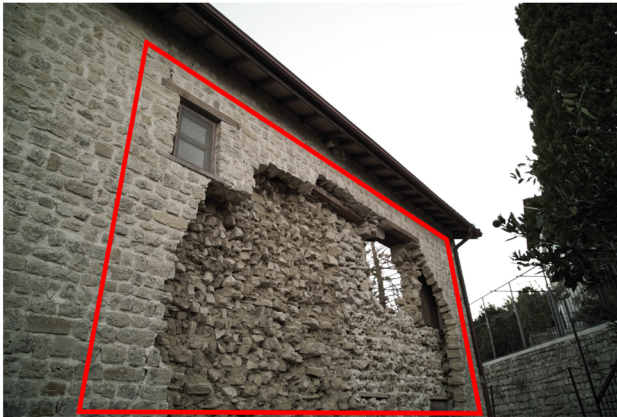
(a) Aerial photograph of the building.

(b) Photograph of bulging in N wall.

(c) N wall out-of-plane distortion from TLS point cloud comparison with vertical plane.

(d) Later photograph showing collapse of the bulging area in N wall

Fig. 9 Geometric distortion analysis of the Vakifli #2 building

as shown in Fig. 9. Maximum out-of-plane bulging of 34.9 cm can be observed from the contour plot. The two-way bending distortion pattern indicates the presence of a restraint at the top of the wall. The large magnitude of the bulging distortion indicates the notable plasticity of the modern restoration mortar used on the surface.

TLS point cloud data collected from a two-storey residential building in Vakifli Village of Samandag District of Hatay province are examined herein (Fig. 9a). This building is referred to as Vakifli #2 building, following the naming convention in Sürmeli (2019) and it is represented with ID R5 in Table A1.

Point clouds of this building are examined since it exhibited counter-intuitive failure modes. Out of plane failures were observed in the transverse E and W walls of this building, despite good corner detailing. This failure appears to have been facilitated by a lack of diaphragm behaviour; photographs (e.g. Figure 9a) indicate that the timber floor structures are one-way spanning and did not restrain the out of plane movements in the E–W direction. Furthermore, an unusual bulging behaviour was visually observed on the northern wall of the building (Figure 9b). While it would be challenging to use manual surveying techniques to quantify this distortion, examination of bulging could be carried out simply by comparing the post-earthquake point cloud to a primitive geometry (e.g. a vertical plane in this case),

Inspired by these observations, recent field examination of this structure in 2024 has indicated the presence of a concrete beam running along the top of the longitudinal wall. A recent failure of the bulging area was also noted (Fig. 9b) (likely due to creep effects), which highlighted internal separation between wall leaves. Poor-quality straw and earth mortar were observed in the internal areas of the wall, which might have facilitated the separation between the wall leaves and the observed bulging behaviour.

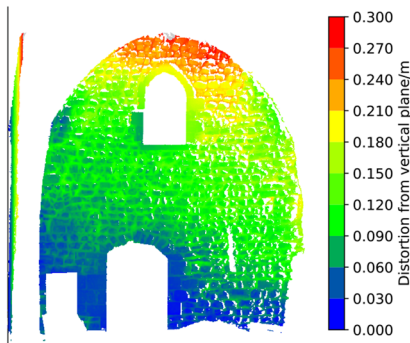
(a) An aerial photograph of the church.

(b) Elevation views of the S wall out of plane distortions obtained from comparisons between TLS data and a vertical plane.

(c) Perspective views of the W vault out of plane distortions obtained from comparisons between TLS data and a horizontal plane.

Fig. 10 Distortion evaluation of St George Sarilar Orthodox Church

To understand how the west vault resisted the seismic loading while the adjacent and the geometrically similar east vault collapsed, a quantitative assessment of its geometric distortions was conducted using point cloud data. The distortion of the internal face of the southern wall supporting the west vault is shown in Fig. 10b, where the colours indicate the horizontal distance between a primitive vertical plane and the point cloud. Note that two orthogonal elevation views of the same wall is provided Fig. 10b. A large southward movement, measuring 30 cm at the top of the wall, is observed, indicating more than 5% lateral residual drift. Site observations demonstrated that the construction gaps between the modern reinforced concrete porch and the southern wall have closed due to these displacements, with the wall abutting on the porch. The porch appears to have arrested the lateral movements of the south wall supporting the vault, preventing collapse.

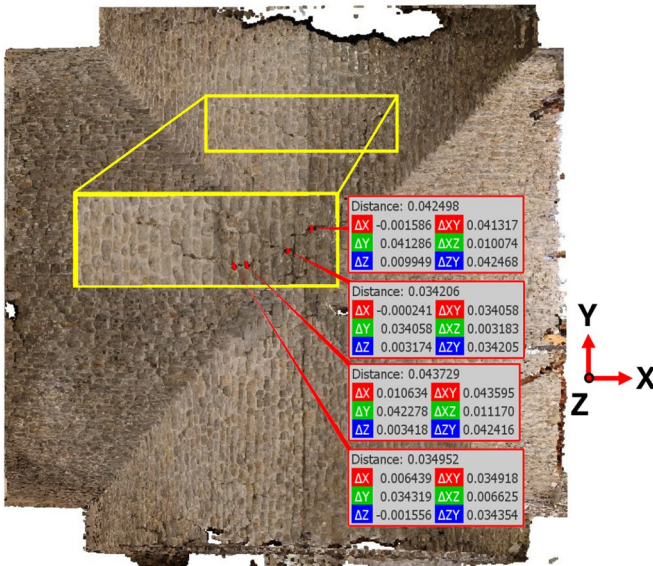
As an example, the standing west vault in St George Sarilar Orthodox Church exhibited smeared cracking in different parts of the vault (see Fig. 11a). In some locations, stone units had fallen off and large gaps had appeared in the vault soffit. Measurements of some cleaner cracks (with widths in the order of centimetres) were acquired from point-to-point distances between crack edges. These measurements are illustrated in Fig. 11b. Where a worm’s eye view of the vault is provided. To do this analysis, photogrammetry point clouds were used, since their realistic representation of colour helps identify crack edges (where there is a transition to darker colours). It should be noted that the manual pointwise measurement of

(a) Interior view.

(b) Manual crack measurements from the photogrammetry point cloud of the St George Sarilar Orthodox Church west vault using point to point distances.

Fig. 11 West vault in St George Sarilar Orthodox Church

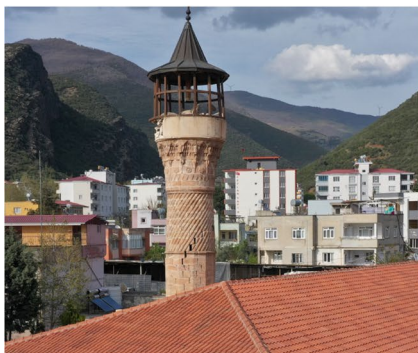
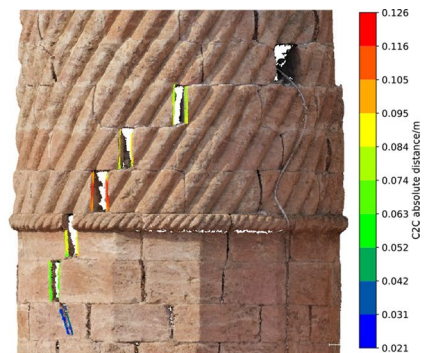
Drone photographs were used to generate point clouds since the minaret was otherwise inaccessible. The edges of the large shear crack are delineated clearly in the point cloud in Fig. 2b. To see the variation in crack openings, the crack edges were manually segmented and the closest distance between the edges was determined. Different from the procedure adopted earlier in Fig. 11b, the closest distance was evaluated from the distances between locally fitted planes on the crack edges to minimise the influence of measurement noise on the crack width measurements. The result is shown in Fig. 12b. Where crack widths up to 12 cm can be observed. The width first increases and then reduces with increasing height.

(a) Aerial photograph.

(b) Crack measurements.

Fig. 12 Semi-automated crack measurements from the photogrammetry point cloud of the minaret of the Agcabey mosque using plane to plane distances

Agcabey mosque was originally constructed during the 15th century. The building is located in the Bahce district of Osmaniye. Although the prayer hall building was reconstructed during the 19th century, the minaret (see Fig. 12a) is thought to date from the original construction. The stone voussoirs of the minaret experienced large amounts of sliding during the earthquake, causing through thickness separations between the units.
