31 August 2025 Eastern Afghanistan Earthquake

A Joint Virtual Reconnaissance Report

Earthquake Engineering Field Investigation Team (EEFIT),
Association Française du génie Parasismique (AFPS), NED
University of Engineering & Technology, and RedR

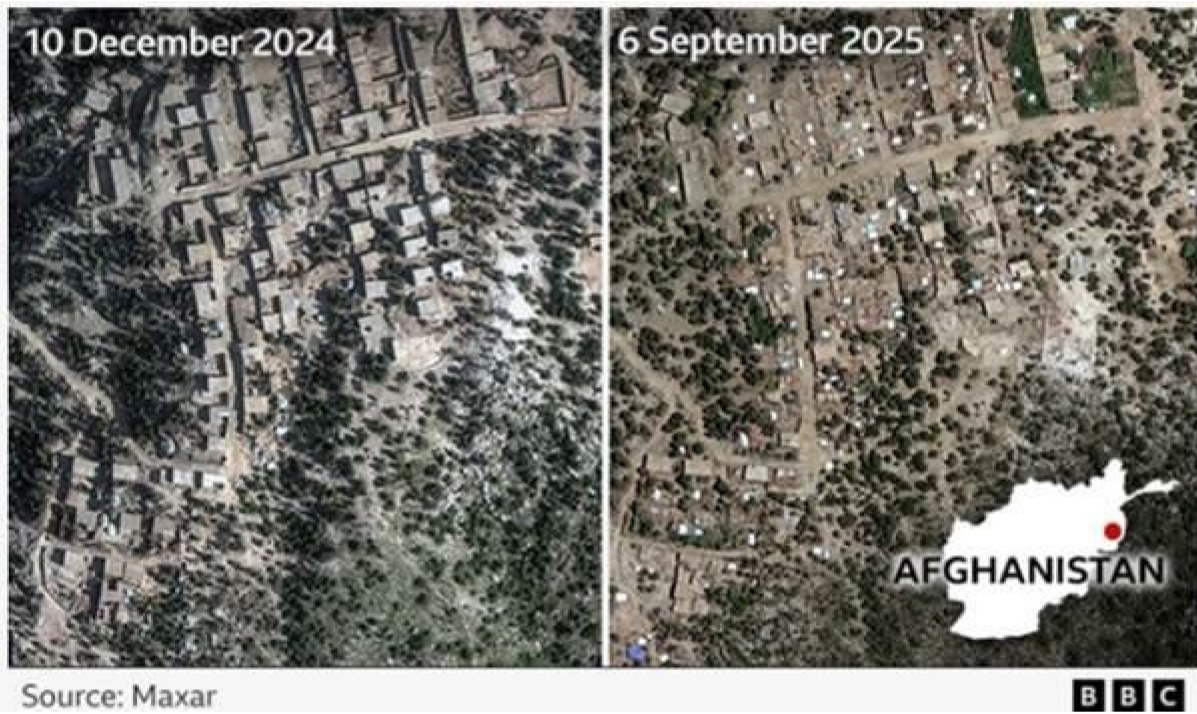
Figure 2.4: Before-and-after optical satellite images from MAXAR of villages in Afghanistan impacted by the earthquake (Top: <https://www.bbc.com/news/live/cq5jgz23114t>; Bottom: <https://www.bbc.com/news/live/cq5jgz23114t>)

Figure 2.4 illustrates the extent of damage in affected villages in Ghaziabad District, which are situated on vulnerable ground conditions. Approximately half of the buildings in these settlements were reduced to rubble, with many of the remaining structures showing signs of significant structural distress.

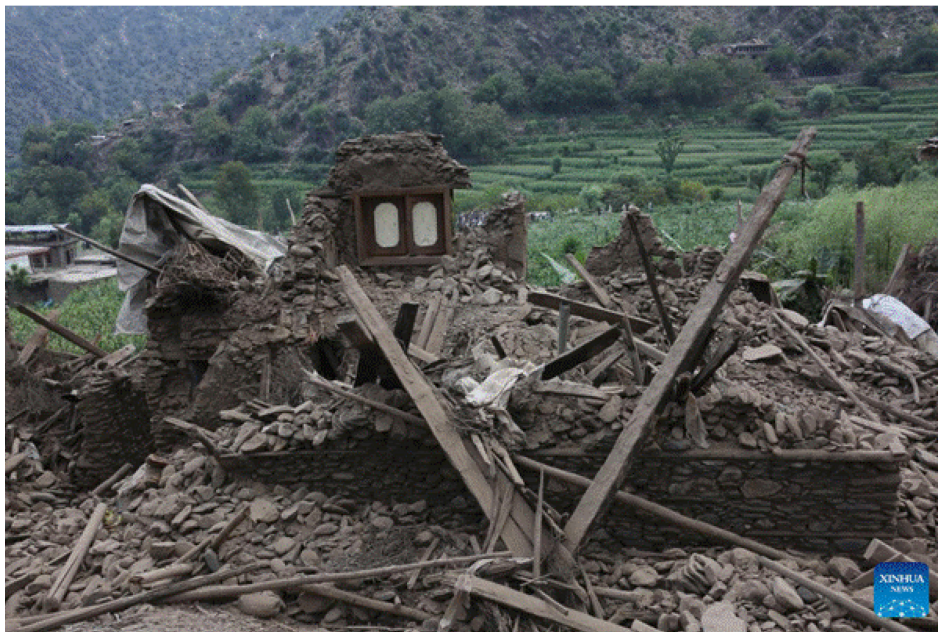
Figure 4.2: Complete collapse of unreinforced house at Nurgal district of Kunar province (Xinhua, 2025)

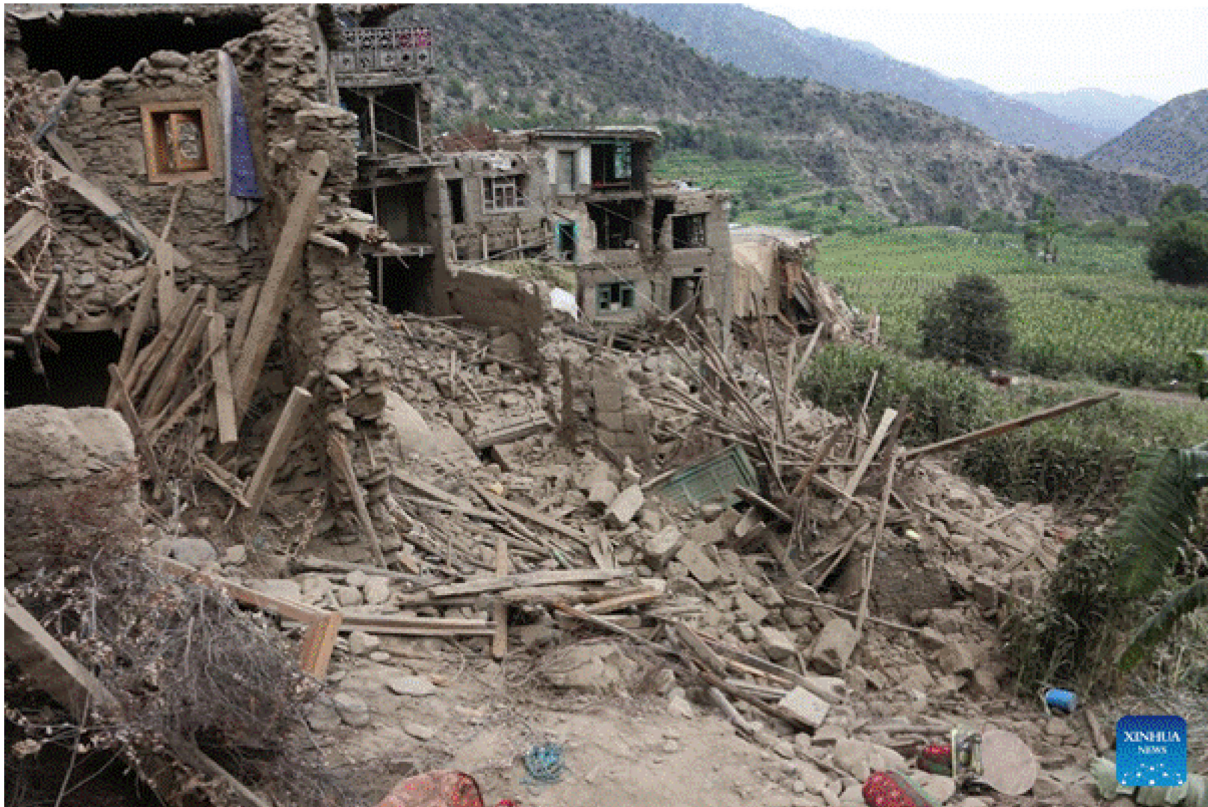
Figure 4.3: Houses built onto slopes damaged by differential movement at Nurgal district of Kunar province (Xinhua, 2025)

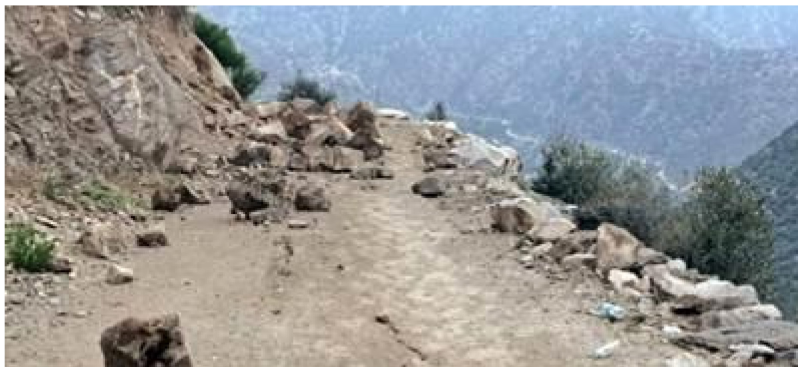
Figure 4.7: Rockfall blocking road access (Miyamoto International, 2025a)

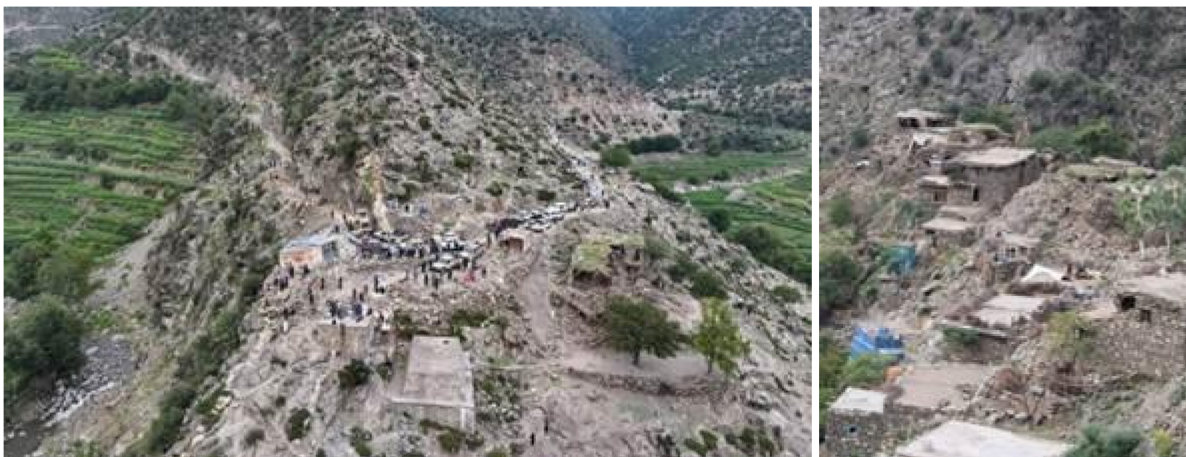
Figure 4.8: Devastation of villages sited on sloping terrain aggravated by landslides (Left: Tareq, 2025; Right: Islamicreliefau, 2025)

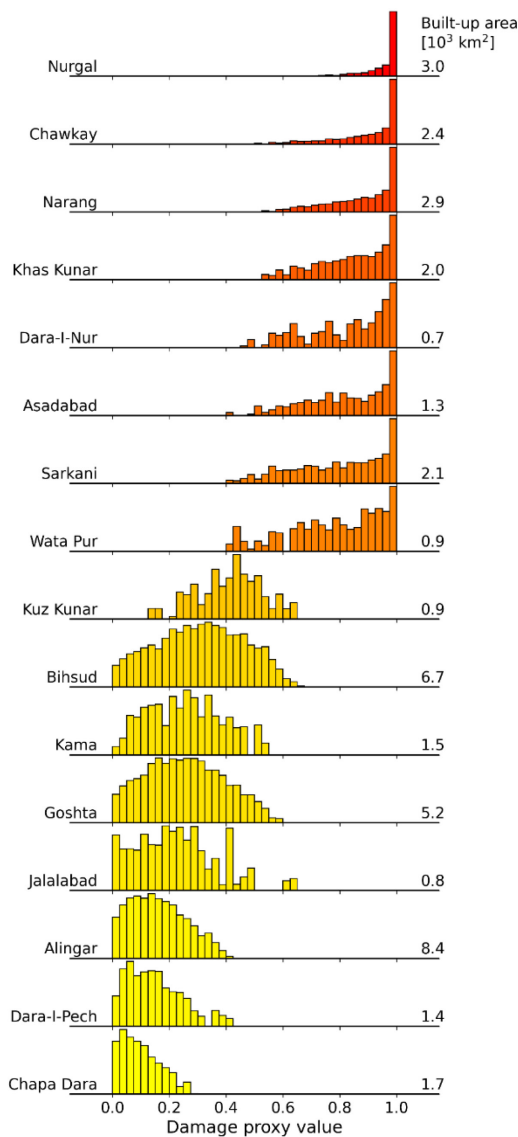
Figure 5.2: Differences of the histograms of damage proxy values between a pre-event and a co-event coherence image for several districts near the earthquake epicentre. Values below 0 are not shown. The damage proxy values are derived from coherence time series as described in Appendix A. Increasing damage proxy values correspond to increasing likelihood of change. The total built-up area mapped per district is indicated on the right.

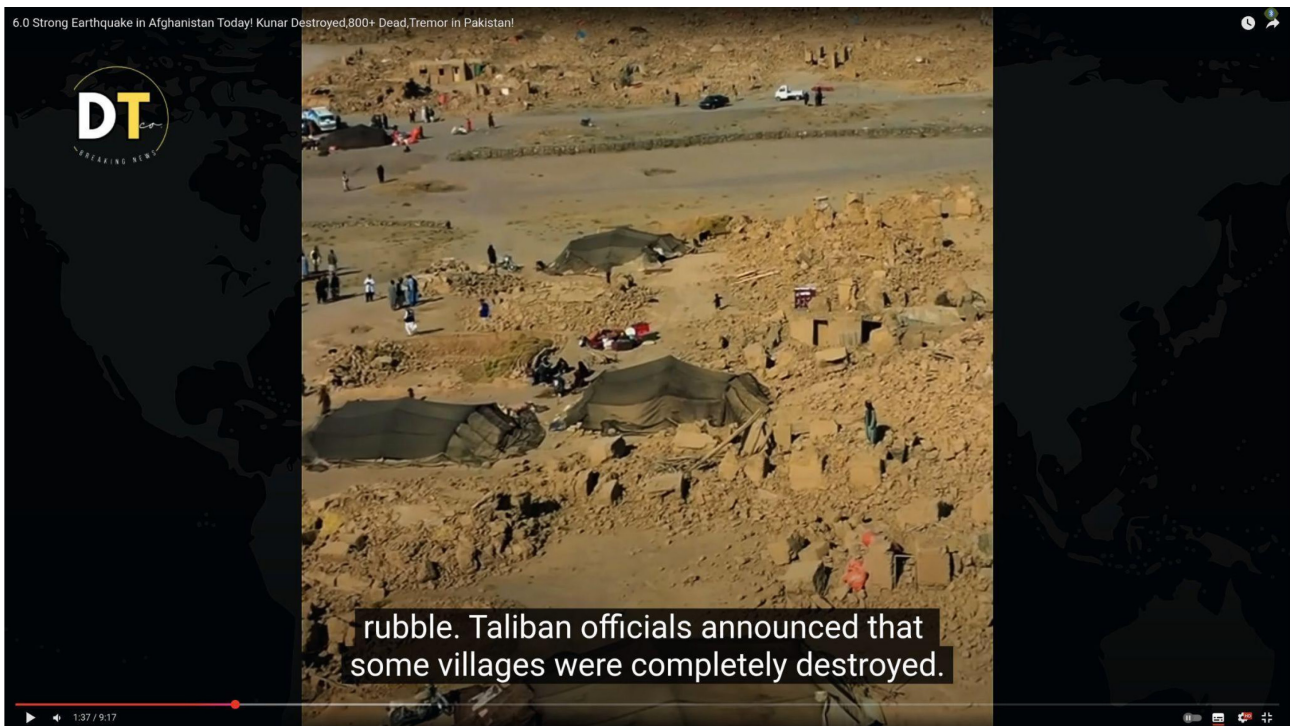
Figure 5.5: Completely destroyed village (Youtube, 'Disaster Today' channel <https://tinyurl.com/2ewrd2fn>)

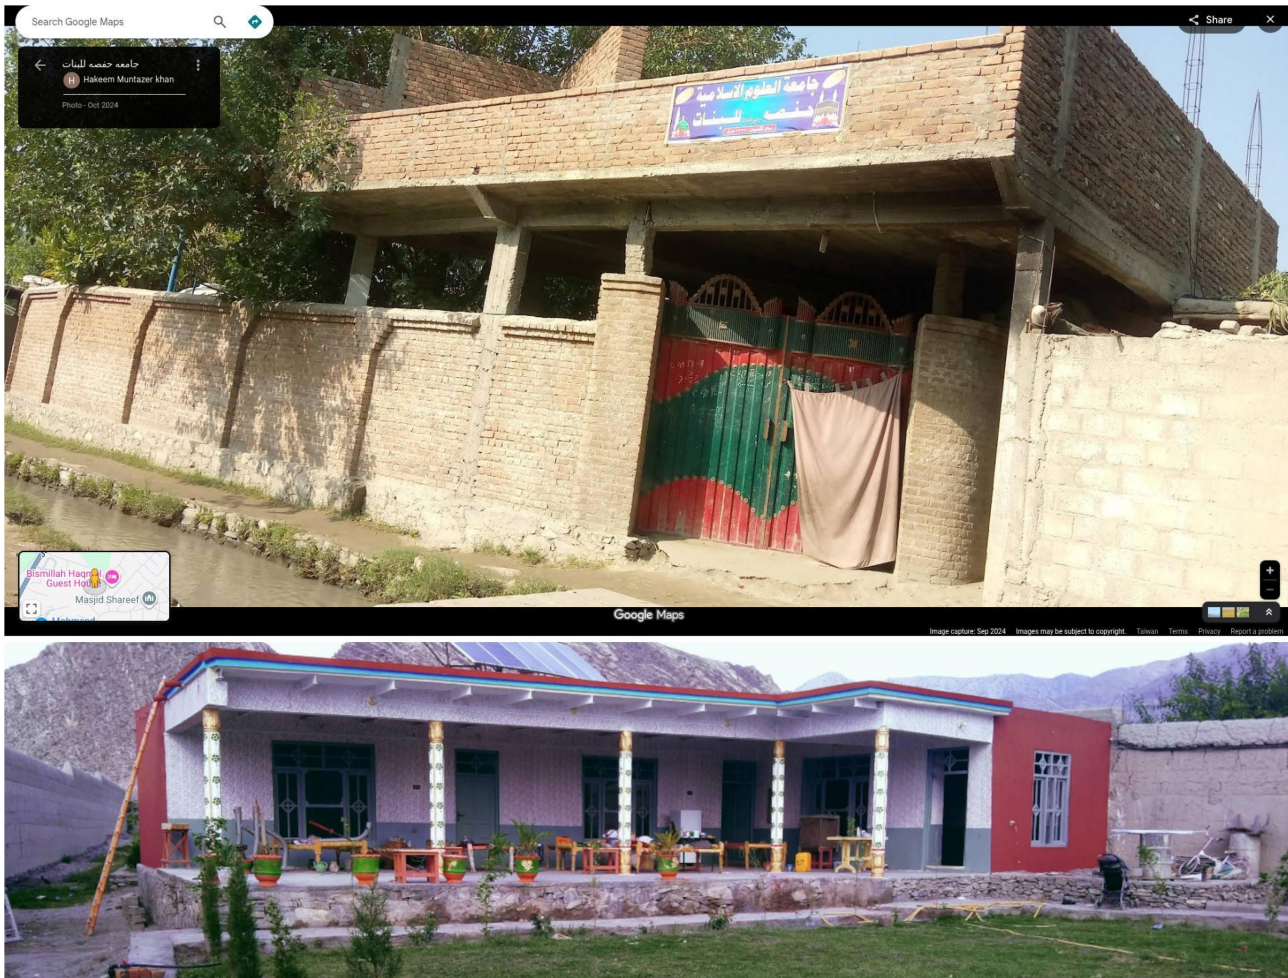
Figure 5.8: Kunar Valley. Top: typical RC and masonry construction; Bottom: RC, masonry and steel

In residential construction, particularly in peri-urban areas, a hybrid approach is often observed. Builders combine traditional materials like unfired mudbrick or stone with modern elements such as concrete columns or steel reinforcement (Figure 5.8). These hybrids aim to improve resilience but often lack proper engineering input, resulting in inconsistent performance during earthquakes. While some structures were likely damaged, no media photos documenting such cases were found - possibly because the damage was relatively minor compared to other areas affected by the earthquake.

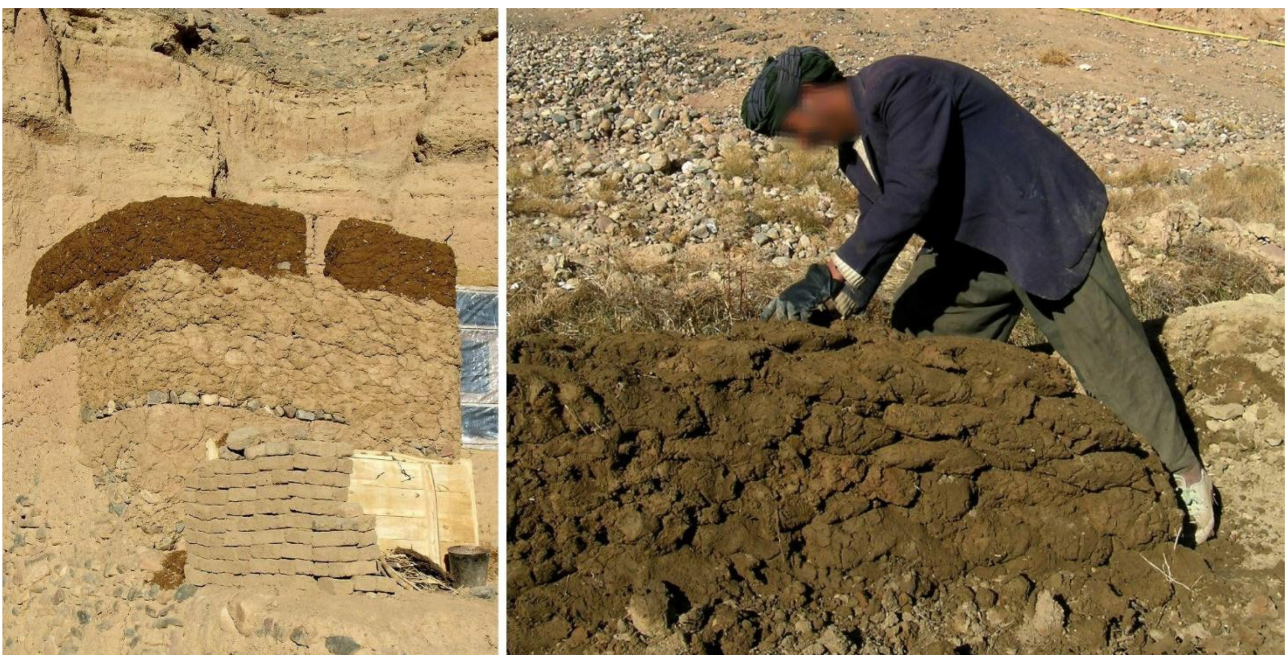
Figure 5.9: Walls under construction in the valley of Bamiyan, Afghanistan

Pakhsa, the local term, is one of the most widespread traditional wall construction methods in Afghanistan, particularly in central and eastern regions (Szabo and Barfield 1991, Kast et al., 2024). Like rammed-earth, pisé, it is built in horizontal layers, less than 1m high, using earth with low water content. Contrary to rammed-earth, no framework is used during construction and, consequently, earth cannot be as well compacted, therefore it is more similar to “cob”. Small lumps of earth (*jom*) are shaped by hand and are energetically thrown on the wall under construction by the masons (*bana*) (Figure 5.9). Shovels are used to pass earth to the mason and regularise the wall surfaces. Traces left by the layering process and by the lumps can be seen on the surface of the walls.

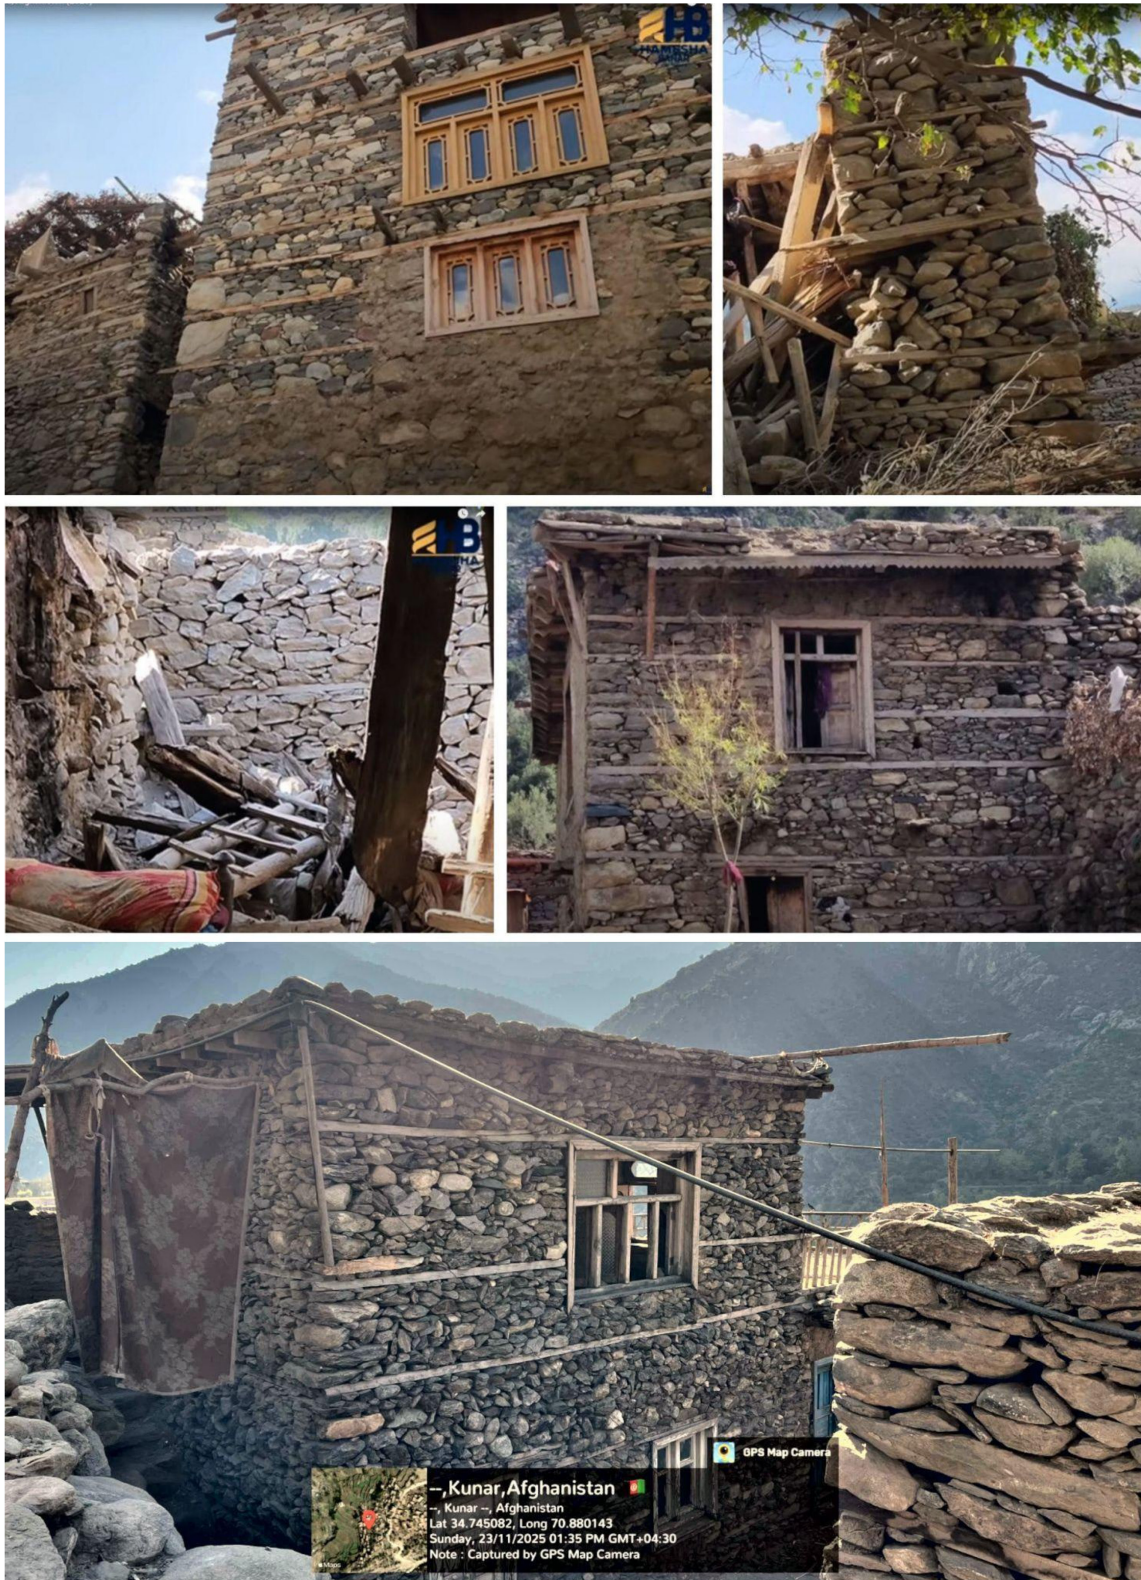
Figure 5.10: Examples of bonds (Upper 4: Youtube, Hameshabahar Afghanistan channel <https://tinyurl.com/3hwuskw>)

The walls are built using rubble masonry, where the stones are typically either uncoursed, roughly levelled or, in the highest-quality constructions, laid in uniform horizontal courses. The bonding quality exhibits considerable variations (Figure 5.10). Some walls were clearly built by skilled builders; others lacked professional care. Describing Nuristani architecture, Samizay (1975) and Oliver (1997) distinguish the skilled carpenters (*bari*) from the unskilled labourers (*shewala*). Financial constraints, lack or loss of traditional skills, and lack of engineering guidance often lead to structurally weak constructions.

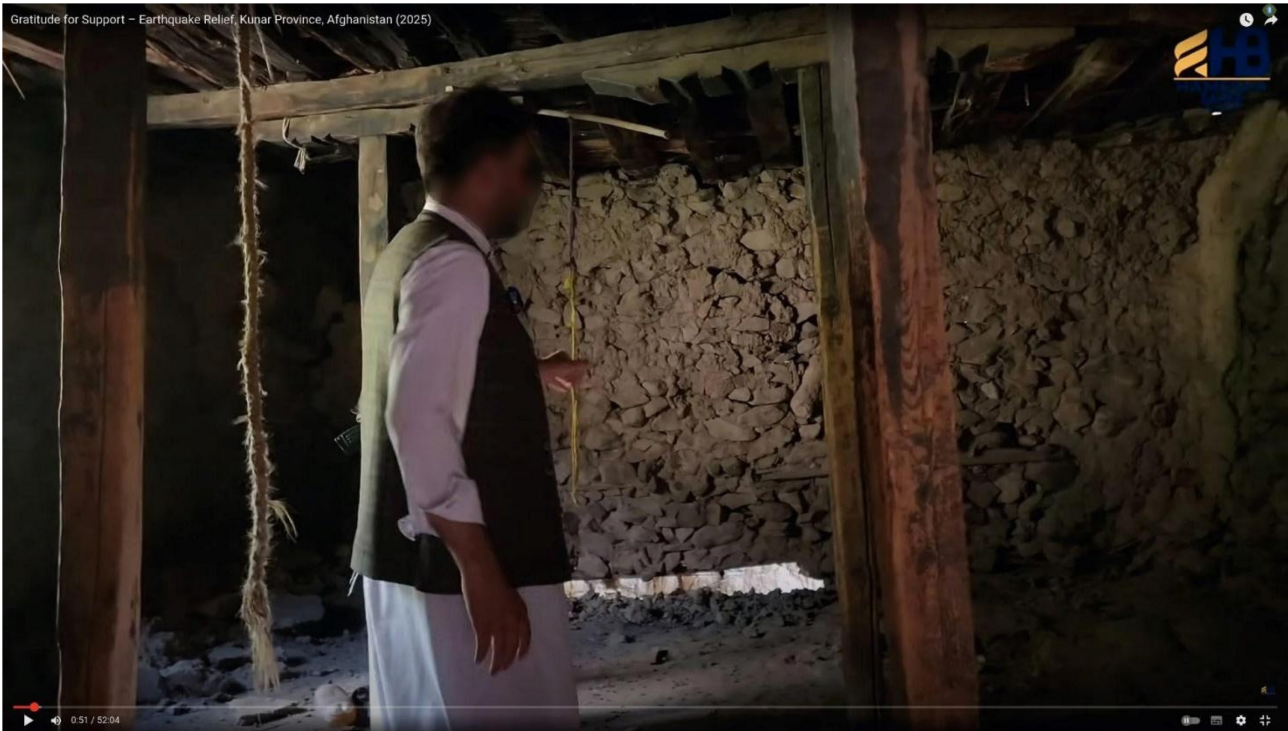
Figure 5.11: Space with intermediate wooden pillars (Youtube, Hameshabahar Afghanistan channel <https://tinyurl.com/3hwusksw>)

In this region of Afghanistan, most roofs are flat. From what can be observed from photographs, similar construction techniques appear to be used in plains and mountains. They are constructed using timber joists spanning across walls. Beams are formed of unhewn timber. To span larger rooms, intermediate wooden pillars supporting transverse beams are sometimes used (Figures 5.10 and 5.18). It cannot be verified from photographs, but poplar is known to be commonly used in Afghanistan for these structural elements (Szabo and Barfield, 1991).

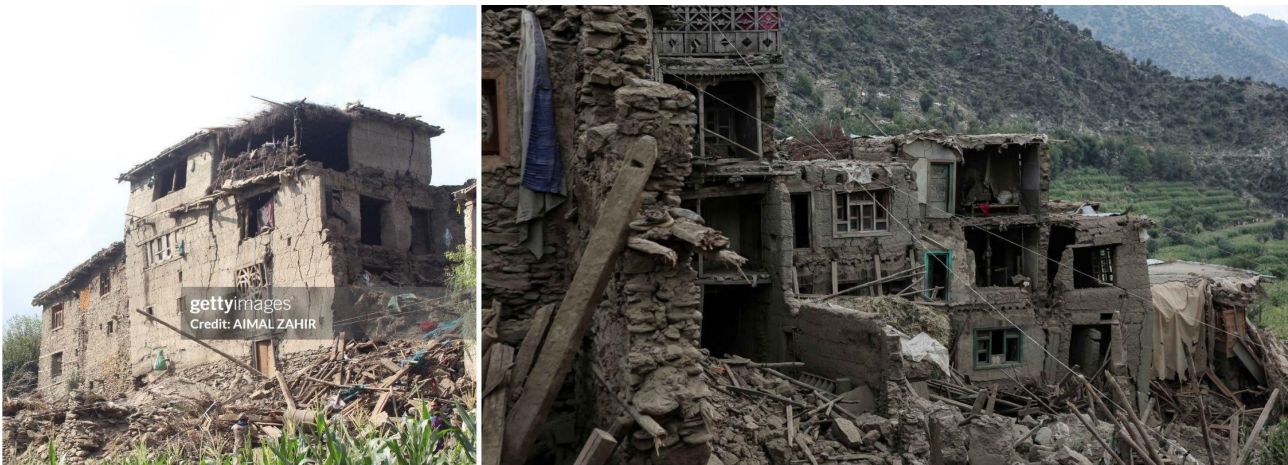
Figure 5.12: Structural elements connections. Left - Getty images; Right, source unverified

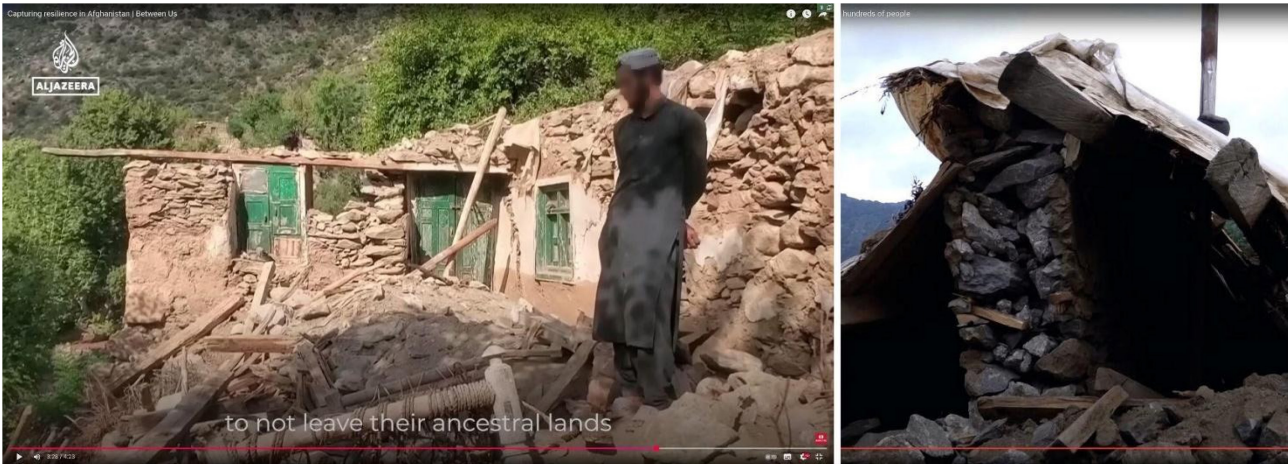
Figure 5.13: Wall coherence. Left: delamination (Credit: Youtube, Aljazeera English channel <https://tinyurl.com/8bhbe5x6>), Right: absence of through stone (Credit: YouTube, Watan Nandara channel <https://tinyurl.com/yxnchrsb>)

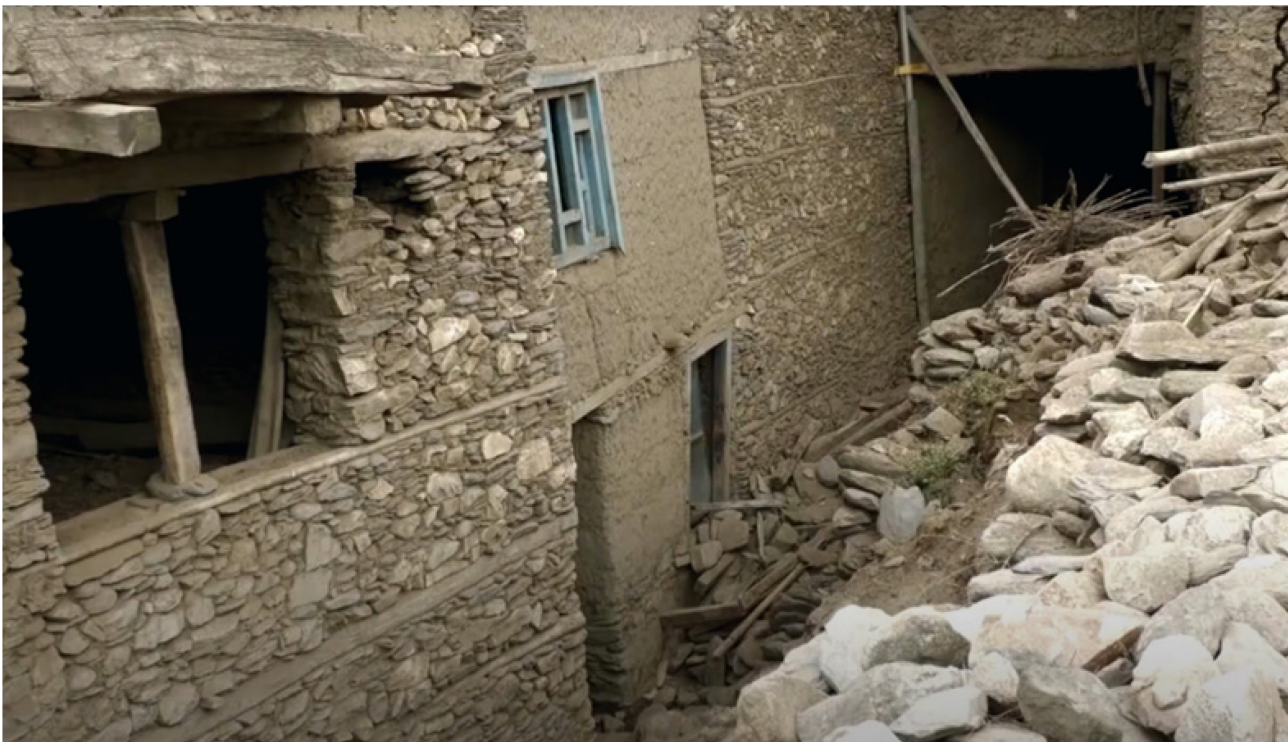
Figure 5.14: Stone and timber structure beside cob construction (Youtube, NewsX World channel <https://tinyurl.com/58sbnt8b>)

The hybrid stone-and-timber construction typical of mountainous areas reflects a possible local awareness of seismic risk (Figure 5.14), yet it often performed poorly. A fundamental deficiency remains the pronounced vulnerability of walls to out-of-plane failure. Stone masonry frequently exhibits weak bonding; even when mortar is present, it is typically mud mortar with negligible strength. Wall cohesion, therefore, depends largely on stone interlocking, friction, and the limited contribution of timber elements.

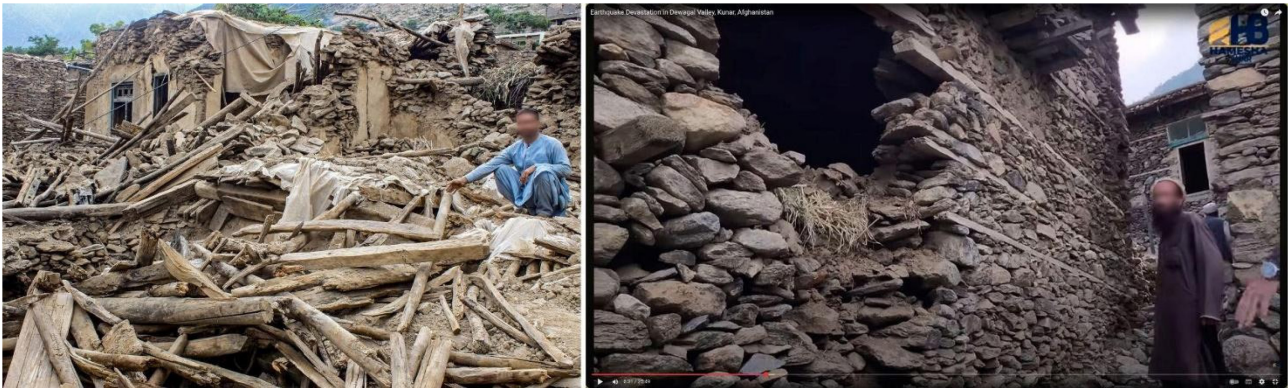
Figure 5.15: A series of damaged stone masonry buildings. Left: AFP/Getty Images; Right: Dewagal Valley (Youtube, Hameshabahar Afghanistan channel <https://tinyurl.com/5xacux3v>)

rough-hewn (possibly shaped by axes or adzes) or left round (Figure 5.15). The presence or absence of connections between perpendicular members, on corners, and along the walls, through pegs or other means cannot be ascertained from the available data. The potential effectiveness of these timber members as reinforcing elements clearly depends on their interconnections and correct integration with the masonry fabric and consequently of skilled workers. When built in a continuous fashion, tie-beams enhance structural integrity and robustness of load-bearing masonry walls, and can reduce the risk of crack propagation - and were shown to change the seismic performance for the better (Vintzileou, 2008; Spense and Coburn, 1992; Aktas et al., 2022).

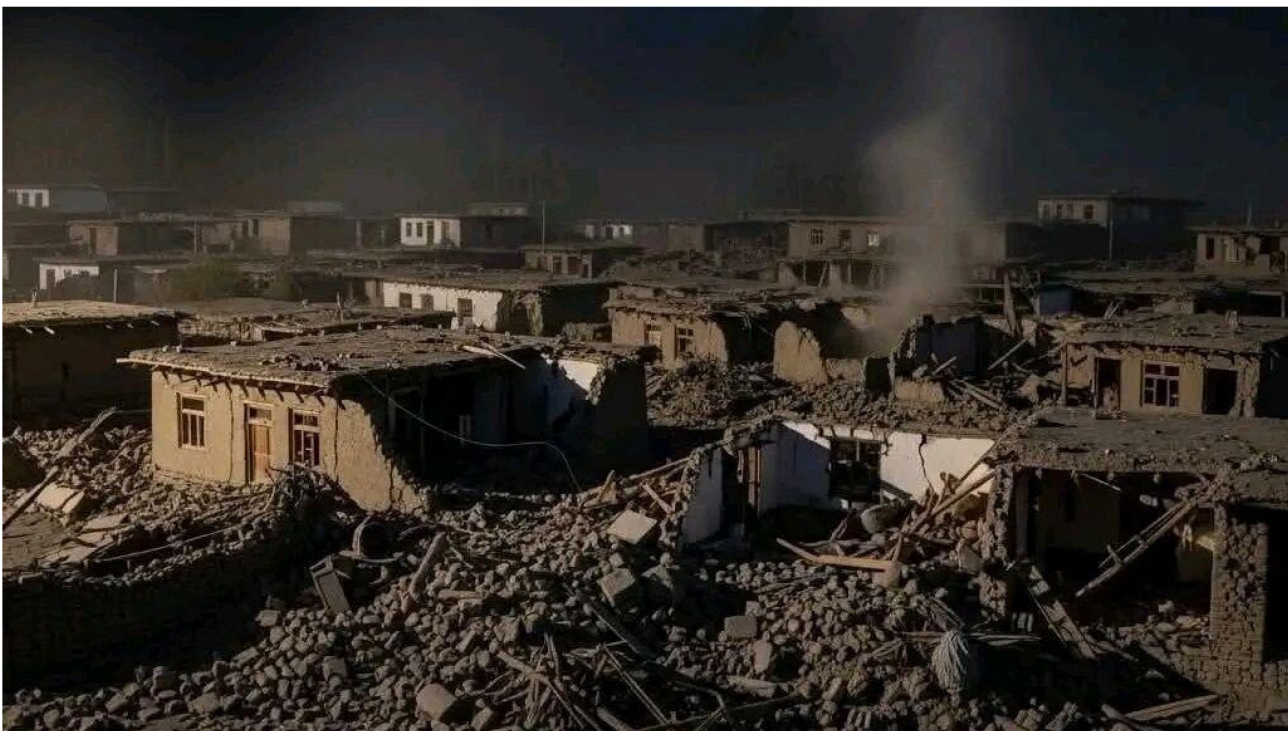
Fig. 5.16: Damaged adobe houses. Unidentified village (India Today NE <https://tinyurl.com/2zrdve7e>)

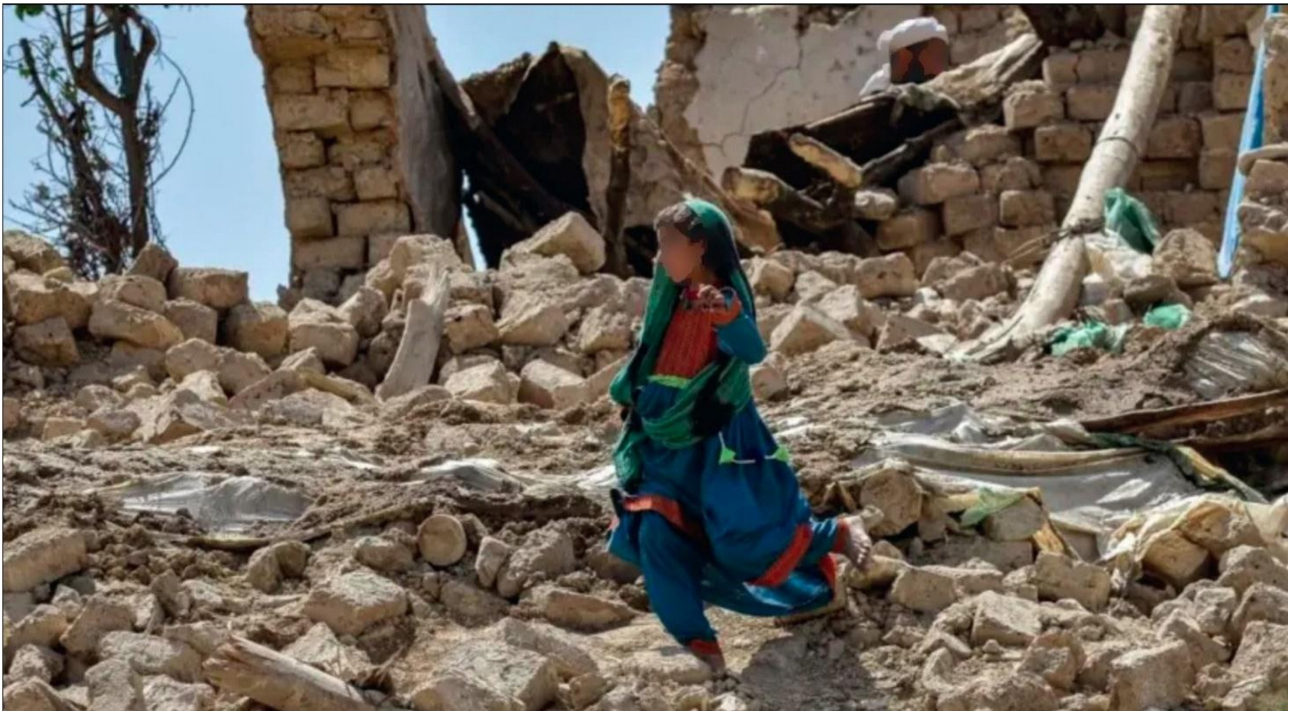
Fig. 5.17: Damaged adobe houses. Unidentified village (BBC News, Getty Image <https://tinyurl.com/yc3e8xma>)

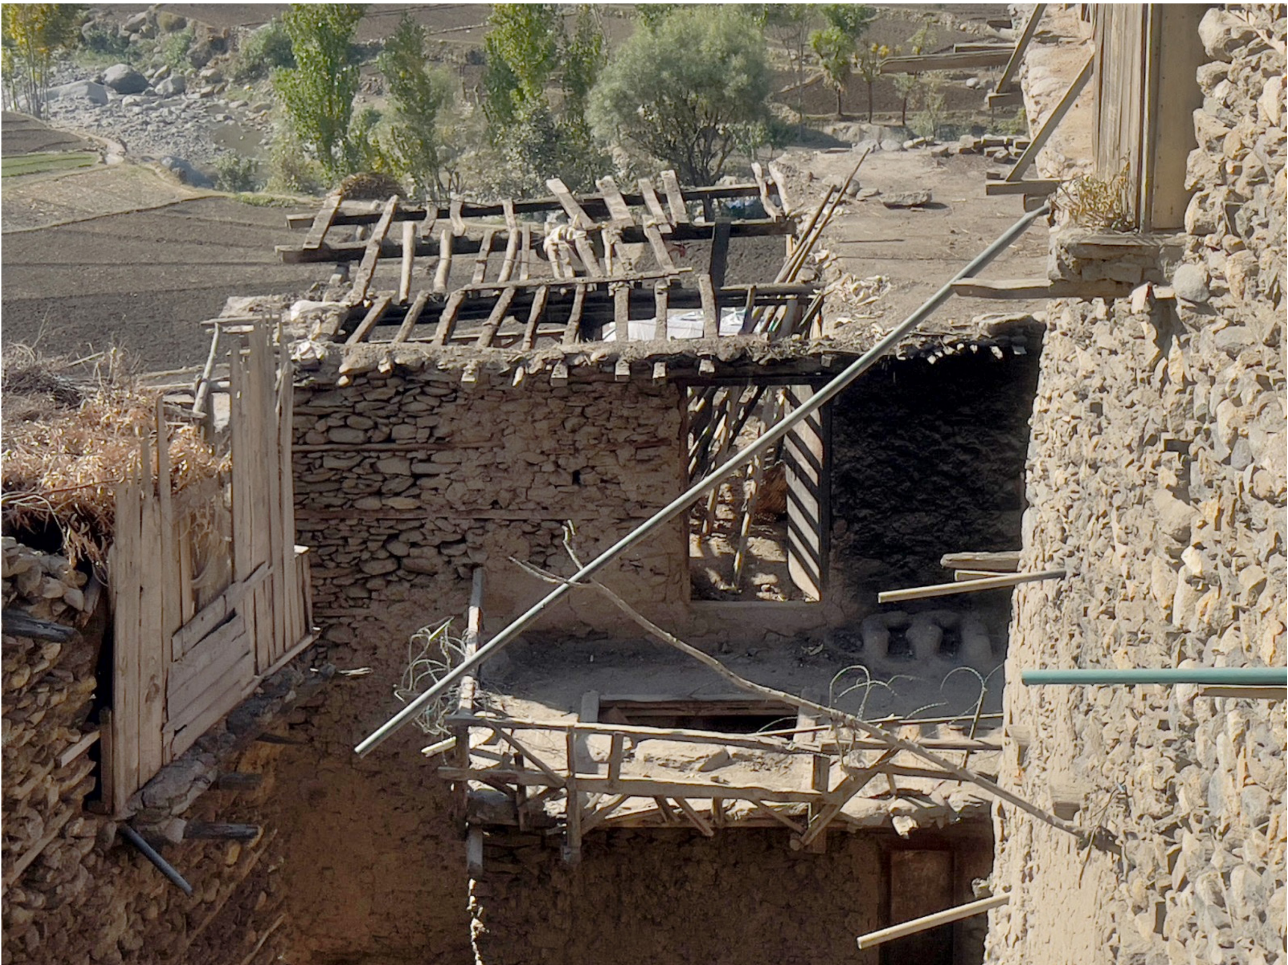
Figure 5.18: Ceiling structure

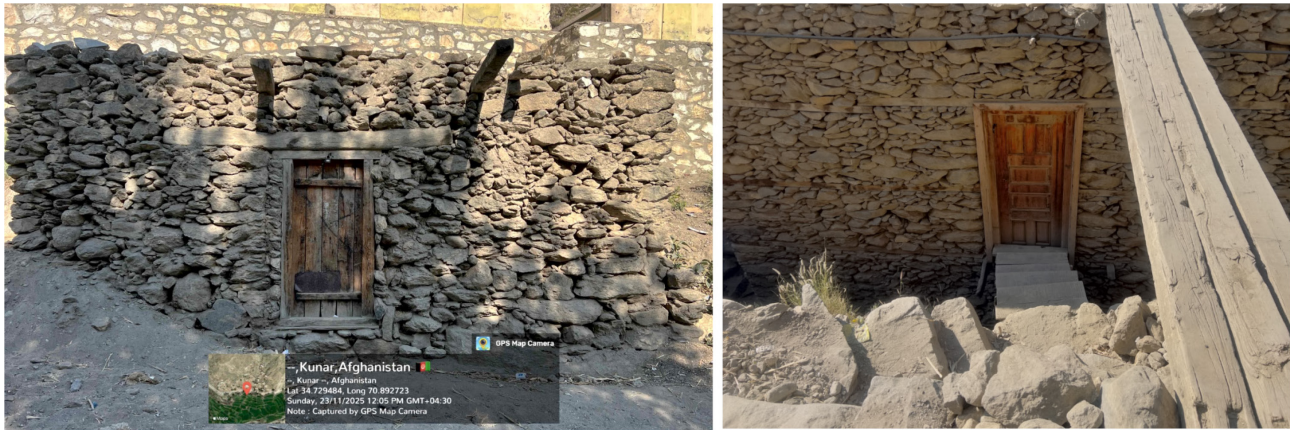
Figure 5.19: Doors

Window and door lintels are made of sawn, roughly shaped, or even unhewn timber. Doors and windows frames and sashes are better crafted (Figures 5.13 and 5.19), with a solid built made of sawn timber. Colour differences observed on photographs may indicate that more durable wood species are used for joinery (oak and spindle tree wood).

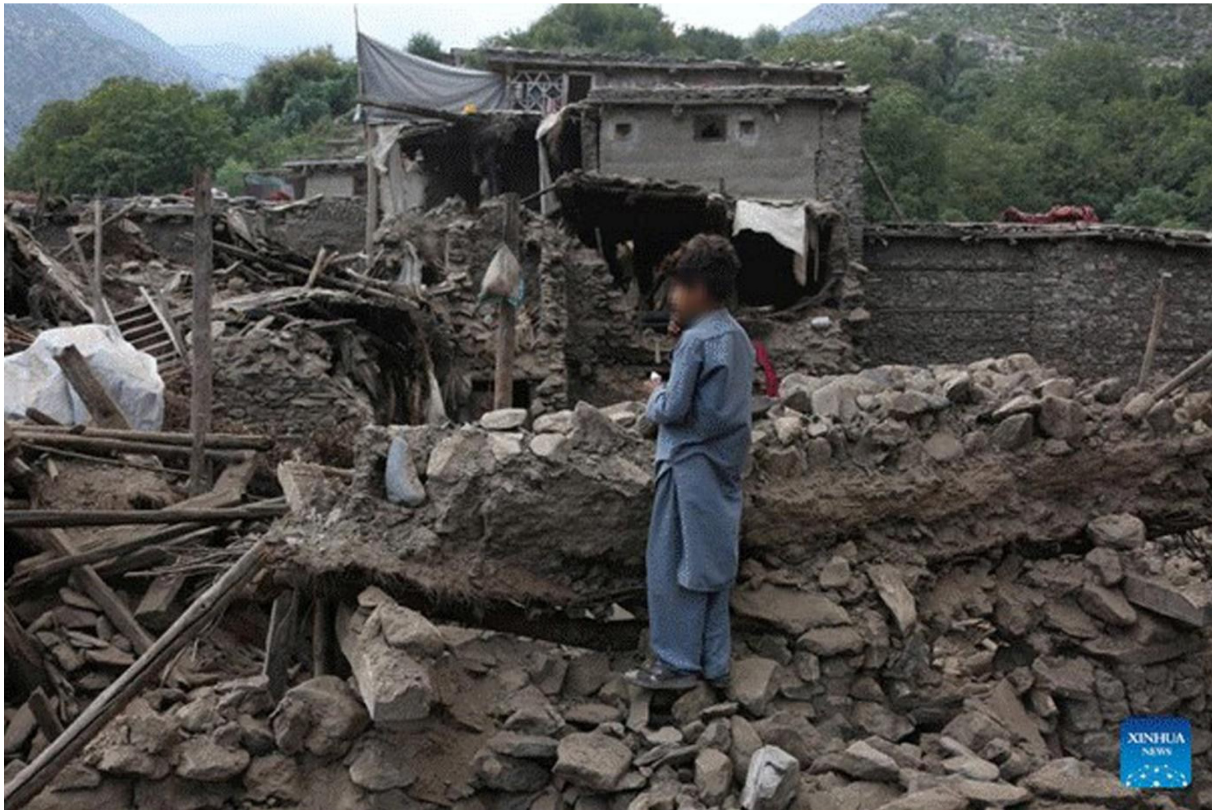
Figure 5.20: Unreinforced strip foundation of collapsed house at Nurgal district of Kunar province (Xinhua, 2025)

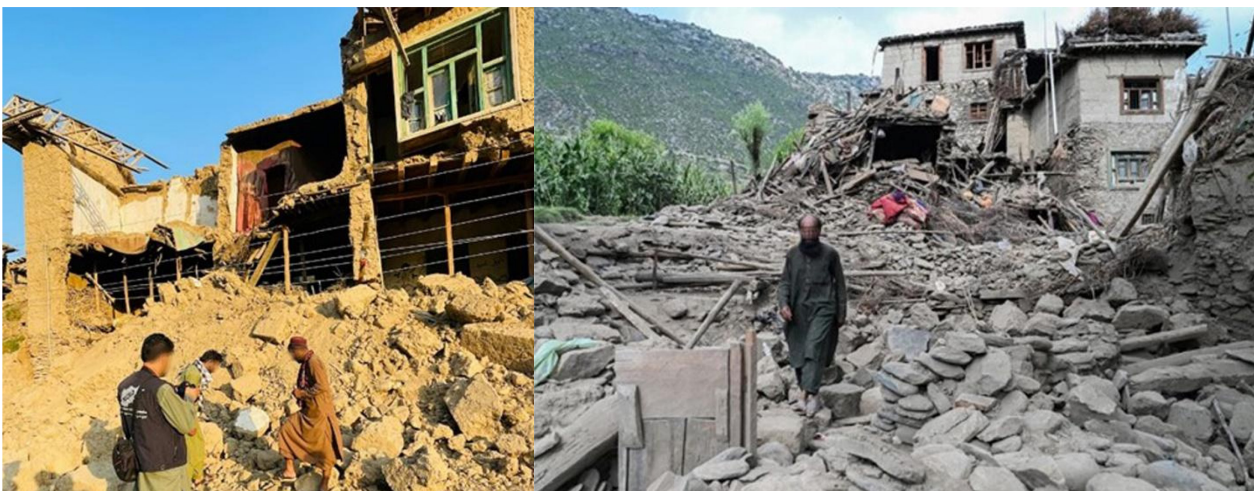
Figure 5.22: Cob walls. The lines marking the interfaces between layers can be clearly distinguished – this technique can be used in the whole structure (credit: NCRO [left]) or on top of a stone masonry ground floor (AFP via Getty Images)

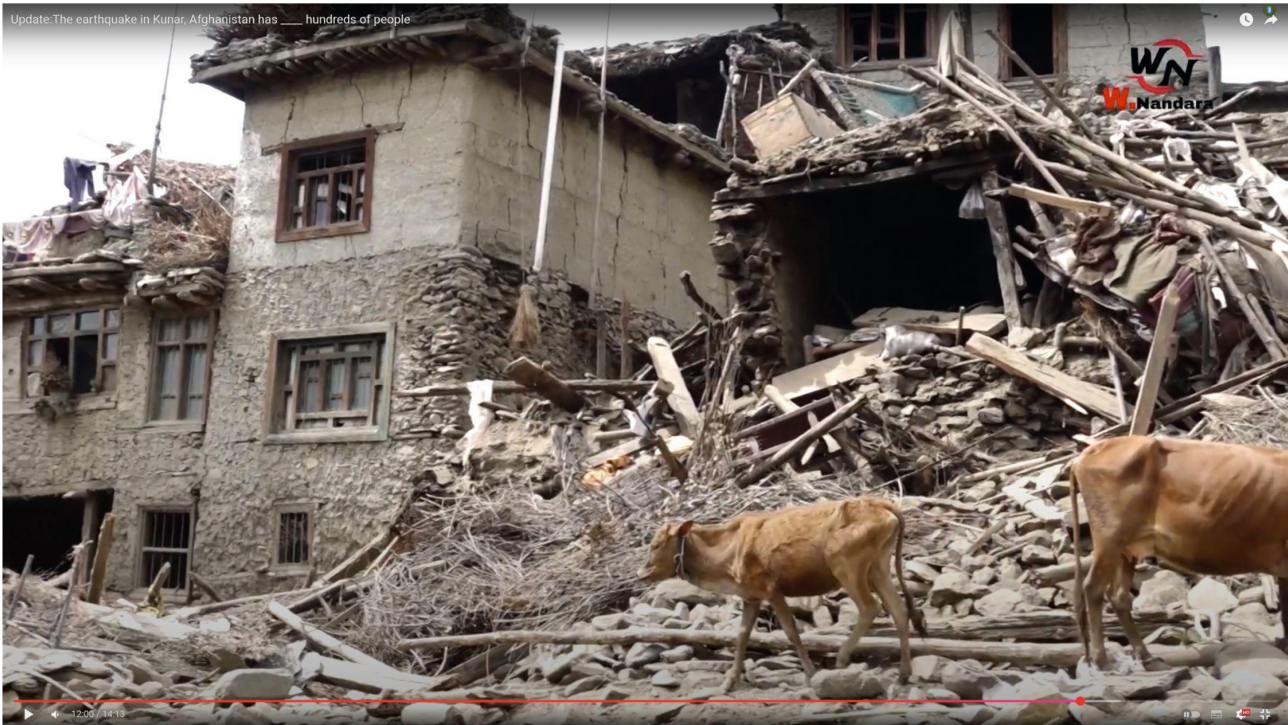
Figure 5.23: Cob wall built on top of a stone wall (YouTube, Watan Nandara channel <https://tinyurl.com/yxnchrbsb>)

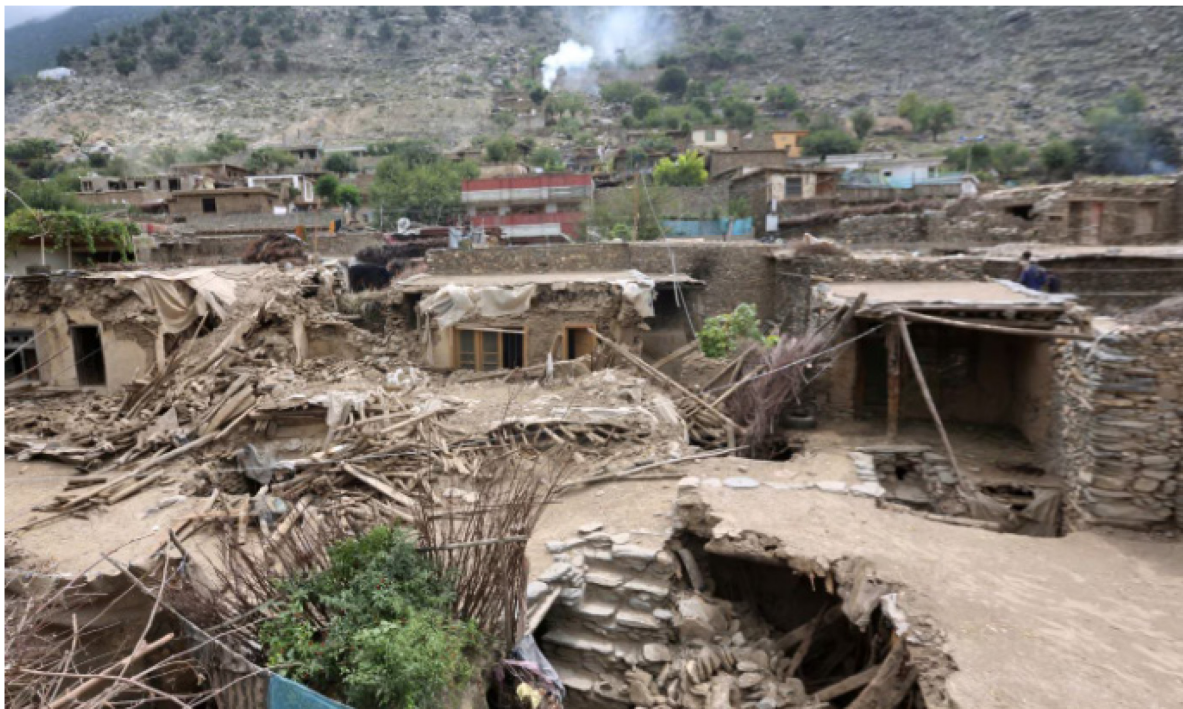
Figure 5.24: Typical internal staircase arrangement in affected multi-story houses

A complex network of internal and external staircases provides access to vertically expanded dwellings and connects different floors within the same household (Figure 5.24). This configuration is common in multi-storey dwellings across Kunar, Nangarhar, and Laghman. Lower floors are frequently used for livestock shelter or storage, while upper floors serve as living spaces, particularly in rural and high-altitude areas dependent on subsistence agriculture (Hallet and Samizay, 1975).

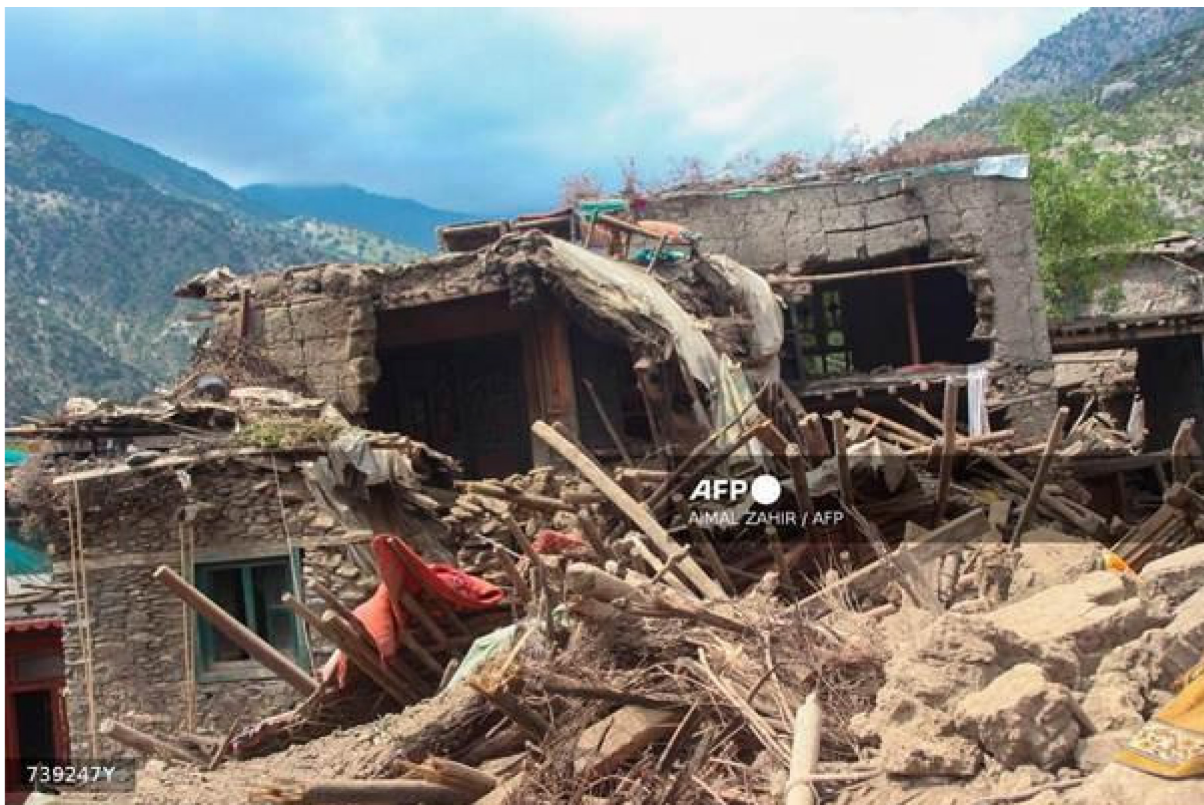
Figure 5.25: A damaged and tilted house situated on sloped terrain in Mazar Dara village, Nurgal district, Kunar province (Zahir, 2025)
