31 August 2025 Eastern Afghanistan Earthquake

A Joint Virtual Reconnaissance Report

Earthquake Engineering Field Investigation Team (EEFIT),
Association Française du génie Parasismique (AFPS), NED
University of Engineering & Technology, and RedR

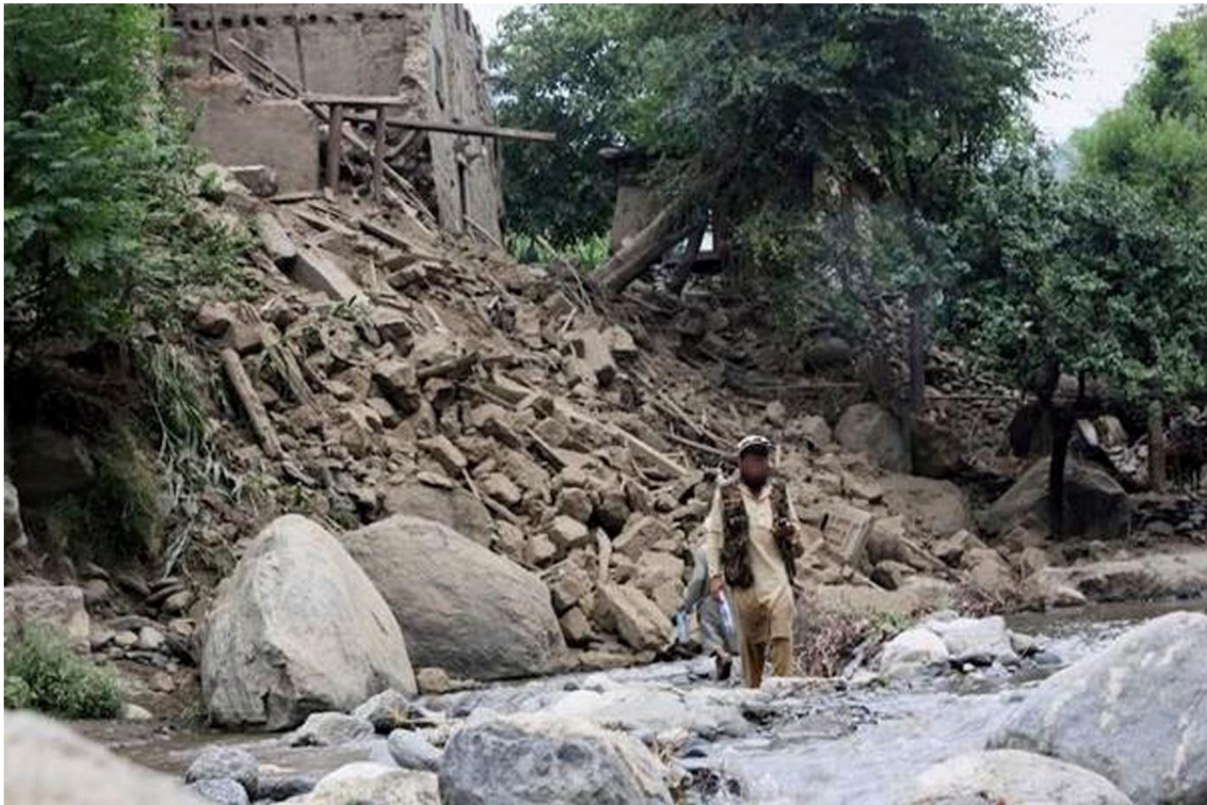
Figure 5.26: Heavy damage to a house sited on sloped ground in Mazar Dara, Kunar province (Associated Press, 2025b)

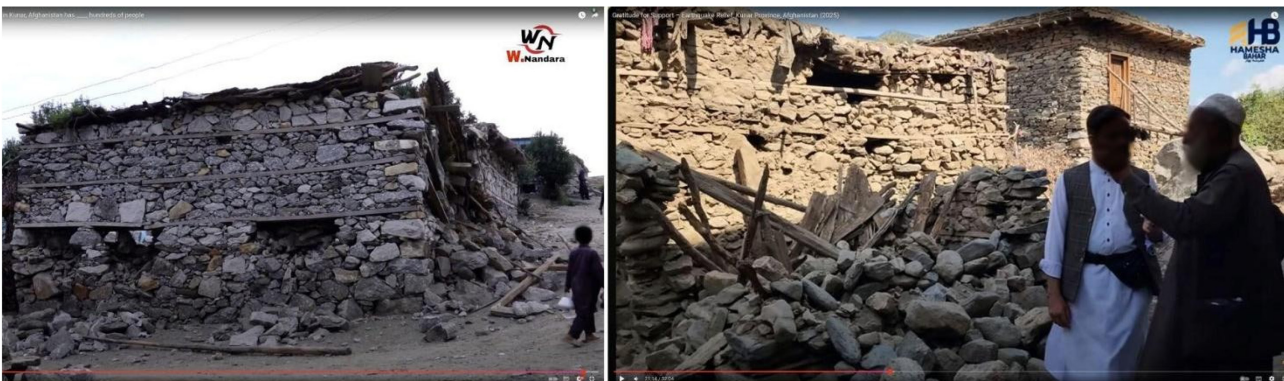
Figure 5.27: Stone/Timber connection. Left: YouTube, Watan Nandara channel <https://tinyurl.com/yxnchrsb>; Right: Youtube, Hameshabahar Afghanistan channel <https://tinyurl.com/3hwusksw>

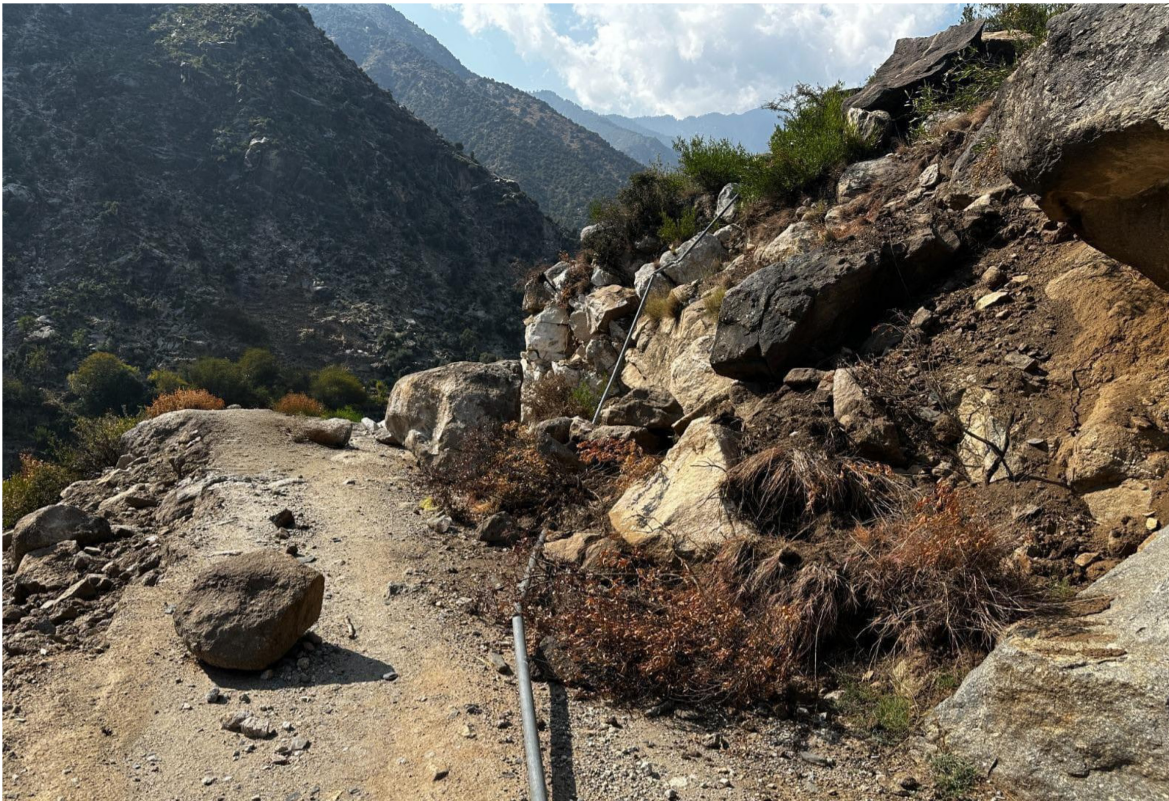
Figure 6.2: Example of damages to a water supply pipe due to rockfalls

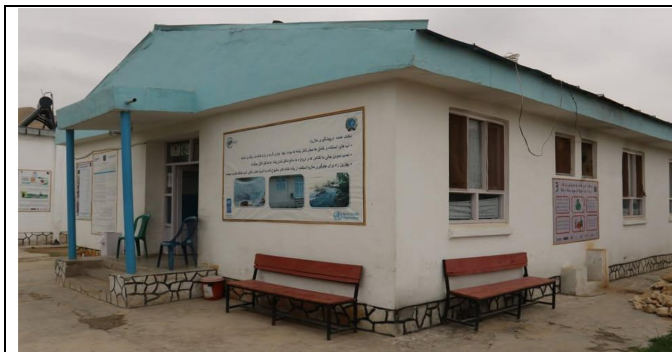
Hazrat Sultan district's health clinic
(source: WBA
<https://www.facebook.com/WorldBankAfghanistan/posts/established-40-years-ago-as-a-health-outpost-and-converted-to-a-health-center-in/896694510758773/>)

The following photos show typical type BHC health facilities in the eastern provinces of Afghanistan. These are single-story buildings, likely constructed from brick. A district hospital is also shown. This building is a two-storey building made of RC.

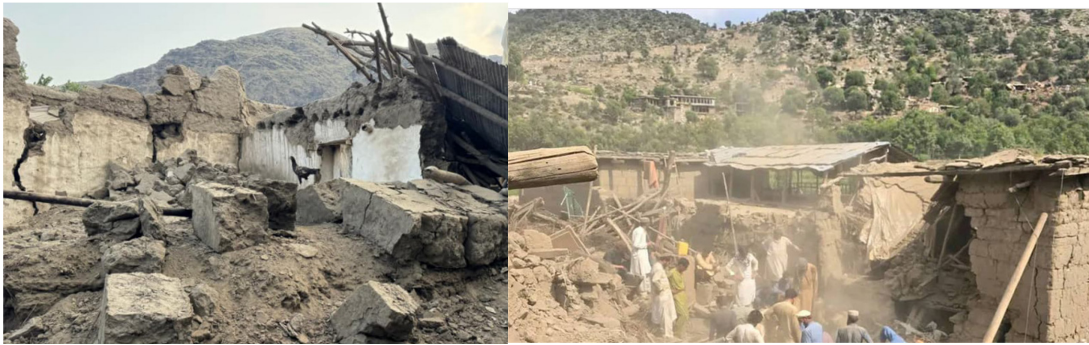
Figure 6.10: Structural devastation of associated industrial infrastructure (UN News, 2025)

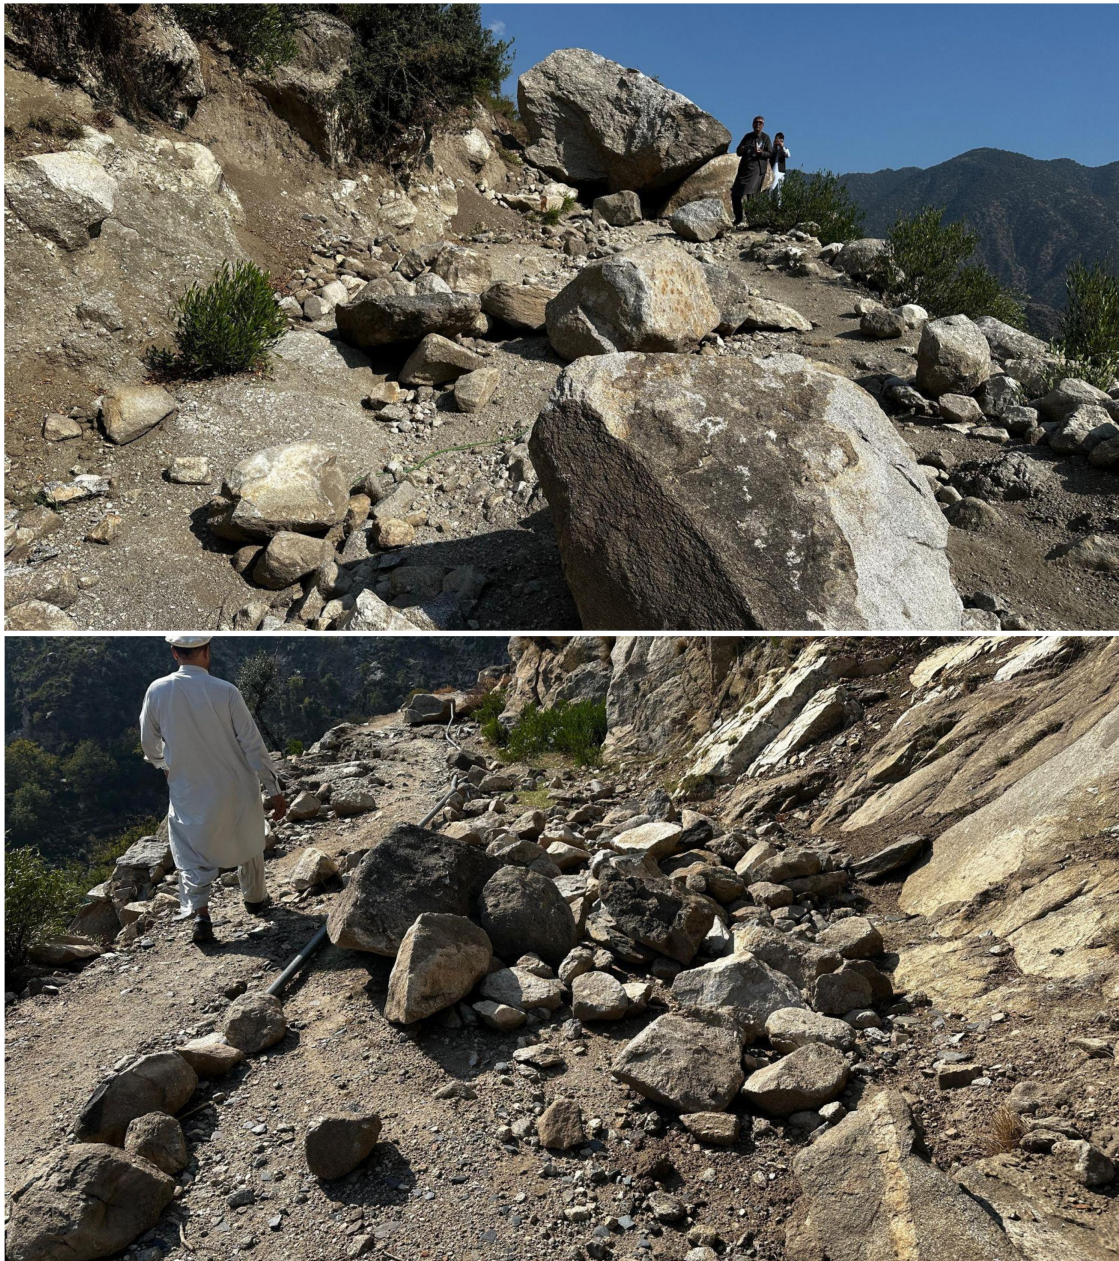
Figure 6.11: Examples of road passage blocking due to rockfalls

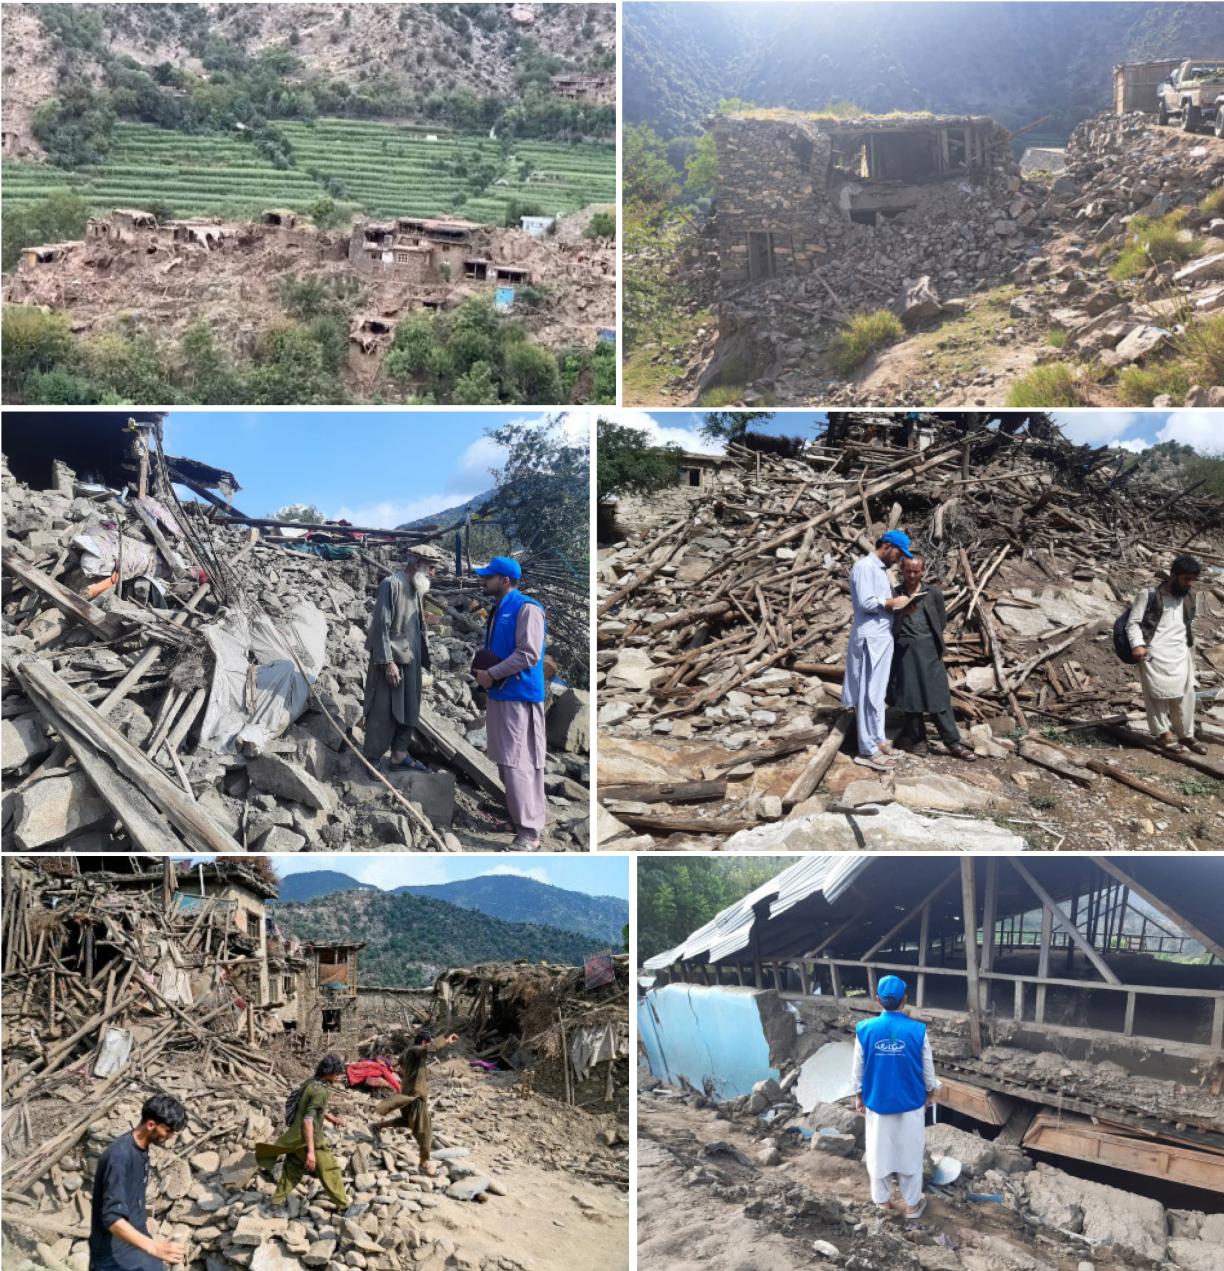
Figure B.3: Earthquake damaged stone masonry buildings in Kunar

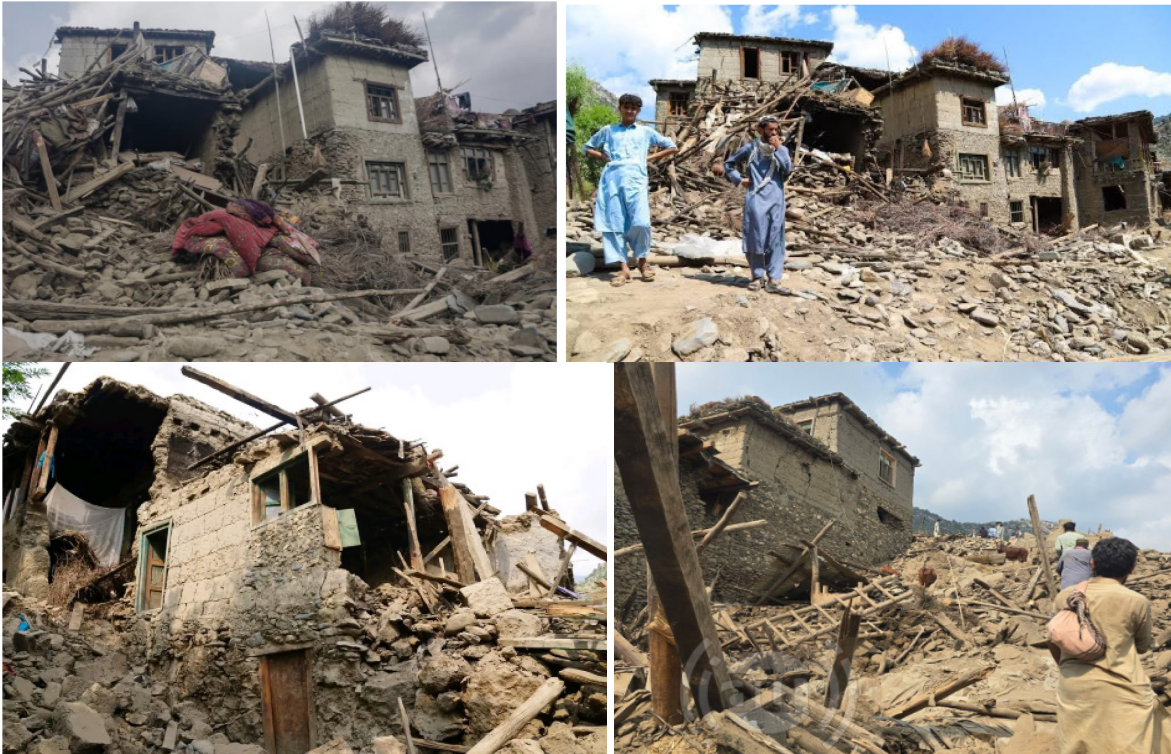
Figure B.4: Earthquake damaged buildings in Kunar with stone and cob walls

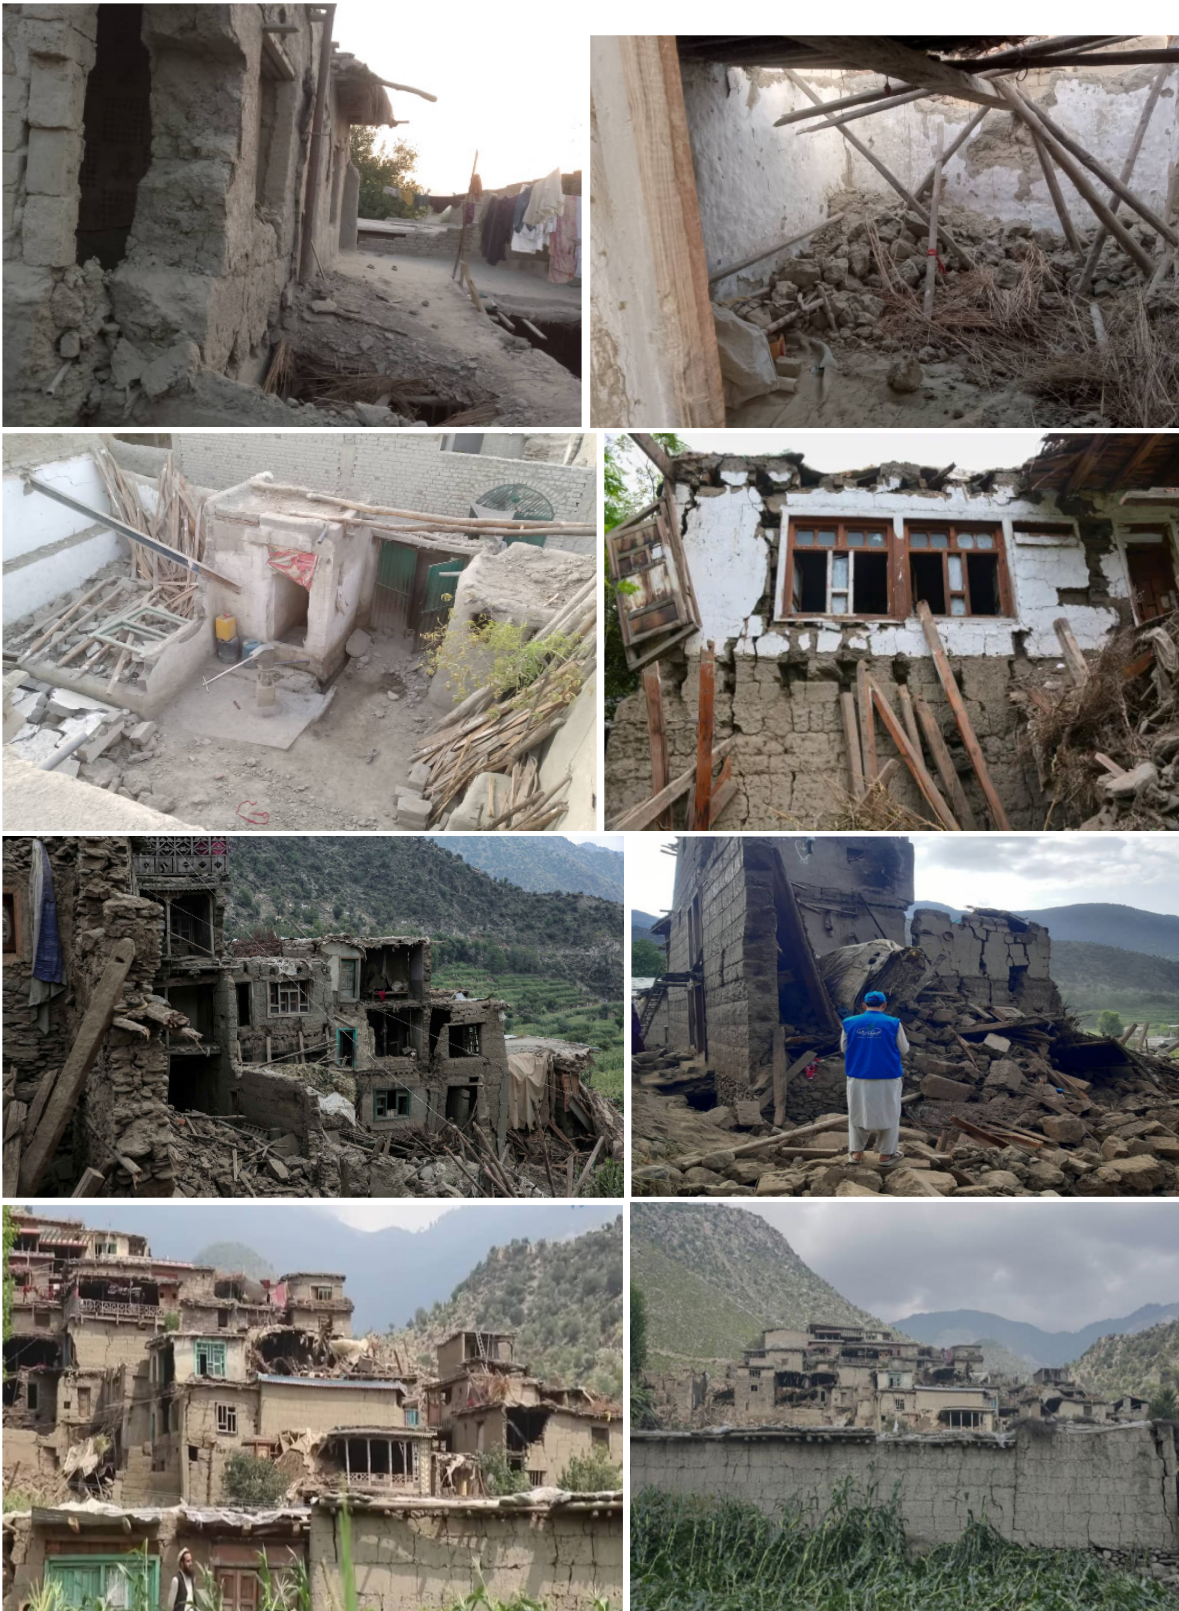
Figure B.5: Earthen structure affected by earthquake
