# Champlain Towers South forensic report findings

This month, Alastair Soane, Principal Consultant for CROSS, discusses the recently published report into this catastrophic collapse and considers the implications for building safety improvements.

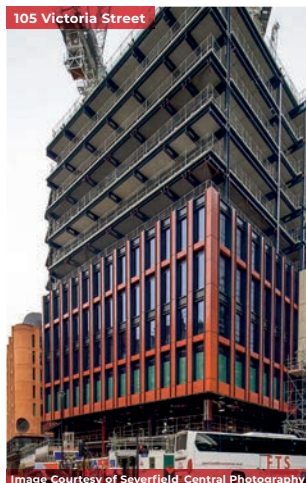
Image Courtesy of Severfield\_Central Photography

At **105 Victoria Street**, Severfield fabricated the steelwork for a frame comprising long-span Fabsec cellular beams that support open, flexible floorplates. The project incorporates complex transfer structures and extended spans to satisfy architectural aspirations and sustainability objectives. Fabsec's contribution was central: the cellular beams, designed and optimised using the **FBEAM®** software, enabled engineers to minimise steel weight, provide efficient service integration, and robust fire limit state performance.

A key enabler on both schemes is the integration of Sherwin-Williams **FIRETEX®** intumescent coating technologies within the **FBEAM®** workflow. This provides certified passive fire protection while supporting compliance with the Building Safety Act 2022. Sherwin-Williams' focus on traceability, digital record keeping, and maintaining the "Golden Thread" ensures every coated element is documented from design through installation. **FBEAM®**'s interoperability with Tekla Structural Designer (TSD) and RAM Structures further strengthens digital assurance and record capture.

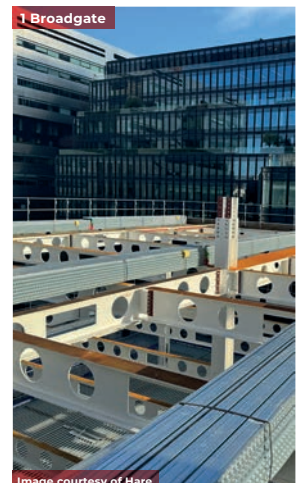
Image courtesy of Hare

**1 Broadgate**, fabricated by Hare, delivers two levels of retail space with new office accommodation above. The steel frame again makes extensive use of Fabsec cellular beams to create large, column-free floorplates suited to contemporary office layouts. Through the **FBEAM®** application, engineers were able to optimise both ambient and fire design, refine intumescent coating requirements, and achieve material cost, and embodied-carbon savings.
