**SEISMIC RISK MITIGATION
FOR THE EAST AFRICAN
COUNTRIES. CASE STUDY:
SALIMA, MALAWI**

EEFIT research grant - 2018

Dr. Viviana Iris Novelli
PRA in Earthquake Impact

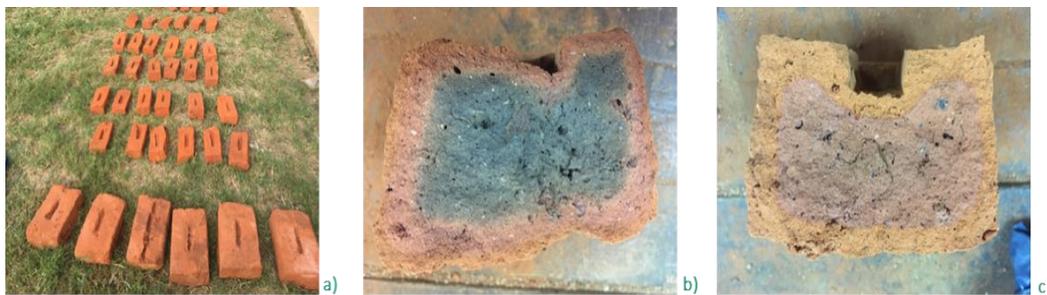
Figure 6: Masonry adopted for the specimens.

At least 6 specimens were prepared for each of different test. Specimens were built using local commercially produced bricks with nominal dimensions of 200mm × 90mm × 50mm. Those bricks, although they were from the same batch, exhibited a large variation in the fabric quality (i.e. colour, shape, and size, as illustrated in Figure 6).

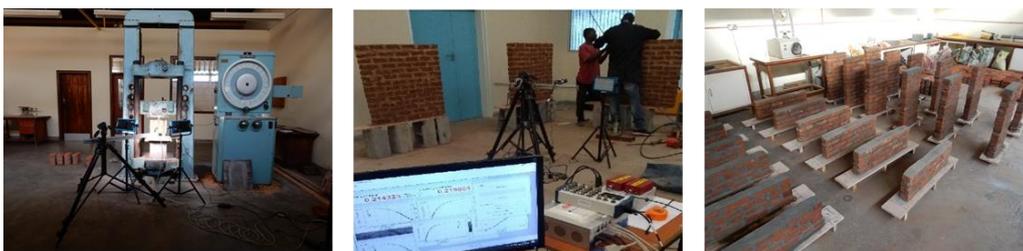
Figure 7: Typical testing configurations.

The equipment used for the experiments consisted of a combination of some testing rigs mountable on the specimens directly, a laboratory's strong floor, and a high-precision video tracking system for measurement of displacements, and synchronised analogue load cell signals connected onto it for measurement of maximum strengths. Some typical photos of the basic testing configurations are shown in Figure 7.

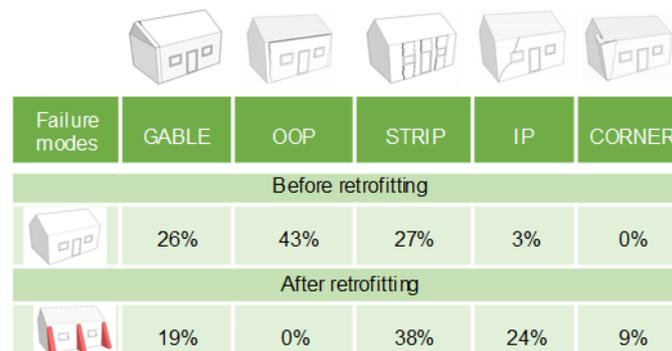
Failure modes associated with the identified collapse load factor multipliers derived from FaMIVE are illustrated in Figure 13. These are classified into five categories: 1) *GABLE*: predominantly occurs on walls with gables which are not connected to roofs, and therefore fail in overturning; 2) *OOP* (out-of-plane): predominantly occurs on single-skin walls with poor-quality materials and poor connections between walls and between walls and the roof, causing overturning of a single façade; 3) *STRIP*: predominantly occurs on single-/double-skin walls with medium quality materials and good connections between walls and between walls and the roof, causing overturning of vertical strips of piers or spandrels; 4) *IP* (in-plane): predominantly occurs on single/double-skin walls with medium to good quality materials and good quality connections between walls and between walls and the roof, causing shear failure of a single façade 5) *CORNER* (corner failure): predominantly occurs on buildings with good quality materials and good quality connections between walls and between walls and the roof, causing overturning of at least two orthogonal adjacent façades.

Figure 13: Failure mode proportions for the inspected building sample in Salima before and after the retrofitting plan proposed in Section 6.2. (Adapted from Novelli et al. 2019-c).

As expected from the on-site surveys, since a lack of connections between the walls and roof and poor quality construction materials were frequently observed in the inspected buildings (see Table 1), *OOP* is the most likely failure mode with a percentage of 43%, followed by *STRIP* (27%), then *GABLE* (26%). Only 3% of the inspected houses are expected to fail *IP*, and *CORNER* is not the identified failure mechanism for any of the investigated buildings. The results highlight that even buildings of typology C, built with double-skin walls, fired bricks with a good fabric quality, are expected to fail mostly due to overturning of gables, walls, spandrels and piers.

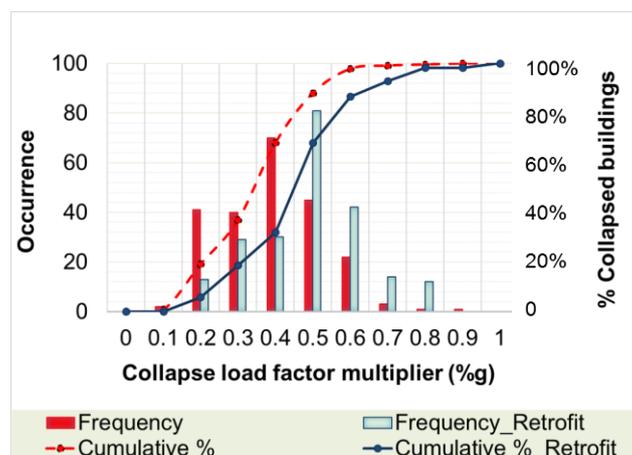
Figure 16: Occurrence of the identified collapse load factor multipliers and cumulative damage curves for the inspected building sample in Salima before and after the retrofitting plan proposed in Section 6.2. (Adapted from Novelli et al. 2019-c).

The impact of the buttresses is also underlined by the cumulative damage curves shown in Figure 16, where the median of λ before and after retrofitting is increased from 0.34g to 0.47g. Furthermore, the initial slope of the cumulative damage curve is changed: the one derived for buildings before retrofitting has a steeper initial slope than the one derived after retrofitting (e.g. for $\lambda = 0.30g$, the percentages of collapsed buildings are 40% and 20% before and after retrofitting, respectively).

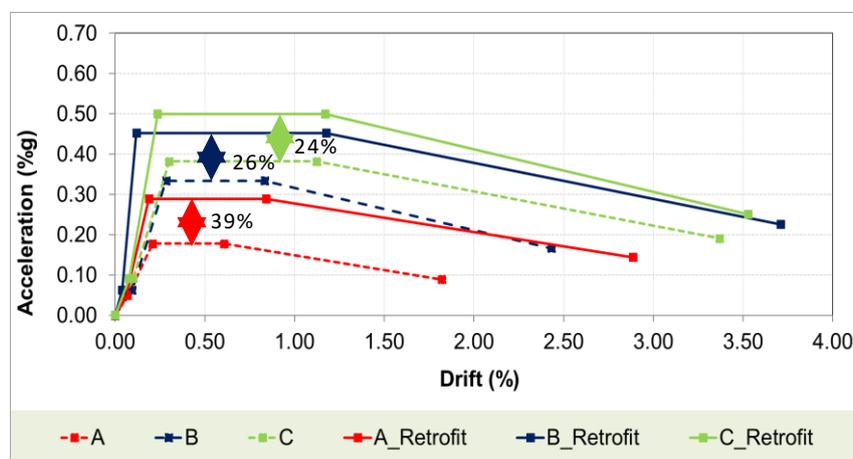
Figure 17: Capacity curves for a) typologies A, B and C; and b) failure mode classes (GABLE, STRIP, IP, OOP, and CORNER) for the inspected building sample in Salima before and after the retrofitting plan proposed in Section 6.2. (Adapted from Novelli et al. 2019-c).

Figure 17 shows different capacity curves derived for the building typologies A, B, and C identified in Salima before and after the retrofitting plan proposed in Section 6.2. As expected from the definition of the three typologies, it is noticeable that the building typology A (typology of buildings characterised by low quality materials and construction details) has the lowest values of maximum acceleration and drift compared to B and C. Regarding the positive influence of the buttresses, this is mainly highlighted by the increment of acceleration in all identified building typologies (increment of 39% in A, 26% in B, and 24% in C).

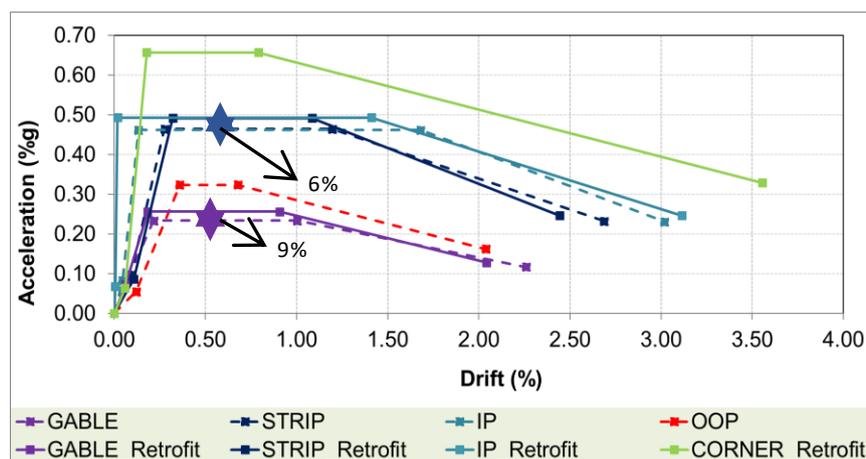
Figure 18: Capacity curves for a) typologies A, B and C; and b) failure mode classes (GABLE, STRIP, IP, OOP, and CORNER) for the inspected building sample in Salima before and after the retrofitting plan proposed in Section 6.2. (Adapted from Novelli et al. 2019-c).

Capacity curves are also derived for failure mode classes, as illustrated in Figure 18. The curves confirm that weaker buildings in topology A and B fail in *GABLE* and *OOP* modes, since they have the lowest values of structural capacity compared to the other failure modes. The presence of buttresses increases the capacity of buildings failing in the *GABLE* mode (increment of 9% before and after retrofitting), while *OOP* is prevented, as already identified in Figure 13. *IP* and *STRIP* modes are triggered by the same maximum acceleration value and occur for buildings of typology B made of good fabric quality. The presence of buttresses improves the capacities of these failure modes by 6%. This confirms

that the chosen retrofitting solution, aiming at preventing overturning of facades, positively increases the proportion of buildings failing in *IP* and *STRIP* (see Figure 13). In contrast, when buttresses are introduced in buildings with mud mortar, their presence provides only a small increment in the capacity of the single failure mode class, due to the poor bonding in the masonry. This is particularly underlined by the high capacity of *CORNER*, failure modes which occur only in buildings built with good brick fabric quality and 1:6Fcement-sand mortar.

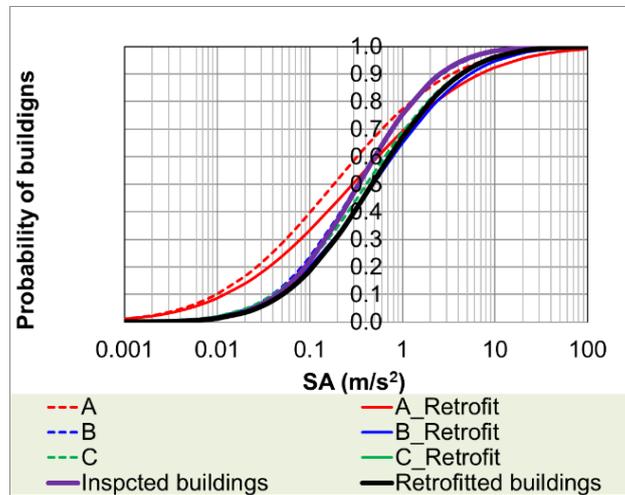
The fragility curves in Figure 19, obtained using the equations 1) and 2) show the performance of the inspected buildings in Salima, classified according to the typologies A, B and C, introduced in section 4. As expected, buildings of typology A, made of fired bricks with single skin walls are the weakest structures (e.g. for $SA = 0.20 \text{ m/s}^2$ and 0.30 m/s^2 ; the percentage of collapsed buildings is 52 and 59, respectively; against 35 and 43 obtained for

Figure 19: Comparison between fragility curves derived before and after retrofitting for the inspected buildings classified according to building typologies identified in Section 4.

Confirming the results discussed in section 7.1 for the capacity curves, buttresses particularly enhance the seismic response of buildings in typology A, preventing out of plane failure, collapse mechanism with the highest probability of occurrence due to the lack of connections between walls and gables of these houses (e.g. for $SA=0.20$ m/s²; the percentage of collapsed buildings of typology A is reduced from 52 to 44, see Table 2). It is also worth to note that buildings of typology C, classified as the strongest typologies, have only a slightly better performance compared to the other inspected buildings in Salima (e.g. total percentage of collapsed buildings in typology C is only 3% or 4% smaller than the ones identified for buildings of typology B before and after retrofitting, respectively, see Table 2). This is because, as discussed in Section 7.1, their seismic performance is highly dependent on the poor content of cement in the mortar adopted for these houses (e.g.

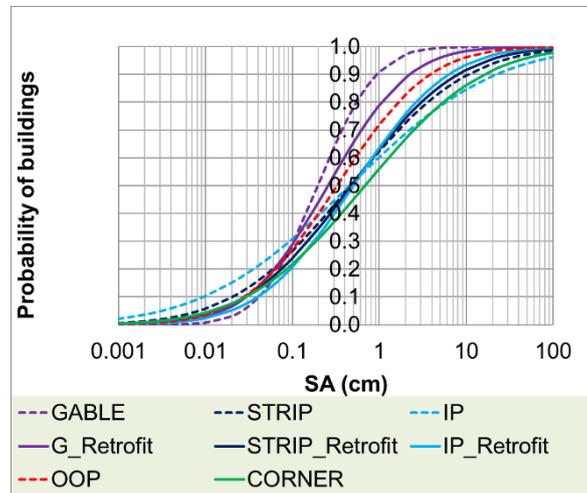
Figure 20: Comparison between fragility curves derived before and after retrofitting for the inspected buildings classified according to the failure modes identified in Section 6.2.

Fragility curves in Figure 20 are derived classifying inspected facades in Salima with reference to the failure modes estimated in Section 6.2. These functions show that percentages of collapsed buildings are notably higher for *OOP* and *GABLE*, which mainly occur for buildings in typology A, compared to *IP*, *STRIP* and *CORNER*, mainly occurring for buildings in typology B and typology C (e.g. for $SA = 0.20 \text{ m/s}^2$; the percentage of collapsed buildings is 51, 40, and 31 for *GABLE*, *OOP* and *CORNER*, respectively, see Table 3). This confirms that only a combination of a good construction practice and materials (e.g. using cement content in the mortar as recommended in the guidelines, employing bricks with a good fabric quality; constructing good connections) *GABLE*, and *OOP* can be prevented, and buildings performance for small values of *SA* can be enhanced,
