**The Indian Ocean Tsunami of 26 December 2004:
Mission Findings in Sri Lanka and Thailand**

**Antonios Pomonis, Risk Management Solutions
Dr Tiziana Rossetto, University College London
Dr Navin Peiris, Arup, London
Dr Sean Wilkinson, University of Newcastle
Domenico Del Re, Buro Happold, London
Raymond Koo, Arup, Hong Kong
Raul Manlapig, Arup, Philippines
Dr Stewart Gallocher, Halcrow, Glasgow**

Earthquake Engineering Field Investigation Team
Institution of Structural Engineers
11 Upper Belgrave Street
London SW1X 8BH
United Kingdom

February 2006

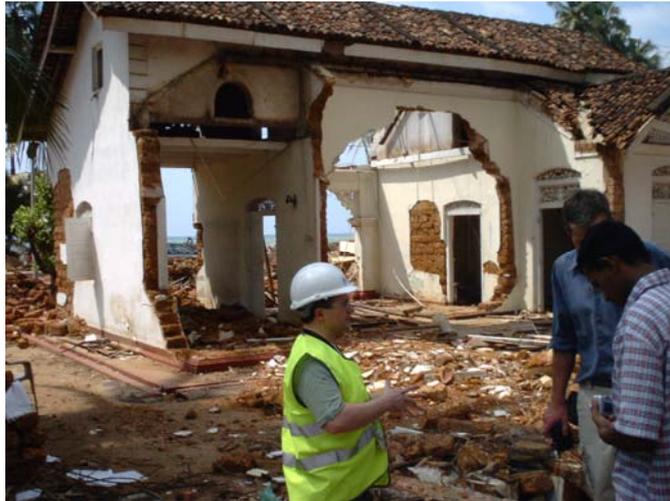
Driving south from Kalutara town it is clear that the level of tsunami inundation is becoming more and more severe with the first signs of devastation seen in Paiyagala village. This is the first coastal village on Road A2 south of Galle that was clearly devastated by the force of the tsunami. Its location is on the coast spreading out on either side of the road and the railway line roughly midway between the towns of Kalutara and Beruwala. Almost all of the masonry buildings adjacent to the roadway collapsed or were severely damaged, although some concrete frame 2-storey houses survived virtually intact. Extensive but repairable damage extended for about 200m inland of the coastal road. Evidence of flood inundation is visible up to 700m and according to local witnesses may have reached 1km. In general the damage to masonry was concentrated on panels facing the sea, whilst those perpendicular to it remained standing (see Figure 2.2).

Figure 2.2: Typical damage to brick masonry walls parallel to the coastline, observed in Paiyagala (Kalutara District)

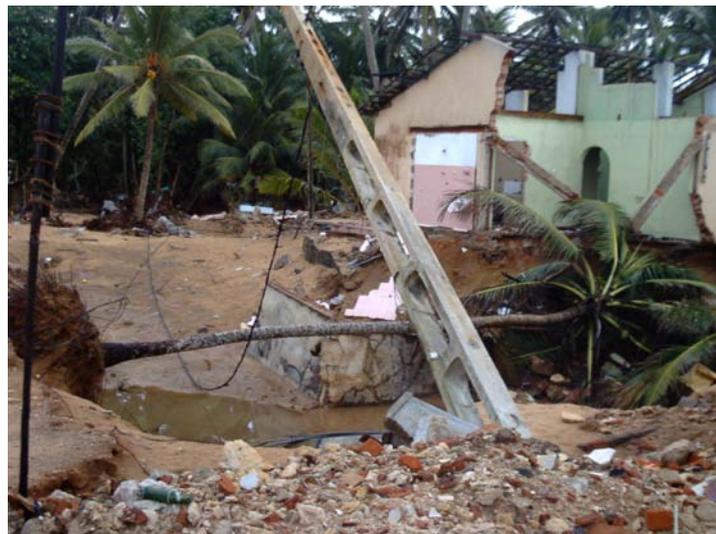
Figure 2.3: Scour damage seen in Kahawa (Galle District)

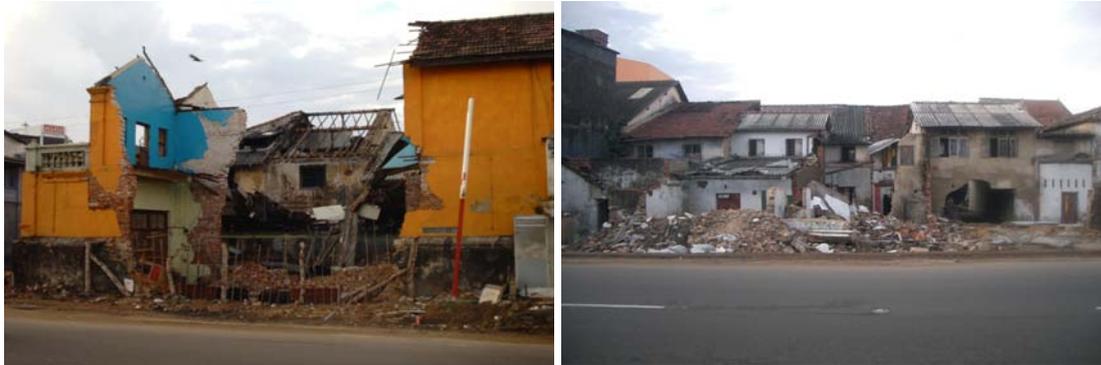
Figure 2.4: Damage to masonry houses in Galle City

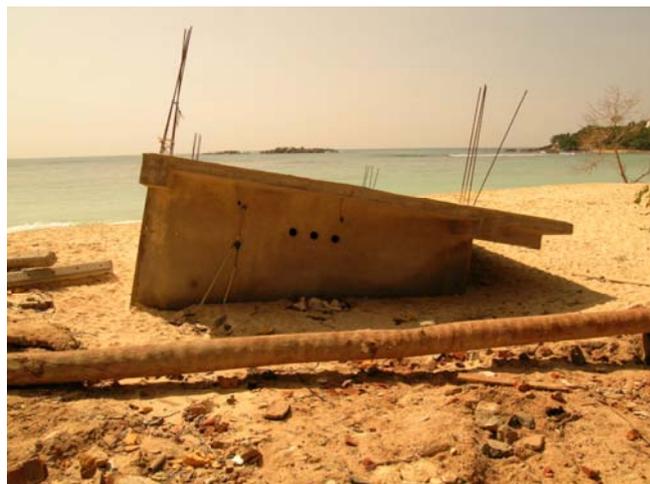
Figure 2.6: Evidence of Liquefaction damage to a small public utility building in Unawatuna (Galle District)

The building types in Unawatuna generally consist of commercial developments with a mixture of hotels and restaurants constructed from a combination of masonry and reinforced concrete. An example of foundation failure to a two storey concrete building on the shore is shown in Figure 2.5. This building was extremely close to the shoreline and was founded on very soft sand. It is believed that the damage was either due to scouring of the foundation or possibly liquefaction. Further evidence of liquefaction was witnessed approximately 200m from this location and is shown in Figure 2.6.

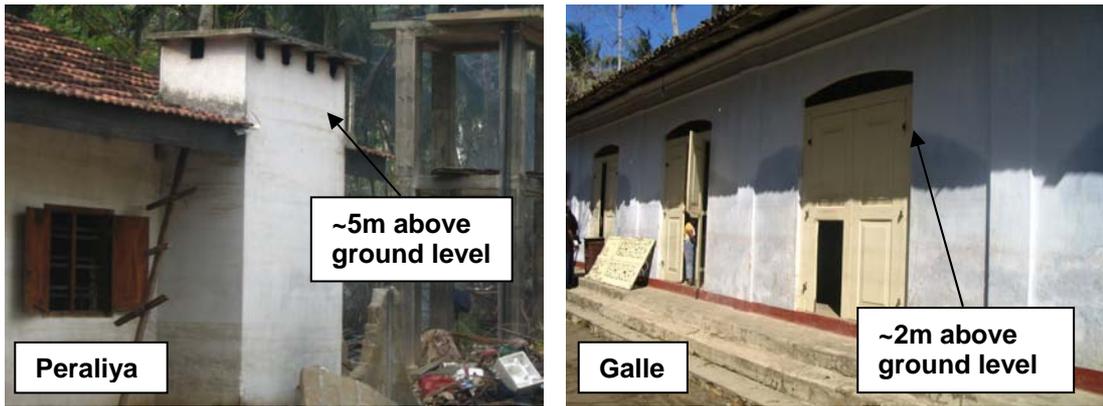
Observations of the tsunami maximum water level, run-up height and inundation distance were made by the EEFIT team at several of the visited locations. Fallen trees and discoloured vegetation provided evidence of extent of inundation while mud traces on buildings, hanging debris and consistent levels of uplifted roof tiles were used as indicators of the tsunami water level. An example of the water level measurements carried out by EEFIT is shown in Figure 2.7 and Table 2.1 summarizes some measurements taken by EEFIT during their survey.

Figure 2.7: Example of the water height measurements carried out by EEFIT

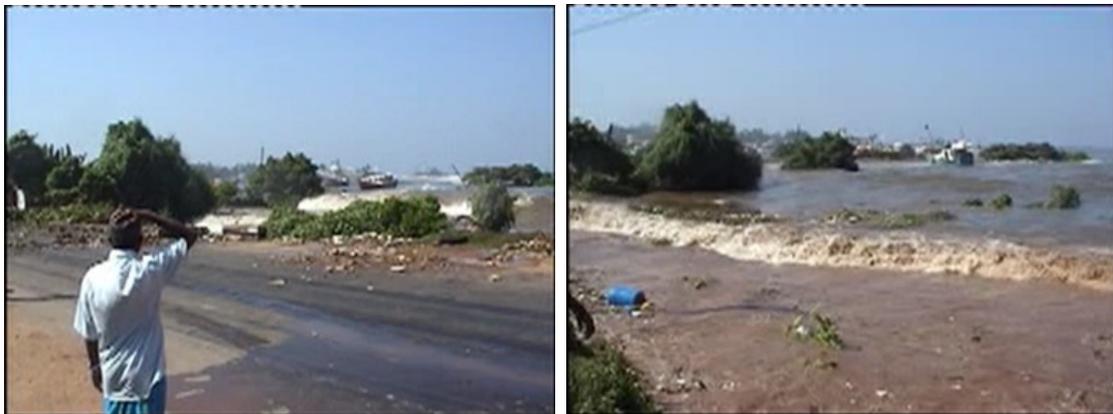
Figures 2.14 shows the advancing tsunami waves following the recede as captured by the eyewitness video (Hamza, 2005). More waves followed with the momentous rise of the sea level following some wave arrivals. Figure 2.15 shows the tsunami waves arriving near the Beruwala harbour that inundated the Route A2. At this instant the fishing harbour in the distance was completely inundated. Figure 2.16 shows the state of the rockfill breakwater at the Beruwala fishing harbour when the recede took place and after the tsunami waves have arrived. The height of the water at this location could be estimated to be about 5m from the video images.

Figure 2.15: Arrival of more tsunami waves and inundation of Road A2 (Hamza, 2005)

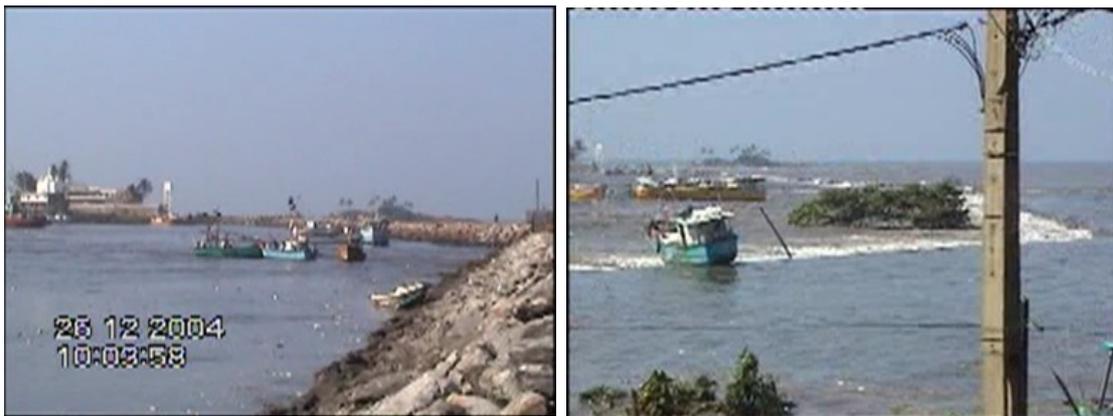
Figure 2.16: State of the Beruwala fishing harbour breakwater during the recede and after the arrival of tsunami waves (Hamza, 2005)

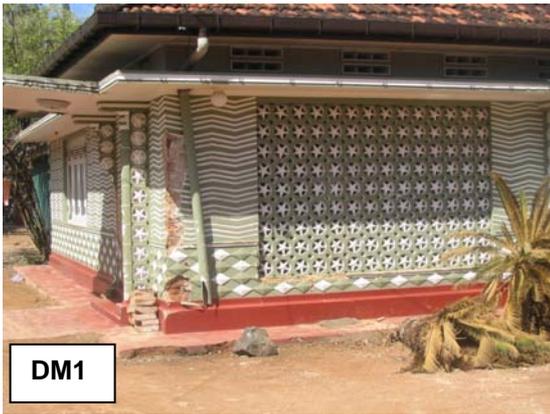
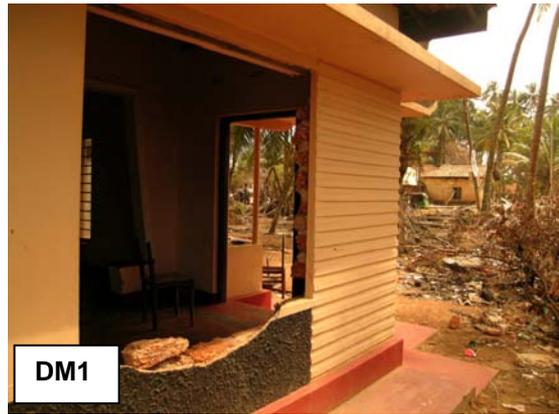
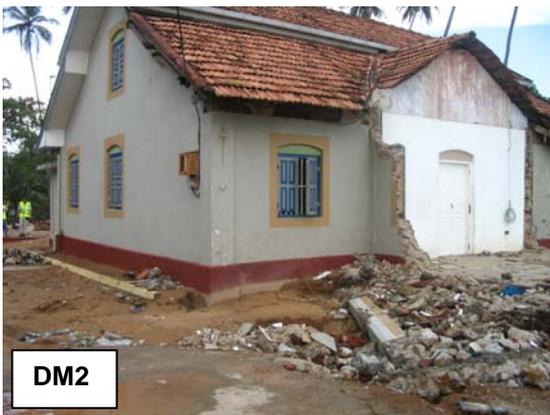
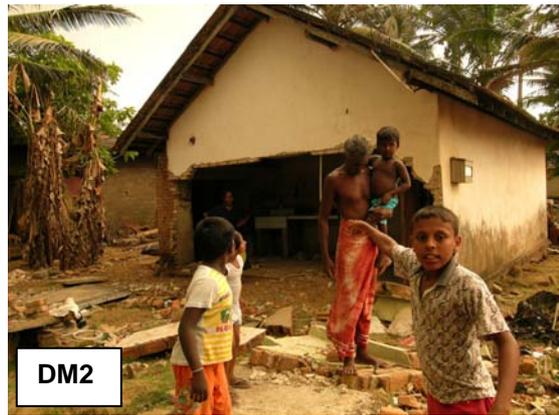
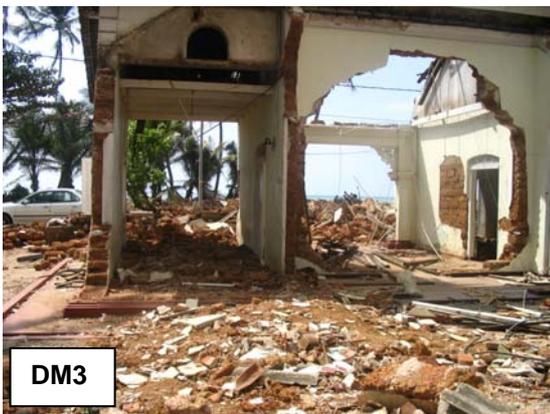
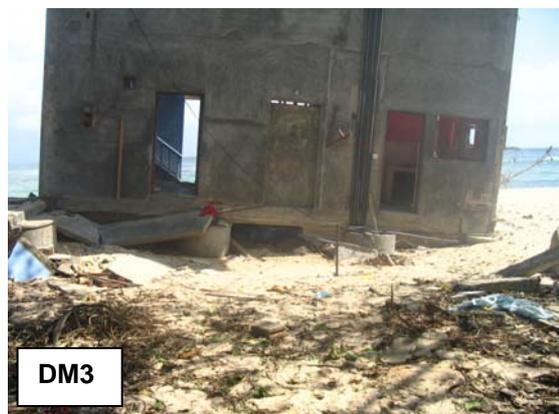
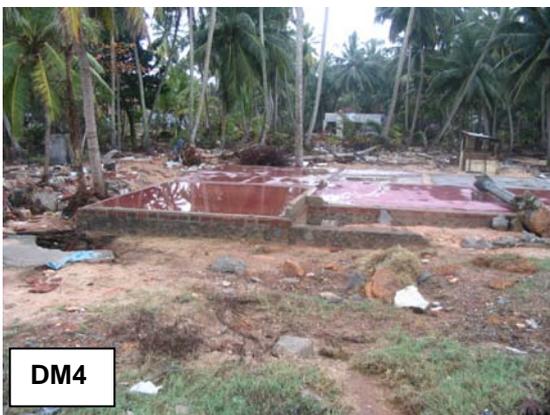
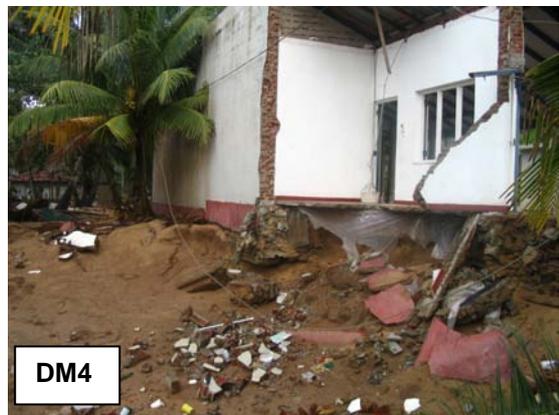
Figure 2.23: Photographs illustrating categories of damage DM1 to DM4 in unreinforced masonry structures in Sri Lanka

Figure 2.23 illustrates the typical damage associated with levels DM1 to DM4 for the unreinforced masonry structures in Sri Lanka. The above damage scale was also used for the timber light frame structures found in some of the visited coastal areas. Damage scale developed for Thailand in Section 3.4.3 was used to describe the damage to low-rise and mid-rise RC structures. Although many structures withstood the force of water from the tsunami with little or no damage, the damage to content could not be avoided due to inundation. The above damage scales developed are therefore limited to describing structural damage.

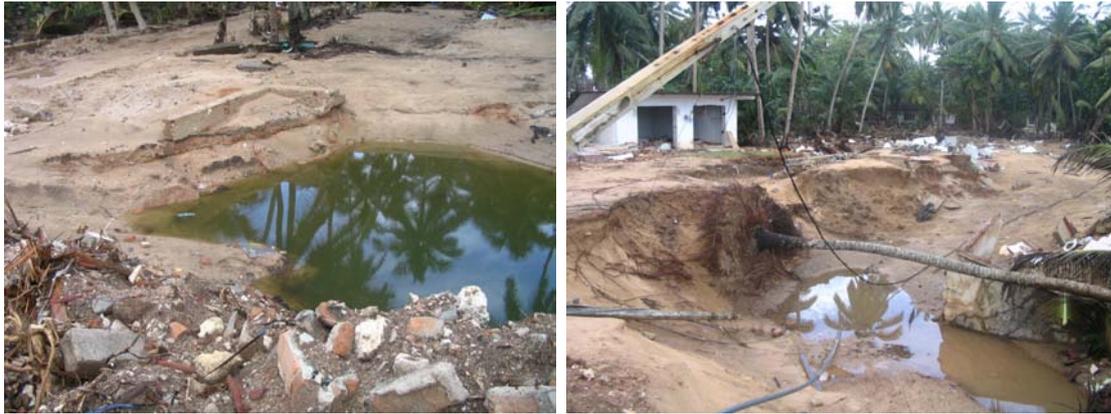
First sign of heavy scouring was observed in Kahawa by Road A2 as shown in Figure 2.26. The damaged pieces of foundation indicate that there was a house at this location prior to the tsunami. Scouring appears to be wide spread and was responsible for damage to some of the houses, which would otherwise have survived from heavy structural damage.

Figure 2.26: Scouring and destruction of houses in Kahawa, Sri Lanka

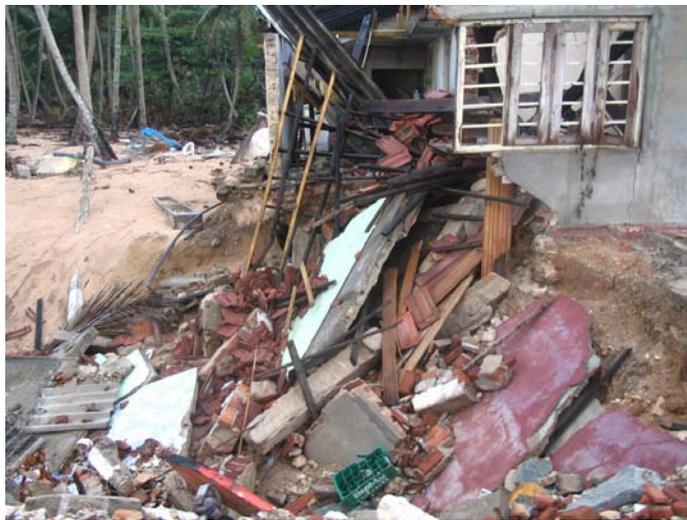
Figure 2.27 shows a masonry residential structure (Cat. C), which had lost part of the structure due to scouring and undermining of foundations (DM3). A close examination of the cross-section of scour holes revealed that the loose to medium dense sands in these areas exist to a depth of 3m or more, which appears to be underlain by dense clayey sandy soils. The loose to medium dense sand are susceptible to erosion and hence leading to scouring as observed in these areas.

Figure 2.27: Collapse of part of the Cat. C masonry structure to a scour hole in Kahawa

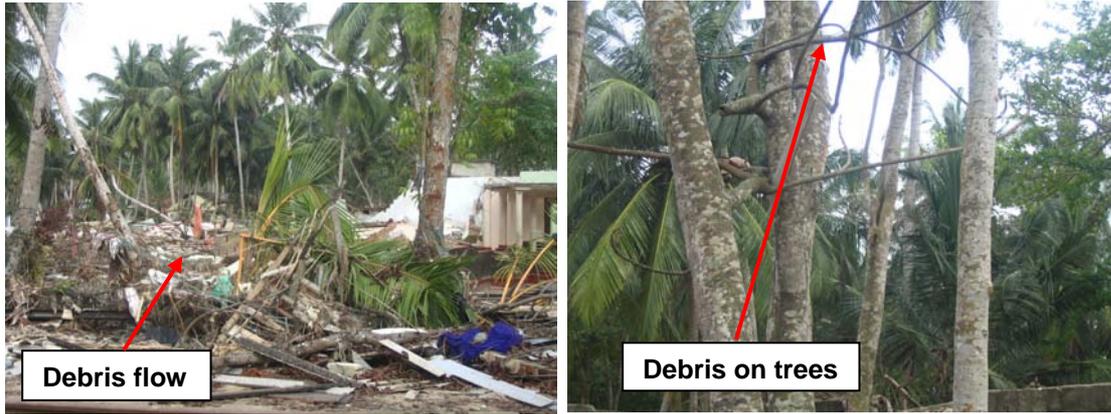
Peraliya was the site of the train that derailed during the tsunami killing about 1500 people, who were largely travelling on the train to Matara from Colombo. The site despite the dense coconut trees and vegetation was the site of the heaviest damage in the southwest of Sri Lanka. Figure 2.29 shows evidence of debris flow about 200m from the coastline. Evidence of high tsunami water levels is visible from the debris trapped on trees. KUDPRI measured a water level of 10m relative to the mean sea level at this location.

Figure 2.29: Site of debris flow at Peraliya and evidence of water level from debris on trees

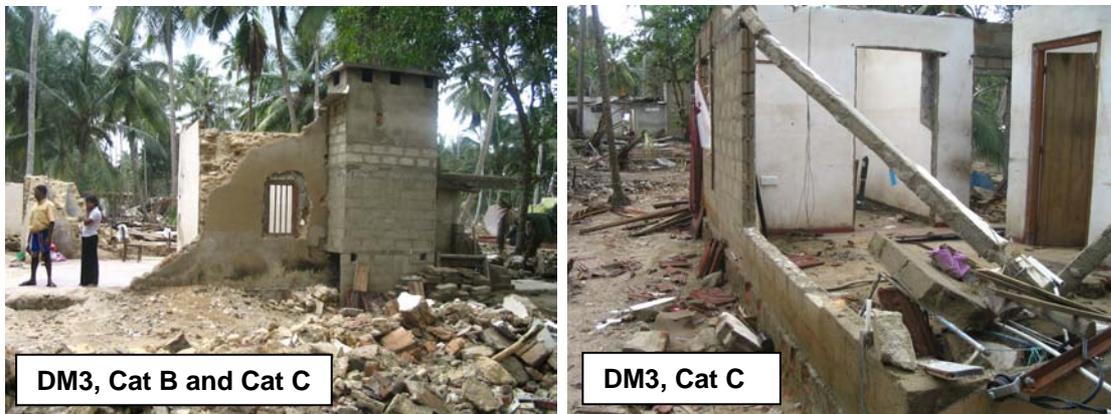
Heavy damage was seen as far as 300m from the coastline in many of the masonry houses, which were largely Cat. C (Figure 2.30). The structural damage was caused by collapse of masonry wall panels, which lead to the loss of structural capacity (DM3), hence many of the house will have to be demolished. The damage level becomes less severe away from the coastline. Figure 2.31 shows a moderately damaged masonry house (DM2, Cat. C) at about 400m from the coastline, which could be re-used following reconstruction of the damaged masonry panels. The displaced roof tiles are an indication of the water level at this location. Figure 2.31 also shows an undamaged 2-storey house (DC0, Cat. D), which was under construction prior to the tsunami. The house is of RC frame and slab construction with masonry infill panels made of solid brick for the first storey walls and cement blocks for the second storey walls. According to the eyewitness accounts the tsunami water has travelled as far as a lake about 800m from the coastline. Figure 2.32 shows the damaged parapet wall of a Buddhist temple located by the lake. The temple buildings are intact despite the water level at this location measured to be about 5m above ground level from the silt traces on the chimney wall (see Figure 2.7).

Figure 2.30: Heavily damaged (DM3) masonry structures at about 300m from the coastline in Peraliya

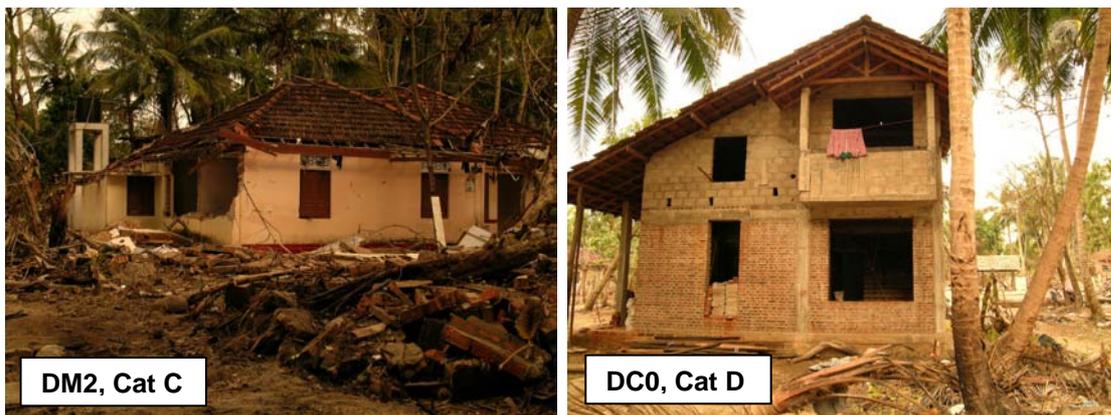
Figure 2.31: Moderately damaged Cat. C masonry house at about 400m from the coastline. Undamaged RC frame and slab structure with masonry infill panels under construction prior to the tsunami

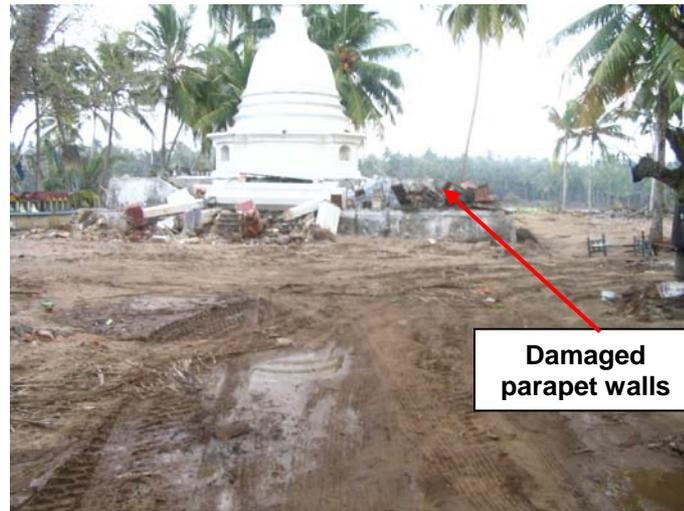
Figure 2.32: Damaged parapet walls and columns at the Buddhist temple located about 800m from the coastline

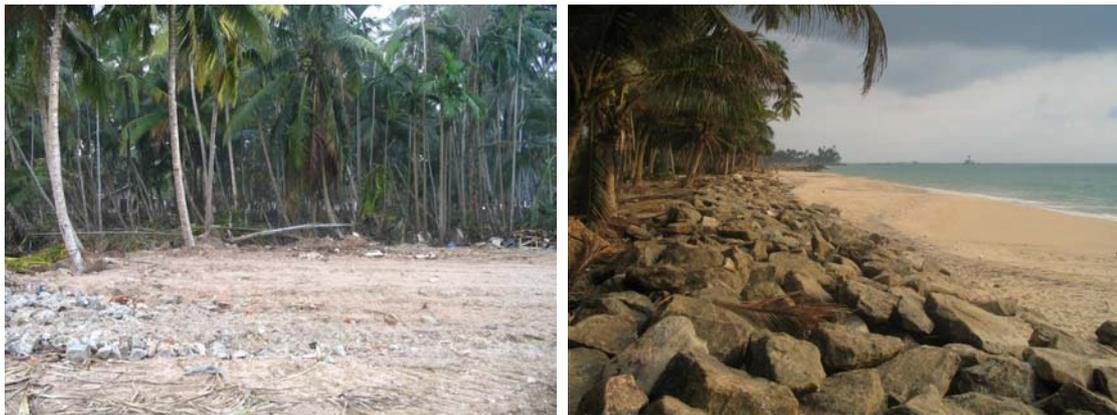
The distribution of houses is fairly sparse in Peraliya such that there are palm trees and shallow vegetation in the areas surrounding the detached houses. However, the flow velocities at Peraliya must have been high enough to cause extensive damage to a considerable distance from the coast. Figure 2.33 shows fallen palm trees at the location of the Buddhist temple about 800m from the coastline. Despite the height and extent of inundation, there was no evidence of erosion or scour in this area. The

surficial soils in this area are dark brown clayey sandy soils. The shore appears to be shallow in this area and there is some rock protection along the coastline as shown in Figure 2.33.

Figure 2.33: Fallen coconut trees at about 800m from the coastline suggesting significant flow velocities at this distance. Coastal protection at the coastline of Peraliya

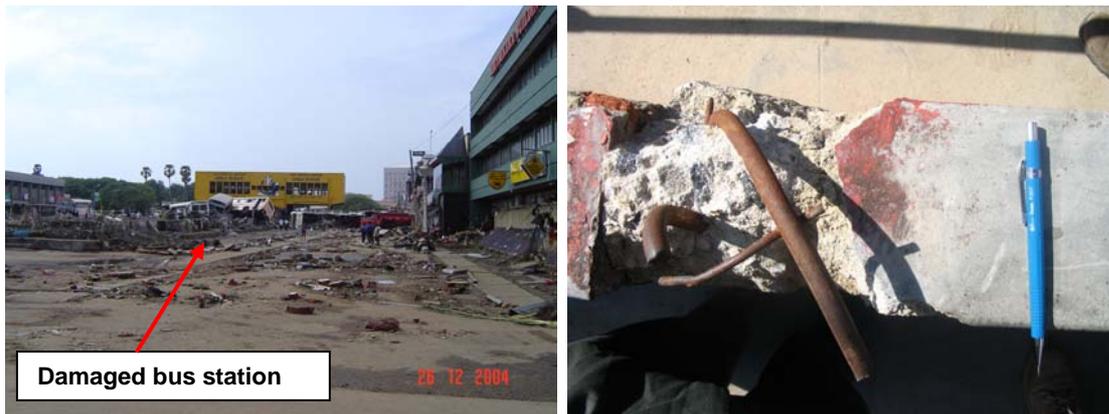
The bus station structures at the centre of the city were heavily damaged beyond use as shown in Figure 2.36 where there was evidence of tensile failure or reinforcement in the columns supporting the roof structures. Several ground floor shops adjacent to the bus stand appears to have suffered content damage due to inundation but there were no visible structural damage to the shopping complex, which is a 3-storey RC building with masonry infill (Cat. E). The steel structures of the stadium stands and the score board in the Galle international cricket ground were completely damaged and there was an obvious change in the colour of the grass, which can also be seen in the satellite image in Figure 2.35. The houses and commercial outlets within the Galle Fort escaped the direct impact of the tsunami, protected by the rampart wall of the Fort.

Figure 2.36: Heavily damaged Galle bus station (photo by Dennis Knight, Halcrow). Tensile failure of reinforcing bars of columns supporting the roof structures of the bus station

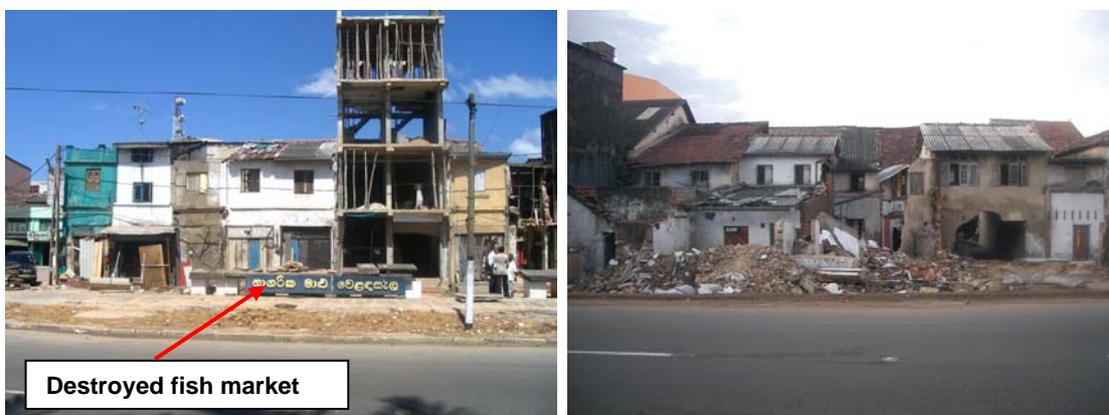
To the east of the city centre, the Road A2 runs around the natural harbour until it reaches the Magalle bridge near the road access to the Galle Harbour. The shops and other buildings facing the Road A2 behind the harbour suffered collapse or heavy damage as shown in Figure 2.37. These are a mixture of masonry structures and RC structures of 2 or 3-storey (Cat. D) with masonry infill walls. Several masonry structures collapsed such as the fish market building constructed of columns made of Cat. B masonry (see Figure 2.37). The damage in RC structures was to masonry infill panels facing the sea (DC2) and there were cases of roof damage and cracks in some RC structural members (DC3). There was no evidence of substantial structural damage in the streets behind Road A2 nearer to the city centre, which are largely commercial outlets of mixed masonry and RC construction.

Figure 2.37: Damaged commercial buildings behind Galle Harbour on Road A2

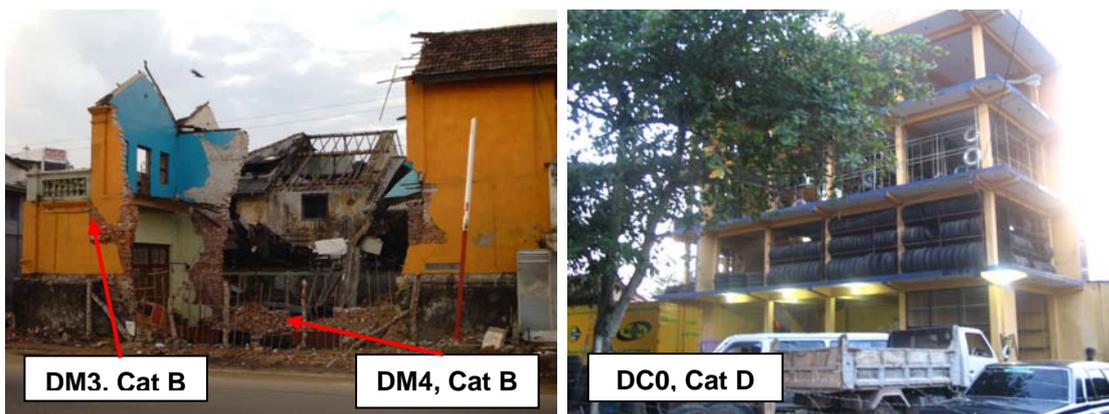
Figure 2.38: Damaged masonry structures in the street behind Road A2. Undamaged RC structure on the same street used for vehicle servicing

However substantial damage was observed in the street behind Road A2 nearer to Galle Harbour as shown in Figure 2.38. There were several damaged Cat. B and Cat. C masonry structures (DM2 and DM3) and infill wall collapses in RC frame and slab structures (DC2). One structure that survived undamaged was a 3-storey building with an open plan in the ground floor used as a service centre (see Figure 2.38).

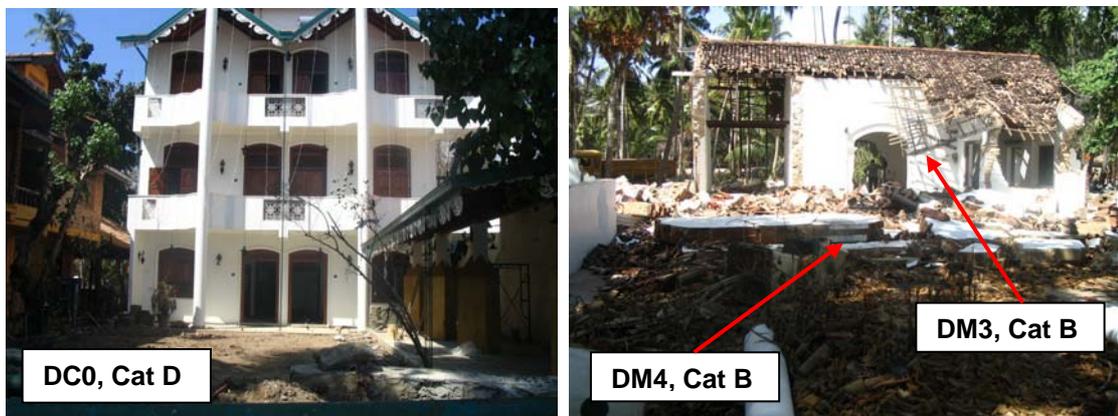
Figure 2.39: Undamaged hotel 20m from the shoreline. Collapse and heavy damage to a Cat B masonry house at the same distance

The residential developments are mostly located behind these developments and the area is abundant with shallow and dense vegetation among coconut trees. Figure 2.39 shows an undamaged 3-storey RC frame and slab hotel structure about 20m away from the coastline and toward the eastern part of the bay. At the same distance from the shore and few blocks away is a Cat. B masonry house with part of the structure facing the sea collapsed and the remaining structure damaged beyond repair (DM3).

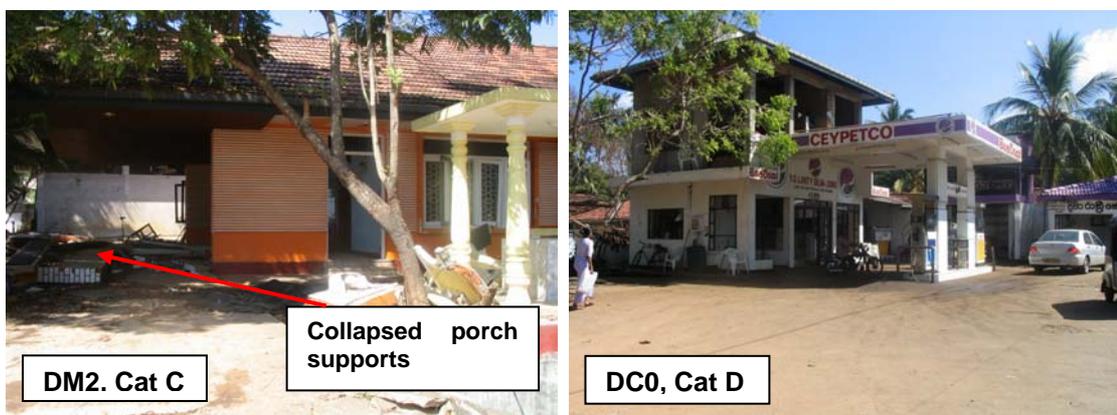
Figure 2.42: Moderate damage to a masonry house facing the bay. Undamaged filling station facing the bay

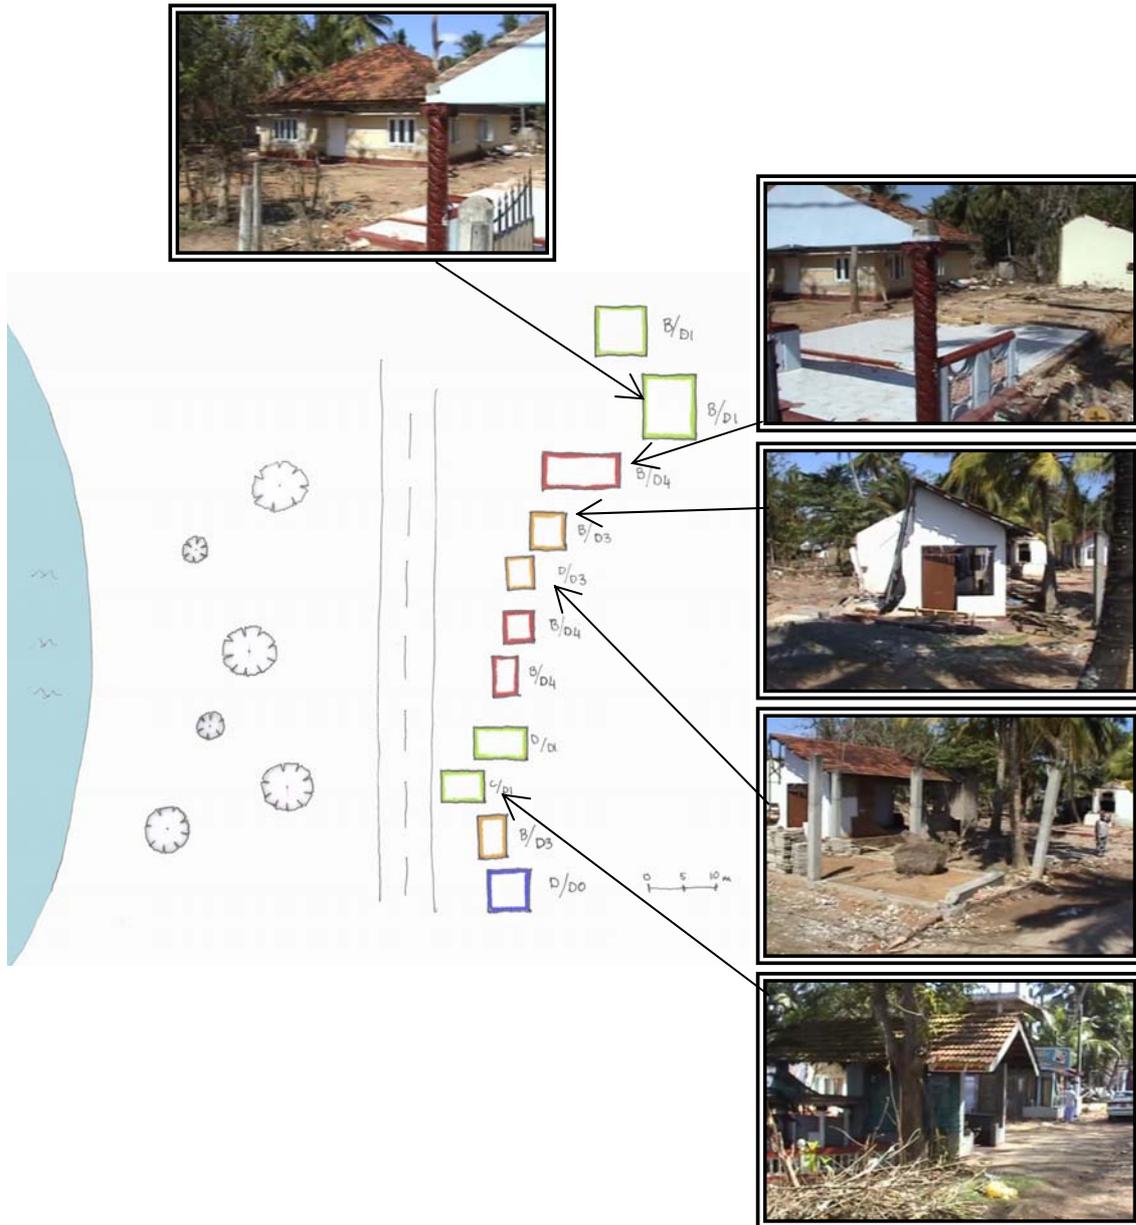
The survey along road A2 is shown in Figure 2.43. Between the coastal road and the shore is a strip of land with sparse vegetation consisting of mature coconut trees. There were silt traces on the walls of houses at a height of 2m above ground level at a distance of 80-90m from the shore. The ground is generally level and rising approximately 2.5m above the sea level at the shore. The size and construction types of the 11 buildings surveyed along the coastal road varied (Cat. B and C masonry and Cat. D RC structures) and as a consequence there was a considerable variation in the extent of damage. For the same tsunami hazard, some masonry buildings collapsed whilst others survived with very little damage. It was not possible to confirm whether the presence of cross walls might have improved the wave resistance capacity of the standing buildings.

Figure 2.43: Detailed walkover survey observations at Welligama

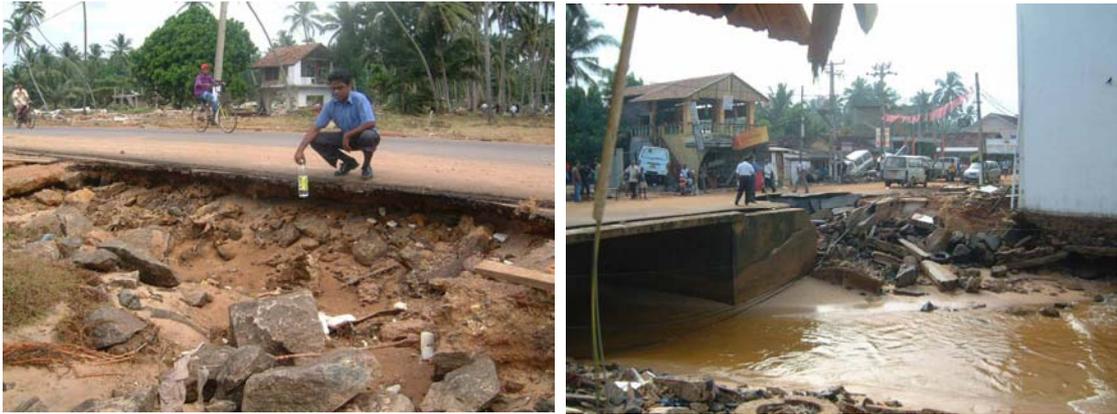
Figure 2.53: Light scour damage at the roadside exposed to the sea (Photo by RDA). Collapse of part of the road in Hikkaduwa due to scour in the exposed side to the sea (photo provided by Dennis Knight, Halcrow-Sri Lanka)

The typical road construction technique is clearly evident in Figures 2.53 and 2.55 where the bitumen road surface is founded on a compacted layer of gravely soils about 400mm thick overlying the sand. This type of profile is susceptible to the weakening effects of the underlying sand. The damaged locations of Road A2 were made passable within about 10 days after the disaster as shown in Figure 2.52. Figure 2.55 shows a section of the road that has collapsed and the state observed at the time of the survey.

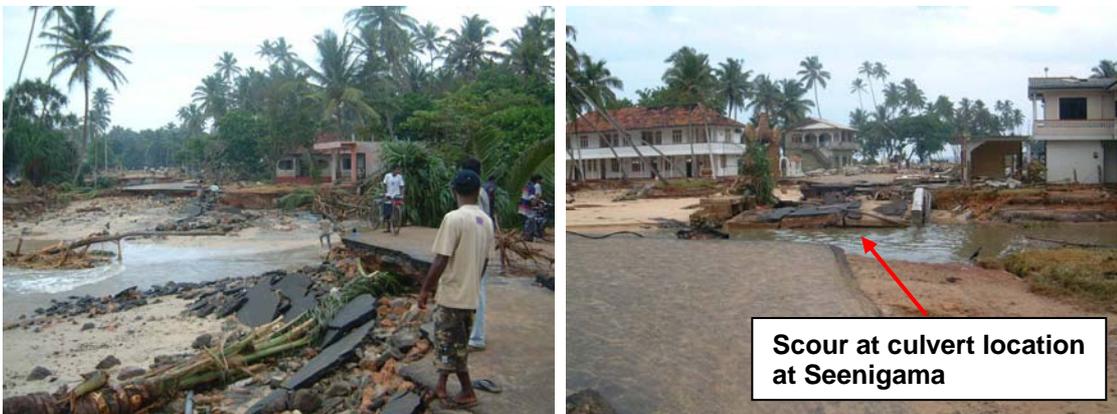
Road A2 was damaged in several locations, mostly due to erosion and scouring of the ground below and at locations of bridges and culverts. Figures 2.53 to 2.55 show examples of scour damage to the road where the extent of damage varied from light roadside scour to heavy damage across the road rendering it impassable. Roadside sections that are directly exposed to the seaside appear to have suffered severe damage. Some road sections although protected by a sea wall or an embankment with sufficient vegetation, suffered damage due to scouring, which undermined the founding subgrade (Figure 2.55). Locations of culverts were particularly vulnerable to scour damage. Figure 2.54 shows

severe damage across the Road A2 in Seenigama (north of Hikkaduwa) where the culvert exposed to the sea was completely washed away making it impassible.

Figure 2.54: Heavy damage to the road near Hikkaduwa due to scouring making the road impassable (Photo by RDA). Completely washed away culvert in Seenigama making Road A2 impassable (Photo by RDA)

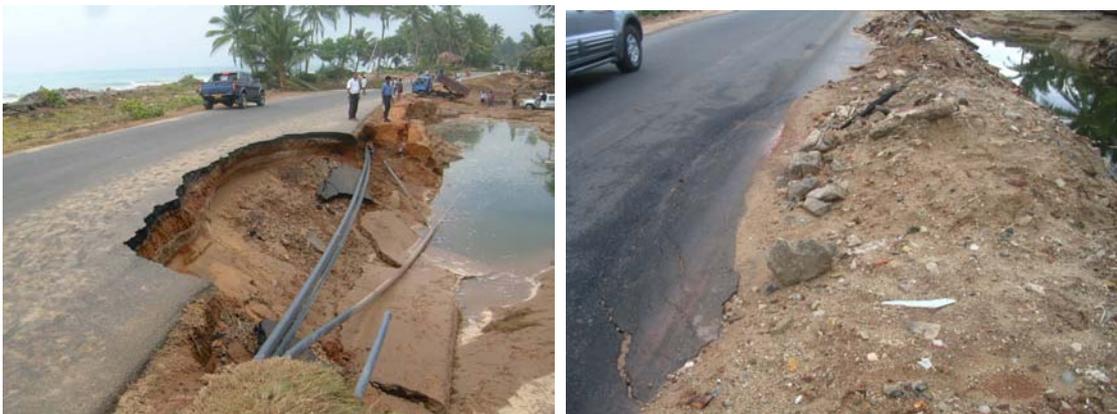
Figure 2.55: Collapsed section of Road A2 in Kahawa due to scouring on the exposed land side (Photo by RDA) and the state after repair as observed by EEFIT

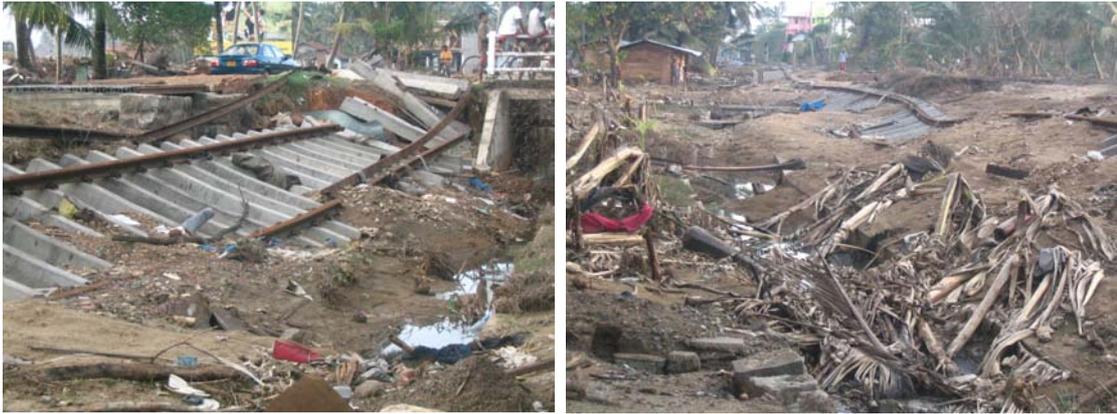
Figure 2.57: Damaged section of railroad near Hikkaduwa due to collapse of the embankment possibly driven by erosion and scouring

Typical damaged section of the railway near Hikkaduwa is shown in Figure 2.57, where the embankment failure possibly caused by scouring and erosion led to the distortion of the recently repaired track. Figure 2.58 shows the derailment at Peraliya (north of Hikkaduwa). Water levels as high as 10m were recorded in this area by KUDPRI (Figure 2.8). The high water levels and possibly high velocities of flow would have been sufficient to uplift the rail carriages and drag them a considerable distance away from the railroad. At the time of the field mission, work was being done to prepare the ballast and place the precast reinforced concrete sleepers for the track. Clearly the railway authority has given great priority to making this lifeline operational as soon as possible.

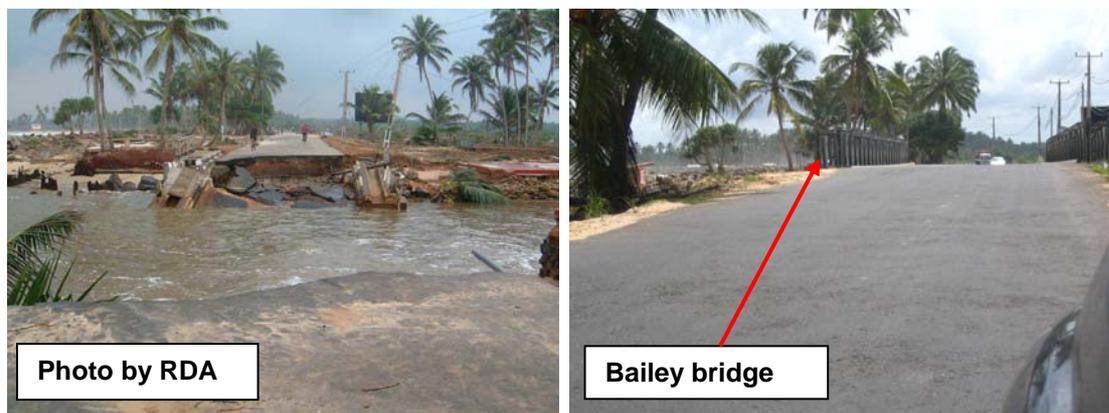
Three bridges suffered severe damage on the Route A2 in Akurala, Magalle and Goviyapana. Figure 2.59 shows the completely destroyed bridge at Akurala where the bridge deck appeared to have collapsed and disintegrated along with its abutments. The bridge appears to have been of Type 1 judging from the debris with a span of about 10m. The crossing has been restored by placing a temporary Bailey bridge.

Figure 2.59: Destroyed bridge (Type 1) at Akurala and the replaced Bailey bridge

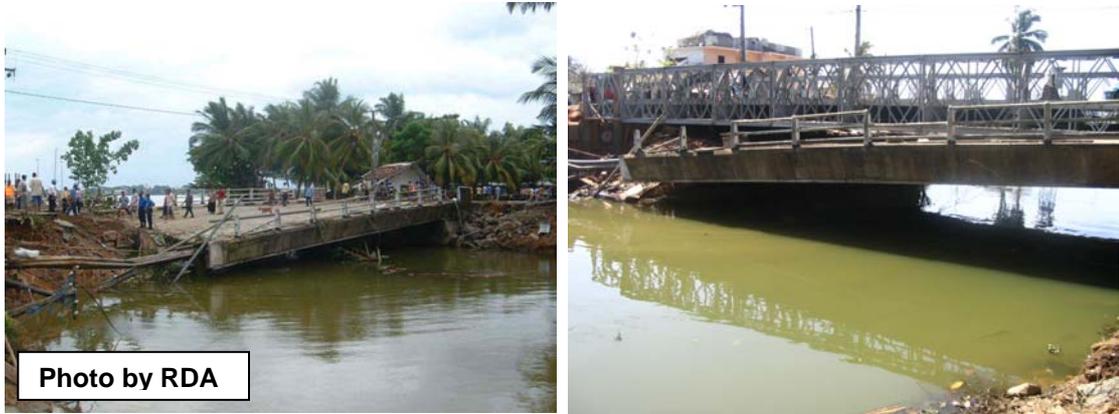
Figure 2.60 shows the damaged Magalle Bridge (Type 1) south of Galle City on the route to Matara. The 8m long RC deck slab failed when its masonry retaining wall type abutment was severely damaged and washed away. The abutment disintegration appears to have been caused by scouring and erosion from the receding water where the retained side of the abutment was exposed to the river on the landward side as shown in Figure 2.61. The seaward side of the abutment is however protected by the abutment structures (or rock armour) running parallel to the road hence the advancing tsunami could not damage the abutments. A temporary Bailey bridge was placed to maintain the flow of traffic across this major route.

Figure 2.60: Collapsed Magalle Bridge (Type 1) south of Galle due to abutment erosion and scour damage. Temporary Bailey bridge in place to restore the vital crossing

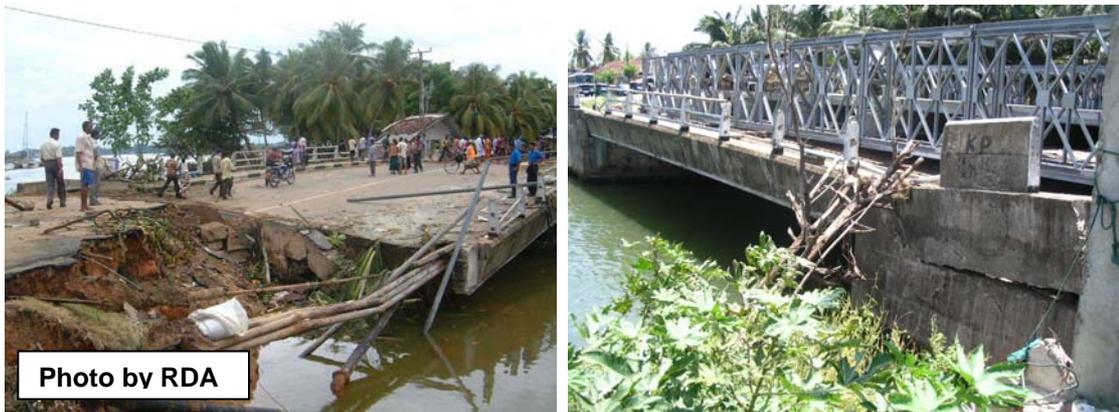
Figure 2.61: Exposed retained side of the abutment in the landward side at damaged Magalle bridge. Protected abutment on the seaward side by abutment structures running parallel to the road

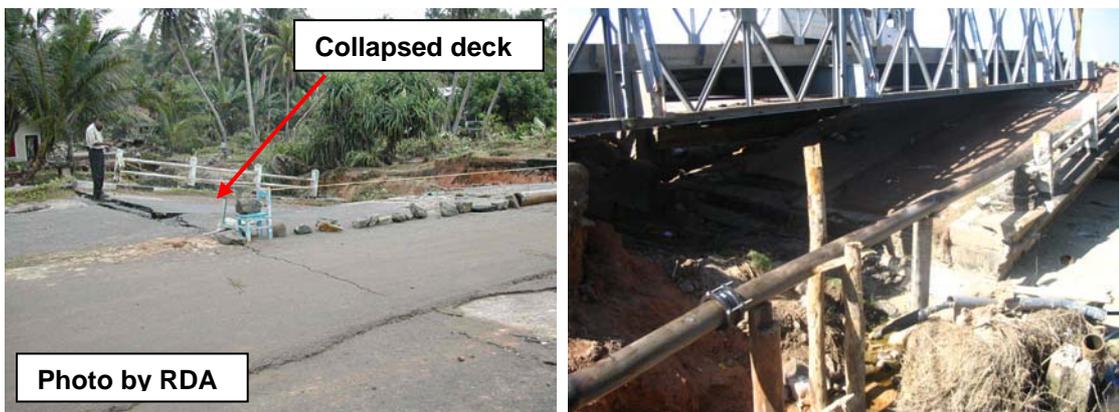
The 6.5m long Type 1 bridge at Goviyapana (between Ahangama and Weligama) lost its southbound lane (furthest from the sea) due to scouring of its abutments as shown in Figure 2.62. The damage to the masonry abutments appears to have taken place from the receding water since the abutment on the landward side is exposed as with the Magalle bridge. The southbound carriage was restored by a temporary Bailey bridge.

Figure 2.62: Collapsed southbound carriage of Goviyapana bridge (Type 1). Collapse due to erosion and scour damage to the abutment on the landward side. Temporary Bailey bridge in place to restore the carriage way

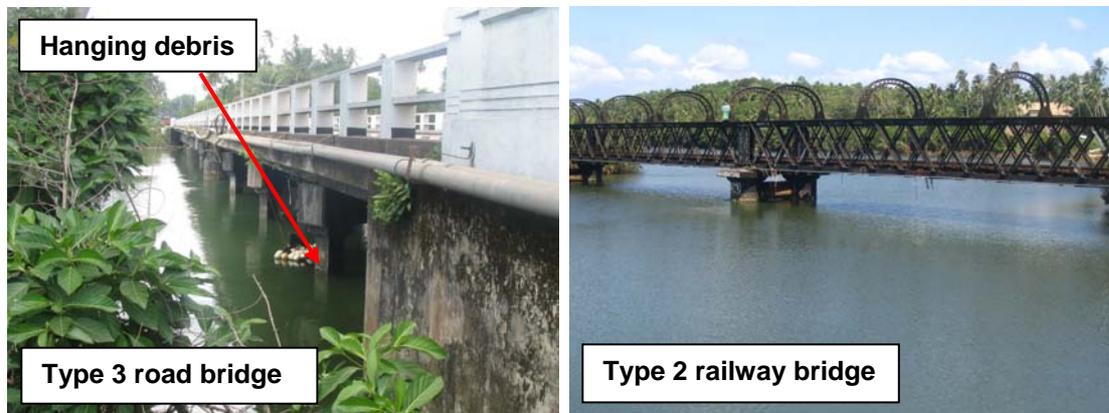
At Weligama two parallel 80m span bridges had performed well and were undamaged despite evidence (hanging debris) that they had been overtopped by rising water levels in the river due to the tsunami (Figure 2.63). The bridges consisted of a RC slab road bridge (Type 3) along Road A2 supported at 5m spans by reinforced concrete piers and a steel truss type railway bridge (Type 2).

Figure 2.63: Two parallel 80m span bridges (Types 2 and 3) at Weligama that performed well. Note the presence of a fishing net suspended from the base of the road bridge deck, indicating water probably overtopped the bridge during the tsunami

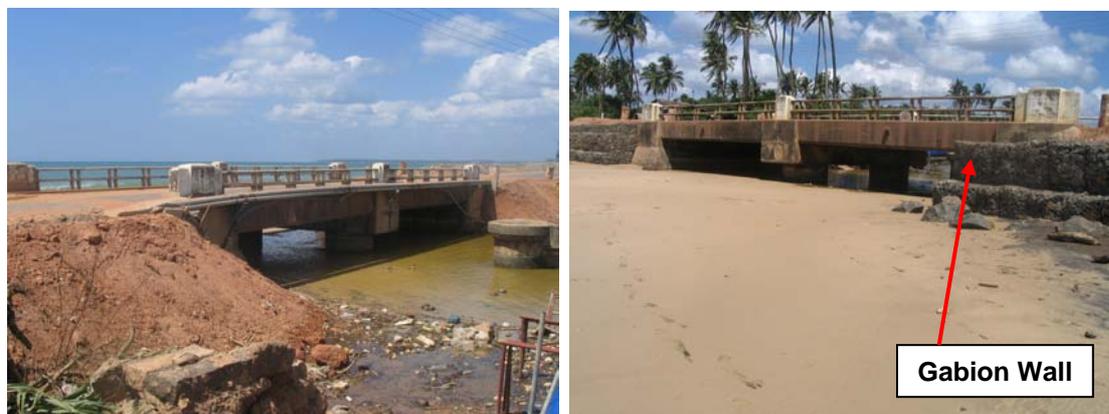
The 15m long bridge (Type 1) in Devinuwara (Dondra) has suffered damage to the approaches as shown in Figure 2.64. The approaches appear to have been exposed to the sea prior to the tsunami hence may have been damaged by the advancing tsunami. The approaches have been restored by backfilling to the level of the bridge and constructing a gabion protection wall. The bridge deck was not damaged despite the damage to approaches and exposure of the abutments since the abutments are reinforced concrete unlike the bridges in Magalle and Goviyapana where the abutments were masonry with a concrete facing. Gabion wall was constructed to reduce the exposure of the abutments to the sea.

Figure 2.64: Damage to Devundara (Dondra) bridge (Type 1) approaches. Approaches restored and gabion protection wall constructed on the side exposed to the sea

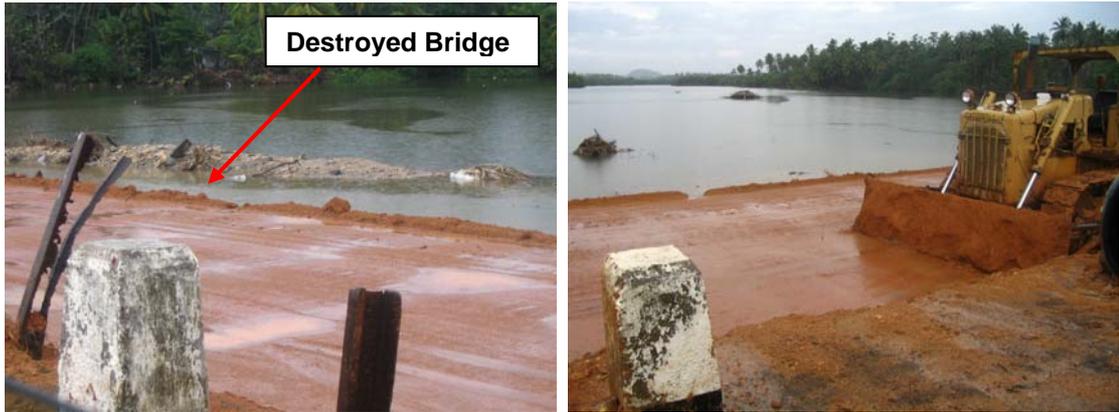
Although most of the railway bridges were Type 2 and suffered little or no structural damage, two causeway bridges were observed by EEFIT to have been destroyed. Figure 2.65 shows the causeway bridge at Kosgoda just north of Balapitiya where a 300m long causeway bridge section was complete destroyed. At the time of the survey, backfill was in place adjacent to the existing Road A2 to relay a new track. The 150m long causeway bridge just south of Ambalangoda was also destroyed and a new crossing was under construction at the time of the survey similar to that in Kosgoda.

Figure 2.65: Destroyed causeway bridge at Kosgoda (north of Balapitiya). Backfilling and leveling taking place to lay a new railway track

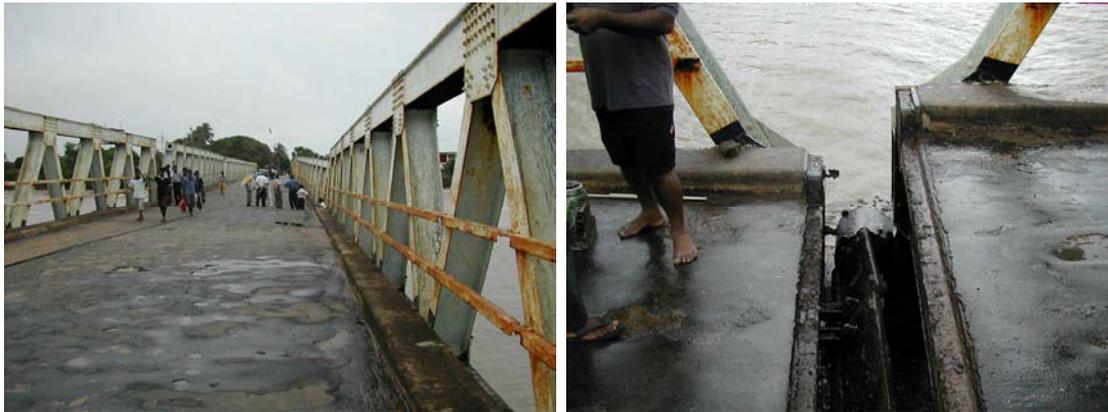
Figure 2.67: Severe distortions to the Arugambe bridge due to tsunami impact and foundation settlement and shearing at the connections to the piers (Photos by RDA)
