**The Indian Ocean Tsunami of 26 December 2004:
Mission Findings in Sri Lanka and Thailand**

**Antonios Pomonis, Risk Management Solutions
Dr Tiziana Rossetto, University College London
Dr Navin Peiris, Arup, London
Dr Sean Wilkinson, University of Newcastle
Domenico Del Re, Buro Happold, London
Raymond Koo, Arup, Hong Kong
Raul Manlapig, Arup, Philippines
Dr Stewart Gallocher, Halcrow, Glasgow**

Earthquake Engineering Field Investigation Team
Institution of Structural Engineers
11 Upper Belgrave Street
London SW1X 8BH
United Kingdom

February 2006

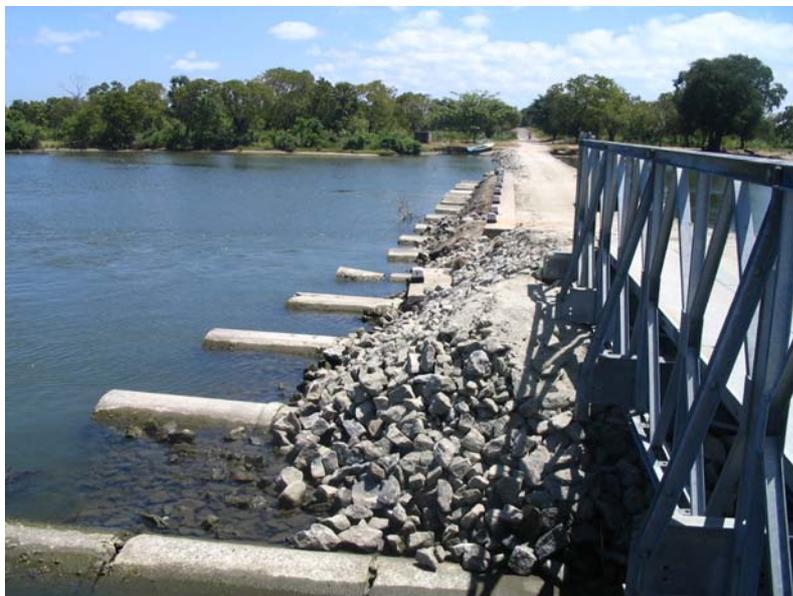
Figure 2.68: Restored causeway bridge in Kinniya near Trincomalee (Photo by Anton Pillai, Arup)

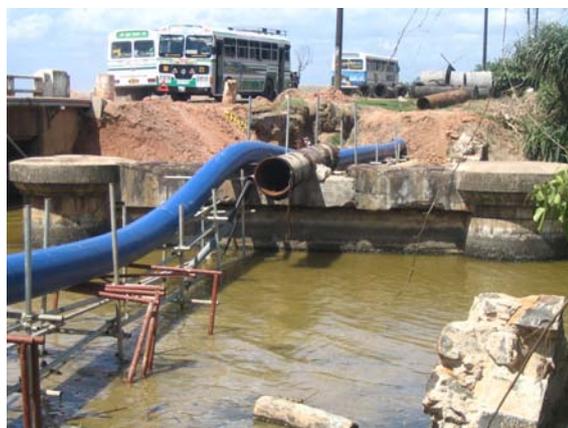
Figure 2.69: Newly restored water supply across an old bridge crossing in Dondra adjacent to the bridge where the abutments were eroded

The drinking water supply system was restored within about 10 days after the disaster in the Western and Southern provinces. Figure 2.69 shows a newly restored water supply across an old bridge crossing in Dondra adjacent to the bridge where the abutments were eroded (see Figure 2.64). Bottled water was supplied in the interim period. Some areas where the water supply system could not be repaired were supplied drinking quality water using tankers by the National Water Supply and Drainage Board (NWSDB). Figure 2.70 shows a tanker refilling from a roadside supply point in Hikkaduwa.

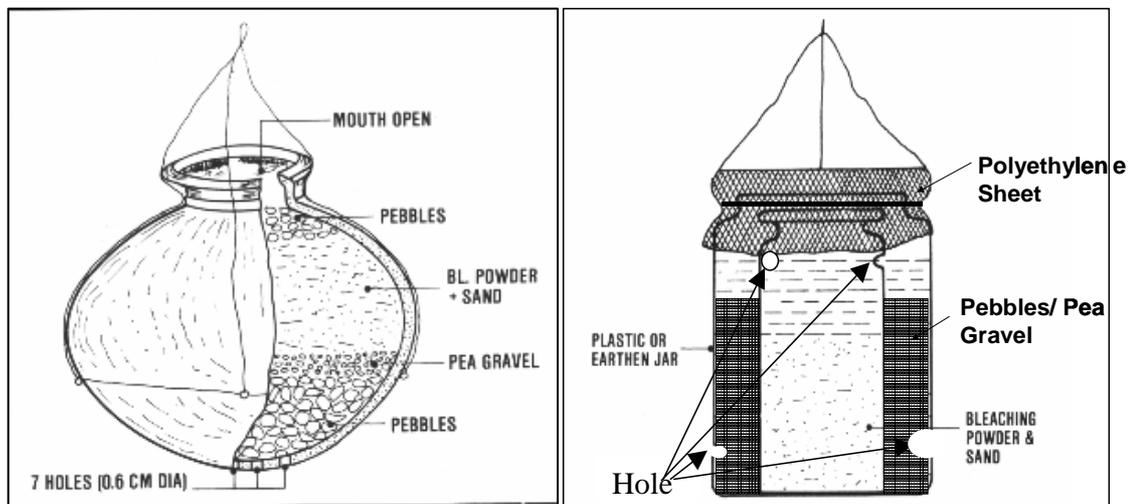
Figure 2.71: Purification of well water for drinking using pot chlorination (Surendran, 2005)

locally available material and bleaching powder (or chlorinated lime) as shown in Figure 2.71 (Surendran, 2005).

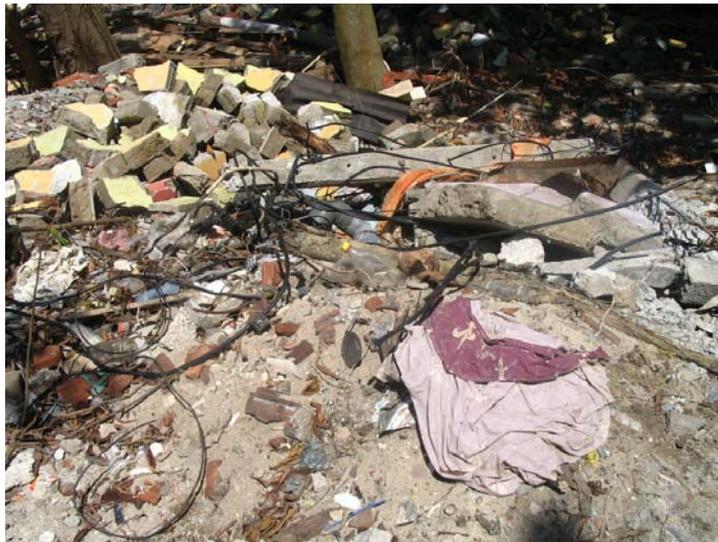
Figure 2.72: Damaged local electricity supply pole in Unawatuna Beach

Many supply poles were not damaged directly from the tsunami since their smaller cross sectional area offers little resistance to the flow of water. Damage shown above may have been due to debris flow and impact from other collapsing structures. Due to the localized damage, the power supply was quickly restored in the Western and Southern Provinces within two weeks. Lighting needs were met using paraffin lamps while electricity was being restored.

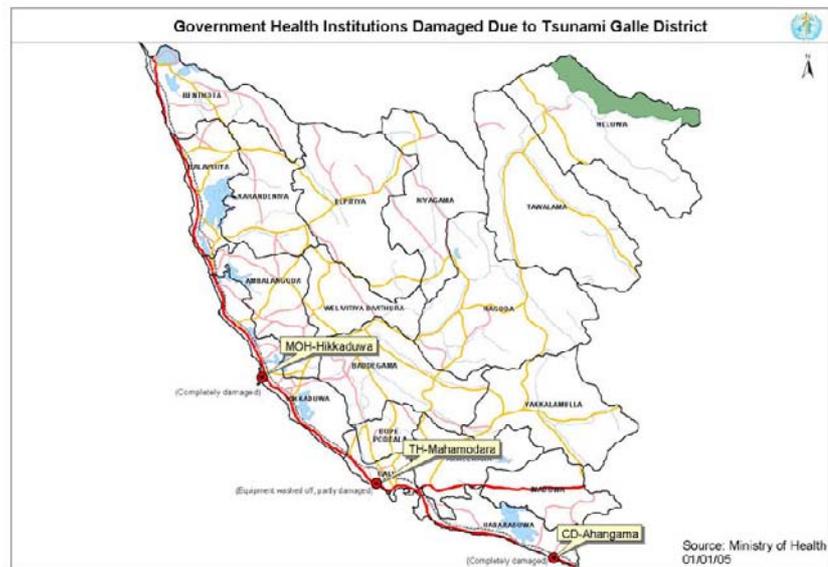
Figure 2.73: Damaged hospitals in Galle District (Southern Province)

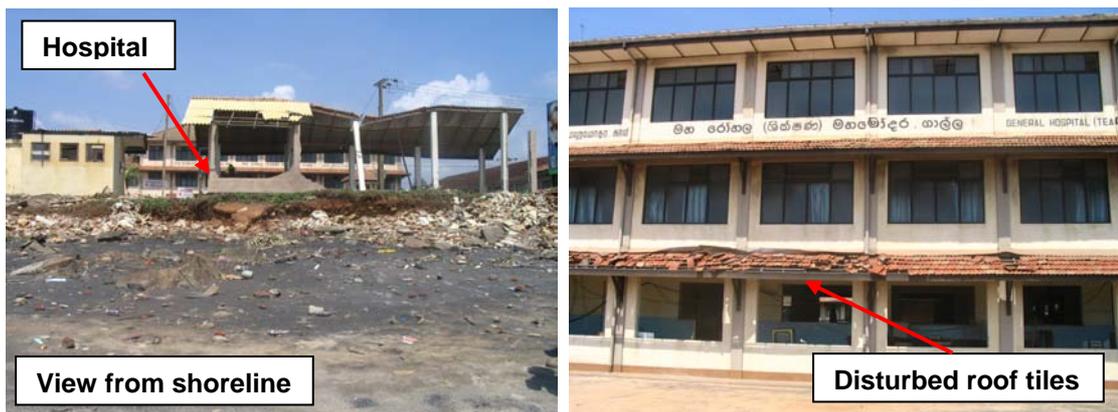
Figure 2.74: Mahamodara hospital (Galle) suffered moderate damage but lost equipment in the ground floor due to inundation

Figure 2.74 shows the Mahamodara hospital in Galle located within 100m of the coastline. The hospital structures were typically 3-storey reinforced concrete frame and slab type (Cat. D) with masonry infill panels. The structures suffered moderate damage (DC1) with the load bearing members intact. However the ground floor facilities were completely destroyed from the advancing tsunami and inundation killing and injuring patients and staff. It should be noted that patients, staff and those who managed to go up to the upper storeys survived the tsunami since the water level did not rise above the first floor as indicated from the disturbed tiles on the shading overhangs (see Figure 2.74). The hospitals services have since been moved to Karapitiya hospital in Galle that survived the tsunami since it is located on high ground at a distance of about 1km from the coast. More hospitals were damaged in the Eastern and Northeast Provinces as shown in Figure 2.75 and the damage was substantial since the exposure to the tsunami was high in these areas. Figure 2.76 shows the damaged Kinniya hospital in Trincomalee (Pillai, 2005). Many of the healthcare facilities were provided at makeshift hospitals set up near camps for internally displaced persons.

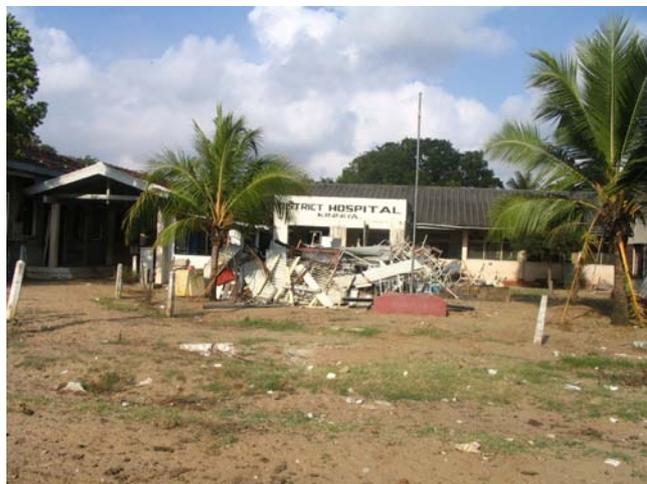
Figure 2.76: Damaged Kinniya district hospital in Trincomalee (Photo by Anton Pillai, Arup)

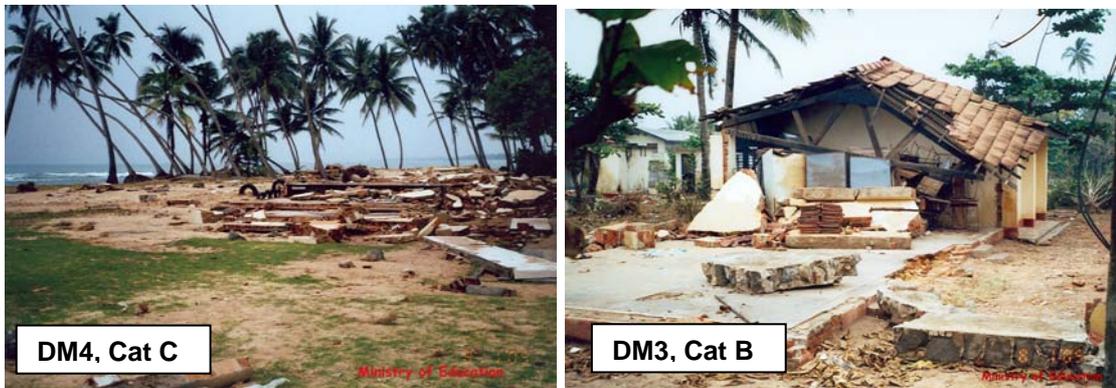
Figure 2.77: Destroyed school (Cat. C) in Akurala and heavily damaged school building (Cat. B) in Gintota (Southern Province)

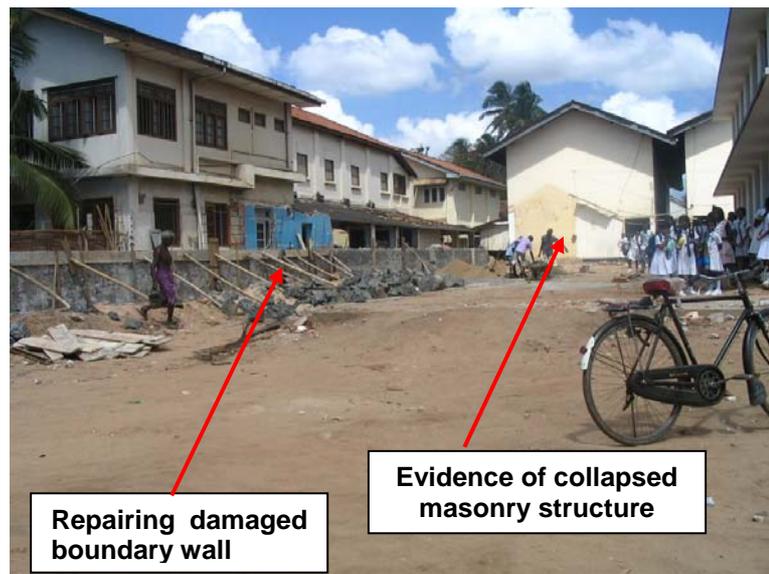
Figure 2.78: School in Matara (Cat. D) suffered minor damage with damage to a masonry structure attached to a school building and to the boundary wall under repair

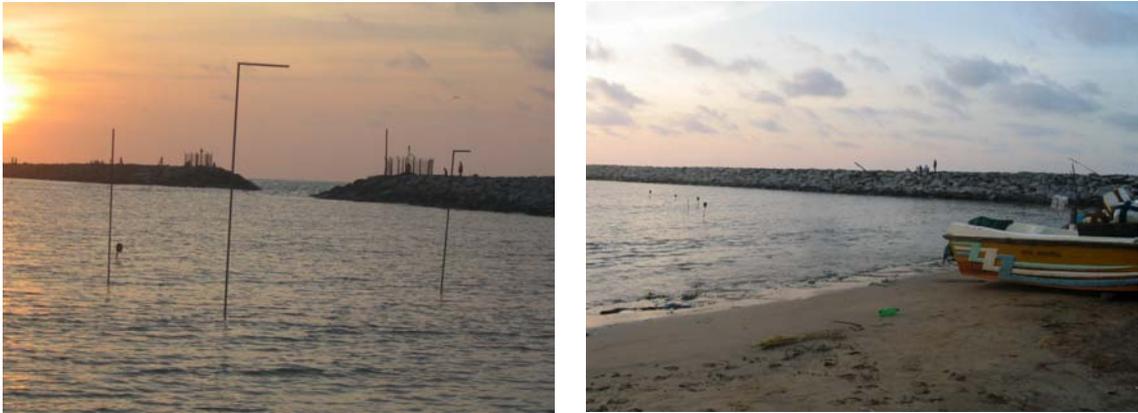
Fishing harbours and boat landings encountered during the EEFIT survey appears to have survived with little damage to the harbour protection structures. Figure 2.80 shows the harbour in Beruwala where the breakwater appears to be intact with no indication of displacement of the rockfill. Figure 2.16 shows the breakwater overtopped by the rising tsunami water but remaining intact. The small fishing harbour in Hikkaduwa has also survived the tsunami with a small region of slope failure within the harbour side as

Figure 2.80: Beruwala fishing harbour with no visible damage to the breakwater

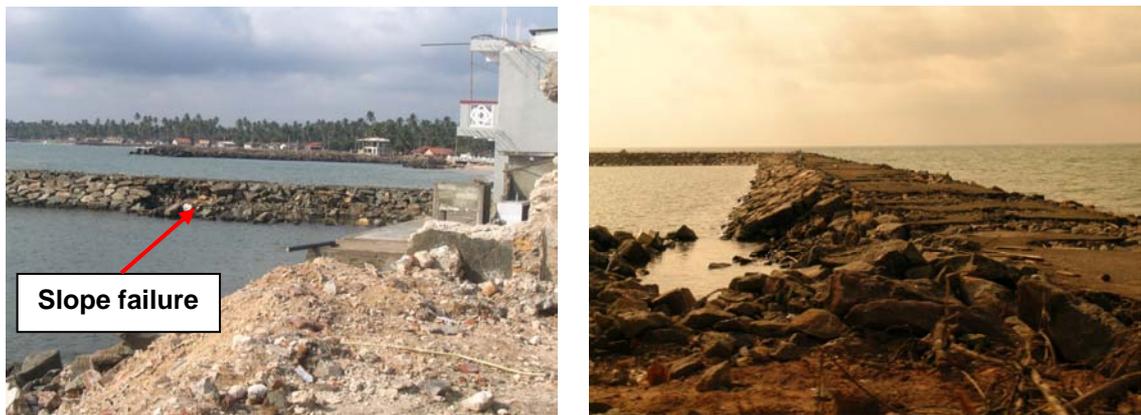
shown in Figure 2.81. Asian Development Bank (2005) reports that there was considerable damage to fishing harbours in Hambantota and Trincomalee districts. Many of these harbours require extensive dredging and removal of debris and sand from the basin. There were damages to the service facilities and harbour equipment including shore structures, dredgers, heavy mechanical equipment, ice plants, buildings, boat repair yards etc.

Figure 2.81: Slope failure in the harbour side of the rockfill breakwater in Hikkaduwa

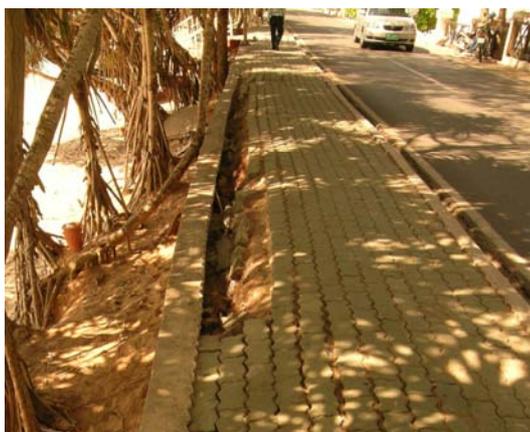
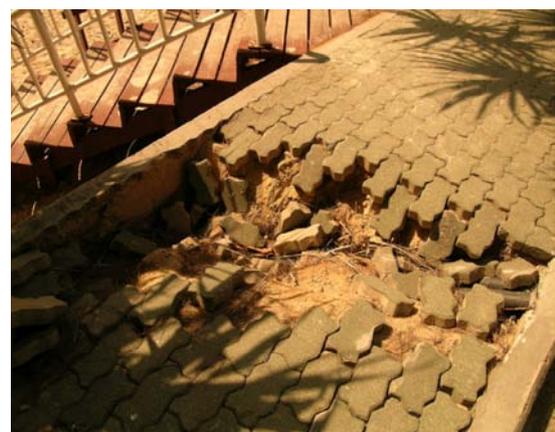
Figure 3. 3: Minor seawall damage at Kata Beach

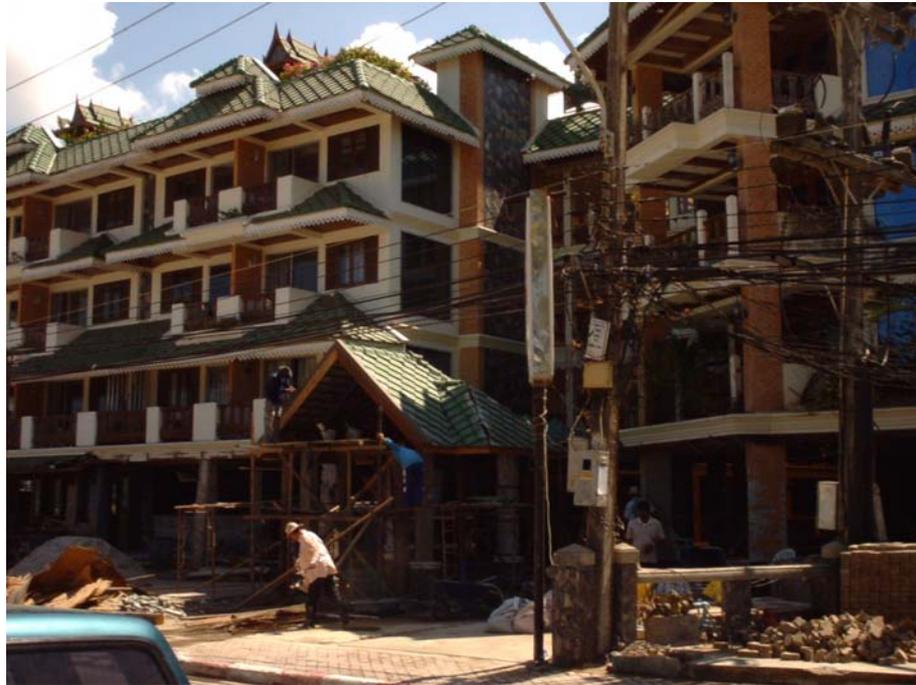
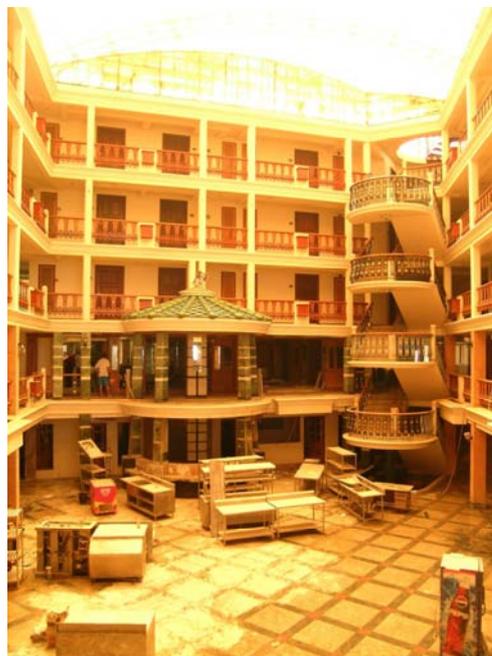
Figure 3. 5: Sea Pearl Beach Hotel on Thaweewong Road, Patong: (a) external view of hotel entrance and (b) internal view of the hotel. The hotel had moderately damaged infill masonry walls and columns in the basement and ground floors. Broken windows in the 1st storey of the building indicate a flood height of 5m above ground level. The hotel was under repair at the time of the field mission.

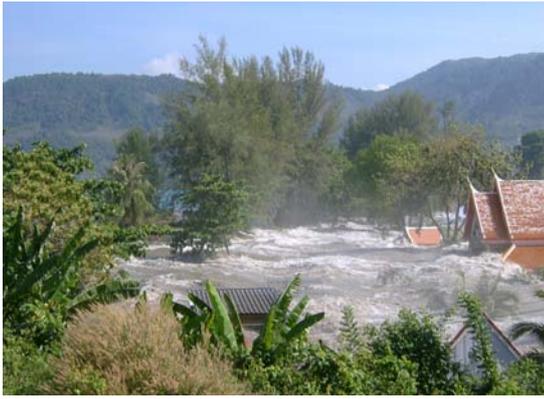
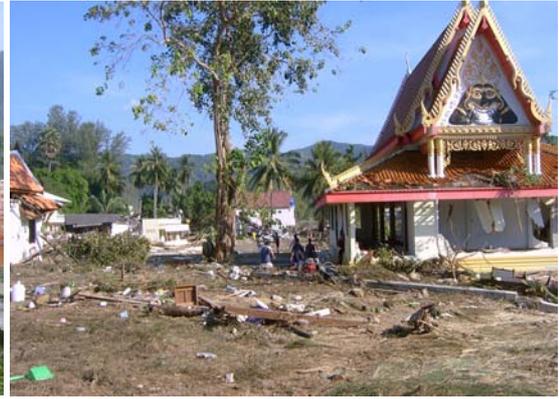
Figure 3.7: Pictures of traditional Thai Buddhist temples at Kamala Beach during (a) and after (b) the tsunami (Source: Srivichai S., Chid tong Y., Supratid S., and Shuto N., Rangsit University, Thailand).

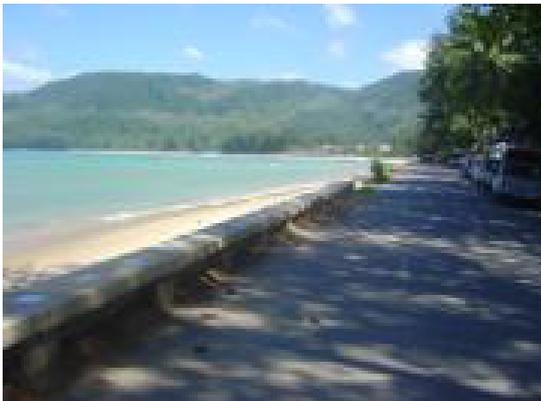
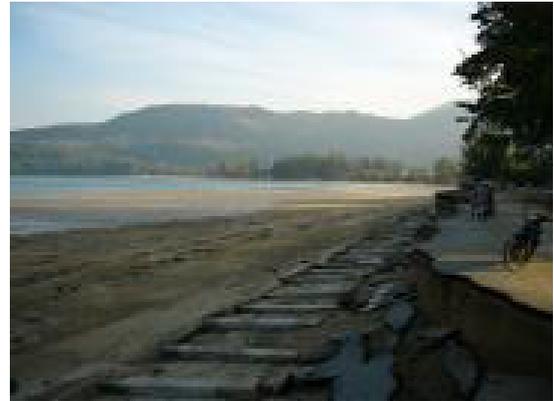
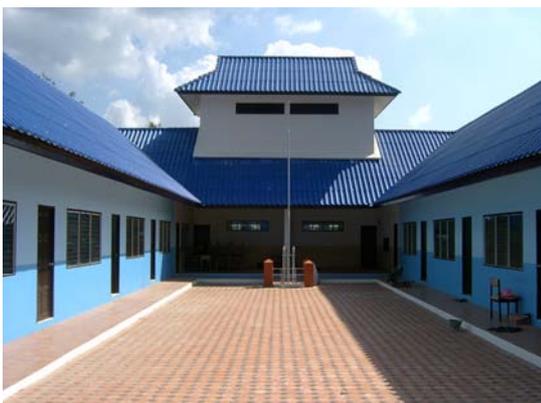
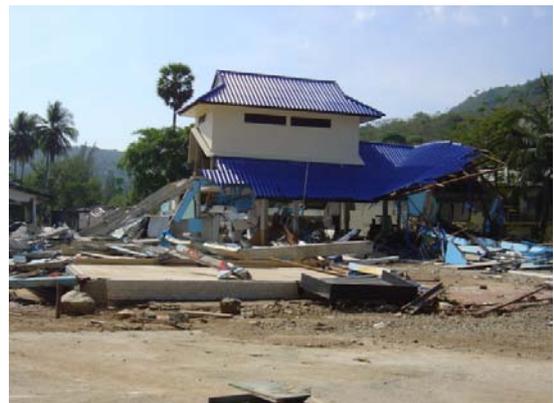
Figure 3.8: Pictures of (a) coastal road and (b) a school at Kamala Beach. before (left) and after (right) the tsunami (Source: Srivichai S., Chid tong Y., Supratid S., and Shuto N., Rangsit University, Thailand).

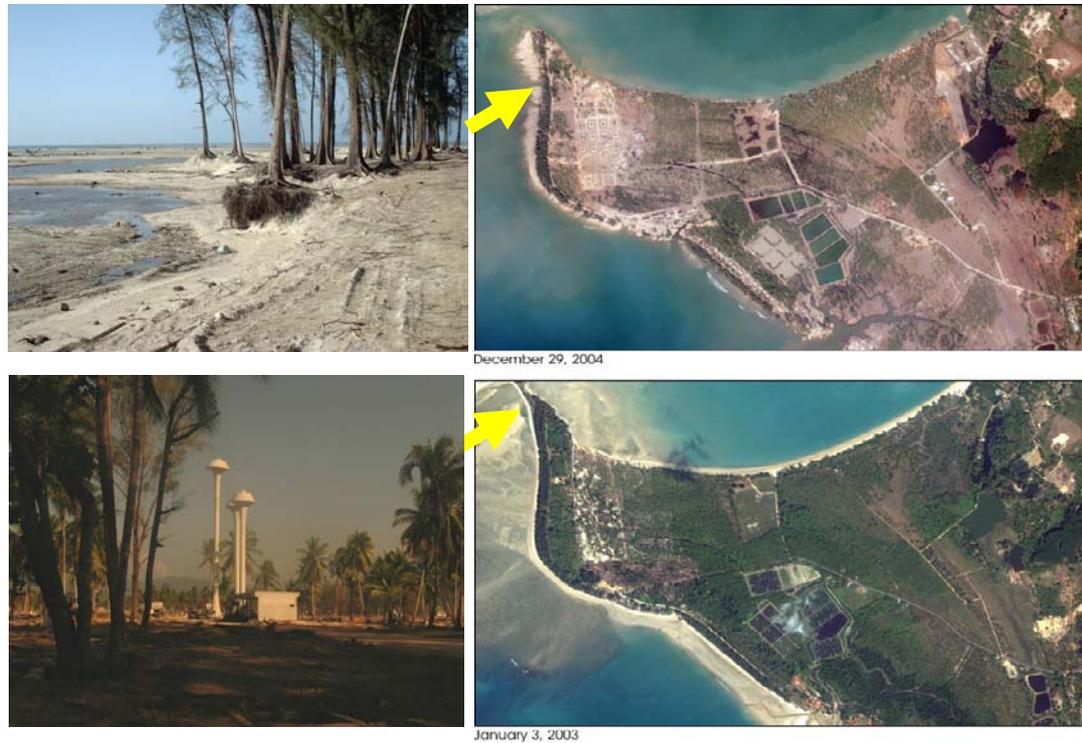
Figure 3. 13: IKONOS satellite pictures of the Laem Pakarang Cape in Khao Lak before and after the tsunami (lower and upper right, respectively (<http://earthobservatory.nasa.gov>), and beach erosion (upper left) observed at the location indicated by the arrows. Water towers observed at this and all other locations generally survived intact.

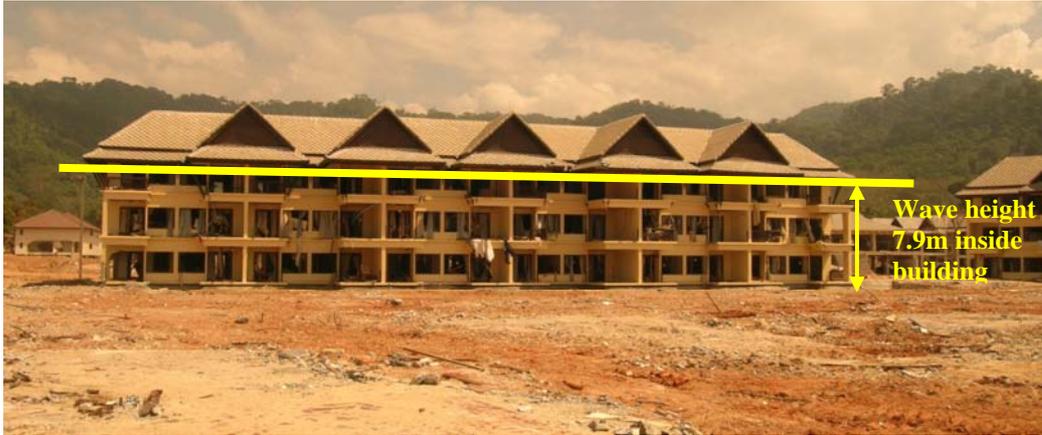
Figure 3. 15: Khao Lak Seaview Resort. Wave height was established from measurements made inside this hotel, sited approximately 150m from the beach and approximately one metre above sea level. There were only small 'bar' and pool type structures between this building and the ocean (all of which had been destroyed). Structural damage to this building was limited to windows and a few masonry infill walls, with the corner columns on the left front side also damaged presumably from debris impact.

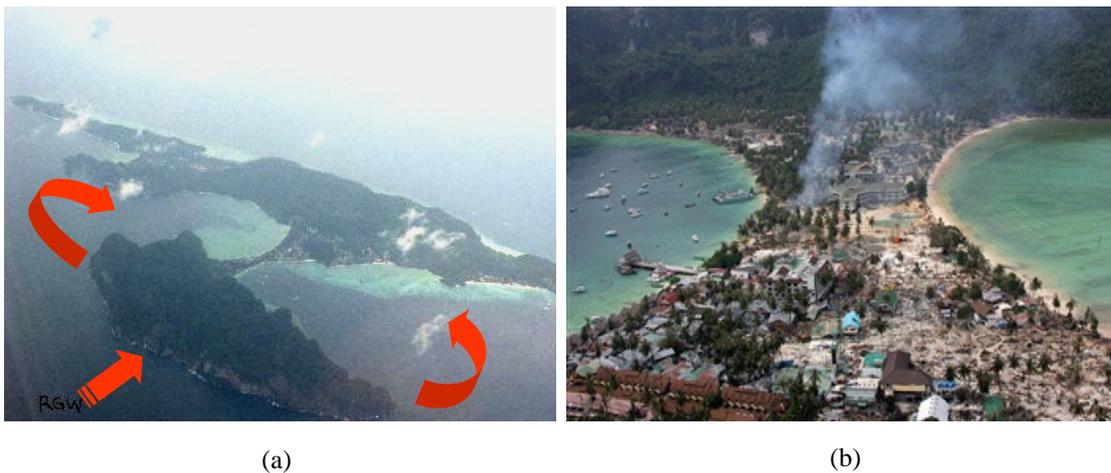
Phi Phi Island (Figure 3.16a), part of Krabi Province, lies approximately 54km east of the southernmost tip of Phuket Island. The land between Ton Sai bay to the south and Loh Dalam bay to the north is a narrow sand tombolo and was swept by the tsunami (Figure 3.16b). The tombolo is barely 200 metres wide at its narrowest and increases to a maximum of 1km at the foot of the cliffs to its east and west. These karstic cliffs are the remnants of ancient coral reefs, a geo-morphological feature common in the Andaman Sea and other parts of Southeast Asia (e.g. Ha Long bay in Vietnam), and rise steeply from the sea to form the rest of Phi Phi Island. The waves hit the land strip from both bays, first from the north and a few minutes later from the south (Figure 3.16a).

Figure 3. 16: Aerial views of Phi Phi Island and Ton Sai Bay: (a) The arrows indicate how the tsunami was refracted around the western granite cliff and hit the narrow land strip (tombolo) from both the North and South directions. (b) Ton Sai Bay four days after the tsunami.

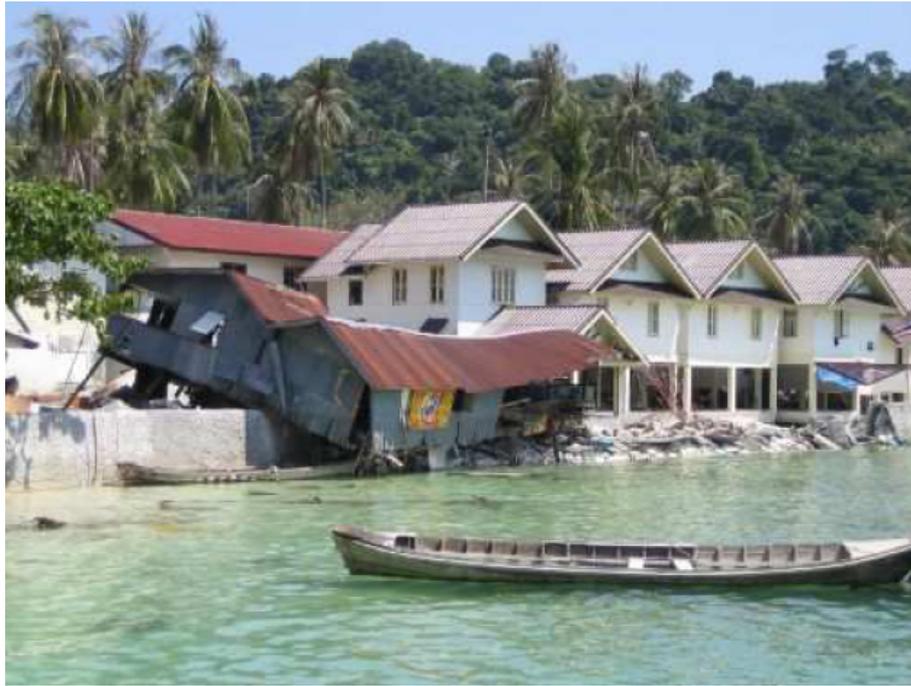
Figure 3. 17: A collapsed timber frame and corrugated iron-clad habitation on the Southeast coast of Ton Sai bay, Phi Phi Island.

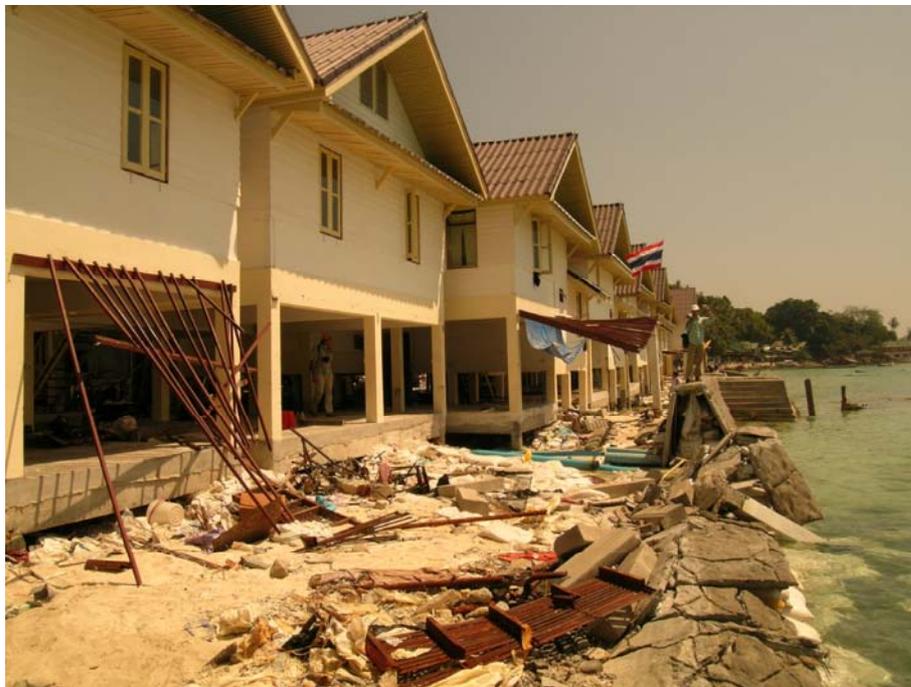
Figure 3. 18: Reinforced concrete frames with open ground stories on the south-eastern side of Ton Sai Bay, Phi Phi Island.

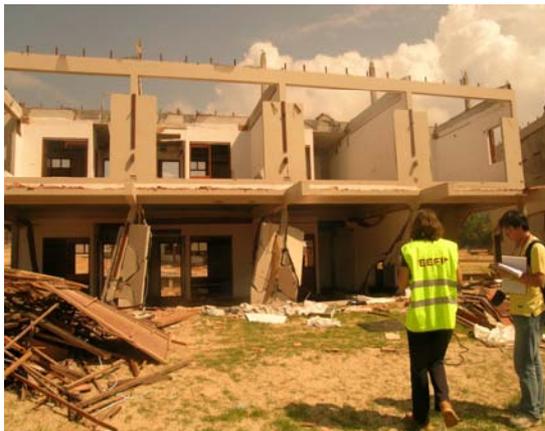
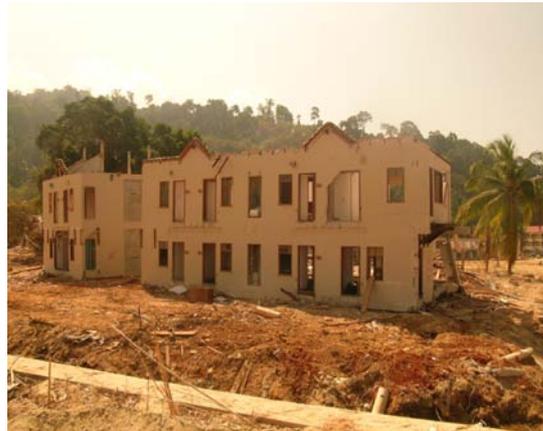
Figure 3. 25: Damage on two sides of the same building in Khao Lak, oriented with its smaller plan dimension parallel to the shore: (a) shows that one side of the structure has suffered a soft storey failure, while (b) shows the other side of the structure has reasonable structural integrity.

Infill walls were generally observed to be 100mm thick un-reinforced masonry made of clay bricks or concrete blocks on cement mortar. In the better quality construction double-skin walls are built. These infills are considered non-structural by the Thai codes. Many of these infills suffered severe damage or collapse when located close to the shoreline and oriented parallel to the sea. Masonry infill walls perpendicular to the beach were seen to significantly increase the in-plane resistance to the tsunami as shown by Figure 3.25. In this building, one side resisted the tsunami by frame action, whilst the other

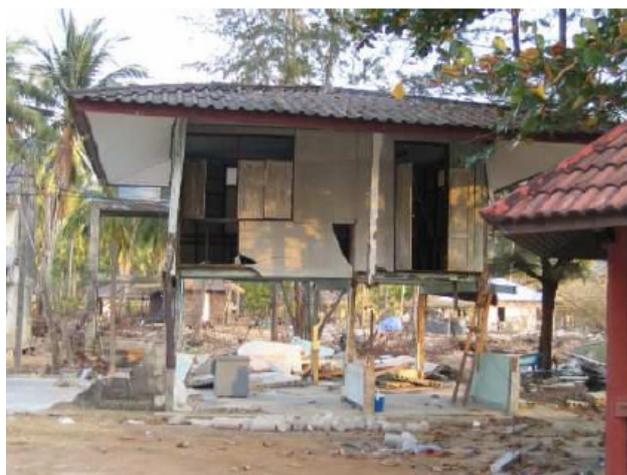
Very few such buildings survived the impact of the tsunami especially when water depths exceeded three metres (see Figure 3.26). The main characteristics of these structures are their light weight and their large proportion of openings (to aid ventilation in the tropical climate). Traditional Thai architecture contains numerous types of such buildings, but their contribution to the general construction activity of recent decades has decreased. They still constitute the predominant construction type in non-touristic fishing villages (e.g. Ban Nam Kaem in Phang Nga province). They were also seen in Bang Thao near waterways, supported on stilts and near the sea with some protection from wetness on the lower part of the wooden columns, and on dry land in Laem Pakarang. The roofs of these buildings are typically pitched timber and are either thatched or tiled.

Figure 3. 26: Timber frame structure in near collapse damage state located approximately 100m from the shore line at Kamala Beach.

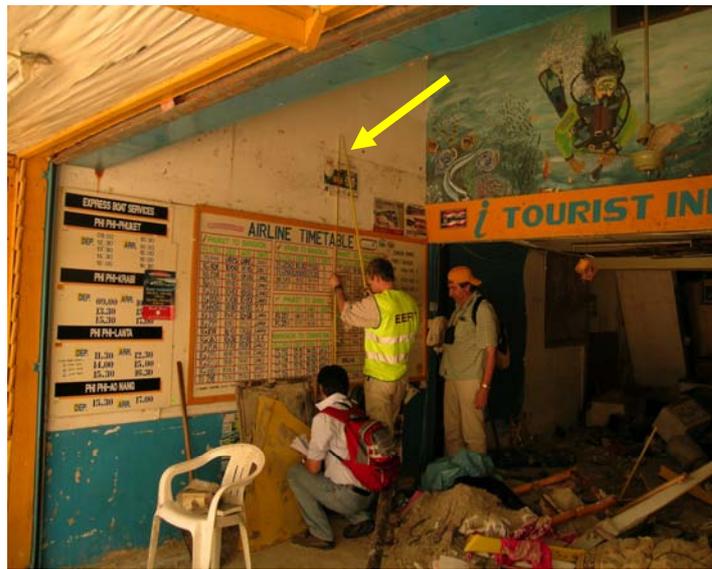
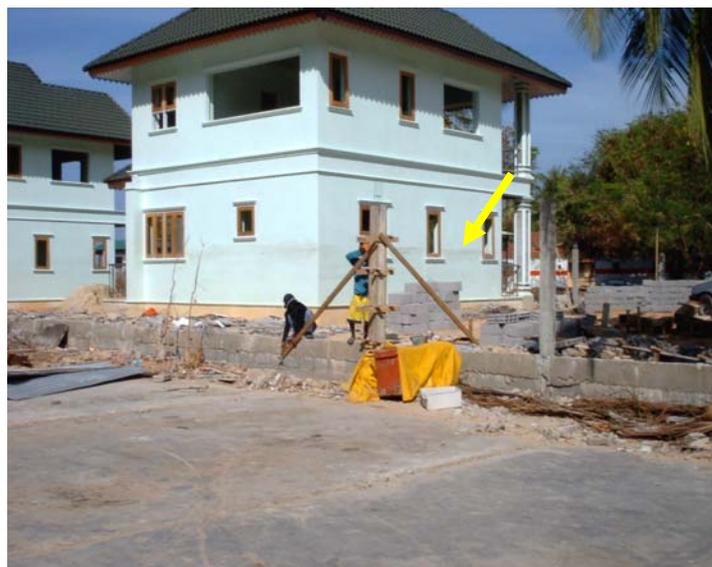
Observations of the wave height were made by the EEFIT team at several locations along the Thai coast between Khao Lak and Kata Beach, and on Phi Phi Island. Mud lines on buildings, hanging debris and consistent levels of uplifted roof tiles were used as indications of the water level (Figure 3.27). The level of stripped bark on palm trees was not used as an indication of the inundation height due to the flexibility of the palm trees and the likelihood of their bending significantly during the tsunami. The geographical coordinates were obtained from GPS readings.

Figure 3. 27: Examples of the mud lines (indicated with arrow) used to measure tsunami water height above ground in (a) Phi Phi Island and (b) Bang Tao.

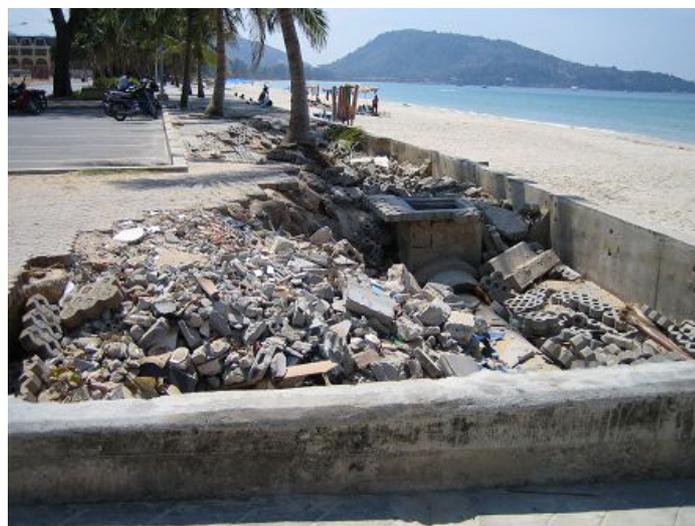
Figure 3. 42: Damaged pavement at Patong Beach, approximately 30m from the sea.

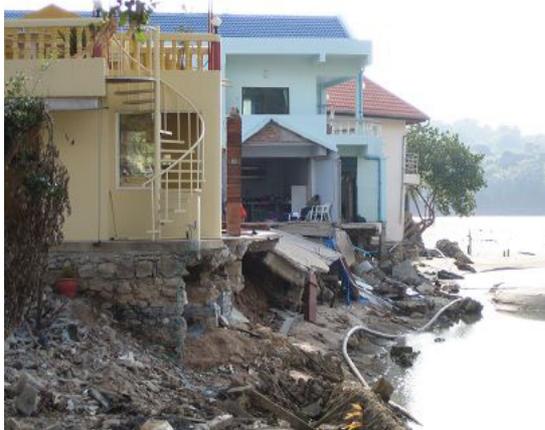
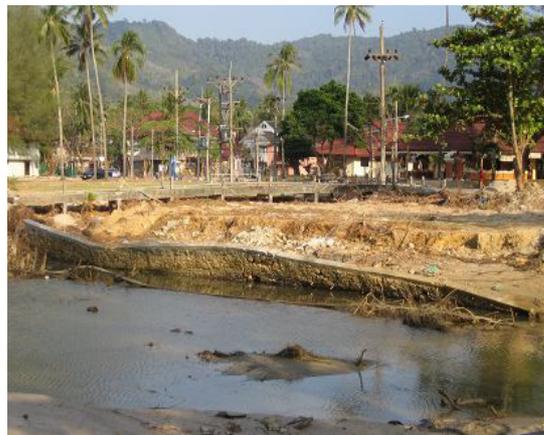
Most of the masonry walls (see Figure 3.44) and concrete gravity walls (see Figure 3.45) adjacent to the beachfront had suffered tilting, and/or partial or total collapse. It is unclear whether the incoming or outgoing waves caused this damage. Reinforced concrete retaining walls fared much better with the majority showing no apparent damage (an example is shown in Figure 3.46).

Figure 3. 44: Damaged masonry retaining sea wall in Kamala Beach.

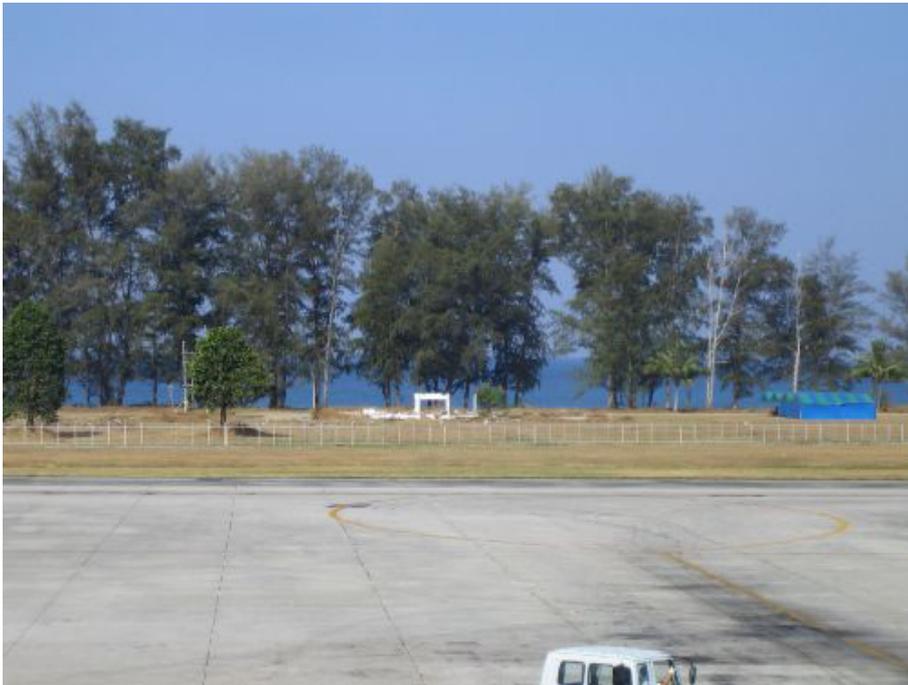
Flooding on the runway was reported at Phuket International Airport. The airport was closed for several hours due to high levels of sand and dust blown up by the initial shock of the wave. No significant damage was reported at the airport runway and buildings, however part of the lighting system was temporarily affected. The airport was re-opened by the Sunday evening of 27th December 2004 when flights arrived to Phuket from Bangkok containing aid workers that assisted the early stages of the rescue and clean-up efforts. Figure 3.47 shows the airport runway one month after the tsunami occurred.

Figure 3. 47: The runway at Phuket International Airport.

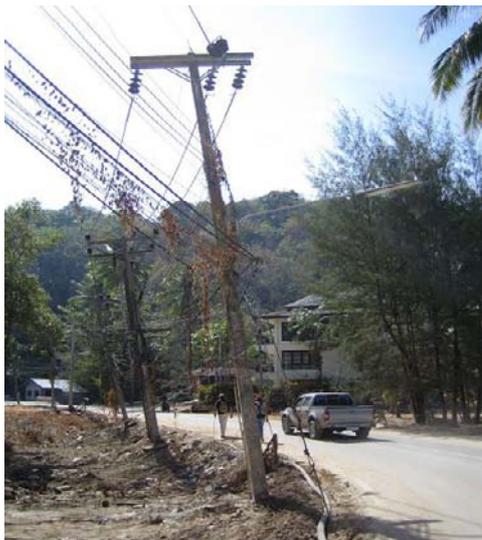
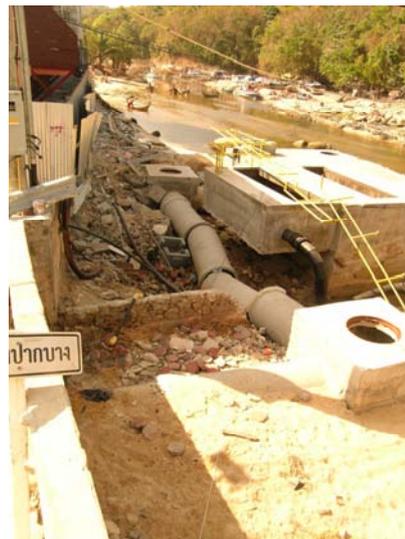
There was no serious long term disruption to the water and electricity supply in Phuket. Minor damage to electricity distribution posts on Bang Thao Beach was observed (see Figure 3.48) as well as Khao Lak and the beachfront of Patong. Electricity supply to tsunami affected areas of Phuket was temporarily suspended for two or three days with supply restricted to inundated areas. It is assumed that in the heavily affected areas of Khao Lak both water and electricity supplies were completely damaged. However, the speed with which supply was reinstated was remarkable. One month after the tsunami complete replacement of local overhead supply along damaged sections of the network was observed in Khao Lak and in Ban Nam Kaem (Bell et al. 2005). Some damage to drainage pipes was observed at the southern end of Patong Beach at the river inlet as shown in Figure 3.48. Flotation of underground services was also observed at several points around Khao Lak

Figure 3. 48: Examples of damage to water supply and electricity. Left: Minor damage to an electric power post on Bang Thao Beach located at approximately 150m from the coastline. Right: Damaged drainage pipe at the south of Patong Beach which is located at the river inlet.
