Observations from the 28th April 2007 Kent (Folkestone) Earthquake and Implications for EMS-98 Intensity Evaluation

Tiziana Rossetto¹, Matthew Free² and Marc Hill³

First published: 8 June 2012

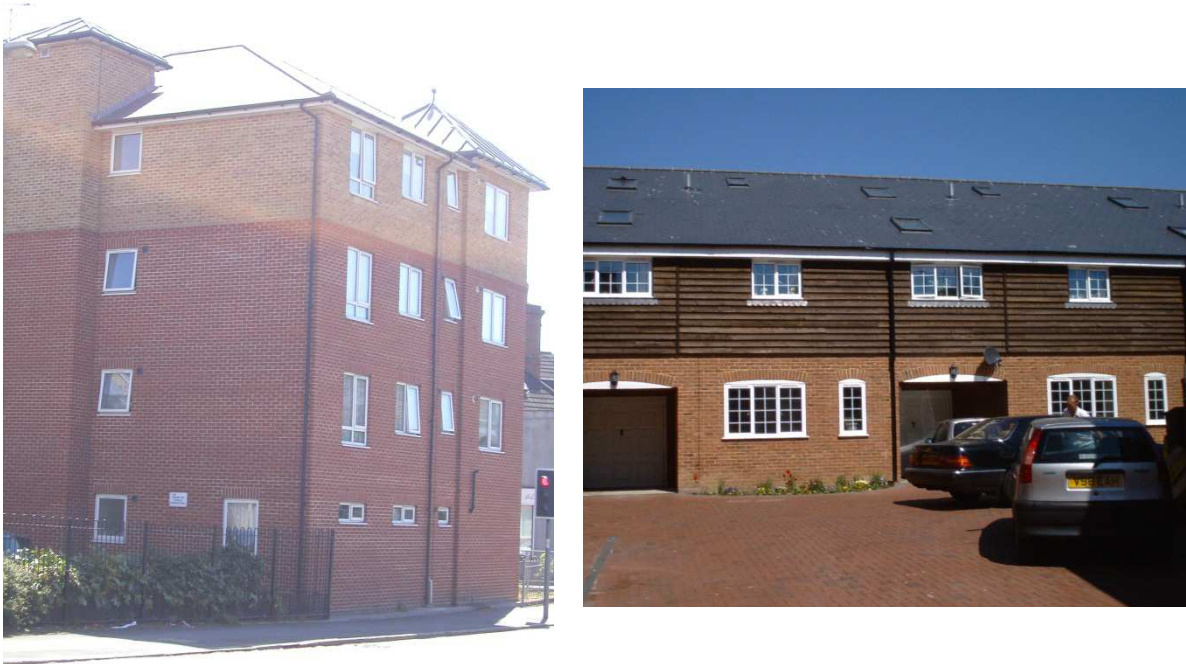
No recently constructed masonry buildings were seen to be damaged by the earthquake as illustrated in Figure 17. This is to be expected in a small earthquake and highlights the importance of good construction and maintenance in helping resist strong ground-shaking.

Figure 17: Examples of modern brick buildings with no damage. (left: building located at the junction of Park Farm road and Pavilion road, right: Pavilion Road).

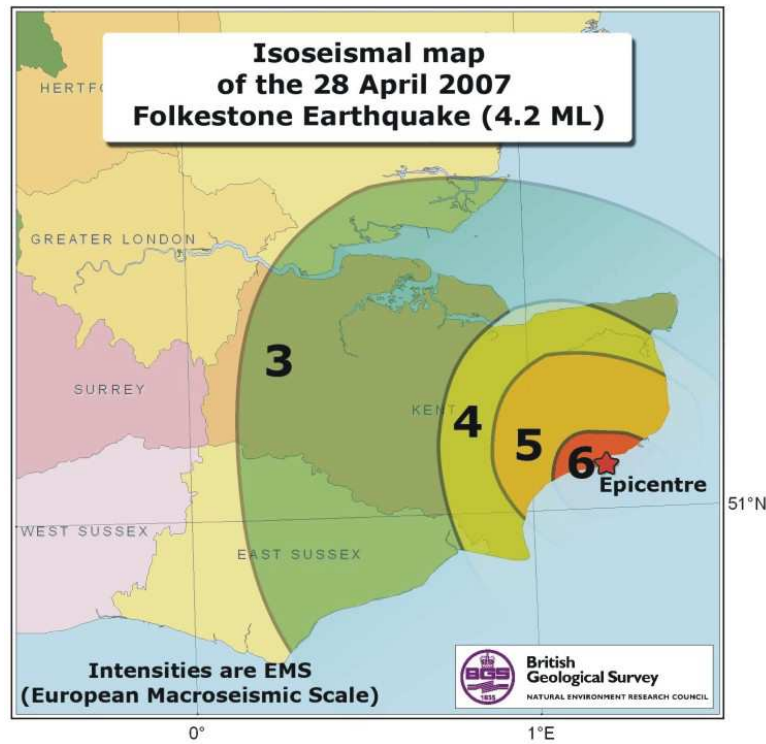
These observations differ with the intensity maps produced by BGS (reproduced in Figure 18), which peak at Intensity VII in central Folkestone and have wide isoseismals of Intensity VI and V extending far beyond the bounds of Folkestone. The BGS made preliminary assessments based on their online macroseismic questionnaire. However, as it is well-known that such questionnaires are unreliable for assigning large Intensity values, they also sent a team to look at the damage to verify the high levels of intensity being assigned by the questionnaire (Musson and Walker, 2007).

So why the discrepancy? This discrepancy arises from the assignment of grade 2 and 3 damage by BGS to housing in Folkestone where severe chimney damage has occurred. Essentially their interpretation of the EMS-98 Intensity damage scale is that only one element of the description of damage needs to be satisfied (i.e. damage to chimneys) to assign the level of damage. However, the general understanding in earthquake engineering is that all descriptive elements of the damage state should be satisfied in order for the damage state to be achieved. It is clearly wrong to assign intensity values based on one element only, more so if the assessment is made on the basis of a non-structural element such as a chimney. It is simple to see the problem if one thinks what the intensity assignment would be if there had been no chimneys in the affected houses. These values clearly can therefore not be used to compare the effects of the Folkestone earthquake with other European or international earthquake events, which assign EMS Intensity values based on a comprehensive satisfaction of the descriptive criteria in the damage scales.

In view of these arguments it is the authors' opinion that the BGS mapped intensity levels need to be decreased to values consistent with the observed building damage, as suggested herein.

Figure 18: Intensity map produced by the British Geological Survey (http://www.earthquakes.bgs.ac.uk/macroseismics/folkestone_macro.htm).
