The Ji-Ji, Taiwan Earthquake of 21 September 1999

Earthquake Engineering Field Investigation Team

Institution of Structural Engineers

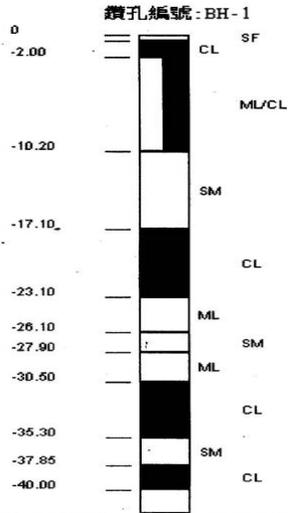
Fig.12 Soil classification based on bore hole data

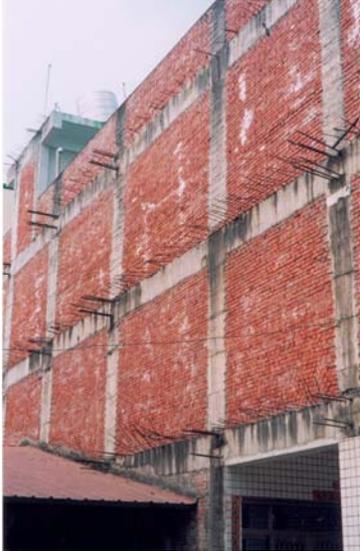
Most urban structures are built of reinforced concrete, with structural steel adopted for tall buildings. Unreinforced brick walls and infill panels are common, even in recent construction. Figure 26 shows typical construction.

Figure 26: Typical urban construction of a reinforced concrete frame with brick infill
