THE KASHMIR, PAKISTAN  
EARTHQUAKE OF 8 OCTOBER 2005  
A FIELD REPORT BY EEFIT

## A FIELD REPORT BY EEFIT

July 2008

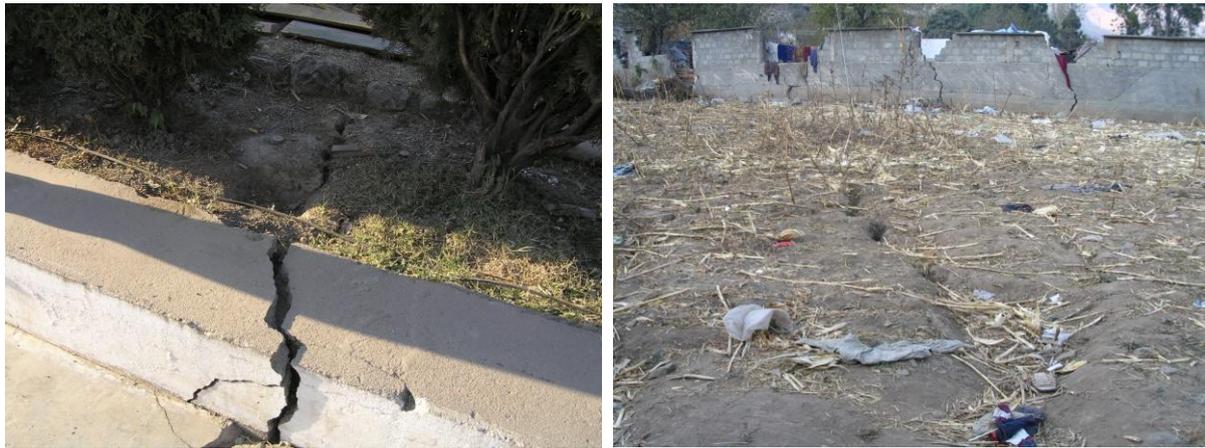
The surface trace of the causative fault as interpreted from the map of ground displacements from radar amplitude measurements (COMET, 2005) approximately coincides with that predicted by Bilham (2005) from observation of the location and orientation of large landslides resulting from the event. The majority of the landslides were indeed observed by Bilham (2005) and by EEFIT to extend from Balakot to a few kilometers SE of Muzaffarabad. An extension of this line of landslides was also observed by EEFIT together with Dr Bijan Kazai of the EERI team to coincide with a series of ground cracks running for 200-300 m through the town of Balakot (see Figure 3.2 for location). These were not associated with any direct land sliding and might be a further surface expression of the fault movement below the earth's surface or simply one of local slumping (Figure 2.8). The two black dots plotted on Figure 2.6 show some of the GPS readings taken of the crack trace. These dots are seen to lie almost directly over the fault line location prediction made by COMET (2005). However, this is a preliminary observation and more detailed follow up work on our observations is required before anything may be concluded. It is likely that fault rupture on the Muzaffarabad fault was mostly "blind" since there are many blind thrust faults in the region (MonaLisa, 2005).

**Figure 2.8: Photos of ground cracks observed by EEFIT and Dr Bijan Kazai (of Columbia University, New York, and member of EERI team) to run through Balakot in a NNW-SSE direction**

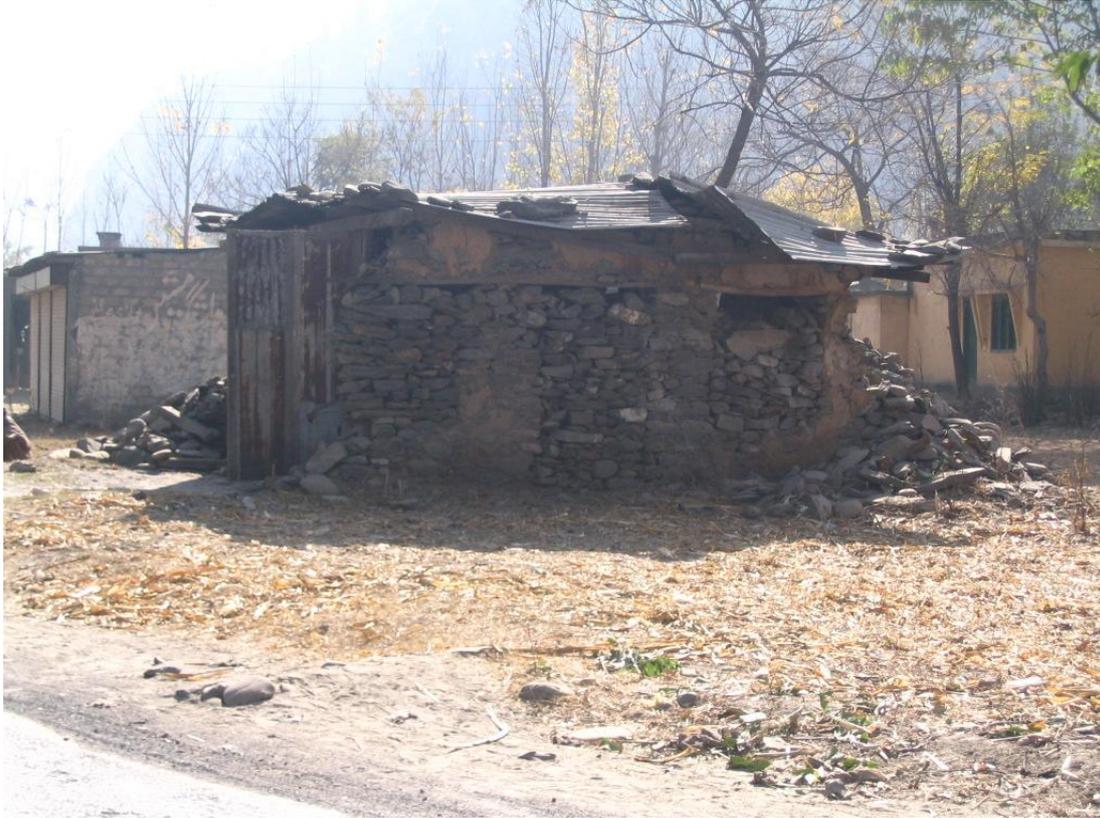
These buildings consist of walls made of stone (mostly rounded) irregularly laid in a cement, sand mud mortar or in some cases dry stacked. The roof is either a flat thatch/mud roof supported on wood beams or irregularly placed corrugated galvanized iron (GI) sheets. Figure 3.1 shows a typical unreinforced stone masonry building used for residential purpose. These types of houses locally known as “Katcha” or non-permanent houses are very common in rural or village areas rather than in the cities. Stone masonry buildings used for government or official buildings have stones that are cut and laid regularly using cement sand and mud mixtures with lintel beams above openings. Figure 3.2 shows the cracked walls of a government agricultural research office building north of Mansehra.

**Figure 3.1: Typical unreinforced stone masonry wall house (Katcha house)**

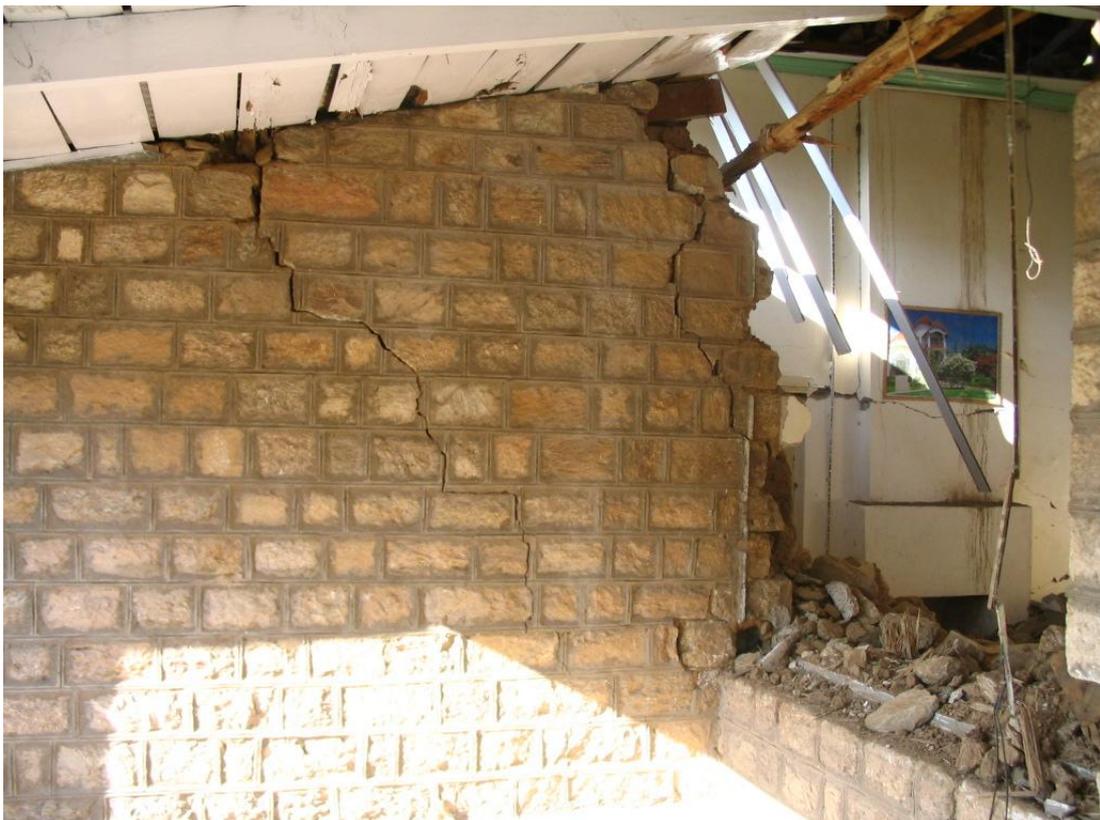
**Figure 3.2: Typical unreinforced stone masonry government or official building**

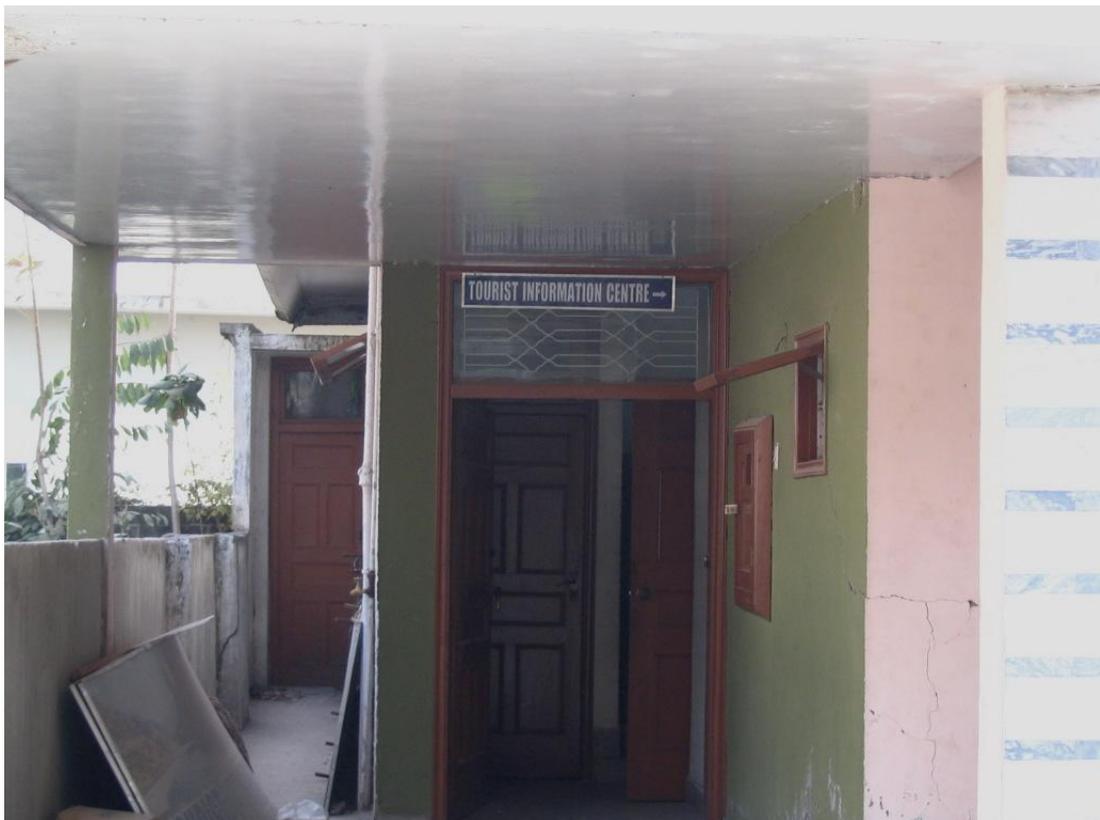
**Figure 3.6: Unreinforced brick masonry government building in Muzaffarabad**

Unreinforced brick masonry is mostly used for commercial/retail and government buildings in city areas. Very few are used for residential purposes since the unit cost of brick is higher than other forms of masonry. The residential buildings are known as “Pucca” or permanent houses. The roof of these structures is either made of light-weight pitched wood truss covered with corrugated GI sheets or of flat reinforced concrete (RC) slabs. Figure 3.5 shows a collapsed unreinforced brick masonry house in Balakot. Some brick masonry buildings are two storeys high with a RC slab roof. Figure 3.6 shows a government building (Muzaffarabad tourist information office) built using fired brick masonry walls with rendering.

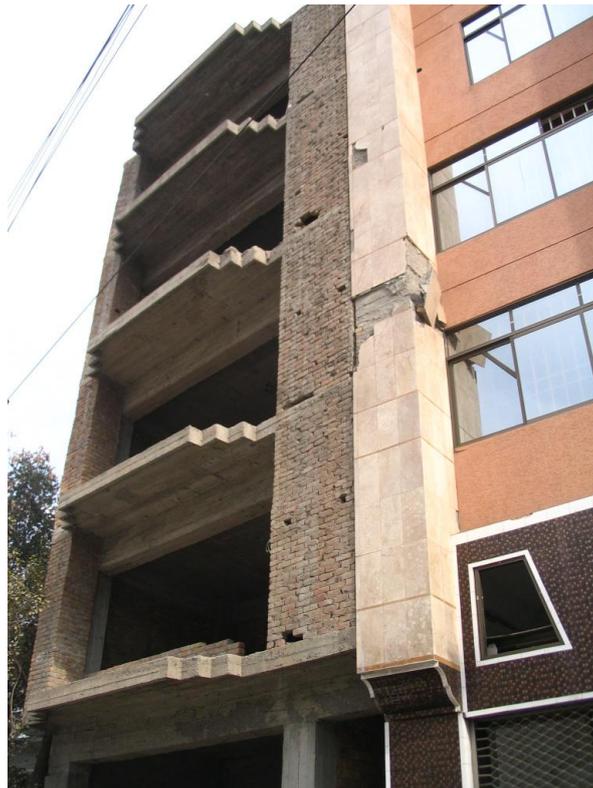
**Figure 3.8: Multi-storey RC building under construction adjacent to an existing office building in Muzaffarabad**

Reinforced Concrete (RC) construction is primarily used for commercial and retail buildings. The configuration consists of an RC frame with masonry infill. Figure 3.7 shows a typical RC frame commercial building, which was moderately damaged during the earthquake. Multi-storey RC structures have a composite RC frame and slab structure which extends to the roof level often used for housing services such as water tanks, air conditioning units etc. Figure 3.8 shows a multi-storey building in Muzaffarabad under construction adjacent to an existing multi-storey building used for office and retail.

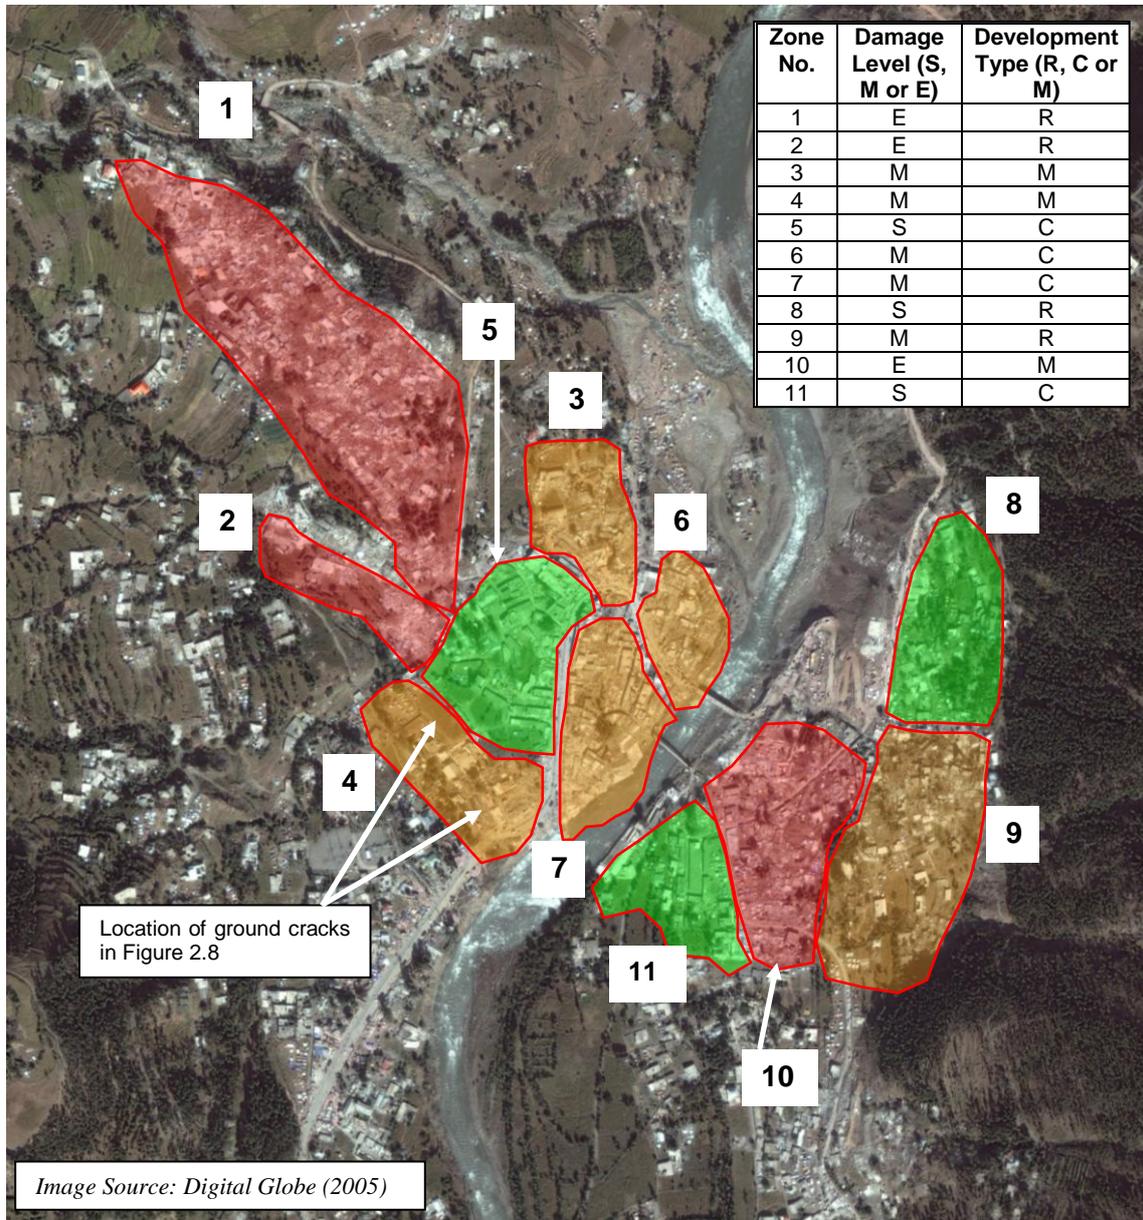
Figure 3.10 shows a satellite image of Balakot taken after the earthquake (Digital Globe, 2005), which was used to identify key locations of building damage. The city was divided into several zones and each zone was assigned a damage level (using the 3-level damage scale for satellite imagery described above) based on visual inspection of the satellite image, photos taken during the ground survey and those from close-up helicopter flights by the US Army (see Figures 3.11 to 3.18). The damage zoning indicates that Balakot largely experienced moderate to extensive damage with some areas experiencing slight damage. The extensive damage occurred in the residential areas of the city, particularly on the hill north-west of the city centre (zone 1) also shown in Figure 3.11. There was no indication of landslide activity in this zone hence the collapse of largely residential buildings may have been due to strong ground shaking, possibly amplified due to the ridge effect. The moderate and heavily damaged zones appear to follow a linear trend from north-west (zone 1) to east of Kunhar River (zone 10). This direction appears to be parallel to the inferred strike direction of the fault that ruptured causing the October 8 earthquake (see Figure 2.6).

**Figure 3.10: Selected damaged areas in Balakot city**

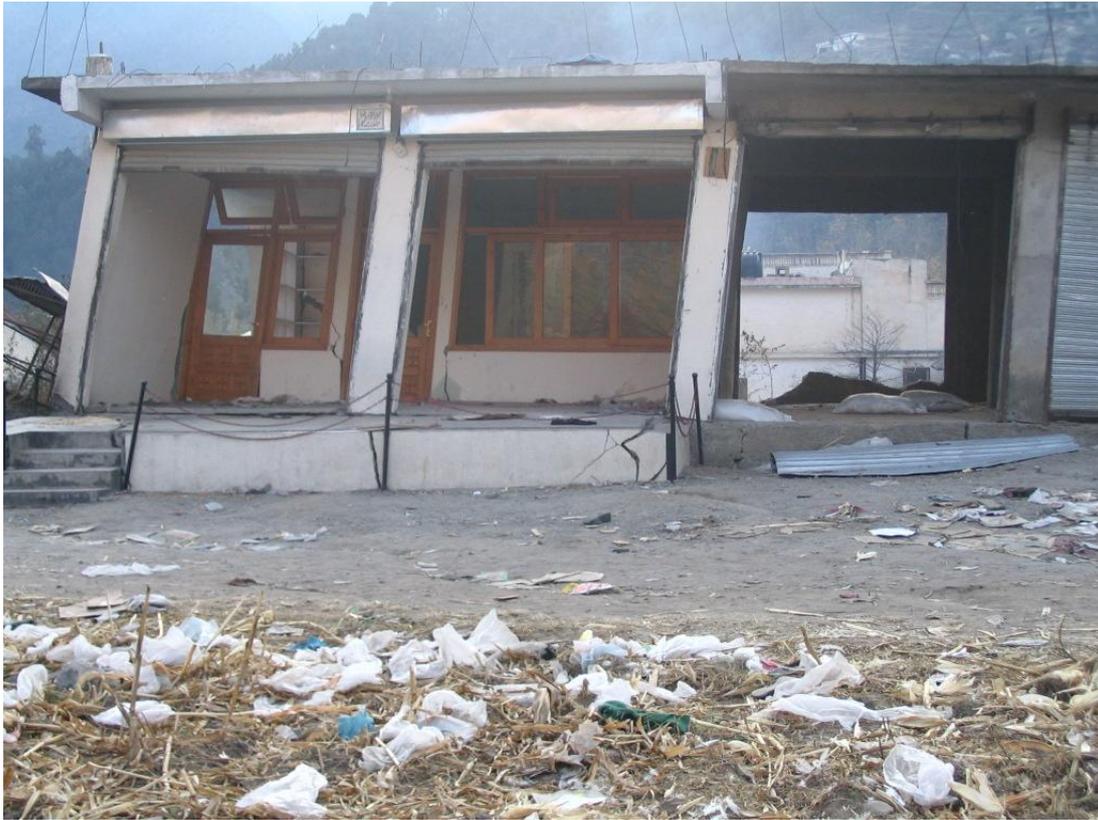
**Figure 3.18: Deformed RC frame structure with rotation at the column/slab connection**

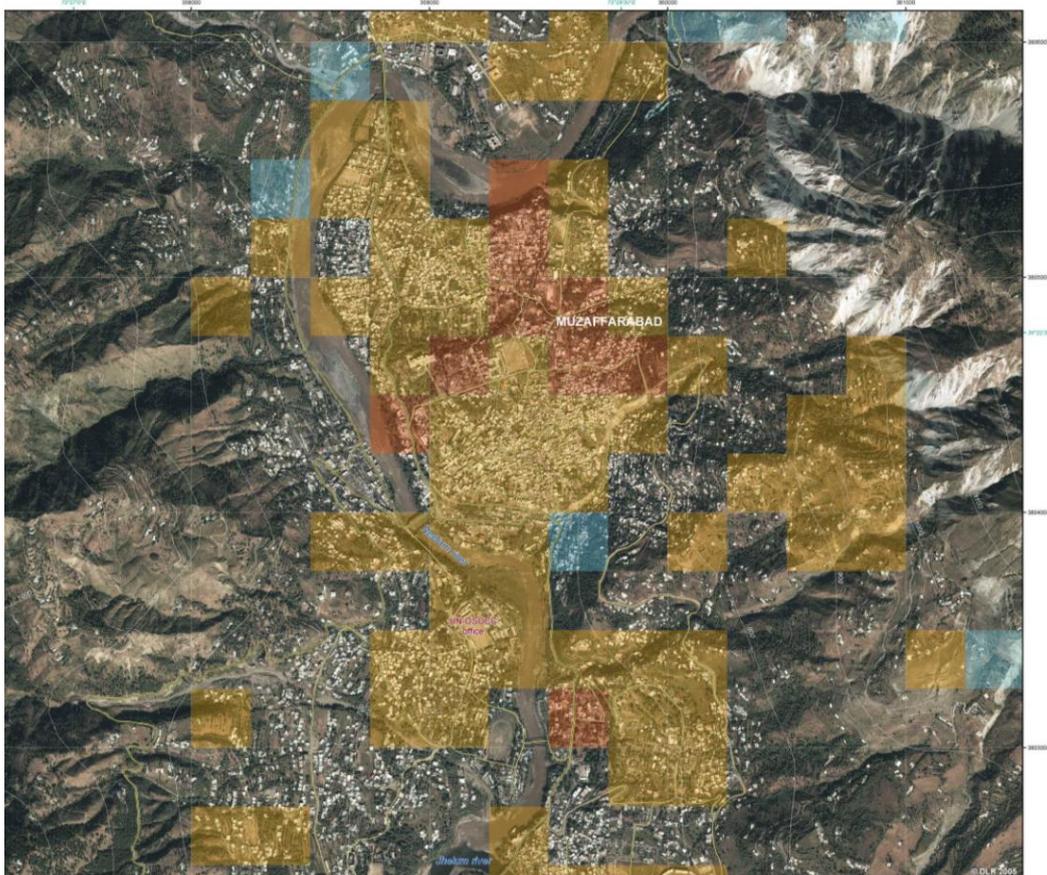
**Figure 3.19: Satellite image of Muzaffarabad city centre after the earthquake with spatial damage levels (UNOSAT, 2005)**

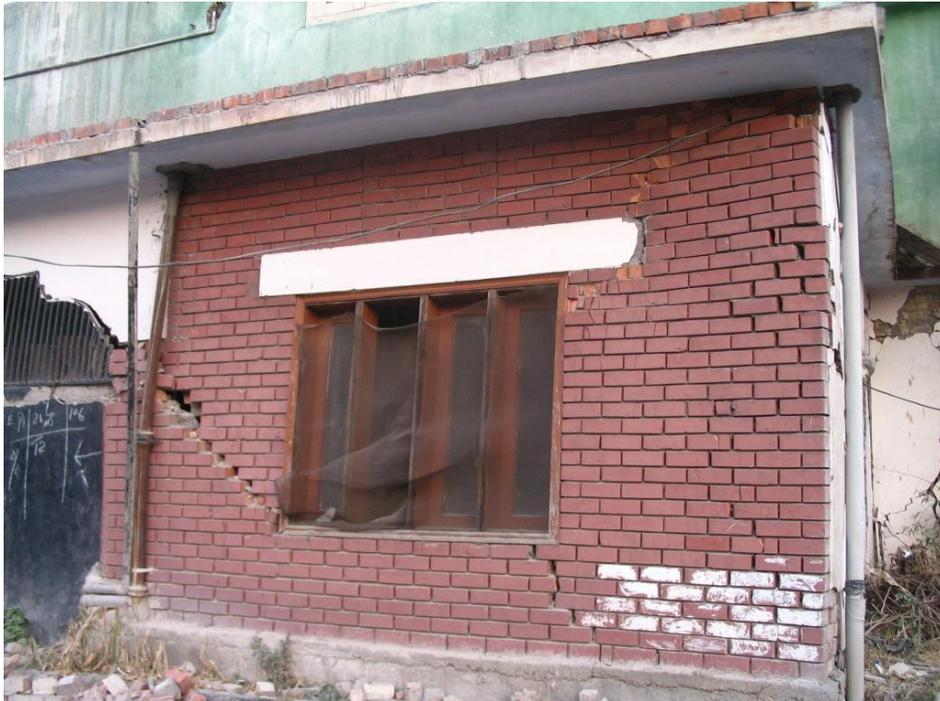
**Figure 3.21: Diagonal shear cracks through window on a brick URM residential building, moderate damage, Muzaffarabad**

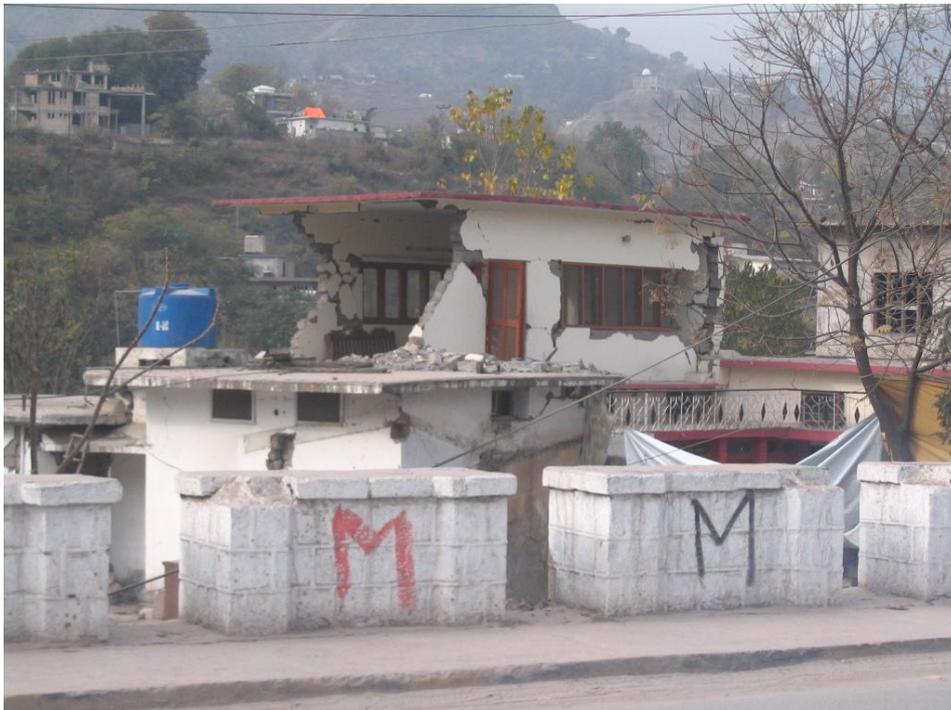
**Figure 3.22: Partially collapsed upper floor walls of a 2-storey concrete block URM residential building with RC slab floors and roof. Shear and out-of-plane failure of concrete block bearing walls, Muzaffarabad**

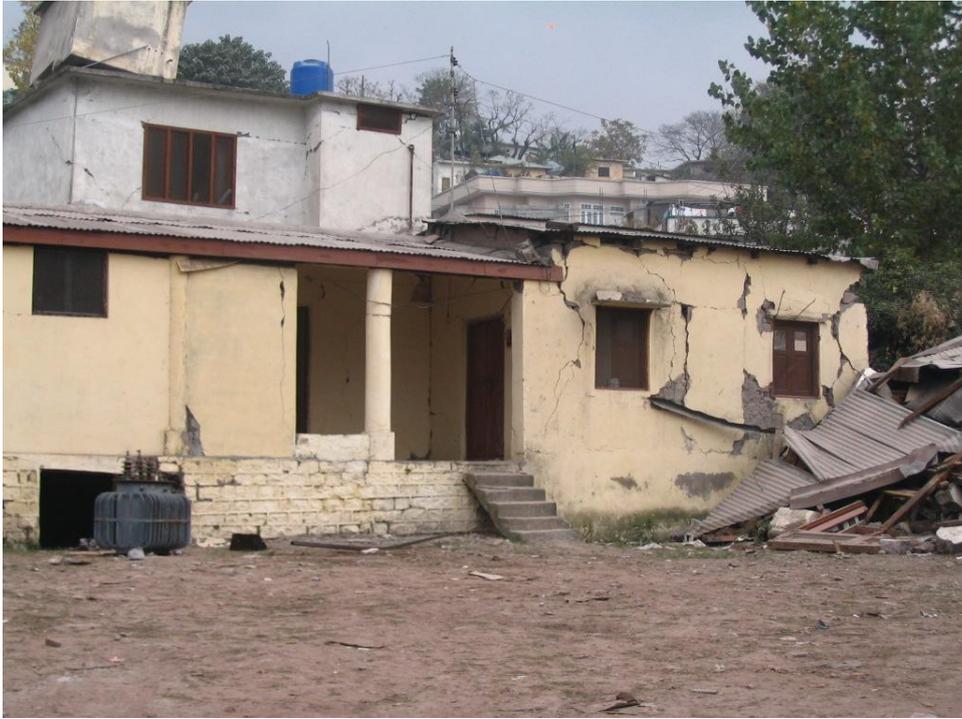
**Figure 3.23: Shear cracks through the concrete block masonry wall of a residential building, moderate damage, Muzaffarbad**

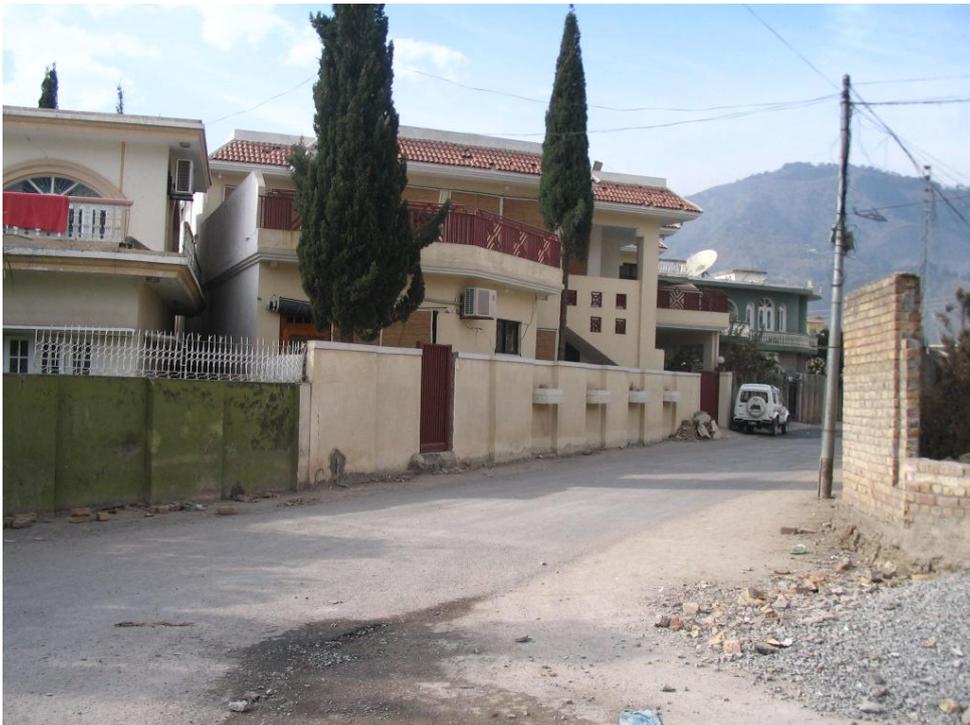
**Figure 3.24: Undamaged RC frame and slab residential building with concrete block masonry infill walls, Muzaffarabad**

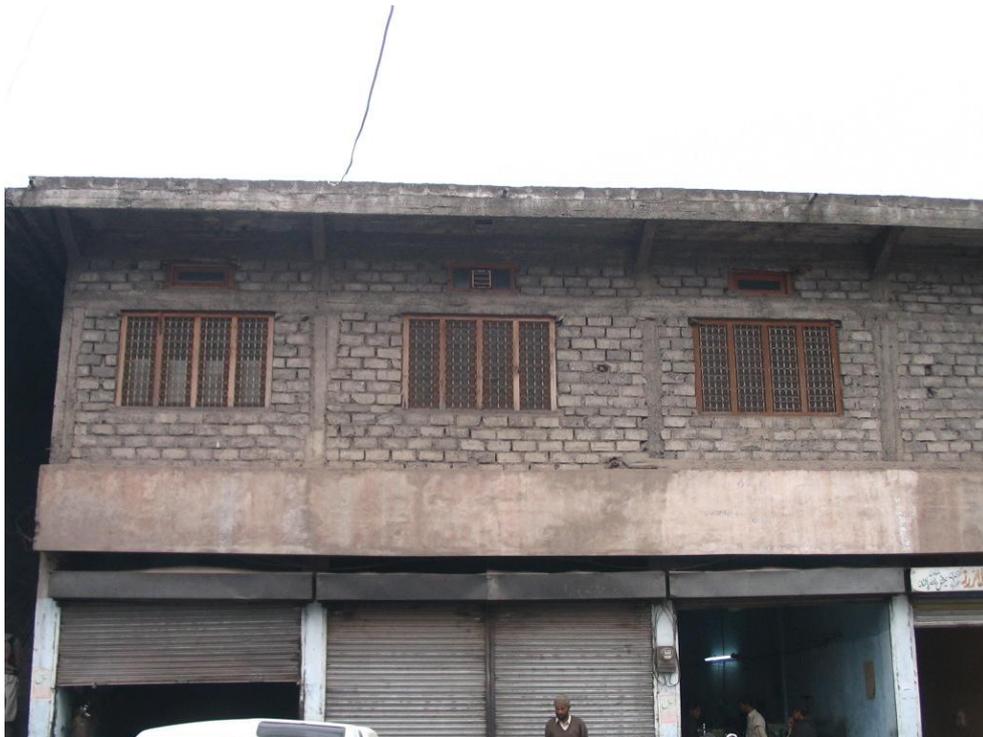
**Figure 3.28: Undamaged RC frame and slab commercial building with concrete block masonry infill walls. RC lintel beam continuous over the structure perimeter, Muzaffarabad**

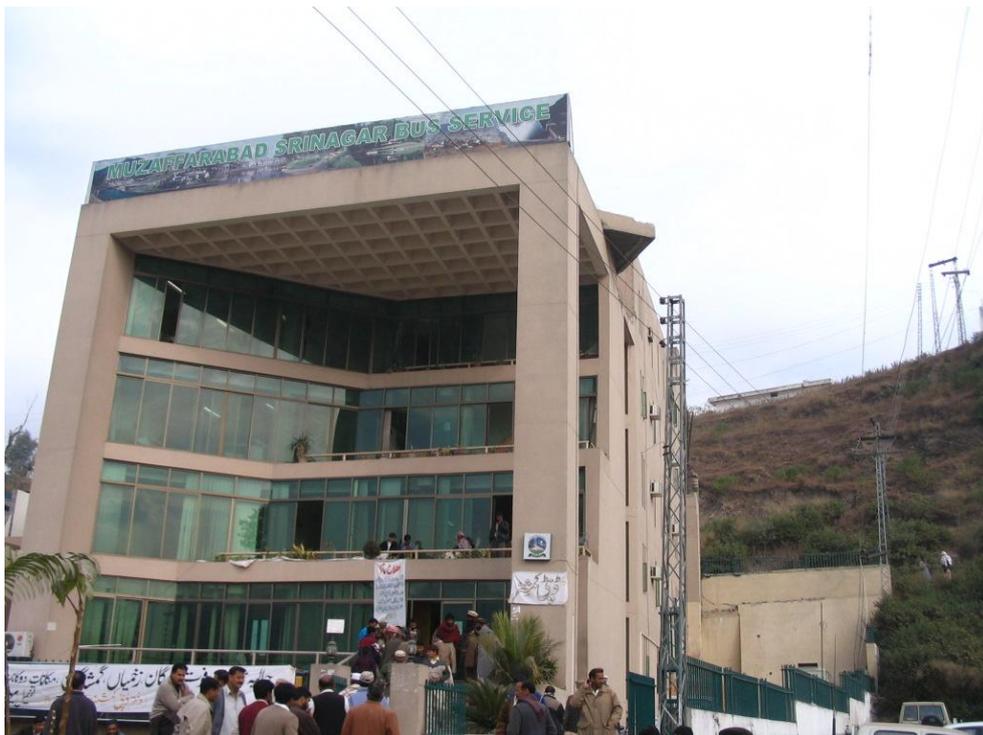
**Figure 3.34: Undamaged RC frame and slab commercial building, Muzaffarabad**

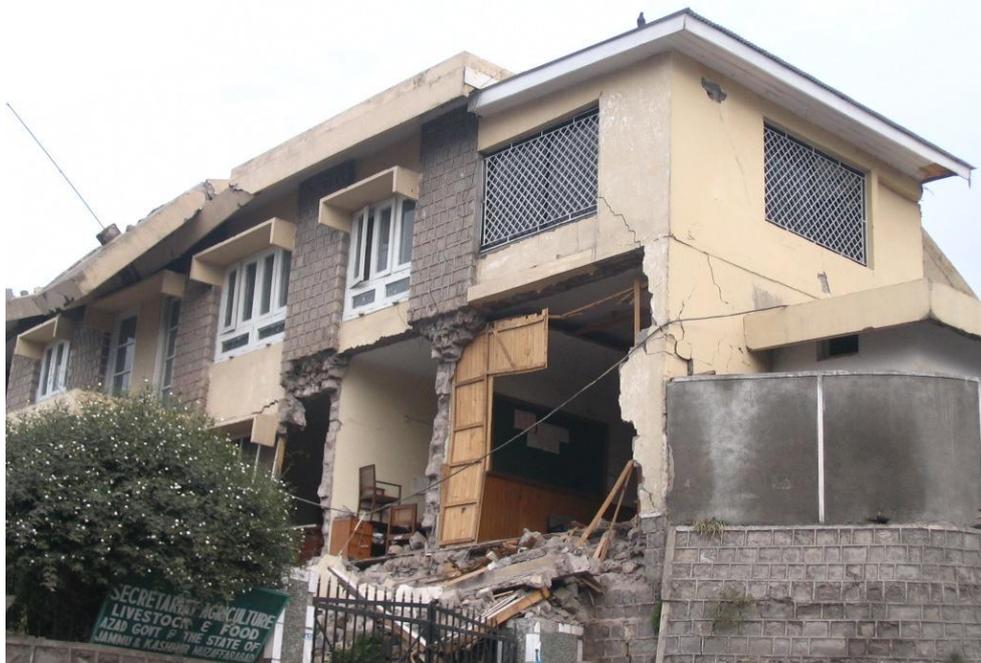
Figures 3.35 to 3.40 show damage to some of the government buildings in Muzaffarabad. The Muzaffarabad Supreme Court building was built using brick masonry with an RC roof structure. Both diagonal and horizontal cracks were observed at numerous locations (Figures 3.35 and 3.36). The building however was functional and its ground floor was used as a makeshift hospital by the Turkish Red Crescent. Figure 3.37 shows an example of diagonal shear cracks through brick URM walls in the Muzaffarabad Tourist Information Office. Shear cracks were also visible inside and outside of the State Bank of Pakistan Building (Figure 3.38) where the walls were brick URM. Despite the damage, both buildings were fully functional at the time of the survey. The 3-storey concrete block URM building of the AJK Secretariat of Agriculture suffered extensive damage (Figure 3.39). A wall section in the ground floor collapsed and the RC roof slab collapsed onto the 1<sup>st</sup> floor. There is no visible sign of an RC frame present, hence the RC roof and floor slabs are supported by concrete block URM walls.

**Figure 3.39: Collapsed wall sections of the concrete block URM, 3-storey building of the AJK Secretariat of Agriculture, Livestock and Food. Collapsed RC slab roof, extensive damage**

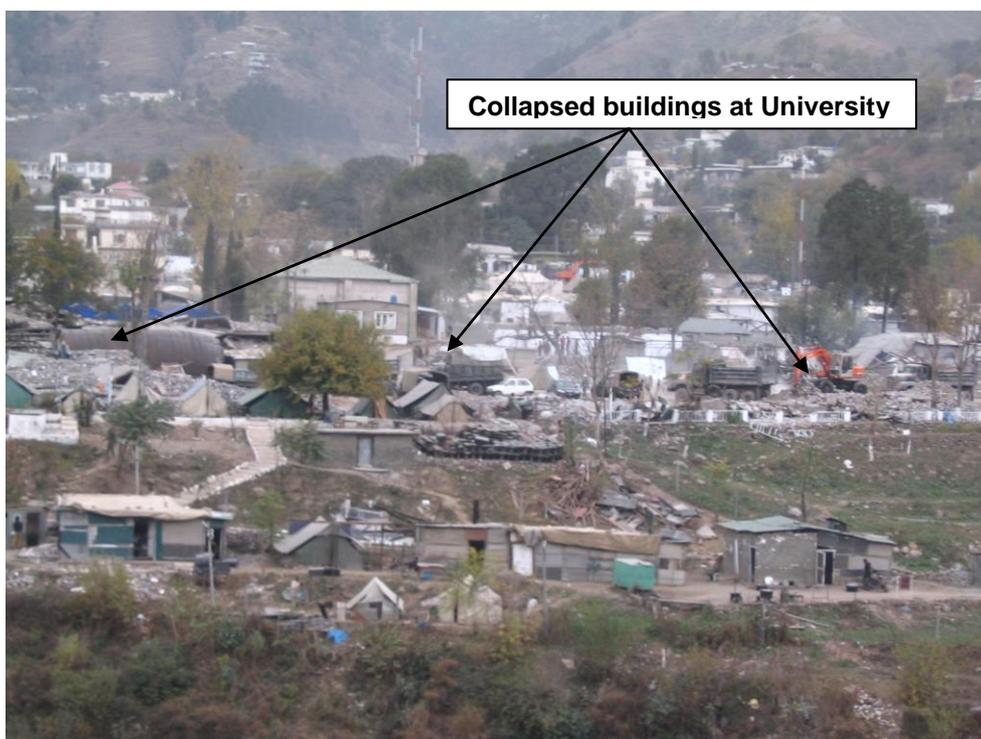
**Figure 3.42: Collapsed concrete block URM buildings of the University of AJK, Muzaffarabad**

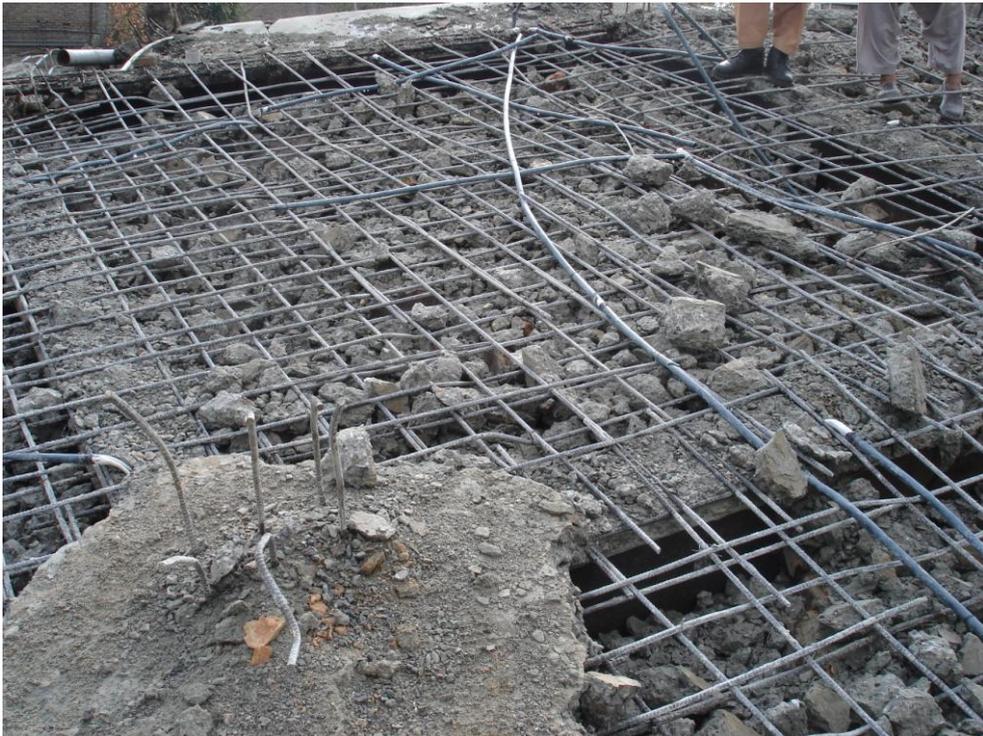
**Figure 3.45: Reinforcement layout of a collapsed slab revealed after removing the concrete**

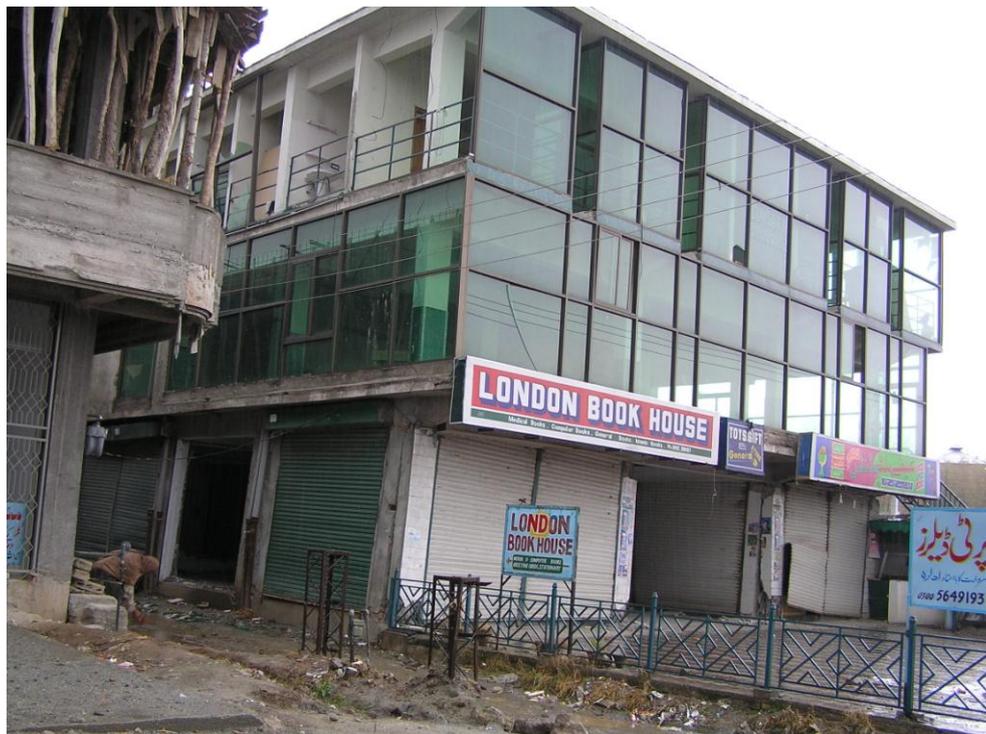
**Figure 3.49: Permanent drift at ground floor due to soft-storey in RC frame and slab 3-storey commercial structure, Abbottabad. The ground floor drift prevented large deformation at upper floors, hence glass frontage was intact**

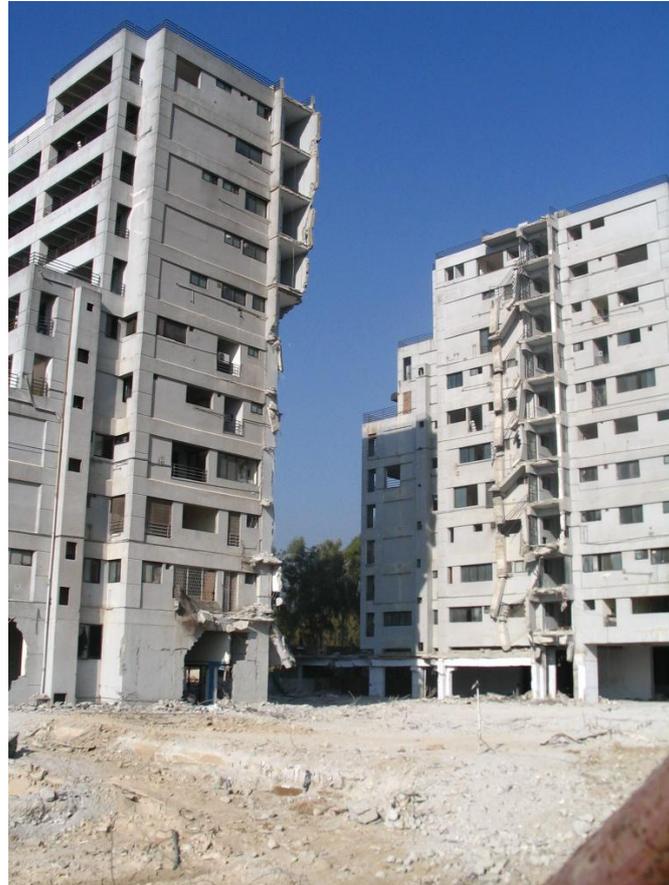
Islamabad is located about 100km southwest of the epicentre and experienced moderate ground shaking from the earthquake. The only major collapse reported was one of the 11-storey residential apartment buildings in the Margala Towers complex constructed just over 10 years ago. Figure 3.50 shows the site after clearance where the adjacent buildings were unoccupied at the time of the survey.

**Figure 3.50: Margalla Towers and the site of the collapsed building in Islamabad**

About 100 people died during the building collapse, however there were no reported secondary damage or casualties due to fires. Inspection of adjacent buildings gave clues on the nature of the construction of the collapsed building. The floors of the building are reinforced concrete slabs supported on reinforced concrete beams and columns founded on probably a raft foundation. Each building has a basement and therefore the basement floor is a soft storey as shown in Figure 3.51. The adjacent buildings do not indicate damage to the reinforced concrete elements except spalling of concrete at the movement joints between adjacent buildings due to pounding during the earthquake. The masonry walls acting as partition walls for the apartments show in-plane and out-of-plane shear cracks. The building that collapsed was the last to be constructed in the complex. The fact that adjacent buildings did not suffer major damage to the structural load bearing elements suggests that the collapsed building may have been defective, for it to suffer a major collapse due to the ground motion 100km from the epicentre.

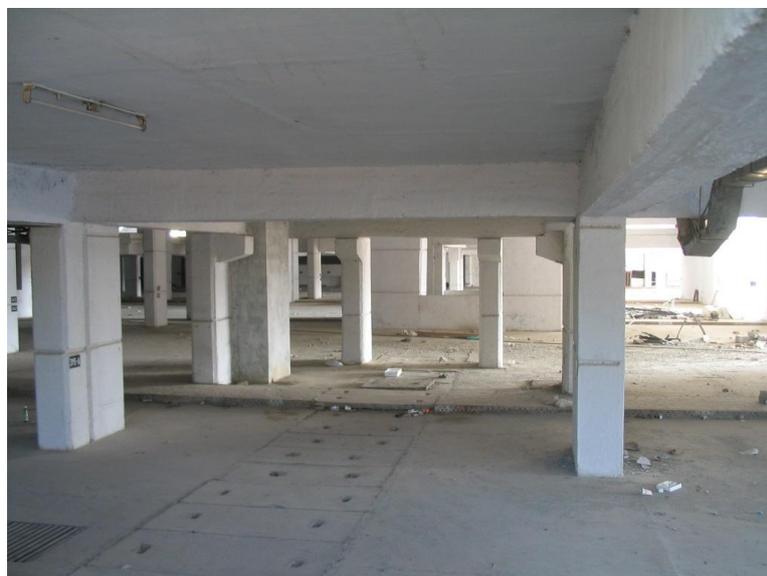
**Figure 3.51: Soft-storey basement in a building adjacent to the collapsed building at Margalla Towers**

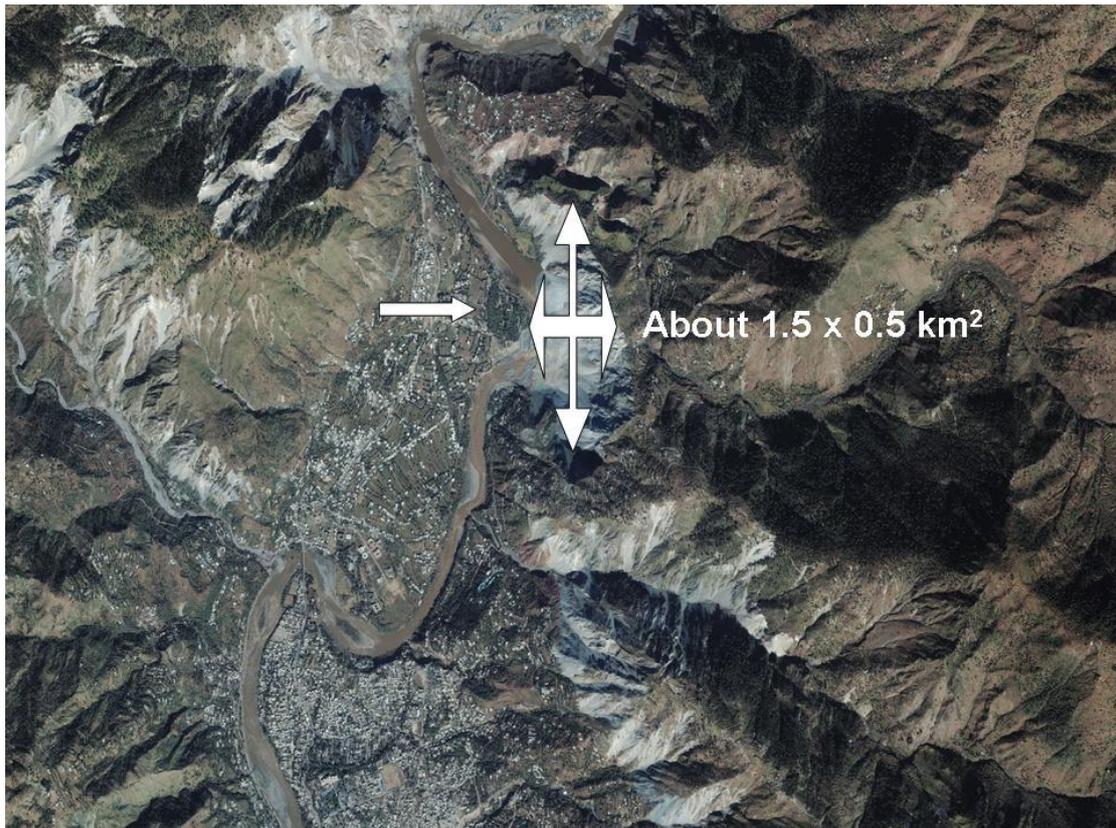
The Chela Bandi, Muzaffarabad landslide is viewed in Figures 4.4 and 4.5 along the eastward pointing arrow indicated in the satellite imagery of Figure 4.6. This landslide temporarily blocked the Nilam River which can be seen in the satellite image (Fig. 4.6) flowing N to S and around the city of Muzaffarabad, but this blockage was quickly breached. This impressive landslide, although deep cutting, is largely surficial. Most of the debris detached from the dolomite limestone mountain side is shale and dolomite. Its extent is about 1.5 x 0.5 km<sup>2</sup> and probably has volume close to 10<sup>6</sup> m<sup>3</sup>. Other landslides are visible in this image to the E of Muzaffarabad and elsewhere. The fault (Balakot-Murree-Muzaffarabad) probably lies at the foot of the landslide in these photographs and satellite image. The main face of this mountainside and landslide runs NNW-SSE and faces WSW and the hanging wall along the Balakot-Murree-Muzaffarabad Fault underwent elastic rebound of at least 3 m horizontally to the SW accompanied by 4-5 m uplift (Figure 4.2). An additional but vital point is that the Muzaffarabad landslide at A in Figure 4.7 is adjacent to the maximum coseismic slip in the major asperity on the fault plane model between Balakot and Muzaffarabad.

Figure 4.6: Main landslide at Chela Bandi, north of Muzafarrabad, imaged from space (Image NASA) with extent 1.5 km N-S and 0.5 km E-W. Arrow to the left indicates point of view in photographs of Figures 4.4 and 4.5

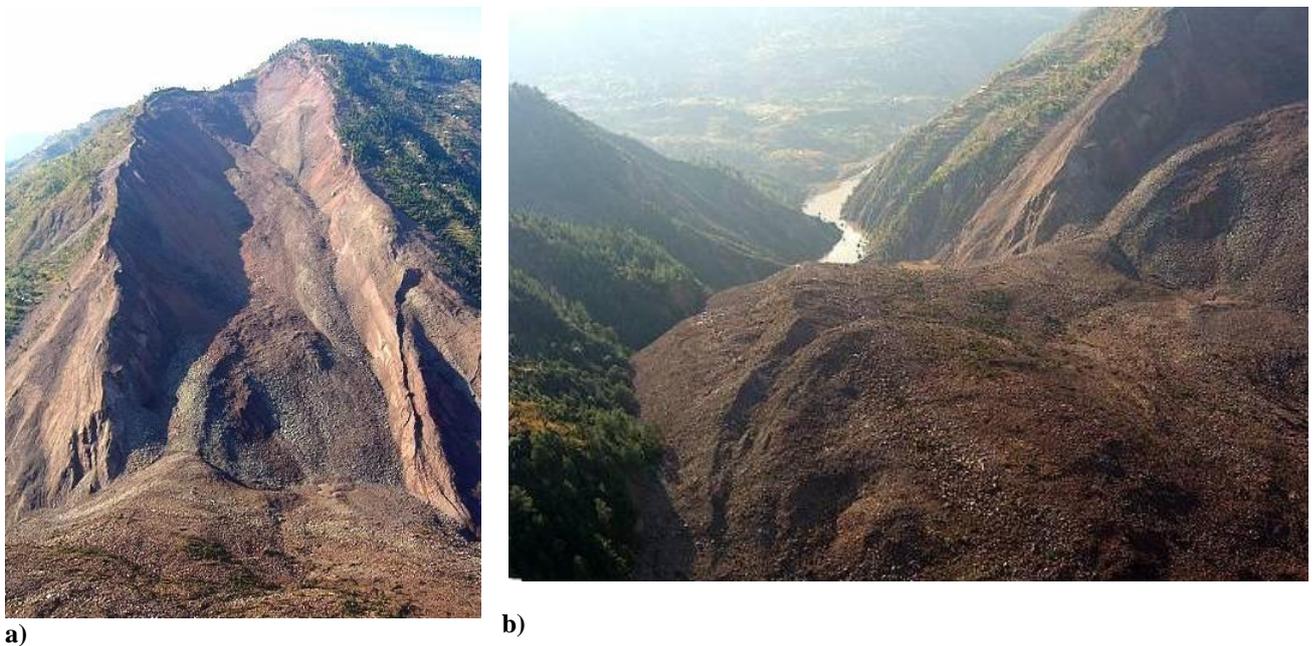
The second deep cutting landslide to be considered is the most significant; this is the Hattian slide (according to Schneider, 2006, also referred to as the Chikar slide, the Dana slide, or the Dandbeh slide,) and this occurred at location “slide B” in Fig. 4.2 displacement map, which is just south of the township of Bhagsar and the Jhelum River in the Pir Punjal Mountains. Schneider (2006) places the origin of this slide on Dana Hill (2080 m above sea level at 34° 09' N, 73° 43' E) and its run (Fig. 4.8a-b) buried the village of Dandbeh. The extent of the slide from origin scarp to toe indicated by arrow in the photograph Fig. 4.9 is about 2,850 m long (C. Scawthorn, personal communication) with volume in the range 1-6 10<sup>6</sup> m<sup>3</sup>. The run down reported by Schneider was a drop of 1,000 m and distance of 2.75 km covering an area of 5 km<sup>2</sup> within half a minute. The slide then ran up the far side of the valley, overtopping the crest and into the next valley. It dammed two tributaries of the Jhelum River and so also formed a tertiary hazard of future flooding from two dammed lakes, the larger being in the first valley crossed and the second smaller dam and lake being in the second valley. There is evidence of an earlier slide at this locality, overridden by the Hattian slide and perhaps associated with an earthquake in 1955 (Schneider, 2006). The Hattian slide is also very visible in satellite imagery Fig. 4.10. The Hattian slide is again on the hanging wall of the fault located at “slide B” in the Muzaffarabad-Bagh segment of the fault. Although this location is associated with high uplifts of 4-5 m in the displacement map (Fig. 4.2) it was not subjected to the very large 3 m SW horizontal elastic rebounds that occurred in the thrusting along the Balakot-Murree-Muzaffarabad segment. Instead, just W of the Hattian slide location the pure thrust mechanism changes to include a significant component of right lateral strike-slip motion in the remainder of the Muzaffarabad-Bagh segment. At B in Fig. 4.7 the Hattian slide is also adjacent to significant coseismic slip in the lesser asperity on the fault plane model that exists in the SE part of the Muzaffarabad-Bagh fault segment.

**Figure 4.8: The Hattian slide, Pir Punjal Mountains: the major landslide in the Kashmir 2005 earthquake. a) the source and high energy channel of the slide b) landslide material resulting in damming of two tributaries of the Jhelum River (photos by Charles Scawthorn)**

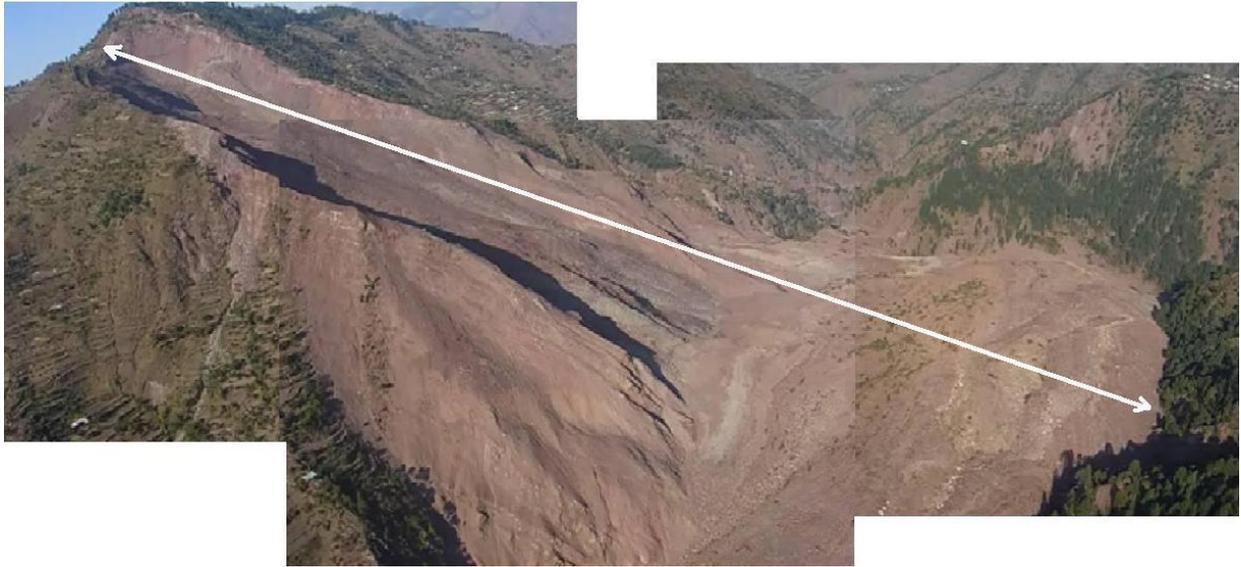
**Figure 4.9: The Hattian slide, Pir Punjal Mountains: the major landslide in the Kashmir 2005 earthquake. This deep cutting landslide from source scarp to toe (white arrow) stretches over approximately 2,850 m (photo collage by Charles Scawthorn)**

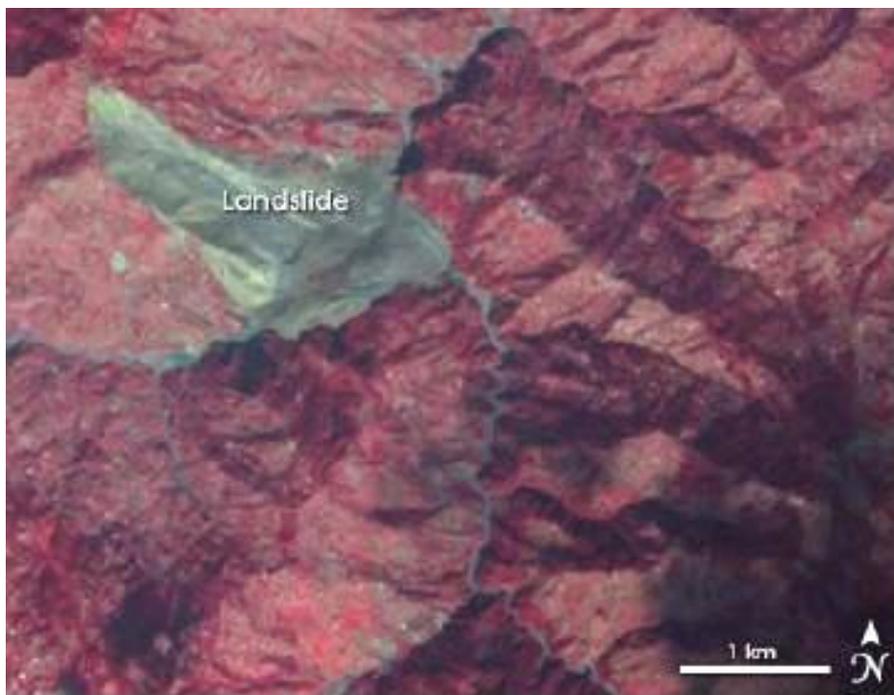
**Figure 4.10: The Hattian slide, Pir Punjal Mountains: the major landslide in the Kashmir 2005 earthquake. An overall perspective from space (image by NASA), note the tributary rivers**

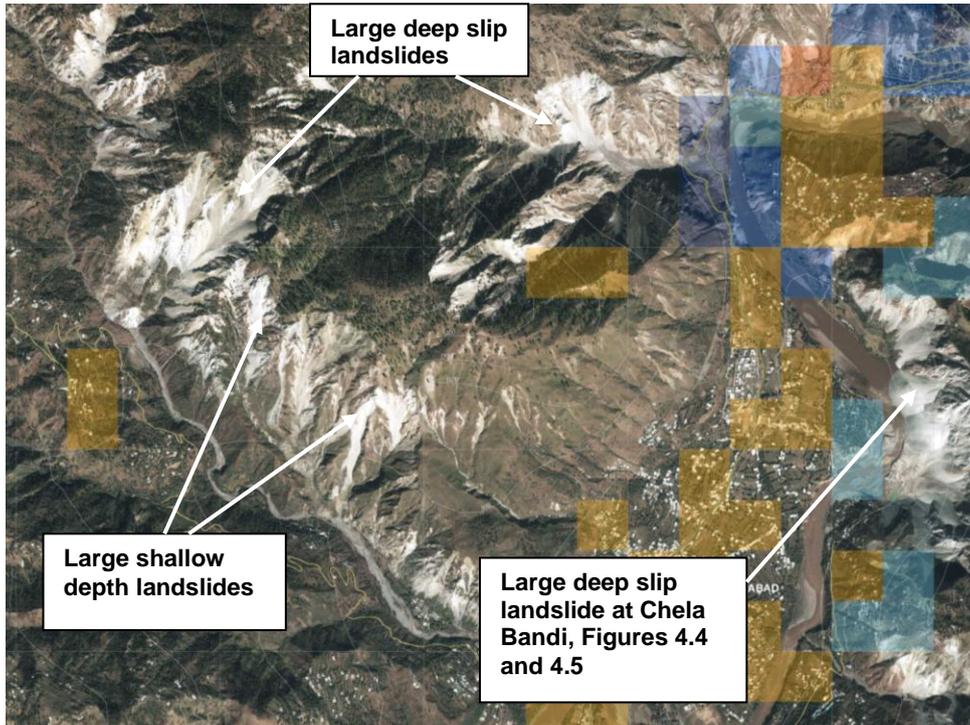
**Figure 4.11: Landslides in the northern part of Muzaffarabad City, AJK (UNOSAT, 2005)**
