THE KASHMIR, PAKISTAN  
EARTHQUAKE OF 8 OCTOBER 2005  
A FIELD REPORT BY EEFIT

## A FIELD REPORT BY EEFIT

July 2008

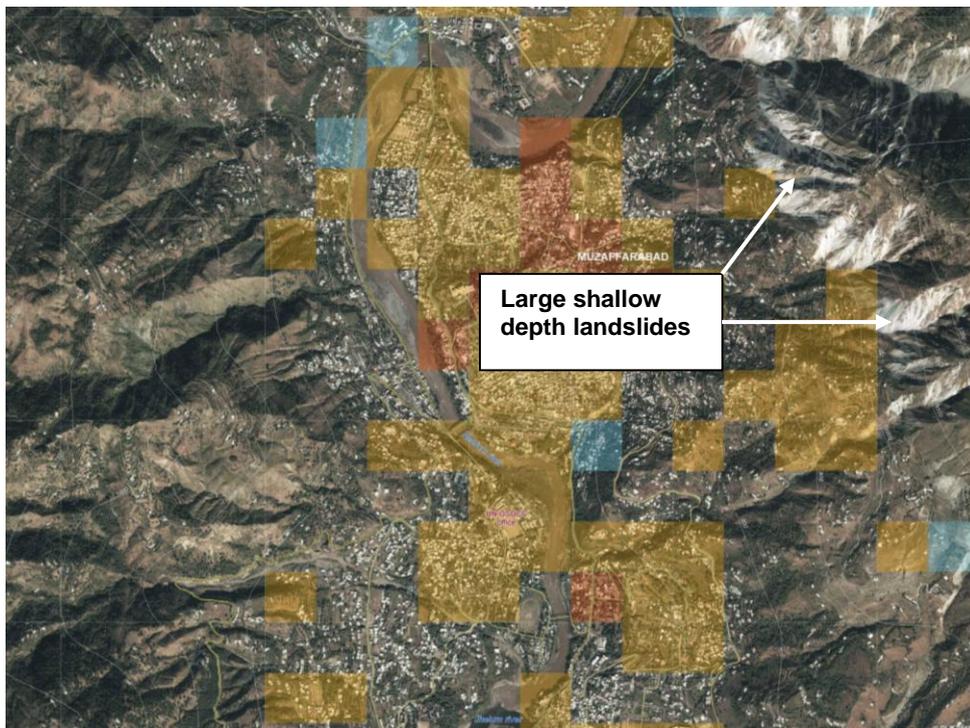
In addition to the deep slip slide already described at Chela Bandi, just north of Muzaffarabad, there were several landslides of different sizes as imaged in Figures 4.11 and 4.12. A number of deep slips and shallow slips of large volume movements occurred north of Muzaffarabad City. The deeper slips involved large sections of the mountains sliding down and slumping. Figure 4.13 shows in greater detail the shallow depth large landslides east of Nelum River in Muzaffarabad City.

**Figure 4.12: Landslides in the central part of Muzaffarabad City, AJK (UNOSAT, 2005)**

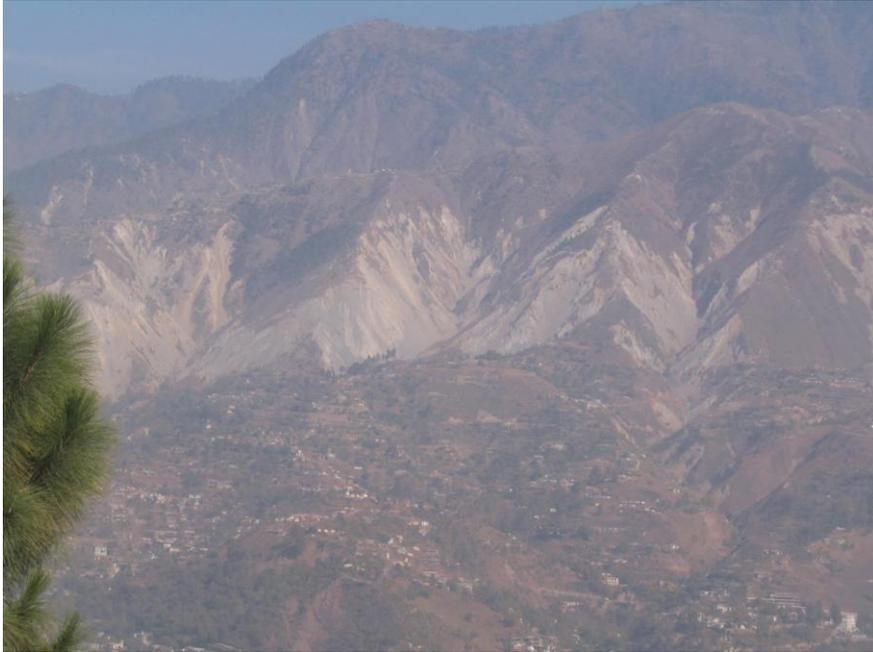
**Figure 4.13: Large shallow depth landslides east of Nelum River in Muzaffarabad**

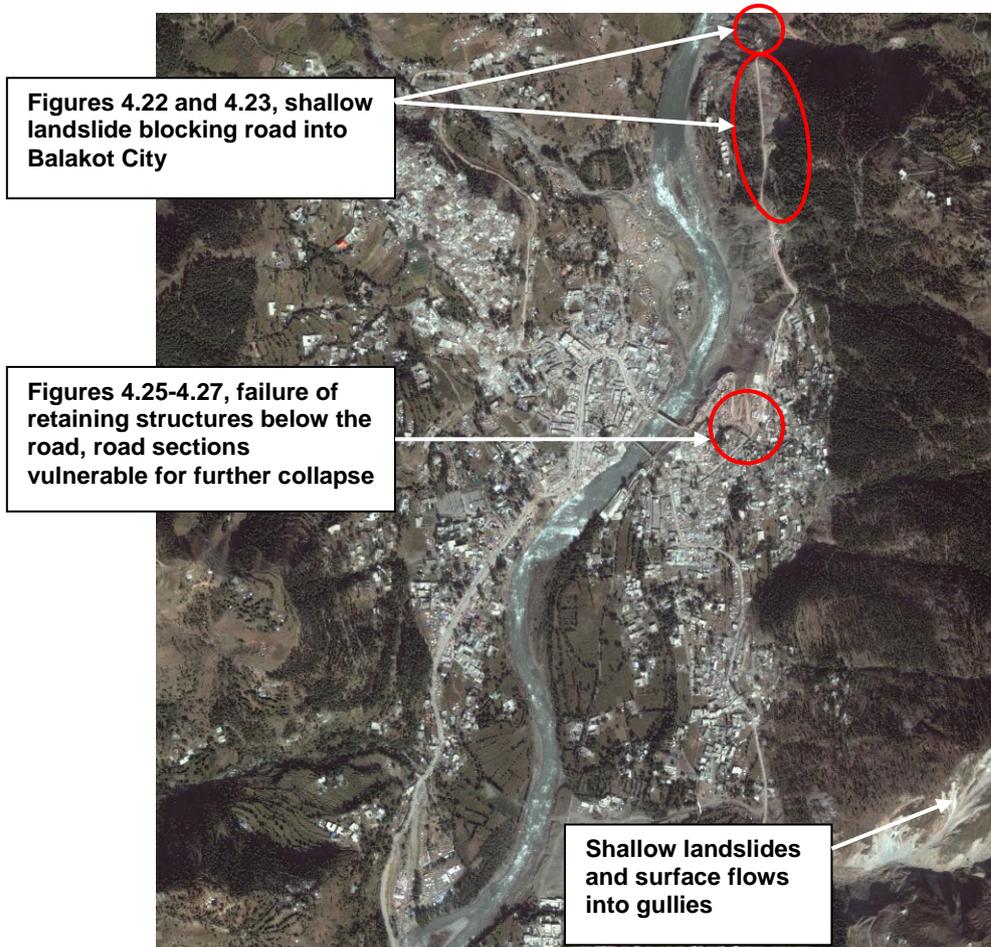
Balakot, although not affected by deep cutting landslides, was greatly affected by other landslides. Figure 4.14 shows locations of landslides and geotechnical failures identified using a satellite image of Balakot. The type of landslides in Balakot was shallow depth slides, where the steep sloped surficial soils have slipped and slumped to form a less steep profile. Access on some roads to the city were blocked – impact to roads is discussed later. Figure 4.14 also illustrates some surface flows into gullies as a common feature of these landslides.

**Figure 4.14: Location of landslides and ground failures in Balakot City (Digital Globe, 2005)**

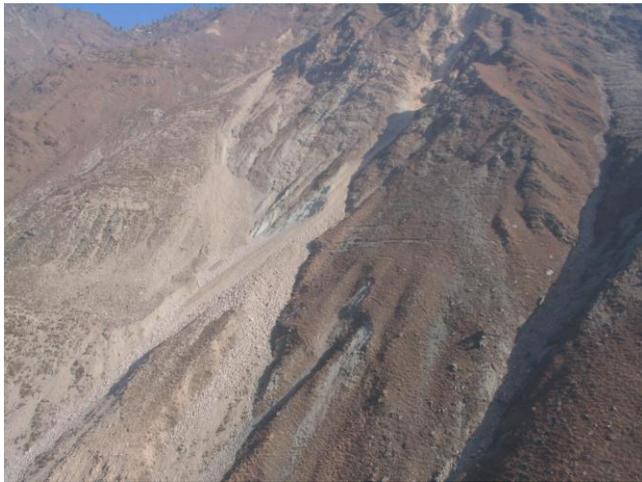
- c) Shallow landslides and flows into gullies (Muzaffarabad-Nausari),
- d) Shallow landslide blocking a road and exposing the foundations of a building above. Other slope failures blocking the same road (Muzaffarabad-Nausari),

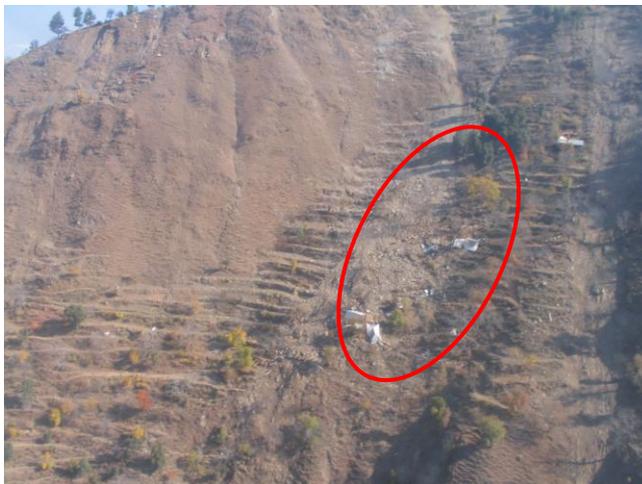
- e) Collapse of buildings on a shallow landslide (Muzaffarabad-Nausari),
- f) Large shallow depth landslide and a disrupted landslide evident from the scarp and cracks outlining the displaced volume (Muzaffarabad-Ghari),

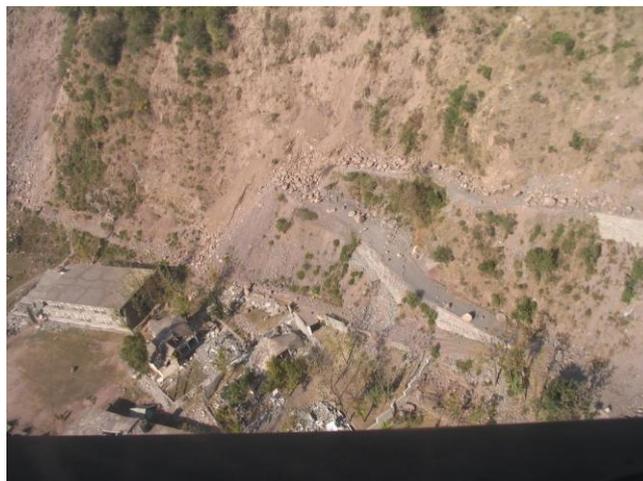
**j)**

- j) Shallow landslides and rock falls blocking the road (Muzaffarabad-Ghari),
- k) Terraces and damaged buildings (Muzaffarabad-Conoko),
- l) Two river side landslides (Islamabad-Dhanni Nelam),

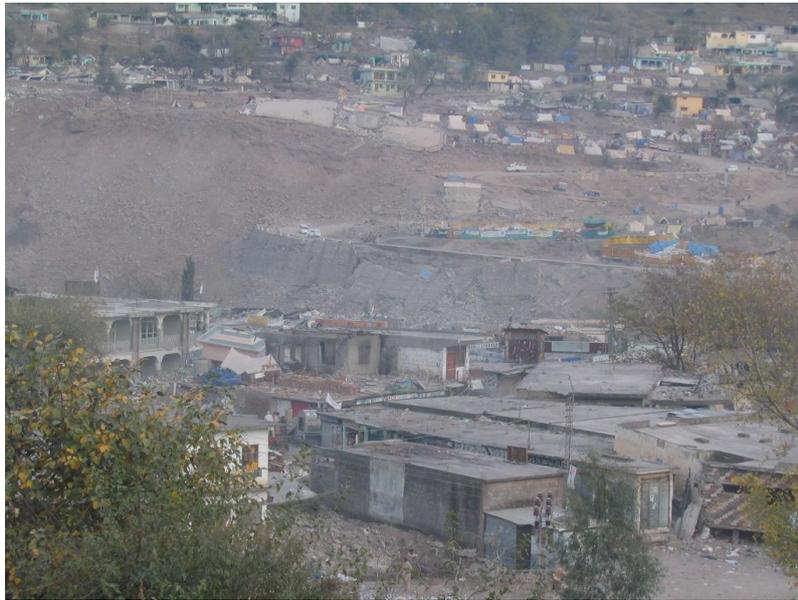
There were several geotechnical structures that performed badly during the Kashmir Earthquake. These primarily impacted the roads and adjacent structures and lifelines, and many of these were either retaining structures or structures providing facing protection to slopes. Figure 4.20 shows a collapsed concrete retaining wall and facing structure below a road descending into Balakot from the north (see also Figure 4.14). The damaged retaining wall does not appear to have any anchoring to provide sufficient support to the road above. The damage to the retaining structures poses a danger to the road above as it is exposed from slope failure or erosion from rain. A concrete gravity retaining wall by the Kunhar River in Balakot appears to have displaced toward the river as shown in Figure 4.21. However, there is no evidence of any impact on the retained side from this movement.

**Figure 4.20: Collapsed retaining wall and concrete facing structures in Balakot**

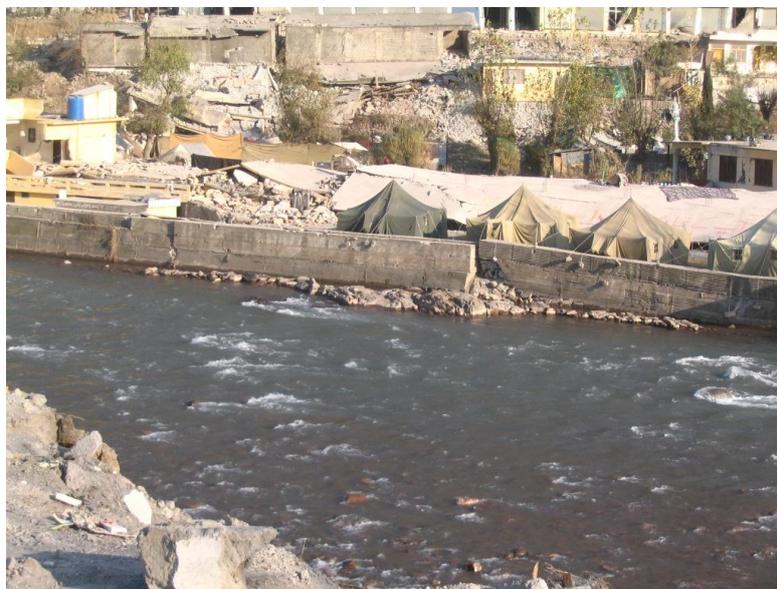
**Figure 4.21: Displaced concrete gravity retaining wall by Kunhar River in Balakot**

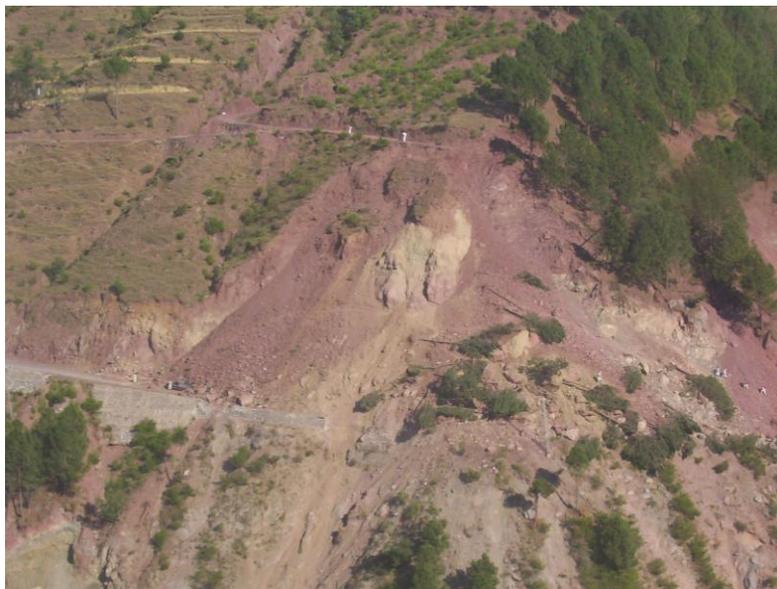
The nature of the mountainous terrain and topography meant that the road network or system was heavily exposed. Figure 4.22 shows a shallow depth landslide in Balakot, where the northern access road to the city was blocked. Figure 4.23 shows another landslide on the same route where there was a combination of rock falls and soil flow. The landslide here exposed the underlying rock that makes up the mountains in this region. Although the landslides in Figures 4.22 and 4.23 are local events, impact of such local events is broader as they degrade the road network by temporarily blocking the road, and thus removing a link from the network.

**Figure 4.22: Shallow depth landslide and slumping of soils blocking an access road to Balakot City, NWFP (photo by Kathrin Renner (Arup) and US Army)**

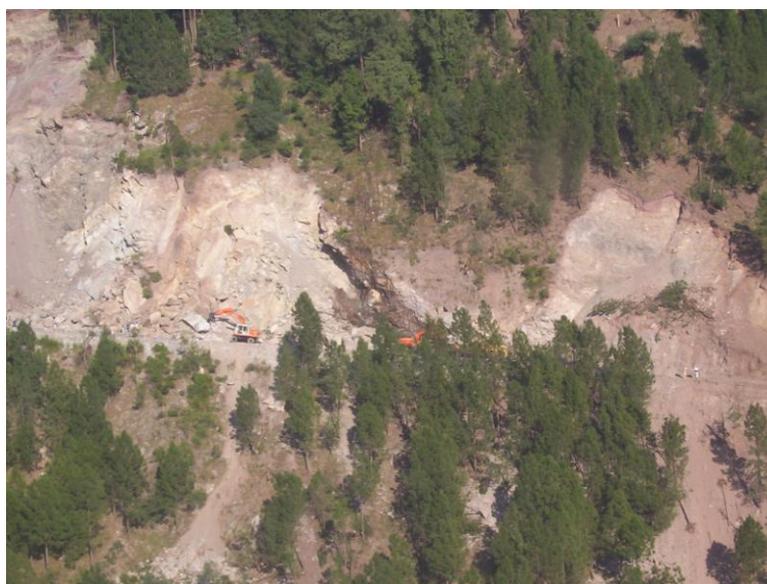
**Figure 4.23: Shallow depth landslide exposing the underlying rock. Mixture of rock fall and soil flow block the northern access road to Balakot City, NWFP (photo by Kathrin Renner (Arup) and US Army)**

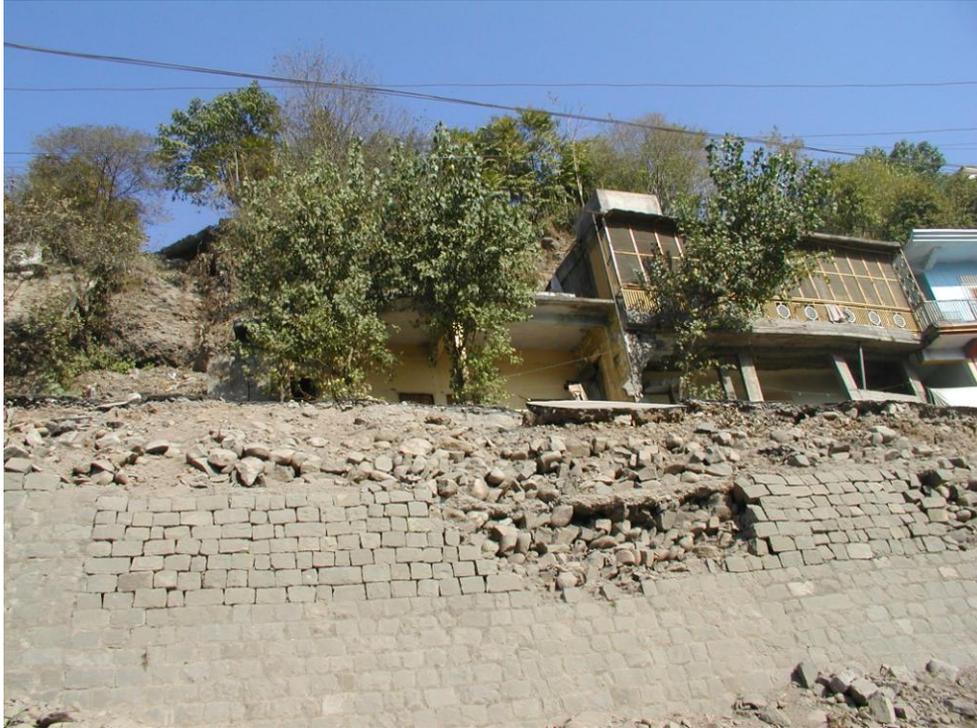
Figure 4.24 shows a distant view of collapsed concrete retaining wall section below a major route in Muzaffarabad City that runs just above the Nelum River. This collapse is similar to that in Balakot in Figure 4.20 where there appears to be no anchoring in the retaining wall system. The collapsed section leaves the road vulnerable to further damage from slope failures or erosion from rain. A few hundred metres further along this route to the north (leftwards in Figure 4.24), a stone masonry built retaining wall had failed and slipped slightly down slope. It was not keyed in to the slope it was intended to maintain. Slippage of this gravity retaining wall undercut buildings as seen in Figure 4.25.

**Figure 4.25: Stone block masonry retaining wall in Muzaffarabad: slippage and collapse of this wall undermined buildings**

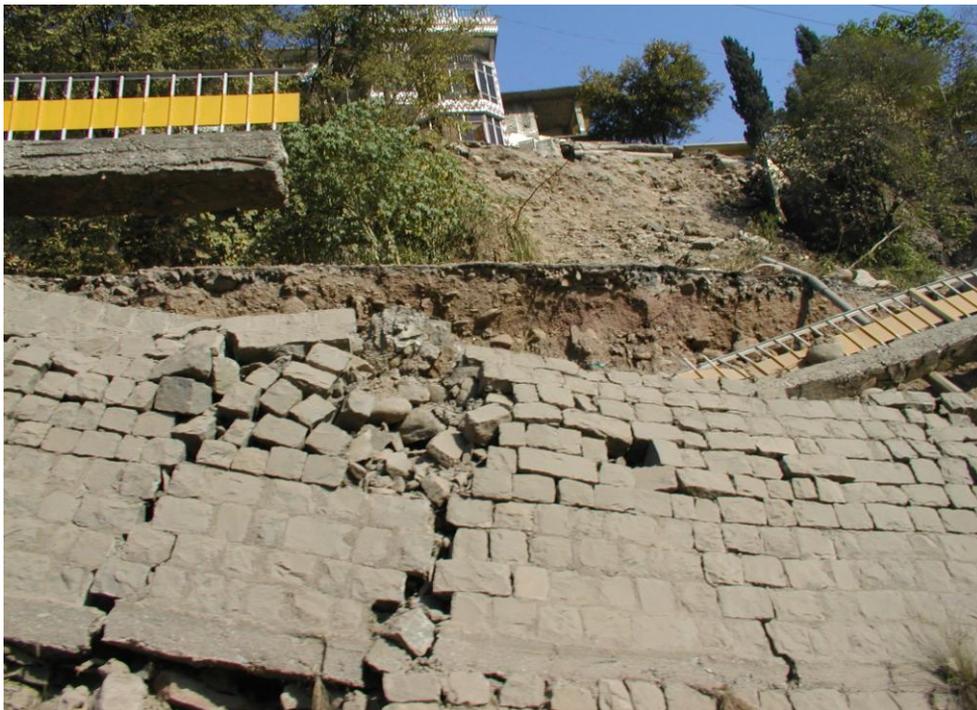
Such gravity retaining walls often supplied only superficial facing support against a slope. The same wall when it slipped not only undercut housing, but also roads and pavements as shown in Figure 4.26. In this photograph in Muzaffarabad the stone block wall has slipped and cracked; the yellow ochre band top-left is a surviving length of safety railing along a pavement behind which the road itself has also slipped away down slope.

**Figure 4.26: Stone block masonry retaining wall in Muzaffarabad, just to the right of Figure 4.25: slippage and collapse of this wall also undermined pavement and road**

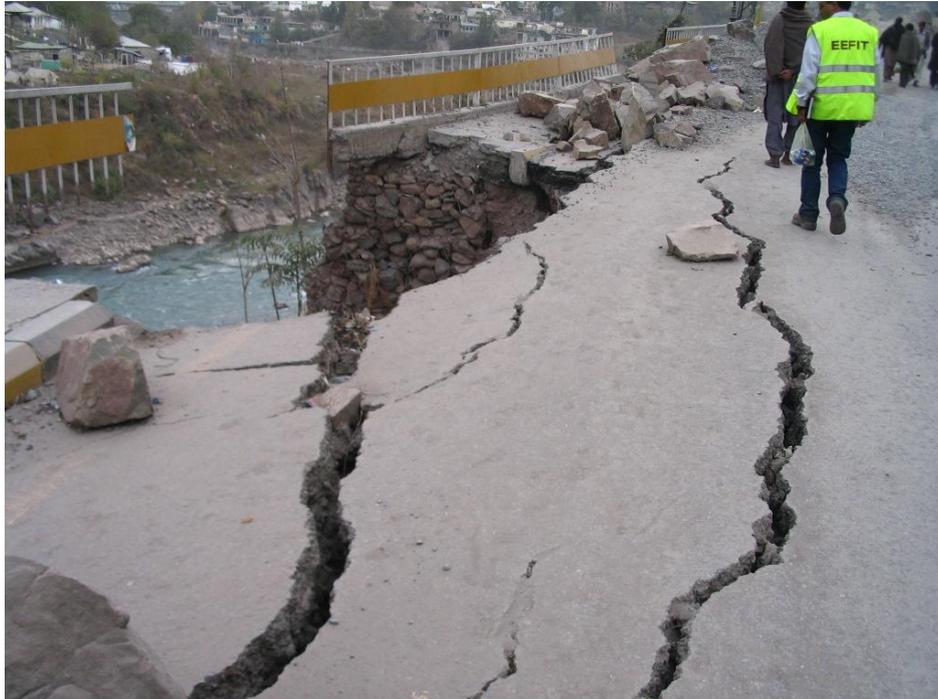
The road above the retaining wall of Figures 4.25 and 4.26 is illustrated in Figures 4.27 and 4.28. Figure 4.27 shows a collapsed section of this major route through Muzaffarabad city. The collapse of the retaining wall led to the collapse of a section of the road and the pavement and cracks to appear on the road surface. Similar cracking was also observed further along the same route as shown in Figure 4.28. The cracked road sections are exposed to likely further damage unless the collapsed retaining wall sections are quickly repaired to prevent further slope failure or soil erosion.

**Figure 4.27: Retaining wall collapse leading to unstable pavement and road sections on a major route through Muzaffarabad**

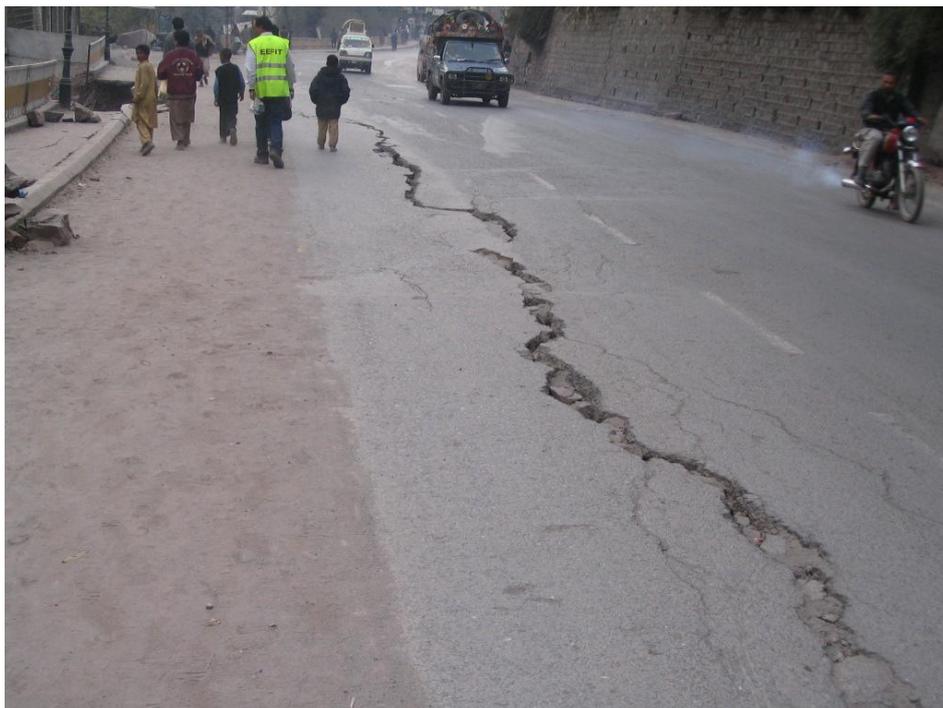
**Figure 4.28: Cracks through a major route through Muzaffarabad due to collapsed retaining wall section**

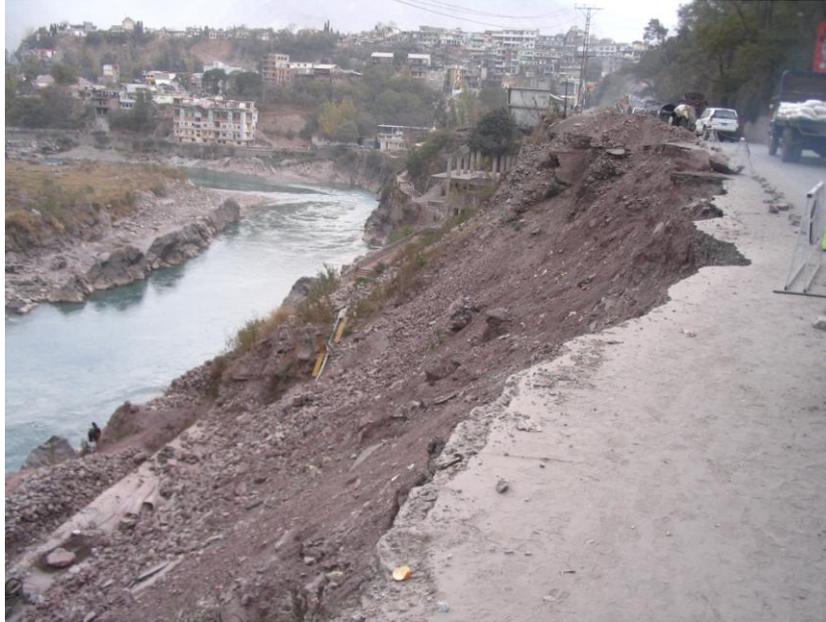
The danger of further undercutting and erosion to road surfaces was a common problem in Muzaffarabad. Figure 4.29 shows an unstable slope cutting back through a road in Muzaffarabad.

**Figure 4.29: Slope failure adjacent to a major route through Muzaffarabad City, danger of further erosion of the road surface**

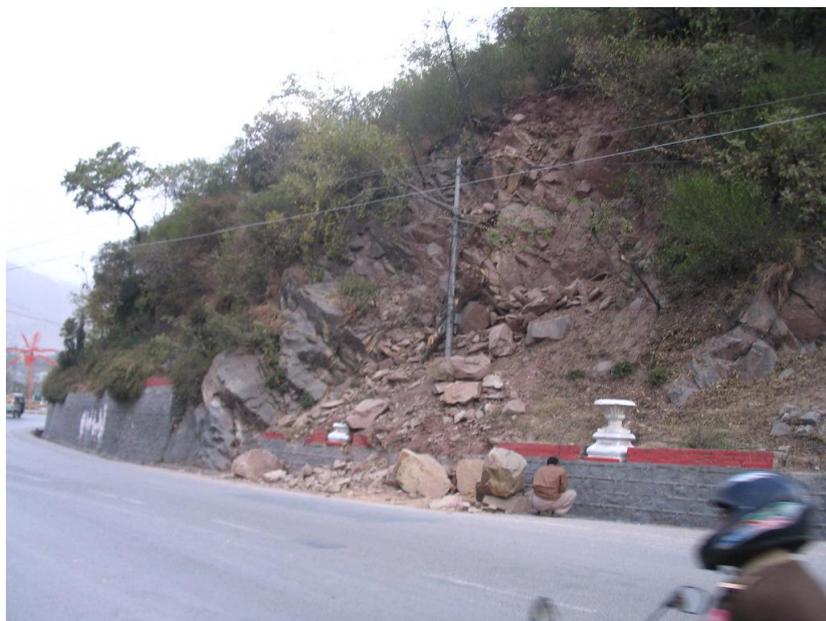
In addition to these containment and continued erosion problems, there had been severe rock falls and showers during the earthquake. A minor rock fall that had been partially cleared is shown in Figure 4.30. The slope material seen behind the skeletal building in Figure 4.31 lies directly behind the road edge seen in Figure 4.5. Road cracking is clear in Figure 4.5. In addition, at the time of the earthquake, it was reported that the cobble and boulder material that constitutes the slope in Figure 4.31 showered down on to vehicles on the road below causing fatalities.

**Figure 4.30: Minor rock fall onto a main route through Muzaffarabad City**

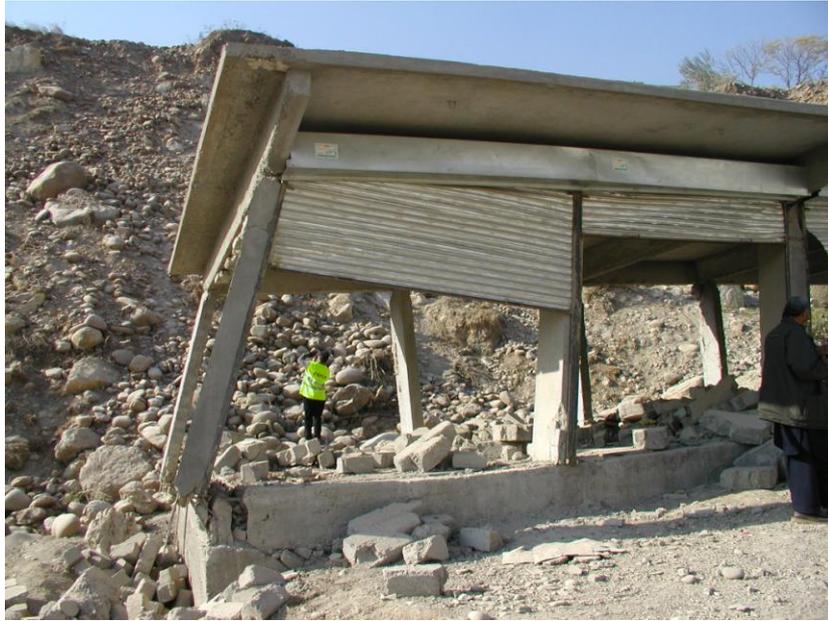
**Figure 4.31: Rock falls and showers. Cobble and boulder material on slopes showered down on road transport during the earthquake. This site in Muzaffarabad City is above and behind the cracked road edge visible in Figure 4.5**

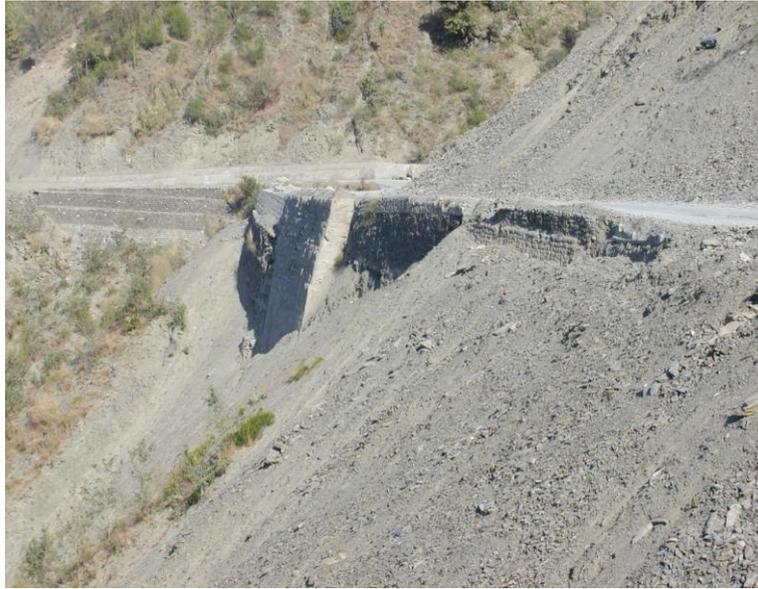
The nature of the mountainous terrain and topography meant that the road lifeline system was heavily exposed. It remains so. Roads of necessity either contour along river valley sides or hair-pin bend their way up hillsides; the photograph Figure 4.32 illustrates the Balakot-Muzaffarabad valley road south of the Masher junction. Photograph Figure 4.33 is from the same point; this road was cut by landslide reactivation of the scree slope during the earthquake. Undercutting of the abutment is also apparent as an ongoing problem. Incipient landslides also pose a further ongoing problem.

**Figure 4.33: Road network and topography: reactivated landslide blocked this road for about 24 hours and has started to undercut the abutment. View from the same position as Figure 4.32**

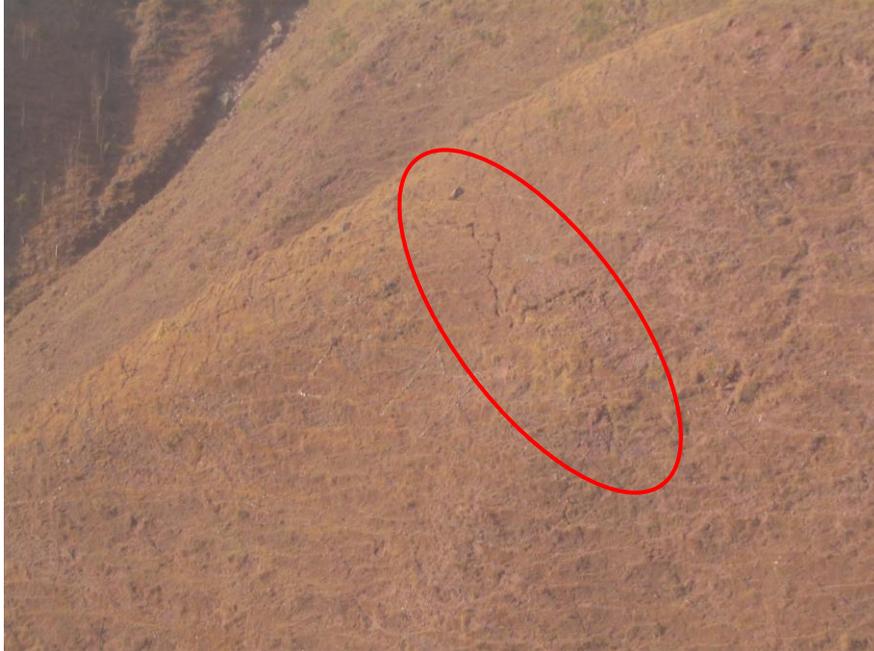
Not all visible ground cracks and potential slides had reached maturity as full landslides, several preserved a threat for the futurity. Figure 4.35 shows a mountain side viewed during a relief flight Muzaffarabad-Ghari in which ground cracks are visible. A more extreme example is apparent in Figure 4.36 in which the upper extension crack of an incipient landslide is visible. This incipient landslide has cracked through the road in two places.

**Figure 4.35: Ground cracks indicating a possible disrupted landslide**

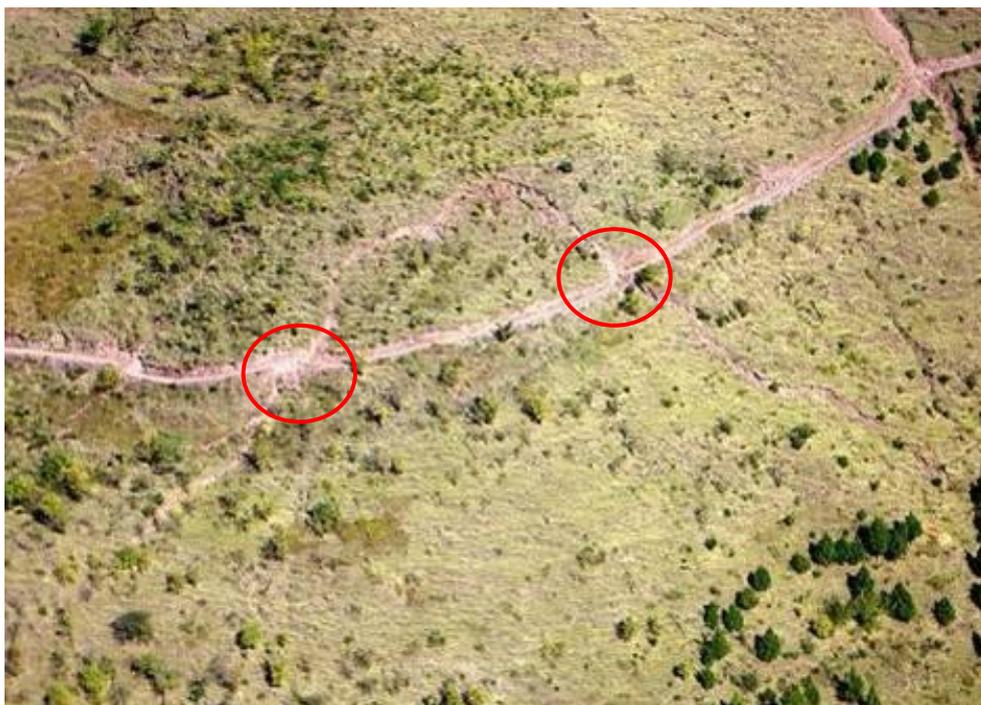
**Figure 4.36: Incipient landslide threat to road: the road is cut in two places by cracking (photo by Charles Scawthorn)**

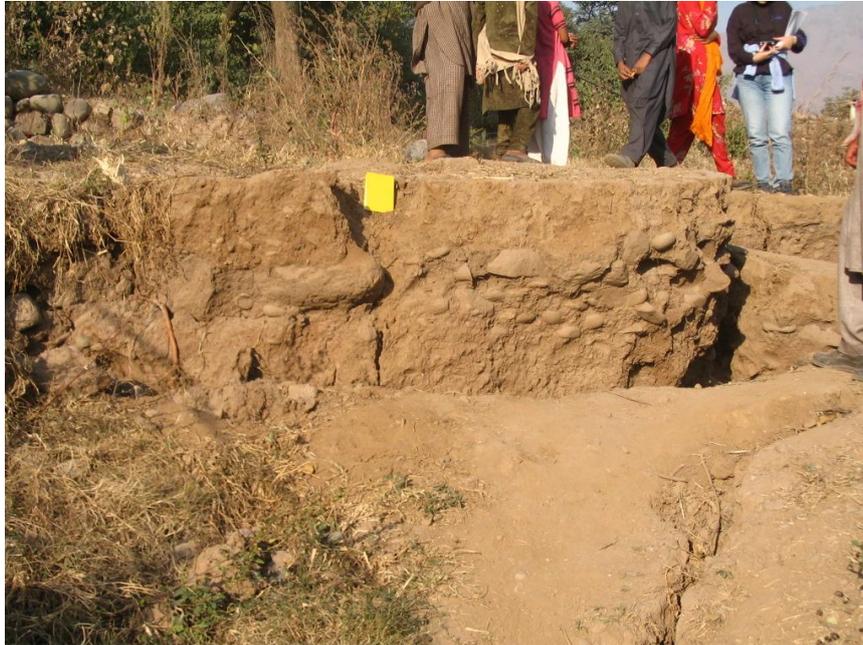
In addition to the incipient landslides on mountainside there was also observation of disrupted slides in soil. Figure 4.37 shows a scarp of one disrupted slide, near Muzaffarabad, and the ground cracks that were extending from the scarp are shown in Figure 4.38. These ground cracks extended almost parallel to the slope and some of the cracks had resulted in damage to buildings due to foundation differential settlement. These disrupted landslides also pose a danger to the people living on the landslide, as well as those in the area downhill, since the disrupted slide could eventually flow due to the weight of water from a heavy rainfall or snow melt following the winter, or through disturbance in a future earthquake.

**Figure 4.37: Scarp of a disrupted landslide west of Nelum River, Muzaffarabad**

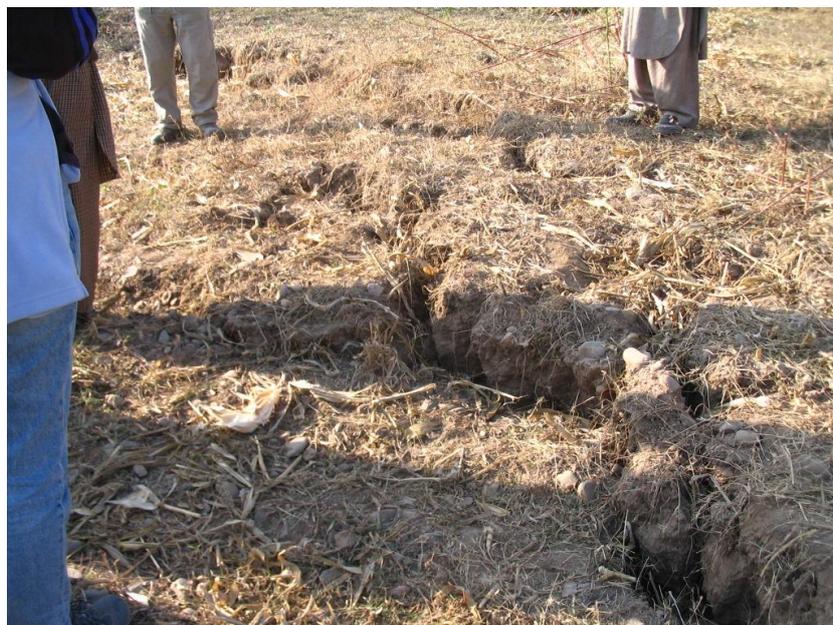
**Figure 4.38: Ground cracks, an extension of the scarp of the disrupted landslide west of Nelum River shown in Figure 4.8**

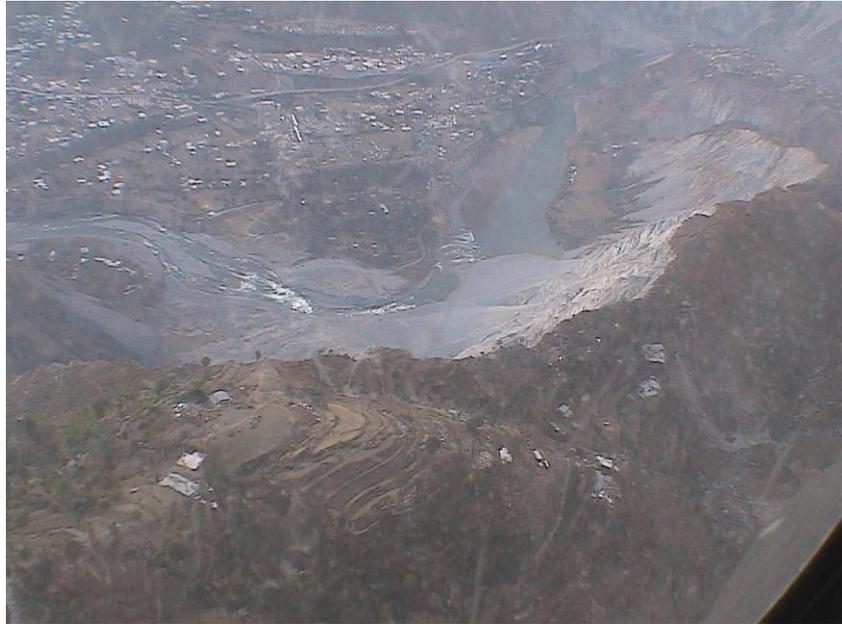
The landslides also created impacts on a traditional way of life in the mountains that is endemic. Agriculture in these hills is linked to preservation and tending of terraces on steep slopes. Evidence of such terracing is visible in Figure 4.40 on the hill tops even above the large landslide at Chela Bandi (see Figures 4.4-4.6) north of Muzaffarabad City overlooking Nilam River. This type of agricultural terracing is a characteristic of the region. A typical mountain rural view is shown in Fig. 4.41. In this example the terracing extends down a spur of a hill on which some buildings are visibly damaged and some have collapsed. Relief shelters are also visible. In some cases agricultural terraces were simply truncated by steep landslide as in Figure 4.42. Others, on a typical hill side in the upper part of Figure 4.43, have been partly truncated by a reactivated slide and slipped, while in the foreground the valley-side road is also threatened.

**Figure 4.40: Agricultural terraces disturbed above the Chela Bandi landslide of Figure 4.5**

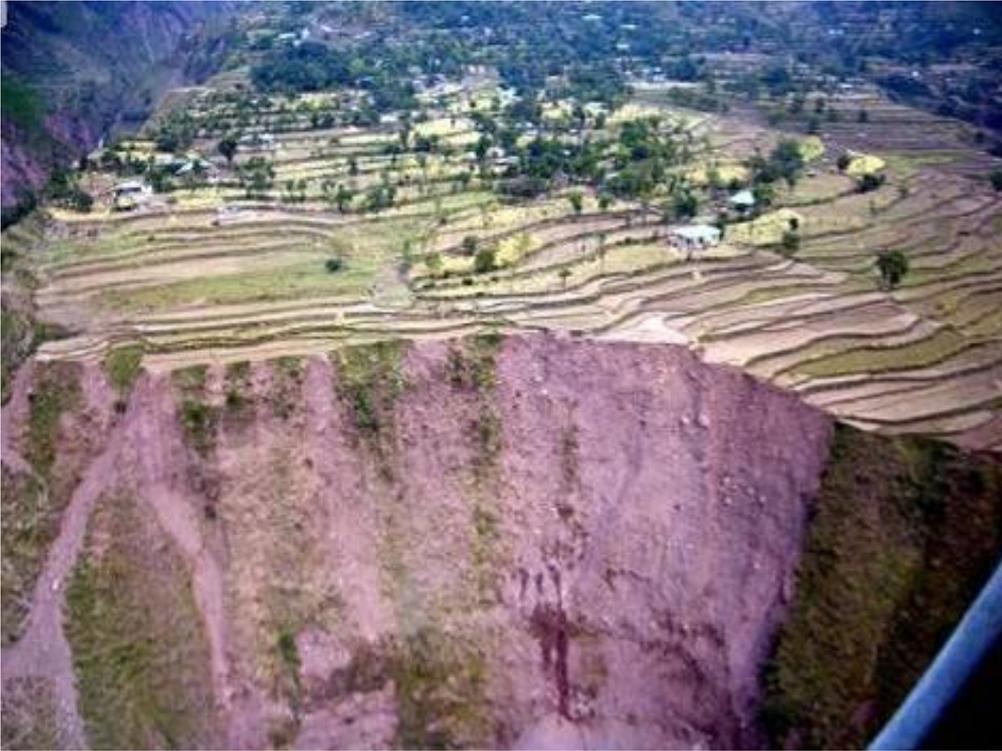
**Figure 4.42: Agricultural terraces simply truncated by a steep landslide (photo by Charles Scawthorn)**

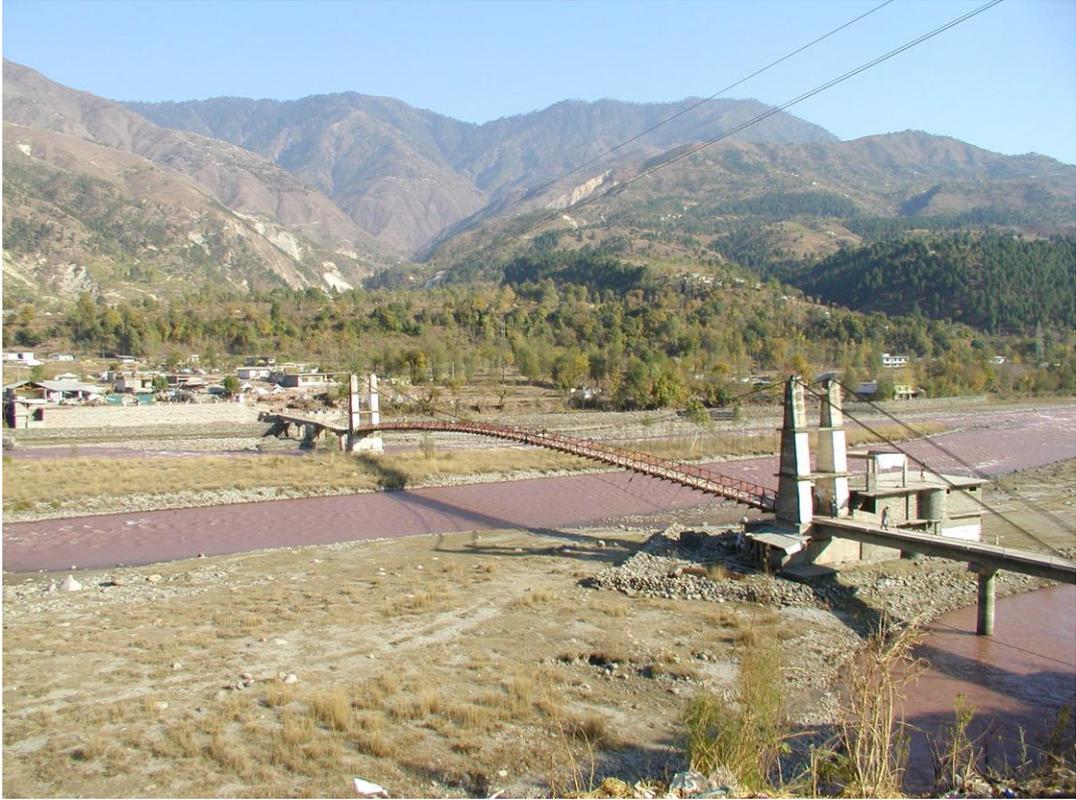
Figures 5.3 and 5.4 show two undamaged pedestrian footbridges of similar construction. However, the bridge in Figure 5.4 shows missing timber deck elements, which may or may not have been removed following the earthquake. Figure 5.5 shows undamaged bridges in Muzaffarabad. The pedestrian bridge shown in Figure 5.8 has a visible crack running through one of its masonry abutments (see Figure 5.9). Again, this bridge was fully functional at the time of the survey.

**Figure 5.3: Undamaged pedestrian footbridge crossing Kunhar River on route to Balakot**

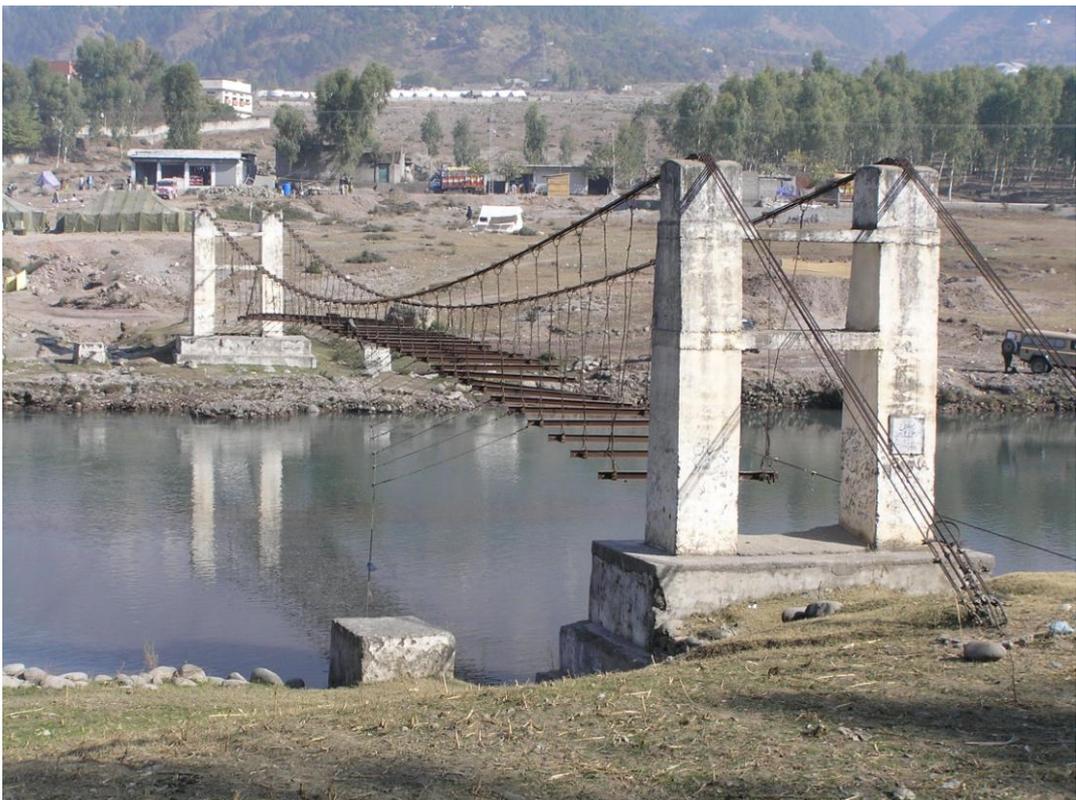
**Figure 5.4: Undamaged pedestrian footbridge in Ghari Habibullah, near the NWFP/AJK border**

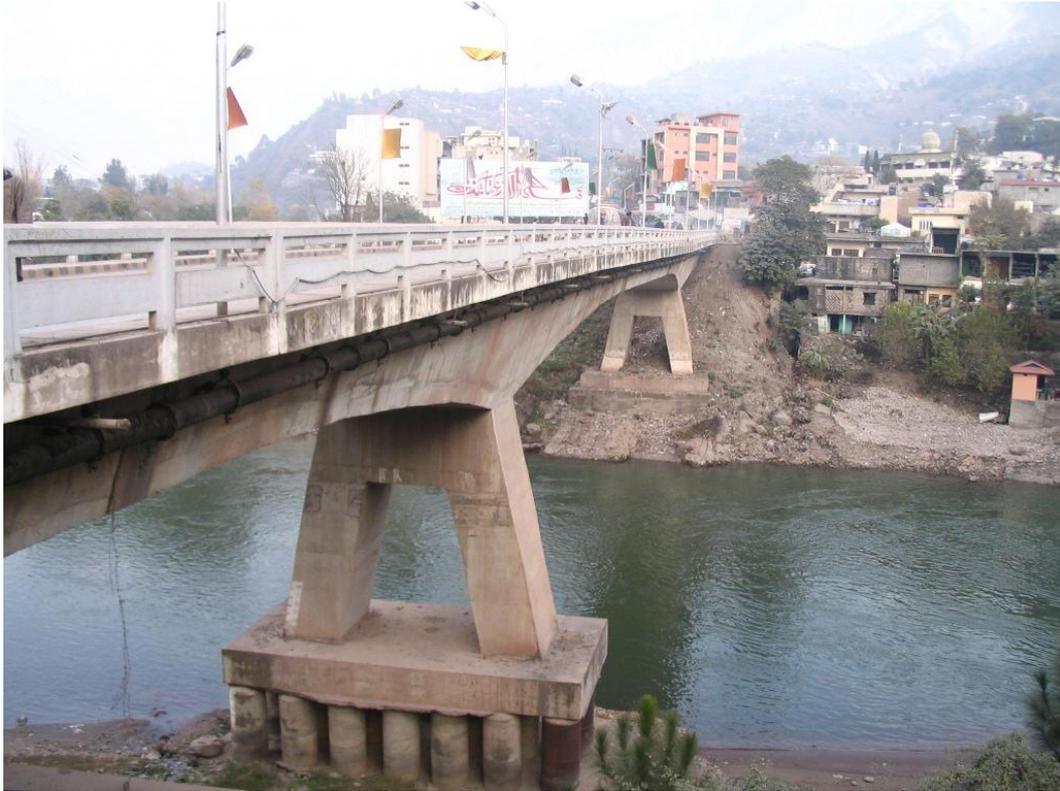
**Figure 5.5: Undamaged vehicle bridge across Jhelum River in Muzaffarabad. RC bridge deck, multi-span with integral abutments supported on RC piles with steel casing**

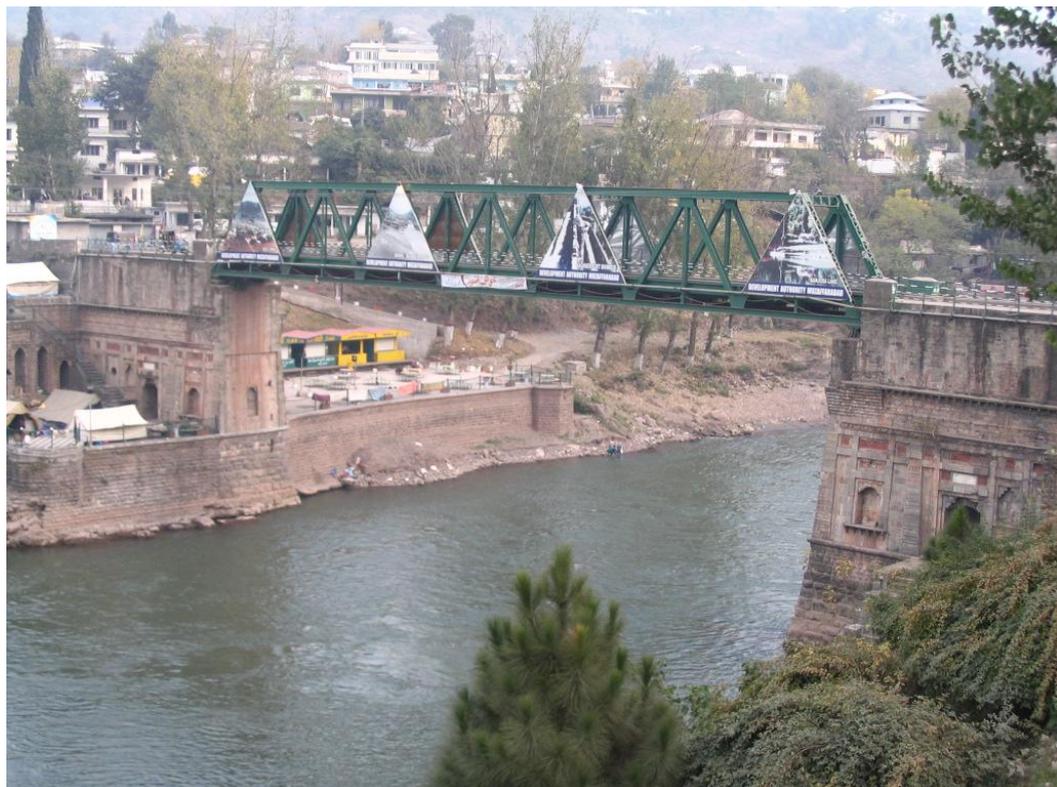
**Figure 5.6: Undamaged pedestrian bridge across Jhelum River, Muzaffarabad. Bridge consists of steel truss single span simply supported on brick masonry gravity abutments**

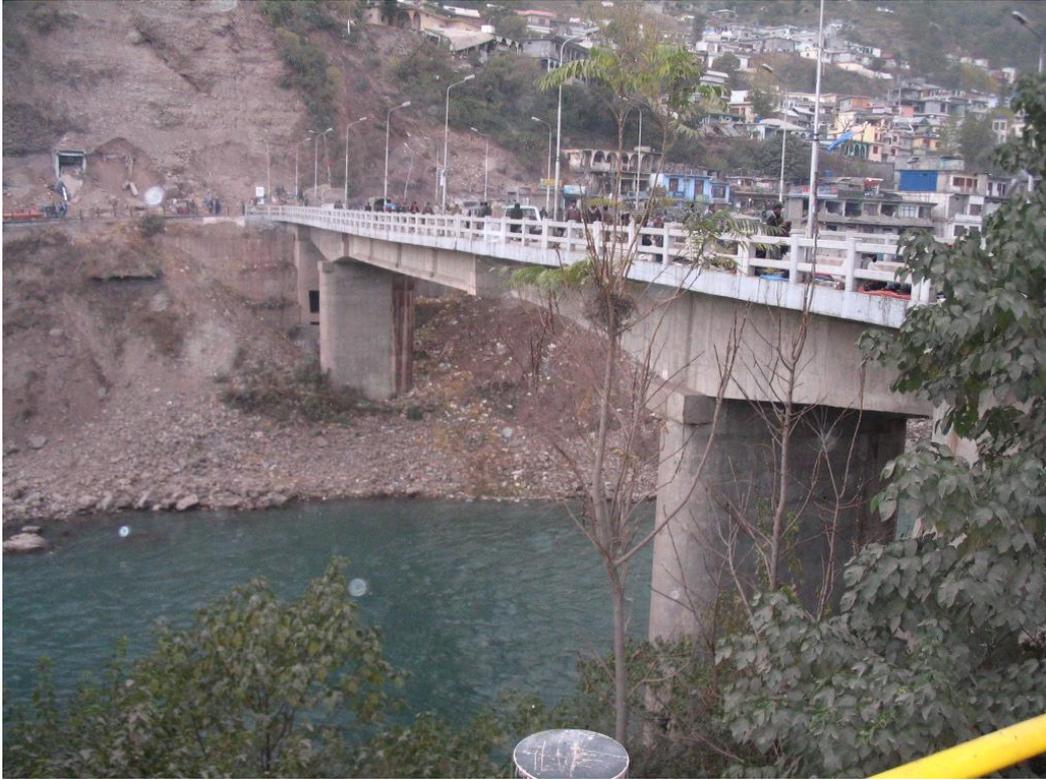
**Figure 5.7: Undamaged vehicle bridge across Nelum River, Muzaffarabad. RC spans simply supported on RC piers and abutment**

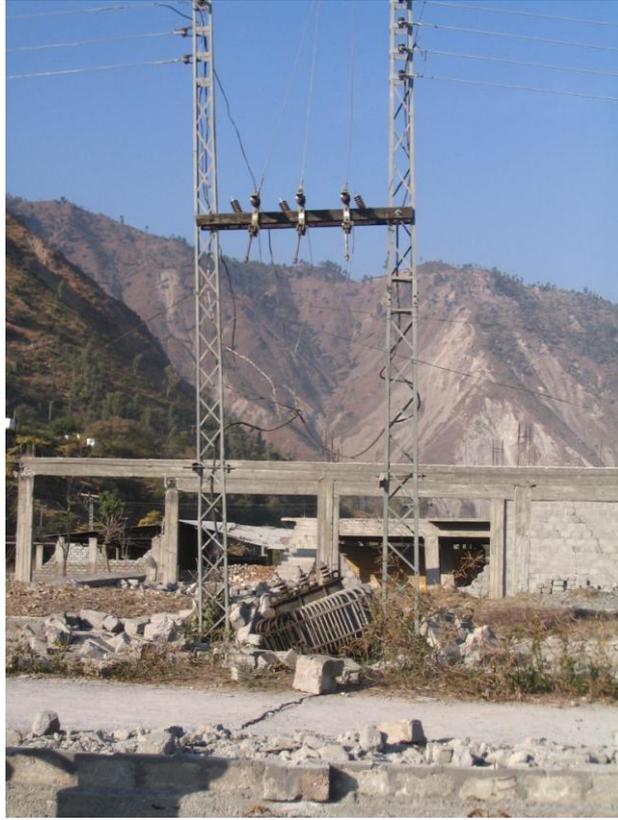
The electricity distribution systems ranging from the primary and secondary distribution networks to consumer substations suffered damage during the earthquake (ADB-WB, 2005). Figure 5.12 shows a local distribution transformer that has detached itself from the supporting frame. The transmission networks are vulnerable from landslides as shown in Figure 5.13 where a transmission tower is located on a scarp of a shallow depth landslide.

**Figure 5.12: Transformer unit detached from the supporting structure, Muzaffarabad**

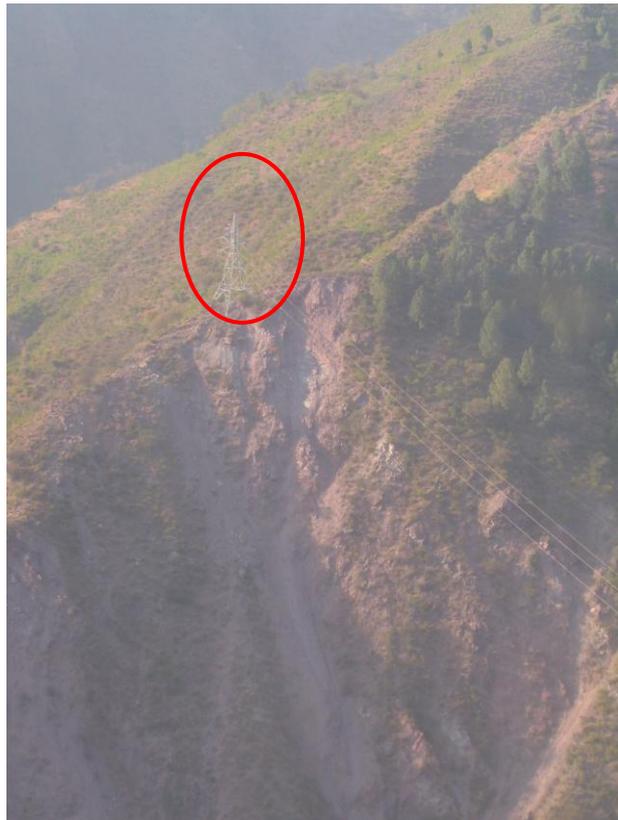
**Figure 5.13: Potentially vulnerable transmission tower on the crest of a shallow depth landslide**
