THE M_w8.8 MAULE CHILE EARTHQUAKE OF 27TH FEBRUARY 2010

A PRELIMINARY FIELD REPORT BY EEFIT

The M_w 8.8 Maule Chile Earthquake of 27th February 2010

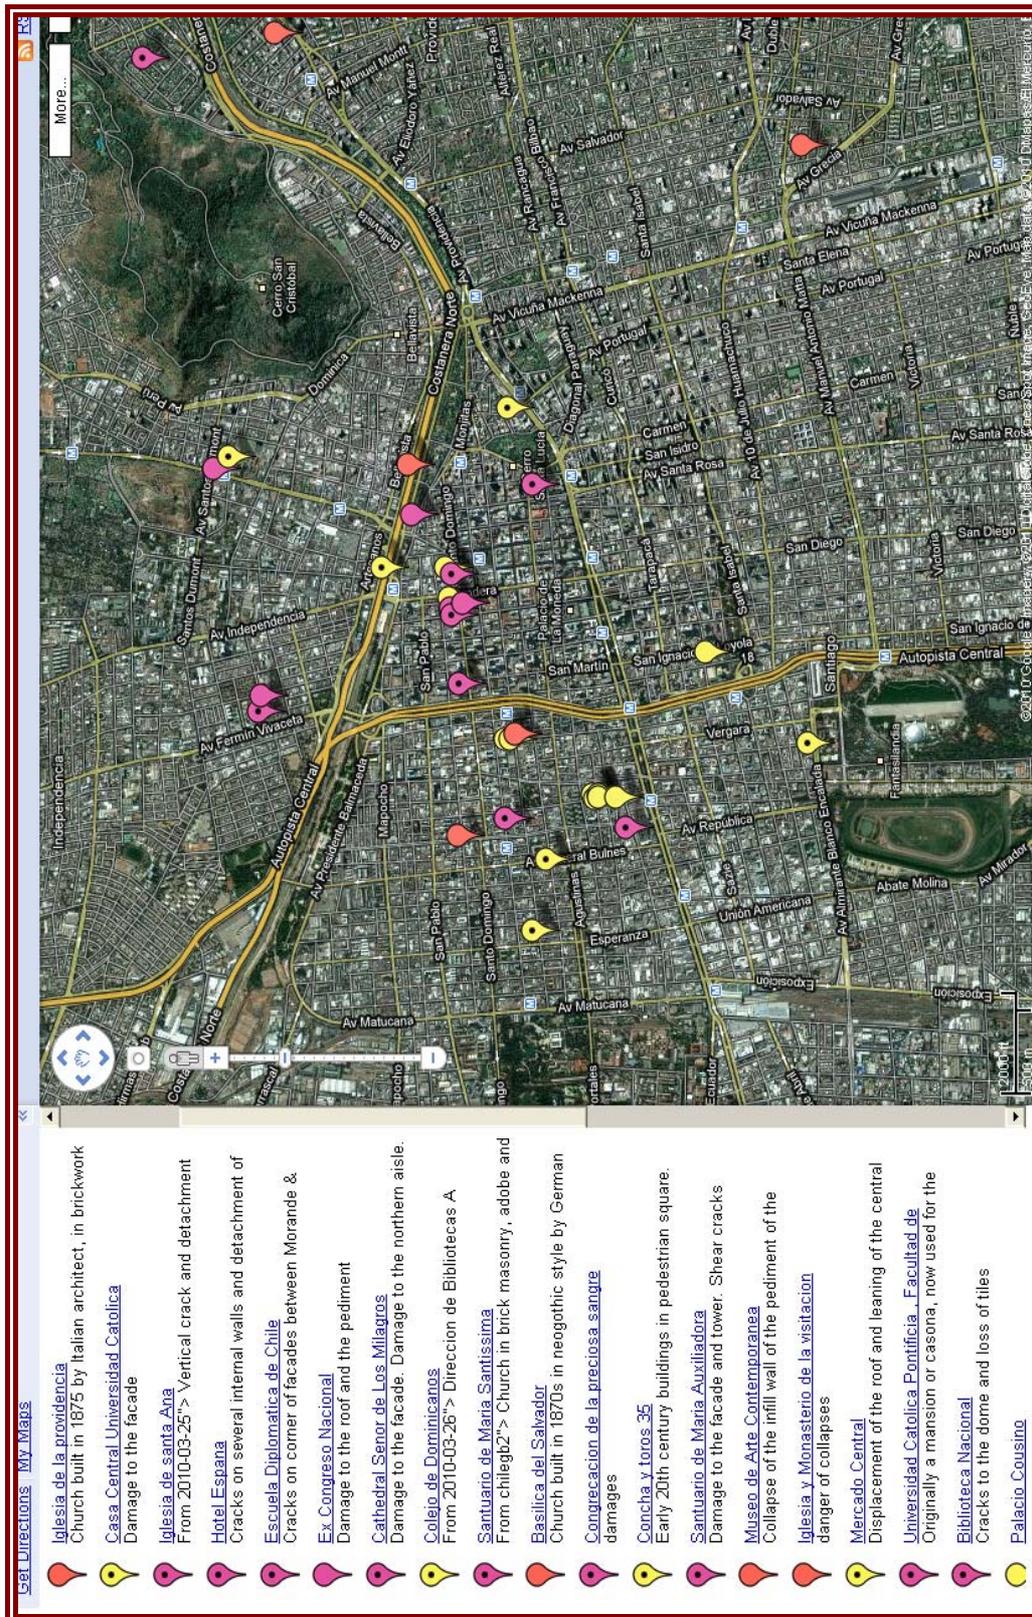
The list of buildings visited and level of damage observed in each of them is shown in Figure 3-2 were the location of the visited building within Santiago is also shown. Damage ranged from partial collapse (in red) to structural damage (in purple) to damage to architectural finishes or very localised collapse (in yellow).

Figure 3-2: Interactive map of historic sites visited in Santiago, 26 to 31st March 2010

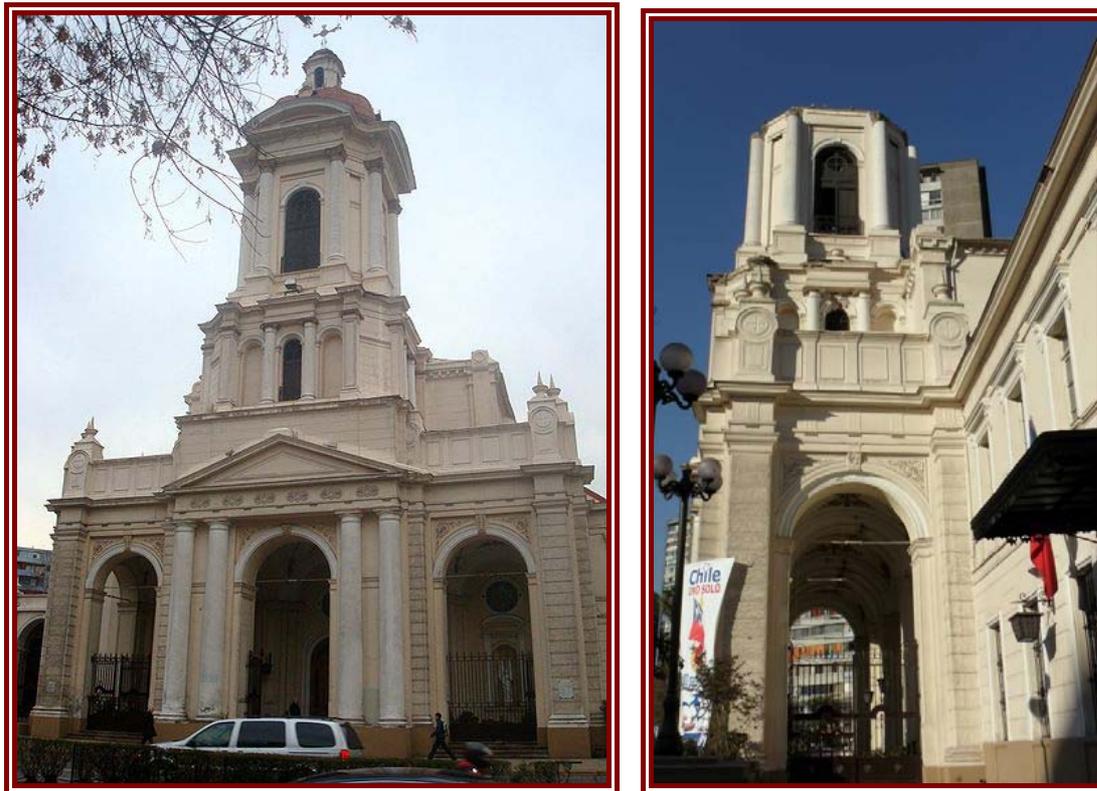
The church, shown before and after the event of 27 February 2010 in Figure 3-3, was built between 1881 and 1890 to a design by the Italian architect Eduardo Provasoli, in neo renaissance style. The church occupies one of the sides of the plot which host the remains of a partially enclosed two-storey cloister, which was once part of an orphanage called Casa Nacional del Nino, run by the congregations of nuns of the Providencia. This church has been catalogued as a national monument since 1989.

Damage is instead evident at the keystones of the vaults forming the front portico, notwithstanding the presence of transversal anchors. No evidence of pullout of the anchors from the masonry could be observed. Vertical cracks were also observed in the apse, severing this form the main body of the church. Apart from the loss of the top of the bell tower the rest of the damage was of level DG2–DG3 (EMS '98).

Figure 3-3: Iglesia de la Providencia: Façade elevation before and after the earthquake. The cap of the bell tower has been lost.

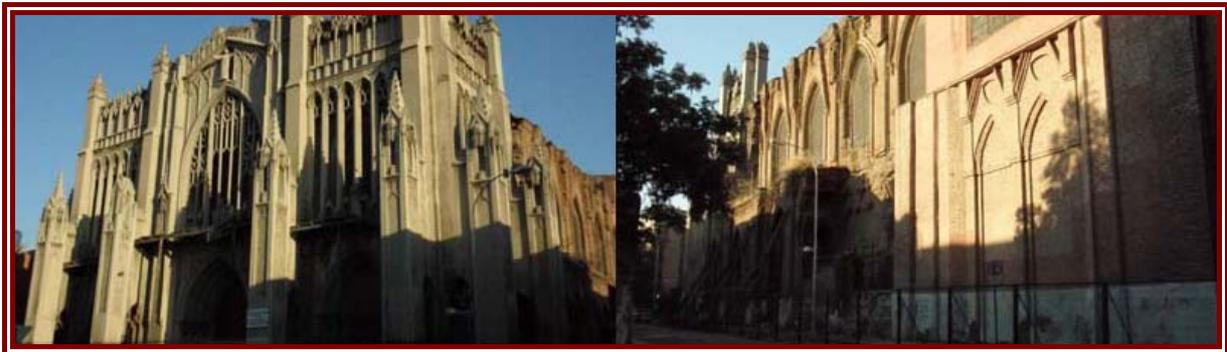
In Figure 3-5 the façade and southern elevation with signs of neglect and partial reconstruction following the 1985 earthquake are shown. The south façade had been propped and the building cordoned off for a long time prior to the earthquake. The damage caused by the latest event is recorded in Figure 3-6.

Figure 3-5: Western and southern elevation of the Basilica del Salvador

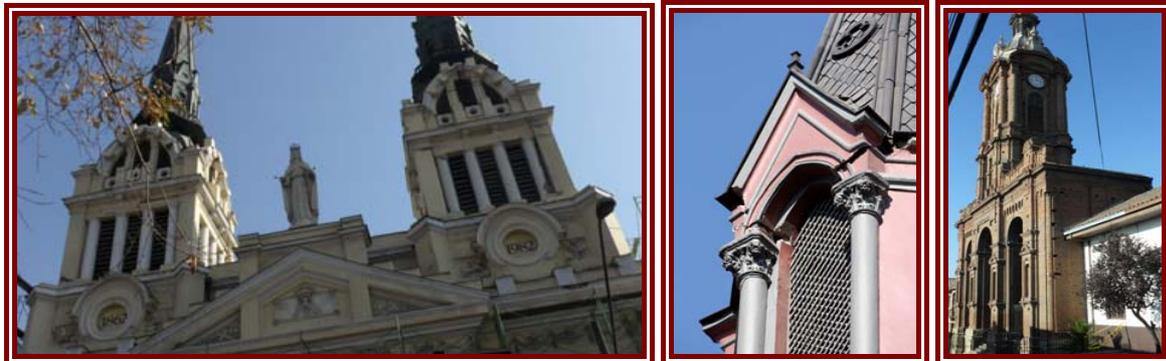
The configuration with one or two towers on the front façade is common to many churches in Santiago, and damage to the towers to different degrees was recorded in many instances. The main other damage observed was detachment of the façade from the rest of the church. Examples are

included in Figure 3-7 for other three buildings in different locations in Santiago and in Valparaiso. These two mechanisms represent well known major vulnerabilities of church like masonry structures and have been codified following the Friuli, Italy earthquake 1974 and Umbria–Marche, Italy earthquake 1997.

Figure 3-7: a) Twin bell towers in brickwork and timber of the Maria Santissima Sanctuary, damage in the columns and leaning of the timber structure of the left tower. b) Church of Enrique Mac Iver, shear failure at the base of the spire. c) Church of convent of San Francisco in Valparaiso. The convent was initially set in 1845 and the church in 1851 completed with the façade, also by Edoardo Provasoli, in 1890. Was declared national monument in 1983 and partially destroyed by a fire in the same year. It shows vertical cracks over the façade arches and cracks at the base of the tower. Damage to the arches more pronounced than in the case of the Providencia.

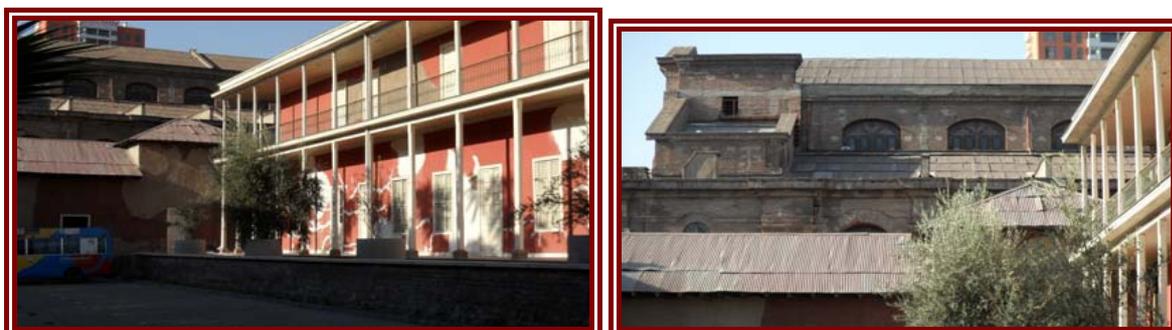
The first building has been restored and strengthened for the past 5 years. The strategy was to improve weather-tightness and resilience of the adobe walls by plastering them using a layer 10 mm thick of lime-based mortar held by chicken wire mesh. However the bonding between the plaster and the adobe was very poor and most internal and external walls completely lost it, This created substantial disruption to work and damage of some equipment, although no structural damage was visible (Figure 3-8) The annex church of Recoleta Dominica, built in brickwork with mud mortar had suffered important damage in the 1985 earthquake. The defacing strengthening and repatching carried out using concrete admixture and concrete ring beams are visible on the masonry fabric.

Figure 3-8: Convento de Dominicani and Recoleta Dominica church

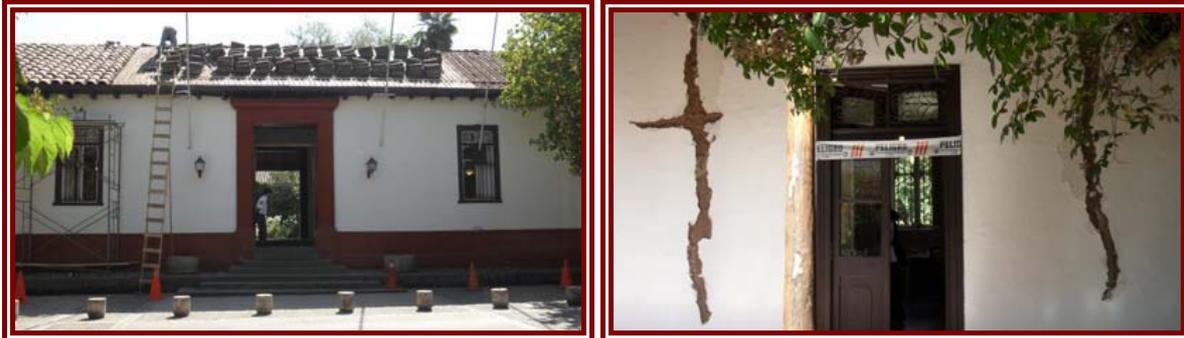
The Architectural Faculty building suffered more serious damage, with numerous through-depth cracks in perimeter and spine walls and one partial collapse. The most severe damage was in locations that had already been repaired after the 1985 earthquake using epoxy resins or concrete mixture with reinforcement and where they had been strengthened with shotcreting. Although some areas had been cordoned off and helmets had been distributed to staff, the majority of the rooms were open and with full student occupancy.

Figure 3-9: The faculty of Architecture of the Universidad Pontificia Catolica de Chile. The school of architecture, first set in 1894, is hosted in mansion buildings of the mid 19th century re-adapted for institutional use.

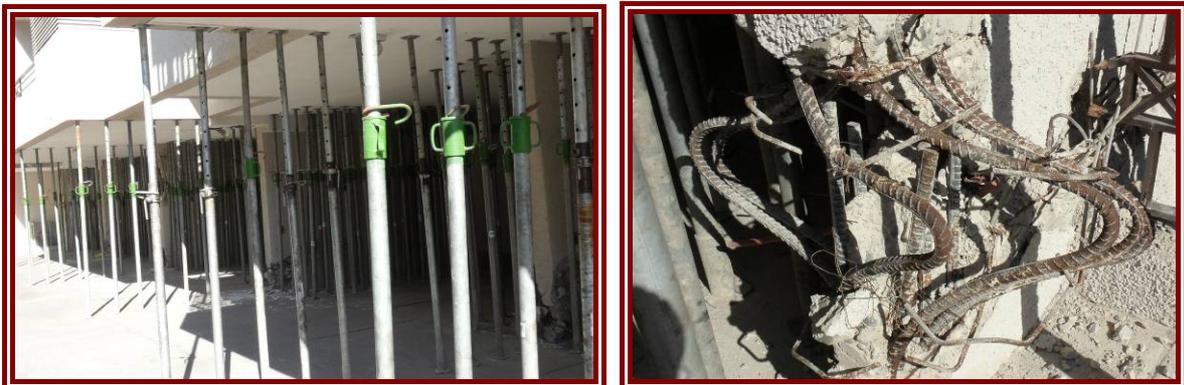
Another example of buckling failure in shear walls is shown in Figure 3-12. In this case, buckling was severe, and the building was propped over the entire basement level.

Figure 3-12: Propping due to severe buckling in boundary zones of shear walls

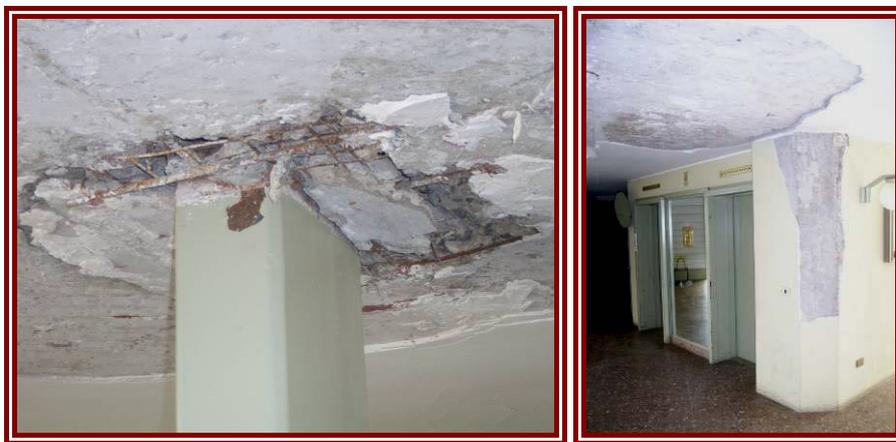
Several apartment buildings on the waterfront in Viña del Mar also suffered damage. The 15-storey waterfront apartment building shown in Figure 3-13 appeared to be a mixed reinforced concrete shear wall and moment frame system. There was evidence of damage at the base of shear walls (Figure 3-13, middle) and at beam-column joints (Figure 3-13, right). Internally, there was also evidence of punching shear failure (Figure 3-14, left) and damage to shear walls and ceilings (Figure 3-14, right).

Figure 3-14: Waterfront apartment building, Viña del Mar, internal damage

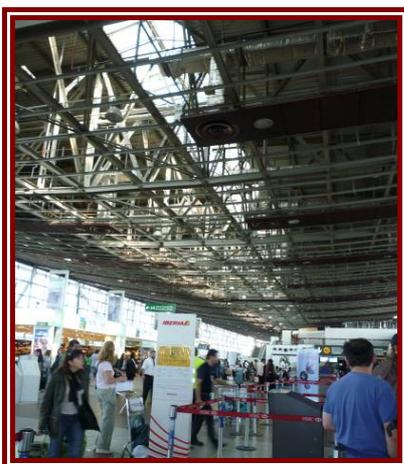
Santiago airport suffered severe non-structural damage, including collapse of the suspended ceilings over much of the terminal buildings (see Figure 3-21). In the days following the earthquake, international flights were redirected to alternative airports, where passengers would go through customs and passport control and would then take a local flight to Santiago. At the time of the team's visit, the airport was fully operational, except for some of the shops and eateries in the terminals, although the suspended ceilings had not been repaired.

Figure 3-21 Santiago airport – suspended ceiling collapse

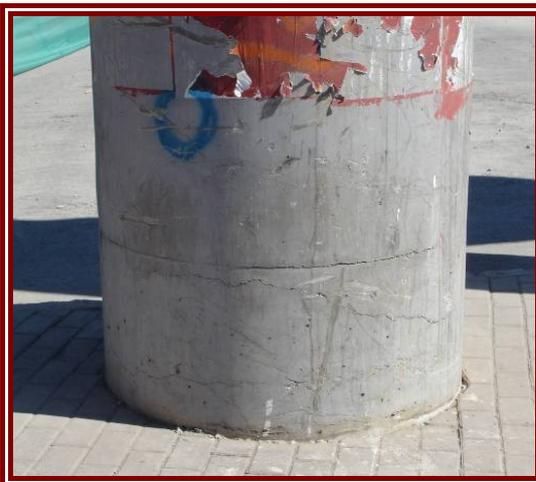
Some minor cracking was noted at the bottom of the columns in the minor bending axis of the portals (Figure 3-24) but the main damage was at the top of the portals (Figure 3-25) where the steel brackets intended to provide vertical and lateral support to the deck beams had been pushed out of the concrete. Looking at those steel restraints that remained undamaged suggested that the deck beams had failed by rotating clockwise on plan and had subsequently fallen off their bearings.

Figure 3-24: Minor cracking at base of concrete columns

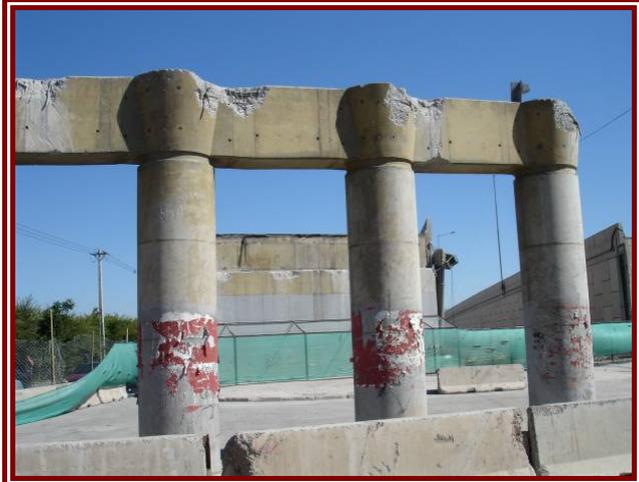
Figure 3-25: Damage to tops of support portals.

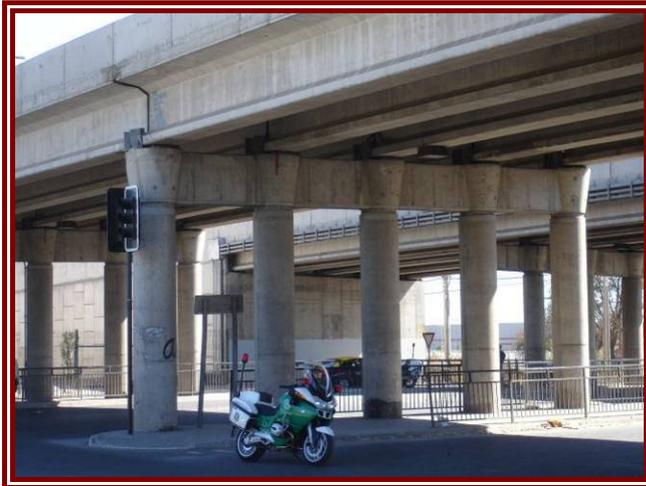
North of these bridges, the middle set of bridges (Figure 3-26) had not collapsed but showed significant damage to the restraint system. Unlike the southernmost set of bridges these were not skew bridges.

Figure 3-26: The middle set of overpass bridges.

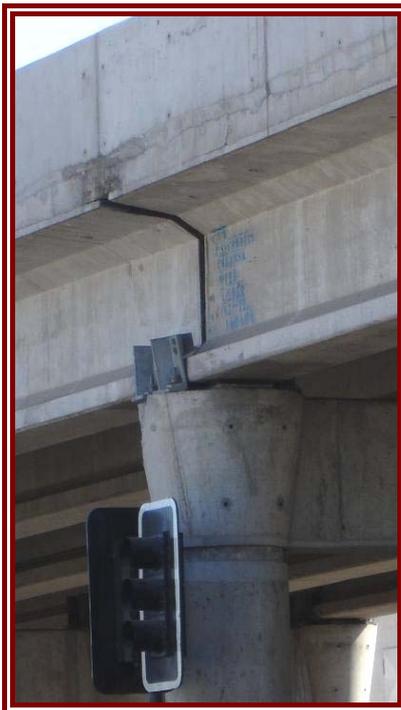
It was clear that these bridges had also experienced significant lateral forces but, in this case, the forces were not high enough to unseat the deck beams. Many of the steel brackets restraining the bridge deck were bent (Figure 3.27) and several showed signs of shear failure of the concrete (Figure 3.28). As with the southernmost set of bridges those steel restraints that remained undamaged suggested that the deck beams had also rotated clockwise on plan.

Figure 3-27: Damage to deck restraints. Figure 3-28: Spalling of concrete around holding down bolts

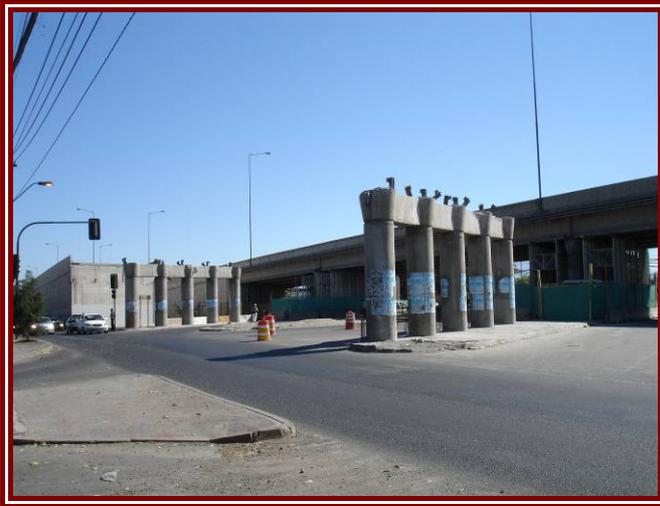
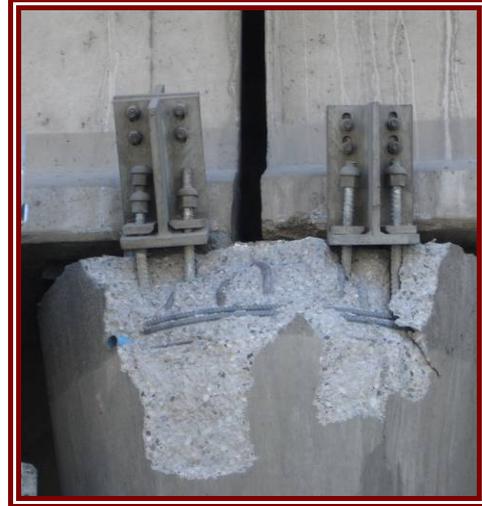
At the northern most set of overpass bridges, again skew, (Figure 3.29) the eastern carriageway had collapsed while the western carriage way remained intact but badly damaged. Similar damage to the restraint system was observed (Figure 3.30) with the deck beams again rotating clockwise on plan.

Figure 3-29: The northernmost set of overpass bridges. Figure 3-30: Severe spalling of concrete at holding down bolts

None of these bridges showed signs of foundation failure either at the internal supports or at the abutments but at all three sights there were obvious signs of high lateral forces on the bridge decks. Borehole data collected by Cruz et al. 1993 state that this area of Santiago has “*Alternating layers of low to medium plasticity silts and clays, interbedded with gravel layers. From the surface to about 9 m depth the deposits have a soft consistency, low relative density and SPT N value of 2-4. The S wave velocity is around 200 m/s from the surface to a depth of 10m. Below about 9m the strata have a firm to hard consistency and medium to very high relative density and the SPT N value is 35. The depth to water table is about 2 m, the depth to rock about 100 m*”. Cruz et al. 1993 also show that in this area the ground motions can be four times larger than at hard rock sites in Santiago. Therefore it is likely that amplification of ground motions due to the site conditions led to the damage to these particular bridges, with the skew bridges sustaining more damage than the normal bridges. The restraint system for the deck beams was also inadequate to carry the lateral forces to which it was subjected.

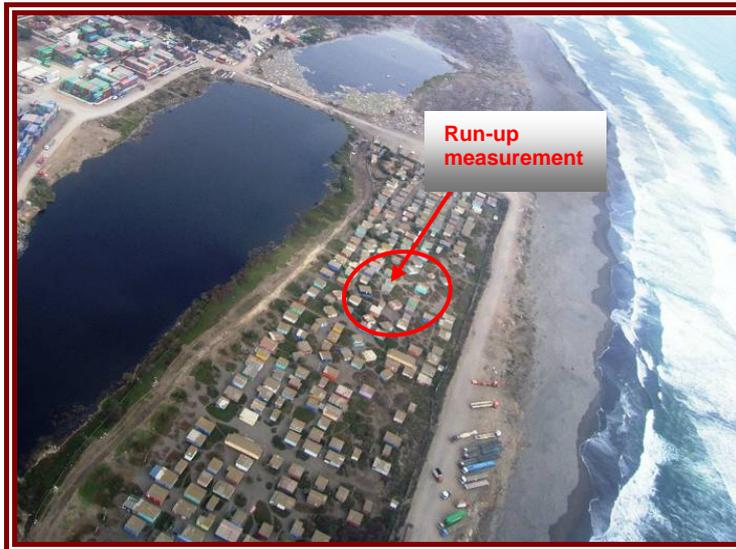
As can be seen in Figure 3.32, which is the area to the top of Figure 3.31, the visible debris is of building material from similar structures to those seen in the foreground Figure 3.31. This is very severe damage and the previous grid layout can still be seen where the structures used to be. It would appear that the sea dyke protected the area to the north (Figure 3.31), but the unprotected area to the south (Figure 3.32) was completely lost to the tsunami.

Figure 3-31: Area protected by sea dyke structure

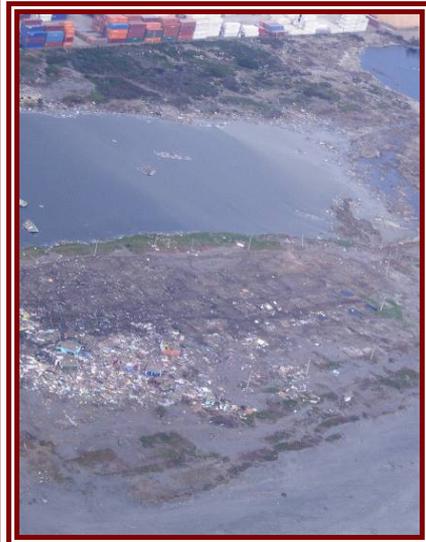
Figure 3-32: Area lost outside dyke

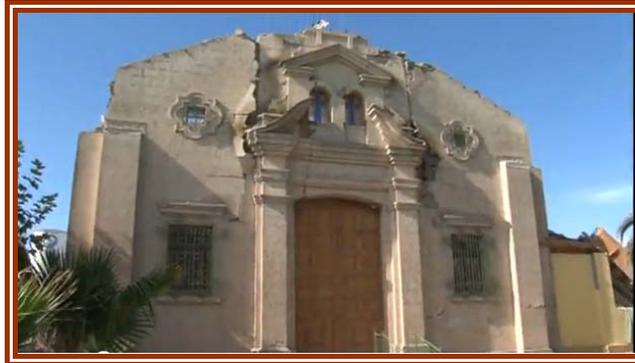
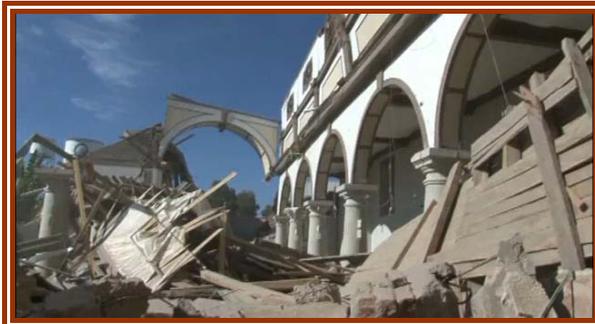
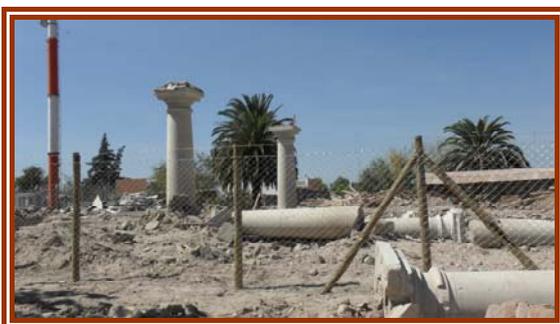
In Peralillo there are three major historic buildings, The church, almost 100 years old, the Casona y Parque, and the old school, listed as National Monument.. The Church was I adobe with timber columns encased in concrete to simulate Doric neoclassical columns, and an upper structure with vault and roof in timber. The church had successfully survived the 1960 and the 1985 earthquake, but according to the technical Office of the Corporacion del Patrimonio de Colchaga the damage was to extensive to warrant restoration and it was completely demolished, without retaining not even the façade, which was in a very particular style. The Casona belonged to one of the oldest family in Peralillo, Echeñique Errázuriz, built by a French architect at the beginning of the 20th century, in mud, fired brick and and timber frame, set in a large parquet with a lake. The Casona, partially collapsed after the earthquake, was also demolished, while the Old Primary School built in the same style with timber framed brickwork, suffered modest damage and is being restored. Ford Chile is supporting the reconstruction effort in Peralillo.

Figure 4-3: Peralillo, The Church, just after the earthquake and what was left after the bulldozers.

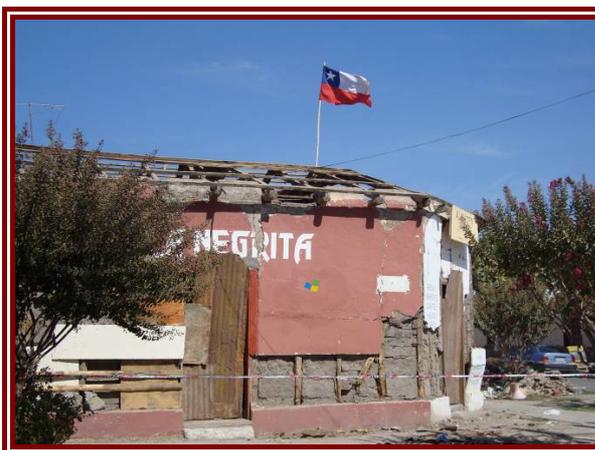
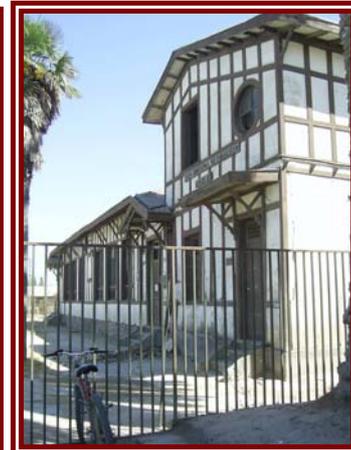
Figure 4-4: Peralillo, town house in adobe confined with wood columns (quincha) and the old school, with similar construction, which did not suffer any damage.

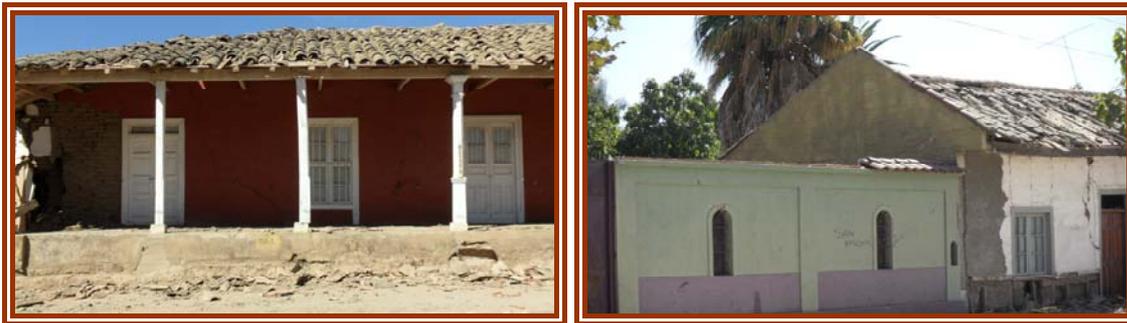
have a front porch shading the façade. The porches are made of timber elements connected with scarf joints and timber pins between posts and beams and between beams and rafter as it is visible from the pictures in Figure 4-5. In a minor number of cases the end walls are made of confined brick masonry. The rationale for this is that, even if the adobe façade detaches and partially falls, the ridge beam will be supported by the more stable end walls, and hence roof collapse will be prevented. Broadly speaking, observation has confirmed that this arrangement works.

Figure 4-5: Left: Peralillo Adobe house with porch. The scarf joints on the beams are visible over the columns; the porch is connected with horizontal struts to the adobe wall, hence providing some lateral restraint. The central column in the picture has shifted laterally from its support. Right: townhouse with confined masonry end walls. The adobe façade shows vertical cracks and the roof as partially caved in, but is still supported.

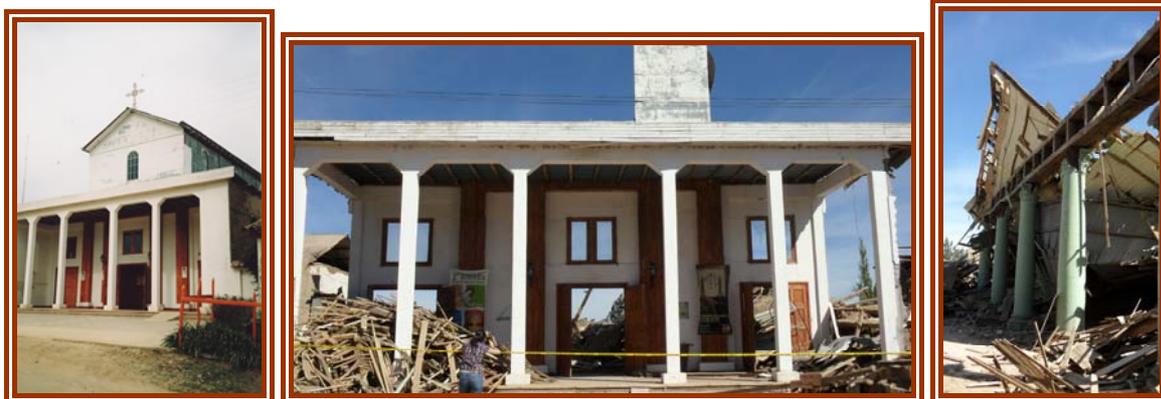
Pumanque is a small village of 3442 inhabitants, just south of Peralillo, initially settled in the 17th Century and is first mentioned in the bishopric documents in the XVIII century. A chapel was in existence in 1767, but the present church was erected in 1824. The original building was made of quincha (timber frame infilled with adobe) with a roof of straws and the floor of rammed earth. This building fell in disrepair and a new building was completed in 1870. This second building was destroyed by the earthquake of 1906 and the current one, with steel columns and timber walls and roof, was completed between 1910 and 1929 and retrofitted with concrete after the 1985 earthquake. As a result of the current earthquake only the retrofitted facade is left standing.

Figure 4-6: Pumanque: Nueva Senora del Rosario Church, before and after the earthquake. The green columns of the main nave are made of a steel profile with an outer concrete casting and the roof rests on a timber verendeel truss.

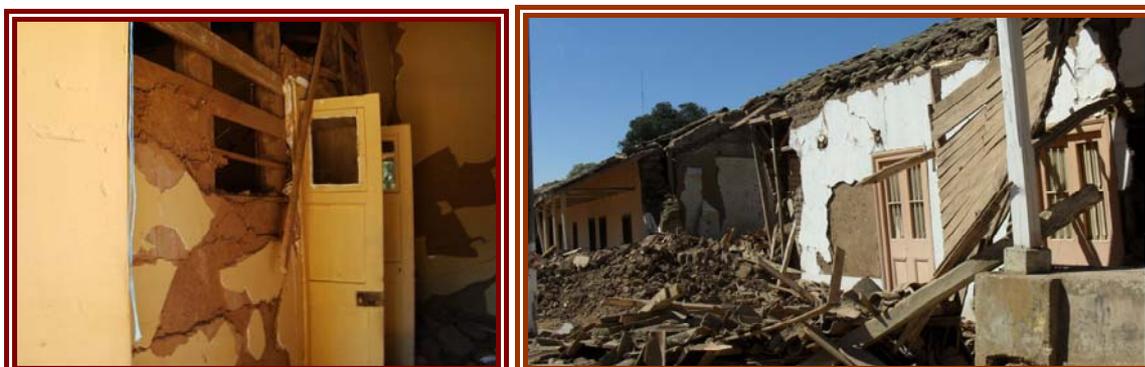
Figure 4-7: Pumanque: Adobe house confined with lightweight timber and damage to row of houses on main street.

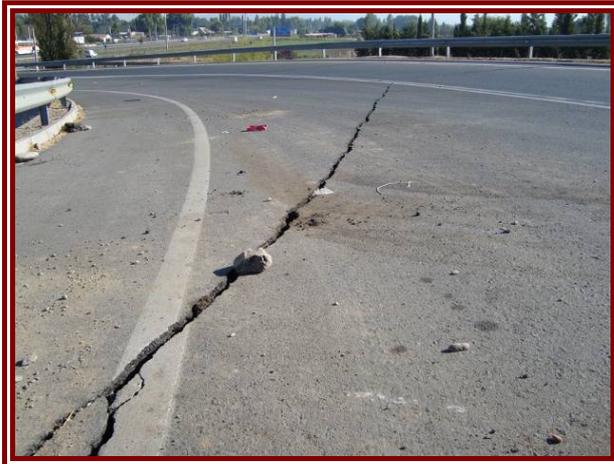
The main road between Santiago and San Fernando had several detours mainly due to cracks in the pavement caused by either slope failure or lateral spreading. Some of the bridges suffered settlement and rotation; minor lateral spreading in the embankments was also observed (Figure 4-14 and Figure 4-15).

Figure 4-14: Crack in 5 Sur Road between Santiago and San Fernando City.

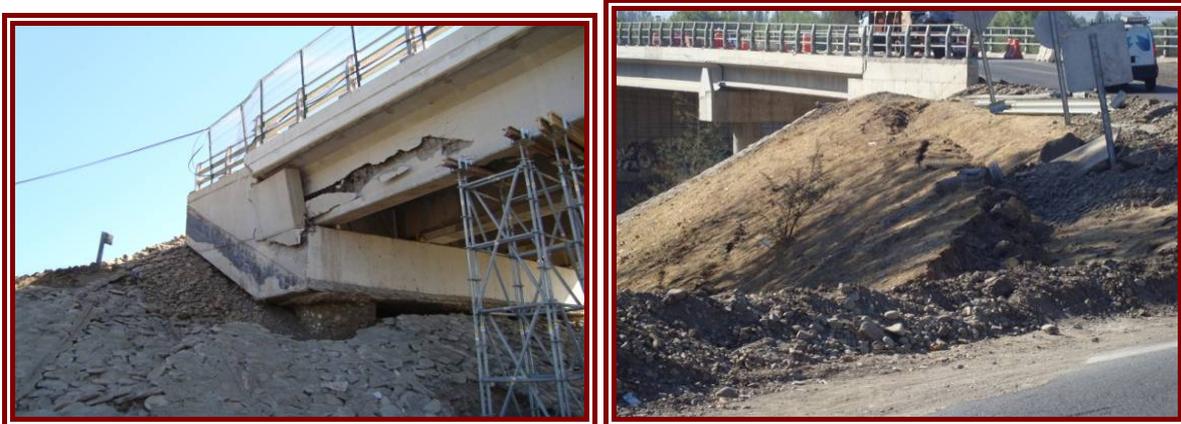
Figure 4-15: a) Bridge; b) Embankment along 5 Sur Road Santiago-San Fernando City

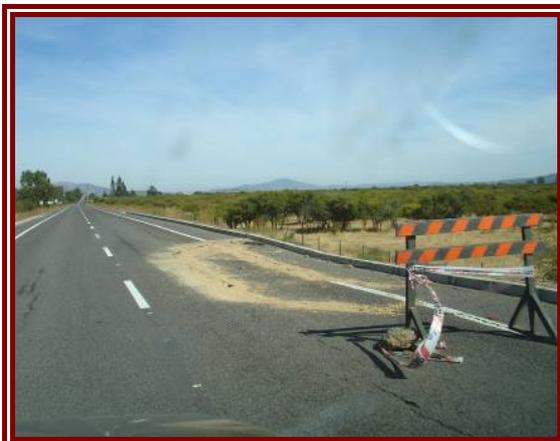
Where the team travelled off route 5 the same sorts of problems to the more minor bridges were noted. There were also many localised problems with settlement and lateral spreading of roads (Figure 4-16) near rivers and on embankments. However these types of slope failures were generally not apparent in natural slopes. One of the few examples of slope failures seen is shown in Figure 4-17 and like other failures it was very localized and of minor importance.

Figure 4-16: Typical damage to minor roads

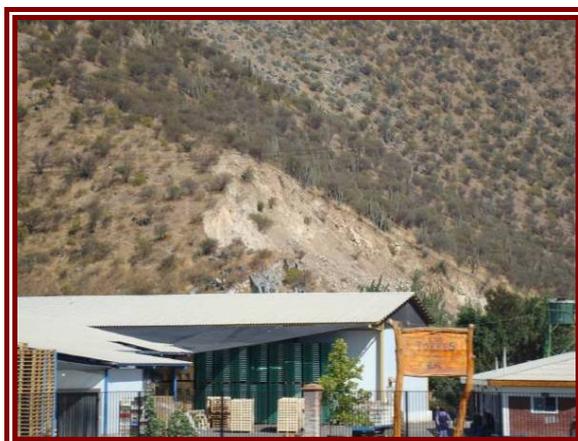
Figure 4-17: Minor slope failure Main Road 5 Sur, between Santiago and Curico.

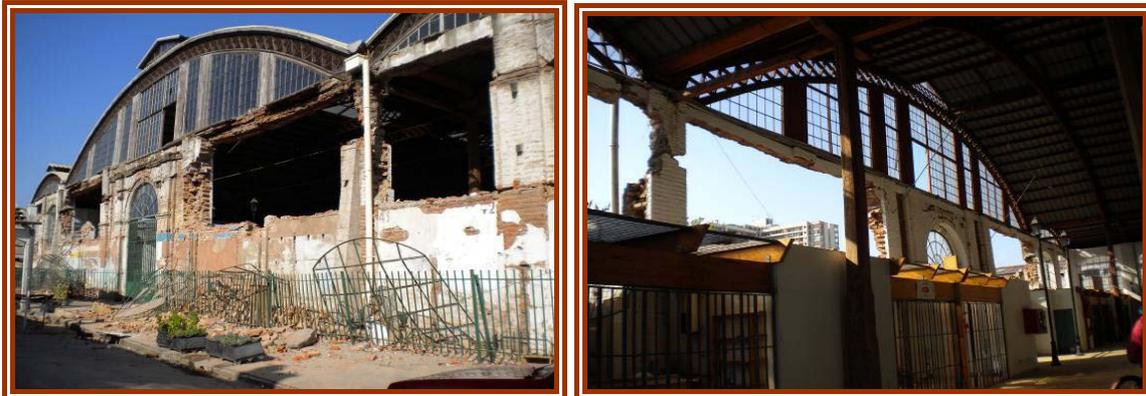
In Talca severe damage was recorded on many adobe buildings, and some of the early 20th century buildings around the Plaza Mayor, although for these the damage was structural but without collapses. An exception is constituted by the Central Market buildings. These had been already abandoned and were in disrepair, with various studies already proposed for their rehabilitation and change of use. However part of the end walls collapsed and currently what is left is threaten with demolition.

Figure 5-2: Central markets in Talca

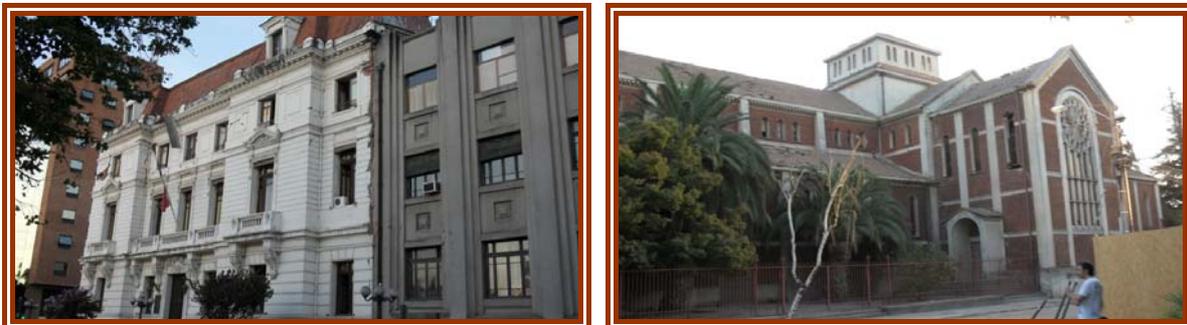
The main church in Talca is built in confined masonry and although it sustained a few cracks, the damage is essentially moderate.

Figure 5-3: Left: example of hammering between to masonry buildings in Plaza mayor and right, Cathedral of Talca

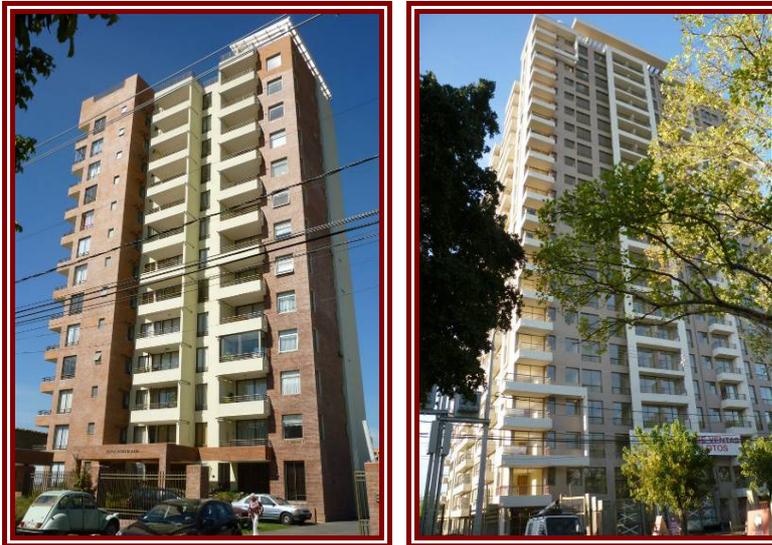
Two reasonably typical multi-storey apartment buildings from Talca are shown in Figure 5-5, both of which were essentially undamaged. The team could find no indications of any damage in the 13-storey Edificio Costa Azul (left; opened 2008), aside from some superficial cracks in internal partitions which had already been repaired at the time of visit. There was no observable cracking in beams and shear walls on the ground level or basement level. A 22-storey apartment building on Av O'Higgins (right) also seemed to be unscathed, although the team were not able to visit the interior.

Figure 5-5: Typical undamaged apartment buildings in Talca: Edificio Costa Azul (left) and new building under construction on Av O'Higgins (right).

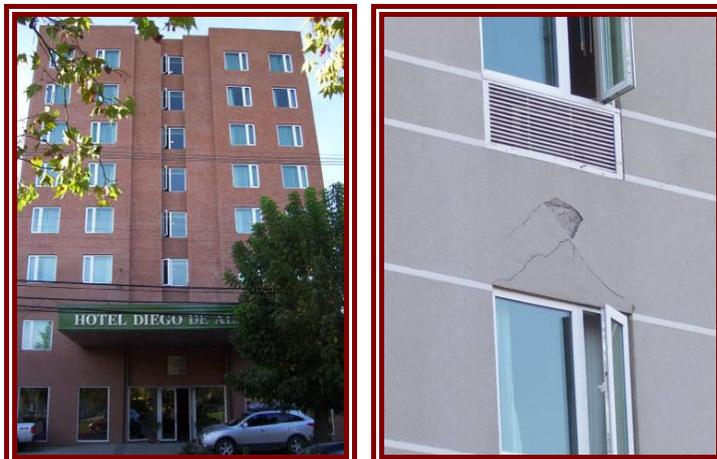
The 8-storey Hotel Diego de Almagro building, where the team was based in Talca, was lightly damaged, with cracking in façade panels above windows at the 2nd and 3rd floors (Figure 5-6), and internal cracking to partitions.

Figure 5-6: Hotel Diego de Almagro and light damage above windows on 2nd and 3rd floors

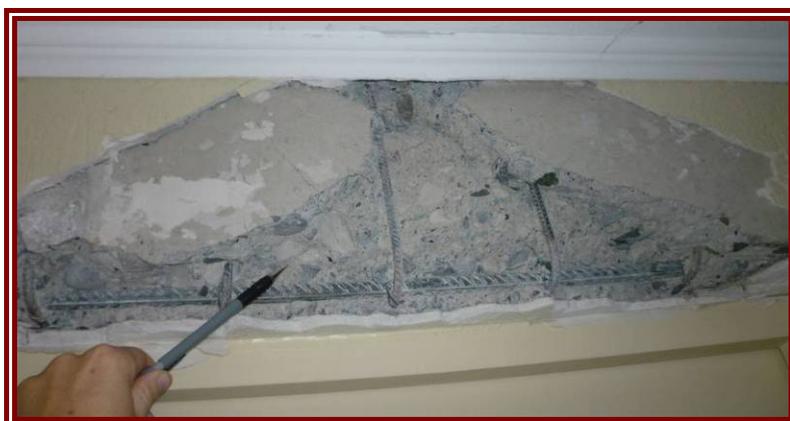
A notable feature in the Edificio Amalfi was the heavy spalling damage to lintel beams above doorways in almost every apartment in the building (Figure 5-8). From structural drawings, the lintels were typically 475 mm × 200 mm deep with 0.25% conventional (horizontal) reinforcement top and bottom – this relatively light reinforcement could explain the heavy damage observed. It is not clear if the lintel beams were intended to act as primary beams, coupling the shear walls, but it appears that they were merely architectural with minimal reinforcement. Nevertheless, the links at 150 mm spacing appear to have successfully confined the core concrete, and only spalling of cover concrete was observed.

Figure 5-8: Edificio Amalfi – Heavy spalling of door lintels but core concrete intact.

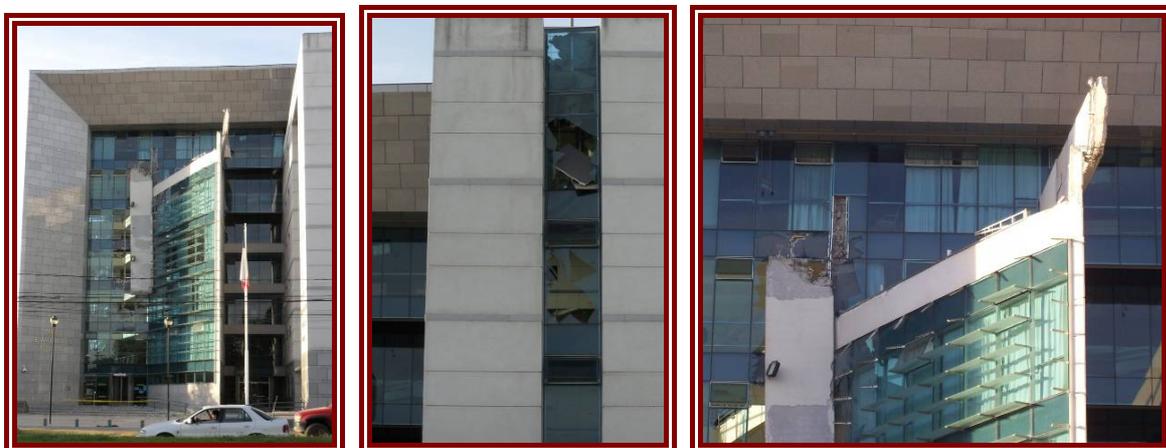
Figure 5-10: Talca Court of Appeals building

The other modern building in Talca that did not achieve life safe performance was the Court of Appeals building on Av O'Higgins. The building was a reinforced concrete shear wall building, L-shaped in plan but with a triangular section attached to one of the legs of the L (Figure 5-10, left). Apart from some damage to glass panels between shear walls (Figure 5-10, middle), there did not appear to be significant damage to the main L-shaped body of the structure. However, a large beam along the top of the triangular section had completely unseated, smashing into the structure below, and was left dangling from limited reinforcement at the time of the team's visit (Figure 5-10, right). There appeared to be little or no reinforcement connecting the two beams, and they were seated on a very small “column” supporting their weight but providing insignificant resistance to their inertia. The team's impression was that the detail was purely architectural, and yet could have compromised the “life safe” performance of the building had the earthquake occurred at a time when it was occupied.

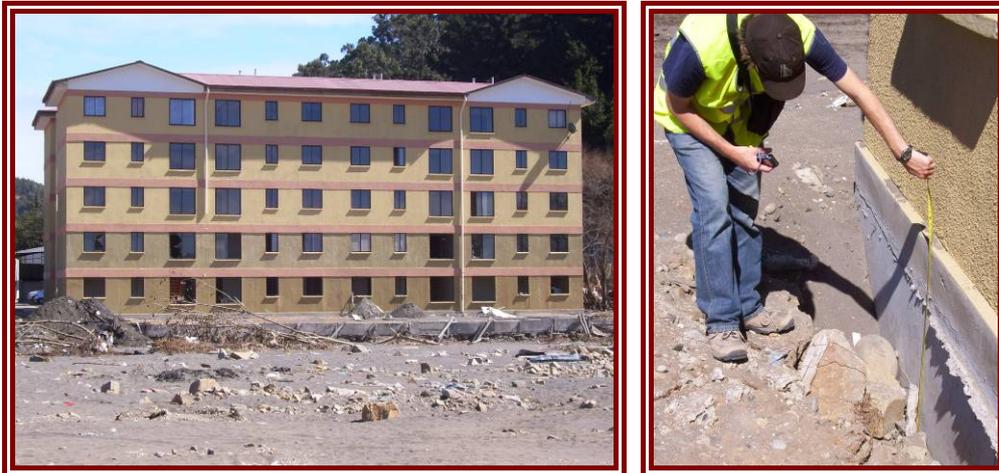
Outside of Talca, the team visited some modern low- to mid-rise buildings in the tsunami-affected Constitución and Pelluhue. Two identical five-storey apartment buildings (one shown in Figure 5-11, left) experienced very little structural damage, despite wave heights above the ground level (evidenced by broken windows on the ground and first floors), and scour of up to 300 mm at the foundations (Figure 5-11, right).

Figure 5-11: Apartment building near waterfront in Constitución and scour at foundations

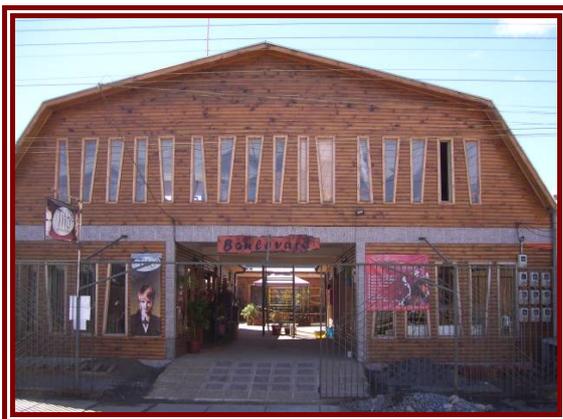
Another successfully performing modern building was a two-storey house on O'Higgins – the third street back from the river in Constitución (Figure 5-12). The building had a reinforced concrete frame in the ground storey, with timber infills, and a timber frame / timber infill first storey. The only visible damage was a cracked façade tile that covered the concrete frame at the base of the column. The owners of the building were very interested in explaining to the team the level of engineering that had gone into the construction, and its subsequent successful performance, in contrast to most other buildings in this area of Constitución. The pride that the owners felt for a non-traditional building solution was an interesting lesson to draw from the team's visit, and could be contrasted with the desire for "culturally-appropriate technologies" common to post-disaster reconstruction.

Figure 5-12: RC frame building with timber infills and practically no damage

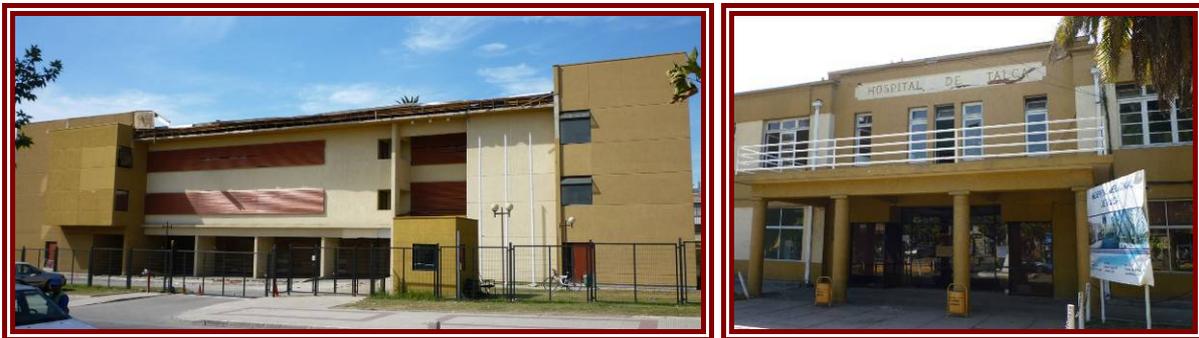
One of the more modern buildings, a clinic, lost a parapet along its front façade, and sustained minor damage to façade cladding (Figure 5-13, left). There did not appear to be any damage to the lower levels. There was apparent damage to older confined masonry buildings (Figure 5-13, right), but it was difficult to determine the extent of damage from outside the hospital compound. There was no discernable damage to the Centro de Diagnostico Terapeutico building (Figure 5-14).

Figure 5-13: Damage to hospital buildings in Talca

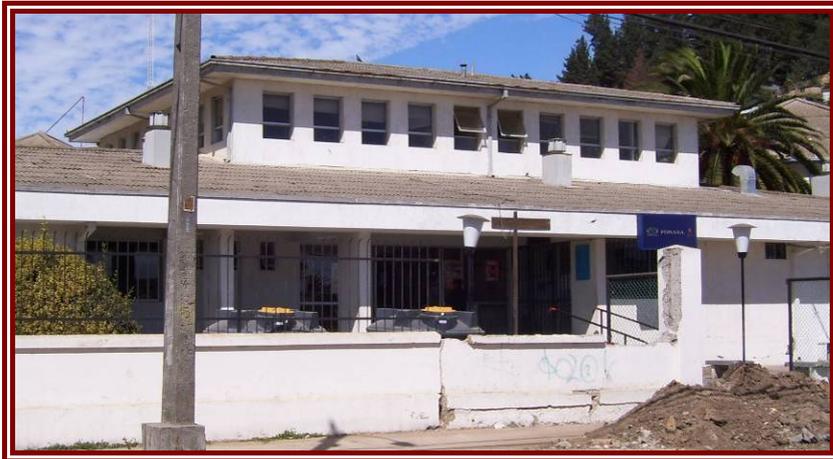
The hospital in Constitución appeared to have sustained only minor damage, notwithstanding the pile of rubble on the footpath outside which suggested more internal damage (Figure 5-15). According to hospital workers, it was operational immediately following the earthquake. The hospital, located at the south-east end of the city centre, appeared to have been above the height of the tsunami.

Figure 5-15: Minor damage to hospital building in Constitución

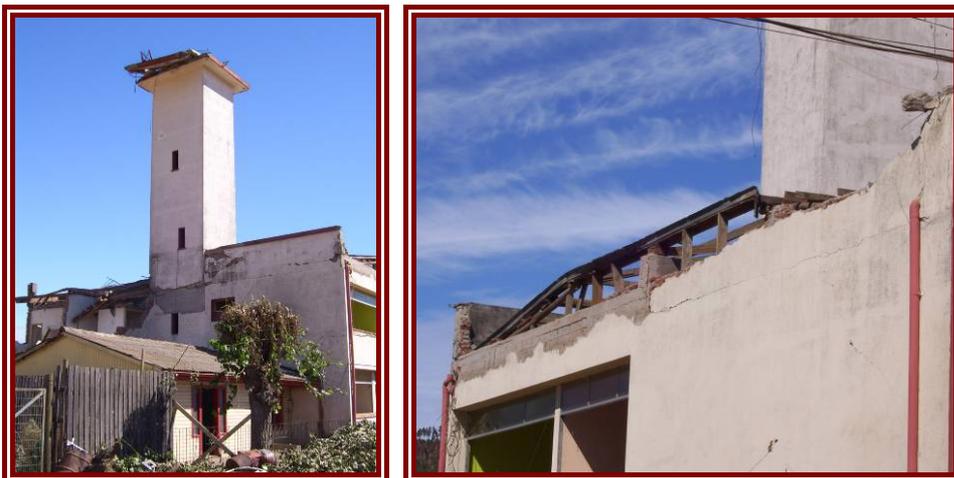
The masonry fire station in Constitución was heavily damaged by the earthquake and tsunami (Figure 5-16), and was not in operation at the time of the team's visit. Damage included the collapse of a belltower and parapets around the roof of the station, and severe damage to external walls.

Figure 5-16: Severe damage to fire station in Constitución including collapsed tower and parapet, and damage to external walls

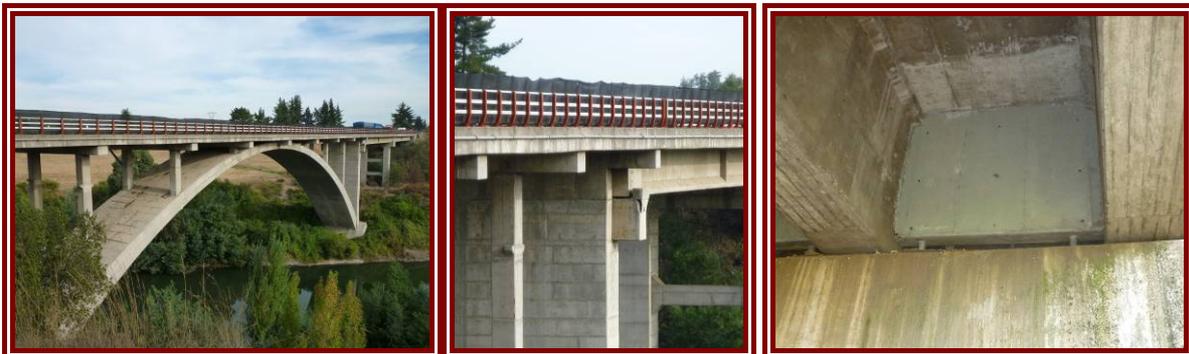
The northbound bridge (Figure 5-20, left) showed no discernable damage, except shear failure of the transverse shear key closest to mid-span (Figure 5-20, centre). Other shear keys did not appear to be damaged. Interestingly, there was evidence of either repair (following previous earthquakes) or retrofit at the end of the bridge, where ~250 mm thick panels of concrete had been cast between girders (Figure 5-20, right).

Figure 5-20: Rio Claro Bridge (northbound traffic), shear failure of transverse shear key at midspan, and evidence of retrofit or repair from previous earthquakes

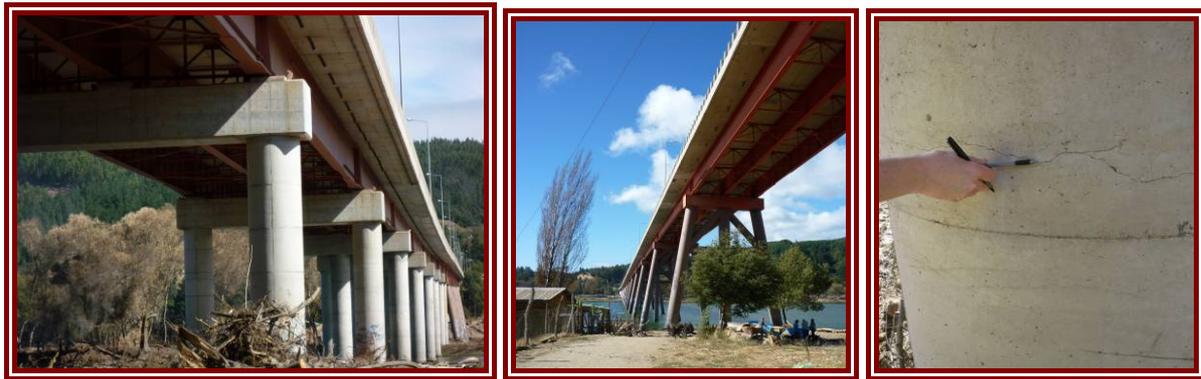
The bridge is of composite construction – spans at the north-east end are supported on 2 or 3 circular concrete piers, connected by a concrete pier cap (Figure 5-21 left); spans at the south-west end are supported on raked steel piers and a steel pier cap (Figure 5-21 centre). The steel piers were presumably required to support the taller spans at the south-west end. Some of the concrete piers showed signs of light cracking (~1mm) due to transverse movement, on both the upstream and downstream sides (Figure 5-21 right). The concrete bridge deck was supported on steel I-girders.

Figure 5-21: Cardenal Raul Silva Henriquez Bridge, Constitución. Concrete piers at north-east end, and raked steel piers at south-west end. Light cracking to concrete piers.
