THE M_w8.8 MAULE CHILE EARTHQUAKE OF 27TH FEBRUARY 2010

A PRELIMINARY FIELD REPORT BY EEFIT

The M_w 8.8 Maule Chile Earthquake of 27th February 2010

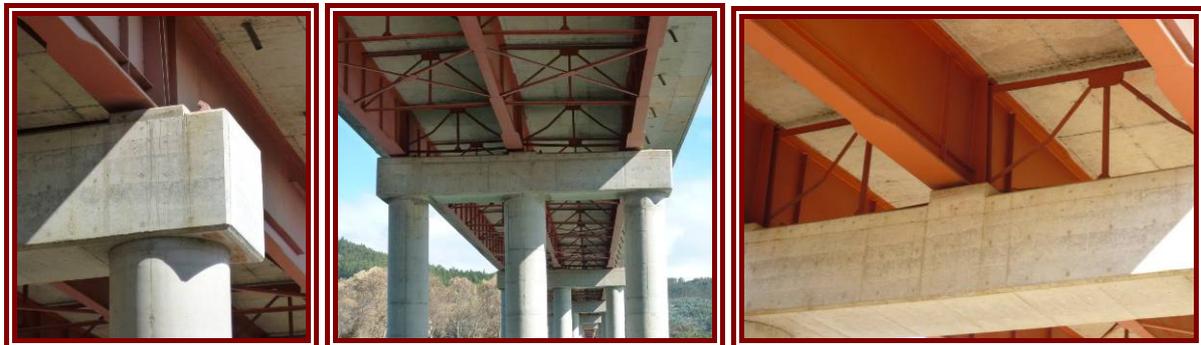
Aside from the light concrete cracking, the bridge had undergone significant lateral movement, and steel transverse shear keys on both sides were almost completely flattened in some locations (Figure 5-22, left and centre). Of more concern, there was significant residual transverse displacement – around 300mm at mid-span – of the deck towards the upstream side. It seems that the bridge was fortunate to survive the earthquake without unseating, and that the deck will need to be jacked back into position before the next major earthquake occurs.

There was also evidence of buckling of steel members used for lateral bracing of the steel girders, presumably due to lengthening under tensile yielding, followed by buckling in the compression cycle (Figure 5-22, centre and right). The buckling was mostly evident in the upstream side, consistent with the residual displacement of the bridge being towards the upstream.

Figure 5-22: Cardenal Raul Silva Henriquez Bridge, Constitución. Displaced shear keys and significant residual lateral displacement, residual displacement along bridge and buckling of girder lateral bracing.

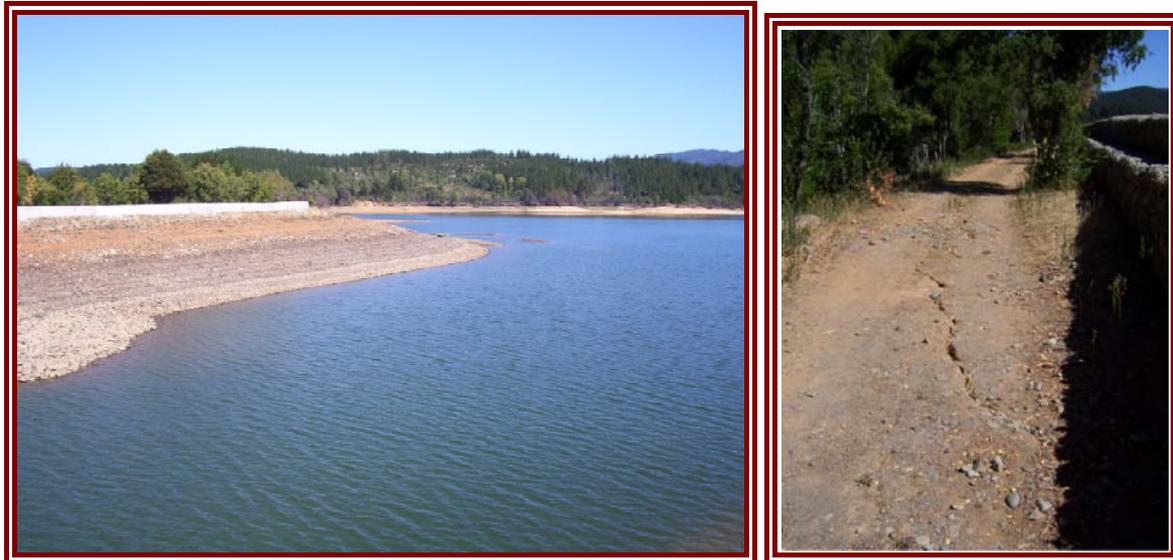
Figure 5-25: San Esteban Reservoir

Since damage to the main water storage reservoirs was limited and due to logistical constraints only two dams were visited. The first was the San Esteban reservoir, which is shown in Figure 5-25. This is an embankment dam reservoir. The pictures show the low level of the reservoir, but despite this some minor longitudinal cracking was observed along the crest to the north side of the sluice gate.

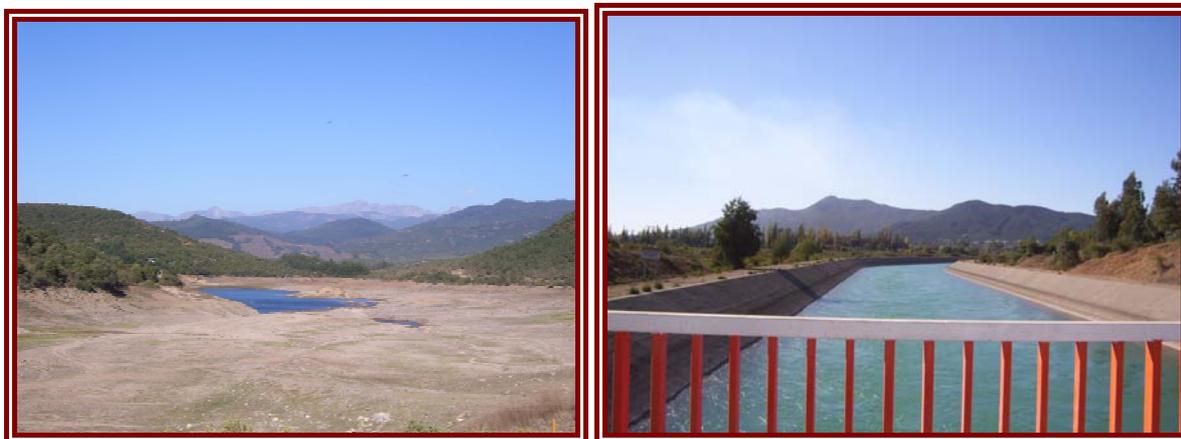
Figure 5-26: Colbun Dam

Figure 5-26 shows the upper Colbun Dam and the main channel leading from the Lower dam. Clearly the water level was very low. No damage was observed to the main embankment dams during our brief inspection. However, it is understood that one of the levees (away from the dam) collapsed two days after the largest of the aftershocks on the 11th May 2010. The exact reason for the failure is unclear (GEER, 2010).

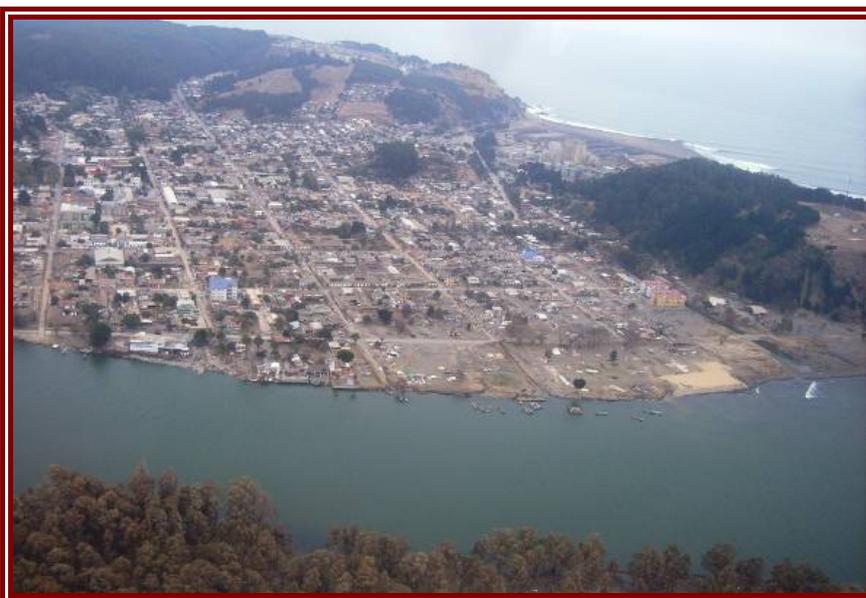
This survey indicated extensive damage to the city along the south bank of Rio Maule. High water marks were noted on several buildings that indicate a minimum tsunami flow depths above ground level were between 4 to 5m close to the river, reducing to about 1.5 to 2m further inland.

Extensive damage to structures in the inundation zone was visible from the air and from the ground the effects of scour could be clearly seen. The first two streets from the shoreline were almost totally destroyed, where the structures had been subjected to the most severe effects of the waves close to the river.

Figure 5-28: Aerial shot of Constitución looking south across the Rio Maule

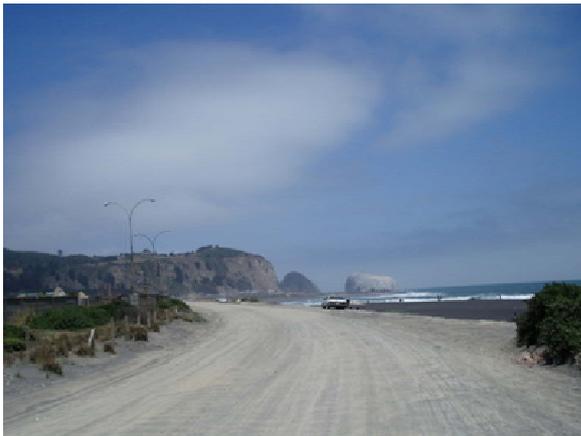
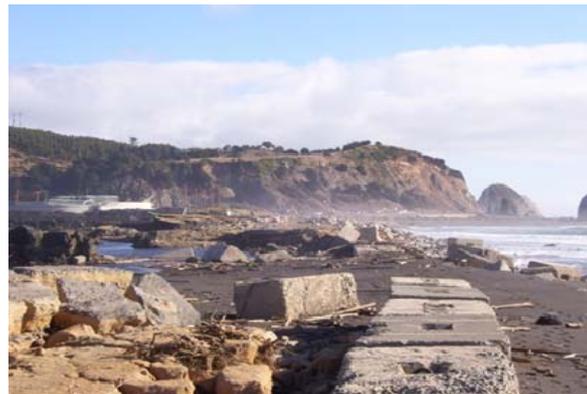
Figure 5-32: Seawall in front of the Arauco plant, before and after tsunami

Figure 5-32 (a) and (b) show before and after photographs of the sea-wall, comprising large reinforced concrete blocks and an embankment, along the coast in front of the Arauco plant.

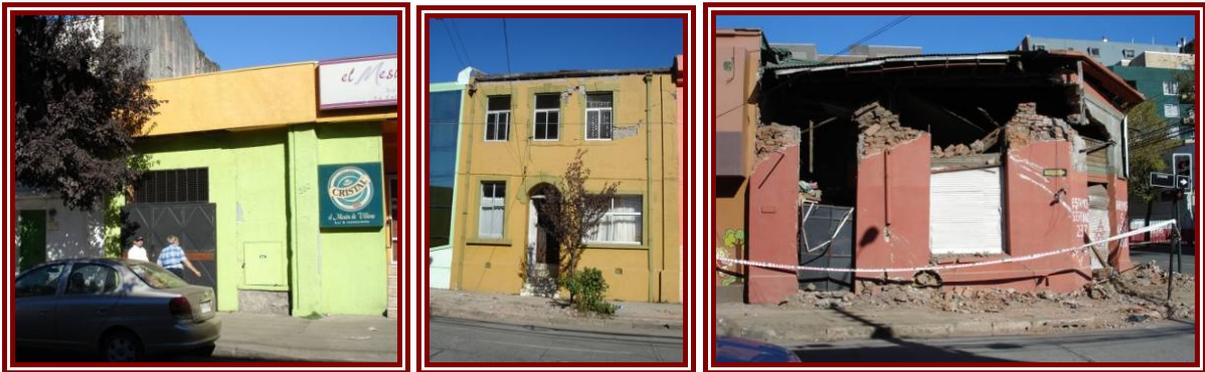
Figure 6-2: Examples of damage assessment from photos: (left to right) Superficial damage, Moderate Damage, Substantial to Very heavy damage

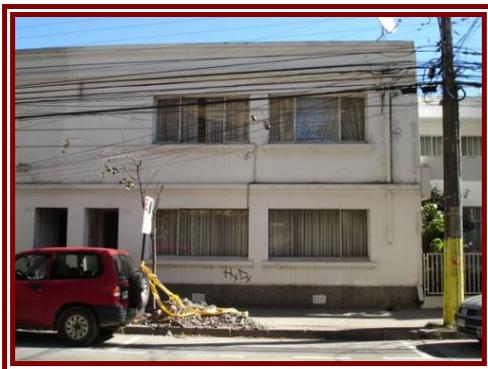
Figure 6-3: Example of rubble left outside a property indicating some level of damage internally but no obvious external damage

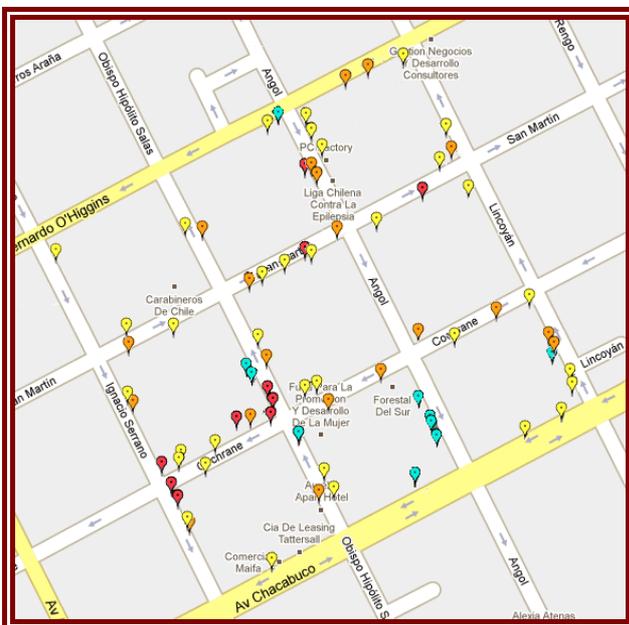
Figure 6-4: Block survey showing locations of damaged structures: Superficial damage (Yellow), Moderate Damage (Orange), Substantial or Very heavy damage (Red), Rubble on street (Blue).

Figure 6-4 shows a map of all the damage noted in the 9 block survey area. A total of 34 buildings were assessed as showing superficial damage (Yellow), 20 showing moderate damage (Orange), 10 showing substantial or very heavy damage (Red) and a further 10 buildings had rubble on street in

front of the building (Blue). Therefore of the 382 buildings surveyed 30 (8%) had obvious structural damage). No very clear patterns of damage emerge but there does appear to be a concentration of very badly damaged structures in the southern part of this area. In this area many of the buildings appeared to be older with the unconfined masonry buildings amongst them performing least well.

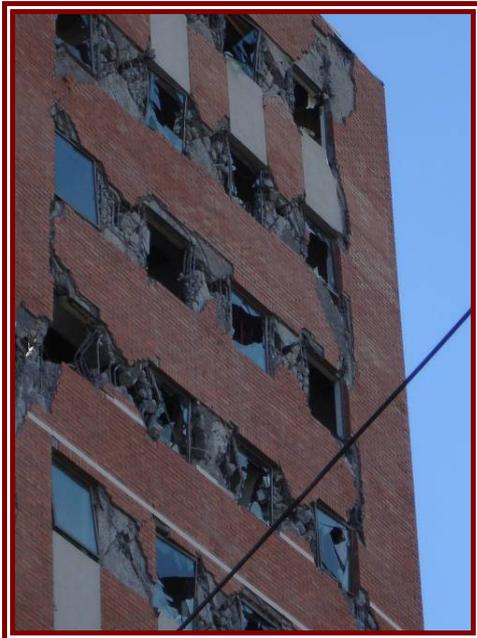
Figure 6-6 shows some of the extensive shear damage to the concrete forming the façade. This type of damage was visible around all of the upper storeys of this building. At the time of this report the City Council of Concepcion had decided that the Torre O'Higgins building will be partially demolished, from storey 10 upwards. Their evaluation of the building concluded that the basement and lower floor of the building don't have any damage.

Figure 6-6: Extensive damage to the external façade of Torre O'Higgins 241

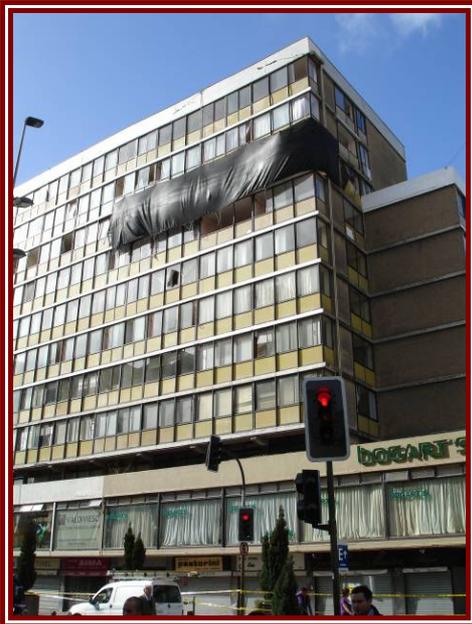
Caupolican 518 (Category 1)

This building "Universidad de Concepcion", which was in one of the main shopping districts in the city, did not show a large amount of external damage apart from at one corner (Figure 6-7). Although internal access was not possible, looking through the widows it was clear there had been some damage to many of the internal concrete shear walls at the connections between the tops of the walls and the ceilings. The damage, although apparently not that serious must have been extensive though because the building had been classified as Category 1 i.e. dangerous and in need of demolition. However at the time of this writing this report the original evaluation had been slightly modified and it

had been subsequently been decided that only partial demolition of the building was necessary. In this case only the top three levels out of the total of 11 floors will be demolished.

Figure 6-7: Damage to one corner of Caupolican 518

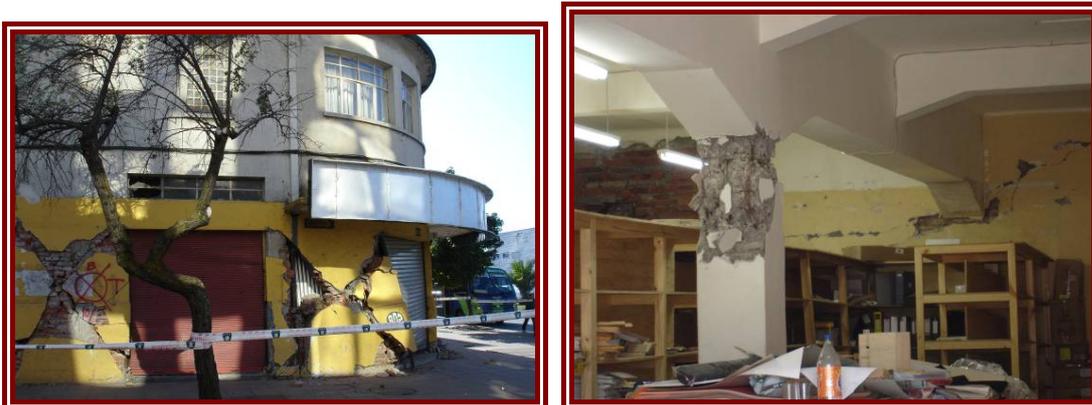
This building (Figure 6-14) was typical of the many smaller concrete framed buildings that the team observed throughout Concepción that had not been included on the list produced by the City Council. Although very badly damaged the building was still occupied when the team visited and was still being used as a business premises. The main 16mm reinforcement in the frame were smooth rather than ribbed with 6mm links at about 150 mm centres and a plastic hinge had formed at the top of every column where it connected to the floor beam above.

Figure 6-14: Views of the damage to Anibol Pinto 820

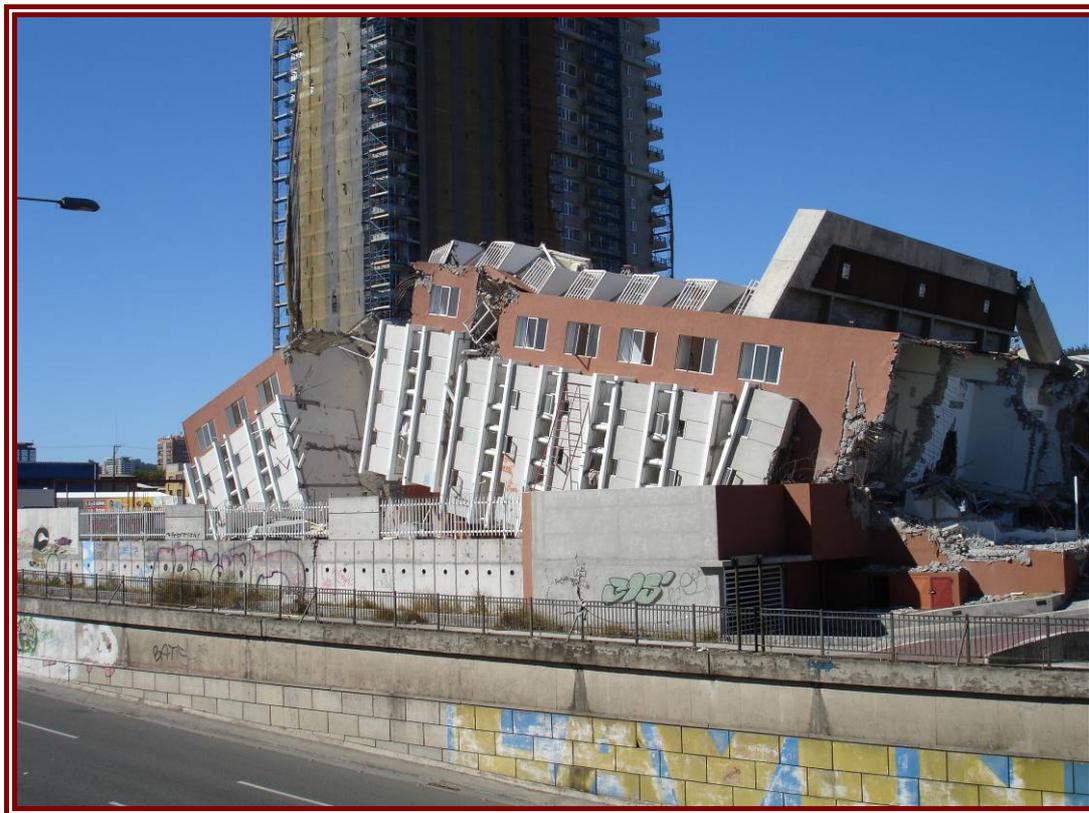
The 12 storey Torre Alto Rio Building was one of the more unusual building collapses seen by the team in Concepción. The building (Figure 6-15, Figure 6-16, Figure 6-17) had toppled over with the building falling Northward and then splitting in half. It was not clear what the cause of failure was although it may have been related to the ground conditions. In this case the building was designed for soil type II according to the Chilean code. It is not known what the ground conditions at the site are but it is worth noting that the building was relatively close (600m) to the shoreline of the Biobio river and the tall building at the junction of Maipu & Arturo Prat (seen in the background of Figure 6-

16) was designed for soil III. This tall apartment building at the corner of Maipu & Arturo Prat which had only just been completed also suffered some damage especially to the ground floor level. Subsequent to the visit the team has learnt that this building will probably be demolished because of the extent of damage. In the case of the Torre Alto Rio Building, because there were several casualties, it is believed that there will be a number of forensic analyses to try to determine the exact cause of collapse.

Figure 6-16: Torre Alto Rio (collapsed away from photographer)

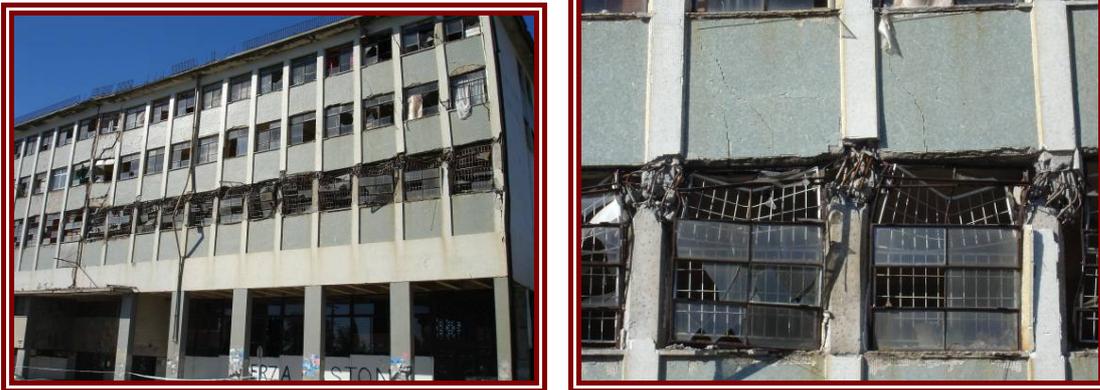
This RC concrete building on the coast at Talcahuano is believed to be about 60 years old and is formed from two very similar buildings with a joint down the middle. The building had a two storey basement that had been filled with water by the tsunami. All the columns at 1st floor level on one half of the building were very badly damaged while the other half of the building remained relatively intact. At the time of this writing this report this building is in the process of being demolished.

Figure 6-18: Arturoi Prat 88, Talcahuano

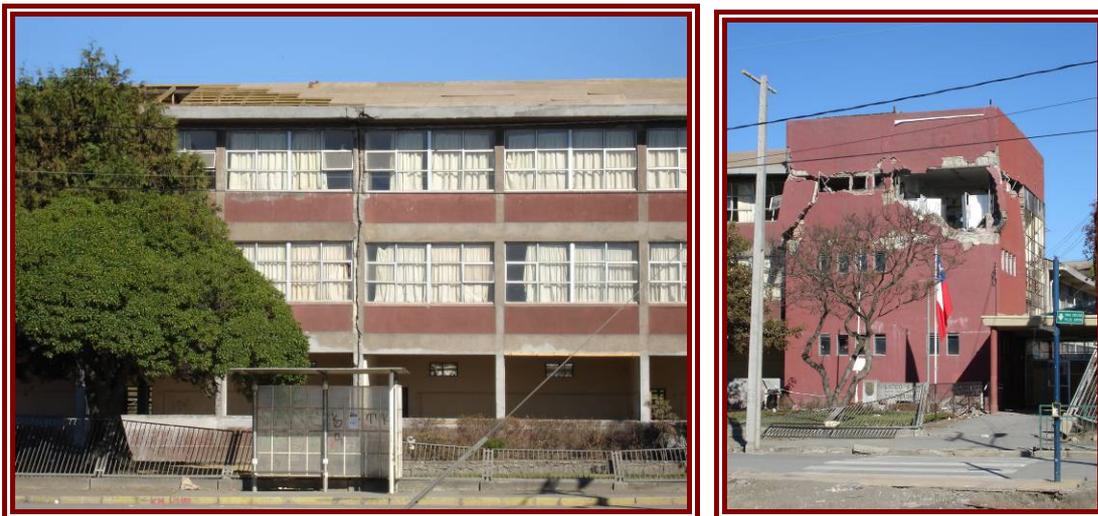
This large concrete building school building right on the coast at Talcahuano had been damaged both by the tsunami and by the earthquake. The main section of the school was constructed as a concrete frame (Figure 6-19 left) with small masonry infill panels and this performed well in the earthquake. However the square tower (Figure 6-19 right) that formed the entrance to the building performed much less well. This entrance building with half of one face being glazed over its full height was constructed from confined masonry and it may have been the asymmetry of the building that lead to the severe damage at one corner and the loss of a large masonry panel.

Figure 6-19: Liceo A21 Blanco Encalada, Talcahuano

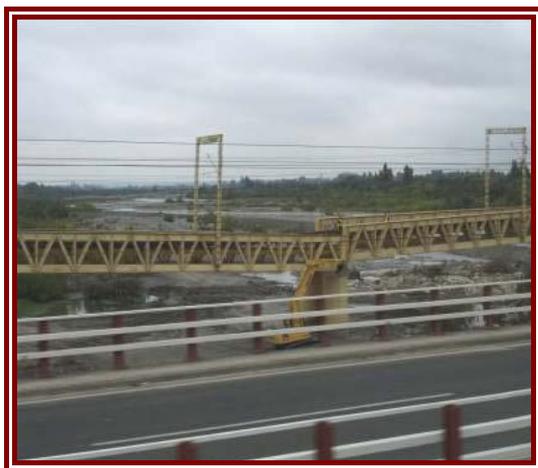
The majority of damaged bridges seen down route 5 were precast concrete bridges but there were a few exceptions. In a few places the predominantly steel bridges for the main railway line (Figure 6-21) running close to route 5 were also badly damaged, however no failures of the steel were noted and most damage appeared to be at the bearings. Just south of Chillan a small length of one of the central sections of an older in-situ concrete bridge had collapsed (Figure 6-22). In this case the points of failure were not over supports and it appears as if the concrete section has failed in shear (possibly at construction joints). Again it is worth noting that along route 5 the northbound and southbound carriageways often ran across rivers on two separate parallel bridges. One of these bridges being an older 2 lane bridge, and the second an extra bridge that was built (after 1994) to carry an extra carriageway when the route 5 was widened to two lanes each direction. Therefore although many individual bridges had spans down the team saw no cases where both bridges were damaged. This had allowed route 5 to remain open with traffic being rerouted to the remaining intact bridge.

Figure 6-21: Badly damaged railway bridge

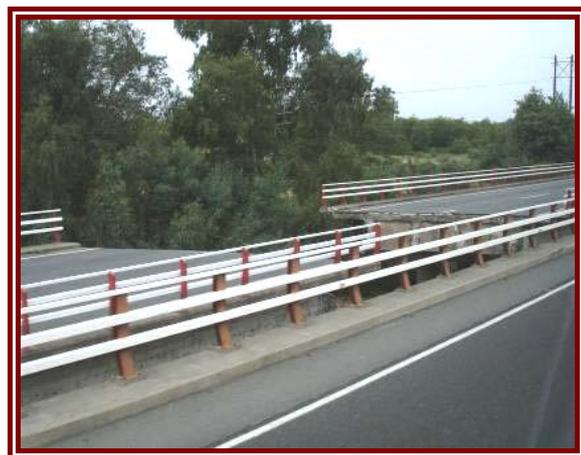
Figure 6-22: Collapsed skew span

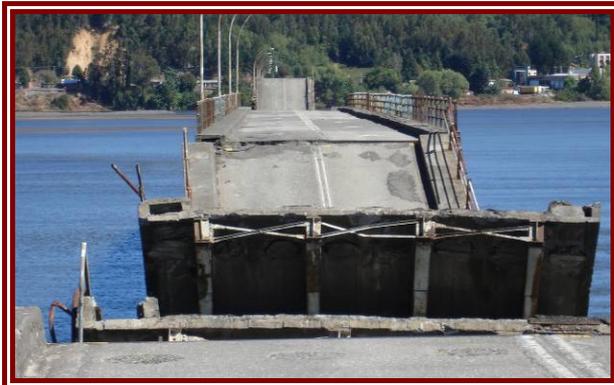
multiple spans. The bridge was in a poor state of repair, much of the steelwork was badly corroded (Figure 6-24) and many of the expansion joints (over every support) had been filled with tarmac which showed signs that there had been significant longitudinal movement of the deck during the earthquake. There was evidence of considerable lateral spreading of the north bank of the river at this location with cracks appearing in the ground up to 70m from the shoreline (Figure 6-25).

Figure 6-24: Span failure in the Puente Viejo Bridge

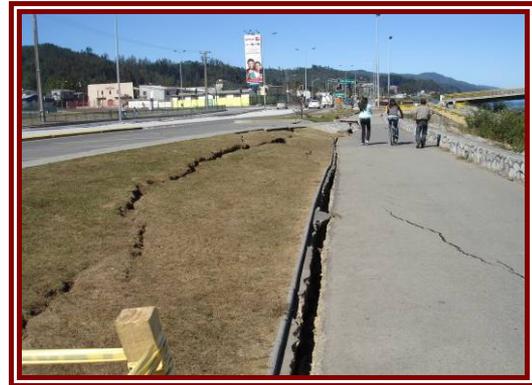
Figure 6-25: Evidence of lateral spreading on the north bank of Biobío river

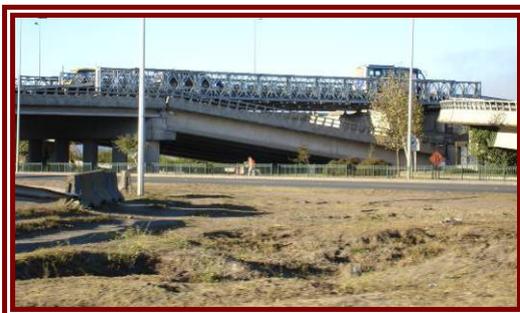
Figure 6-26: Collapsed approach span on the Llacolen bridge

The nearby 2157 m Llacolen (2000) bridge (Figure 6-26) suffered damage to one approach span reducing the traffic to one lane after the earthquake, again signs of lateral spreading were evident on the north bank of the bridge. The Juan Pablo II (1968) bridge (Figure-6-27) was constructed in response to the the growth of habitants in San Pedro de la Paz and also showed signs of settlement to some of the supports mid-river. Although the bridge remained open when the team visited this bridge has subsequently been is closed because of its risk of imminent failure. Evidence of liquefaction was observed as sand boils on the north bank of the bridge, which can explain the settlement and lateral displacement. In all these three cases it looked as if lateral spreading and possibly liquefaction contributed to the damage to the bridges which are situated on the sandy sediments of Bio-Bio River (Figures 6-23 to 6-27). No obvious signs of damage were observed to the steel truss Biobío Railroad Bridge (1889).

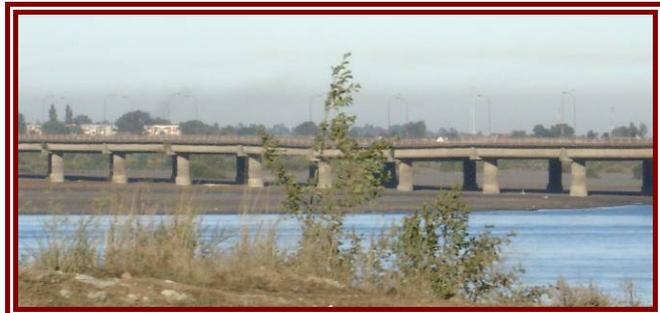
Figure 6-27: Signs of pier settlement on the Juan Pablo II bridge

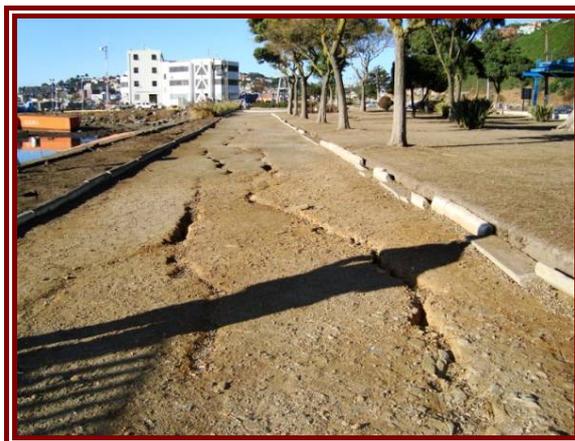
Lateral spreading and longitudinal cracks (Figure 6-28) and the displacement of retaining walls along the coast of Talcahuano (Figure 6-29) were probably produced by the increase in pore water pressure in the soil due to the tsunami.

Figure 6-28: Longitudinal cracks Talcahuano Port

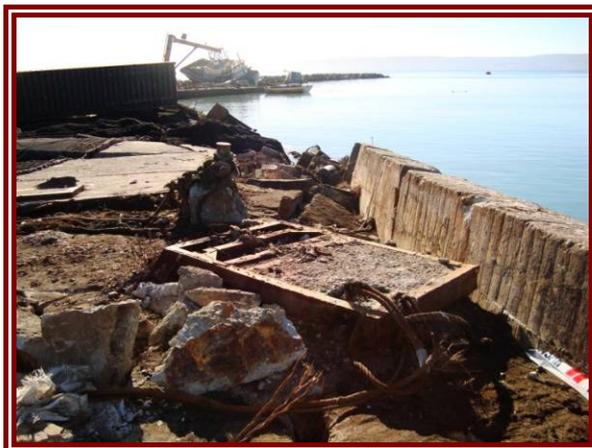
Figure 6-29: Retaining wall failure Talcahuano Port

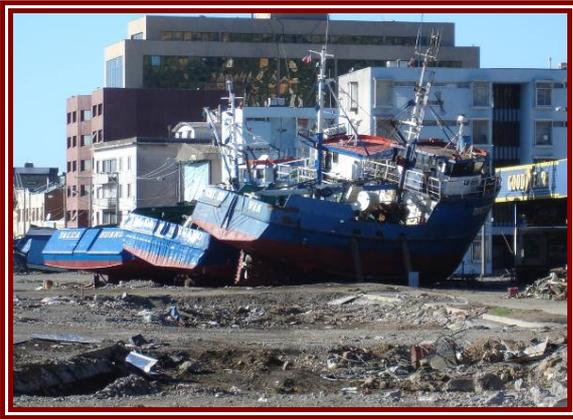
Several ships at Talcahuano port were lifted onto the dockside by the tsunami (Figure 6-30) and hundreds of containers were also moved causing structural damage to buildings due to impact. These containers were scattered about the coastline of the bay and some had drifted large distances. Scour damage to building foundations along the waterfront was a very common occurrence (Figure 6-31).

Figure 6-30: Vessels several metres inland

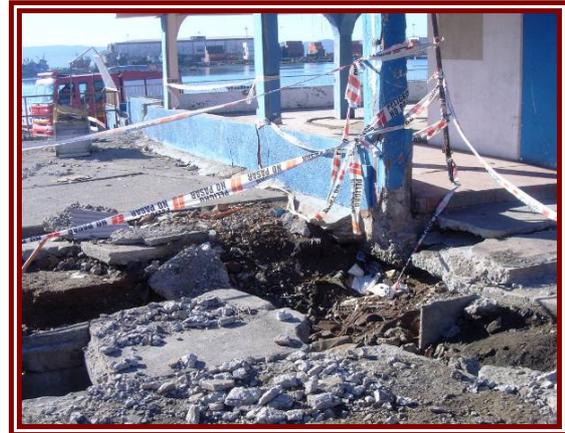
Figure 6-31: Scour damage to building foundation

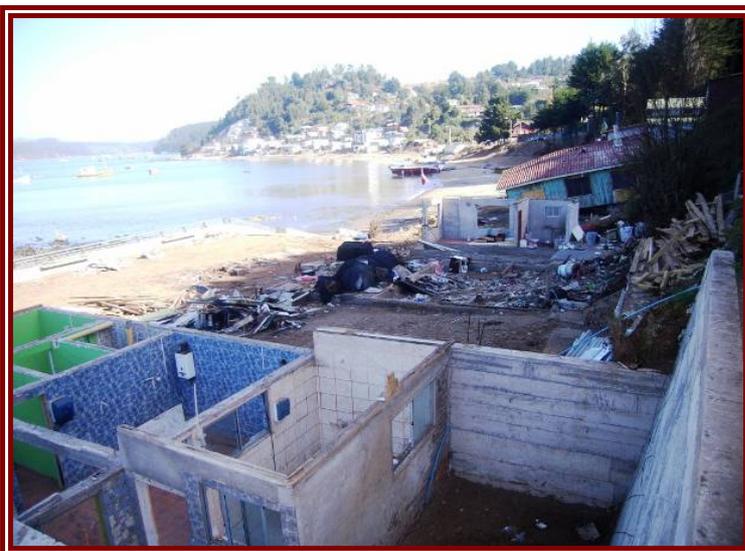
Figure 6-32: Damage to water front, Coliumo

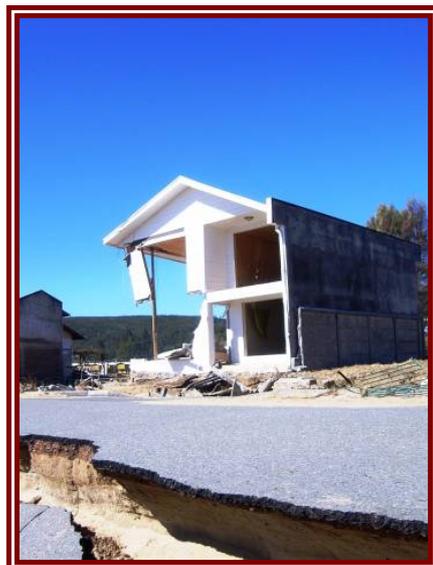
Figure 6-33: Damage to house and road, Dichato

As can be seen, scour once again was a source of failures on this very sandy soil (Figure 6-33). In places buildings were completely undermined by the strong currents generated. The small structures shown in Figure 6-34 were 400 metres from the beach.

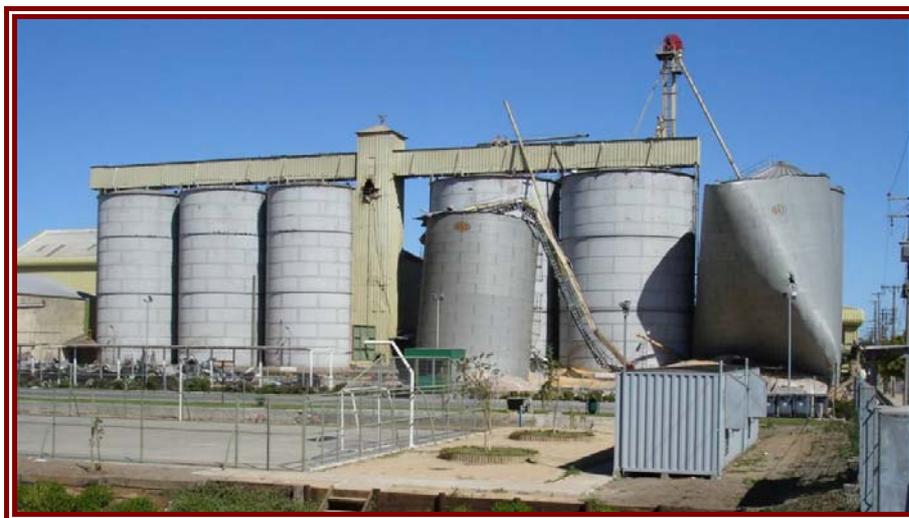
At the junction of Manuel Montt and Miguel Zanãrtu was a complex of 14 grain silos (Figure 6-35) that was badly damaged during the earthquake. The site originally comprised 4 larger silos and 10 smaller silos, Figure 6-19. After the earthquake the silos that remained standing were generally those that had a more significant restraint at their tops, figure 6-18. Those silos that were essentially free standing collapsed completely or were very badly damaged (Figure 6-36). The silos that remained standing were also of different construction (riveted solid plates with two intermediate external stiffening rings) compared to those that had collapsed (light weight cold formed ribbed panels with bolted connections). It appears that the site had been extended with the addition of 9 extra silos at some time in the past and it was these more recent additions that performed very badly.

Figure 6-35: Damage to a complex of 14 grain silos showing severe buckling of one of the remaining silos. Differences in the construction of silos are also apparent.

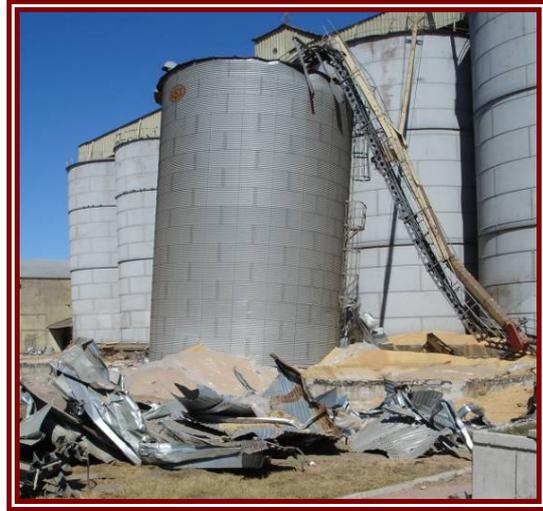
Figure 6-37: Leaning silo and damaged grain conveyor

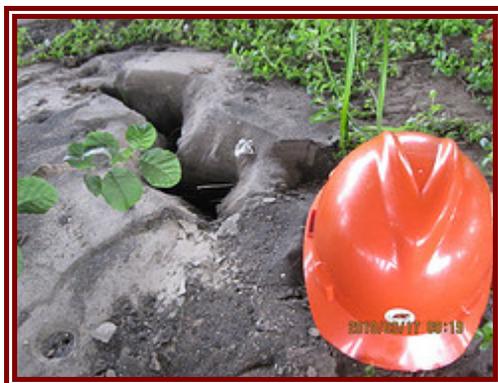
The large crack observed in the ends of the bridges and in the coast of the river evidence the clearly the lateral spreading generated and the loose conditions of the sand.

Figure 8-3: Evidence of liquefaction near the Bio-Bio River in Concepción.
<http://poweredbyorange.com/blog/>

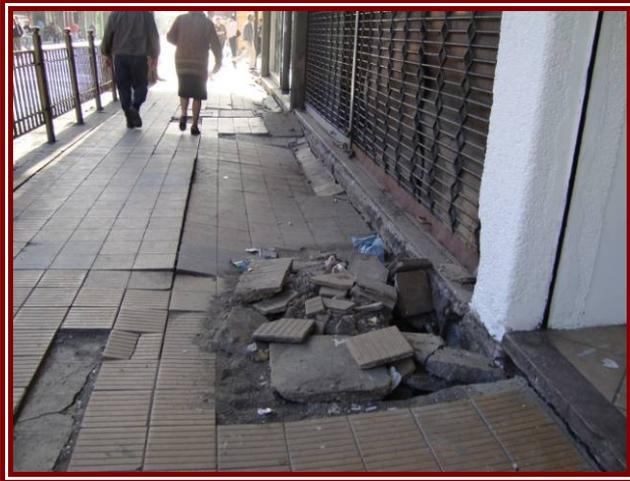
Other important aspect observed in Concepción was the damage in the pedestrian paths which had several settlements, not more than 0.30 m., the majority caused by the destruction of water pipelines.

Figure 8-4: Settlement due to water pipeline damage, city of Concepción.

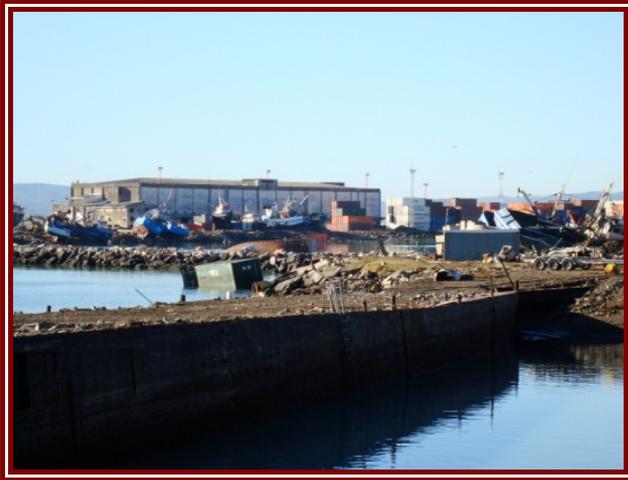
Figure 8-6: Talcahuano Port after the earthquake
