THE CHILEAN EARTHQUAKE OF 3 MARCH 1985

A FIELD REPORT BY EEFIT

ED Booth MA MICE MStructE
Ove Arup & Partners, London

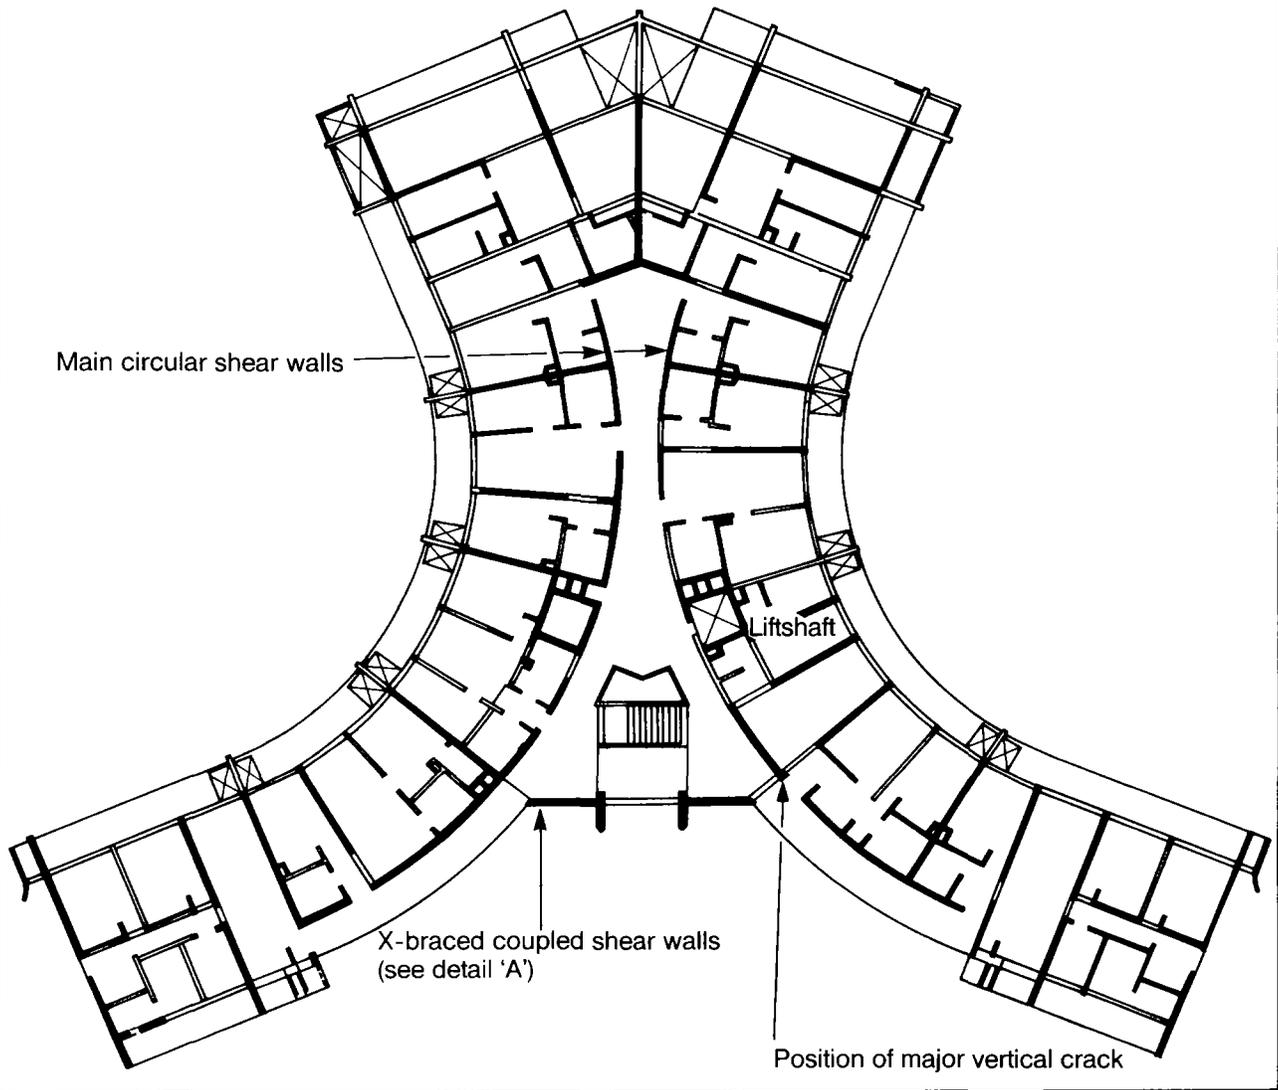
Figure 5.2

PLAN VIEW OF HANGARUA APARTMENTS,
VINA DEL MAR

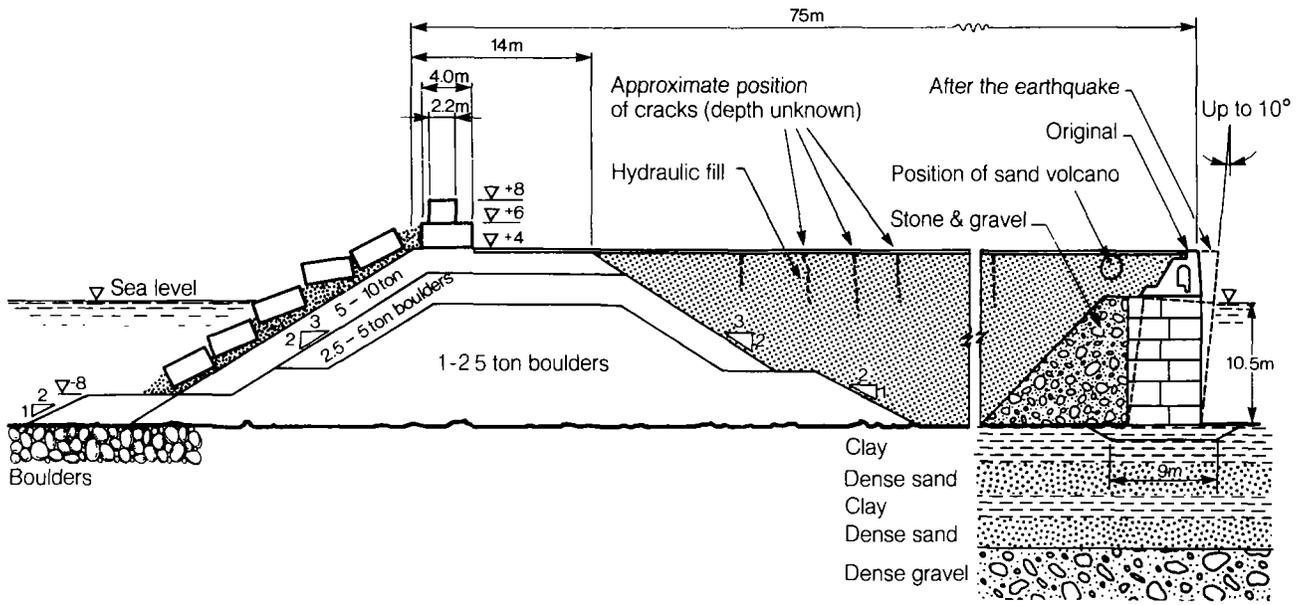
Figure 5.5

The main feature of the San Antonio harbour facilities is a long embankment mole (Figure 5.4) which has three berths for ships up to 18,000 tons. The part of the mole which collapsed (Figure 5.5) is constructed from hydraulic fill behind a massive block quay wall, founded on clay and dense sand. The southern end of the mole is formed from an anchored sheet pile, and did not fail. A number of reinforced concrete frame and steel frame warehouses are located on the mole.

The 1971 earthquake (Lastrico et al, Ref. 16) caused the top of the quay wall to tilt outwards by up to 500 mm and the backfill to settle by a similar amount, while a longitudinal crack running almost the full length of the mole, was observed. The 1985 earthquake caused similar and more extensive damage (Plate 5.42). Nearly all the gravity quay wall collapsed due to tilting, and multiple longitudinal cracks developed along the embankment as a result of movement of the wall. The primary cause of failure was probably liquefaction of the hydraulic fill in the centre of the embankment giving rise to increased pressures against the wall. The sea defence wall along the western edge of the quay was formed from massive concrete blocks laid to a shallow slope (see left of Plate 5.42(a) and Figure 5.5) and was undamaged.

CROSS SECTION THROUGH DAMAGED QUAY,
SAN ANTONIO

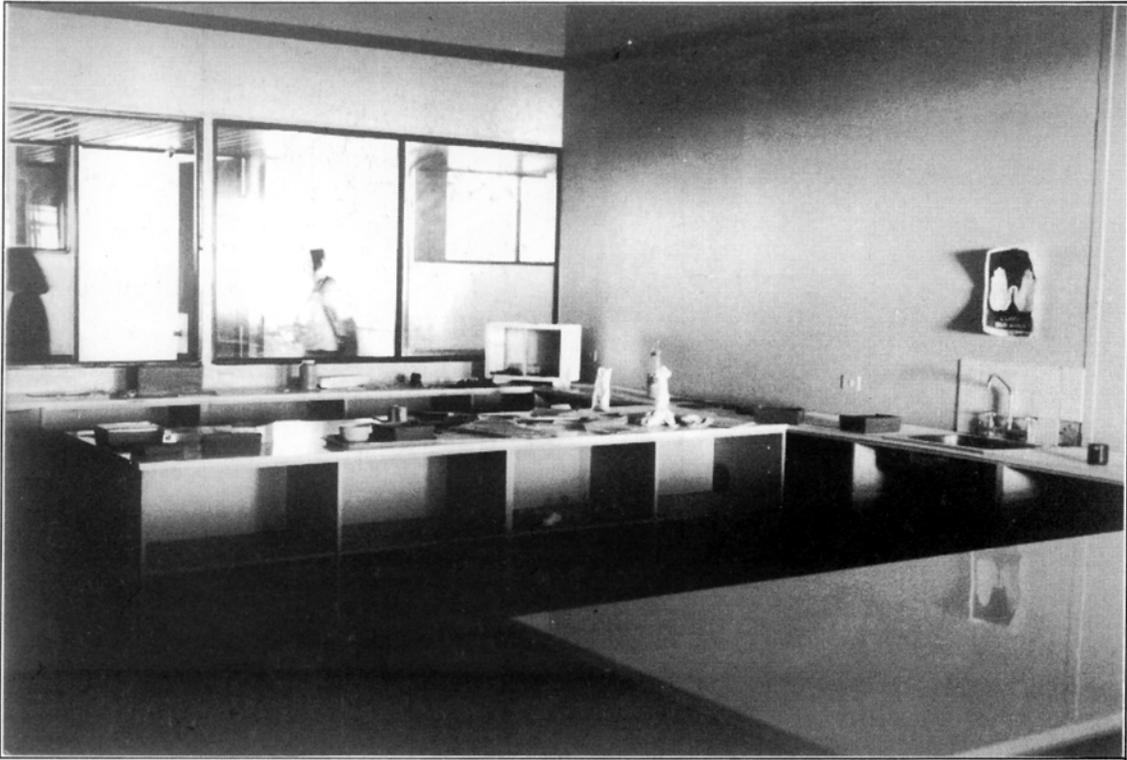
PLATE 5.3 Interior of Claudio Vicuna Hospital, San Antonio

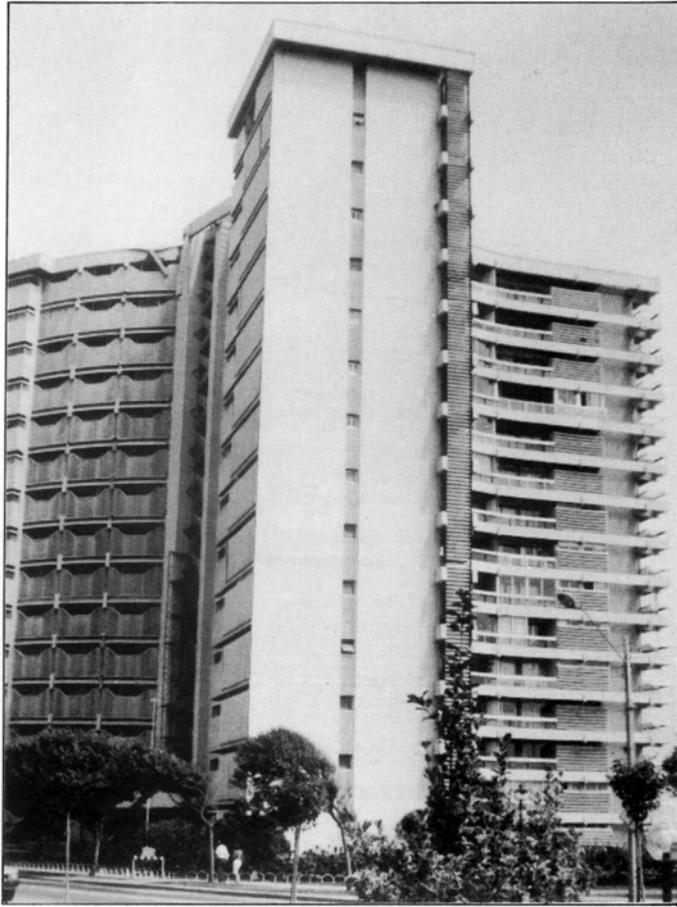
PLATE 5.7 Hangaroa apartments, Viña del Mar

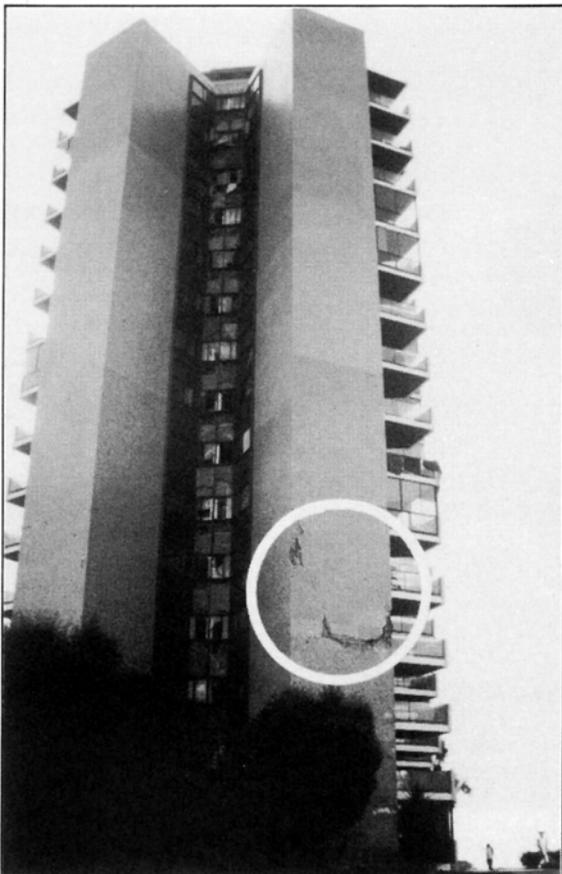
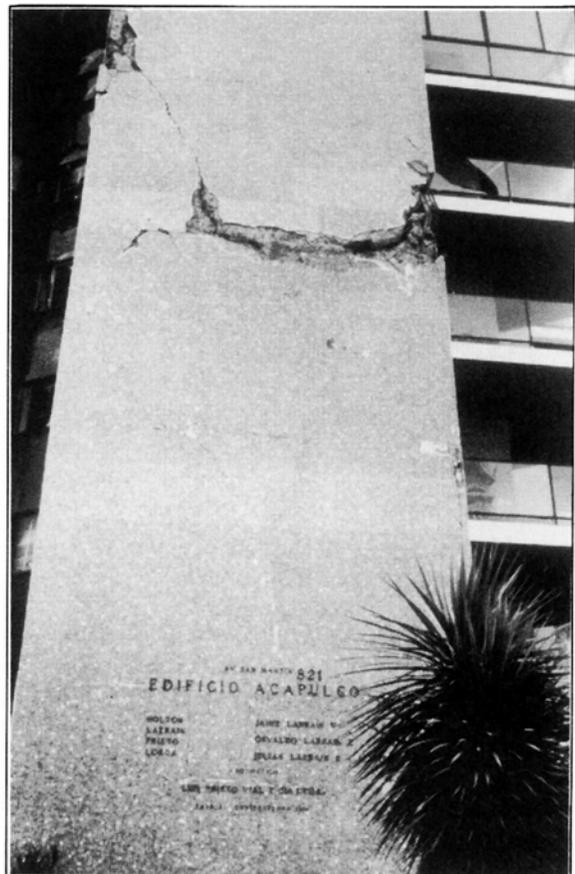
PLATE 5.10(a) Elevation
Damaged shear wall, Acapulco apartments

PLATE 5.10(b) Detail

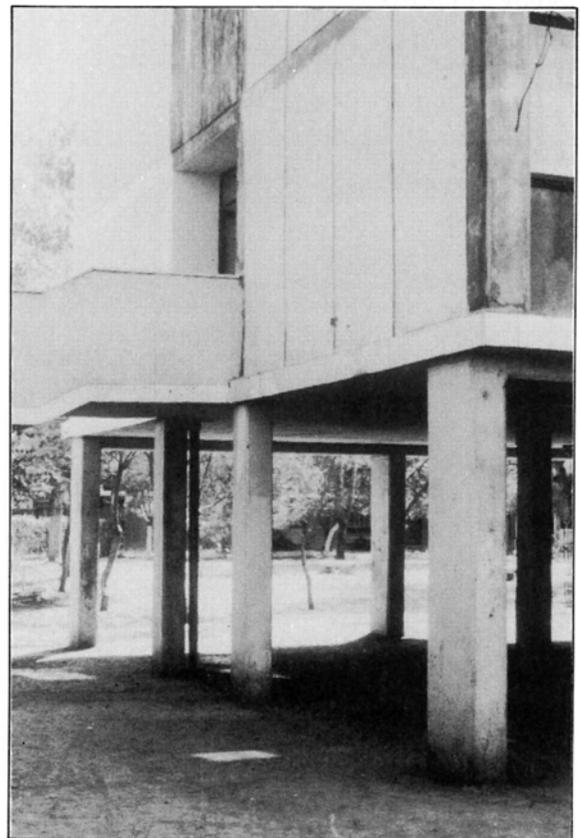
PLATE 5.17 Undamaged block at Villa Olympia
with similarities to block in PLATE 5.16

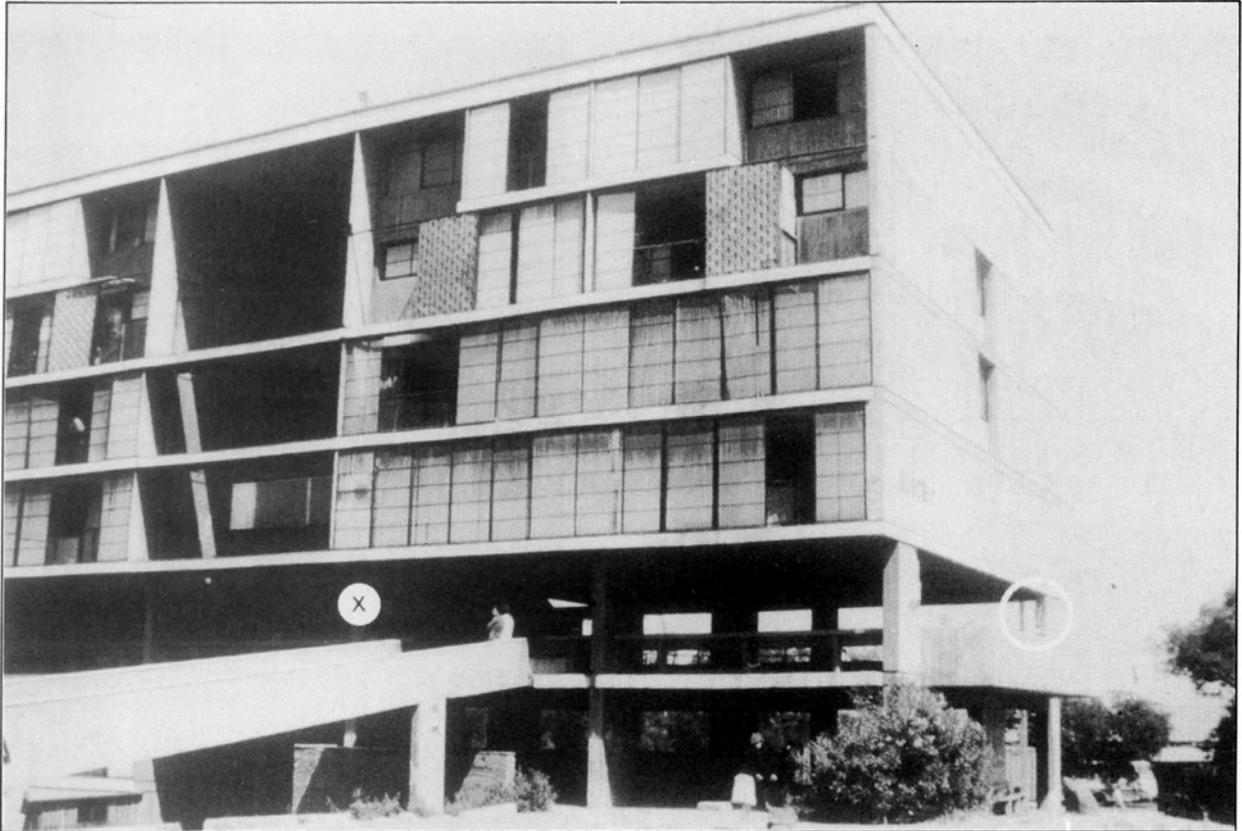
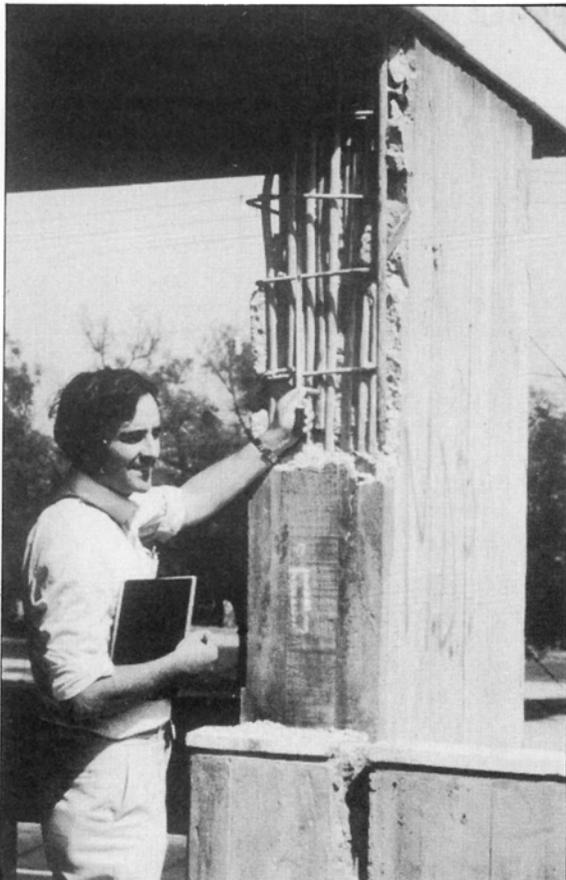
PLATE 5.18(a) Elevation

Location X
PLATE 5.20

PLATE 5.18(b) Damage to end of Block 1,
Villa Portales, Santiago

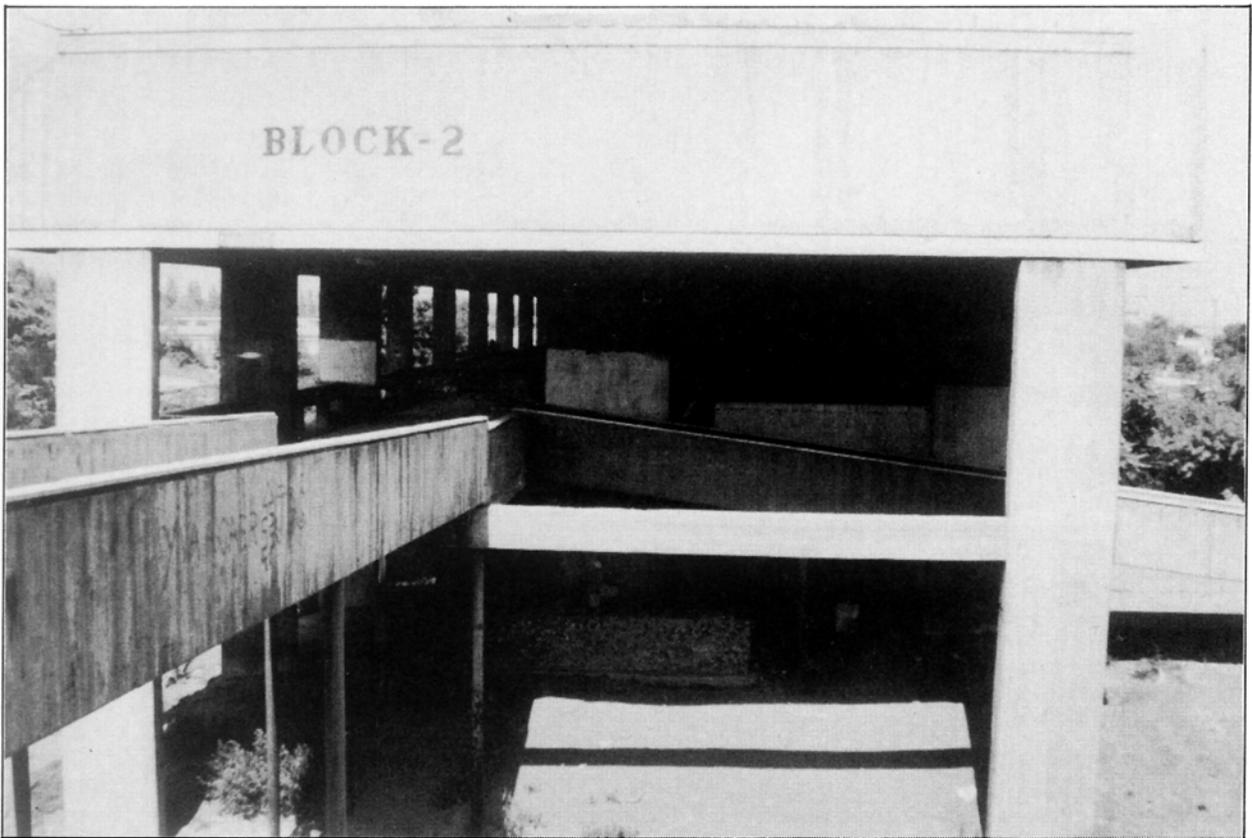
PLATE 5.19 Undamaged block parallel and adjacent to Block 1, with similar layout, Villa Portales

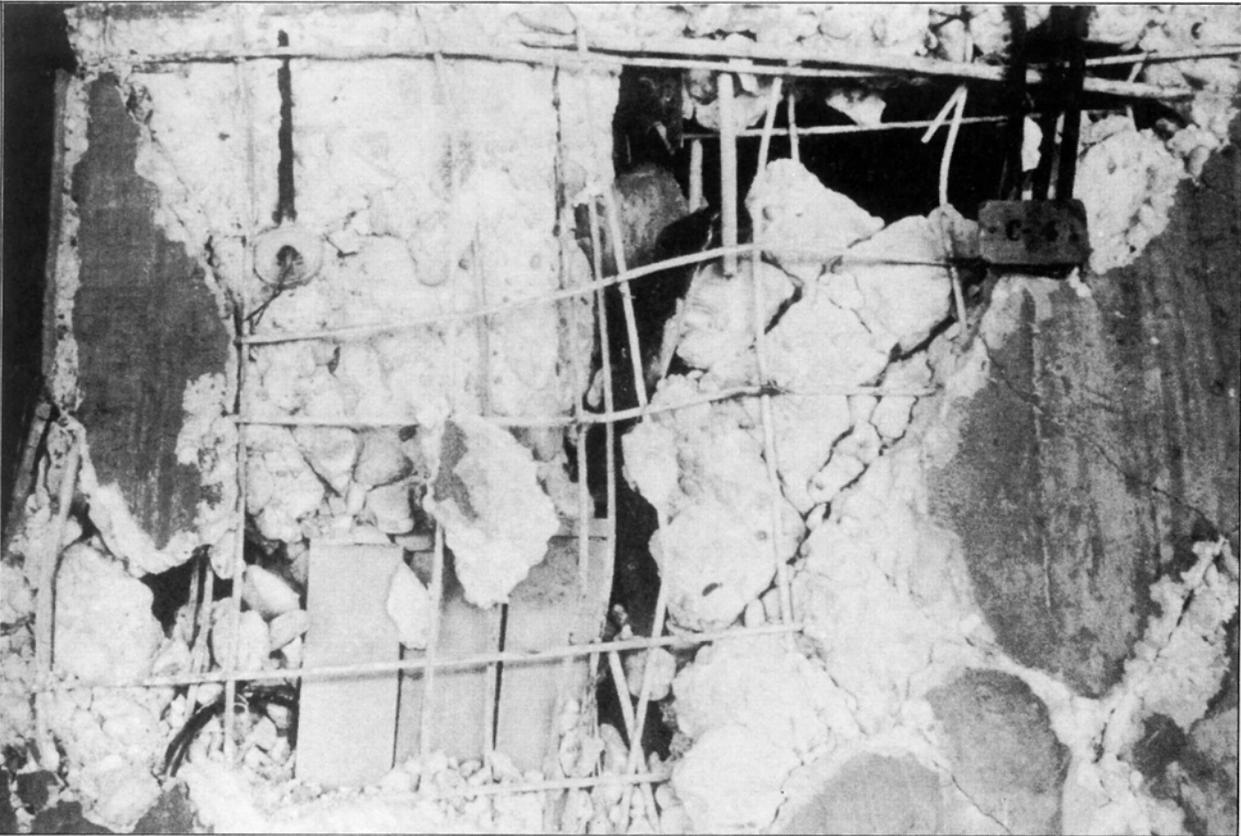
PLATE 5.20 Damage to internal shear wall in Villa Portales (location X, PLATE 5.18)

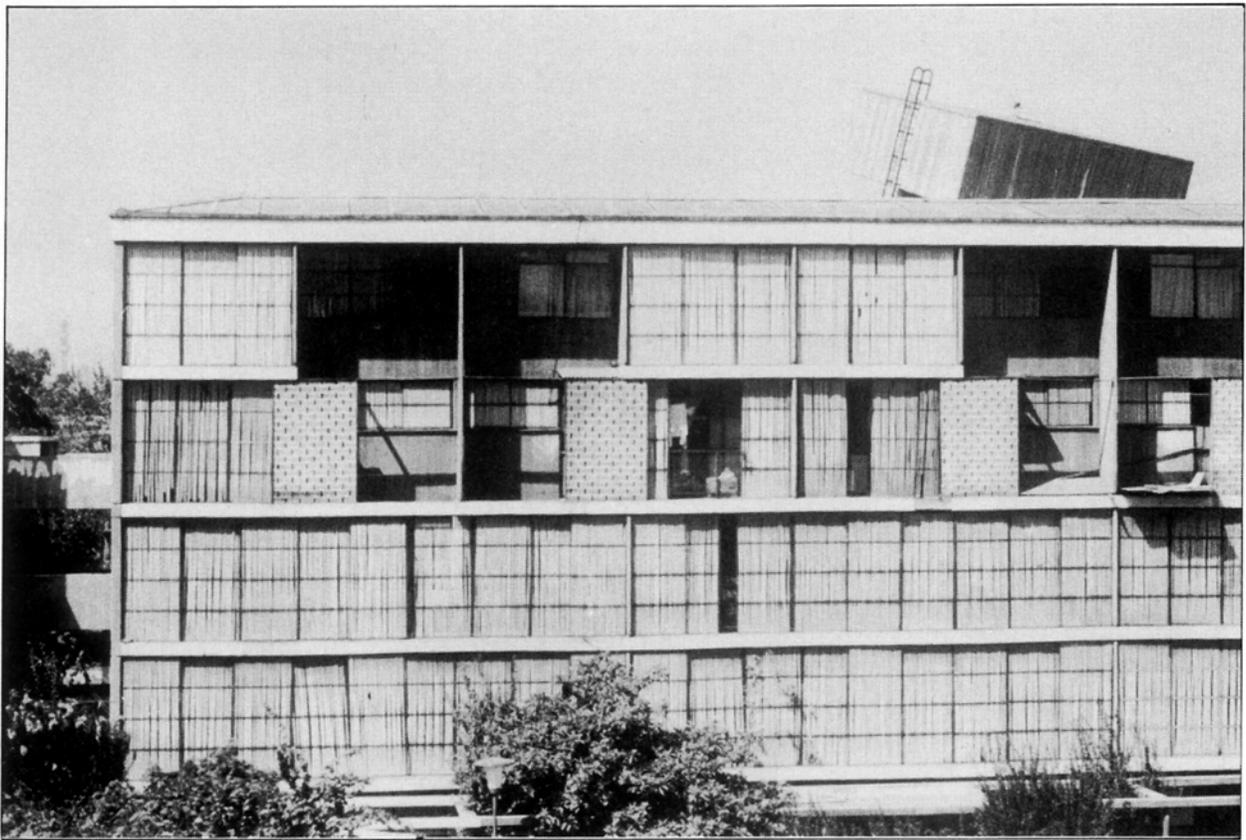
PLATE 5.21 Damaged roof tank, Villa Portales, Santiago

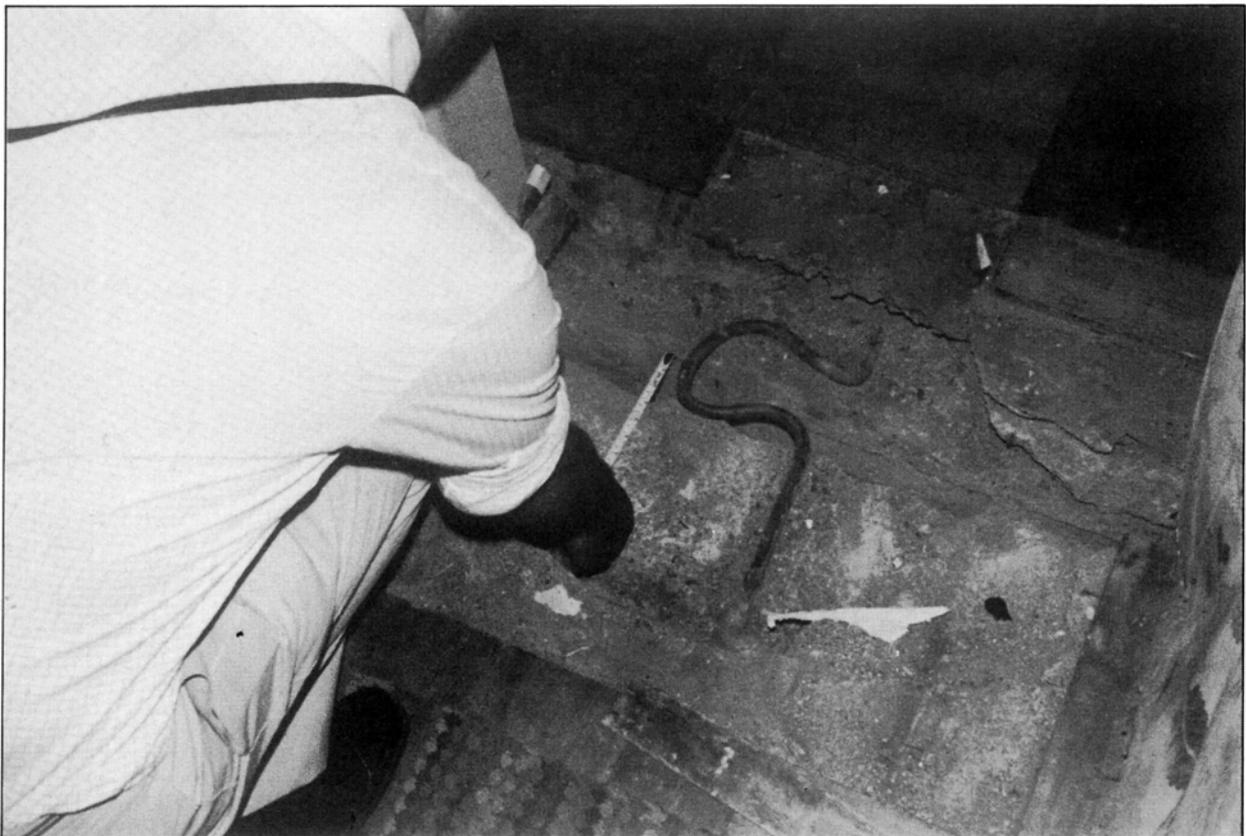
- viii) Water pipes crossing expansion joints had split in previous quakes. A U- loop had been subsequently provided (Plate 5.22) and seemed to have worked well in this earthquake.

PLATE 5.22 Expansion loop in water pipe crossing expansion joint, Villa Portales, Santiago

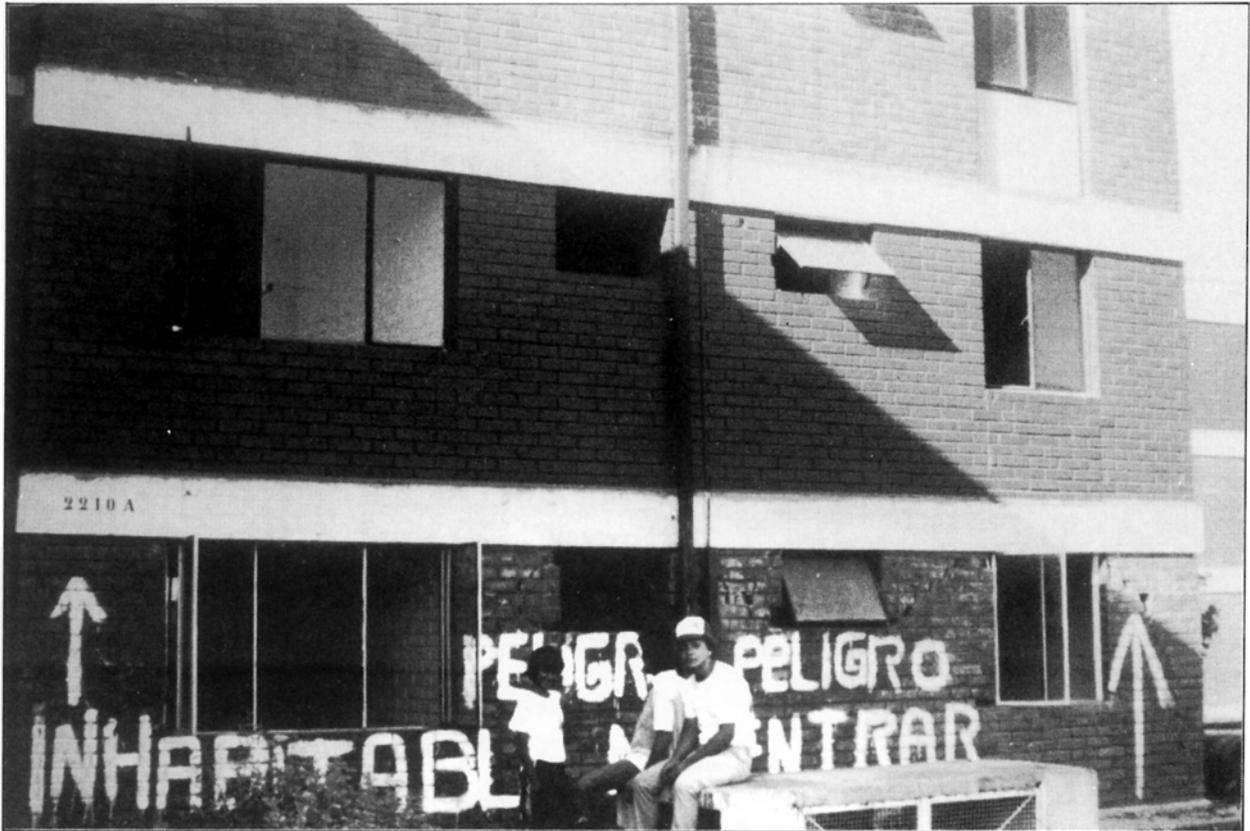
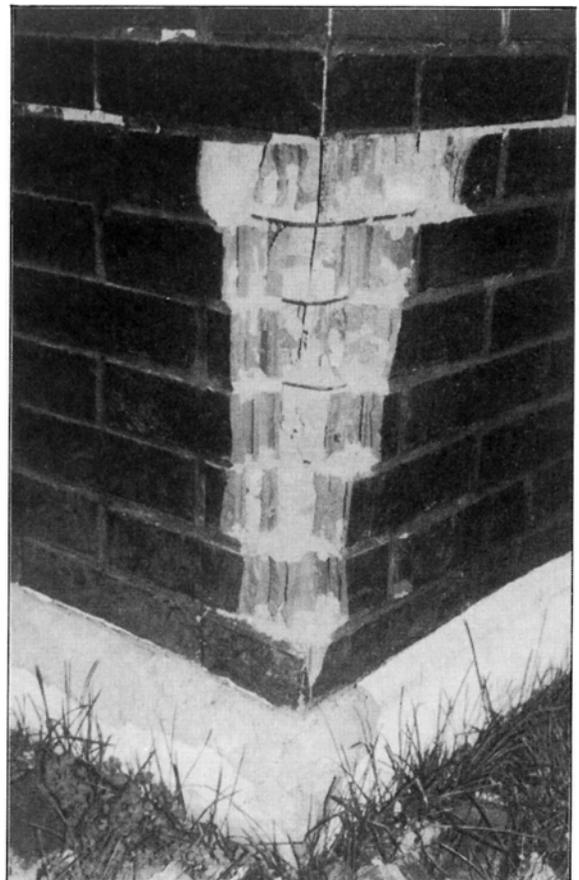
PLATE 5.23(a) Elevation

PLATE 5.23(b) Detail of damaged brickwork
Villa Santa Carolina, Santiago

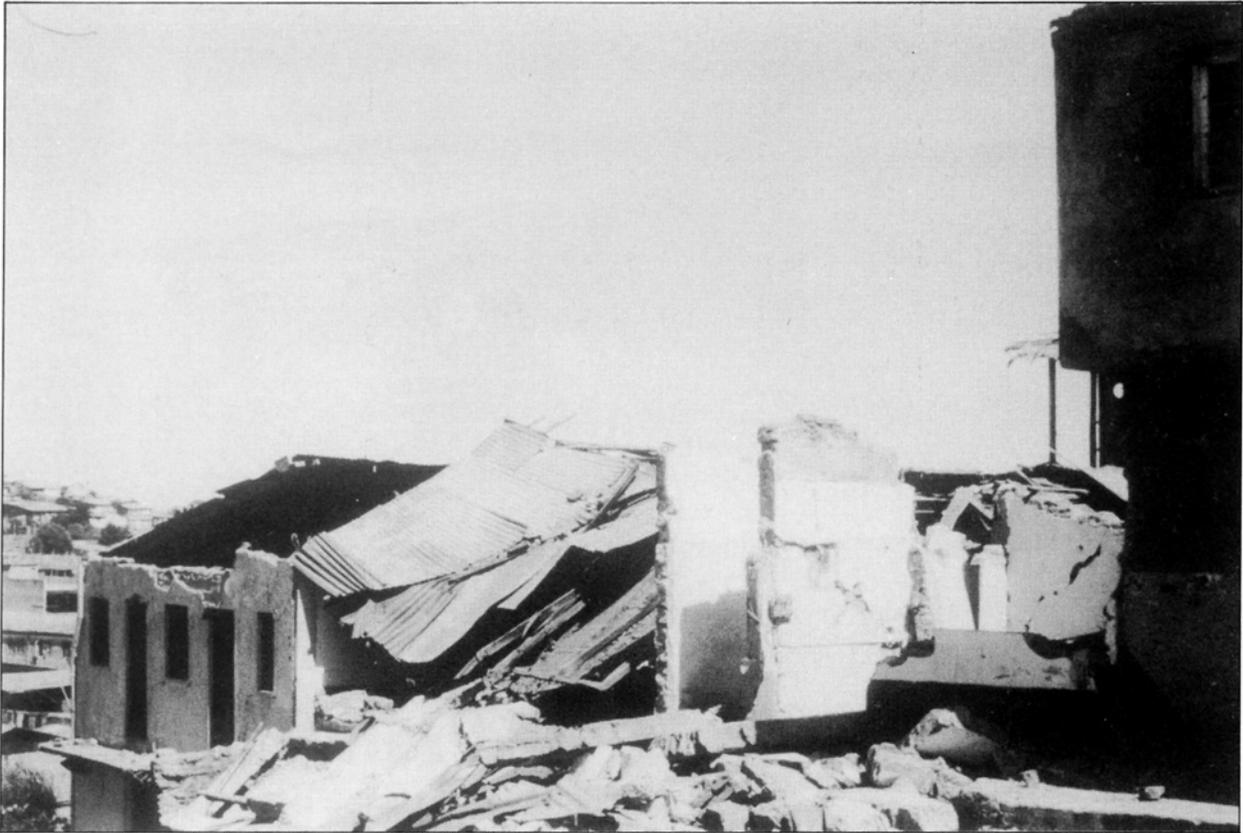
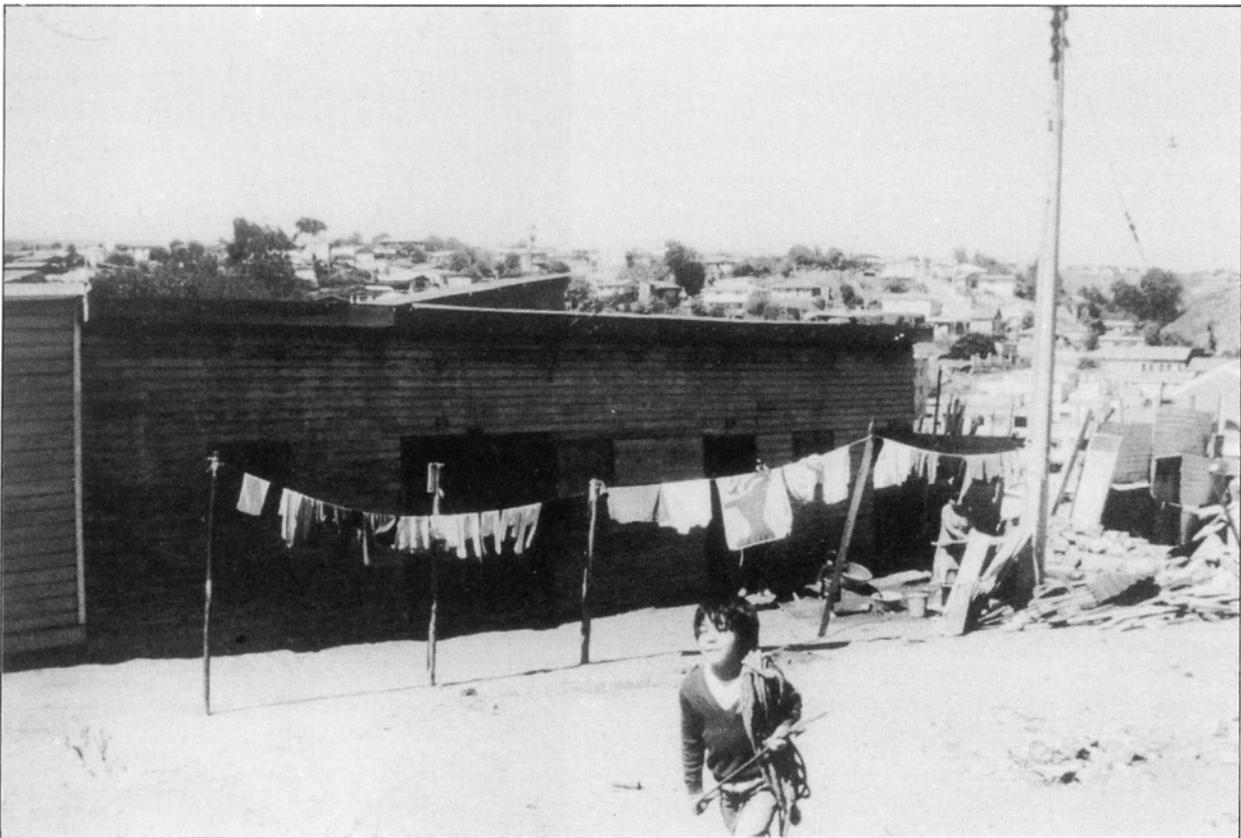
One and two storey wooden houses, even those of poor construction, escaped the earthquake largely unscathed. A dramatic example was seen in San Antonio, where a street had masonry buildings on one side and wooden ones on the other. Local people confirmed the immediate impression that the wooden house had been almost undamaged while the masonry ones were badly damaged (Plate 5.24).

PLATE 5.24(a) Heavily damaged masonry houses

PLATE 5.24(b) Undamaged wooden house
Comparitive damage in a San Antonio street

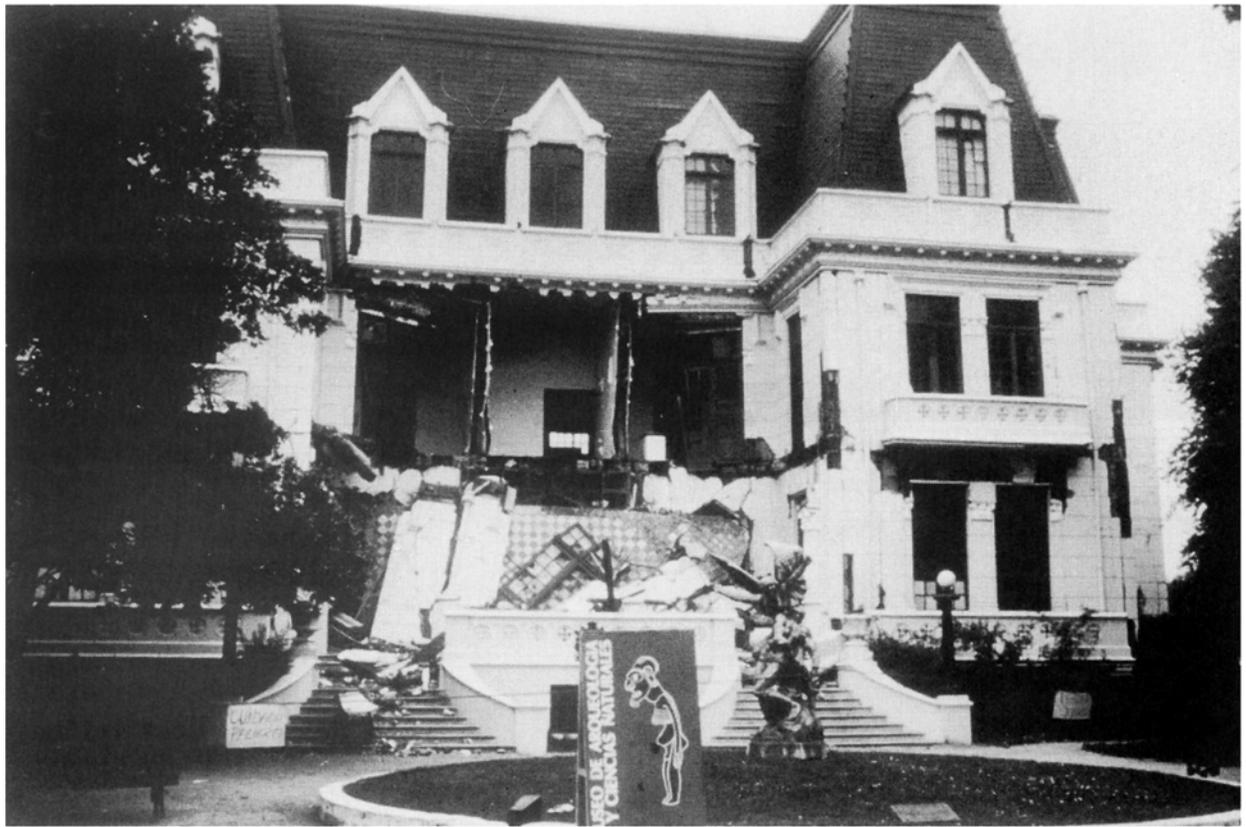
Part of the front facade of the Archaeology and Natural History museum collapsed (Plate 5.25).

PLATE 5.25 Museum of archeology and natural history, Viña del Mar

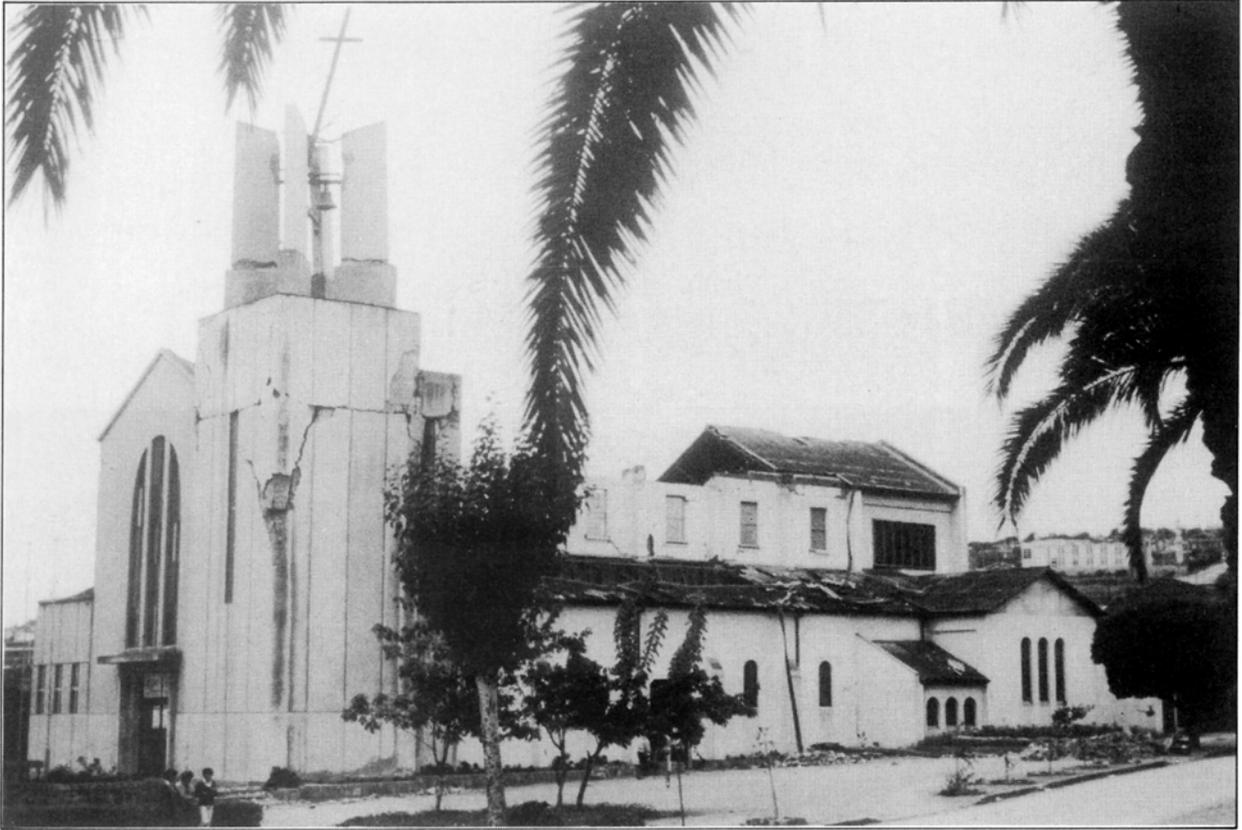
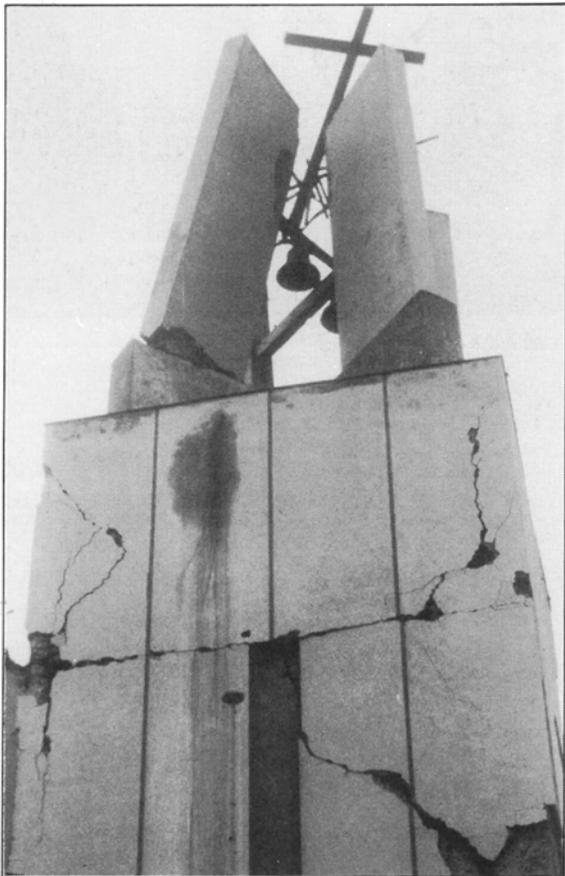
PLATE 5.26(a) Elevation

Some of the structure of the modern looking church appeared to be in reinforced concrete. It suffered damage to roof and campanile (Plate 5.26). Llolleo is just south of San Antonio, and had a strong motion instrument which recorded 0.86g. A smaller Spanish style unreinforced religious building adjacent to the strong motion instrument appeared extensively cracked (Plate 5.27), and it was difficult to understand why it had not collapsed.

PLATE 5.26(b) Detail of spire
Church at Lolloo

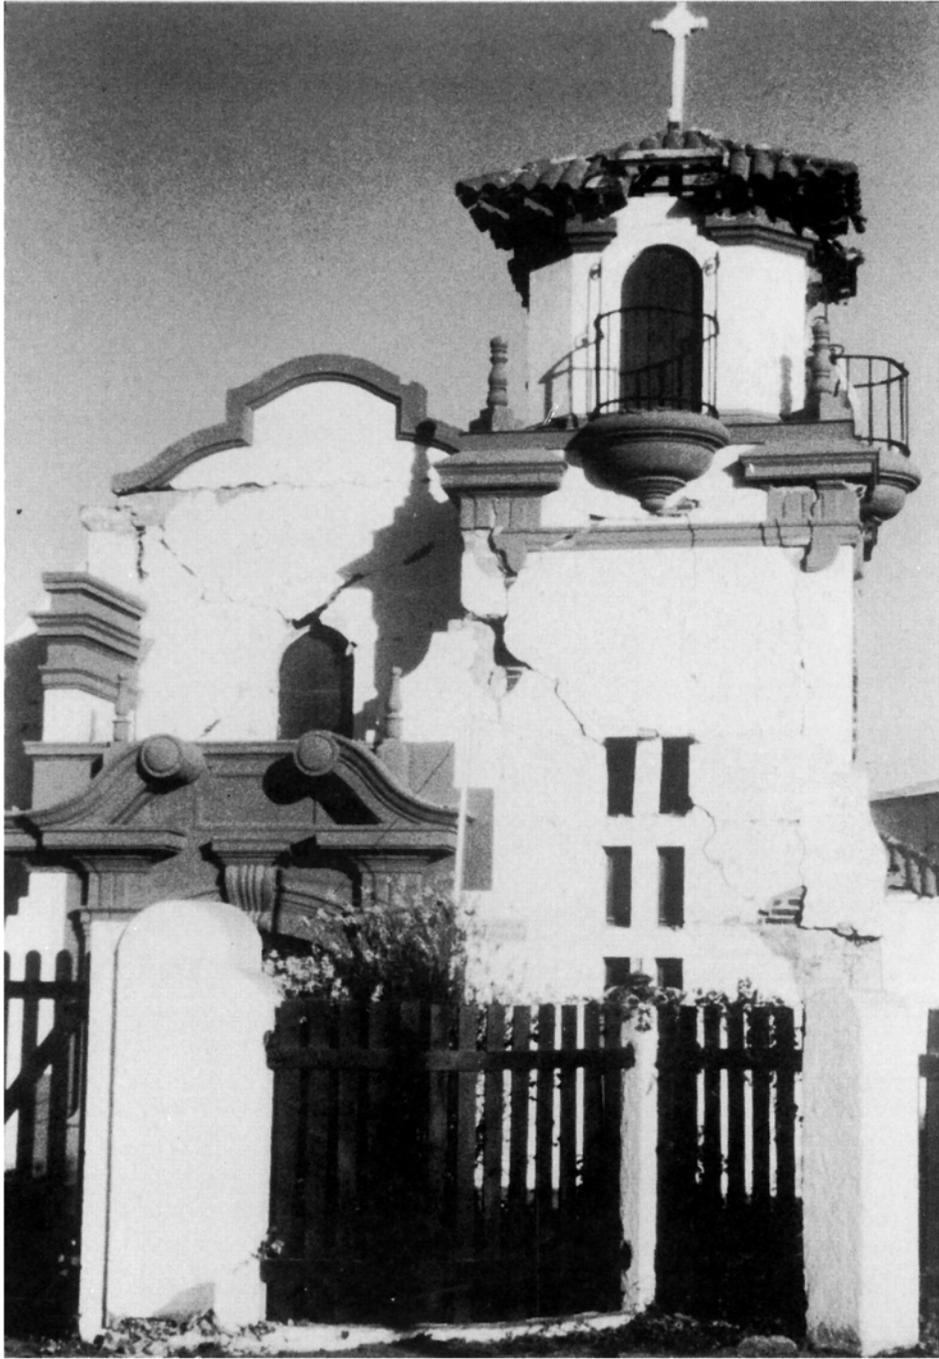
PLATE 5.27 Religious building, Lolloo

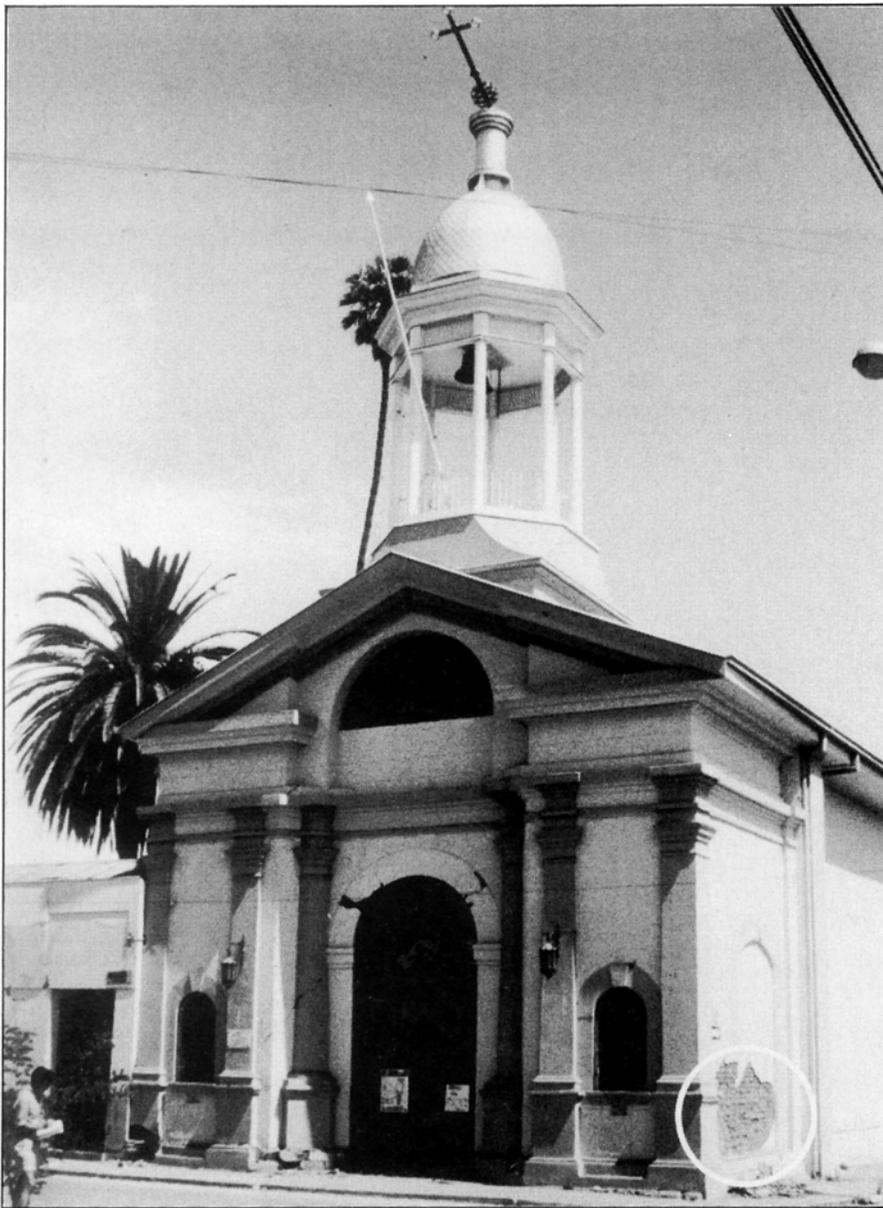
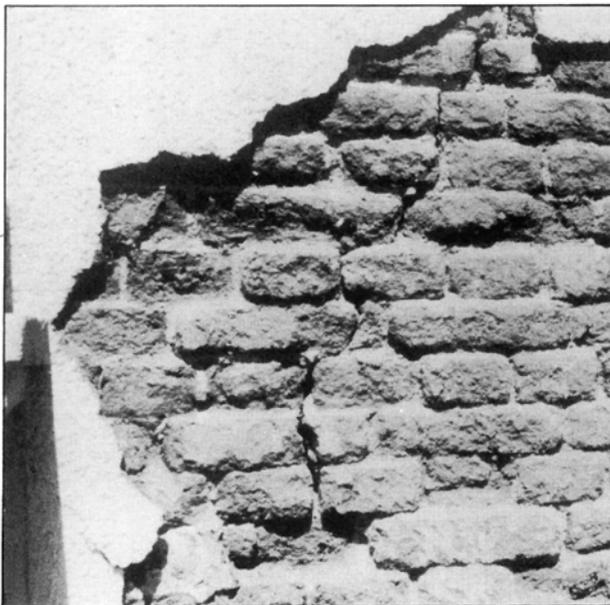
Extensive cracking was observed in both the unreinforced churches. (Plate 5.28)

PLATE 5.28(a) Elevation. Note tilted cross

PLATE 5.28(b) Detail of cracked adobe bricks
Church at Melipilla

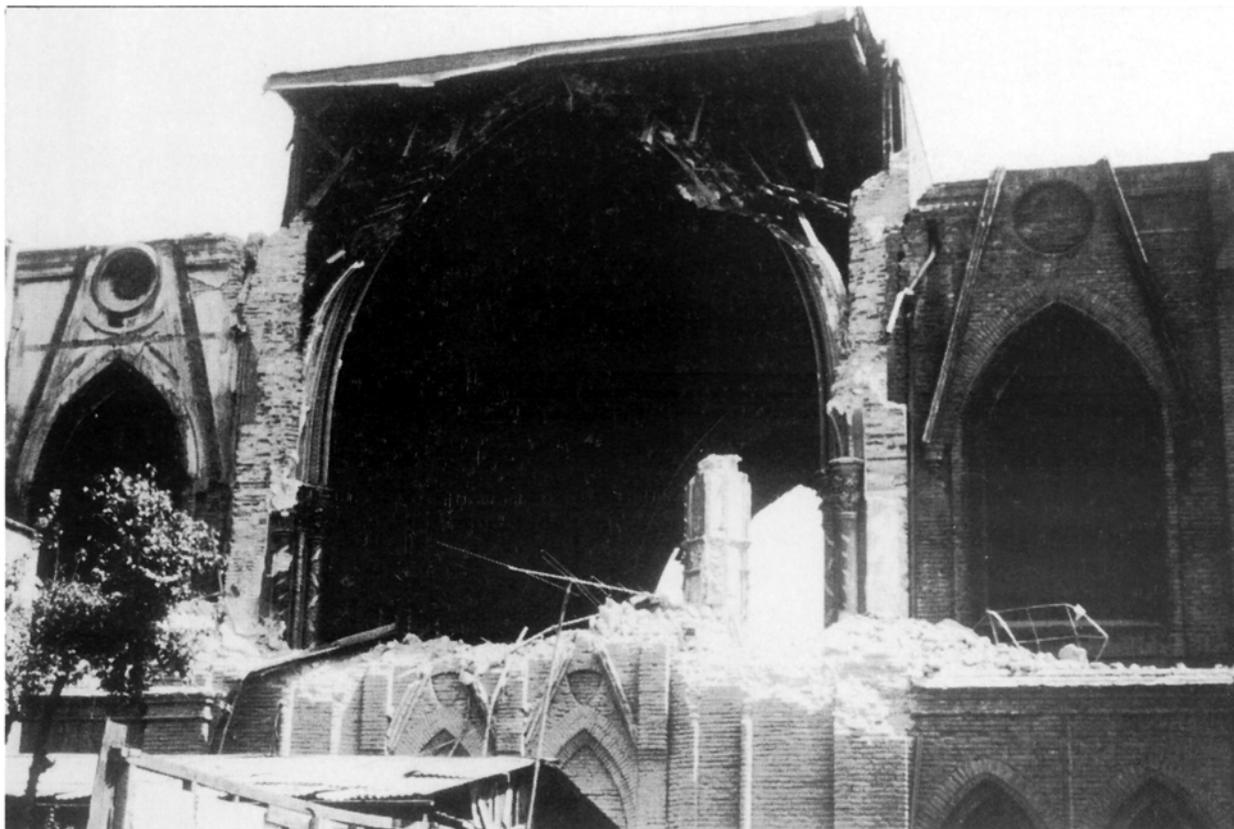
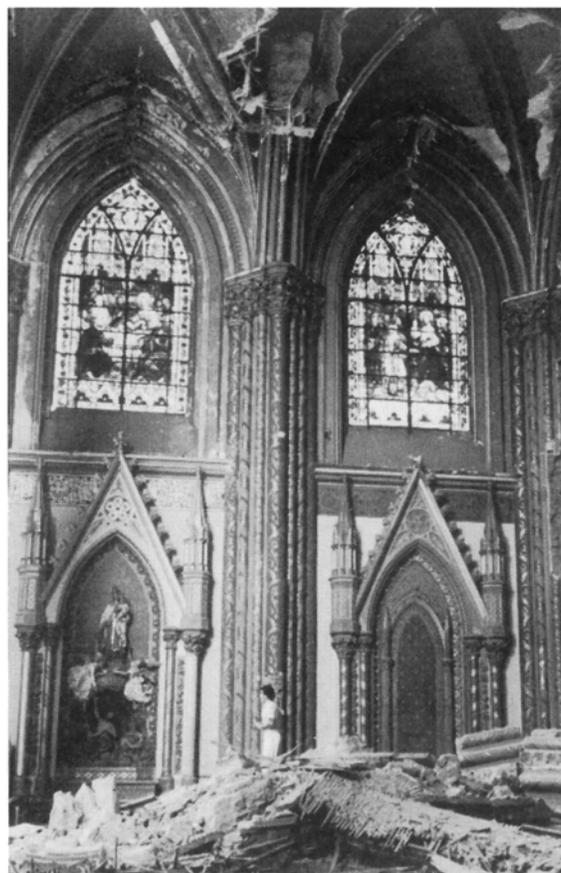
The Basilica del Salvador, (Plate 5.29) started in 1870 and completed in 1920, was built in unreinforced, but good quality fired brick with mortar joints. Two of the internal columns and parts of the external walls collapsed and there was extensive cracking.

PLATE 5.29(a) External view

PLATE 5.29(b) Interior view
Basilica del Salvador, Santiago
