THE CHILEAN EARTHQUAKE OF 3 MARCH 1985

A FIELD REPORT BY EEFIT

ED Booth MA MICE MStructE
Ove Arup & Partners, London

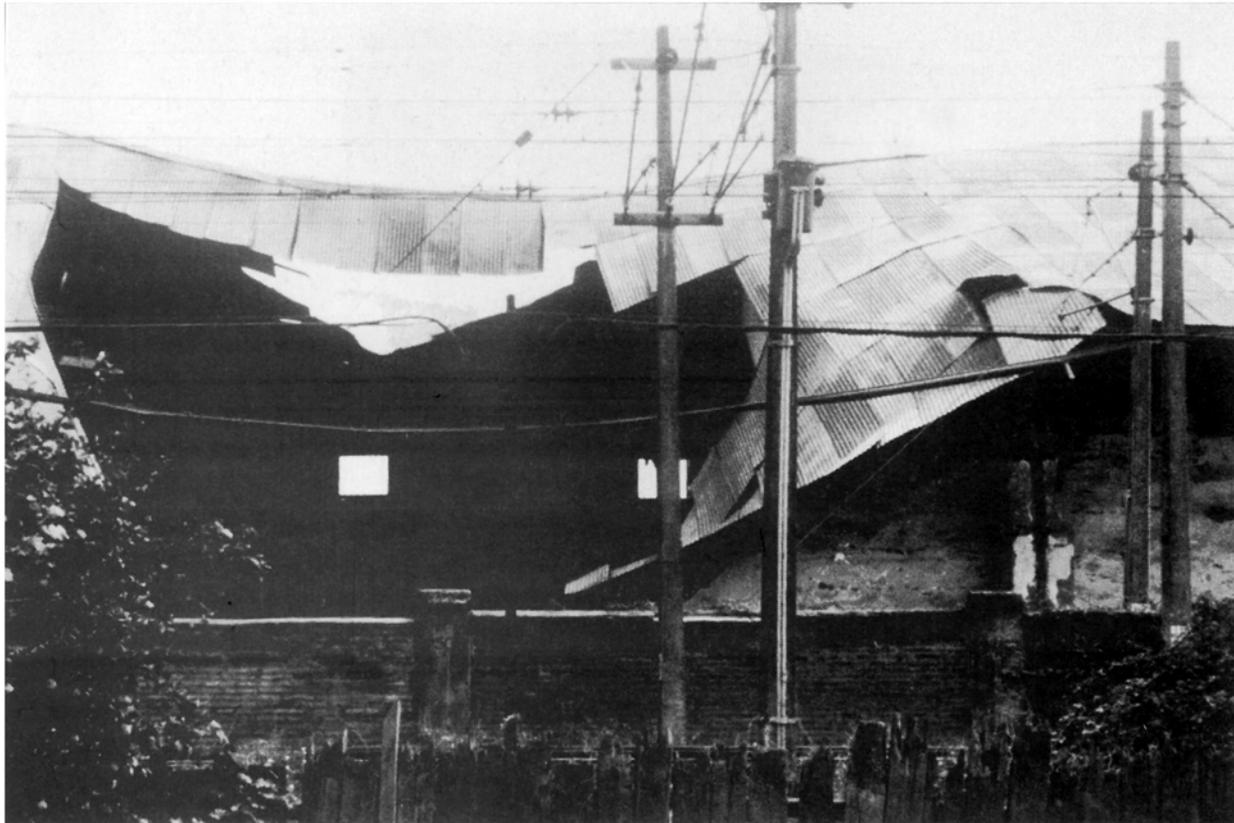
A large railway shed, about 10m high with adobe walls strengthened by adobe buttresses, and a timber truss, corrugated iron roof, suffered a partial collapse (Plate 5.30). This type of structure would be expected to be susceptible to earthquake damage. The fact that the collapse was not more extensive, and the lack of damage in the adjacent unreinforced masonry signal box (Plate 5.31) and some other adobe buildings in Rengo reinforces the view (Section 5.4) that the concentration of damage in Rengo may owe as much to poor construction as to soil effects causing amplified motion. The undamaged steel frame shop (Section 5.7c) also supports this view.

PLATE 5.30 Adobe warehouse, Rengo

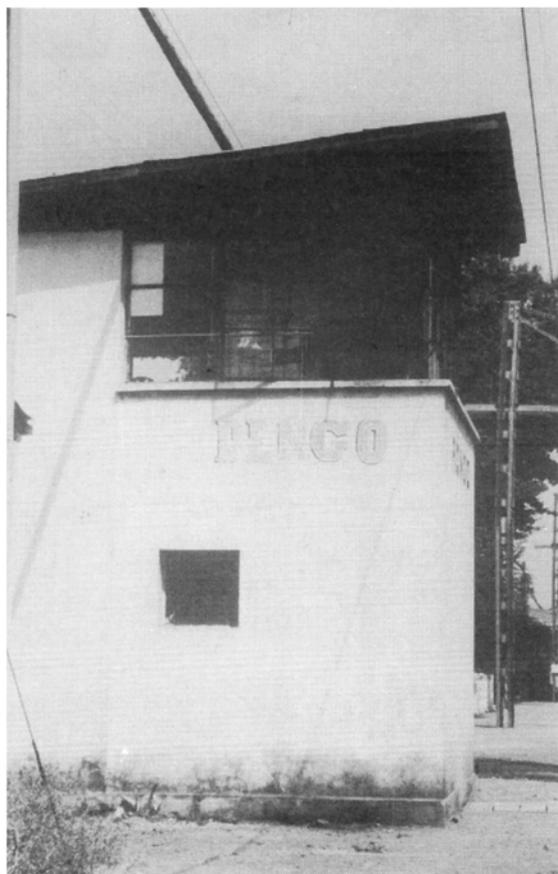
PLATE 5.31 Signal box, Rengo

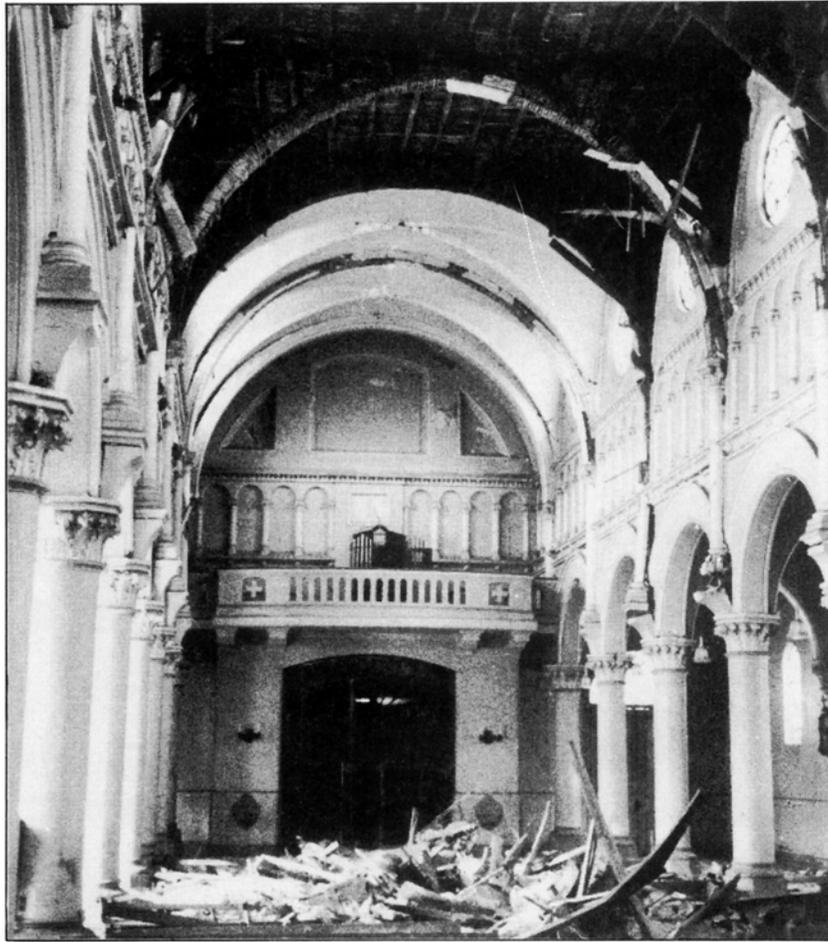
Extensive cracking and collapse of the false ceiling were found in a church building, the Sanctuar Santa Rosa (Plate 5.32).

PLATE 5.32 Santuar Santa Rosa, Pelequan

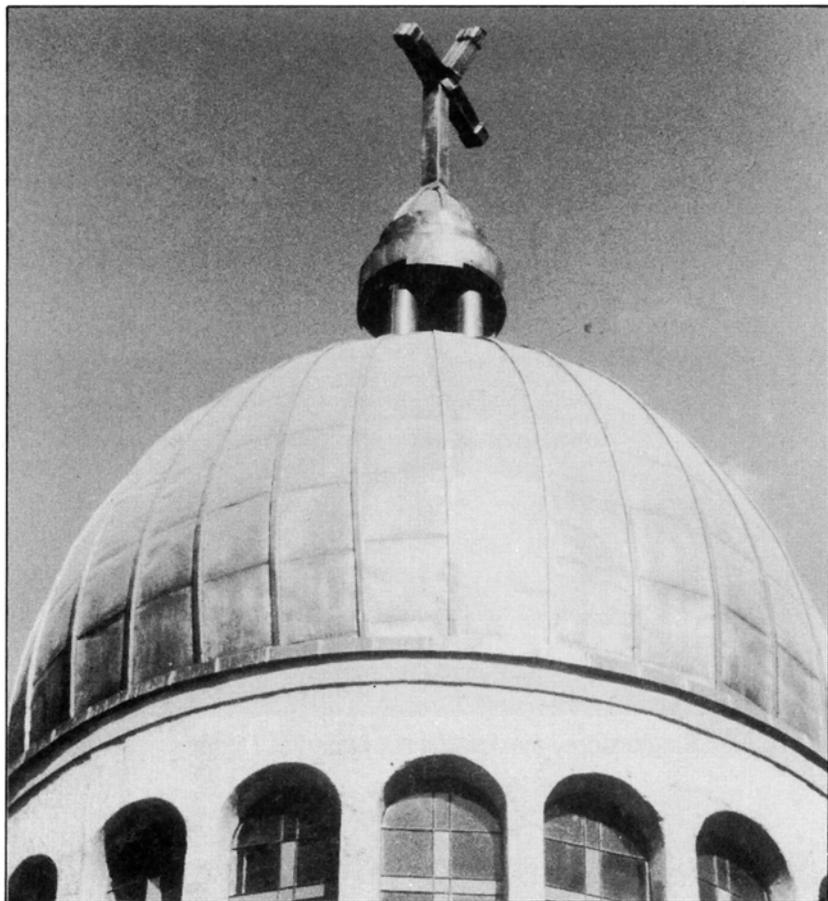
Two large churches were visited. The older was severely cracked. The newer church, built in 1914 with a concrete dome added in 1956 was in fired brick and suffered little structural damage. The significant feature was that the copper cross on top of the dome was tilted to the west by the earthquake (Plate 5.33), suggesting that strong motions were present in Curico, 100km from the source area. Crosses on other adjacent churches were also tilted, though not necessarily to the west. The pastor of the church confirmed that he had felt strong enough vertical and horizontal motion in the ground floor of his house to necessitate clutching for support.

PLATE 5.33 Cross on newer church, Curico

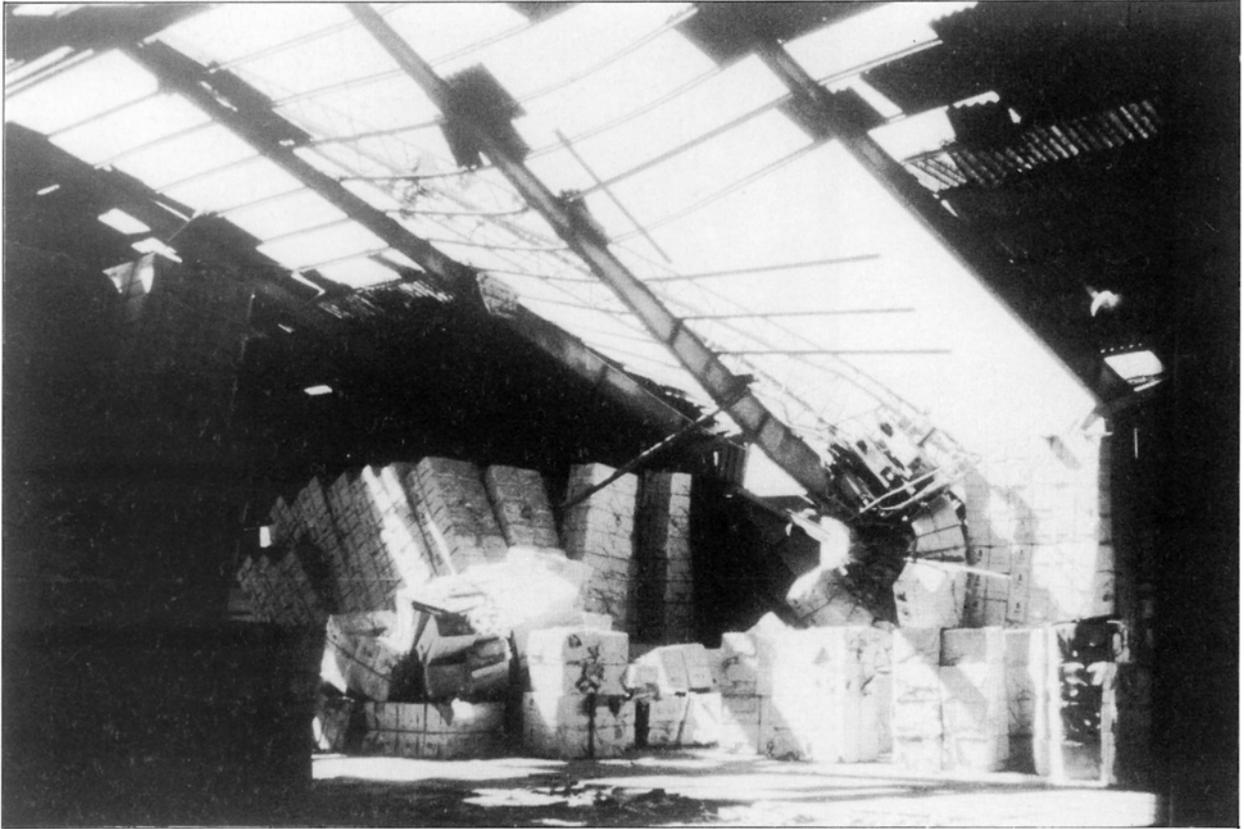
PLATE 5.34 Portal frame shed, San Antonio docks

Several dock-side cranes toppled on to the steel framed warehouses as the quay wall failed (Plate 5.34). These warehouses use three pinned arch frames rather than rigid portal frames and performed very well, despite spreading of the arches by more than a metre due to the movements of the embankment.

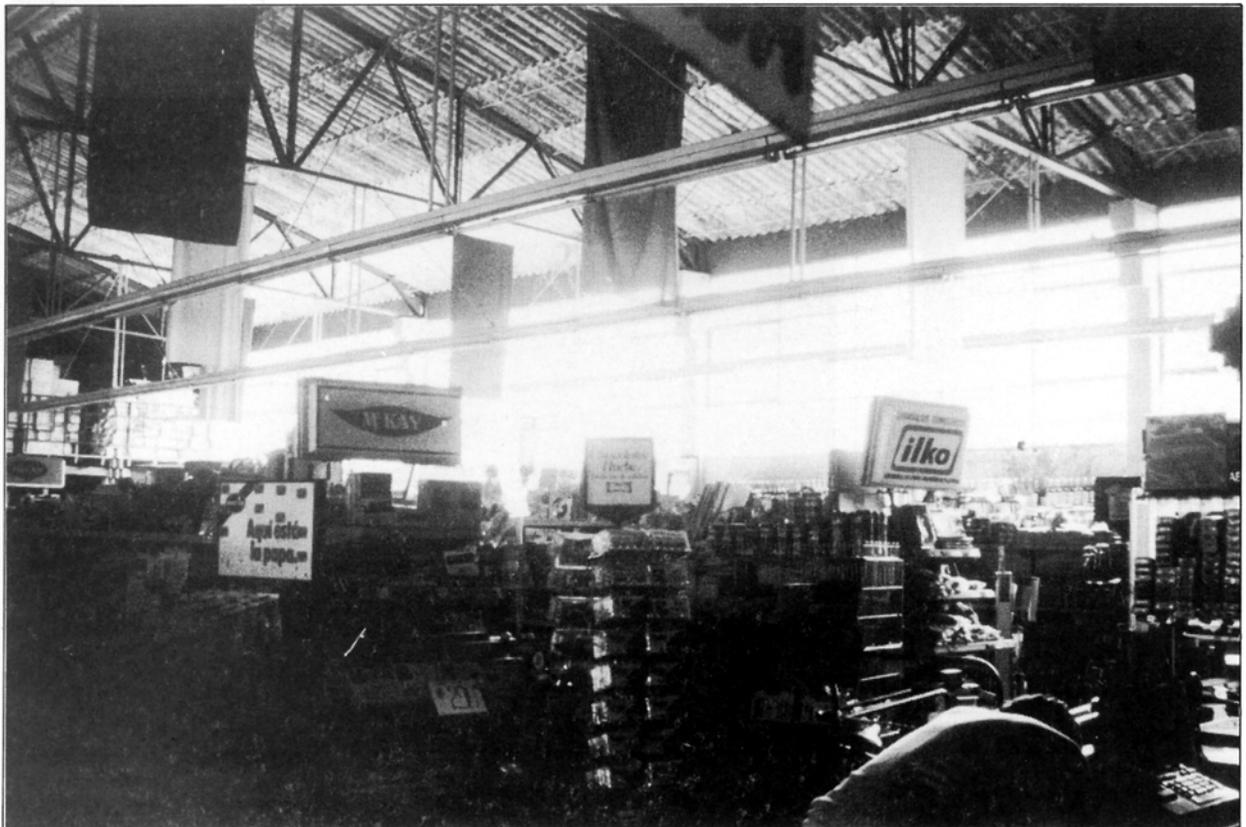
PLATE 5.35 Single storey steel frame supermarket, Rengo

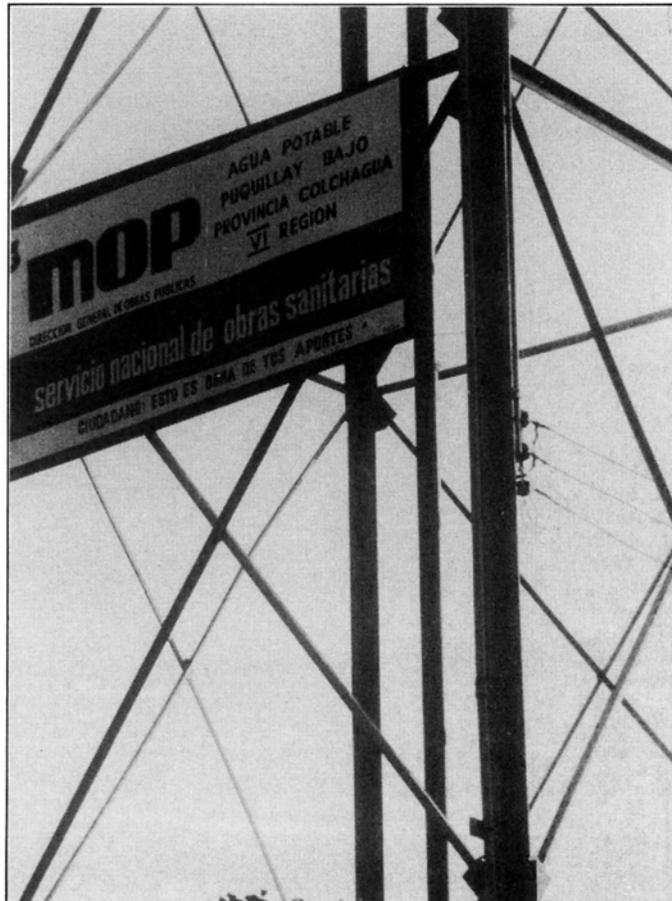
PLATE 5.36(b) Detail of buckled braces
Water tower, Puquillay Bajo

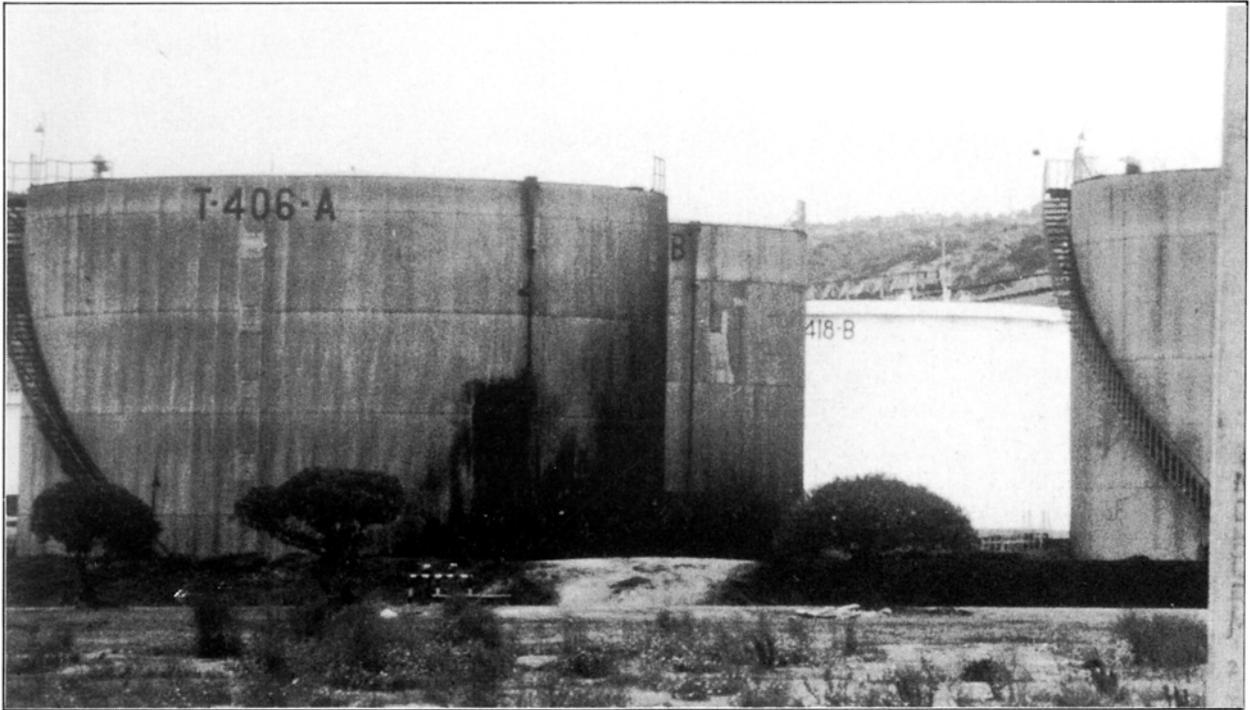
PLATE 5.39 Damaged oil storage tanks, Concon

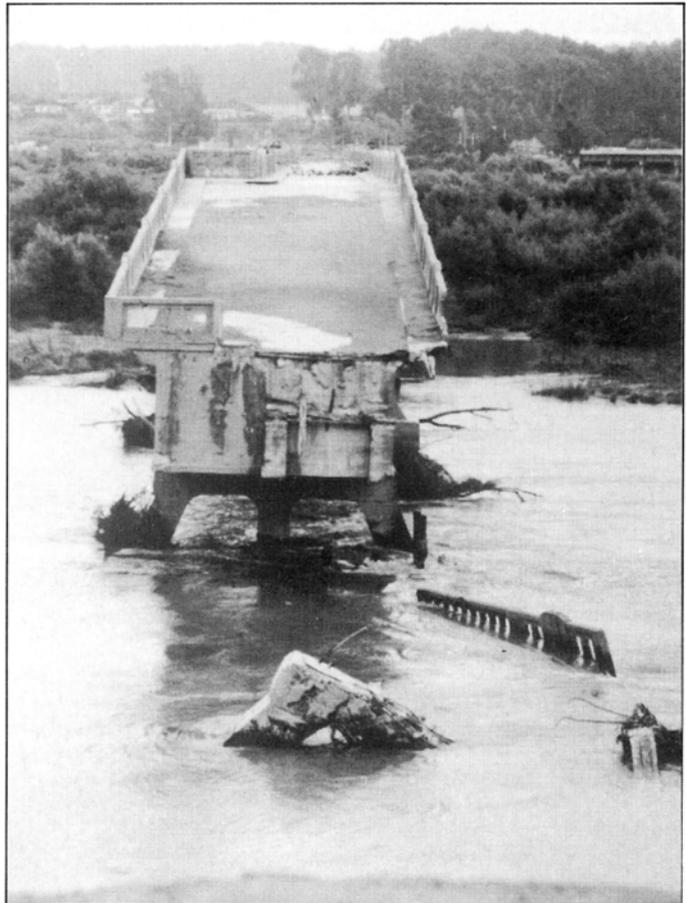
PLATE 5.40 Old bridge over River Maipo, Lolleo

The older bridge (Plate 5.40), unused since completion of the newer one, was sited about 0.5km upstream. The EERI team (Ref. 4) reports that it had been used for target practice by the army, and it may have been weakened both by this and by previous flood damage. A river pier was lost, another had sunk, but there was no sign of any lateral movement.

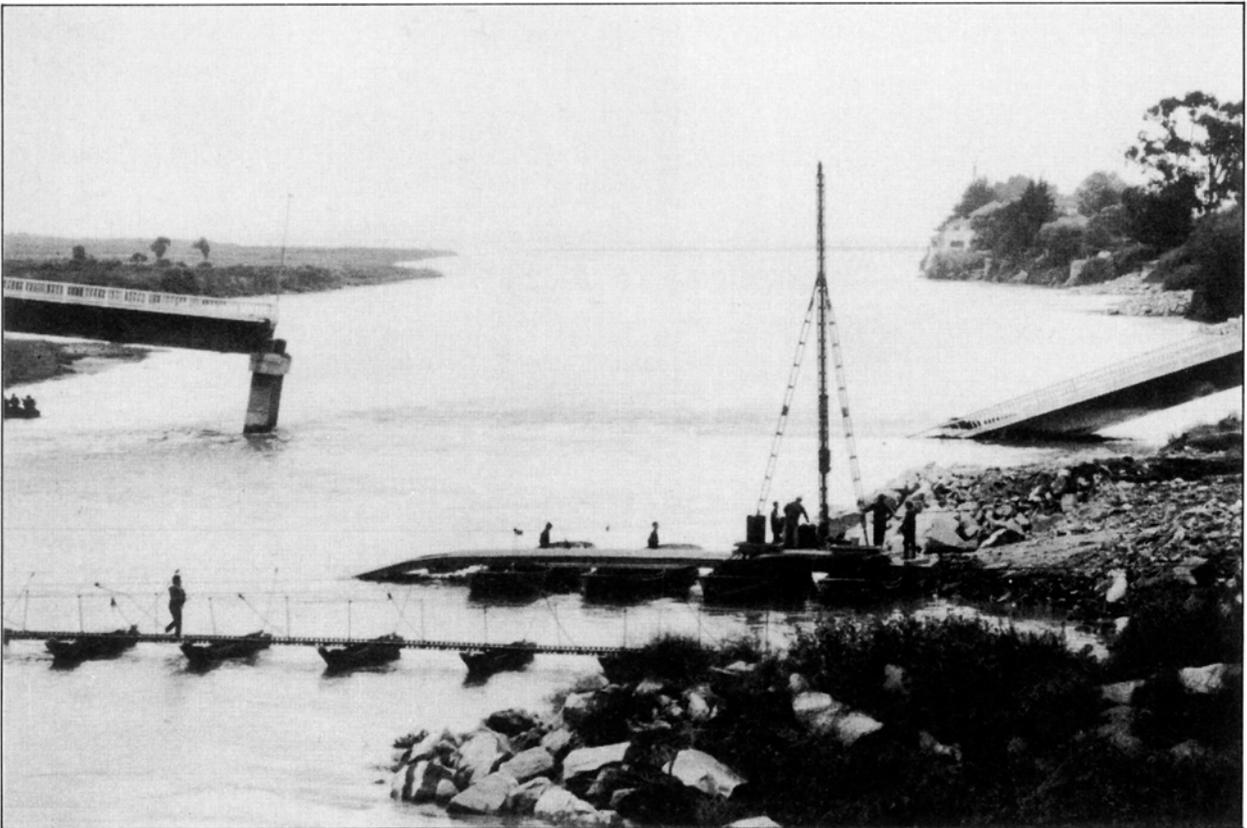
The army had provided a pedestrian pontoon bridge within a few days of the earthquake (Plate 5.41(b), foreground), and appeared almost ready to launch a Bailey type vehicular bridge over the 250m crossing 2 weeks after the event.

PLATE 5.41(b) Looking west (downstream) Note pontoon footbridge in foreground
Ponte lo Gallardo, River Maipo, Llolleo

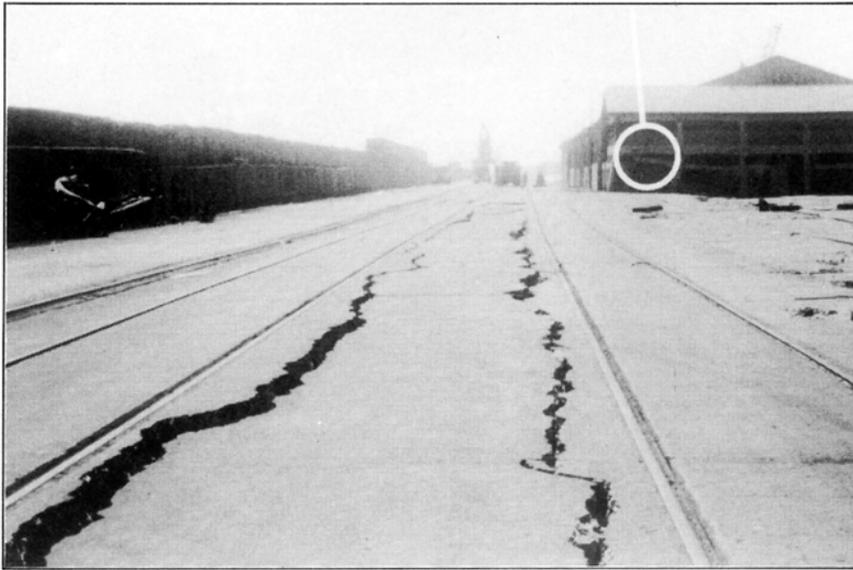
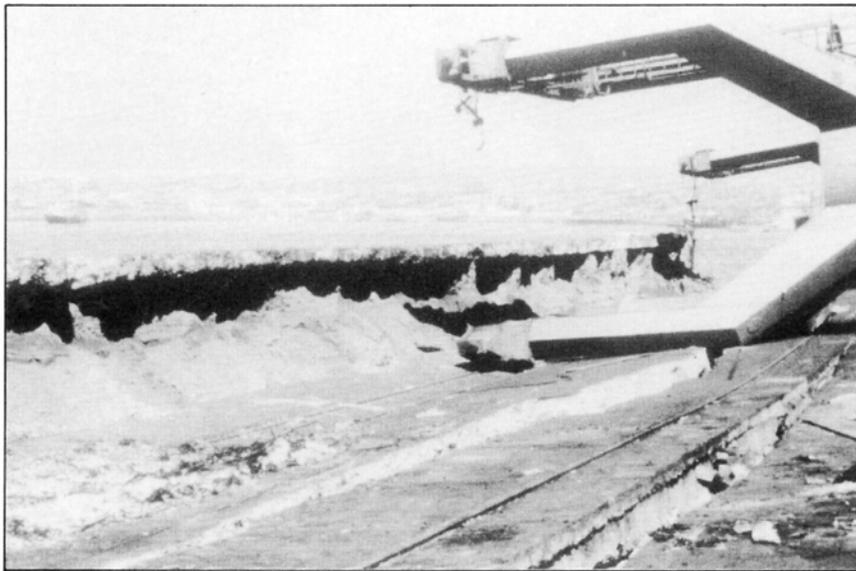
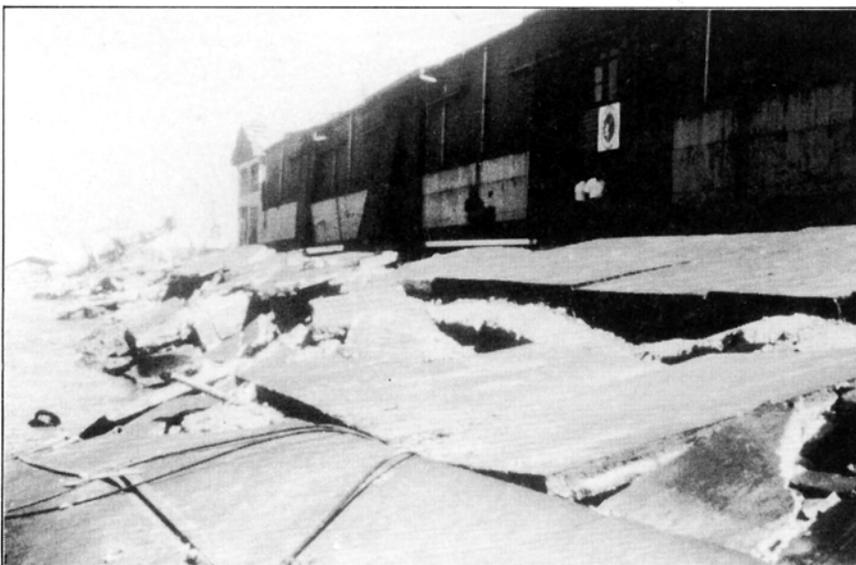
The 1971 earthquake (Lastrico et al, Ref. 16) caused the top of the quay wall to tilt outwards by up to 500 mm and the backfill to settle by a similar amount, while a longitudinal crack running almost the full length of the mole, was observed. The 1985 earthquake caused similar and more extensive damage (Plate 5.42). Nearly all the gravity quay wall collapsed due to tilting, and multiple longitudinal cracks developed along the embankment as a result of movement of the wall. The primary cause of failure was probably liquefaction of the hydraulic fill in the centre of the embankment giving rise to increased pressures against the wall. The sea defence wall along the western edge of the quay was formed from massive concrete blocks laid to a shallow slope (see left of Plate 5.42(a) and Figure 5.5) and was undamaged.

PLATE 5.42(a) From Point X, Fig 5.4, looking north

PLATE 5.42(b) From Point Y, Fig 5.4, looking south

PLATE 5.42(c) From Point Z, Fig 5.4, looking south
Damaged quay at San Antonio docks

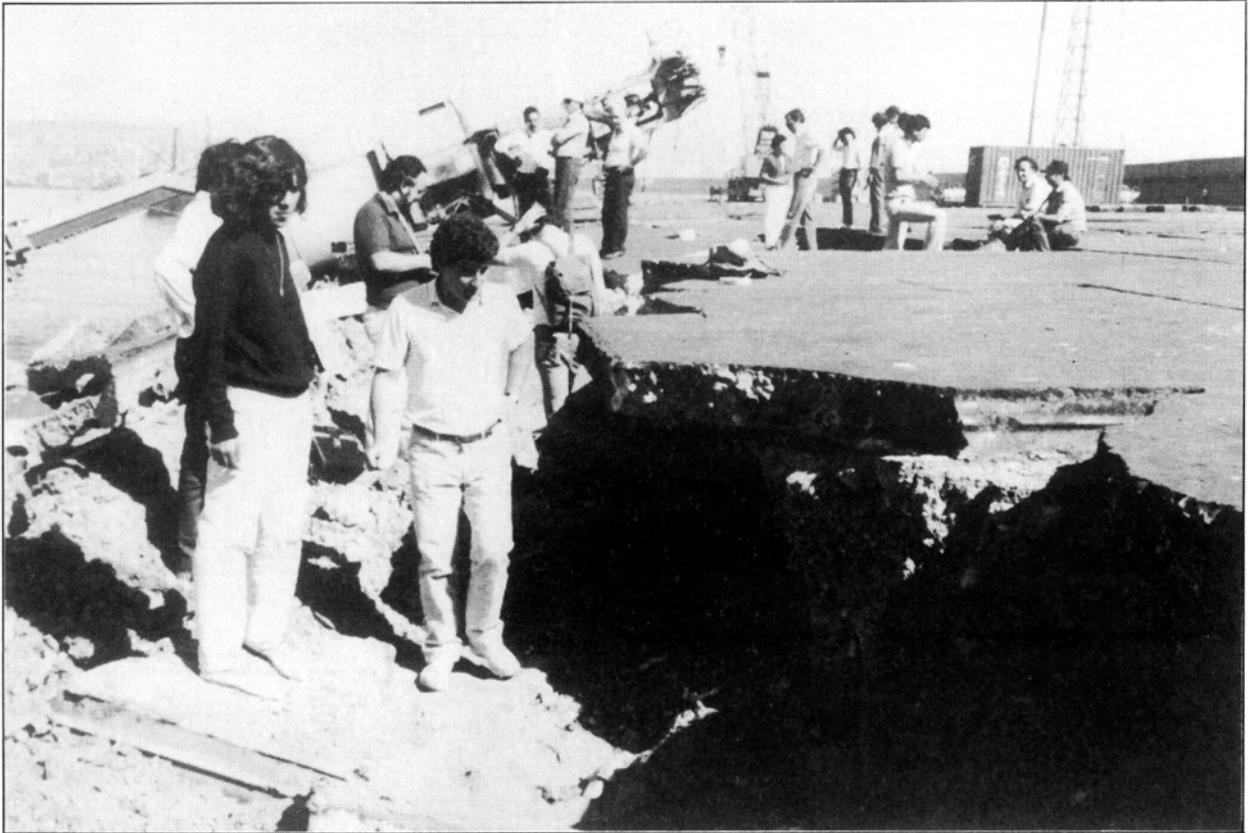
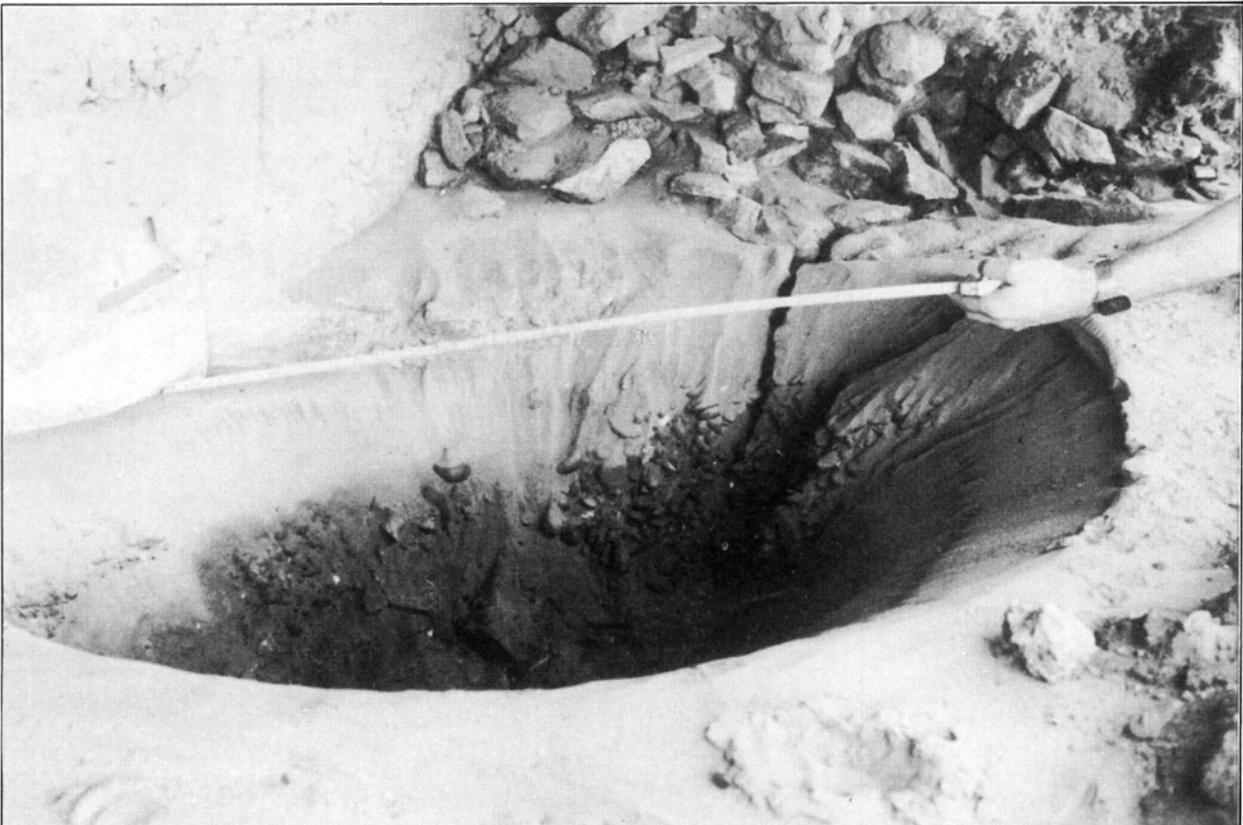
A sand volcano about 1 m diameter and 1 m deep, (Plate 5.43) was found under a section of the concrete paving slab adjacent to the quay wall. The hole was surrounded by fine sand, suggesting that water had first been forced out of the hole and had then drained back in, probably as the wall began to move. One of the warehouses contained a large number of copper ingots and consequently there would have been a considerable surcharge close to the quay wall.

PLATE 5.43(a) Location of sand volcano

PLATE 5.43(b) Detail of sand volcano near point Z, Fig 5.4, San Antonio Docks

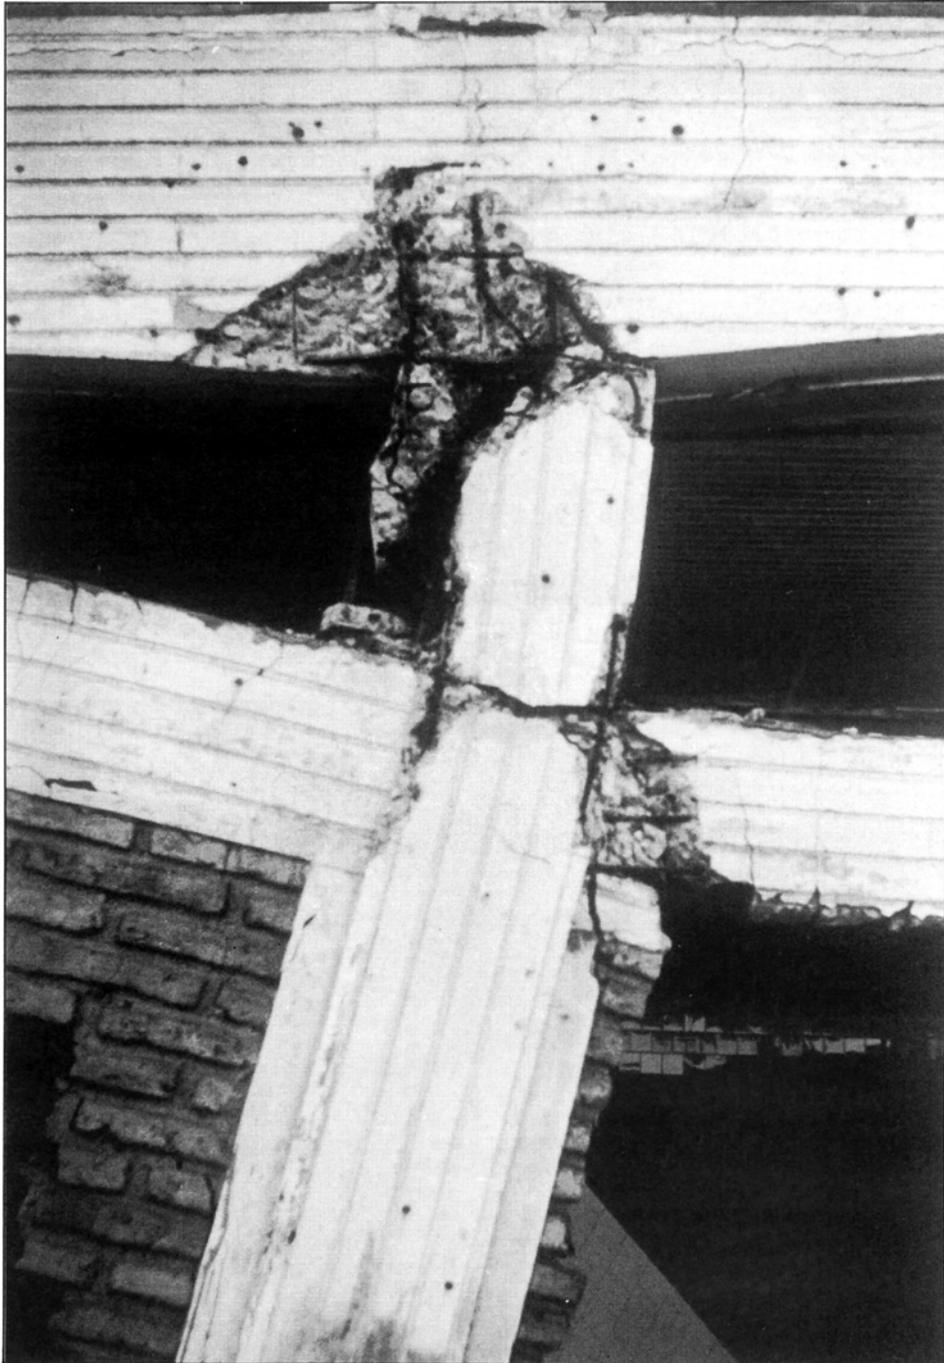
The adjacent concrete framed warehouse suffered severe damage due to spreading of the foundations across the cracks in the embankment (Plate 5.44). Damage to all the dock-side structures appeared to be due to earthquake induced differential foundation movements rather than earthquake induced inertia forces.

PLATE 5.44 Damaged to rc frame building due to lateral spread of quay, San Antonio Docks [see PLATE 5.42 (a)]

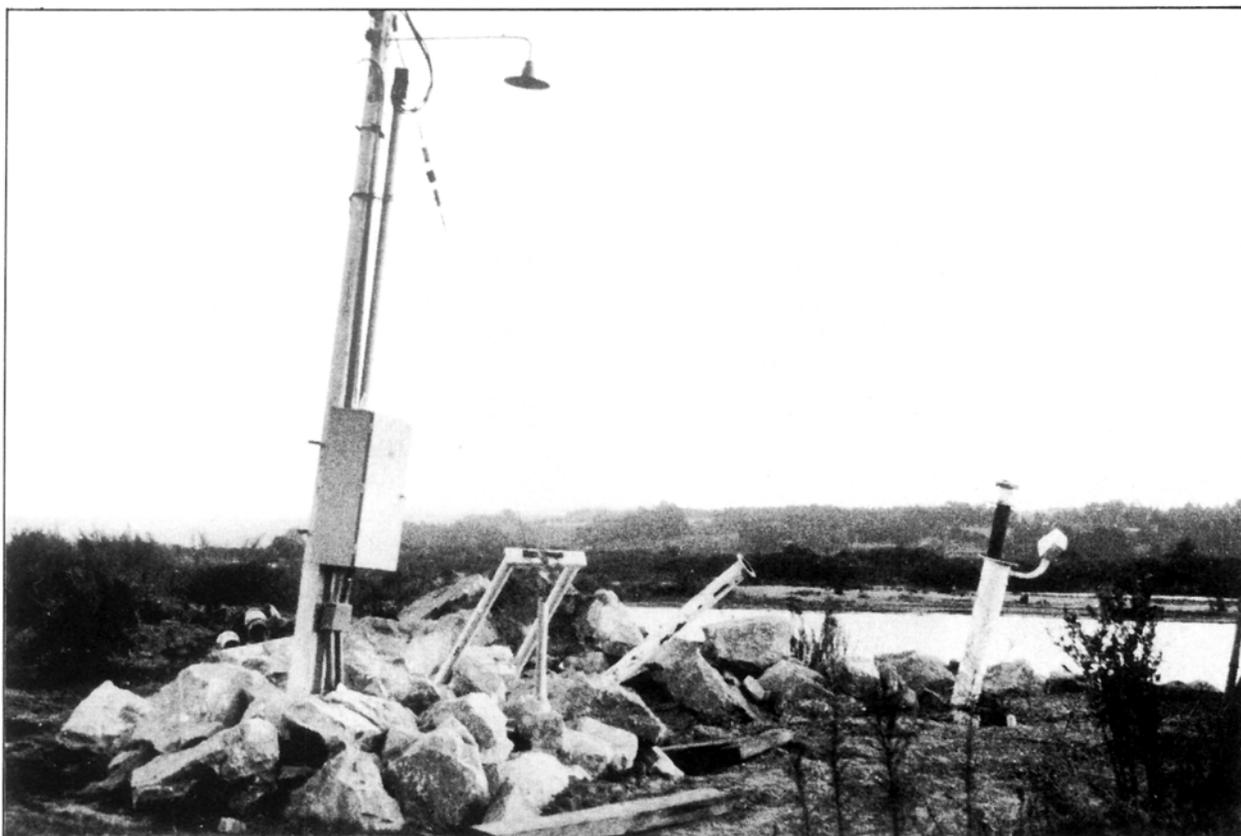
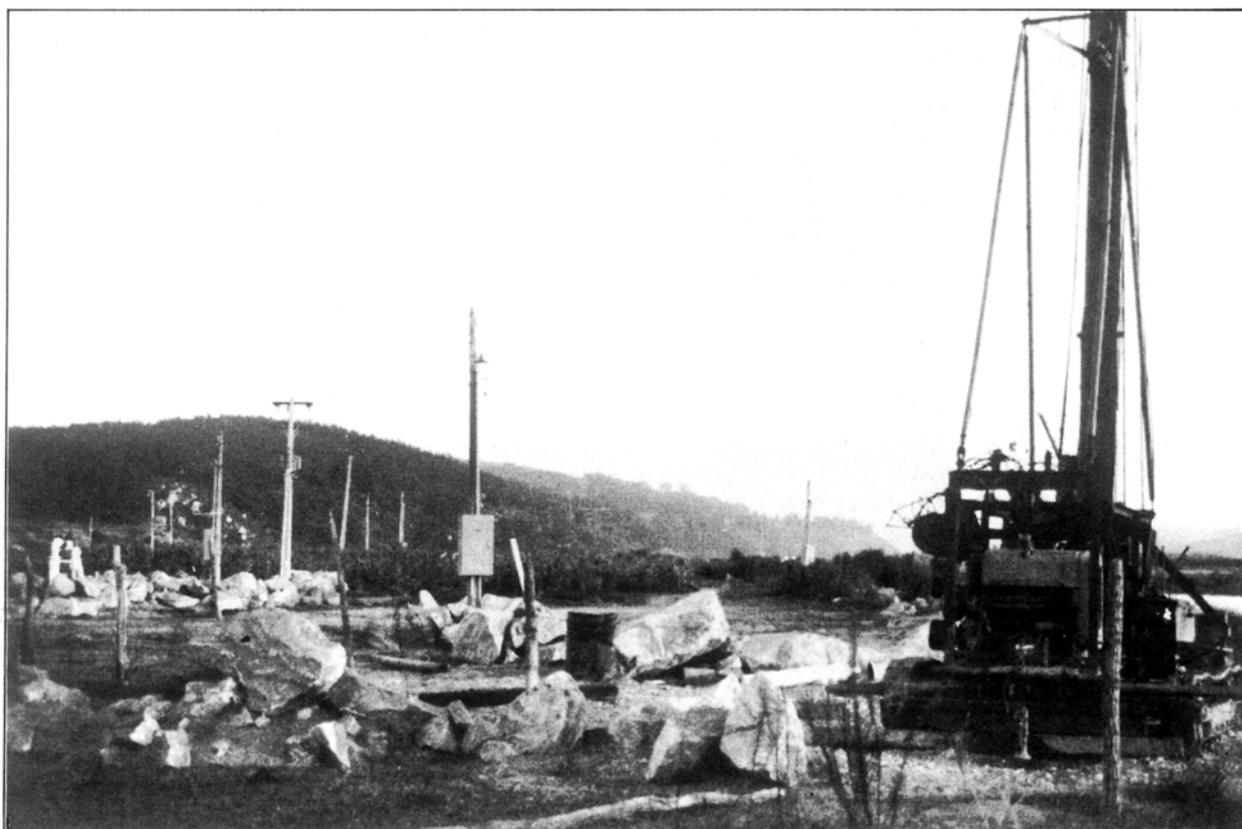
The pumping station consisted of a pumphouse feeding a large diameter watermain supplying Valparaiso and some water treatment and storage tanks. The station was fed from about 5 well points, located about 0.5km away in the River Maipo flood plane (Plate 5.45) near the edge of fill about 1.5m high, some 15m from the river bank. The structure of the pumphouse had been damaged by the 1985 earthquake but at the time of the EEFIT visit was operational and supplying water to Valparaiso.

PLATE 5.45(a) Failed well point

PLATE 5.45(b) Installation of new well point
Well points supplying Lolloe pumping station

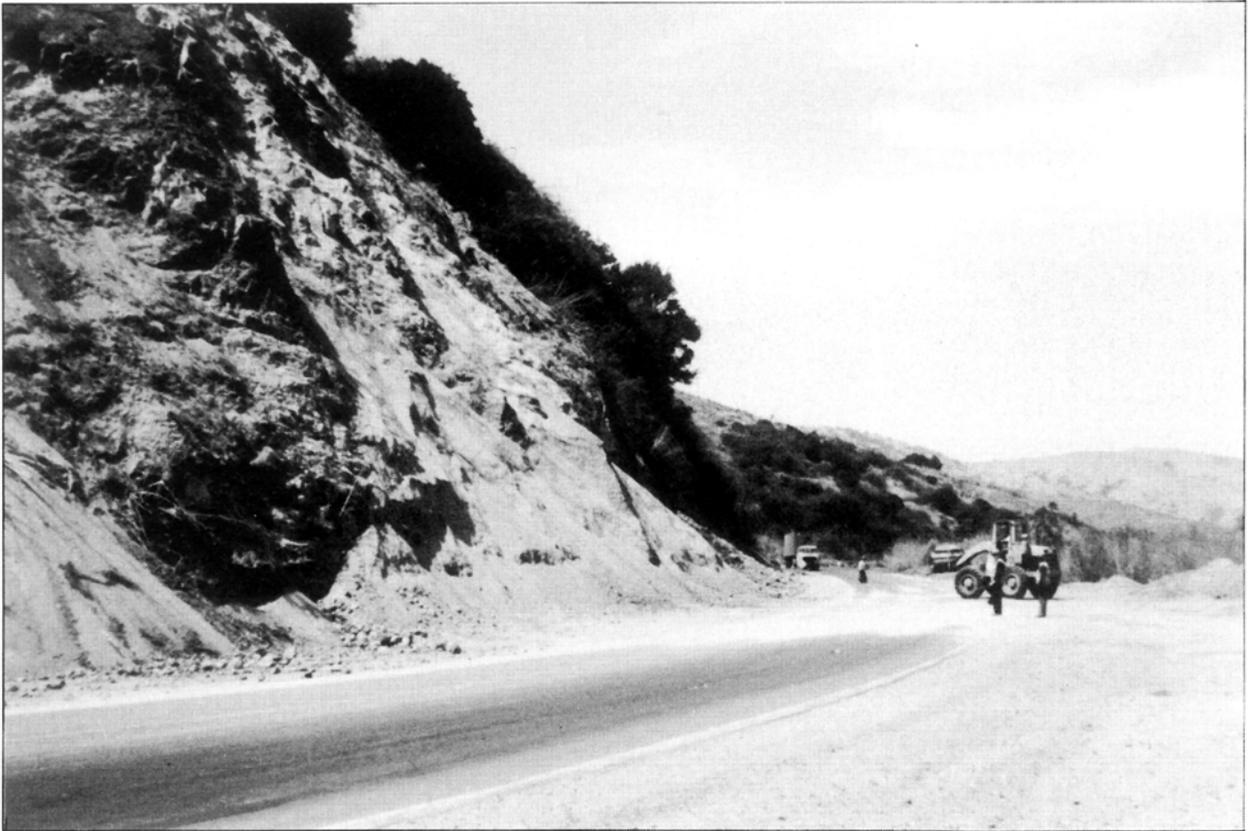
A number of other minor failures were observed by the EEFIT team. Cracks in road bridge embankments appeared quite common and were noticed up to 100km south of Santiago. A minor fall from a road cutting just east of San Antonio was observed, which partially blocked the road (Plate 5.46) and more major rock falls in the mountains on the main road between Santiago and Valparaiso were also reported, though not seen by the EEFIT team. Embankment failures on the coast north of Vina del Mar were also observed in partially cemented silty sand.

PLATE 5.46 Slip on road cutting near San Antonio.
