THE M_w 6.2 AMATRICE, ITALY EARTHQUAKE

OF 24th AUGUST 2016

A FIELD REPORT BY EEFIT

May 2019

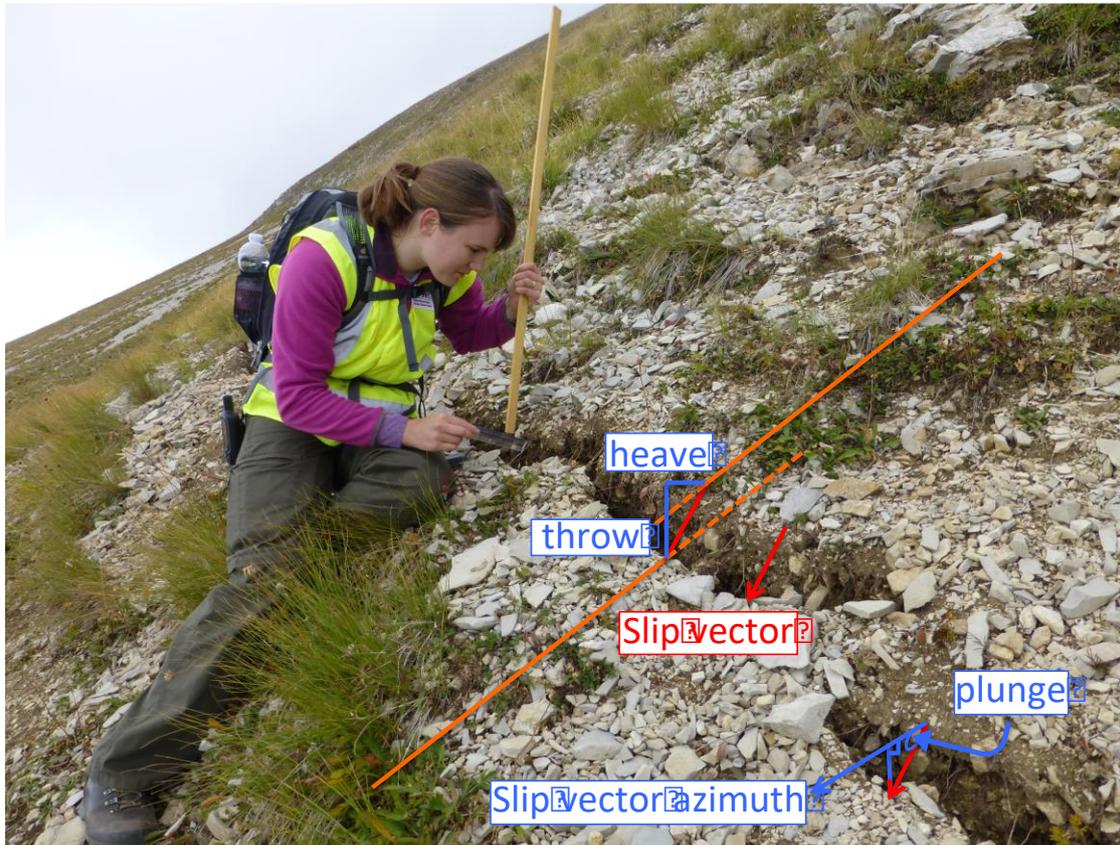
Figure 2-6 Explanation of measurements taken in the field, photograph taken looking north-west along the fault rupture.

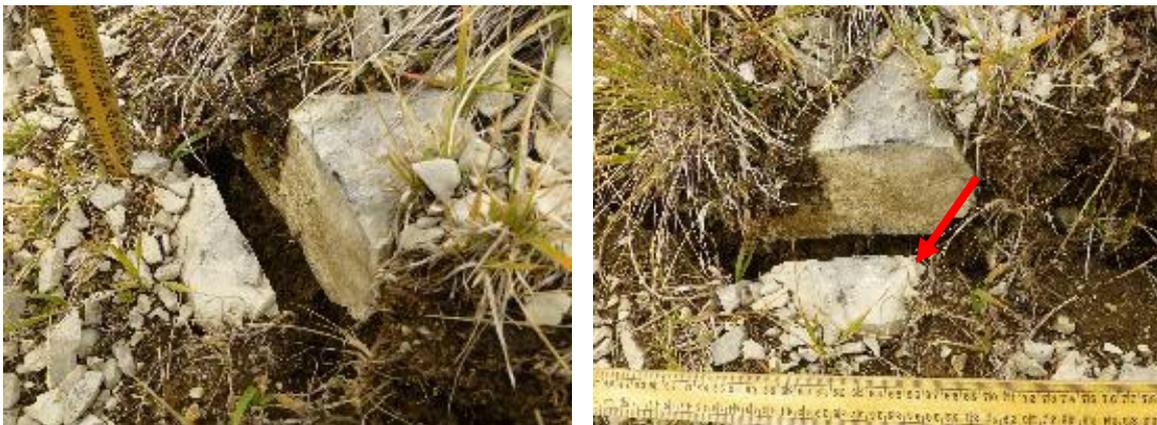
Figure 2-7: 12cm long rock split in two along rupture, the red arrow indicates the slip vector, deduced because the sides of the rock were joined together prior to the earthquake rupturing. UTM: 33T 357958,4741996.

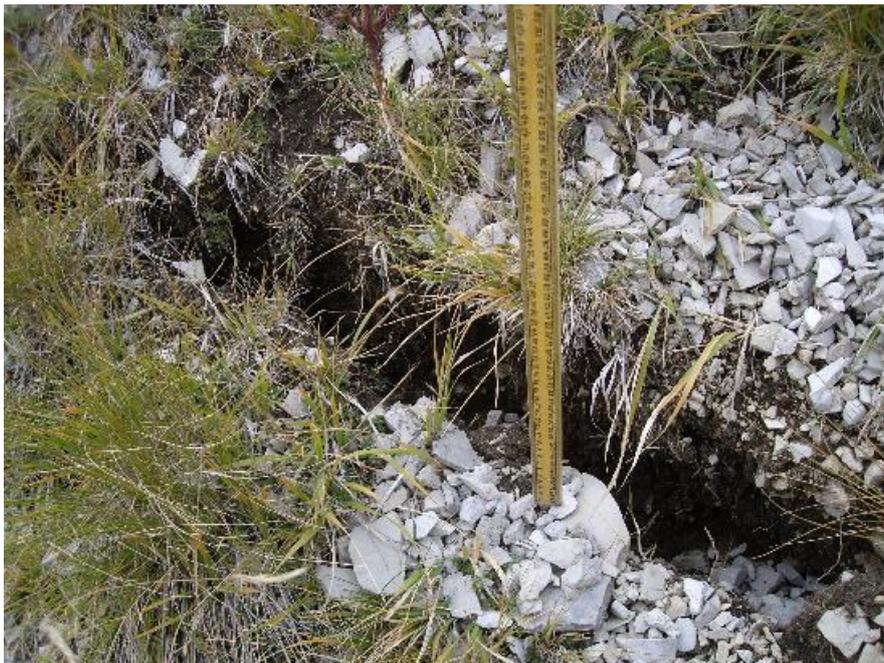
Figure 2-9 Example of rupture offset. Observed total offset in some locations was up to 30cm, with a throw (vertical offset) up to 28cm.

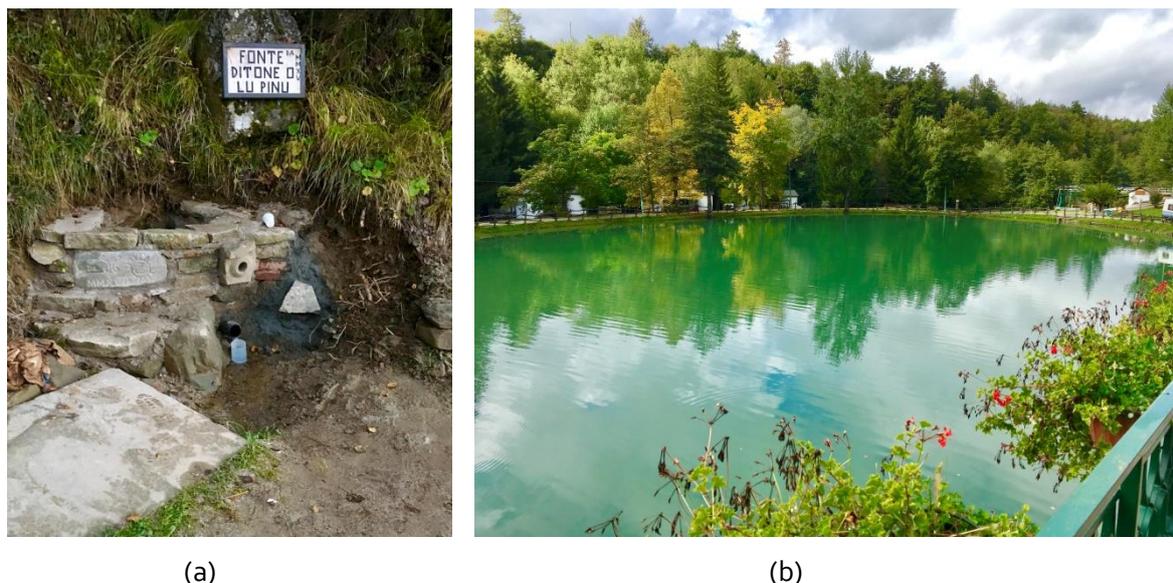
- significant variation of the flow-rate of springs, i.e. spring along SS577 road, between Arquata del Tronto and Pescara del Tronto shown in Figure 4-3a;
- anomalous waves up to 1m height in a small artificial pond (see Figure 4-3b), 5km south of Amatrice. The latter was observed immediately after the 24 August 2016 mainshock by a local eyewitness interviewed by the EEFIT team. No liquefaction phenomena were recorded in the surveyed area

Figure 4-3 Examples of hydrological anomalies and water effects: (a) Spring along SS577 road near Campotosto Lake (see Figure 4-1 for location), which exhibited drop in water flow-rate following the 24 August 2016 earthquake; (b) artificial pond located 5 km south of Amatrice where a local eyewitness reported anomalous waves up to 1m high, lasting for about 3 minutes after the mainshock.

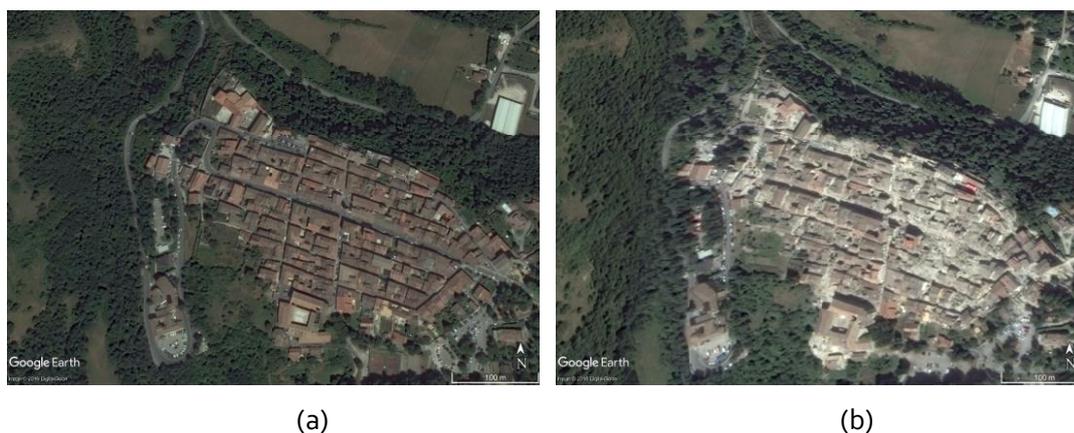
Figure 4-5 shows two satellite images of Amatrice taken before (Figure 4-5a) and after (Figure 4-5b) the 24 August 2016 earthquake. The extent of damage is clearly seen from the damage proxy map (DMP) shown in Figure 4-6. The DPM was derived by comparing Interferometer Synthetic Aperture Radar (InSAR) data from the Italian Space Agency's COSMO SkyMed Spotlight before and after mainshock. The DPMs for the entire epicentral region are available from the Advanced Rapid Imaging and Analysis (ARIA) Center for Natural Hazards (<http://aria.jpl.nasa.gov/>). The colour grading from yellow to red indicates increasing ground deformation. From the figure, it can be seen that most of

Figure 4-5 : Google Earth satellite image of Amatrice: (a) before first mainshock on 24th August 2016; (b) after first mainshock on 24th August 2016.

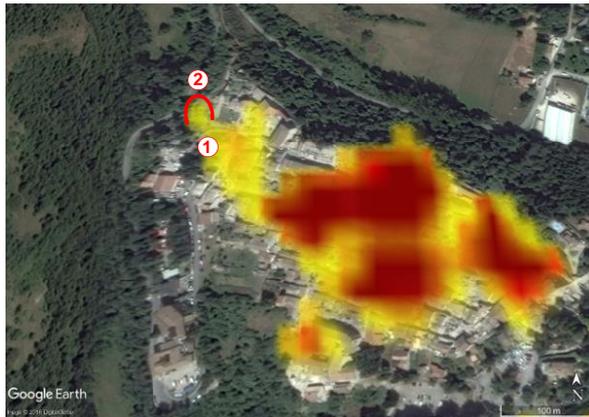
the damage was concentrated in the central part of the historic town, where the presence of thick soft deposits, together with the steep topography of the area, were partially responsible for local site effects resulting in the higher concentration of damage.

Figure 4-6: Damage Proxy Map (DPM) of Amatrice available from the Advanced Rapid Imaging and Analysis (ARIA) Center for Natural HazardsMD (https://aria-share.jpl.nasa.gov/events/20160824-Italy_EQ/DPM/). The colour grading from yellow to red indicates increasingly higher ground deformation

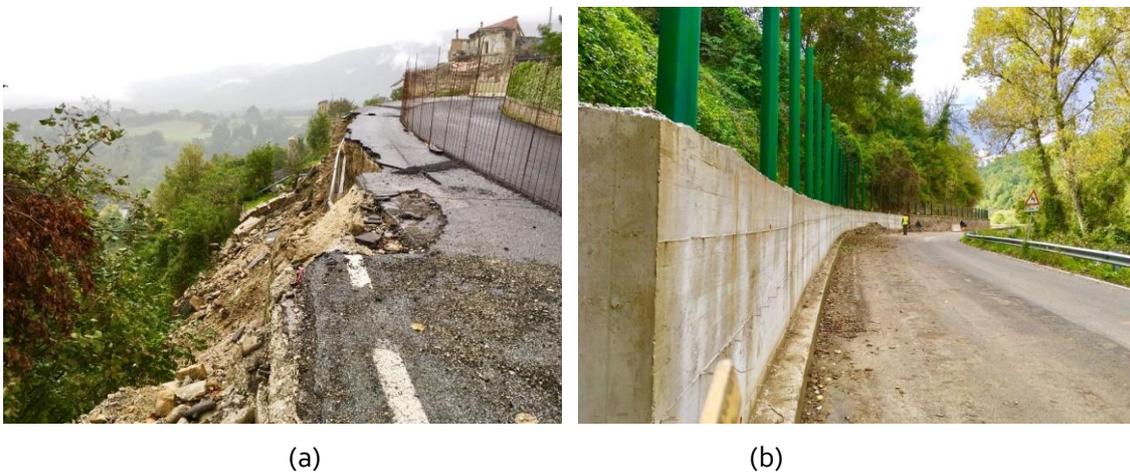
The most severe environmental effect was observed along the road adjacent to the hillside located on the northwest extremity of the town (see Figure 4-7). This consisted of disrupted soil slide whose crest (point 1 in Figure 4-6) and toe (point 2 in Figure 4-6) were confined by the SS260 road. The segment of the road running along the crest of the slope was supported by a masonry gravity retaining wall that partially collapsed. At the base of the failed slope, a new retaining wall was being constructed at the time of EEFIT mission (see Figure 4-7b). The failure plane of the slide was relatively shallow, possibly located at the interface between the soft colluvial deposit and the underlying flysch formation. The exposed scarp at the head of the slide (see Figure 4-7a) was almost vertical and exhibited little backward rotation. The displaced material consisted of lightly cemented gravel, sand and silt blocks, which disintegrated during the downward movement. The material displaced was estimated to be approximately of the order of 6,000m³.

Figure 4-7 : Slide and retaining wall failure observed along SS260 road on the northern-western part of Amatrice: (a) view from the crest and collapsed retaining wall whose debris are visible in the background; (b) view from the base. The displaced material had already been removed and a new retaining wall was being constructed at the time of the EEFIT mission (October 2016). An existing undamaged retaining wall is visible in the background.

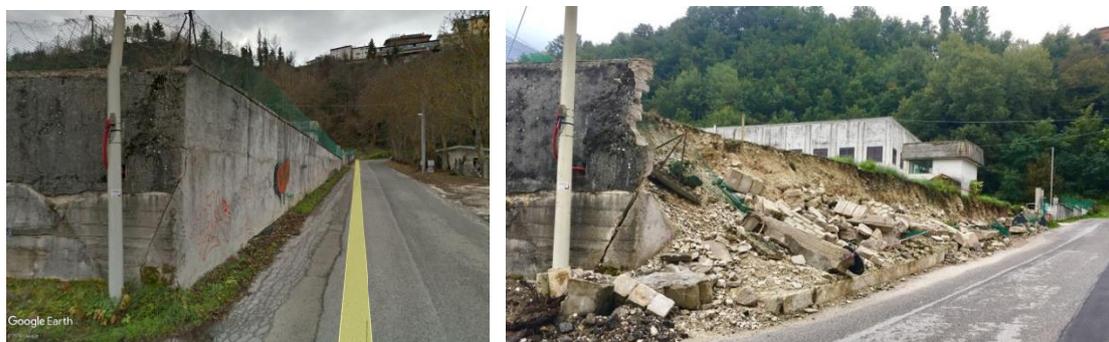
Figure 4-8 : Retaining wall failure located in the locality "Ponte Sommati": (a) Google street view before 24th August 2016 event; (b) collapsed retaining wall.

Figure 4-8 shows the collapse of a cantilever retaining wall, located in the locality “Ponte Sommati”. This was a small retaining structure, with dimensions of 2.5m high and 50m long, which supported a relatively shallow slope. The cause of the collapse was attributed to a poor engineering design and insufficient reinforcement at the connection between masonry filling and the surrounding reinforced concrete frames.

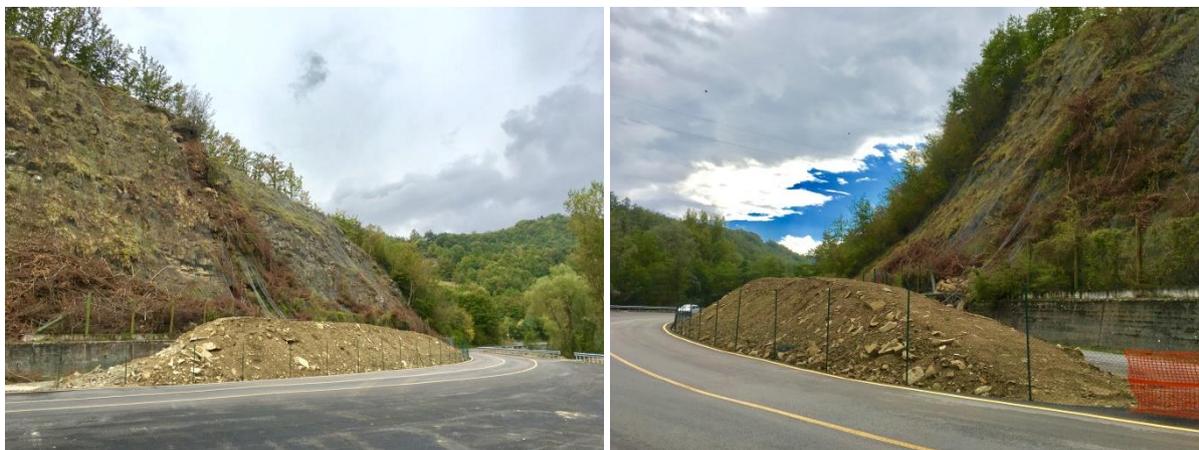
One of the largest rock falls observed in the epicentral area was observed along the SS260 road, approximately 4km north of Amatrice. At the time of the EEFIT mission, a protective embankment and new road had been constructed adjacent to the failed slope (see Figure 4-9). The slope was protected by a 1.8m high retaining wall supporting a catchment fence, made of hexagonal wire mesh draped over the slope. Boulders –with dimensions up to 0.6m across, detached from the highly fractured flysch formation, and descended by bounding and rolling along the hillslope. Several larger boulders punched through the catchment fence and were still visible on the main road. It was difficult to estimate the total volume of material displaced as this had been partially removed at the time of the EEFIT survey.

Figure 4-9: Rock fall along the SR260. The detached boulders punched through the wire mesh and catchment fence located above the retaining wall. A protective embankment and new road had been already constructed on the side of the old road at the time of the EEFIT mission.

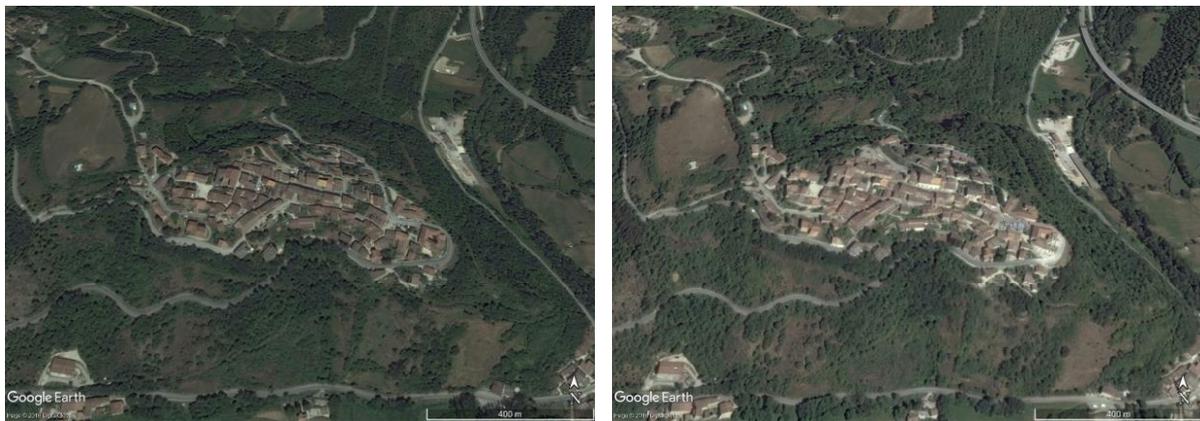
Figure 4-11 shows two aerial satellite images of Accumoli taken before and after the 24 August 2016 earthquake. Although the extent of damage is not clearly visible, the damage proxy map shown in Figure 4-12 shows that most of the damage occurred on the eastern extremity of the old town, where multiple instability phenomena were observed by the EEFIT team. As shown in Figure 4-13 these multiple slides resulted in significant horizontal and vertical ground displacements, and cracks on the road pavement. Furthermore, a reinforced-concrete gravity retaining wall exhibited substantial rotation and outward displacement of up to 60cm (Figure 4-13b). The largest slide was observed on the western extremity of the town, which displaced over 10,000m³ of material.

Figure 4-11: Google Earth satellite image of Accumoli: (a) before first mainshock; (b) after first mainshock.

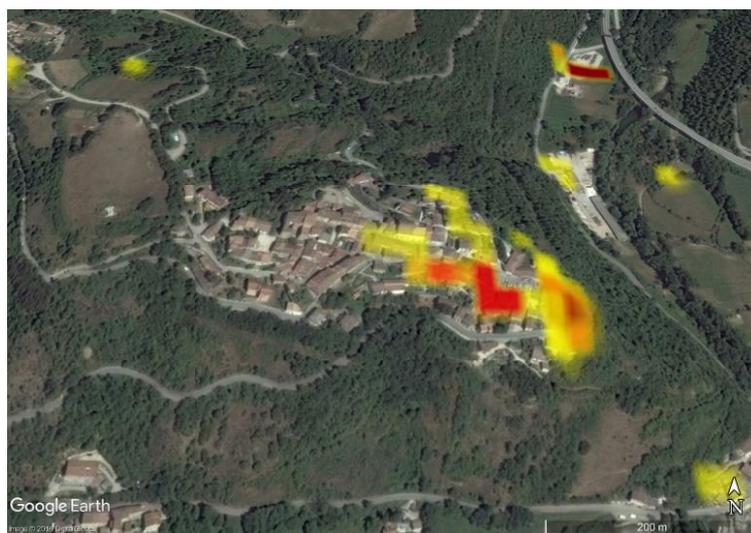
Figure 4-12: Damage Proxy Map (DPM) of Accumoli available from the Advanced Rapid Imaging and Analysis (ARIA) Center for Natural HazardsMD (https://aria-share.jpl.nasa.gov/events/20160824-Italy_EQ/DPM/). The colour grading from yellow to red indicates increasingly higher ground deformation.

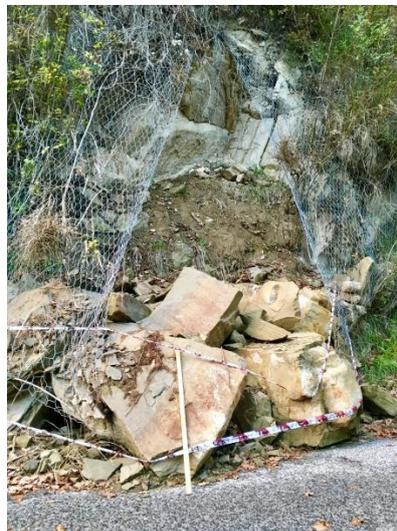
Because of the presence of highly fractured flysch formations, rock falls and slides were common in the area. Figure 4-14 shows an example of rock slide observed along the main access road to Accumoli, whereby boulders up to 1.2m diameter, which detached from the bedrock and slid along an almost planar sliding surface and punched through the protective wire mesh.

Figure 4-14: Rock slide along the main access road to Accumoli, where boulders detached from the bedrock and punched through the wire mesh.

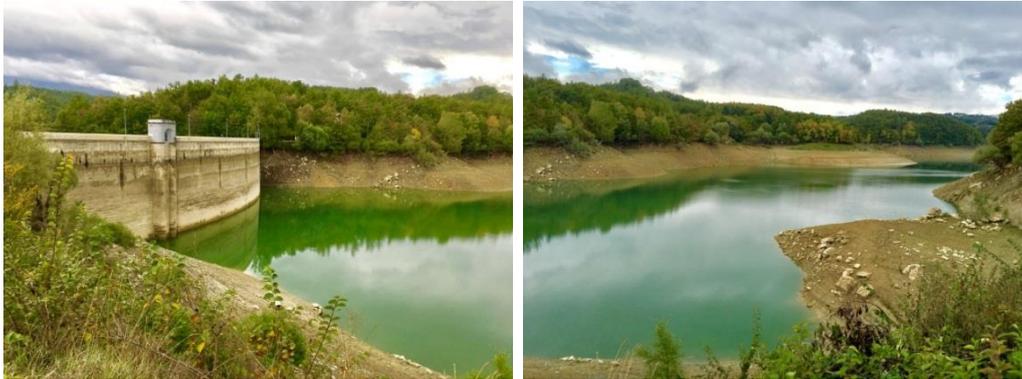
Scanderello lake is located 2km North-East of Amatrice and is impounded by a single concrete gravity dam shown in (Figure 4-25). The dam was not damaged by the seismic event, but personnel from Enel, the owner of the dam, interviewed by the EEFIT team confirmed that, following the main shock, the water level in the reservoir was lowered by 4 to 6m, as a mean f precaution. The decrease in water level can also be appreciated from the change in colour along the shoreline shown in Figure 4-25.

Figure 4-25: Scanderello reservoir and dam: (a) upstream view of Scanderello; (b) view of Scanderello lake.

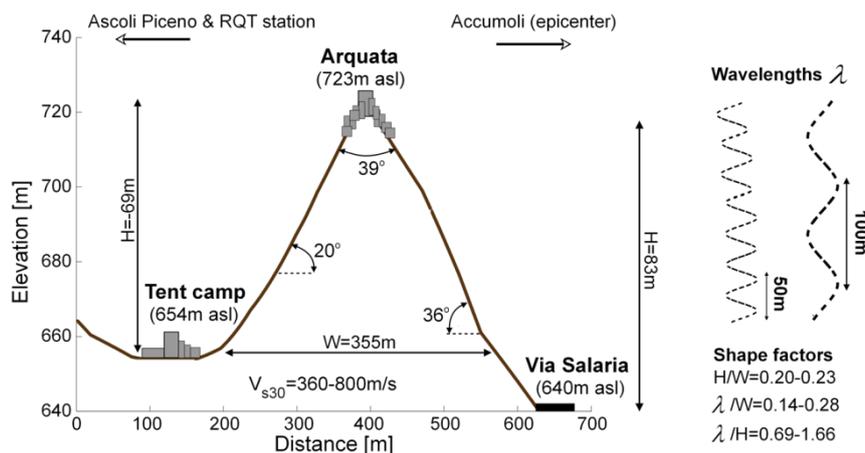
Topographic effects are interpreted to have played a major role in the concentration of damage in several towns due to their peculiar topography and geomorphological settings. Topographic effects are responsible for the amplification of seismic wave due to topographic irregularities, such as steep and narrow mountains range and hills. The concentration of damage in Arquata del Tronto, which is presented and discussed in detail in chapter 5, suggested that topographic effects may have played a significant role in the extent of the damage. Arquata del Tronto is located on the crest of a relatively high and steep ridge, which is schematically depicted in Figure 4-26. Because of its topographical features, the municipality of Arquata del Tronto falls into Category 4 of both the Italian Building Code NTC Norme Tecniche per le Costruzioni (2008) and Eurocode 8: Part 5 (CEN, 2004). Thus, it is expected an amplification of the peak ground acceleration by a factor of 1.4.

Figure 4-26: Topographical features of Arquata del Tronto: (a) schematic topography of Arquata del Tronto and main geometrical feature. (b) computed wave length of seismic waves induced by 24 August 2016 earthquake.

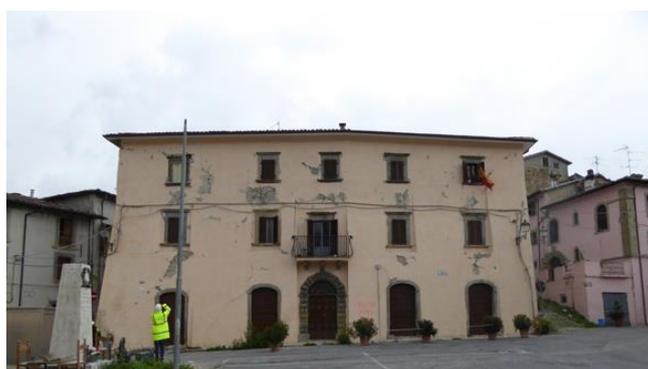
Figure 5-3 Alignment of vertical openings in the main square in Accumoli. The building also has buttresses to the first two storeys of the façade

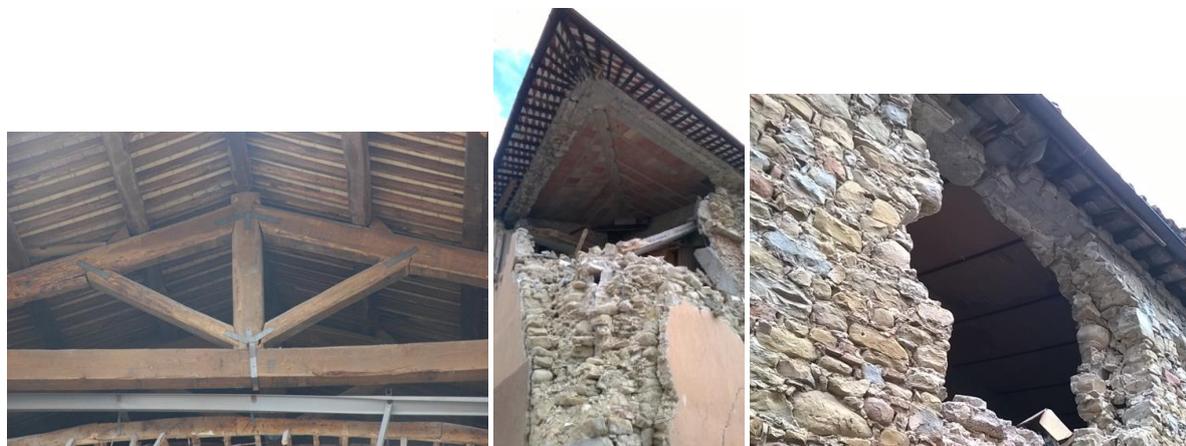
Figure 5-4: Examples of (a) traditional wooden roof structure; (b) concrete roof with lightweight brick tiles; (c) steel beam profile roof on mixed masonry -concrete ring beam.

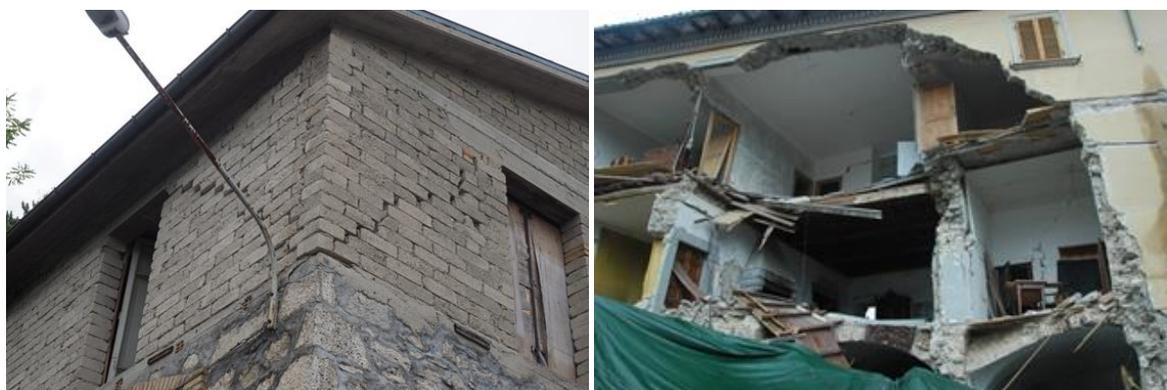
Figure 5-5 shows a typical case of an upper storey built in modern brickwork added over a roughly dressed stone masonry older structure. The stone masonry had been extensively repointed and ring beams and roof slabs are visible. The difference in stiffness between the two storeys and weight of the roof can be the reason for the observed shear crack pattern, denouncing the expulsion of the corner.

Figure 5-5: a) Shear crack of corner in building with second floor addition in concrete blocks and ring beams; b) out of plane failure of façade wall of 3 storey high building with traditional vaulted structures at ground storey, intermediate timber floors and RC roof slab. No evidence of ties.

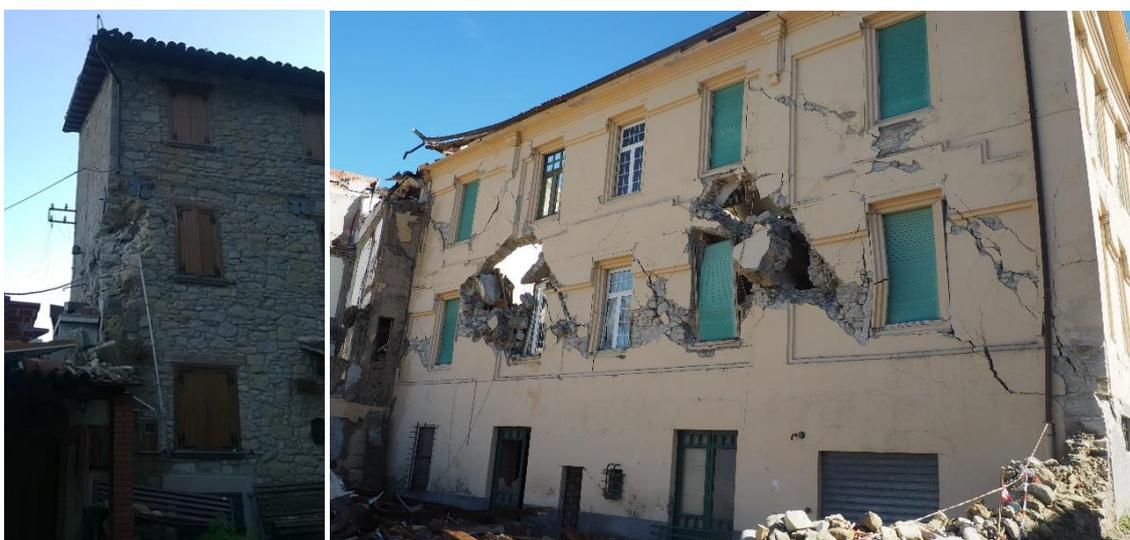
Figure 5-7: a) stone masonry building with ties and grouting of the rubble stone masonry in Pescara del Tronto; b) ONMI Institute in Amatrice, where seven people died. The concrete beams can be seen punching through the façade.

Anchors together with proper grouting and repointing seemed to have in general performed better than other solutions. The example in Figure 5-7a is one of the few buildings that survived in Pescara del Tronto, where earthquake intensity was classified as X-XI of the CMS scale, by the Italian Civil Protection. The building is equipped with ties and had the mortar reinstated, and despite the collapse of a small portion of the corner, due to the presence of water pipes, it survived the earthquake. Figure 5.7b shows a large masonry building in Amatrice, in which traditional floors had been substituted with reinforced concrete beams, which can be seen punching the façade.

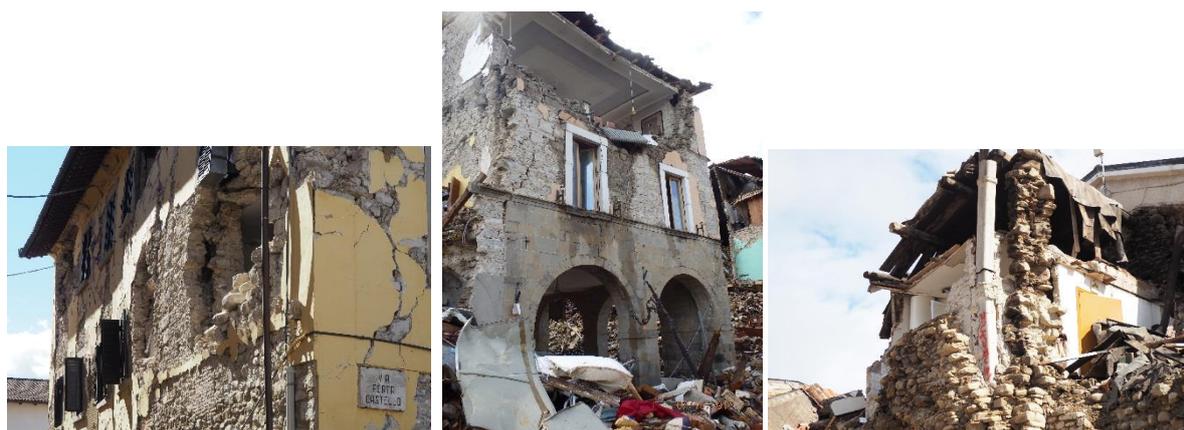
From the observation of masonry walls still standing a multi-layered wall system has been generally identified (see Figure 5-8a) often made of rounded fluvial cobbles and boulders, with poor or almost no inner connection, and cast in a sandy or mud based mortar. Building's height is mostly two to three storeys, with a minority of buildings with 4 storeys. The older buildings have vaulted structures at the ground level and timber floor structures at the upper storey (Figure 5-8). Although the façades show generally a regular distribution of openings vertically aligned, in buildings that had lost their façade it was common to see different floor structures at different levels, with more modern and stiffer concrete slabs with prefabricated concrete joists at the upper storey and solid cast slabs. Traditionally roofs were also made of simple timber rafters and purlin systems or, for wider spans, trusses. However, in the late twentieth century many of these were replaced with solid concrete slabs supported on the masonry walls by means of ring beams.

Chimneys have been spotted among the wall fabric of almost all the residential buildings, very often located at the corners, substantially reducing the integrity of the connections among orthogonal wall and hence the capacity of the system to withstand lateral loading.

Figure 5-8: Amatrice. a) Typical 2 leaves with cavity masonry wall system. b) Vaulted structures at the ground level of a three storey building. c) Inner chimney, located at the corner of a residential unit.

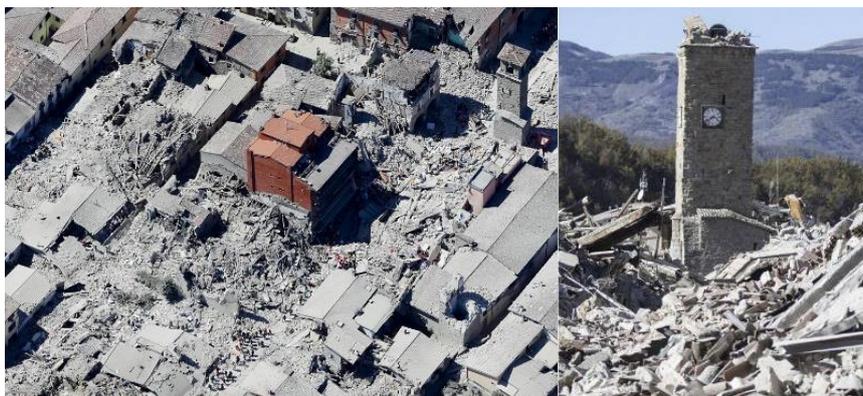
There were no many buildings left to be affected by the subsequent earthquake swarm that occurred during October 2016. The most emblematic cases were the so called 'red building' (Figure 5-10) and the civic tower of Amatrice shown in Figure 5-11. The residential brick building, which had withstood the seismic event of the 24th of August, collapsed during the earthquake on October 26th 2016, together with what was left of the Municipality Building. The top part of the civic tower collapsed during the 30th October event, together with the partially still-standing bell tower of the Saint Agustin Church, located at the entrance of the 'red zone'.

Figure 5-10: 'Red Building' and Civic tower, Corso Umberto I, Amatrice from

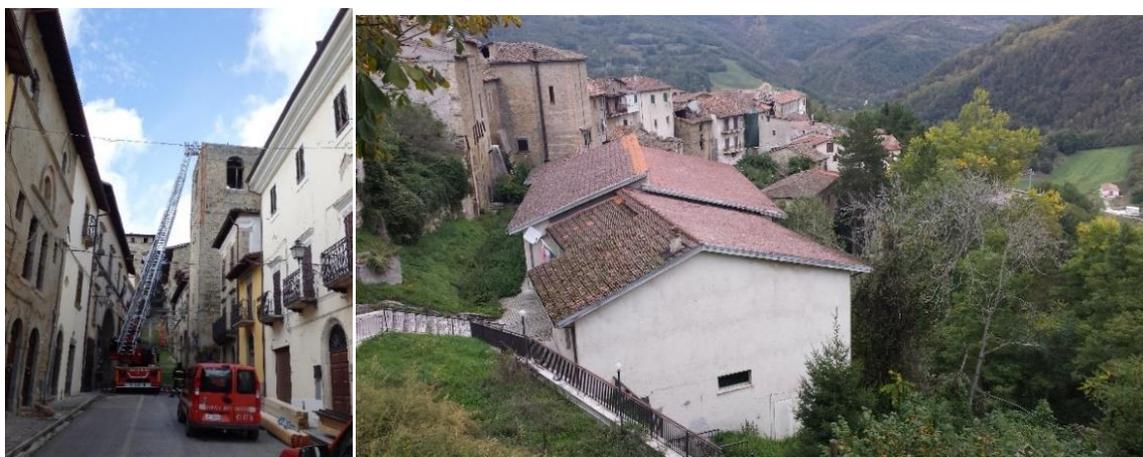
Figure 5-12: Accumoli a) Main street; b) view of the relationship between the building stock and the natural environment.

Although the village of Accumoli is the closest village to the epicentre of the August 24th earthquake, the level of damage recorded was not as intense as Amatrice or Pescara del Tronto. It was notable that many buildings had not been properly maintained in years and the damage observed after the 24th August was clearly concentrated on such buildings. No complete collapse was observed, while structural damage ranged from roof failure to some disconnections among walls, denouncing incipient out-of-plane mechanisms and shear cracks in buildings along the main street that had been refurbished and possibly retrofitted.

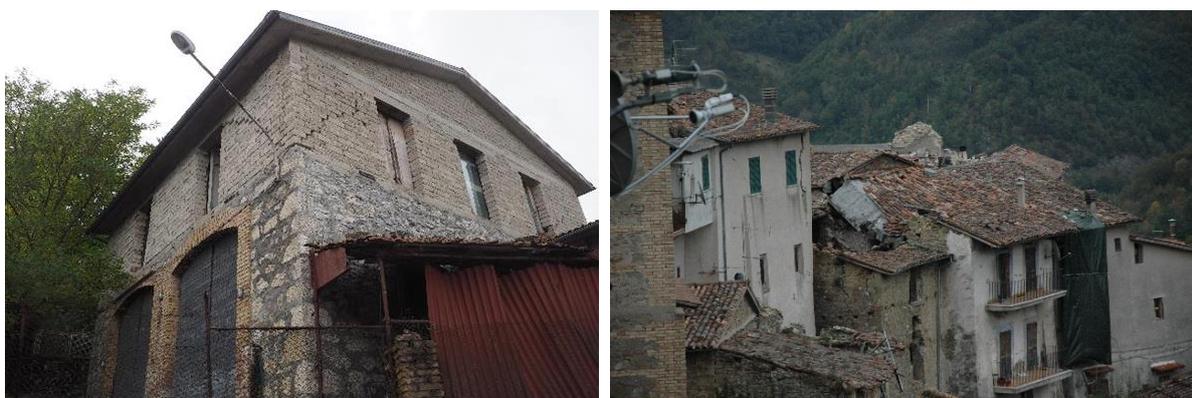
Figure 5-13 a) Corner expulsion in a building retrofitted with ring beam; b) Roof failures and vertical cracks in several poorly maintained buildings.

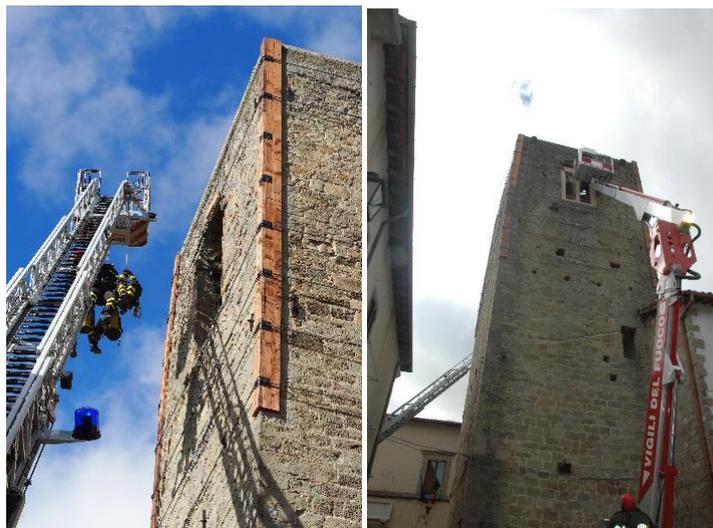
While the team was collecting data in Accumoli, the Fire Department shoring specialist squad were on site conducting a shoring and propping intervention of the XII century Civic Tower and to remove the bell tower. The work in progress is shown in Figure 5-14.

Figure 5-14 : Civic Tower in Accumoli: live intervention by Vigili del Fuoco to secure the tower with temporary shoring and hoops

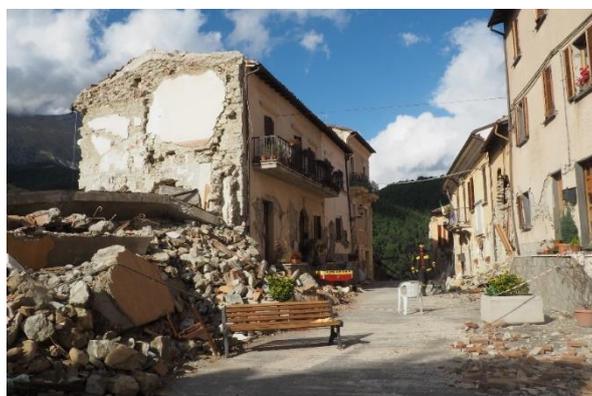
On the contrary, the old historical city centre located on the top of the hill is predominantly characterised by masonry buildings clustered around the main Piazza (Fig 5.17). Most buildings have masonry walls and timber horizontal structures. However, many of these old buildings have been retrofitted with ringbeams and concrete slabs.

Figure 5-17: Masonry Buildings around the main Piazza in Arquata del Tronto Alta

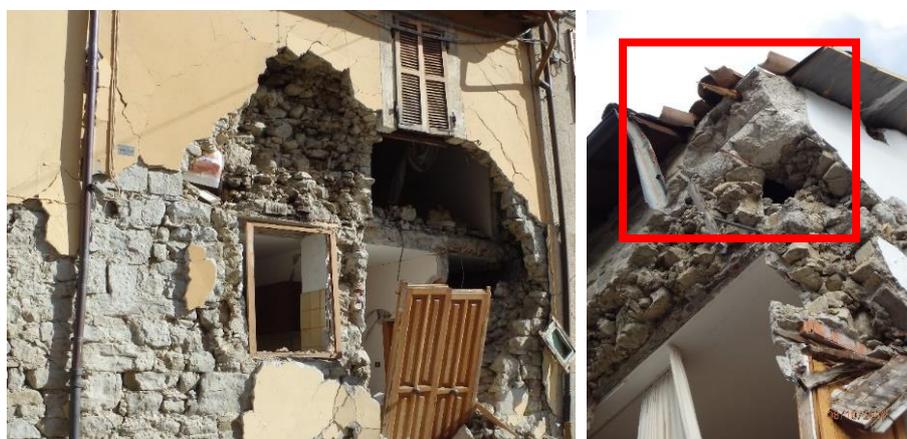
The overall quality of the stone masonry walls was generally observed as relatively poor. Stones are river round pebbles and cobbles bonded with poor mud and lime mortar. In some cases, grouting had been implemented but the quality of the work was poor. The level of connection among wall's leaves is poor (refer to Figure 5-18) with few through stones. Some buildings had corner stones and quoins. Some of the buildings also had ties, the effectiveness of those strengthening interventions was very low, due to the poor quality of the masonry walls they were restraining. A minority of well executed and effective strengthening interventions were observed.

Figure 5-18: a) Detail of masonry wall and ties in Arquata del Tronto Alta; b) details of anchor and ring beam above.

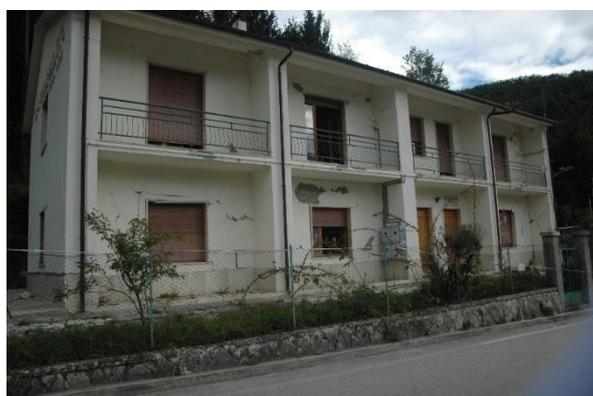
The damage recorded in Arquata Bassa was relatively modest when compared to the upper and older part of the town. No collapse was recorded, but there were a few RC buildings with high structural damage, namely the local school. Representative of the level of damage in this part of the town is the 'Casa Forestale' building, where most of the damage is superficial and not structural, and is mainly located around the openings in the form of shear cracks (Figure 5-19). The macro seismic intensity level attributed by the EEFIT team is VII-VIII of the EMS' 98 scale (see Grünthal, 1998).

Figure 5-19: Casa Forestale in Arquata del Tronto Bassa

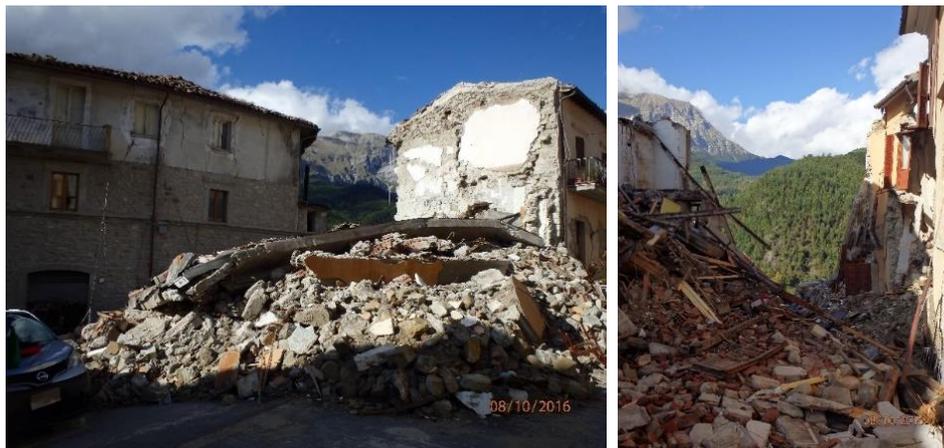
Figure 5-20 a) and b) Collapsed buildings in the main Piazza of Arquata del Tronto Alta

There was not much left to survey from the buildings shown in Figure 5-20a) and b), except from the clear presence of the heavy concrete roof which had a detrimental effect on the overall behaviour of the building. The building in Figure 5-21a shows all the subsequent forms of strengthening interventions which have weakened the overall structure leading to full collapse. The 600 mm ring beam shown in Figure 5-20b) which was sat on the fourth floor masonry wall to support the roof above, had a very detrimental effect on the stability of the wall under seismic excitation. The overall seismic performance is interpreted to have been worsened by the corner position of the building unit within the building stock as well as the steep slope upon which the building is constructed.

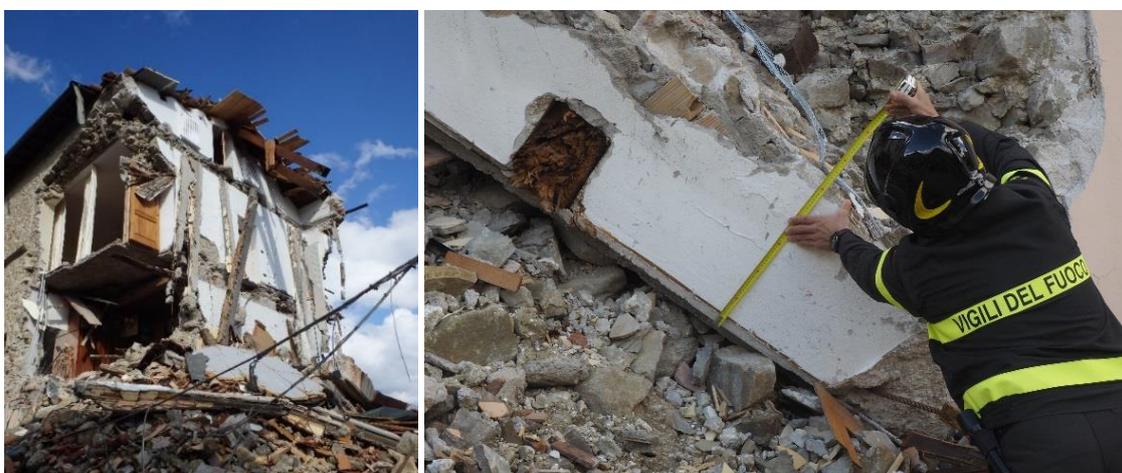
Figure 5-21 a) and b) Collapsed corner building and its ring beam

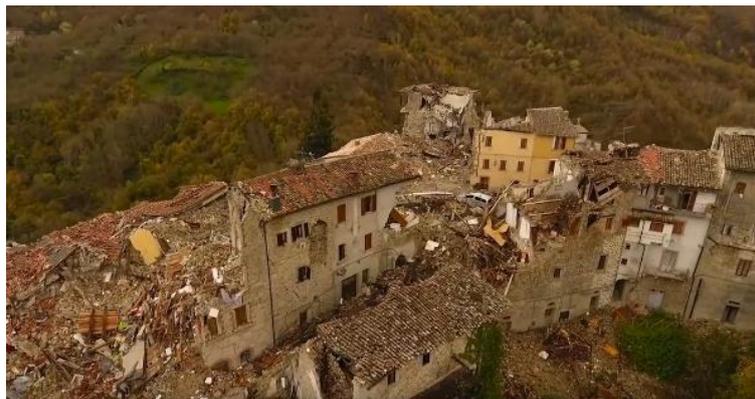
Following the two seismic events of October 2016, Arquata Del Tronto Alta has been nearly completely destroyed as shown in Figure 5-22, while Arquata Del Tronto Bassa, was evacuated. It can be argued that in the case of Arquata del Tronto, no shoring or propping intervention was in place, as the Team had observed in other towns visited, such as Castelluccio, Accumoli or Norcia, and as a result the weakened buildings were more susceptible to further damage and collapse by the later events.

Figure 5-22 Arquata del Tronto Alta after the October 2016 seismic events
<https://www.youtube.com/watch?v=q56R3j3BhIQ>

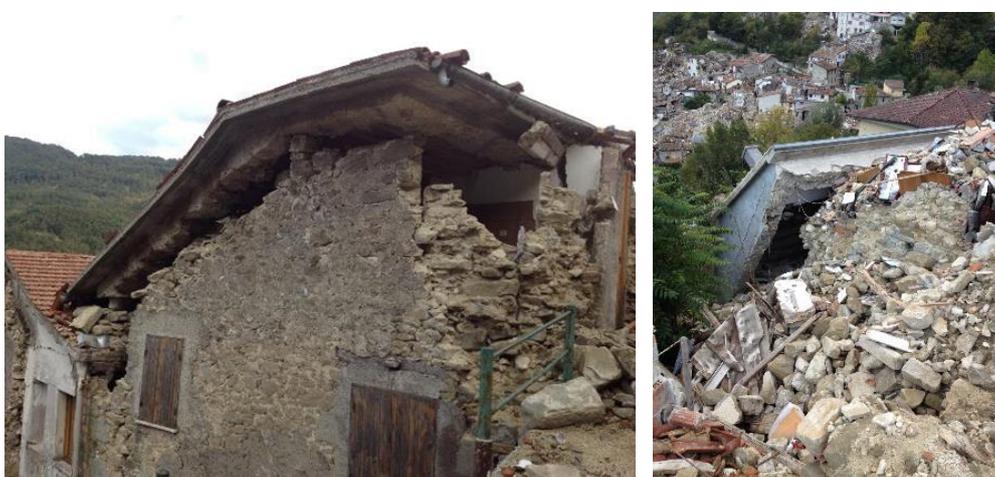
Figure 5-23: Heavy concrete roofs in Pescara del Tronto, causing partial and total collapse

In addition to the extremely poor quality of load bearing structures and the lack of connection between orthogonal walls, the presence of heavy reinforced concrete roofs has represented the worst additional element leading most of the buildings of the village to partial or total collapse as shown in Figure 5-23.

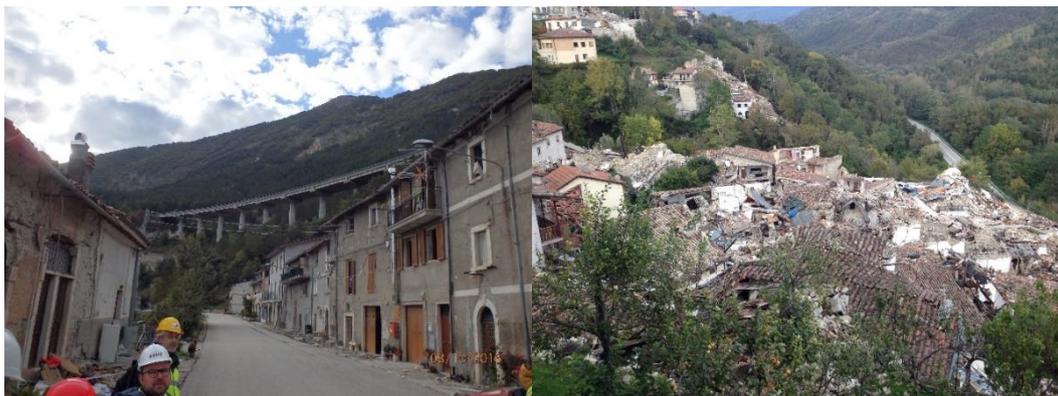
In terms of structural damage, it is worth noting that, while the building located along the Salaria Road were heavily damaged but still standing (Figure 5-24), the ones located within the valley experienced complete collapse. The structural damage observed on the buildings that were still standing shows that the combined effect of in-plane action and out-of-plane actions was further exacerbated by the thrusting wooden roofs, in some cases, as shown in Figure 5-25.

Figure 5-24: Buildings along Via Salaria and buildings in the valley

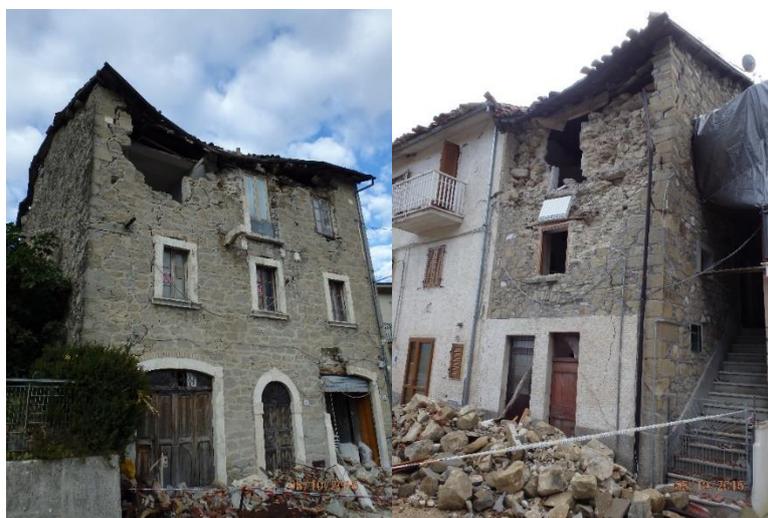
Figure 5-25: Typical structural damage recorded in Pescara del Tronto along the Salaria Road.

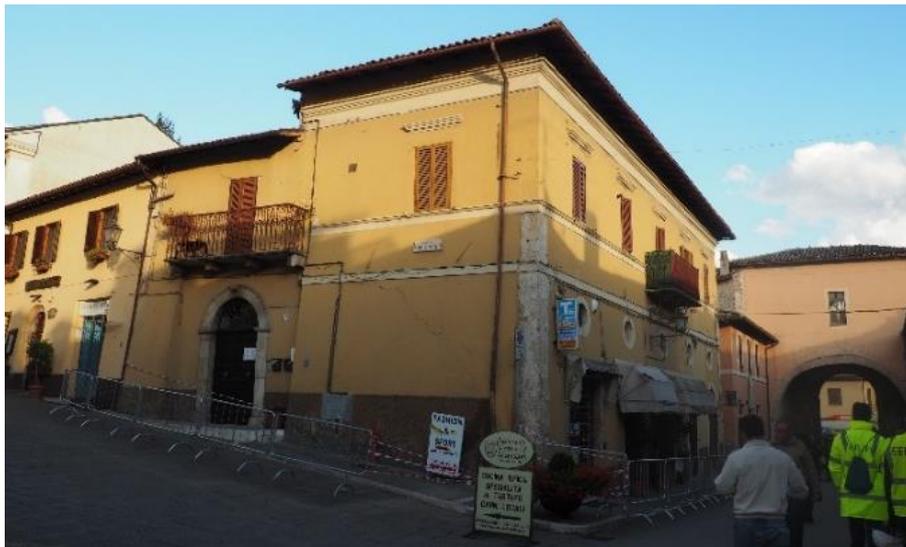
visit both the Cathedral and the Basilica. Buildings were overall in very good conditions compared to other towns visited. The level of damage was comparatively modest. Figure 5-28 shows the typical level of damage observed in a building strengthened with metal ties and buttresses (located at ground floor).

Figure 5-28 Residential building in Norcia, nearby Porta Romana. Note the buttresses, ties, and quoins, as prescribed in the 1859 decree. A diagonal airline crack is visible in the return wall.

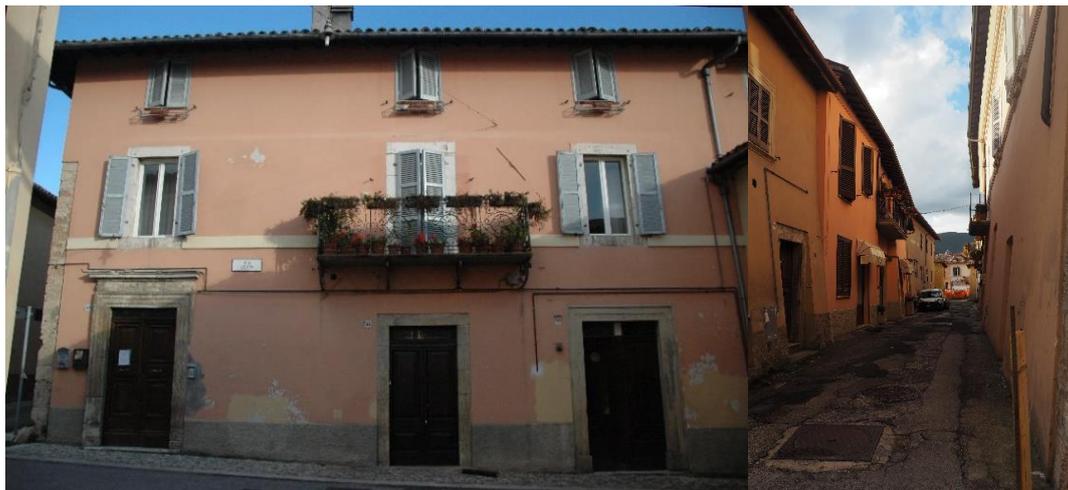
Figure 5-29 Residential building in Norcia, nearby St Benedict Basilica. Ties and quoins are visible

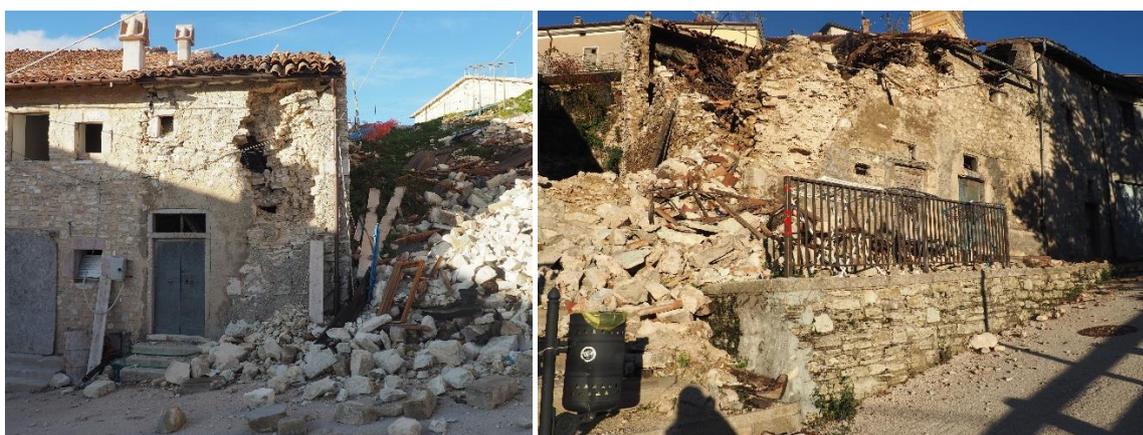
While on site, the EEFIT team collected damage data of most of the houses located in the lower part of the village. Traditional masonry buildings have from 2 to 4 storeys made of traditional stonework with wooden roofs and timber horizontal structures as shown in Figure 5-31. However, many roof structures have been replaced with concrete slabs and ringbeams, where buildings have been refurbished for touristic purposes. The quality of stonework used and the level of inner connection between masonry leaves is relatively poor. Strengthening or restraining elements (ties, buttresses, ring beams) that could help preventing out of plane mechanisms and enhance the box-behaviour were relatively sparse and many buildings were in a state of disrepair and neglect. The complete detachment between opposite facades is shown in Figure 5-32 a) and b)

Figure 5-31 Traditional stonework and horizontal structural elements in Castelluccio

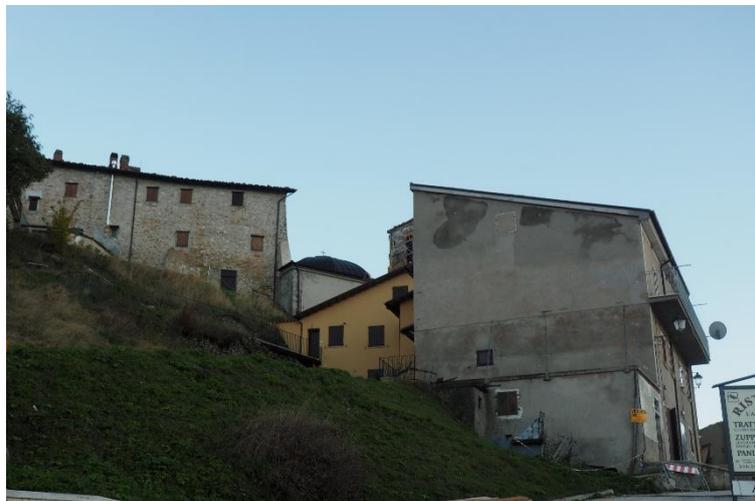
The few RC buildings with infill frames located in the lower part of the town are 4 to 5 storeys. However, due to the steep ground slope which characterise the village orography, the common three-storey-level house would present a ground floor (used as basement) with entrance at lower street-level, a middle storey functional to connect to the upper floor (used as living space), with main entrance at upper street-level, as shown in Figure 5-33. The damage level recorded in RC buildings

surveyed was relatively low and mainly ascribable to in plane actions and detachment between infills and main concrete frame, as shown in Figure 5-34.

Figure 5-33 Typical residential building on steep slope. The building on the right is a concrete frame. The damage observed in this structure is shown in Figure 5-34
