THE M_w 6.2 AMATRICE, ITALY EARTHQUAKE

OF 24th AUGUST 2016

A FIELD REPORT BY EEFIT

May 2019

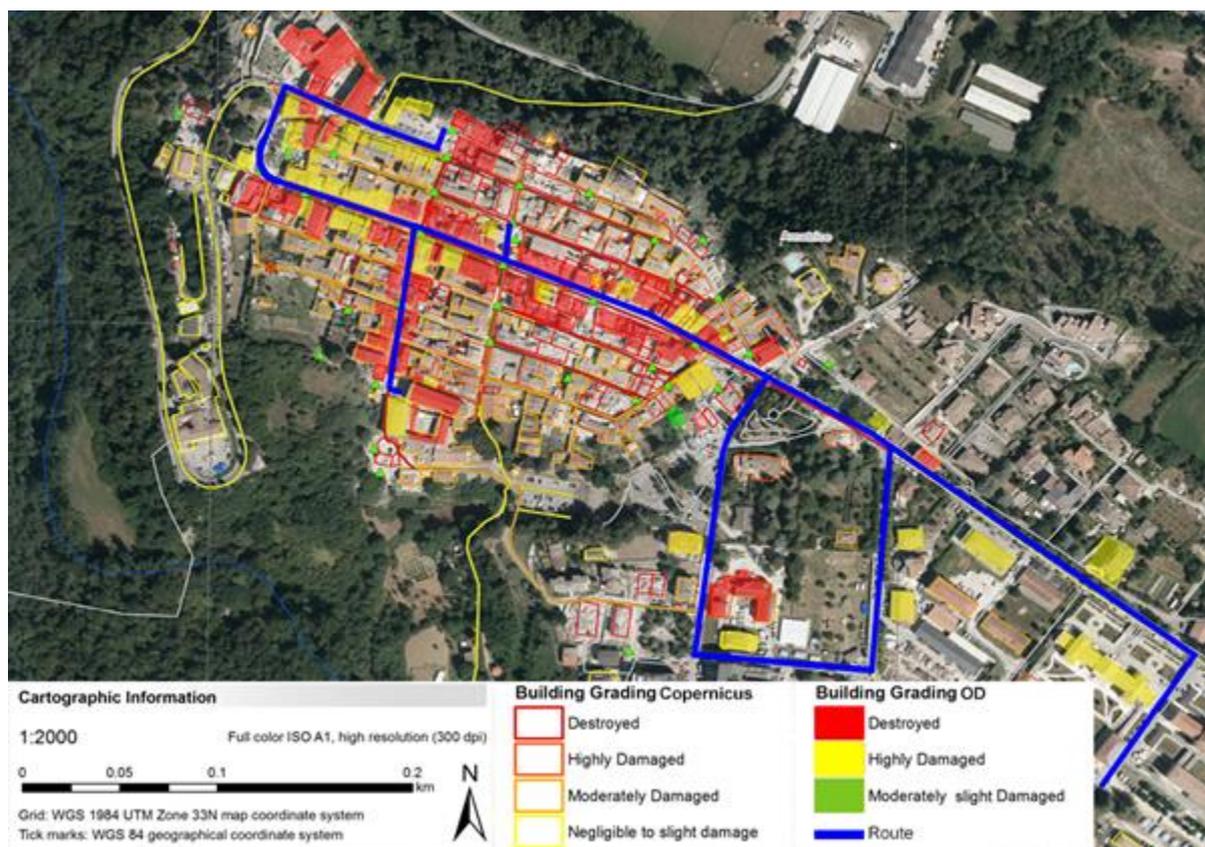
In terms of on-site damage collection, the extent of improvement achieved by integrating Rapid Visual Survey Form data with ODC imagery, was considerable. The map shown in Figure 5-36 for the town of Amatrice, shows the data collection using the RVS Forms and ODC imagery.

Figure 5-36 Amatrice: mapping of damage collected through RVS Forms and OD imagery categorised in three classes overlaid on the Copernicus map with mapping of damaged buildings after the 24th August 2016. The route followed by the team is shown in blue.

The EMS 98 damage rating and the tagging classification showed substantial agreement. The data used for the tagging classification was also mapped for each of the towns visited, to integrate the RVS forms data and OD imagery. The mapped distribution are overlapped on the damage maps provided by the European Emergency Management Service Copernicus (Copernicus EMS, n.d.) based on satellite remote sensing and mapped on aerial images. The comparison between the on-site damage collection and the aerial views shows good agreement in the case of Amatrice (Figure 5-36)

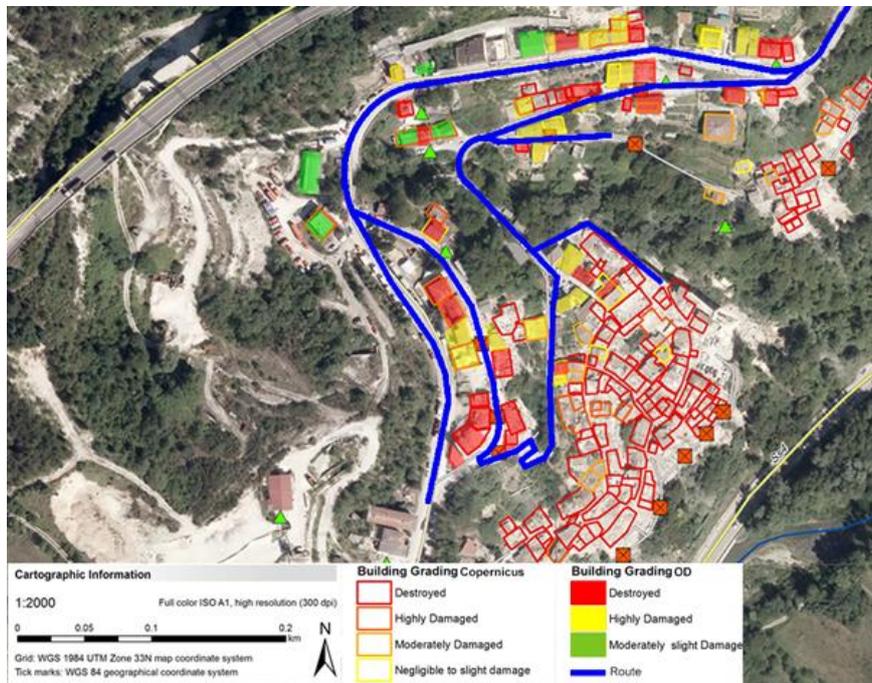
and Pescara Del Tronto (Figure 5-38), where the extent of damage was such that the two layers corresponded almost completely.

Figure 5-38 Pescara del Tronto map: Copernicus layer and EEFIT team survey results

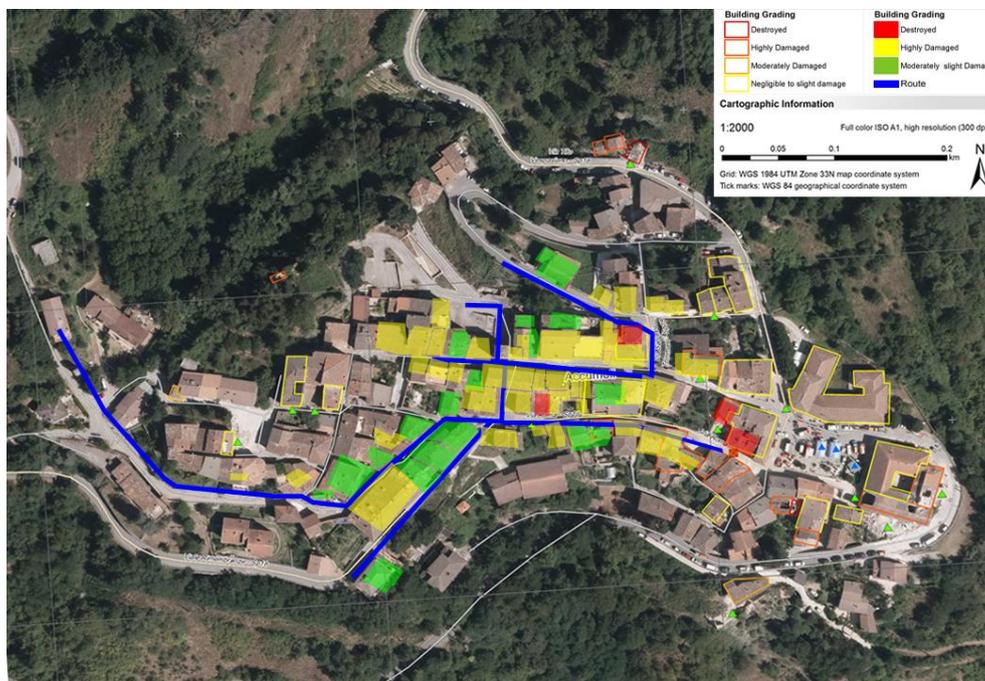
Figure 5-39 Accumoli map: Copernicus layer and EEFIT team survey results

In the case of Accumoli (Figure 5-39), where the level and extent of damage was more limited, the comparison between the Copernicus and EEFIT mapping shows evident mismatch, owing to the inability of the horizontal satellite picture to capture structural damage when there is no major failure

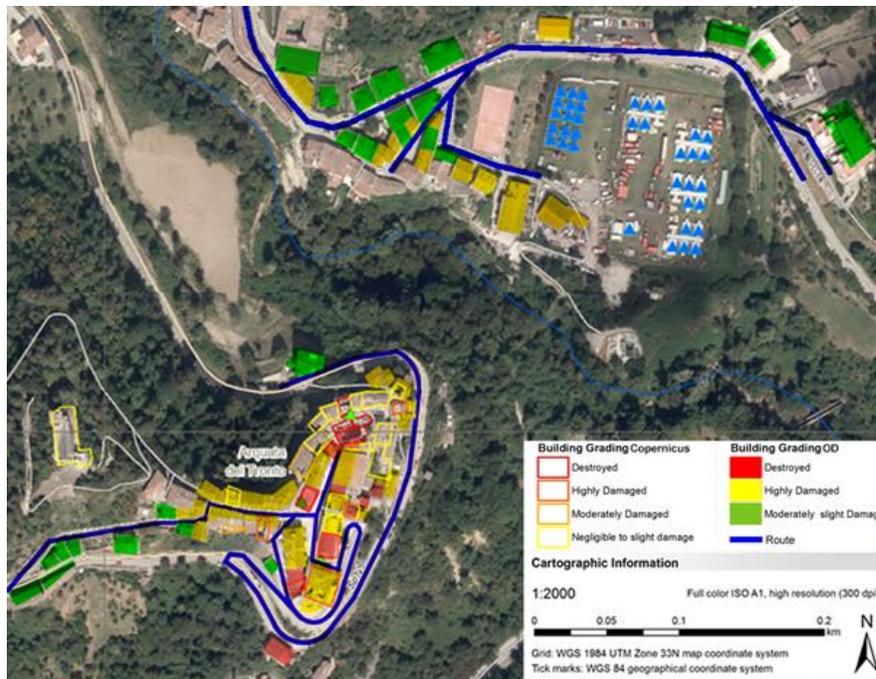
visible at roof level. The case of Arquata del Tronto is a representative example of the extent of this mismatch. The lower part of the town was not even mapped, thus indicating that the buildings were considered as not damaged (see Figure 5-40). The major differences between aerial and ground views were fully understood after the site deployment.

Figure 5-40 Arquata del Tronto map: Copernicus layer and EEFIT team survey results

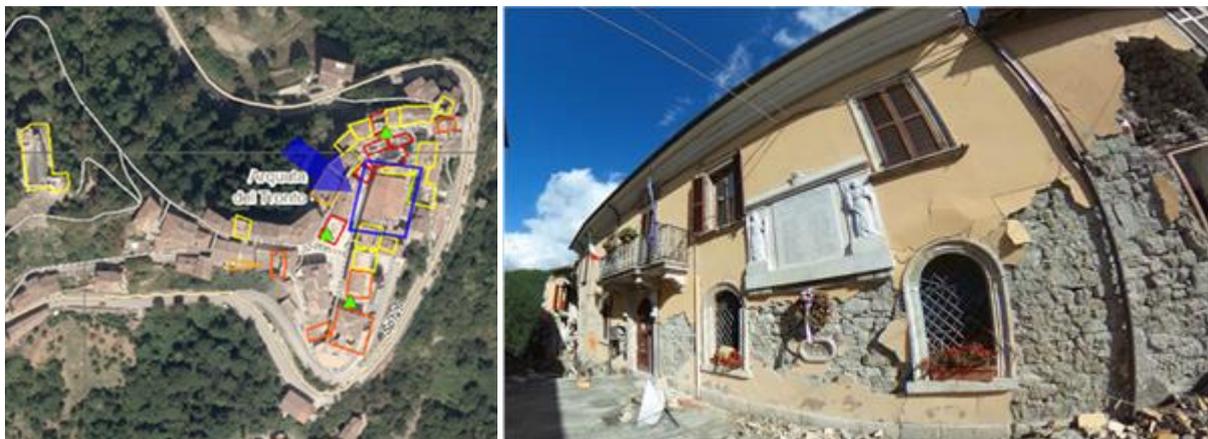
The building marked in blue in Figure 5-41a was classified as no damaged by the Copernicus map. The field survey and the pictures taken via OD camera demonstrate the real condition of the building which, although was not damaged at roof level, was however extremely damaged in its walls (see Figure 5-41b). Other similar cases are discussed in Stone et al.(2018).

Figure 5-41 Arquata del Tronto (a) aerial view of the City Hall Building from Copernicus; (b) photographic record © Valentina Putrino

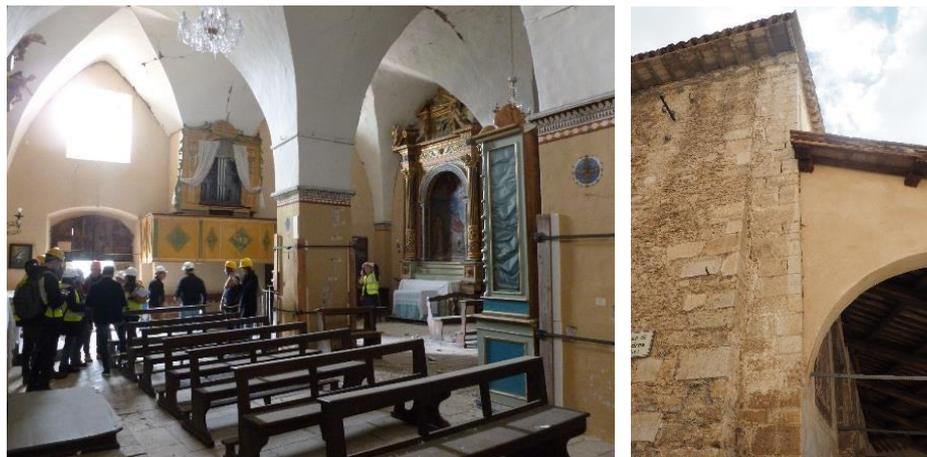
The main potential collapse mechanism identified was the overturning of the front façade wall. This was highlighted by a vertical crack at the building corner indicating detachment of the facade, particularly above the porch roof.

Figure 6-4 Interior view highlighting widespread cracks and detachment of the front façade wall; b) Vertical crack between the façade and the edge spine wall.

The cracked building corner is shown in Figure 6-4b where the loose quoin elements can also be observed. Further indications of the façade overturning mechanism were: (1) large cracking at the cross-vaulting edge at the façade support (Figure 6-4a), and (2) shear damage at the springer of the central spine wall arch with associated pull out of the timber tie.

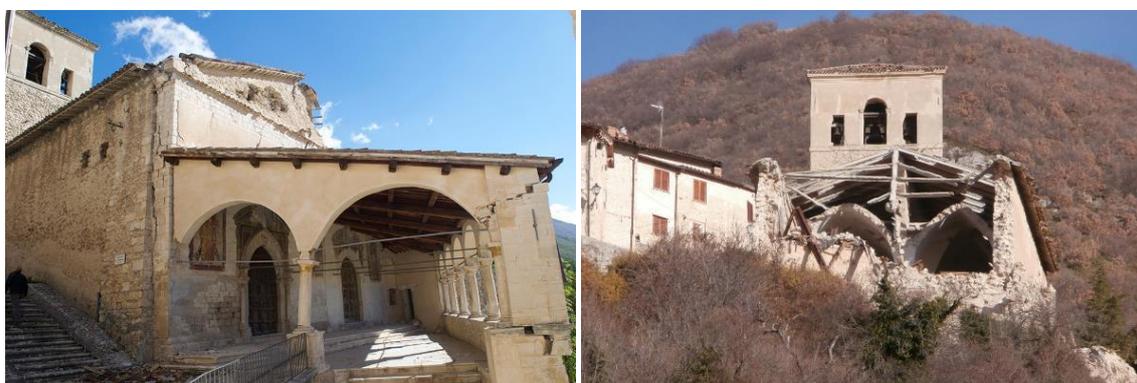
Following the 26th October shocks, the church suffered severe damage. Figure 6-5a shows that the façade overturning mechanism further developed as highlighted by the wall rotation and width of the crack, which appears much wider than what observed during the EEFIT mission. The porch structure appears to have restrained the façade (possibly preventing the total collapse), however, it suffered severe horizontal displacements in the order of over 100mm. The wrought iron ties likely prevented collapse of the porch structure, but induced shear failure of the columns, possibly triggered by the stiffness of the steel edge beam.

A second visit by EEFIT members in December 2016 collected some photographs at distance providing information on the damage that the church suffered after the 30th October earthquake (see Figure 6-5b). The façade wall and entrance porch had totally collapsed. The gate arch annexed to the porch also suffered total collapse. The bell tower appears still standing although it shows severe cracks. The concrete roof slab has collapsed in several locations. The internal ceiling vaults appears still standing although their level of damage is not known.

Figure 6-5 a) Damage to the front façade and entrance porch after the 26th October shocks (courtesy of Ing. Andrea Giannantoni); b) Collapse of the front façade and entrance porch after the 30th October earthquake.

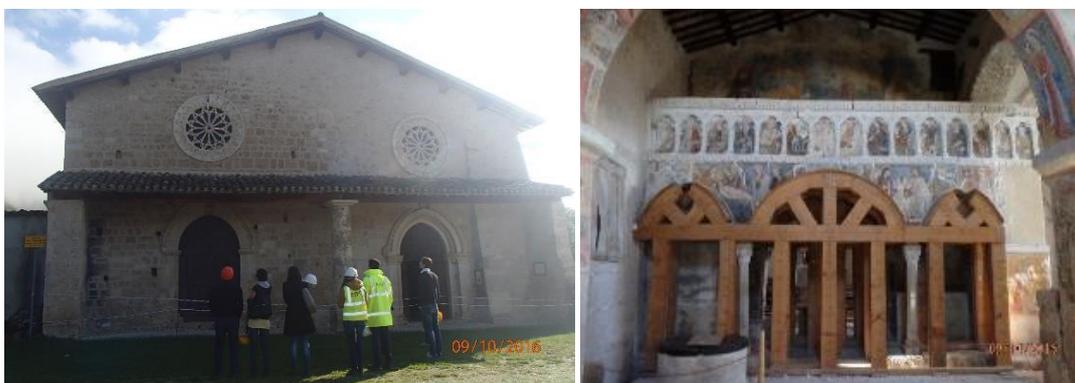
Figure 6-6 a) Front view of the S. Salvatore Church in Campi; b) The screen supported by a timber shoring system in the northern nave

The church was closed to the public at the time of the visit following the recommendation of the post-earthquake assessment. The assessment also recommended shoring works but these had not been carried out at the time of visiting. The propping on the *screen* arches dated to before the 24th of August 2016, highlighting that damage was likely present before the earthquake. The *screen* structure was still standing in early October 2016, although with sever cracking (Figure 6-7). The façade showed various cracks, the most notable being a diagonal crack through the north rose window (Figure 6-8a). Further cracks were observed at the interface between the ceiling vaults and the façade, highlighting possible detachment of the wall. These cracks were observed from both below and above the vault surface. One of the central pier pillar had a vertical split. The two parts were likely built at different times and presented no through thickness elements. The overall crack pattern highlights that a transversal mechanism of vibration was activated for this church.

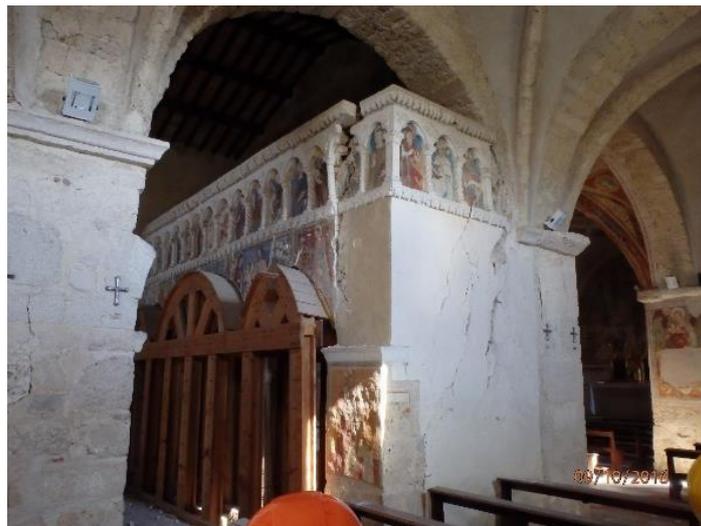
Figure 6-7 Sever damage of the screen structure, showing overturning of the balustrade and shear failure of the supporting wall.

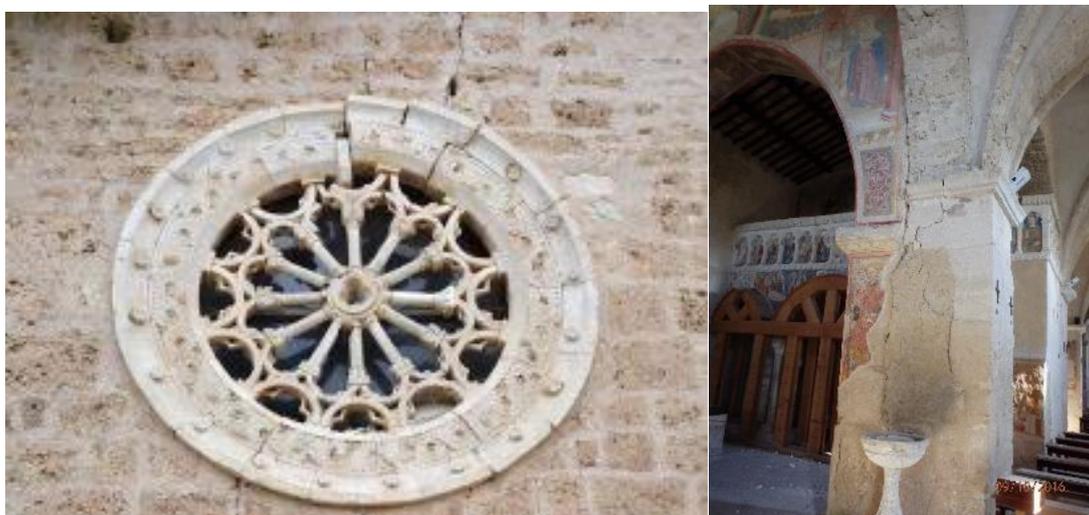
Figure 6-8 a) Diagonal crack through the rose window; b) Pillar split through vertical crack, and shear failure of the top part corresponding to the same damage observed in figure 6.7 for the screen wall.

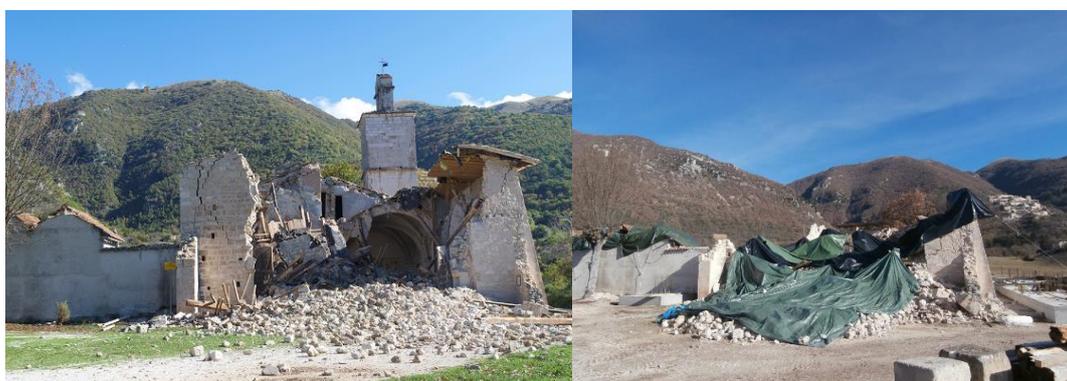
Following the 26th October earthquakes, the church suffered severe collapses. Figure 6-9a shows that the façade wall, ceiling vaults, central piers and roof have all collapsed. The side and back walls, and bell tower were still standing although cracks are visible in these elements. The screen structure is not visible, but it is likely to have partially collapsed. A second visit by EEFIT members in December witnessed the additional inflicted by the 30th October earthquake (Figure 6-9b). The building had collapsed completely with only a portion of the southern and back walls still standing. The bell tower also completely collapsed. Building works were taking place to construct a canopy roof above the entire church footprint. This was possibly for the protection and recovery of the fresco decorations.

Figure 6-9 a) Church collapse after the 26th October earthquakes (image from <http://www.umbria24.it>); b) Complete collapse after the 30th October earthquake

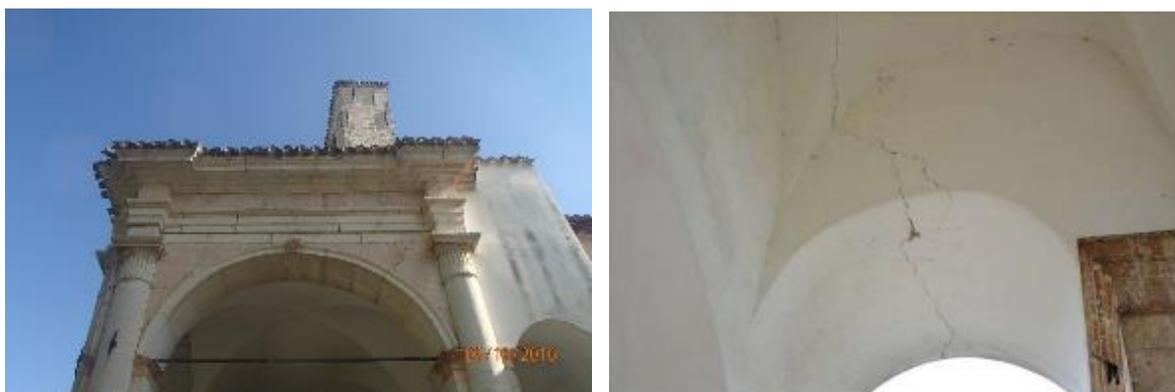
The church was closed to the public at the time of visiting following the recommendation of the post-earthquake assessment. The assessment also recommended shoring works to the portico but these had not been carried out at the time of the visit. The level of damage was not particularly significant if compared with the other church buildings inspected. The only damage of significance were some transversal cracks in the southern most arch and vault of the porch (Figure 6-13), indicating a local detachment of the porch from the main façade. Distributed small width cracks were also observed in the church side walls, without a clear pattern. The bell gable showed no sign of damage at the time of visit.

Figure 6-13 a) Loose stones and b) transversal cracks, in the porch southern arches.

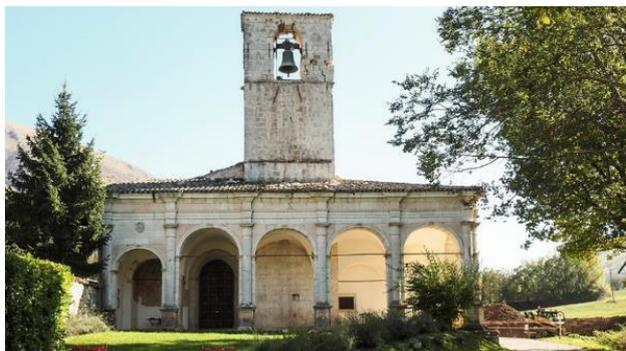
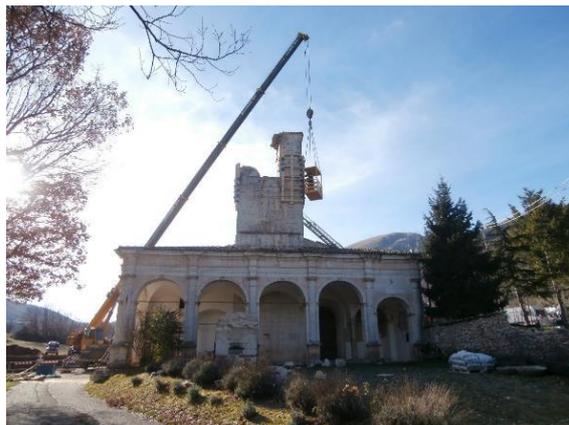
Limited information is available on the damage suffered due to the 26th October earthquakes. Figure 6-14a shows some damage to the bell gable, specifically shear cracks to one of the piers. The follow up EEFIT visit in December 2016 found the fire brigade carrying out temporary shoring works for the bell gable. The southern pier had suffered further damaged and had been removed by the fire brigade. In fact, the large piece of gable missing was laying on the church front yard and did not appear to have collapsed onto the roof (see Figure 6-14b).

Figure 6-14 a) Front elevation after the 26th October shocks (image from <http://www.umbria24.it>); b) Front elevation in December 2016. Note damage to the bell piece laying on the front yard.

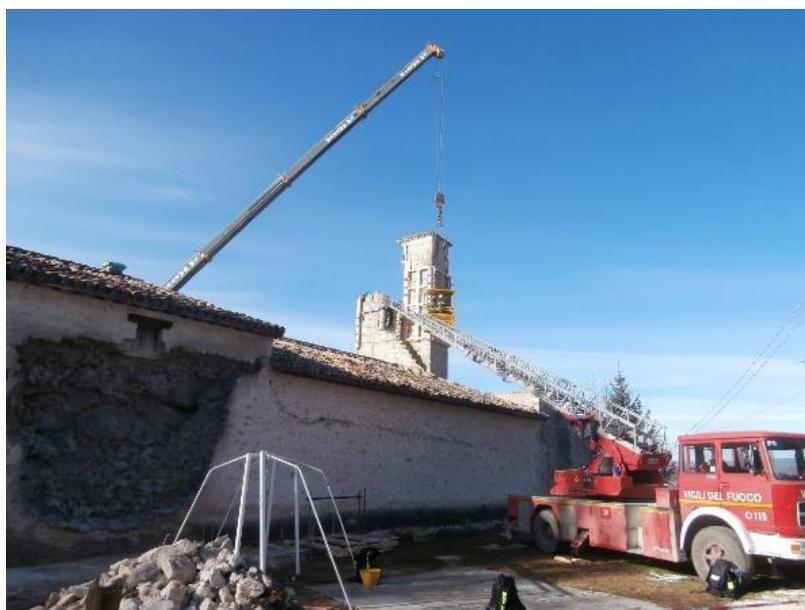
The side walls of the presbytery have suffered partial collapse of the outer masonry leaf. This highlights possible three leaf masonry type. Such wall collapse is visible in Figure 6-15 along with a long horizontal crack on the northern wall elevation. This horizontal crack was likely caused by the thrust exerted by the roof timber rafters which was further magnified by the seismic accelerations.

Figure 6-15 North elevation in December 2016.

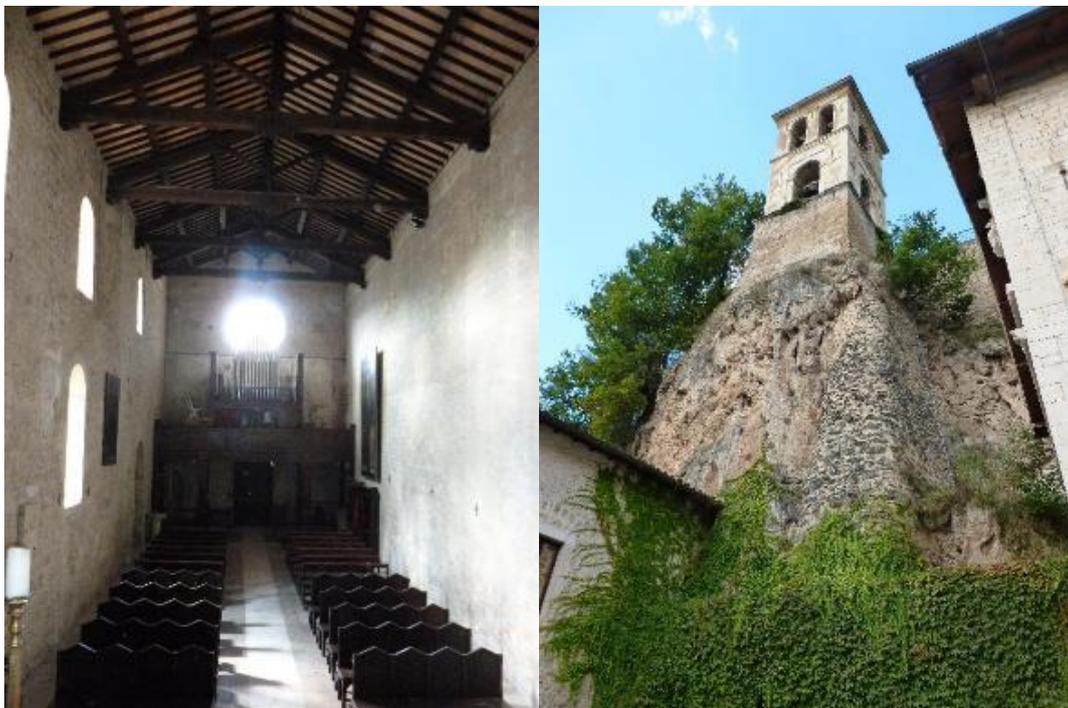
Figure 6-17 a) View of the nave interior; b) Relative position of bell tower and the façade on the right.

The church was closed to the public at the time of the visit following the recommendation of the post-earthquake assessment. The assessment also recommended shoring works to the façade and bell tower, but these works had not been carried out at the time of the visit.

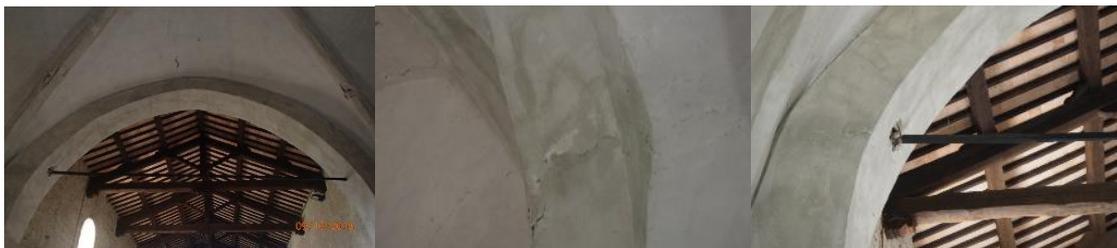
The team observed widespread cracks on the church building with the following being the most notable damage. The chancel arch presented evidence of the formations of three pins (see detail of the cracks in the photographs in Figure 6-18) with the likely trigger being the overturning of the southern side wall. This was highlighted by the pull out of the steel tie on the south side as well as by further detachment cracks in the chancel vault. The rotations of the pins, as suggested by the direction of openings of the cracks, is also compatible with a two-bar mechanism moving towards the southern wall (Figure 6-19).

Figure 6-18 View of chancel arch and cracks highlighting hinges formation. Note pull out of the steel tie.

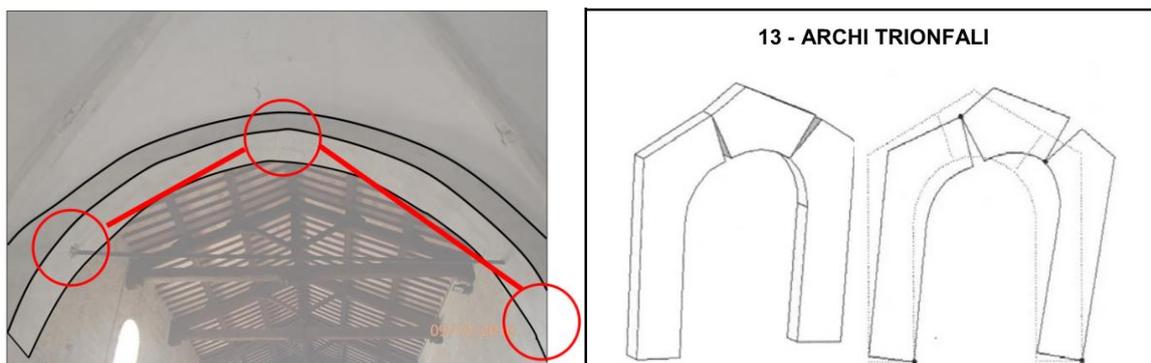
Figure 6-19 a) Schematic mechanism at the chancel arch. b) Mechanism as tabulated in [1].

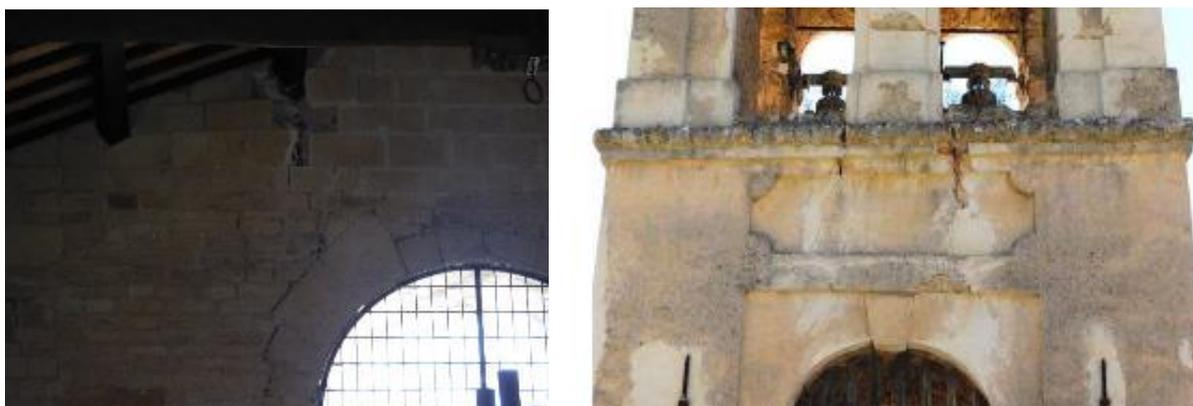
Figure 6-20 a) Cracks on the façade wall by the rose window. b) Cracks on the bell tower.

Notable damage was observed on the façade wall both on the external and internal surfaces. Severe cracks originated under the roof timber purlins and propagated to the rose window (Figure 6-20a). Further cracks were observed in the annexed sacristy building. The bell tower also showed some cracks between the piers (Figure 6-20b).

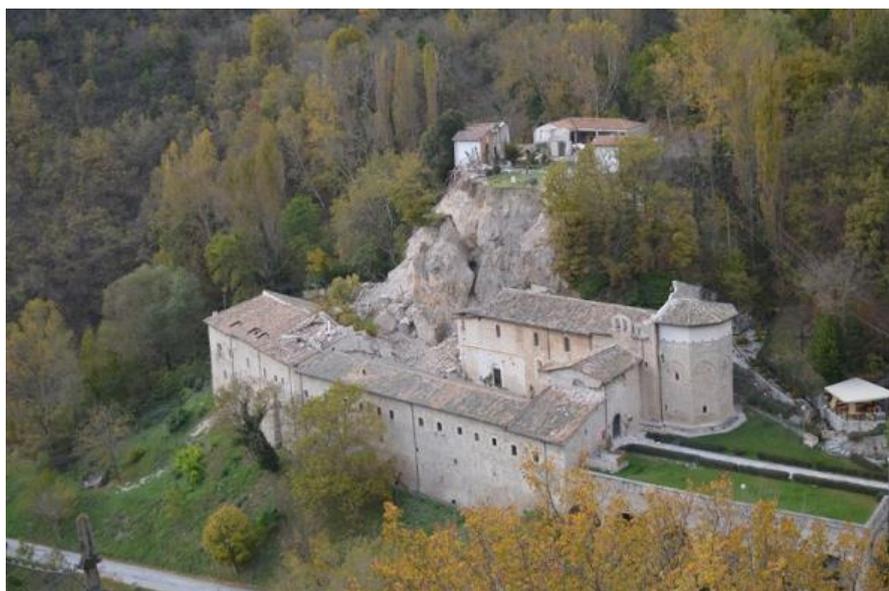
The EEFIT members have not had the opportunity to carry out a follow up visit in December 2016 as the road leading to the Abbey was closed because of landslides. Some information on the damage suffered after the October earthquakes are reported, based on photographs published in the press. It is known that a portion of the top façade collapsed due to the 26th October shocks (Figure 6-21a). This collapse is compatible with the top façade mechanism observed during the EEFIT visit as described above. Greater damage due to the 30th October earthquake can be observed in Figure 6-21b and Figure 6-22. The cliff on the church north side partially detached and collapsed. The collapse involved part of the cemetery buildings above as well as the entire bell tower. It appears that debris have fallen onto the church demolishing part of the roof, façade and northern wall. The wall by the apse, which extended above the roof, has also partially collapsed.

Figure 6-22 Abbey site after 30th October earthquake with bell tower collapse and cliff failure visible (image from <http://www.umbria24.it>).

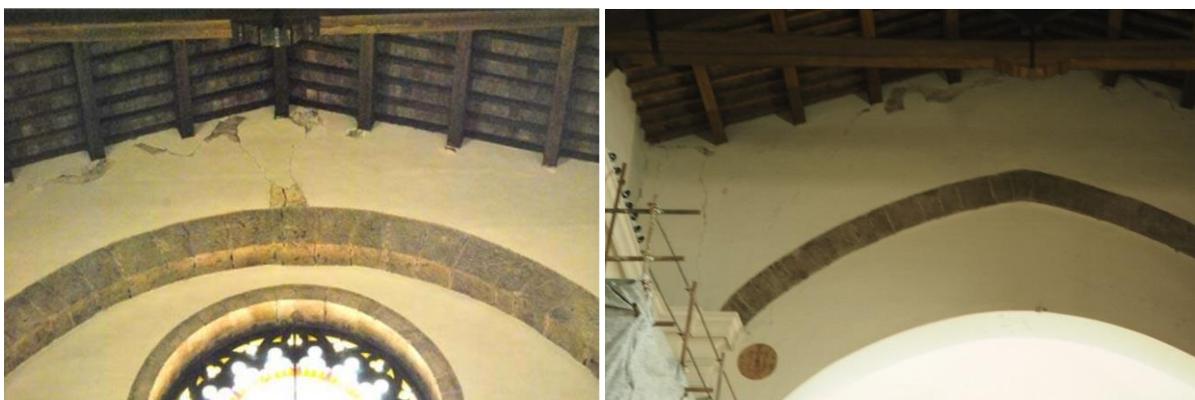
Figure 6-24 Cracks and initial pull-out of purlins a) on the front façade and b) above the chancel arch

The church was closed to the public at the time of the visit following the recommendation of the post-earthquake assessment. The assessment did not recommend any shoring works. There were scaffolding installed at the time of visit which the team understood were required by internal redecoration works (Figure 6-23b). The church structure presented widespread cracks and numerous debris on the floor. Numerous cracks were observed at the roof walls connections, particularly the purlins had partially pulled out from the front façade and above the chancel arch (Figure 6-24).

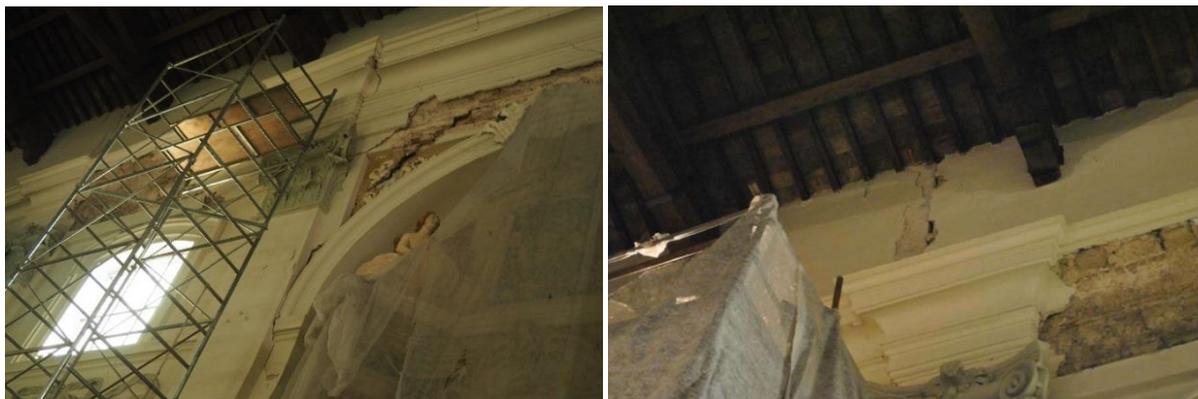
The side walls also showed numerous large cracks. The crack patterns appeared either sub vertical or in direction that followed discontinuities within the masonry fabric e.g. niches and side altars (Figure 6-25).

Figure 6-25 Large cracks on the side walls.

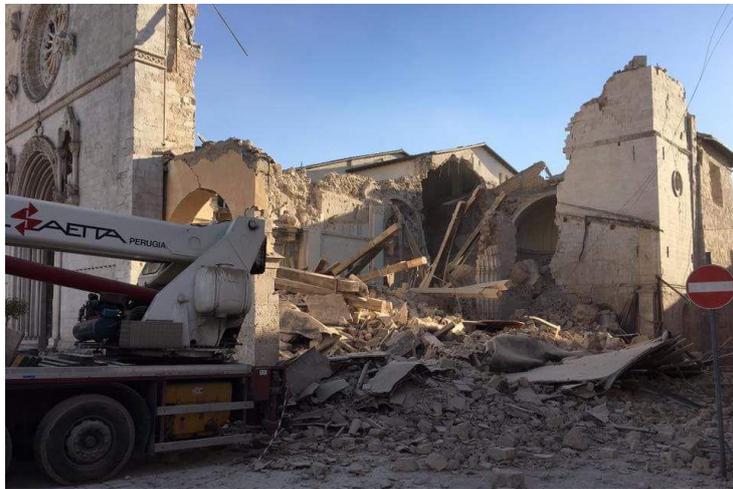
Several press articles reported that the bell tower collapsed onto the Cathedral building during the earthquake causing widespread collapse of the main nave and transept. Although this is unverified, the substantial collapses to the building southern side by the bell tower are compatible with such assumption (Figure 6-27). The fire brigades installed a steel shoring structure to stabilise the now freestanding façade.

Figure 6-27 Collapse of the S. Benedetto Cathedral following the 30th October earthquake (image from <http://www.umbria24.it>).

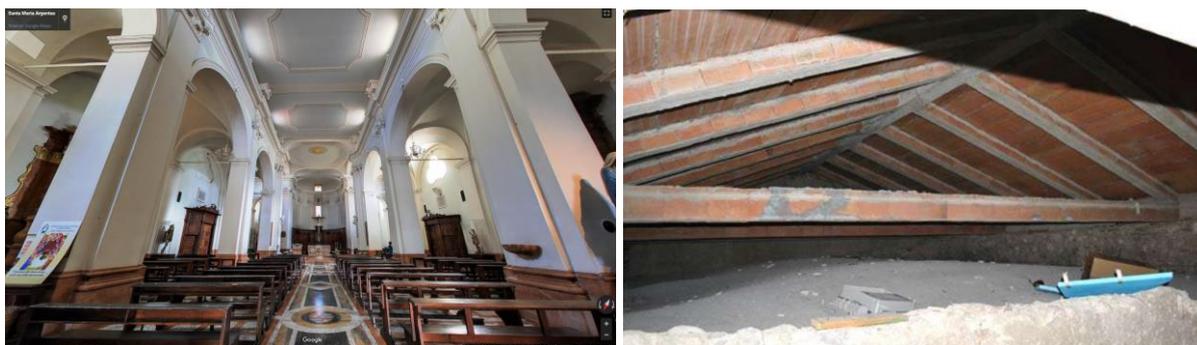
The church was closed to the public at the time of visit following the recommendation of the post-earthquake assessment. The assessment did not recommend any shoring works. The roof structure is of recent construction (likely 1980s) and made of reinforced concrete trusses and concrete ring beams supporting a concrete slab above hollow clay planks (Figure 6-30).

Figure 6-30 a) Interior view of the St Maria Argentea Cathedral from the front entrance (image from Google Street View). b) Building roof structure (courtesy of Ing. Andrea Giannantoni).

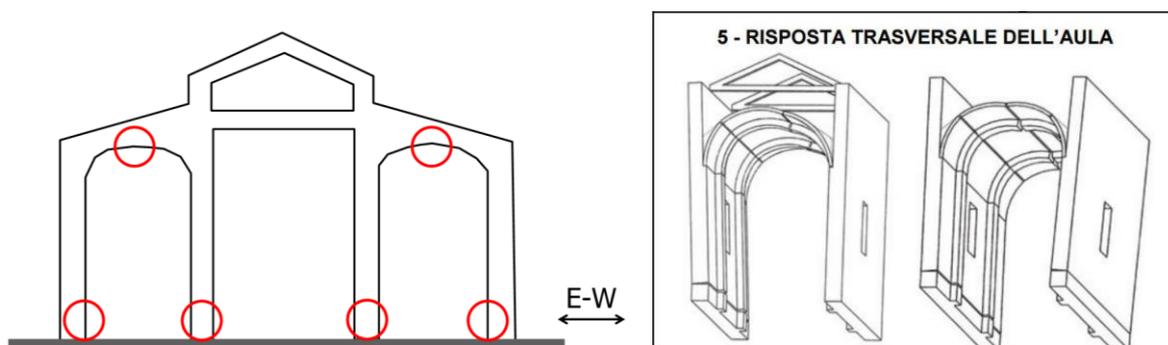
The cracks observed were compatible with a portal frame type mechanism for the overall building on the transverse (east-west) direction (Figure 6-32). The church geometry suggests a possible global three bay frame arrangement in which the two side frame bays were composed by the external walls and central pillars interconnected by the vaulted ceilings (and metal ties); and the central frame bay was composed by the pillars connected by the central nave ceiling slab. No cracks were observed at the central nave ceiling which is likely related to the more modern and less vulnerable to lateral movement, concrete construction.

Figure 6-32 a) Schematic transverse mechanism. b) Mechanism as tabulated in MiBAC (2006)

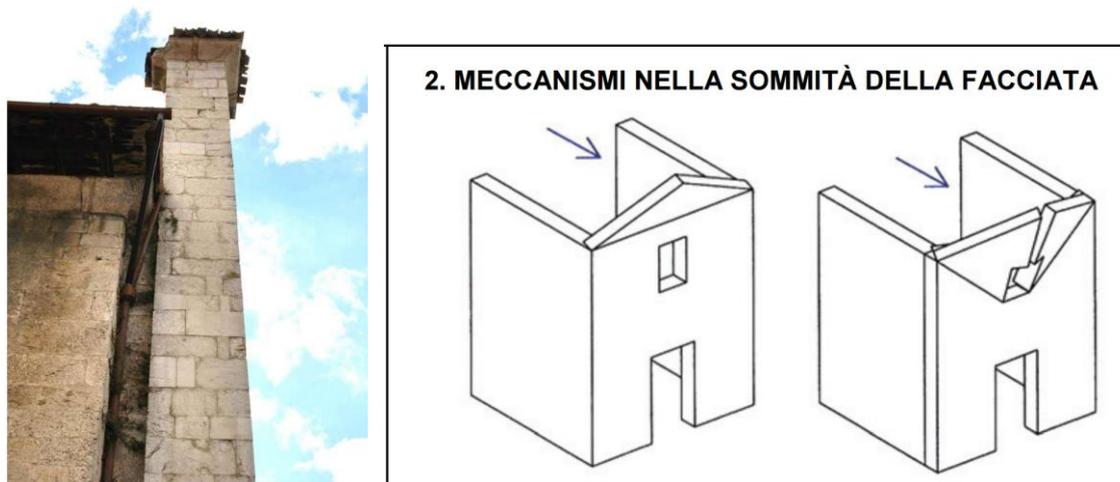
Other significant damage was observed from the outside of the building. The front façade gable showed horizontal cracks just above where the roof connects (Figure 6-32a). This cracking was compatible with an overturning mechanism for the upper portion of the façade (Figure 6-32b).

Figure 6-33 a) Horizontal cracks at the façade gable. b) Mechanism as tabulated in MiBAC (2006).

The façade gable has also collapsed on the square in front. The possibility of such mechanism was identified during the mission. The portion of the façade still-standing has lost part of the outer masonry leaf highlighting a layered stonework fabric (Figure 6-33). The bell tower is still standing although it appears severely damaged by the bell chamber.

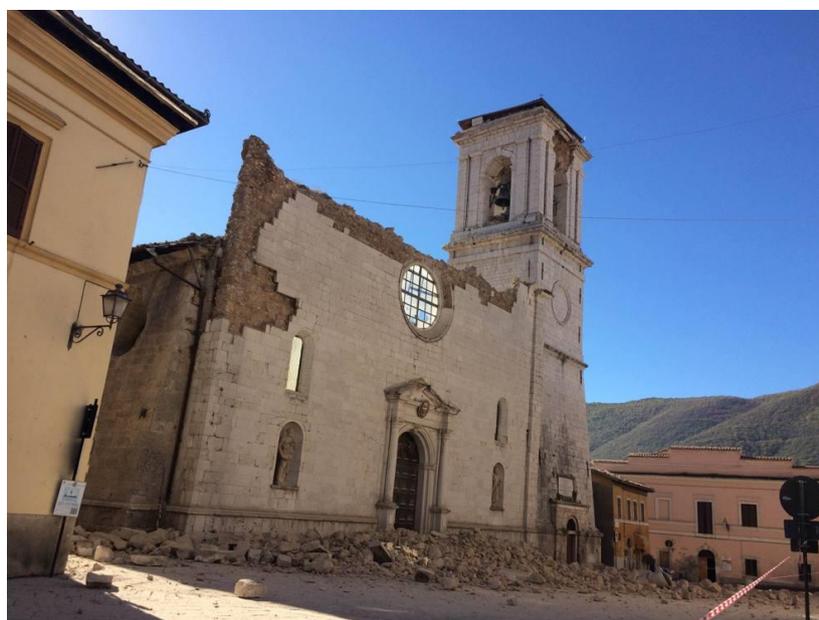
Following the 30th October earthquake, the St Maria Argentea Cathedral suffered severe damage and partial collapse. Photographs published in the press show that the church roof has completely collapsed, most likely because of the high mass of the concrete construction (Figure 6-33).

Figure 6-34 St Maria Argentea Cathedral front view after October the 30th earthquake (images from <http://www.umbria24.it>).

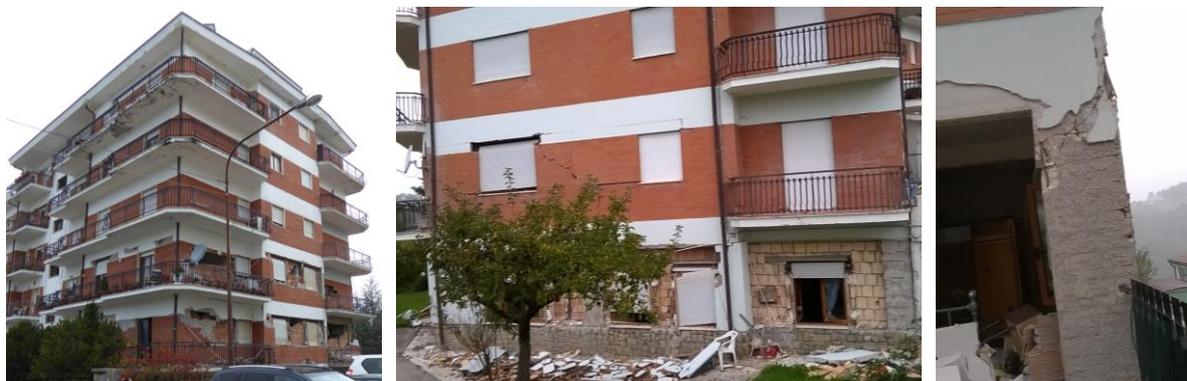
Figure 7-2 Amatrice, latitude 42;37;33.25 – longitude 13;17;27.58, 5-storey RC building, DG4

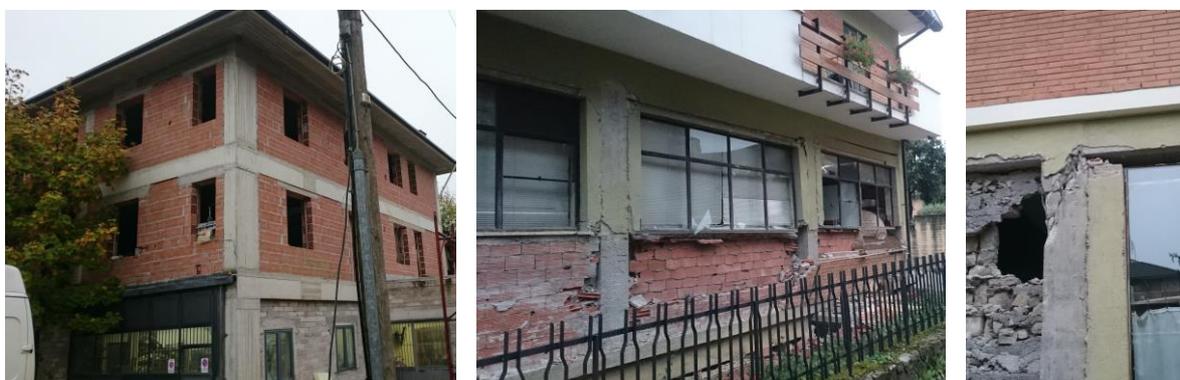
A final example was of a very recently constructed building Figure 7-4. At the time of the survey it was still unoccupied and is assumed to be designed according to the most recent code. There was no observed damage and the relative dimensions of columns with respect to the beams emphasize the capacity design principle used for its design. An interesting comparison can be made to an older RC building on the same street where the infill masonry panels were damaged (Figure 7-4b) and shear failures documented (Figure 7-4c).

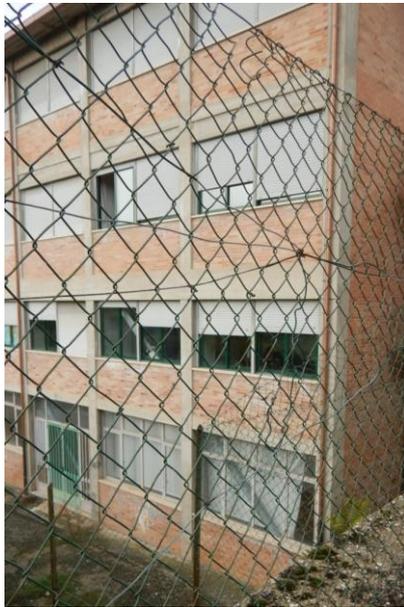
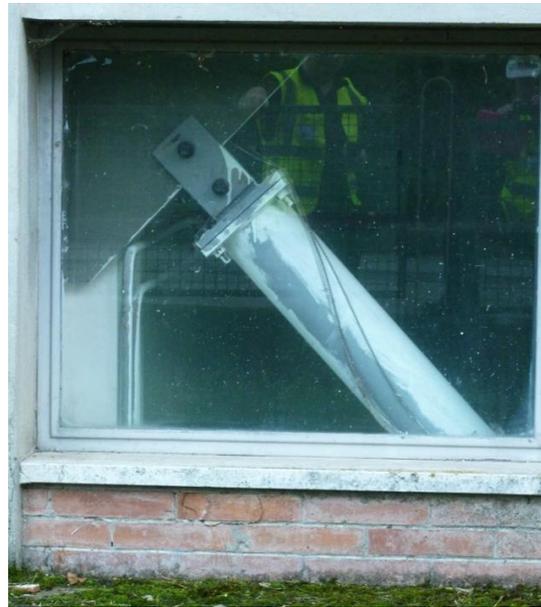
The school had been retrofitted (probably after the 1997 Umbria earthquake) with tubular steel bracing. This was seen in a number of bays along the length of the building (Figure 7-10) and at least the basement and first storey levels (Figure 7-11). It was not possible to see if any bracing intervention

Figure 7-11 Istituto Tecnico commerciale (lat. 42.791702, long. 13.095641), (a) North elevation - tubular steel bracing in the basement and first storey levels (at least) and (b) detail.

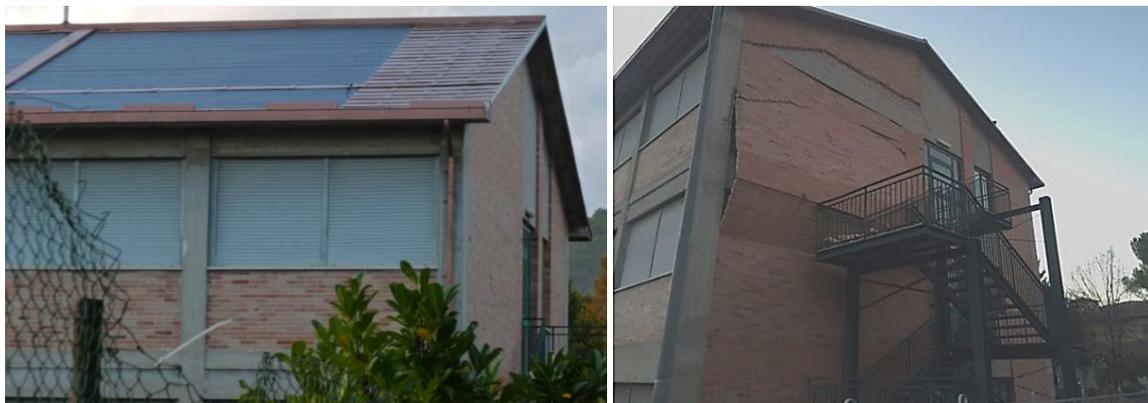
A further modification appears to have been made to the roof. The aerial photograph from Bing (Figure 7-7) indicates uniform material, presumably heavy tiles. The team observed a non-uniform, apparently lightweight material (Figure 7-12). This is assumed to be a waterproofing membrane, which replicates the appearance of tiles but removes objects with the potential to fall.

Figure 7-12 Istituto Tecnico commerciale (lat. 42.791702, long. 13.095641), roof appears to have been retrofitted to a thin, light weight material.

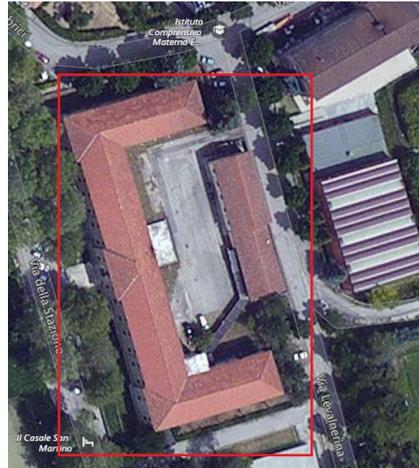
continued operation of this school. The team assigned EMS-98 DG1 to this structure. It is noted, however, that further damage to the gable occurred in the subsequent earthquake on the 30th October (Figure 7.13). The way the gable damaged still suggest the presence of a kind of reinforcement in the plaster or in the finishing such as fibres.

Figure 7-13 Norcia Istituto Comprensivo (lat 42.791217, long 13.095542), aerial view of the school in Norcia from Bing

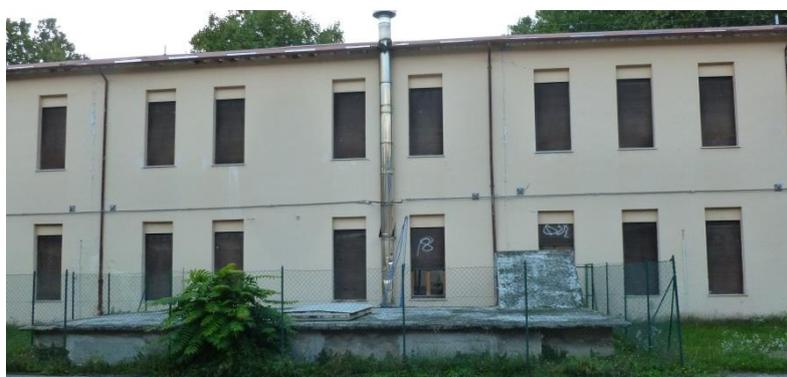
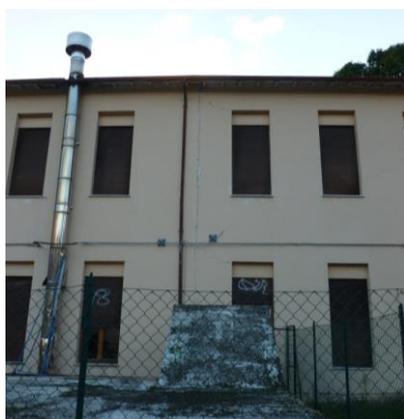
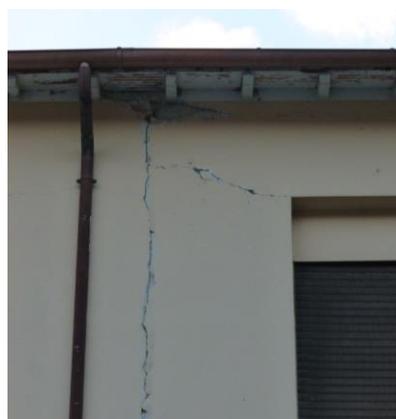
The team observed in plane damage to the masonry panels (Figure 7-17), which did not appear to be significant. The school was, however, closed. It is, therefore, assumed that there is extensive internal damage. The school had been retrofitted with regular, bi-directional ties at the first-floor level. Information on the time of this intervention is not available. It was not possible to determine whether there is a roof ring beam. The roof does, however, appear to have been modified in a similar manner to the Istituto Commerciale. The aerial photograph from Bing (Figure 7-13) again shows a uniform material. The team observed a non-uniform, apparently lightweight material (Figure 7-18). Such intervention can be also the result of regular maintenance actions taken in recent years and not related to seismic interventions.

Figure 7-17 Norcia Istituto Comprensivo (lat 42.791217, long 13.095542), (a), (b) 'C' building, example of external damage and possible service pit, (c) zoom on large vertical crack, DG2

The EEFIT team assigned EMS-98 DG2 on the basis of the external damage, even if the expectation is that official surveys classified the school in higher DG. It is likely that they managed to get into the building and to observe more extensive damage leading to the non-use condition found in October during the mission.

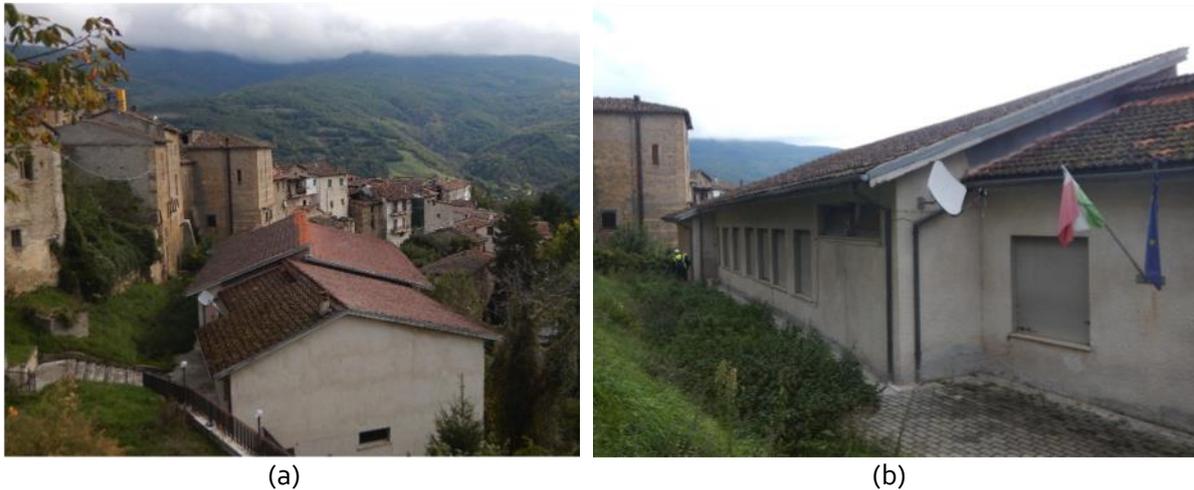
relatively regular (**Error! Reference source not found.**). The inspection showed evidence of damage to the roof (Figure 7-22a and Figure 7-22b) and limited damage to infills (Figure 7-23b). The school was not in use at the time of the inspection (Figure 7-23), and significant cracks in the internal infills were observed (Figure 7-23b). The school was classified as DG2 according to EMS98 on the basis of roof damage and cracks observed. The classification from the survey was of a level of damage between DG1 and DG2, but the evidence of the school not in use, made the building to be classified in DG2, given also the fact it was located on a slope.

Figure 7-22 Accumoli Scuola dell'Infanzia (lat. 42.693956, long. 13.246677), (a) East and (b) North views of the school.
