THE M_w 6.2 AMATRICE, ITALY EARTHQUAKE

OF 24th AUGUST 2016

A FIELD REPORT BY EEFIT

May 2019

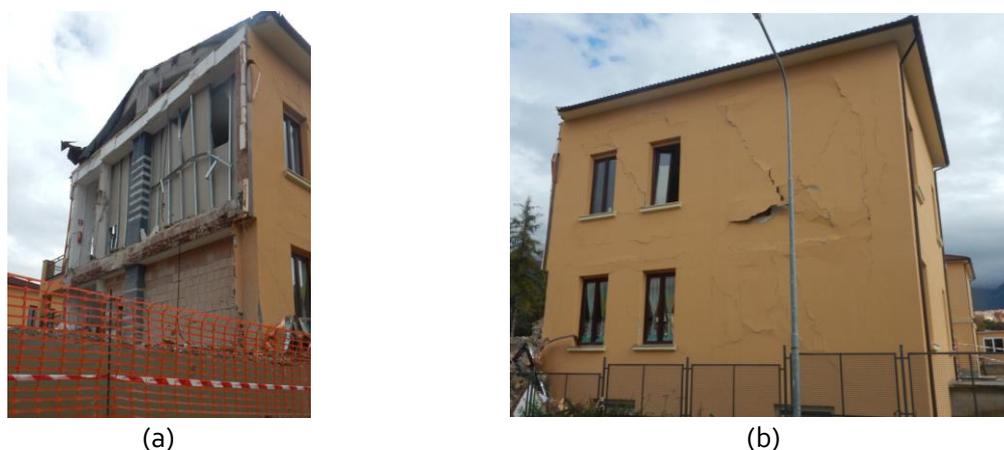
later, probably in the 1970s (see Figure 7-25 and Figure 7-26). The school was subjected to retrofitting in 2012, consisting of confinement of columns with FRP wrapping. This appear to have involved only the RC structure. At the time of the EEFIT mission the masonry part of the school, which collapsed during the August event, was being demolished. Debris was removed and it was easy to observe from the outside the intervention made in recent years to the RC frame (see Figure 7-26). Evidence of fibre reinforced material (FRP) applied in stripes to the columns of all storeys to increase shear capacity was evident (Figure 7-26a), and application of reinforced plaster was clear from the way crack occurred in the finishing of the RC part of the building (Figure 7-26b).

Figure 7-26 Amatrice School Capranica (lat. 42°37'38.10"N, long. 13°17'27.49"E), (a) evidence of the retrofitting intervention with FRP on columns of the RC part of the building; (b) evidence of cracked plaster from which the presence of fibres of reinforcement as prevented failure and produced a more widespread cracking.

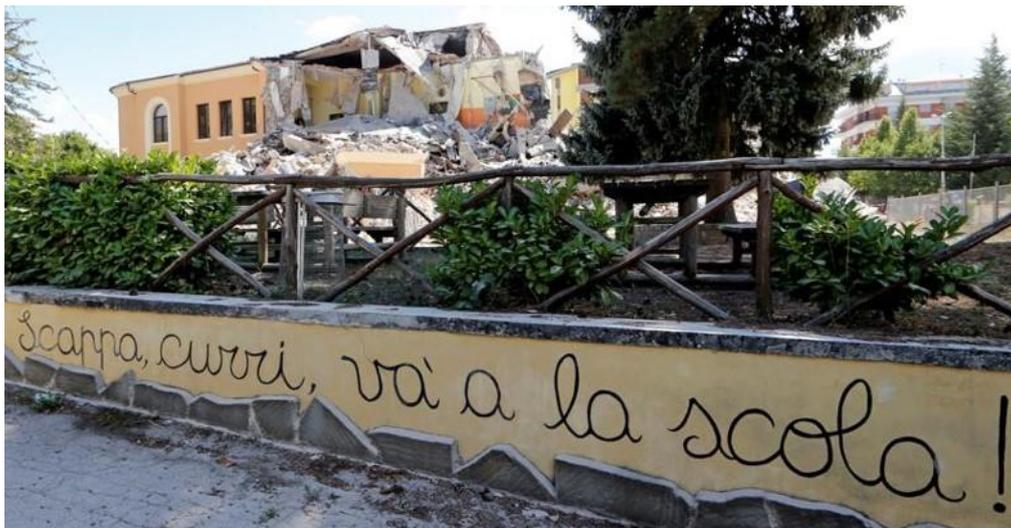
Figure 7-27 Amatrice School Capranica (lat. 42°37'38.10"N, long. 13°17'27.49"E), Photo of the collapsed school taken in the aftermath of the event from newspaper archives online (http://www.huffingtonpost.it/2016/08/28/scuola-amatrice-crollata-_n_11746166.htmlview)

The collapse of this school had a very high profile in the media. Newspapers and televisions reported the pictures of the collapse of the “retrofitted school” in Amatrice. Figure 7-27 shows a photo collected from newspaper archive reporting the collapse of the masonry building. However, the interventions documented in Figure 7-26 appear to have worked reasonably well, even if it is evident that the retrofitting did not target the more vulnerable masonry building.

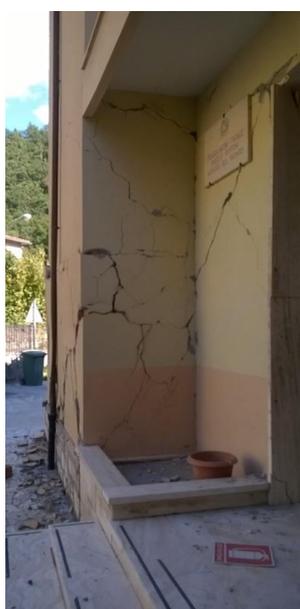
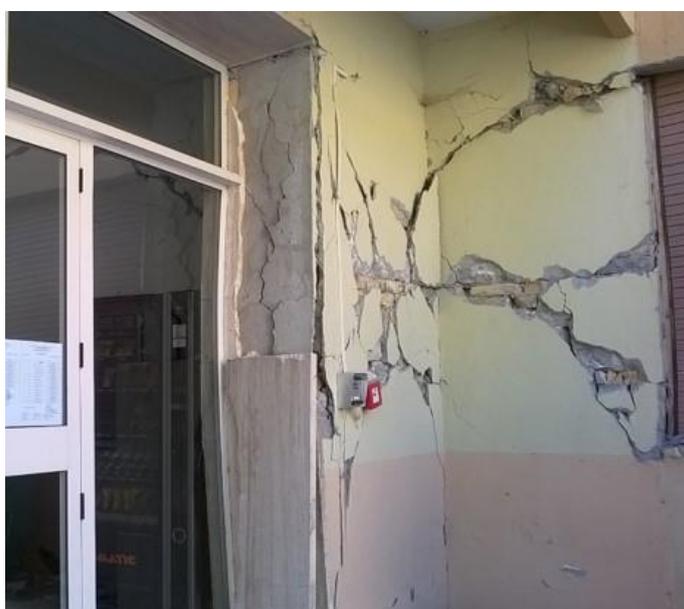
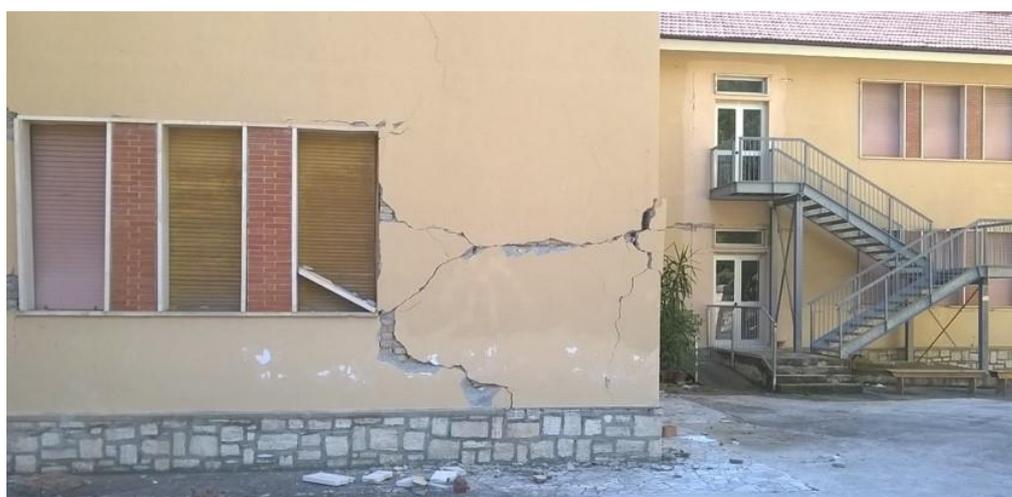
Figure 7-30 Arquata del Tronto – Scuola Media Ruffini (lat. $42^{\circ}46'34.82''\text{N}$, long. $13^{\circ}17'38.90''\text{E}$), (a), (b) damage of the main entrance and (c) in the front façade of the building.

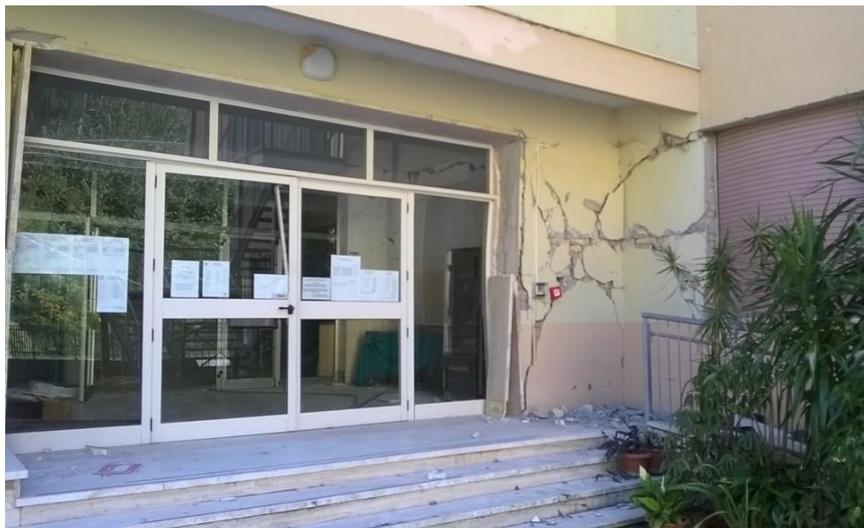
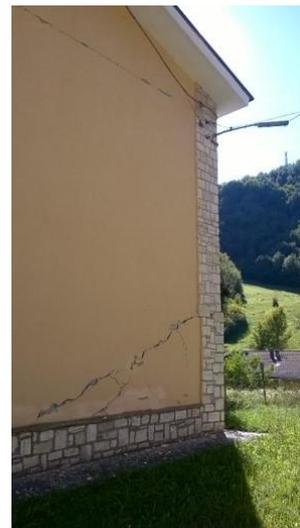
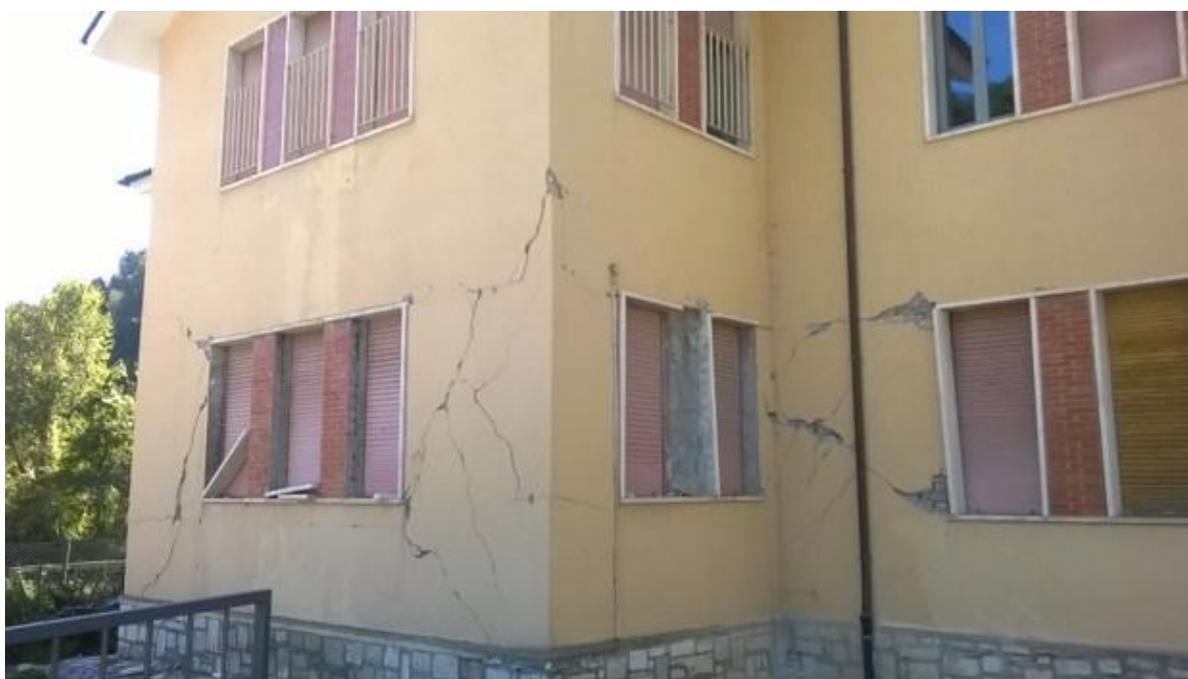
The Scuola Media Ruffini in the “Borgo” area of Arquata del Tronto (Figure 7-28) is most likely a two-storey masonry structure, reasonably recent (probably constructed between 1980 and 1990 or subjected to recent interventions) with quoins in the corners (Figure 7-29). The school was heavily damaged after the earthquakes (Figure 7-30). During the survey, it was classified as DG₃ and it was clearly unusable. Damage was widespread in all the piers of the structure, see Figure 7-31, with evident cracks in the roof and the quoins (Figure 7-31b).

Figure 7-31 Arquata del Tronto – Scuola Media Ruffini (lat. 42°46'34.82"N, long. 13°17'38.90"E), (a) full view of damage in the main entrance, (b) damage to the quoin, (c) heavy damage and cracking to walls.

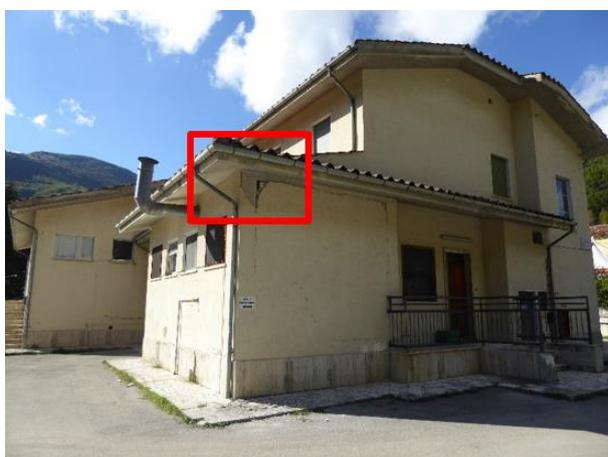
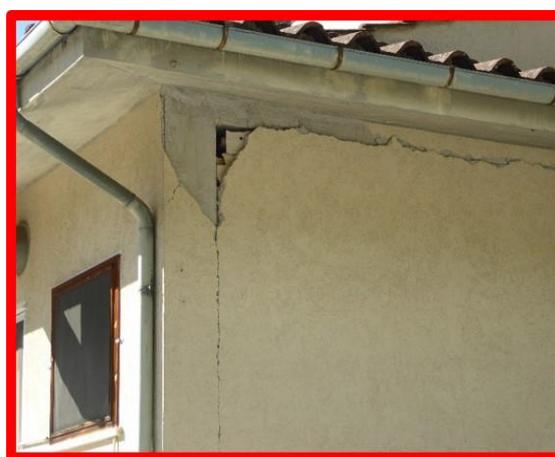
Figure 7-34 Arquata del Tronto – Scuola Materna Gallo Flavi (lat. 42°46'38.82"N, long. 13°17'44.58"E), (a) localization of corner crushing of the masonry infill, (b) zoom of corner crushing

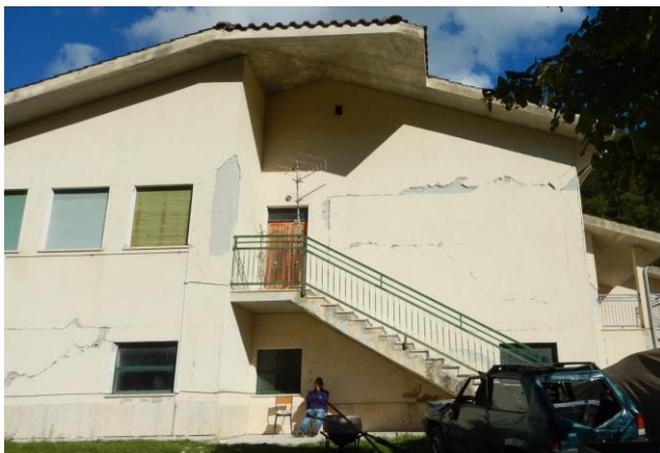
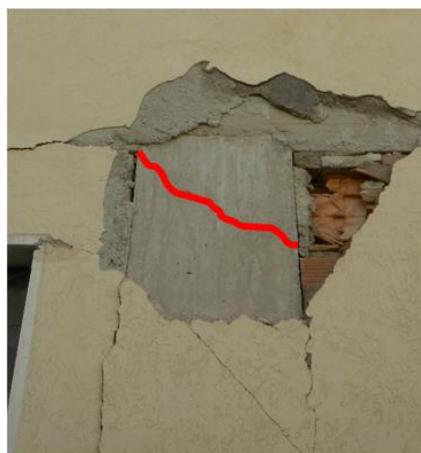
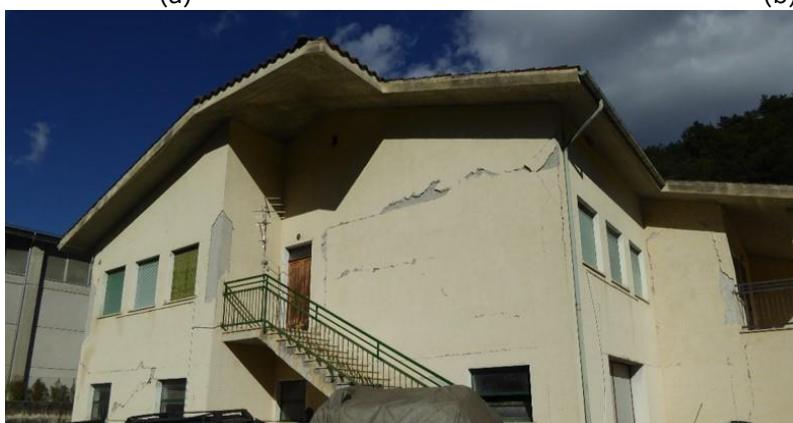
The evidence of shear failures in columns is a typical characteristics of obsolete RC seismic design and similar failures were observed in the damage surveys made after the 2009 L'Aquila earthquake in Italy as shown in damage reports (Ricci et al., 2011) and empirical approaches for the potential evaluation of shear failure occurrence in RC columns (e.g., De Luca and Verderame, 2013).

Figure 7-35 Arquata del Tronto – Scuola Materna Gallo Flavi (lat. $42^{\circ}46'38.82''\text{N}$, long. $13^{\circ}17'44.58''\text{E}$), (a) secondary entrance of the building, (b) onset of shear failure in column, (c) general overview of the damage in the building.

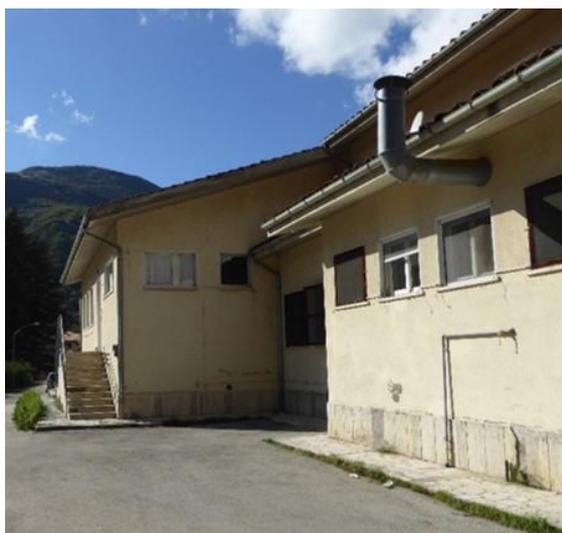
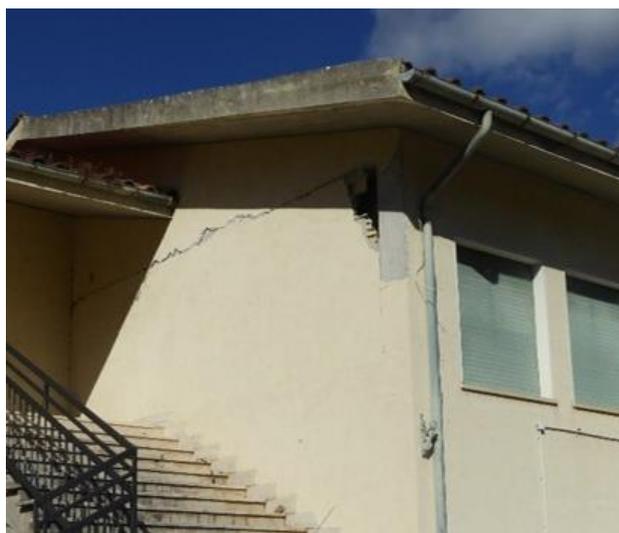
Figure 7-36 Arquata del Tronto – Scuola Materna Gallo Flavi (lat. $42^{\circ}46'38.82''\text{N}$, long. $13^{\circ}17'44.58''\text{E}$) (a) side view of the main entrance of the building, (b) corner crushing in the infills.

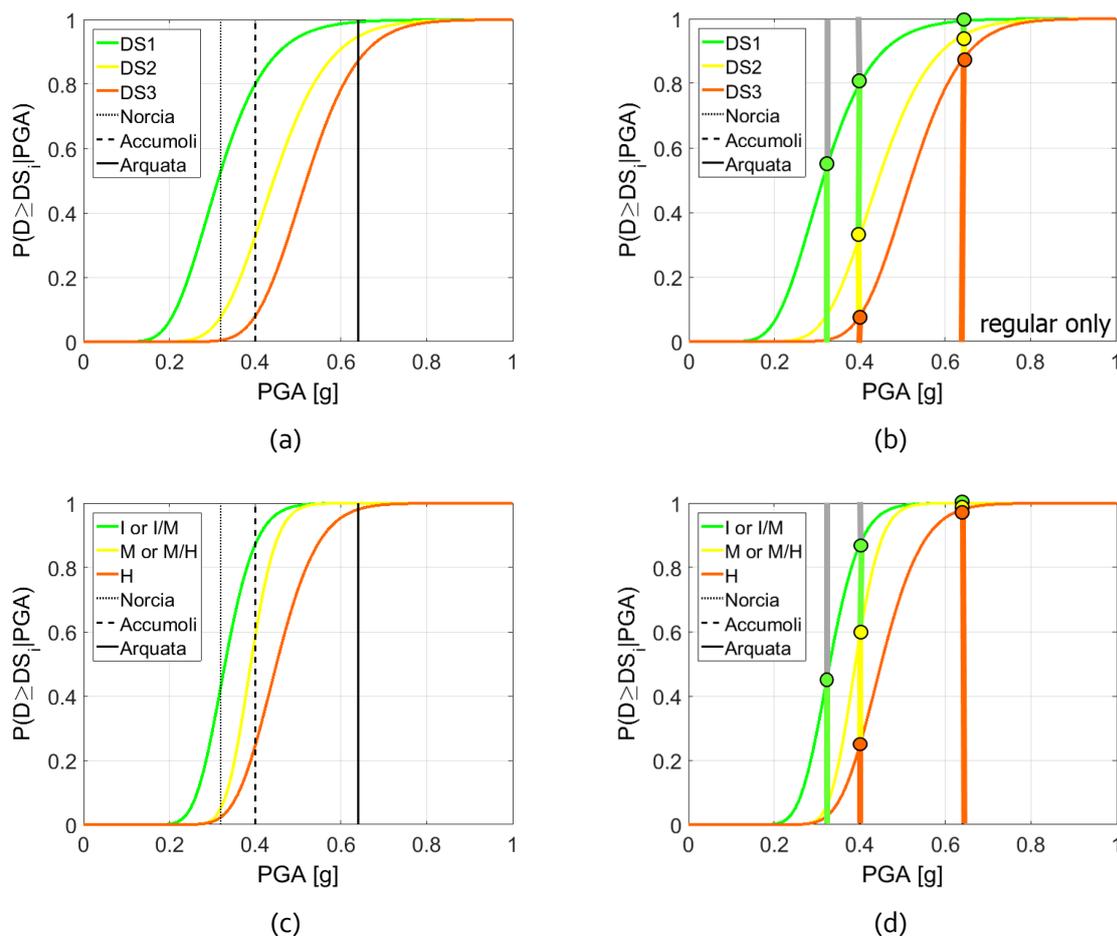
A preliminary comparison of the damage evaluation carried out for three of the schools surveyed during the mission (see Table 7-1) is provided with respect to empirical fragility curves derived on the basis of damage data collected after the 2009 L'Aquila earthquake (Figure 7-37). In particular, the Istituto Commerciale of Norcia, the Scuola dell'Infanzia in Accumoli and the Scuola Materna Gallo Flavi, classified respectively as DG₁, DG₂ and DG₃ are compared assuming Peak Ground Acceleration (PGA) as intensity measure and assuming the value of the USGS shake map of the 24th of August earthquake. A fair agreement between the most likely predicted damage is found in both the cases of fragility calibrated for regular structures (Figure 7-37a and Figure 7-37b) and non-regular structures (Figure 7-37c and Figure 7-37d). The school in Accumoli shows some mismatch with De Luca et al. fragilities functions (calibrated on regular buildings only) and such difference might be the result of the additional vulnerability caused by the fact the building is built up on a slope.

Figure 7-37 Observational fragility curves calibrated on RC survey data from L'Aquila earthquake (a) De Luca et al. (2015), (c) Liel and Lynch (2012) and evaluation of damage probability at the PGA of Norcia (0.32g), Accumoli (0.40g) and Arquata del Tronto (0.64g)

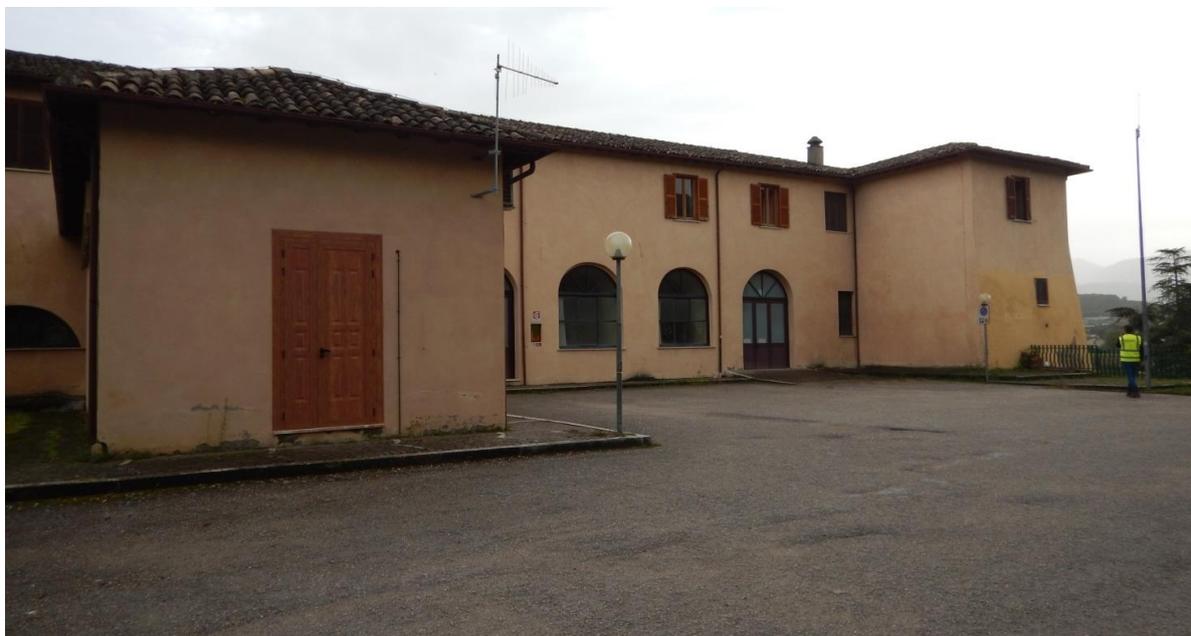
The structure did not suffer significant damage during the 24th August earthquake and it was fully operational, at the time of the visit. Therefore, an external survey only has been undertaken, showing only minor damage. The main block only has been surveyed (Figure 7-40), this being the only one having reported minor damages. The building is a 2-storey masonry structure with timber roof. The

Figure 7-40 Norcia hospital (lat. 42°47'22.83"N, long. 13° 5'50.28"E). East Elevation.

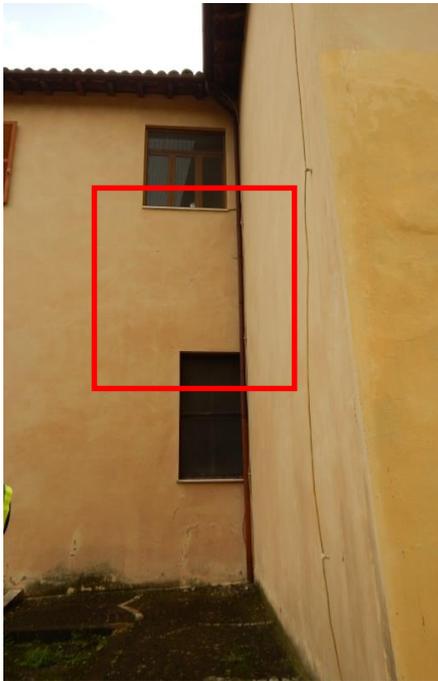
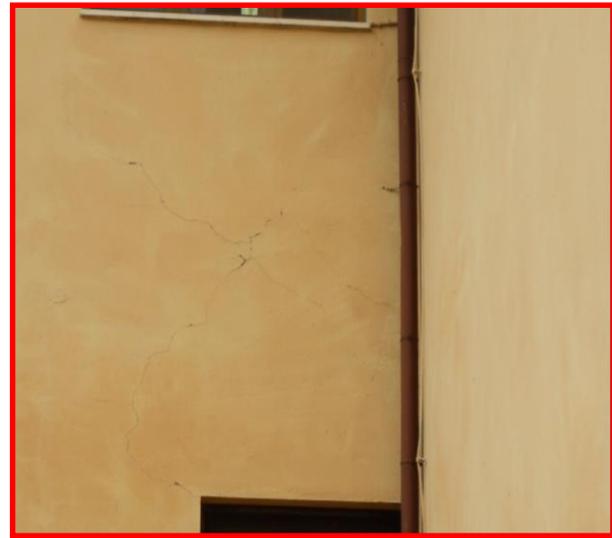
Some cracking between the 1st and 2nd storey windows was observed by the team. An example of the cracking is provided in Figure 7-42, where a shear crack has been observed in the masonry spandrel. Figure 7-43 shows that the building was provided with some antiseismic protection, consisting in the

Figure 7-42 Norcia hospital (lat. 42°47'22.83"N, long. 13° 5'50.28"E). (a) Onset of shear cracking in piers, (b) zoom of cracks.

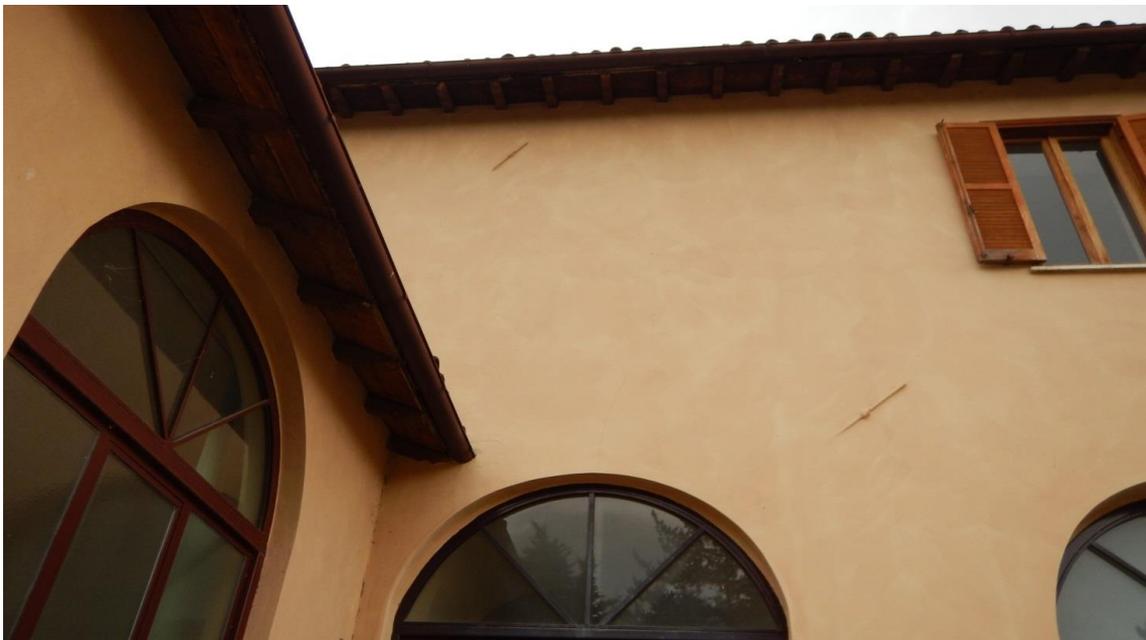
use of rods to provide out-of-plane stability to the masonry walls. The building was assigned an EMS-98 DG1 by the team. During the mainshock of 26th October, the week after the end of the EEFIT mission, the hospital has reported more severe damage and has been temporarily closed.

Figure 7-43 Norcia hospital (lat. 42°47'22.83"N, long. 13° 5'50.28"E). Steel ties.

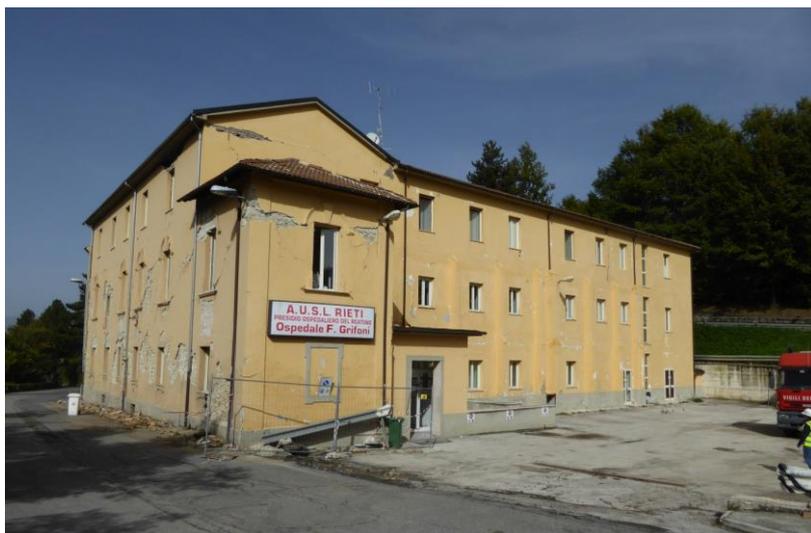
The hospital in Amatrice was inspected by the team and due to the level of damage it was not in use. Located half way up the hillside on the outskirts of the main town centre of Amatrice (see Figure 7-44a), the building is composed of several blocks which can be broadly split into two components, the older southern blocks and the newer northern blocks (see Figure 7-44b). The hospital complex is of mixed construction, with the southern blocks constructed of masonry, and the northern block being RC with masonry infill. The slope gradient is significant from the east to the west with the SS260 road winding around the perimeter. When the team inspected the hospital the three-storey masonry part of the building had performed the worst with visible masonry in-plane failures throughout (Figure 7-45).

Figure 7-45 Amatrice hospital (lat. $42^{\circ}37'40.85''\text{N}$, long. $13^{\circ}17'10.37''\text{E}$). Three-storey masonry part of the hospital.

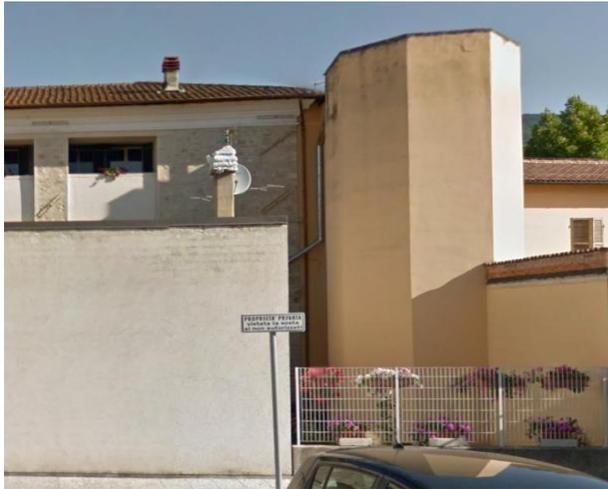
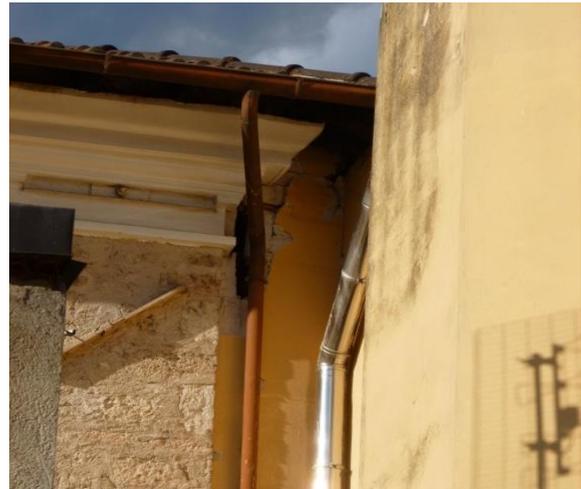
Figure 7-49 Norcia Caserma (lat. $42^{\circ}47'41.37''\text{N}$; long. $13^{\circ}5'31.19''\text{E}$). Location of building irregularity, (a) pre- (Google Street View) and (b) post- earthquake condition.

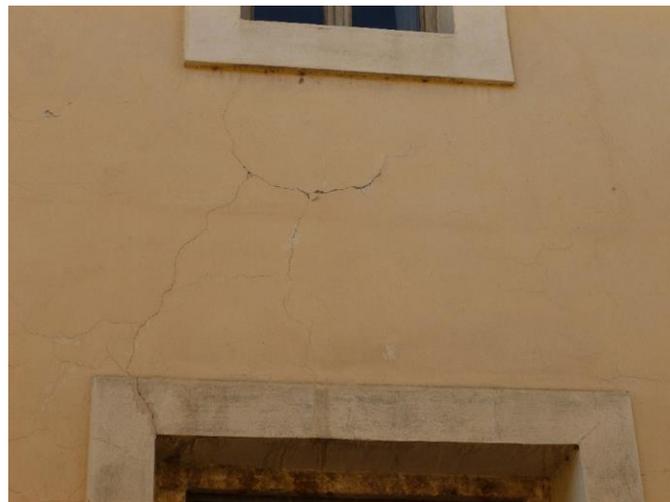
Figure 7-50 Norcia Caserma (lat. $42^{\circ}47'41.37''\text{N}$; long. $13^{\circ}5'31.19''\text{E}$). Cracking between windows

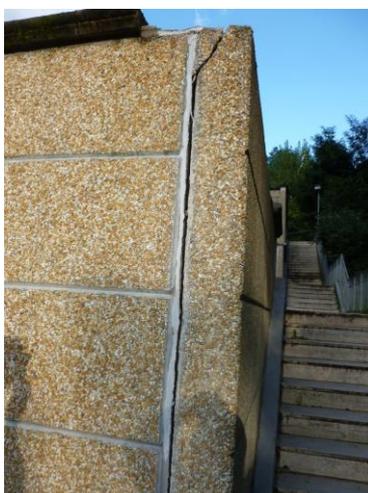
During the mission the Local Operative Centre set up by national Civil Protection in the municipality of Norcia was surveyed. The structure did not show any significant damage and, in fact, it was selected as location for the Centro Operativo Comunale (Figure 7-51). The only nonstructural damage observed was the incipient detachment of a precast panel in its top corner (see Figure 7-52).

Figure 7-52 Norcia COC (lat. $42^{\circ}47'43.89''\text{N}$; long. $13^{\circ}5'29.26''\text{E}$). nonstructural damage to precast panel.

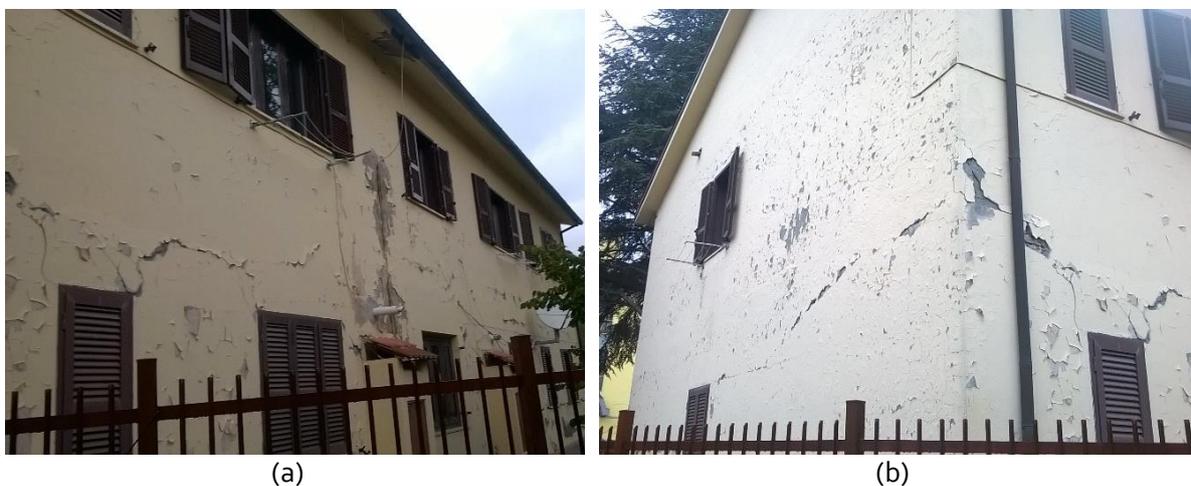
The Amatrice Corpo Forestale is a 2-storey masonry wall structure. It has a rectangular plan (see Figure 7-56). The pre-earthquake condition of the building (Google Maps) is shown in Figure 7-57. The team observed cracking on all exterior walls (Figure 7-58). An EMS-98 DG2 was assigned by the team.

Figure 7-58 Amatrice Corpo Forestale (lat. 42°37'34.33"N long. 13°17'31.24"E) damage observed, widespread cracking to (a) East and (b) North facades.

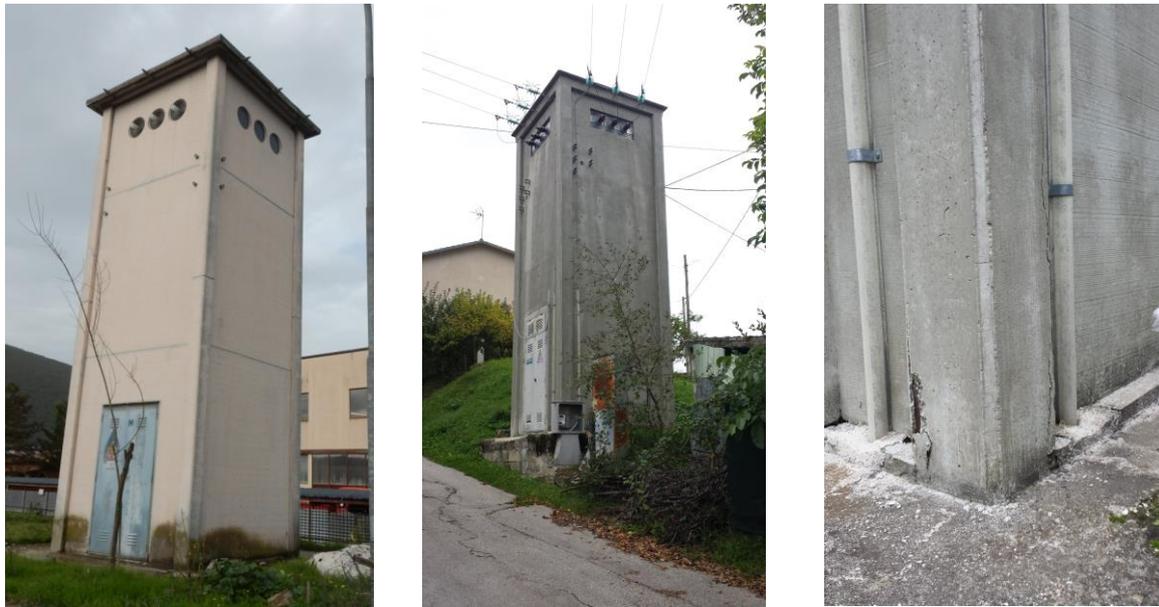
region". Two electricity transformer buildings were surveyed in the city of Accumoli (Figure 7-59), both were constructed in RC and showed a very limited amount of damage with some limited cracking to the first one (buried cables type, see Figure 7-59a), and evidence of concrete spalling at the base of the column for the second (aerial cables types, see Figure 7-59c). The damage level of the two transformers was classified as DG1 according to EMS98. Both transformer building seemed to be operational at the time of the inspection.

Figure 7-59 Accumoli (a) Electricity Transformer with buried cables (lat. $42^{\circ}39'24.966''$ N; long. $13^{\circ}16'14.808''$ E), (b) with visible aerial cables (lat. $42^{\circ}41'40.9826''$ N; long. $13^{\circ}14'43.1531''$ E) (c) concrete spalling zoom of damage at base column of transformer in (b)

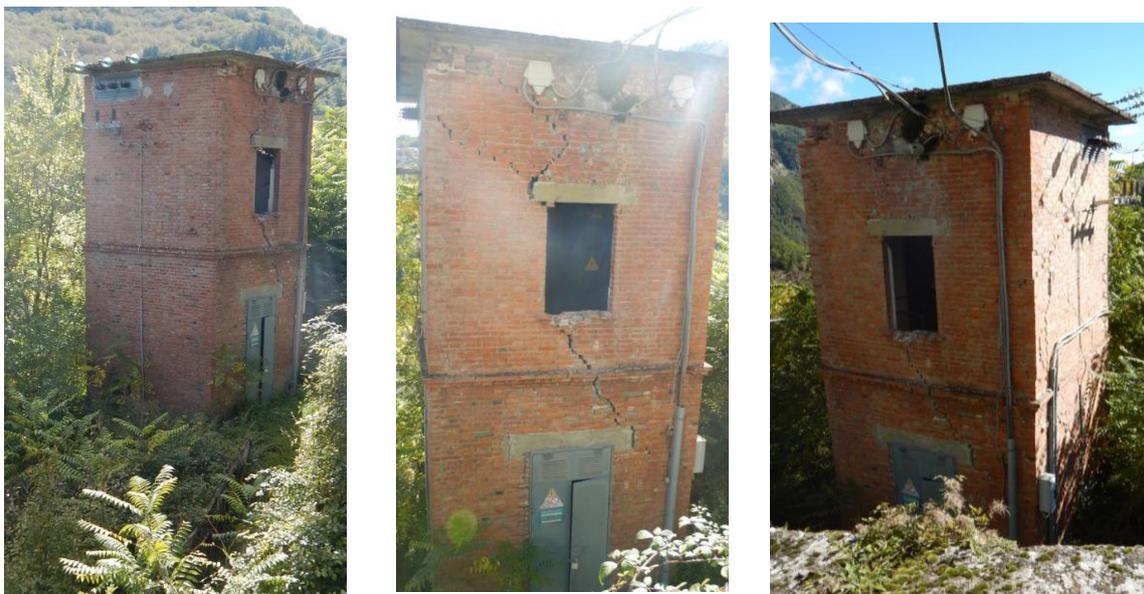
Figure 7-60 Arquata del Tronto – Electricity Transformer (lat. $42^{\circ}46'21.912''$ N; long. $13^{\circ}17'50.022''$ E), very heavy damage in masonry with deep cracks in piers and spandrels.

A masonry electricity transformer building was surveyed in the city of Arquata del Tronto (Figure 7-60 and Figure 7-61). The level of damage was very heavy cracking throughout the spandrel and piers. This transformer was classified in DG₃ according to EMS₉₈. Notwithstanding the very heavy damage the cable system seemed to be still functional, even if the visual survey did not provide any evidence on the functionality of it (considering also that the all area around was evacuated at the time of the inspection).

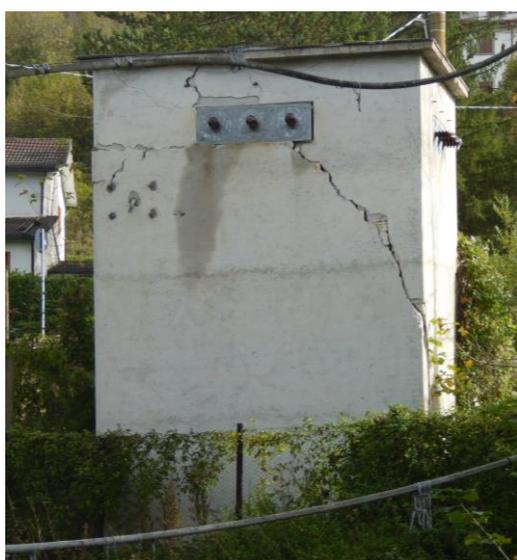
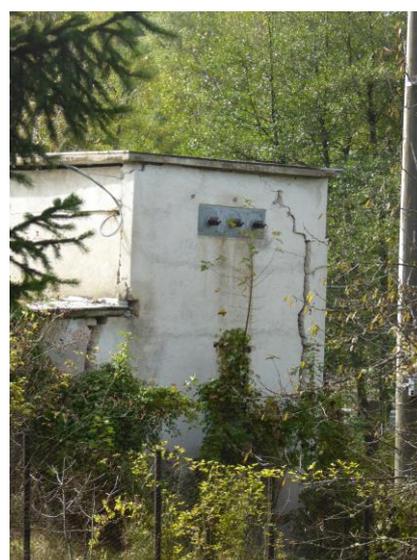
A masonry electricity transformer building was surveyed also in Amatrice (Figure 7-62). The level of damage was heavy also in this case with deep cracks in the masonry walls. The damage was classified as DG₃ also for this transformer. No information was available on the functionality of the transformer at the time of the survey. An electricity transformer building was survived along the SS₄ Salaria road between Grisciano and Pescara del Tronto (Figure 7-63). The transformer was in RC with irregularity in elevation between the first and the second level. Some cracking at the level of the door entrance was visible, but the level of damage was considered to be minor leading to a DG₁ classification. The transformer building appeared to be functional at the time of the survey.

Figure 7-62 Amatrice – Electricity Transformer (lat. $42^{\circ}37'4.19''N$; long $13^{\circ}17'33.79''E$), buried cables.

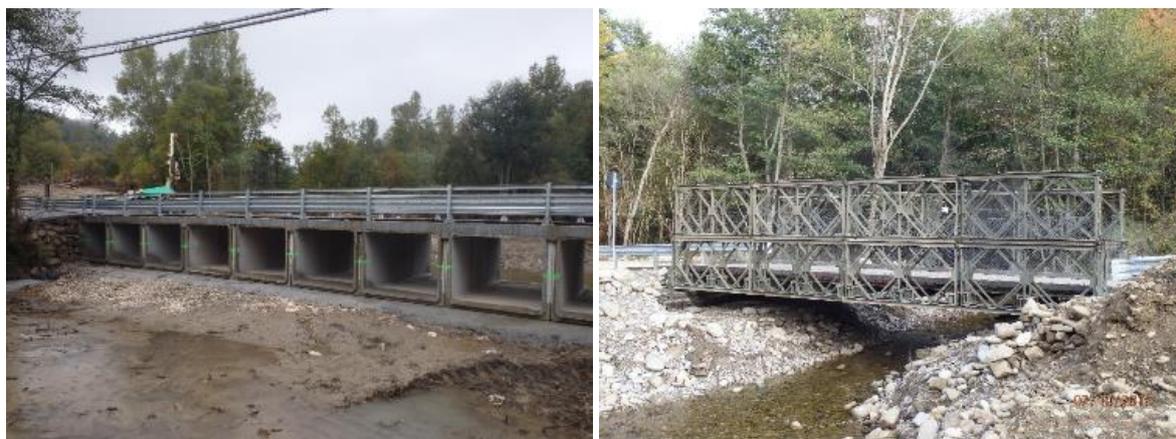
Figure 8-3 Temporary bridge bypassing Ponte a Tre Occhi; b) Temporary bridge near Ponte delle Rose.

Thanks to the collaboration between Italian Civil Protection and the Army, two temporary bridges were built. Figure 8-3 shows a temporary bridge which is part of a road by-passing the closed "Ponte a Tre Occhi". Built very rapidly and opened to traffic only 10 days after the earthquake struck, this bridge is crossing a small river with a limited water flow. This allowed an upstream diversion of the river in order to realise a concrete sublayer slab on the riverbed, and the placement of ten 3x3m precast concrete culverts. A cast in situ deck slab was overlaid to distribute the vehicles loads over the vertical webs of the precast elements. The restored river flow passes through the precast elements. At the time of the visit, ground Investigation were underway as part of the construction of a new permanent bridge that will eventually replace the temporary bridge and possibly the damaged pre-existing bridge if deemed not repairable.

A second bypass bridge (shown in Figure 8-3b) was built to increase the traffic capacity of the East access road as an alternative to the "Ponte delle Rose" bridge. It was opened at the beginning of October 2016 according to press reports. Despite the damage sustained (refer to section 8.4.1), the Ponte delle Rose was not closed, but created a bottleneck to the traffic due to its limited width. The army built a 12m span Bailey bridge to address the issue. The bridge is a typical military construction type that can be deployed quickly. Its modular construction allows to cover relatively small spans by assembling preformed steel frames connected into truss beams. Two truss beams are connected by transverse steel beams forming the deck and also form the bridge parapets.

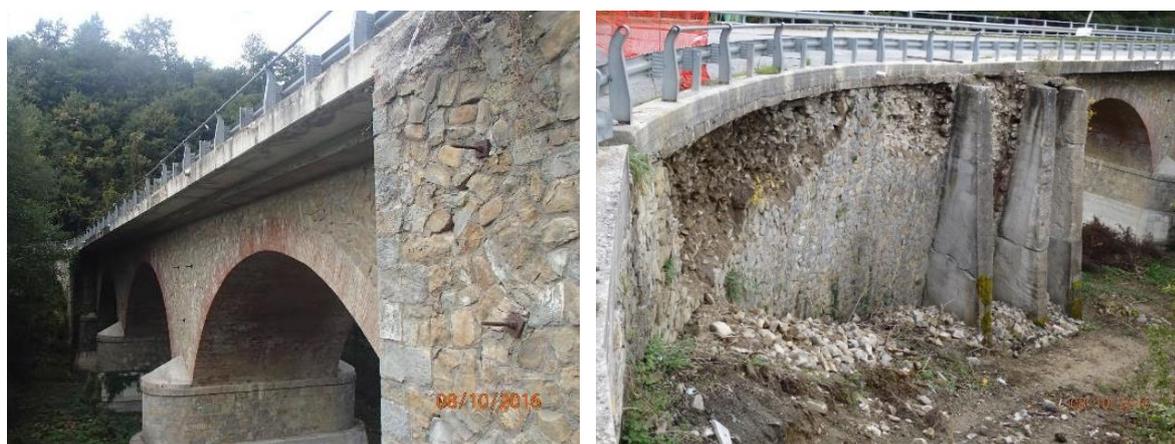
Figure 8-4 "Ponte a Tre Occhi" bridge southern view. Concrete buttresses on the eastern abutment

The bridge presents some structural elements not part of the initial structure which were part of later strengthening works. Three unreinforced concrete gravity buttresses are placed against the northern wall of the East abutment (see Figure 8-4). Several tie rods crossing the full bridge width is also visible on the abutments and at the arch spandrels. The general condition of the bridge is very good with little decay observed in all elements. The masonry appears in good state with evidence of relative recent re-pointing works.

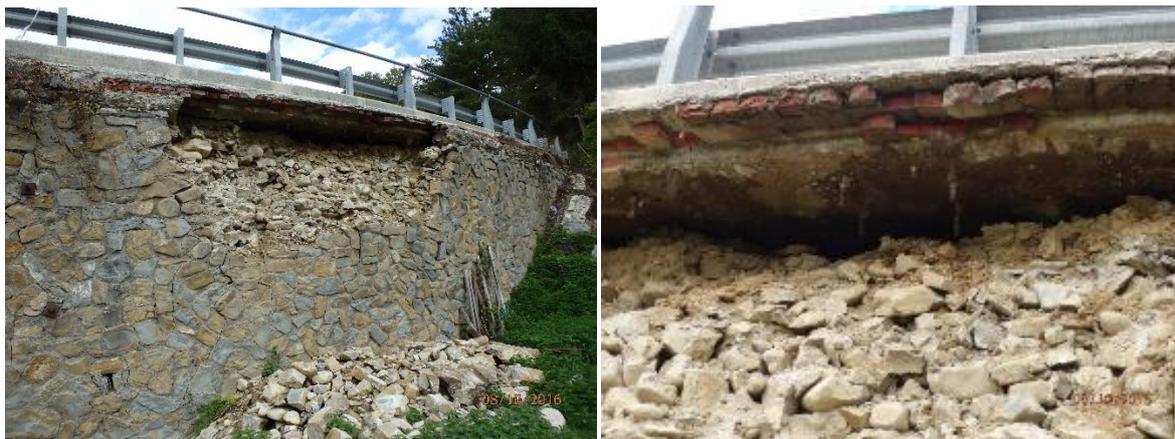
The settlements are caused by failure of the retaining walls with substantial loss of infill beneath the deck at both abutments. The level of damage at the eastern abutment is particularly extensive and was observed on both the southern and northern walls as shown in Figure 8-7.

The southern wall retains approximately up to 5m of loose infill and partially collapsed (see Figure 8-7). The retaining wall demonstrated to be of insufficient thickness, being constructed with one leaf of irregular stones only. The failure exposed the bridge deck concrete slab and steel connectors, which were not effective in anchoring the loose material and wall below (see Figure 8-8).

Figure 8-7 Failure of the East abutment southern wall; b) detail of the exposed deck slab connectors

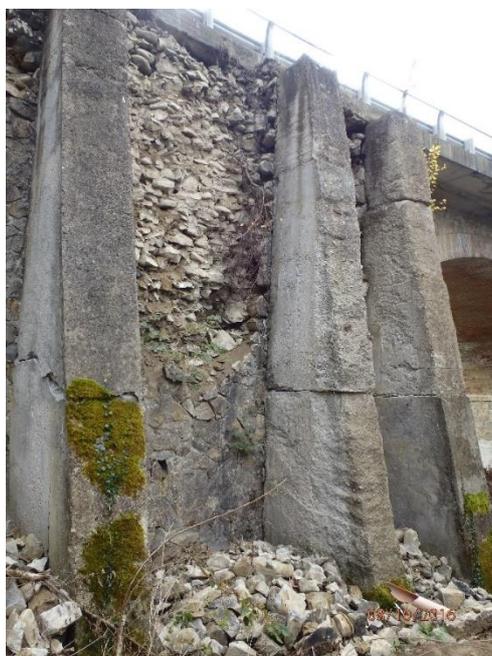
The gravity buttresses shown in Figure 8-8 have been ineffective as shoring measure, showing signs of both global overturning failure as well as shear failure at the cold joints between different pours. The abutment masonry retaining walls are, as in the southern wall, made of a single leaf of irregular stones which has collapsed in multiple points leading to the loss of infill. The wall has also collapsed by the tie rod anchorages leaving them exposed and further indicating inadequate quality of the anchorage detailing (refer to Figure 8-9).

Figure 8-8 Gravity buttresses failure

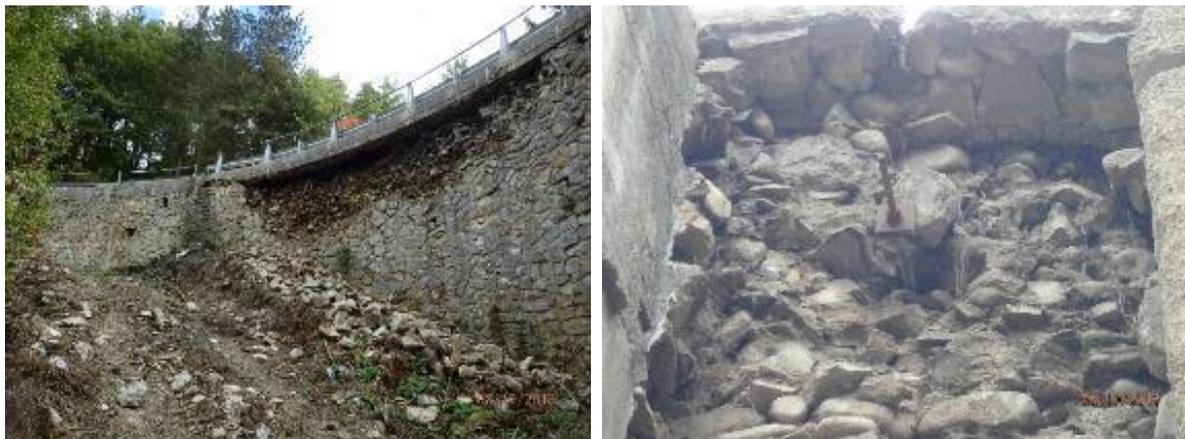
The northern wall shown in Figure 8-7 and Figure 8-8 is the part of the structure that suffered most damage. The wall retains up to approximately 10m of fill and has three concrete buttresses, which have been added at some point during the lifetime of the bridge (Figure 8-7). These are probably the result of previous issues with the stability of the abutment, possibly determined by the uneven overall soil loading on the abutment walls. This uneven ground pressure was then likely further exacerbated by the seismic accelerations.

Figure 8-9 Failure of the East abutment northern wall; b) detail of tie rod anchorages exposed

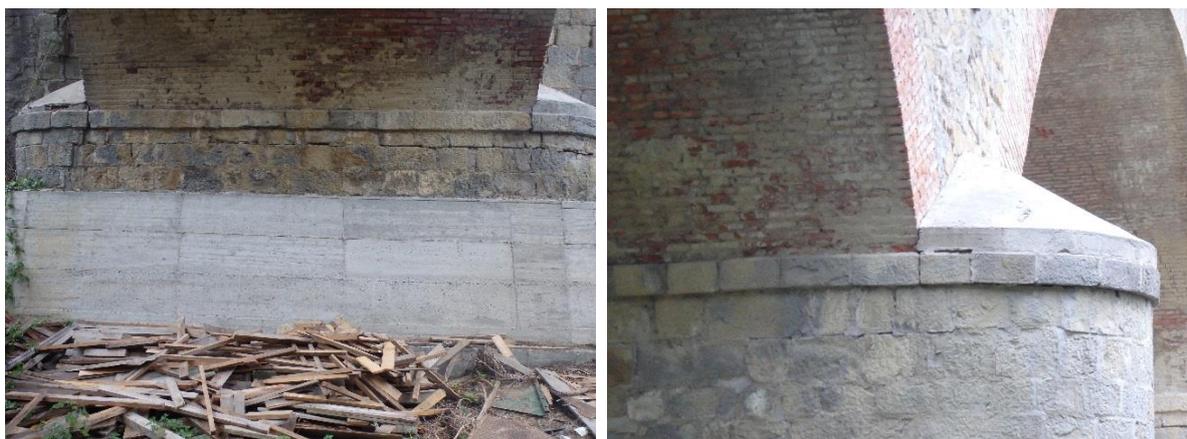
Recurring horizontal cracks were observed at all pier heads both by the arch springers and at the cutwater caps as shown in Figure 8-11. The cracks are the likely results of the seismic base shear forces transferred from the bridge onto the piers. No evidence of horizontal displacements was observed in all but one pier i.e. the one by the East abutment. This has the edge cutwaters dislodged further confirming the movements highlighted by the diagonal cracks observed at the adjacent arch soffit.

Figure 8-11 Horizontal cracks at pier heads

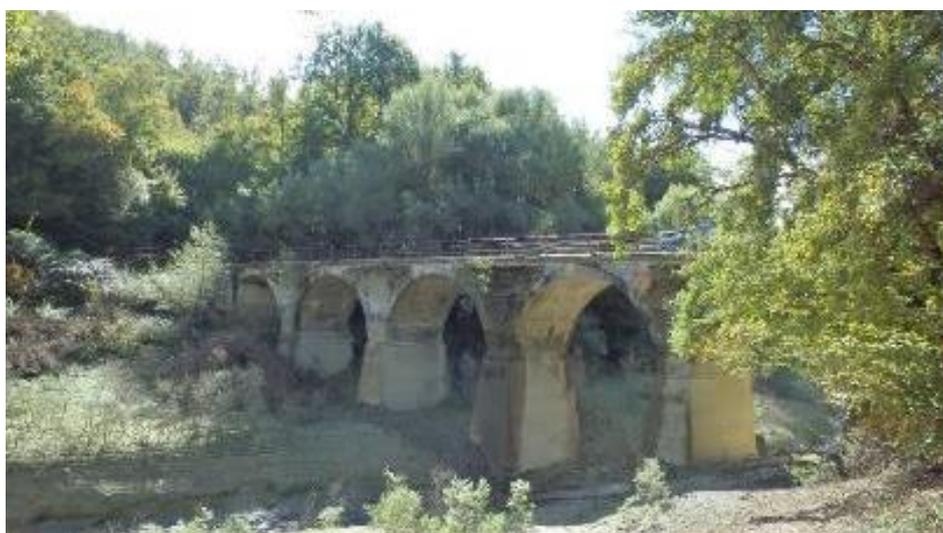
Figure 8-12 “Ponte a Cinque Occhi” bridge North West view

The bridge was refurbished and strengthened, with varying success, most likely in the 1980s. The interventions observed comprised: (1) encasing the abutments with reinforced concrete walls hiding the pre-existing structure (Figure 8-12). (2) Rendering the arches soffit with a thin (~50mm) unreinforced concrete lining (Figure 8-13). (3) Concrete lining walls were possibly also applied onto the piers, although this is uncertain (Figure 8-14). (4) Creation of masking walls made of clay hollow bricks at the spandrels (Figure 8-15). (5) Unreinforced concrete deck-edge upstands and metal parapet railings.

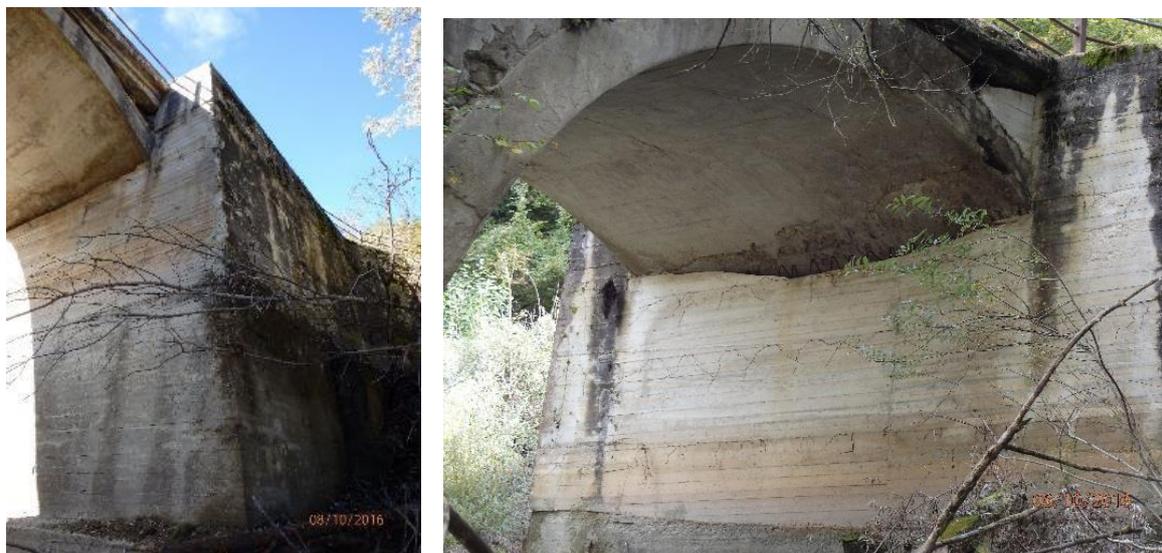
Figure 8-13 Images showing the RC abutment walls and arches concrete lining

The bridge appeared in a moderate-to-severe state of decay which is the likely result of lack-of maintenance in the years leading to the seismic event. The decay was further exacerbated by the inappropriate deck drainage system implemented as part of the strengthening works. As a result, not all the damage can be attributed in its entirety to the 24th August earthquake.

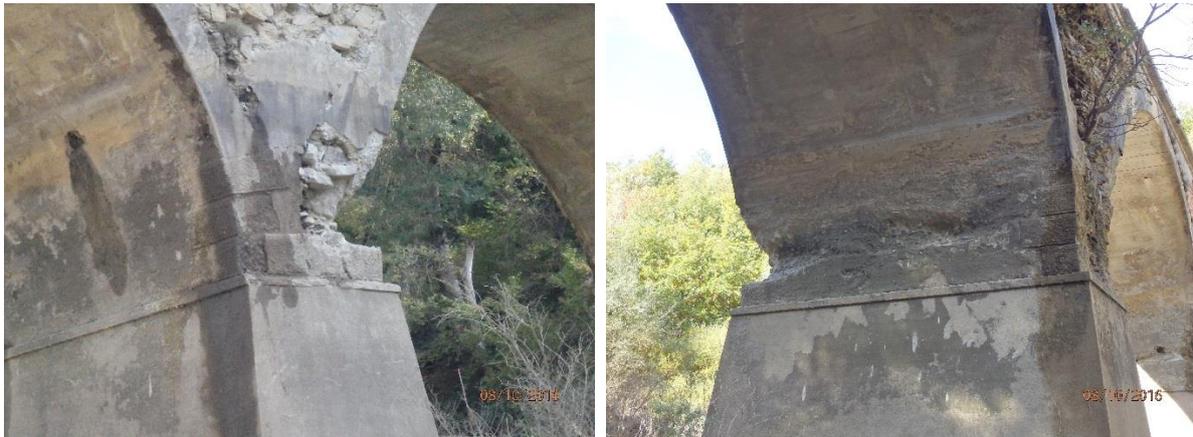
The main arch showed widespread damage (Figure 8-14 and Figure 8-15) with substantial reduction of the cross section at the pier springers, up to the formation of a hinge. The hinges are identified through substantial horizontal cracking, and localised ejection of both concrete liner and masonry voussoirs. The hinges may have formed as a result of relative longitudinal (i.e. along the bridge length) displacements between the arches-deck-abutments rigid system and the taller piers.

Figure 8-15 Hinges by the pier springers
