THE M_w 6.2 AMATRICE, ITALY EARTHQUAKE

OF 24th AUGUST 2016

A FIELD REPORT BY EEFIT

May 2019

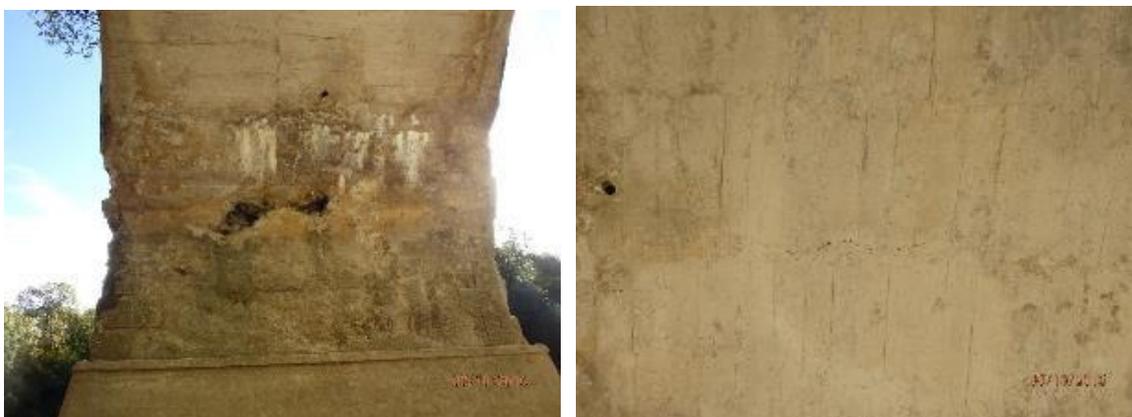
Figure 8-16 Localised ejection of material at the arch soffit (left), bridge arch longitudinal cracking (right)

The spandrel failure shown in Figure 8-16 highlighted some loss of fill at the arches extrados. This is of particular concern in localised zones adjacent to the carriageway kerb in which the deck edge is practically unsupported. It is understood that restriction to a single lane traffic system was requested to prevent vehicle tyre imposing concentrated loads onto the critical deck edges, however, this was not implemented at the time of the visit.

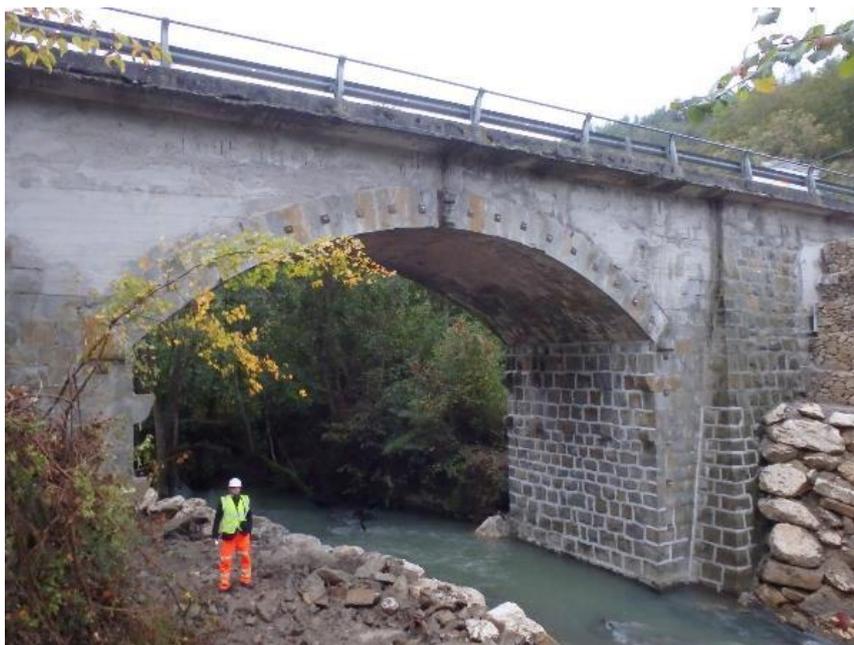
The bridge is mostly made of cut stone masonry, see Figure 8-18. The only exceptions are the deck, which is a reinforced concrete slab likely part of later widening works, and the northern spandrel wall, which is also of concrete construction. The bridge and SR260 road were fully operational at the time of the visit. However, the SR260 road was subject to an extensive rock-fall just 100m south of the bridge that led to its closure in the aftermath of the 24th of August earthquake. The road was reopened through the slewed diversion shown Figure 8-18. The bridge was likely repaired and strengthened after the seismic event; the road diversion included a new construction vehicle access to the bridge. At the time of the visit, the river embankments and bridge abutments earthworks (including gabion walls) appeared of fresh construction. The abutment masonry appeared recently repointed (Figure 8-19) and the bridge arch northern edge included new steel tie rods (Figure 8-20).

Figure 8-18 SR260 Road Bridge North view

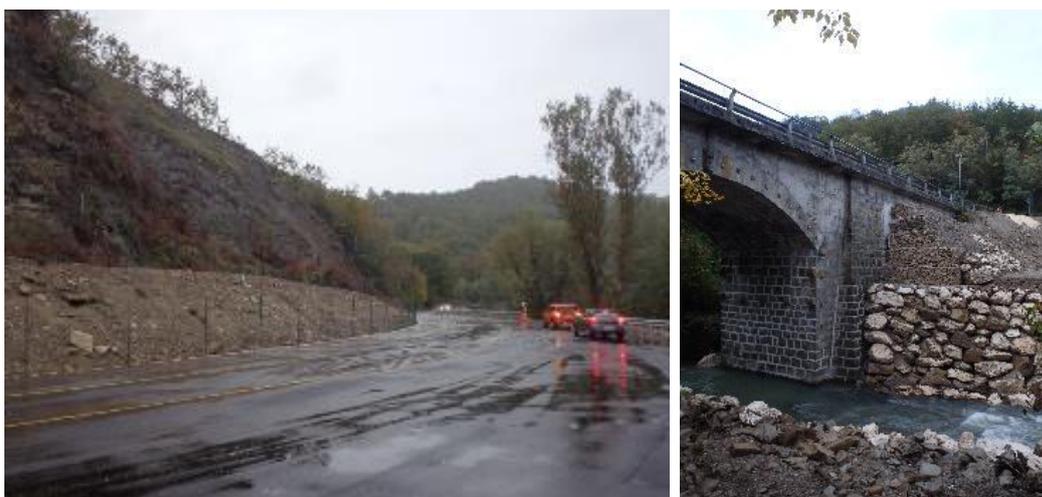
Figure 8-19 SR260 diversion (left), newly made earthworks and gabions at the West abutment (right)

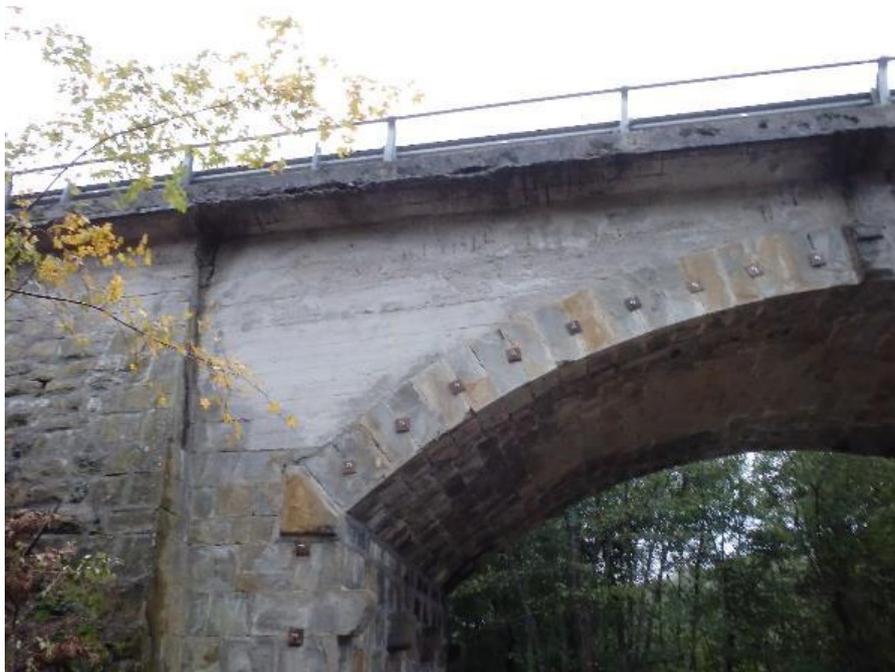
The only damage observed during the visit was the detachment of the side arches at either edge of the barrel vault. These are highlighted by the presence of meridian cracks running along the back of the facing stones as shown in Figure 8-21. The cracks point to a lack of transverse masonry connection within the masonry barrel vault, which led to the side displacements under the horizontal seismic accelerations. Such damage was (partially) repaired in the recent works and the northern arch was tied back with a series of steel capping plates anchored inside the masonry with threaded steel rods (Figure 8-21). There is no evidence of the rod passing through the body of the bridge and anchoring on the South elevation

The North side also presents a concrete spandrel wall that differ from the southern one, retaining the original stone wall. Possibly the bridge North side suffered the higher level of damage and was therefore subject to the more extensive repair works.

Figure 8-21 Tie rods and concrete spandrel at the bridge North side

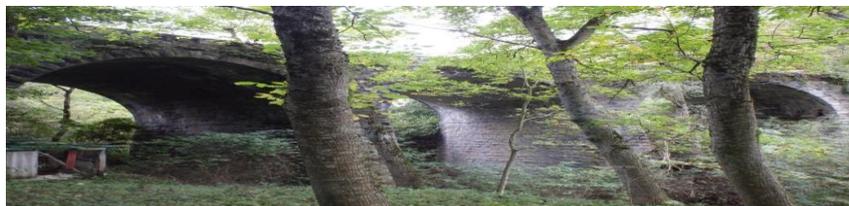
is made of cut stone masonry. The bridge width is approximately 10m. The barrel vault soffits are lined in unreinforced concrete. These are likely not part of the original construction and they are the only evidence of structural modification at a visual inspection. The bridge appeared in fair condition with no severe sign of decay but just some vegetation overgrowth and damp patches.

Figure 8-22 Tufo bridge East view

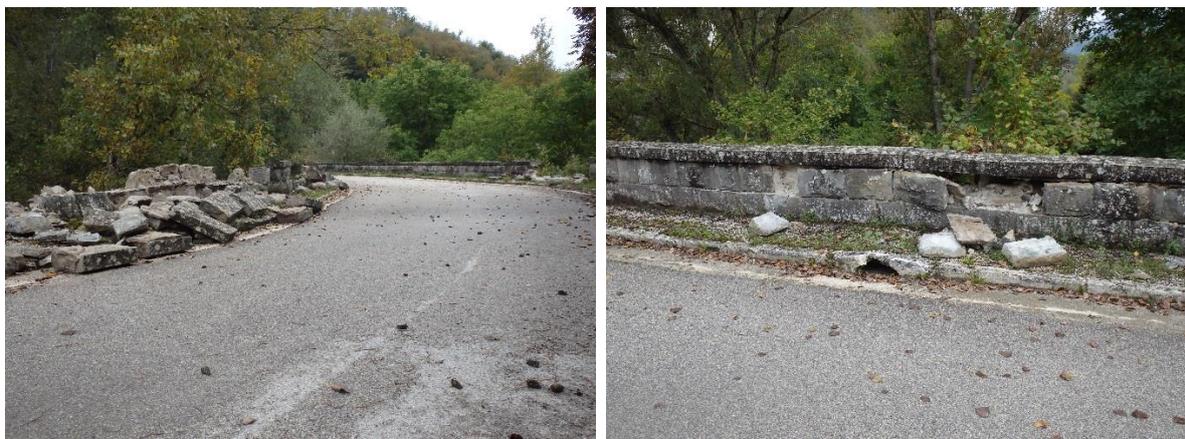
Figure 8-23 Collapse (left) and damage (right) of the masonry parapets.

The bridge showed widespread damage caused by the August the 24th earthquake and it was closed to traffic at the time of the visit. There was severe damage of the masonry parapets, which partially collapsed in various points as shown in Figure 8-23. The carriageway shows a vertical sag (approx. 100mm) in correspondence of the North abutment (Figure 8-23). This can be related directly to the damage observed in the first span below where the abutment wall is partially collapsed from the arch springer to the foundation level (Figure 8-24). This led to loss of structural wall and to the infill behind being exposed. The same barrel presents a detachment of the edge arch at the spandrel connection in the area just above the collapse (Figure 8-24). The detachment is related to a diagonal crack that

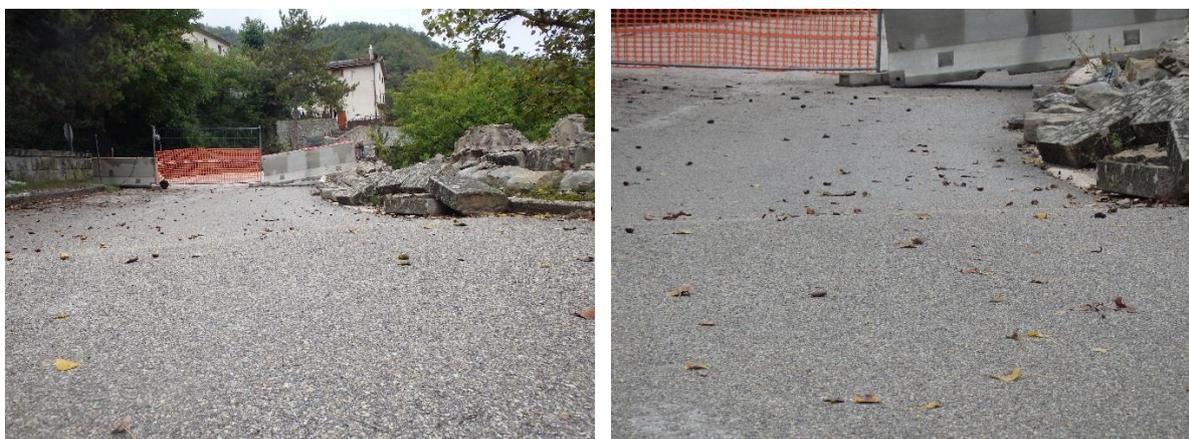
Figure 8-24 Vertical sag by the North abutment

extends halfway into the barrel vault. This zone is likely to have suffered from a combination of sideways pressure imposed by the abutment infill and loss of support from the abutment wall collapse.

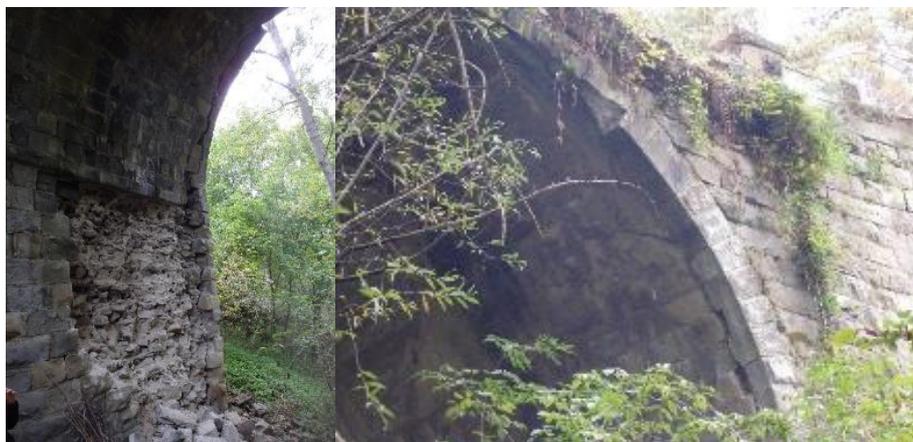
Figure 8-25 North abutment failure (left); detachment of the edge arch at the spandrel connection (right)

All the arches presented widespread cracking, the most notable being recurring horizontal cracks at the southern haunches (Figure 8-25). These indicate the possible formation of hinges caused by the seismic acceleration. One of the piers shown in Figure 8-25 presented vertical cracks indicating the possibility of increased axial loads during the earthquake.

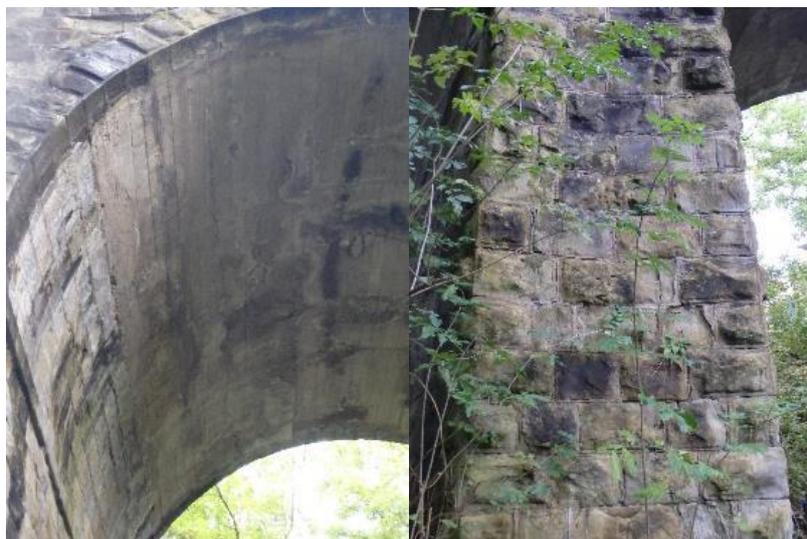
Figure 8-26 Horizontal cracks at the haunch (left), pier vertical cracks (right)

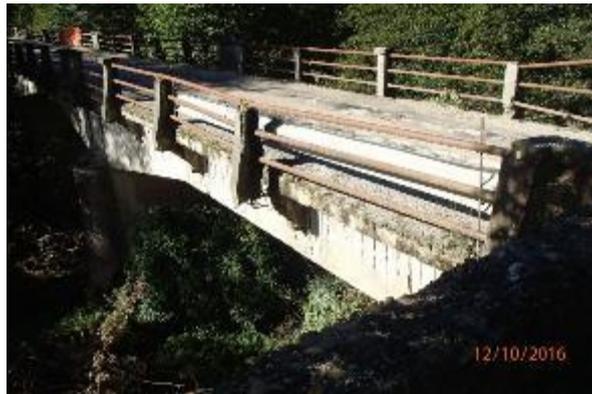
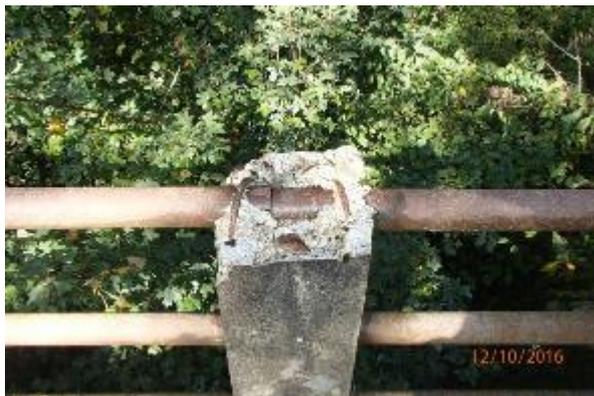
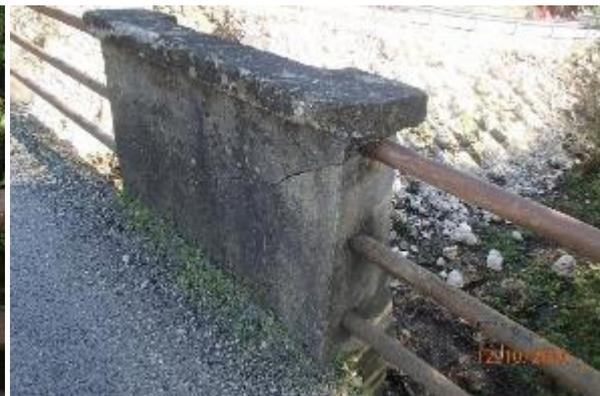
According to information gathered on site from the military troop guarding the bridge, following the seismic event of the 24th of August, the bridge was not closed but a restriction was imposed to a maximum weight of 3.5 tonnes to passing vehicles. Even though the damage on the primary elements of the bridge were not significant, some significant damage to its parapet required this restriction.

Figure 8-28 Damage on the parapet and details of the parapet

The earthquake heavily damaged the parapet's small columns; some of them have been completely detached from the deck and were only supported by the steel tubes. The damage suggests a faulty detail connection for the parapet members. In fact, the damage concentrated mainly where movement of the deck was not restrained. At mid-span, the joint in the deck was not matched by a joint in the parapet, and on the abutments the last parapet column appears to be rigidly connected to the abutment and not to the deck.

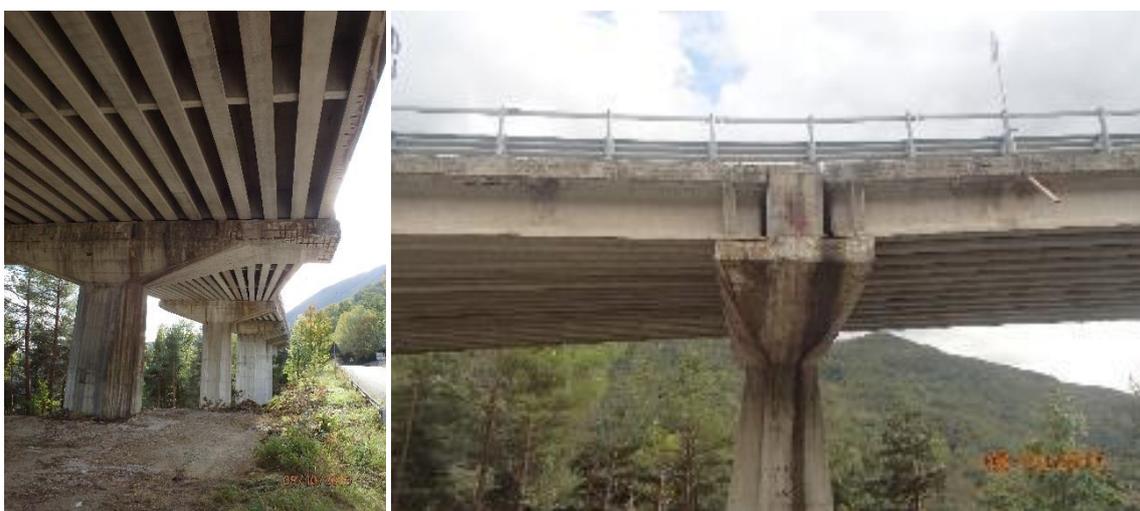
Figure 8-32 shows the first viaduct of this type inspected during the mission. This is a large multi span viaduct with span length of approx. 22m, characterized by single column piers of different height. The deck spans are separated by a vertical diaphragm above the pier heads, so two movement joints are formed at every pier. No shear keys have been identified so transversal displacement are unrestrained. The lack of proper drainage between the deck spans produces rundown and leakage at the pier crosshead, which shows signs of deterioration of the concrete cover and advanced state of corrosion of the exposed reinforcement.

Figure 8-32 General view of the first viaduct investigated ($42^{\circ}45'23.6''N$ $13^{\circ}16'37.6''E$)

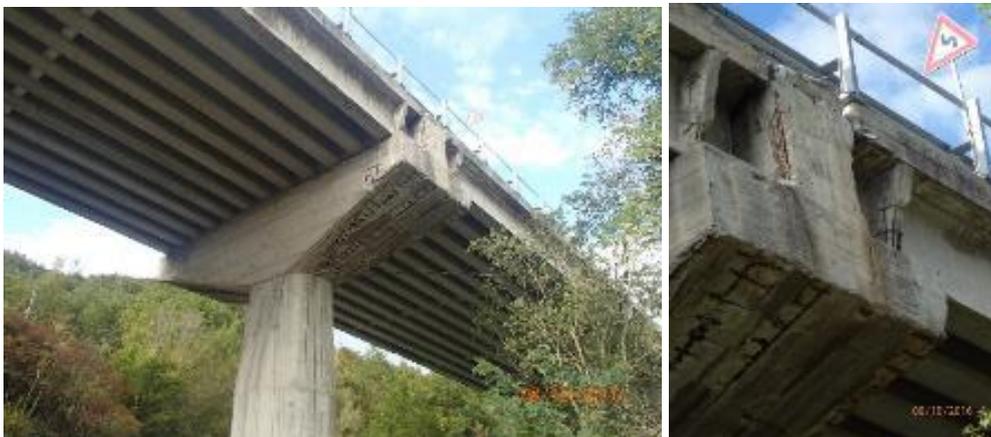
be generally assumed that the fundamental periods of the piers (apart from the shortest) are of the order of 1 sec, so the expected accelerations should not be the highest on the spectrum. The uncontrolled seismic displacements can cause issues. As shown in Figure 8-33 below, structural damage was identified on one pier crosshead wall, where a visible crack has been probably caused by the pounding effect during the seismic event.

Figure 8-33 Damage observed on the first viaduct investigated ($42^{\circ}45'23.6''\text{N}$ $13^{\circ}16'37.6''\text{E}$)

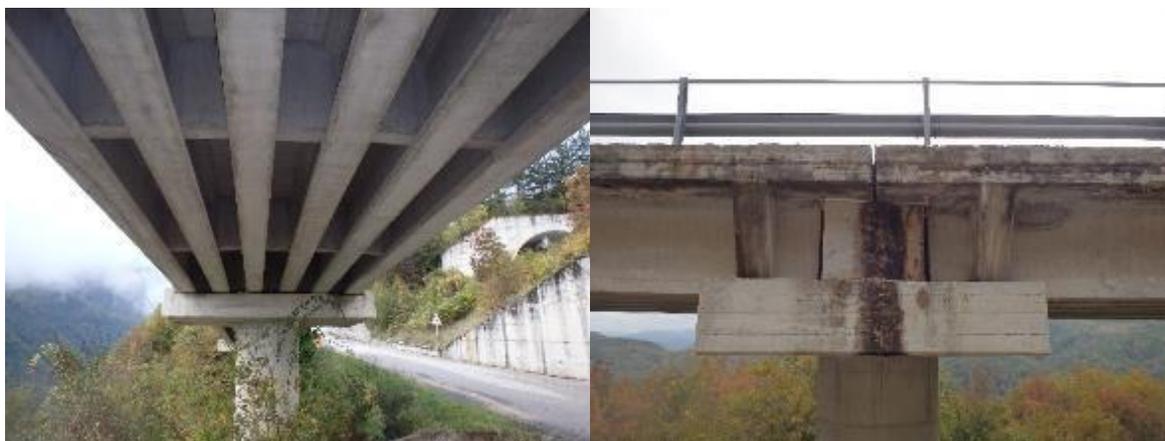
The second concrete viaduct inspected is also multi-span, with a typical span length of approx. 22m, with piers of varying height (Figure 8-34). In this case the slabs of adjacent spans extend over the pier's crosshead wall, resulting in only one movement joint (Figure 8-34). Shear keys are visible on both sides of the pier crosshead to limit transversal displacement. It has been possible to inspect the piers' crossheads, with the support of Vigili del Fuoco, checking the presence and the condition of the bearing pads. These are shown in Figure 8-35.

Figure 8-34 General view of the second viaduct investigated ($42^{\circ}44'21.8''\text{N}$ $13^{\circ}14'37.7''\text{E}$)

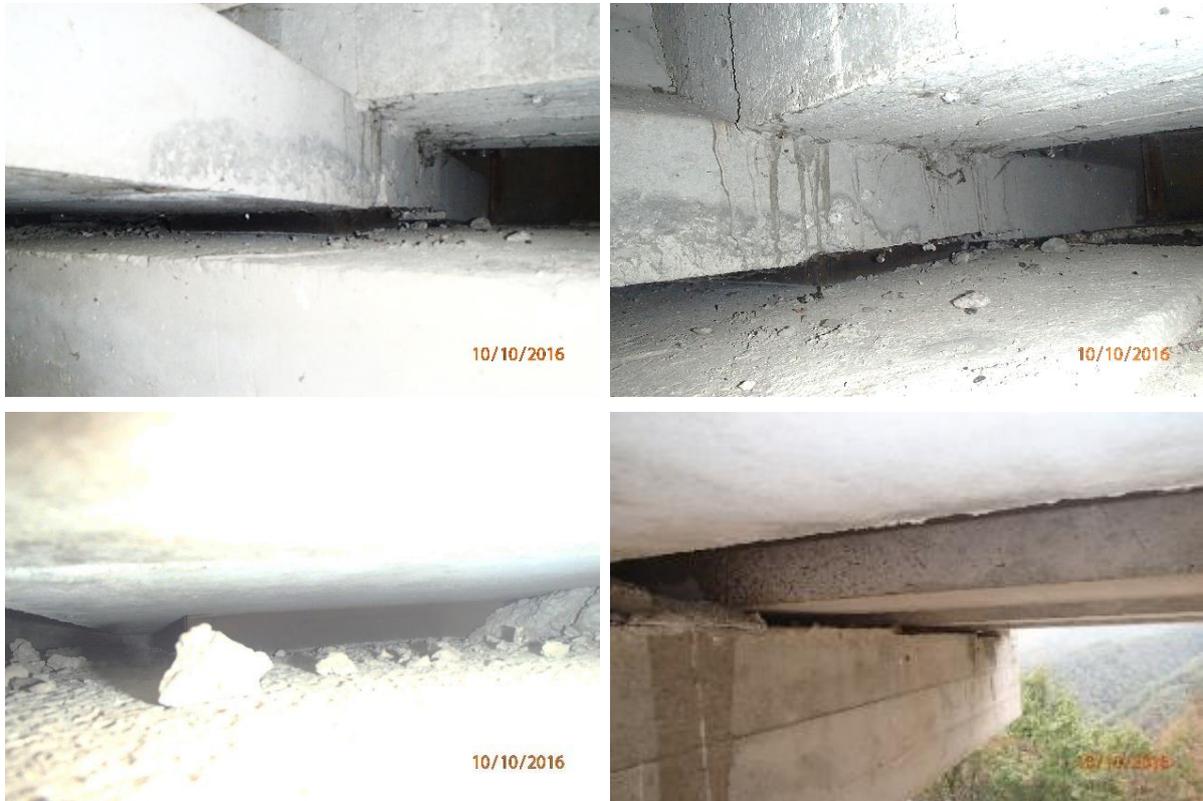
No structural damage after the earthquake was identified. The general good state of the bearing pads suggests they may have been recently replaced. On the other hand, poor detailing of the expansion joint creates a poor water drainage system which causes leakage and deterioration of the pier crossheads. It was not possible to identify the presence of a specific device adopted as expansion joint. In the gap between the concrete slabs only a curved sheet probably of plastic material collecting water is visible. Furthermore, in Italy it is quite common to find the expansion joints filled with the upper tarmac layer, which should accommodate the small predicted displacements of the deck. This asphalt fill material can break under larger displacements imposed by major seismic event, creating

Figure 8-35 Bearing pads of the second viaduct investigated

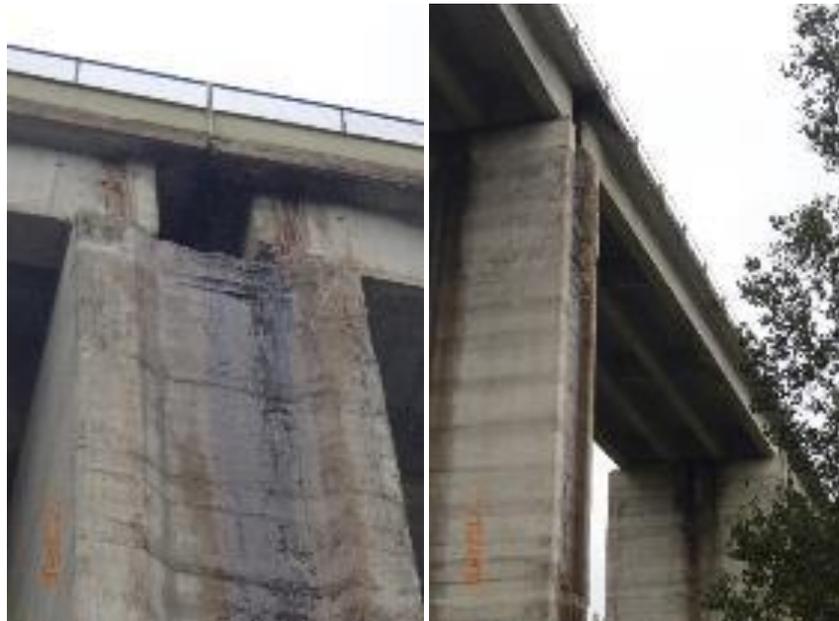
carriageway have been extensively modernised through time, and, for the most part, is today a double carriage way with two lanes in each direction. The inspection a viaduct along the SS4 (shown in Figure 8-36) was difficult because of its location, so only some details have been observed. According to the ESM database the bridge experienced a value of PGA equal to 0.867 (g) (Luzy et al., 2016). Apart from the drainage deficiency, causing advanced deterioration, the presence of a shear key at the abutment restraining transversal displacement can be observed. This element probably failed during the seismic event. In fact, a visible crack can be observed in Figure 8-37, and this suggests the lack of seismic provisions in the original design.

Figure 8-37 General view of the SS4 viaduct (42.700073 N, 13.252225 E)

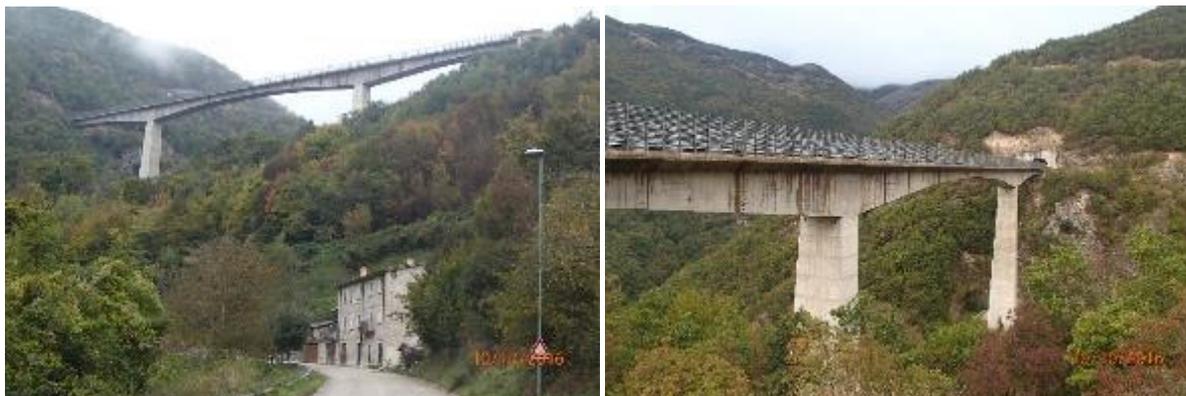
The only abutment investigated, accommodating an expansion joint, has been found in good conditions. The deck structure is integral with the piers and the bridge is therefore characterized by a different dynamic behaviour from the simply supported deck viaducts presented before. Due to its dimensions, it is likely that the fundamental periods of the structure are large enough to maintain a low level of accelerations, even if big displacements must be expected.

Figure 8-39 General view of the fifth viaduct investigated ($42^{\circ}44'27.4''\text{N } 13^{\circ}14'14.0''\text{E}$)

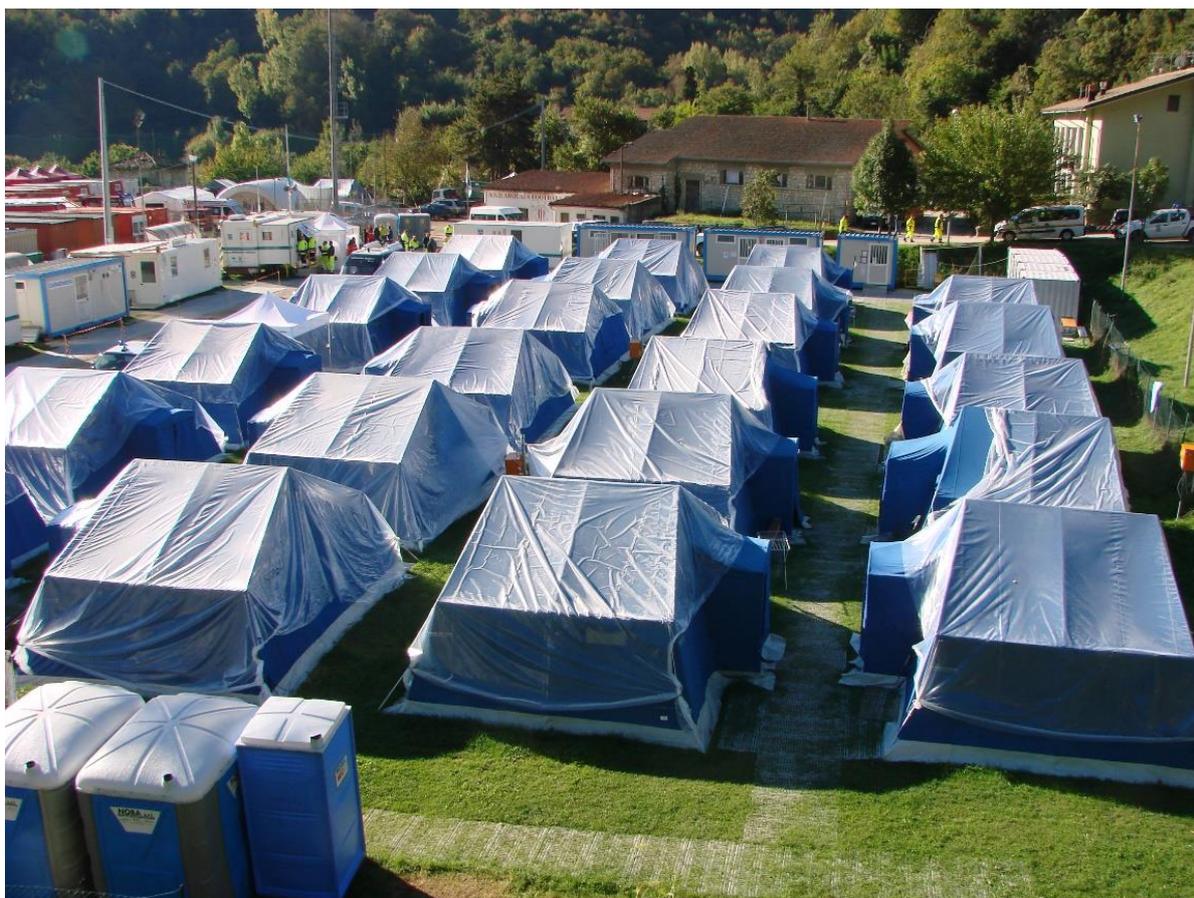
At the time of the EEFIT team fieldwork, the tent camps (Figure 9-1) that had been erected at Amatrice and Arquata del Tronto were gradually being emptied as their inhabitants were transferred to hotels or elsewhere. This had already happened at Accumoli, while for Pescara del Tronto the inhabitants were amalgamated with those of nearby Pescara. Those residents who had an alternative to being lodged at the expense of the Regional Governments in hotels could request a *contribuzione di autonoma sistemazione*, a monetary support to help them find their own lodging. Many of the hotels were distant from the affected area in major towns such as Rieti, Ascoli Piceno and Teramo, as locally there was relatively little hotel accommodation and any such structures tended to be damaged.

Figure 9-1 Tent camp at Arquata del Tronto, 8 October 2016.

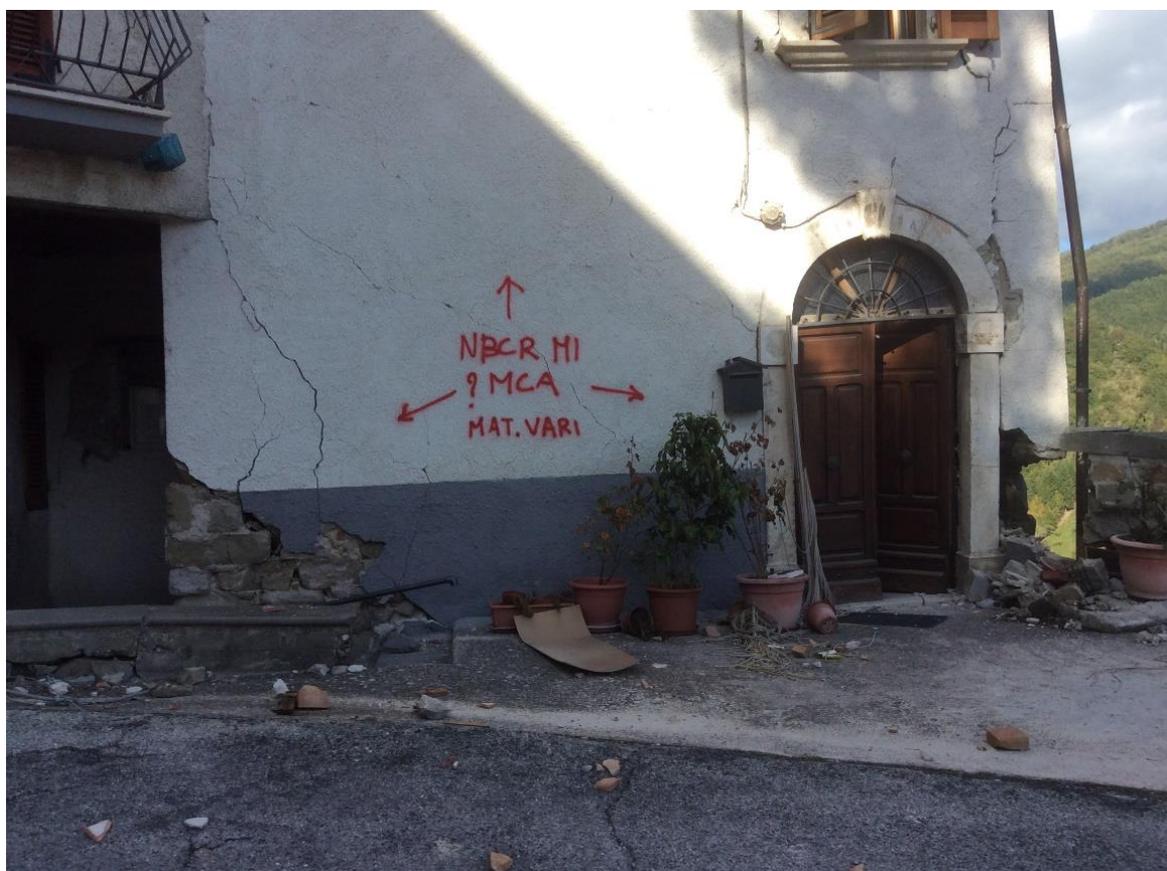
Figure 9-2 Fire Service notation of hazardous materials in a damaged building

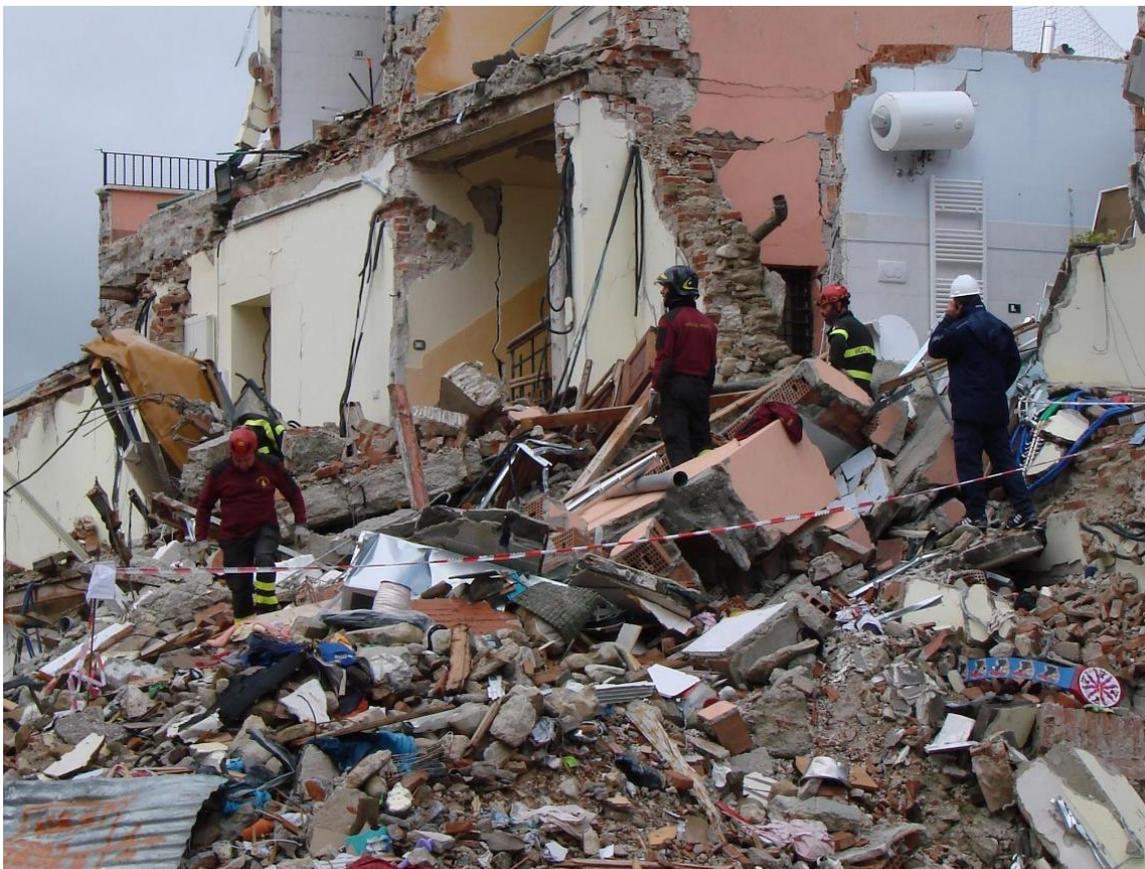
Figure 9-3 Firemen securing a commercial premises in Amatrice centre.
