THE MUISNE, ECUADOR EARTHQUAKE OF 16 APRIL 2016

A FIELD REPORT BY EEFIT

THE M_w7.8 MUISNE ECUADOR EARTHQUAKE OF 16 APRIL 2016

September 2018

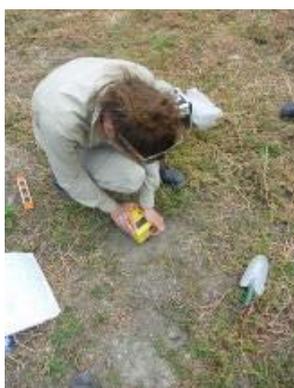
Figure 3-7 Microtremor test set up in Tarqui, Manta.

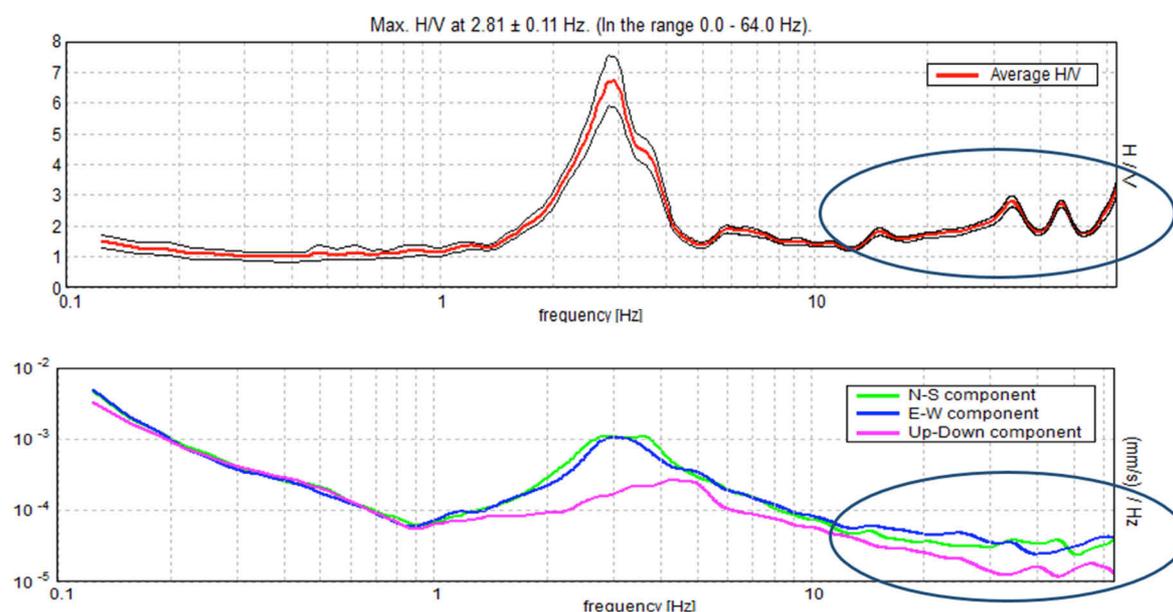
TROMINO® is designed to minimise the influence on measurements of external noise (wind, electronic noise, noise induced by external cables and so on). However, the device should be placed during the recording far from noise sources, especially from electromagnetic sources such as mobile phones -cellular and cordless-, PCs, displays, and monitors). These can emit strong pulsed electromagnetic fields which appear as background noise on the trace. The strongest perturbation observed during the field measurement was hence close to the APO1 seismometer station, located within a meteorological station area. This can be seen in the “wobbly” end of the spectra in Figure 3-8.

Figure 3-8 APO1 (T9) amplitude spectrum of the recorded surface waves and H/V spectral ratio.

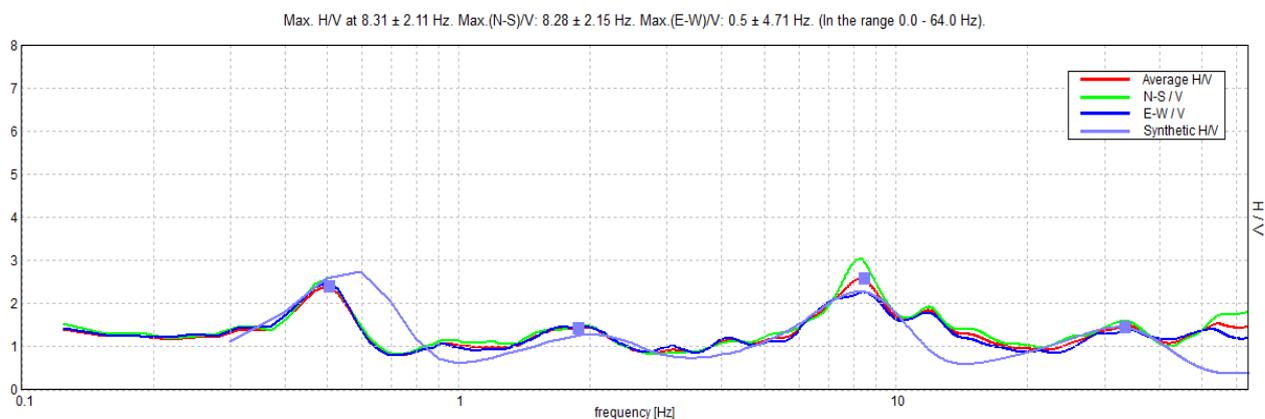
The T1 recording could not be used due to excessive noise although the general reading is in good agreement with record at T2. As shown in Figure 3-11 and Figure 3-12, the H/V spectra obtained at T2 and T13 locations have similarities but also some differences that justify deriving two distinct V_s profiles. They are sited at the Manta Shelter location and just outside of the most damaged area of Tarqui, respectively.

Figure 3-11 Comparison of the H/V T2 in-situ measurement and its fit to V_s profile model at the Shelter location, Manta.

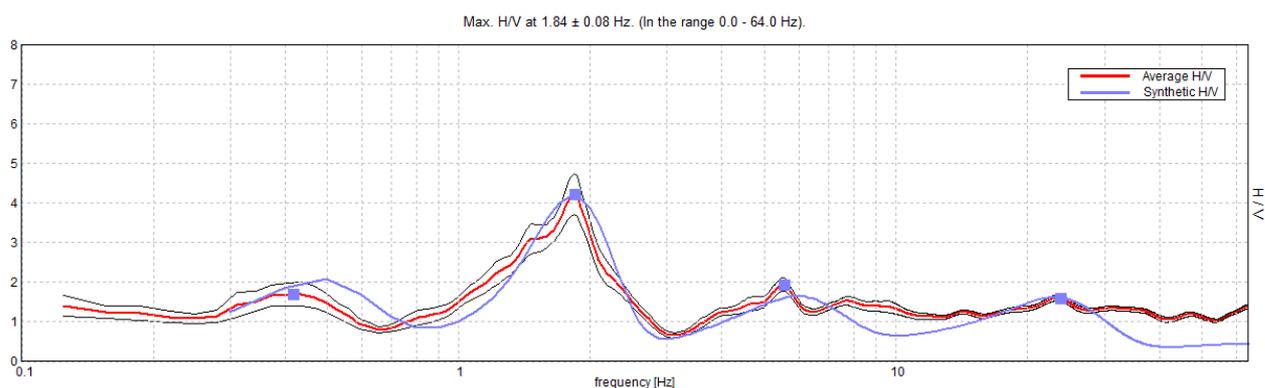
Figure 3-12 Comparison of the H/V T13 in-situ measurement and its fit to V_s profile model at Tarqui, Manta.

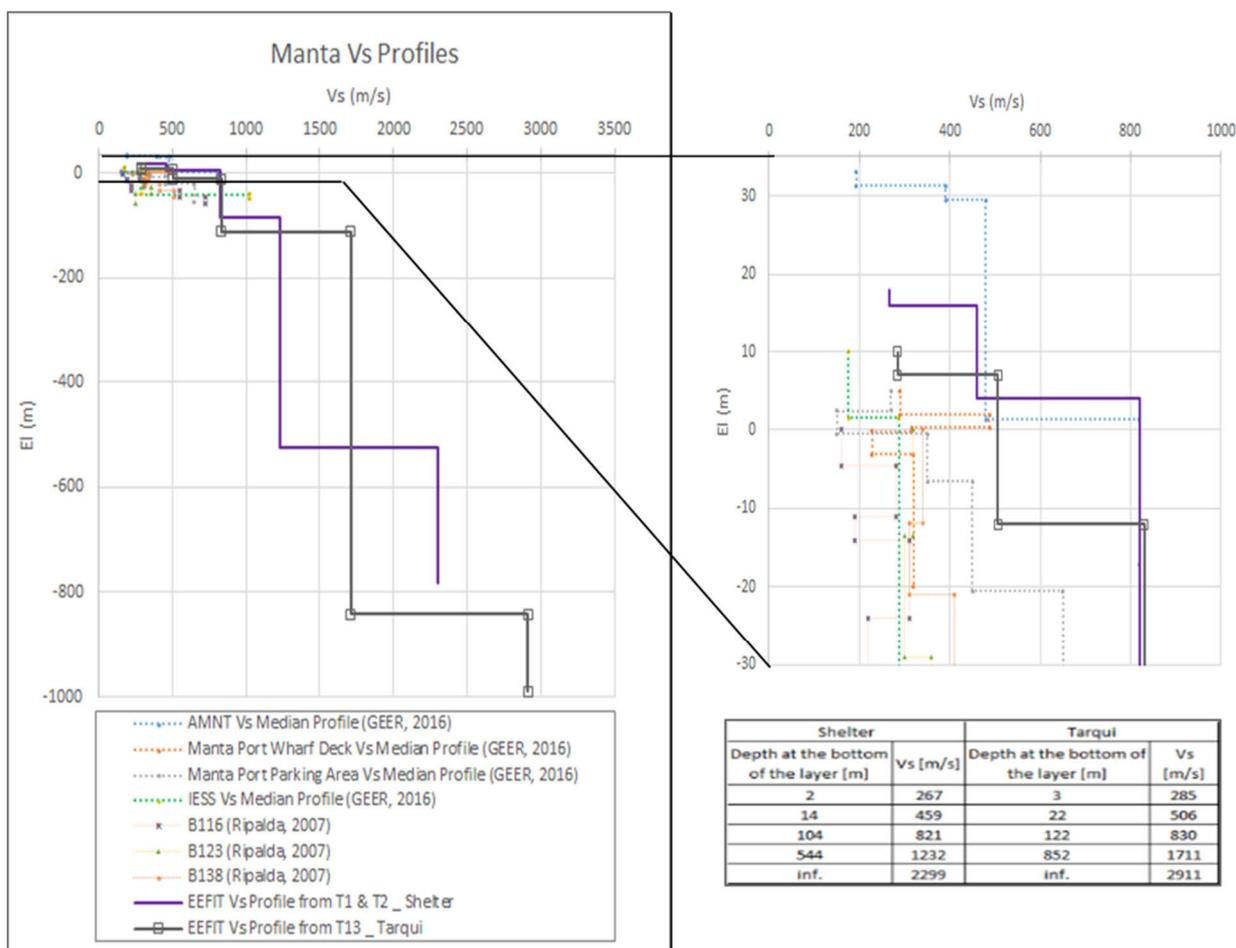
The V_s profiles derived through an inversion constrained by a first peak corresponding to a shallow stratigraphic transition at 2-3m depth are shown in Figure 3-13.

It should be noted that the shorter the reading, the less reliable the deeper layer interfaces (lower frequency peaks) are in the interpretation of the microtremor test. For a 15min reading, it is unlikely that any interface below 100m can be accurately defined. Therefore, the V_s profiles derived hereby, although matching fairly well down to frequencies as low as 0.4Hz, should only be considered as indicative below 100m.

Figure 3-13 Vs profile models for Manta.

The profile derived at the site of the shelter, further away from the centre, hence best matches the profile at the seismometer station AMNT, which is located furthest on the other side of the river estuary (see Figure 3-13). In Tarqui and in the port area, closer to the river, sites are softer. The EEFIT microtremor test in Tarqui corresponds fairly well to the GEER (2016) HVSR tests results. Their minimum site frequencies varied from about 0.6 to 2.7Hz, with increasing values towards the river (Appendix A and Figure 3-7).

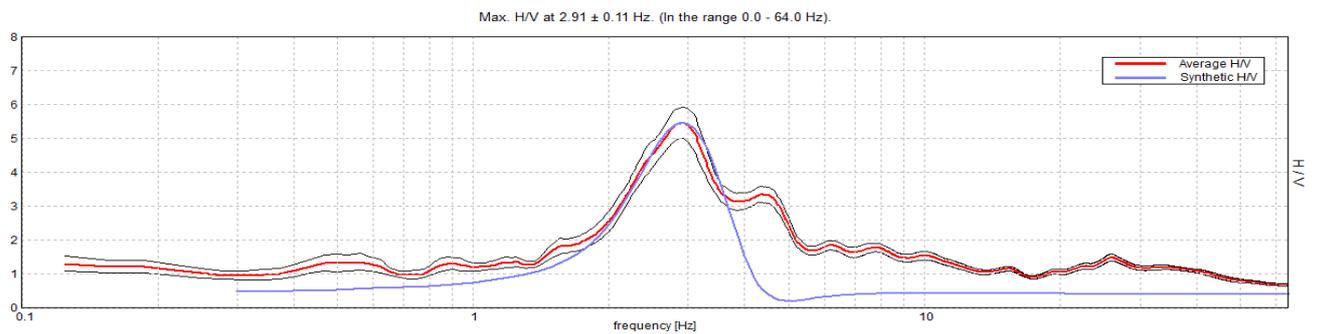
APO1 (T6 to T9)

The readings at T6 to T9 close to APO1 were very consistent with each other, proving very little lateral variation in stratigraphy along the alignment of the measurements. Figure 3-14 shows the reading at T8 and the H/V spectral ratio corresponding to the simplified Vs model derived for the botanical garden sites (T6 to T9). Figure 3-19 shows that the simplified Vs model is in good agreement with the APO1 in-situ Vs measurement carried out by GEER (2006).

H = 32m; $V_s = 360$ m/s; $V_{s,l} = 780$ m/s

Figure 3-14 H/V T8 reading and corresponding spectrum for V_s simplified model derived for the Botanical Garden sites (T6-T9).

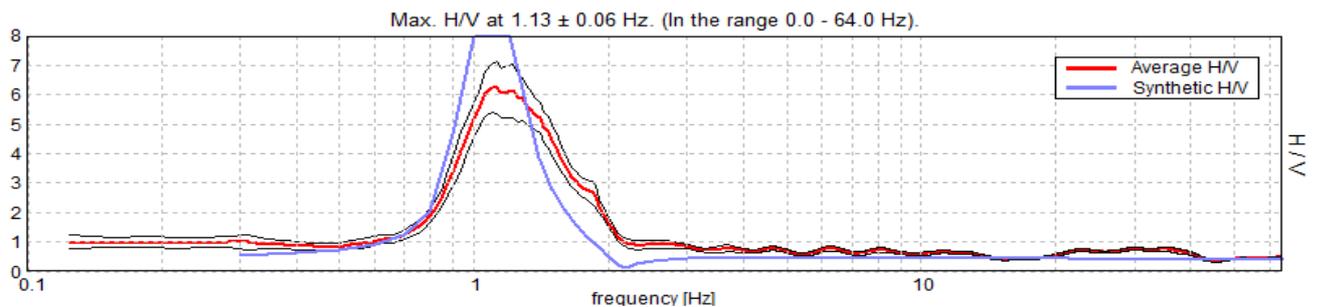
Z0 (T3 & T4)

The measurements in Z0 (T3 and T4) are very similar and therefore interpreted together for a common Vs simplified model (Figure 3-19). The reading at T5 is also fairly similar to those at T3 and T4, although it has a distinct single peak whilst in Z0, the main peak is bi-headed, indicating the presence of two main stratigraphic interfaces close together.

Option 1: H = 32m; $V_s = 144$ m/s; $V_{s,l} = 800$ m/s

Figure 3-15 H/V T4 reading and corresponding spectrum for the first option of interpretation of the V_s simplified model derived for the Z0 sites (T3 & T4).

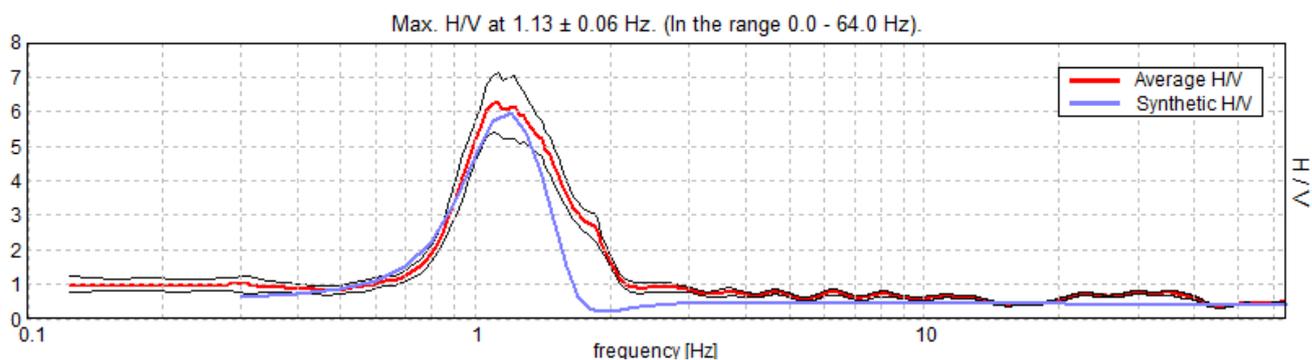
Option 2: H = 80m; $V_s = 360$ m/s; $V_{s,l} = 800$ m/s

Figure 3-16 H/V T4 reading and corresponding spectrum for the second option of interpretation of the V_s simplified model derived for the Z0 sites (T3 & T4).

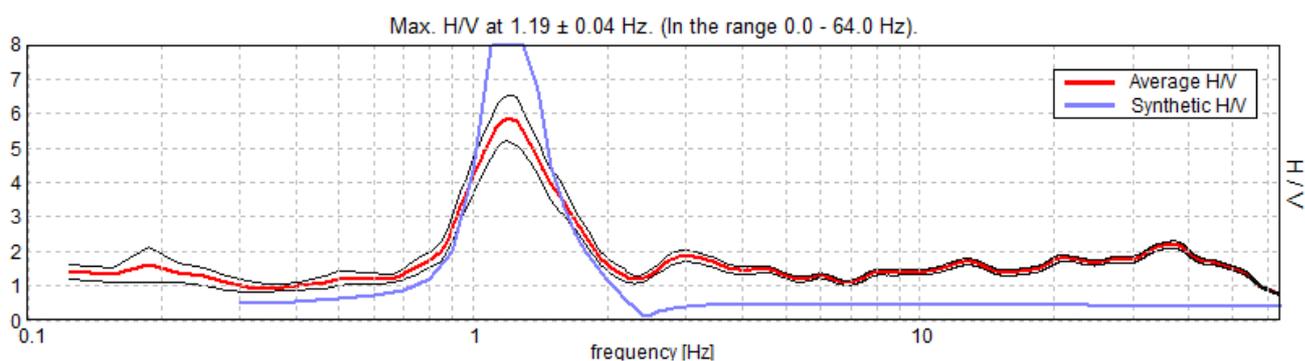
River Bank (T5)

Option 1: $H=28\text{m}$; $V_s = 140 \text{ m/s}$; $V_{s,i}=1000\text{m/s}$

Figure 3-17 H/V reading and corresponding spectrum for the first option of interpretation of the V_s simplified model derived for the Portoviejo river bank at T5.

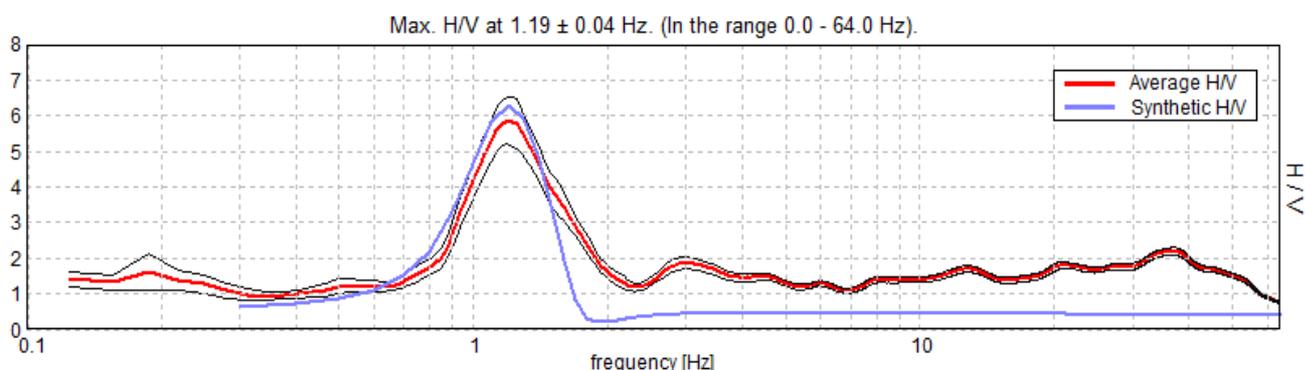
Option 2: $H=76 \text{ m}$; $V_s=340\text{m/s}$; $V_{s,i}=800\text{m/s}$

Figure 3-18 H/V reading and corresponding spectrum for the second option of interpretation of the V_s simplified model derived for the Portoviejo river bank at T5.

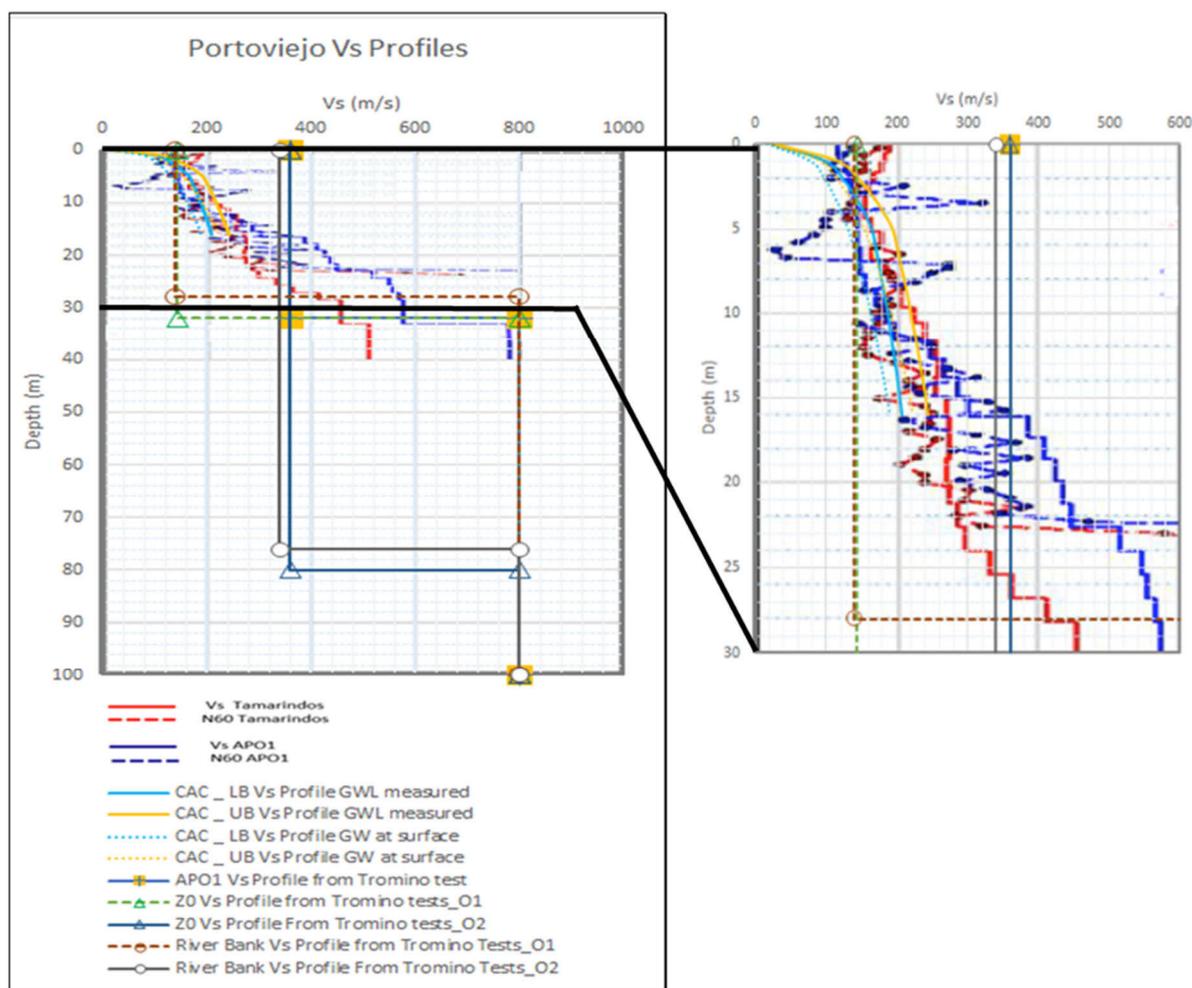
Figure 3-19 Interpreted V_s measurements and models for Portoviejo. The Tamarindos and APO1 MASW and MAM V_s measurements come from GEER (2016). The CAC V_s profiles are derived from SPT-N measurements (Hidroplan, 2016) (see Appendix A).

Table 3-8 and Figure 3-19 show that the V_s profiles at the different ground investigation locations are fairly consistent in terms of superficial alluvial deposits. The main difference is the depth to bedrock, which is interpreted, as expected, to be deeper in the sites closer to the river (T3 to T5). These sites also correspond to the locations of high levels of damage observed (zone 0 and bank of the river). However, the damage intensity distribution cannot be solely explained by this basin effect, since this trend was not observed along the river symmetrically. It may be hypothesised that the seismic wave amplification may have been increased by the topography. The shortest distance to higher bedrock levels (hills) from the sites on deeper alluvial deposits indeed corresponds to where most of the damage was concentrated (see arrows in Figure 3-27).

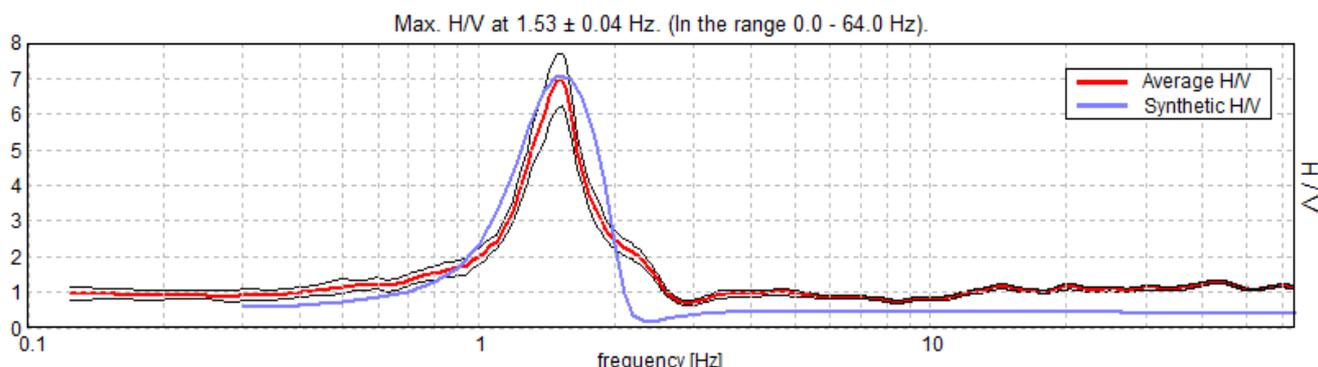
Bahía Alcivar Hospital (T10)

Both readings are very clear and show distinct dominant peak, at 0.68Hz and 1.53Hz for T12 and T10 respectively. Two options for the interpretation of T10 in terms of V_s profile are proposed (see Figure 3-20 and Figure 3-21).

The first one is constrained by the average V_s derived from the SPT measurements at the closest available ground investigation site PMB, *i.e.* 400m/s (see Figure 3-23). The second one is constrained on the other hand by the depth to bedrock to be close to that of the NW bridge measurements. The two options provide a very good and very similar match to the recorded H/V spectral ratios. However, as seen in Figure 3-5, the geology differs on the North and South side of the Chone river at the mouth of the estuary, and therefore Option 1 of the V_s interpretation of the T10 recording is likely to be closer to the field condition.

Option 1: $H=72$; $V_s = 400$; $V_{s,l} = 1000\text{m/s}$

Figure 3-20 H/V reading and corresponding spectrum for the first option of interpretation of the V_s simplified model derived for the Bahía Hospital site T10.

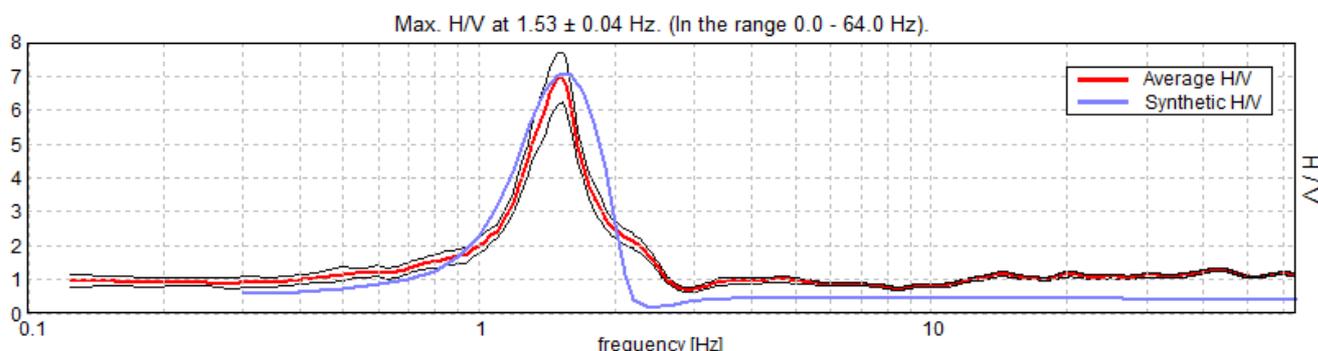
Option 2: $H = 100$; $V_s = 560$ m/s; $V_{s,l} = 1400\text{m/s}$

Figure 3-21 H/V reading and corresponding spectrum for the second option of interpretation of the V_s simplified model derived for the Bahía Hospital site T10.

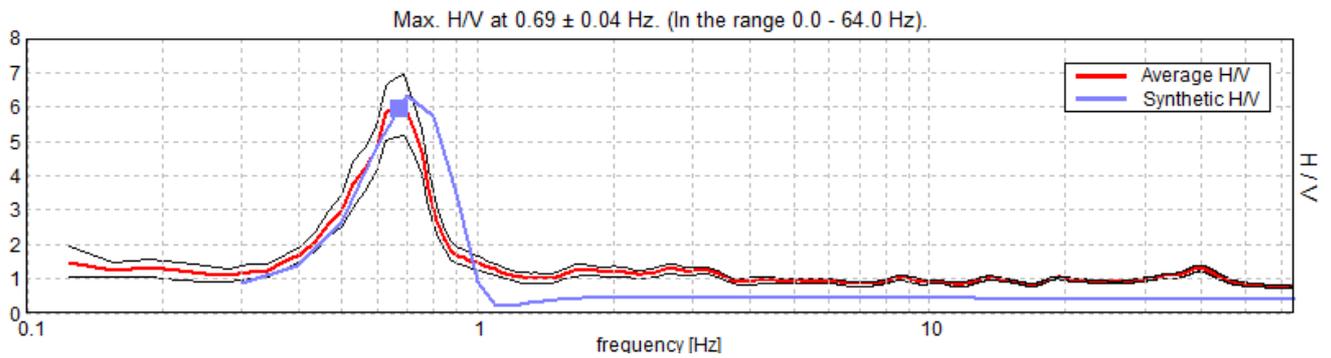
NW embankment of the Los Caras Bridge (T12)

The T12 V_s interpretation matches well the SPT-based V_s simplified profile for the Los Caras bridge (GEER, 2016), courtesy of the Ecuador's army Corps of Engineers, on the basis of which it was constrained, *i.e.* the depth to bedrock of about 70m (see Figure 3-23). It also provides a good fit in terms of H/V spectral ratio to the record (Figure 3-22).

$H= 75\text{m}$; $V_s = 200\text{m/s}$; $V_{s,l} = 489\text{m/s}$

Figure 3-22 H/V reading and corresponding spectrum for the V_s simplified model derived for the NW embankment of the Los Caras Bridge, site T12.

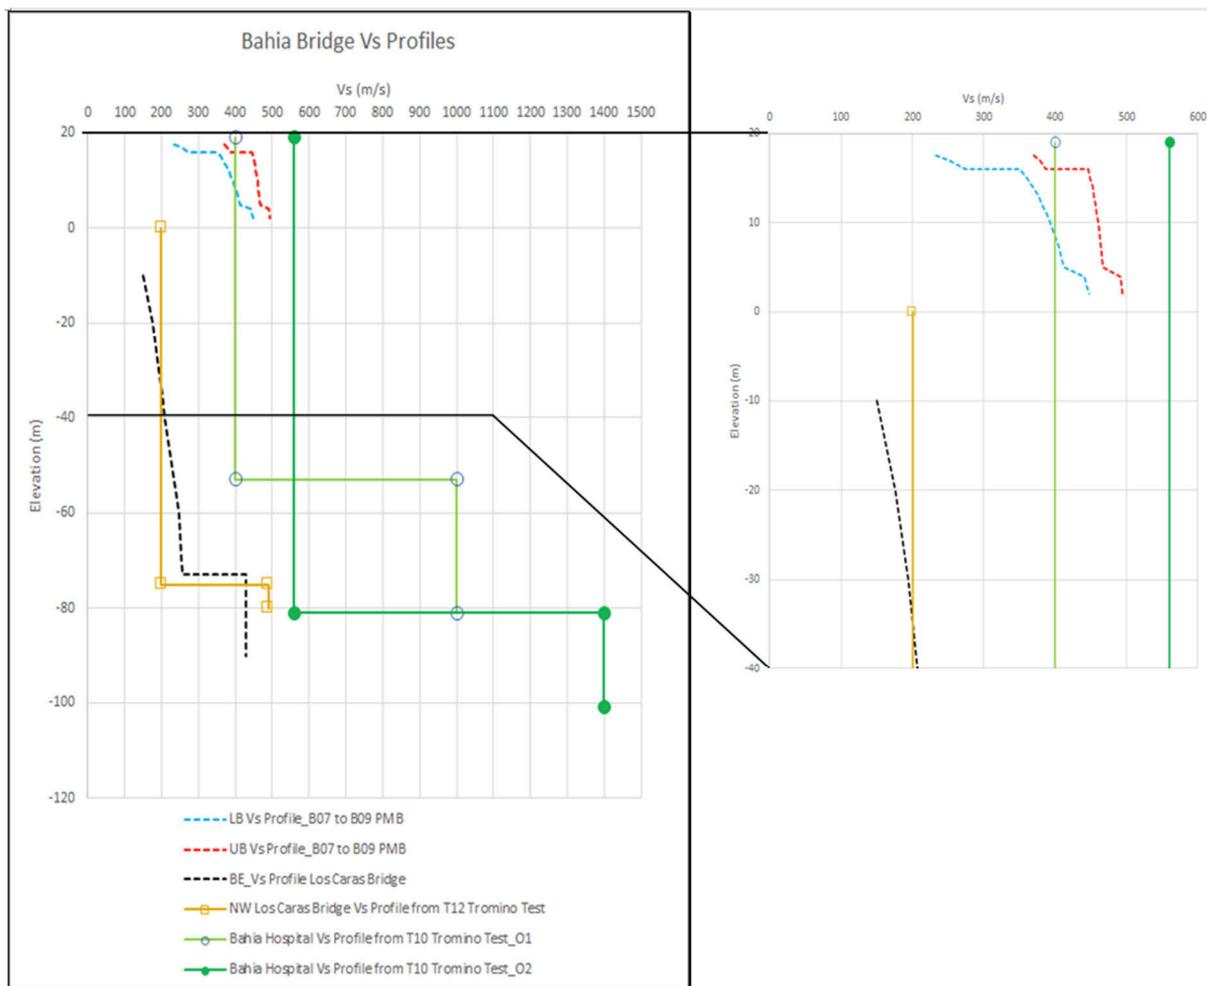
Figure 3-23 V_s profiles for Bahía. The PMB profiles are derived based on SPT-N values from LUP (2016), and the Los Caras Bridge best estimate V_s profile is based on a SPT-N simplified profile provided to GEER (2016) by the Ecuador's Army Corps of Engineers (see Appendix A).

The two microtremor tests carried out on each side of the mouth of the Chone Estuary in Bahía de Caraquez (T12) and San Vicente (T10) are in good agreement with the nearby ground investigation results from other sources: *i.e.* the LUP (2016) data and the Los Caras bridge GI data taken from GEER (2016) respectively (Table 3-9). The ground investigations carried out close to the North embankment of the Los Caras bridge on the San Vicente side indicate a softer profile, categorised as Class D, compared to the sites categorised as Class C on the Bahía de Caraquez side (Figure 3-23).

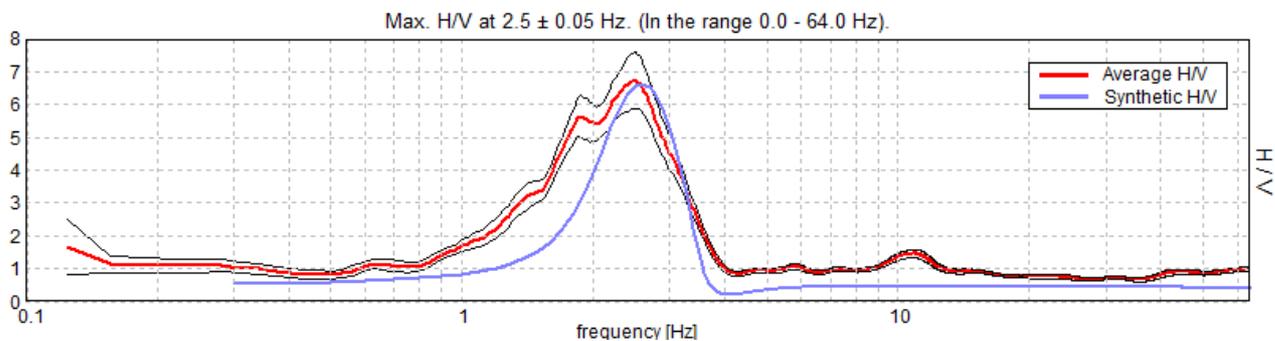
was only very slightly damaged, with a crack observed on the ceiling and no more significant damage reported by the owner. The seismometer was located in the garden. Quite a lot of noise of heavy traffic and machinery was noted during the tests, but they do not seem to have had a significant impact on the reading, which remains clear (Figure 3-24). A simplified V_s profile was derived which corresponds well with the GEER (2016) in-situ measurement (Figure 3-25).

Figure 3-24 Comparison of the APED microtremor test reading H/V ratio to that of the corresponding simplified V_s profile derived.

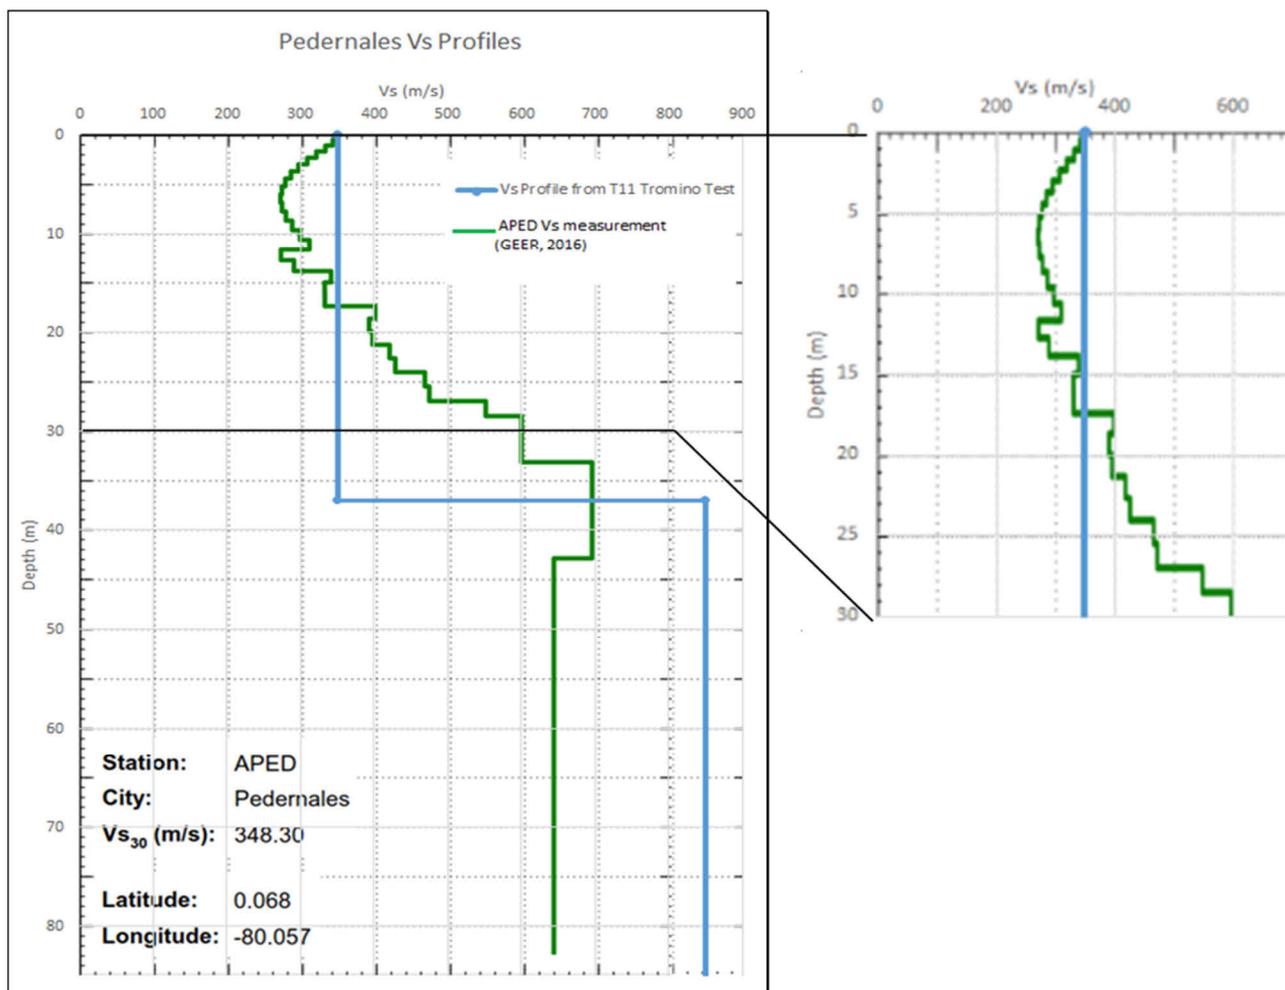
Figure 3-25 V_s profile derived for APED, Pedernales.

Limited ground investigation is available for Pedernales. However, the V_s profile inversion from the microtremor test carried out during the mission close to the seismometer station APED matches well with the in-situ V_s measurement results from GEER (2016) (see Figure 3-25). Over the first 30m depth, the average shear wave velocity is assessed to be around 350m/s, hence corresponding to a relatively stiff Site Class D site.

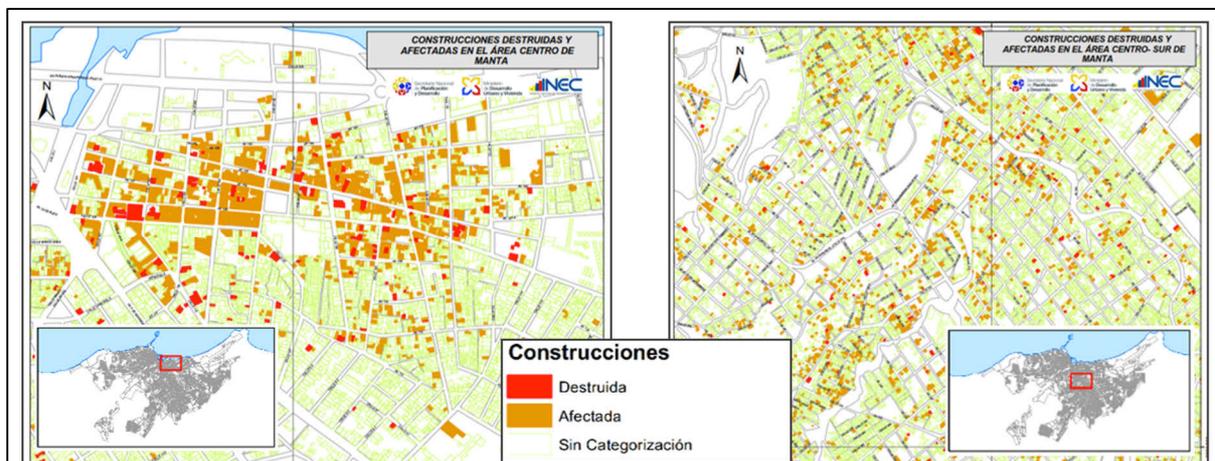
It would also be necessary to gather more information in a North-South direction to better describe the variability in soil conditions of Manta and its potential correlation to damage distribution. More ground investigation (GI) is therefore needed to fully understand the site effect contribution to the relatively high concentration of damage in northern Tarqui observed compared to its surroundings (see Figure 3-26).

Figure 3-26 Preliminary rapid assessment damage map (IGM, 2016).

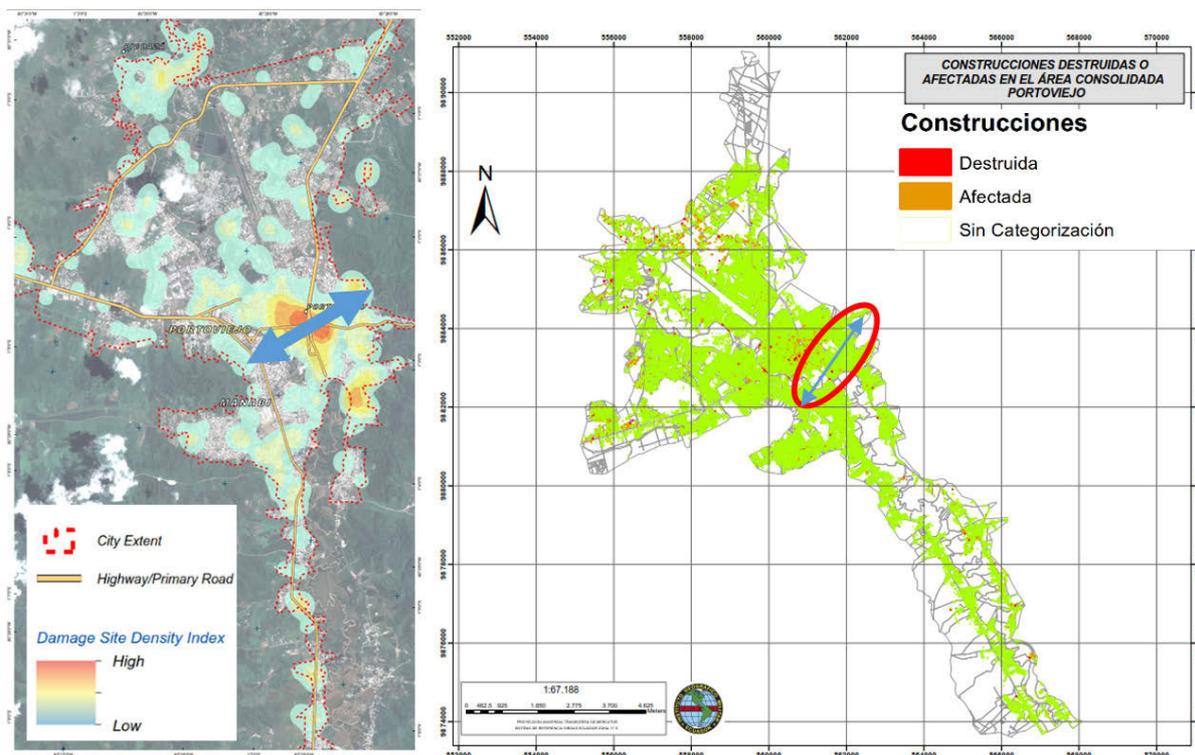
Figure 3-27 shows the rapid damage assessment carried out based on satellite imagery by UNOSAT for Portoviejo as well as the one carried out by IGM. Both maps are in fairly good agreement in terms of identification of the most damaged area. It corresponds to quite a localised area in the city centre. The seven microtremor tests carried out by EEFIT in the city and the other ground investigation data presented in Appendix A were analysed to understand the potential site effect contribution to the damage intensity distribution.

Figure 3-27 Rapid damage assessment map for Portoviejo (a - UNOSAT, 2016; b- IGM, 2016).

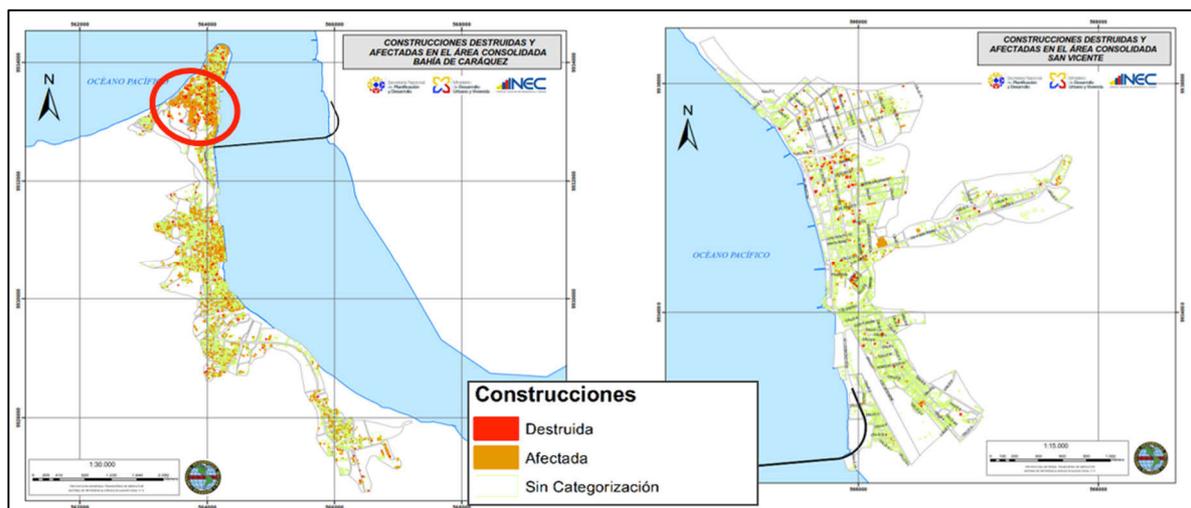
As shown in Appendix A, this difference may be associated to a difference in geology, whereby the north bank is associated to the Borbon formation, whilst the southern side is characterised by the presence of the older Onzole formation. The topography is also steeper on the Bahía side than in San Vicente where thicker estuarine deposits may be present. Finally, the concentration of higher damage levels in the circled area in Figure 3-28 may potentially partly be due to some degree of topographic effect, since it corresponds to some of the higher grounds. The topographic differential was of about 30m between the end of the peninsula and the furthest inland part of the area circled in red. However, a significant number of structures remained not categorised in the peninsula at the time Figure 3-28 was issued. On site, some significant damage was observed there as well (see Section F).

Figure 3-28 Rapid damage assessment map for Bahía de Caraquez and San Vicente, across the Chone Estuary (IGM, 2016).

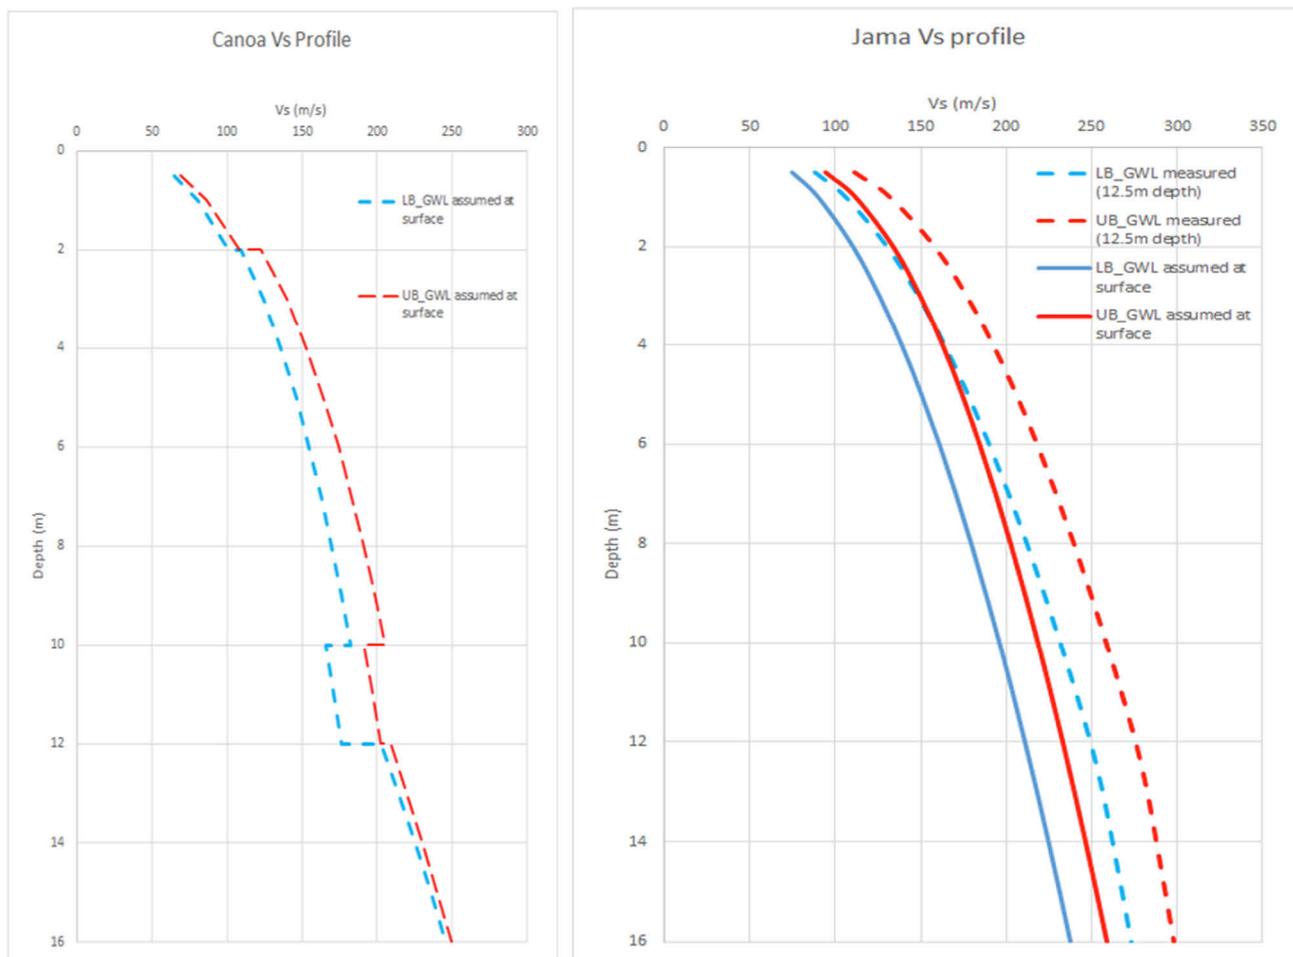
observed at these locations. The V_s profiles derived from the SPT measurements carried out down to 16m depth using the PEER (Wair *et al.*, 2012) SPT- V_s correlation recommendations are shown in Figure 3-30. The profiles are very similar at both locations and if the trend continues for the following 15m depth, the site can be expected to be categorised as Site Class D. This would of course need to be confirmed and evidenced by further ground investigation.

Figure 3-30 Jama and Canoa SPT-based V_s profiles (based on LUP (2016) measurements).

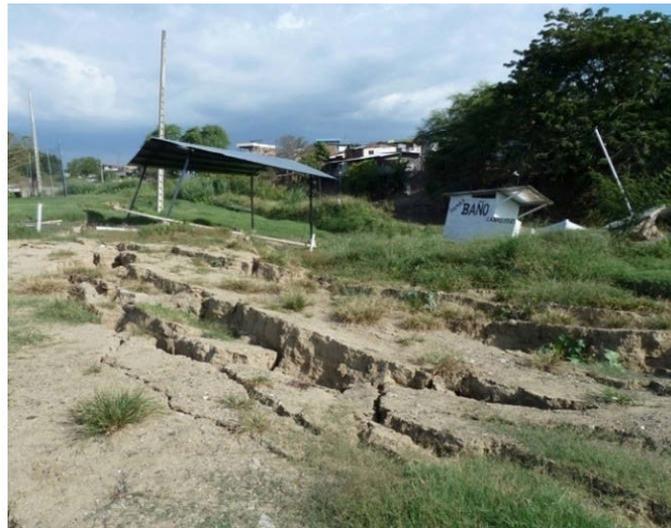
Liquefaction induced lateral spreading caused damage to a significant number of structures in Portoviejo. The example of the induced settlement and rotation of two structures adjacent to a sport pitch beside the Rio Portoviejo are shown in Figure 4-4. The damage to the pitch surface was also extremely detrimental to the owners of the land and operators of the pitch, with whom the team met and talked. Concern on the loss of revenue from pitch rental business interruption was great, as was the cost to remodel the damaged surface to make it operable again. Section 7.2.3. also mentions the damage induced to a footbridge close by.

Figure 4-4 Structural damage due to lateral spreading along Rio Portoviejo consisting in the rotation and settlement of structures at sports pitch.

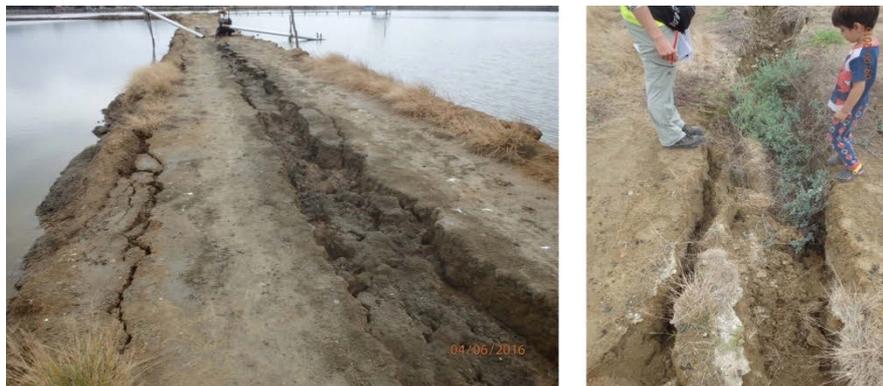
Figure 4-7 Liquefaction induced damage to shrimp farm dykes in Chone River estuary.

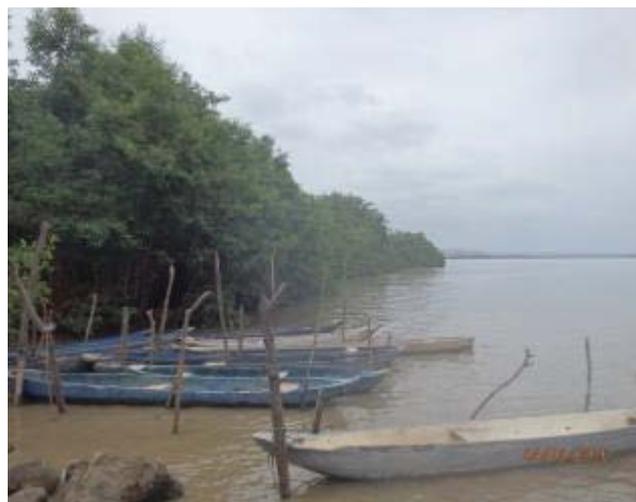
In addition to the lateral spreading of shrimp farm dykes, lateral spreading of mangrove swamps in the River Chone Estuary (Figure 4-8) was observed. These mangrove swamps fall within a nature reserve, Refugio de Vida Silvestre – Islas Corazon y Fragatas. Some of these areas were identified as having been affected by liquefaction during the satellite image analysis conducted by the British Geological Survey (BGS). Significant rotation of mangrove

trees was observed along the northern bank of the River Chone. From discussions with locals, it was understood that lateral movements of trees along the river bank of up to 15m occurred. Given the density of this vegetation and the natural environment, these significant movements would not have been noticeable to a first time visitor to the area. It is understood, from discussions with locals, mangrove swamps in the centre and south of the river were affected in a similar manner and to a similar extent. However, this was not verified by the EEFIT mission.

Figure 4-8 Lateral spreading of mangrove swamps in Chone River Estuary.

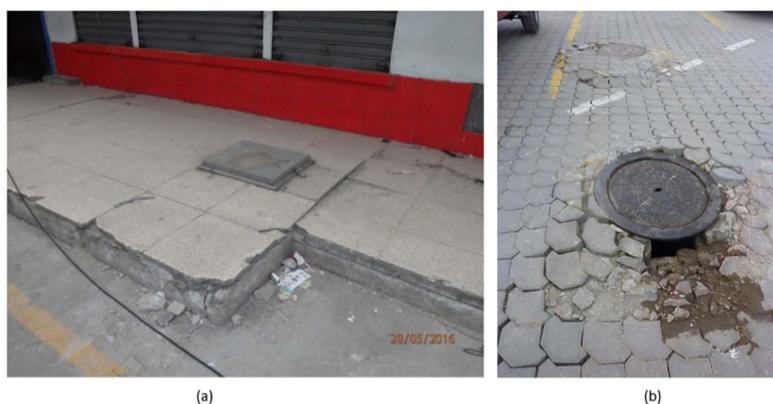
Liquefaction induced uplift of a pipe by 20mm and a manhole by 40mm in Manta were observed (Figure 4-9a). Two potential sand boils were observed close by. In Pedernales, manholes protruding by 30mm were observed (Figure 4-9b). The limited uplift of these structures is likely to have been due to the conditions of the soil surrounding the backfilled trenches, which will have had a notable effect on the drainage conditions (Yasuada and Kiku, 2006).

Figure 4-9 Protrusion of manholes in Manta (a) and Pedernales (b).

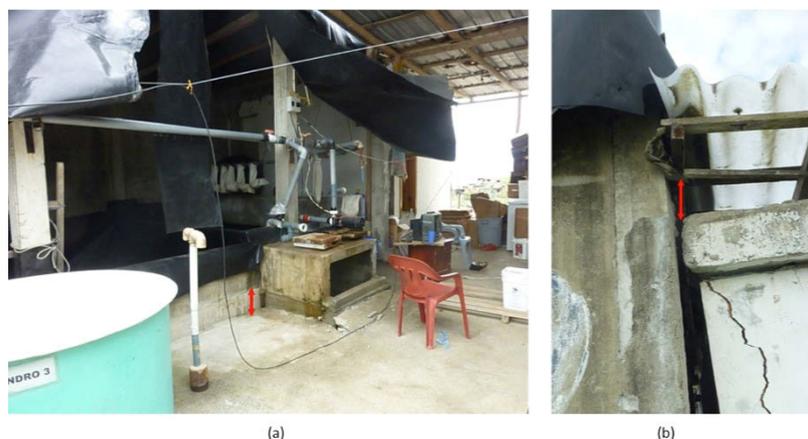
On the seafront in Pedernales, a shrimp farm showed evidence of the effect of liquefaction induced buoyancy on underground structures. The shrimp farm consists of multiple structures adjacent to one another. One of the structures contained concrete underground storage tanks which extended approximately 3m below the ground surface. These tanks were used in the shrimp farming process, and were empty at the time of the earthquake. The other adjacent structures housed above ground storage tanks and a sizeable amount of machinery. They did not have any underground storage tanks. The absolute settlements of the structures were not known since the surrounding ground has settled. However, the differential settlement was measured and showed a relative uplift of 210mm between the structure housing the underground storage tanks and the structure behind it (Figure 4-10a) and 120mm higher than the white structure to its right (Figure 4-10b).

Figure 4-10 Relative uplift of structure with underground storage tanks in Pedernales, showing locations of measured relative settlement.

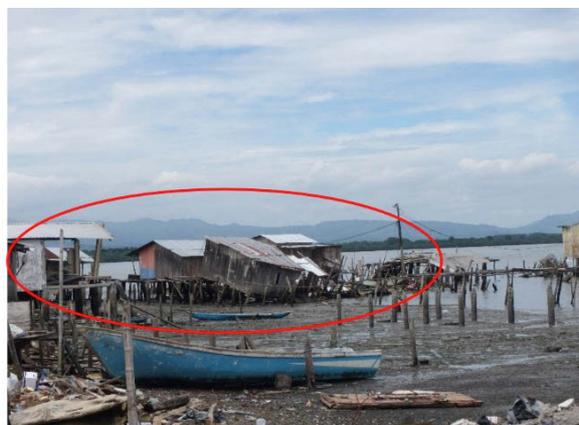
In Chamanga, a large number of residential buildings were constructed on timber piles. Piers to launch fishing boats were also constructed in this fashion. The piles were reportedly

embedded 1.5m into the riverbed. A sizable number of these residential buildings and piers collapsed due to the earthquake (Figure 4-11). This is likely to be due to the piles having insufficient lateral and vertical capacity when the soil liquefied. This is despite the structures built on them being relatively lightweight which demonstrates the possibility of soil liquefaction occurrence.

Figure 4-11 Collapse of structures on timber piles in Chamanga.

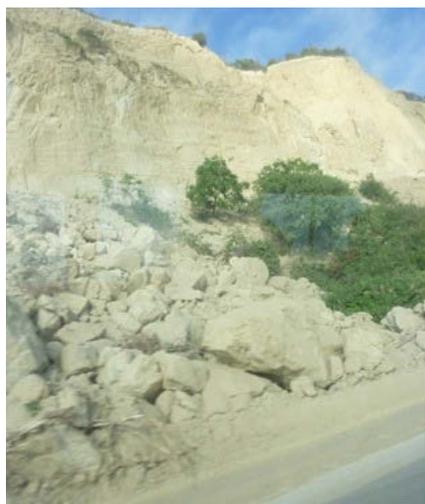
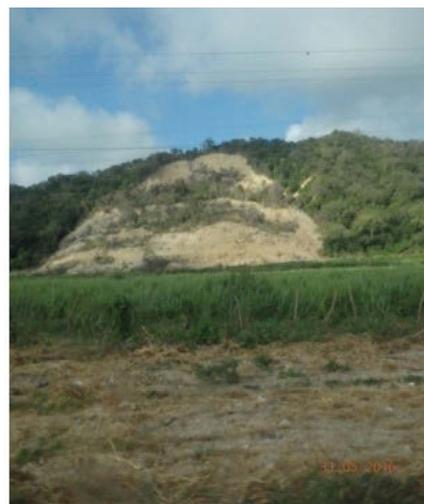
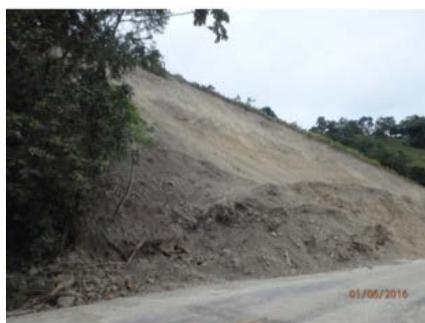
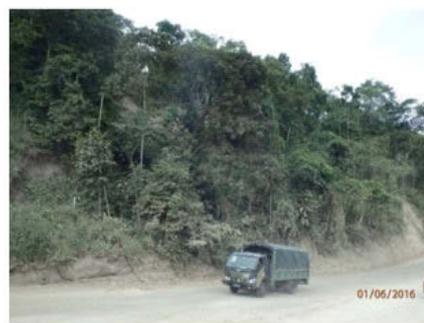
Figure 4-15 Examples of landslides observed. Coastal landslides observed from Highway 15 between San Vicente and Canoa, a) shallow seated, b) deep seated. Landslides in low-lying hills near San Isidro, c) shallow seated, d) deep seated.

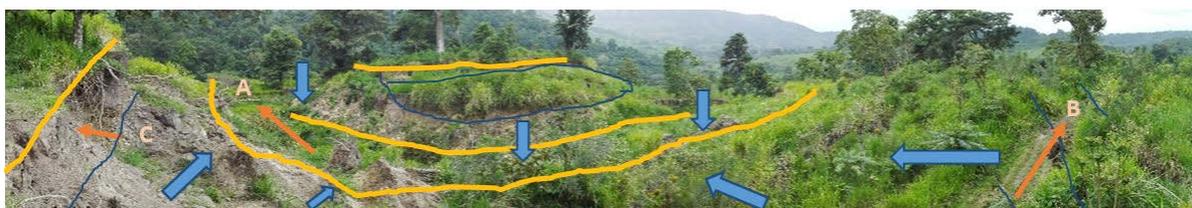
The affected site was not inhabited. A dirt track used by local farmers crossed the edge of the site. The soil failed in an alignment and in the directions shown on Figure 4-18, of which an aerial drone image is shown in Figure 4-19. Primary and secondary scars of the landslides are shown in Figure 4-18 and some of the secondary features in the alignment of B are shown in Figure 4-20. A superficial clayey shale deposit was observed on the scars, as shown in Figure 4-21.

Figure 4-18 Panoramic view of the ground failure at Site A (yellow lines indicate primary scars, and blue ones the secondary ones; the blue arrows show the movement of the soil).

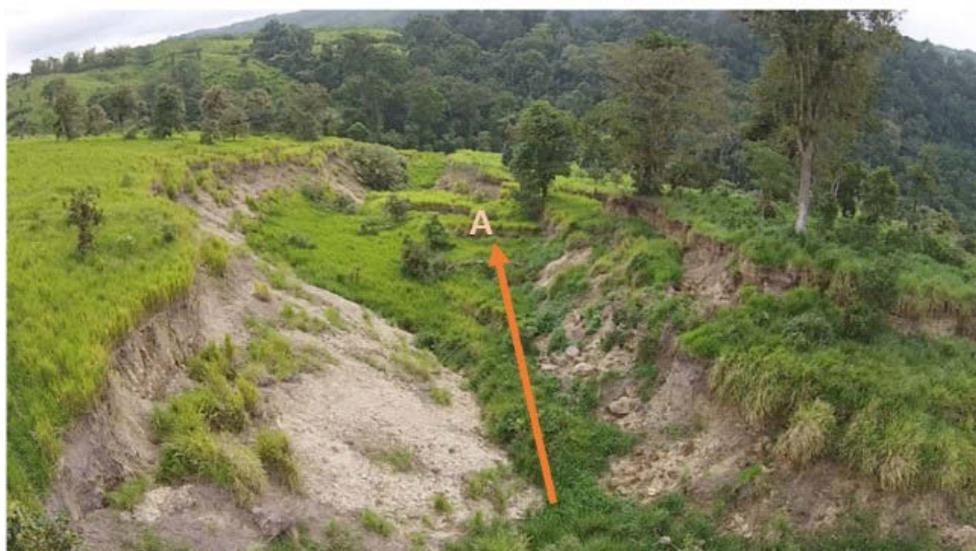
Figure 4-19 Isidro site A taken from a drone, looking along the ridge at location (A) on figure above.
