THE MUISNE, ECUADOR EARTHQUAKE OF 16 APRIL 2016

A FIELD REPORT BY EEFIT

THE M_w7.8 MUISNE ECUADOR EARTHQUAKE OF 16 APRIL 2016

September 2018

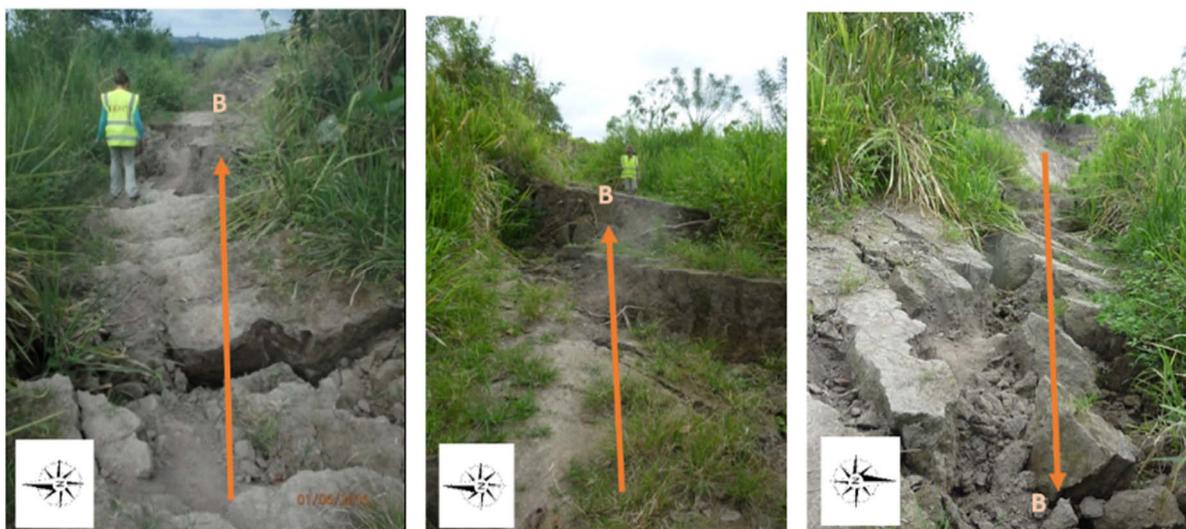
Figure 4-20 San Isidro site A, rotation and translation of surficial blocks of soil close to the head of the slope. Photo taken of ground along the path defined as (B) on panoramic picture above.

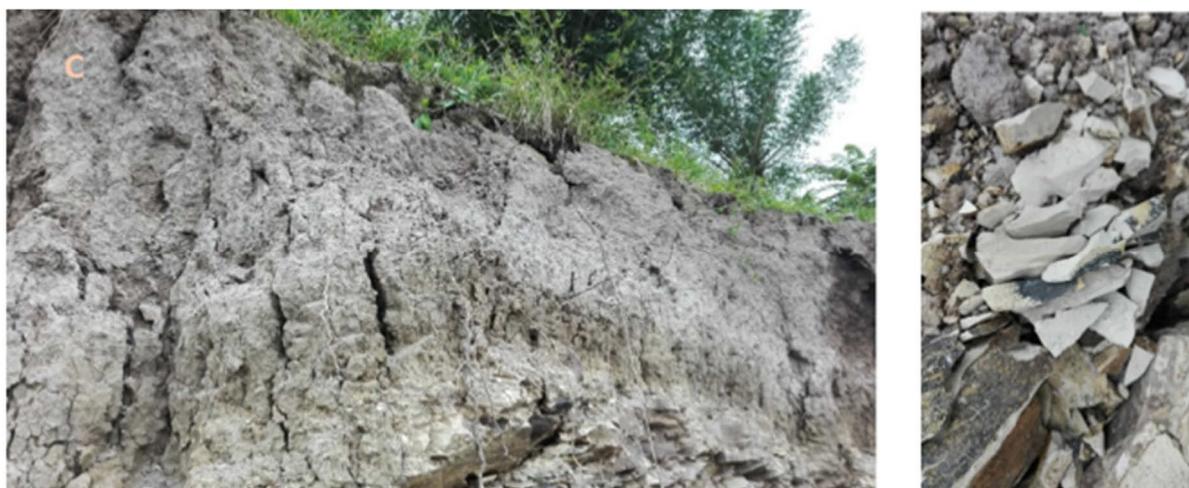
Figure 4-21 Face of scar at location C shown on panoramic picture of Site A above.

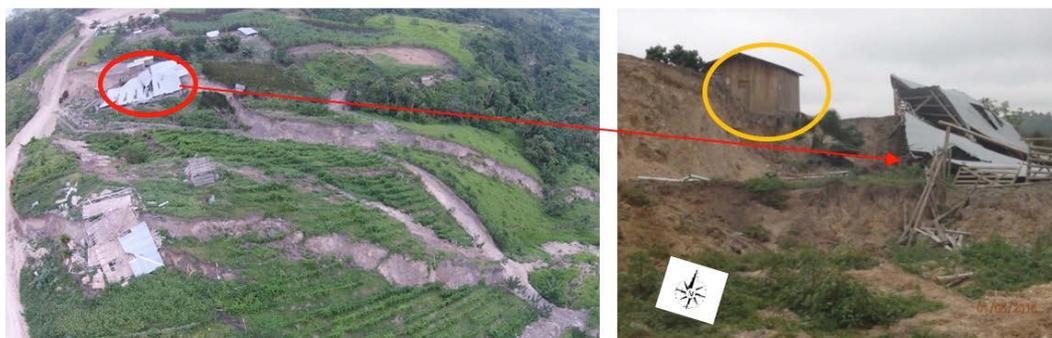
The affected site was located further away in the South-West direction from San Isidro as shown in Figure 4-17. It mainly affected one property comprising four structures associated to a cattle ranch. Eighty heads of cattle were lost in the earthquake, and three buildings collapsed. Luckily, the structure used for accommodation next to the collapsed cattle ranch stayed intact, and the three inhabitants in the house at the time of the earthquake survived (see Figure 4-22). A river runs below the site, along the toe of the slope.

Figure 4-22 San Isidro site B, taken from a drone. A river runs through the trees at the bottom of the slope, to the right of the figure (the yellow circle shows the intact house next to the slope that failed).

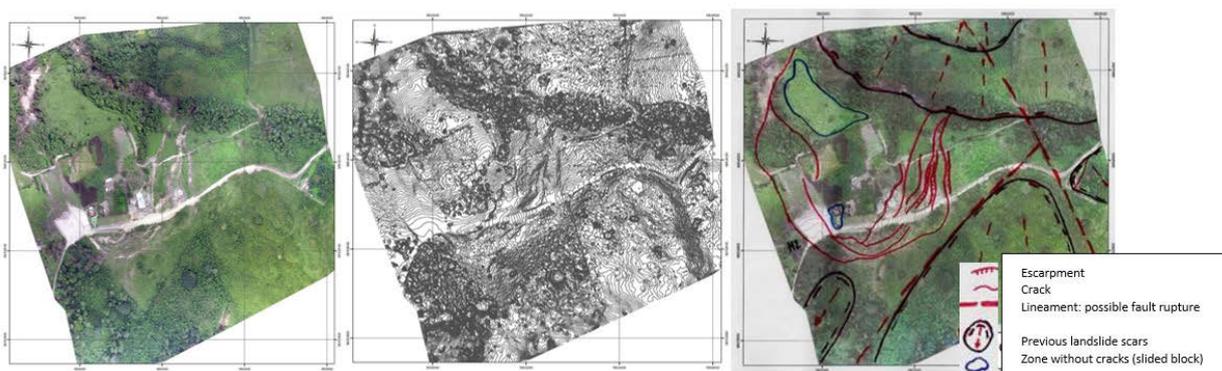
Echeverria (2016) proposes an analysis of the landslide mechanism based on the analysis of drone imagery looking at the scars observed (Figure 4-23). Two potential faults that may have contributed to the damage observed were identified. Further analysis and work is likely to go into determining the causes of these dramatic landslides and those observed in the surrounding area to better understand the geodynamics and tectonics at play.

Figure 4-23 El Relleno San Isidro Site B Landslide analysis by Echeverria (2016).

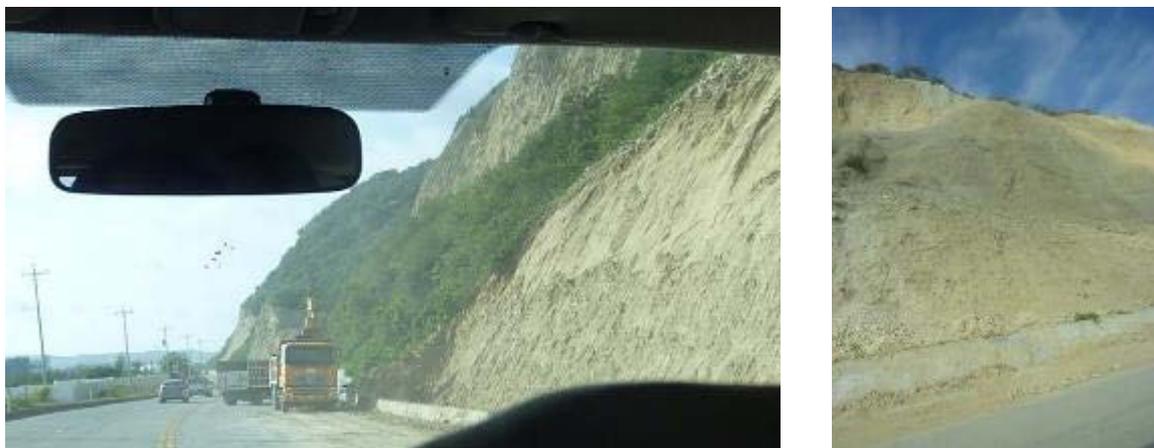
Most of the landslides were associated to the mainshock but several were indicated by local residents to have occurred following the significant aftershock of the week preceding the mission. Road rehabilitation works were still being carried out in many locations (Figure 4-26).

Figure 4-26 Road Rehabilitation Works carried out on the coastal road between San Vicente and Canoa.

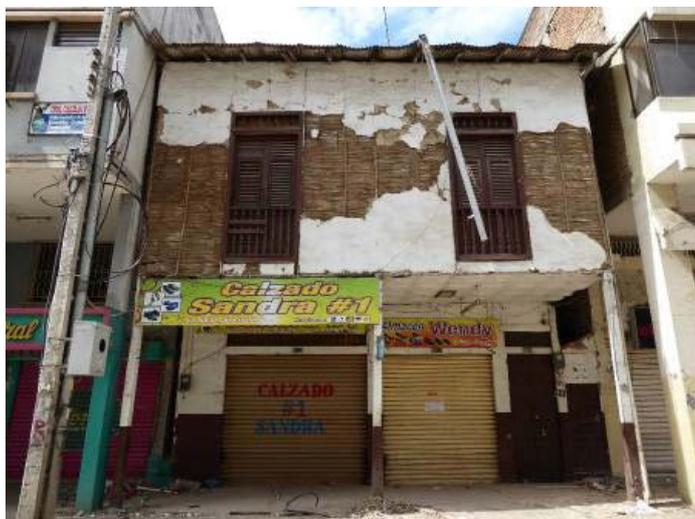
It is very common to see the ground floor used for retail with an overhang, while the upper floor may be residential or used for storage. Properly constructed and maintained *quincha* has been shown to possess good structural unity and some ductility, and thus can behave well in earthquake shaking (López *et al.*, 2004; Gutiérrez, 2000). In addition, since it is relatively light, it attracts less seismic load. However, it requires a reasonable standard of construction, detailing and maintenance to avoid deterioration through rot or insect attack. The *quincha* structures observed tended to be relatively old (>40 years), often showing serious signs of rot and insect (especially termite) attack.

Figure 6-3 Quincha structure.

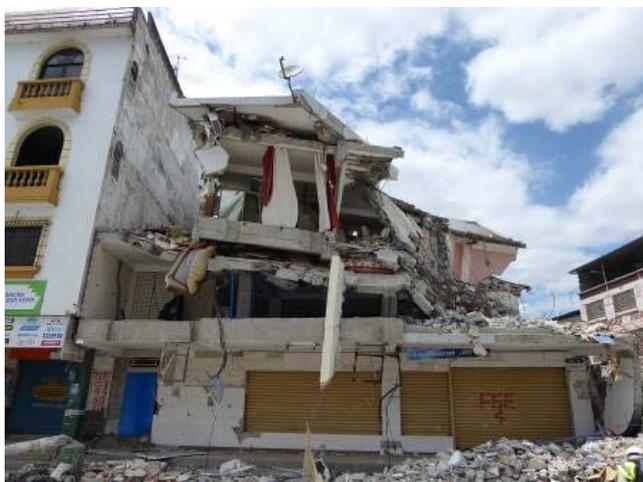
Damaged RC structures observed generally failed some or all of these requirements (Figure 6-6). In addition, they could not truly be considered to be confined masonry structures because the detailing was still inadequate and the masonry inadequately confined.

Figure 6-6 Collapsed building, showing failure of façade and frame.

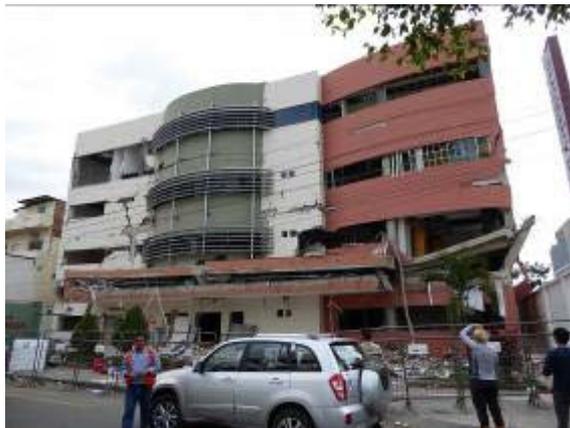
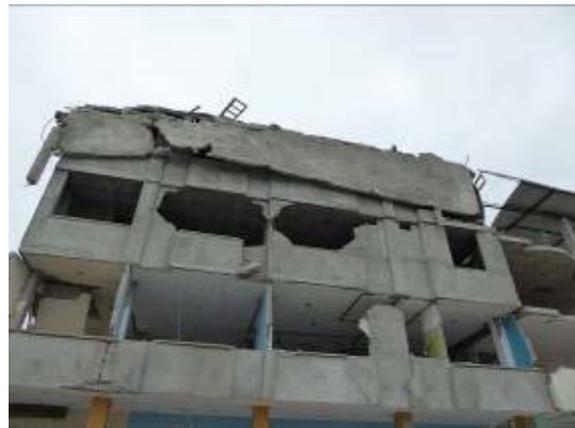
Upper floor soft/weak storey failures occur when a floor is weaker in strength or less stiff than the adjacent storeys, resulting in load concentration at this floor level, which can exceed the capacity and result in damage to or collapse of that floor (Figure 6-9). This form of collapse was seen in a number of buildings, interestingly many of which were at an upper floor instead of a ground floor (which is generally more typical). Some of the soft/weak storey failures are likely due to a discontinuity in frame and/or masonry strength between floors, while it is suspected that others are due to inadequate lapping of primary column reinforcement (see item e) *Inadequate laps*).

Figure 6-9 Weak and soft storey failures.

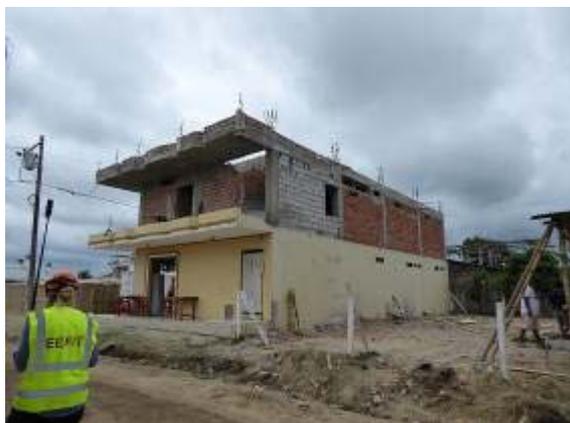
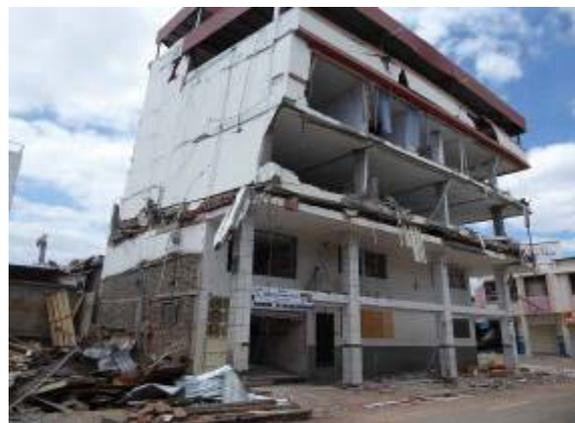
A number of buildings experienced upper floor weak/soft storeys without a clear change in stiffness or strength. It is known that the reinforcement bars come in set lengths, and when placed for construction the top of the bars were often observed to rise just above the second floor. It is common to build just two storeys initially and leave extra reinforcement exposed, ready for an additional floor in the future (Figure 6-10).

In many cases, the amount of reinforcement sticking out waiting for future construction may not be sufficient for a proper reinforcement lap, which would lead to a weak and brittle connection between old and new. In addition, the reinforcement bars are often left out for many years and so can experience surface corrosion, which can weaken their bond to the new concrete once poured. Finally, all of the rebar is often lapped at one height, causing potentially weak spots in the same location in all columns, causing in turn specific floors which are relatively weaker than those above or below.

Figure 6-10 Exposed reinforcement with possible inadequate lap lengths for future construction, and an upper storey soft/weak storey failure.

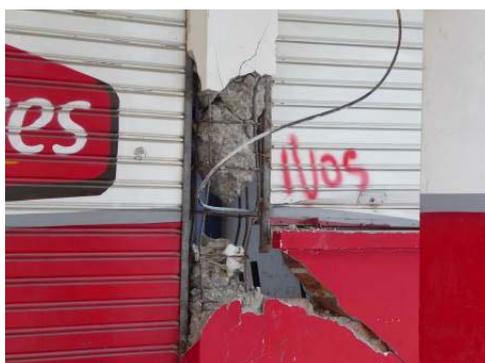
This failure occurs when partial height stiff walls are constructed against columns. This construction promotes a brittle shear failure mode prior to a ductile flexural mode (Figure 6-11 and Figure 6-12). This failure mode was seen in a number of buildings, with a reoccurring detail of high level windows for the full length of the frame bays.

Figure 6-12 Short columns at a shop front – note the local crushing of the masonry lining up with an imaginary compression strut and local shear failure of the column.

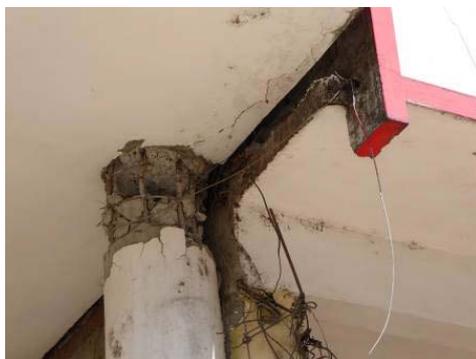
Pounding occurs when buildings move out of sync in an earthquake and impact on each other. In very few locations seismic gaps were seen in-between buildings and floor slabs were often out of alignment, leading to localised pounding (Figure 6-14).

Figure 6-14 Pounding of a column head by a slab of an adjacent building.

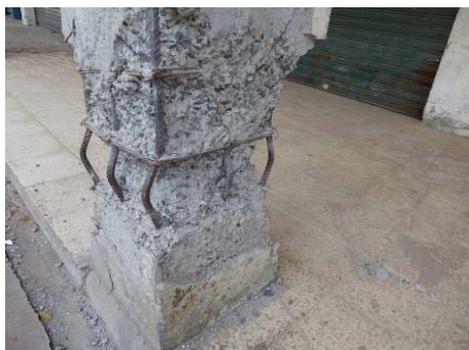
Designated plastic hinges in RC elements require special detailing to ensure they yield in a controllable and ductile manner, as opposed to a brittle manner. Where plastic hinges were seen, damage was often seen to be brittle, with failure mechanisms involving local concrete crushing and bursting, and buckling of longitudinal reinforcement, instead of pure tensile yielding of bars (Figure 6-15).

Figure 6-15 Inadequate design of plastic hinges.

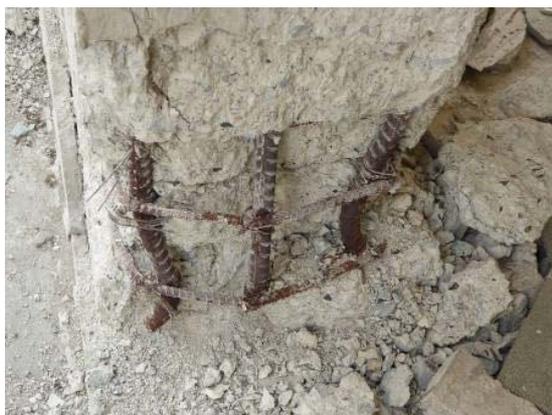
The concrete used in RC frames was observed to be of low quality in some areas (Figure 6-17), likely for a number of reasons:

- Inadequate mix design – some concrete clearly had too much or too little coarse aggregate.
- Excess water – with informal construction, it is common to add excess water to the mix to improve workability, which weakens the concrete.
- Poor compaction – some concrete clearly had not been properly compacted and voids were evident at the bottom of pours.

Figure 6-17 Poor quality concrete.

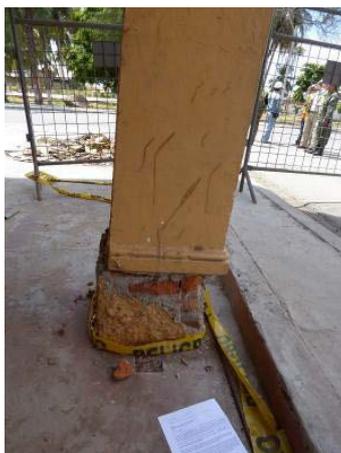
In some buildings, it was evident that the traditional connections used to connect timber elements together were not robust enough to resist lateral loads, or in some cases may even have been missing (Figure 6-19).

Figure 6-19 Lack of positive connection between frame and masonry upstand, leading to sliding of column laterally.

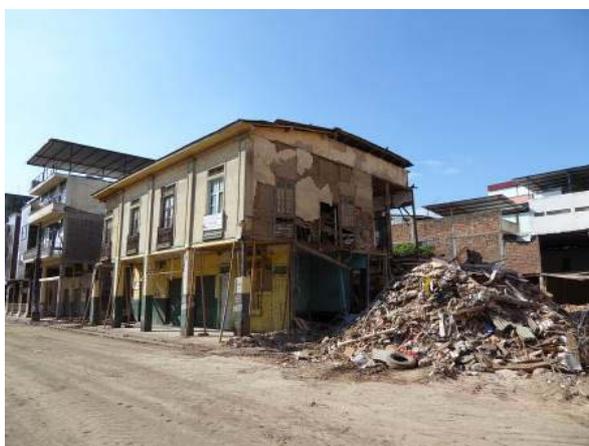
Some buildings appeared to have damage to their sides facing other buildings that had collapsed, while the remainder was undamaged. This suggests that debris from adjacent buildings while they collapsed (or in some cases were crudely knocked down) may have damaged the facades of timber/bamboo buildings (Figure 6-20). While this may be applicable to all building types, it may be more significant for timber or bamboo buildings, which are inherently less resistant against heavy debris impact compared to concrete framed buildings.

Figure 6-20 Possible damage due to debris from adjacent buildings.

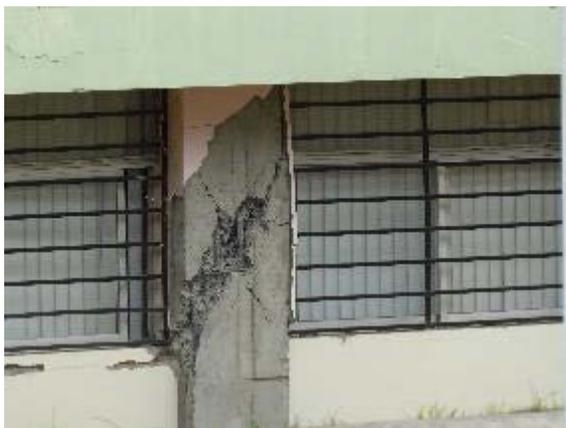
Figure 6-27 Shear cracking due to short column effect.

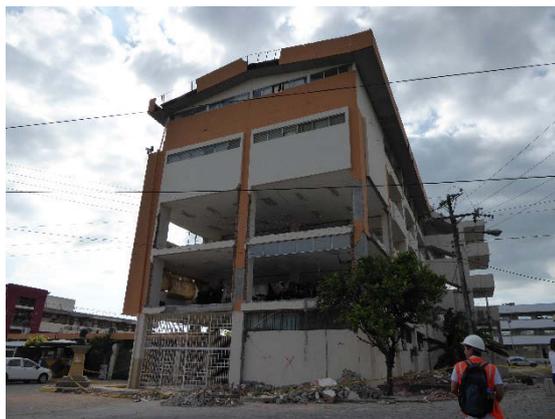
Figure 6-28 Complete out-of-plane failure of masonry perimeter infill walls.

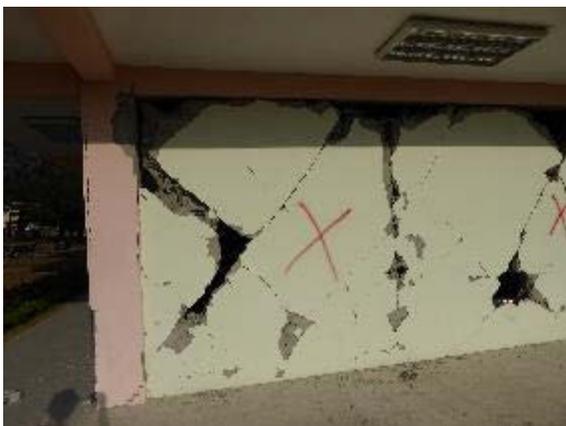
Figure 6-29 In-plane shear cracking of masonry infill walls.

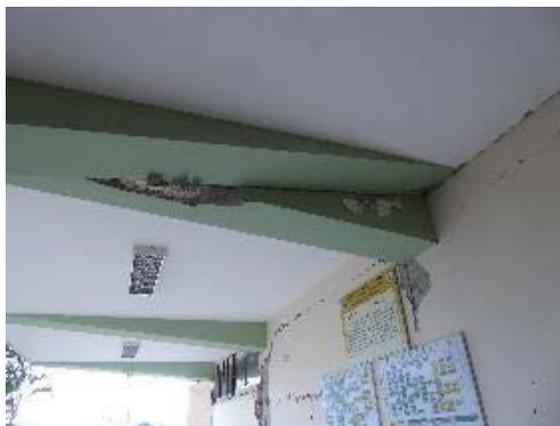
Figure 6-30 Pounding at movement joint.

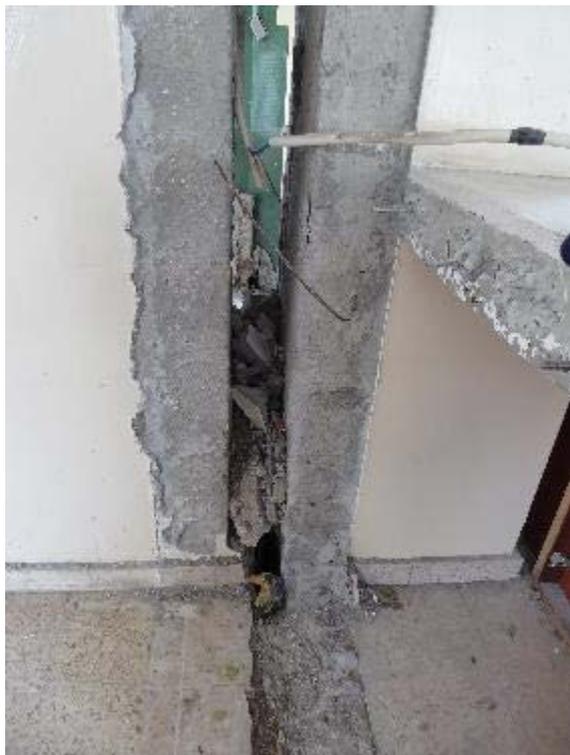
Movement joints were seen between some of the buildings, but in many cases, they were very small in size or filled in with rubble, thus ineffective (Figure 6-31). Two buildings were seen to have permanent lateral drift in the order of around 50mm (Figure 6-32).

Figure 6-31 Movement joint filled with rubble (prior to event).

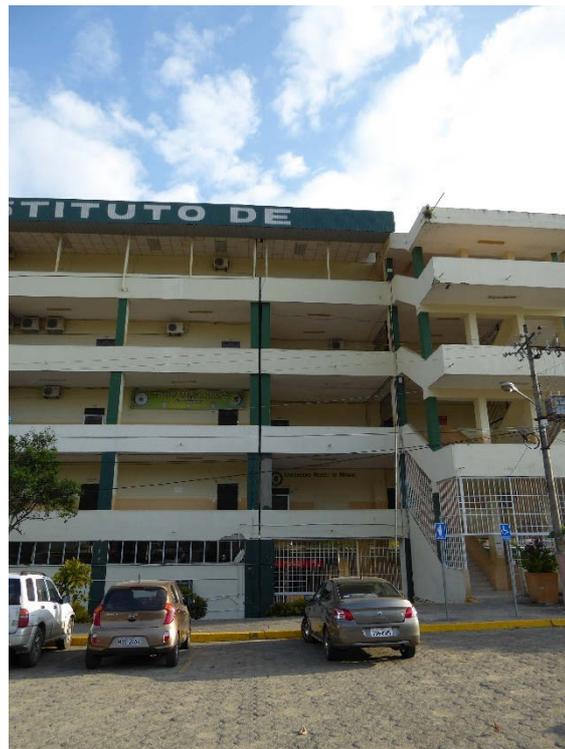
Figure 6-32 Permanent lateral drift of buildings relative to one another of approximately 50mm (follow movement joint below “DE”).

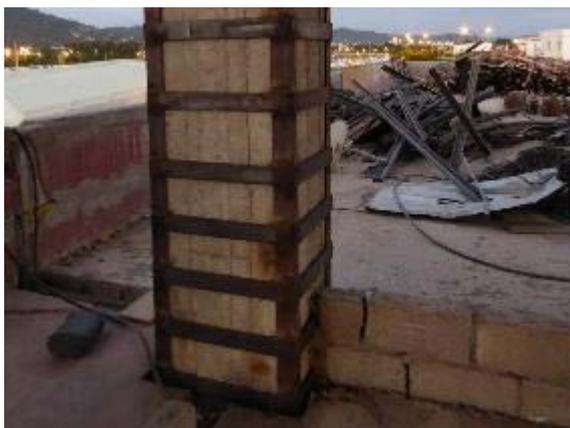
The structural team briefly reviewed one of the two storey buildings of the disused Portoviejo Airport (the site of a major temporary shelter camp). The team observed retrofitting of existing reinforced concrete columns which commenced prior to the earthquake (Figure 6-33). The retrofit consisted of steel angles fitted to the corners of the columns, with side plates site welded to the angles. The retrofit was presumably designed to either confine the concrete, or provide additional shear capacity. The design was considered questionable, since the site weld quality was poor (Figure 6-34) and the steel plates were not fixed tight up against the rough concrete surface.

Figure 6-33 Steel plate retrofit to reinforced concrete column.

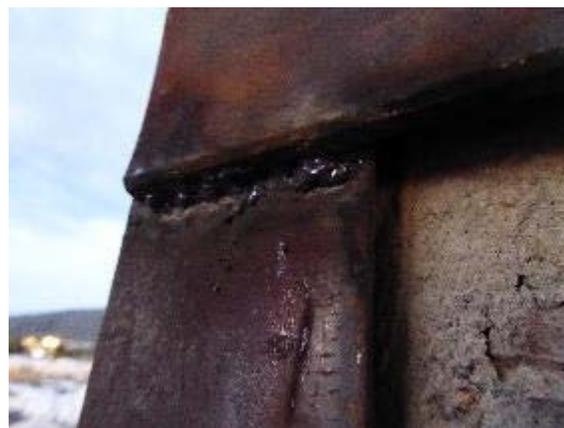
Figure 6-34 Site welded steel plate.

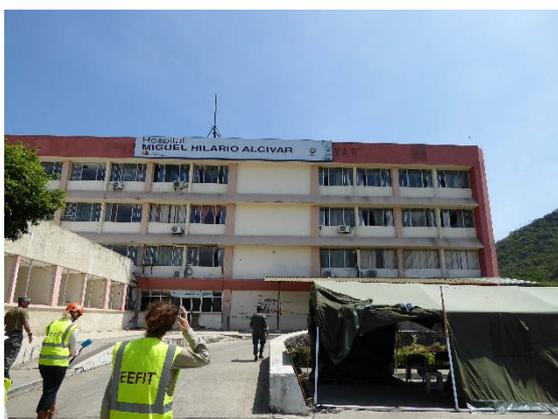
Figure 6-35 Hospital Miguel Hilario Alcivar De Bahía De Caraquez.

This four-storey long building consisted of a reinforced concrete frame with masonry infill (Figure 6-35). The building experienced heavy non-structural damage to many internal and external masonry walls, some which fell completely out-of-plane (Figure 6-35 and Figure 6-36). Significant damage was also seen to the services and false ceilings (Figure 6-36 and Figure 6-37). The structure appeared to experience only minor structural damage. The building had been retrofitted after the 1998 earthquake through the addition of RC shear walls in each elevation coupled to the columns, which were also retrofitted by concrete jacking. Minor damage was seen at the connection between the coupled columns and the new RC shear walls (Figure 6-38) – the detail connecting the two did not appear optimal.

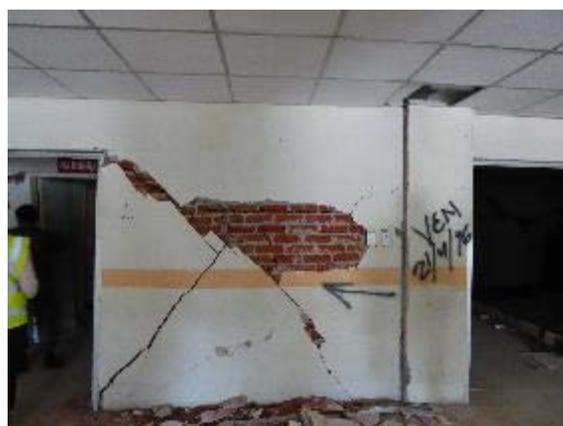
Figure 6-36 In-plane shear cracks.

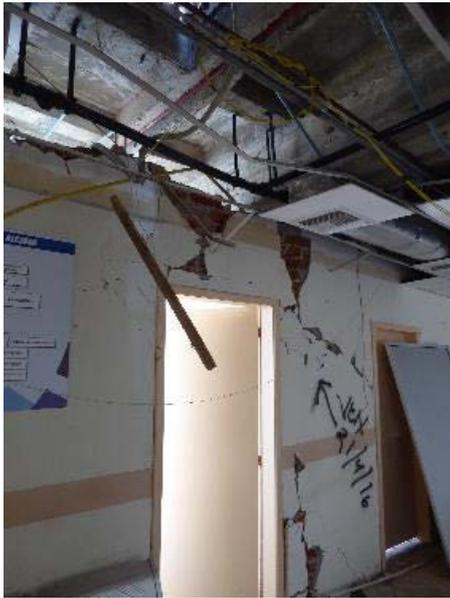
Figure 6-37 Significant damage to false ceiling and fittings.

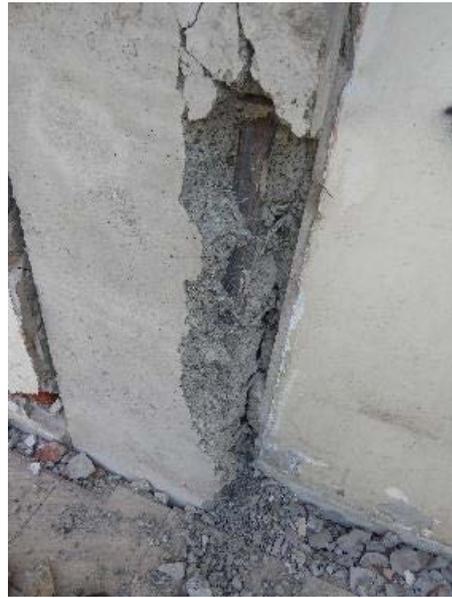
Figure 6-38 Damage at interface between coupled column and shear wall.

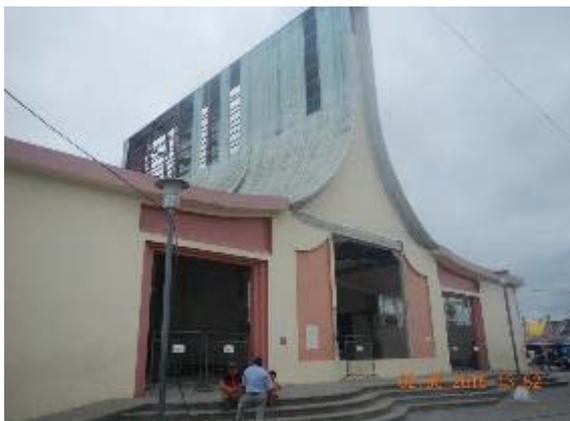
This building was a tall single storey reinforced concrete framed building with a steel upper roof (Figure 6-39). Clay bricks were used for the unreinforced perimeter walls. Non-structural damage was heavy, with some significant masonry wall damage, and many dislodged heavy ceiling tiles (Figure 6-40). Roof cladding panels had also fallen during the earthquake. Observed structural damage was light and appeared to be generally caused by connections to the masonry infill walls.

Figure 6-39 Pedernales Cathedral, with damage to the roof and masonry façade.

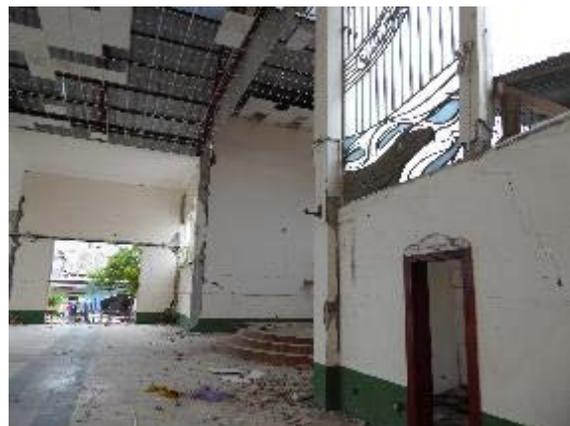
Figure 6-40 Internal damage to ceiling tiles and masonry walls.

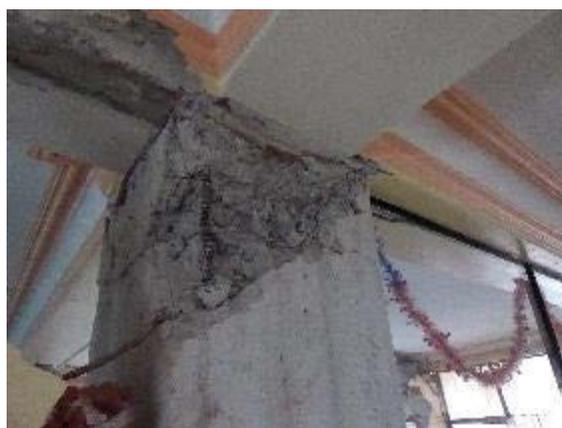
Figure 6-42 Local damage to head of RC column.

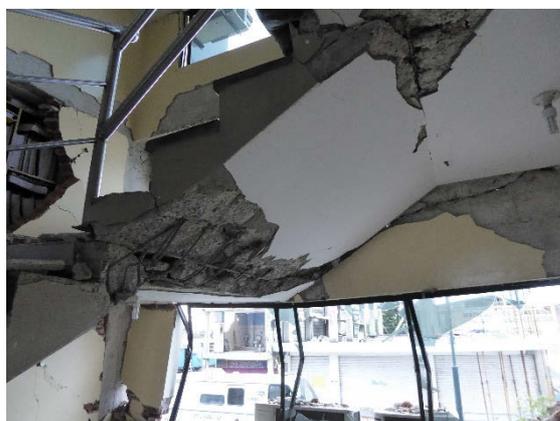
Figure 6-43 Moderate damage to RC staircase.

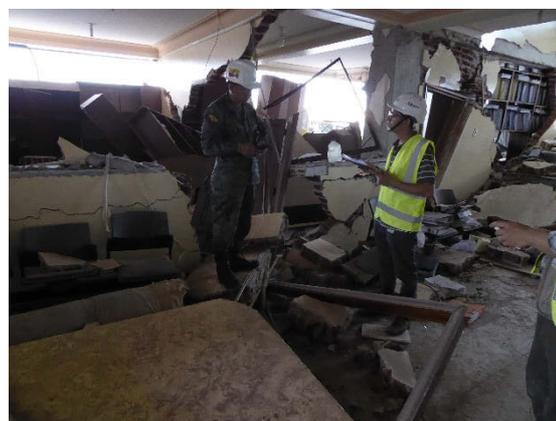
This is a five-storey building in Pedernales, with an RC frame and clay brick masonry infill (Figure 6-41). The building is one of the main government offices in Pedernales. The frame had a reasonable beam and column size aspect ratio, and the reinforcement detailing appeared reasonable (where exposed). Structural damage was light to moderate, with some cracking and spalling at the beam-column connections (Figure 6-42), and moderate damage to the RC staircase (Figure 6-43). Non-structural damage was heavy, with complete failure of many internal and external masonry wall panels (Figure 6-43 and Figure 6-44).

Figure 6-44 Heavy non-structural damage to internal and external masonry wall panels.

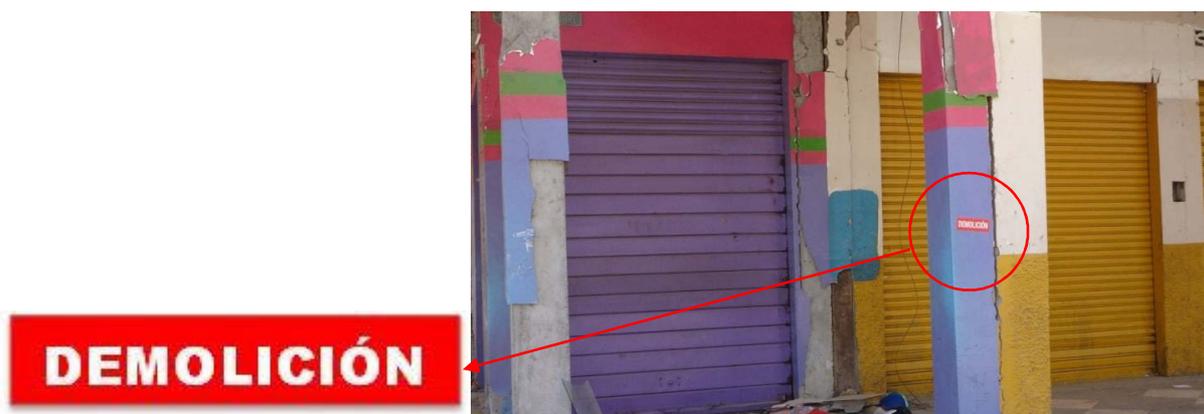
Figure 6-48 Placard for demolition.

Due to the immediate availability of vehicles for demolitions provided by Ecuadorian government, many buildings had already been demolished before the arrival of the EUCPT. These had been selected for demolition without a structured procedure. Demolitions were often performed with inadequate vehicles and there were some concerns for public safety. As a result, the municipality requested an assessment prior to proceeding with further demolition work in order to ensure that no buildings that could be salvaged would be demolished. The evaluation was performed only on the red tagged buildings in Zone Zero and surrounding areas. For this purpose, a specific form was drafted by EUCPT experts in order to report back the result of the assessment. Figure 6-48 illustrates the placard that was used to identify red-tagged buildings that required demolition. This placard was generally added to those shown in Figure 6-47.

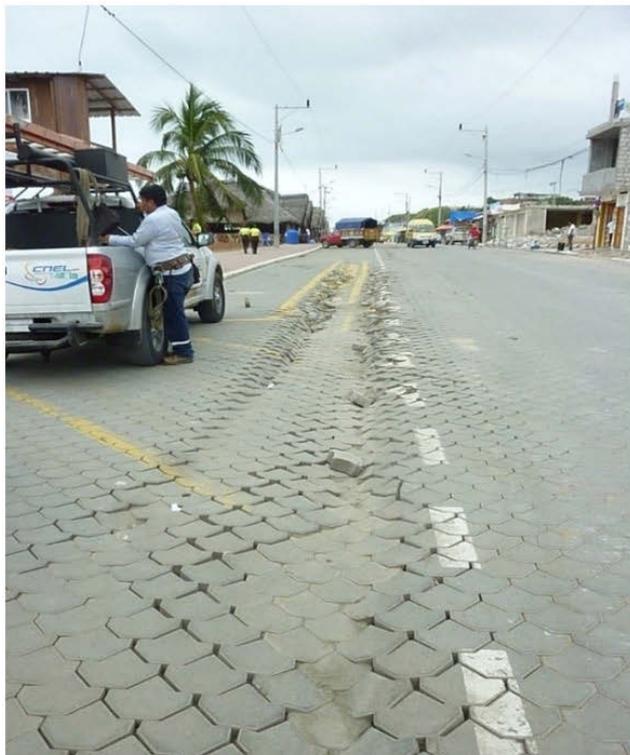
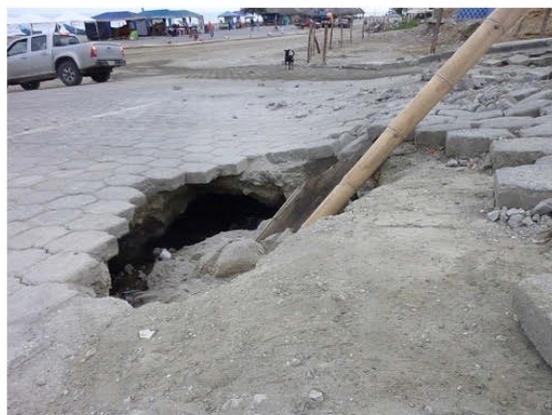
Figure 7-4 Road damage in Pedernales due to settlement of trench fill (a) and settlement of sand underneath (b).

Along the seafrent in Pedernales, vertical settlements of 100mm were observed for rectangular cross sections parallel to the road (Figure 7-4). This damage is believed to have been caused by liquefaction of poorly compacted fill material. The protrusion of manholes nearby demonstrates the high possibility of liquefaction of the fill material.

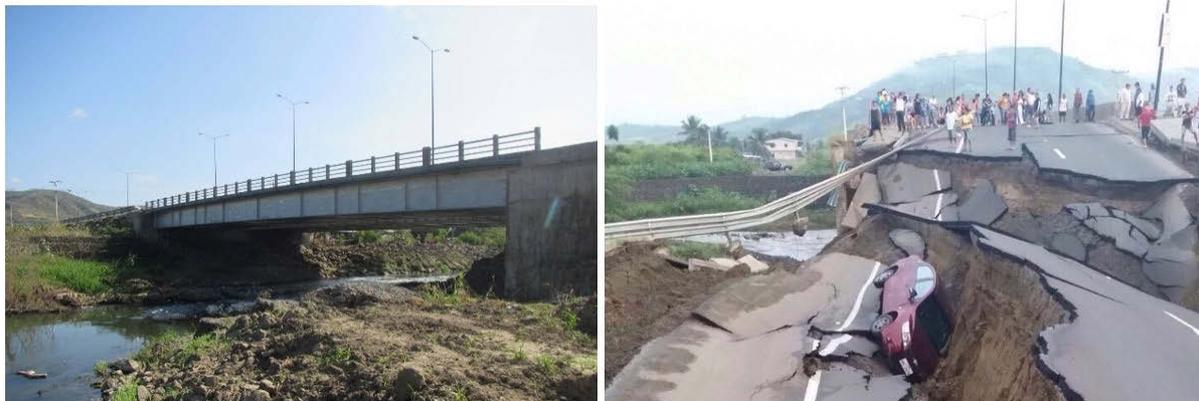
Figure 7-5 Mejía bridge – Highway 39A Portoviejo – Rocafuerte (-0.9899N; -80.4697E). Gabion walls provided on this side of the bridge only. Left – from EEFIT mission; Right - from EERI (2016), posted on twitter just after the main shock (<http://www.eqclearinghouse.org/>).

On the second day of the mission, the team headed to Portoviejo from Manta. Along the highway 39A, the team stopped at the location of the Mejía bridge (-0.9899N; -80.4697E), which crosses the River Portoviejo, to make observations on the bridge's seismic performance after heavy damage was initially reported (see Figure 7-5).

The bridge consists of two separate sections (two lanes and shoulders each side) with a single simply supported span composed of steel girders (see Figure 7-5). The deck is made of composite concrete and metal decking construction. The bridge is supported by reinforced concrete abutments at both ends with monolithic return wingwalls. Gabion walls were provided for retention of ground on one side of the bridge only, at both ends next to the abutments.

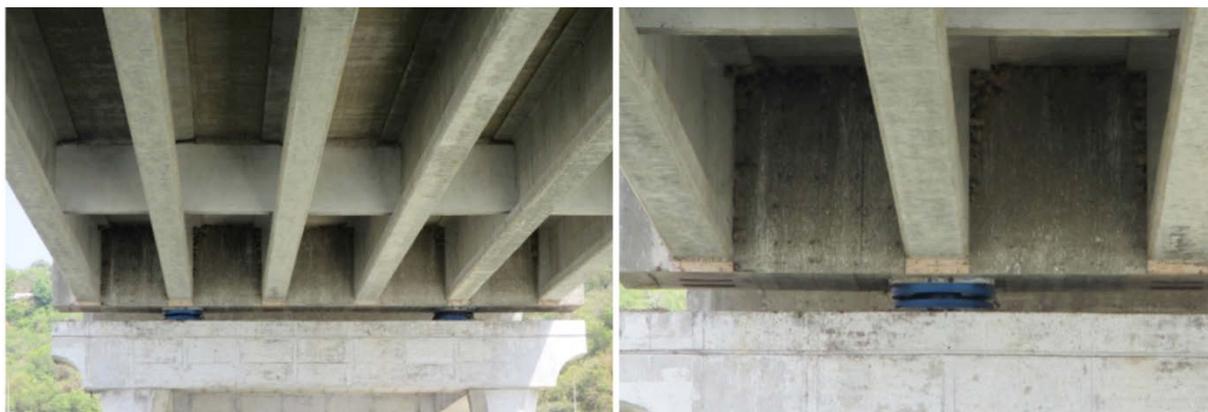
One of the key features of the bridge is that it used seismic isolators in between the bridge decks and the piers; the first example of the use of this technology in Ecuador. Triple friction pendulum isolators were used, designed to accommodate around 50-60cm of lateral displacement in any direction. Each pier had four seismic isolators; one on top of each pier column (see Figure 7-12).

Figure 7-12 Los Caras bridge, location of seismic isolators (left) and close-up view of seismic isolator (right).

The bridge performed well during the seismic shaking, and remained operable immediately after the earthquake. A team from Ecuador's Army Corps of Engineers, including Prof. Marcelo Romo, inspected the bridge after the main shock and found no evidence that required the closure of the bridge. The EEFIT team surveyed the bridge on a boat, accompanied by the bridge design engineer. The observations corroborated that the superstructure of the main section did not suffer any major structural damage. The seismic isolators performed within their deformation capacities in all but one of the bridge's piers, Pier 12 (with piers numbered from 1 to 48, starting at the west side of the bridge).

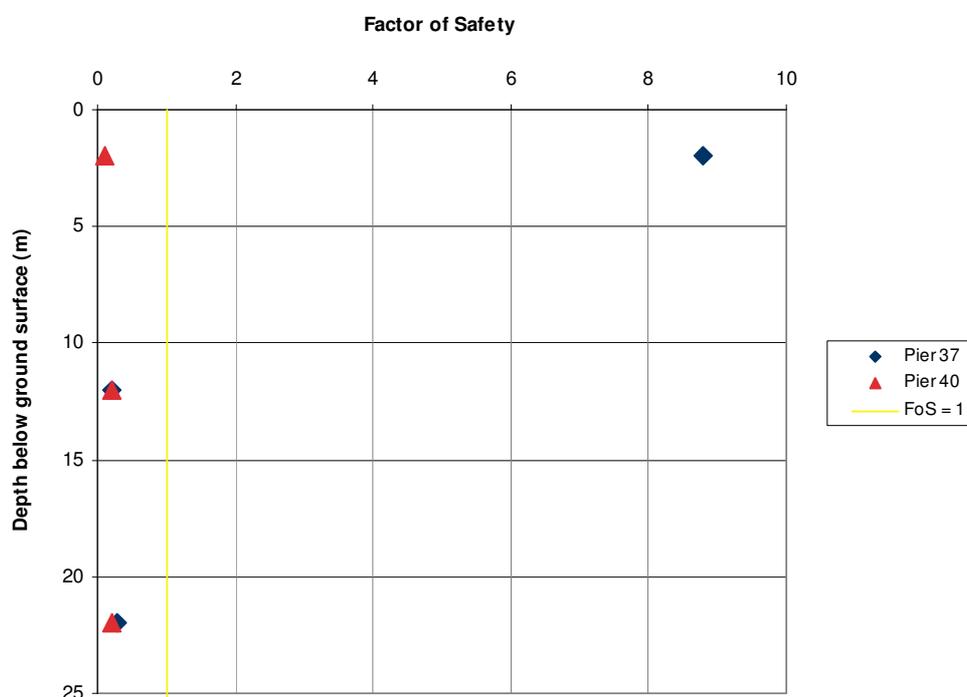
Figure 7-13 Los Caras Bridge liquefaction susceptibility analysis.

The results of the calculations are presented in Table 7-1 and Figure 7-13. A factor of safety less than 1 indicates that liquefaction is expected to have occurred in the silty sand layer at both piers 37 and 40 of the Los Caras bridge where ground investigation information was available down to 22m depth. The high earthquake induced cyclic stress ratio (CSR) value at a depth of 2m below the ground surface is due to a high ratio of total vertical stress to effective vertical stress at this depth because the water table is well above the ground surface. The appropriateness of the procedure at this depth is questionable.

Based on the relatively consistent geological profile from P36 to P42 according to the information provided by the Army’s Corps of Engineers (see Appendix A), liquefaction is likely to have occurred at similar depths along the bridge alignment at least for this segment of the bridge. It is therefore likely that liquefaction occurred in the ground surrounding Pier 12 and may have contributed to the seismic isolator exceeding its maximum design displacement. The specificity of the situation at Pier 12 that has caused higher displacements would need to be looked at in the light of detailed ground investigation information along the entire bridge, including at Pier 12. Lateral stratigraphic variations along the bridge alignment may have induced higher relative displacements on the piles than designed for, and more ground data would allow accurate conclusions to be drawn. The information relative to the liquefaction criteria for which the bridge was designed was not provided, nor the detailed ground investigation report on which the simplified geological model was based. More detailed information and analyses would be required to assess how appropriate the design may be considering the liquefaction risk, and what remediation works may be needed.

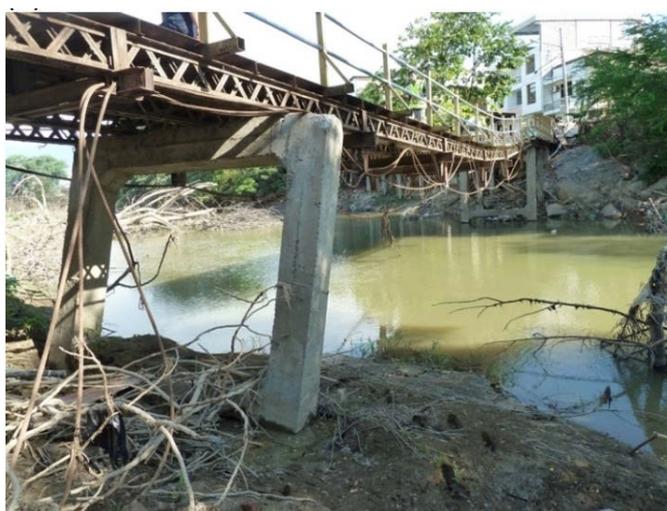
In Pedernales, liquefaction-induced lateral spreading caused the pile foundations of Puente Chile, a pedestrian bridge across the river, to rotate towards the river (see Figure 7-17). The foundations had also displaced relative to the bridge deck in the direction parallel to the river. The bridge was still in frequent use by locals at the time of the reconnaissance mission, despite this notable damage to the bridge foundations.

Figure 7-17 Structural damage due to lateral spreading along Rio Portoviejo observed on the rotation and lateral displacement of foundations of the Puente Chile in Pedernales.

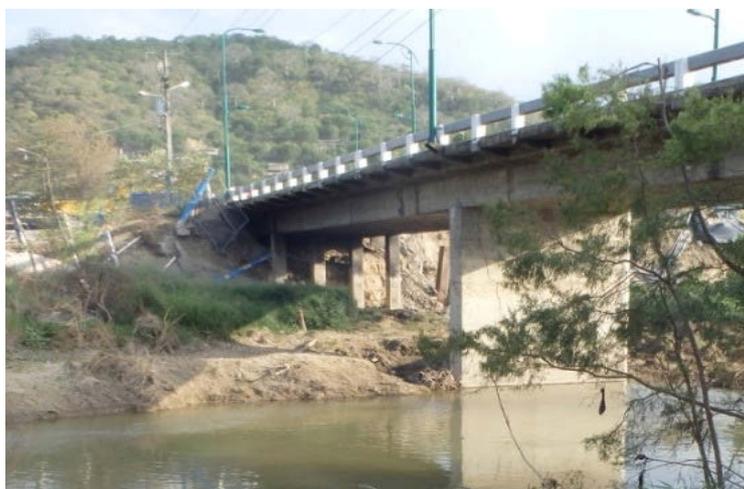
For example, the movement of soil due to lateral spreading has exposed an increased proportion of the Velasco Ibarra bridge piled foundations (Figure 7-18). This will have reduced the capacity of the bridge abutment foundations, but it has not yet affected the serviceability of the bridge.

Figure 7-18 Movement of soil from around the Velasco Ibarra bridge foundations.

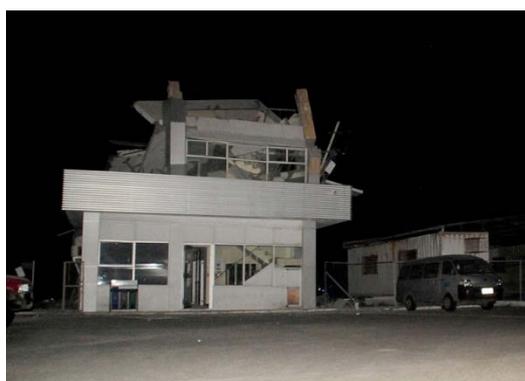
The Airport of Manta was also heavily affected by the event, as the control tower collapsed (Figure 7-21). Nevertheless, the airport still operated at a restricted capacity at the time of the mission.

Figure 7-21 Airport control tower collapse.

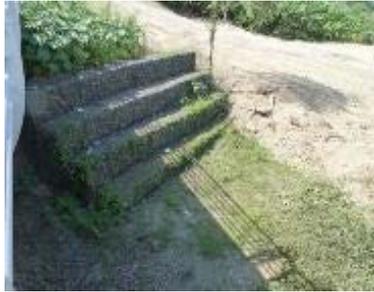
Map ID	Coordinates	Accuracy of BGS identification		Co-seismicity validation by locals	Visual Assessment Reliability Estimate		Observations	Discussion with locals	Photos
		Location	Type		Reliability Level	Comment			
1	-1.062656, -80.449346	X	NA	?	Adequate		<p>No major damage observed. Potentially some lateral spreading, but no signs of significant spreading.</p> <p>BGS mapping may correspond to flooded area rather than slope failure.</p>	<p>Flooding occurred around bridge in the days before the main shock.</p> <p>Local interviewed also mentioned that the municipality had changed the course of the river around this section to avoid too many meanders, thereby possibly aggravating the vulnerability of the river banks following floods due to increased speeds of the water.</p>

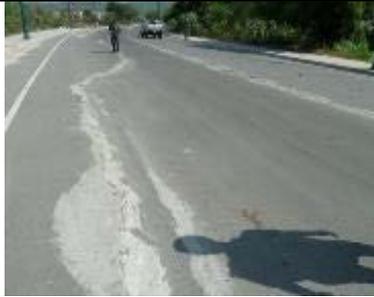
2	-1.062988, -80.449746	✓	X	✓	Adequate		<p>Road approach to bridge on north side had cracks parallel and perpendicular to road. Cracks had been filled in, but looked like slight spread of road to sides.</p> <p>No landslide</p>	<p>Discussion with locals supporting evidence of co-seismicity of failure.</p>

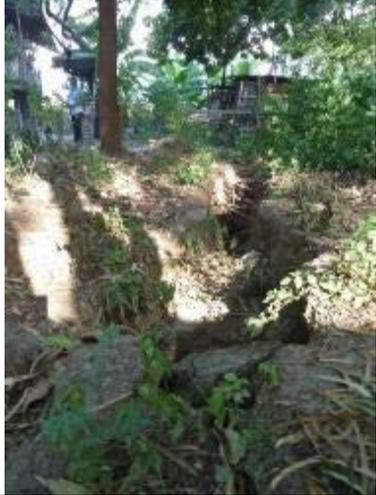
Map ID	Coordinates	Accuracy of BGS identification		Co-seismicity validation by locals	Visual Assessment Reliability Estimate		Observations	Discussion with locals	Photos
		Location	Type		Reliability Level	Comment			
3	-1.062683, -80.450329	✓	X	✓	Good		<p>Large crack formed, approximately 60 cm wide, running parallel to the river for over 30m, located in between house and river. Close to edge of river, looks to have been spreading of land into river.</p> <p>No landslide observed.</p>	<p>Neither houses close by suffered major damage – cracks to concrete flooring in one of them.</p>

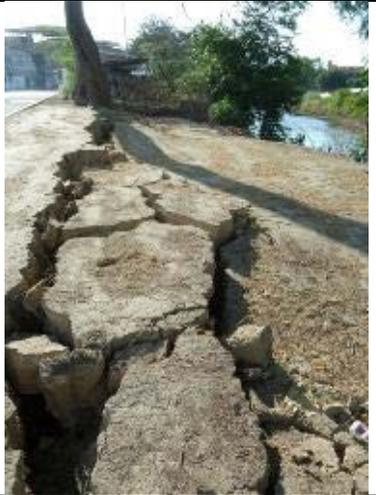
4	-1.063181, -80.450495	X	NA	✓	Good		<p>Significant amount of lateral spreading observed. Large cracks at top of slope. House further along slope had 1 m settlement of their patio, and lateral movement too (not measured). A retaining wall had rotated outwards.</p>	<p>Told that a bar under construction next door (roof and floors of bamboo) collapsed into the river. Building material has since been taken away by river or has been stolen.</p>

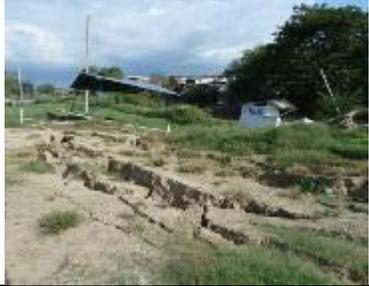
Map ID	Coordinates	Accuracy of BGS identification		Co-seismicity validation by locals	Visual Assessment Reliability Estimate		Observations	Discussion with locals	Photos
		Location	Type		Reliability Level	Comment			
5	-1.061453, -80.451259	✓	X	✓	Good		Evidence of liquefaction-induced lateral spreading. Portal frame structure suffered significant settlement and rotation. Footing for football stand had settled approximately 2 m and moved laterally about 2 m.	Football pitch not commercially operable since earthquake with no prospect of how and when the owners may be able to carry out the necessary works and get back to being fully operable as a rented pitch for local football teams.

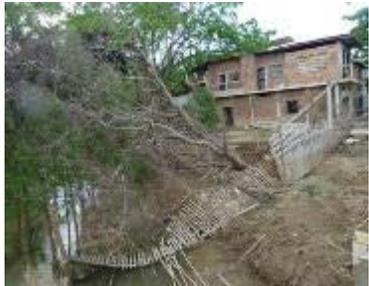
6	-1.061275, -80.451510	✓	X	✓	Good		Significant rotation of bridge foundations into river. Evidence of liquefaction induced lateral spreading.	Told this house was flooded at time of earthquake. Told bridge had settled 60cm. Told trees moved 5m laterally into the river. Said river had been redirected around their house – used to run behind it, but now runs in front. Also river to the west of their house is protected due to native trees being present, so does not get dredged and does not have the river bank slope reengineered annually.

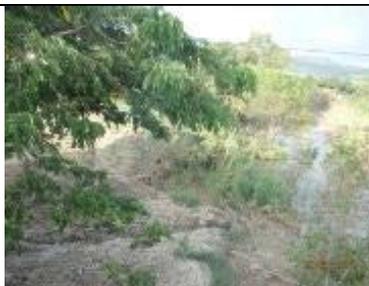
7	-1.059800, -80.457436	X	NA	✓	Good		Significant lateral spreading into the river.	Flooded before earthquake, water knee height at houses. At time of earthquake water receding. Told that earthquake caused spreading of ground into river and rotation of trees.

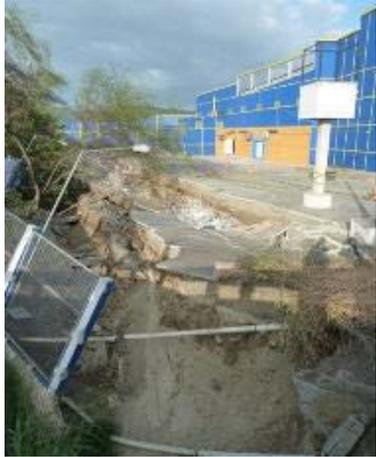
Map ID	Coordinates	Accuracy of BGS identification		Co-seismicity validation by locals	Visual Assessment Reliability Estimate		Observations	Discussion with locals	Photos
		Location	Type		Reliability Level	Comment			
8	-1.060450, -80.457982	X	NA	✓	Good		<p>Large slope failure damaged the car park of a supermarket to the extent that it was still closed at the time of the mission.</p> <p>Next to the car park, the bridge abutment suffered damage. Part of the bridge deck which was previously on fill was dangerously cracked and hanging without any support above the empty space left by the landslide below. No safety signs.</p>	<p>Told fill material had been used to extend the car park of new supermarket out into the edge of the river hence possibly aggravating the pre- earthquake flooding than before the works were carried out in previous years.</p> <p>The car park of the supermarket has not been operable since event.</p>

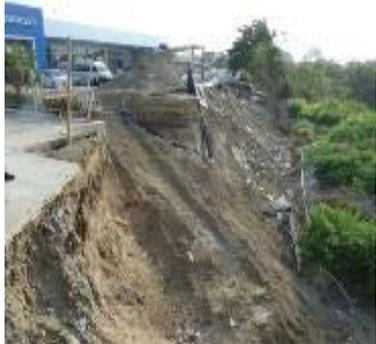
9	-1.060591, -80.458651	✓	?	✓	Adequate	<p>Extent of contribution of liquefaction to landslide not clear.</p> <p>Clearing and rehabilitation works undergone</p>	<p>Large slope failure with soil movement away from garage into the river and in direction away from bridge.</p> <p>A couple of structures were completely damaged, as well as some car park area.</p> <p>However, some evidence of foundation failure (tilting of shallow raft foundation) could be observed. Evidence of pipe flotation was also observed, indicating liquefaction.</p>	<p>The earthquake was apparently followed by a large movement of land into river, engulfing 8 cars.</p> <p>The garage remained partially operable, with considerable rehabilitation works ongoing since the earthquake. The debris of the completely damaged structures had been already removed.</p>

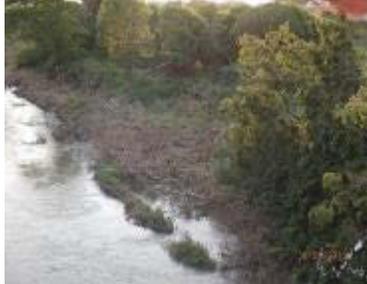
Map ID	Coordinates	Accuracy of BGS identification		Co-seismicity validation by locals	Visual Assessment Reliability Estimate		Observations	Discussion with locals	Photos
		Location	Type		Reliability Level	Comment			
10	-1.060063, -80.458596	✓	X	✓	Poor	Observation from afar	Potential scar and small slide noted from afar (on the bridge), as access was not possible. The visual assessment of the land movement appeared closer to the bridge than mapped by BGS.	Discussion with locals supporting evidence of co-seismicity of failure, rather than flood damage.

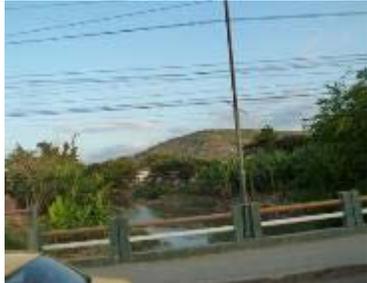
11	-1.060013, -80.461145	✓	X	✓	Poor	Observation from car. No time to stop or get access	No direct observation	Told that was damage in this area due to liquefaction induced lateral spreading. Damage to buildings, including a school. Unfortunately, did not have time to stop and visit. Photos taken from the minibus

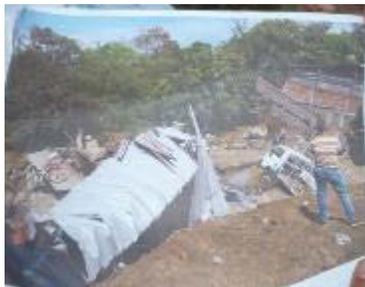
Map ID	Coordinates	Accuracy of BGS identification		Co-seismicity validation by locals	Visual Assessment Reliability Estimate		Observations	Discussion with locals	Photos
		Location	Type		Reliability Level	Comment			
12	-1.048593, -80.471044	X	NA	✓	Adequate	Site already cleared.	<p>Under a cloud on BGS map.</p> <p>All collapsed houses had been cleared and the terrain remodelled. The less damaged adjacent structures and the observation of the ground on the banks of the river provided evidence of major slope failure, including concentric lines of failures in the damaged tiled patio of a historical house next to the river.</p> <p>Slope failure scar showed evidence that ground on which buildings are built is made of remodelled and re-compacted soil from the river.</p>	<p>Shown post earthquake photos from the municipality's report. 7 houses collapsed and 4 fatalities reported. Many of the adjacent houses considerably damaged.</p> <p>Very high water level of the river and saturated ground of the banks of the river at the foot of the damaged houses reported.</p> <p>Locals shared testimony of general practice in all Portoviejo of manually dredging and compacting the loose soil deposited in the river after the annual floods during the wet season to reshape the banks of the river. Once dry, it could be used as terrain to build structures upon such as in this case.</p>
