THE MUISNE, ECUADOR EARTHQUAKE OF 16 APRIL 2016

A FIELD REPORT BY EEFIT

THE M_w7.8 MUISNE ECUADOR EARTHQUAKE OF 16 APRIL 2016

September 2018

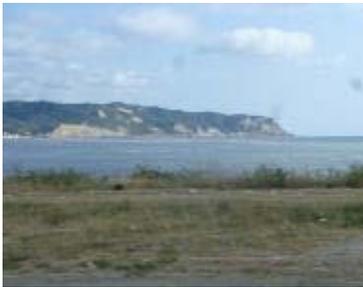
Map ID	Coordinates	Accuracy of BGS identification		Co-seismicity validation by locals	Visual Assessment Reliability Estimate		Observations	Discussion with locals	Photos
		Location	Type		Reliability Level	Comment			
1	-0.609010, -80.444420	✓	✓	?	Poor	Observation point far from scars and co-seismicity unsure	<p>Viewed from a distance, from the end of the peninsula in Bahía de Caráquez and from the coast opposite in San Vicente.</p> <p>Slopes looked to have little vegetation on them which may indicate recent landslides. The point of observation was too far from the scars to distinguish them individually and make a detailed assessment of the BGS mapping accuracy.</p>	<p>According to reports, these cliffs are prone to landslides over a long extent of the coast, especially in and after the wet season which was prior to the main shock.</p> <p>Some of the recent scars may have been co-seismic but which exactly was not clear in the oral accounts of the event.</p>

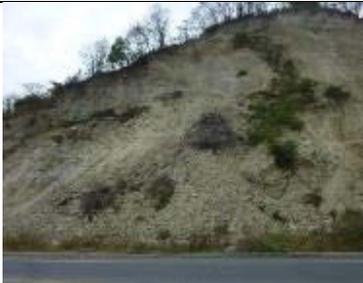
2	-0.601983, -80.402002	✓	✓	✓	Adequate	Limited time spent at site.	See photo.	<p>Discussion with locals supporting evidence of co-seismicity of failure.</p>

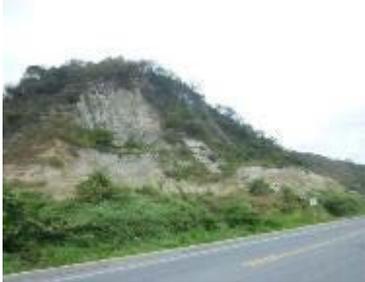
Map ID	Coordinates	Accuracy of BGS identification		Co-seismicity validation by locals	Visual Assessment Reliability Estimate		Observations	Discussion with locals	Photos
		Location	Type		Reliability Level	Comment			
3	-0.605204, -80.397303	X	NA	✓	Adequate	Limited time spent at site.	Two main scars could be observed, the upper one showing some vegetation having grown in the slope, whilst the bottom one does not. It would corroborate a recent reactivation of a previous slide at the toe of the slope.	The site was previously an informal quarry, one of many in the region. The slope was left without any stabilisation.

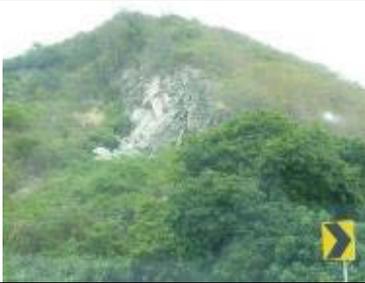
4	-0.605986, -80.394861	X	NA	✓	Poor	Limited time spent at site. Observation point far from scar and angle not allowing to see extent fully.	Under cloud on map. Significant rock slide.	Discussion with locals supporting evidence of co-seismicity of failure.

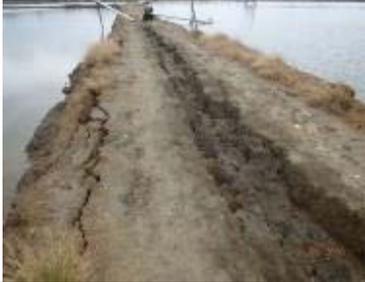
5	-0.606094, -80.398049	X	NA	✓	Good		Liquefaction induced lateral spreading and settlement of shrimp farm dykes. Crack widths approximately 50 cm wide. Settlements of approximately 1 m. Dykes running roughly N-S experienced more damage than those running E-W	According to the shrimp farm manager, damage to the dams significantly affected production.

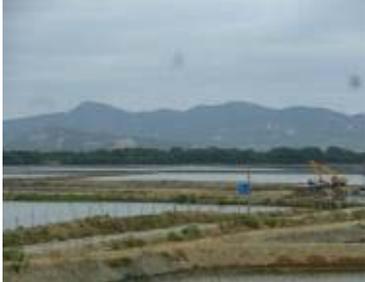
Map ID	Coordinates	Accuracy of BGS identification		Co-seismicity validation by locals	Visual Assessment Reliability Estimate		Observations	Discussion with locals	Photos
		Location	Type		Reliability Level	Comment			
6	-0.607813, -80.393328	X	NA	✓	Poor	Retrofit works already undergone	Next shrimp farm along from the one above. Considerable reconstruction work already taken place.	Similar damage to most shrimp farms within the estuary.

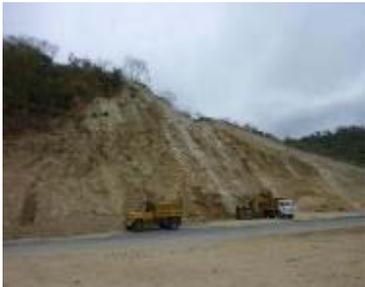
8	-0.620812, -80.382837	✓	✓	?	Poor	Rehabilitation works having already altered slope failure.	Face of the scar modified by ongoing works associated to the rehabilitation of the road, which seems to have been engulfed by the slide. Untouched top of slope shows large upper boundary of the scar. Unsafe clearing practice of removing soil from toe of slope without stabilisation or safety measures taken to avoid further slide from the top on workers.	Co-seismicity could not be validated with locals but ongoing rehabilitation works may provide evidence of recent failure likely to be associated to earthquake

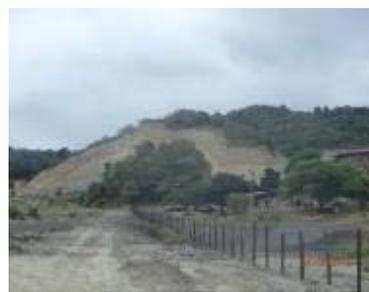
Map ID	Coordinates	Accuracy of BGS identification		Co-seismicity validation by locals	Visual Assessment Reliability Estimate		Observations	Discussion with locals	Photos
		Location	Type		Reliability Level	Comment			
9	-0.621530, -80.382699	X	NA	✓	Good		<p>Large scale circular scar of slope failure observed next to quarry behind the main road.</p> <p>Evidence of major rock fall in quarry also observed.</p>	<p>Discussion with locals supporting evidence of co-seismicity of failure.</p>

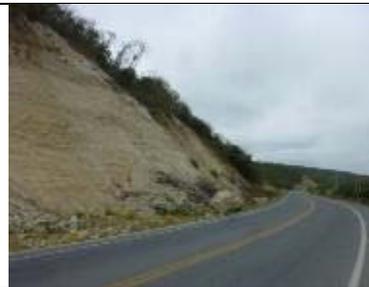
10	-0.640501, -80.382973	✓	✓	✓	Good		<p>Fresh landslide scar and large boulders at toe slope.</p> <p>Evidence of major lateral spreading of road in direction of the lagoon. Substantial cracks 30-40 cm wide, 160 cm deep.</p>	<p>Discussion with locals supporting evidence of co-seismicity of failure.</p>

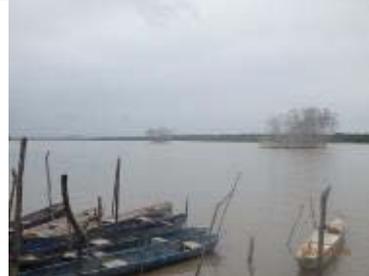
11	-0.638964, -80.360506	✓	✓	✓	Good		<p>Significant cracking in dirt track, likely due to liquefaction.</p> <p>Mangrove trees into river.</p>	<p>Discussion with locals supporting evidence of co-seismicity of failure and displacement of the mangrove into the river from lateral spreading following main shock.</p>

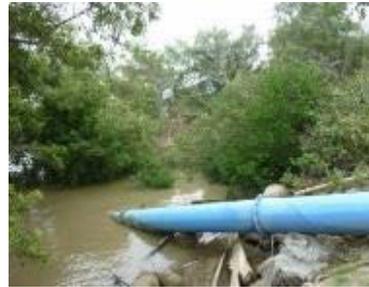
Map ID	Coordinates	Accuracy of BGS identification		Co-seismicity validation by locals	Visual Assessment Reliability Estimate		Observations	Discussion with locals	Photos
		Location	Type		Reliability Level	Comment			
12	-0.639077, -80.362471	✓	✓	✓	Good		Some masonry damage to small water pumping station used for shrimp farming. Damage to pipe and pipe supports from ground failure. Wooden props of the pipe and the structure's shallow foundation tilted in the direction of the river. Trees tops nearby tilted towards, if not in, the river.	Told that all trees were vertical before. Trees previously in same alignment on bank as pumping station, which would thereby provide some evidence of roughly 15 m lateral movement.

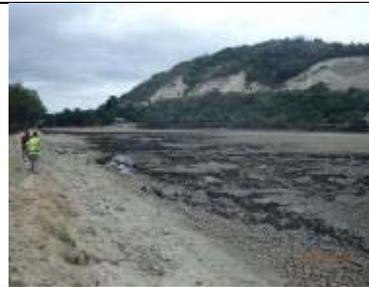
13	-0.640087, -80.366996	✓	✓	✓	Good	-	Liquefaction and large dyke failure at a shrimp farm basin. Dyke already been reconstructed, but pool not filled yet. Large amounts of cracking and spreading observed in the empty pool.	During the main event, the dyke failed; all water flooded out of pool into the river, then wave of water refilled the pool, and then it all flooded out again. The entire culture of shrimps from this large basin was lost.

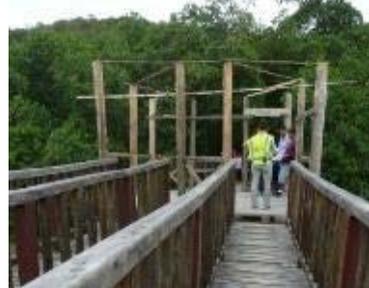
14	-0.641688, -80.369571	X	NA	✓	Good	-	This site corresponded to the visitor entry point to the local natural reserve, focused on the wildlife and natural environment of the estuary. Two small wooden piers for exploration of the estuary by boat showed signs of damage. Piles at end were tilting into the river.	Jetty lost roof in main shock. Told lateral land movement at edge of river approximately 10 m (confirmed by observation 12).

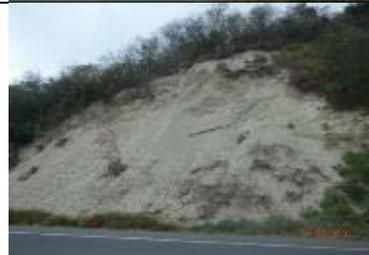
17	-0.642839, -80.373470	✓	✓	✓	Good		Landslide scar along road. A major crack in diagonal across the road causing localised partial closure of road surface was observed. The crack was approximately 10 cm wide.	Discussion with locals supporting evidence of co-seismicity of failure.
