# **The Central Sulawesi, Indonesia Earthquake and Tsunami of 28<sup>th</sup> September 2018 – A Field Report by EEFIT-TDMRC**

01/11/2019

Prof Tiziana Rossetto, EPICentre, University College London

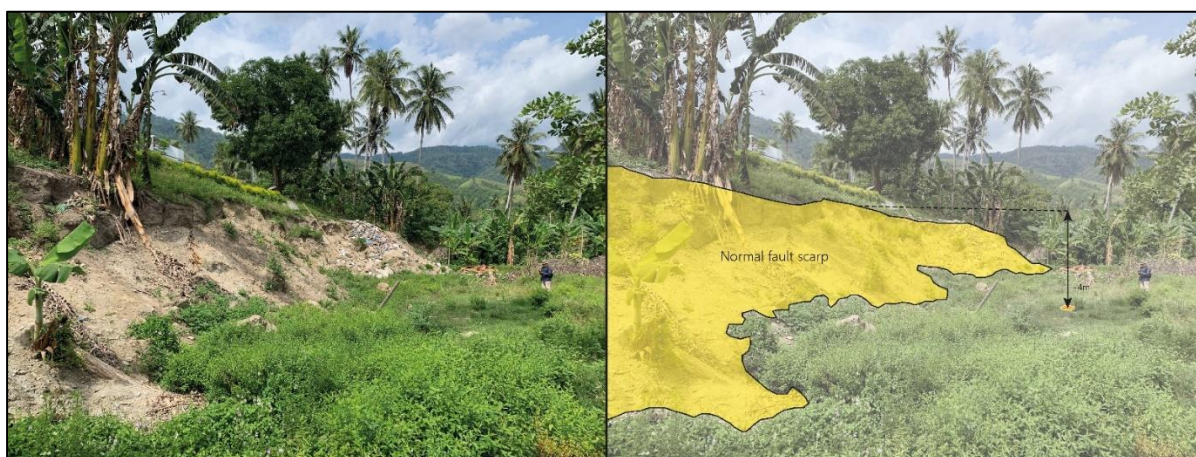
The Gulf of Palu and the valley extending to the south of the city are thought to have formed due to fault interactions causing a pull-apart basin, of which the fault rupture seems to have occurred along the westernmost bounding fault. The fault demonstrates step-over faulting, (which is typical of pull-apart basins), in the south of the valley and likely underlying the gulf itself where it crosses over the bay. The step-over fault in the south of the valley represents an extensional bend and exhibits up to 4m of normal displacement in this area (Figure 3.2). Significant breaks of slope in the area of the oblique bend may represent relict fault scarps.

Figure 3.2 – Normal fault scarp displaying vertical displacement of approximately 4m in the south of Palu valley.

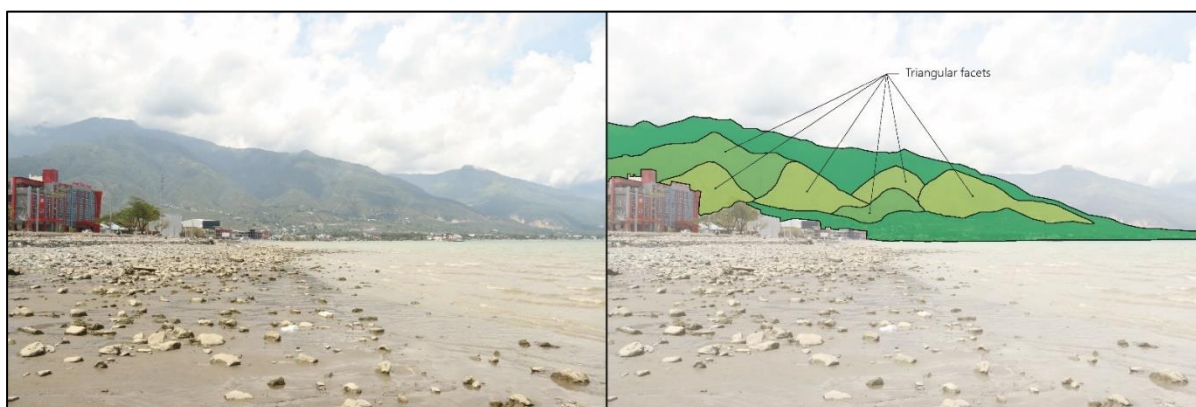
Tectonic geomorphological features such as triangular facets, hanging valleys and offset drainage lines on the western side of the valley (Figure 3.3) suggest that this represents the main fault scarp of the fault system, as proposed by Socquet et al. (2006), demonstrating a history of both strike-slip and normal displacement.

Figure 3.3 – Triangular facets on the western side of Palu valley.

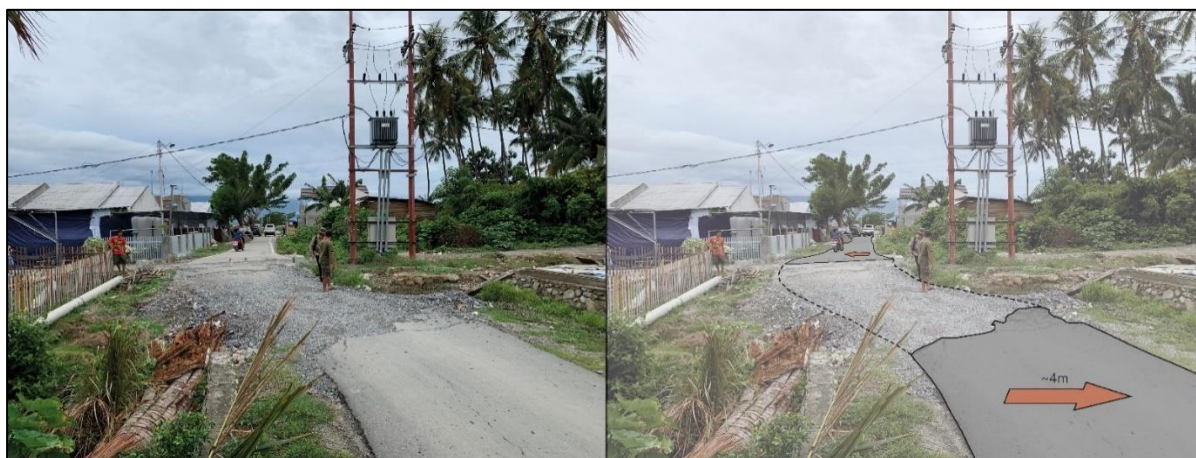
Figure 3.4 – Offset road due to strike-slip fault displacement.

Numerous expressions of the fault surface rupture were identified throughout the area, typically by the offset of linear features such as roads (Figure 3.4), but also dramatic continuous surface ruptures through agricultural land (Figure 3.5). Left-lateral strike-slip displacement was measured by the Team to be a maximum of 5m at Pewunu (Figure 3.6), and typically between 3-4m. It is possible that, given the proximity of the Pewunu area to the valley sides and steep terrain, the soil is thinner and thus the greater displacements in the bedrock are more closely represented at the surface.

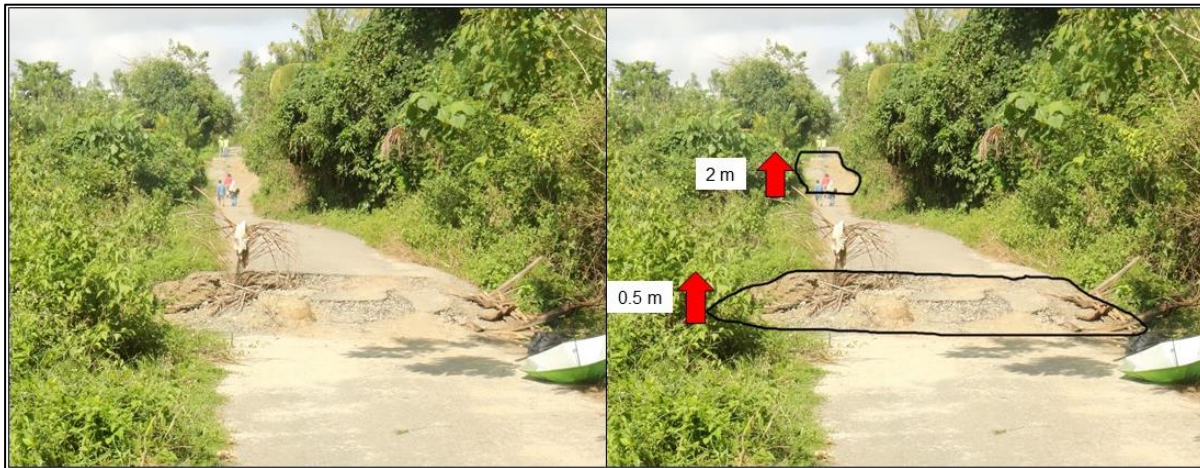
Figure 3.7 – Normal faulting observed North of Labua on the East side of Palu Bay. Photo taken facing North East

To the East of Palu Bay and north of the settlement of Labua, two surface expressions of predominantly normal displacement were observed in close proximity as shown in Figure 3.7. Vertical offsets of 0.5 m were measured for the smaller, more westerly point (nearer the camera in Figure 3.7) and 2 m for the larger rupture. Although surface debris indicated recent movement had occurred on these surfaces, it is unclear whether these measured offsets were entirely caused by the 28<sup>th</sup> September earthquake, as a water channel alongside the larger fault surface showed a breakage with an offset of 0.6 m vertically and 0.4 m to the right (Figure 3.8). This channel also showed evidence of prior patchwork repairs, suggesting that it is possible that previous events may have also contributed to the 2 m total that was measured. Figure 3.9 presents an overview of the mapped and inferred fault locations.

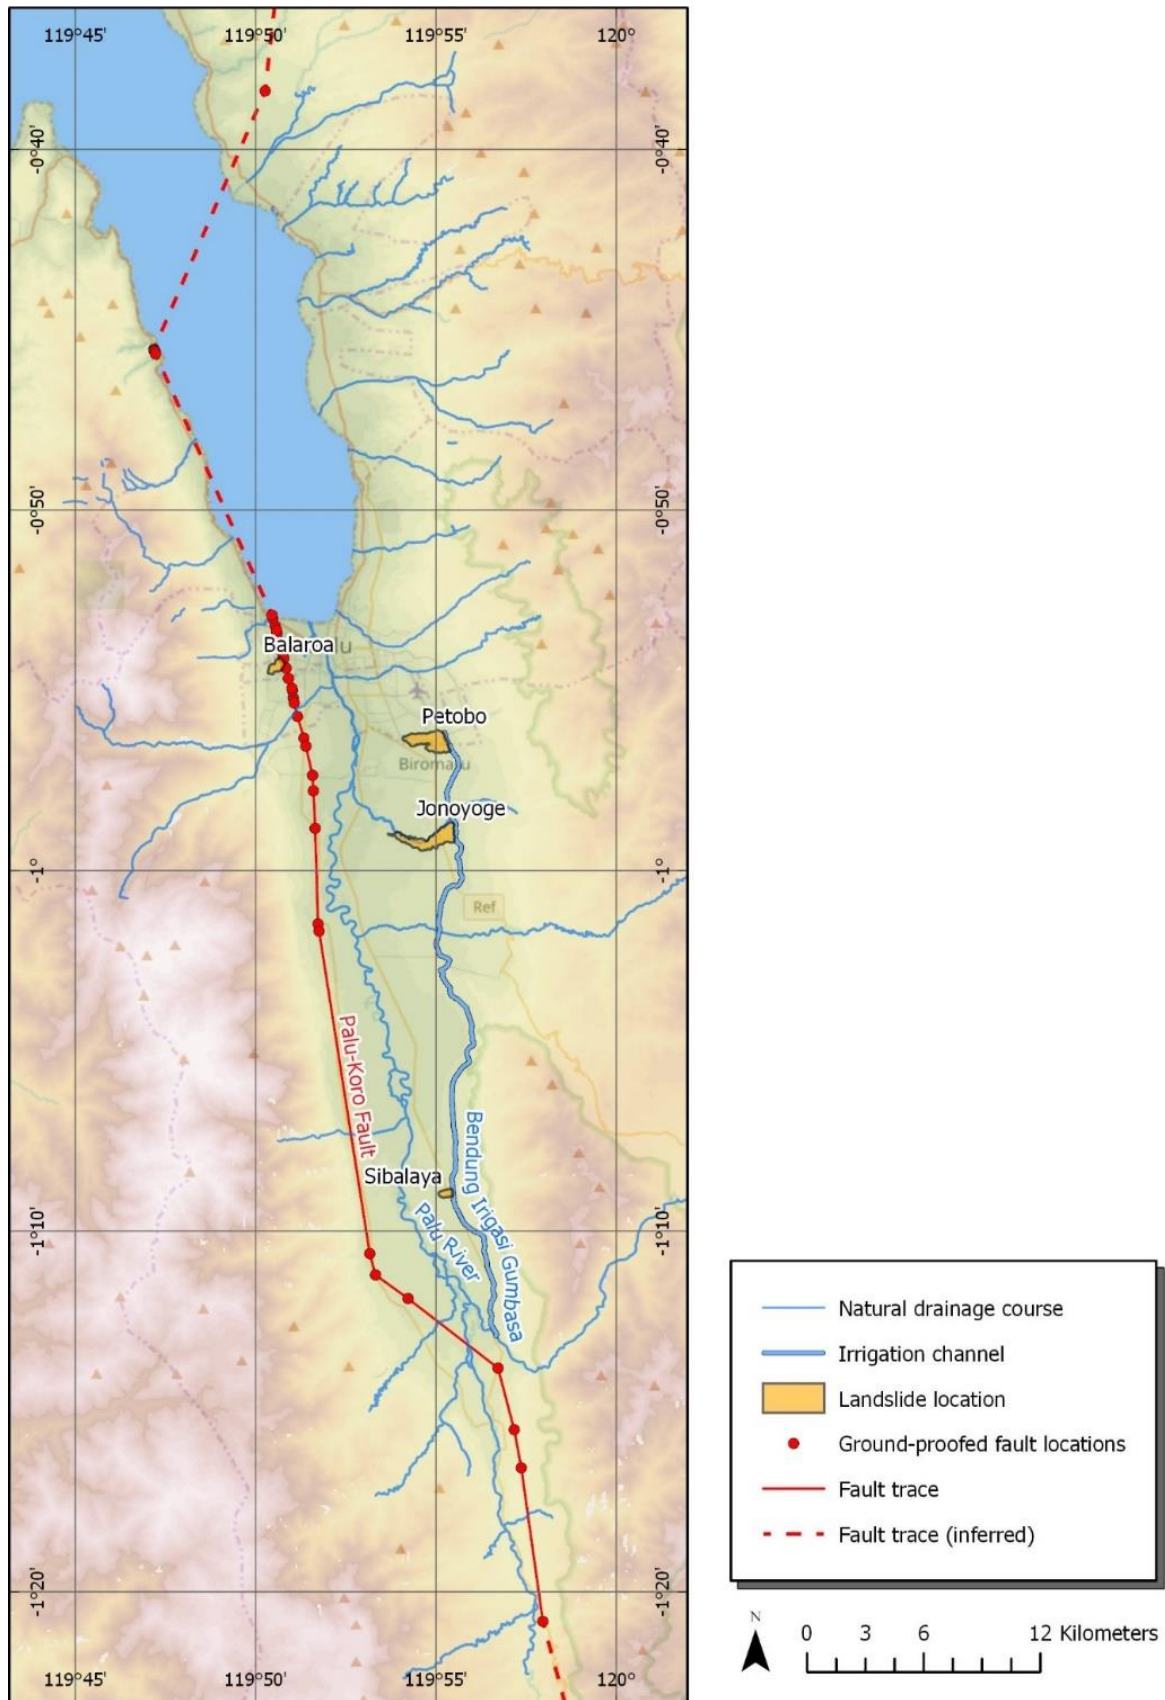
Figure 3.9 – Overview of Palu valley showing the Palu-Koro Fault, major landslides, Bendung Irigasi Gumbasa irrigation channel and the major natural drainage courses.

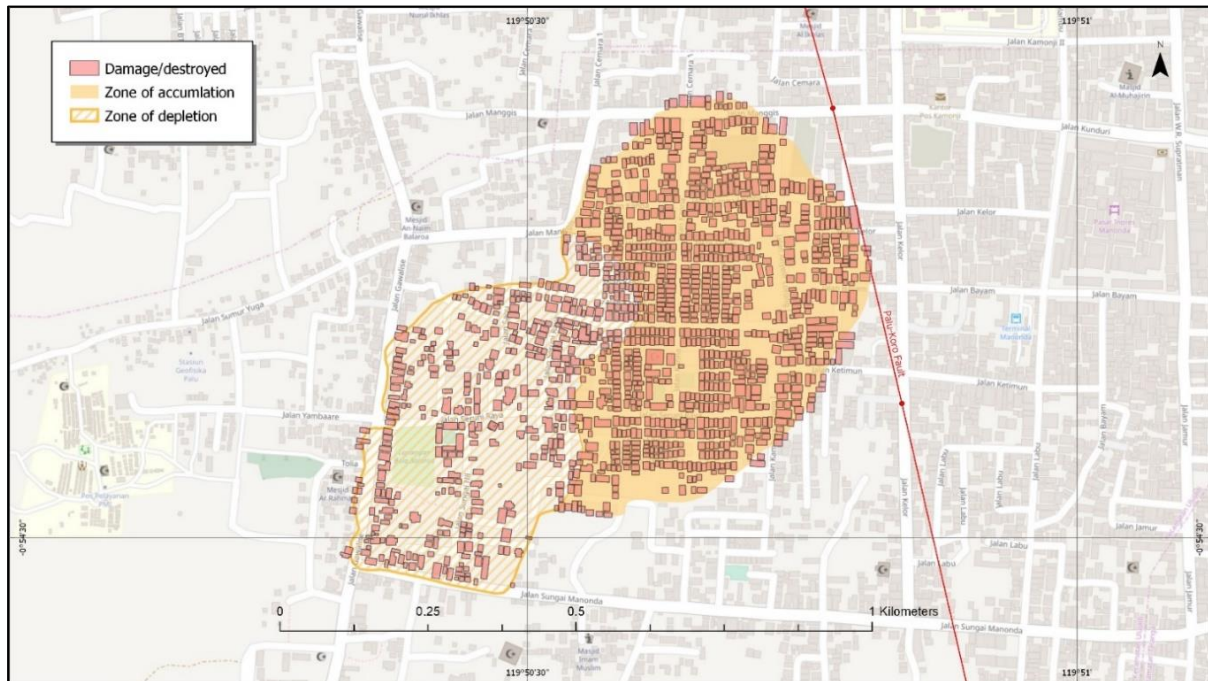
Figure 4.1 – Overview of the Petobo landslide area showing zones of depletion and accumulation as well as damaged buildings and the Palu-Koro Fault surface rupture.

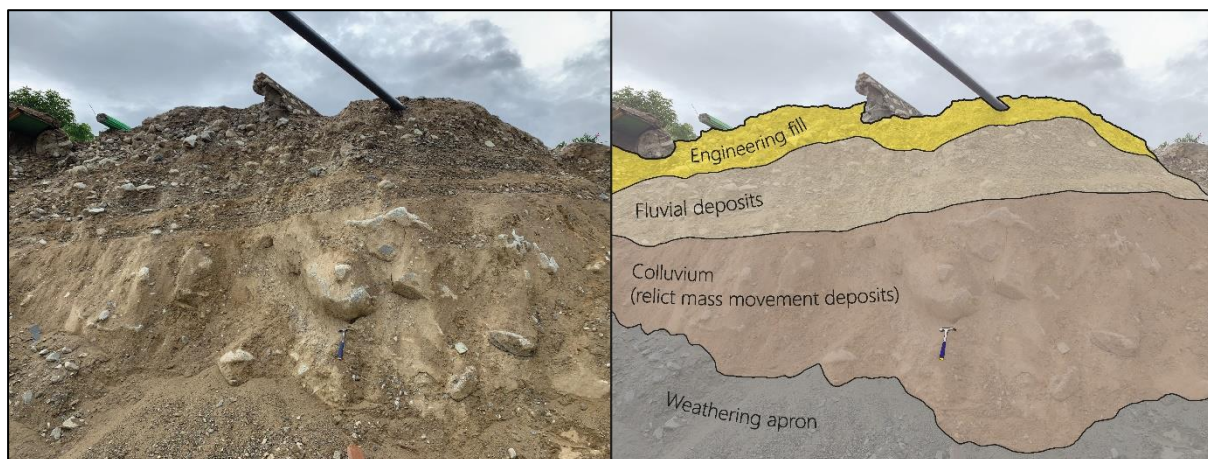
- <1m granular engineering fill, predominantly sandy gravel and cobbles;
- 1-2m of fluvial deposits comprising sandy gravel, gravelly sand, silty sand, sandy silt; and
- Underlying granitoid subangular to sub-rounded cobbles and boulders in a gravelly medium to coarse sand matrix – suspected colluvium / previous landslide deposit, base not proven.

Many large boulders, similar to those observed in the colluvium, were also noticed scattered across the zone of depletion across the upper part of the landslide. Accounts from local geologists and engineers suggested colluvial material was widespread in the valley side areas.

Figure 4.2 – Geological profile exposed in Balaroa Landslide head scarp.

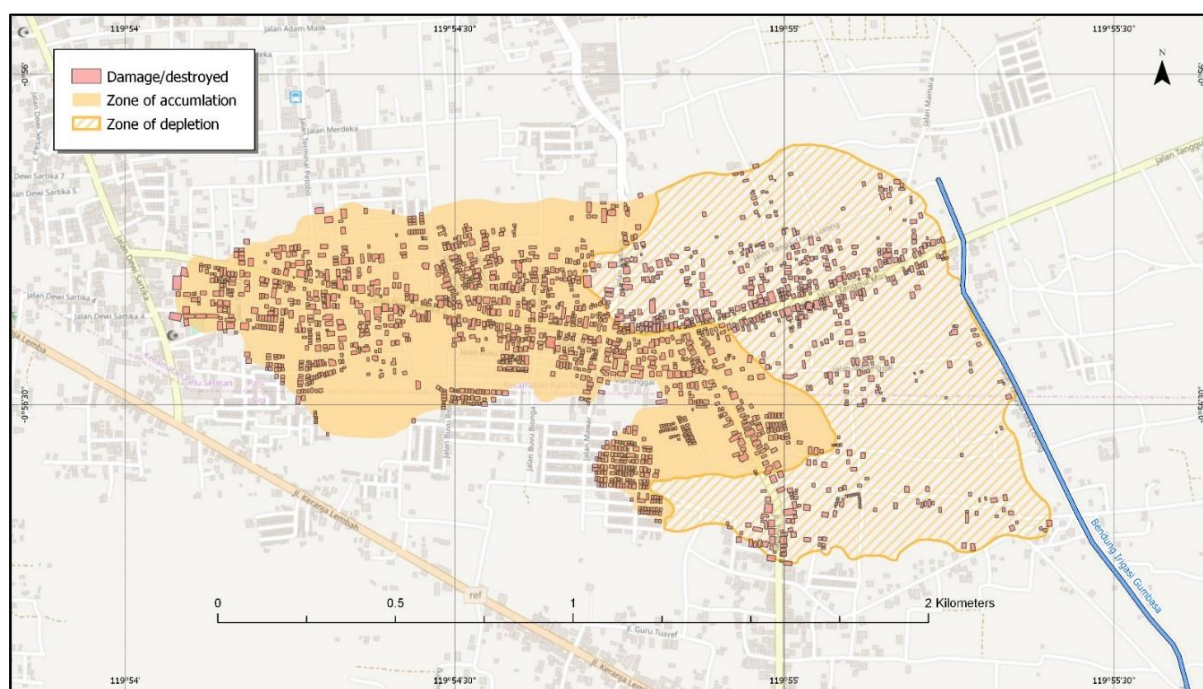
The Petobo Landslide occurred in the south-eastern district of Petobo, Palu city with evidence suggesting the landslide occurred during the earthquake ground shaking. The landslide has a head scarp of approximately 1km wide with a runout approximately 2km long; the head scarp was measured to be approximately 8-9m at its highest. The overall slope angle from the top of the head scarp to the toe was approximately 3°. It has reasonably well-defined zones of depletion and accumulation with most debris being deposited 1km to the west of the head scarp (Figure 4.3) along the main runout. There is also partial back-sloping of the main debris lobe around the central area of the landslide.

Figure 4.3 – Overview of the Petobo landslide area showing zones of depletion and accumulation as well as damaged buildings and the location of the Bendung Irigasi Gumbasa irrigation channel.

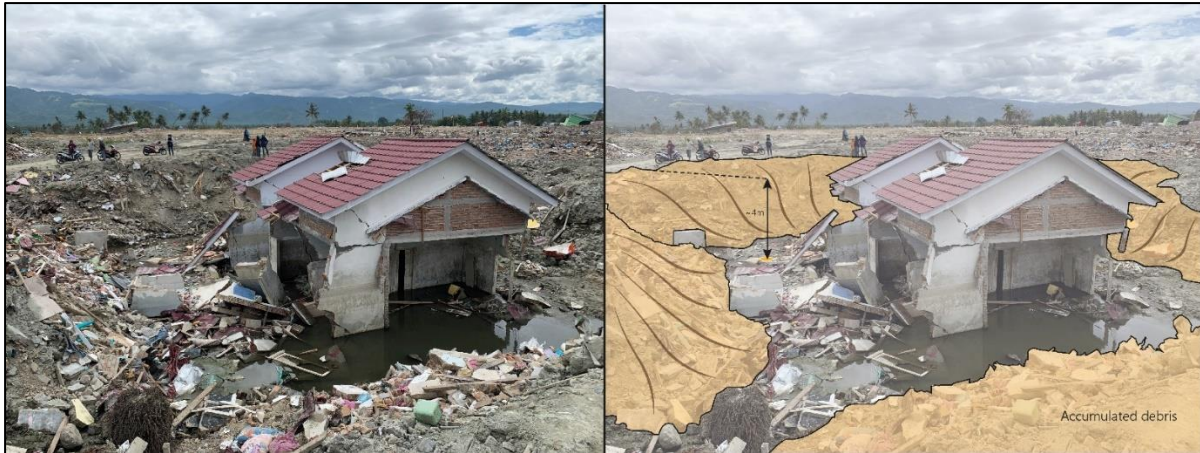
In the upper part of the landslide there is a finger of ground that has been partially inundated with debris but has largely stayed in situ and as a result this has led to a secondary runout, approximately 1km long, to the south of this finger. Much of the lower depositional part of the landslide had been cleared, however, a damaged house situated in a gully formed in the debris with the base at original ground level suggested the deposited debris thickness was approximately 4m (Figure 4.4). Elsewhere, debris has been used to form an embankment for an access road.

Figure 4.4 – Deposited debris thickness in the accumulation zone of the Petobo Landslide.

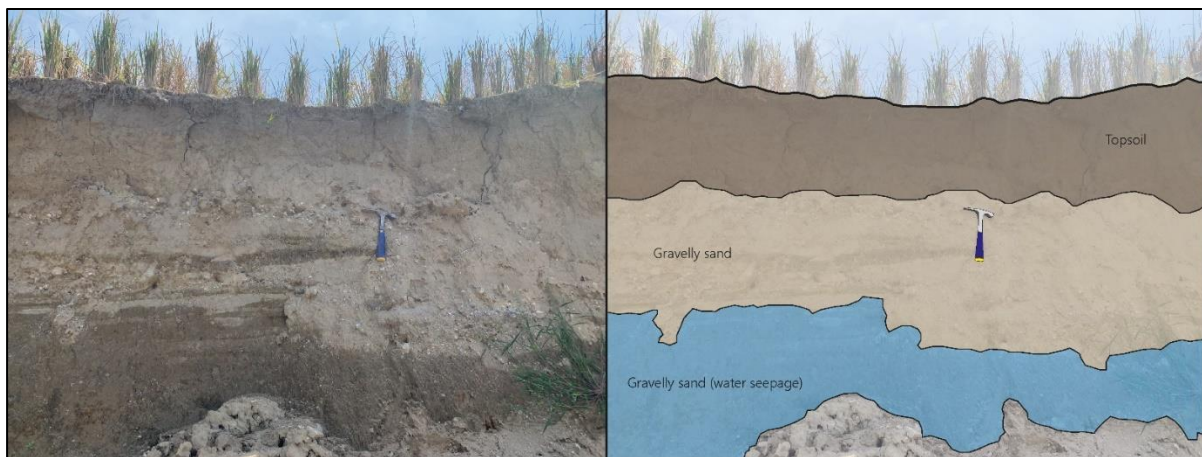
Subsurface materials were exposed in the head scarp (Figure 4.7) demonstrating the following succession:

- <1m of agriculturally reworked topsoil; and
- Underlying fluvial/alluvial deposits comprising occasionally gravelly fine to medium sand with occasional layers of increased fines content – base not proven.

Figure 4.7 – Geological profile exposed in Petobo Landslide head scarp.

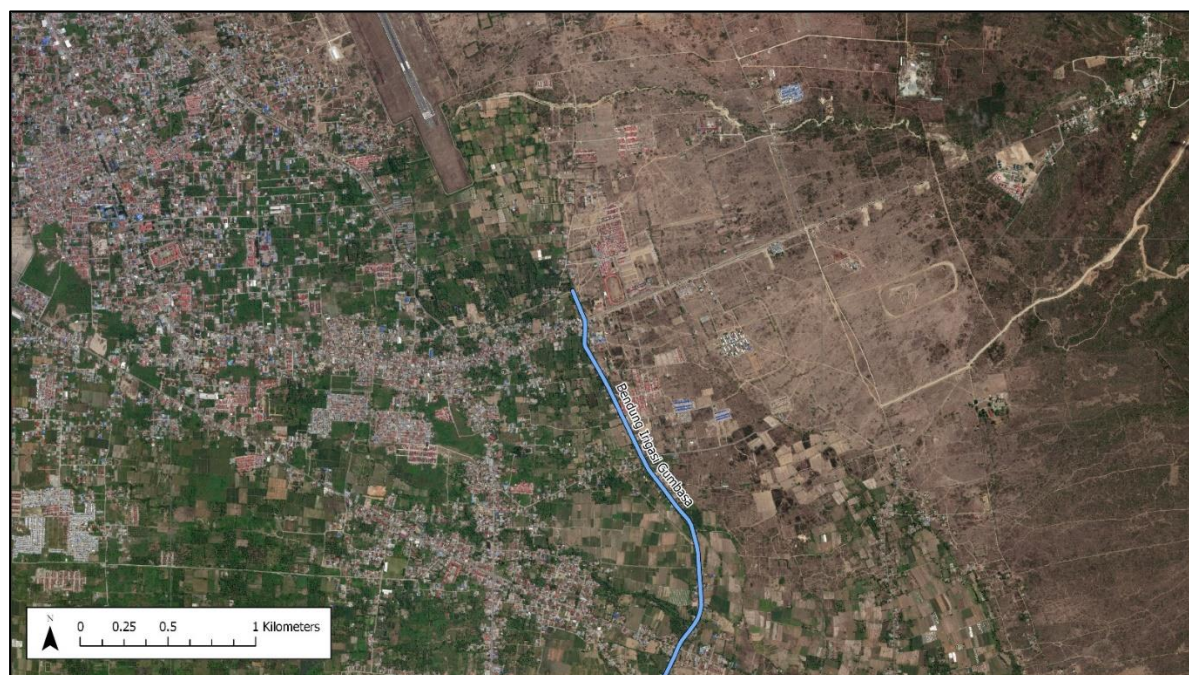
Anecdotal evidence suggests that ground water in the area above the irrigation channel, as terrain steepens, is much deeper between 15-30m below ground level. This is reflected in the aerial photography and satellite imagery of the area, with the land above the irrigation channel observed to be brown (no vegetation), whereas below the channel the ground is green in colour, indicating significant vegetation growth and agriculture (Figure 4.9). There is also limited urban development upslope of the channel as groundwater extraction is likely more challenging.

Figure 4.9 – Difference in vegetation growth due to groundwater conditions on either side of the Bendung Irigasi Gumbasa in the Petobo area. Green vegetation growth (left) indicates wetter ground conditions as opposed to brown land with lack of vegetation growth (right) indicating mostly dry ground.

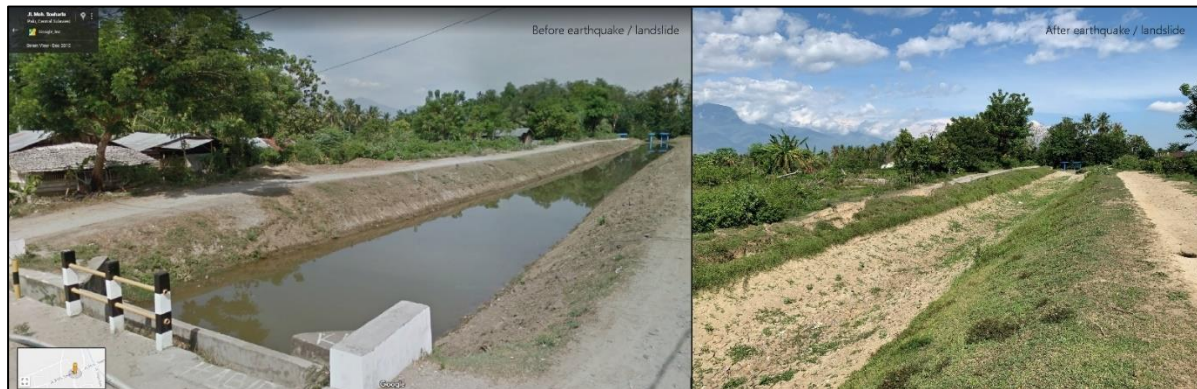
It is notable that both the Petobo and Jono Oge landslides, as well as a much smaller (but still significant) failure in the town of Sibalaya to the south, all initiated along the irrigation channel (Figure 4.3). Eyewitnesses remarked that prior to the earthquake the irrigation channel was full of water and rapidly emptied during the ground shaking (Figure 4.10). Local eyewitnesses at the confluence where the main channel flow control structures are situated reported that flow to the irrigation was stopped in the evening after the earthquake and, at the time of the mission, the entire channel was observed by the EEFIT-TDMRC to be dry except for some localised ponding.

Figure 4.10 – Far northern end of the Bendung Iriqasi Gumbasa irrigation channel above the head of the Petobo Landslide before (left) and after (right) the earthquake.

Representatives from the MoPWPH suggested that there were plans to restore the irrigation channel following the landslide, adding to it an impermeable geosynthetic clay liner (GCL) as well as upgrade the local drainage network. They also remarked that a new residential area was planned at the southern end of the airport, to the north of the Petobo Landslide. The airport was pre-existing to the development of the main irrigation channel and it is possible the continuation of the channel was restricted by planning restrictions related to the airport (see Figure 4.8).

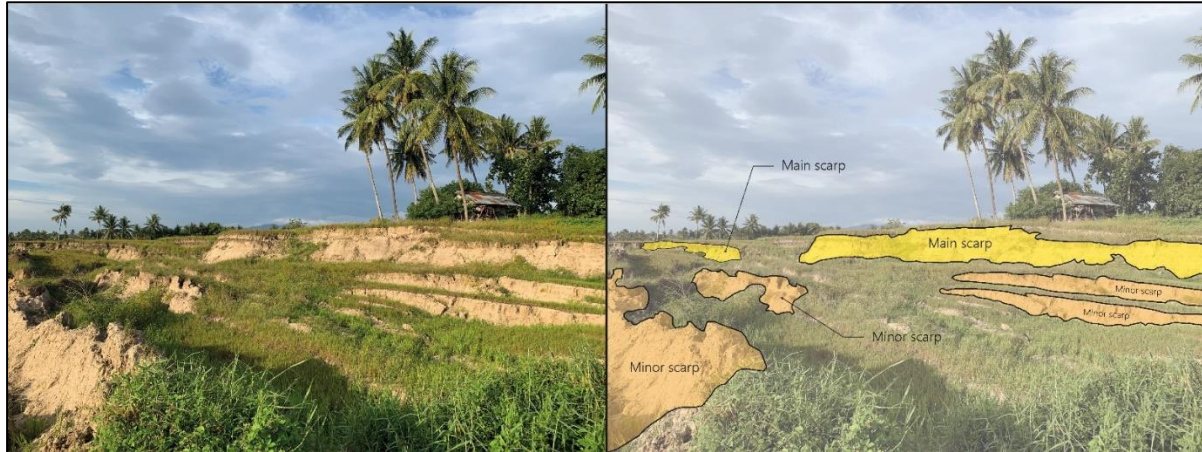
The exposed part of the head scarp was measured to be 3-4m at its highest, although measurement was partially obstructed back-tilted blocks. Significant minor scarps were observed due to abundant back-tilted blocks remaining intact (Figure 4.11). The overall slope angle from the top of the head scarp to the toe was less than  $1^\circ$  – the length of the runout and this low angle suggests the landslide was extremely fluid and thus mobile. The landslide is bounded to the north by a major drainage line – the same drainage line that it eventually becomes entrained in.

Figure 4.11 – Upper part of the Jono Oge Landslide with the main scarp and minor scarps indicated.

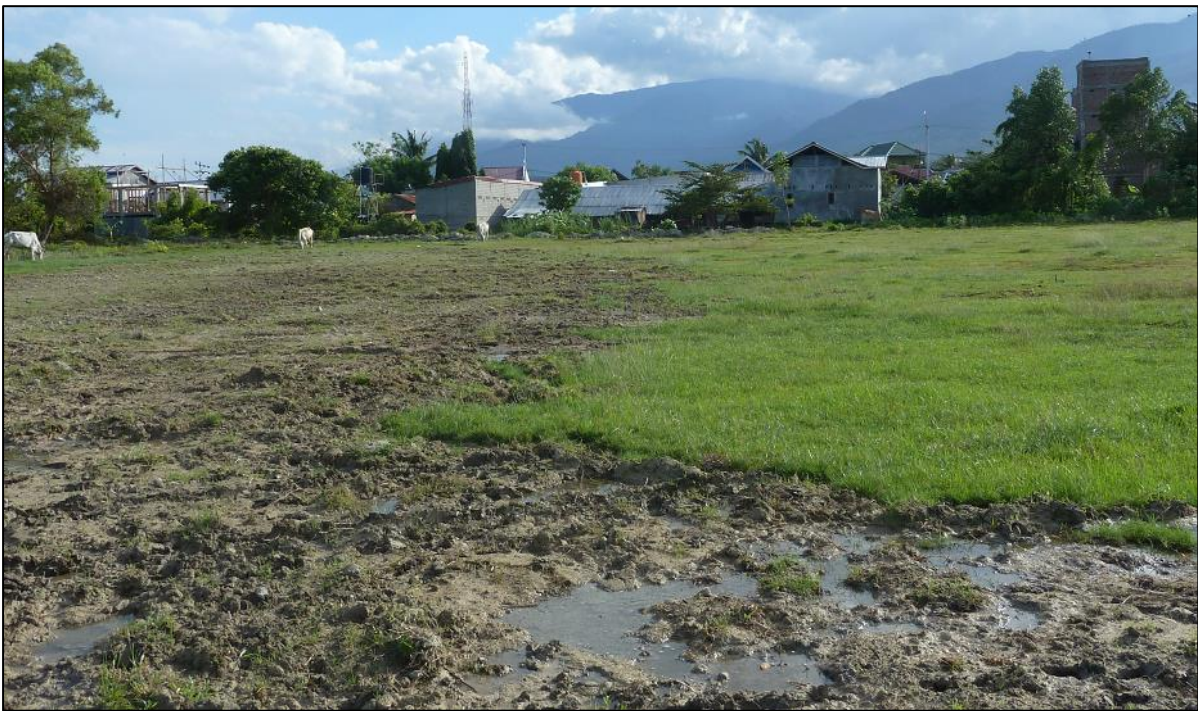
Near the fault in Palu City, particularly in the Lasoso suburb, a small number of liquefaction-induced settlements of structures were observed (e.g. Figure 5.5 and 5.6). Furthermore, the Gelanggang Mahasiswa sports field in Kabonena was crossed by the fault and was observed to be covered in ejecta (Figure 5.2 and 5.3) classified as very gravelly sand (Figure 5.4). A vertical offset of 300 mm around the field suggested settlement of this amount, relative to nearby soils that showed no evidence of liquefaction.

*Figure 5.3.- Liquefaction ejecta in a field at Gelanggang Mahasiswa, Kabonena. The ejecta, is seen to follow the path of the fault across the field, although the soil on both sides appears to have settled by a similar distance.*

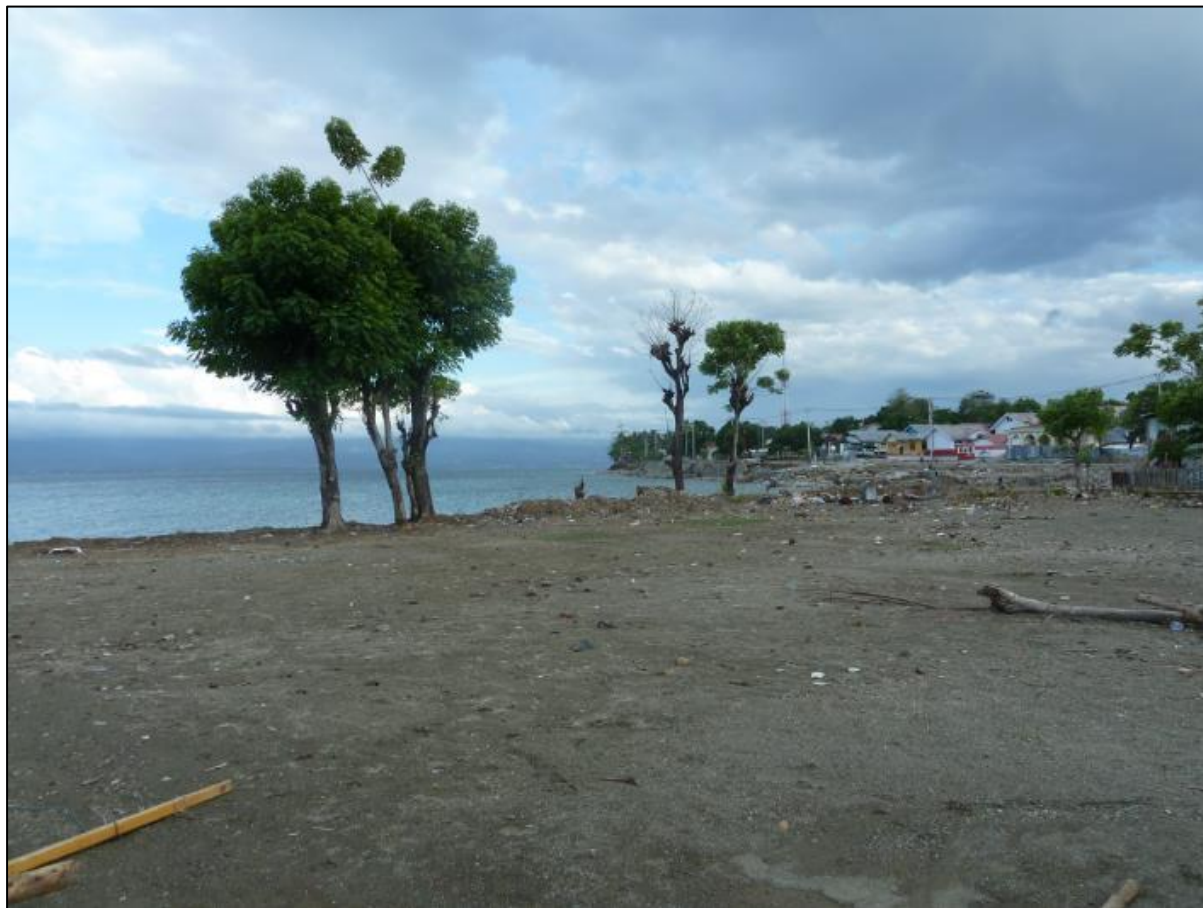
The road at Loli Tasiburi ran near the coast, through tsunami damaged/destroyed dwellings. Locals reported that large areas of coastline had broken off and fallen into the sea, with one indicating Palu, visible in the distance around a headland, which he reported had previously been obscured by the land (Figure 5.20). An eyewitness described the soil “bubbling”, and two large upwards spurts of water on the beach (at this point he ran for cover up the hill). The soil at the site was very gravelly sand (Figure 5.21), and black in colour. It was reported that “Tasiburi” means “black sand” in the local Kaili dialect.

The soil type and inevitable high groundwater level suggest liquefaction was a clear possibility, and the eyewitness reports are consistent with soil liquefying. The team concluded that liquefaction had therefore occurred in the coastal soil, and either the resultant large settlements were sufficient to submerge the coastal land or (more likely) lateral spreading has taken the shoreline into the Bay.

Figure 5.20 - Waterfront at Loli Tasiburi. Note the headland in the background which locals had indicated is now far shorter than before.

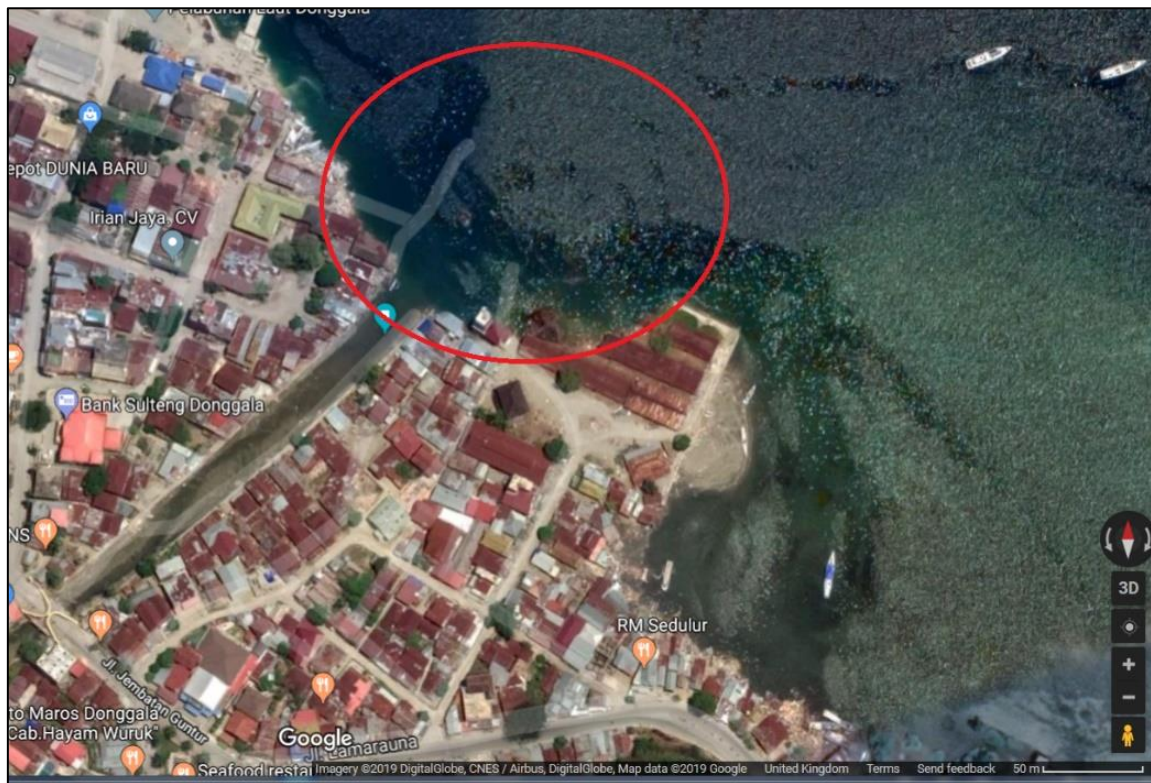
North of Loli Tasiburi was the town of Donggala, with a small port. Further shoreline-reducing liquefaction was seen here, as indicated by the “bite” into the current land shape compared to the overlay of roads shown in Figure 5.22, which is taken from Google Maps. Figure 5.23 shows a photograph of the bay post-earthquake, first across the “bite” (Fig 5.23a) and secondly showing evidence of soil having displaced from beneath a heavy concrete structure (Fig 5.23b). This soil displacement may have occurred through liquefaction induced spreading, as seen in other places, although scour may also have played a part, especially if the soil generated excess pore pressures and was in a softened state at the moment of tsunami wave inundation.

Figure 5.22 - Aerial photograph of post-earthquake Donggala port, overlain by prior road map showing missing land around the estuary mouth.

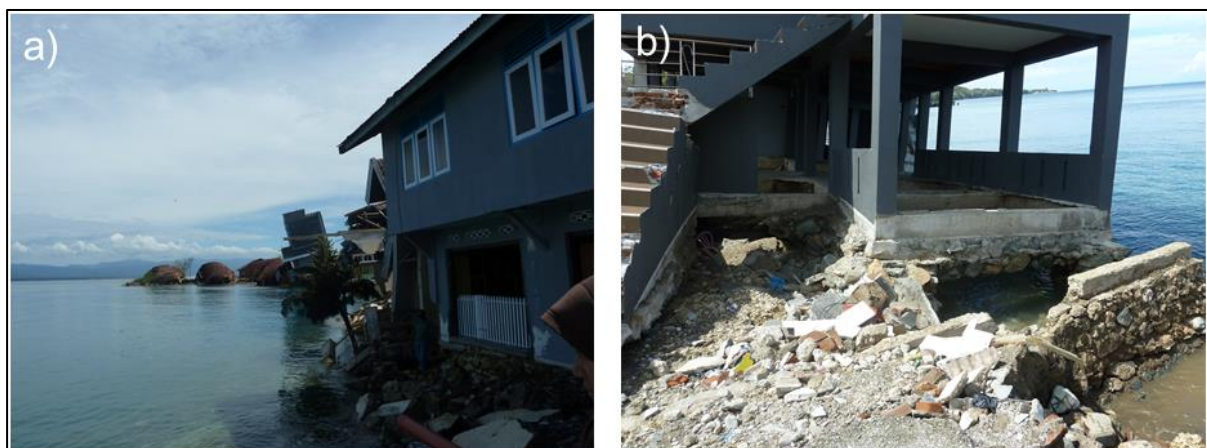
Figure 5.23.- Photographs of Donggala Port, looking a) South East across the estuary towards the partially collapsed metal rooved storage houses b) detail beneath the concrete structure seen tilted on the South edge of the bay, showing evidence of soil having been displaced from beneath the structure.

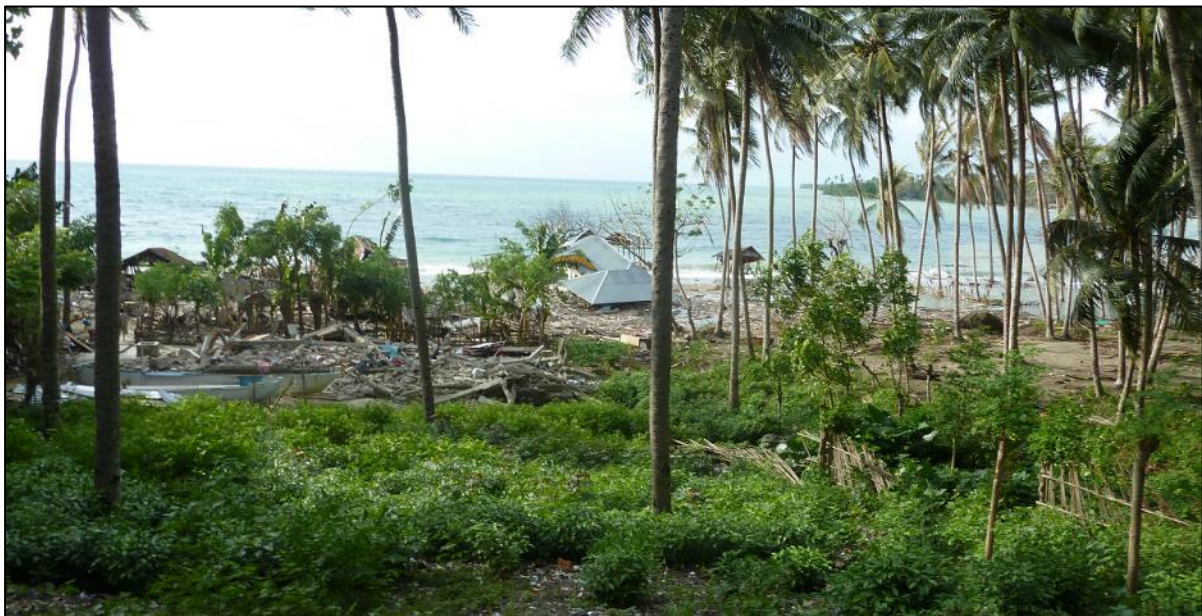
The land sloped down towards the beach (Figure 5.26), and large cracks parallel to the shore were observed South of the estuary (Figure 5.27 and 5.28), with some ejecta of a uniformly graded fine silica sand. According to local reports, the seafront road and seven dwellings had moved into the sea (Figure 5.29), experiencing both large settlement and lateral displacement consistent with liquefaction and lateral spreading.

*Figure 5.26 – Lero: View down towards the sea. The seafront had previously been the site of seven homes and a road.*

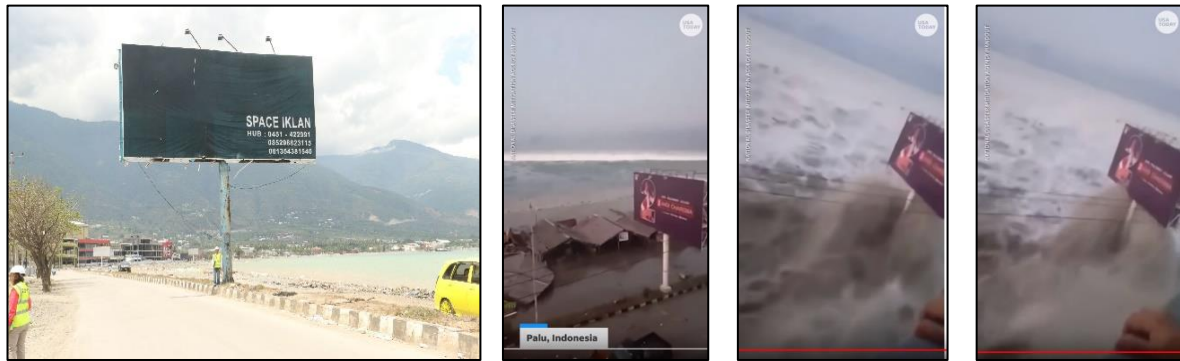
Evident from Figure 6.4 is that, in general, the inundation heights increase towards the head of the bay, with 7m inundation height consistently measured. Figure 6.5 provides an indication of what an inundation height of 7 – 8 m looks like. The left-hand image is a photograph of a team member standing against an advertising board at the southern tip of the bay, (Jalan Taman Ria, Balaroa, 0 53' 1.6" S 119 50' 53.4" E), alongside 3 frames taken of the same sign (rear side) during the tsunami. Obviously, some of the wave is highly aerated so it does not have the same force as green water loading.

Figure 6.5 - Tsunami inundation at Jalan Taman Ria, Balaroa ( $0^{\circ} 53' 1.58'' S$   $119^{\circ} 50' 53.42'' E$ ).

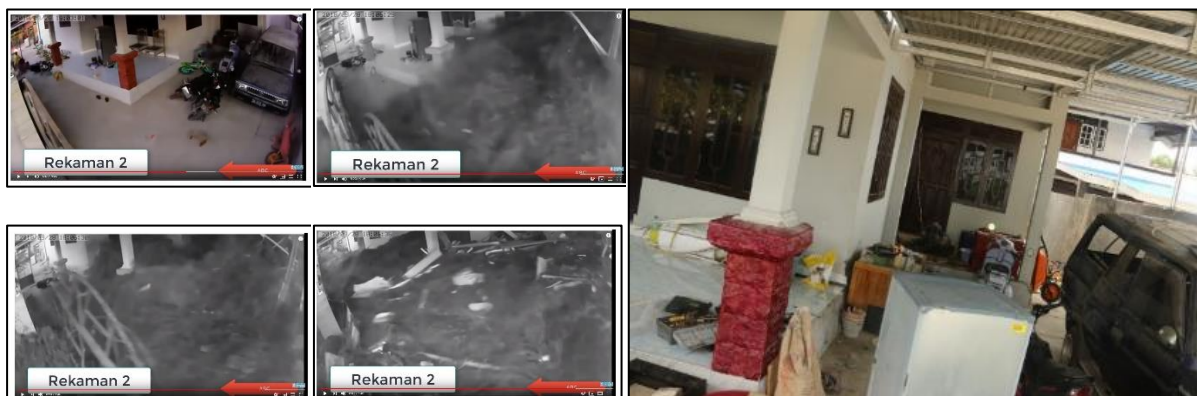
Wani is a town on the east coast of Palu Bay that suffered considerable damage due to the tsunami, (see Figure 6.10), and was made famous as the location of a household CCTV footage that showed the effect of the earthquake followed three and a half minutes later by the tsunami (Figure 6.11). The Team identified the house at which the CCTV was recorded (coordinates: 0 41'38.532" latitude; 119 50'31.422" longitude), and from comparison of measureable features of the house that were visible in the video, estimate the maximum inundation depth (above grade) at the site of the house to have been around 1.2m.

Figure 6.11 - Video frames at 18:03:01, 18:06:29, 18:06:30, 18:06:36 and during the EEFIT mission. Notice the mopeds have fallen over, following by the bore-like tsunami about 3 minutes later. This short arrival time supports the argument, discussed in Section 6.2.1, for a secondary tsunami source within Palu Bay.

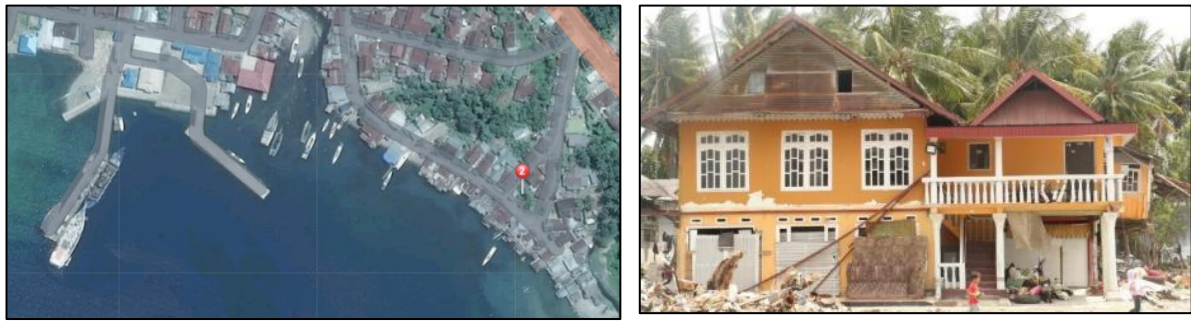
Whilst in Wani, at the location shown in Figure 6.12 (left), the Team heard the dramatic account of a man who saw the water coming out of the ground during the earthquake so got into his car to pick up his wife and mother. Having got into his car, the man only had time close the window, before he felt water rise up to his knees. It then went dark due to the wave, then light again. The car stopped and he broke the window to climb to the balcony of the house shown in Figure 6.12 (right). Whilst he was at top of the rear stairs he heard the next wave and the sound of debris. He then saw a fast-flowing stream of water and people screaming for help. After the water receded he was reunited with his wife and mother.

Figure 6.12 - Location (left) and photograph (right) of the house where the man in the car ended up at around 50 m inland from the sea

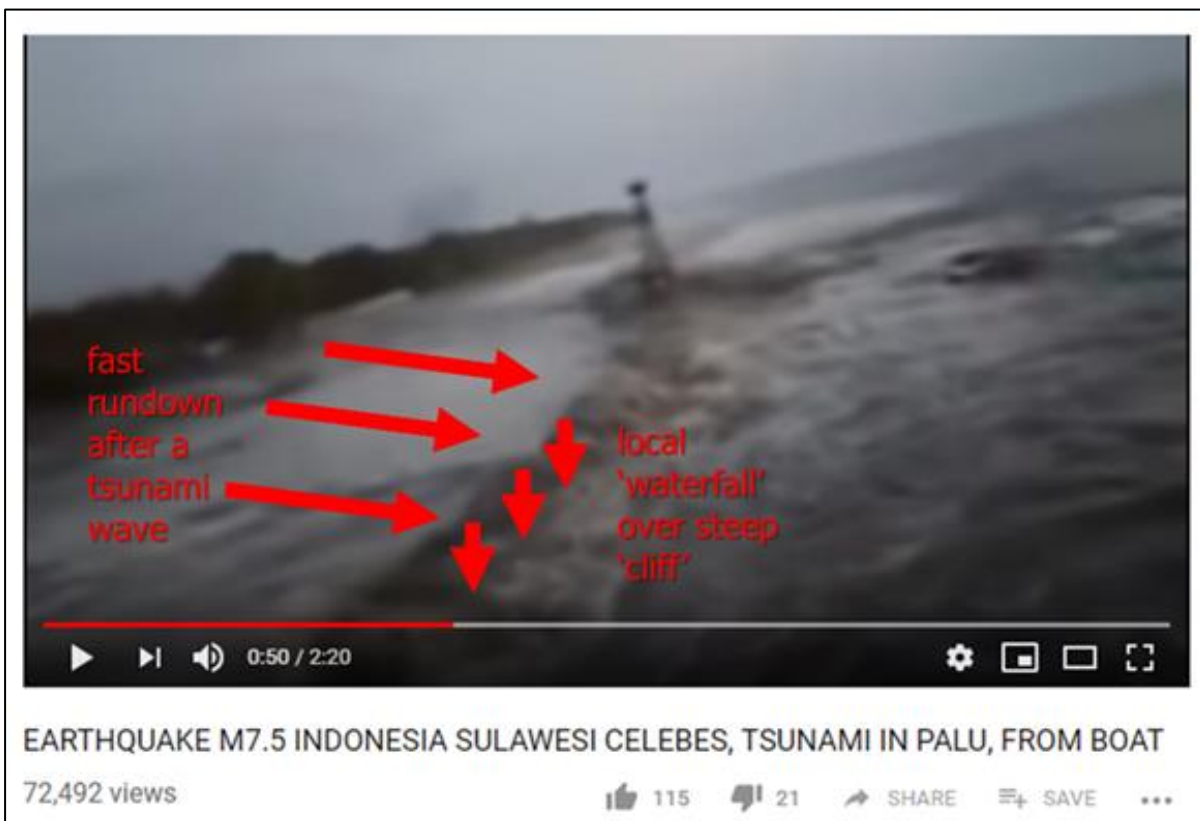
A coastal landslide occurred shortly after the earthquake, creating local tsunami at the river mouth and with subsequent land subsidence causing a number of houses to collapse into the sea. The cross-shore profile of shallow water bathymetry reveals the depth, suggesting the size of the landslide. Figure 6.14 is an annotated YouTube video frame showing the wave rundown which reveals the cliff-like structure on the seabed, presumably following a submarine landslide.

Figure 6.14 - Youtube video frame indicating wave rundown and the sharp change in bathymetry following a submarine landslide.

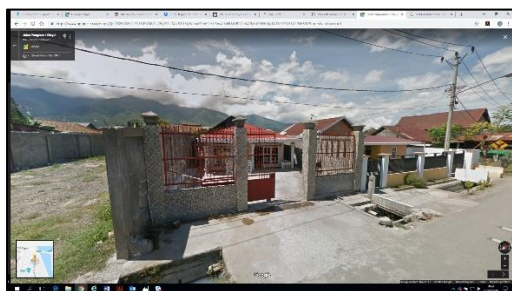
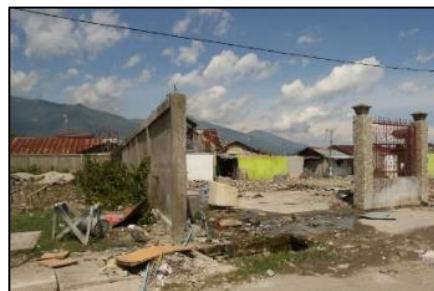
Location 1, looking  
westward

The left-hand column of Figure 6.19 shows Google Streetview scenes from before the earthquake/tsunami and the right hand column show the same locations captured during the TDMRC-EEFIT mission. North of Location 1 (Figure 6.18), there was severe devastation and damaged structures had already been cleared. The first row of Figure 6.19 corresponds to Location 1 looking westwards, surrounded by ornamental walls and a gate. There was simply no sign of the house when we visited. Also, at Location 1 but looking eastwards, the timber structure with rusty steel roof evident from Google Street-view had also disappeared, but the neighbouring house seemed largely unaffected. The photographs at Location 2 which are shown in the third row of Figure 6.19, about 50 m further south, illustrate the care with which vertical inundation needed to be established, as the pre-tsunami photograph shows a significant discolouration line which is due to rising damp, common in that area.

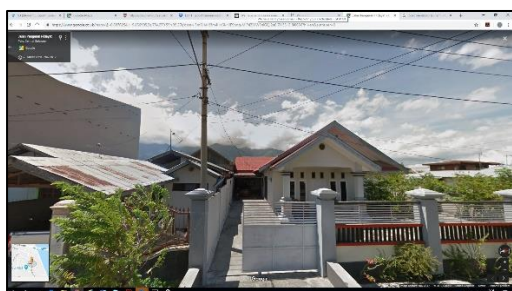
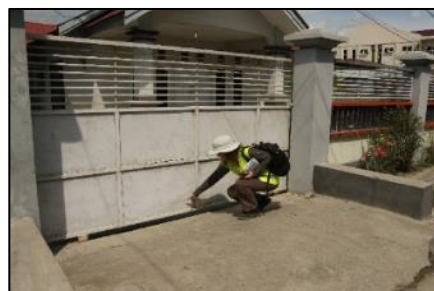
Location 3, looking  
westward

Only by obtaining additional clues *e.g.* from a faint black line on the white timber door can an accurate level be ascertained. The fourth row of Figure 6.19, corresponds to Location 3 facing westward, a further 50 m or further south, which revealed a watermark on a set of metal gates, protecting a house which seemed unaffected. Finally, the bottom row, also at Location 3 but looking eastwards, shows remediation work that has been undertaken. Here, a wide, sloping kerb had been constructed right up to the timber doors. Enquiries at that location solicited the fact that due to local coastal subsidence the high tides were reaching the same extent as the horizontal inundation of the tsunami, so this protective kerb had been erected to address on-going flooding issues. This new flooding hazard was apparently also bringing crocodiles into Palu.

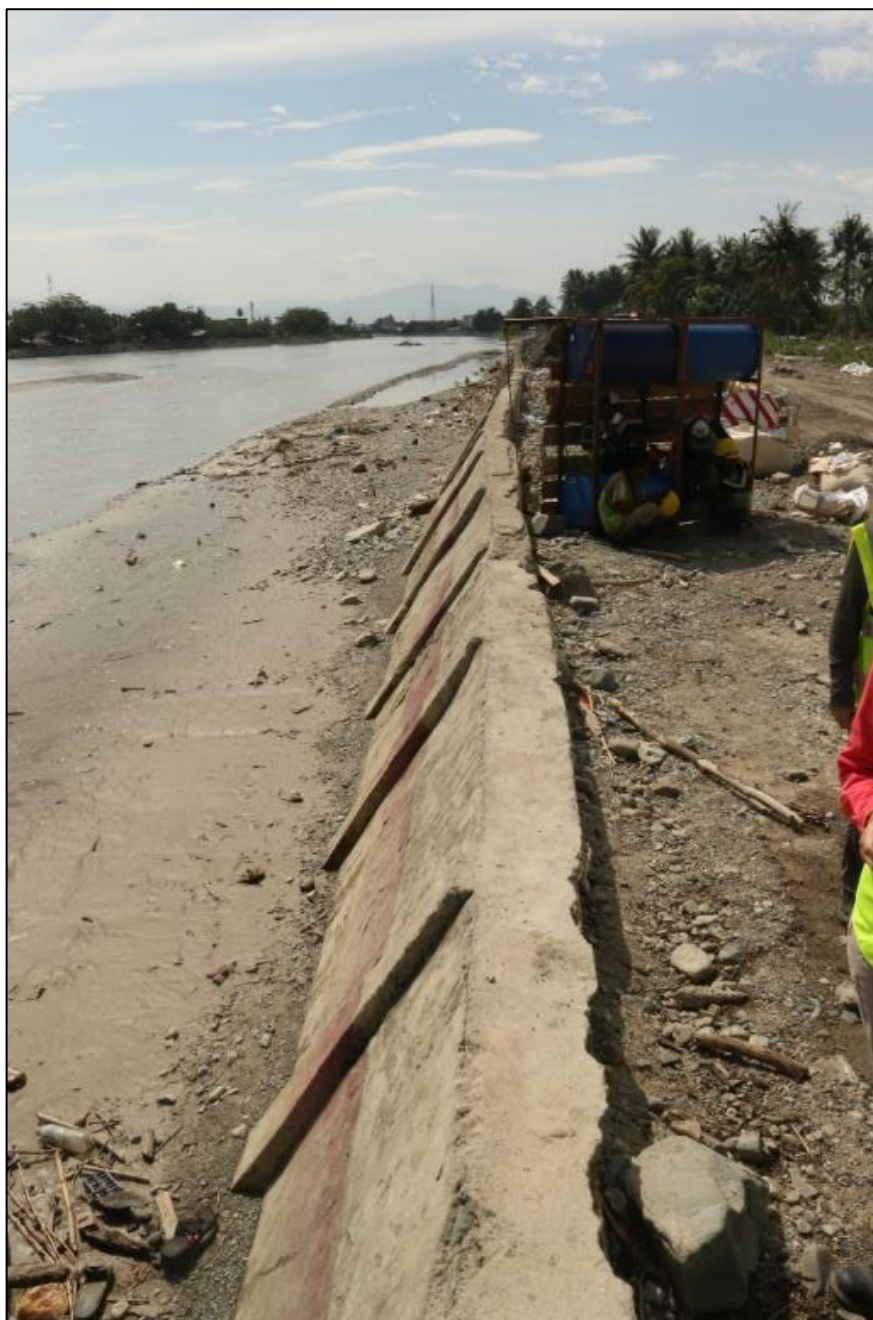
In contrast to another EEFIT mission to Japan in 2011, the tsunami did not evidently travel up the Palu river, despite its considerable height at the southern end of the bay. Considering the substantial building damage seen at the shoreline near the mouth of the river, one would expect to see building damage continued some way upstream along the river, on the riverbanks. It was verified by visiting the neighbourhood on the west side of Palu river, just inland from the coast, that there was no damage. Eyewitnesses also said they just saw boats bobbing up and down but no significant overtopping of the river wall (Figure 6.20) close to their house. It is probable that there was a mitigating effect on the tsunami from the collapsed Palu Bridge IV (Figure 6.21). The bridge collapsed during the ground shaking, and fallen bridge deck is likely to have acted as a barrier to the tsunami, mitigating its effects on the river.

Figure 6.20 - Concrete river wall near entrance to the Palu river
