# **The Central Sulawesi, Indonesia Earthquake and Tsunami of 28<sup>th</sup> September 2018 – A Field Report by EEFIT-TDMRC**

01/11/2019

Prof Tiziana Rossetto, EPICentre, University College London

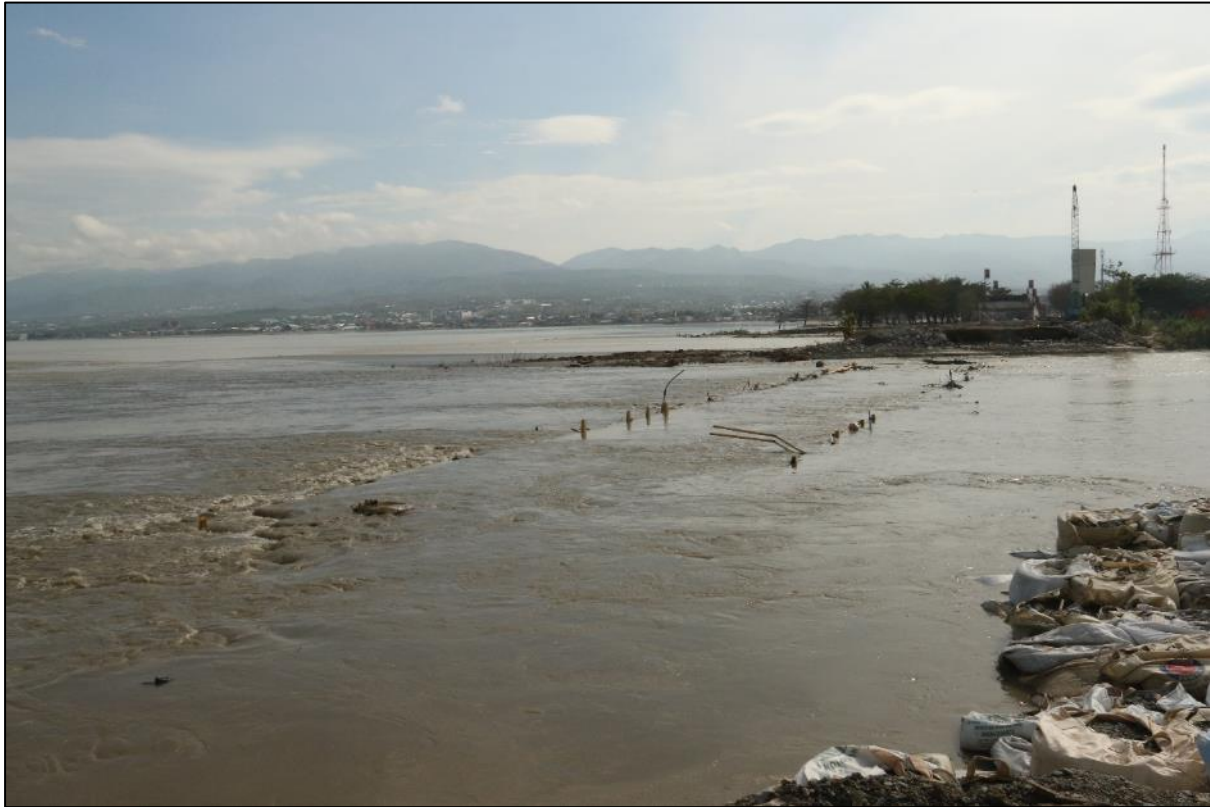
In contrast to another EEFIT mission to Japan in 2011, the tsunami did not evidently travel up the Palu river, despite its considerable height at the southern end of the bay. Considering the substantial building damage seen at the shoreline near the mouth of the river, one would expect to see building damage continued some way upstream along the river, on the riverbanks. It was verified by visiting the neighbourhood on the west side of Palu river, just inland from the coast, that there was no damage. Eyewitnesses also said they just saw boats bobbing up and down but no significant overtopping of the river wall (Figure 6.20) close to their house. It is probable that there was a mitigating effect on the tsunami from the collapsed Palu Bridge IV (Figure 6.21). The bridge collapsed during the ground shaking, and fallen bridge deck is likely to have acted as a barrier to the tsunami, mitigating its effects on the river.

*Figure 6.21 - Submerged bridge deck of the Palu Bridge IV which may have acted as a submerged breakwater to the tsunami waves, preventing them travelling up the river*

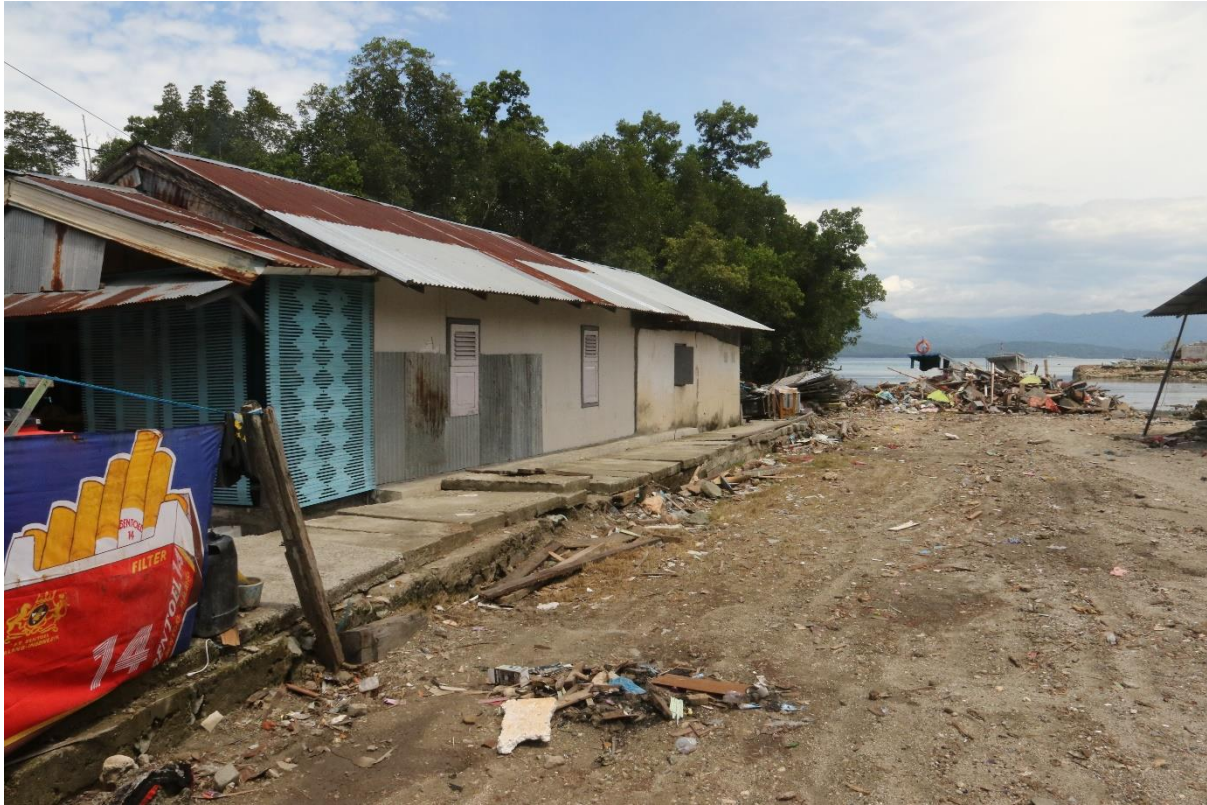
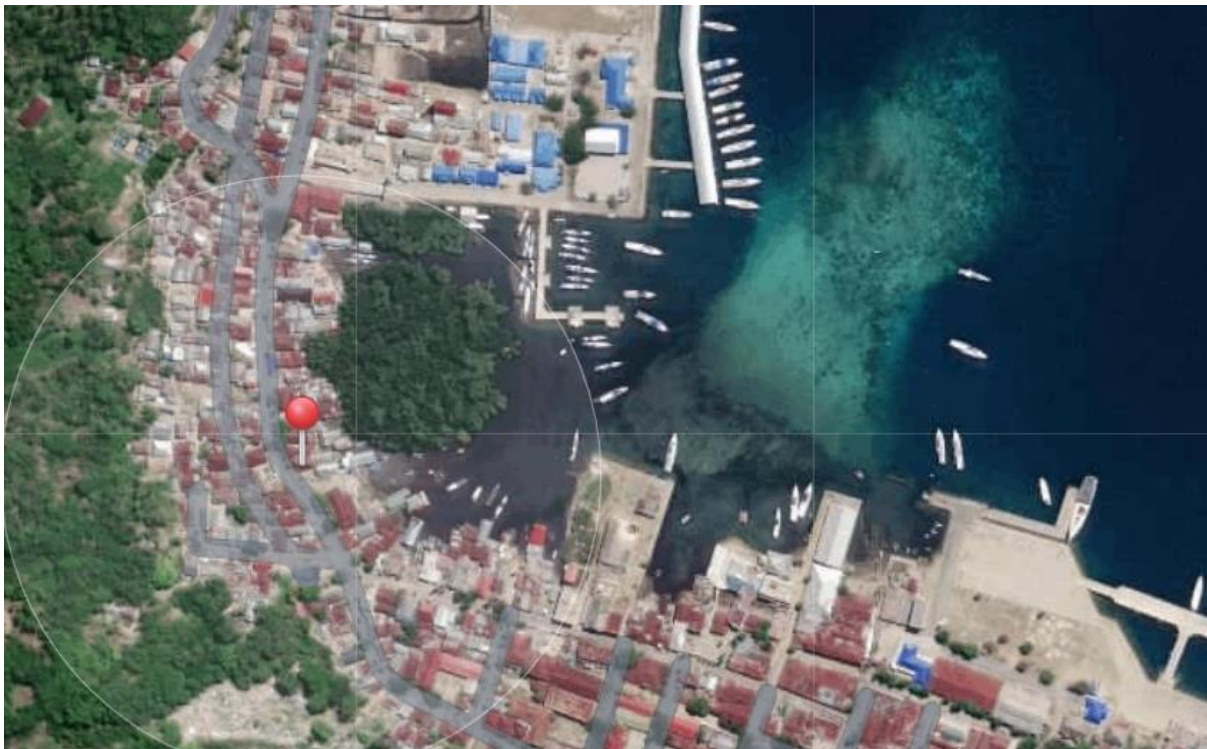
Mangroves are native to Indonesia, and in some locations were seen to provide some limited protection from the tsunami inundation. Mangroves in Labuan Bajo were said to have provided some protection to some poor quality 1960s housing (Figure 6.22), locally resulting in no damage.

Figure 6.22 - (top) Poor quality 1960s housing in Labuan Bajo that has been sheltered by a large area of mangroves at the shoreline. (below) A map showing the position of the building within the port, behind the large green area of mangroves

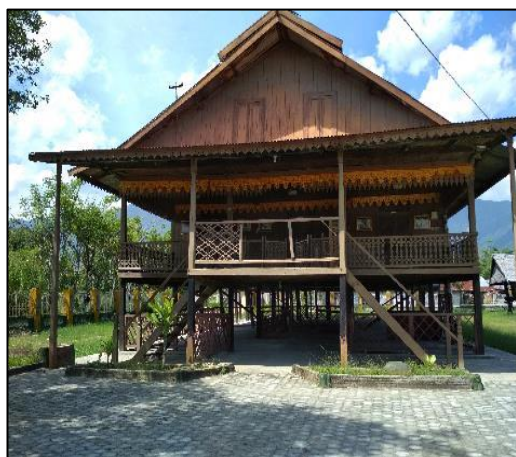
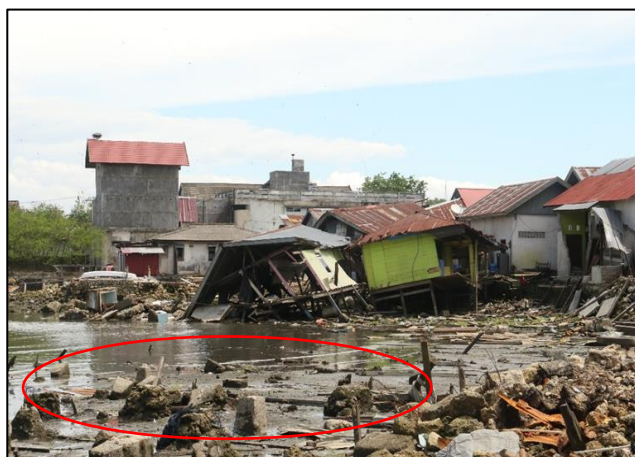
The stilt houses showed varied performance under the earthquake and tsunami. At the shore-front these structures performed badly due to ground subsidence and the tsunami inundation reaching the first floor. For example, Figure 7.4-right shows the remains of the stilt houses foundations of the fisherman village in Labuan Bajo Donggala. However, in other areas, where the tsunami inundation did not exceed the ground floor, this type of housing was seen to perform well due to their open ground floor offering little resistance to the flow. Only two examples of stilt houses were surveyed by the Team in an area of Palu that had not been inundated by the tsunami. These were both at the Heritage site of the palace of the Princes of Palu, with the first (Figure 7.4-left, the palace) being undamaged by the earthquake ground shaking, whilst the neighbouring very small structure exhibited severe tilting.

Figure 7.4 - Performance of timber stilt houses in Palu and Dongqala, Central Sulawesi: Left – The palace of the Princes of Palu. This structure was affected by ground shaking but not tsunami inundation and was undamaged. Right - The remaining concrete foundations of the timber stilt houses in the Labuan Bajo Fisherman Village, shown in red circle. Collapsed stilt houses can be seen in the background.

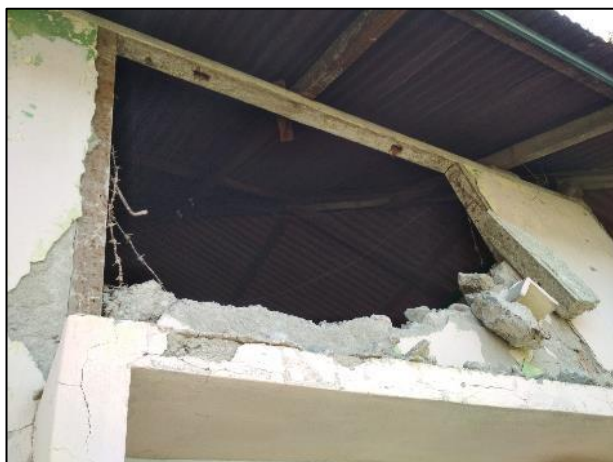
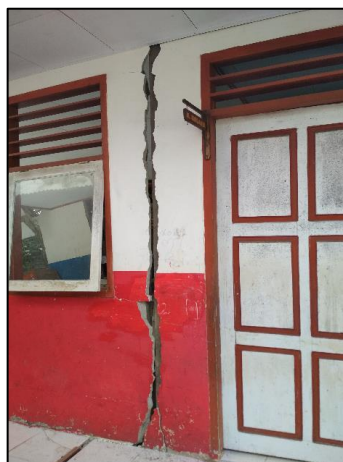
The typical earthquake induced damage observed in these buildings was out-of-plane failure of the infill walls or separation between the infill and frame due to differential settlement (see Figure 7.8).

Figure 7.8 - Typical earthquake damage observed in infilled timber frame construction. Left - Out-of-plane failure of infill panels. Right - Separation of infill from frame due to differential settlement of foundations.

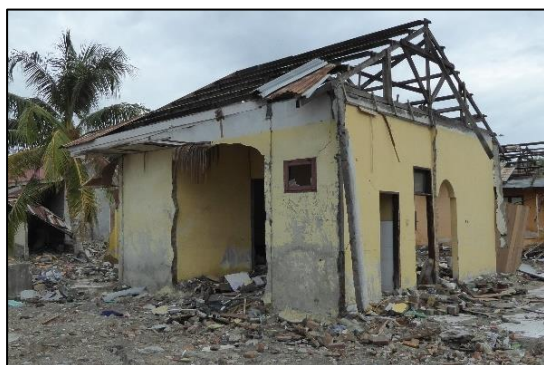
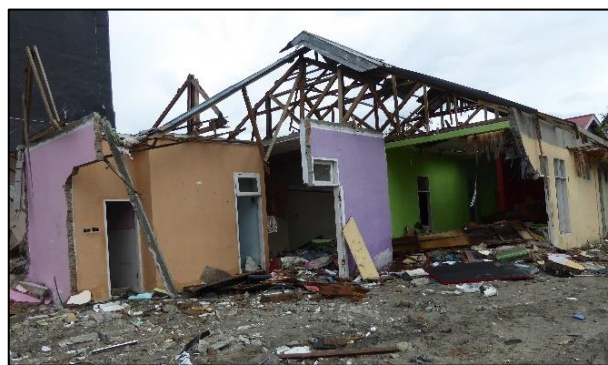
Figure 7.10 – Heavily damaged CM houses in Palu bay area along the Jl. Rajamoili road, about 100m from coastline. The walls of this house were directly hit by the tsunami inundation.

Typical damage sustained by CM houses along the coast line in Palu bay area is shown in Figure 7.10. The main damage pattern is the out of plane failure of walls directly hit by the tsunami waves. The tie-columns, being small in size and having poor reinforcement detailing, also suffered shear damage. However, as shown in Figure 7.11, sheltered houses near the coastline were unaffected, indicating that the effect of ground shaking was modest in this area.

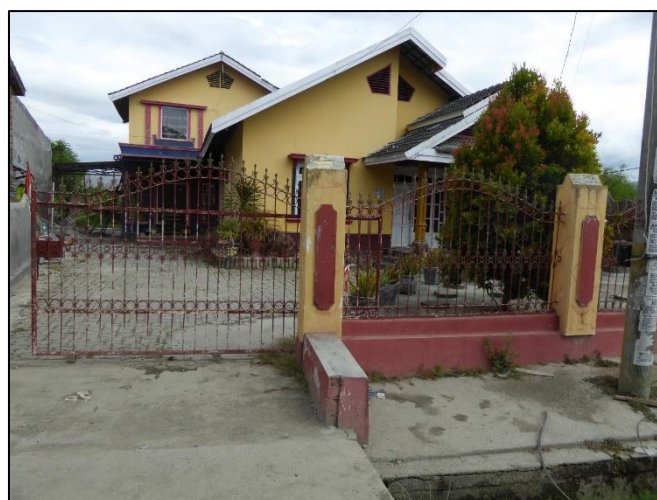
Figure 7.11 – Undamaged CM houses in Palu bay area along the Jl. Rajamoili road. These houses were sheltered from the tsunami inundation by other houses-buildings.

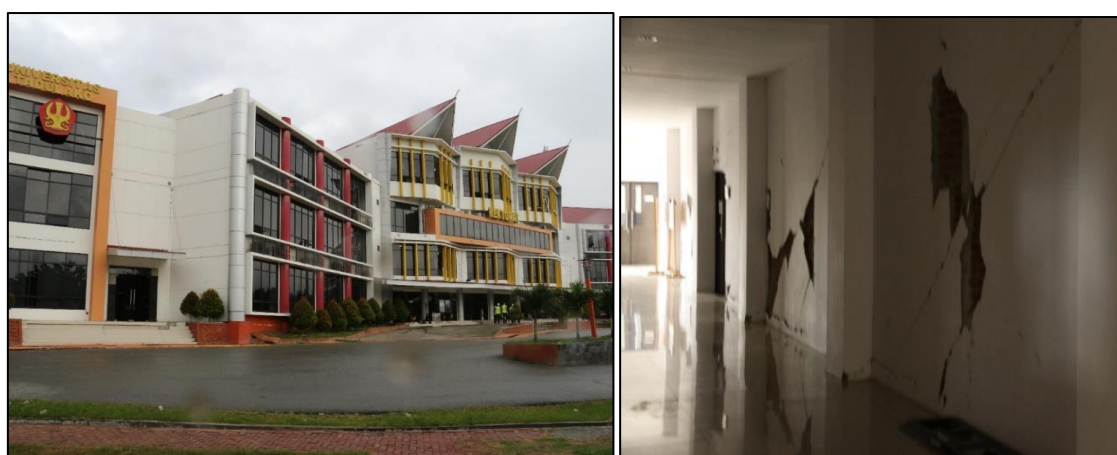
The Rector's office building is of 3 stories, has piled foundations and large open spaces at the ground storey. It is observed that the main damage is due to the in-plane shear cracking of brick partitions, the falling of suspended ceiling and breaking of windows. No damage to structural elements was observed and no casualties were sustained in this building. Some movement was apparent in a vertical construction joint at the south end of the structure, indicating a 2-5cm settlement of the north side relative to the south. This was evidenced also by displacement of paving outside the building. Also, relative movement of the structure and ground was seen to cause a reduction in the width of drains to

Figure 7.19 - Tadulako University Rektorat (DET2): exterior view (left); damage to internal infill panels (right)

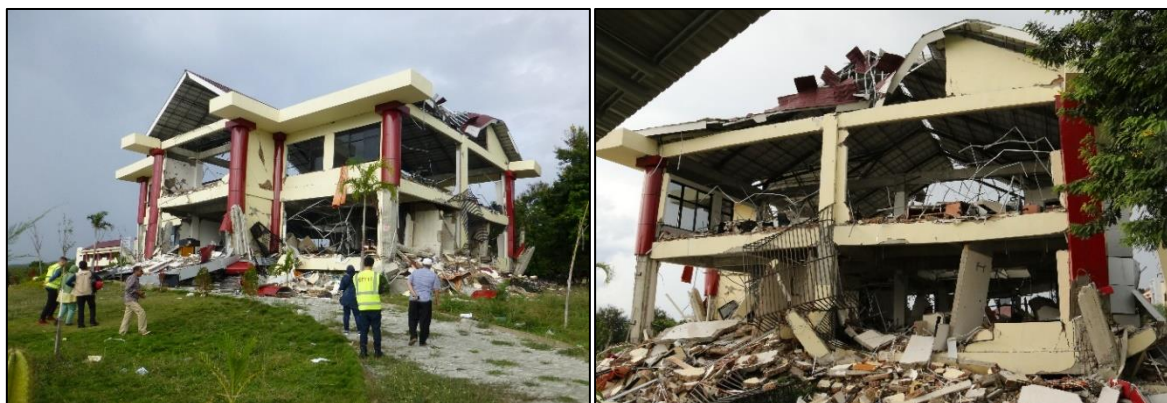
Figure 7.20 shows the collapse of a 3-storey reinforced concrete frame building, part of the Faculty of Social and Political Sciences, at the university campus. This building had been built in 2016, and failure occurred through the activation of a soft-storey type mechanism, due to plastic hinge formation in the beam-column joints. The building has a plan approximately 20m x 12m. The primary beams are large (500mm deep by 300mm wide), span up to 6m in the shorter dimension of the building and have secondary beams of large size (250mm deep by 250mm wide) framing into them at 3m intervals. No columns support the primary beams at mid span, where there is the primary to secondary beam connection. The columns are larger than the beams (500mm x 500mm in plan) and are reinforced with 10 x 25mm ribbed diameter longitudinal reinforcing bars.

Figure 7.20 - Tadulako Univerity collapsed 3-storey building of the Faculty of Social and Political Sciences. Left – front view. Right – back view.

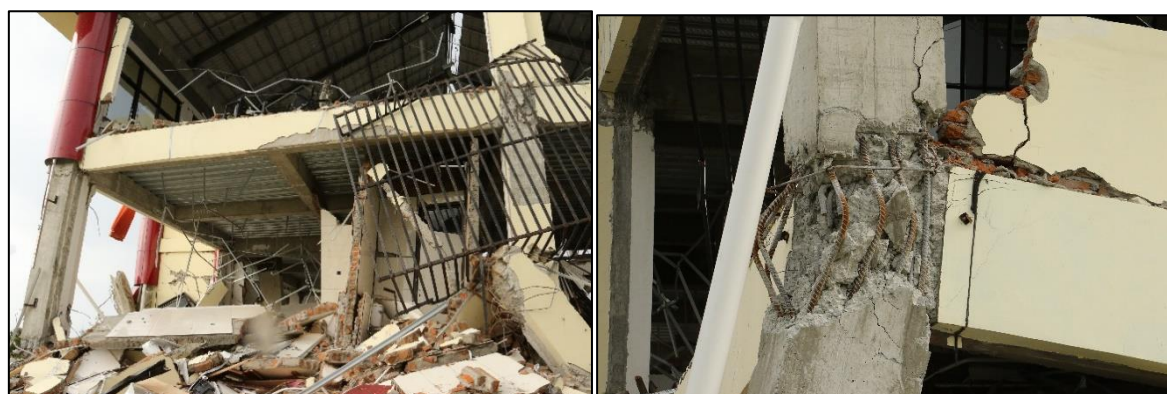
Shear reinforcement in the columns consists of smooth 10mm diameter hoops with 90degree hooks, at 140mm spacing. The roof is pitched and consists of a lightweight steel cover (CGI) on steel beams that terminate on the top beam of the frame. The floors consist of shaped sections of steel plate supporting concrete screed. The latter provides little/no contribution to the moment capacity or restraint of the beams. This, combined with the similar size of beams and columns, the soft-storey mechanism at ground level and lack of any shear reinforcement in the joints, has led to beam-column connection failure and building collapse. Concrete spalling of an exterior beam-column joint can be seen in Figure 7.21 – left and a failed exterior joint can be seen in Figure 7.21 - right).

Figure 7.21 - Tadulako Univerity collapsed 3-storey building of the Faculty of Social and Political Sciences. Left – Side view of the building. Right – Failed external joint.

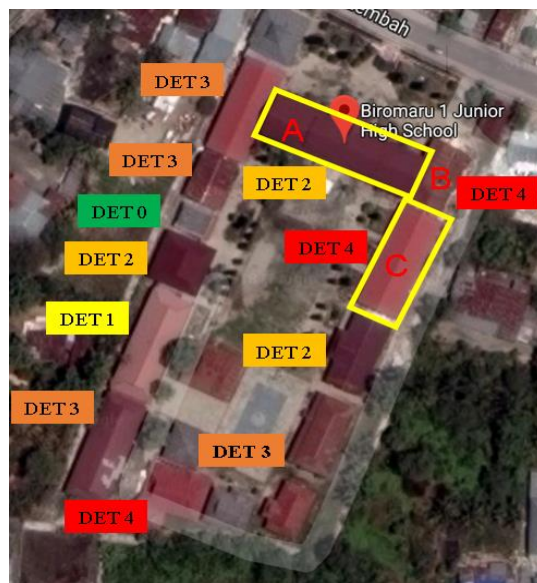
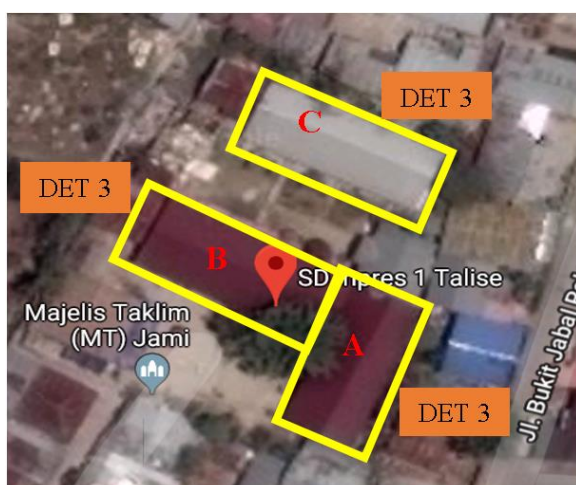
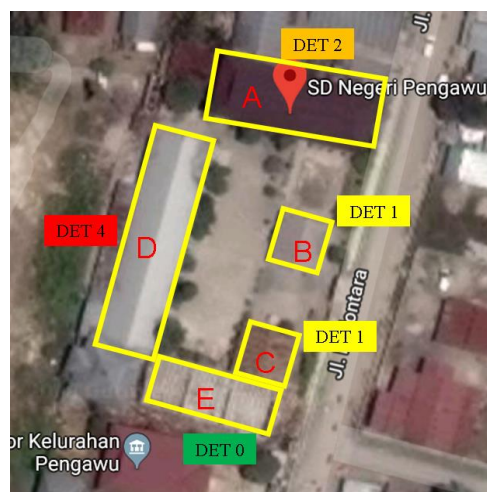
Figure 7.24 – Damage observed in buildings at three school complexes.

(a) SMP Negeri 1 Biromaru School in Sigi. Building A is a 2 storey RC infilled frame structure, whilst all other buildings are one-storey CM construction). Building B was reduced to rubble, whilst most of the other CM buildings suffered range of damage states – from slight (DET2), very heavy (DET3) to partial collapse of their shorter walls (DET4).

(b) SD Inpres 1 Talise School in North Palu. Affected only by shaking (not ground failure) from the earthquake. All three buildings are single-storey CM buildings. All suffered unreparable damage (DET3). Main damage mechanisms are separation of walls and gable failure, due to poor quality materials and ineffective confinement.

(c) SD Negeri Pengawu School in Palu. Two small-plan single-storey CM buildings (B and C) suffered minor, repairable damage. The large plan CM single-storey building D suffered heavy damage to collapse of some walls (DET4) due to differential ground movement. Building E is CM but was under construction at time of earthquake. Building A is a 2-storey RC infilled frame structure.

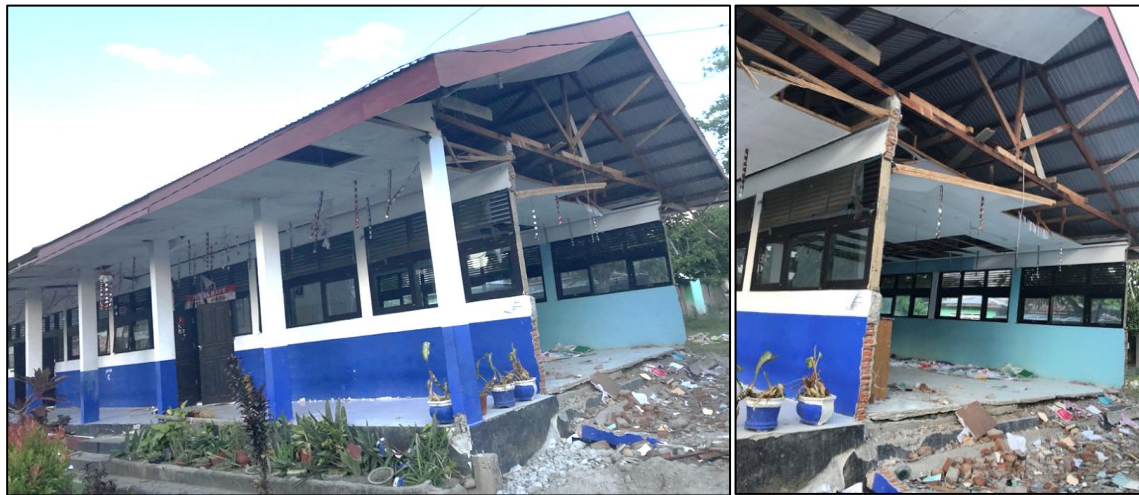
Figure 7.26a shows the complete collapse of the shorter wall of a CM school building in Sigi area. All the cross walls of this building suffered either collapse or detachment due to extensive damage in the out-of-plane direction. However, the in-plane damage was limited (Figure 7.26b). The heavy damage suffered by this building is attributed to the long, thin and poorly confined cross walls, poorly reinforced tie-elements and deteriorated material quality.

Figure 7.26 - Heavy damage sustained by CM school buildings at SMP Negeri 1 Biromaru School. (a) Out-of-plane collapse of the shorter wall in Building C (see Fig. 7.24). All the other cross walls either collapsed or are on the verge of collapse. (b) In-plane flexural and shear cracks through the spandrels. (c) In-plane flexural and shear cracks through the tie-columns.

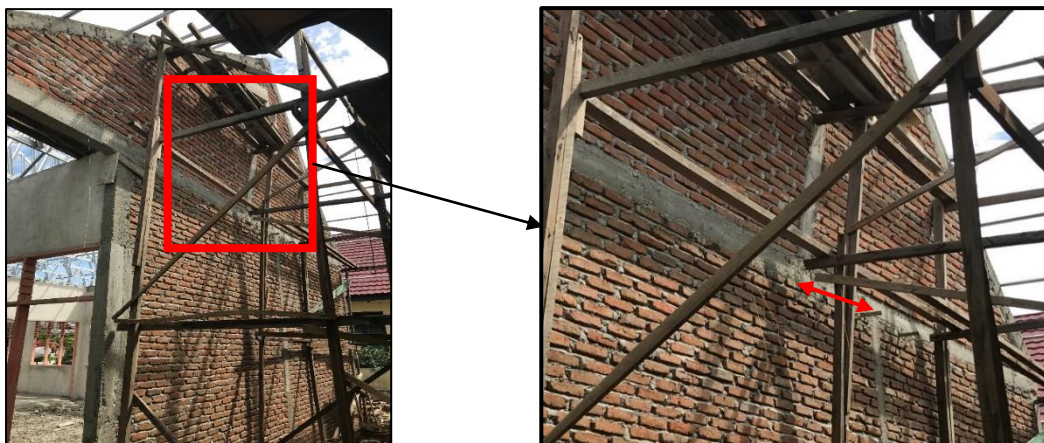
The EEFIT-TDMRC visited one school that was still under construction at the time of the earthquake. This CM school building, shown in Figure 7.28, did not suffer any apparent damage. The level of confinement of the masonry panels and gables was seen to be good, but a construction defect was observed, in that the middle tie-column is not continuous up to the full gable height.

Figure 7.28 - Confined masonry school building (E in Fig. 7.24) in SD Negeri Pengawu school in Palu that was under construction at the time of the earthquake. Note the offset of the middle tie-column at the tie-beam level.

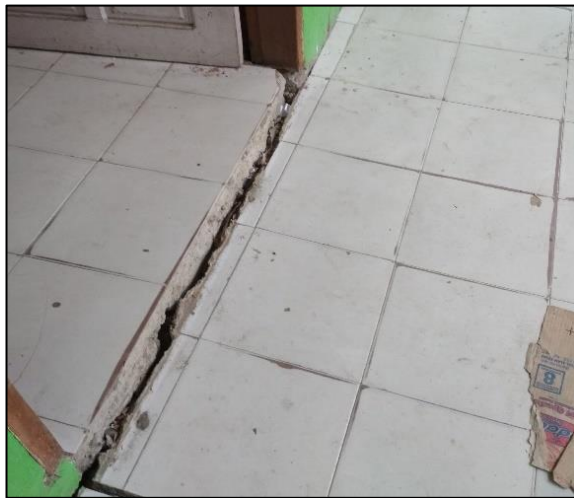
In many of the observed schools, ground failure precipitated damage. Differential settlement of buildings was common in the Sigi area and areas either side of Palu bay. Figure 7.29 shows some examples of the amplified damage due to the combined effect of the ground shaking and differential settlement.

Figure 1.29 - Extensive damaged in CM building (building D in Fig. 7.24c) in SD Negeri Pengawu school due to differential settlement. (a) differential movement of ground across a ground crack passing under the building caused failure of the floor. (b), (c) and (d) show crack opening induced by differential ground movement.

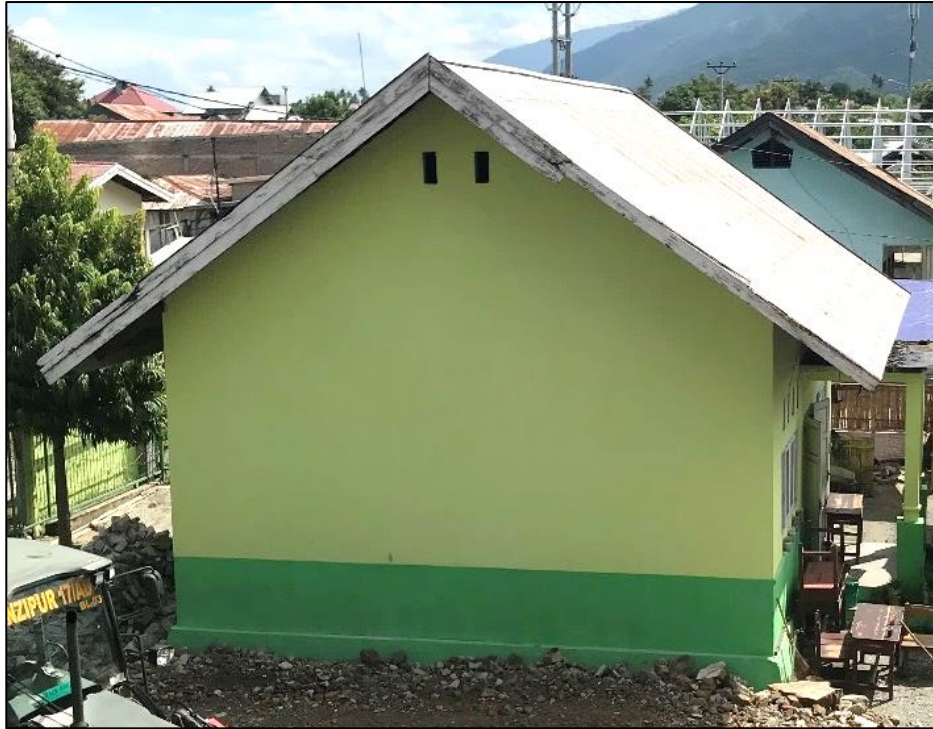
CM buildings with small plans and limited openings performed well, as expected, and only suffered no/slight damage (DET0/1) due to their box-like behaviour e.g. see Figure 7.30.

Figure 7.30 - A small plan box-type CM school building that suffered no damage (building B in Fig. 7.24c) in SD Negeri Pengawu school.

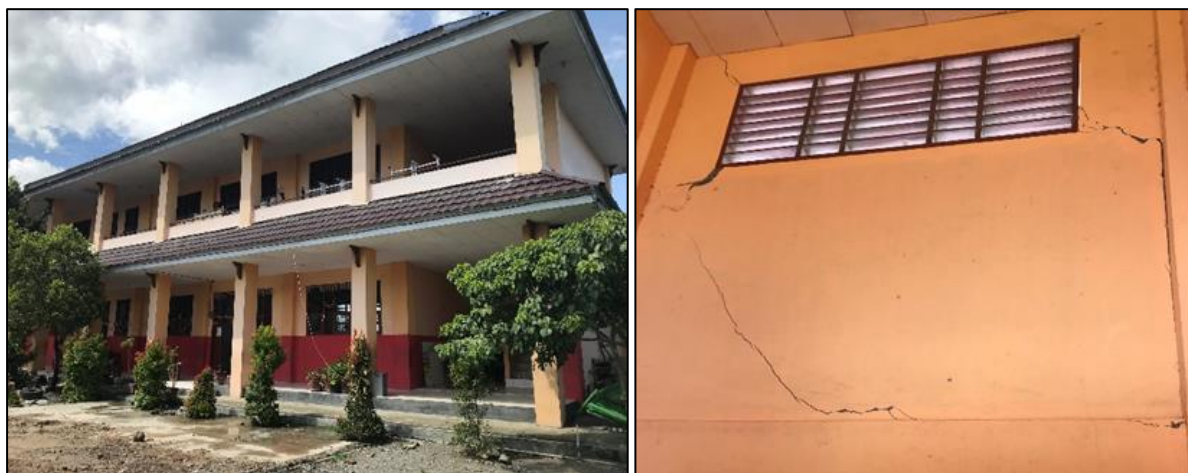
damage observed in RC frame school buildings that were subjected to earthquake ground shaking only, and another example is shown in Figure 7.33.

Figure 7.33 - SD Negeri Pengawu School in Palu (Building A in Fig. 7.24c). Left – 2-storey RC school building that sustained moderate damage to infill panels. Right – Damage to the infill walls

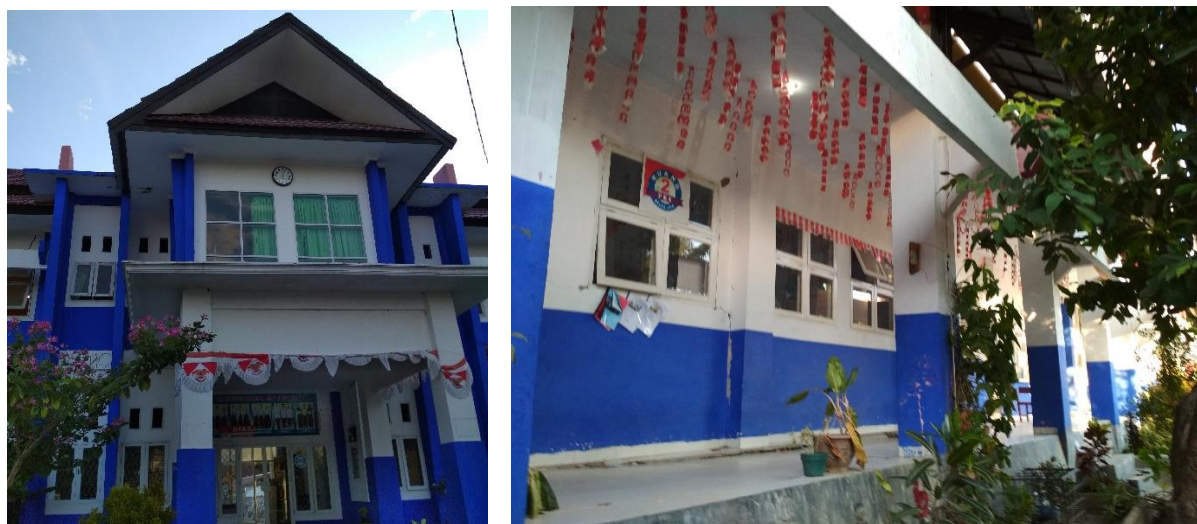
Building A at SMP Negeri 1 Biromaru School (refer to Figure 7.24) is a 2-storey RC frame with brick masonry infill (see Figure 7.34). This sustained damage to columns at the rear side of the building that were supporting the balconied areas. The columns, which were founded on made ground, suffered failure at their foundation as this made ground was affected by the earthquake. This failure is not depicted well in Figure 7.34 – right, as the column failure was to the left of the picture taken. Nevertheless, Figure 7.34 does show the columns supporting the balcony, and some separation of the made ground with the school wall (brown crack).

*Figure 7.34 - SMP Negeri 1 Biromaru School, Building A in Fig. 7.24a. Left – front entrance to the building. Right – the rear of the building showing columns that support the balcony sited on a 1m high “slab” of made ground covered in concrete screed.*

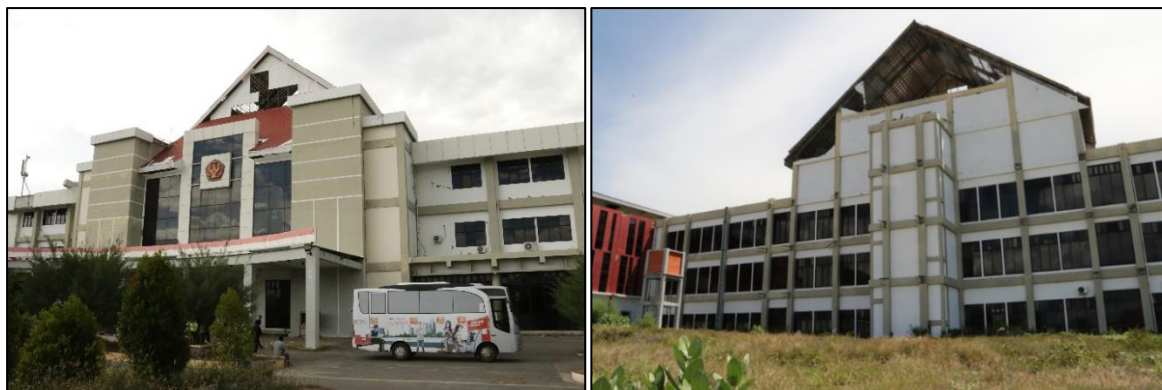
Building A has its long dimension in the N-S direction and is 3 storeys high (Figure 7.36). This building sustained heavy non-structural damage to masonry infills and partitions (Figure 7.367–Right and Figure 7.39 - Left), shattering of the glass cladding of the front entrance, falling of ceiling covering and light fittings (Figure 7.39 - Middle). However, no structural damage was observed. Approximate column dimensions are 500mm x 500mm and beam dimensions are 600mm x 500mm, with the beams being

Figure 7.36 - Tadulako University Hospital Building A. Left – Front view. Right – rear view, showing damage to gable.

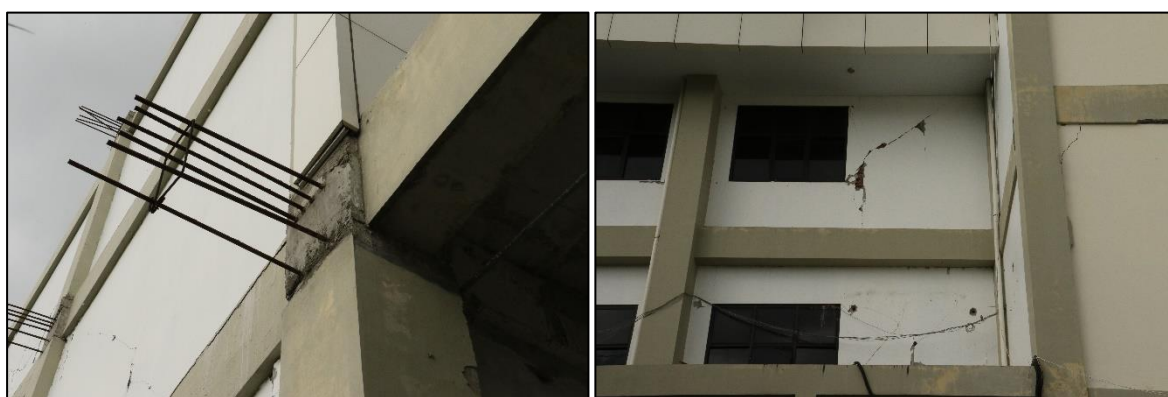
reinforced with 6 x 20mm diameter steel reinforcing bars (as observed from its protrusion from the side of the building, see Figure 7.37 - Left).

Figure 7.37 - Tadulako University Hospital Building A. Left – Beam reinforcement detailing. Right – damage to brick masonry infills.

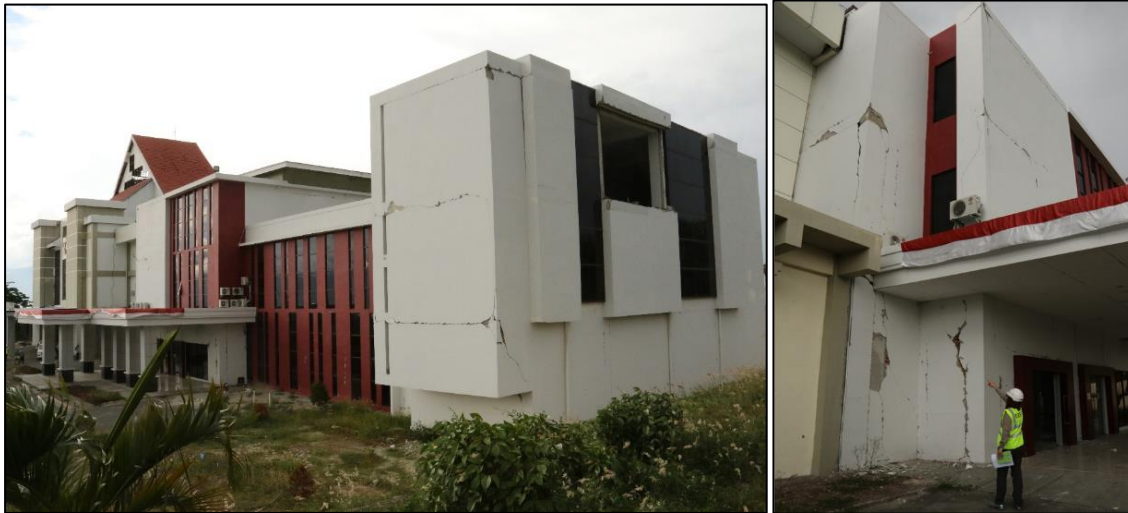
Building B, with long dimension spanning E-W, is 3 storeys high and sustained damage to masonry infill and partition walls (Figure 7.38 - Left). Buildings A and B are separated by a small spacing that is filled with masonry blocks. At the separation location the beams of Building B extend out from the frame to provide support for the internal floor that connects the buildings. Some localised pounding damage is seen where these have hit the structure of Building A during the ground shaking (Figure 7.38 –Right and Figure 7.39-Right).

Figure 7.38 - Tadulako University Hospital Building B. Left – Side view of Building B, showing out of plane failure of infill wall at second floor (n.b. plane of infill wall is E-W). Right – location of damage due to pounding between Buildings A and B.

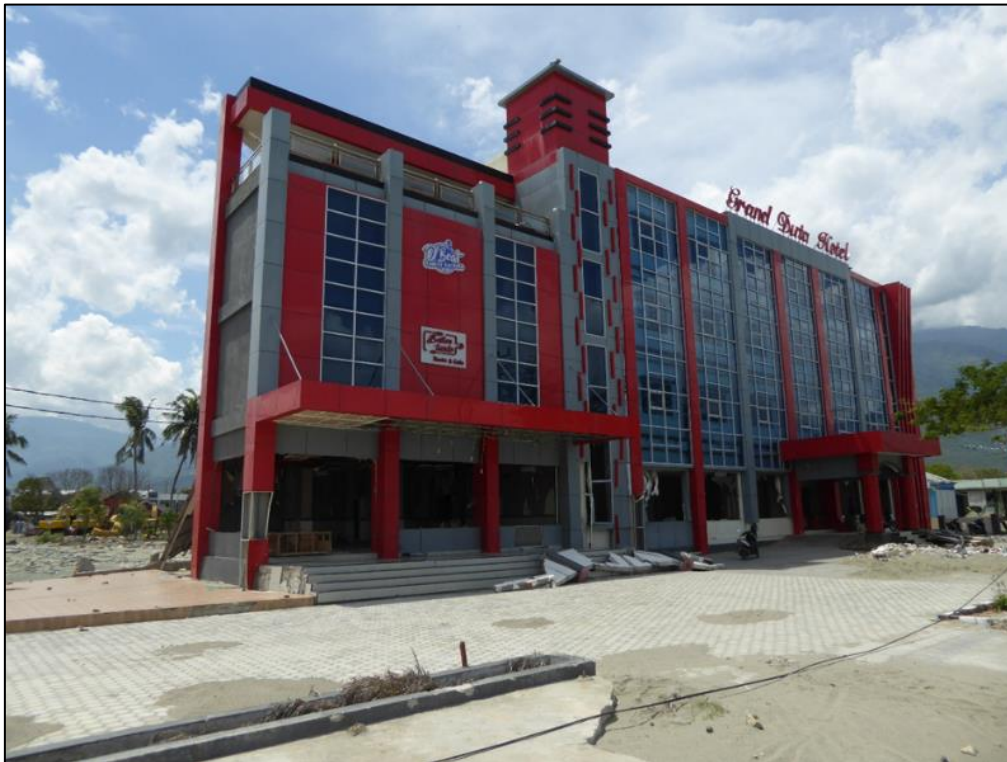
The Grand Duta Hotel consists mainly of two reinforced concrete frame buildings (connected via an RC elevator shaft (Figure 7.42). The three-storey building to the East of the elevator shaft had 3 bays of 3.5m span, whilst the four-storey structure to the West of the elevator had 7 bays of 3.5m span. The building did not suffer any damage due to the earthquake ground shaking, but did suffer damage to its ground floor windows, cladding and internal fittings due to the tsunami inundation. Damage to the main internal staircase's railing at the ground floor was sustained due to its being impacted by a desk carried by the tsunami inundation (Figure 7.43). Inundation here was estimated at 1.5m above grade, as indicated by water marks.

No damage was observed to structural elements. Ground floor column sizes were 500mm x 400mm, whilst beams were 550mm deep by 400mm wide.

Figure 7.42 – Grand Duta Hotel, Palu Beach..

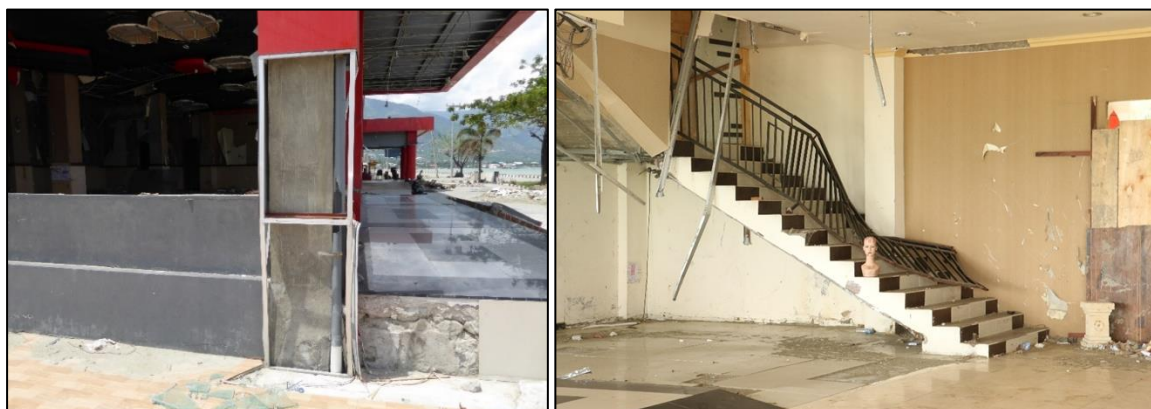
Figure 7.43 – Grand Duta Hotel, Left – image of intact column at ground floor. Right – Image of staircase inside the ground floor of the hotel. The staircase railing was damaged when it was hit by a large desk moved by the tsunami inundation.

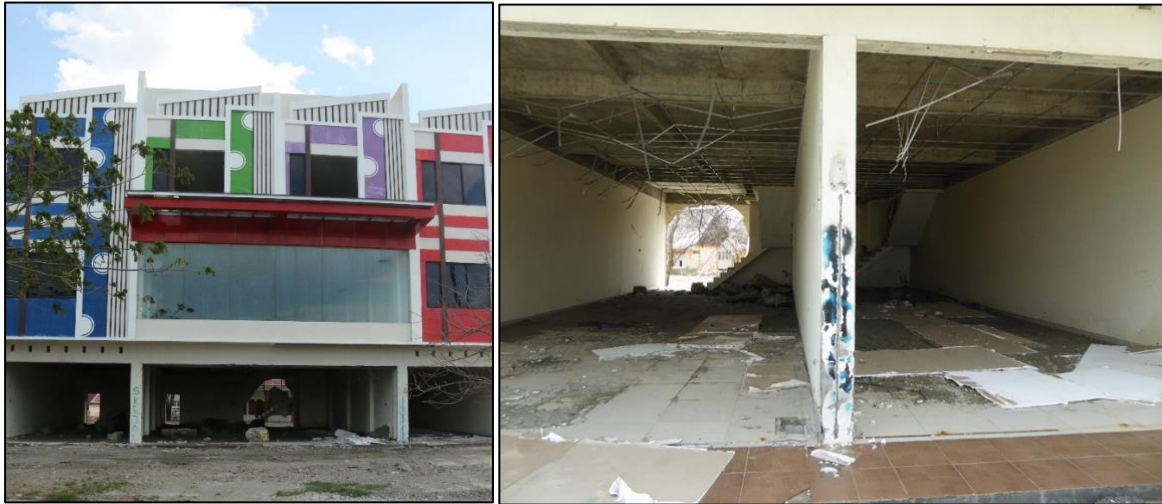
Further west from the Grand Duta Hotel was another reinforced concrete building that also showed no structural damage, despite having been inundated by the tsunami. This structure, shown in Figure 7.44 was three-storeys high and is a moment resisting frame that presents large openings to the sea-front. The large openings at the ground floor offered little resistance to the tsunami inundation, and evidence of inundation included the blow out of infill walls at the back of the structure, as well as the presence of parts of sea defences evident inside the building ground floor. Tsunami inundation was limited to the ground storey, as evidenced by the glass in the 1<sup>st</sup> floor of the building still being intact.

Figure 7.44 – Three –storey RC building near the Grand Duta Hotel. This structure was inundated by the tsunami at its ground floor, but sustained no structural damage, just non-structural damage to sea front windows and to back walls and to fittings at ground-floor level.

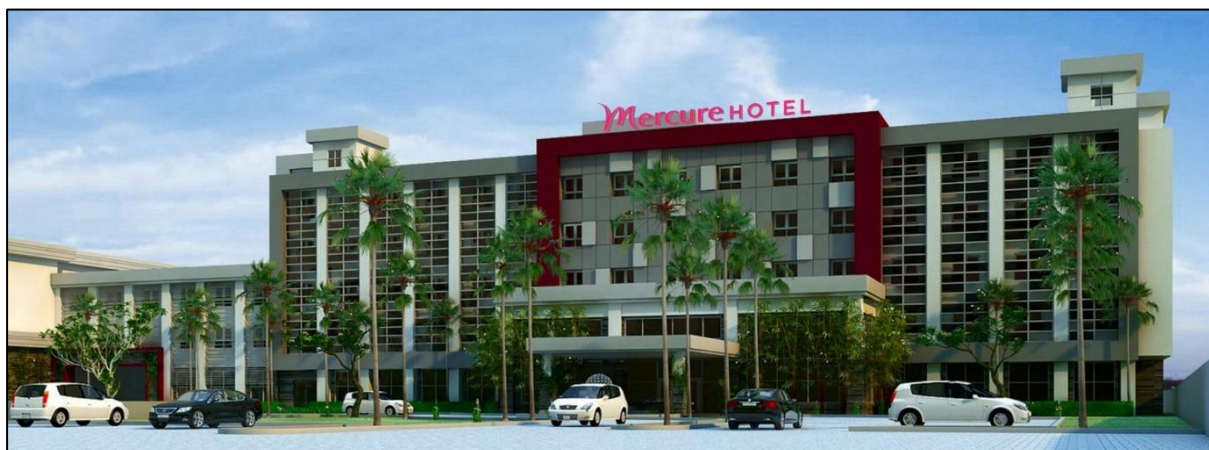
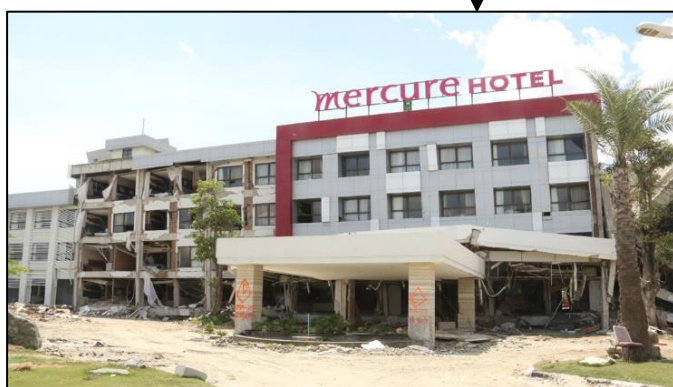
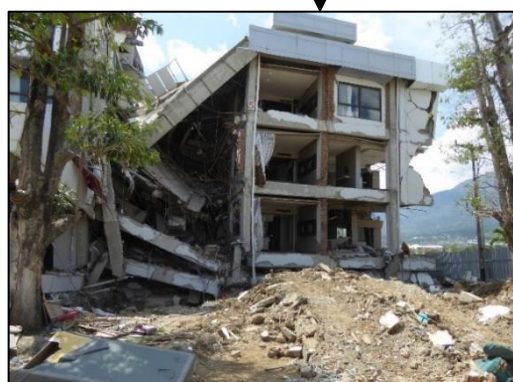
The Mercure Hotel consists of a series of buildings, with the main ones, shown in Figure 7.45 being three interconnected 5 storey reinforced concrete frame buildings, and a 3-storey reinforced concrete frame building. All the 5 storey buildings suffered soft-ground storey failure as shown in Figure 7.45, with the western wing also suffering the pancake failure of one of its bays. Details of the reinforced concrete elements are shown in Figure 7.46. Column sizes were approximately 350mm x 350mm and were reinforced with 8 x 25mm diameter reinforcing bars. Beams were large, of 650mm depth and 350mm width, to span the 8m bay widths. No shear reinforcement was observed in the exposed joints (see Figures 7.46 and 7.47). Like in the case of the collapsed RC frame building in Tadulako University, the remaining structure showed damage concentration at/near the joints, suggesting the soft-storey failure initiated at the joints and columns (rather than columns alone).

Little evidence of tsunami inundation was seen at the Mercure Hotel, which is therefore believed to have mainly been affected by the earthquake ground shaking.

Figure 7.45 – Mercure Hotel, which suffered soft-storey failure of ground floor. Top – Image of the hotel before the earthquake, Source: Tripadvisor.com. Bottom – Pictures of the Hotel after the earthquake, showing the soft-storey failure of the ground storey of the structure.

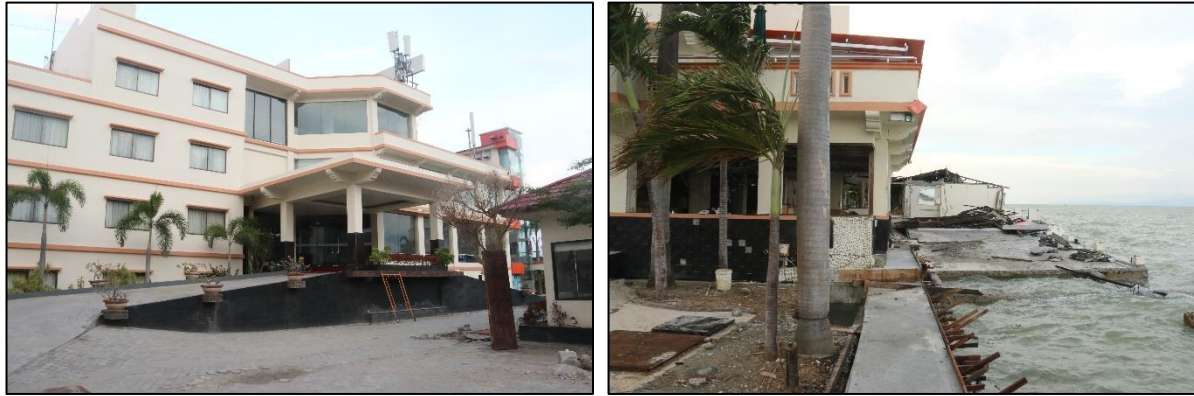
The EEFIT-TDMRC mission visited this hotel just to the north-west of Palu city, coincidentally arriving when the owner and the building designers were on site. Whilst the front facade of the hotel looked unaffected, the rear terrace of the hotel facing the sea was washed away (Figure 7.48). A single storey confined masonry building on the seaward side had collapsed but the main reinforced concrete structure of the hotel did not sustain any visible structural damage. Non-structural damage was sustained to the ground floor of the hotel on its seaward side, with the tsunami inundation breaking 12 mm thick glass and damaging internal fittings (Figure 7.49).

Figure 7.48 - Swiss Belhotel (Left) Undamaged front facade facing away from the bay (Right) Loss of confined masonry one-storey buildings to the shoreward side of the hotel

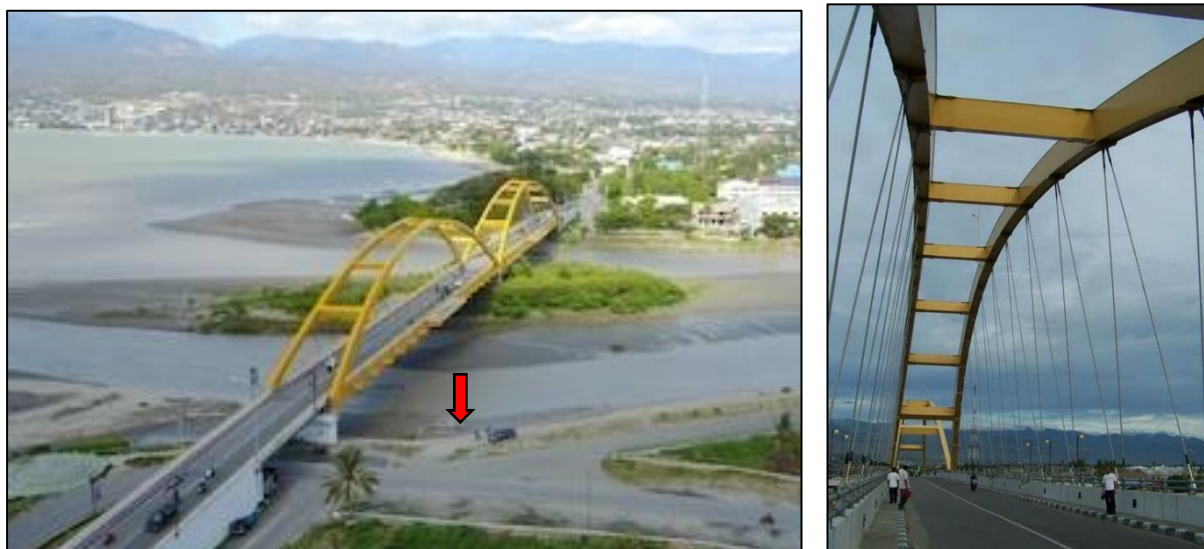
Figure 7.52 - Images of Ponulele bridge before the earthquake and tsunami. The location of the liquefaction jet seen by the EEFIT-TDMRC Team is indicated by the red arrow in the picture on the right. Source for photos: Shutterstock.com.

On the west side of the river mouth, starting from the western bridge pier and going south, strong evidence of liquefaction was seen by the TDMRC-EEFIT team. A large liquefaction hole was observed very near the western bridge pier, at the location of the red arrow on Figure 7.52. Liquefaction was also confirmed by local residents who reported seeing “water spurting from the ground like a geyser”. It was reported to the Team that measurements made by the local authorities indicated the western bridge pier had sunk by 50cm.

It is therefore postulated that the bridge failure occurred due to a combination of ground shaking and liquefaction. It is also possible, as indicated in Section 6, that the collapsed bridge deck may have acted as a protective barrier, reducing the intensity of the tsunami flow up the river and reducing inundation.

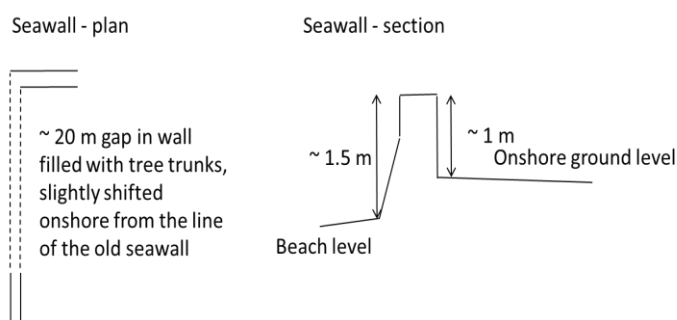
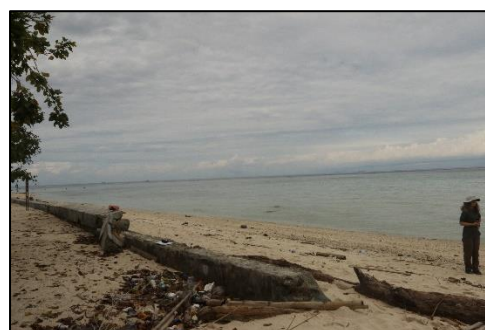
A rudimentary seawall was observed at north-west tip of the mouth of Palu Bay (Figure 7.54). The topography rose quite steeply from the shoreline and the site did not appear to be particularly exposed despite the damage to the seawall which seemed historical due to evidence of weathering of the structure.

Figure 7.54 - Rudimentary seawall. Left - Sketch of layout and section. Right - Damaged sections with tree trunks closing the gap.

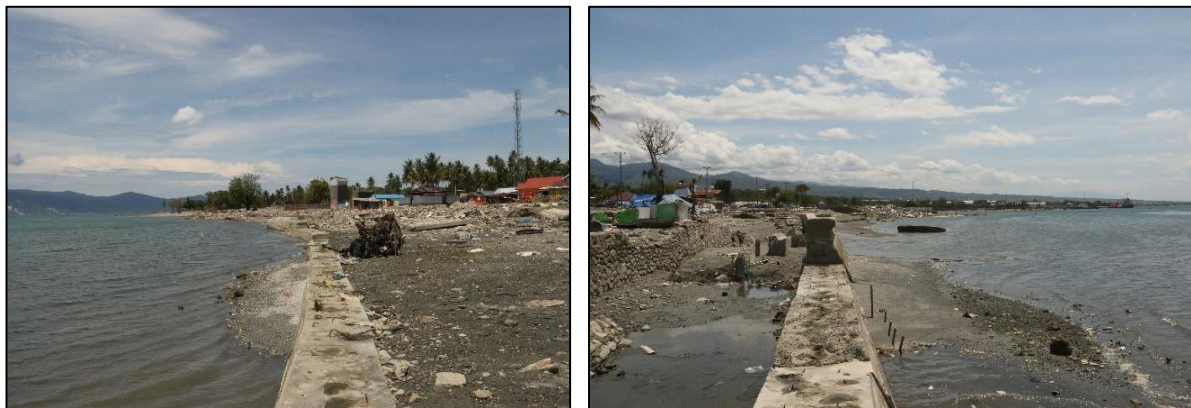
This coastal defence structure had significant visible damage where the top of the wall was missing in many places, revealing ~1 cm rebar approximately every 0.5 m (Figure 7.55). These are presumed to connect to the recurve top of the wall which was still in place at some locations. The damaged seawall was apparently only one year old. Construction details comprised in-situ pouring of concrete of various thicknesses. Slightly further south (tens of metres) there was toppled recurve tops of the wall, but with no rebar connections between the recurve and lower section. The whole structure looked poured in phases from the rear. At the rear of the wall a fairly fast flowing stream was visible. Looking inland the stream could be seen to have flowed through a culvert under the road, but it was not clear how the stream was then routed through the seawall. There was a broken section of the wall, with a length of crest several metres long that could be seen in the sea, slightly to the south of the damage.

Figure 7.55 - Mamboro seawall showing loss of the crest of the structure
