# **The Central Sulawesi, Indonesia Earthquake and Tsunami of 28<sup>th</sup> September 2018 – A Field Report by EEFIT-TDMRC**

01/11/2019

Prof Tiziana Rossetto, EPICentre, University College London

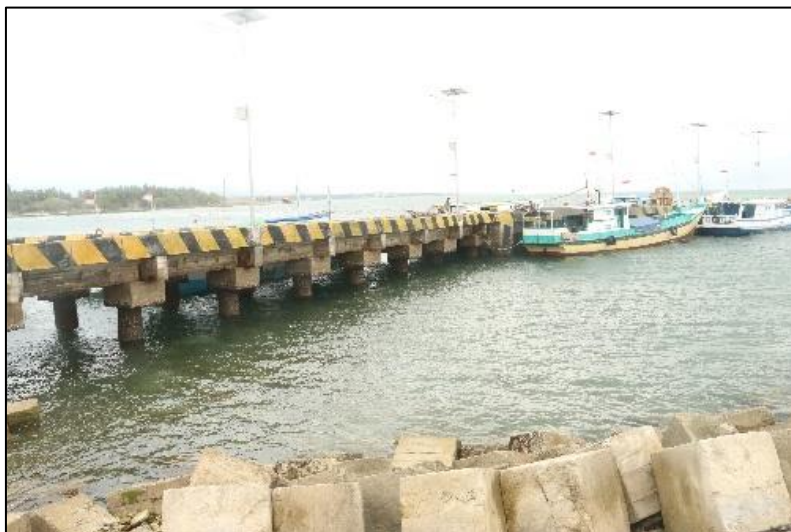
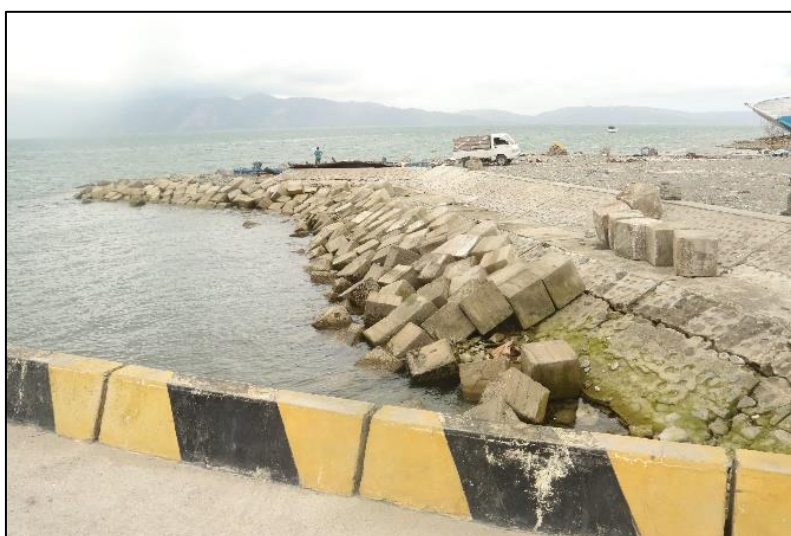
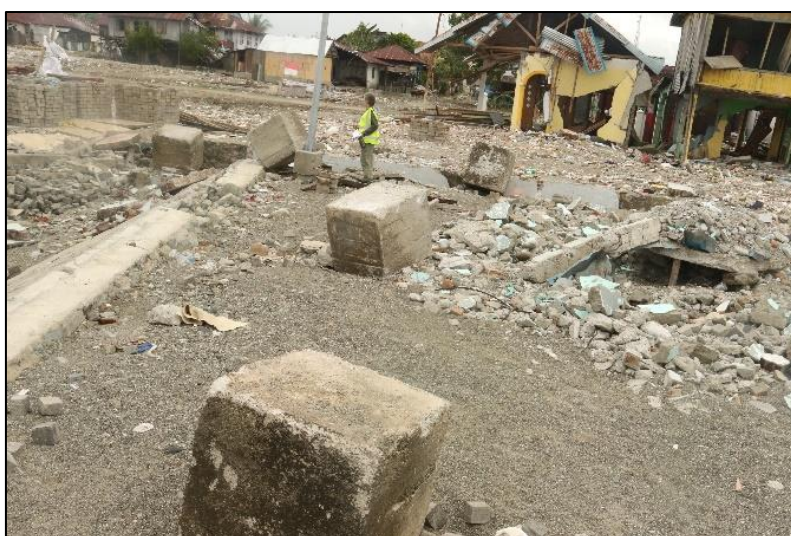
The port comprised a number of structures including a jetty (Figure 7.60) and a revetment which was protected by cubic concrete armour of 0.8 m side length (Figure 7.61). The jetty seemed undamaged. The armour units appeared to be unreinforced but mostly intact. Two or three of the units had been moved inland by the waves.

Figure 7.61 - Jetty structure and revetment at Wani port. Top – Jetty. Middle - Armoured revetment neighbouring the jetty. Bottom - Displaced armour units c. 0.8 m side lengths.

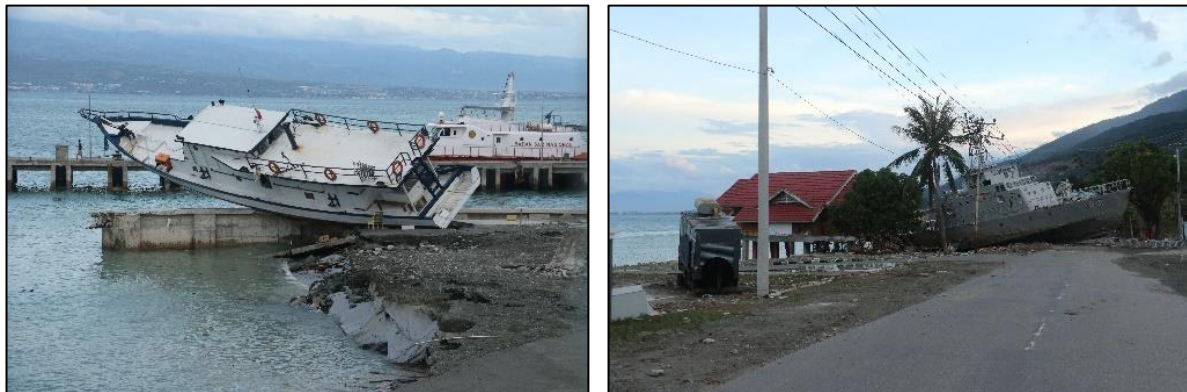
At a number of locations e.g. Watusanpu naval base, Wani and Mambo, the tsunami waves lifted vessels onto the land by a combination of buoyancy and onshore hydrodynamic forces, as shown in Figure 7.63. In some locations these caused damage but in others there were some reports of the protective effect e.g. at Mambo.

Figure 7.63 - Grounded vessels at Watusanpu Naval Base
