# THE 1989 NEWCASTLE AUSTRALIAN EARTHQUAKE

## A FIELD REPORT BY EEFIT

MARCH 1991

**J. W. Pappin**

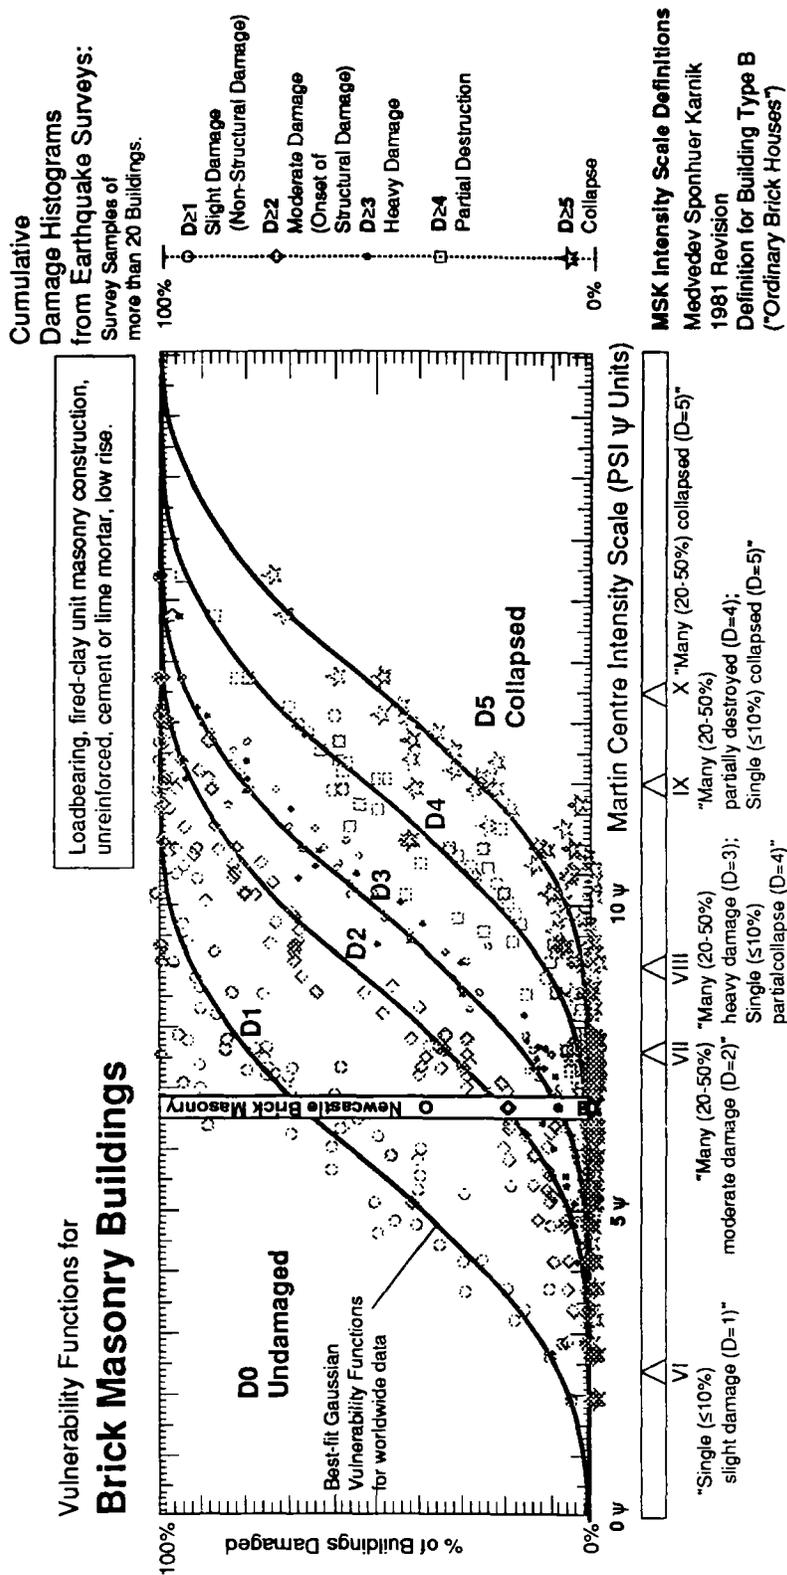
**Figure 6.8**

**Distribution of damage to Newcastle brick masonry buildings compared to similar building stock in other earthquakes worldwide (from Coburn et al. 1990)**

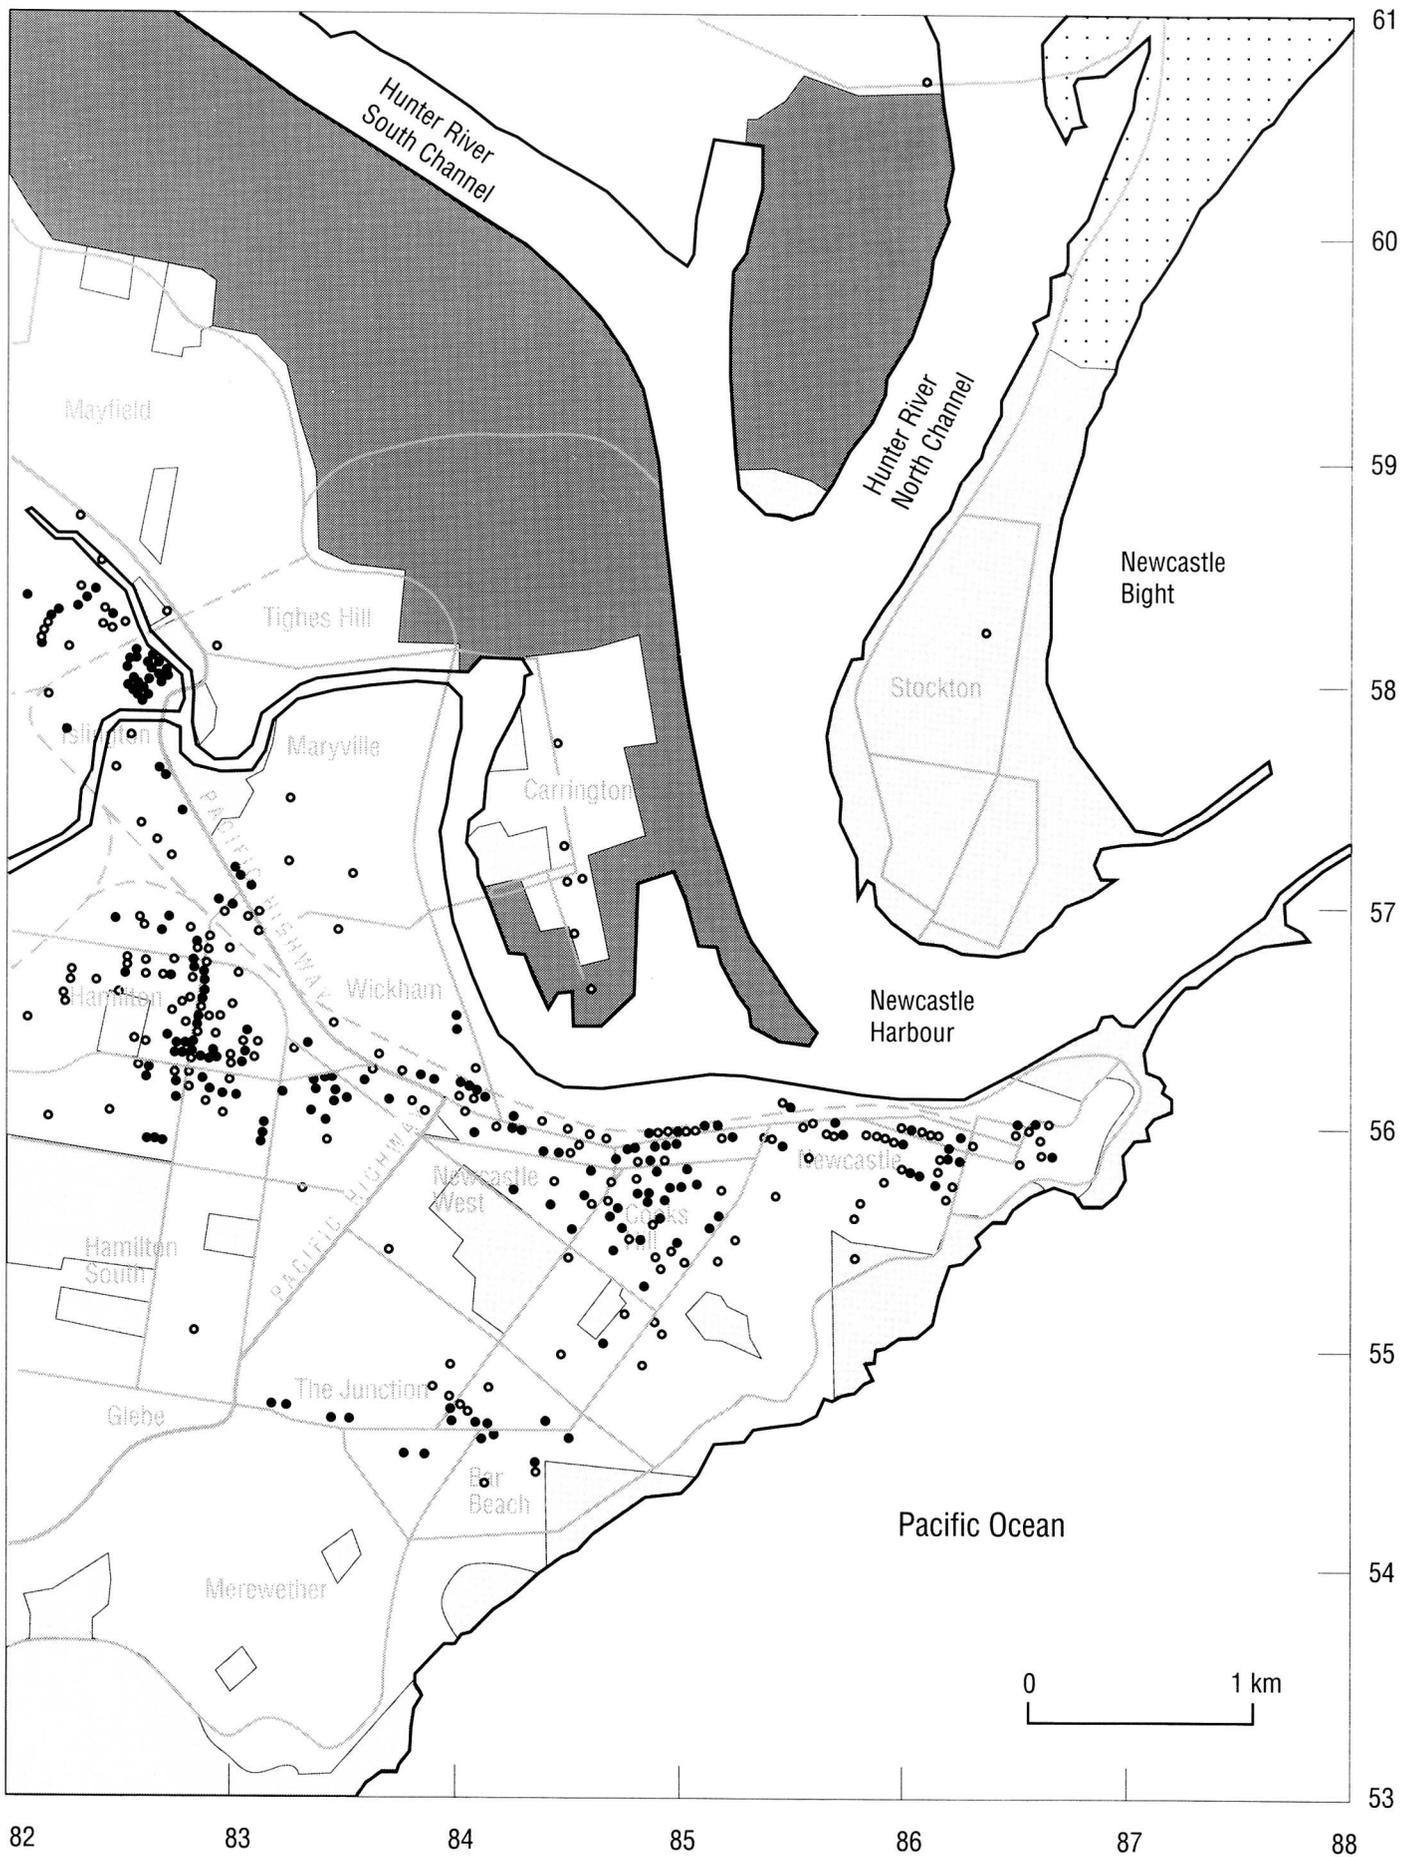
**Figure 6.9**

**Locations of structures with moderate or heavy damage from EEFIT general survey**

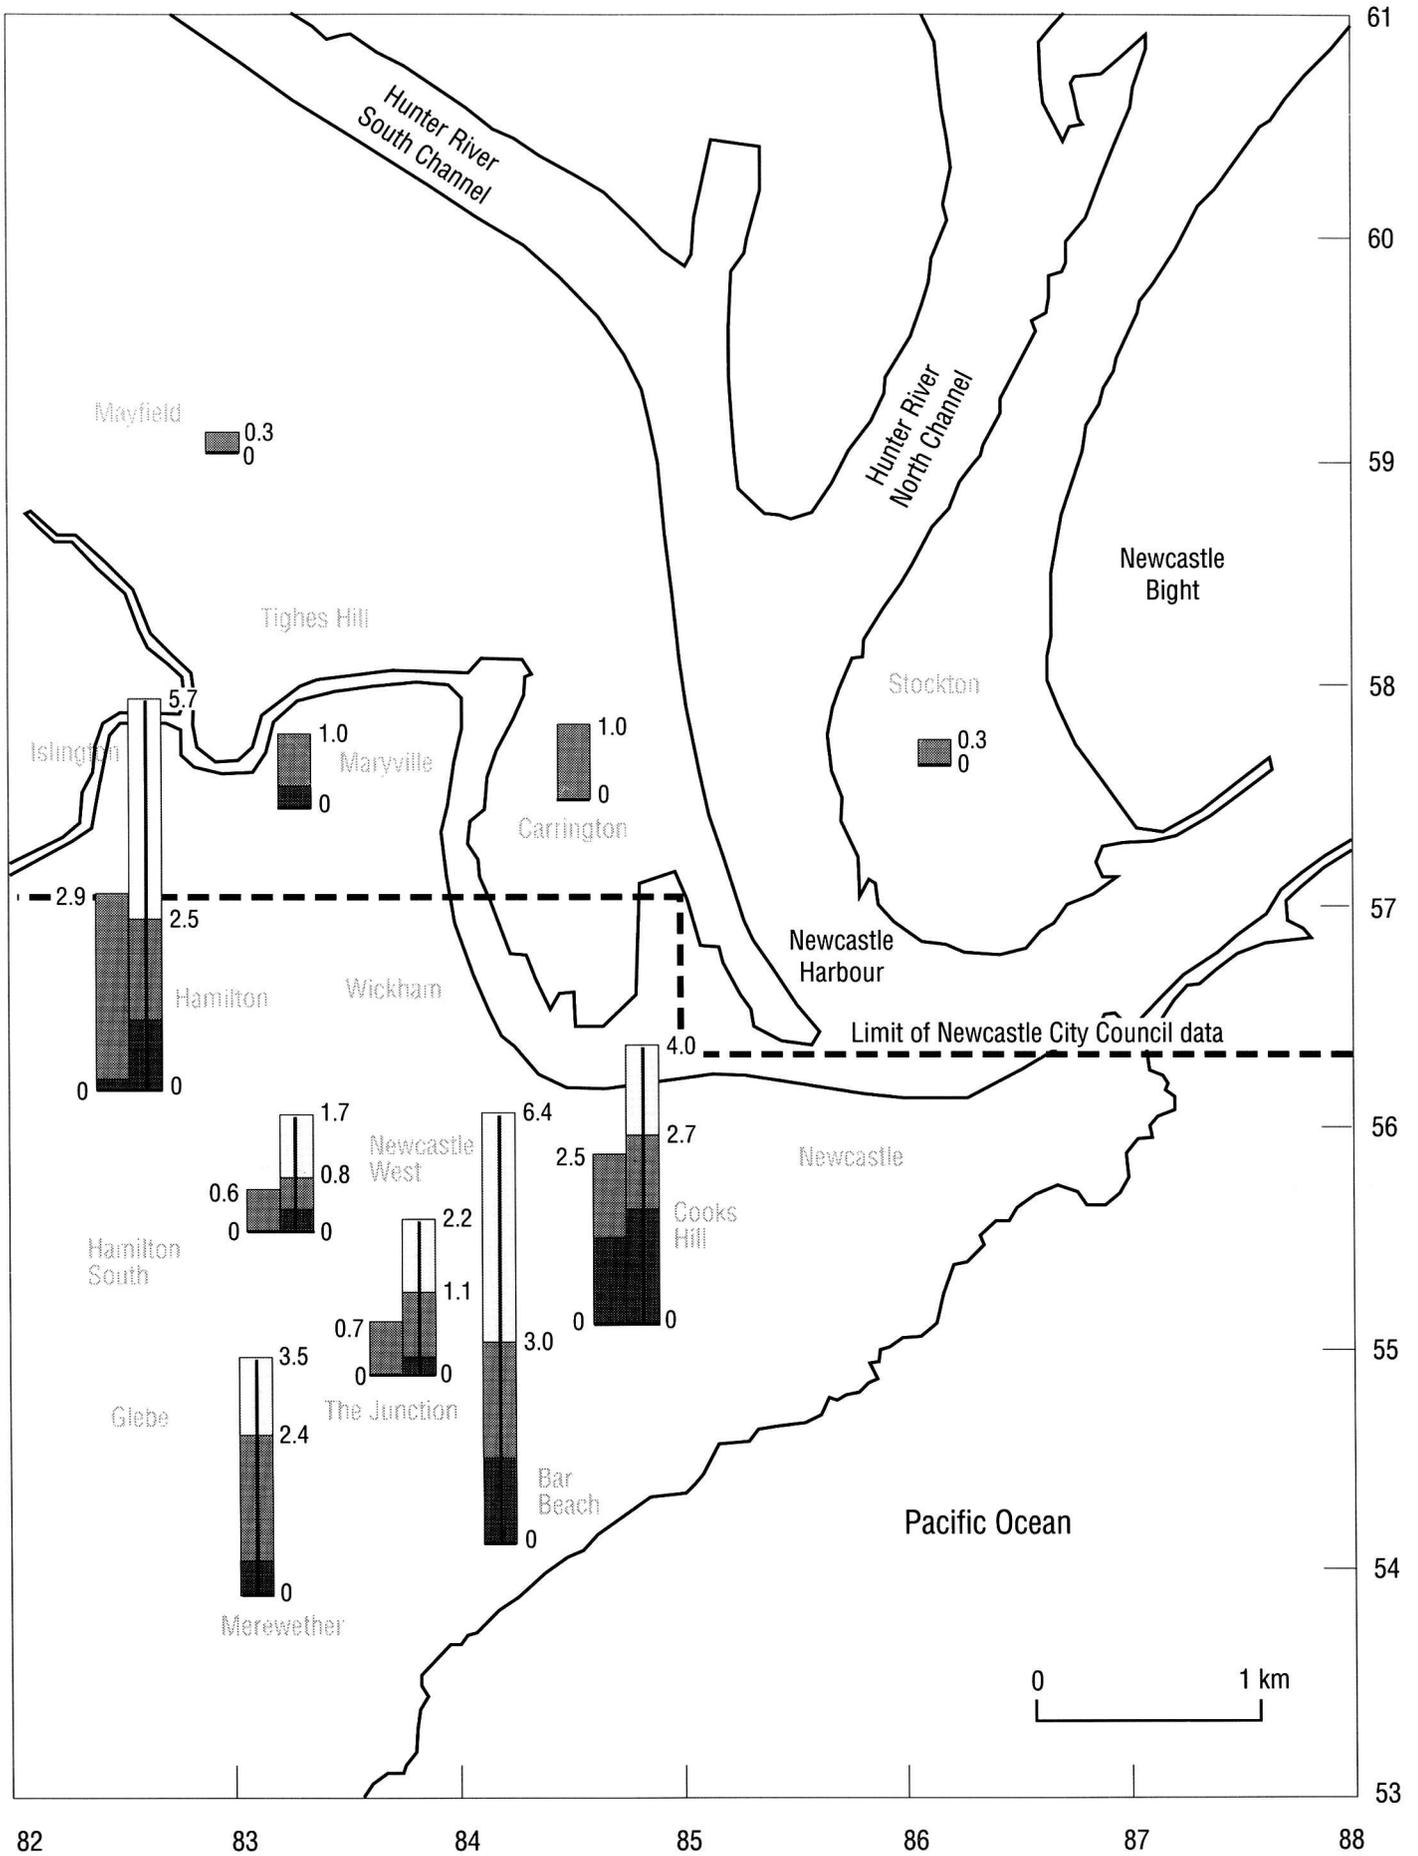
Figure 6.10

Percentages of damage to residential buildings

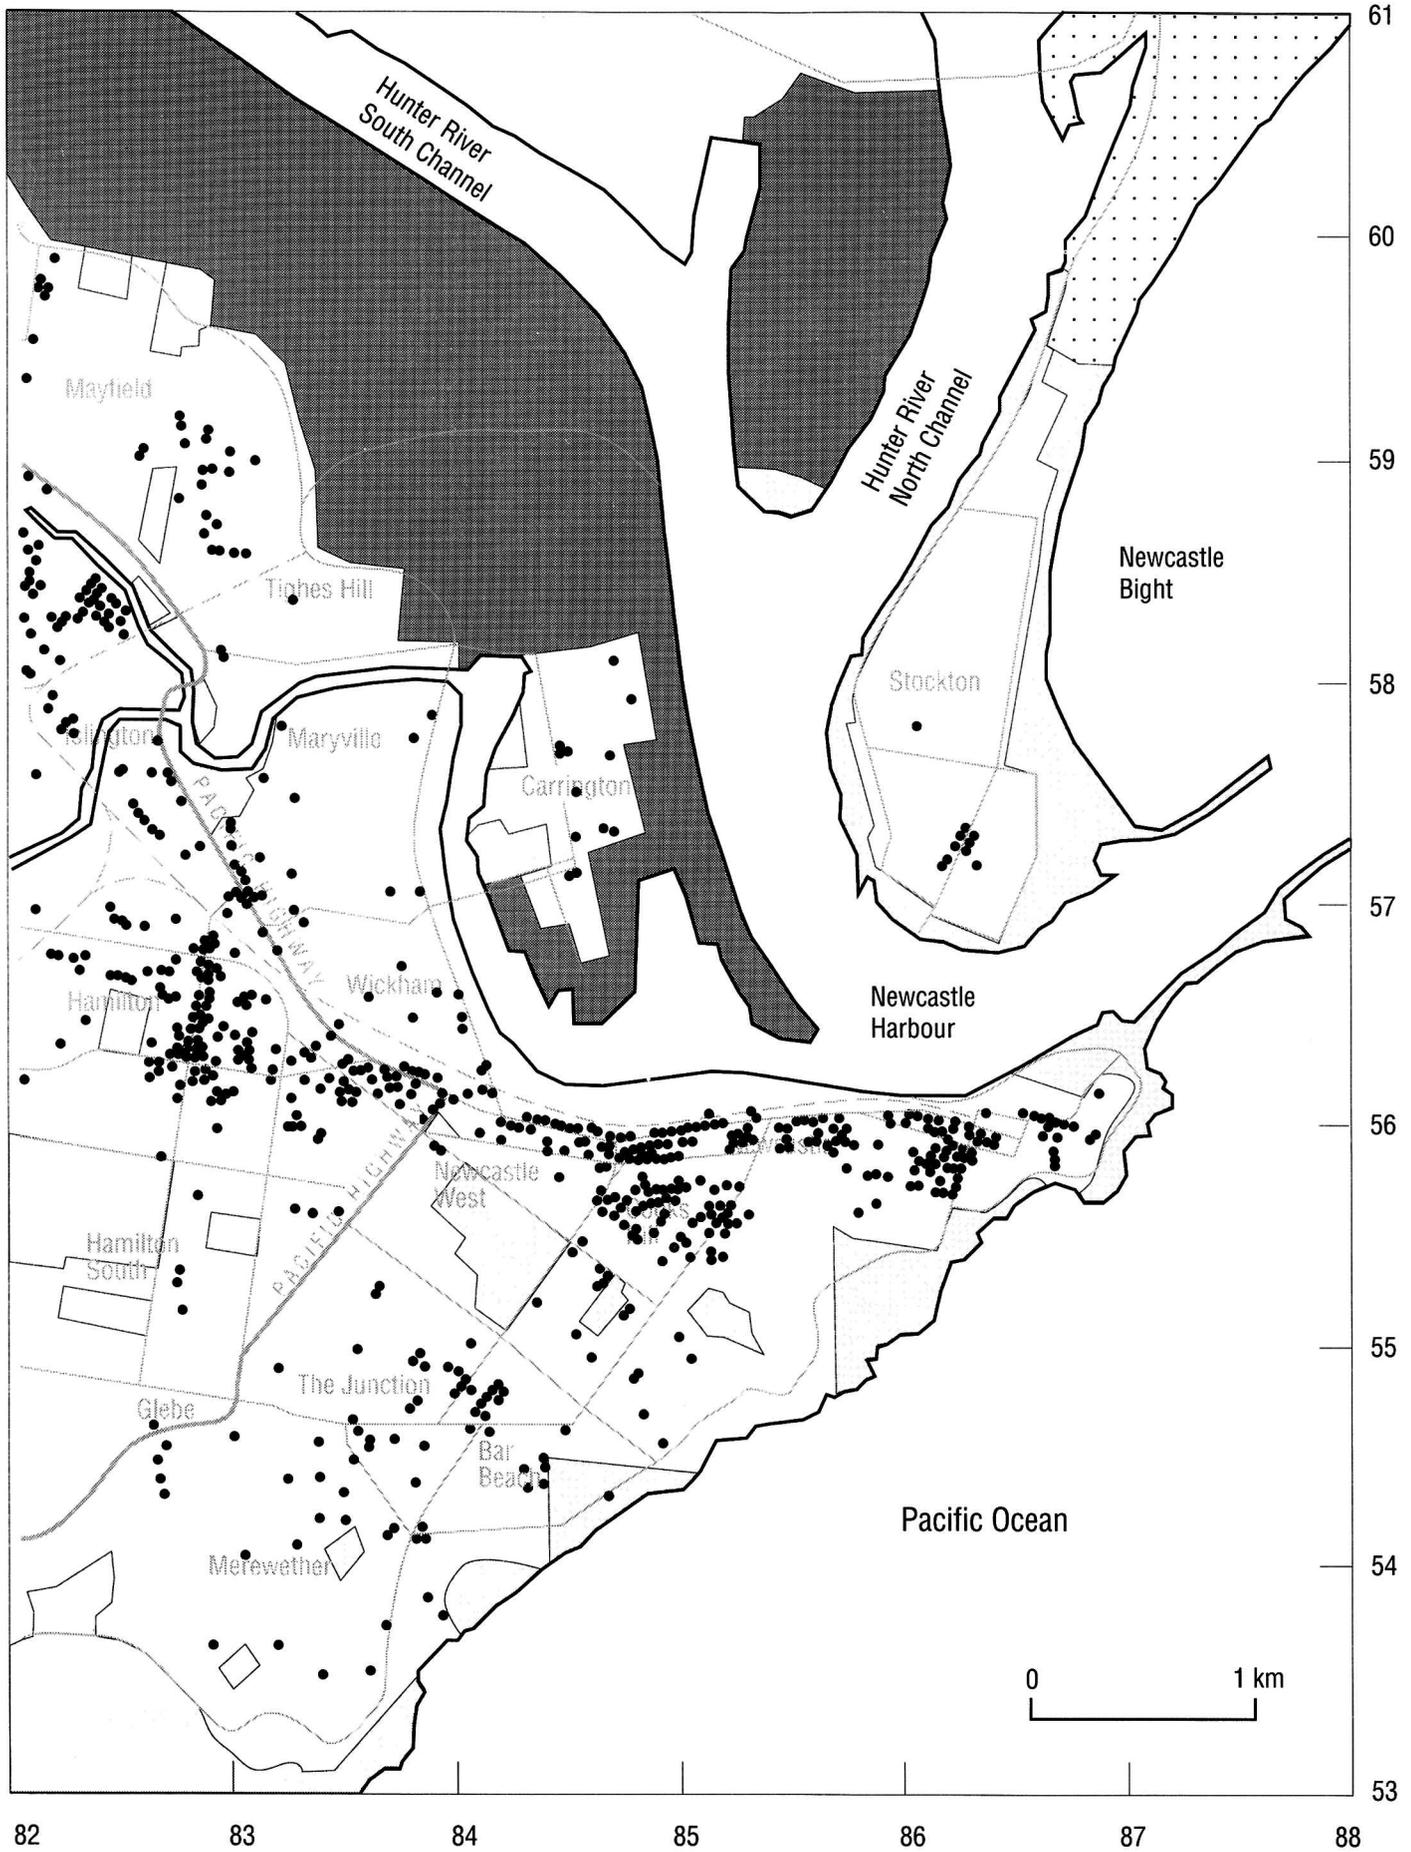
**Figure 6.11**

The Newcastle City Council map showing the locations of all residential buildings damaged in the Red and Amber categories is reproduced in Figure 6.11. The pattern of damage is similar to the EEFIT survey, except in Merewether which was not surveyed by EEFIT, and in Mayfield where the density of damage recorded by EEFIT was much less than that indicated in Figure 6.11.

**Locations of structures with moderate or heavy damage from Newcastle City Council data**

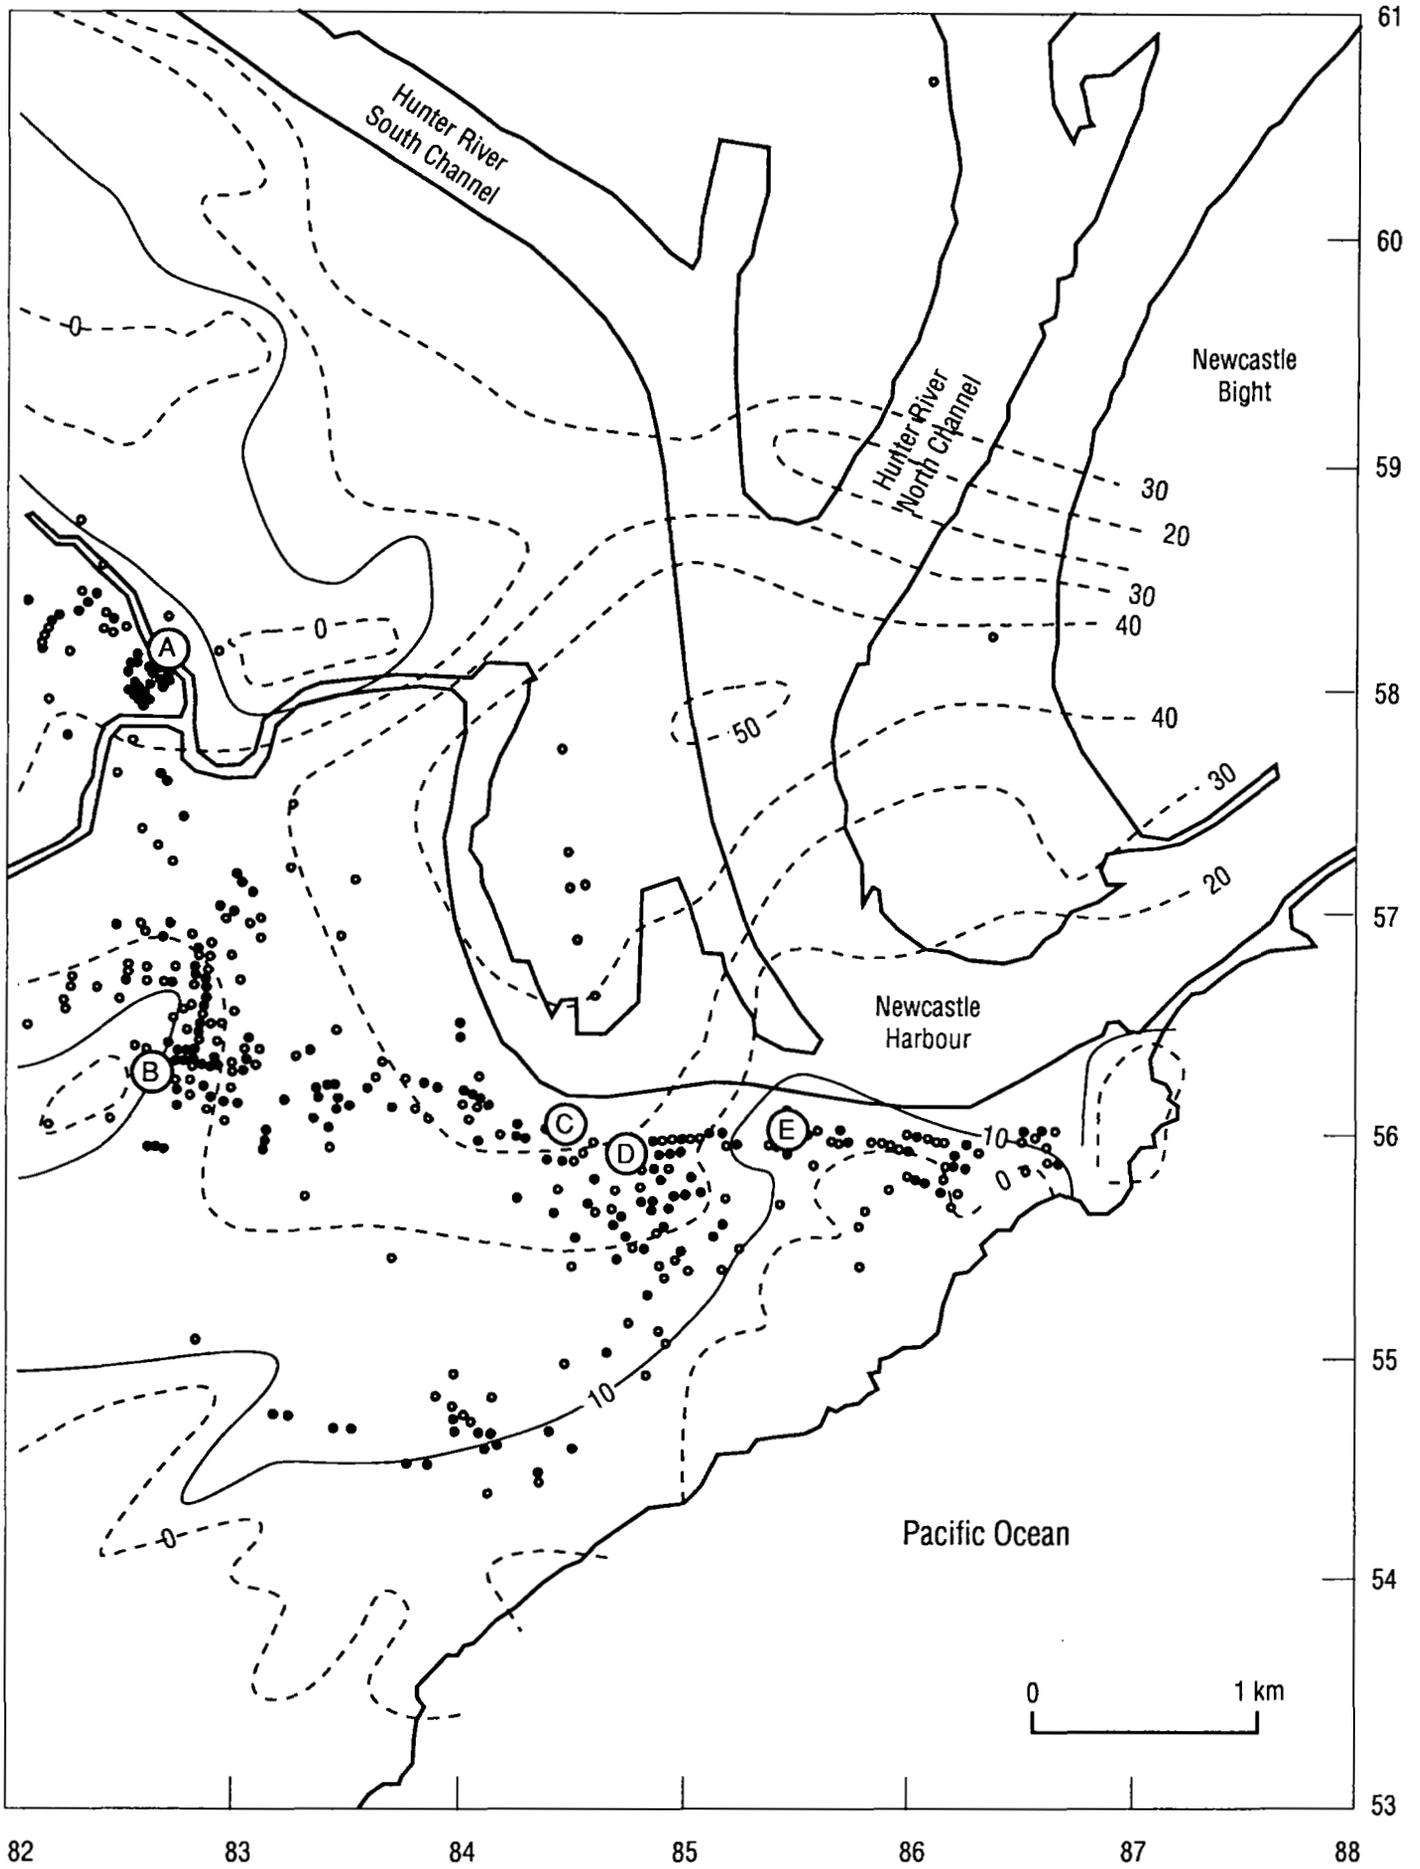
Figure 6.12

Distribution of damage in relation to soil thickness

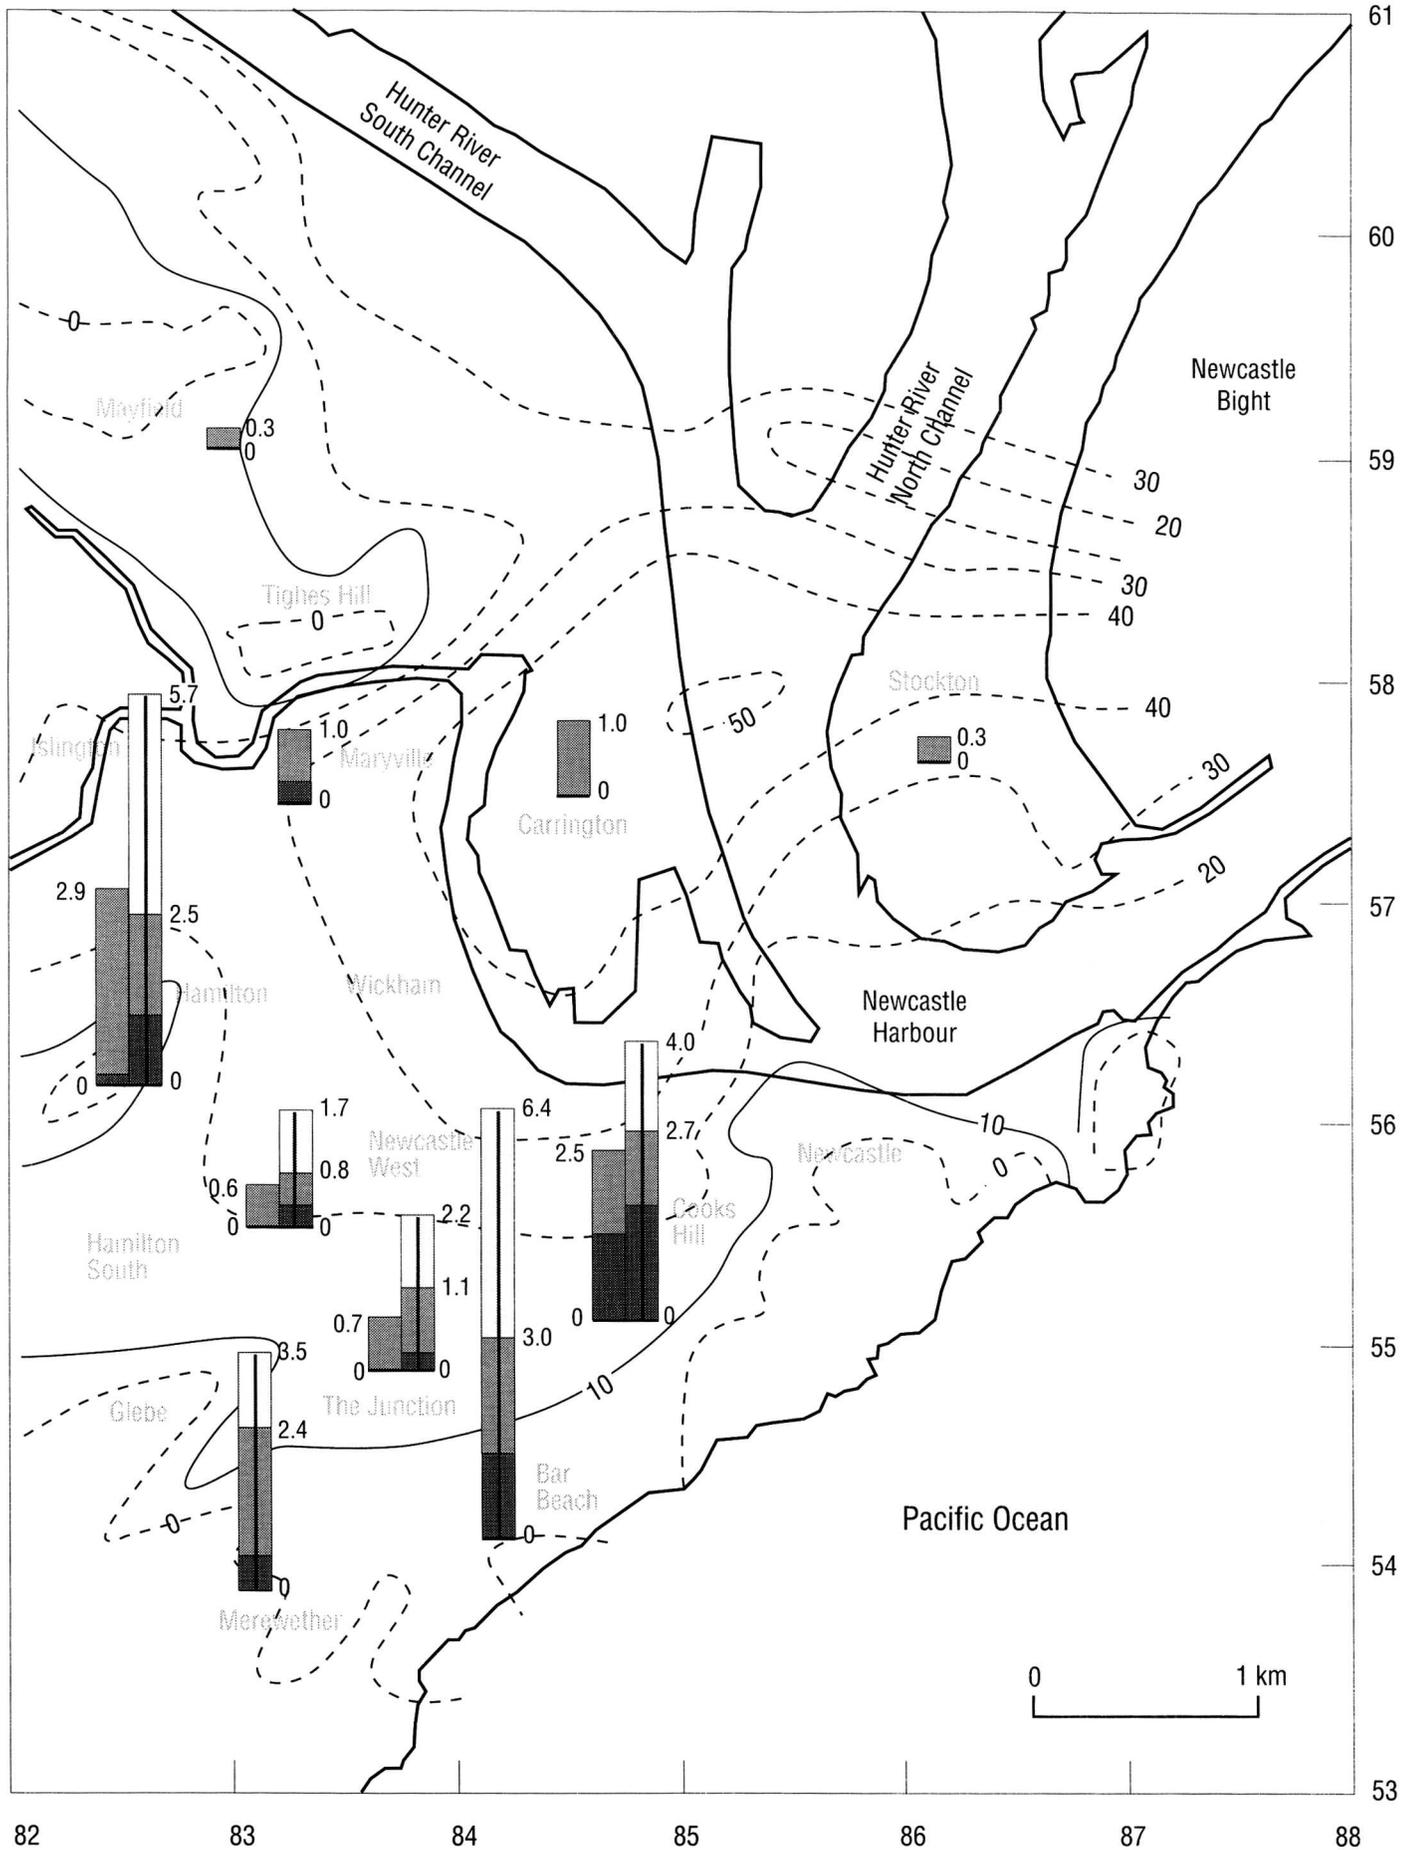
**Figure 6.13**

It is clear that the shallow soil deposits (boreholes B and E) amplify the short period motion (in the range 0.1-0.3 seconds) by factors of 2½-3. Low-rise structures of up to 3 or 4 storeys would therefore be expected to have shown a greater level of damage in the areas underlain by these soils. As the soil thickness increases (boreholes A and D) the amplification is seen to reduce in magnitude but extend over a wider period range. For the deepest deposit (borehole C) a slight attenuation compared with bedrock motion is indicated. These results agree reasonably well with the trends observed in Figure 6.13 but there is too large a variability in the data to draw any firm conclusions.

**Percentages of damage to residential buildings in relation to soil thickness**

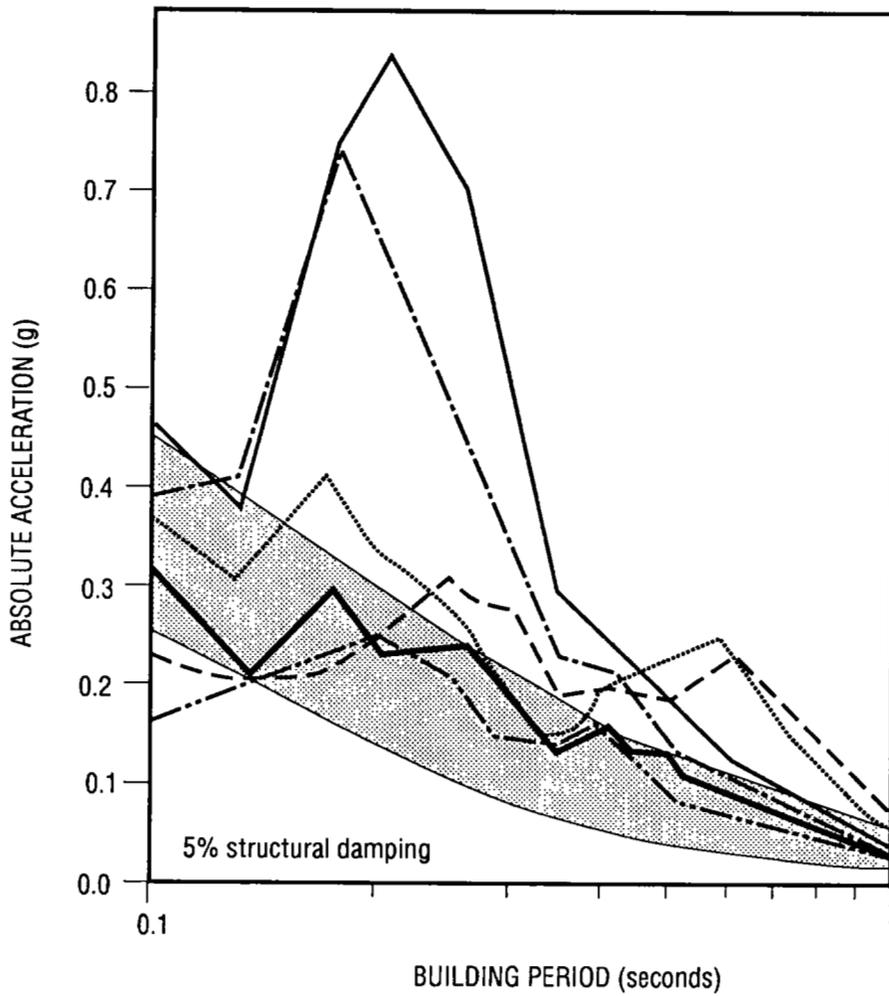
The calculations show that unlike other earthquakes such as Mexico City in 1985 (EEFIT 1986) and San Francisco in 1989 (EEFIT 1991), deep soft soil deposits do not necessarily amplify the bedrock ground motion to any significant extent. This is confirmed by the results of detailed site response analysis by Heidebrecht et al (1990) who conclude that spectral amplification is most significant when the seismic excitation has substantial energy in the region of the site period (which for deep soft sites could be in the order of 1-2.5 seconds). The very high site amplification effects recorded in Mexico City (factors of about 6) and San Francisco resulted from far field earthquakes (epicentral distances of about 400km and 100km, respectively) where the attenuated bedrock motion had a frequency content shifted towards the longer periods. For the lower magnitude, near field earthquake in Newcastle the energy would almost certainly have been concentrated at the shorter periods (Figure 4.5) and would therefore tend to excite site resonance effects in the shallower, stiffer soil deposits as indicated in Figure 6.15.

**Response spectra obtained from study of site response effects**

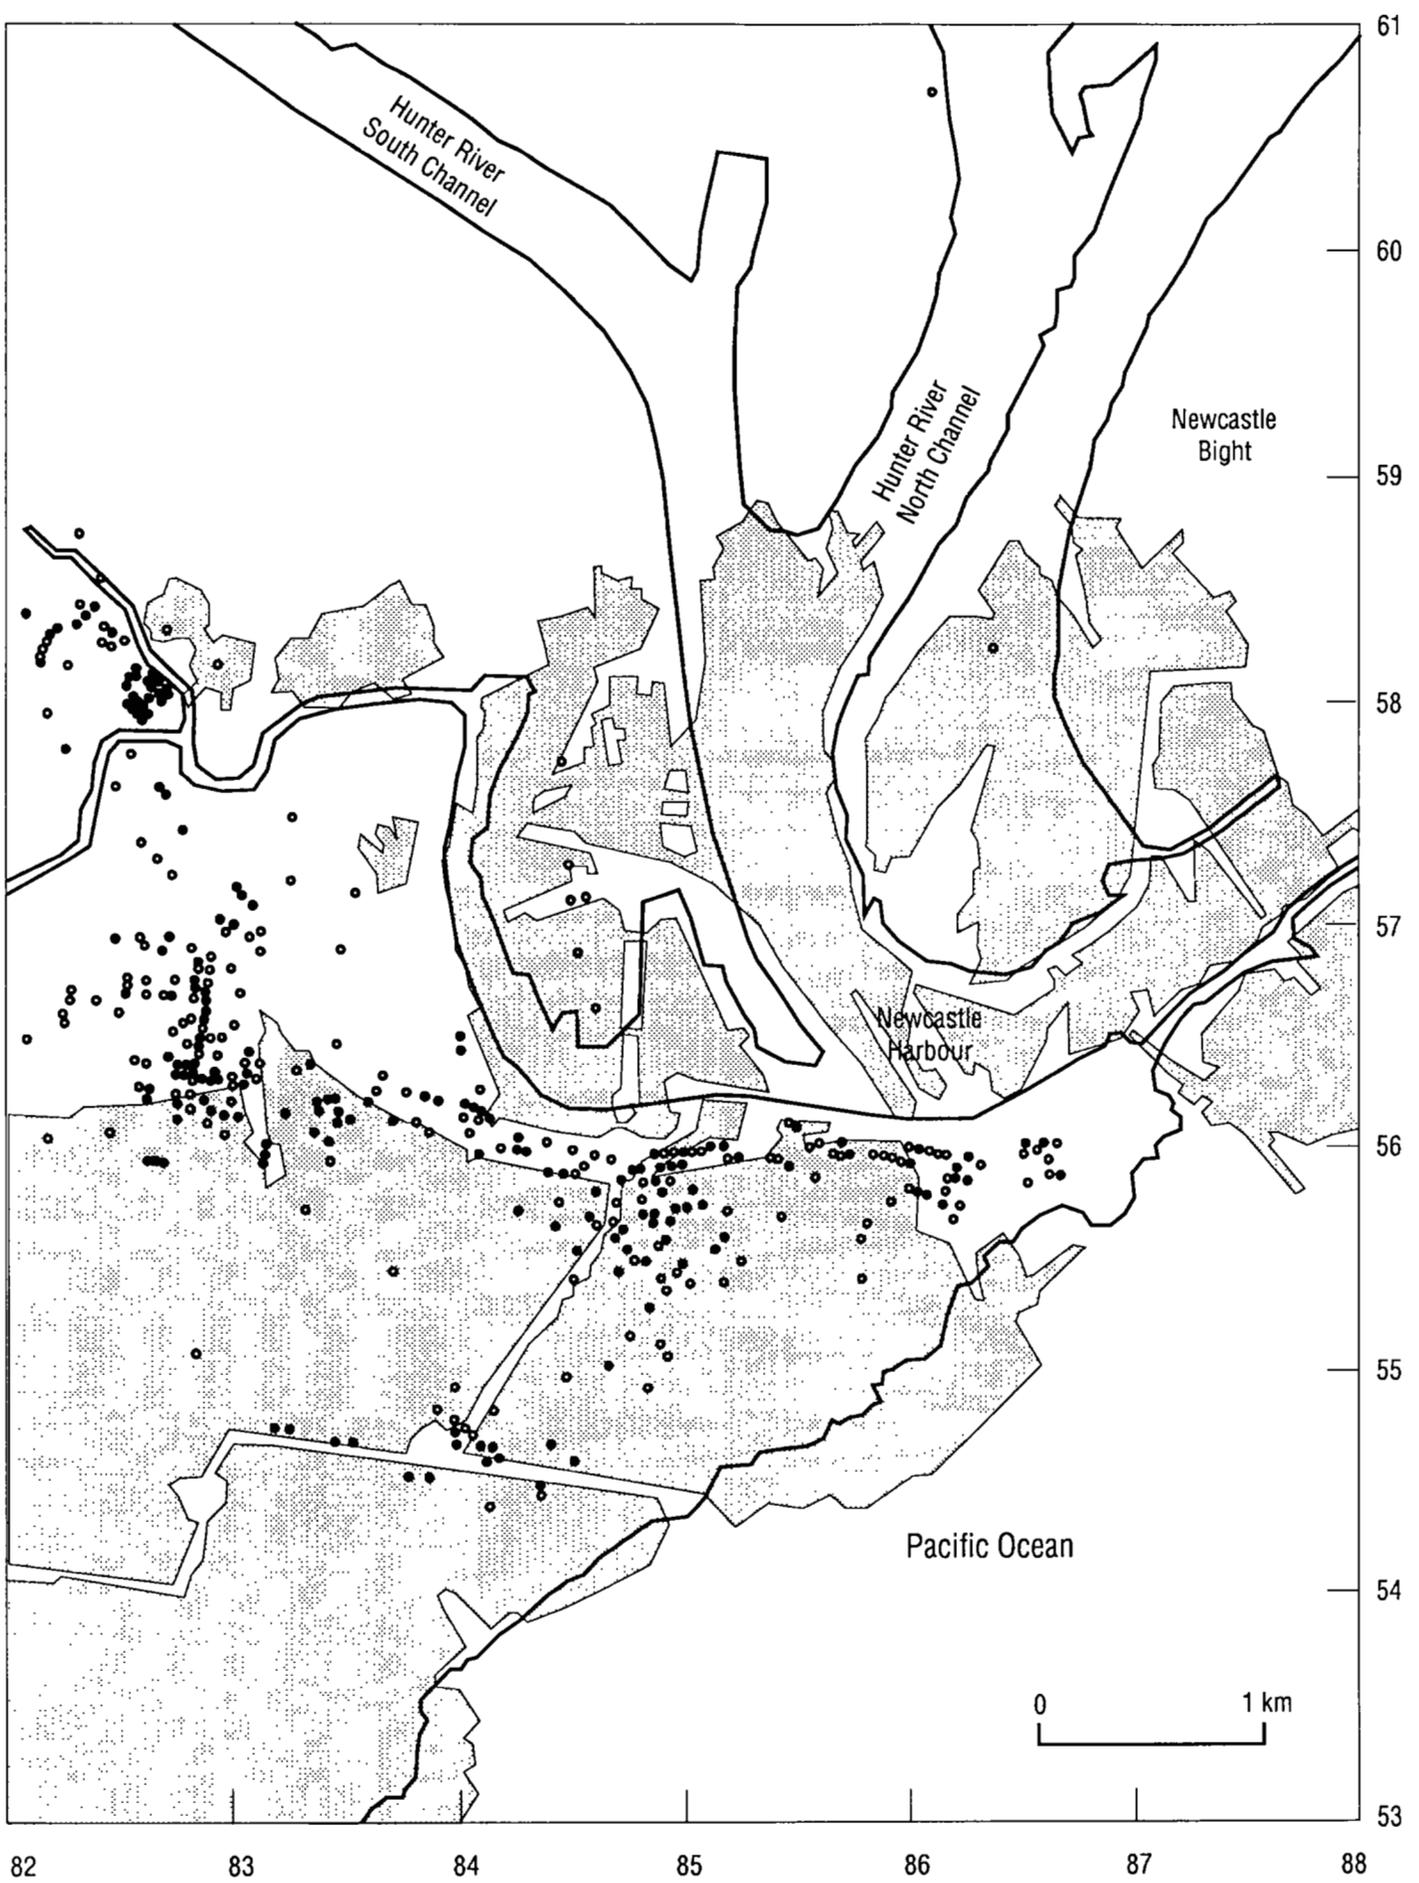
**Figure 6.16**

It is noticeable that in several earthquakes damage has been associated with mining activity. In the Liege earthquake this was associated with settlement induced by mining (EEFIT, 1984). In Newcastle there has been no evidence of damage to mines currently in use. If, however, the pattern of damage is plotted together with the area of coal extraction as in Figure 6.16 there appears to be a clear correlation between damage and the edge of mining activity. This may be due to motion being concentrated at the perimeter of the coal extraction. An alternative explanation is sociological in that the mine perimeters tend to be aligned along major roads. This is also where the most vulnerable buildings are situated and consequently there may be purely historical reasons why the damage is concentrated as it is.

**Distribution of damage in relation to areas of coal extraction**

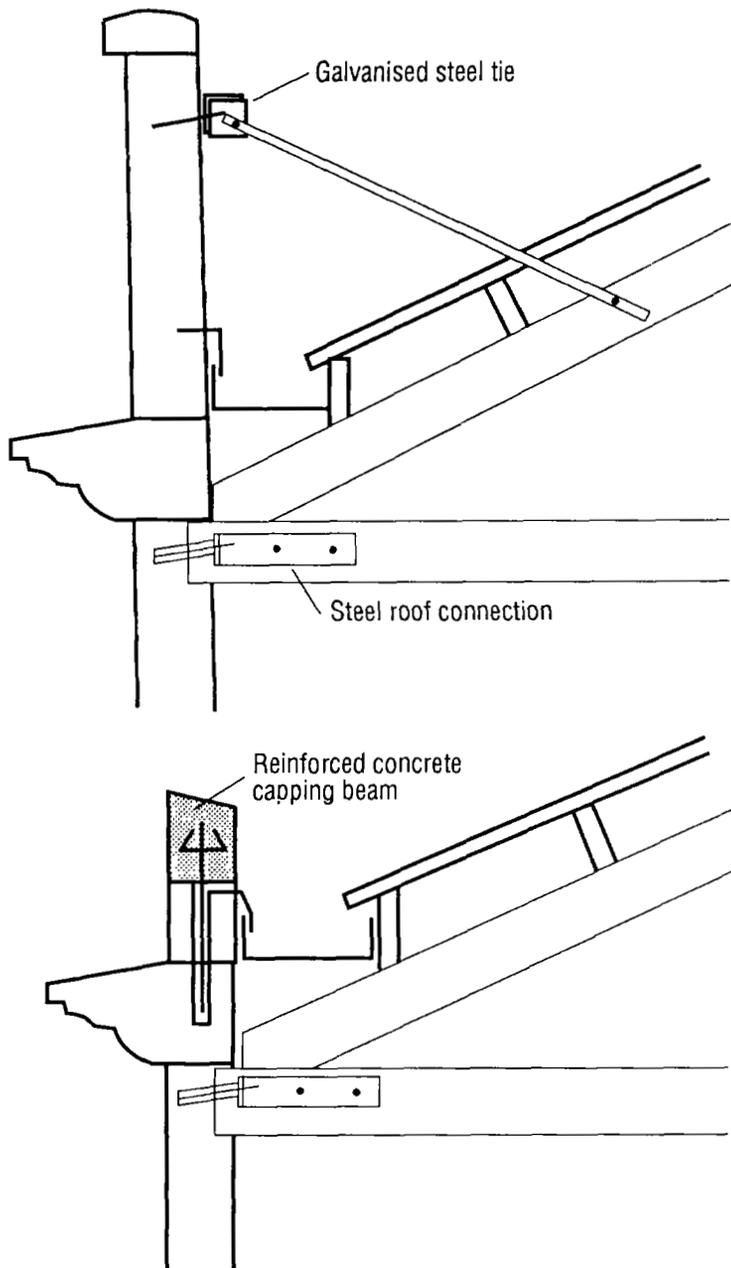
Figure 8.1

Recommended arrangements for  
tying or attaching parapets

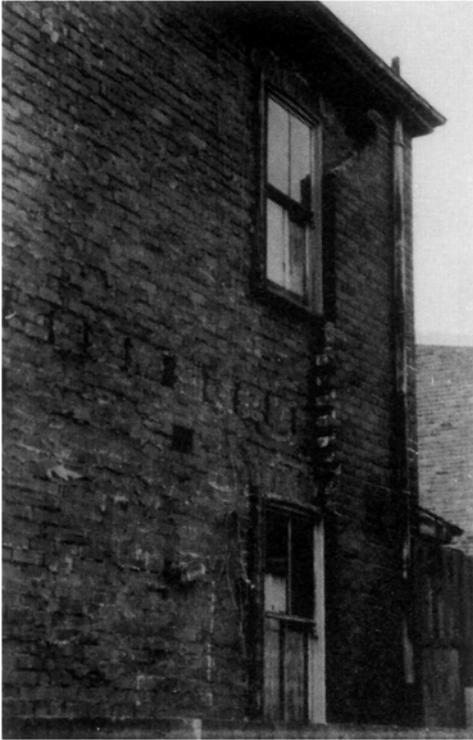
PLATE 5.1 *Collapse of outer skin of cavity unreinforced brick masonry wall (location 18)*

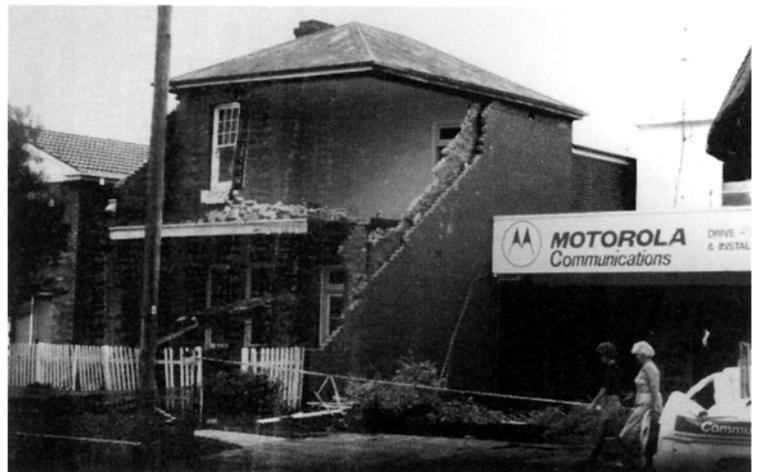
PLATE 5.4 *Front and side wall collapse in modern unreinforced brick masonry two storey dwelling (location 12)*

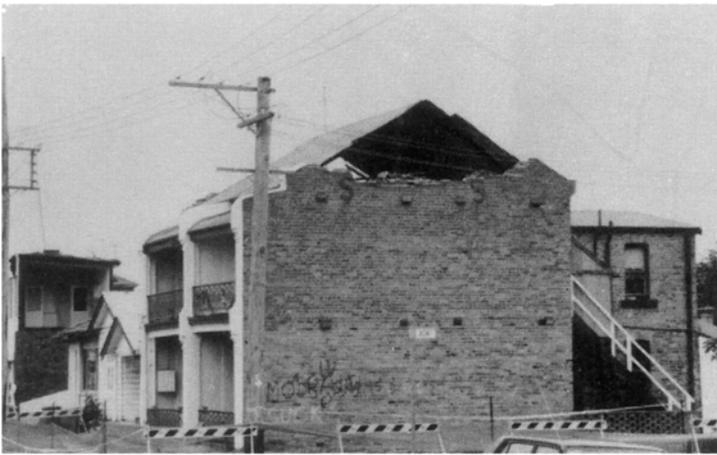
*PLATE 5.5 Gable end wall collapse in residential two storey brick masonry building (location 11)*

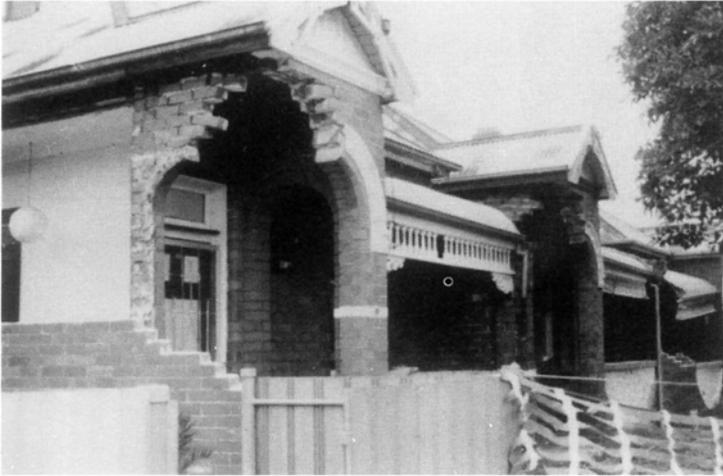
PLATE 5.9 *Damage to exterior ornamental brick columns and arches (location 8)*

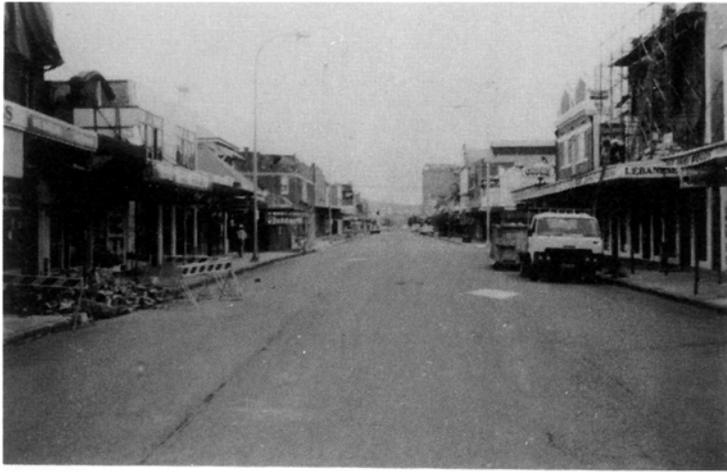
PLATE 5.18 *Heavily damaged section of Beaumont Street, Hamilton, taken 12 days after the earthquake*

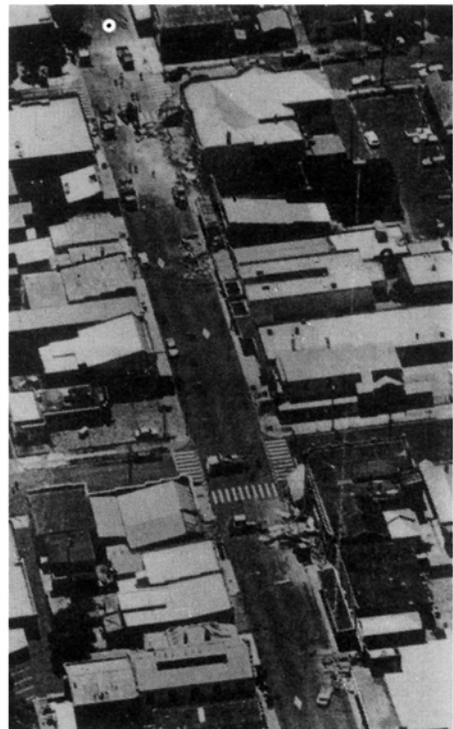
PLATE 5.19 *Aerial photograph of Beaumont Street, Hamilton, taken immediately after the earthquake*

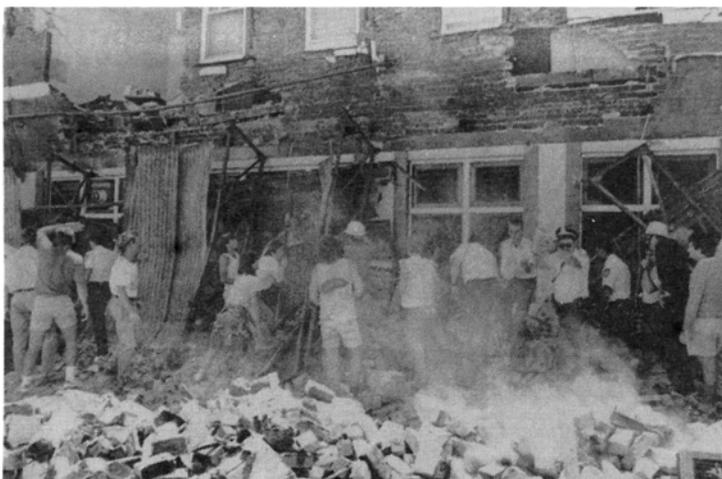
PLATE 5.20 *Rescue operations and emergency strengthening of a partially collapsed two storey brick masonry building in Beaumont Street, Hamilton*
