# THE 1989 NEWCASTLE AUSTRALIAN EARTHQUAKE

## A FIELD REPORT BY EEFIT

MARCH 1991

**J. W. Pappin**

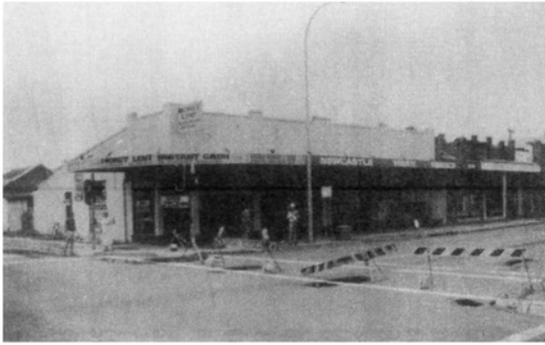
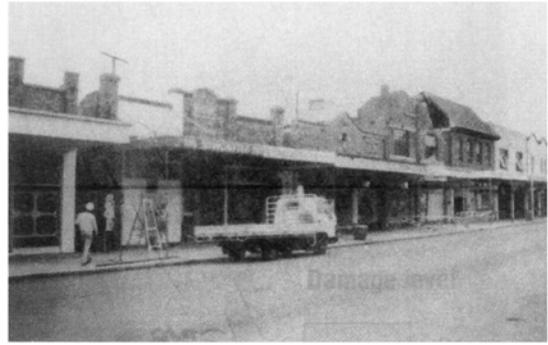
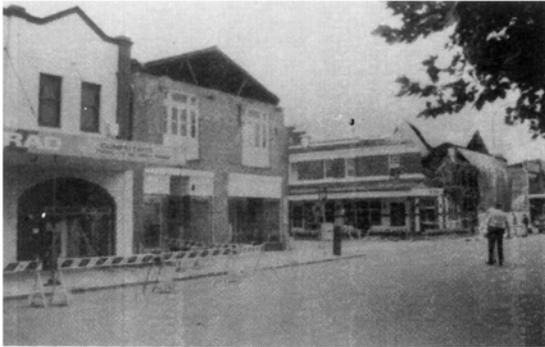
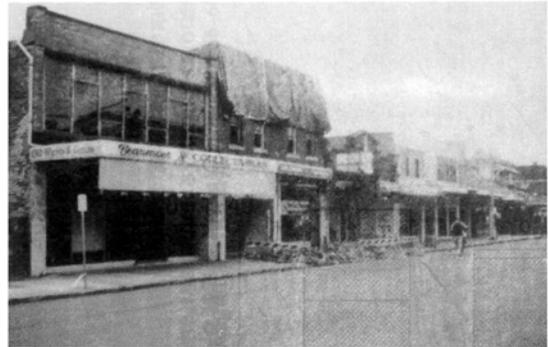
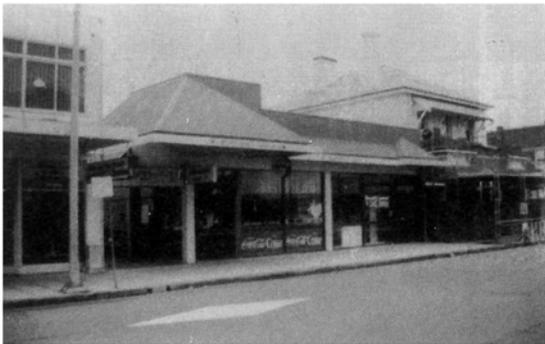
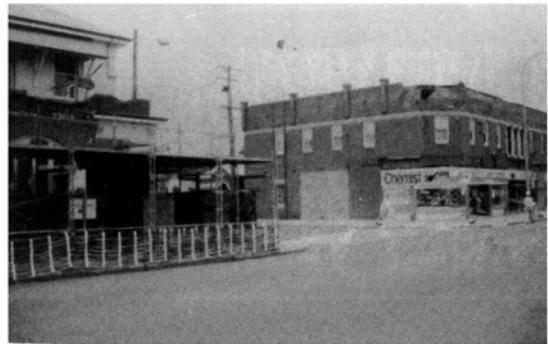
PLATES 5.21 - 5.26 *Sequence of photographs taken of the eastern side of Beaumont Street, Hamilton, 12 days after the earthquake*

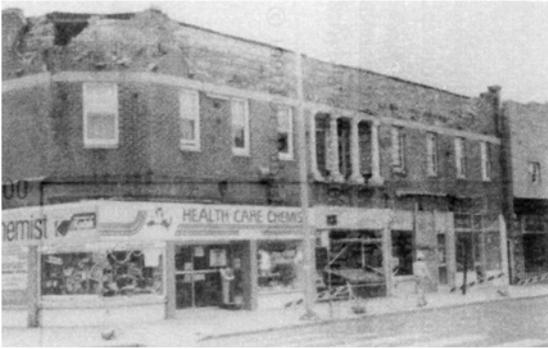
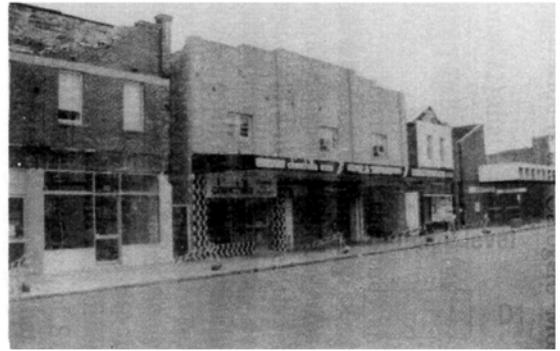
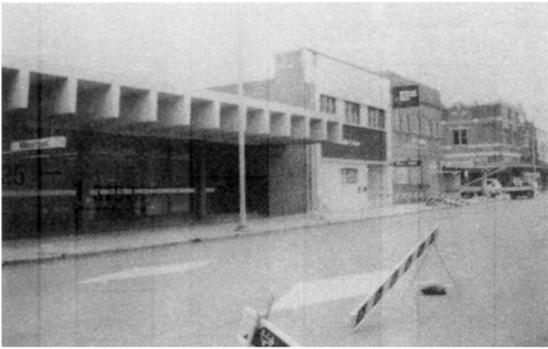
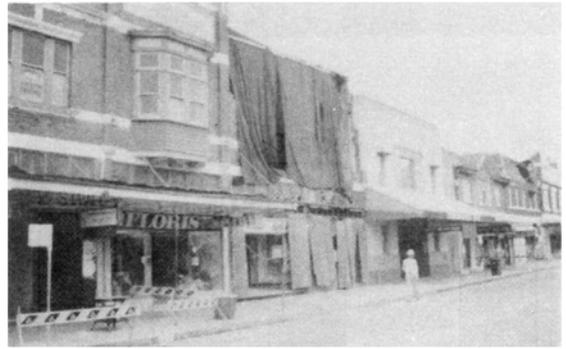
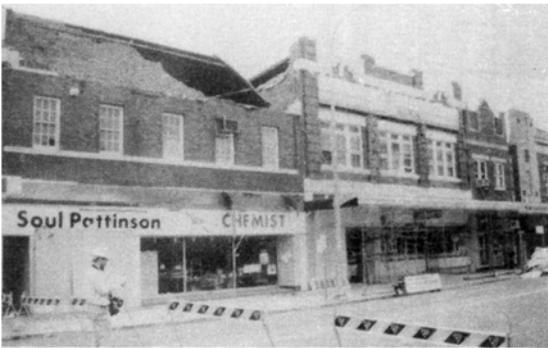
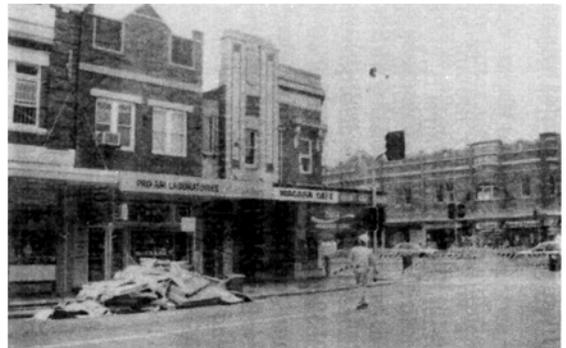
PLATES 5.27 - 5.32 *Sequence of photographs taken of the eastern side of Beaumont Street, Hamilton (continued from previous page)*

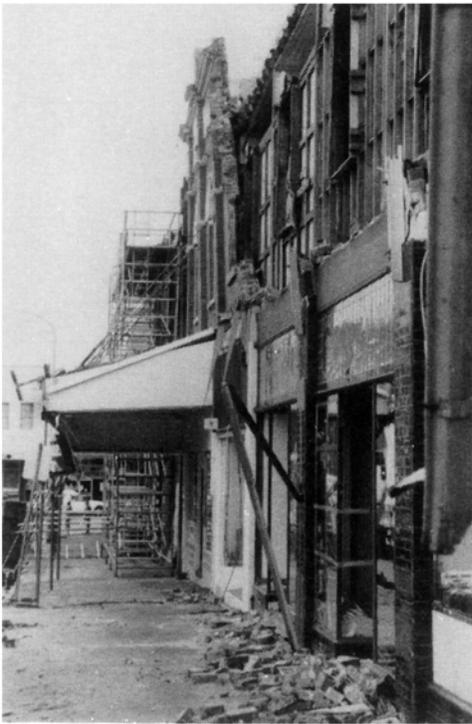
PLATE 5.33 *Collapsed second storey brick masonry facade in two storey commercial building. The remaining facade is leaning dangerously away from the building (location 21)*

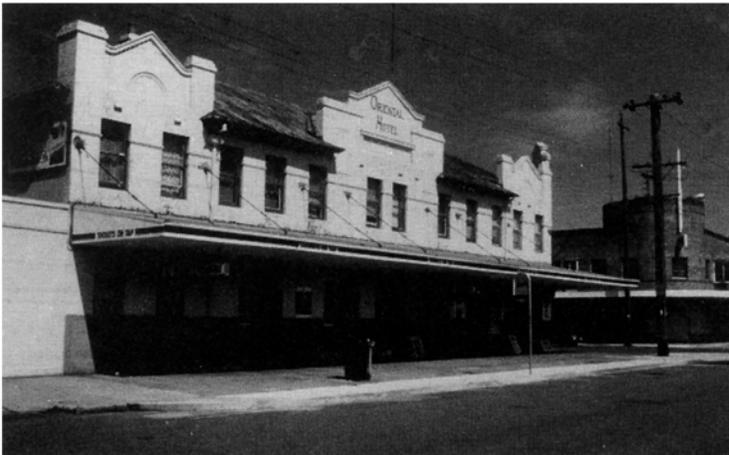
PLATE 5.34 *Long awning tied back to second storey facade, a typical feature of older commercial buildings in Newcastle (location 15)*

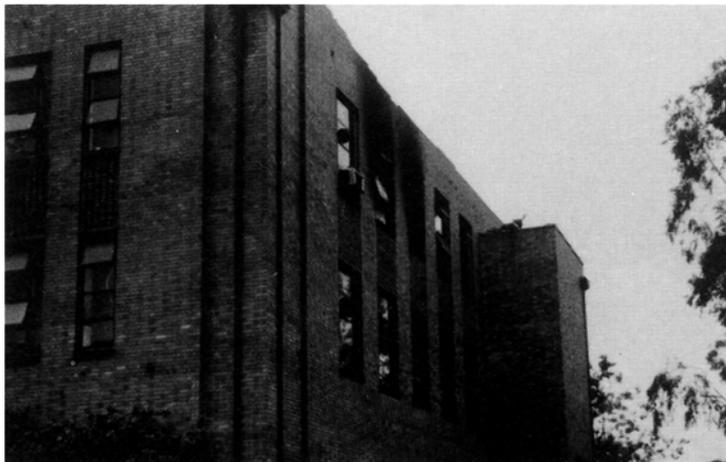
*PLATE 5.47 The earthquake caused a fire to start in a third floor laboratory at the Tighes Hill Technical College, but was soon brought under control*

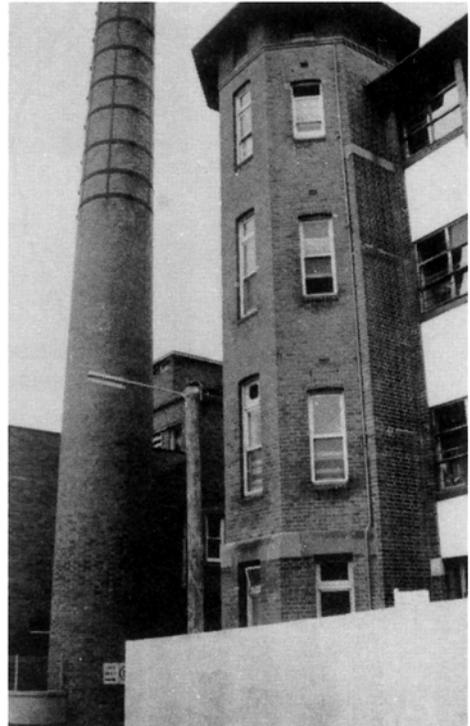
*PLATE 5.49 The 30m high brick chimney at the Royal Newcastle Hospital showed no signs of earthquake damage*

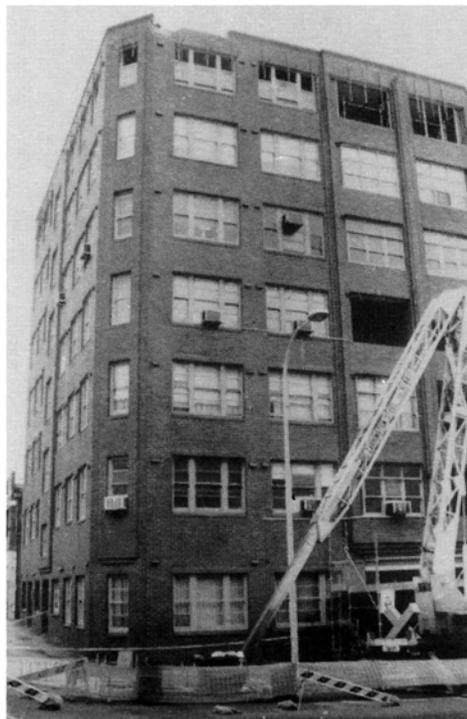
*PLATE 5.50 Parapet failure in a brick clad, seven storey steel framed office building in the Newcastle central business district (location 34)*

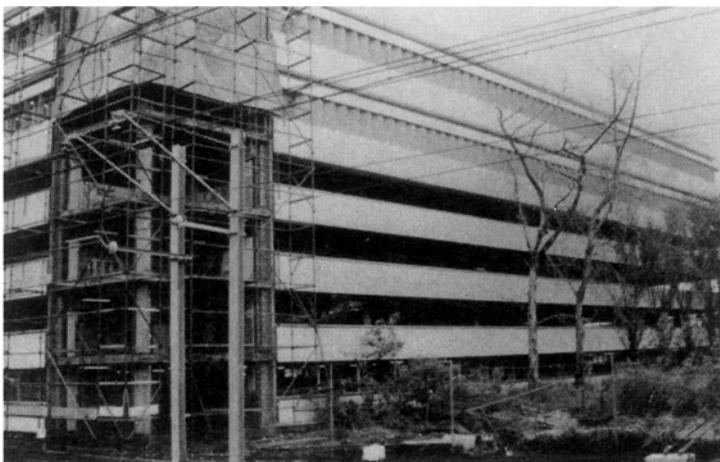
PLATE 5.56 *Total collapse of the lower five storeys of unreinforced brick masonry walling attached to reinforced concrete frame car park and office building (location 29)*

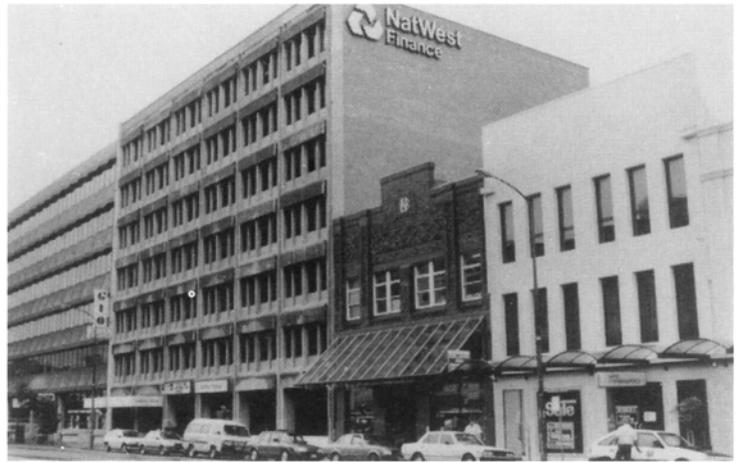
PLATES 5.57 and 5.58 *There was no recorded earthquake damage to these two modern multi-storey reinforced concrete frame and frame-shear wall buildings in the Newcastle central business district (locations 28 and 14)*

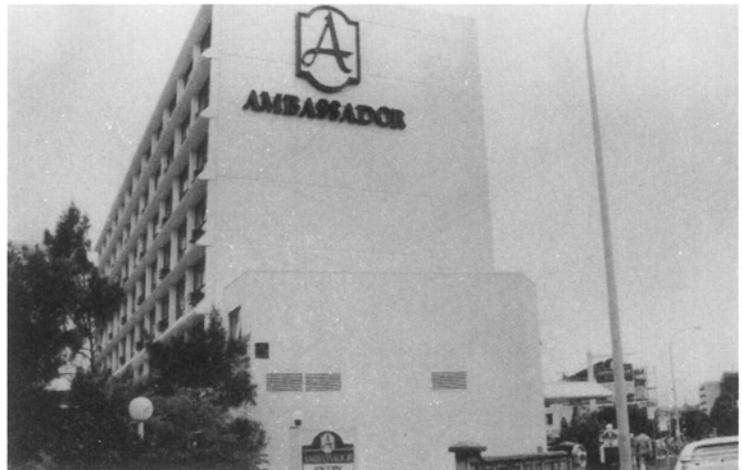
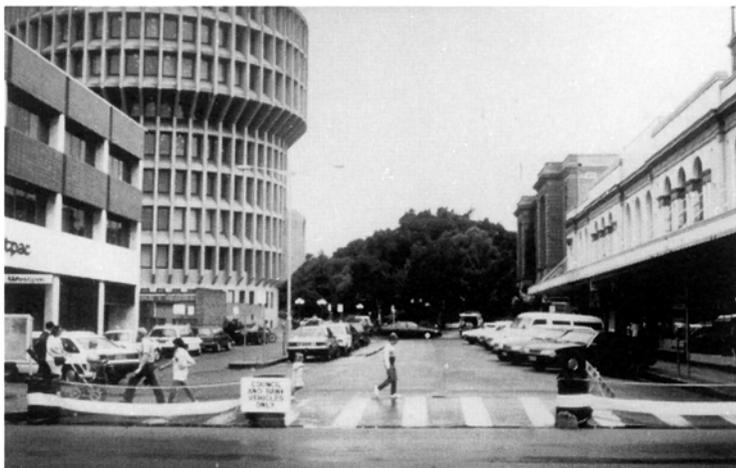
PLATE 5.59 *The Newcastle City Council offices (circular building) in the centre of the city suffered no damage, and operated as the focus for monitoring and directing the building damage assessment surveys (location 27)*

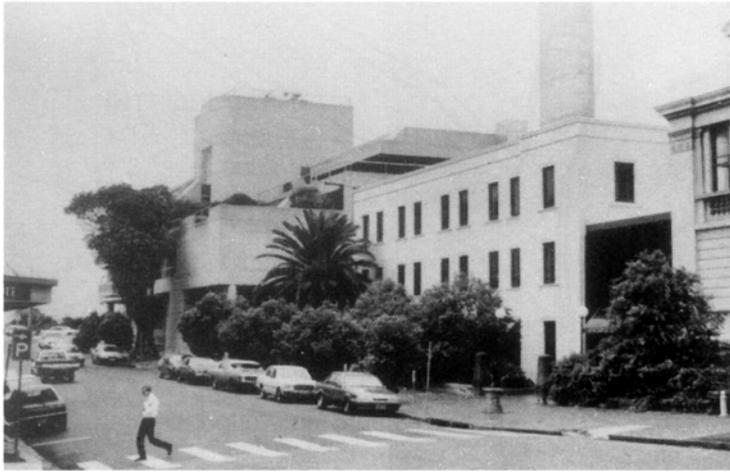
PLATE 5.60 *The police station at the eastern end of the central business district. This building was designed to resist a moderate earthquake and was undamaged (location 33)*

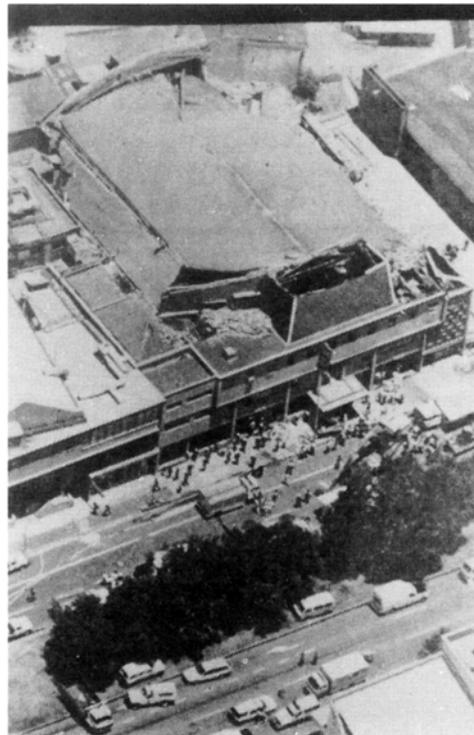
(Plate 7.2), and a cinema in Perry Street. Pressure from Heritage groups built up from the impression that wholesale random demolition was taking place, but in fact only eight major buildings were lost, including the Newcastle Working Mens' Club and The Junction Motel, as discussed in Section 5.3 of this report (see Plates 5.61-5.64).

PLATES 5.61 and 5.62 *Extensive structural damage and collapse at the Newcastle Working Mens' Club, where nine persons died in the earthquake (location 20)*

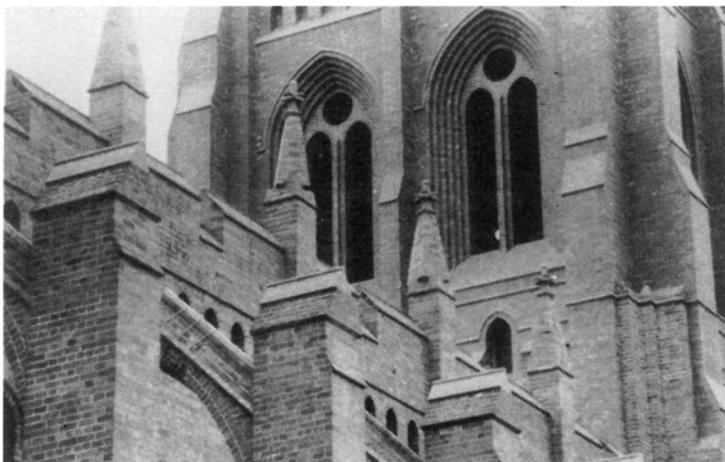
PLATE 5.65 *Rotation of finials mounted on top of the brick masonry parapet at Christ Church Cathedral, Newcastle (location 32)*

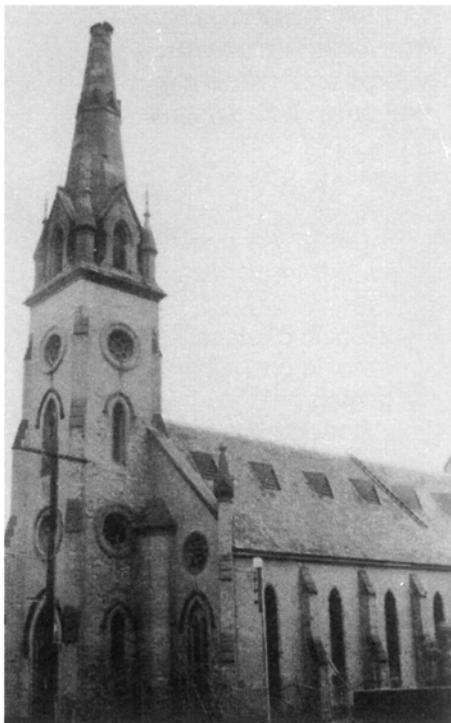
PLATES 5.67 and 5.68 *Partial collapse and severe cracking of masonry spire and tower, a common form of damage to churches in Newcastle (locations 26 and 7)*

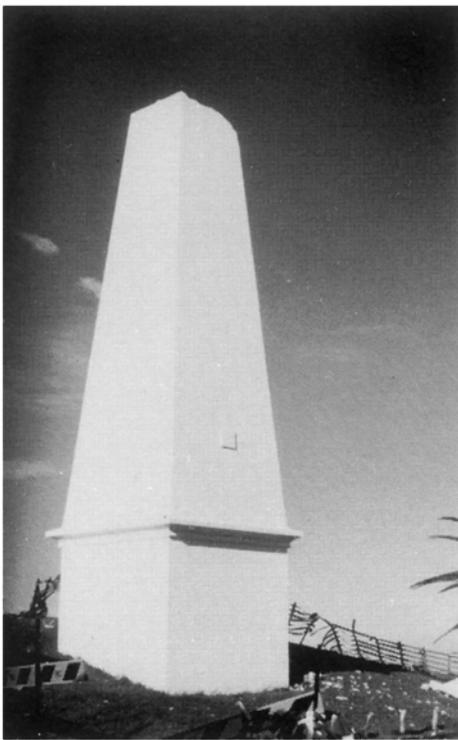
PLATE 5.69 *The war memorial lost its capstone as a result of the earthquake (location 31)*

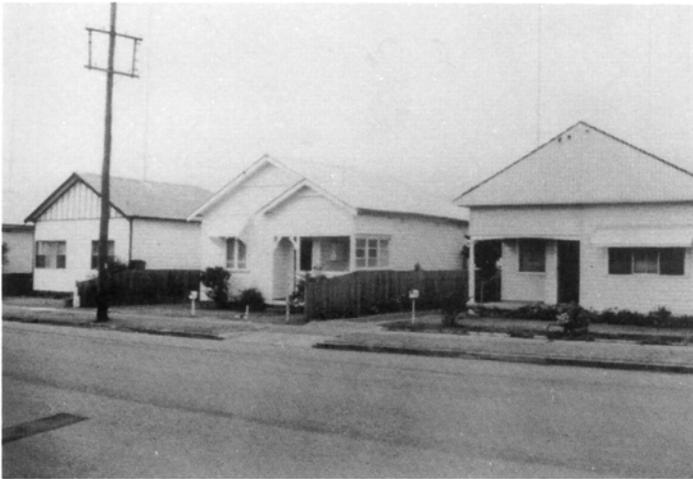
PLATE 5.70 *Typical single storey timber framed weatherboarded dwellings, which suffered only minor damage in the earthquake*

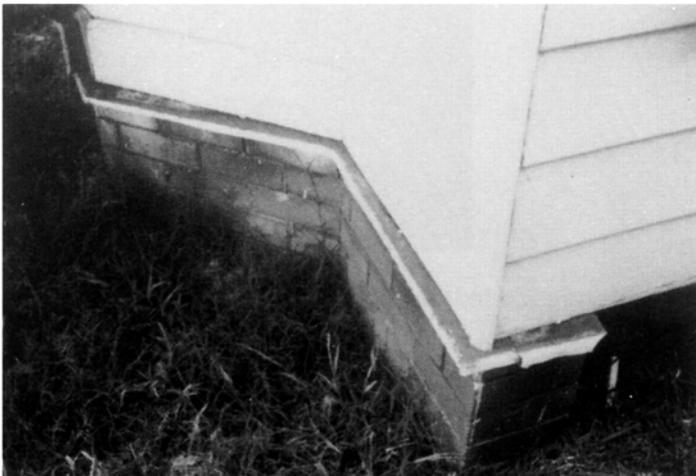
PLATE 5.71 *Sliding movement between timber structure and its support foundations (location 5)*

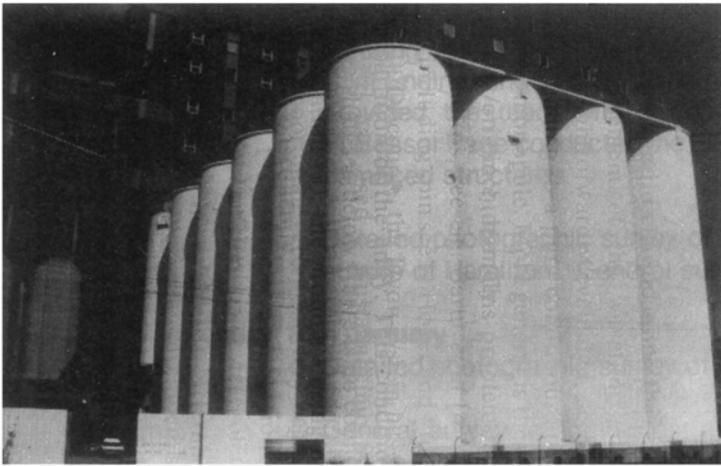
PLATES 5.74 and 5.75 *Minor spalling of concrete in storage silos was the only evident form of damage to industrial facilities in Newcastle (location 16)*

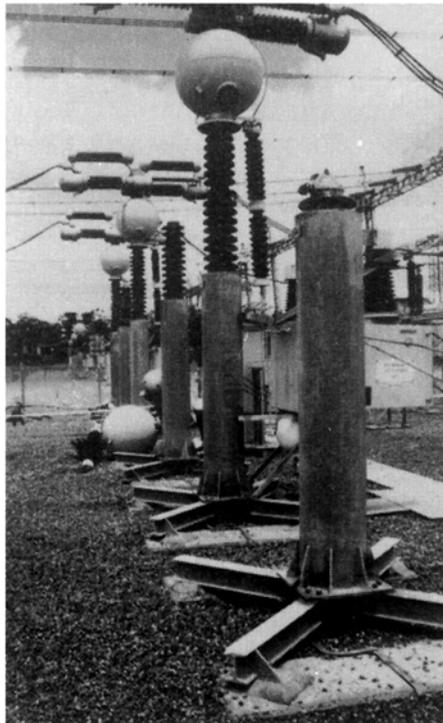
PLATE 5.76 *Failure of porcelain insulators supporting 132kV circuit breakers at Killingworth, 20km west of Newcastle*

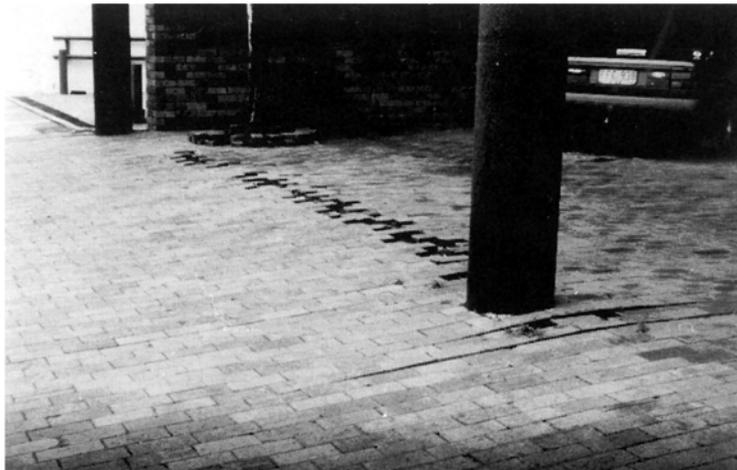
*PLATE 5.78 Evidence of localised ground compression causing bulging of brick paving (location 14)*

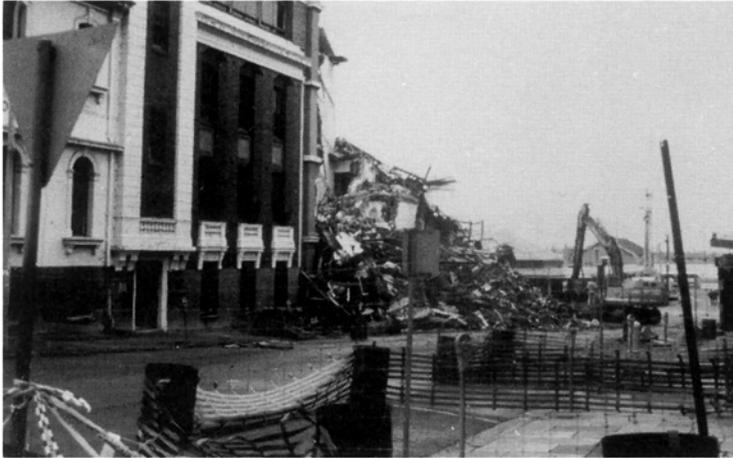
PLATE 7.1 *The George Hotel in the Newcastle central business district, a five-storey unreinforced brick masonry building which had to be demolished nine days after the earthquake (location 34)*

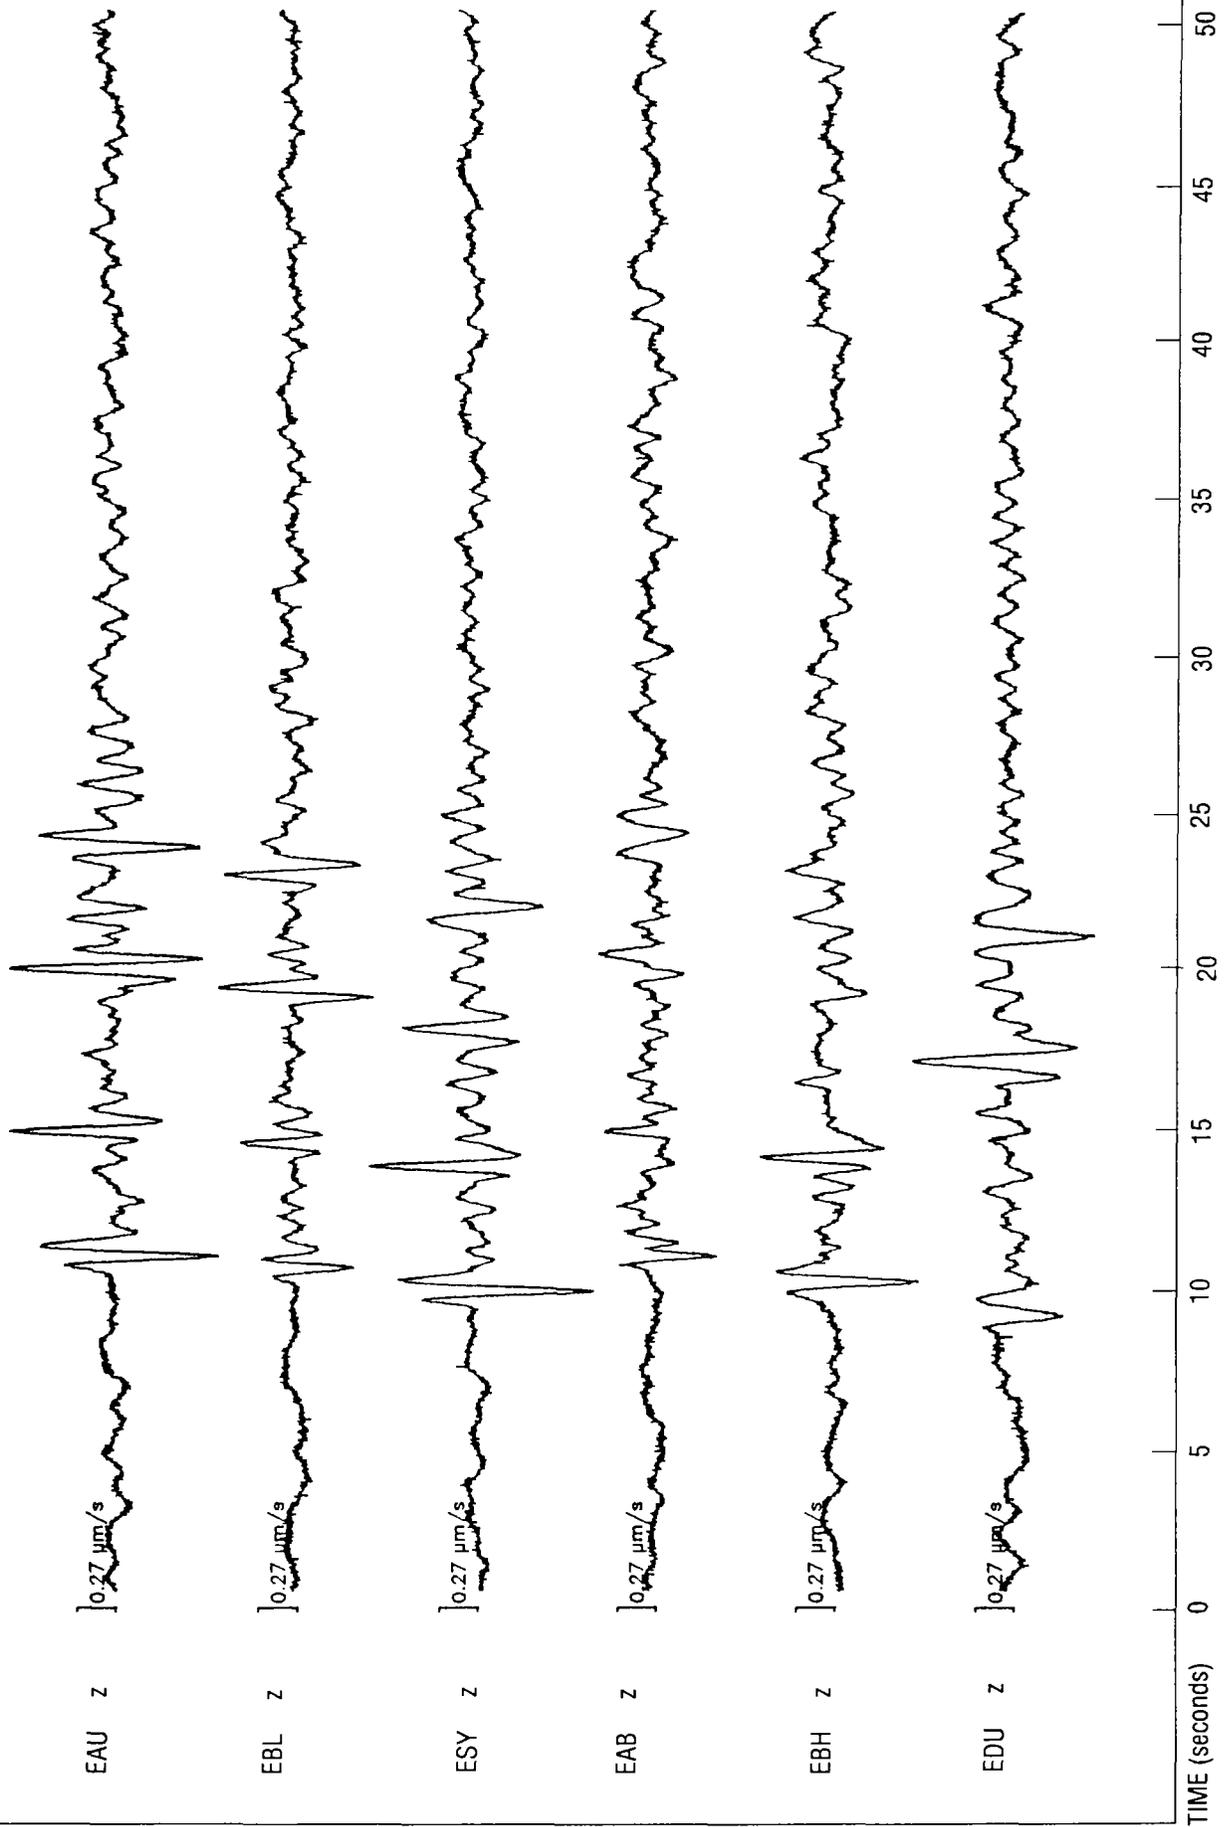
Figure B.1

Of particular interest both to seismologists and engineers are the second and fourth pulses, which at each station follow the preceding phases by 4 seconds, and are of opposite polarity. This indicates that they are surface reflections from near the epicentre, and establishes the time taken for seismic waves to travel from the focus to the surface as 2 seconds. This gives a good constraint on the depth of focus, which for the usual value of velocity in the upper crust must be close to 10km.

Recordings of the Newcastle earthquake made at stations of the BGS Lownet array

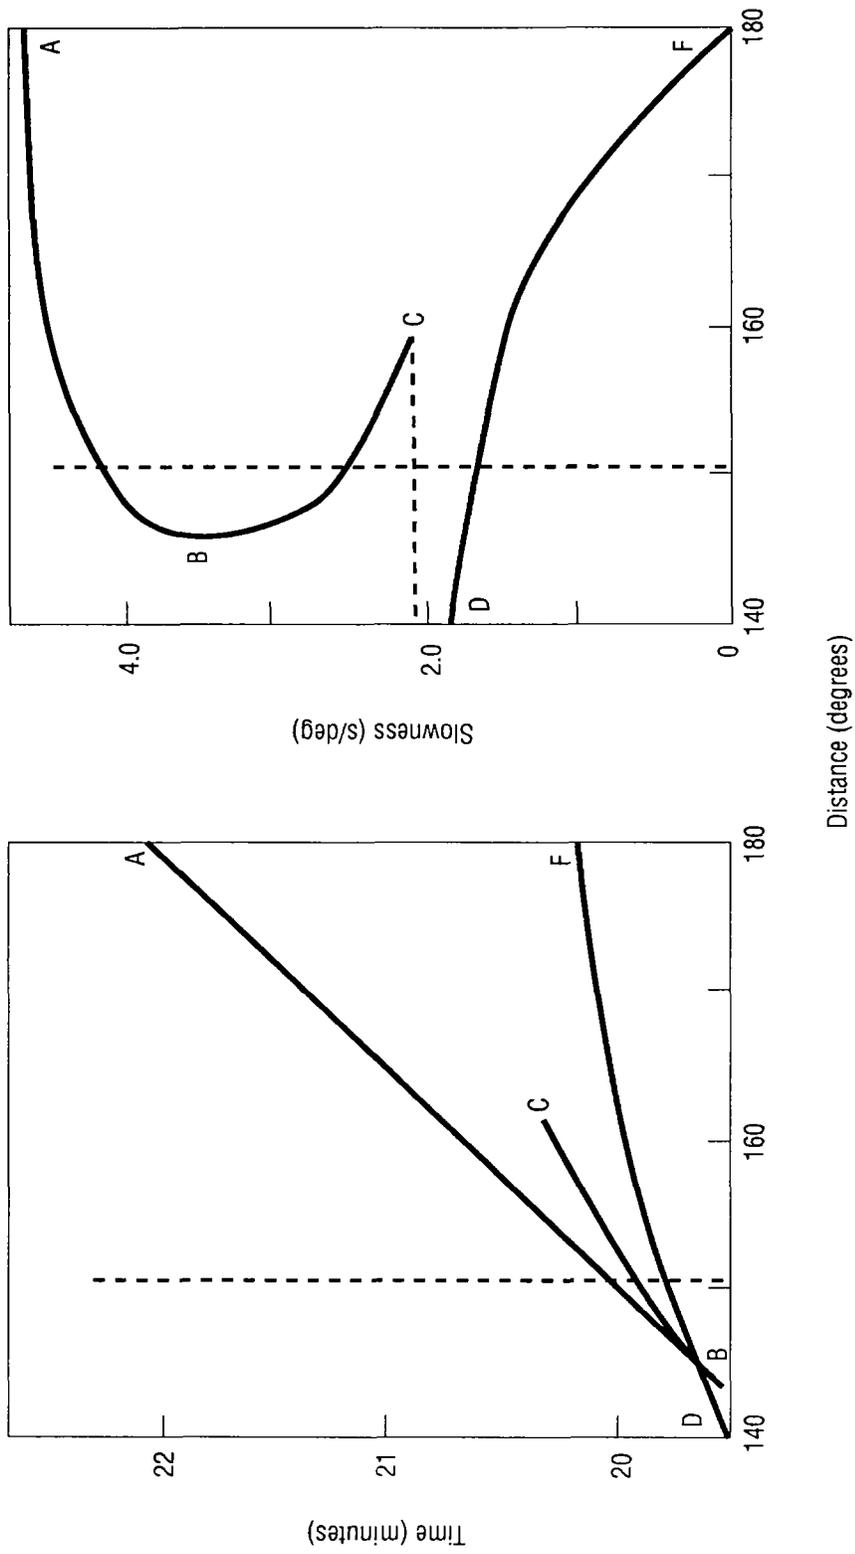
Figure **B.2**

Theoretical travel times of PKP phases and derived value of slowness ( $dT/d\Delta$ )
