THE PADANG, SUMATRA - INDONESIA EARTHQUAKE OF 30 SEPTEMBER 2009

A FIELD REPORT BY EEFIT

Earthquake Engineering Field Investigation Team
Institution of Structural Engineers
11 Upper Belgrave Street
London SW1X 8BH
Tel 0207235 4535
Fax 0207235 4294
Email: mail@eefit.org.uk
December 2009

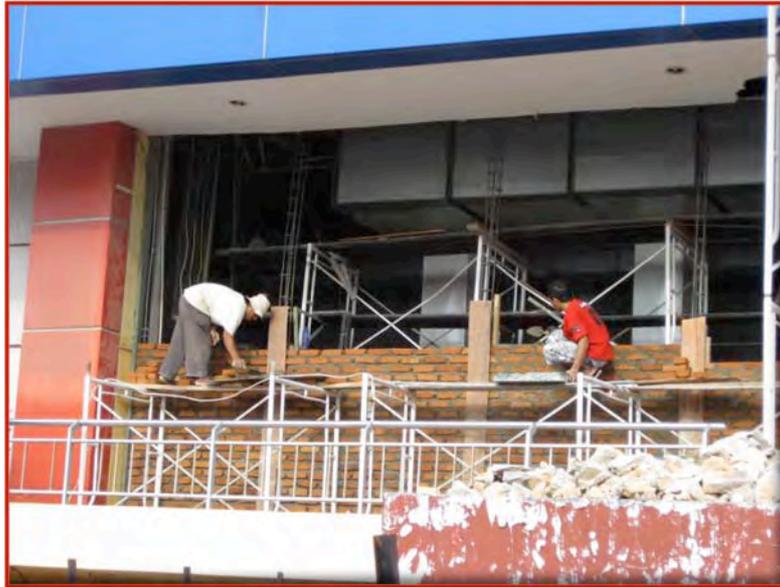
Figure 16. Labourers Rebuilding the Walls of the Ramayana Shopping Centre, Padang.

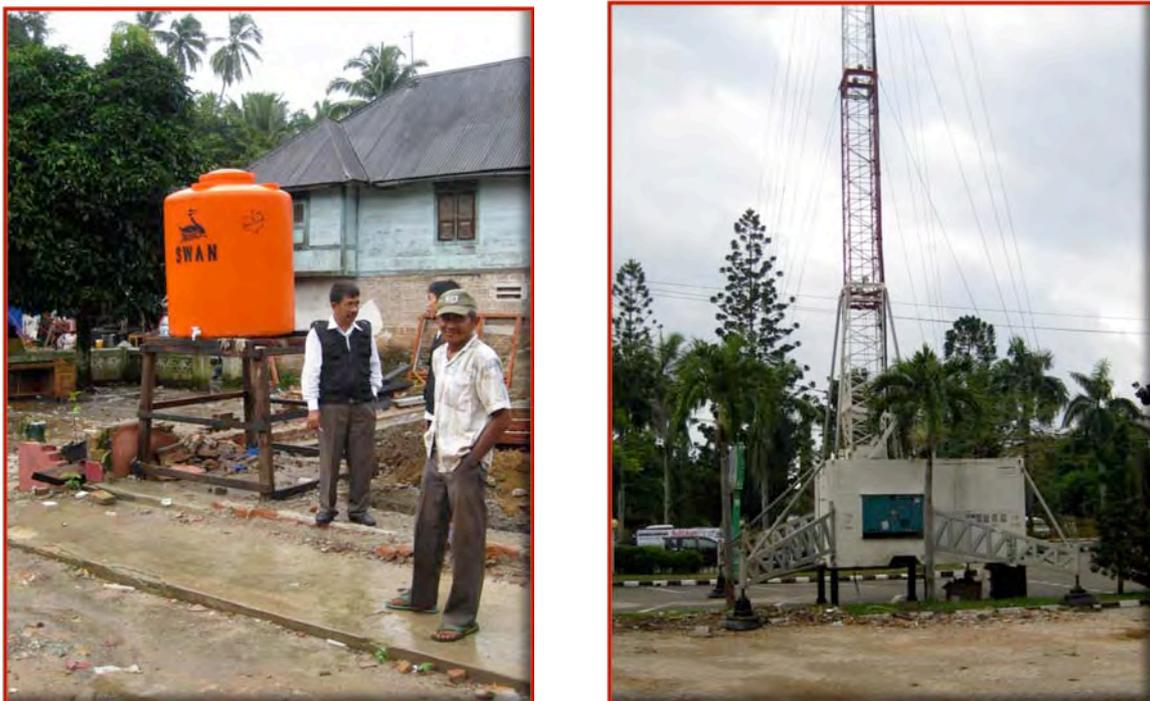
Directly after the earthquake, residents went 10 days without electricity, one month without the complete restoration of the main water supply (but with well access), and about 5 days without mobile phone reception. Today, some of the temporary water tanks that the water company distributed around Western Sumatra are still present (Figure 17). Due to the damage caused to the water company's main building, the water company has set up temporary marquees outside the main building as administrative offices. In addition, small phone towers with generators were set-up throughout Padang (Figure 17).

Figure 17. Water Storage Tank at a Kudu Ganting School (left) and Temporary Mobile Phone Tower at the Inna Maura Hotel (right).

Day 2: On the second day after the earthquake, the water company had started the emergency response program. It obtained another three, 5m³ water trucks from The Department of Civil Works of West Sumatra. In addition to the extra water trucks, 108 units of 2m³ water storage tanks were provided which allowed distribution to other areas of central Padang (see Figure 17).

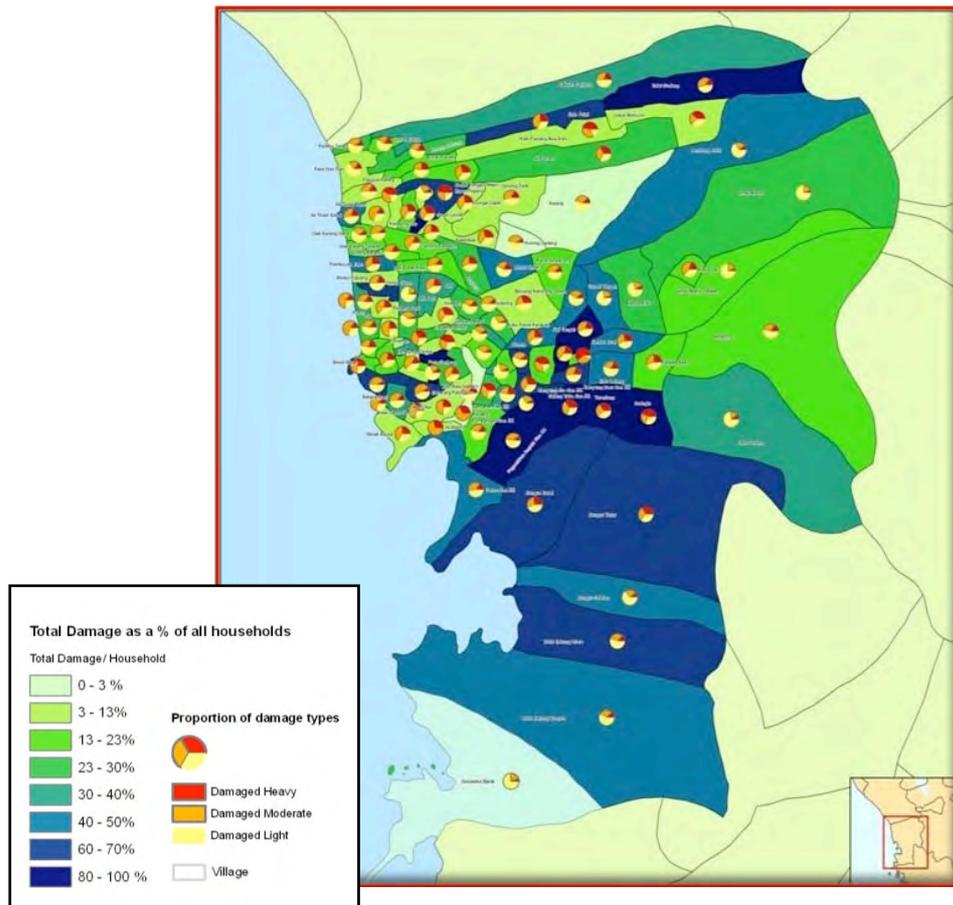
In spite of the large number of residential buildings affected at different degrees (see previous section), severe damage or collapse of residential houses was not widespread in either Padang or Pariaman cities. A detailed survey of residential buildings in the region was carried out by MapAction, an NGO specialised in gathering and mapping information around zones hit by a natural disaster. The results of a survey conducted by MapAction in various areas of Padang City (Figure 20) show that widespread damage (i.e. where 80% to 100% of

households were damaged, represented in the map by dark blue areas) is concentrated in specific parts of the city. However, even in these areas the proportion of houses heavily damaged is in general not extensive; this fact is shown by the pie charts at each surveyed area where red colour denotes heavy damage.

A spurious effect of the map in Figure 20 is that the areas in the Southern part of the city, identified with 40% to 70% of households being damaged (i.e., areas in blue colour tones), correspond to mountain areas not densely populated and where houses are mostly constructed along the shore and up to the skirts of the hills. Therefore even though the map proportionally shows a significant percentage of the city having widespread damage, most of these areas in the South do not have a large number of houses.

The area of Padang city with higher concentration of households affected, as shown in Figure 20, is also shown using Google Map in Figure 22. As observed in the latter figure, the area corresponds to a portion of the city surrounded by mountains where potential “basin” effects may have occurred. This hypothesis needs to be corroborated with a soil map of the city though.

Figure 20. Household damage distribution in areas of Padang City (by MapAction, based on data collected before 21 October). The area with extensive damage, shown in the middle of the map, is presented in Figure 22.

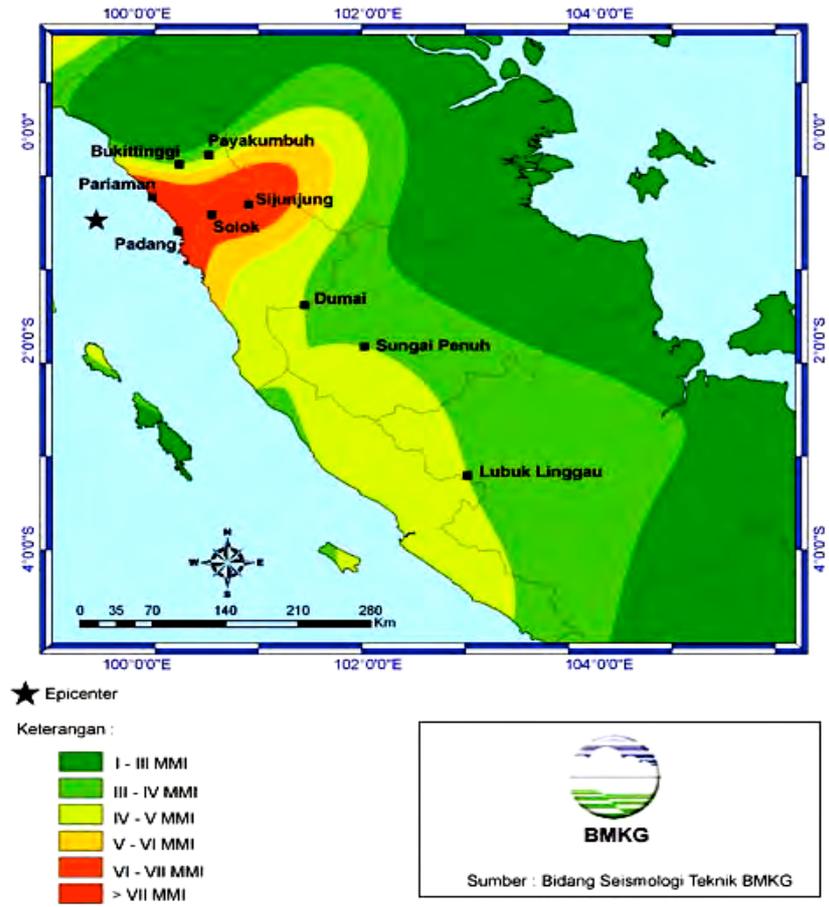
Figure 21 shows the distribution of the intensity of the earthquake effects felt at the surface, reported using the Modified Mercalli Intensity scale and data from BMKG. Both Padang City and Pariaman City (Kota Padang and Kota Pariaman) reported a level 7 intensity or greater, described as greater than “very strong intensity.” The BMKG intensity map is comparable to intensity results produced by MapAction (based on data from the Indonesian Department of Energy and Mineral Resources). The correlation between the damage scales of Figure 20 and Figure 76 and the intensities in Figure 21 are not explicitly expressed, but comparing the figures confirms the expected conclusion that a large percentage of what Map action and BNMP has described as severe damage corresponds to VII MMI. Similarly, very little severe damage to homes is seen in areas corresponding to V MMI.

Figure 21. Isoseismal map for west sumatra earthquake (BMKG, 2009).

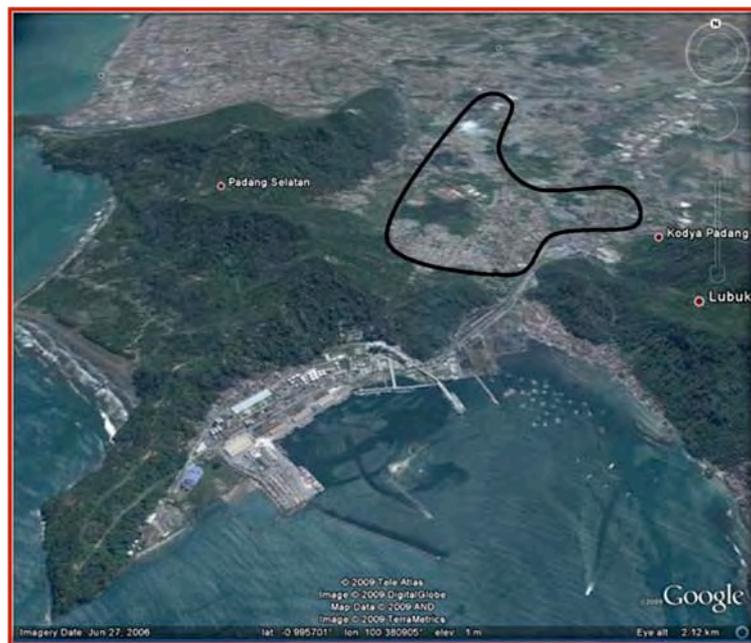
Figure 22. Google Earth 3D visual of the area mapped by MapAction with 80% to 100% of households having a degree of damage.

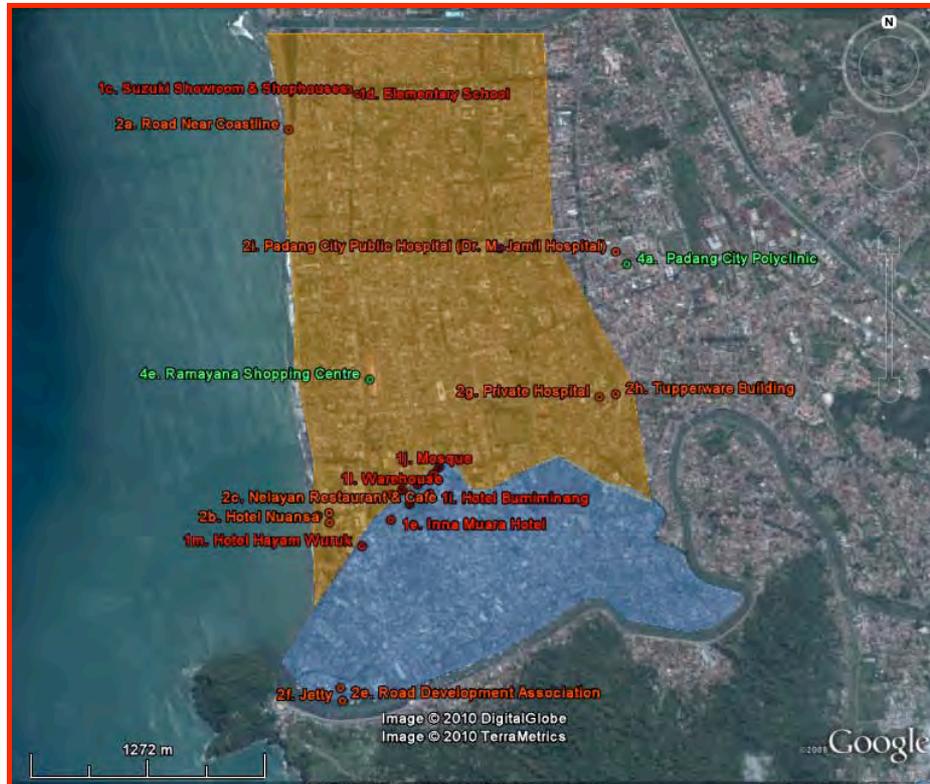
China Town. The region shaded in blue in Figure 24 is the China Town in Padang. The construction in this region was particularly poor and many small buildings were badly damaged. This is the main market for Padang and food supplies were disrupted due to a high proportion of the buildings failing. The building typology often consisted of

unreinforced masonry (without reinforced concrete frames). The major failure mode of these buildings was collapse of external walls. In the case of buildings that did have reinforced concrete frames, the columns were often 150mm x 150mm. These generally fared better; however the columns were often insufficient.

Figure 24. The China Town (shaded in blue) and Central Region (shaded in yellow) in the city of Padang.

Central region. The majority of buildings in this region (shaded in yellow in Figure 24) were greater than two storeys and were reinforced concrete frames with masonry infill. The performance of the buildings was very variable, with damage ranging from minor cracking of masonry infill to total collapse. The majority of buildings suffered at least significant cracking in the masonry infill panels. Few structures had either no cracking or minor cracking. The masonry infill was often observed to have fallen out of the frame. The majority of failures in the structural system of the buildings were the development of plastic hinges in the tops and bottoms of the columns (soft storey failure) as shown in Figure 25. Minor crushing of concrete was often observed in the tops of the columns often without signs of distress in the bottom of the columns. Strong beam- weak column designs were also observed in various commercial buildings, as well as hospitals. According to the University of Bung Hatta engineers, the principle of strong column and weak beam has yet to be fully adopted by designers in the region. Partial or total collapse of engineered structures was evident in many locations. Often these were government buildings.

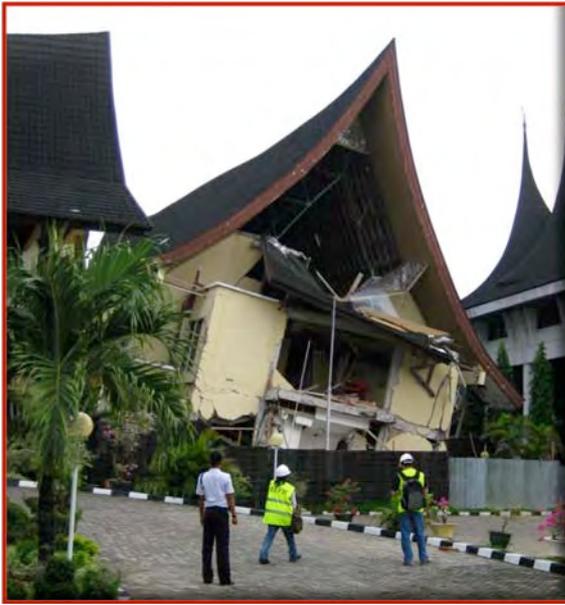
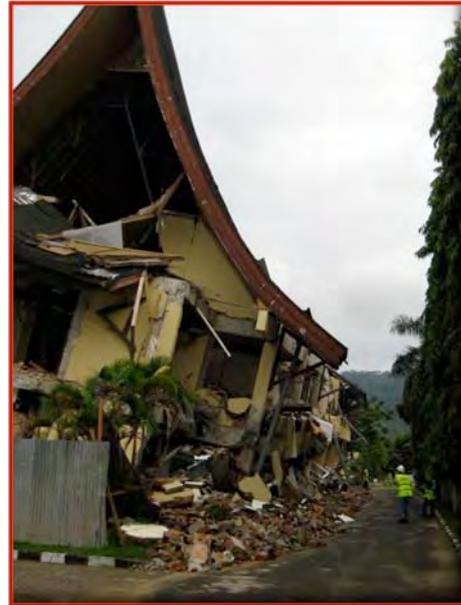
Figure 27. Soft-storey failure of the Inna Maura Hotel.

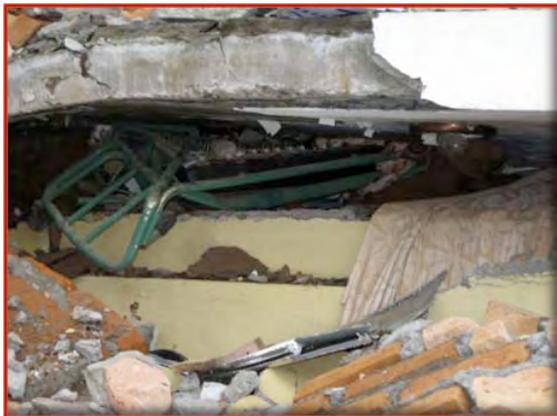
Hotels. There were many multi-story hotels in Padang, with a high variability of damage ranging from complete structural collapse to only secondary elements damaged. Most of the hotels were constructed within the last 30 years. Shear cracking and failure of the masonry infill was also typical in the damaged hotel buildings, similar to the damage noted in the smaller commercial buildings. Soft-storey failures were common, as seen in Hotel Hayam Wuruk, a small hotel in central Padang, a beach hotel, and the Inna Maura Hotel, a high-class hotel in central Padang (Figure 26 and Figure 27). The failure of the Inna Maura hotel was unique, as the majority of the hotel had only minor structural damage, but one wing suffered extreme damage. A lack of transverse reinforcement at the beam-column joints was observed (Figure 28)

Figure 28. Evidence of soft-storey failure, light-fixture and chair at ground level (left) and lack of transverse reinforcement in beam-column connection (right).

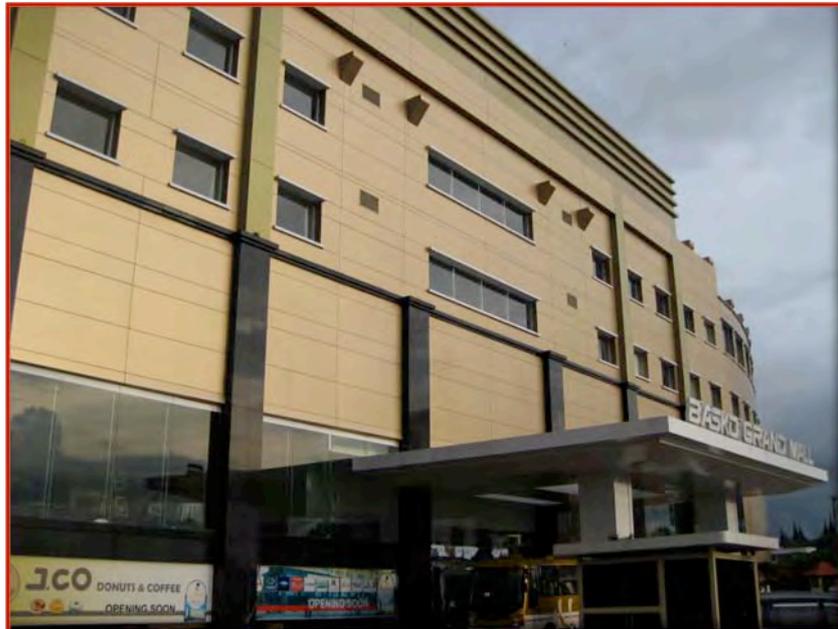
The Basko Grand Shopping Centre had no noticeable structural damage from the exterior, and it is also a very recent construction (Figure 32). However, similar to the Basko Grand Hotel next door, the shopping centre was closed immediately after the earthquake.

Figure 32. Shopping centre with little to no structural damage.

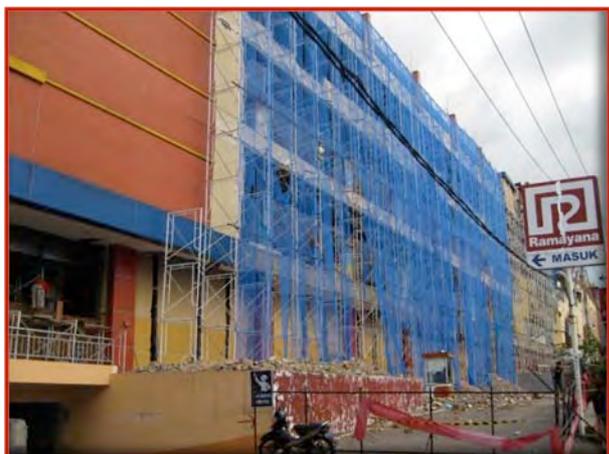
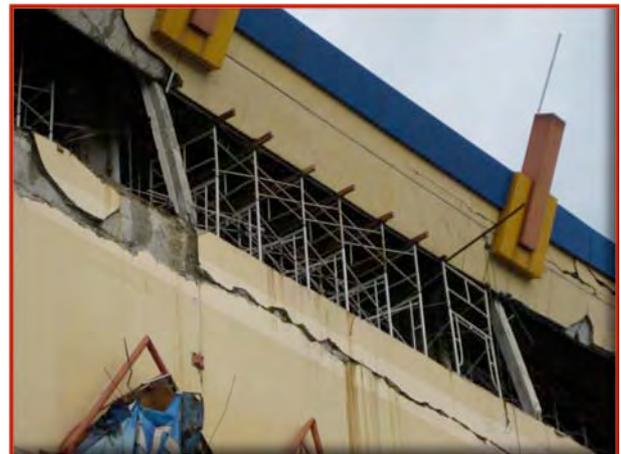
The Ramayana shopping centre was a large four-storey structure. Damage caused by fire was noticeable along a section near the roof, and construction workers were beginning the reconstruction of the masonry walls. It appeared that the masonry infill walls had completely failed, although the primary reinforced concrete columns were robust and suffered no obvious damage. Narrow columns supporting the roof cantilever failed.

Figure 33. Ramayana Shopping Centre (left) and roof column failures (right).

Different construction techniques were being implemented for the reconstruction of the masonry infill. The concrete confining columns were placed more frequently, likely in an attempt to provide additional support for the masonry walls. See Figure 33 and Figure 34.

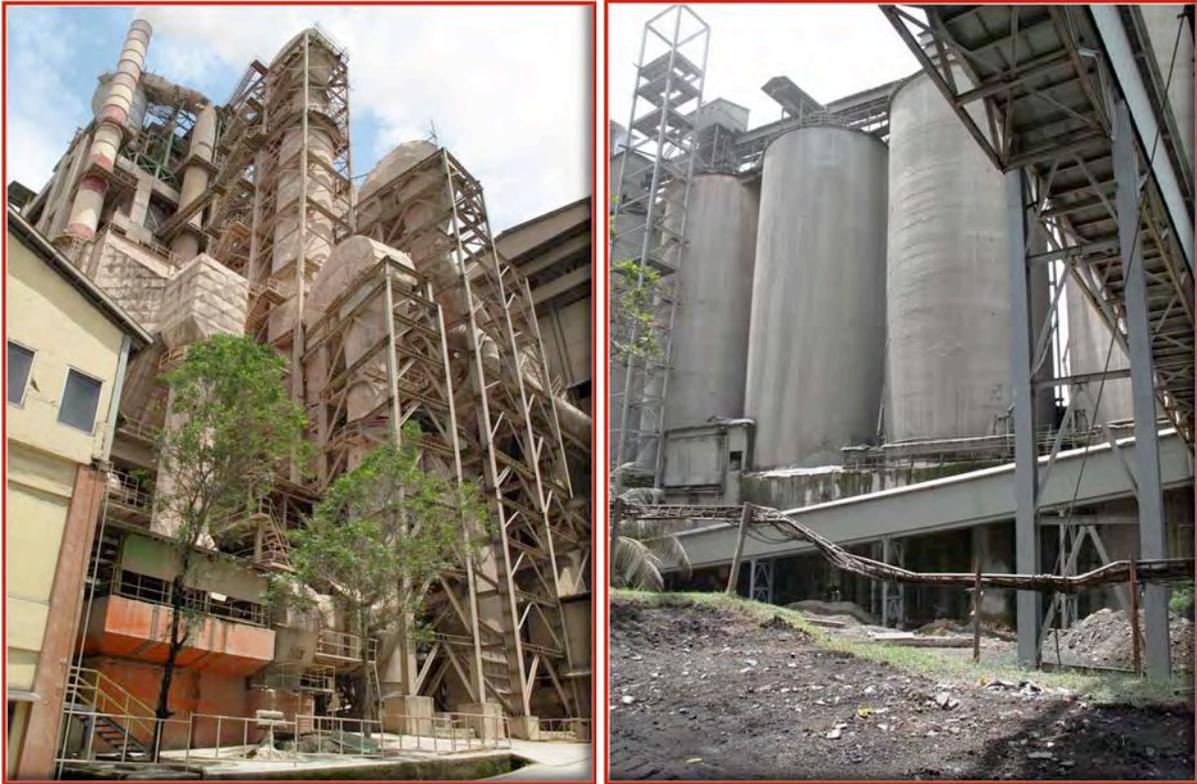
The EEFIT team visited the local cement plant (Figure 38) that, according to its managing director, provides 90% of the cement to the province of Western Sumatra and about 50% to all of Sumatra. They also export cement to Malaysia and Singapore. It is the oldest cement factory in Indonesia (founded in 1910) and directly employs about 2,000 people plus a significant number of people indirectly.

Figure 38. Two areas of the production line of the cement factory (from a total of five lines of production). No structural problems were observed during the visit.

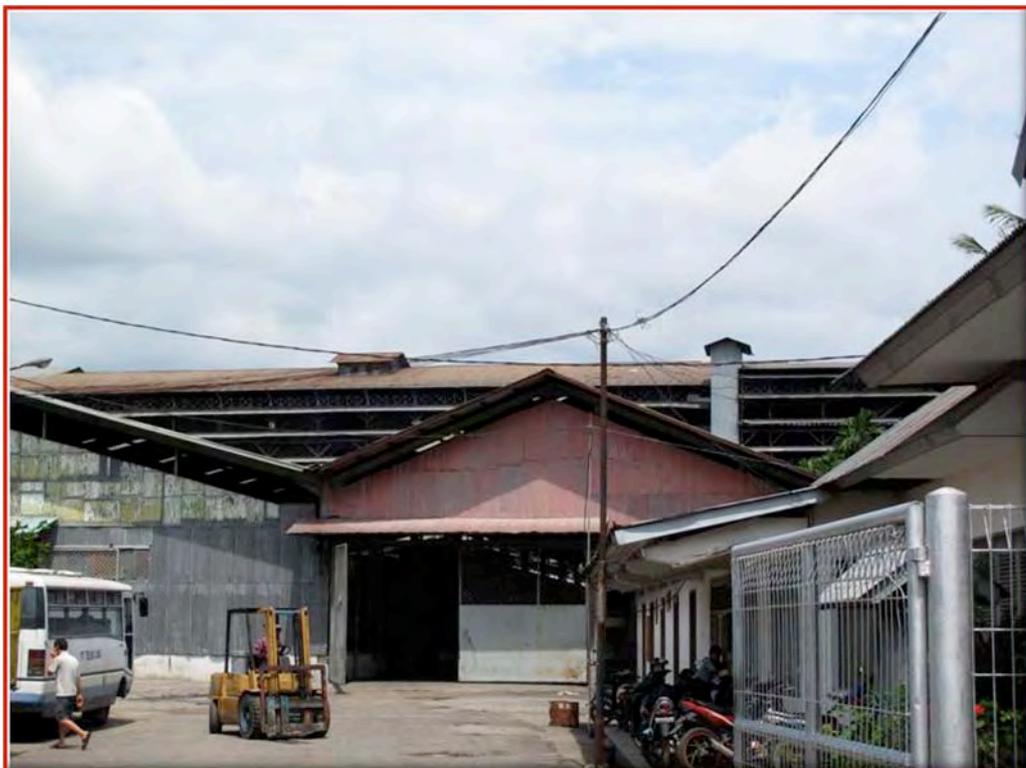
A second industry visited during the survey was a rubber plant that exports materials to some neighbouring countries and the United Arab Emirates (Figure 40). The plant was constructed around 1982 and is a reinforced concrete and steel structure. The plant halted production for ten days because of damage to the reservoir that filters out the poisonous by-product of rubber production (Figure 41). After the tank was repaired, they resumed the rubber production.

Figure 40. Rubber plant in Padang.

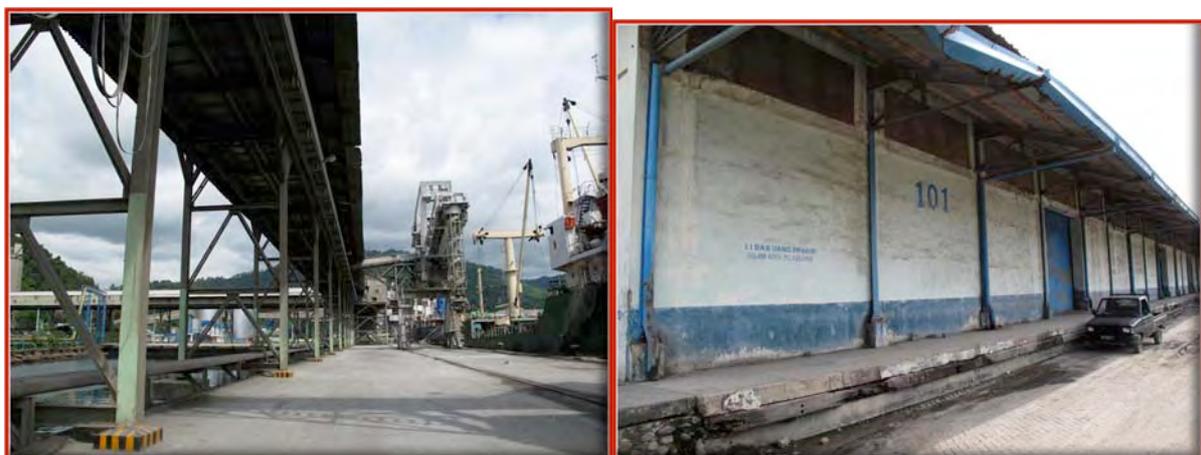
No structural problems were observed in any of the port elements (Figure 42), including a light steel structure and the warehouse made of reinforced concrete moment resisting frames with infill walls. The exception was the collapse of a crane whose principal function was the uploading of cement from the plant (all elements have been removed at the time of the visit, thus no pictures were taken), and the settlement of about 60mm of the access to the dock structure (Figure 43).

Figure 42. No structural damage was observed in any of the port facilities. Left: light steel structure. Right: warehouse of RC moment resistant frames with infill walls.

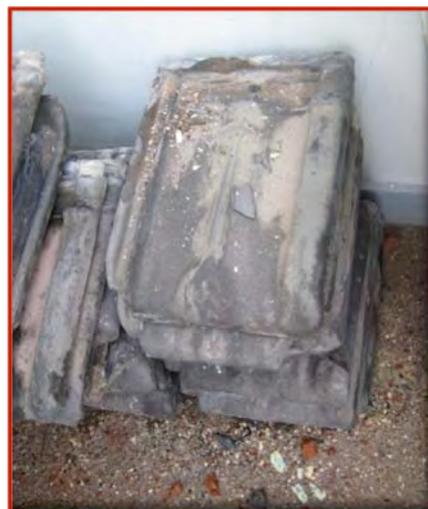
The Yayasan Payoga SD Agnes elementary school, a private school in Padang, was also surveyed. In contrast to the SDN 24 Ujung Gurun elementary school, the masonry walls in this building were well confined and the walls suffered only shear cracking. The school did suffer a roof collapse however, possibly caused by the heavy roof tiles (Figure 47).

Figure 47. Heavy clay roof tiles from the Yayasan Payoga SD Agnes school.

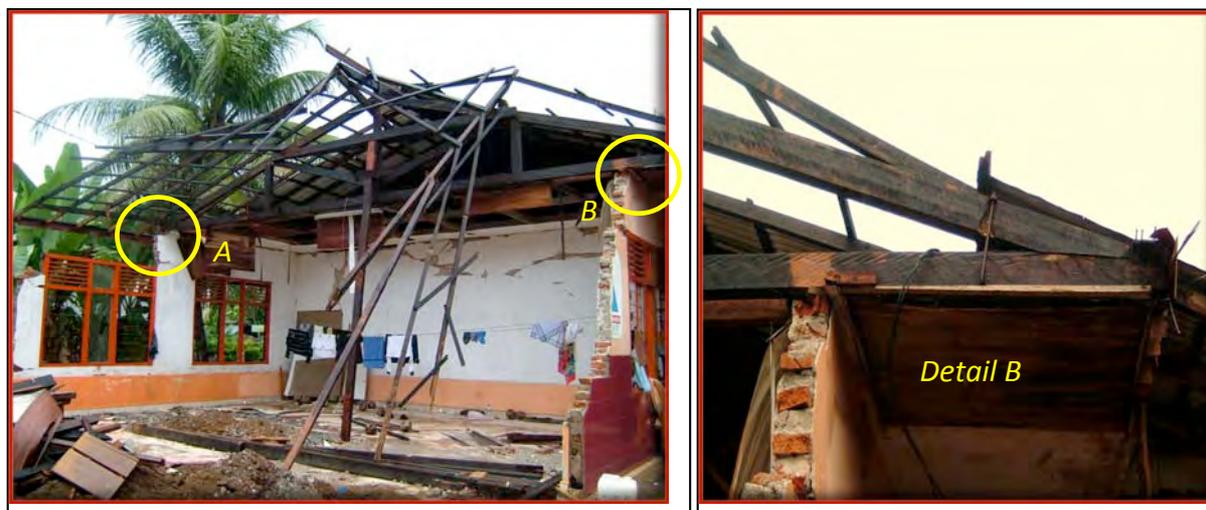
The SDN 01 Lima Kota Timur elementary school, a government school in Pariaman, had a similar structural typology to the Padang schools, without reinforced concrete corner columns. The unconfined masonry walls seemed insufficiently joined, and it appeared that the roof and walls collapsed. There was no anchorage found at the connection between the bearing wall and the roof truss structure, indicating that the roof construction was not appropriately supported in the horizontal direction (Figure 48). As a result the lateral force of the earthquake likely caused the roof construction to displace and fail.

Reconstruction on this school building had already begun, and the replacement bricks were either bricks salvaged from the earthquake, or new bricks of the same exceptionally poor quality (the bricks could be easily crumbled by hand). The local residents showed the team the temporary, timber school building further down the road (

Figure 48. SDN 01 Lima Koto Timur, an elementary school in Padang Pariaman County.

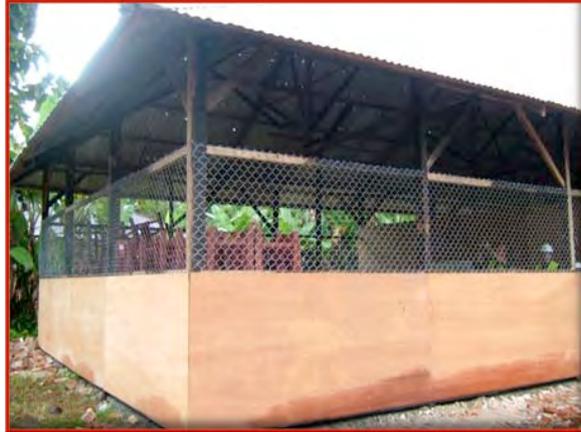
Figure 49. SDN 01 Lima Koto Timur temporary school buildings.

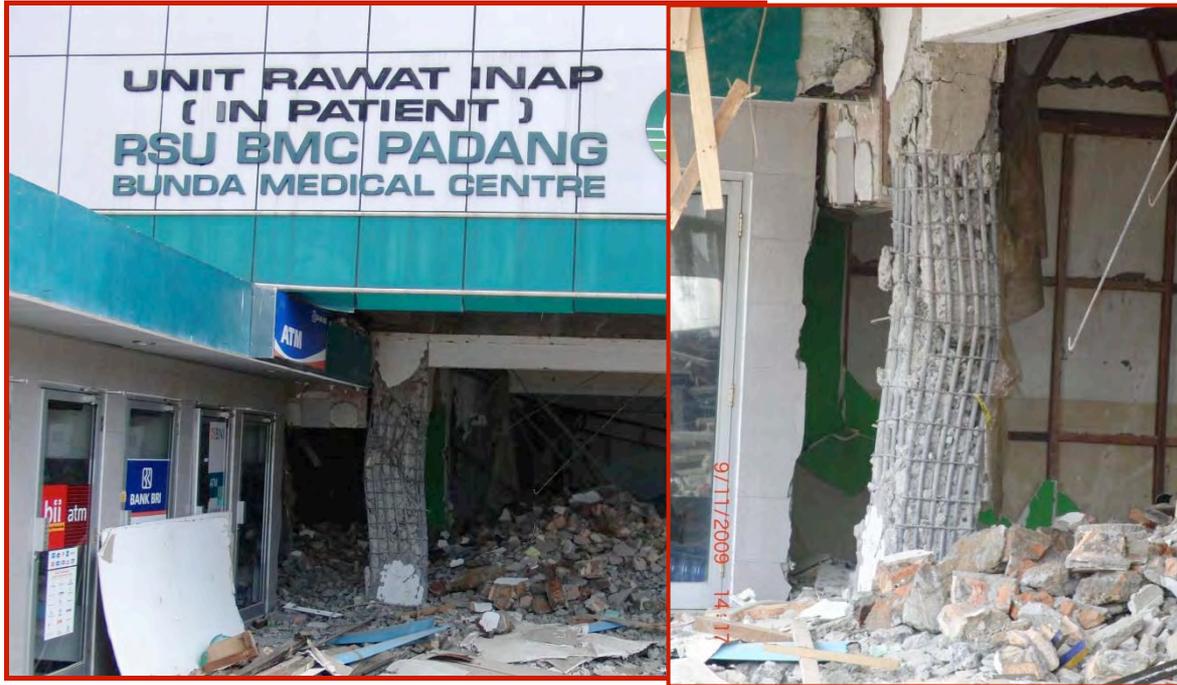
The Bunda Medical Centre had suffered serious damage, with major structural failures in many columns (Figure 50) as well as extensive damage to masonry infill panels and windows (Figure 51). The failed columns were constructed of round smooth bars, with 8mm* smooth confining reinforcement at approximately 150 centres (*lack of access prevented accurate assessment). At the time of the survey the hospital was out of action and repair had started.

Figure 50. Bunda Medical Centre.

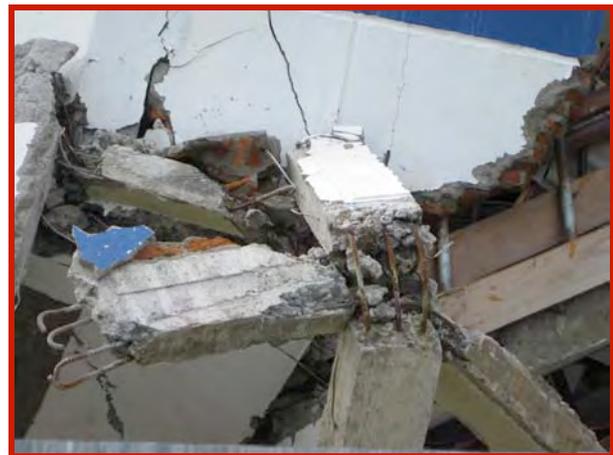
b) failed Connection detail in Polyclinic

Figure 52. Dr. M. Djamil General Hospital Polyclinic

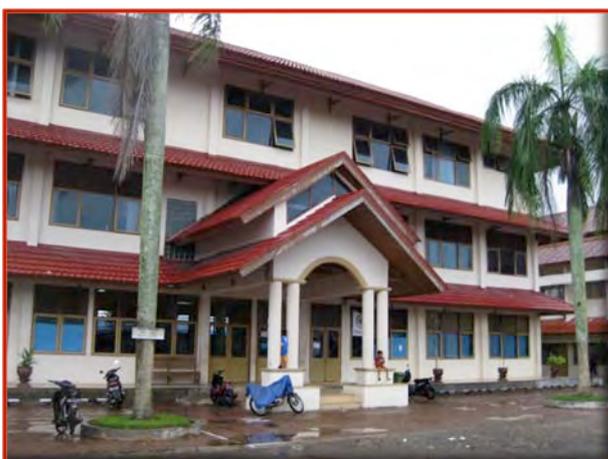
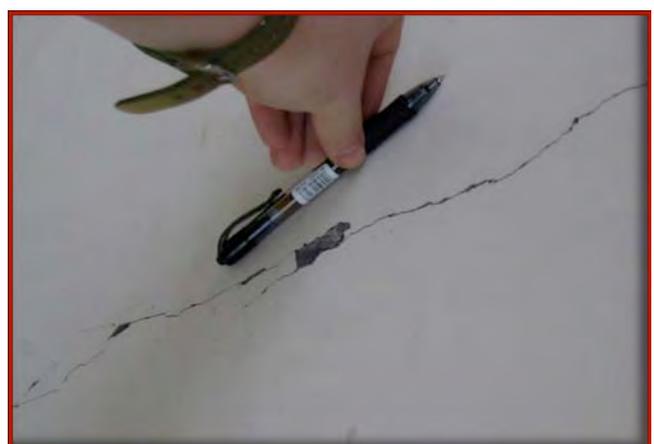
The hospital in Pariaman, although much closer to the fault, sustained virtually no damage. The only visible damage was minor cracking to non-structural masonry. The hospital and cracking on the masonry walls can be seen in Figure 53

Figure 53 Pariaman Hospital

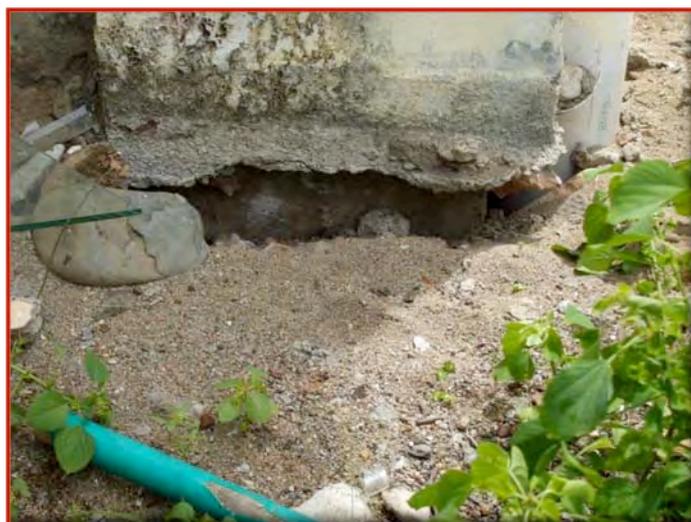
The foundations, however, may have been located on stiffer soil, which therefore resulted in minimal structural damage. Figure 59 illustrates the settlement of the surrounding soil of approximately 100mm relative to the pile foundation. Coarse sand deposits were found in this area as shown in Figure 60.

Figure 59. Settlement of soil around a column of a university building.

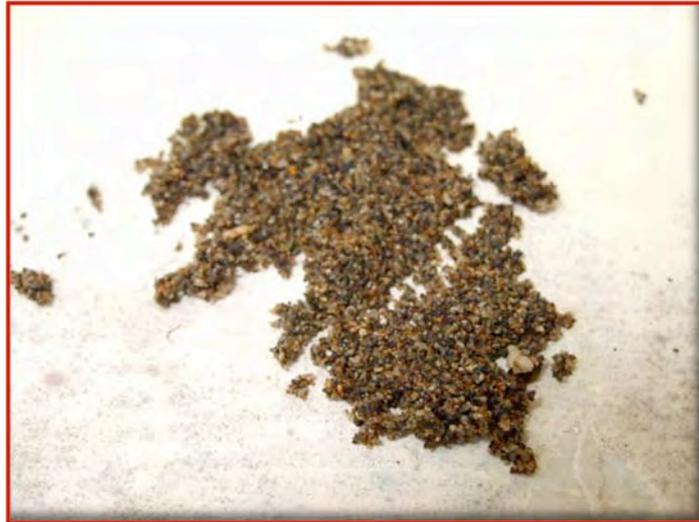
Figure 60. Coarse sand grains found within the proximity of the university building.

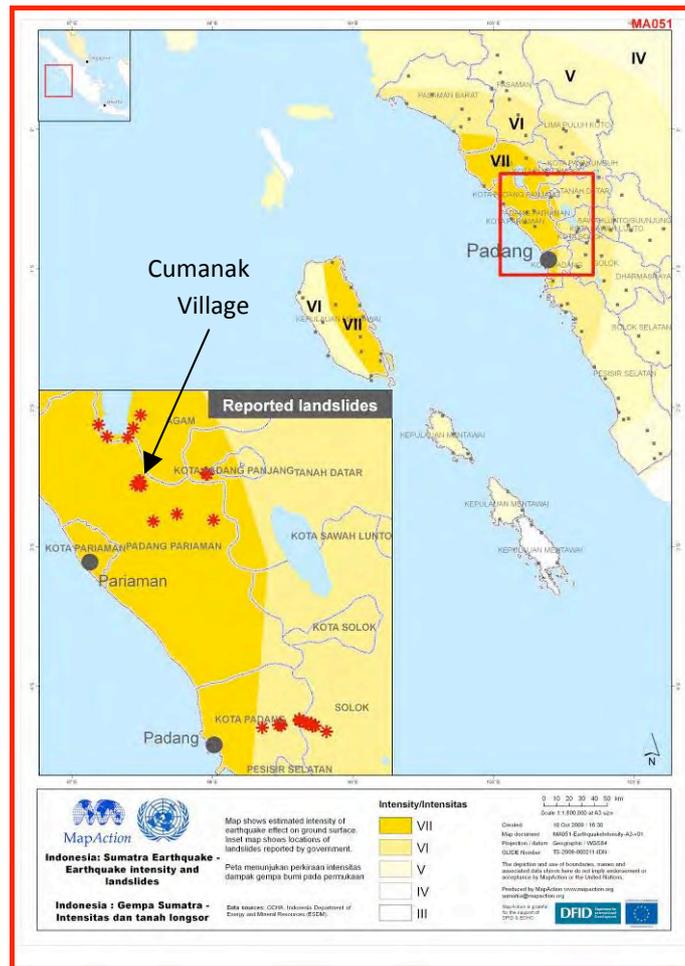
The majority of rural communities living in West Sumatra are situated in agriculturally-intensive villages near the foot of volcanoes. The reason for locating villages in these regions is due to the fertility of the land. The close proximity to steep slopes consisting of weak, weathered pumice makes them particularly susceptible to landslides. ReliefWeb (2009) reported over 1000 landslides triggered by the earthquake. These landslides were particularly clustered in the Gunung Tigo highlands between the districts of Padang Pariaman and Agam districts in the Pariaman region as well as in Kota Padang and Solok districts in the Padang region as indicated in Figure 62. Despite the lower population and population density in these mountainous regions as compared to the urban city area, there was a high number of casualties (about 1/3 of the total fatalities due to the earthquake). This high number of fatalities could be partly attributed to a large number of villagers attending a wedding ceremony in Cumanak Village (see location in Figure 62), where a major landslide occurred, but mainly due to the very lethal nature of the landslides.

Figure 62. Earthquake intensity and landslides.

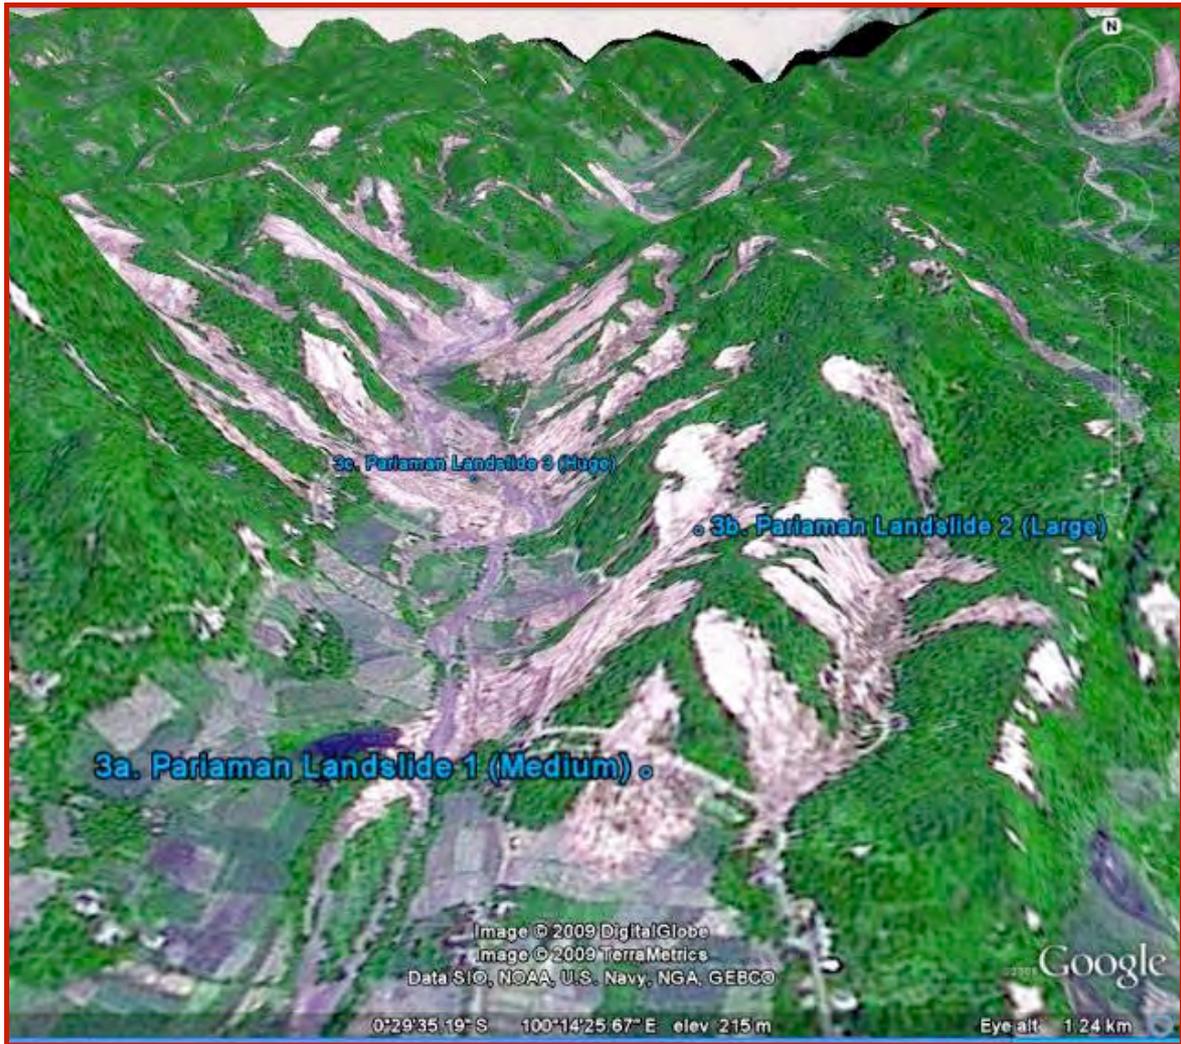
Many of the surviving local residents lost most of their family members. Figure 63 shows the three landslide sites visited in the worst-affected district of Nagari Tandikek in Pariaman. Two villages, Pulau Air and Cumanak were virtually destroyed by these landslides.

Figure 63. Relative locations and topography of three landslide sites visited during the survey, superimposed on Google Earth with NUS CRISPS overlay.

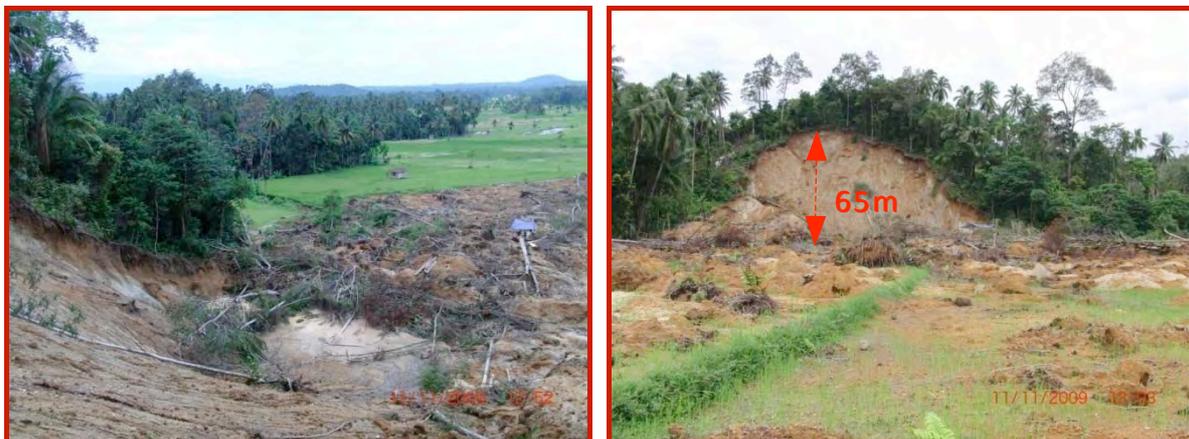
The estimated landslide velocity was 49 m/s following Slingerland and Voight (1979). As the landslide resembles the quarter ellipsoid-shaped mass with its maximum width coinciding with its toe, the landslide volume was approximated to be 10,210 m³ based on the formula by Cruden and Varnes (1996). Figure 64 shows the photos of the landslide taken near the summit and the runoff toe.

Figure 64. Views of Landslide Site 1 near the summit (left) and the runoff toe (right).

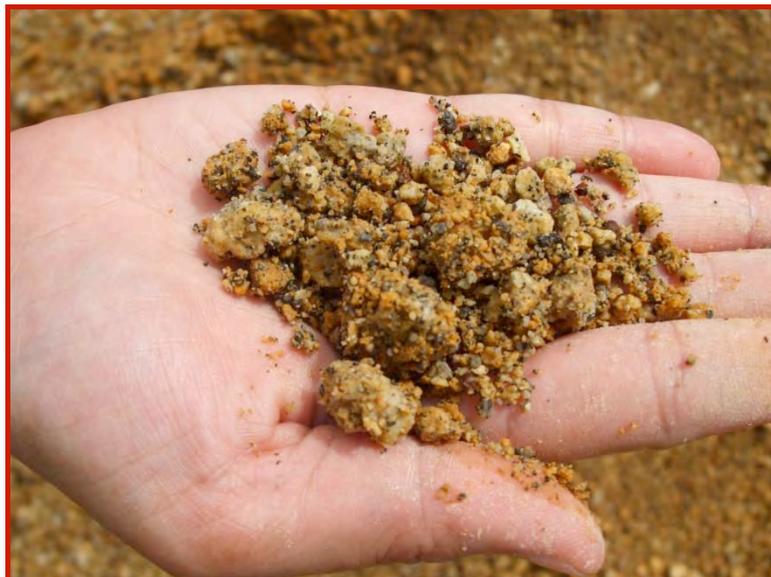
destroyed Kapalo Koto elementary school were the only remains in the site as shown in Figure 65. The soil collected from the surface of the landslide debris was mainly coarse weathered pumice as illustrated in Figure 66. Such lightweight and porous material typically originates from volcanic rocks which underwent rapid cooling and depressurization when they were violently ejected from a volcano. The height of scarp and distance of runoff were about 100 m and 750 m respectively. The estimated landslide velocity was 88 m/s based on the formula by Slingerland and Voight (1979). Table 8 indicates the characteristics of the landslide as measured by a GPS survey.

Figure 66. Weathered pumice collected from the landslide debris.

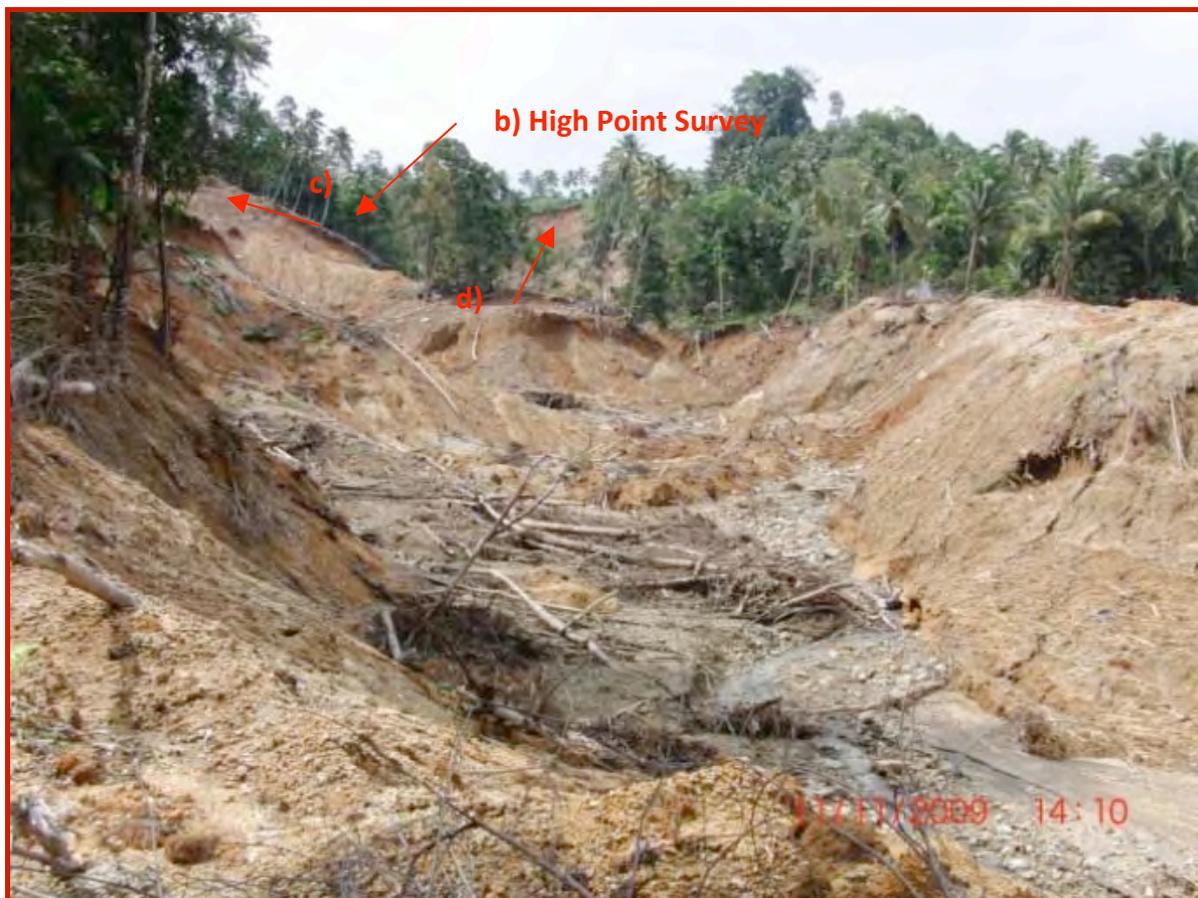
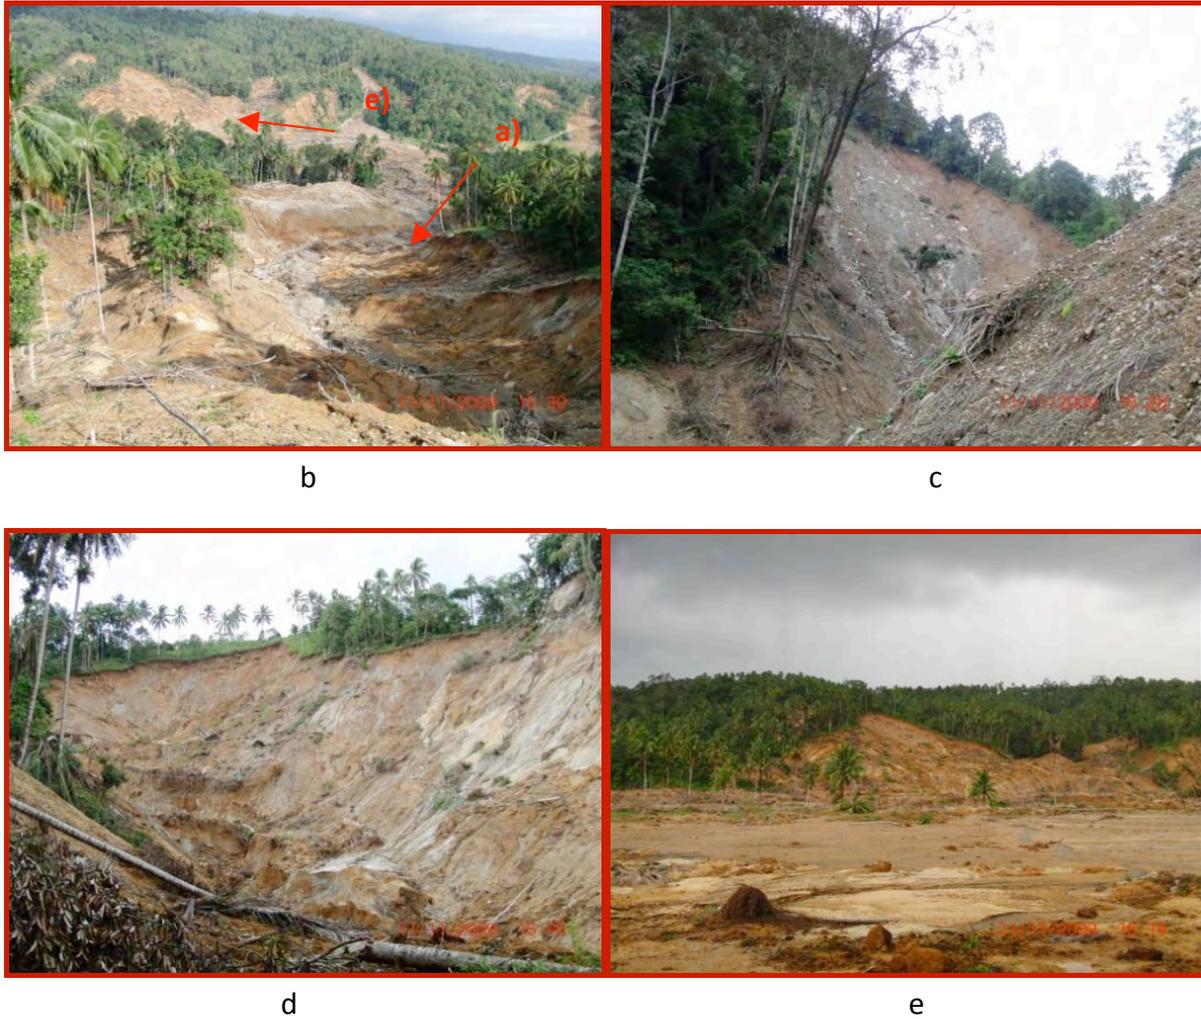
The third landslide visited was the largest site reported with the most number of casualties. The EEFIT team travelled to the site at Cumanak Village by foot. Figure 67 shows elevated views on a section of the landslide site where the village was sited.

- a) View looking up the valley with the high point of the survey indicated as well as locations for photos (c) and (d)
- b) High point of the survey, looking down the valley with the locations for photo (a) and (e)
- c) View looking up the valley from the high point of the survey as indicated in Figure (a)
- d) View looking up the valley from the high point of the survey as indicated in Figure (a)
- e) View looking at landslide adjacent to the surveyed landslide. Photo taken looking approximately as shown in Figure (b)

Figure 67. Various views of Cumanak Village landslides.
