THE PADANG, SUMATRA - INDONESIA EARTHQUAKE OF 30 SEPTEMBER 2009

A FIELD REPORT BY EEFIT

Earthquake Engineering Field Investigation Team
Institution of Structural Engineers
11 Upper Belgrave Street
London SW1X 8BH
Tel 0207235 4535
Fax 0207235 4294
Email: mail@eefit.org.uk
December 2009

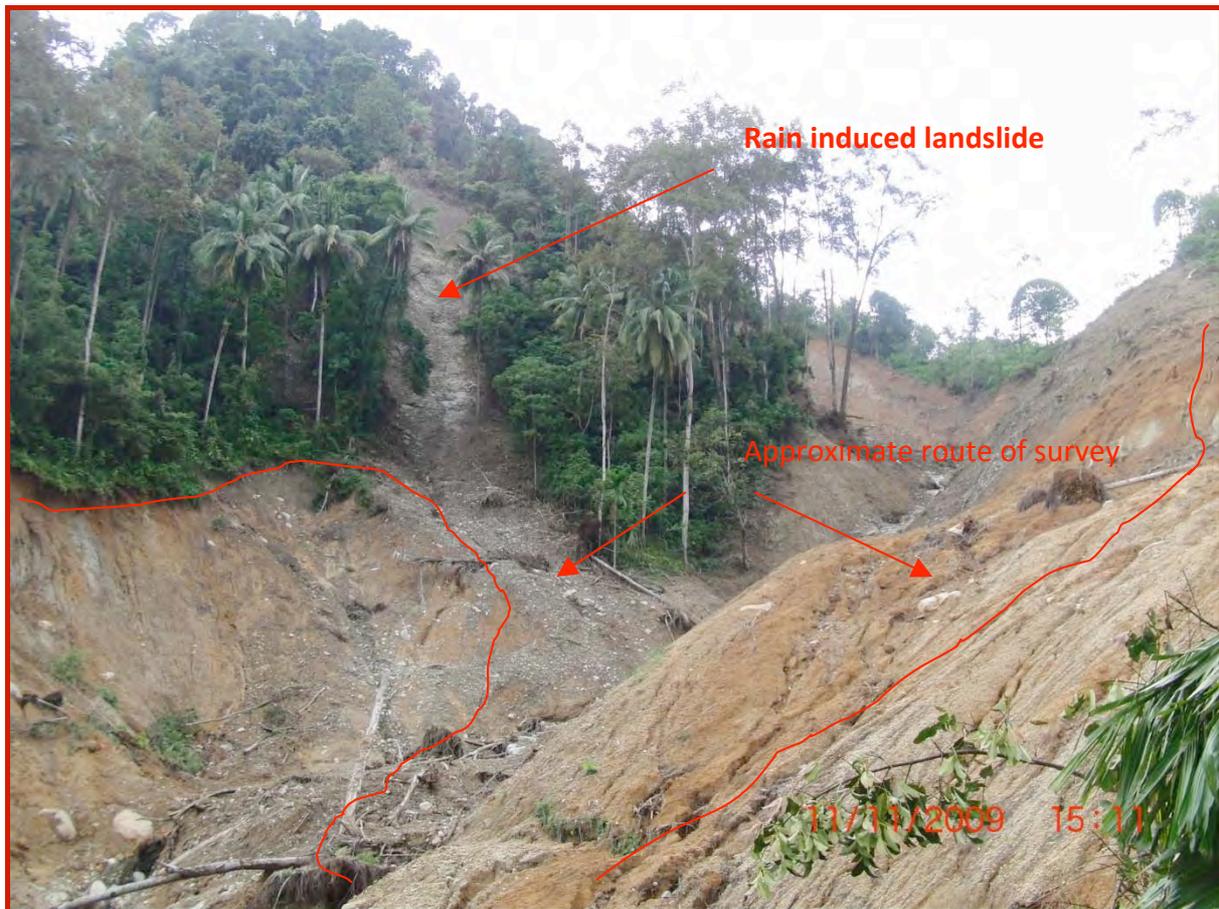
Residents reported that a number of relatively large landslides had occurred since the earthquake. Residents indicated the location of one of these landslides and this is shown in Figure 68 . At the time of the survey the wet season was in progress and there had been the usual high rainfalls. Locals reported that there had not been a great deal of rain in the weeks preceding the earthquake, although there had been heavy rain the night before and during the day of the earthquake. Rock samples taken from the site, were later identified as

pumice and ranged in size from gravel to fist size rock, with the vast majority being less than 10mm in size.

Figure 68. Rain induced landslide.

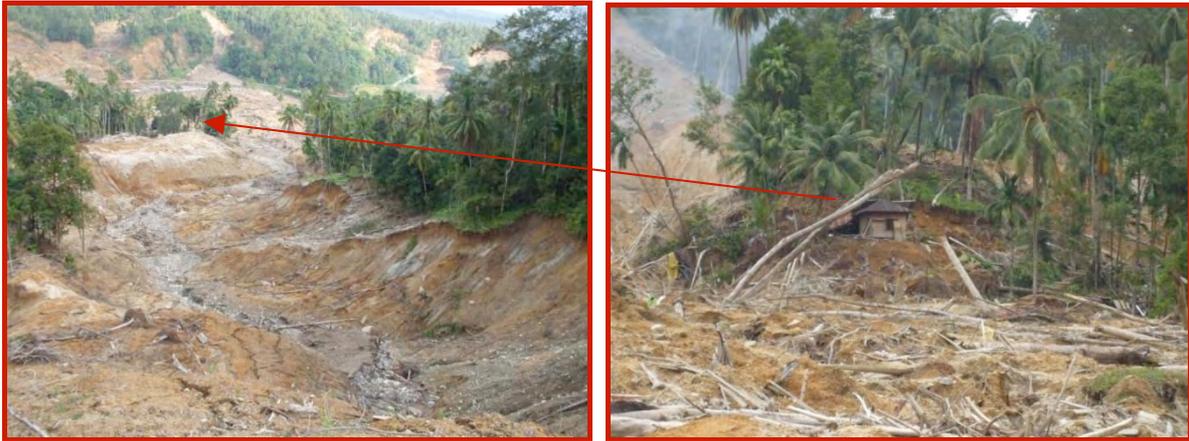
The locals were actively removing debris from their homes for reuse and rebuilding. Only a handful of small houses survived the landslide. Two houses were positioned just outside the landslide's path, while a small timber house (shown in Figure 69) directly in the landslide path also survived. Local residents said that the soil "flew over the top" of the house. The house did not move and its inhabitant survived the landslide. The trees behind the house may have protected it from the majority of the landslide impact. Apart from the pedestrian suspension bridge and handful of houses, no other surviving structures were visible in this area. Local residents said that earthquakes have been particularly frequent in Cumanak, and they noted that the village was located between two volcanoes, Singgalang, an active volcano northwest of the village, and Tandikek, a dormant volcano northeast of the village.

Figure 69. The extend of the landslide taken from the high point of the survey (left), and showing the location one of the few houses which survived the landslide (right).

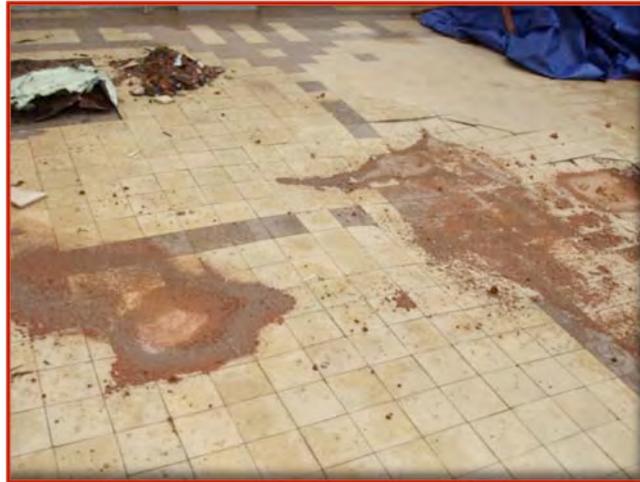
Landwards into the Padang city core, the Mere Amelie Church suffered effects of liquefaction as well. Sand boils were observed in the school beside the church (Yayasan Prayoga SD Agnes school) as shown in Figure 72. This can be substantiated given that these sand boils were predominantly silty sand which came from the soil depths beneath the topsoil. Teaching staffs in Universitas Negeri Padang, a university near the coast and occupants of shophouses also reported seeing fluidised sand seeping through their cracked floor slabs in their compounds. However, these sand boils were cleared up soon after the earthquake to resume lessons and businesses respectively.

Figure 72. Sand boils in adjoining building of Mere Amelie Church.

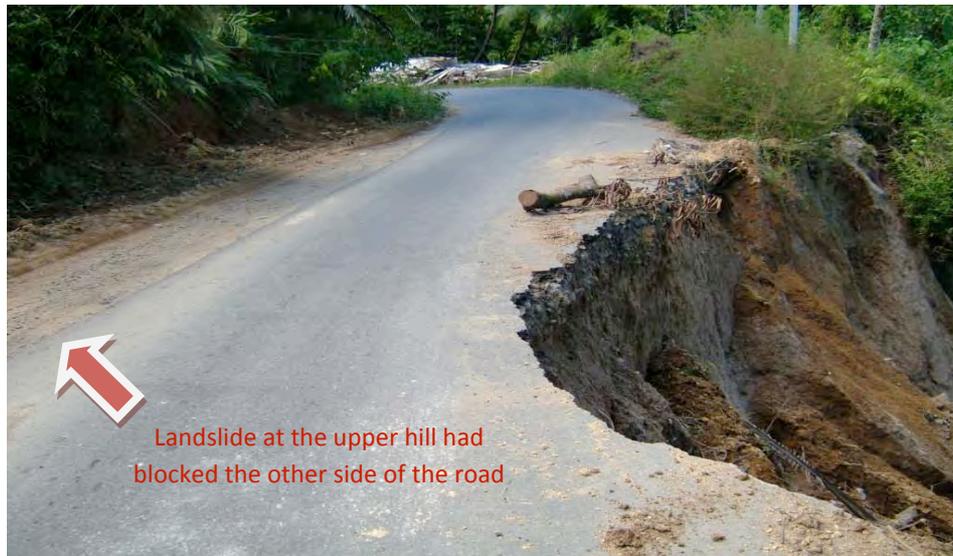
activity and to support survivors (OCHA, 2009). It was also reported that soon after the earthquake, evacuation was mainly focussed in Padang. This resulted in most of the affected remote areas not receiving any aid for days because their situation had not been identified, and several affected areas could not be reached due to blocked roads caused by landslides and major road damage, see Figure 75.

Figure 75. Blocked road in V Koto Timur District, Padang Pariaman County-West Sumatra.
