THE VRANCEA, ROMANIA
EARTHQUAKES OF 30-31 MAY 1990

A FIELD REPORT BY E.E.F.I.T.

November 1990

EEFIT
Earthquake Engineering Field Investigation Team
Institution of Structural Engineers
11, Upper Belgrave Street
London SW1X 8BH, U.K.

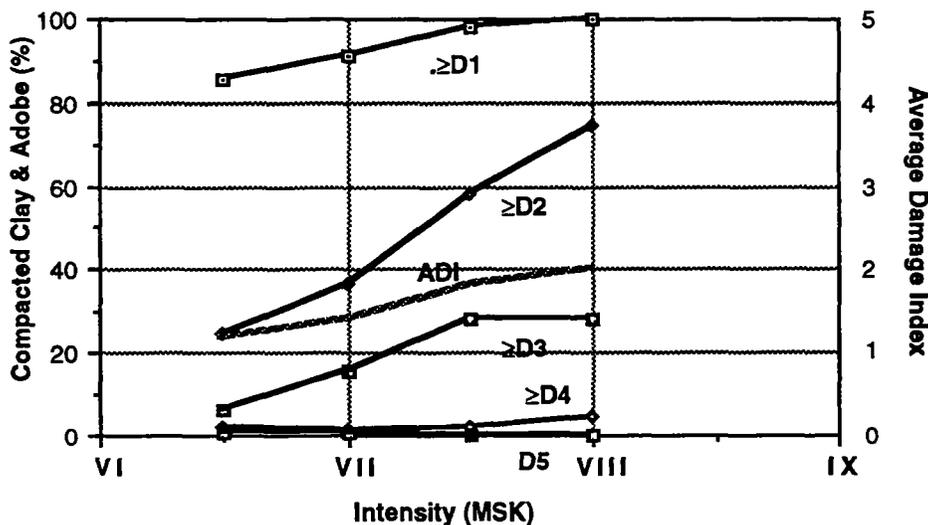
Figure 8 shows the results of an extensive damage survey in Bucharest after the 1977 earthquake. The degrees of damage were assigned according to the MSK scale specifications but also a degree of engineering judgement was involved. Appendix B, summarises the definitions for damage degree assignment for masonry and RC buildings. The representation is in cumulative form (left hand axis). ADI is the *average damage index* (degree) at each intensity (right hand axis). The sample comprises 5984 buildings of adobe, compacted clay and timber frame infilled with clay or mud, mostly built before 1900. In the 1990 earthquakes the damage to this type of buildings in Bucharest was much smaller.

Figure 8: The vulnerability of low-rise compacted clay and adobe buildings (Bucharest, 1977 earthq.).

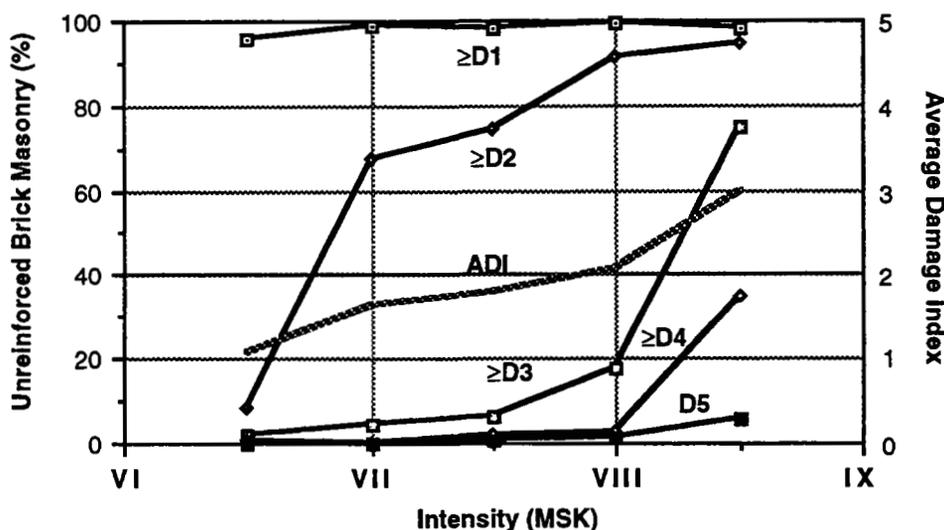
Figure 9: The vulnerability of low-rise unreinforced brick masonry buildings as revealed after a damage survey in Bucharest in 1977.

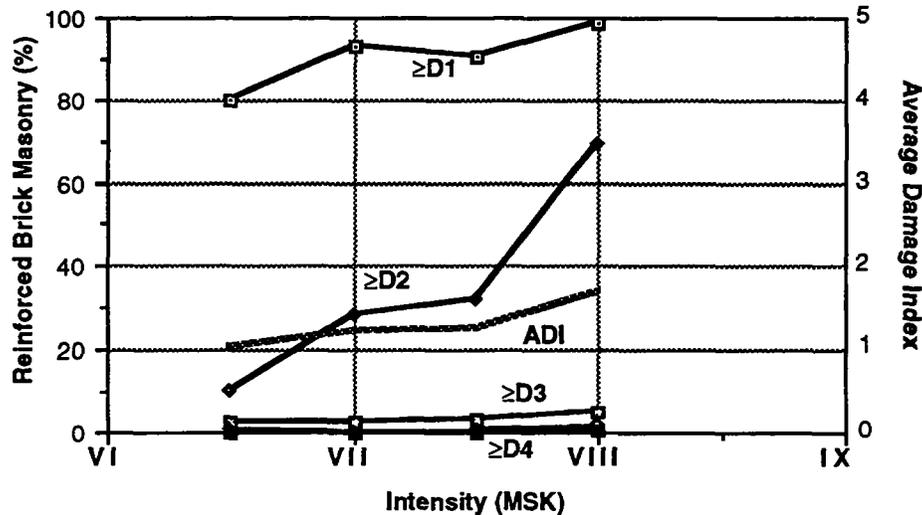
Figure 10 shows the vulnerability of pre-1940 reinforced brick masonry houses in a similar manner to Figure 8 and 9. The main difference from Figure 9 is that the buildings of Figure 10 have as horizontal structure cast-in-situ RC slab with embedded ring beams and sometimes RC lintels. The effect of this improvement in construction practice is readily observed, despite the fact that the latter tend to have a more asymmetric layout and larger proportion of openings. At intensity VIII the proportion of $\geq D4$ was only 0.95%, as opposed to 2.5% of the unreinforced brick masonry and 4.4% of the adobe type of buildings.

Figure 10: The vulnerability of low-rise reinforced brick masonry buildings, built before 1940 (Bucharest, 1977 earthquake).

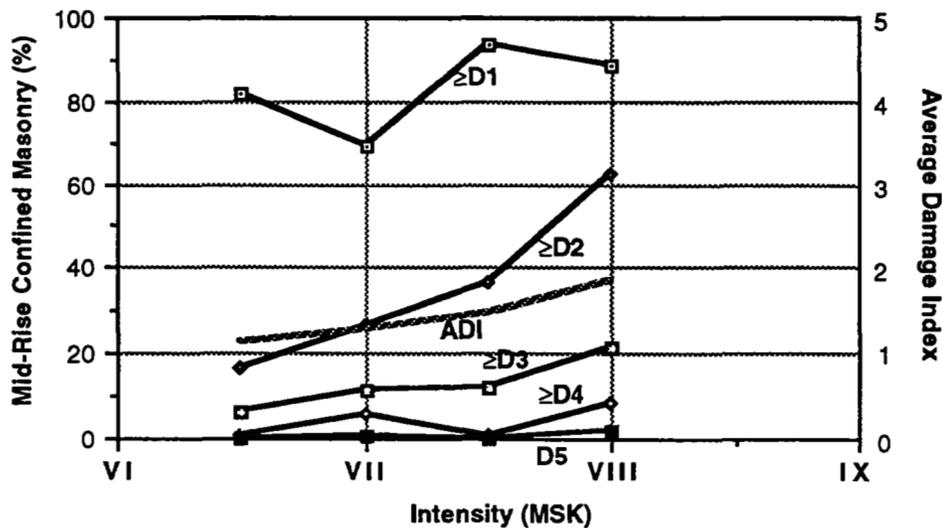
Again the average damage index is similar to that of previous figures. However the distribution of the 5 damage degrees differs from the other construction types with significantly worse life threatening behaviour for the mid-rise confined brick masonry construction. The average damage index should thus be used with care in hazard assessment.

Figure 11: The vulnerability of mid-rise confined brick masonry buildings (Bucharest, 1977).

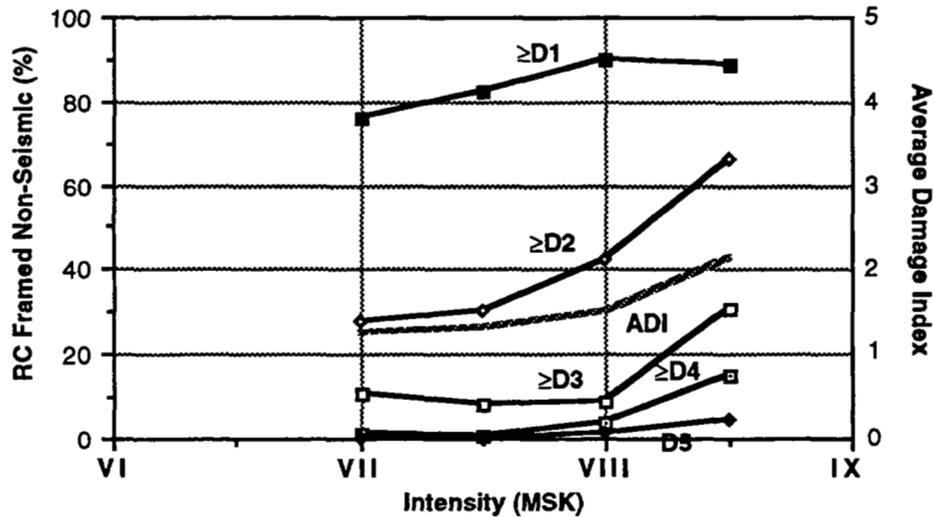
Figure 13 shows the results of the 1977 damage survey. The total number of surveyed buildings was 683 and a total of 30 buildings had damage $\geq D4$ (4.4%) causing a significant proportion of the 1570 deaths during that event. Most of them were in central Bucharest where the intensity reached VIII+. For comparison we can see in Figure 10 that the proportion of $\geq D4$ in low-rise unreinforced brick masonry buildings in the same zone reached 34.4%. At intensity VIII the proportion of $\geq D4$ drops to 3.5%, which is better than the post-1950 confined masonry apartment buildings but worse than the low-rise brick masonry buildings (both unreinforced and reinforced).

Figure 13: The vulnerability of the old RC framed apartment buildings (Bucharest, 1977 earthquake).

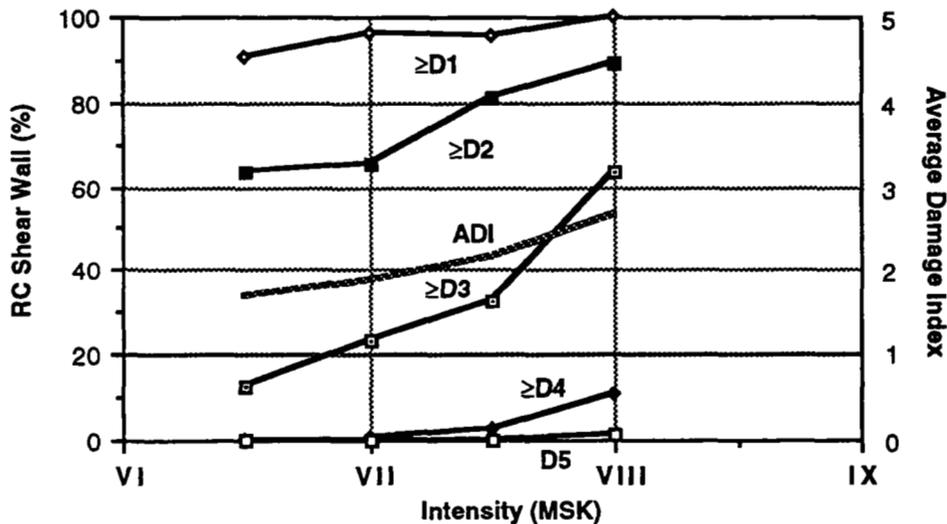
damage. The cast-in-situ shear walls apparently suffered more than the prefabricated ones. This is because of the inferior quality of concrete used on site, and the less effective reinforcement of the shear walls. Figure 14, shows the result of the 1977 damage survey. The sample size is 613 buildings. Despite the improvement by introducing shear walls, at intensity VIII a proportion of 11% suffered damage $\geq D4$ (from which 1.2% was D5). This is much worse than the non-seismic RC framed buildings built in the 1930-1950 period ($\geq D4$ is only 3.5% at intensity VIII). There were no RC shear wall buildings in the central zone of Bucharest that was assigned intensity VIII+. This unusually high degree of damage can be attributed to a combination of factors such as: most of the destroyed buildings had a soft ground storey, the location of the 11 storey buildings was in unfavourable ground conditions, many of the older shear walls were not properly reinforced. Nevertheless the proportion of 11% is very high and more attention should be paid in order to improve the performance of these buildings in future earthquakes.

Figure 14: The vulnerability of multi-storey RC shear wall apartment buildings (Bucharest, 1977 earthquake).

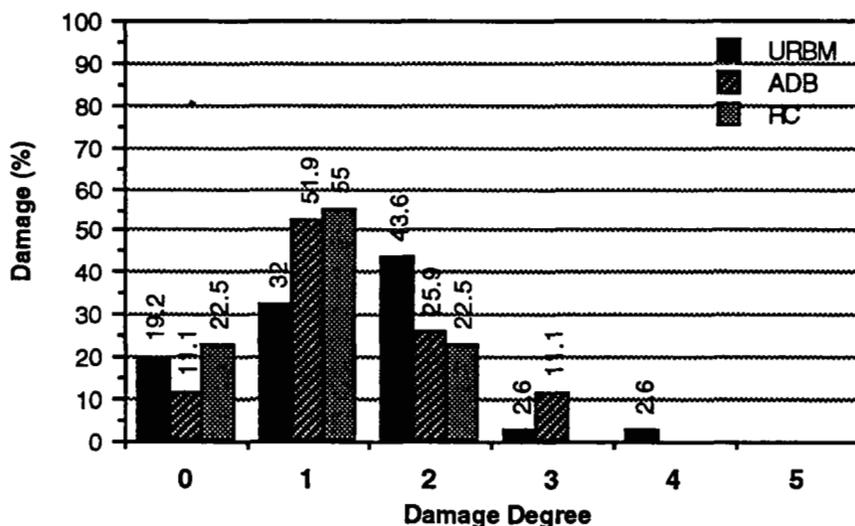
The average damage of brick masonry buildings was similar to that of the adobe buildings. This is mainly due to the non-symmetrical layout effects on the brick buildings. The brick buildings were of much better quality from architectural and structural points of view (Plate 23). However their complex layout (large entrance porches, large openings, higher storey height, verandas etc.) had a negative effect in comparison to the humble adobe-clay type of buildings that have a very simple layout in plan with small openings and lower storey height. Nevertheless, if the motion was more severe the average damage degree of the latter would surely be higher (as seems to be suggested by Figures 8 and 9). This damage distribution is equivalent to MSK intensity VII or slightly smaller.

Figure 16: Damage degree histograms of the three main building types in the survey of Buzau (URBM = Unreinforced Brick Masonry; ADB = Adobe-Clay; RC = RC framed and RC shear wall).

If PGA - I_{MSK} relationships were to be used, the expected intensity would be VIII. This is a strong indication that in the case of intermediate depth earthquakes, PGA is not a good ground motion parameter for vulnerability analysis. In Table 8, the survey results around strong ground motion instruments that recorded peak acceleration around 25%g in four different earthquakes are summarised. We notice that Buzau has the lowest damage of all. **MRSA is the mean spectral acceleration at 5% damping between the two horizontal components and at the period range of 0.1 to 0.3 seconds, typical for low-rise masonry buildings.**

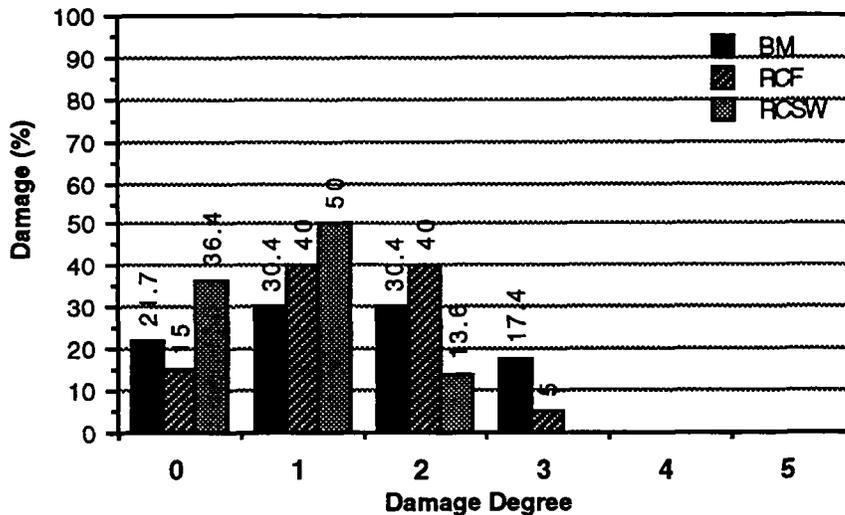
Figure 17: Damage degree histograms of the three main building types in the survey of Focsani (BM = Brick Masonry; ; RCF = RC framed; RCSW = RC shear wall).

It is also evident that the damage in Focsani appears to be somewhat greater than in Buzau, this being quite incompatible with the lower recorded peak acceleration. It is expected that the greater damage in the surveyed area was actually due to the combined effect of the 1986, 1990 earthquakes. Therefore we have to conclude that these damage distributions are more compatible with the 1986 acceleration time history, rather than the 1990 recording. The mean response spectral acceleration of the 1986 recording was 400 cm/sec^2 with the predominant period occurring at 0.48 seconds.

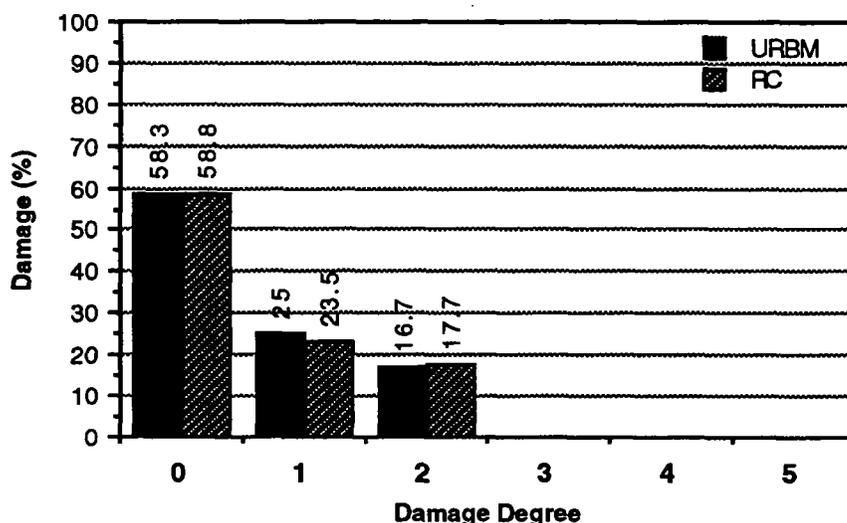
Compared with the other two surveys in Buzau and Focsani we notice a significant difference. Although unfortunately the 1986 acceleration for Valenii de Munte is not known at the moment, the impression from our survey is that it must have been lower or nearly equal to that recorded this year, because there was no evidence of previous damage and repair works. For further comparison in Table 9 the results of three other damage surveys where recorded PGA was similar to Valenii de Munte are given. We notice a wider variation than in Table 8, with Gukasyan (Armenia, 1988) suffering more damage than the two Italian and the Romanian town. We must notice though that the MRSA in Gukasyan is noticeably higher than in the two towns of Italy and almost double that of Valenii de Munte. This emphasises the lower reliability of predicting damage based only on PGA values. Another reason for the lower damage to the masonry buildings in Valenii de Munte is that they were good quality brick masonry mostly one storeyed, while those in the Italian towns were heavier stone masonry many of them two storeyed. In Gukasyan they were built from lightweight tuff volcanic stone and they were mostly single storeyed (EERI - NRC, 1989).

Figure 18: Damage degree histograms of the two main building types in the survey of Valenii de Munte (URBM = Unreinforced Brick Masonry; RC = Reinforced Concrete).

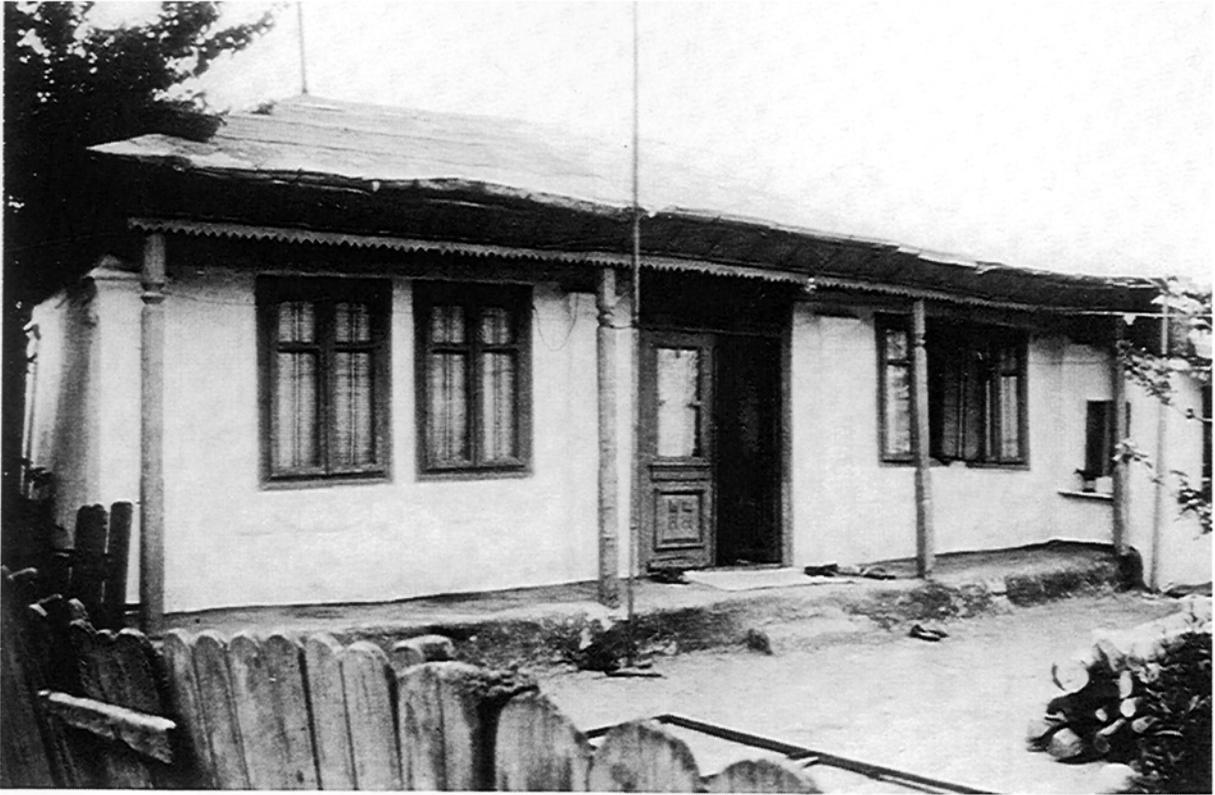
Plate 7: Old compact clay house (Location: Focsani survey, 400 metres from instrument).

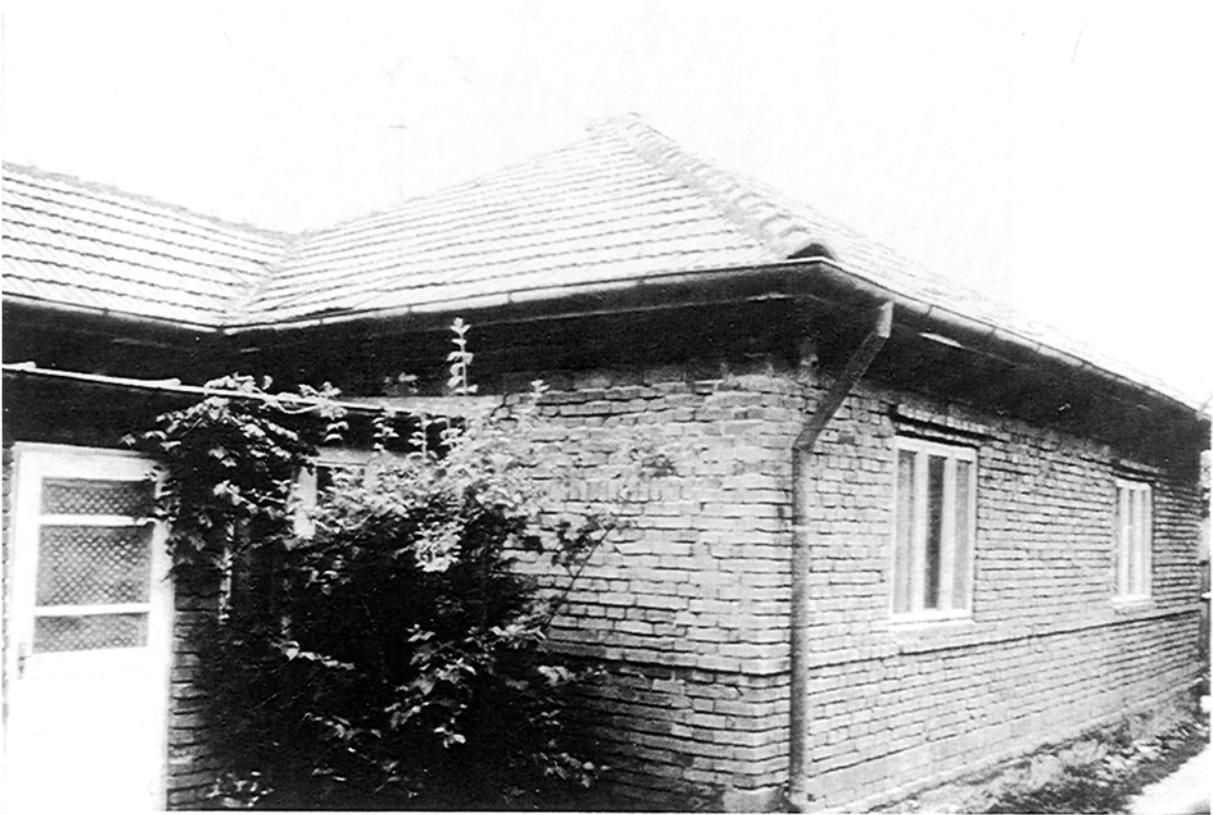
Plate 8: Typical single storey unreinforced brick masonry in cement-lime mortar.

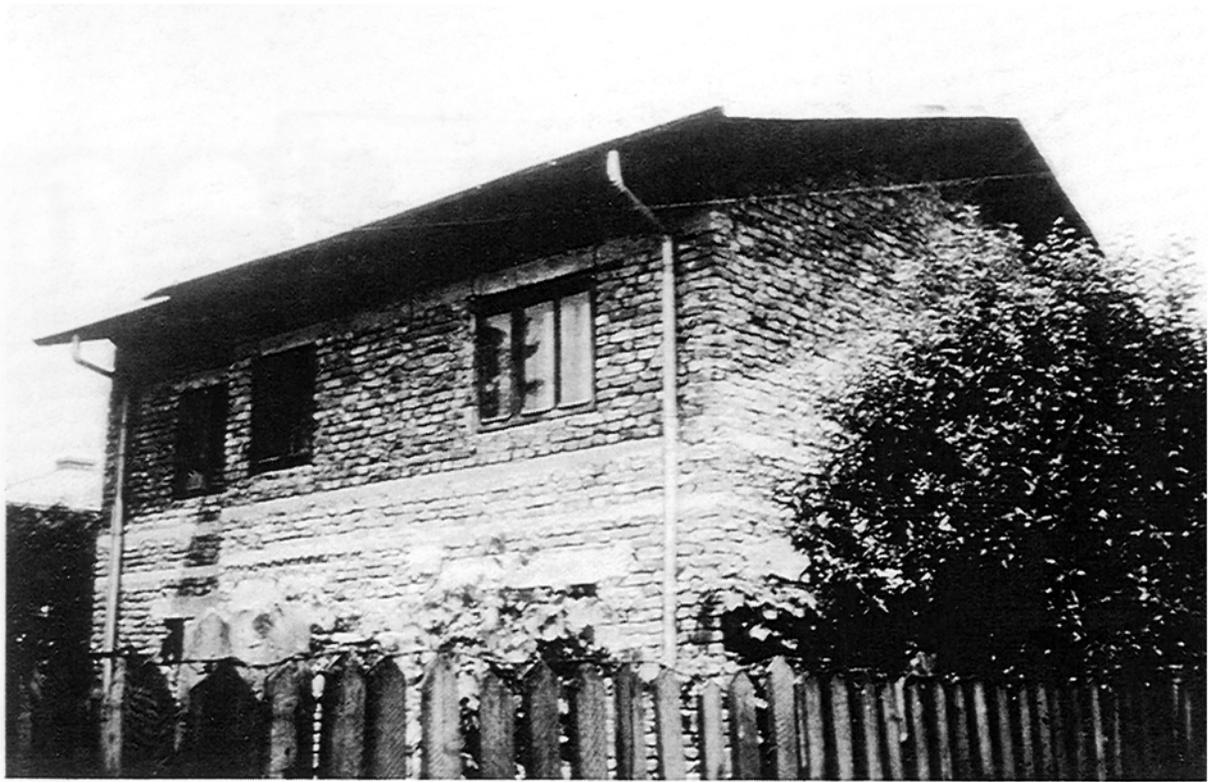
Plate 9: Two storey brick masonry house with RC slab, RC lintels and ring beam in the ground floor.

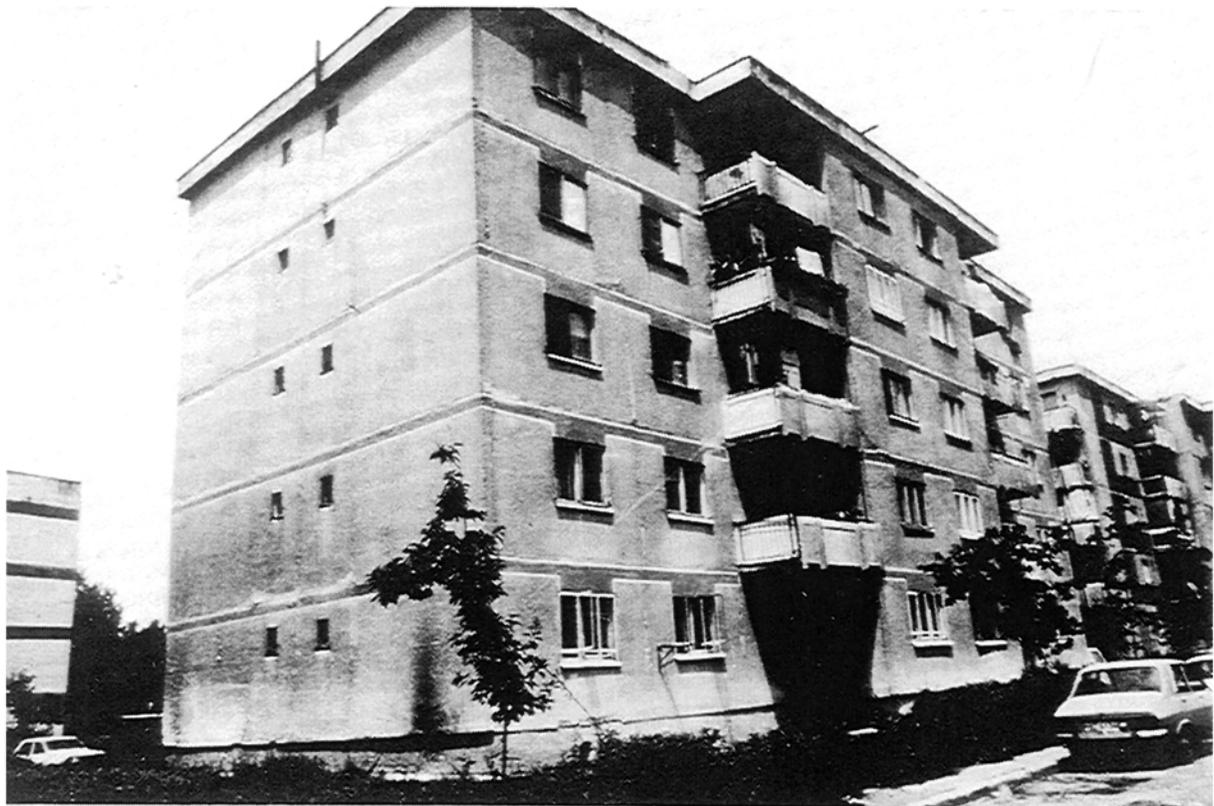
Plate 10: Typical 5 storey confined masonry apartment building, more commonly found in zones of intensity VI and VII.

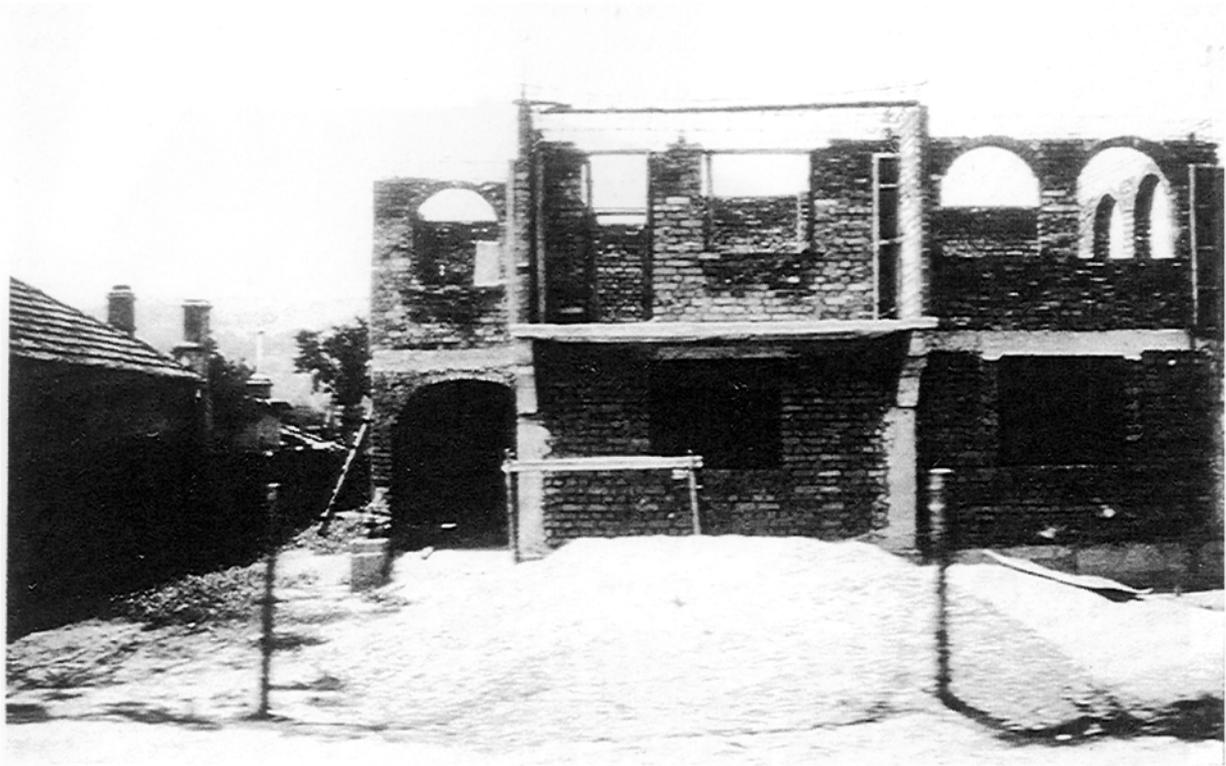
Plate 11: Two storey reinforced brick masonry house. Notice the reinforcing bars in the top floor and columns in the ground floor.

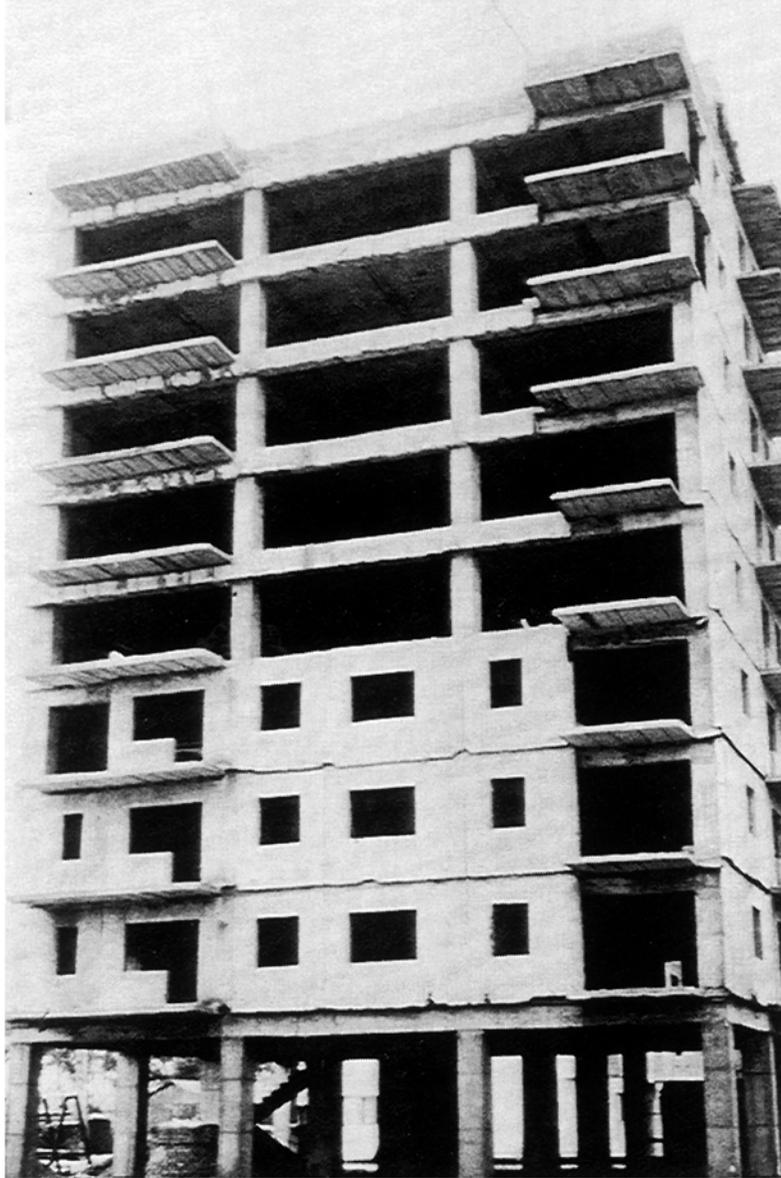
Plate 12: Monolithic RC frame building with RC wall panels instead of infill masonry (Location: Focsani).

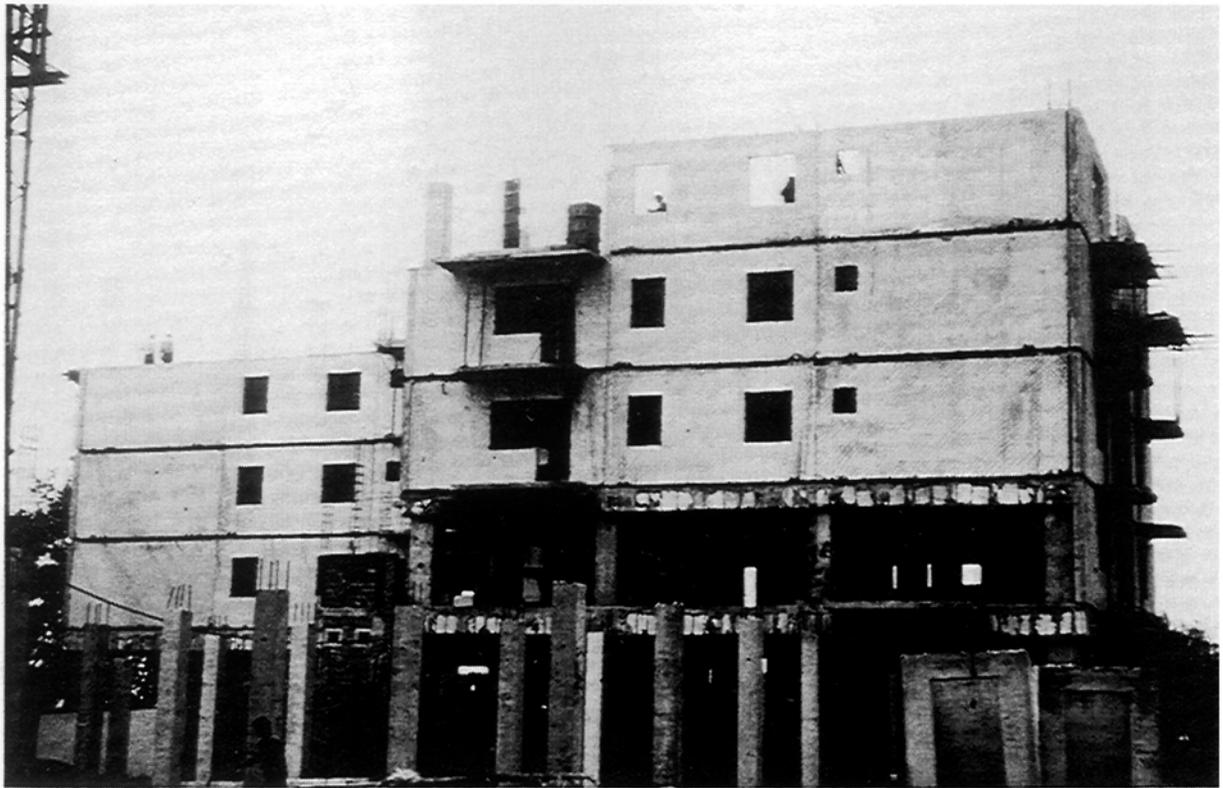
Plate 13: Similar RC frame building under construction (Location: Focsani)

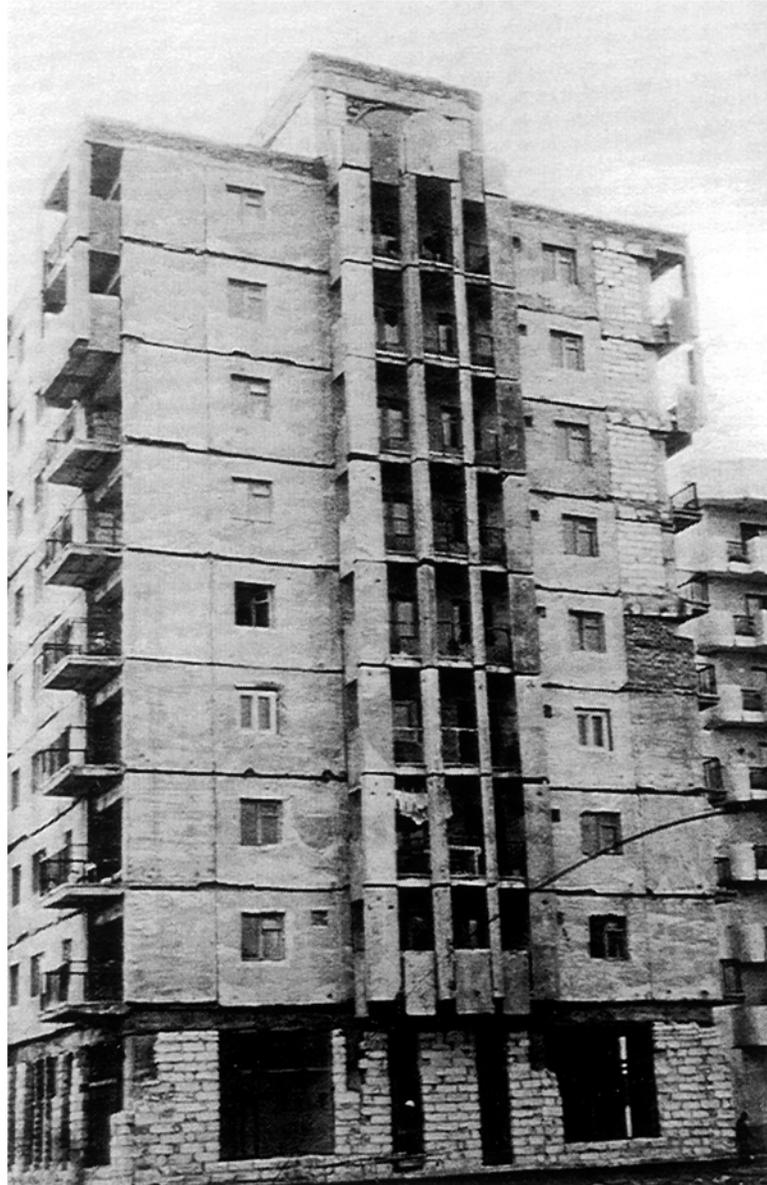
Plate 14: Similar RC frame building in final stage, before plaster is applied (Location: Focsani)

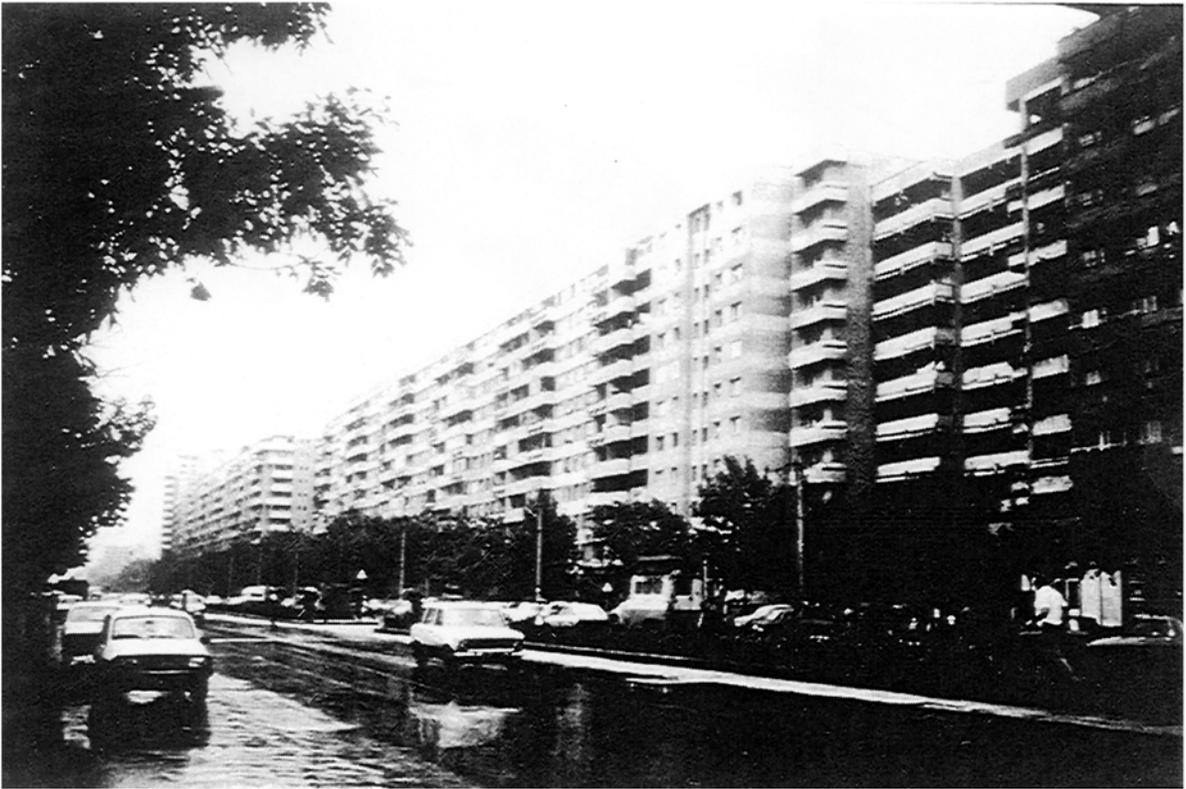
Plate 16: Typical RC with shear walls large apartment block with several expansion joints and entrances (Location: Bucharest).

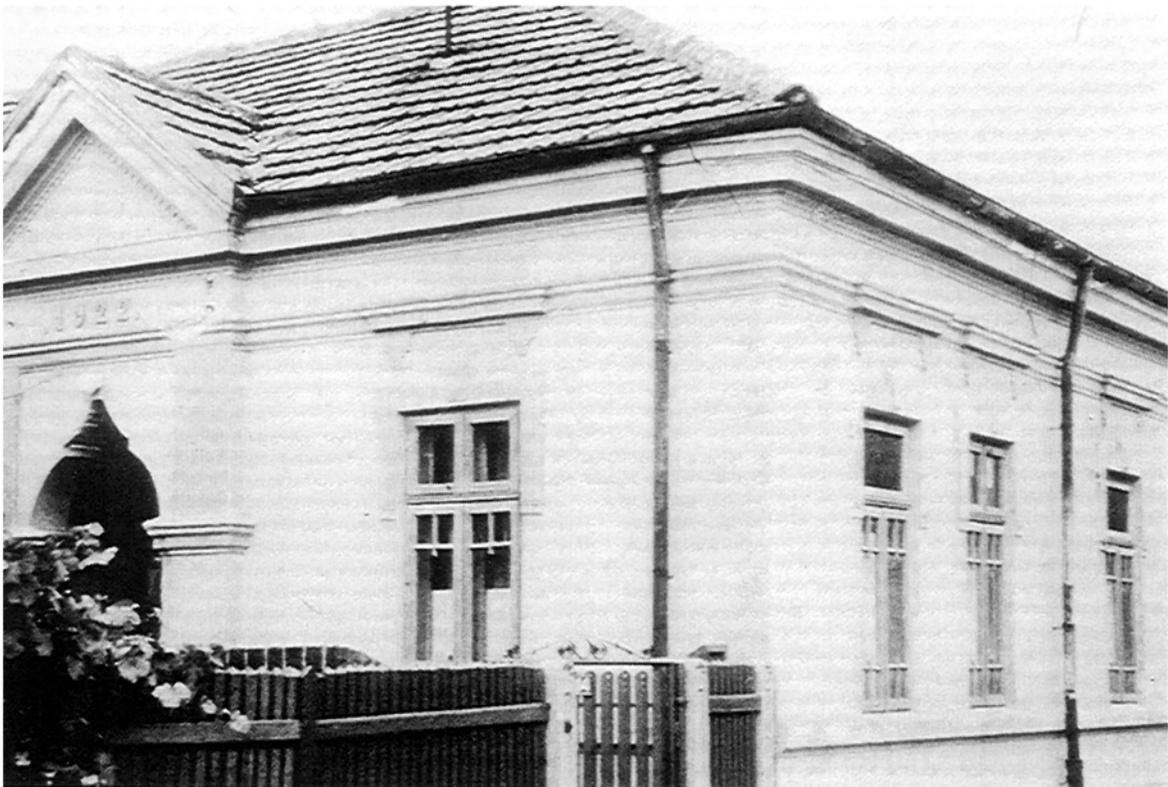
Among the old masonry buildings there was a considerable variation in building types: low-rise brick masonry (Plate 19) being the most numerous (78 buildings), followed by adobe and compact clay buildings (27). Among the brick masonry buildings there were only 8 buildings with two storeys, while

Plate 19: Typical single storey brick masonry building in the Buzau survey.

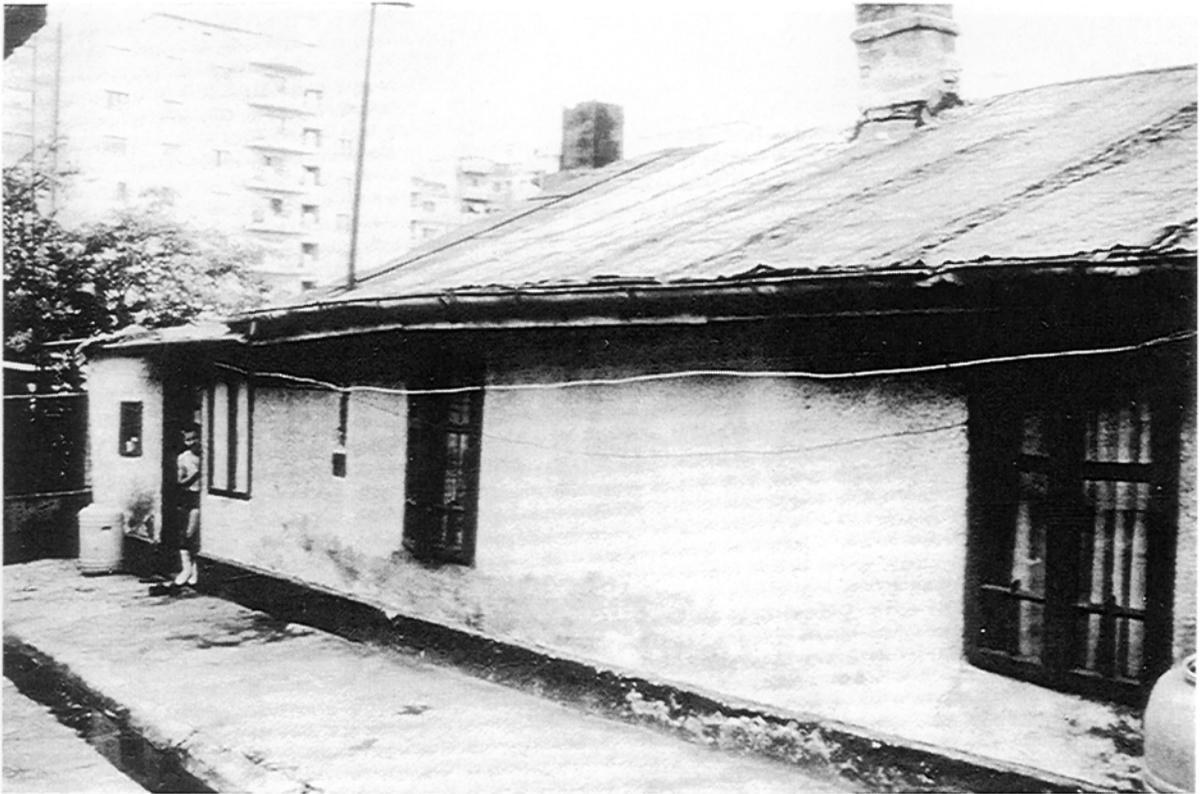
all of the adobe-clay type of buildings were single storeyed (Plate 20). In addition 10 (12.8%) of the brick masonry buildings were reinforced either with RC lintels or with ring beams (RC slabs were in only 2 buildings). The usual storey height of the brick buildings was 3.3 metres, while the adobe houses are lower (2.7 metres). The condition of this housing stock was also quite varied in level of maintenance. Almost all of these houses were built long before 1977, thus surviving all the three earthquake sequences. Evidence of repaired cracks after the 1986 earthquake was widespread (Plate 21). Figure 16 shows the damage degree histograms for the three main building types. For masonry buildings D1 was assigned in the case of small and isolated cracks, D2 in case of wider and more numerous cracks, D3 in case of dislodged masonry, separation of walls in corners (Plate 22), complete chimney collapse or strong diagonal cracks, D4 was given to a few buildings that had lost the upper half of their gable walls. This is somewhat different to the damage degree classification used by the Romanian engineers in 1977 when partial gable wall collapse was assigned only D2 and total gable wall collapse D3.

Plate 20: Typical adobe house in the Buzau survey

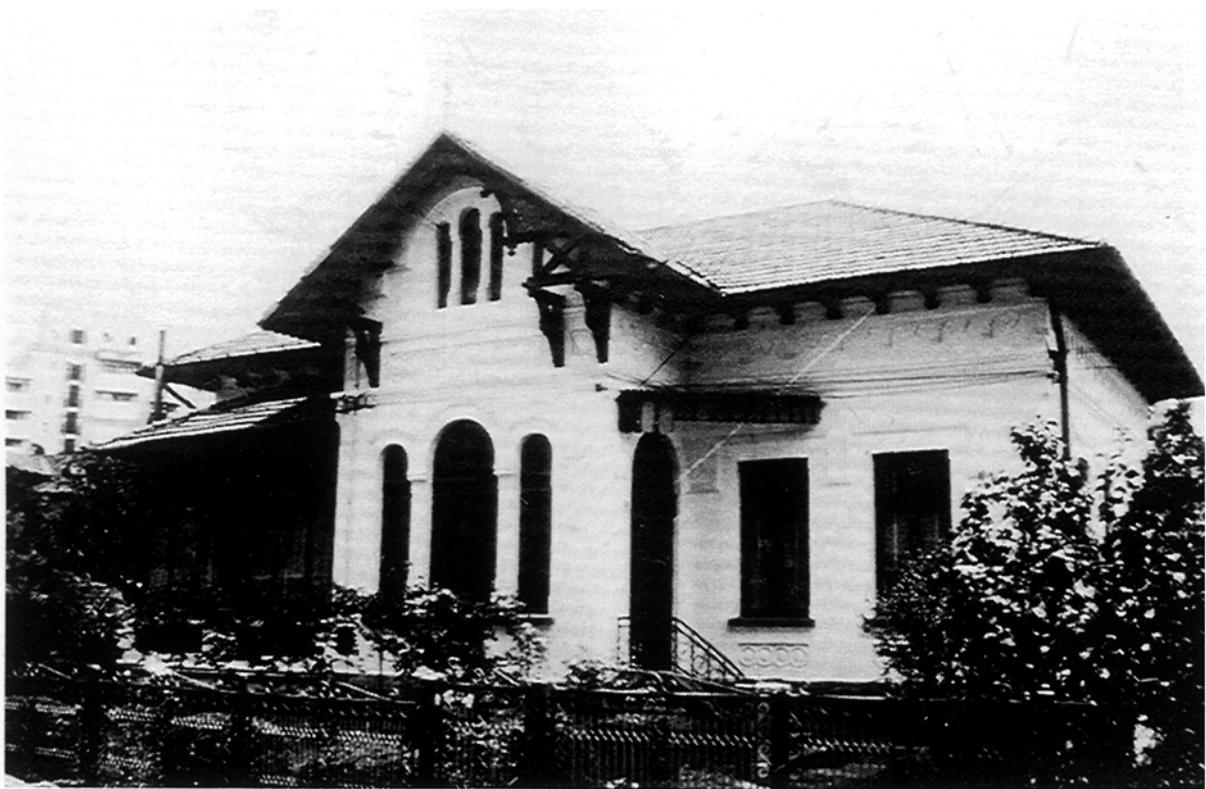
Plate 23: The architectural layout of many of brick masonry buildings was elaborate (Location: Buzau survey).

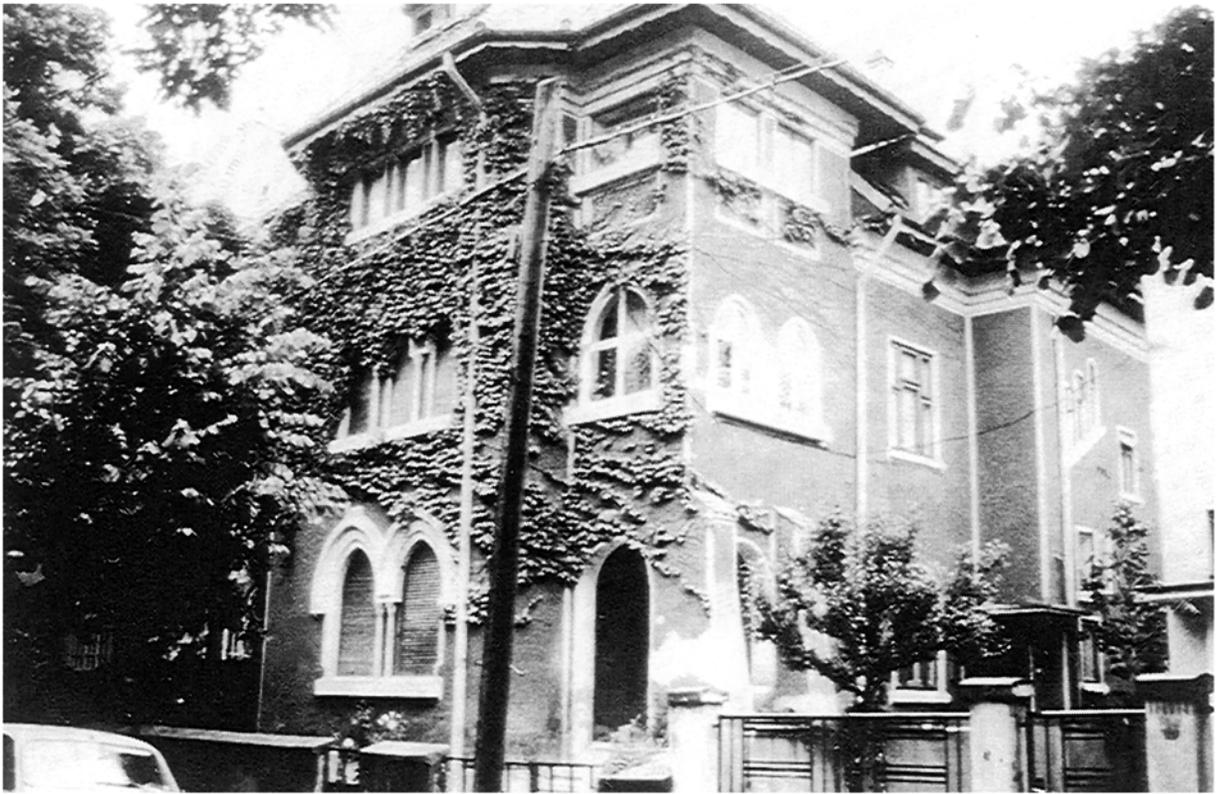
In Mirinescu Street (Bucharest) there was no evidence of damage. The area has mainly two storeyed load-bearing masonry houses of good structural and architectural quality, similar to the building type that suffered the smallest damage in 1977 (Plate 29). The details of the motion recorded in an instrument located at the basement of a two storeyed brick masonry building are not yet known.

Plate 29: Typical building in Mirinescu street survey (Bucharest).
