# **The Liège Earthquake 8th November 1983**

**Damage Inspection Report  
Volume I**

**Ove Arup & Partners**

Job No. 5270/16  
Ref. No. IOE 84-05  
January 1984

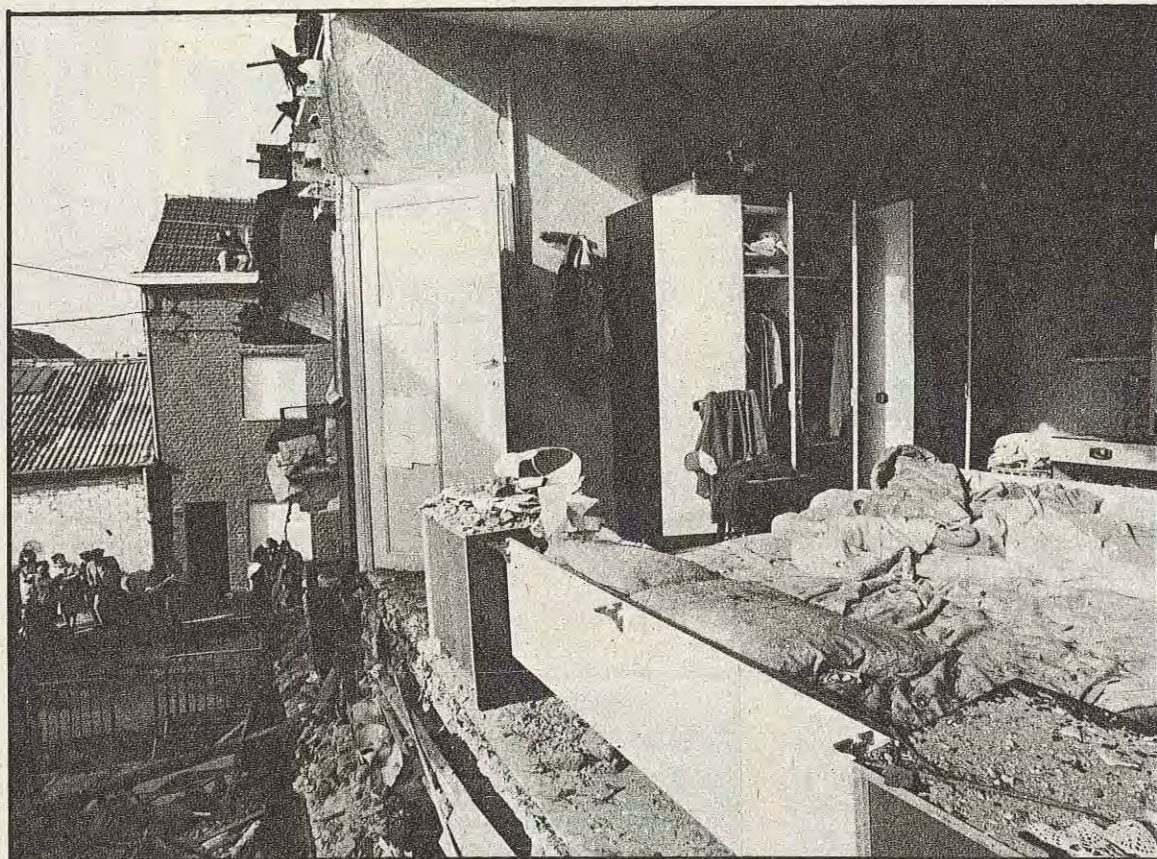
Terrible. Et, pourtant, le pire a été évité dans cette maison de Glain : elle s'est rompue juste au pied d'un lit...

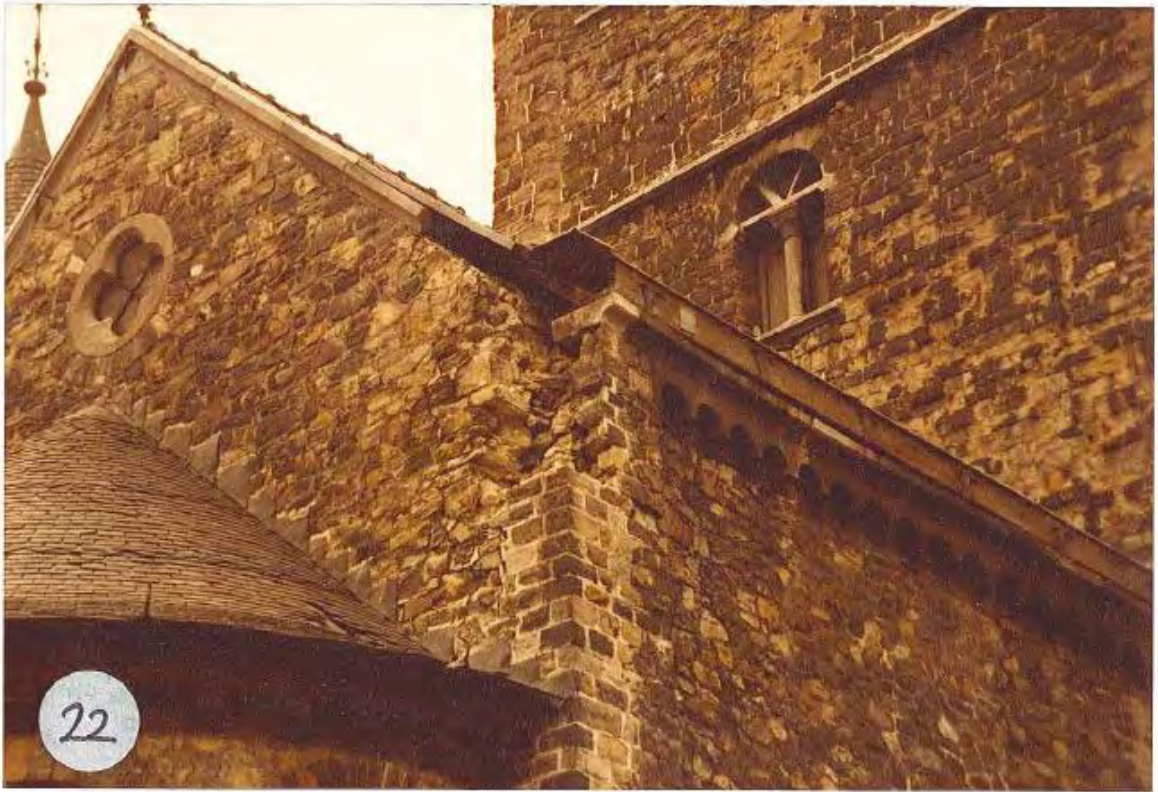
L'EGLISE EST FERMÉE

PAR MESURE DE SÉCURITÉ

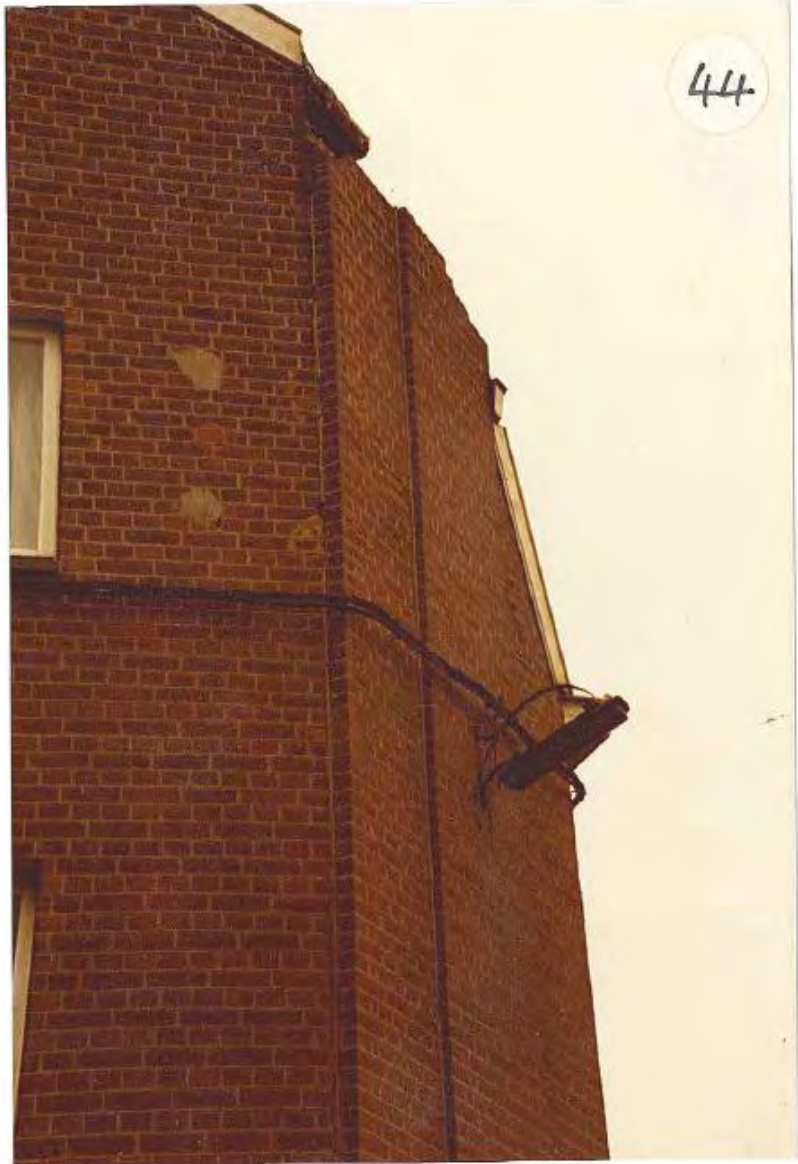
45

44. Rue St Nicholas at Place St Nicholas. Vertical crack at corner of house.
45. Same house as 44.
46. Place St Nicholas. Municipal lorries preparing shoring.
