# THE KUMAMOTO JAPAN EARTHQUAKES OF 14 AND 16 APRIL 2016

# A FIELD REPORT BY EEFIT

Dr. Katsu Goda, *University of Bristol* (Team Leader and Editor) Dr. Grace Campbell, *Arup* Ms. Laura Hulme, *Arup* Mr. Bashar Ismael, *University of Manchester* Dr. Lin Ke, *Willis Re Japan* Ms. Rebekah Marsh, *Mott MacDonald* Prof. Peter Sammonds, *University College London* Dr. Emily So, *University of Cambridge*

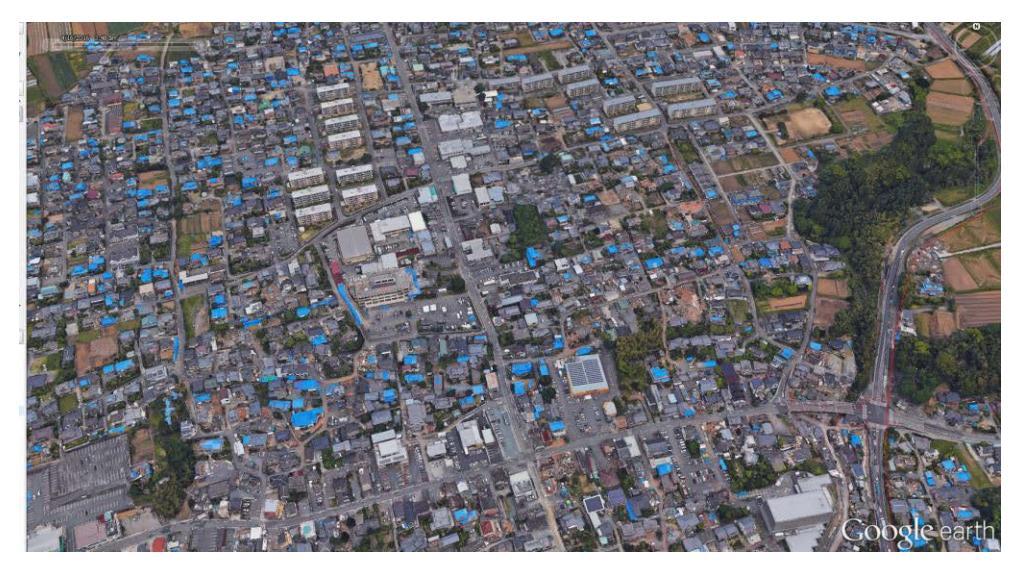
Figure 4.4 Aerial view of Mashiki Town after the 2016 Kumamoto earthquakes (image source: Google Earth).

Mashiki Town is in close proximity to the activated faults of the 2016 Kumamoto earthquakes (Section 2), and suffered severe damage and casualties. Measurements at the KMMH16 station in Mashiki Town showed response accelerations (**Figure 4.2**). Spectral accelerations were particularly high around 1 s in the EW direction. Vertical accelerations were also high. As a residential suburb, the building stock in Mashiki is dominated by single-family dwelling timber buildings of one and two storeys. There are also a number of low-to-medium-rise RC apartment buildings. Along the commercial (retail) streets (Road 28 and Road 235), buildings were generally one- to three-storey steel frames. **Figure 4.3** provides an aerial view of Mashiki Town prior to the earthquakes. It can be seen that the timber frame houses are generally detached with clearance between houses, but are often constructed tight to the narrow streets. **Figure 4.4** shows the same view after the earthquakes. An impression of the proportion of houses that have suffered roof damage can be seen from the blue weatherproofing sheeting; however, there are also many cases of severely damaged buildings that had not been sheeted, as the loss had been total.

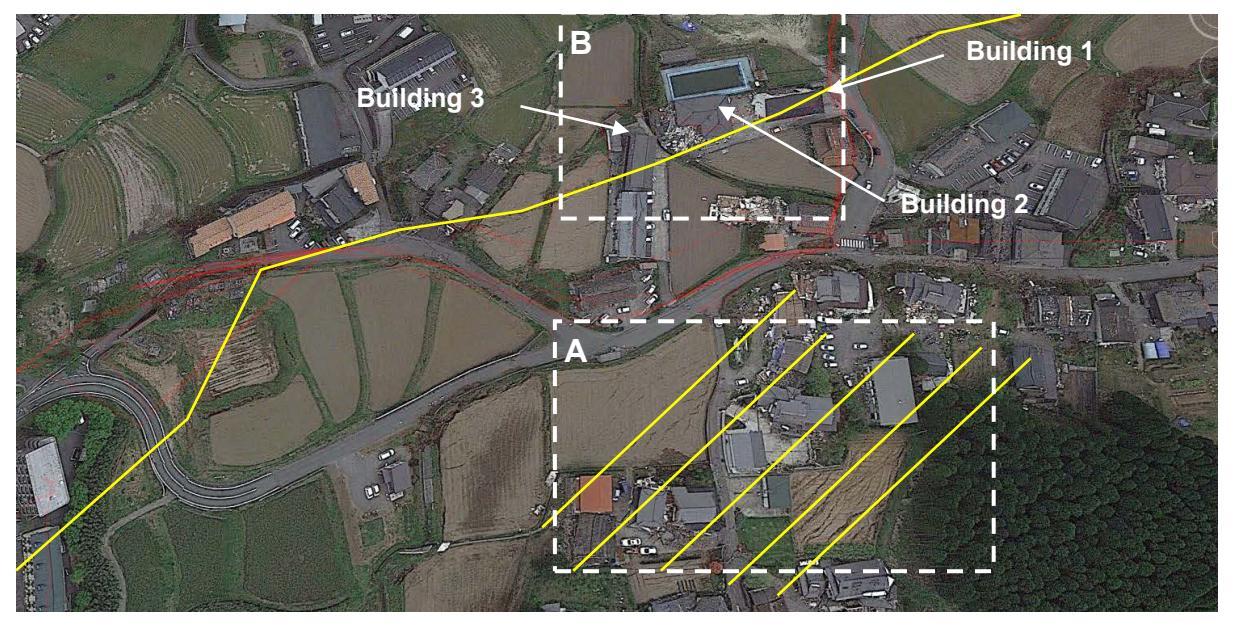
**Figure 4.6** Aerial view of a student complex in the Kawayo district of Minami Aso Village (image source: Google Map).

The EEFIT visited the student village next to Tokai University (Aso campus) in the Kawayo district of Minami Aso Village (**Figure 4.6**). Buildings in this area were a mixture of one- and two-storey timber residential buildings, and also a number of two- to five-storey RC residential buildings. The RC buildings were generally located in the lower parts of the area close to the Shirakawa River gorge. Significant damage had occurred to the majority of timber frame buildings (Goda et al., 2016). Damage to structures had occurred due to ground movement as well as shaking damage. The yellow lines in **Figure 4.6** indicate locations of significant ground ruptures.

In area A, a series of parallel ruptures suggest movement of ground towards the northwest. All timber frame houses in this area had suffered significant damage, loss of cladding and permanent drifts. An example is shown in **Figure 4.7a**.

In area B a significant single rupture had occurred, having dramatic impact on the buildings crossed by the rupture.

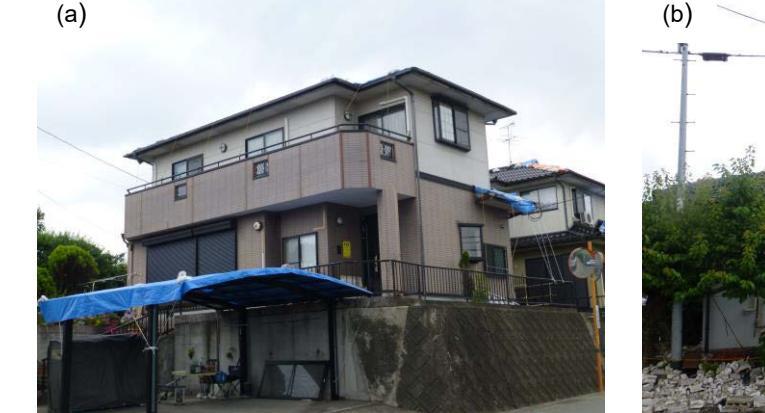
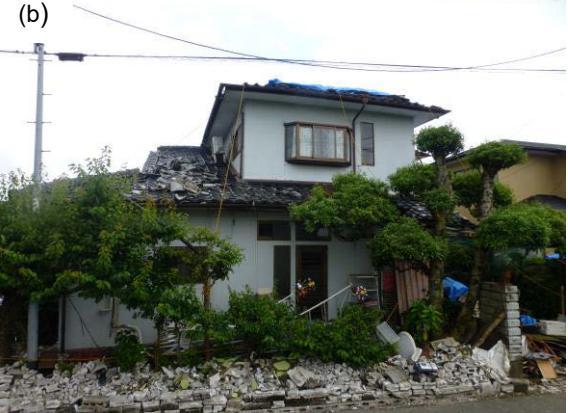
**Figure 4.20** Examples of surveyed timber buildings in Mashiki Town: (a) damage grade 1 or 2, (b) damage grade 3, (c) damage grade 4, and (d) damage grade 5.

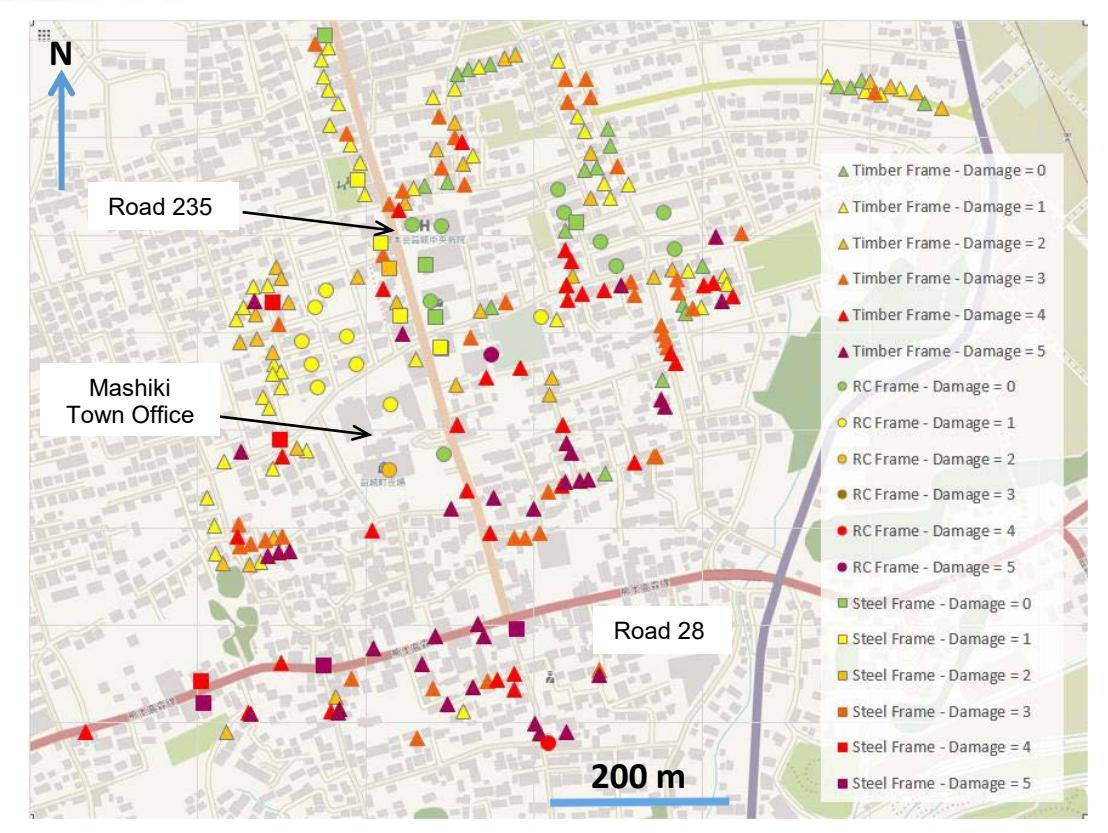
Figure 4.21 Damage survey results in Mashiki Town. The base map was obtained from OpenStreetMap.

- Some buildings could not be recorded clearly, either because they were covered by weatherproofing or because buildings had been removed. However, there were relatively few empty plots in Mashiki Town; the impression was that very few buildings had been removed at the time of the survey.
- Differentiating between the different damage grades can be challenging, particularly at the low end of the damage scale (e.g. grade 1 or 2). This issue was partly mitigated by ensuring a clear photo log of all the buildings surveyed to enable retrospective review and moderation.

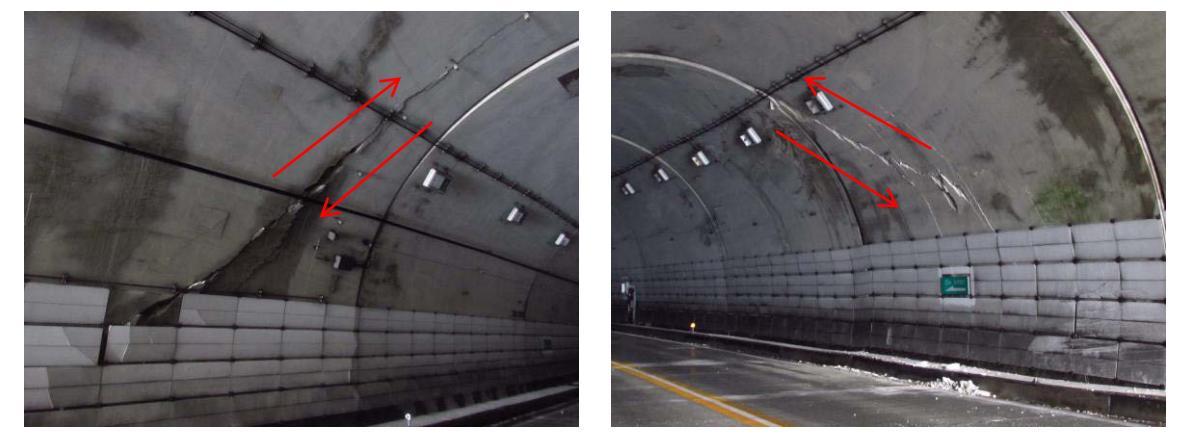
Figure 5.8 Shearing on the side wall of the Tawarayama Tunnel showing a NEE-SWW compression.

The Tawarayama Tunnel (32.8601°N, 130.9646°E) is a road tunnel (Road 28) 2057 m in length that passes through the caldera wall of Mount Aso (**Figure 5.8**). The tunnel portal in the west is located above the Futagawa Fault and as a result suffered high axial compression forces causing fracturing and collapse of the tunnel wall cladding. The fractures in the tunnel wall and the uplifted drain covers indicate a NEE-SWW compression. The shearing in the tunnel is dipping to the southwest and represents compression of the fault rather than lateral shearing of the Futagawa Fault at this location.

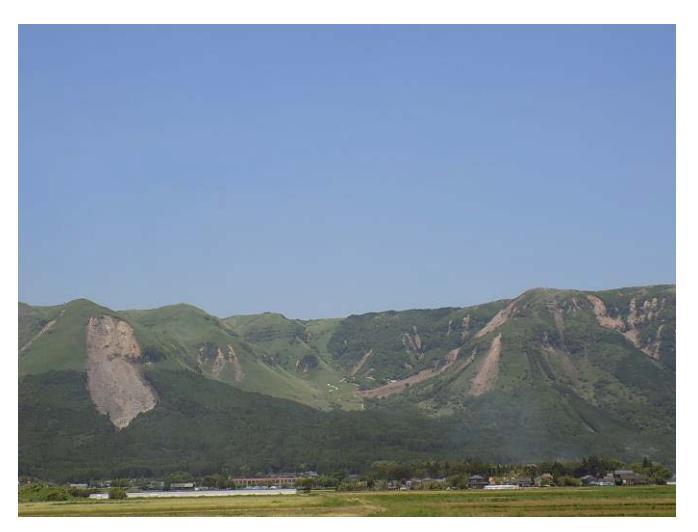
Multiple landslides have been observed around Aso Caldera, including earth flows, debris flows, slides and slumps (**Figure 5.12**). 10 out of 49 deaths during the Kumamoto earthquakes were caused by landslides. The majority of the slope failures occurred around Aso Caldera and Mount Aso where the relief is high. The slopes are commonly gentle at the base (less than 10°) becoming steeper (>60°) towards the top of the Aso Caldera rim where volcanic vents are also observed (**Figure 5.13**). The upper slopes are generally formed of extrusive igneous rocks covered by a thin layer of residual soil and ash, whilst the gentle lower slopes are mainly mantled by thick layers of residual volcanic soils overlying pyroclastic deposits (**Figure 5.14**). Narrow steep valleys are common in this region and steep-side gorges can be up to 70 m in height, which are also prone to multiple cliff collapse during periods of high rain and seismic activity. The highest density of the landslides is concentrated in the areas where strong shaking was observed. This zone is in close proximity to the Futagawa Fault which intersects with the western Caldera wall.

Figure 5.13 Debris flows on the steep sides of Aso Caldera.

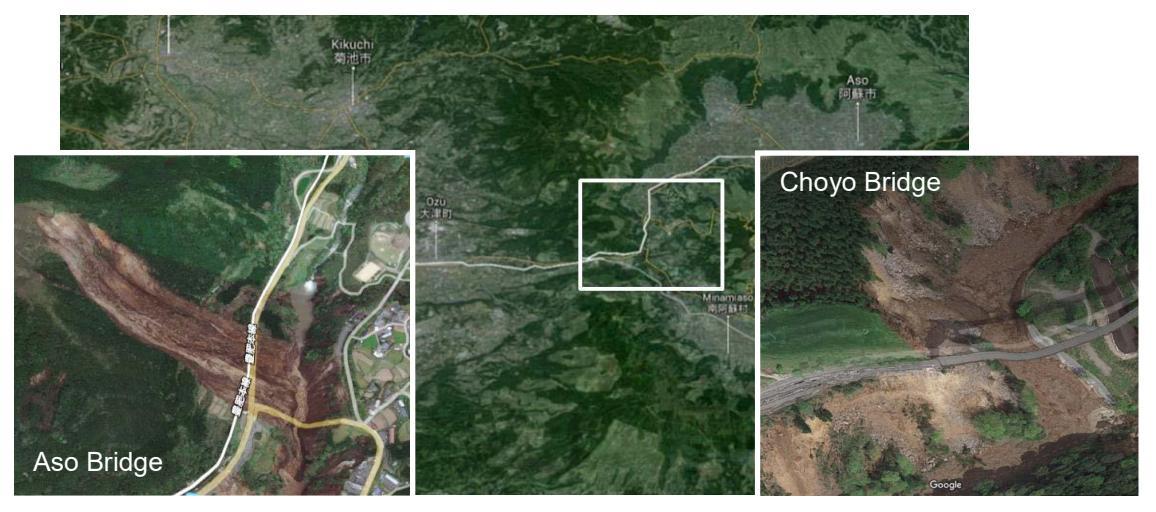
Figure 5.15 Large landslides near the Aso Bridge and Choyo Bridge (image source: Google Map).

A giant landslide, 950-m long and 200-m wide, occurred near the Aso Bridge (32.8841°N, 130.9889°E) in Minami Aso Village (**Figure 5.15**). The failure was a large debris avalanche that originated at the slope crest, depositing hundreds of thousands of cubic metres of rock and soil into the gorge below. Multiple slope failures were also seen downstream. As is shown in **Figure 5.16**, the slide surface was smooth and neat, which implies that the failure was a flow rather than a slide or slump. Several highways nearby (Road 57 and Road 325) were overwhelmed and the Aso Bridge was destroyed. According to local media, one person who was driving near the bridge at the time of the event was killed. At the visit of the Aso Bridge, remotely controlled machinery was seen clearing away the debris and tidying the toe of the failure.

Approximately 1 km downstream of the Aso Bridge, a debris flow was observed near the Choyo Bridge (32.8750°N, 130.9838°E). Large rock/soil flowed down the 50°-60° valley side, as shown in **Figure 5.17**. Extensive cracking was observed at the upslope part of the landslide. The Choyo Bridge and ground transition zone showed significant settlement, thereby suffering great damage. This bridge and several highways nearby were blocked at the time of site visit.

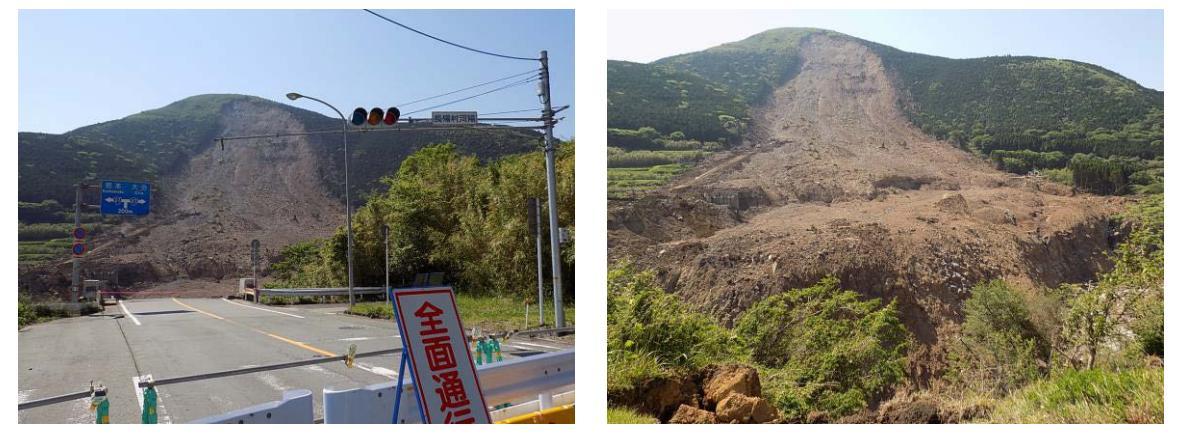
Figure 5.16 Giant earthflow that destroyed the Aso Bridge.

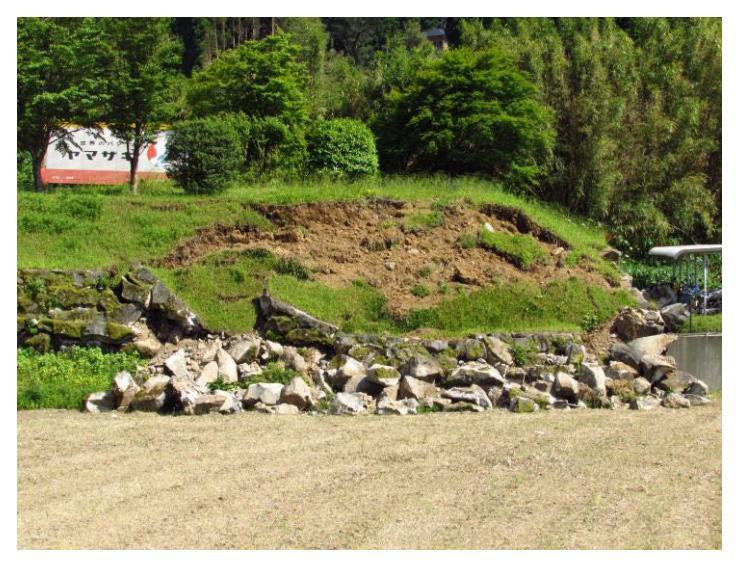
was not apparent as remediation works had already started (**Figure 5.23b**). A large retaining wall in the form of large boulders also failed as a result of slumping of the soil behind the wall (**Figure 5.24**).

Figure 5.24 Slumping of the soil behind a retaining wall in the Kawayo district causing it to collapse.

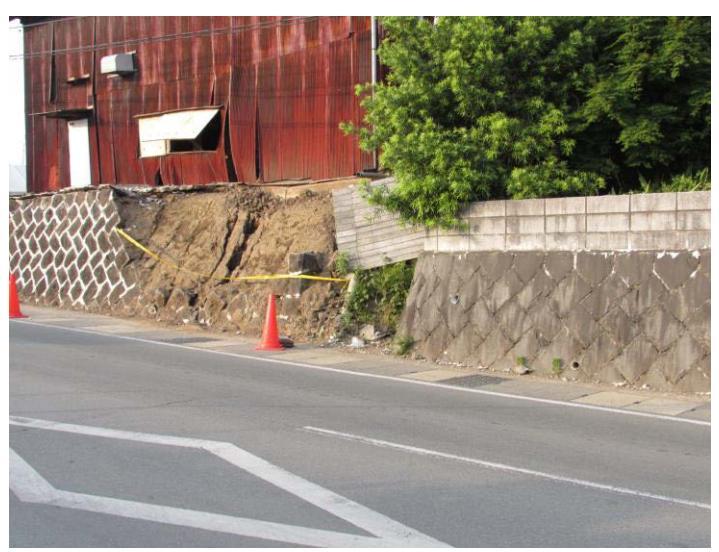
A concrete retaining wall opposite the Mashiki Town Office car park failed, whilst the adjacent retaining structure remained standing (**Figure 5.25**). The neighbouring, intact, retaining wall had inbuild drainage, whereas the partly collapsed retaining wall did not. Seepage channels were visible in the soil behind the wall. A combination of these factors indicates that drainage was a major reason for the collapse.

Figure 5.25 Retaining wall failure in Mashiki Town.

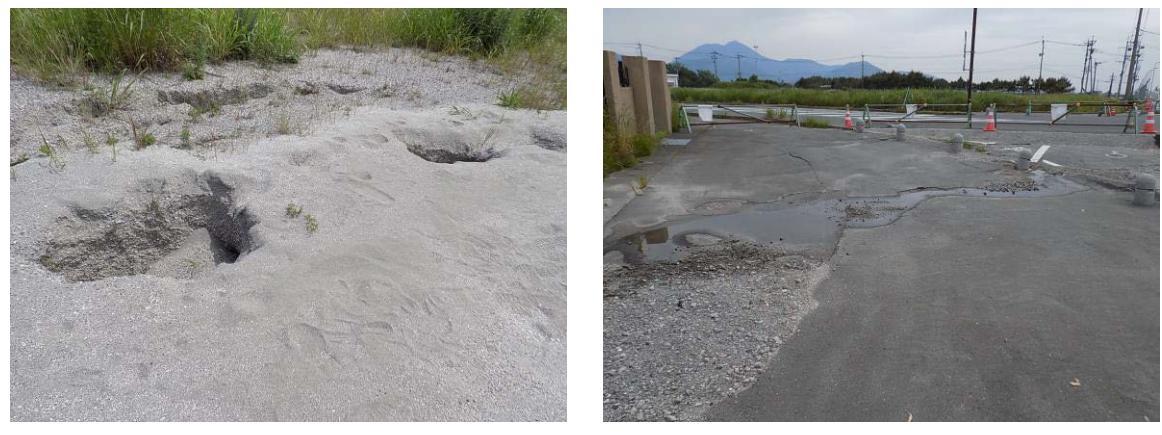
The Kumamoto Port ( $32.7639^{\circ}N$ ,  $130.5894^{\circ}E$ ) is located west of Kumamoto City (**Figure 5.26**). This port is an artificial island built in Ariake Sea. Extensive liquefaction occurred, resulting in ejected sands at various locations (**Figure 5.27**). The possible explanation for sand boils is that, when the pore water pressure is increased during the seismic event, it applies pressure on the above strata causing many cracks and fissures. The pore water pressure is released through these gaps bringing the sands with it. At some locations, there was water on the ground, indicating that the water table was close to the surface. The soil profile for the Kumamoto Port shows that the ground is sand up to 3.5 m from the surface. The estimated peak ground acceleration at the Kumamoto Port was 0.5 g (Goda et al., 2016), which is sufficiently large to trigger liquefaction in sand soil layers (Idriss and Boulanger, 2008).

Figure 5.27 Sand boils at the Kumamoto Port.

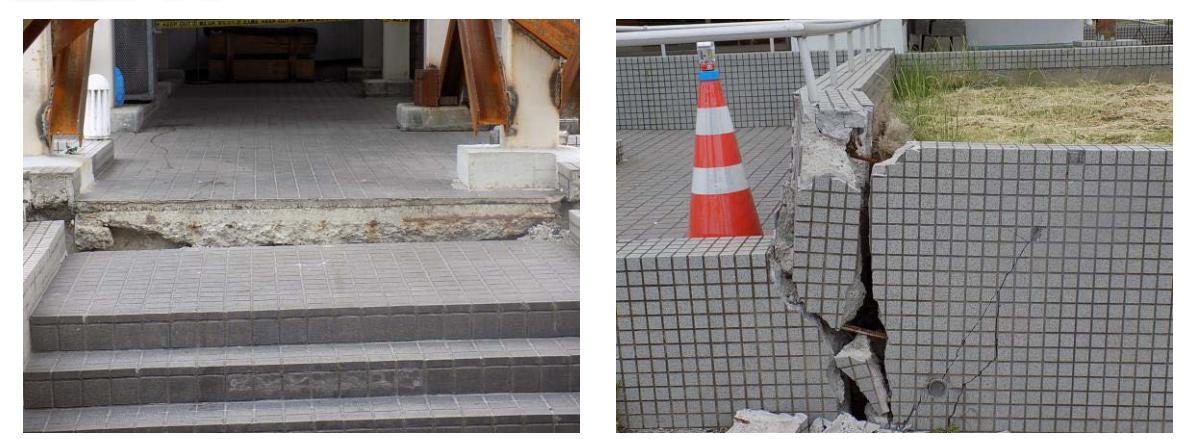
Liquefaction-induced settlements were observed at several locations in the port. The measured settlements ranged between 0.1 m to 0.15 m. **Figure 5.29** shows the induced settlement at the entrance of the main hall, inside the Kumamoto ferry terminal. Ground settlement occurs as water dissipates from soil, therefore, subsurface soil losses a large part of its total volume. This is sometimes accompanied by ejected sands which will also reduce the total volume of soil in the subsurface, resulting in settlement. **Figure 5.30** shows the damage at the ferry terminal where an overpass steel bridge was found to be out of service as a result of liquefaction-induced settlement.

Figure 5.29 Liquefaction-induced failures near the ferry terminal.
