**The Central Sulawesi, Indonesia Earthquake and Tsunami of 28th
September 2018 – A Field Report by EEFIT-TDMRC**

01/11/2019

Prof Tiziana Rossetto, EPICentre, University College London

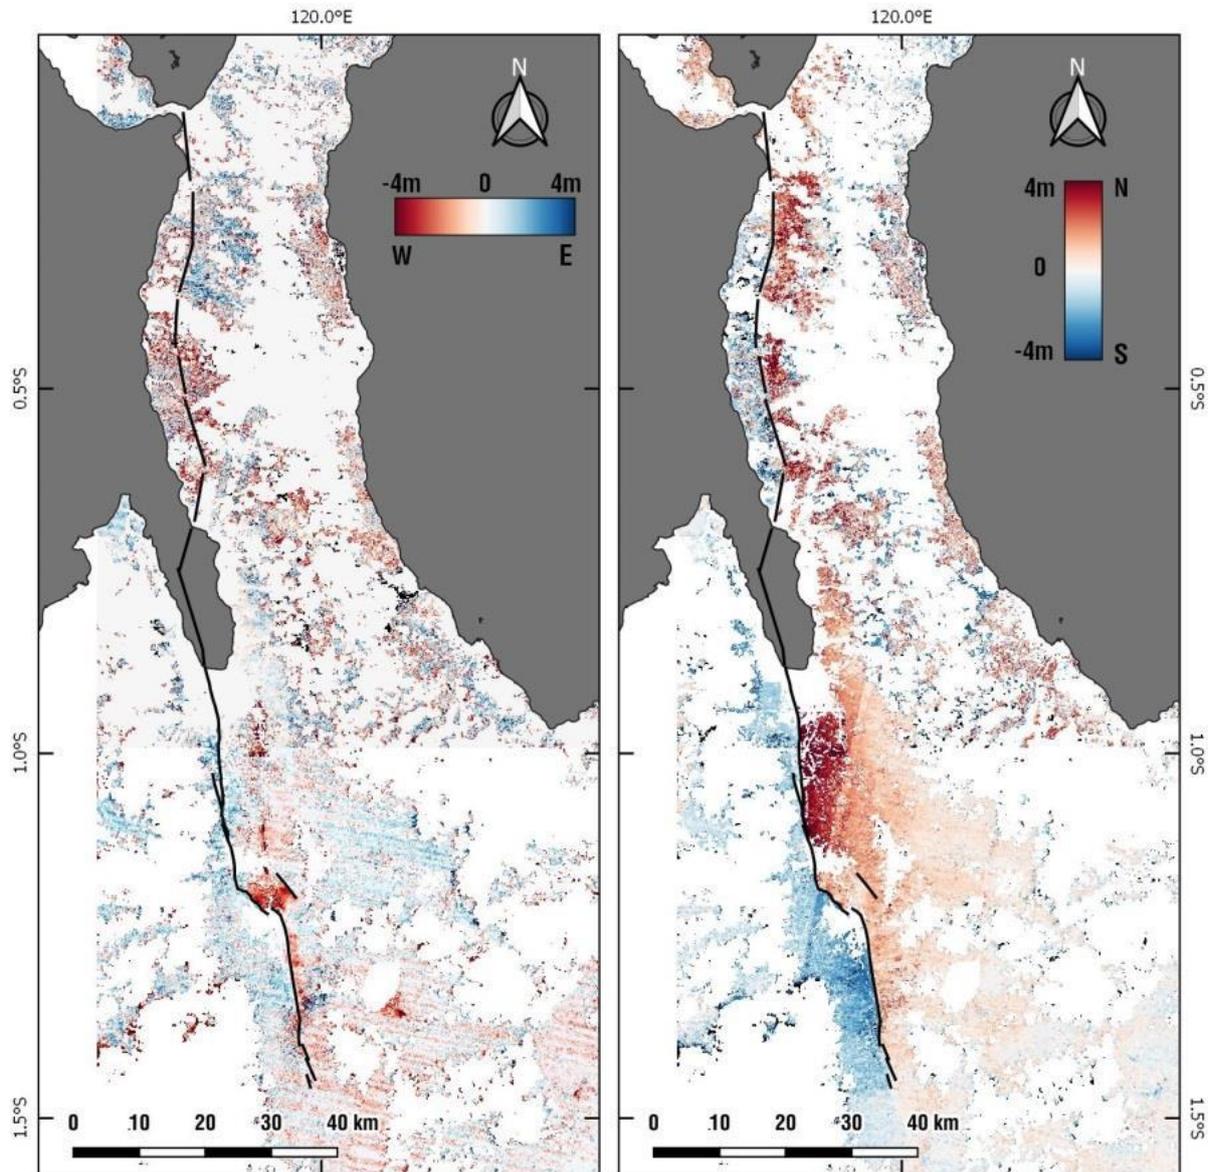
As mentioned previously, the epicentre of the earthquake was situated approximately 80km north of Palu city, and the total fault rupture length along the Palu-Koro Fault was more than 140km with a calculated mean displacement of 3-5m (Valkanotis et al., 2018). Pre-mission information suggested that surface rupture of the fault had occurred and, although the fault had been mapped using satellite imagery and co-seismic displacement analysis (Figure 3.1), part of the mission was focussed on ground-truthing the fault rupture at the surface.

Figure 3.1 – Co-seismic assessment of fault rupture displacement after Valkanotis et al. (2018). The left image is west to east displacement and right image is north to south displacement.

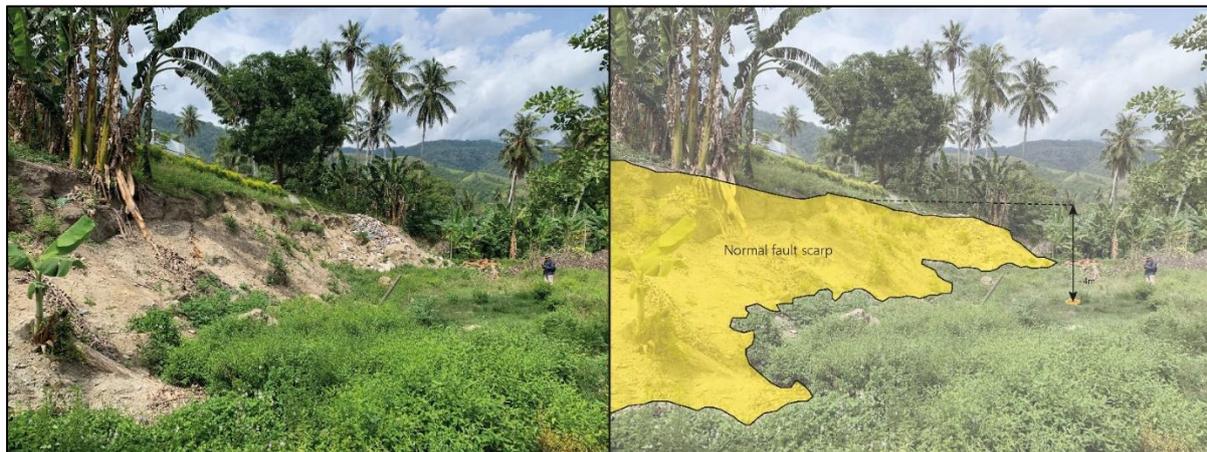
Figure 3.2 – Normal fault scarp displaying vertical displacement of approximately 4m in the south of Palu valley.

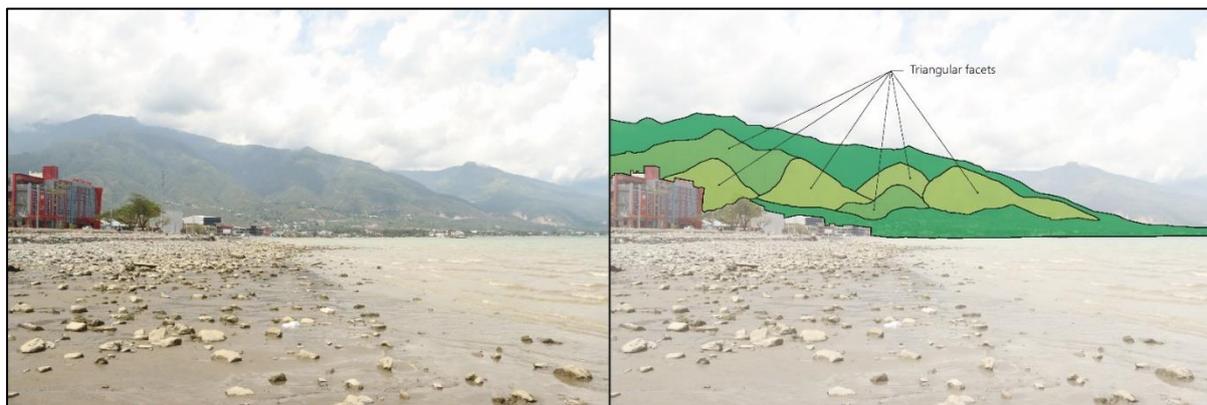
Tectonic geomorphological features such as triangular facets, hanging valleys and offset drainage lines on the western side of the valley (Figure 3.3) suggest that this represents the main fault scarp of the fault system, as proposed by Socquet et al. (2006), demonstrating a history of both strike-slip and normal displacement.

Figure 3.3 – Triangular facets on the western side of Palu valley.

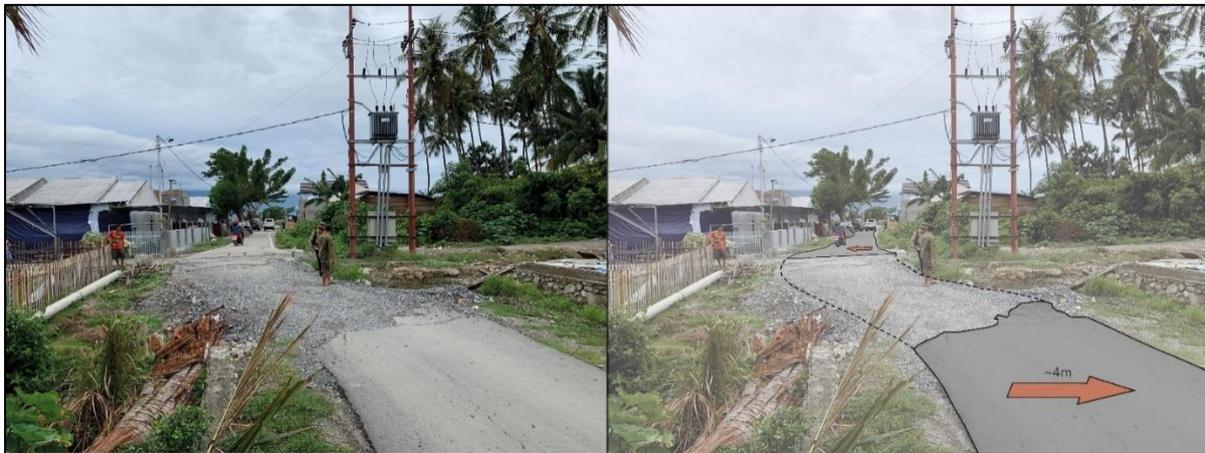
Figure 3.4 – Offset road due to strike-slip fault displacement.

Numerous expressions of the fault surface rupture were identified throughout the area, typically by the offset of linear features such as roads (Figure 3.4), but also dramatic continuous surface ruptures through agricultural land (Figure 3.5). Left-lateral strike-slip displacement was measured by the Team to be a maximum of 5m at Pewunu (Figure 3.6), and typically between 3-4m. It is possible that, given the proximity of the Pewunu area to the valley sides and steep terrain, the soil is thinner and thus the greater displacements in the bedrock are more closely represented at the surface.

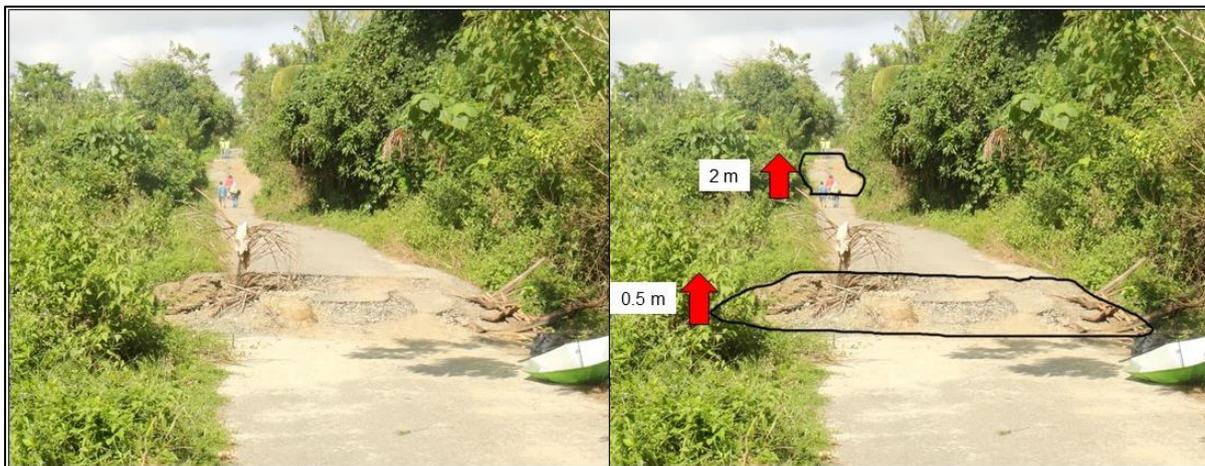
Figure 3.7 – Normal faulting observed North of Labua on the East side of Palu Bay. Photo taken facing North East

To the East of Palu Bay and north of the settlement of Labua, two surface expressions of predominantly normal displacement were observed in close proximity as shown in Figure 3.7. Vertical offsets of 0.5 m were measured for the smaller, more westerly point (nearer the camera in Figure 3.7) and 2 m for the larger rupture. Although surface debris indicated recent movement had occurred on these surfaces, it is unclear whether these measured offsets were entirely caused by the 28th September earthquake, as a water channel alongside the larger fault surface showed a breakage with an offset of 0.6 m vertically and 0.4 m to the right (Figure 3.8). This channel also showed evidence of prior patchwork repairs, suggesting that it is possible that previous events may have also contributed to the 2 m total that was measured. Figure 3.9 presents an overview of the mapped and inferred fault locations.

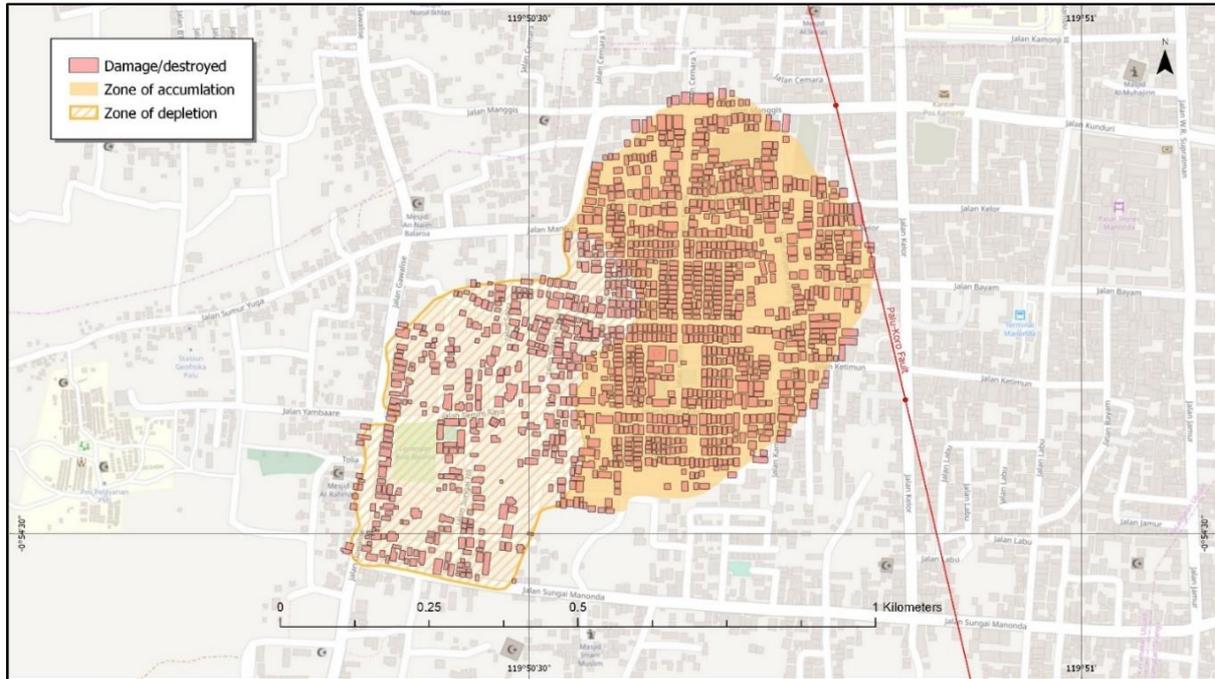
The Balaroa Landslide occurred in the western district of Balaroa in Palu city with anecdotal evidence suggesting the landslide occurred within 1-2 minutes of the earthquake ground shaking commencing. The landslide has a head scarp approximately 0.5km wide and a runout approximately 1km long; the head scarp was measured to be approximately 8-9m at its highest. The overall slope angle from the top of the head scarp to the toe is approximately 3.5°. It has reasonably well-defined zones of depletion and accumulation with most debris being deposited 0.4km east of the head scarp (Figure 4.1). The surface rupture of the Palu-Koro Fault also runs along the toe of the landslide.

Figure 4.1 – Overview of the Petobo landslide area showing zones of depletion and accumulation as well as damaged buildings and the Palu-Koro Fault surface rupture.

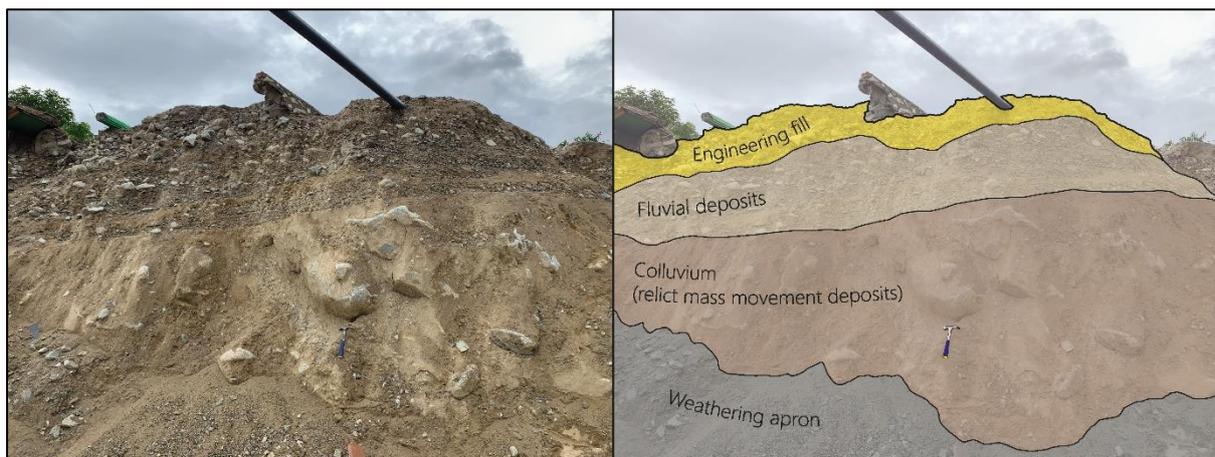
Subsurface materials were exposed at the head scarp (Figure 4.2) demonstrating the following succession:

- <1m granular engineering fill, predominantly sandy gravel and cobbles;
- 1-2m of fluvial deposits comprising sandy gravel, gravelly sand, silty sand, sandy silt; and
- Underlying granitoid subangular to sub-rounded cobbles and boulders in a gravelly medium to coarse sand matrix – suspected colluvium / previous landslide deposit, base not proven.

Figure 4.2 – Geological profile exposed in Balaroa Landslide head scarp.

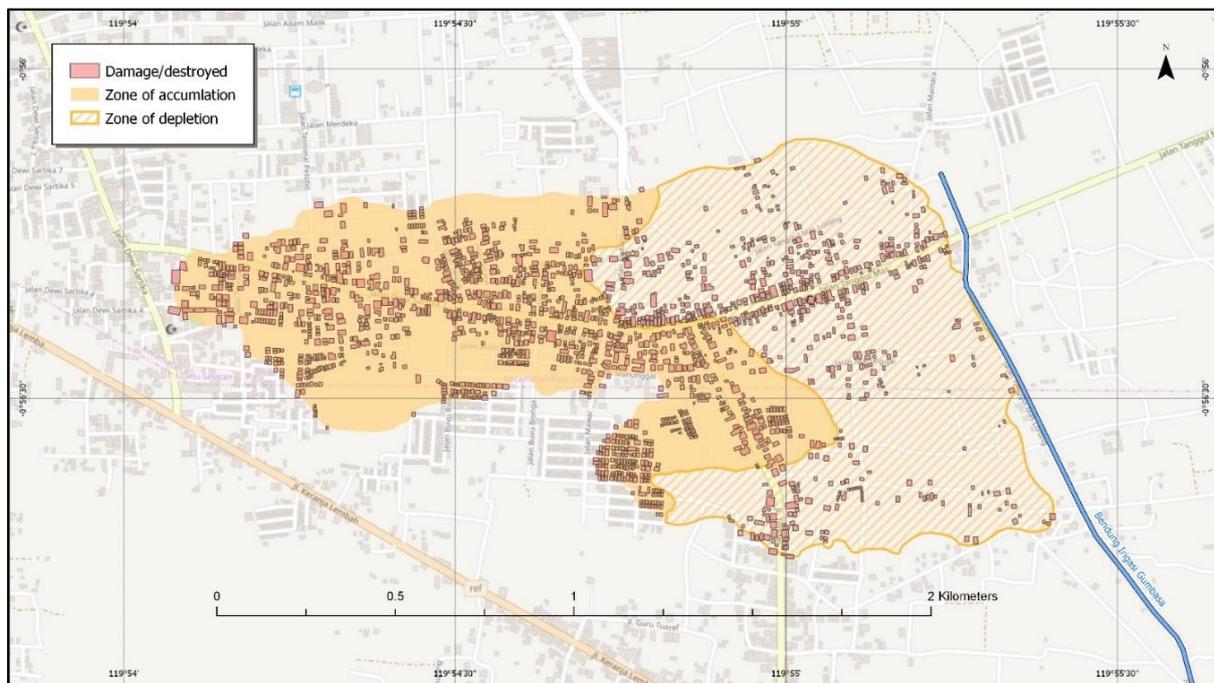
The Petobo Landslide occurred in the south-eastern district of Petobo, Palu city with evidence suggesting the landslide occurred during the earthquake ground shaking. The landslide has a head scarp of approximately 1km wide with a runout approximately 2km long; the head scarp was measured to be approximately 8-9m at its highest. The overall slope angle from the top of the head scarp to the toe was approximately 3°. It has reasonably well-defined zones of depletion and accumulation with most debris being deposited 1km to the west of the head scarp (Figure 4.3) along the main runout. There is also partial back-sloping of the main debris lobe around the central area of the landslide.

Figure 4.3 – Overview of the Petobo landslide area showing zones of depletion and accumulation as well as damaged buildings and the location of the Bendung Irigasi Gumbasa irrigation channel.

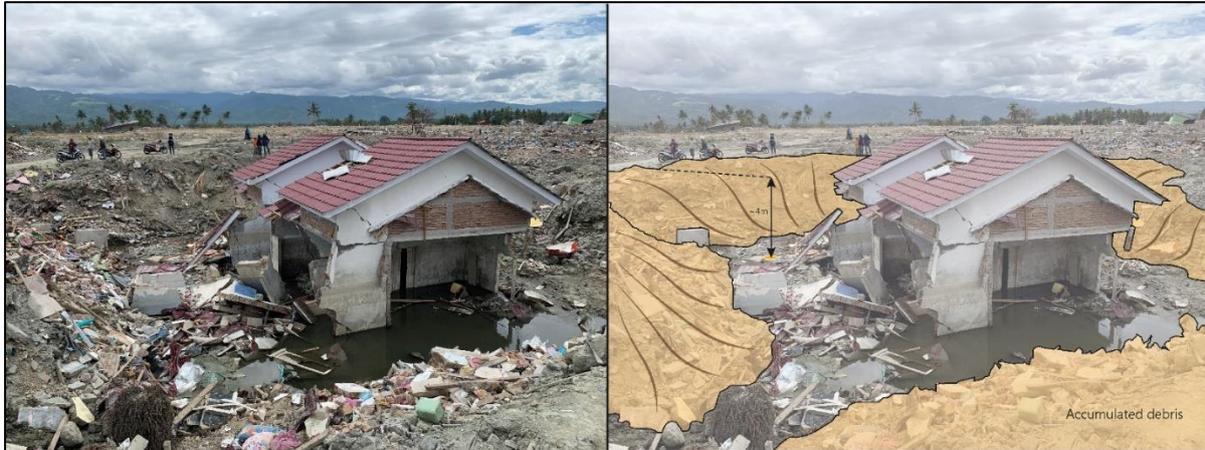
In the upper part of the landslide there is a finger of ground that has been partially inundated with debris but has largely stayed in situ and as a result this has led to a secondary runout, approximately 1km long, to the south of this finger. Much of the lower depositional part of the landslide had been cleared, however, a damaged house situated in a gully formed in the debris with the base at original ground level suggested the deposited debris thickness was approximately 4m (Figure 4.4). Elsewhere, debris has been used to form an embankment for an access road.

Figure 4.4 – Deposited debris thickness in the accumulation zone of the Petobo Landslide.

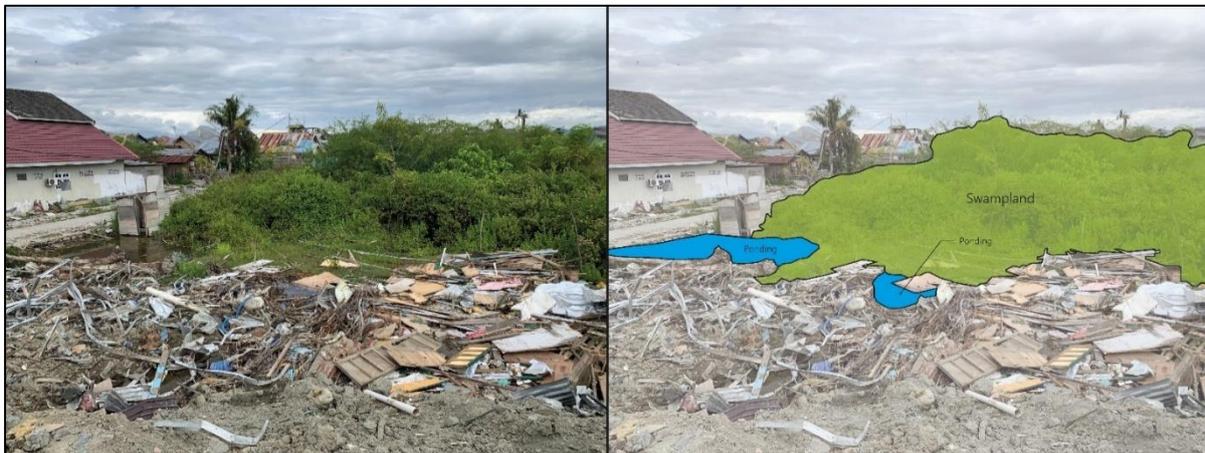
Figure 4.5 – Swampland adjacent to the toe of the Petobo Landslide.

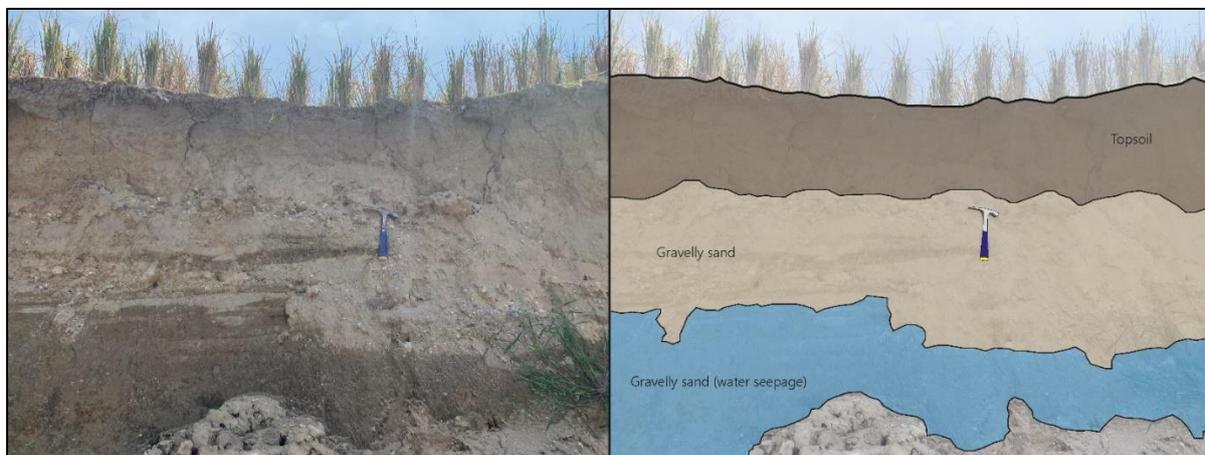
Figure 4.7 – Geological profile exposed in Petobo Landslide head scarp.

Subsurface materials were exposed in the head scarp (Figure 4.7) demonstrating the following succession:

- <1m of agriculturally reworked topsoil; and
- Underlying fluvial/alluvial deposits comprising occasionally gravelly fine to medium sand with occasional layers of increased fines content – base not proven.

This succession was confirmed by a 3m deep borehole hand-drilled prior to the earthquake in the area that is now the upper part of the landslide. Bulk samples of material were collected by EEFIT-TDMRC team from the northern end of the head scarp at depths of 1.6m and 3.1m. These were tested for particle size distribution at University of Dundee as shown in Figure 4.8. The particle size distribution suggested a profile of silty fine sand. Darker patches of wet/damp material were observed in the exposed head scarp suggesting ongoing seepage of groundwater. At a location approximately 1km from the head scarp along the runout natural debris also comprised slightly gravelly silty fine to medium sand.

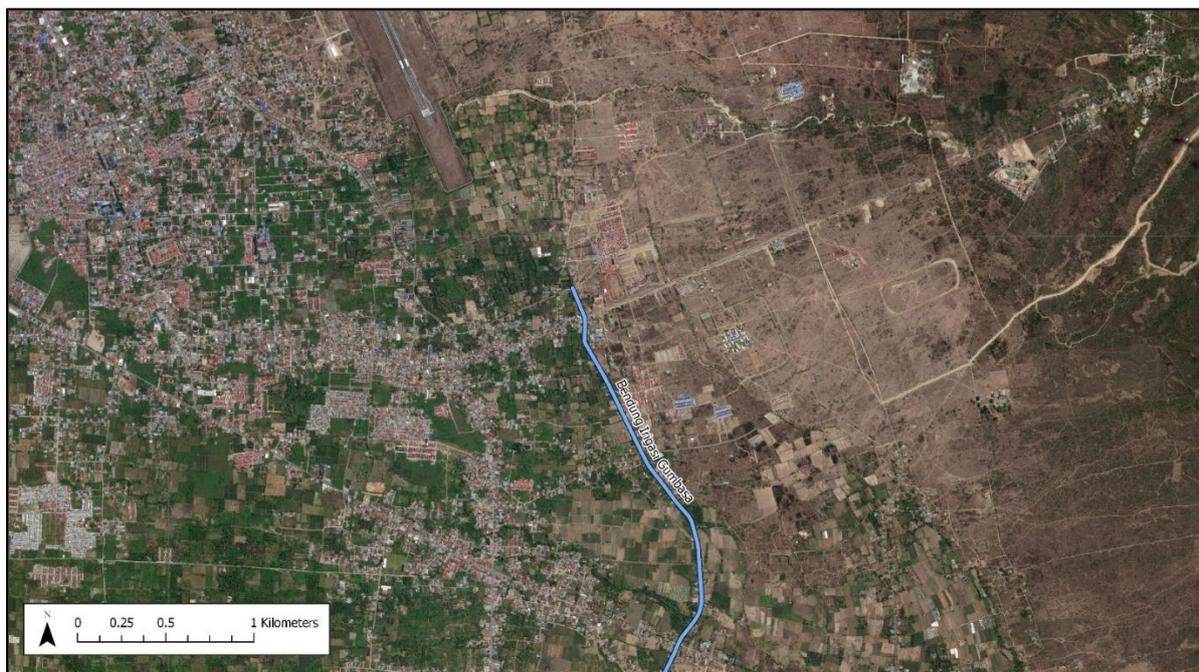
Anecdotal evidence suggests that ground water in the area above the irrigation channel, as terrain steepens, is much deeper between 15-30m below ground level. This is reflected in the aerial photography and satellite imagery of the area, with the land above the irrigation channel observed to be brown (no vegetation), whereas below the channel the ground is green in colour, indicating significant vegetation growth and agriculture (Figure 4.9). There is also limited urban development upslope of the channel as groundwater extraction is likely more challenging.

Figure 4.9 – Difference in vegetation growth due to groundwater conditions on either side of the Bendung Irigasi Gumbasa in the Petobo area. Green vegetation growth (left) indicates wetter ground conditions as opposed to brown land with lack of vegetation growth (right) indicating mostly dry ground.

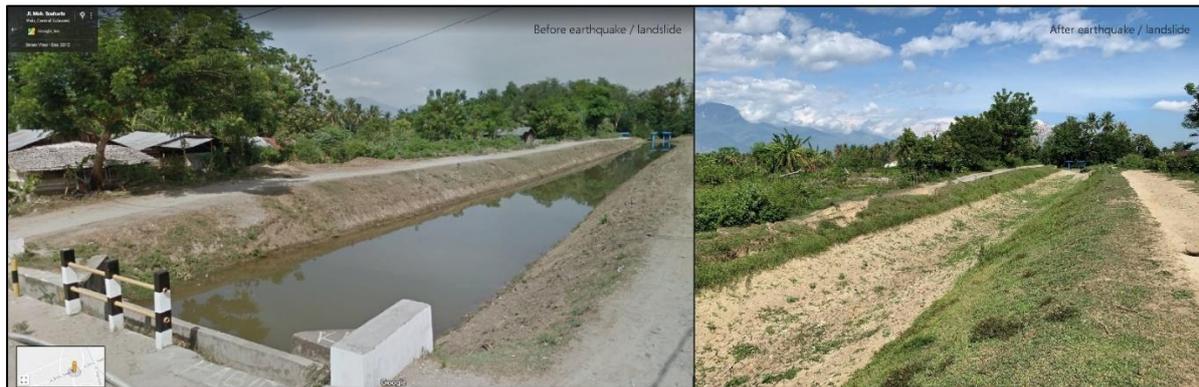
It is notable that both the Petobo and Jono Oge landslides, as well as a much smaller (but still significant) failure in the town of Sibalaya to the south, all initiated along the irrigation channel (Figure 4.3). Eyewitnesses remarked that prior to the earthquake the irrigation channel was full of water and rapidly emptied during the ground shaking (Figure 4.10). Local eyewitnesses at the confluence where the main channel flow control structures are situated reported that flow to the irrigation was stopped in the evening after the earthquake and, at the time of the mission, the entire channel was observed by the EEFIT-TDMRC to be dry except for some localised ponding.

Figure 4.10 – Far northern end of the Bendung Irigasi Gumbasa irrigation channel above the head of the Petobo Landslide before (left) and after (right) the earthquake.

Representatives from the MoPWPH suggested that there were plans to restore the irrigation channel following the landslide, adding to it an impermeable geosynthetic clay liner (GCL) as well as upgrade the local drainage network. They also remarked that a new residential area was planned at the southern end of the airport, to the north of the Petobo Landslide. The airport was pre-existing to the development of the main irrigation channel and it is possible the continuation of the channel was restricted by planning restrictions related to the airport (see Figure 4.8).

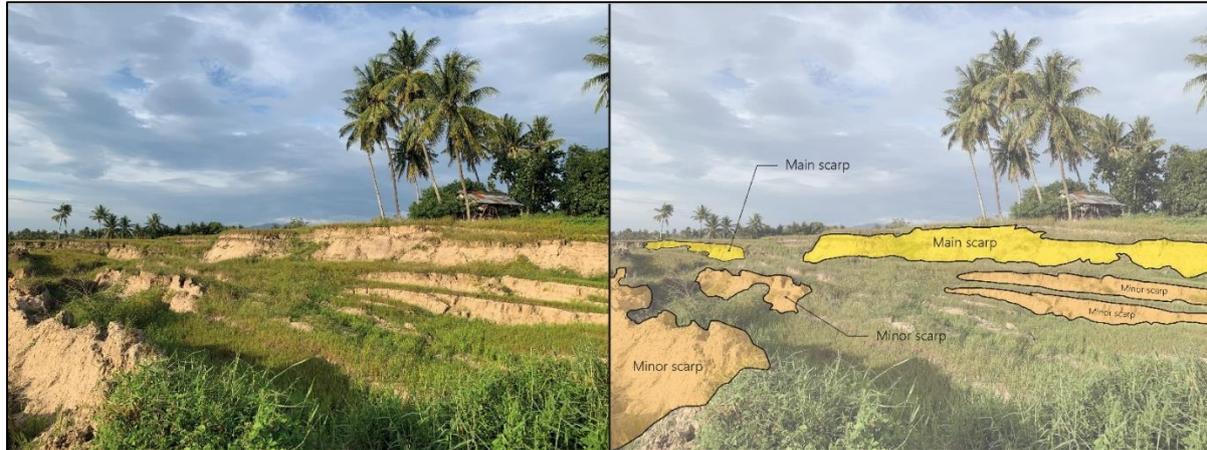
The exposed part of the head scarp was measured to be 3-4m at its highest, although measurement was partially obstructed back-tilted blocks. Significant minor scarps were observed due to abundant back-tilted blocks remaining intact (Figure 4.11). The overall slope angle from the top of the head scarp to the toe was less than 1° – the length of the runout and this low angle suggests the landslide was extremely fluid and thus mobile. The landslide is bounded to the north by a major drainage line – the same drainage line that it eventually becomes entrained in.

Figure 4.11 – Upper part of the Jono Oge Landslide with the main scarp and minor scarps indicated.

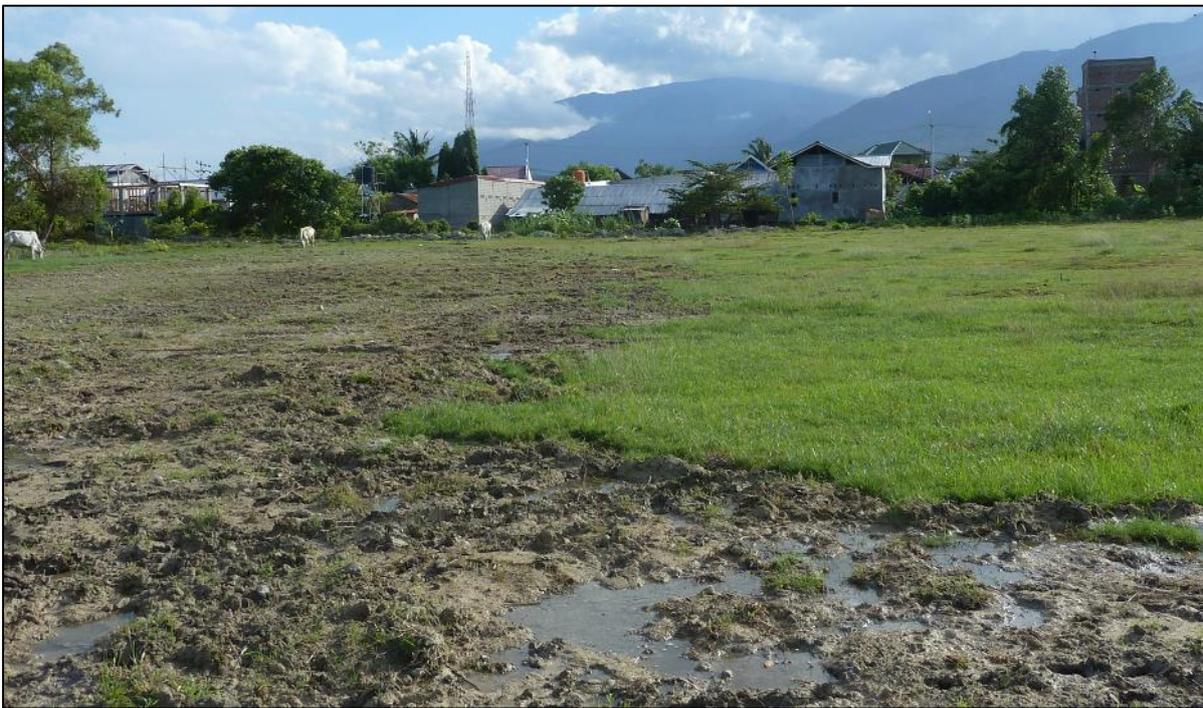
Near the fault in Palu City, particularly in the Lasoso suburb, a small number of liquefaction-induced settlements of structures were observed (e.g. Figure 5.5 and 5.6). Furthermore, the Gelanggang Mahasiswa sports field in Kabonena was crossed by the fault and was observed to be covered in ejecta (Figure 5.2 and 5.3) classified as very gravelly sand (Figure 5.4). A vertical offset of 300 mm around the field suggested settlement of this amount, relative to nearby soils that showed no evidence of liquefaction.

Figure 5.3.- Liquefaction ejecta in a field at Gelanggang Mahasiswa, Kabonena. The ejecta, is seen to follow the path of the fault across the field, although the soil on both sides appears to have settled by a similar distance.

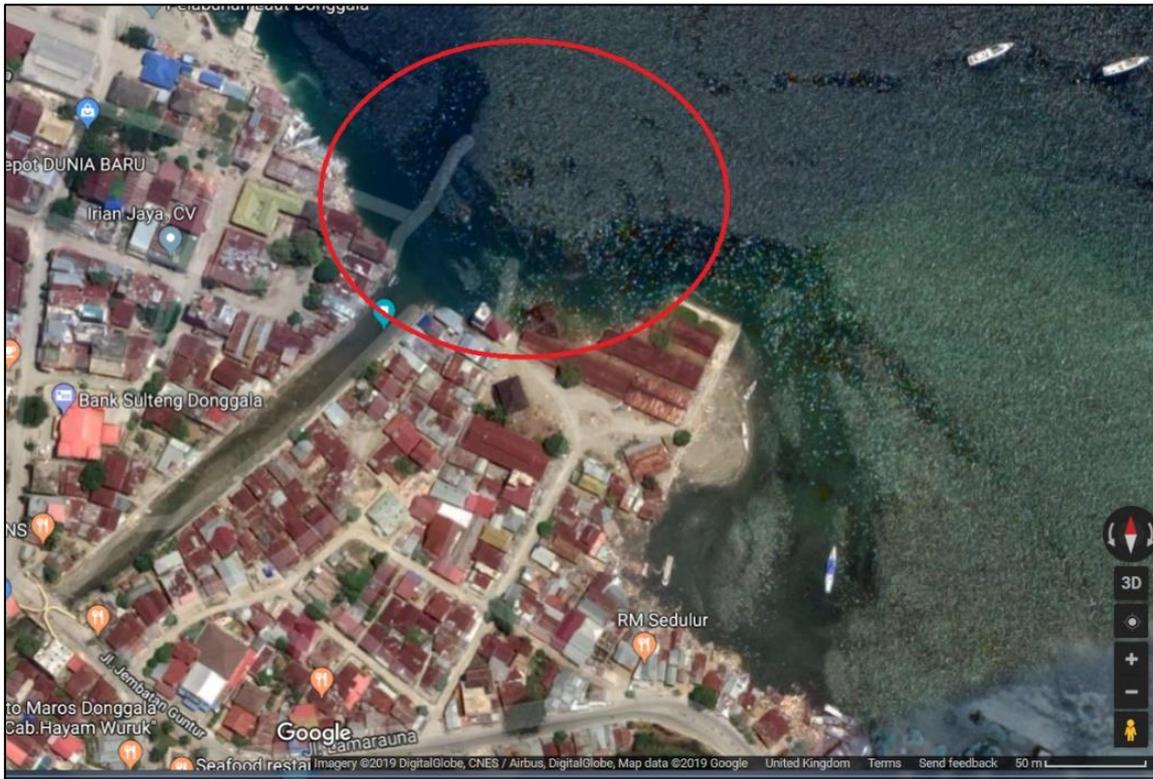
North of Loli Tasiburi was the town of Donggala, with a small port. Further shoreline-reducing liquefaction was seen here, as indicated by the “bite” into the current land shape compared to the overlay of roads shown in Figure 5.22, which is taken from Google Maps. Figure 5.23 shows a photograph of the bay post-earthquake, first across the “bite” (Fig 5.23a) and secondly showing evidence of soil having displaced from beneath a heavy concrete structure (Fig 5.23b). This soil displacement may have occurred through liquefaction induced spreading, as seen in other places, although scour may also have played a part, especially if the soil generated excess pore pressures and was in a softened state at the moment of tsunami wave inundation.

Figure 5.22 - Aerial photograph of post-earthquake Donggala port, overlain by prior road map showing missing land around the estuary mouth.

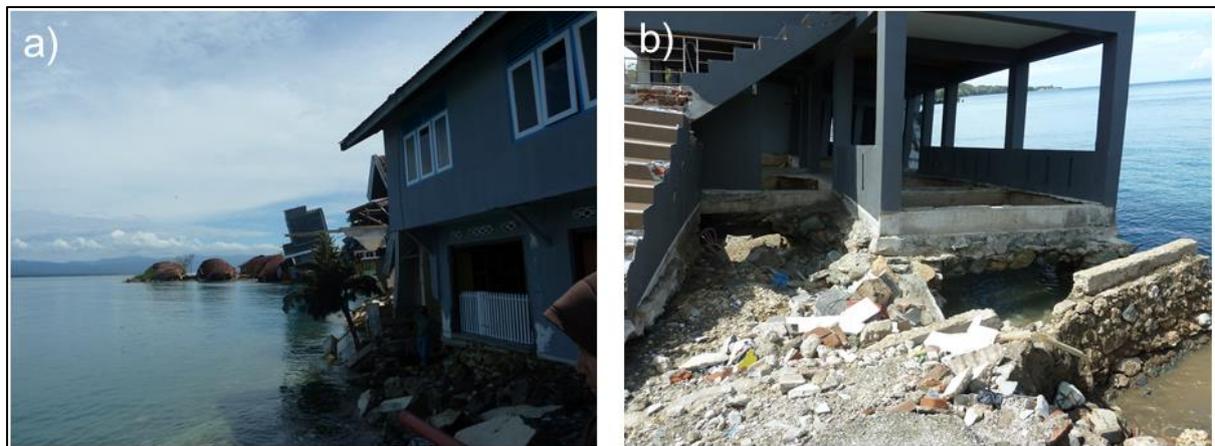
Figure 5.23.- Photographs of Donggala Port, looking a) South East across the estuary towards the partially collapsed metal rooved storage houses b) detail beneath the concrete structure seen tilted on the South edge of the bay, showing evidence of soil having been displaced from beneath the structure.

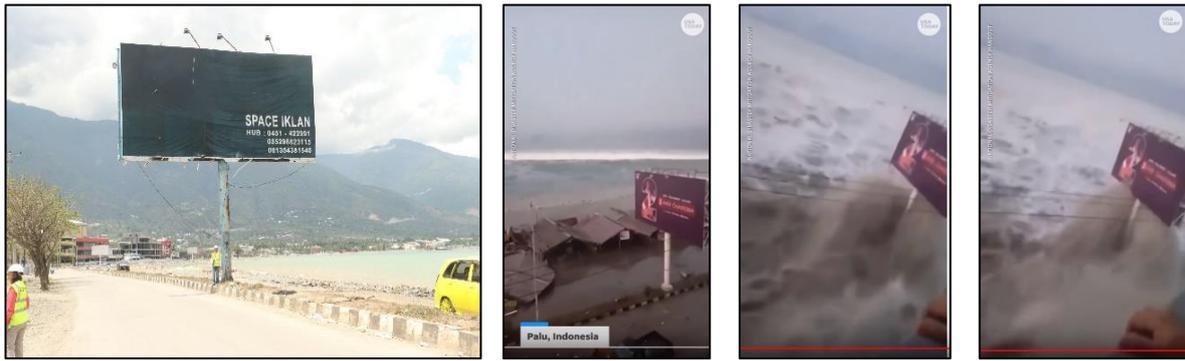
Evident from Figure 6.4 is that, in general, the inundation heights increase towards the head of the bay, with 7m inundation height consistently measured. Figure 6.5 provides an indication of what an inundation height of 7 – 8 m looks like. The left-hand image is a photograph of a team member standing against an advertising board at the southern tip of the bay, (Jalan Taman Ria, Balaroa, 0 53' 1.6" S 119 50' 53.4" E), alongside 3 frames taken of the same sign (rear side) during the tsunami. Obviously, some of the wave is highly aerated so it does not have the same force as green water loading.

Figure 6.5 - Tsunami inundation at Jalan Taman Ria, Balaroa ($0^{\circ} 53' 1.58'' S$ $119^{\circ} 50' 53.42'' E$).

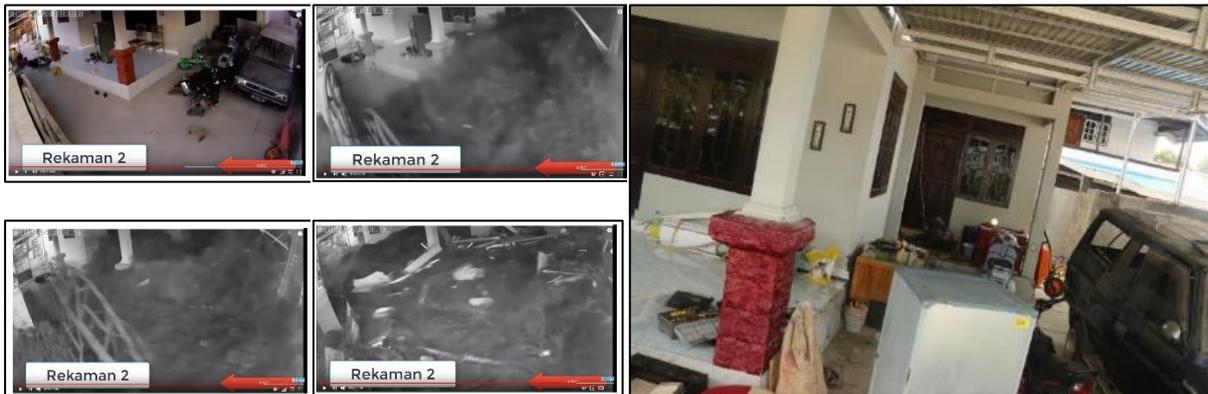
Wani is a town on the east coast of Palu Bay that suffered considerable damage due to the tsunami, (see Figure 6.10), and was made famous as the location of a household CCTV footage that showed the effect of the earthquake followed three and a half minutes later by the tsunami (Figure 6.11). The Team identified the house at which the CCTV was recorded (coordinates: 0 41'38.532" latitude; 119 50'31.422" longitude), and from comparison of measurable features of the house that were visible in the video, estimate the maximum inundation depth (above grade) at the site of the house to have been around 1.2m.

Figure 6.11 - Video frames at 18:03:01, 18:06:29, 18:06:30, 18:06:36 and during the EEFIT mission. Notice the mopeds have fallen over, following by the bore-like tsunami about 3 minutes later. This short arrival time supports the argument, discussed in Section 6.2.1, for a secondary tsunami source within Palu Bay.

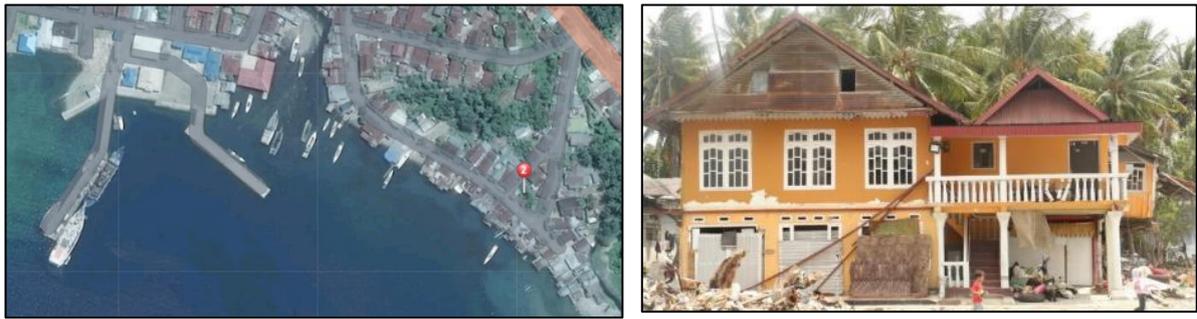
Whilst in Wani, at the location shown in Figure 6.12 (left), the Team heard the dramatic account of a man who saw the water coming out of the ground during the earthquake so got into his car to pick up his wife and mother. Having got into his car, the man only had time close the window, before he felt water rise up to his knees. It then went dark due to the wave, then light again. The car stopped and he broke the window to climb to the balcony of the house shown in Figure 6.12 (right). Whilst he was at top of the rear stairs he heard the next wave and the sound of debris. He then saw a fast-flowing stream of water and people screaming for help. After the water receded he was reunited with his wife and mother.

Figure 6.12 - Location (left) and photograph (right) of the house where the man in the car ended up at around 50 m inland from the sea

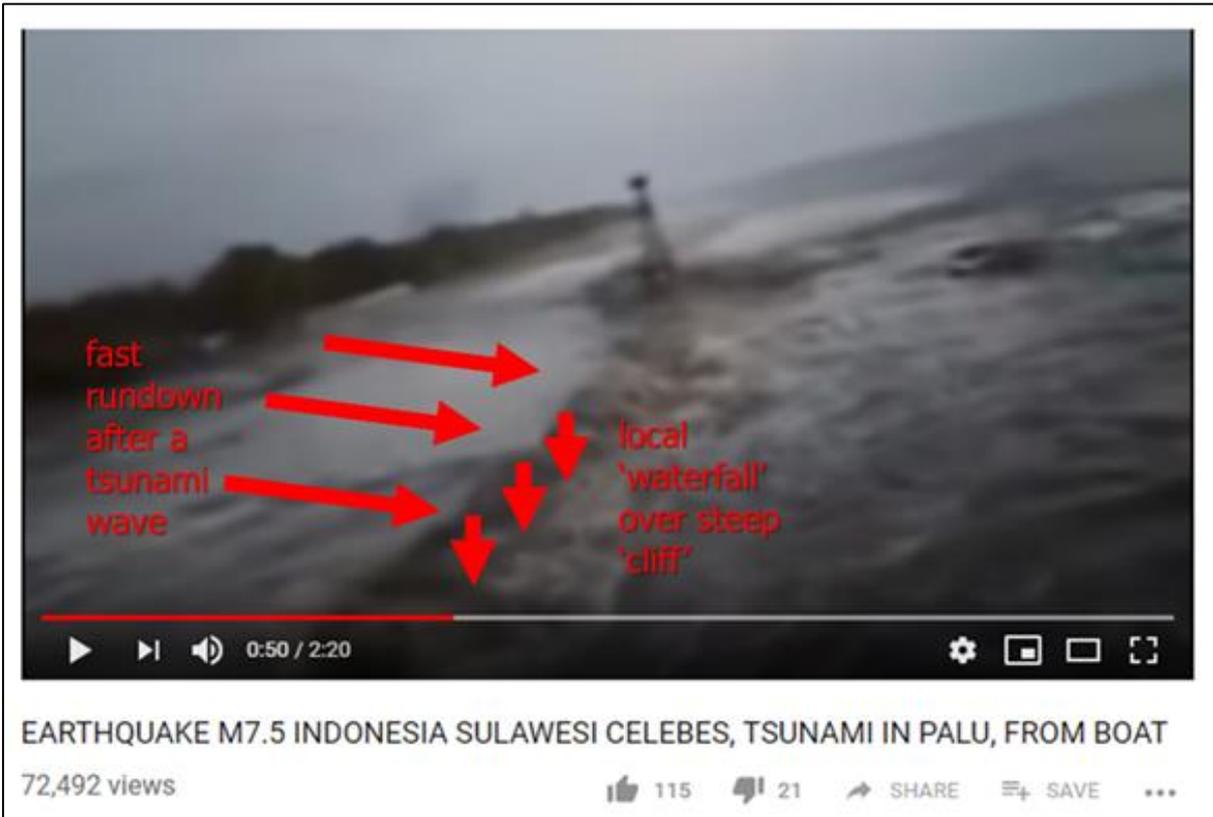
A coastal landslide occurred shortly after the earthquake, creating local tsunami at the river mouth and with subsequent land subsidence causing a number of houses to collapse into the sea. The cross-shore profile of shallow water bathymetry reveals the depth, suggesting the size of the landslide. Figure 6.14 is an annotated YouTube video frame showing the wave rundown which reveals the cliff-like structure on the seabed, presumably following a submarine landslide.

Observations and interviews provide an unclear picture of what exactly happened in this area. The “boiling water” could be consistent with liquefaction of submarine soils in shallow water depths, that might then have produced a landslide. More plausible is that a wave could have been triggered by the land masses shifting into the sea.

Figure 6.14 - Youtube video frame indicating wave rundown and the sharp change in bathymetry following a submarine landslide.

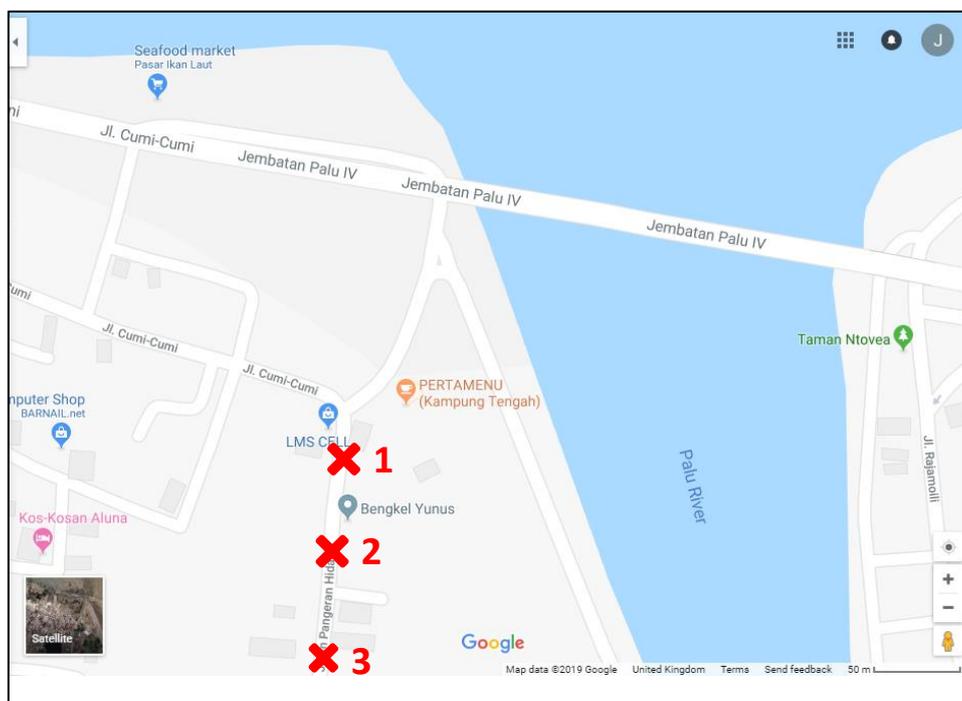
The horizontal extent of the tsunami is regarded to be modest, which is indicative of a landslide generated tsunami i.e. one with relatively short wavelength (Buldakov, 2013). The team investigated inundations along a transect along a southerly direction i.e. from north to south. Three locations are indicated in Figure 6.18, then described in Figure 6.19.

Figure 6.18 - Locations 1, 2 and 3 where inundation was observed and described below

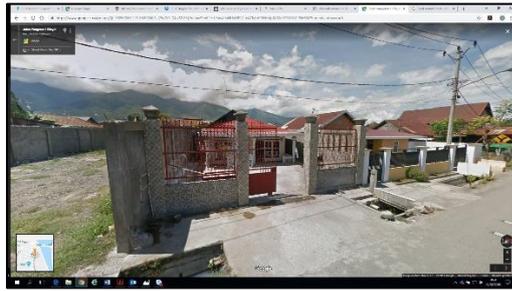
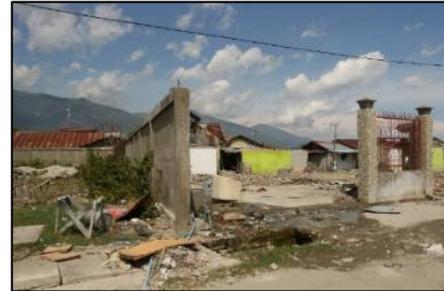
Location 1, looking westward

The left-hand column of Figure 6.19 shows Google Streetview scenes from before the earthquake/tsunami and the right hand column show the same locations captured during the TDMRC-EEFIT mission. North of Location 1 (Figure 6.18), there was severe devastation and damaged structures had already been cleared. The first row of Figure 6.19 corresponds to Location 1 looking westwards, surrounded by ornamental walls and a gate. There was simply no sign of the house when we visited. Also, at Location 1 but looking eastwards, the timber structure with rusty steel roof evident from Google Street-view had also disappeared, but the neighbouring house seemed largely unaffected. The photographs at Location 2 which are shown in the third row of Figure 6.19, about 50 m further south, illustrate the care with which vertical inundation needed to be established, as the pre-tsunami photograph shows a significant discolouration line which is due to rising damp, common in that area.

Figure 6.19 - Evidence of inundation and the respective effects: (Left column) Pre-earthquake/tsunami images from Google Streetview (Right column) EEFIT observations at same locations Descriptions of each location are provided in the paragraph above.

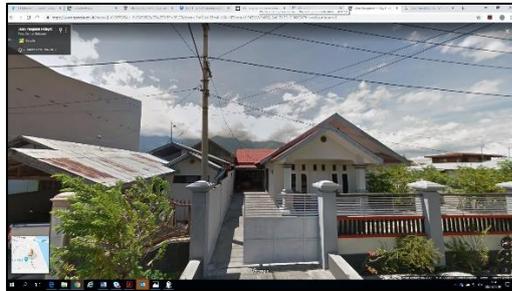
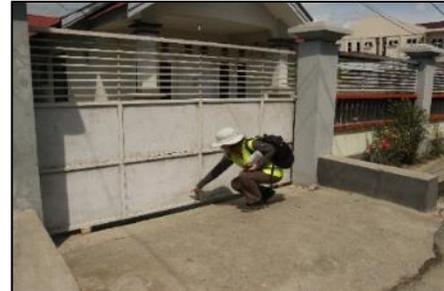
Location 3, looking westward

Only by obtaining additional clues *e.g.* from a faint black line on the white timber door can an accurate level be ascertained. The fourth row of Figure 6.19, corresponds to Location 3 facing westward, a further 50 m or further south, which revealed a watermark on a set of metal gates, protecting a house which seemed unaffected. Finally, the bottom row, also at Location 3 but looking eastwards, shows remediation work that has been undertaken. Here, a wide, sloping kerb had been constructed right up to the timber doors. Enquiries at that location solicited the fact that due to local coastal subsidence the high tides were reaching the same extent as the horizontal inundation of the tsunami, so this protective kerb had been erected to address on-going flooding issues. This new flooding hazard was apparently also bringing crocodiles into Palu.

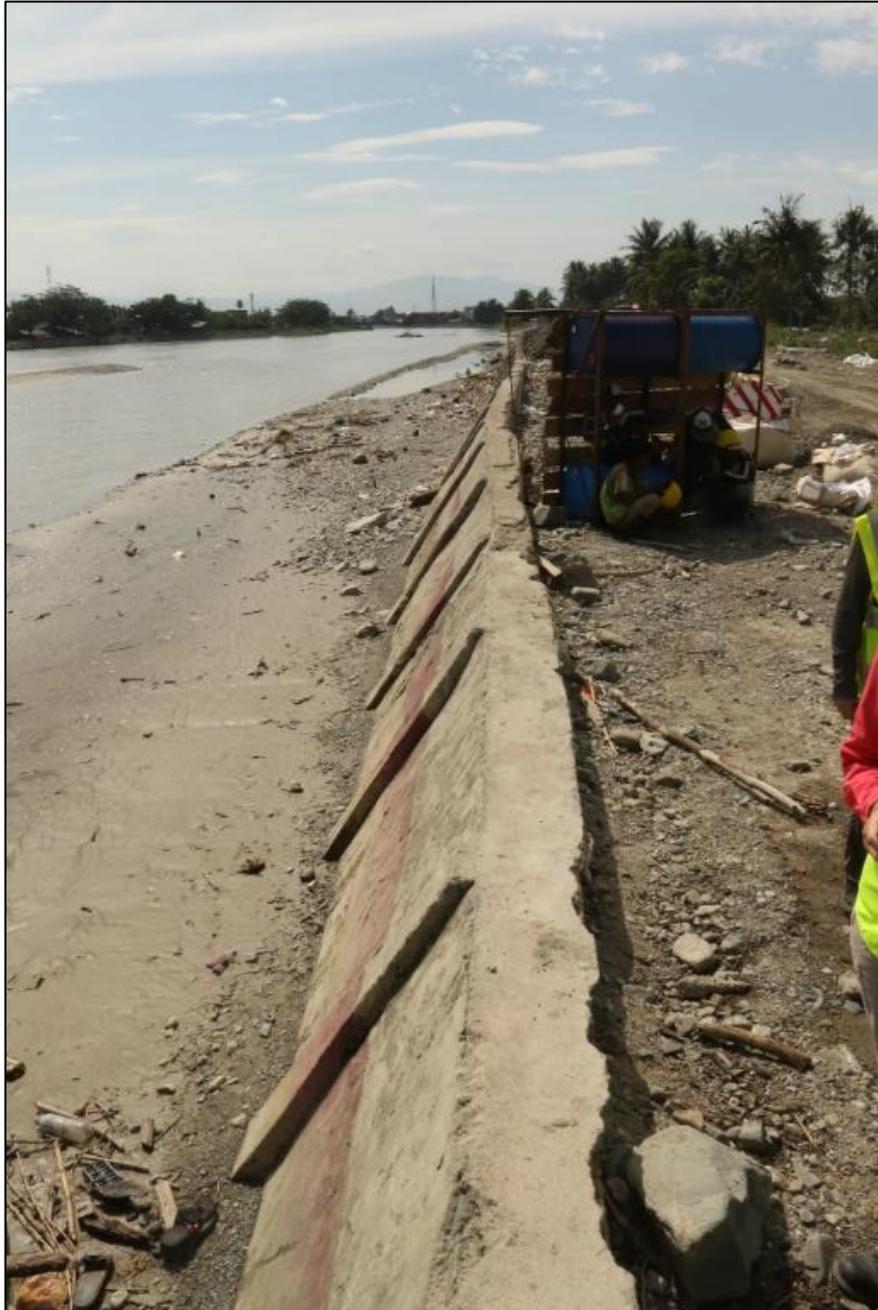
In contrast to another EEFIT mission to Japan in 2011, the tsunami did not evidently travel up the Palu river, despite its considerable height at the southern end of the bay. Considering the substantial building damage seen at the shoreline near the mouth of the river, one would expect to see building damage continued some way upstream along the river, on the riverbanks. It was verified by visiting the neighbourhood on the west side of Palu river, just inland from the coast, that there was no damage. Eyewitnesses also said they just saw boats bobbing up and down but no significant overtopping of the river wall (Figure 6.20) close to their house. It is probable that there was a mitigating effect on the tsunami from the collapsed Palu Bridge IV (Figure 6.21). The bridge collapsed during the ground shaking, and fallen bridge deck is likely to have acted as a barrier to the tsunami, mitigating its effects on the river.

Figure 6.20 - Concrete river wall near entrance to the Palu river

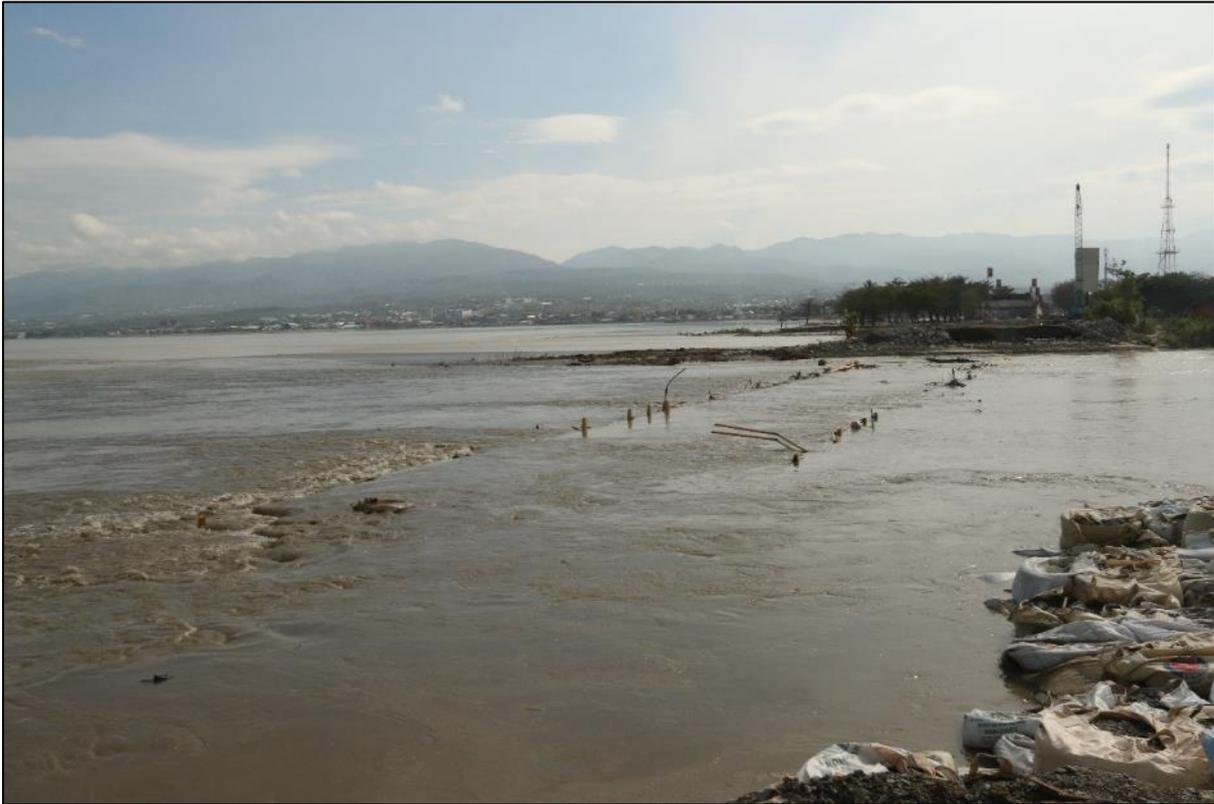
Figure 6.21 - Submerged bridge deck of the Palu Bridge IV which may have acted as a submerged breakwater to the tsunami waves, preventing them travelling up the river
