**The Central Sulawesi, Indonesia Earthquake and Tsunami of 28th
September 2018 – A Field Report by EEFIT-TDMRC**

01/11/2019

Prof Tiziana Rossetto, EPICentre, University College London

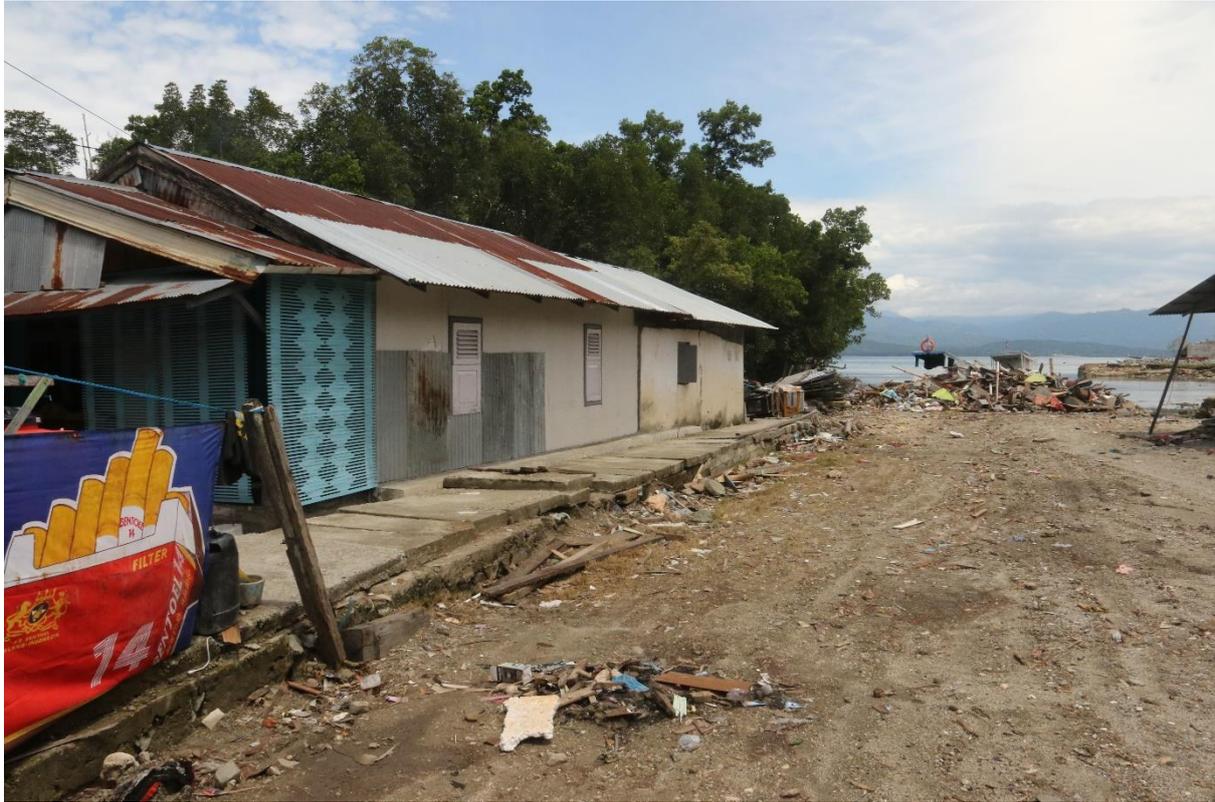
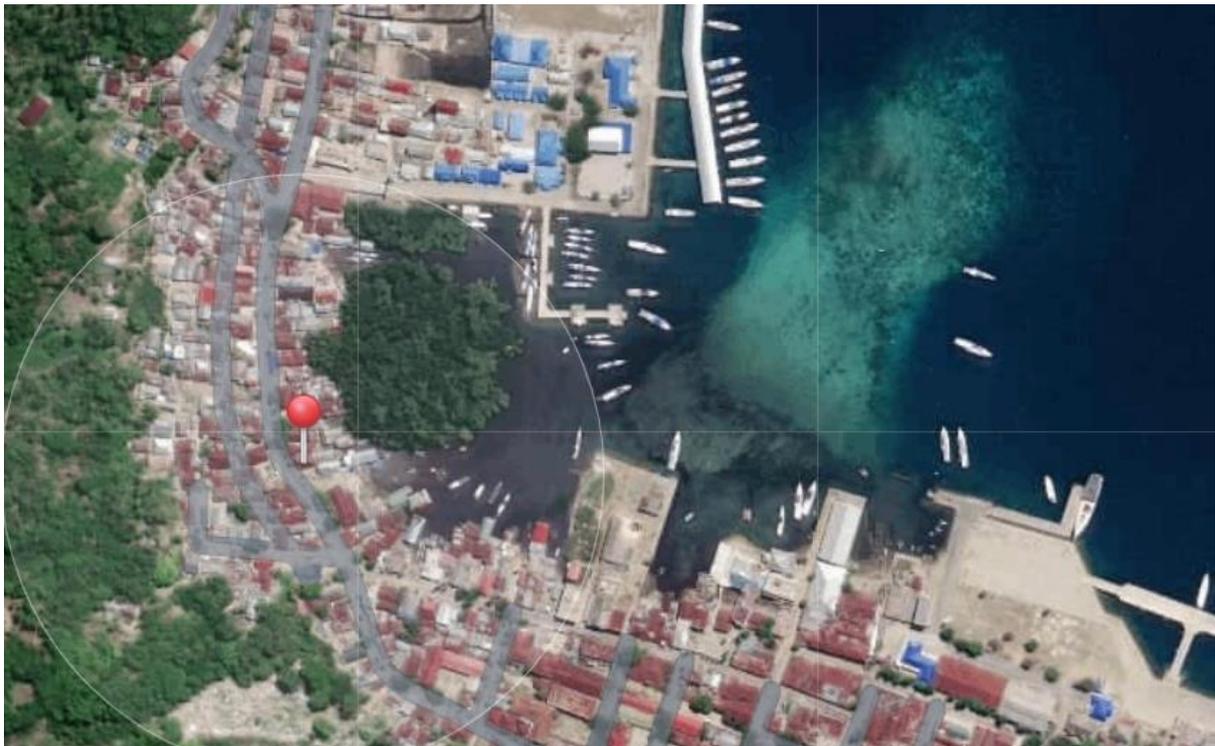
Mangroves are native to Indonesia, and in some locations were seen to provide some limited protection from the tsunami inundation. Mangroves in Labuan Bajo were said to have provided some protection to some poor quality 1960s housing (Figure 6.22), locally resulting in no damage.

Figure 6.22 - (top) Poor quality 1960s housing in Labuan Bajo that has been sheltered by a large area of mangroves at the shoreline. (below) A map showing the position of the building within the port, behind the large green area of mangroves

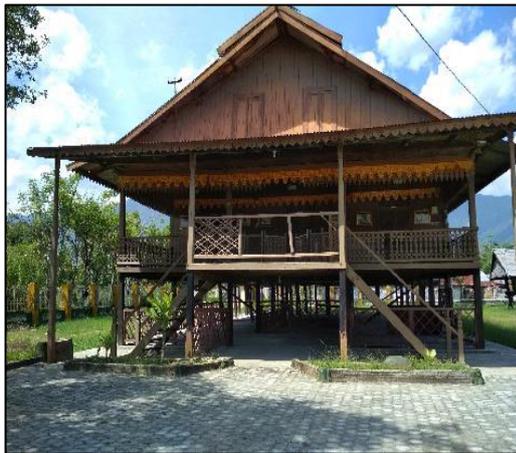
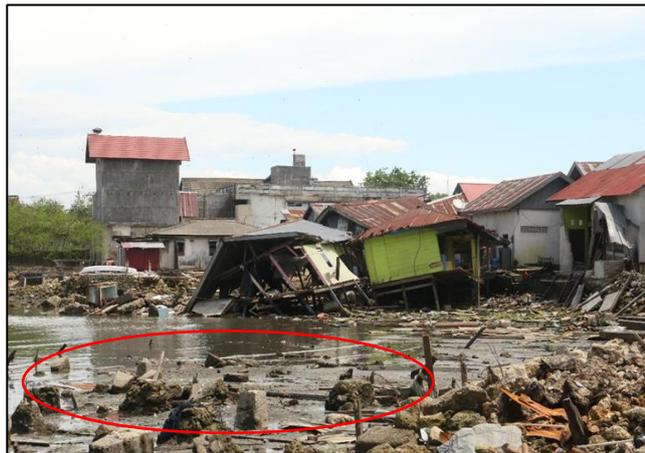
The stilt houses showed varied performance under the earthquake and tsunami. At the shore-front these structures performed badly due to ground subsidence and the tsunami inundation reaching the first floor. For example, Figure 7.4-right shows the remains of the stilt houses foundations of the fisherman village in Labuan Bajo Donggala. However, in other areas, where the tsunami inundation did not exceed the ground floor, this type of housing was seen to perform well due to their open ground floor offering little resistance to the flow. Only two examples of stilt houses were surveyed by the Team in an area of Palu that had not been inundated by the tsunami. These were both at the Heritage site of the palace of the Princes of Palu, with the first (Figure 7.4-left, the palace) being undamaged by the earthquake ground shaking, whilst the neighbouring very small structure exhibited severe tilting.

Figure 7.4 - Performance of timber stilt houses in Palu and Donggala, Central Sulawesi: Left – The palace of the Princes of Palu. This structure was affected by ground shaking but not tsunami inundation and was undamaged. Right - The remaining concrete foundations of the timber stilt houses in the Labuan Bajo Fisherman Village, shown in red circle. Collapsed stilt houses can be seen in the background.

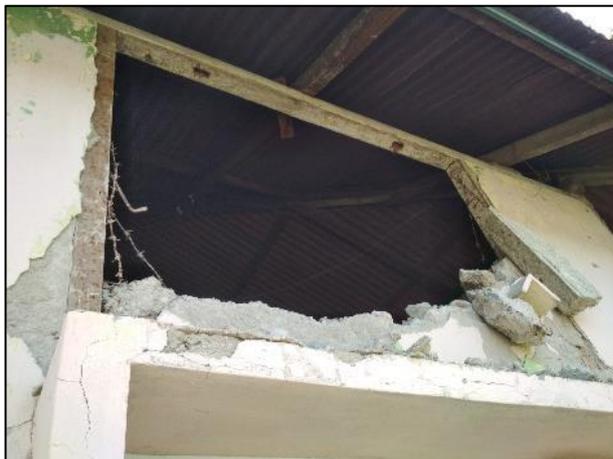
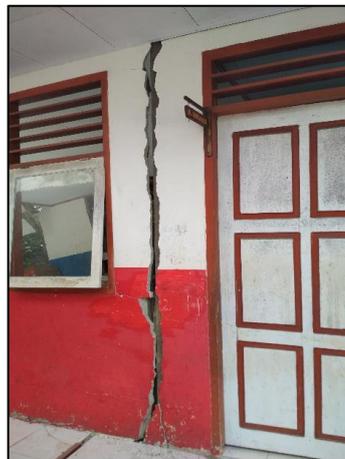
The typical earthquake induced damage observed in these buildings was out-of-plane failure of the infill walls or separation between the infill and frame due to differential settlement (see Figure 7.8).

Figure 7.8 - Typical earthquake damage observed in infilled timber frame construction. Left - Out-of-plane failure of infill panels. Right - Separation of infill from frame due to differential settlement of foundations.

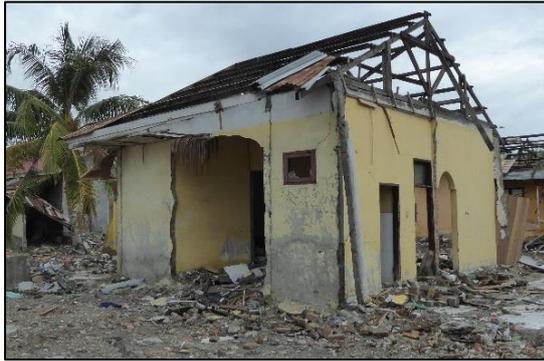
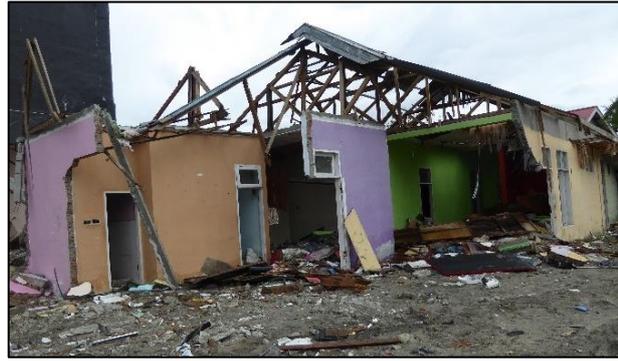
Figure 7.10 – Heavily damaged CM houses in Palu bay area along the Jl. Rajamoili road, about 100m from coastline. The walls of this house were directly hit by the tsunami inundation.

Typical damage sustained by CM houses along the coast line in Palu bay area is shown in Figure 7.10. The main damage pattern is the out of plane failure of walls directly hit by the tsunami waves. The tie-columns, being small in size and having poor reinforcement detailing, also suffered shear damage. However, as shown in Figure 7.11, sheltered houses near the coastline were unaffected, indicating that the effect of ground shaking was modest in this area.

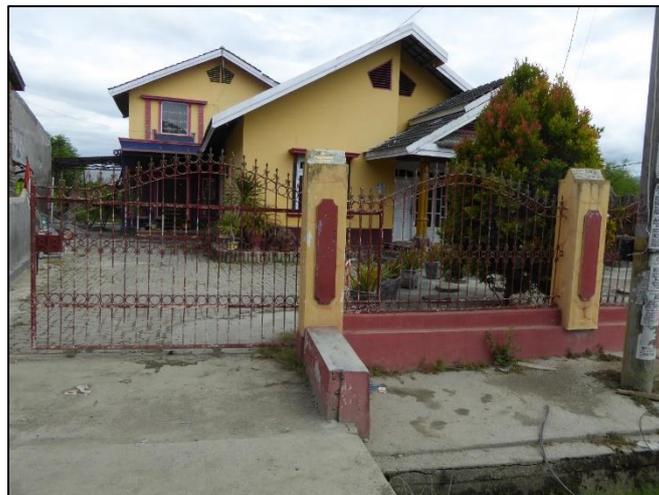
Figure 7.11 – Undamaged CM houses in Palu bay area along the Jl. Rajamoili road. These houses were sheltered from the tsunami inundation by other houses-buildings.

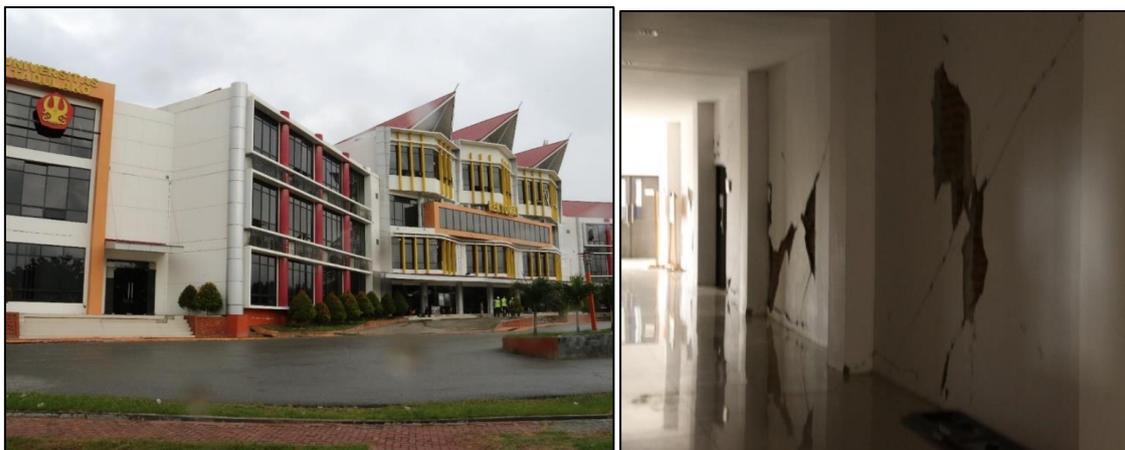
The Rector's office building is of 3 stories, has piled foundations and large open spaces at the ground storey. It is observed that the main damage is due to the in-plane shear cracking of brick partitions, the falling of suspended ceiling and breaking of windows. No damage to structural elements was observed and no casualties were sustained in this building. Some movement was apparent in a vertical construction joint at the south end of the structure, indicating a 2-5cm settlement of the north side relative to the south. This was evidenced also by displacement of paving outside the building. Also, relative movement of the structure and ground was seen to cause a reduction in the width of drains to

Figure 7.19 - Tadulako University Rektorat (DET2): exterior view (left); damage to internal infill panels (right)

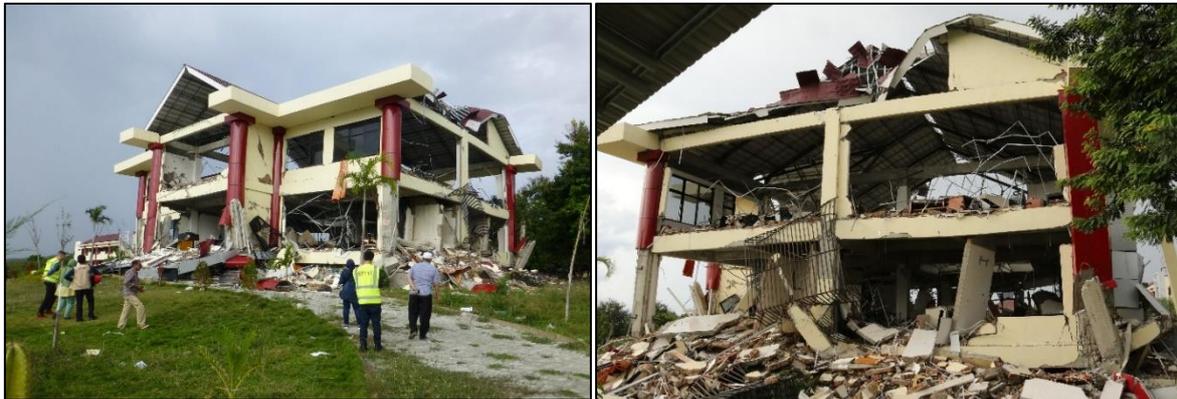
Figure 7.20 shows the collapse of a 3-storey reinforced concrete frame building, part of the Faculty of Social and Political Sciences, at the university campus. This building had been built in 2016, and failure occurred through the activation of a soft-storey type mechanism, due to plastic hinge formation in the beam-column joints. The building has a plan approximately 20m x 12m. The primary beams are large (500mm deep by 300mm wide), span up to 6m in the shorter dimension of the building and have secondary beams of large size (250mm deep by 250mm wide) framing into them at 3m intervals. No columns support the primary beams at mid span, where there is the primary to secondary beam connection. The columns are larger than the beams (500mm x 500mm in plan) and are reinforced with 10 x 25mm ribbed diameter longitudinal reinforcing bars.

Figure 7.20 - Tadulako Univerity collapsed 3-storey building of the Faculty of Social and Political Sciences. Left – front view. Right – back view.

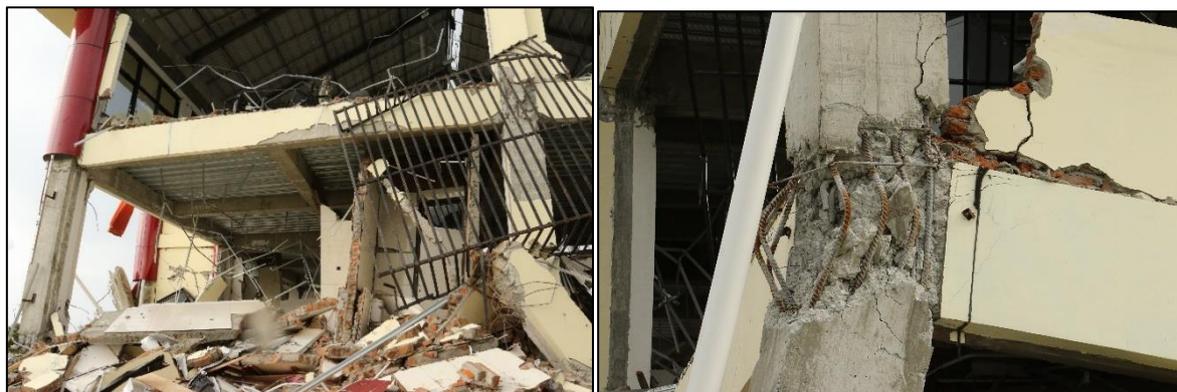
Shear reinforcement in the columns consists of smooth 10mm diameter hoops with 90degree hooks, at 140mm spacing. The roof is pitched and consists of a lightweight steel cover (CGI) on steel beams that terminate on the top beam of the frame. The floors consist of shaped sections of steel plate supporting concrete screed. The latter provides little/no contribution to the moment capacity or restraint of the beams. This, combined with the similar size of beams and columns, the soft-storey mechanism at ground level and lack of any shear reinforcement in the joints, has led to beam-column connection failure and building collapse. Concrete spalling of an exterior beam-column joint can be seen in Figure 7.21 – left and a failed exterior joint can be seen in Figure 7.21 - right).

Figure 7.21 - Tadulako Univerity collapsed 3-storey building of the Faculty of Social and Political Sciences. Left – Side view of the building. Right – Failed external joint.

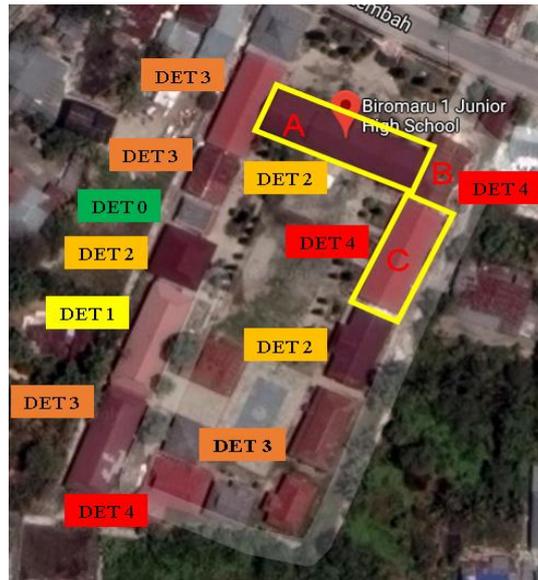
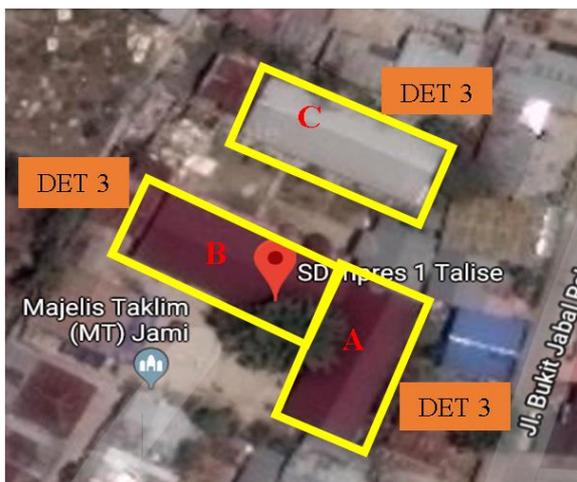
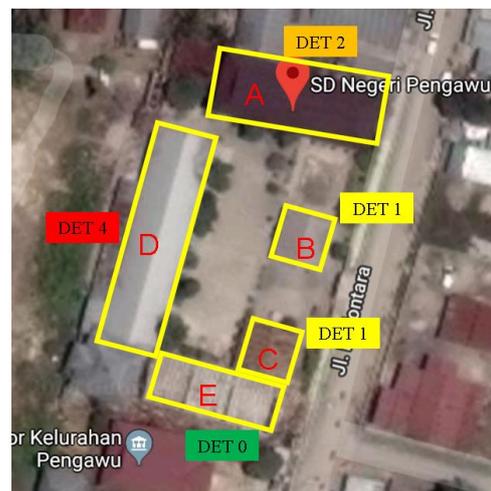
Figure 7.24 – Damage observed in buildings at three school complexes.

(a) SMP Negeri 1 Biromaru School in Sigi. Building A is a 2 storey RC infilled frame structure, whilst all other buildings are one-storey CM construction). Building B was reduced to rubble, whilst most of the other CM buildings suffered range of damage states – from slight (DET2), very heavy (DET3) to partial collapse of their shorter walls (DET4).

(b) SD Inpres 1 Talise School in North Palu. Affected only by shaking (not ground failure) from the earthquake. All three buildings are single-storey CM buildings. All suffered unrepairable damage (DET3). Main damage mechanisms are separation of walls and gable failure, due to poor quality materials and ineffective confinement.

(c) SD Negeri Pengawu School in Palu. Two small-plan single-storey CM buildings (B and C) suffered minor, repairable damage. The large plan CM single-storey building D suffered heavy damage to collapse of some walls (DET4) due to differential ground movement. Building E is CM but was under construction at time of earthquake. Building A is a 2-storey RC infilled frame structure.

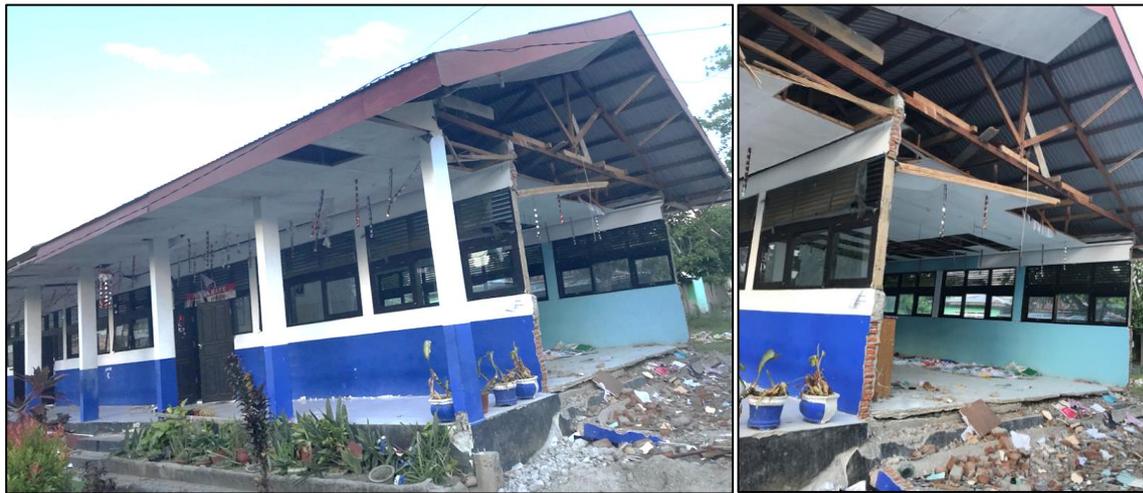
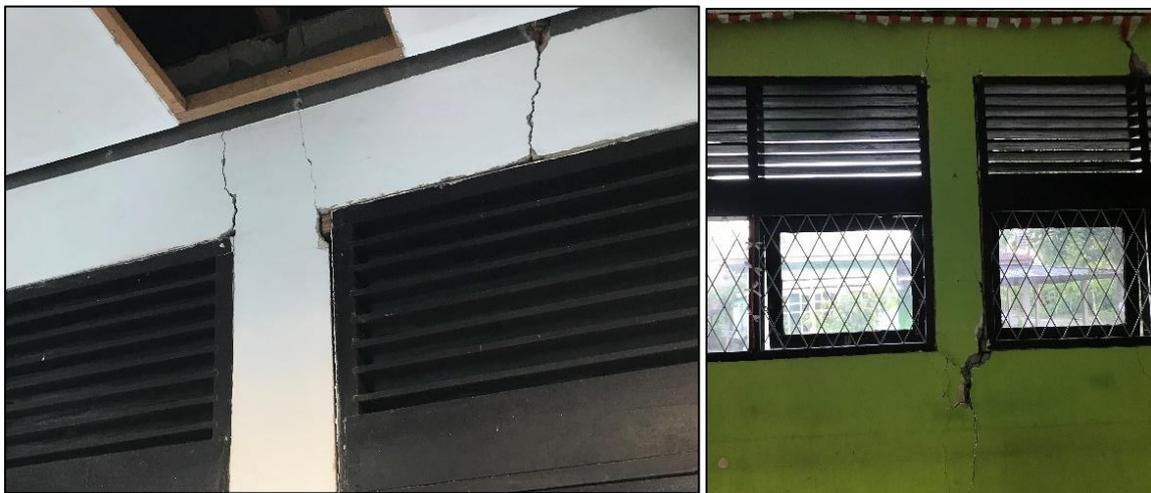
Figure 7.26a shows the complete collapse of the shorter wall of a CM school building in Sigi area. All the cross walls of this building suffered either collapse or detachment due to extensive damage in the out-of-plane direction. However, the in-plane damage was limited (Figure 7.26b). The heavy damage suffered by this building is attributed to the long, thin and poorly confined cross walls, poorly reinforced tie-elements and deteriorated material quality.

Figure 7.26 - Heavy damage sustained by CM school buildings at SMP Negeri 1 Biromaru School. (a) Out-of-plane collapse of the shorter wall in Building C (see Fig. 7.24). All the other cross walls either collapsed or are on the verge of collapse. (b) In-plane flexural and shear cracks through the spandrels. (c) In-plane flexural and shear cracks through the tie-columns.

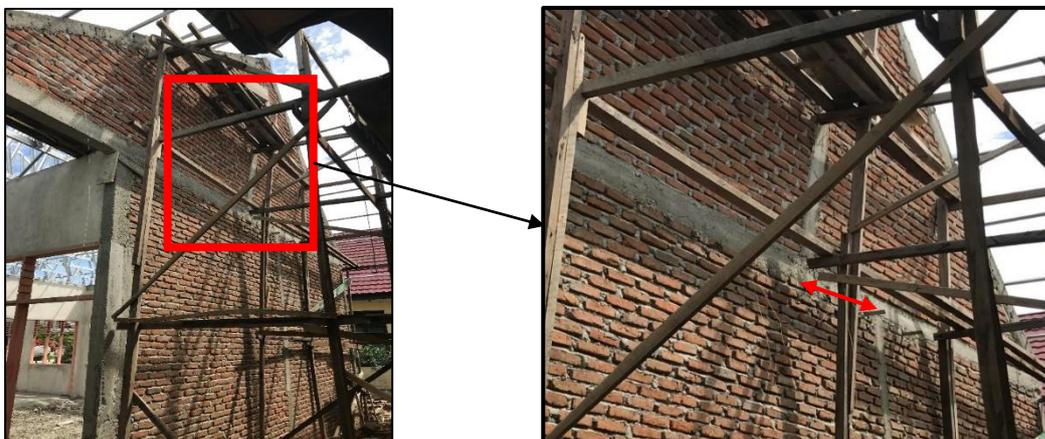
The EEFIT-TDMRC visited one school that was still under construction at the time of the earthquake. This CM school building, shown in Figure 7.28, did not suffer any apparent damage. The level of confinement of the masonry panels and gables was seen to be good, but a construction defect was observed, in that the middle tie-column is not continuous up to the full gable height.

Figure 7.28 - Confined masonry school building (E in Fig. 7.24) in SD Negeri Pengawu school in Palu that was under construction at the time of the earthquake. Note the offset of the middle tie-column at the tie-beam level.

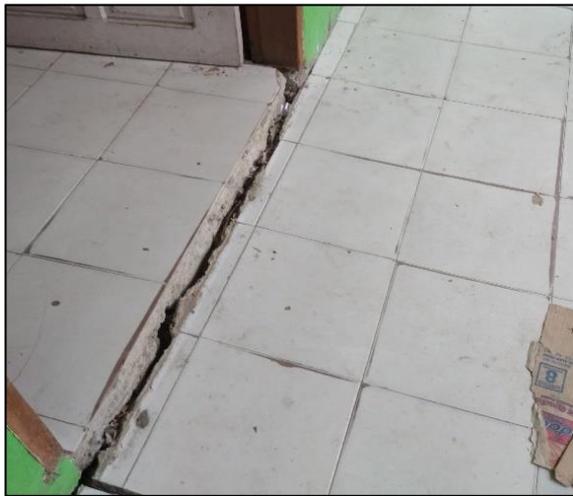
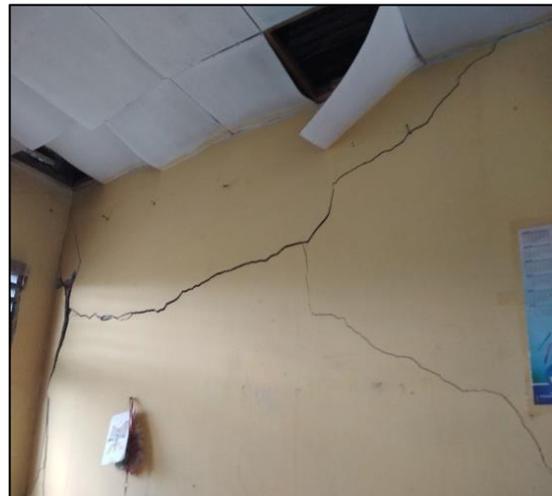
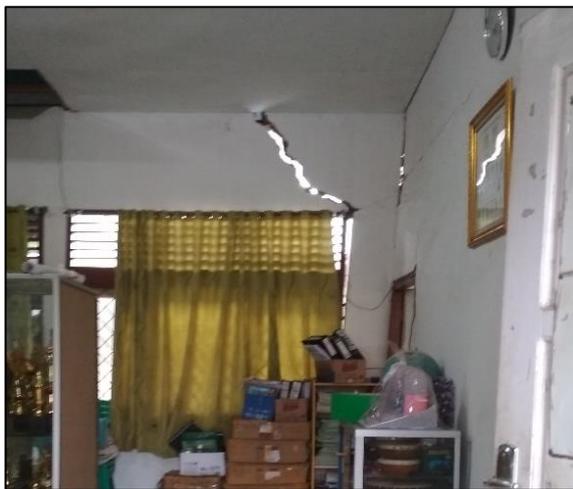
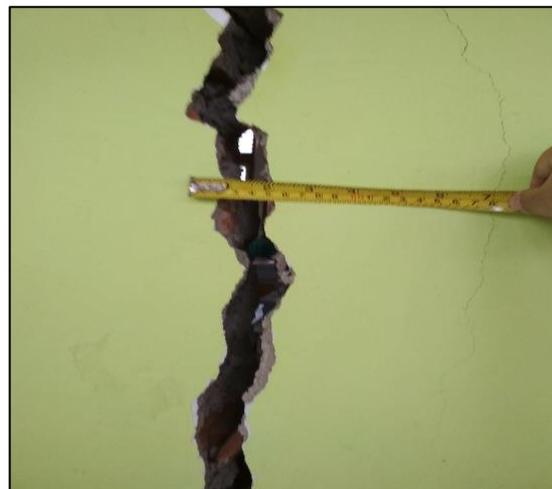
In many of the observed schools, ground failure precipitated damage. Differential settlement of buildings was common in the Sigi area and areas either side of Palu bay. Figure 7.29 shows some examples of the amplified damage due to the combined effect of the ground shaking and differential settlement.

Figure 1.29 - Extensive damaged in CM building (building D in Fig. 7.24c) in SD Negeri Pengawu school due to differential settlement. (a) differential movement of ground across a ground crack passing under the building caused failure of the floor. (b), (c) and (d) show crack opening induced by differential ground movement.

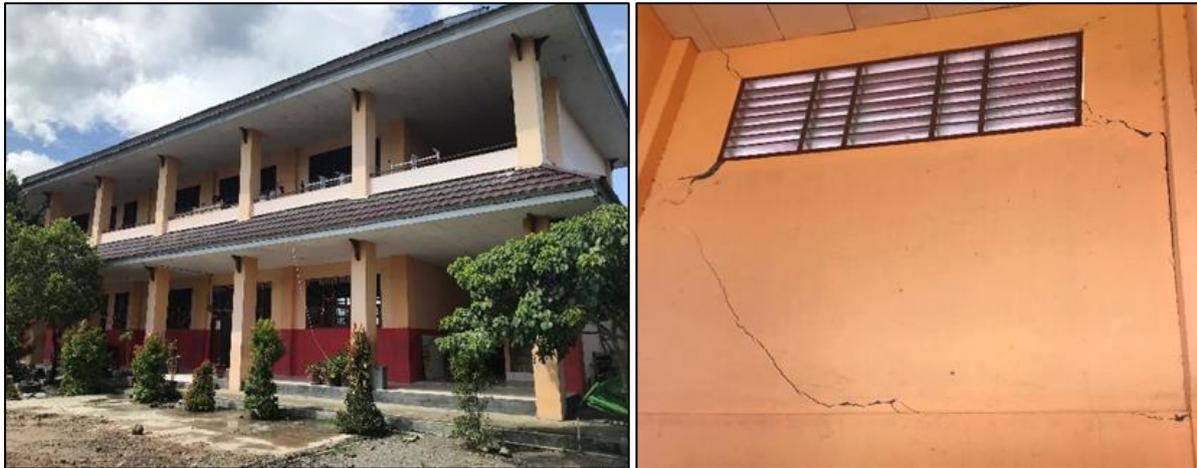
damage observed in RC frame school buildings that were subjected to earthquake ground shaking only, and another example is shown in Figure 7.33.

Figure 7.33 - SD Negeri Pengawu School in Palu (Building A in Fig. 7.24c). Left – 2-storey RC school building that sustained moderate damage to infill panels. Right – Damage to the infill walls

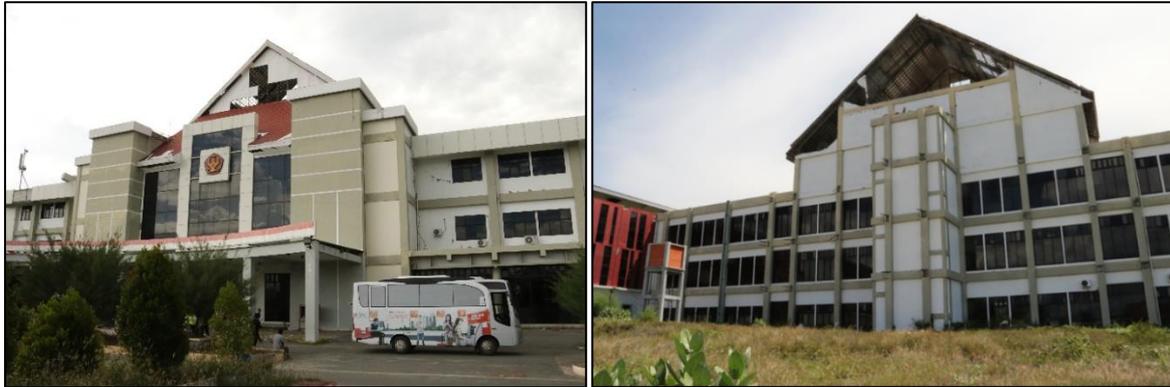
Building A has its long dimension in the N-S direction and is 3 storeys high (Figure 7.36). This building sustained heavy non-structural damage to masonry infills and partitions (Figure 7.367–Right and Figure 7.39 - Left), shattering of the glass cladding of the front entrance, falling of ceiling covering and light fittings (Figure 7.39 - Middle). However, no structural damage was observed. Approximate column dimensions are 500mm x 500mm and beam dimensions are 600mm x 500mm, with the beams being

Figure 7.36 - Tadulako University Hospital Building A. Left – Front view. Right – rear view, showing damage to gable.

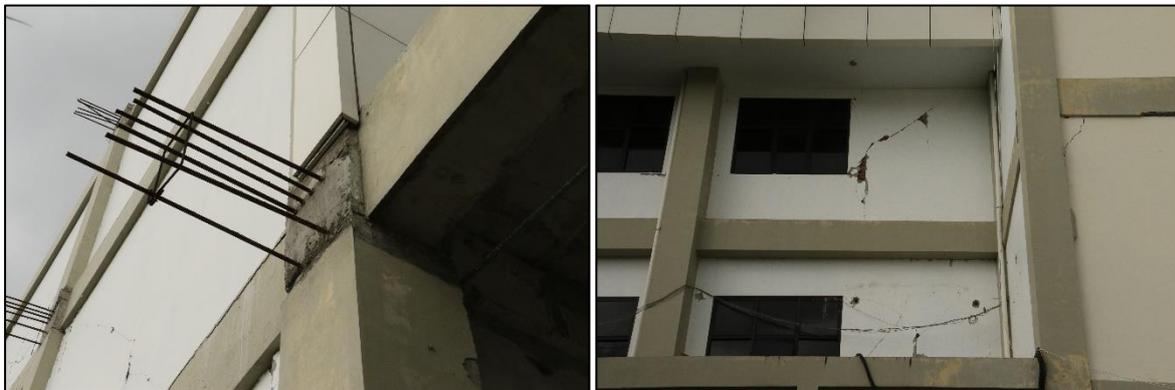
reinforced with 6 x 20mm diameter steel reinforcing bars (as observed from its protrusion from the side of the building, see Figure 7.37 - Left).

Figure 7.37 - Tadulako University Hospital Building A. Left – Beam reinforcement detailing. Right – damage to brick masonry infills.

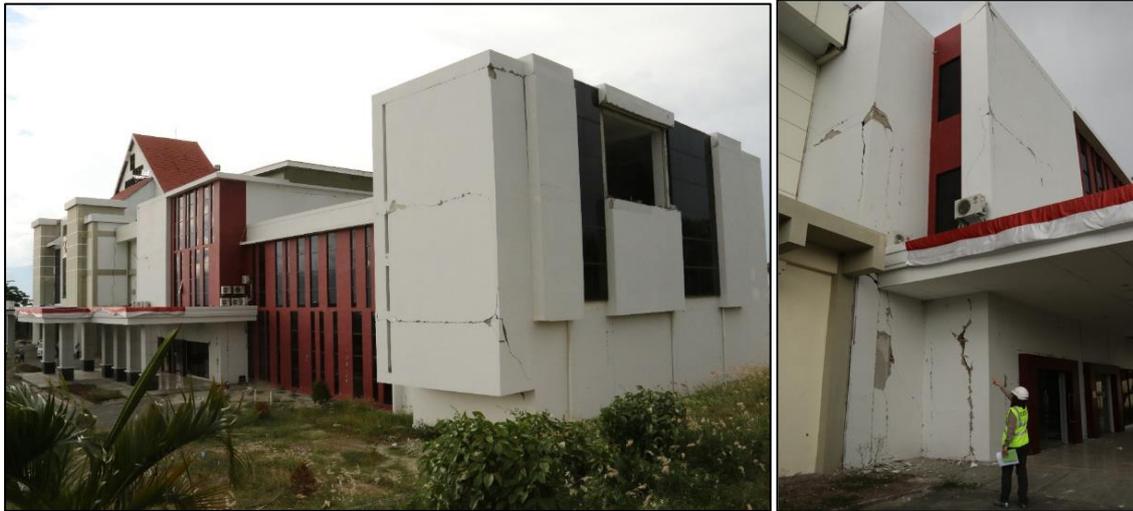
Building B, with long dimension spanning E-W, is 3 storeys high and sustained damage to masonry infill and partition walls (Figure 7.38 - Left). Buildings A and B are separated by a small spacing that is filled with masonry blocks. At the separation location the beams of Building B extend out from the frame to provide support for the internal floor that connects the buildings. Some localised pounding damage is seen where these have hit the structure of Building A during the ground shaking (Figure 7.38 –Right and Figure 7.39-Right).

Figure 7.38 - Tadulako University Hospital Building B. Left – Side view of Building B, showing out of plane failure of infill wall at second floor (n.b. plane of infill wall is E-W). Right – location of damage due to pounding between Buildings A and B.

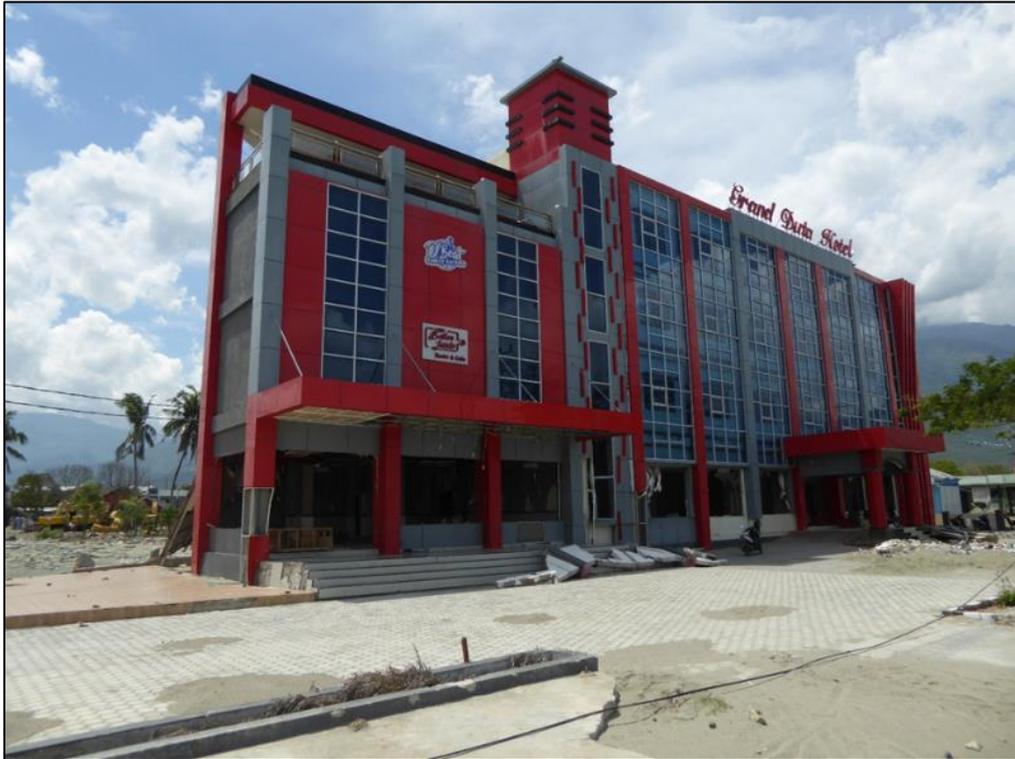
Figure 7.42 – Grand Duta Hotel, Palu Beach..

The Grand Duta Hotel consists mainly of two reinforced concrete frame buildings (connected via an RC elevator shaft (Figure 7.42)). The three-storey building to the East of the elevator shaft had 3 bays of 3.5m span, whilst the four-storey structure to the West of the elevator had 7 bays of 3.5m span. The building did not suffer any damage due to the earthquake ground shaking, but did suffer damage to its ground floor windows, cladding and internal fittings due to the tsunami inundation. Damage to the main internal staircase’s railing at the ground floor was sustained due to its being impacted by a desk carried by the tsunami inundation (Figure 7.43). Inundation here was estimated at 1.5m above grade, as indicated by water marks.

No damage was observed to structural elements. Ground floor column sizes were 500mm x 400mm, whilst beams were 550mm deep by 400mm wide.

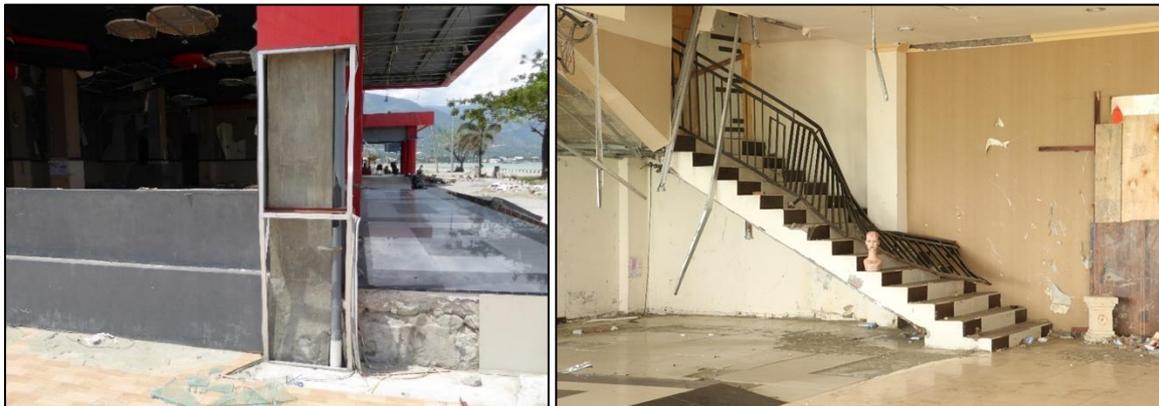
Figure 7.43 – Grand Duta Hotel, Left – image of intact column at ground floor. Right – Image of staircase inside the ground floor of the hotel. The staircase railing was damaged when it was hit by a large desk moved by the tsunami inundation.

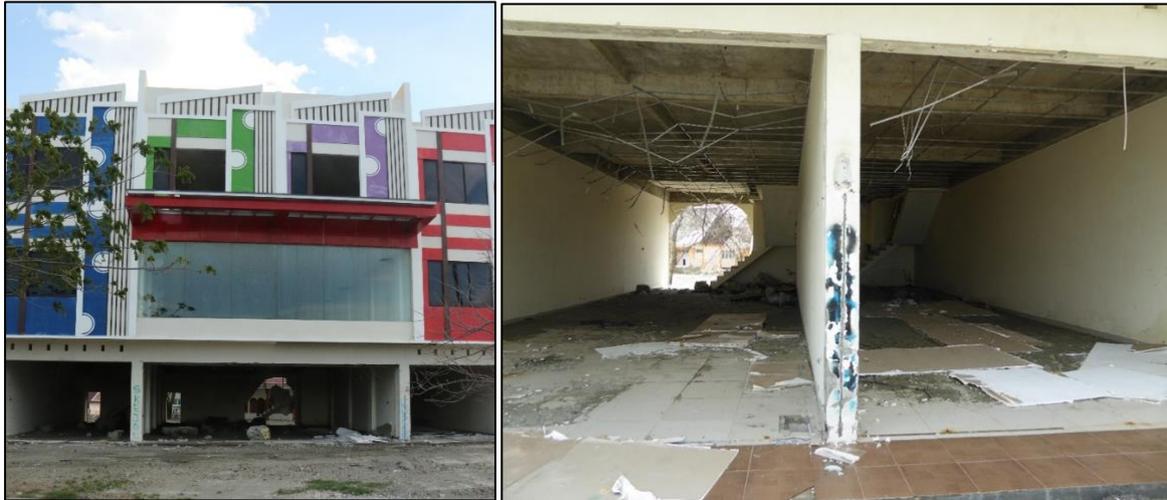
Further west from the Grand Duta Hotel was another reinforced concrete building that also showed no structural damage, despite having been inundated by the tsunami. This structure, shown in Figure 7.44 was three-storeys high and is a moment resisting frame that presents large openings to the sea-front. The large openings at the ground floor offered little resistance to the tsunami inundation, and evidence of inundation included the blow out of infill walls at the back of the structure, as well as the presence of parts of sea defences evident inside the building ground floor. Tsunami inundation was limited to the ground storey, as evidenced by the glass in the 1st floor of the building still being intact.

Figure 7.44 – Three –storey RC building near the Grand Duta Hotel. This structure was inundated by the tsunami at its ground floor, but sustained no structural damage, just non-structural damage to sea front windows and to back walls and to fittings at ground-floor level.

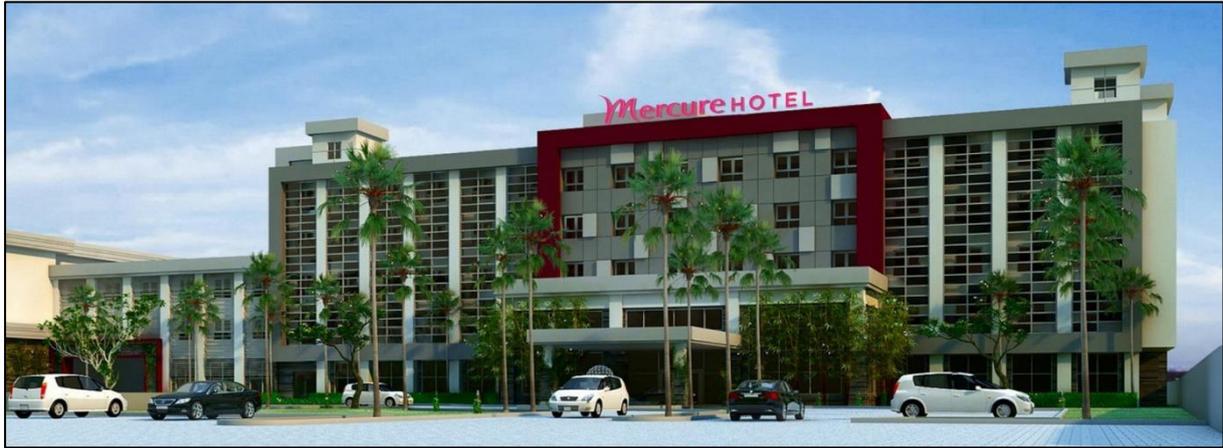
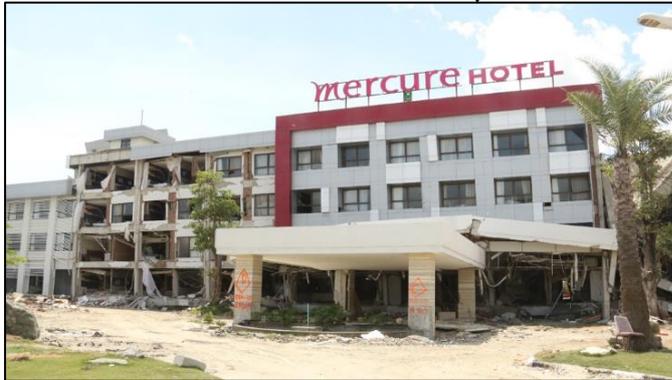
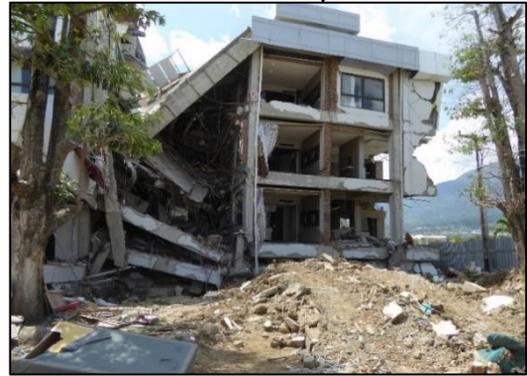
The Mercure Hotel consists of a series of buildings, with the main ones, shown in Figure 7.45 being three interconnected 5 storey reinforced concrete frame buildings, and a 3-storey reinforced concrete frame building. All the 5 storey buildings suffered soft-ground storey failure as shown in Figure 7.45, with the western wing also suffering the pancake failure of one of its bays. Details of the reinforced concrete elements are shown in Figure 7.46. Column sizes were approximately 350mm x 350mm and were reinforced with 8 x 25mm diameter reinforcing bars. Beams were large, of 650mm depth and 350mm width, to span the 8m bay widths. No shear reinforcement was observed in the exposed joints (see Figures 7.46 and 7.47). Like in the case of the collapsed RC frame building in Tadulako University, the remaining structure showed damage concentration at/near the joints, suggesting the soft-storey failure initiated at the joints and columns (rather than columns alone).

Little evidence of tsunami inundation was seen at the Mercure Hotel, which is therefore believed to have mainly been affected by the earthquake ground shaking.

Figure 7.45 – Mercure Hotel, which suffered soft-storey failure of ground floor. Top – Image of the hotel before the earthquake, Source: Tripadvisor.com. Bottom – Pictures of the Hotel after the earthquake, showing the soft-storey failure of the ground storey of the structure.

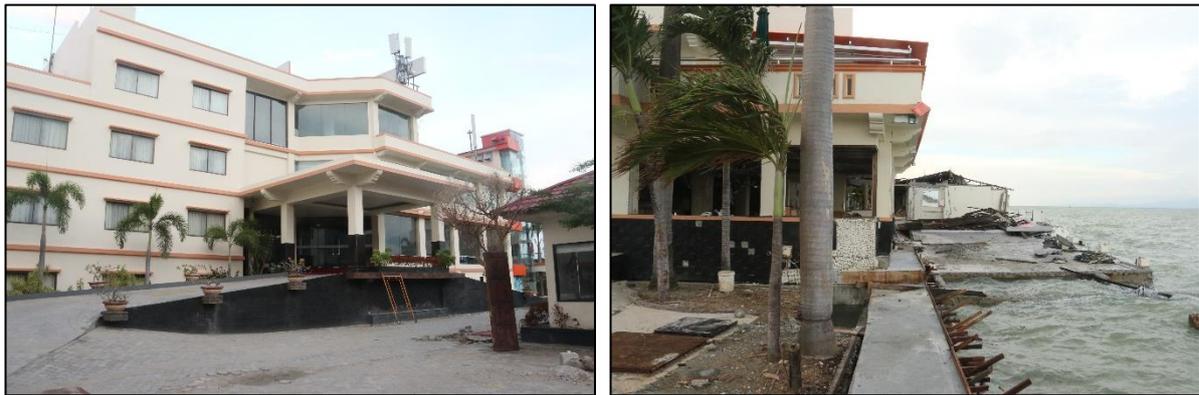
The EEFIT-TDMRC mission visited this hotel just to the north-west of Palu city, coincidentally arriving when the owner and the building designers were on site. Whilst the front facade of the hotel looked unaffected, the rear terrace of the hotel facing the sea was washed away (Figure 7.48). A single storey confined masonry building on the seaward side had collapsed but the main reinforced concrete structure of the hotel did not sustain any visible structural damage. Non-structural damage was sustained to the ground floor of the hotel on its seaward side, with the tsunami inundation breaking 12 mm thick glass and damaging internal fittings (Figure 7.49).

Figure 7.48 - Swiss Belhotel (Left) Undamaged front facade facing away from the bay (Right) Loss of confined masonry one-storey buildings to the shoreward side of the hotel

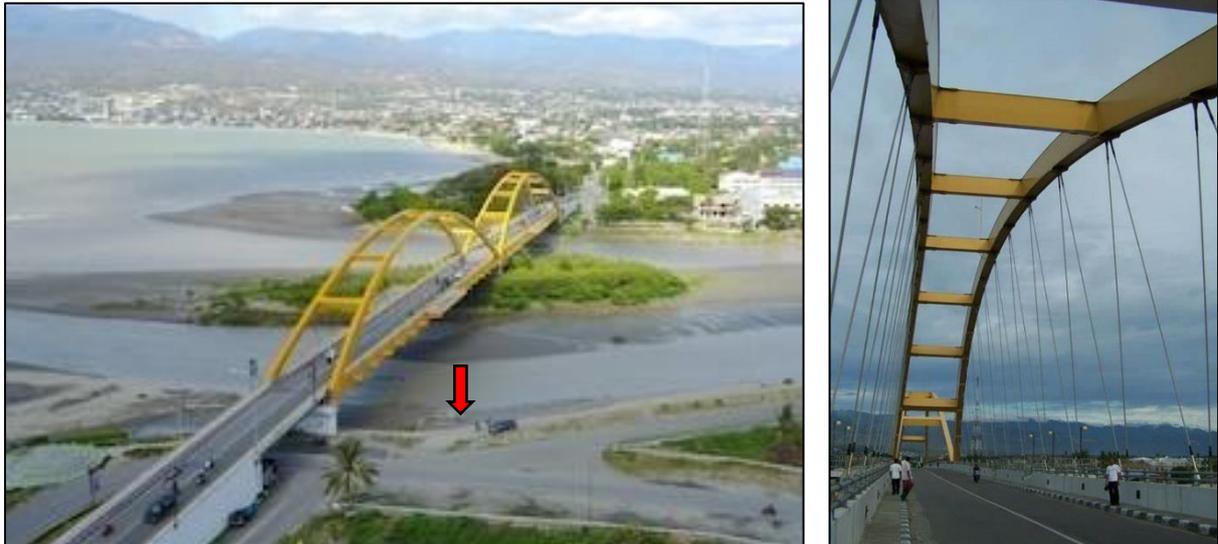
Figure 7.52 - Images of Ponulele bridge before the earthquake and tsunami. The location of the liquefaction jet seen by the EEFIT-TDMRC Team is indicated by the red arrow in the picture on the right. Source for photos: Shutterstock.com.

On the west side of the river mouth, starting from the western bridge pier and going south, strong evidence of liquefaction was seen by the TDMRC-EEFIT team. A large liquefaction hole was observed very near the western bridge pier, at the location of the red arrow on Figure 7.52. Liquefaction was also confirmed by local residents who reported seeing “water spurting from the ground like a geyser”. It was reported to the Team that measurements made by the local authorities indicated the western bridge pier had sunk by 50cm.

It is therefore postulated that the bridge failure occurred due to a combination of ground shaking and liquefaction. It is also possible, as indicated in Section 6, that the collapsed bridge deck may have acted as a protective barrier, reducing the intensity of the tsunami flow up the river and reducing inundation.

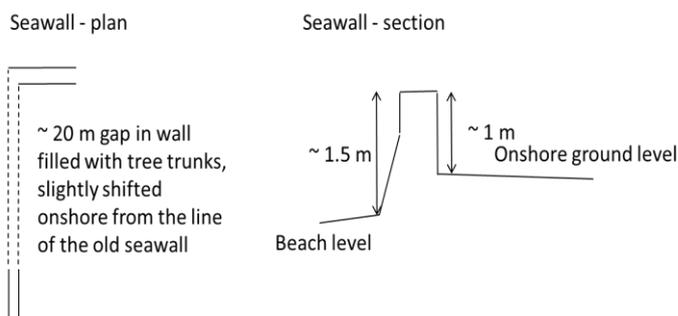
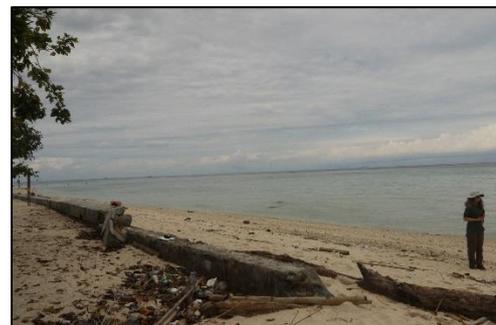
A rudimentary seawall was observed at north-west tip of the mouth of Palu Bay (Figure 7.54). The topography rose quite steeply from the shoreline and the site did not appear to be particularly exposed despite the damage to the seawall which seemed historical due to evidence of weathering of the structure.

Figure 7.54 - Rudimentary seawall. Left - Sketch of layout and section. Right - Damaged sections with tree trunks closing the gap.

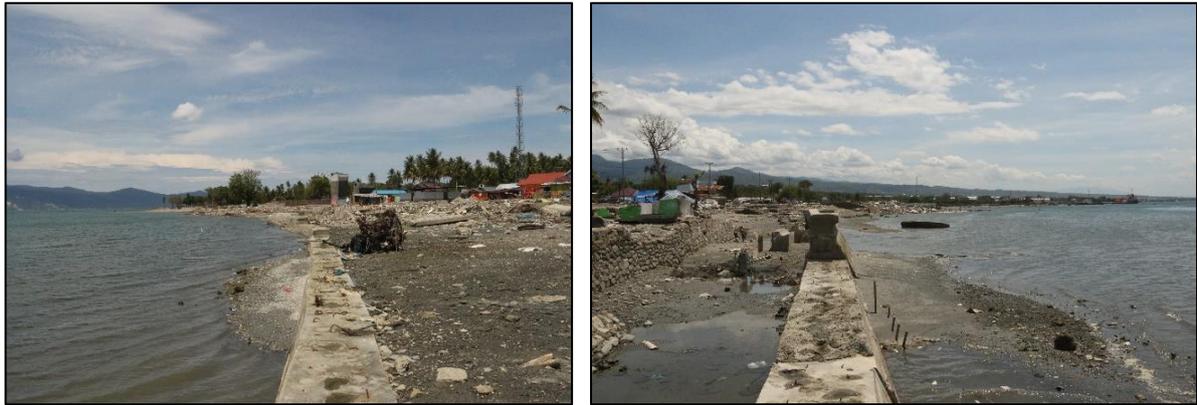
This coastal defence structure had significant visible damage where the top of the wall was missing in many places, revealing ~1 cm rebar approximately every 0.5 m (Figure 7.55). These are presumed to connect to the recurve top of the wall which was still in place at some locations. The damaged seawall was apparently only one year old. Construction details comprised in-situ pouring of concrete of various thicknesses. Slightly further south (tens of metres) there was toppled recurve tops of the wall, but with no rebar connections between the recurve and lower section. The whole structure looked poured in phases from the rear. At the rear of the wall a fairly fast flowing stream was visible. Looking inland the stream could be seen to have flowed through a culvert under the road, but it was not clear how the stream was then routed through the seawall. There was a broken section of the wall, with a length of crest several metres long that could be seen in the sea, slightly to the south of the damage.

Figure 7.55 - Mamboro seawall showing loss of the crest of the structure

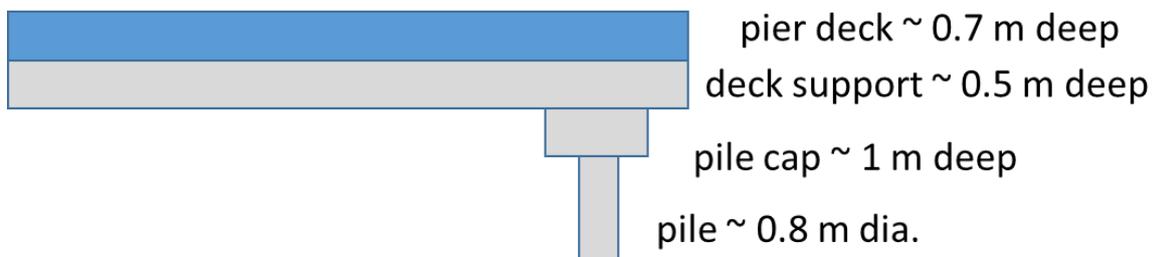
The port comprised a number of structures including a jetty (Figure 7.60) and a revetment which was protected by cubic concrete armour of 0.8 m side length (Figure 7.61). The jetty seemed undamaged. The armour units appeared to be unreinforced but mostly intact. Two or three of the units had been moved inland by the waves.

Figure 7.60 - Sketch of section through undamaged jetty at Wani port

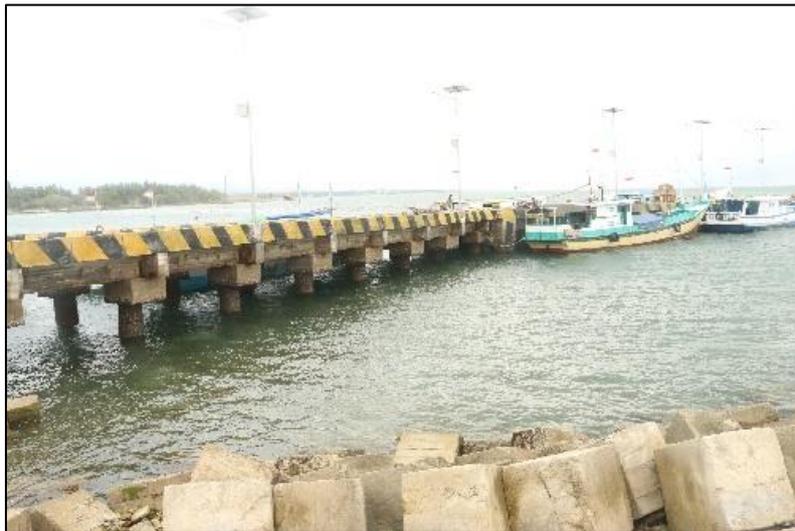
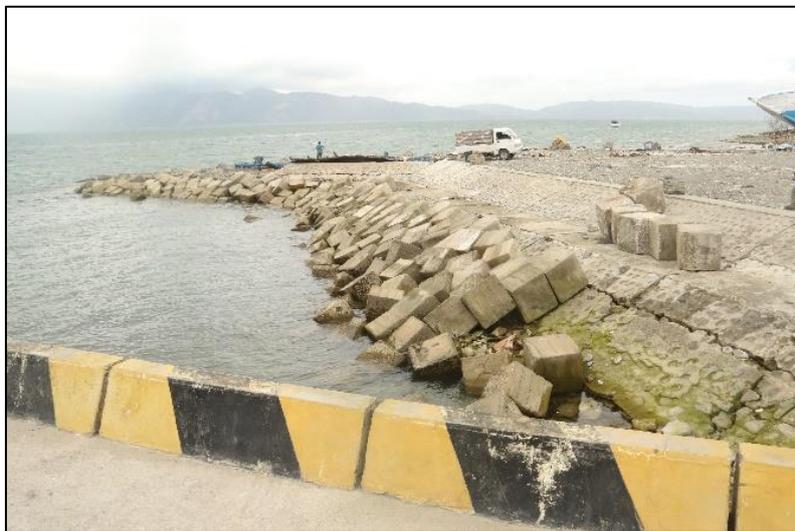
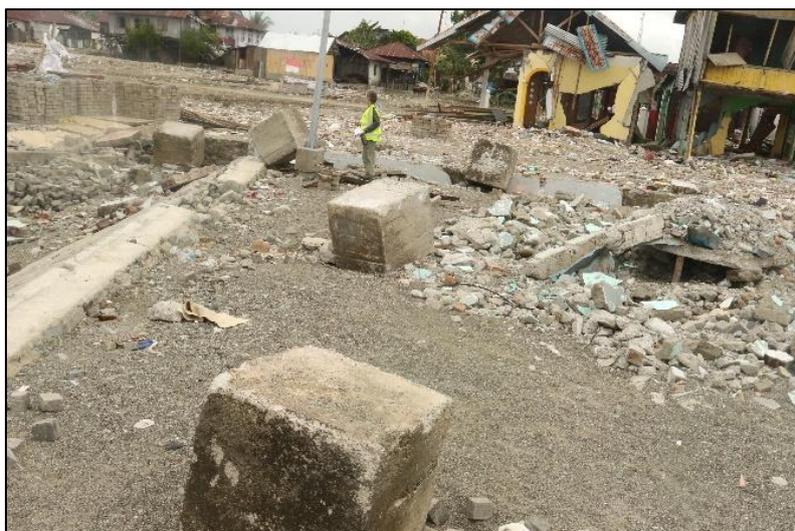
Figure 7.61 - Jetty structure and revetment at Wani port. Top – Jetty. Middle - Armoured revetment neighbouring the jetty. Bottom - Displaced armour units c. 0.8 m side lengths.
