**The Central Sulawesi, Indonesia Earthquake and Tsunami of 28th
September 2018 – A Field Report by EEFIT-TDMRC**

01/11/2019

Prof Tiziana Rossetto, EPICentre, University College London

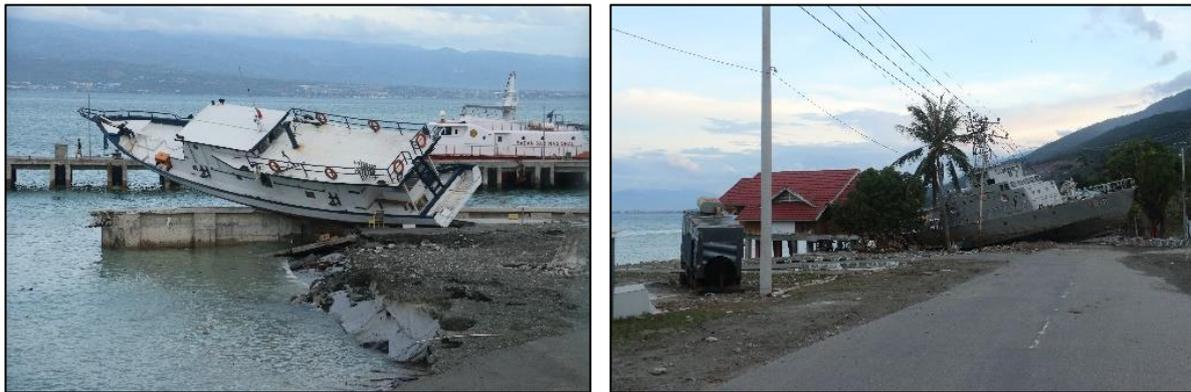
At a number of locations e.g. Watusanpu naval base, Wani and Mamboro, the tsunami waves lifted vessels onto the land by a combination of buoyancy and onshore hydrodynamic forces, as shown in Figure 7.63. In some locations these caused damage but in others there were some reports of the protective effect e.g. at Mamboro.

Figure 7.63 - Grounded vessels at Watusanpu Naval Base
