M7.7 Myanmar Earthquake

March 28, 2025

NHERI DesignSafe Project ID: PRJ-5573

JOINT PRELIMINARY VIRTUAL RECONNAISSANCE REPORT (J-PVRR)

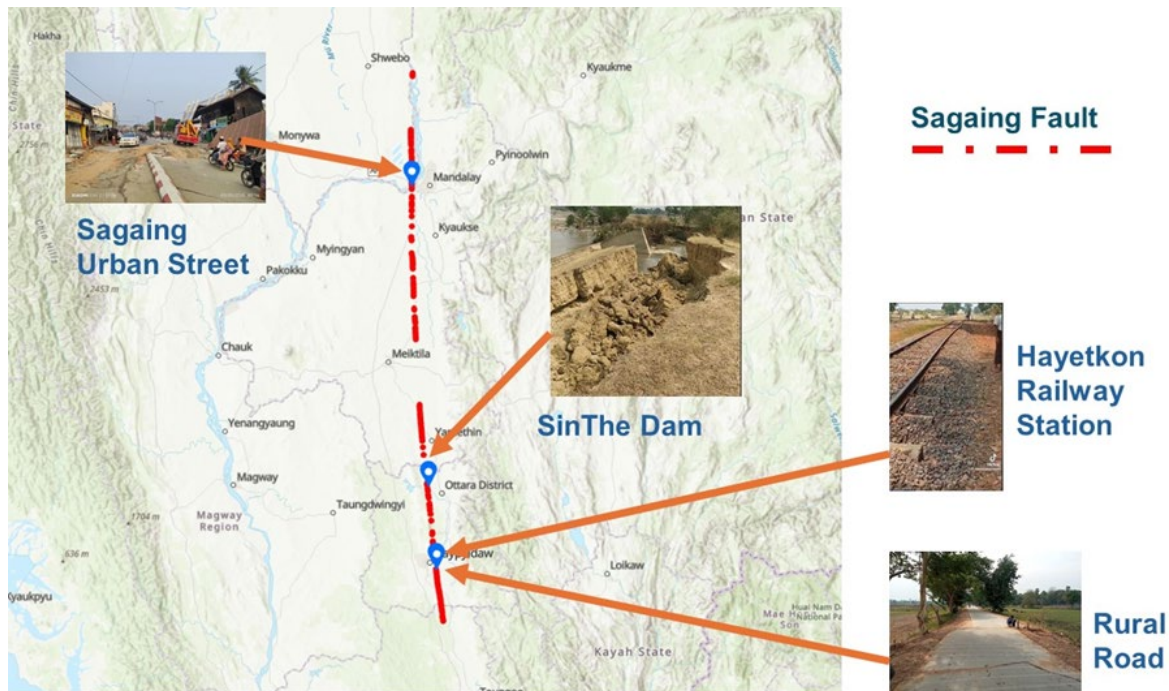
Figure 2.16. Map showing observed offsets of various structures along the Sagaing Fault.

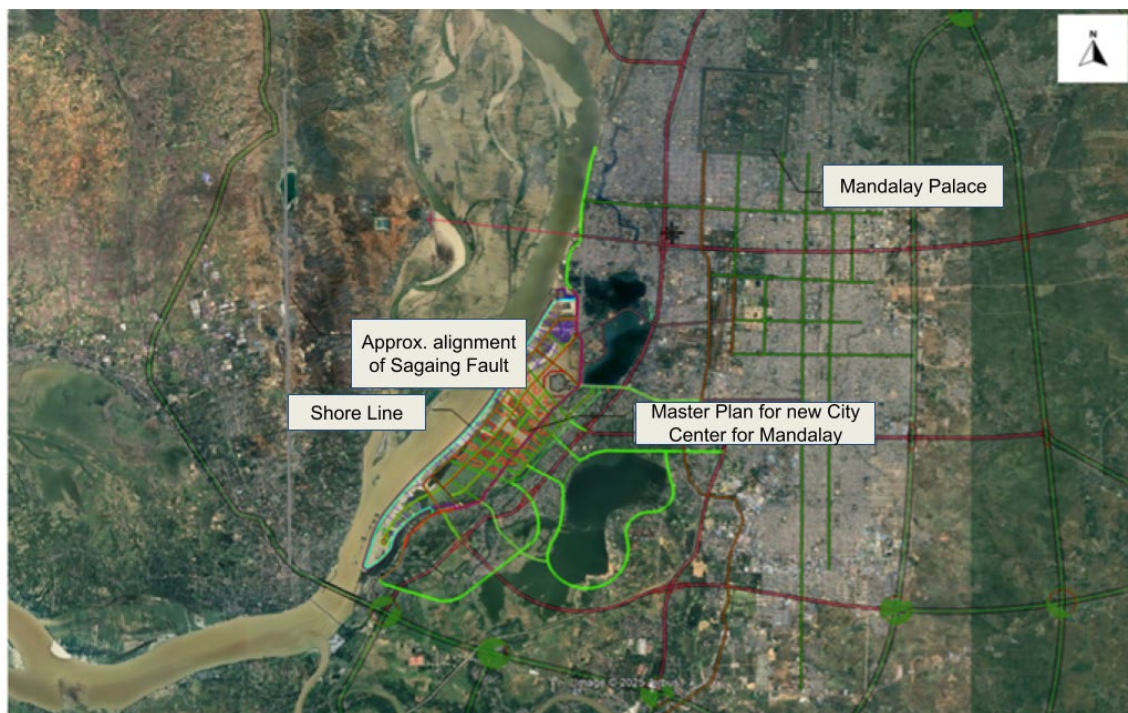
The Amarapura Urban Development Project, shown in Figure 4.6.1 and encompassing Area 5 in Figure 4.1.5 will be built on land composed of loose to medium dense sands, which are recent alluvial sediments deposited by the meandering, ancestral Ayeyarwady River. In its natural state, this soil is susceptible to liquefaction during strong earthquake shaking. Liquefaction results in a loss in strength and stiffness in the underlying sediments, leading to large vertical and lateral deformations, and may have a significant impact on buildings, roads, and underground infrastructure. Thus, ground improvement was proposed to help limit the amount of ground deformation, in particular lateral spreading, that is predicted to occur under earthquake shaking associated with a rupture along the nearby Sagaing Fault.

Figure 4.6.1. Master plan for Amarapura Urban Development Project (River City) (Credit: Mandalay Business Capital City Development Ltd).

In 2020, Tonkin + Taylor International developed shallow and deep ground improvement options to mitigate against effects of liquefaction (i.e., ground settlement and lateral spreading) to achieve the level of performance required for the Amarapura Urban Development Project. These have been progressively implemented using the vibro-flotation method to improve ground density. While ground deformation was observed throughout the Mandalay area (see Fig. 4.6.2), the project team undertaking the ground improvement work observed no appreciable ground

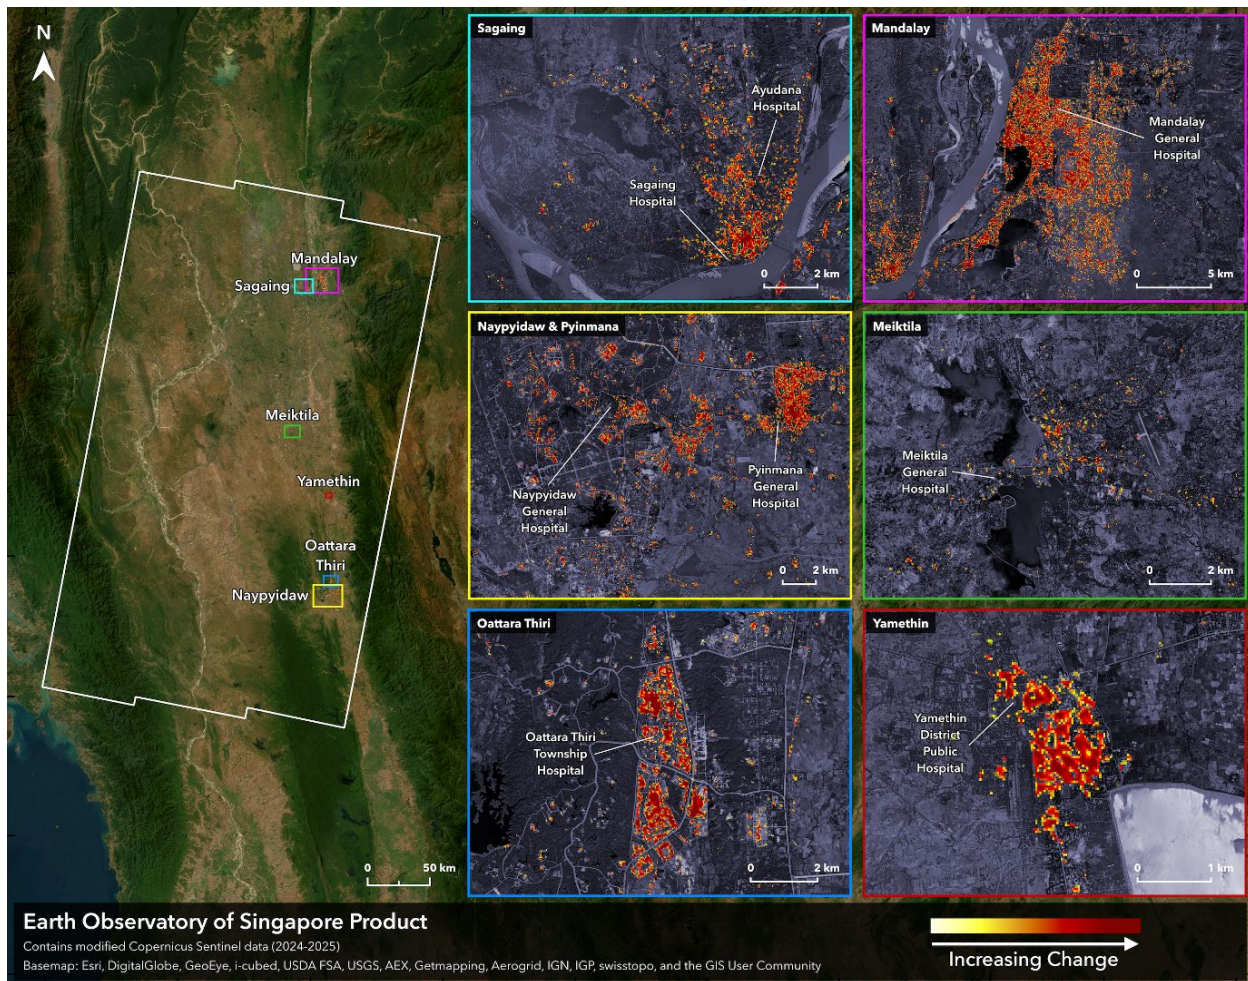
Figure 5.1. Damage Proxy Map for Myanmar (EOS 2025a). The red pixels indicate significant potential damage, based on the detection of ground surface change. Credits: Earth Observatory of Singapore Remote Sensing Lab (EOS-RS), contains modified Copernicus Sentinel data (2024-2025).

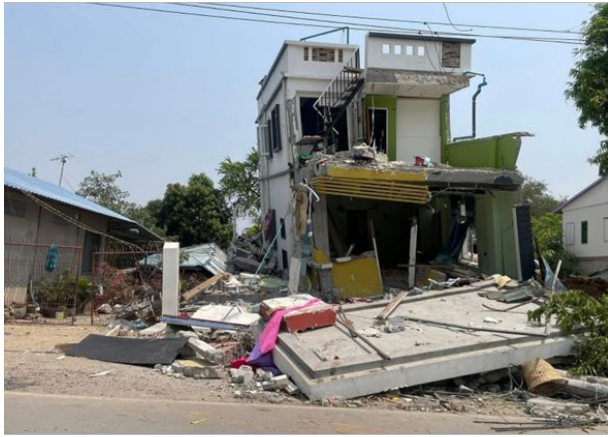
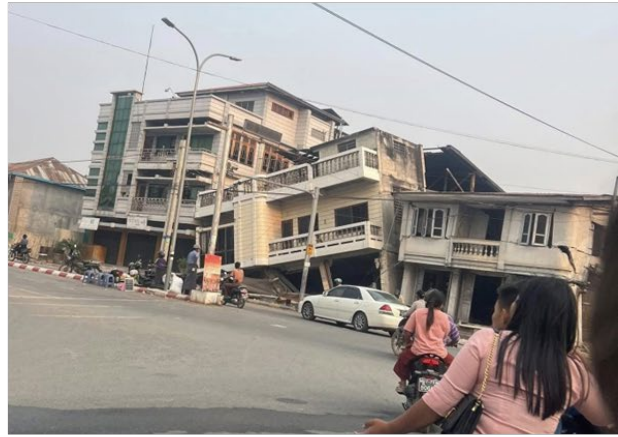
Figure 5.1.2 overviews low-rise buildings with soft-story mechanisms at the ground floor. These primarily reinforced concrete frame structures with unreinforced brick infill walls are characterized by a relatively open ground story to accommodate parking, shops and large entrances, which creates a story weaker and more flexible than those above. Observed failures were not necessarily symmetrical, as shown in Figure 5.1.2 where one of the sides of the first story failed and caused collapse.

Figure 5.1.2. Low-rise buildings with soft-story mechanisms at the first floor (Sources: (a) [@heungburma on X](#), (b) and (c) [@TostevinM on X](#)).

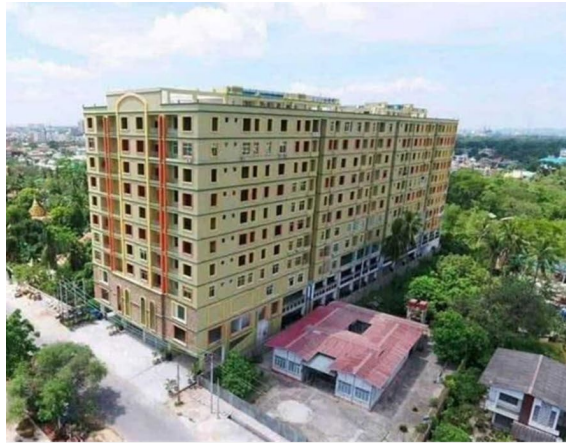
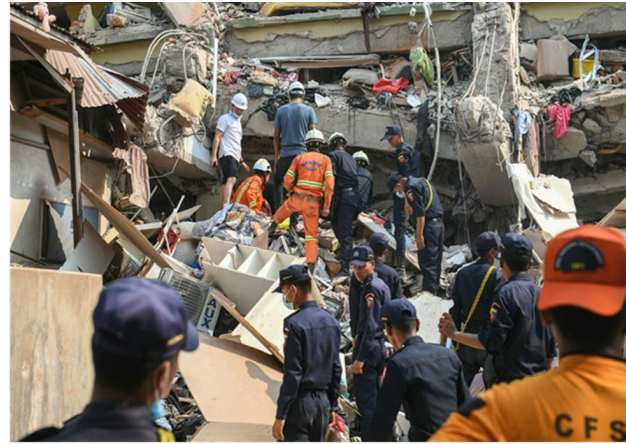
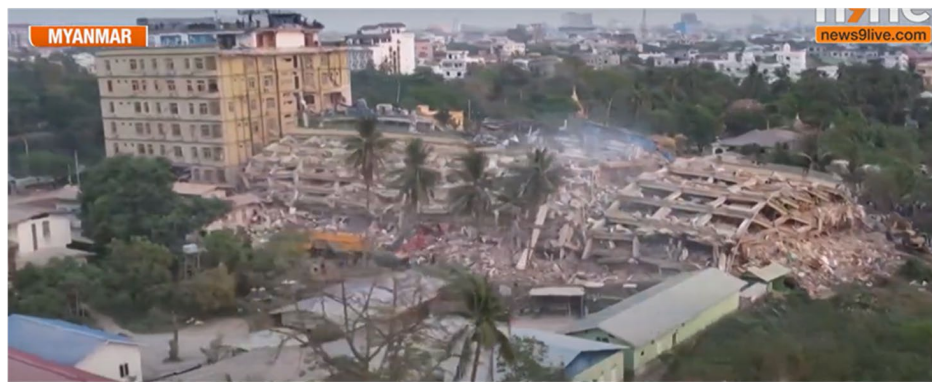
Figure 5.1.3 documents the collapse of the Sky Villa Condominiums. This complex appears to consist of three independent, but similar buildings immediately adjacent to each other. The front building in Figure 5.1.3a suffered collapse of the lower floors, while the middle and rear buildings suffered complete collapse. The buildings consisted of reinforced concrete frames with infill masonry walls in the upper stories. The first story, as seen in Figure 5.1.3a, had fewer structural elements and lacked infill and structural walls, which weakened the first story that collapsed (see Figure 5.1.3b). Video evidence (Fig. 5.1.3c) indicates that at least one building collapse did not occur immediately, but some minutes later.

Figure 5.1.3. Sky Villa Condominium (a) before and (b-c) after the earthquake. (Sources: (a) screengrab from [Eleven Broadcasting on YouTube](#), (b) [@Myanmar38187592 on X](#) (c) screengrab from [NEWS9 Live on YouTube](#)).

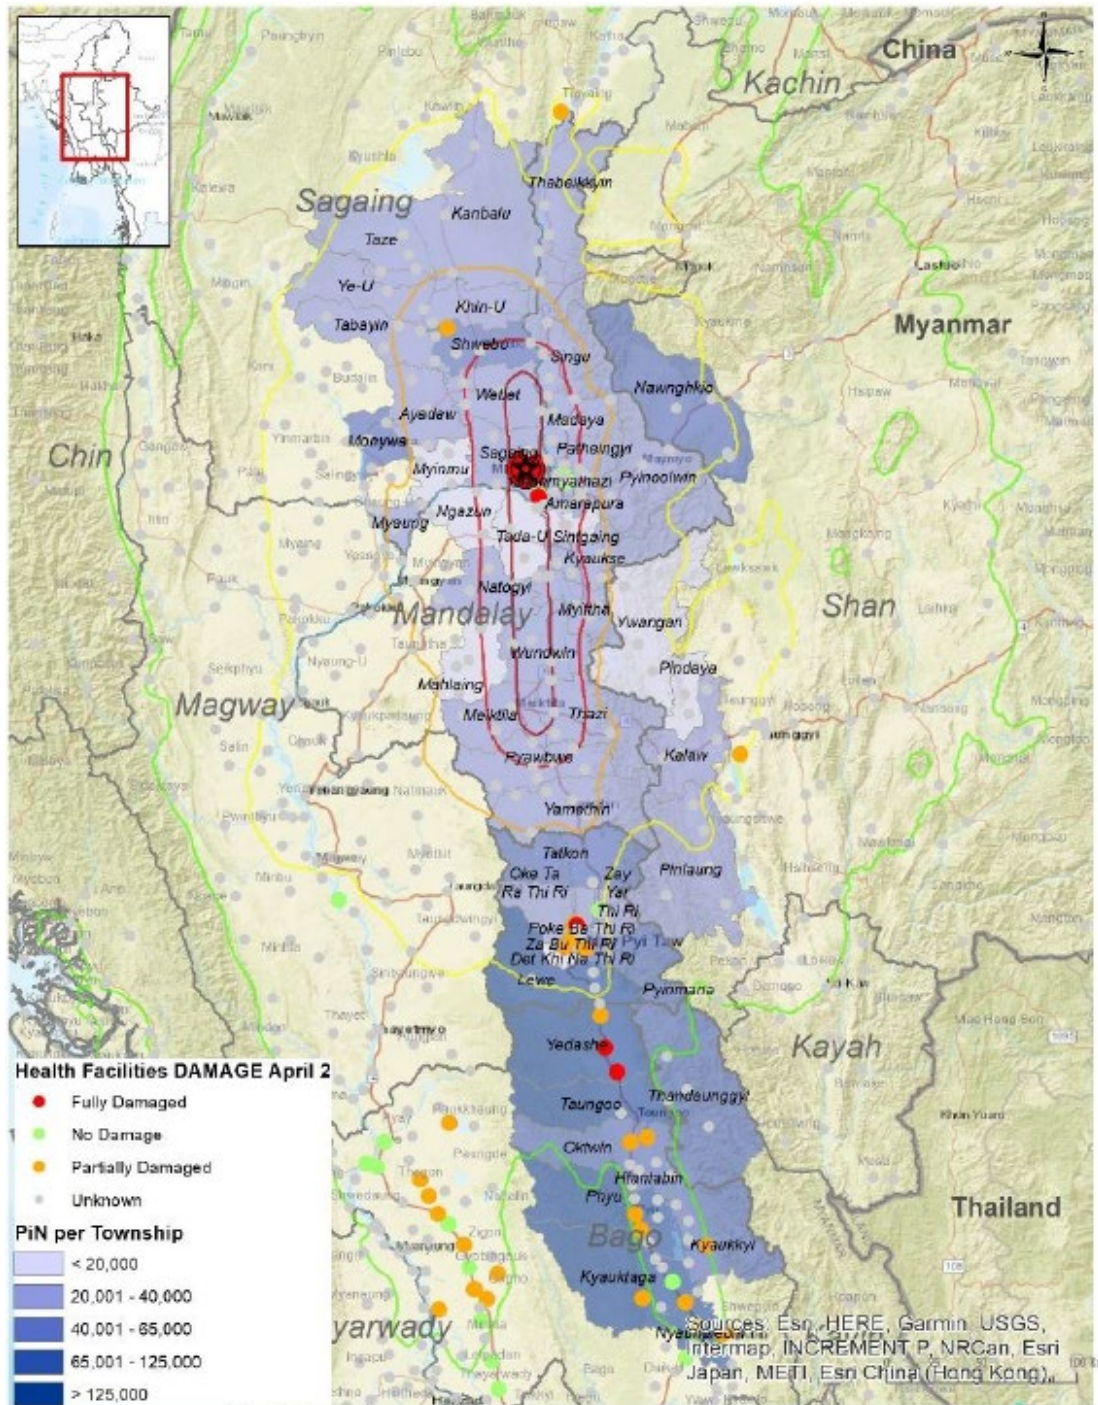
Figure 5.2.1. Location of damaged health facilities verified by health cluster partners as of April 2 (Health Cluster 2025).

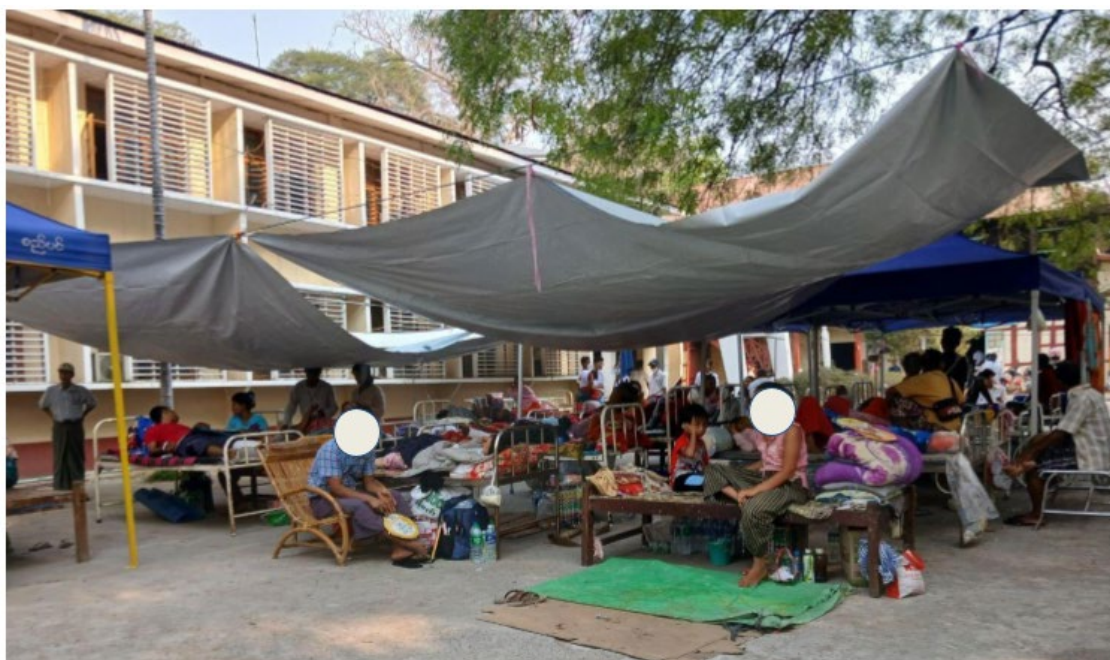
Figure 5.2.6. Patients treated outdoors at Sagaing General Hospital; note no visible damage to the outside of the building shown. Identifiable faces are masked. (Source: [DVB](#)).

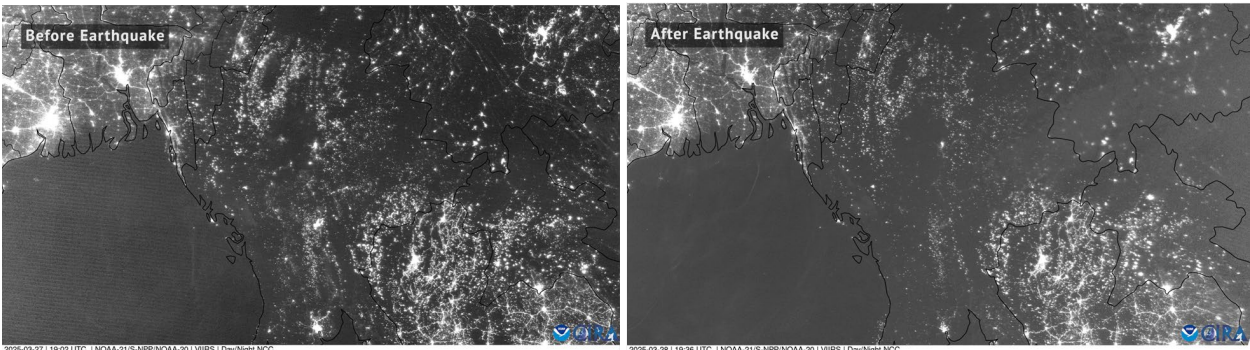
Figure 6.1.1. Nighttime lights over Myanmar before and after the earthquake; reduced illumination post-event (28 Mar 2025) indicates potential power or infrastructure impacts (Source: [CIRA](#)).

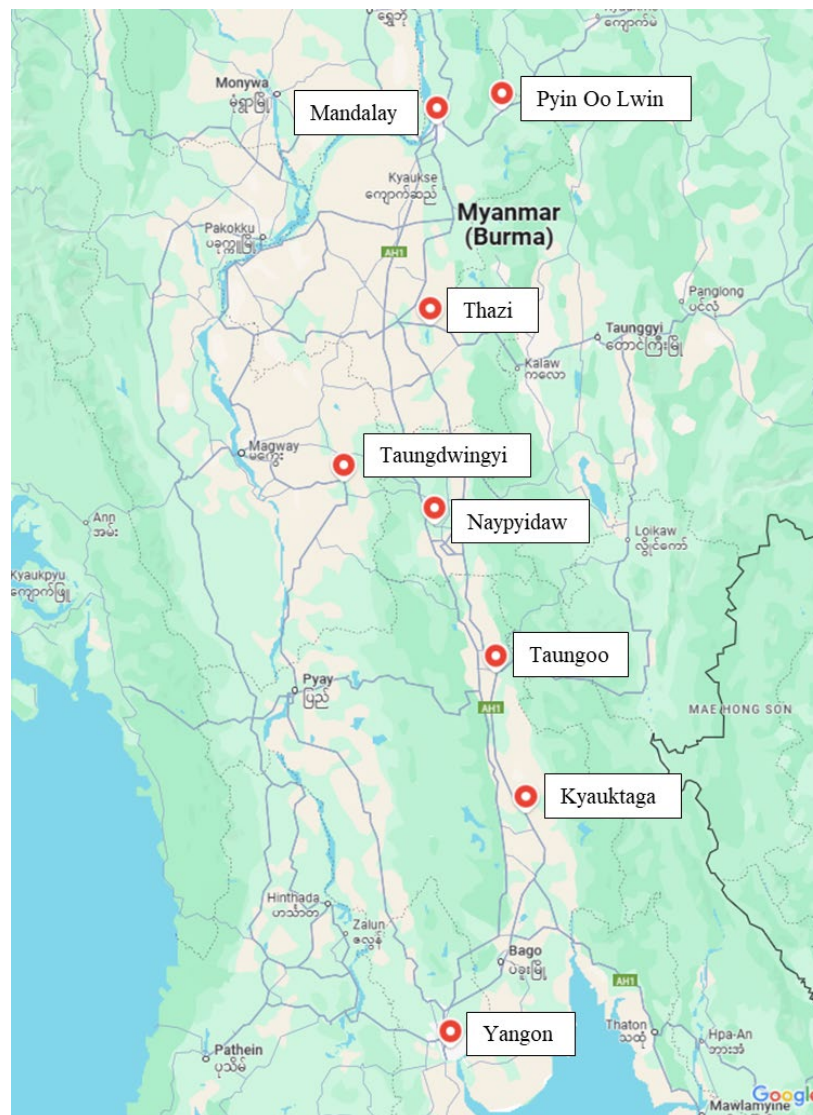
Table 6.3. Number of Track Damage Reports, Listed by Route or Route Start/End Points with Inset Map of Affected Towns and Cities.

Kyaukdaga and Taungoo	23
Taungoo and Nay Pyi Taw	7
Thazi-Mandalay	30
Pyin Oo Lwin-Taung Twin Gyi	11
