THE SAN SALVADOR EARTHQUAKE OF 10 OCTOBER 1986

A FIELD REPORT BY EEFIT

This report was prepared by:

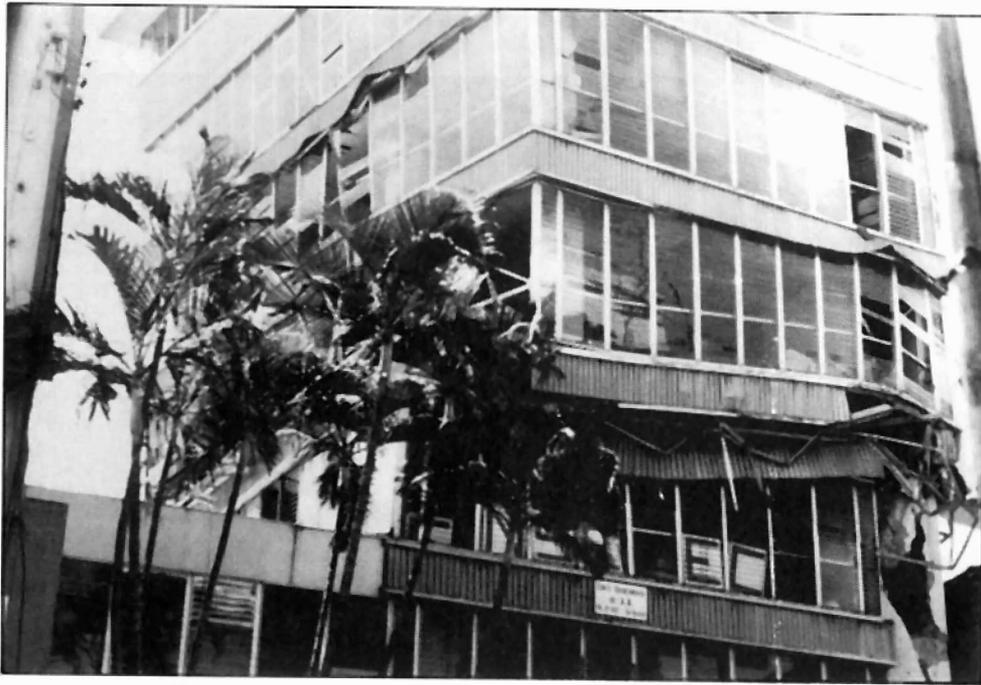
This nine storey office block is a reinforced concrete frame. It is clad with a curtain walling system of glass and corrugated metal. The building has failed at the third floor level where an entire storey has collapsed. The team were unable to gain access to the building or inspect it closely but it appears that this total collapse of an entire storey was possible because of the lack of any substantial walls or partitions (Plate 7).

PLATE 7 : EDIFICIO IZTALCO.

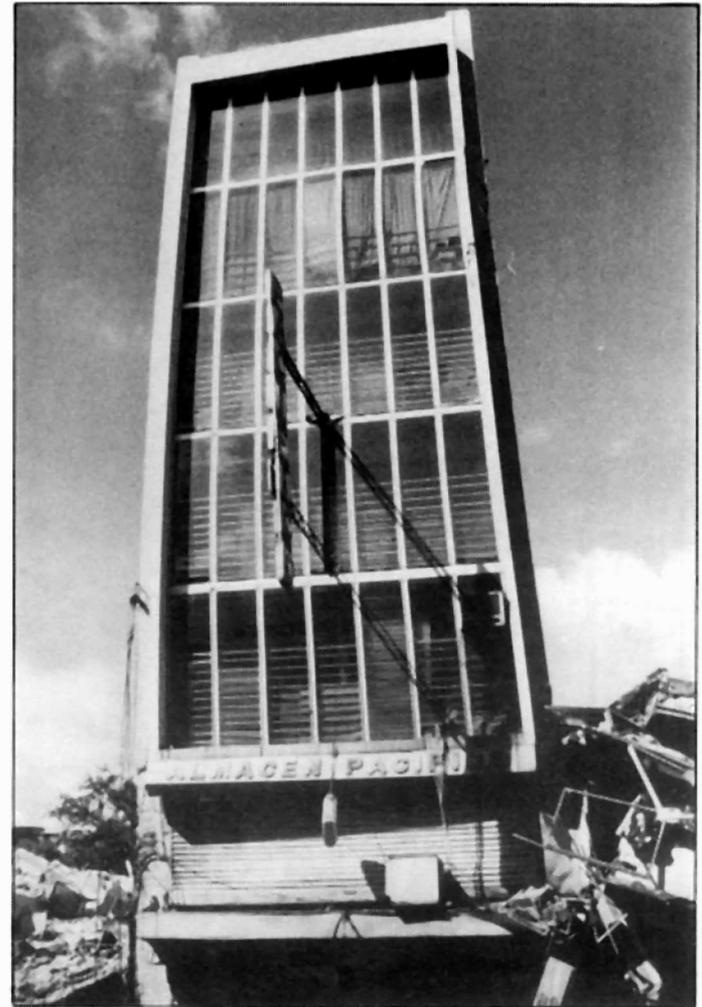
When the Ruben Dario building collapsed it collided with the six storey Almacenes Pacifico causing it to drift up to 600mm at its top (Plate 28). This movement was continuing after 3 weeks and surveyors were monitoring the movement in the hope that they would be able to clear rescue workers from the Ruben Dario site before collapse occurred.

The team was told by rescue workers at the Ruben Dario that they had requested the demolition of the Edificio Pacifico which was standing precariously over the rubble of the Dario (Plate 28), posing an obvious threat to the rescue workers. The owner of the building had refused to allow demolition of the Pacifico.

PLATE 28: ALMACENES PACÍFICO.

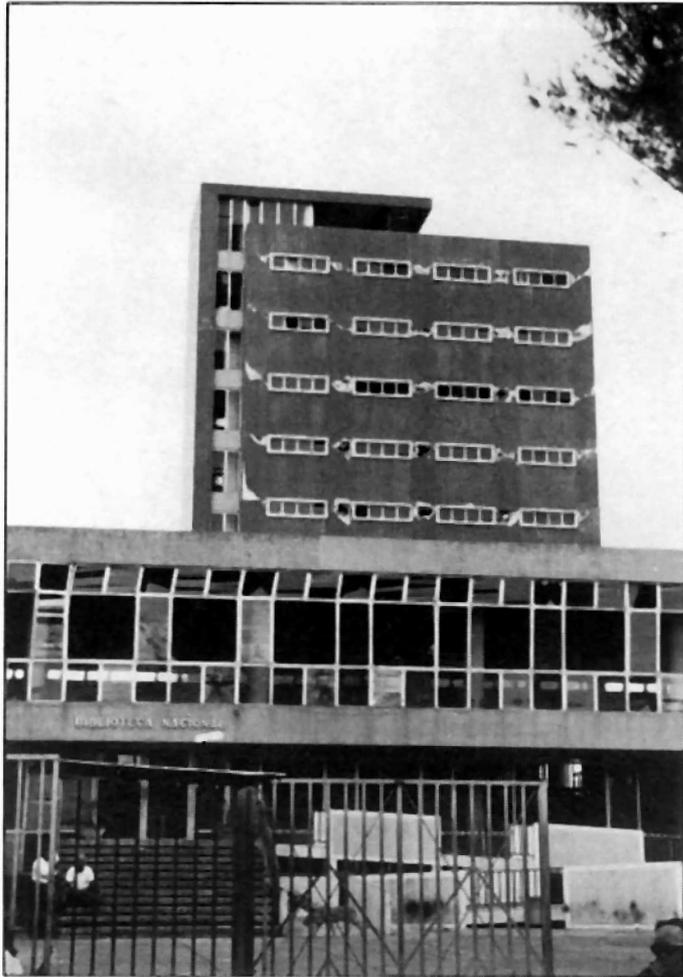
This complex consists of two eight storey towers on adjacent sides of the two storey library building (Plate 29). All three structures were badly damaged by the earthquake. The library building is a very open structure with circular concrete columns, 500mm diameter on a 6m x 7m grid, supporting a concrete slab roof. There are large voids in the floor slab and there are walkways suspended from the concrete roof. The heavy roof has drifted to the east causing distortion of the curtain walling and severe damage to the concrete columns. These columns are braced to the tower blocks at approximately 1m below the roof level; huge shear forces are generated by this restraint and the roof failed completely (Plate 30). The extent of the damage to the columns suggests that they were subjected to large shear loads in two directions and probably to large vertical loads, the combination of which has completely shattered the concrete. The walkways are suspended on 20mm diameter hangers. These have buckled under a temporary compressive load and are curved out of line by 75mm at the midpoint of a 4m long hanger.

PLATE 29 : NATIONAL LIBRARY AND MINISTRY OF EDUCATION.

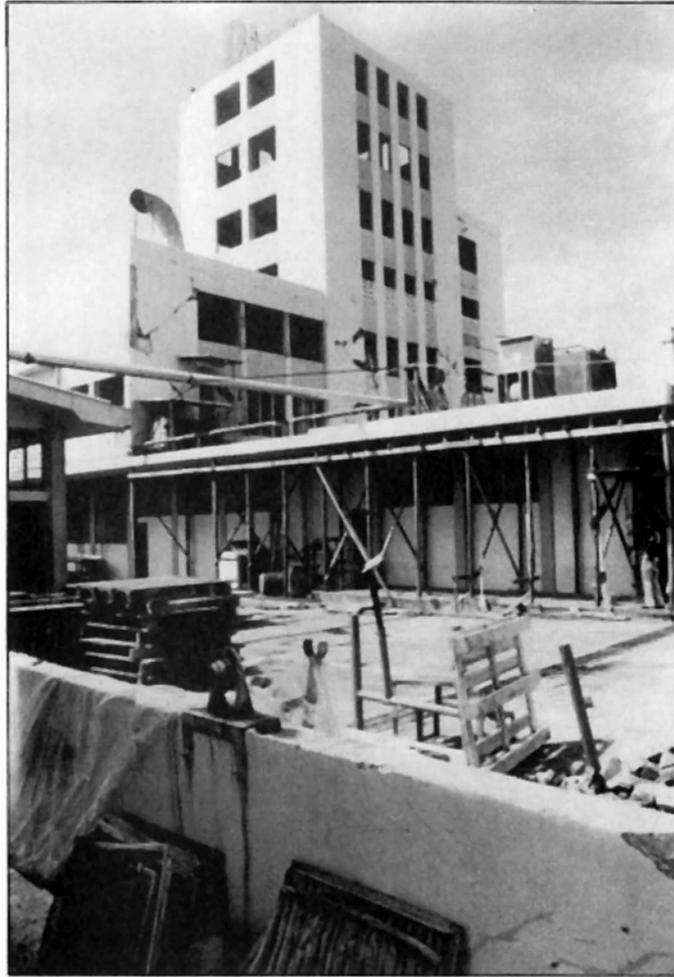
The Unisola plant produces soap and washing power. It consists of one and two storey offices, warehouses, etc., and a six storey drying tower. A two storey steel frame shed used for storage had recently been completed. There was no visible damage to the cladding or the portals of the shed but these were stayed by 10mm diameter bars tensioned diagonally in the plane of the roof. Nearly all of these bars had failed and had been welded together immediately after the earthquake. A six storey reinforced concrete tower at the plant holds a drying cylinder six storeys high (Plate 33). The tower was not designed to resist seismic loads but the cylinder is supported at each floor by large roller bearings which allow for differential movement. Chemicals were stored at the top before passing down the drying cylinder. The tower was heavily loaded at this level during the earthquake. There is damage to the concrete at every level of the tower but particularly at the level where the floor area reduces. An engineer watching the tower from the ground was able to observe 3 cycles of movement of the tower in an east to west direction with the final movement being eastward. Plans for remedial work in the tower included the cessation of all high level storage, the future resiting of all ancillary plant to the lowest possible level in the tower and the removal of the damaged outer columns to leave a slimmer structure supporting only the drying cylinder.

PLATE 33: UNISOLA TOWER

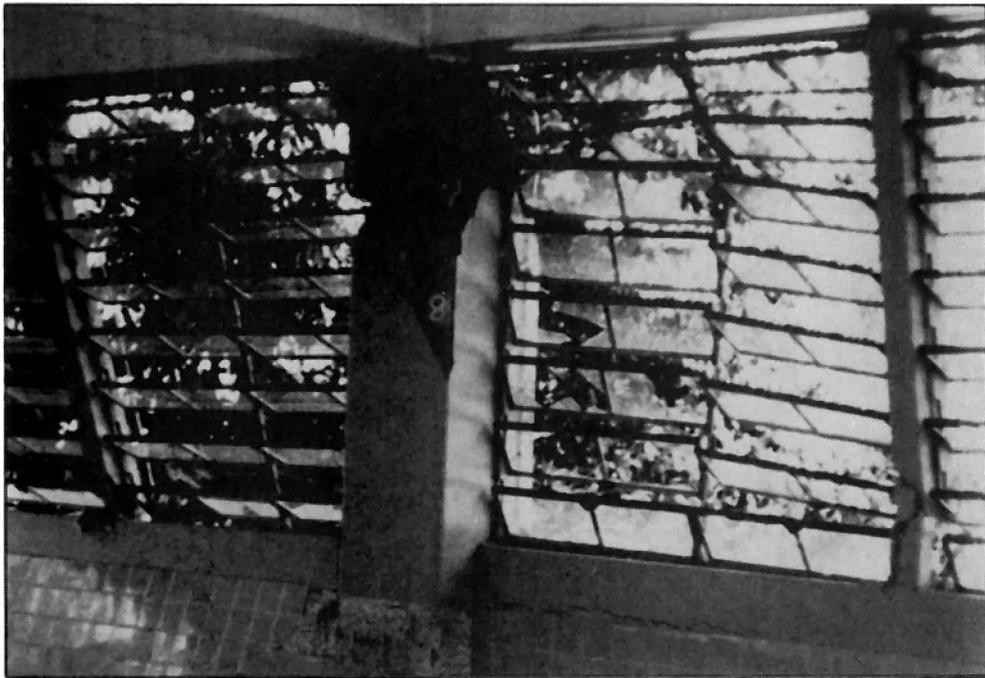
There was surprisingly little damage to glazing during the earthquake. This was due largely to the use of louvred type windows that contain small panes of glass each of which can rotate in its frame (Plate 37). Even buildings that had suffered partial collapse contained unbroken panes of glass. The frames of the windows can undergo large shear displacements and even buckle without the small panes breaking as they move in relation to one another.

PLATE 37 : TYPICAL WINDOW DETAIL.

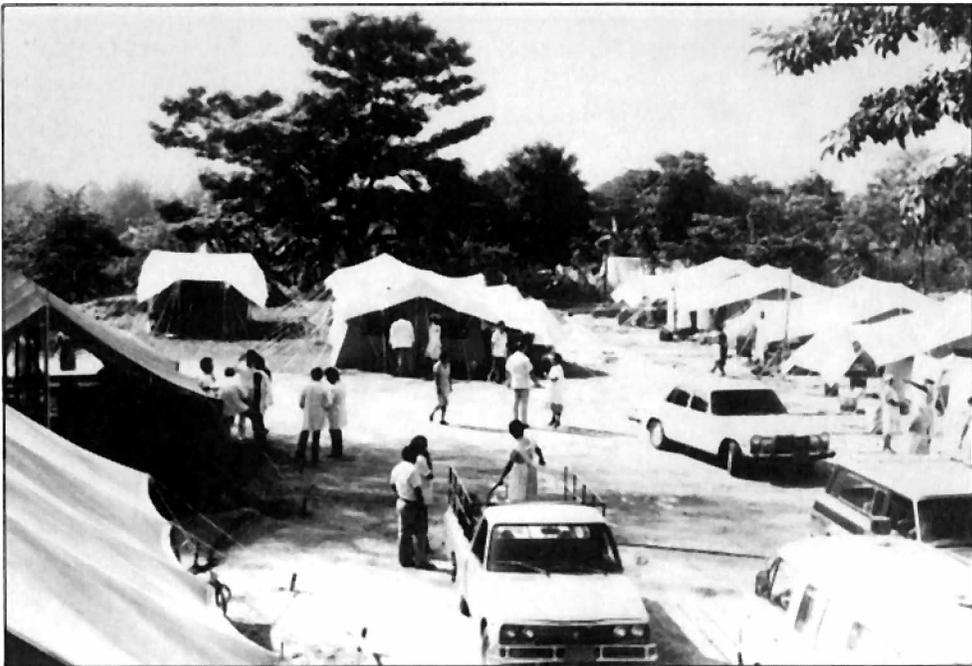
The city's health care infrastructure suffered a great deal of damage in the earthquake. The following centres were the worst affected: the Benjamin Bloom Children's Hospital, the Health Units of the North, San Jacinto and Concepcion and the Military Hospital. As a result, most of the health services were being provided from tents or from buildings temporarily occupied by medical staff (Plate 40). This created numerous difficulties for the health service at a time when it was most greatly needed; as a result of the earthquake the total number of people requiring medical attention had risen to over 10,000.

PLATE 40 : FIELD HOSPITAL AT HOSPITAL BENJAMIN BLOOM.

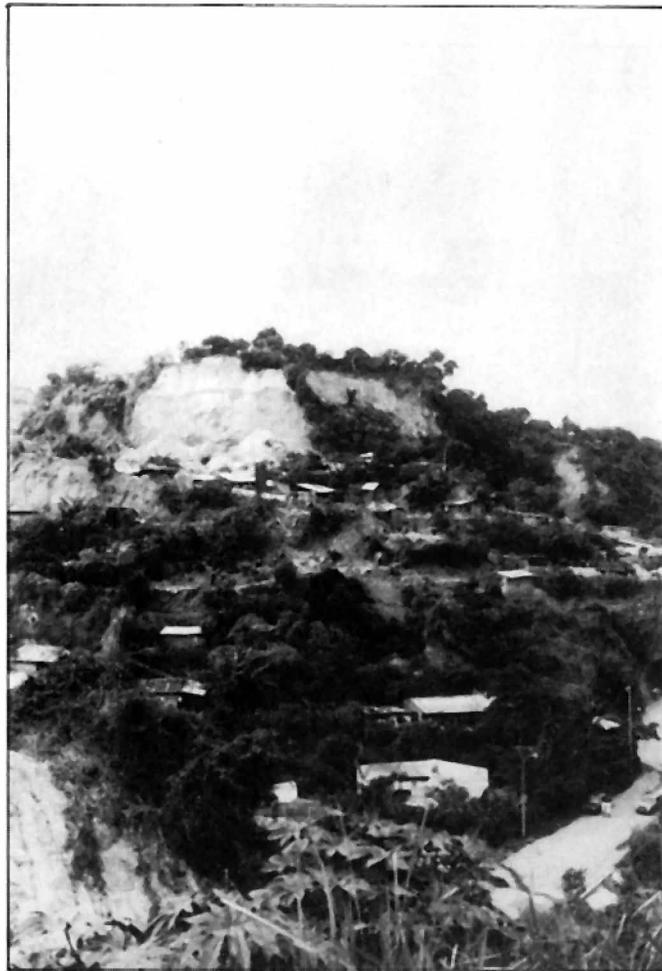
Housing in the wealthier parts of the city did not generally suffer great damage, being of one or two storeys and of sound construction. The Ministry of Planning (MINPLAN) reported that 23,000 houses were destroyed by the earthquake, and 30,000 more were badly damaged. The majority of these houses were situated in the poor areas on the city's periphery, in the north, east and south, including districts such as Mejicanos, San Jacinto and Santa Marta amongst many others (Fig 4). These shanty towns have grown rapidly in recent years with the tide of people migrating to the capital from the countryside, driven by war, drought and poverty. The population of San Salvador, like many other Latin American capitals, has risen sharply over the last two decades; in 1960 the population stood at 200,000 and in 1969, at 400,000. At the time of the earthquake the population had risen as high as 1,500,000. Arriving in a densely populated city, where land prices are very high, these people have been forced to purchase tiny plots of land on terraces cut into steep hillsides (Plate 41). The houses are often constructed so that the cut forms the back wall and the facade is often flush with the front of the terrace step; it is this type of terrain on which many of San Salvador's poor are obliged to live, as much as the type and quality of construction, that gave rise to the large loss of housing in the earthquake. It is known that such geological ridges as those whose slopes the shanty towns occupy, can amplify earthquake induced ground motions, and the vertical cuts are inherently unstable, particularly under earthquake conditions.

PLATE 41 : HOUSING ON STEEP SLOPES IN
SOUTHERN DISTRICTS OF SAN
SALVADOR.

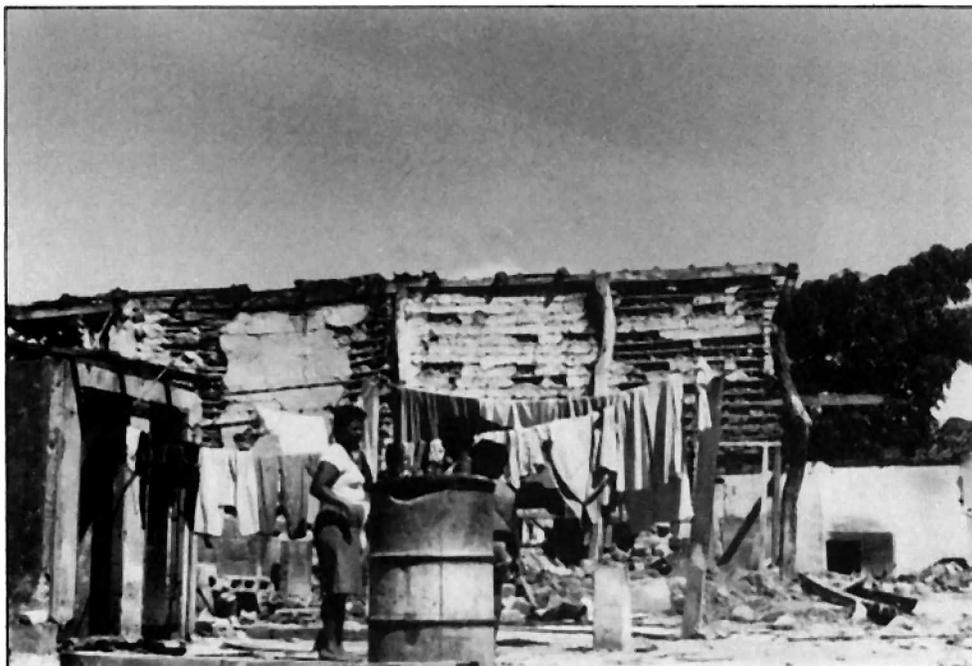
nailed wooden trusses or purlins (Plate 42). Bahareque is very well suited to El Salvador's geography, employing materials that are widely available and at low cost, being easy to construct (some houses had been completely rebuilt within three weeks of the earthquake (Plate 43) and it provides good insulation against the intense tropical heat. Furthermore, when well constructed from good quality materials, bahareque also behaves very well under seismic conditions (Plate 44) much more so than heavier and weaker forms of construction in other parts of Latin America, such as adobe, which is formed from sun-dried clay bricks. The aseismic qualities of bahareque were demonstrated by the large number of houses where the dried mud had simply been shaken out, leaving the flexible frame intact. However, the timber and bamboo are usually used without any sort of preservative treatment being applied, and the action of insects and micro-organisms leads to a complete deterioration within ten to fifteen years, when the houses become very weak.

PLATE 42 : BAHAREQUE HOUSE .

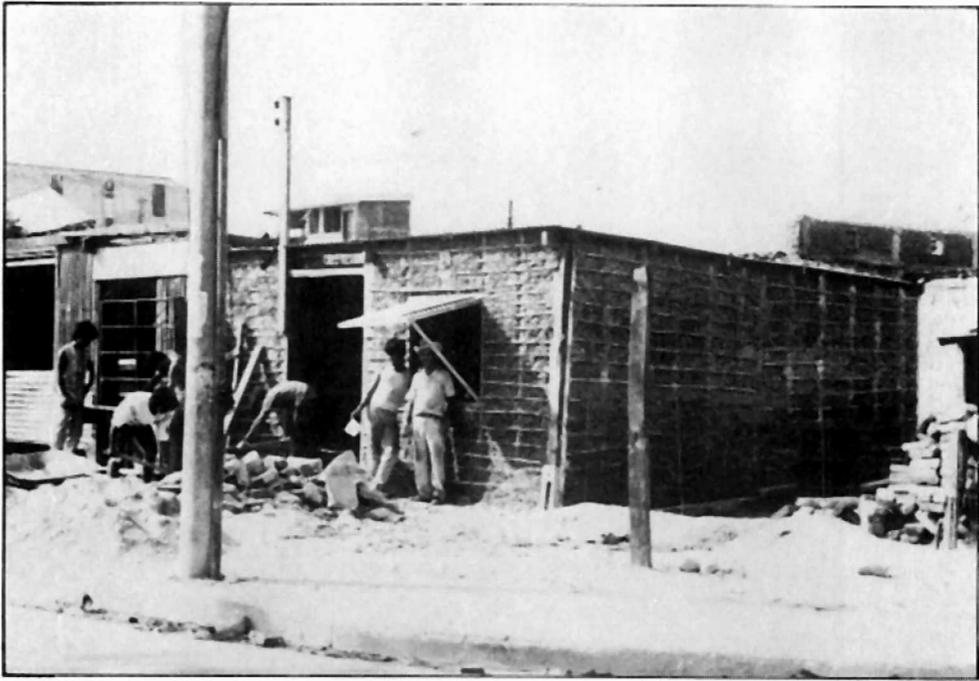
PLATE 43: BAHAREQUE HOUSE, REBUILT WITHIN THREE WEEKS OF EARTHQUAKE.

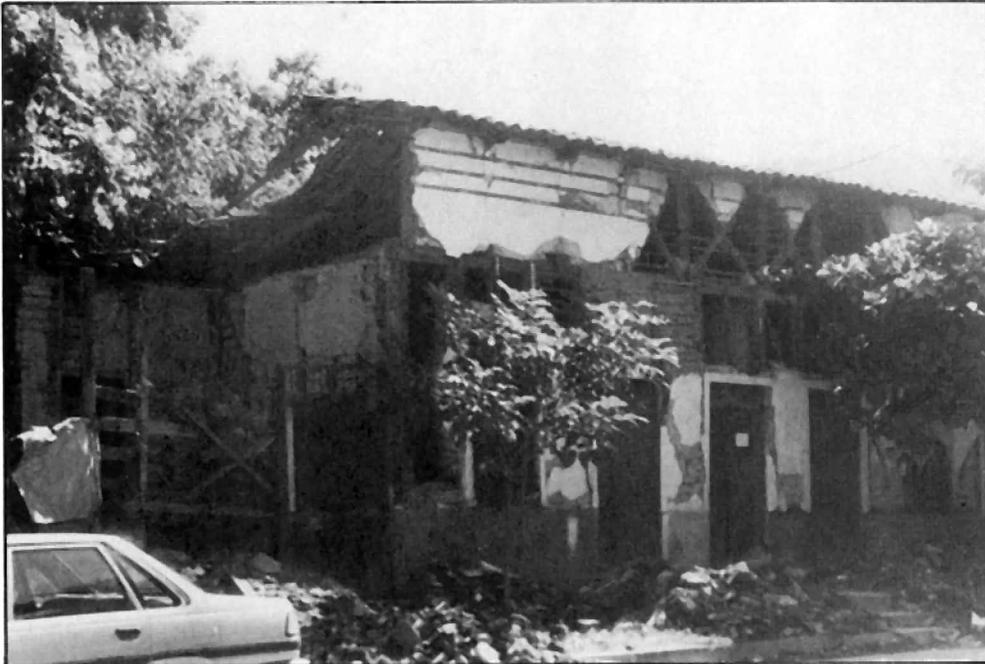
There are few timber houses in San Salvador, probably due its relatively high cost, although timber is often used for the construction of the frames, after which bahareque is used, or corrugated iron or plastic sheeting (called 'lamina') to form the walls of the house (Plate 45). The few houses constructed entirely of timber that were seen had generally performed very well, but again there was much evidence of deterioration of the untreated timber. An obvious hazard with timber construction is the spread of fire, but no large fires followed the earthquake.

PLATE 45: TIMBER FRAMED BUILDING, WITH BAHAREQUE WALLS

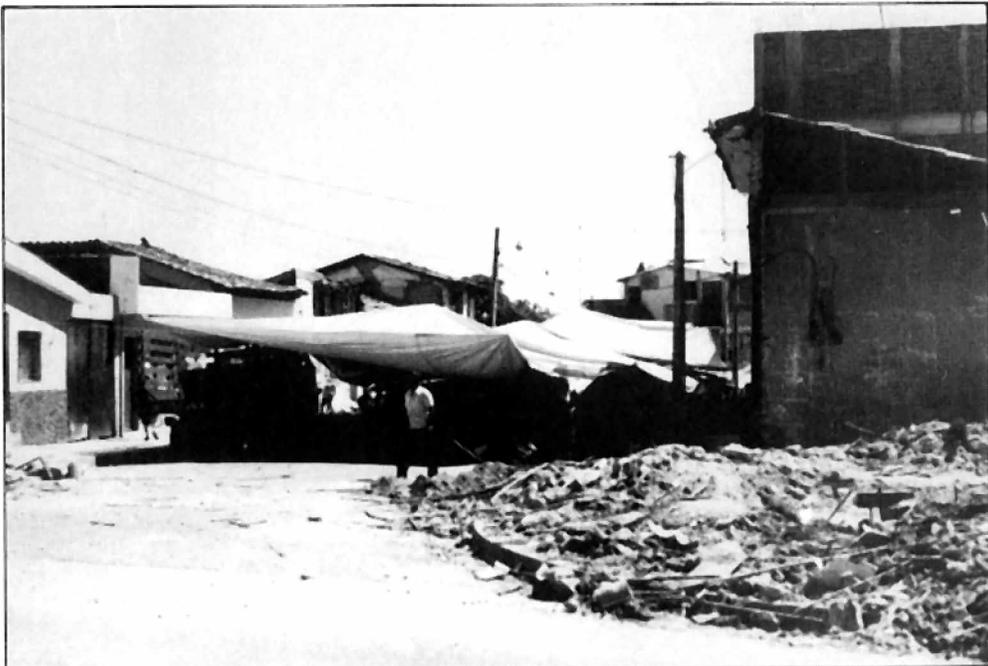
The damage to the city's housing left as many as 300,000 people homeless. Some immediately set about repairing or rebuilding their homes, but many were reluctant to rebuild their homes on the same unsuitable terrain. Large numbers of people returned to other parts of the country from whence they had come to San Salvador in recent years. The majority of the homeless simply erected temporary shelters in the streets, on roundabouts, in parks, almost anywhere that they could find a space to occupy (Plate 46). These shelters were constructed from wood, plastic sheeting, canvas, corrugated iron and any other materials that were available to them; very few of the homeless were sheltered in tents. Although the rainy season was coming to an end at the time of the earthquake, there were some very heavy storms in the weeks after the earthquake, causing havoc to these inadequate shelters.

PLATE 46: TEMPORARY SHELTER ERECTED IN STREETS
