# THE AUGUSTA, SICILY EARTHQUAKE OF 13 DECEMBER 1990

## A FIELD REPORT BY EEFIT

**EEFIT**

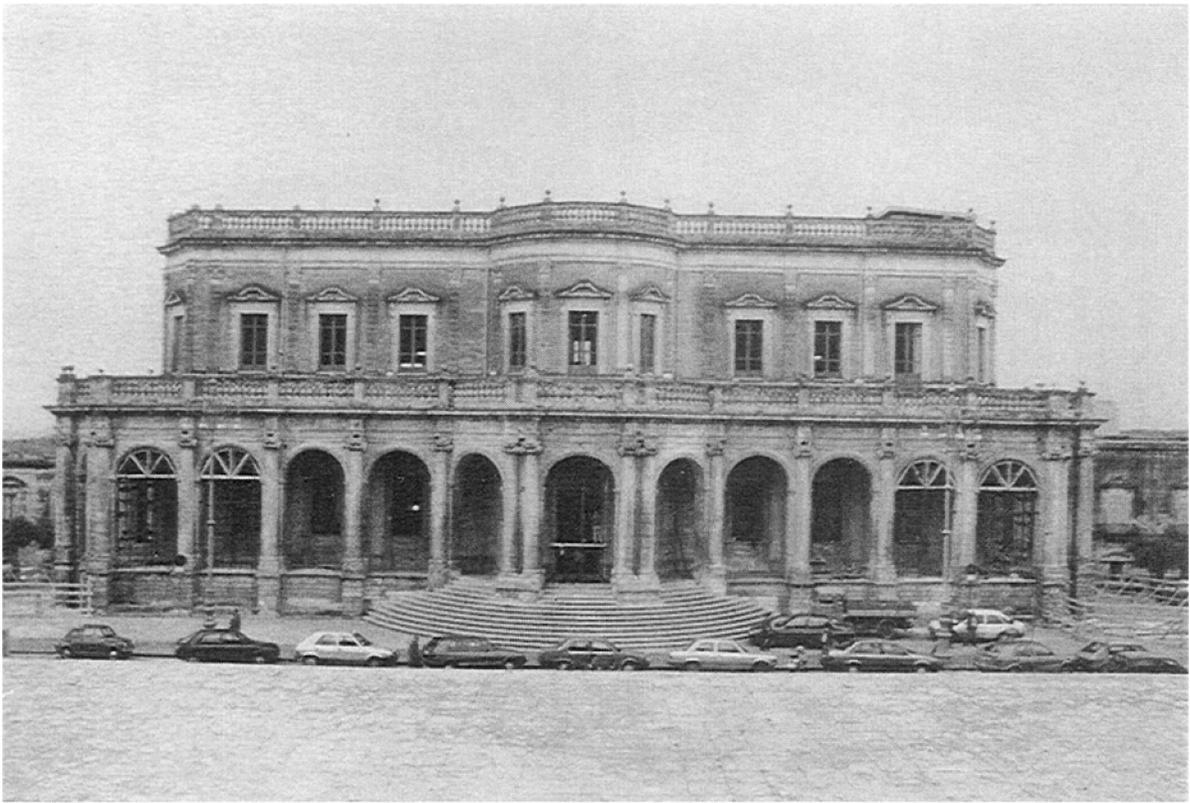
PLATE 3 *Town Hall in Noto*

- i) One and two storey houses of lower income families in towns and villages and of farms. These structures are mostly built in load bearing limestone rubble and lime mortar.
- ii) Two to four storey domestic commercial and administrative buildings. They are predominantly of load bearing random rubble masonry walls incorporating in their façades ashlar stone work ornamentation such as complex entablatures, pilasters and pediments, Plate 2.
- iii) Three to five storey ashlar (cut stone) faced palaces, churches and public buildings. In most cases the ashlar stone is a veneer to lesser quality rubble stonework behind. Rear and party walls, those of lesser value for giving an image, are normally built in rubble stonework, Plates 3 and 4.

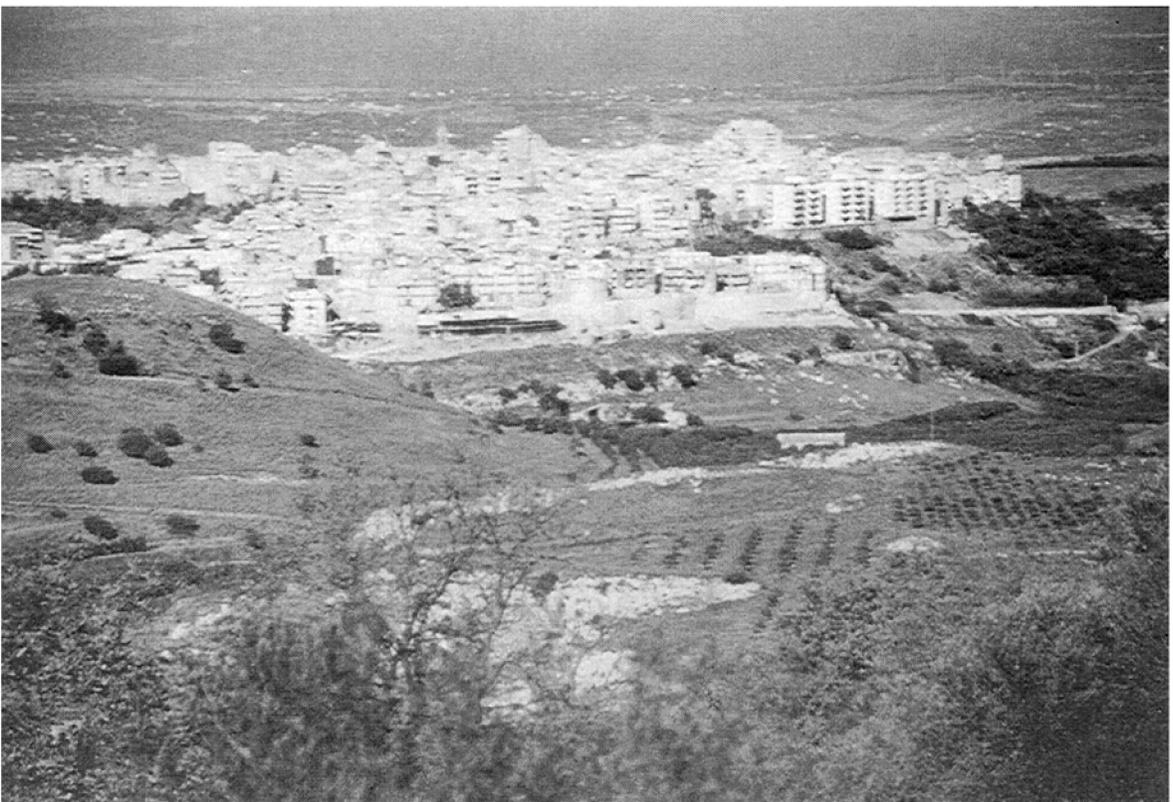
PLATE 10 *General view of Carlentini*

Carlentini like Noto is laid out on a formal grid pattern of streets on a plateau feature of a hill spur crest. Like Noto the spur is surrounded by very steep slopes and cliffs, Plate 10. Throughout most of the town no damage was observed to old and new buildings and no shoring and pavement barriers were present. In the main town square one formal building had entablature damage and all windows were strutted to support the lintels.

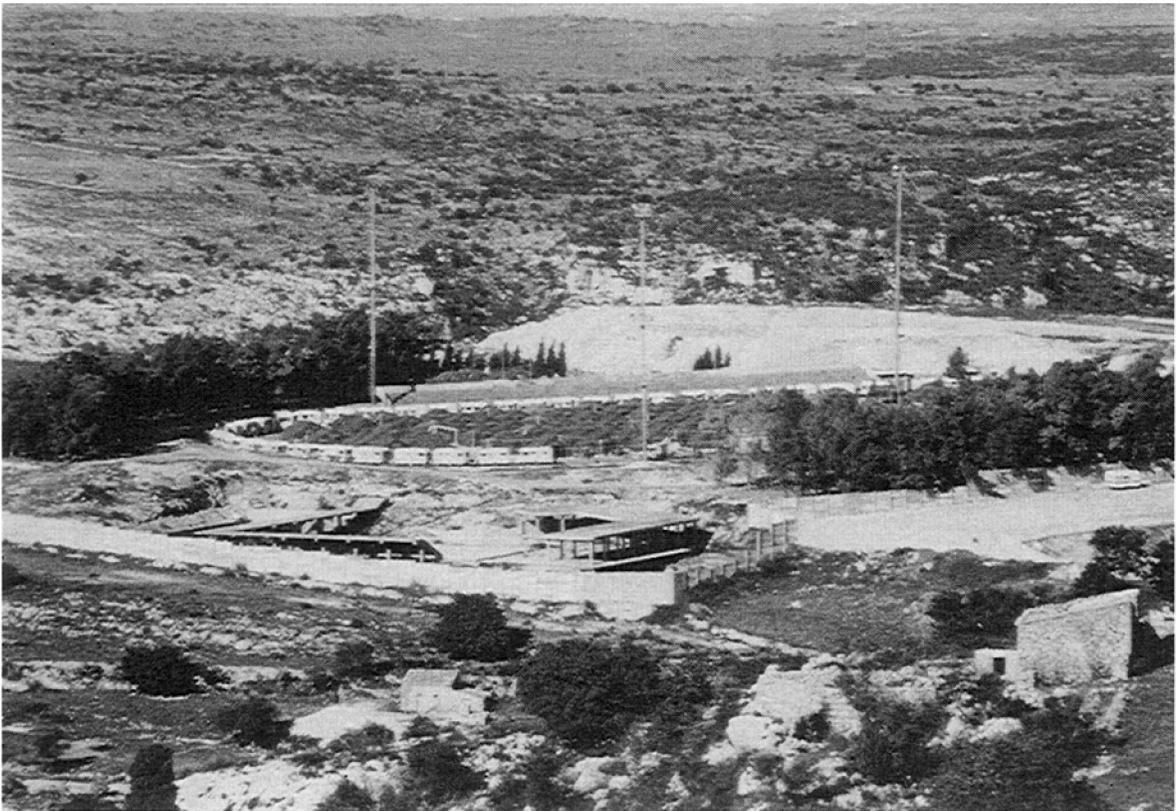
PLATE 11 *Refugee camp near Carlentini*

The significant damage in Carlentini occurred in the NW corner of the town near to a cliff edge where there had been significant collapse of modern three storey houses. Approximately 30 street "blocks" had been cordoned off and all the buildings evacuated, Plate 11. Here the damage could have resulted from local site amplification effects, perhaps exacerbated by reuse of old foundations or building over old basements cut into the underlying limestones. Damage to the traditional houses was much less severe than to the new, but with similar failure mechanisms to those seen in Noto and Melilli. Most damage was to two storey houses with out of plane tilting of façades and falling off of insecure entablatures. No exacerbated effects were apparent where the old type of houses were mixed in with the new and had even been modernised, for example, with the covering of the façades with glazed tiles. It was the collapse of structures here (Plates 12 and 13) that caused the reported 19 deaths.

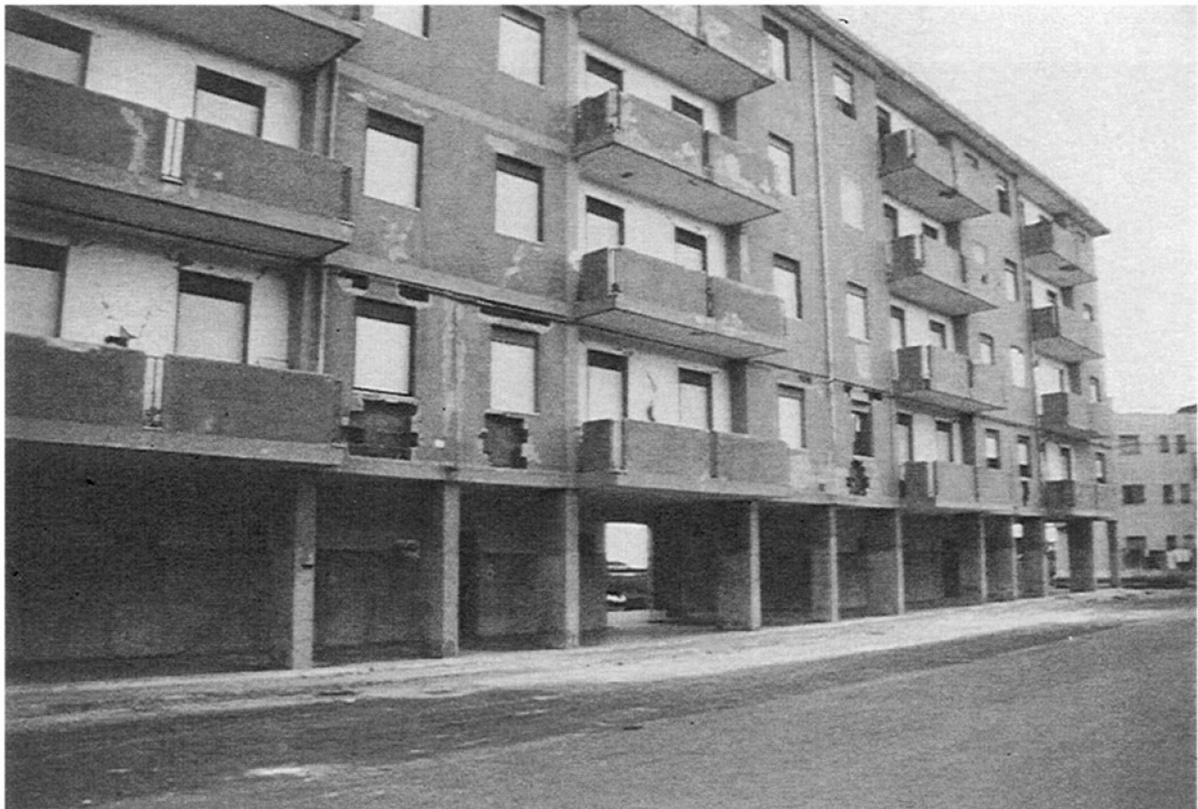
PLATE 14 *Modern flat complex - Augusta*

The flats are five or six storeys in height, the ground storey being mostly open to allow personnel access and car parking, thus providing a 'soft storey' at ground level, Plate 14. A reinforced concrete (RC) frame of columns and beams linked with reinforced concrete slabs form the basic building structure. The RC frame is infilled by exterior and interior masonry panels, in the form of either clay bricks or more commonly hollow tile blocks.
