# The Coy Mistress - a view of masonry behaviour

Based on his 2012 **James Sutherland History Lecture** and drawing on a range of examples, **Dr Bill Harvey (BSc PhD CEng FStructE FICE)** illustrates the difficulties of predicting masonry behaviour.

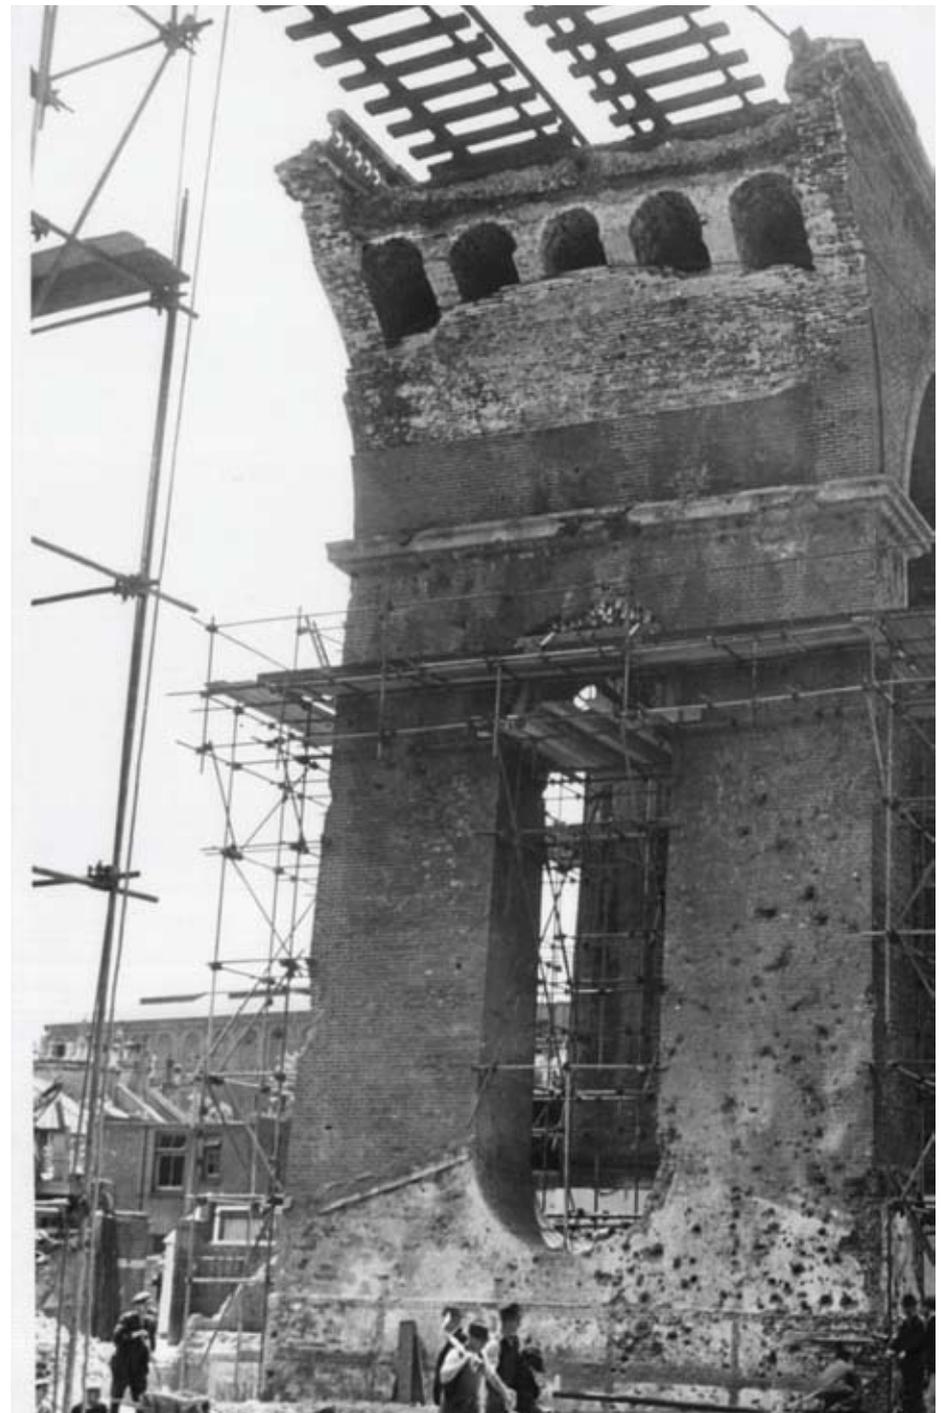
Figure 1 London Road Viaduct. Partially destroyed by a WWII bomb

In May 1943, a bomb dropped in London Road, Brighton. It did not go off immediately but skidded along the road until it hit the railway viaduct. There it destroyed one pier (Fig 1), bringing down the better part of two full spans. Contrary to expectations, the rest of the viaduct did not follow in domino fashion. The adjacent piers certainly leaned into the gap and cracks up to 150mm wide opened in the spandrel walls of the adjacent spans<sup>1</sup>.

Fig. 1 shows the railway tracks to be visible, still in place across the gap. Fig. 2 shows the effect of a restoring force at deck level where 100kN/m width is ample to prevent the pier tipping. The only source for such a force is the railway track. The bridge is about 9m wide so the total force required is 90t. There are six rails including check rails on the inside of the curve but not including the power rails which are ineffective. That means 15t per rail. The capacity of the rails is ample. Transfer to the bridge is less obvious but there are two paths. The first is through the sleepers and ballast. The second results from the kink in the rails at the broken edge as they sag in the gap. The load is, of course, carried back to the abutments in tension not in compression in the suspended rails. We should also recognise that the behaviour observed in Brighton is by no means unique (Fig. 3).

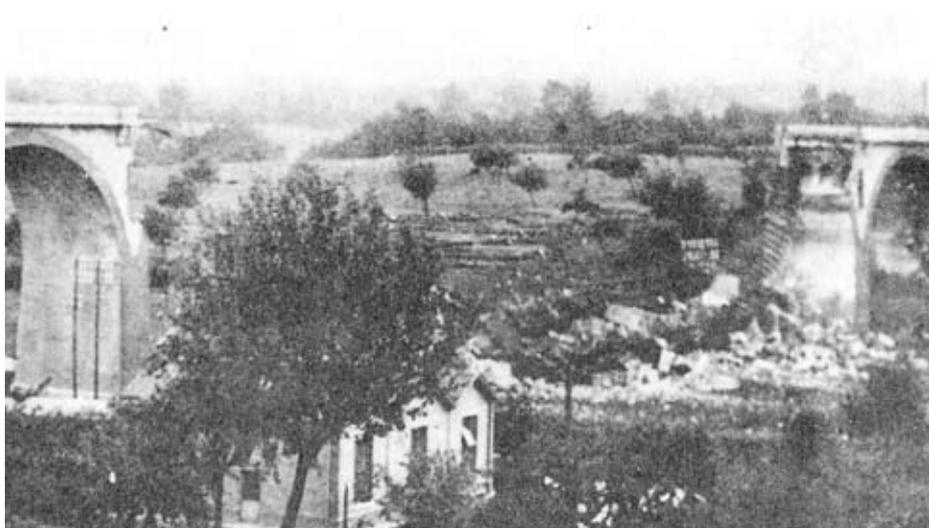
Figure 3 Postcard showing a damaged viaduct at Hirson, Northern France c.1915

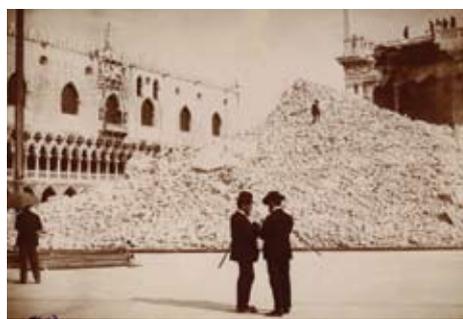
Figure 4 St Marks Belfry Venice. Rebuilt after collapsing in 1906

Collapses such as those in Figs. 4 and 5 are far from uncommon. Only after the

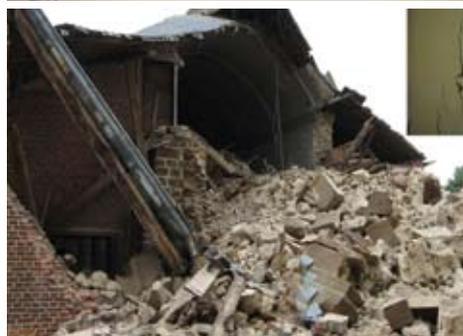
Figure 5 Church tower collapse, Belgium. Typical example of brittle failures. Note cracks (inset right)

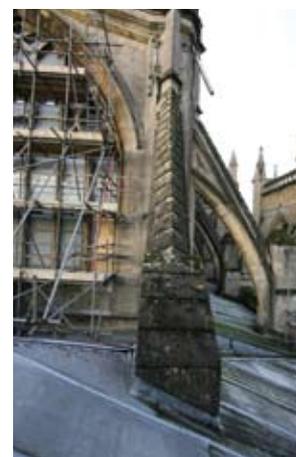
Figure 6 Flying buttress above the retrochoir roof. Wells Cathedral

Wells Cathedral in Somerset is famous for its inverted arches under the tower, but there are other, to me more interesting, things hidden from public view. Each side of the East window is a flying buttress taking the thrust from the side wall of the choir. In a photograph from above it looks perfectly normal except that it drops into the roof of the retrochoir (Fig. 6).

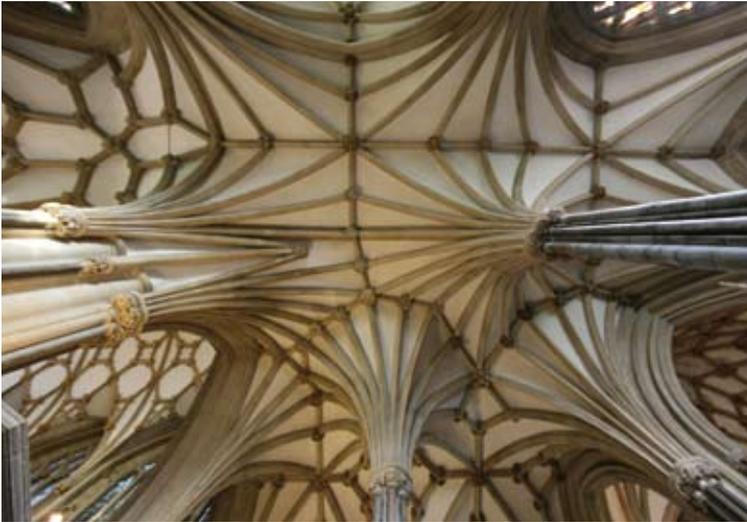
© Figure 7  
Upward view of  
the retrochoir  
vaults.

In the retrochoir itself, there is no sign of it, just a field of modest vaults and slender columns. The buttress lands on the slender column to the right (Fig. 7). Explore the roof space (Fig. 8) and things are much more interesting. The buttress comes down through the roof and steps sideways. The photograph shows that, while it might be possible to think of this in two dimensions, it certainly won't work that way. So how does it work? One thing about masonry is that because it has thickness and great strength, the force can flow along different lines with no external evidence of different behaviour.

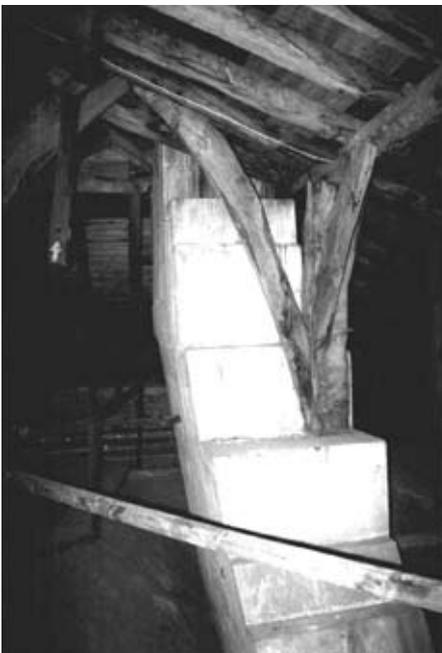
© Figure 8 Side  
slope of the  
buttress within  
the roof

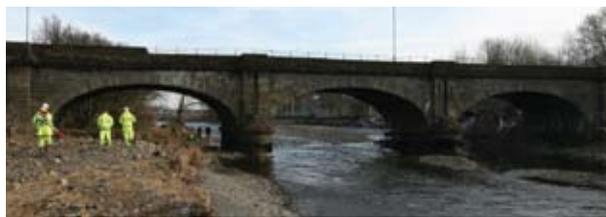
Figure 12  
Calva bridge, Workington (viewed from downstream)

The stone bridge across the River Derwent at Workington (Fig. 12) was built in 1841. It has three spans built to 48ft with a 12ft rise and a three centred shape. Once again this produces interesting geometry with the central radius of 48ft and side radius of 9ft. There are three spans standing on 9ft thick piers. In the floods of November 2009 the south pier suffered severe scour and when the floods subsided the scene in (Fig. 13) was revealed. The bridge has since been repaired and re-opened. Of particular interest to me is how the bridge stood up with such major undermining.

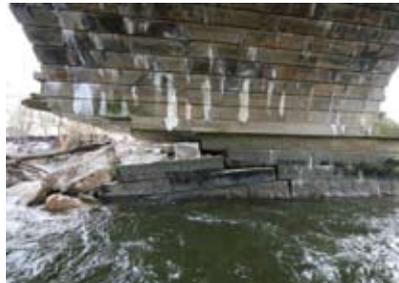
Figure 13  
Pier loss due to scour

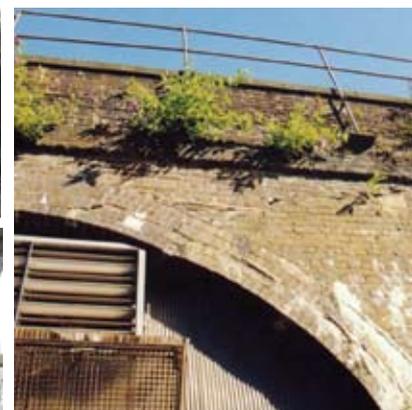
Figure 14  
Effect of a dropped pier with hinges at the crown (intrados) and top of backing (extrados)

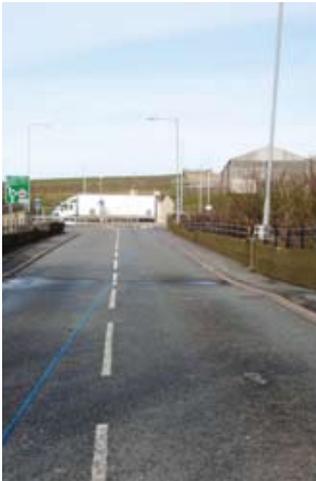
Figure 15  
Calva bridge  
tilting into  
the scour  
hole (reverse  
direction from  
Figs 13 and 16)

At Calva, there was such continuity because it had been filled with concrete some years ago. That is not enough, however, to support the 1000t of stone and concrete over the pier. A study of the final geometry leads to a clear understanding of how that worked. Fig. 15 shows how the pier at Calva tipped and moved sideways. Note the inclined lamppost and the curve in the parapet. But where did the forces go? Indeed, what are the forces?

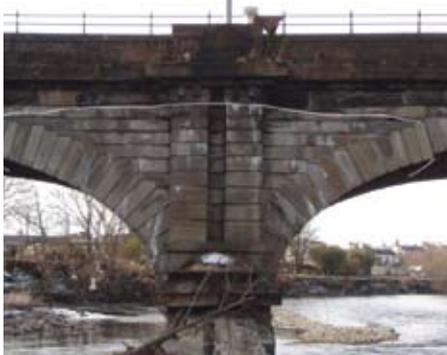
Figure 18 Calva  
pier with cracks  
highlighted

A very simple thrust model of the plan view of the bridge is shown in (Fig. 17). The horizontal force of 400t is applied as a distributed force across the pier unit. Elsewhere there is no horizontal force so the thrust runs in a straight line. The only available reaction is at the abutments so the slope of the thrust to the right of the force is much less than to the left, and that means the eccentricity is much greater just to the right of the pier block than to the left. Though there are cracks on both sides, that to the left is much smaller (Fig 18).

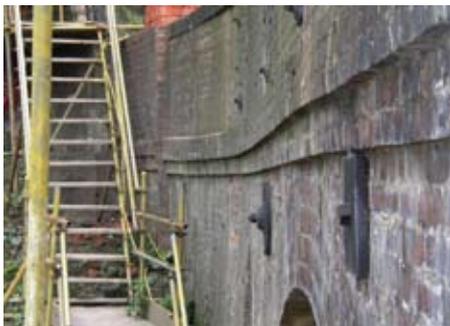
Figure 19 200mm drop in string course at Rockshaw Road

The Figure also shows how the upper part of the spandrel and parapet are arching over the gap, leading to considerable horizontal cracking both in the walls and in the arch.

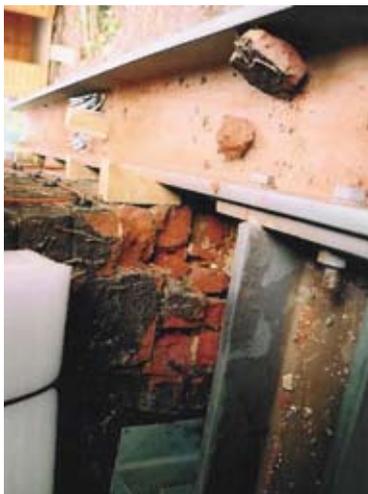
Figure 20 Crushing brickwork. Rockshaw Road rail bridge

At Rockshaw Road, the local council decided to put in a gully to trap water that was running down the hill into a major road and freezing in the winter. Whoever did the installation was lazy. They put the gully just behind the bridge abutment and knocked a hole in the wing wall to drain the water into the railway cutting. That would have been bad enough, but they didn't compact the fill properly so the gully settled and broke its connection. The water was then being channelled directly into the back of the abutment which settled (apparently slowly) by about 200mm beneath the gully. There is a string course in the brickwork which shows the settlement nicely (Fig. 19). Both the spandrel wall and the arch deformed without significant cracking, but the movement threw extra load on to one leg of the pier that began to crush (Fig. 20).

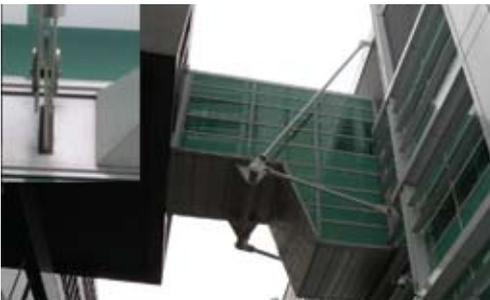
Figure 21 A decoration becomes a structure (Inset left: compression induced buckling)

There are many examples of wrong-headed modelling. Let's begin with one in a different material. In Beaumont Place behind London's University College Hospital is a bridge between two buildings. It appears to have a trussed support, though that is actually an architectural conceit (Fig. 21). The trouble with such elements is they have some stiffness and therefore attract some load.

The apparently large pin is actually just a plate washer on a thin bolt and the plates creating the joint are thin and have buckled in compression (Fig. 21 inset). In the end, of course, it's a truss. It doesn't need pinned joints because the secondary stresses are

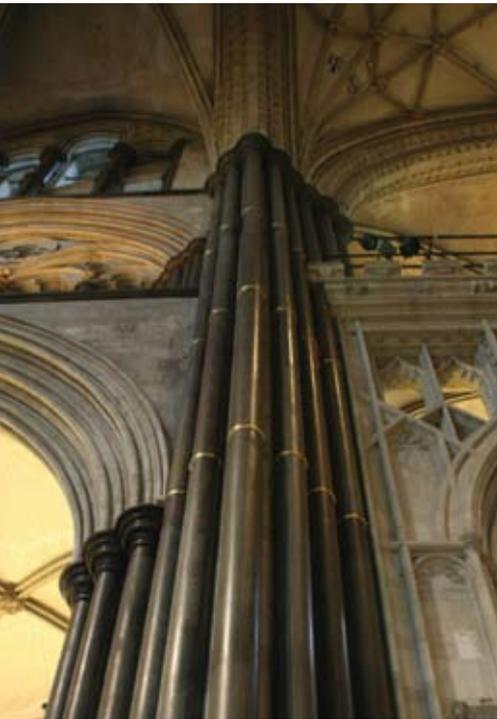
© Figure 23  
Salisbury Cathedral  
tower pier bend

The habit of assuming big things are rigid is fraught with real danger (look at the tower piers of Salisbury Cathedral, Fig 23). The bending stiffness of structures is much lower than axial stiffness. Foundations can usually be treated as rigid but not so often under masonry.
