CROSS Safety Report

Water ingress to cross-laminated timber structural frame

This month we present a CROSS report concerning water ingress causing parts of the cross-laminated timber (CLT) structural frame of an eight-year-old building to rot.

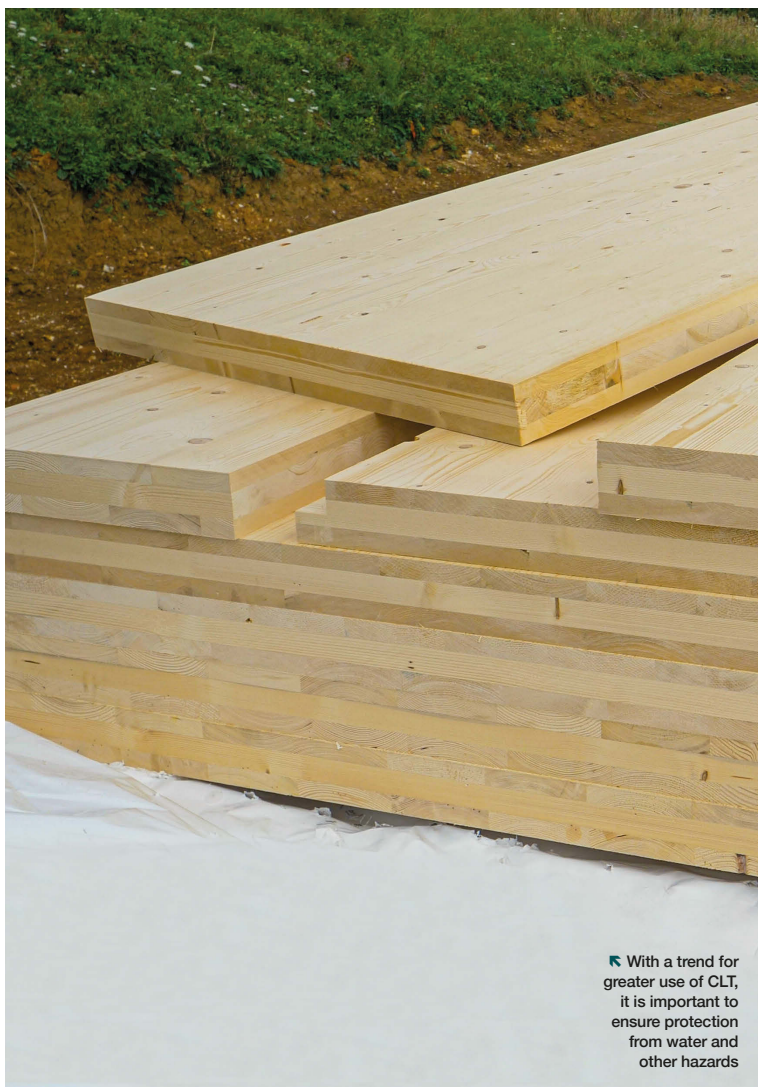
With a trend for greater use of CLT, it is important to ensure protection from water and other hazards
