# PETERBOROUGH SECTION

## SITE VISIT AT WEDGE GROUP GALVANIZING PLANT

### 15 SEPTEMBER 2010

### SAWTRY, CAMBRIDGESHIRE

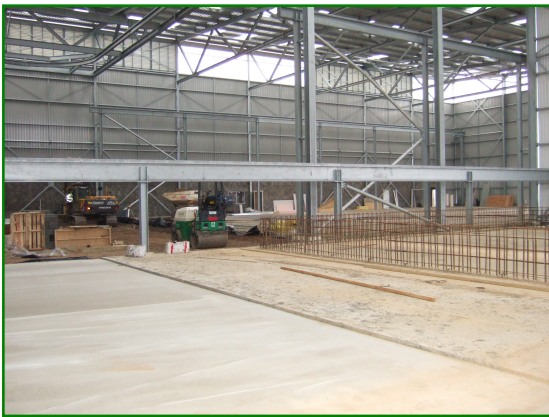
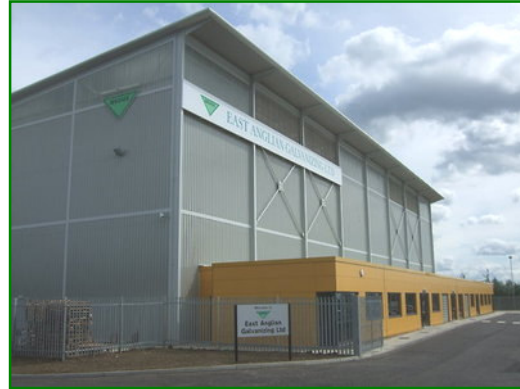
Internal and external views of the new state-of-the-art galvanizing factory

Our September site visit was a visit to the unique Galvanizing Plant in the UK which incorporates the most up to date galvanizing equipment in the industry. The plant which is a subsidiary company of Wedge Group Galvanizing Ltd, the largest galvanizing group in the UK, boasts the latest shell design for the galvanizing process with integrated green systems.

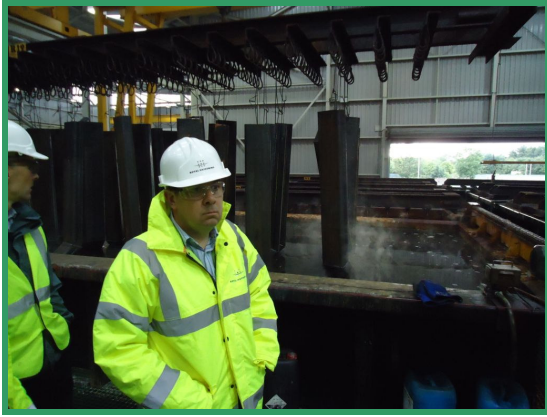
Stuart Broughton, Peterborough Section Chairman inspects the pre-wash baths

***Pre-treatment*** for galvanizing consists of 4 separate stages

- initial inspection to check if items are safe and suitable for galvanizing
- degreasing steel in a solution to remove oils
- pickling with weak acid to clean metal
- fluxing to assist the galvanizing reaction

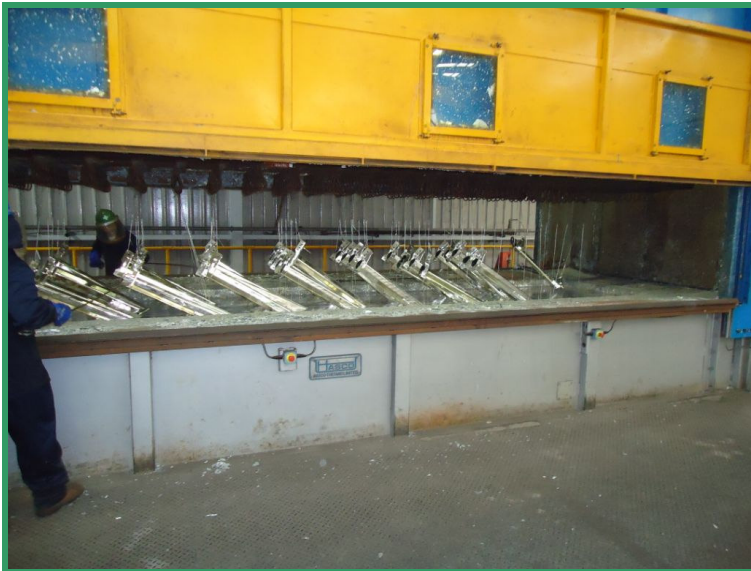
Material is being lifted out of the zinc bath and then transferred to the quench tank.

**Galvanizing** is where material is immersed in molten zinc a temperature of around 450 degrees. During this process the molten zinc reacts with the surface of the steel to form a series of zinc/iron alloys. These alloy layers protect steel from corrosion for 30-40 years. Once removed from zinc bath the product is then transferred into a quench tank where it is allowed to cool.

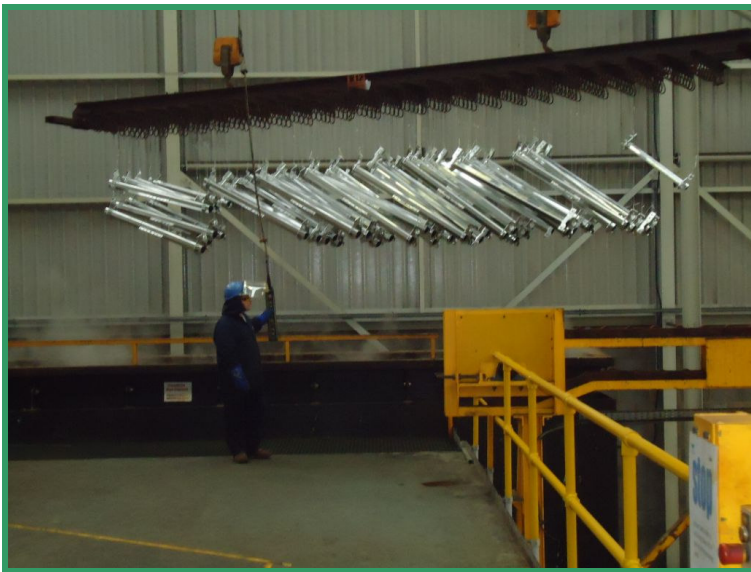
Material is being lowered into the quench tank
