THE LOMA PRIETA EARTHQUAKE OF 17 OCTOBER 1989

A FIELD REPORT BY EEFIT

EEFIT July 1993

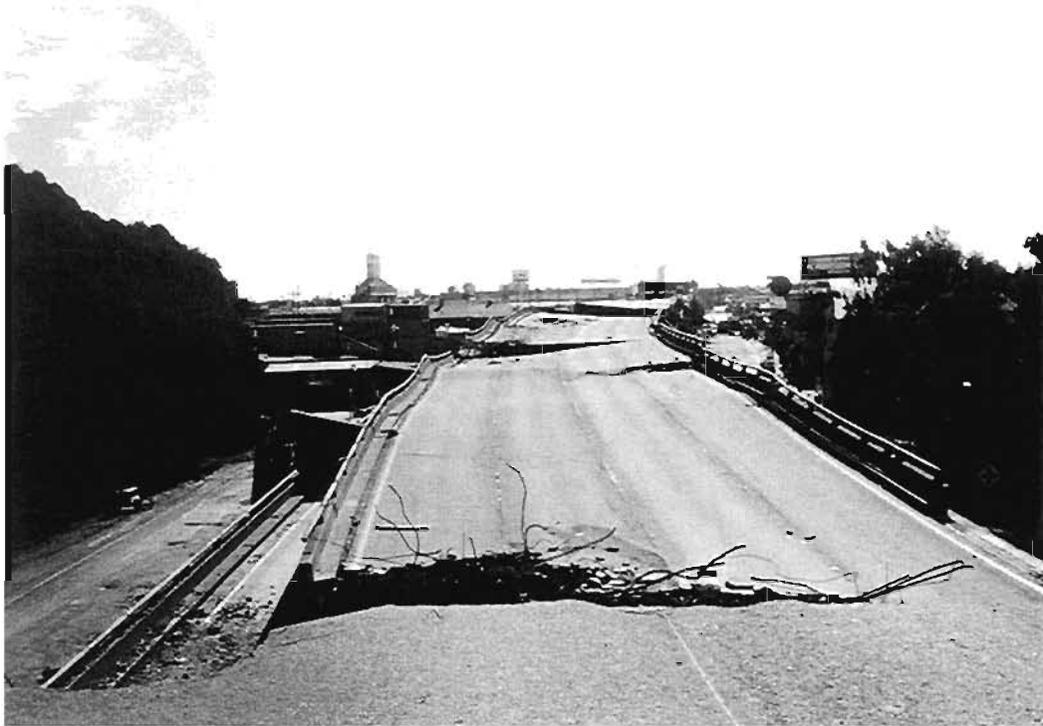
(see Plates 5.1 and 5.2), killing 35 people.

Plate 5.1 : Cypress Street Viaduct - Looking South along collapsed deck

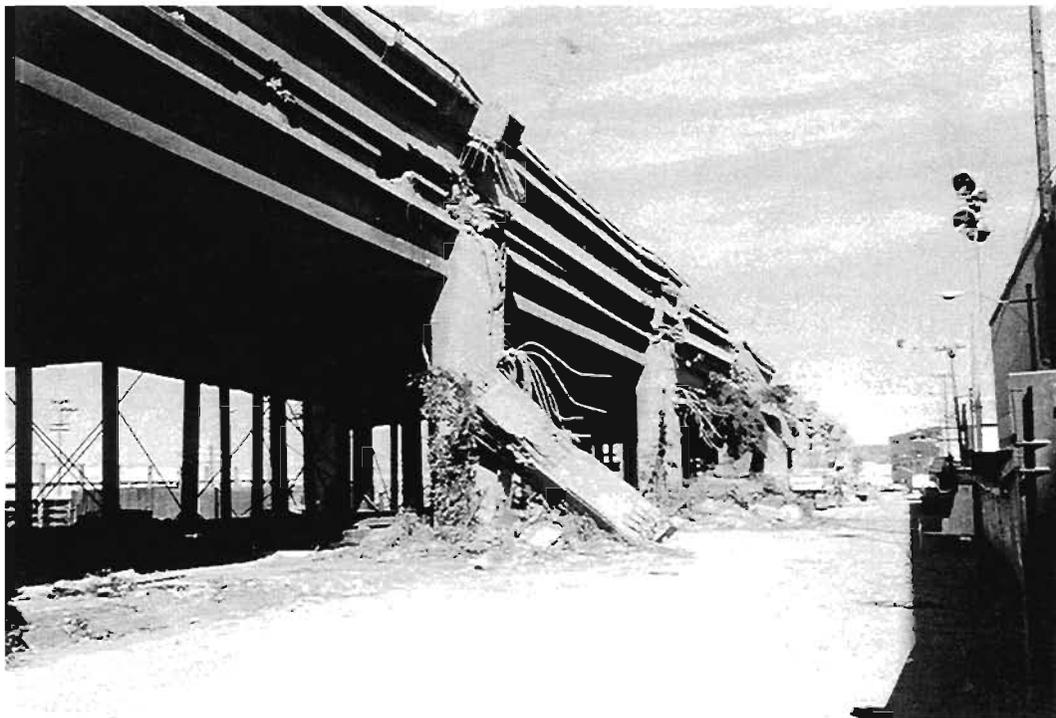
Plate 5.2 : Cypress Street Viaduct - General view of collapsed viaduct

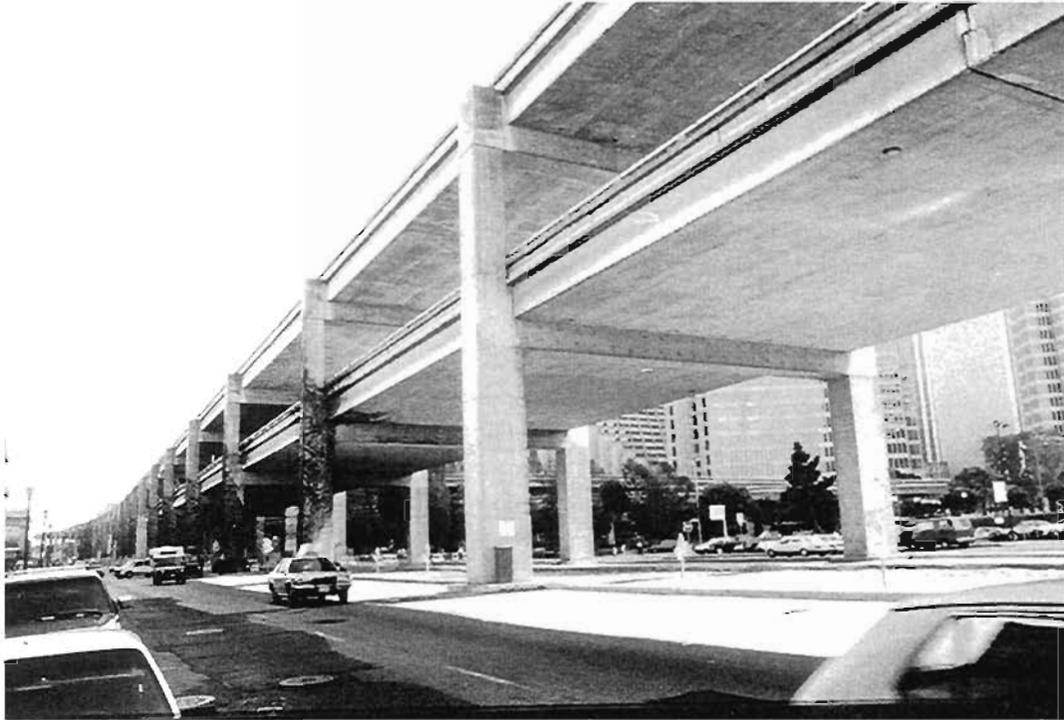
In many respects this structure is similar to Cypress Viaduct, but with some variations, including upper storey columns of constant rectangular section rather than tapered (see Plate 5.5). These 4ftx4.5ft (1.22x1.37m) upper columns were typically reinforced with 0.9% longitudinal steel and 0.5in (13mm) diameter links at 12in (305mm) centres.

Plate 5.5 : Embarcadero Viaduct - General view

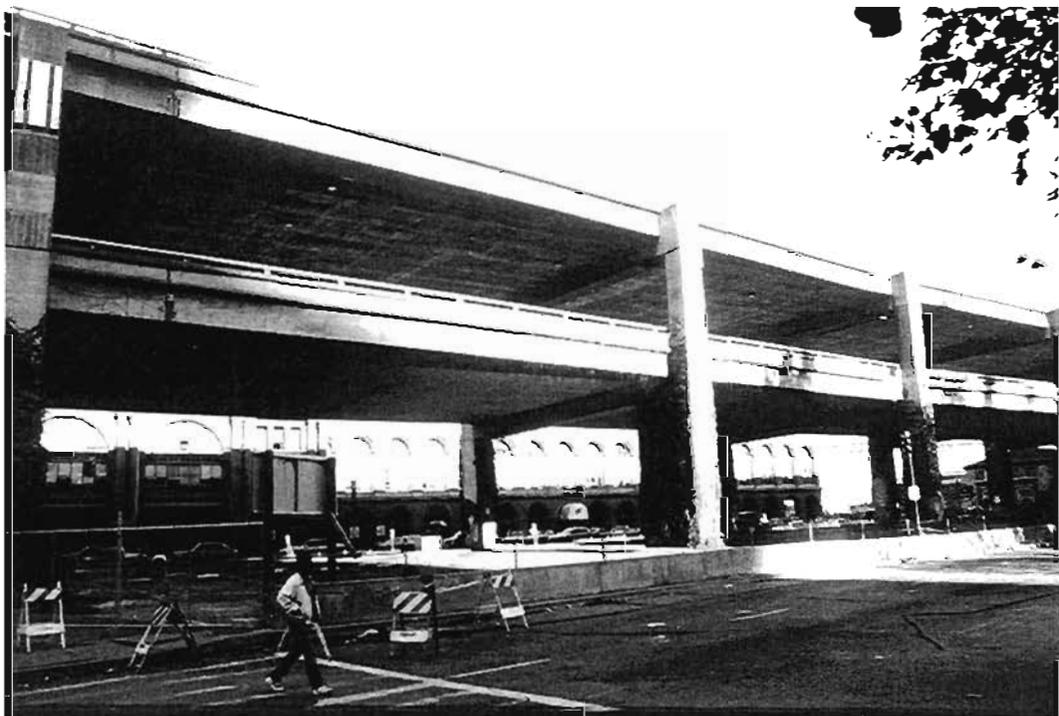
Mid-depth hinge joints were provided at every third span. The width of structural interaction at these joints was increased from 4.75in (120mm) used on the Cypress Viaduct to 6in (150mm). Cable restrainers had been installed across the joints as part of the retrofit programme following the San Fernando earthquake (see Plate 5.6).

Plate 5.6 : Embarcadero Viaduct - Cable restrainers (under metal covers at top left hand corner)

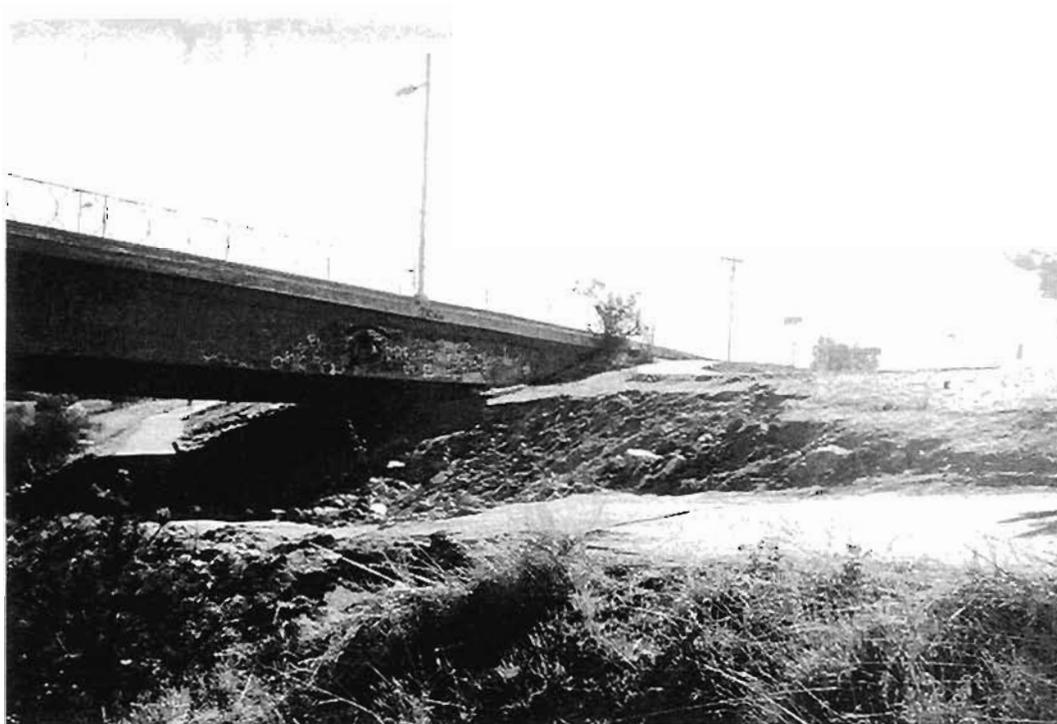
Plate 5.12 : Laurel Street Bridge - Slumping of embankment

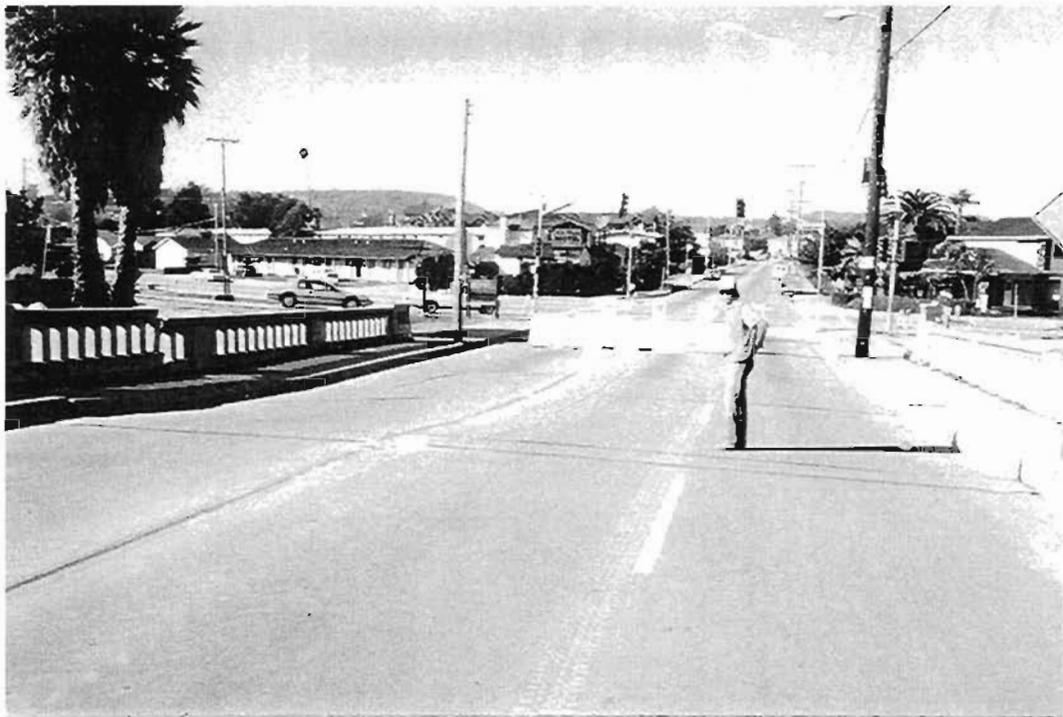
Plate 5.14 : Riverside Avenue Bridge - Settlement of approach embankment

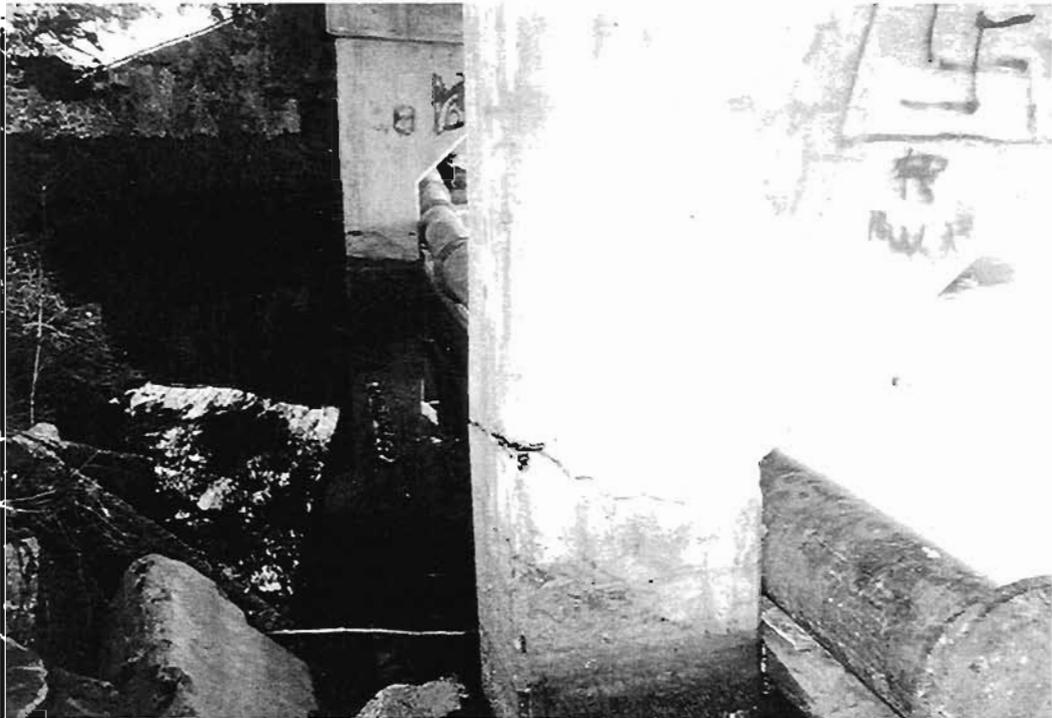
Plate 5.17 : Cut Bias Bridge - North side column showing crushing and toe of adjacent fill

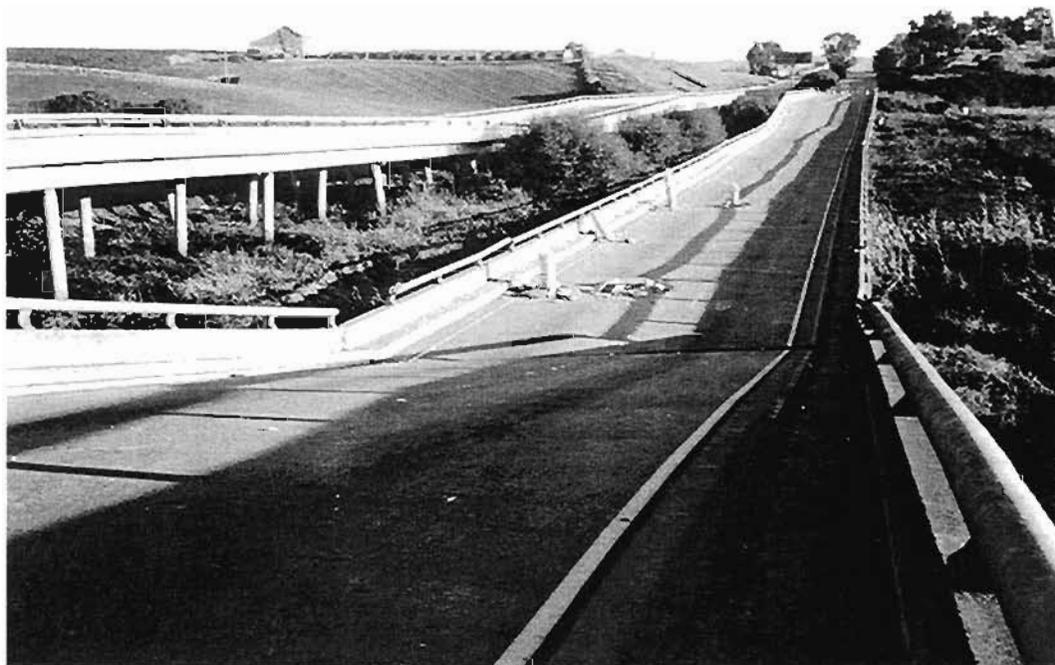
Plate 5.23 : Struve Slough Bridge - Piles punched through deck slab

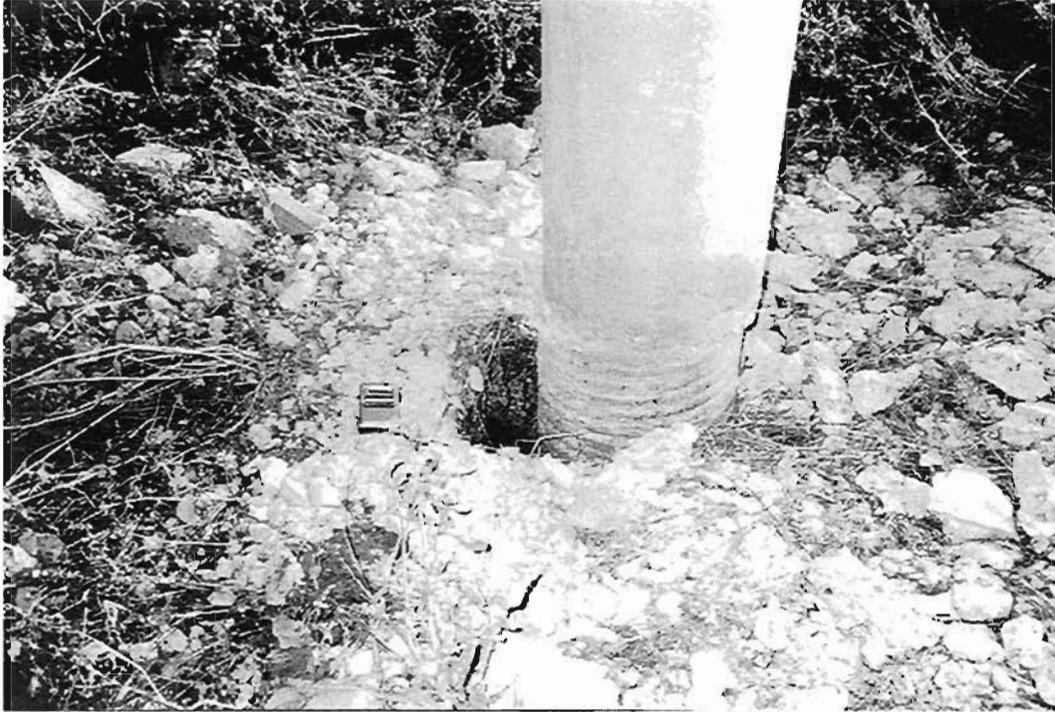
Plate 5.24 : Struve Slough Bridge - Crushed concrete from pile/deck joint above postholing around pile

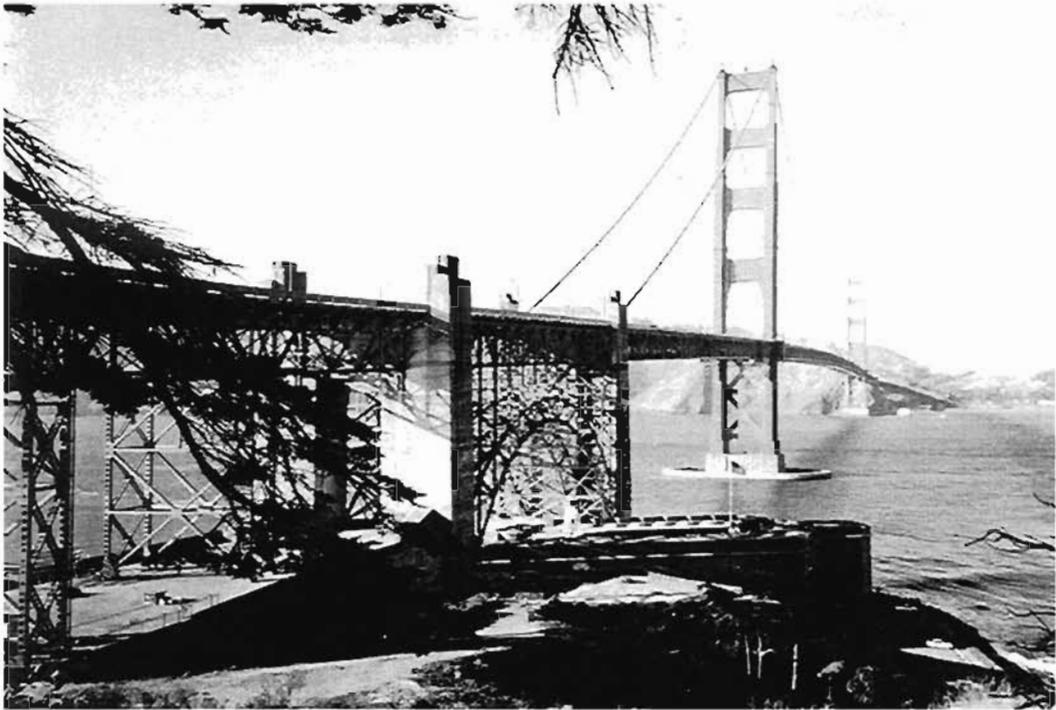
Plate 5.26 : Golden Gate Bridge - General View from South

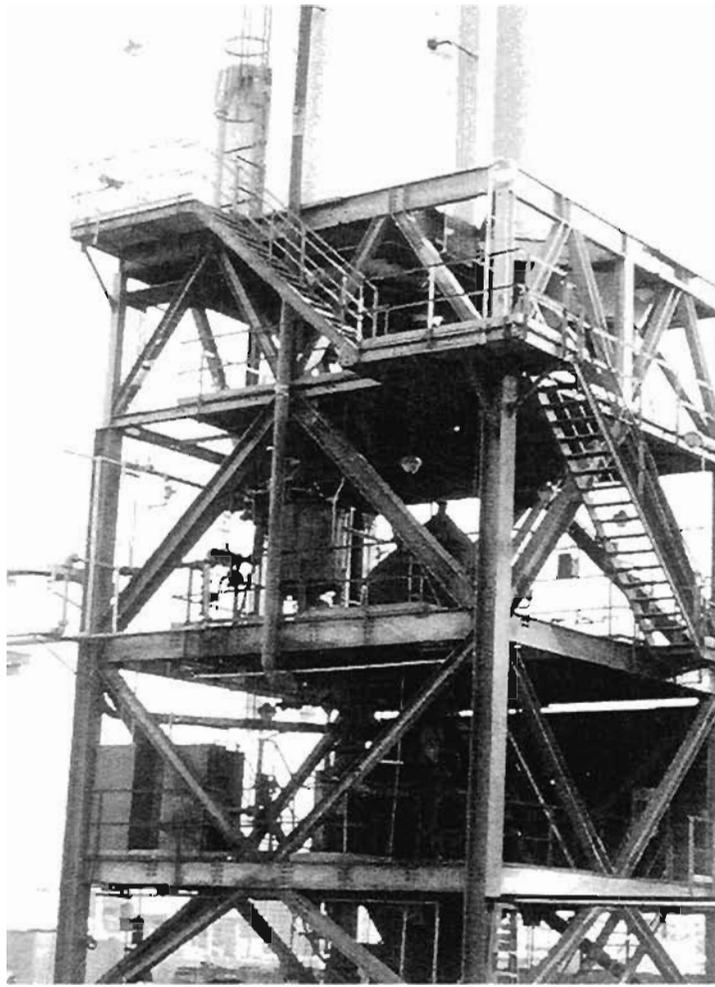
Plate 6.1 : Heavy Bracing Antioch

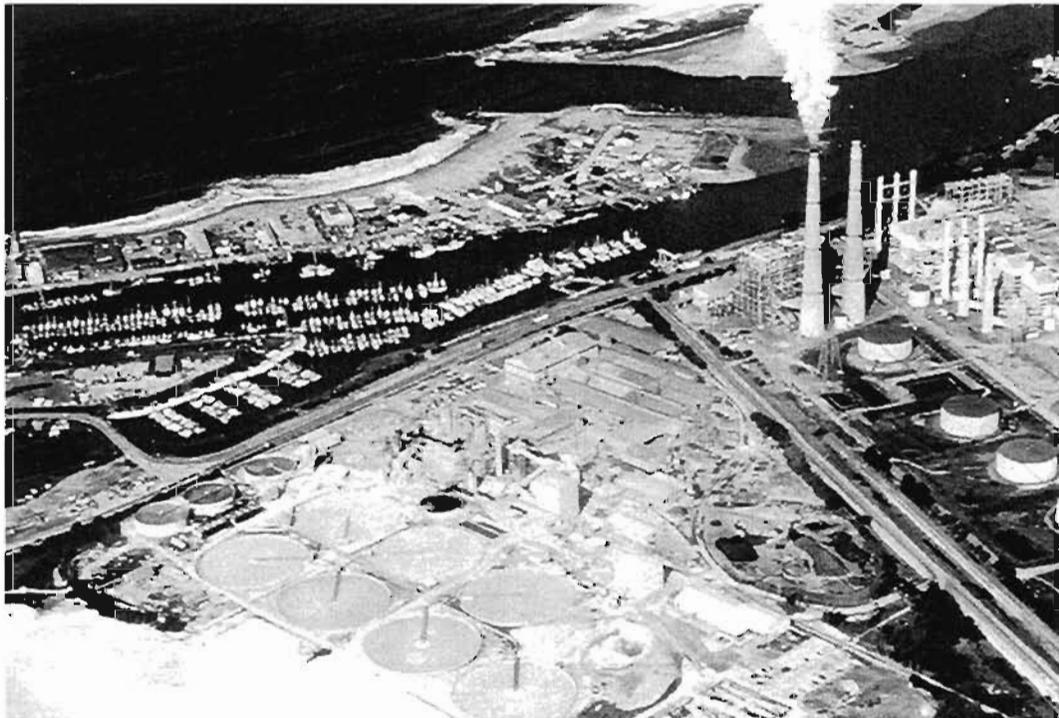
This was a large (2GW) gas/oil fired electricity generating site situated about 20 miles from the epicentre. There were several engineered structures on site (Plate 6.2). Structural damage was only reported for the large, open, steel framed structure housing the two 750 MW generation plants. This structure is approximately 120 m by 90 m by 45 m high and is constructed from very large section steel columns and beams, with large strength of member bolted connections at all major intersections. The structure contained some concrete flooring, but this was not continuous at any height, and whilst a basic structure of 7 storeys was observed, there were many discontinuities in the steelwork. From observation of the internal distribution of plant, it was clear that the loading at each level varied greatly.

Plate 6.2 : PG and E Overall Plan

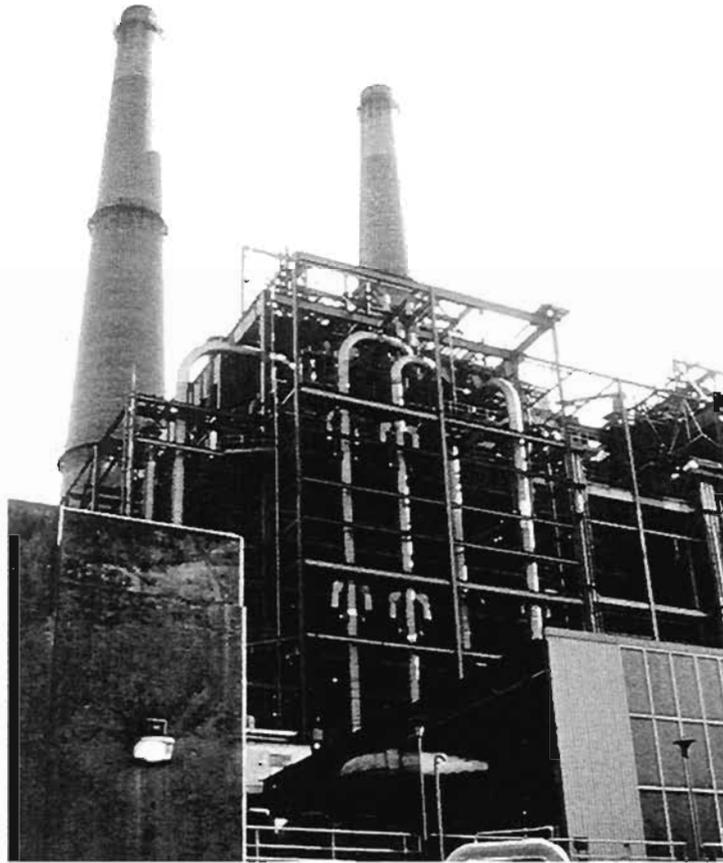
Several instances of structural damage were reported, but they were mostly of a minor nature and none prevented the continued operation of the plant. There appears to be no damage to the major structural steelwork, although one element of minor bracing steelwork between the two large chimneys was observed to have buckled (Plate 6.3). A welded shear block restraining one of the large heat exchangers had failed (Plate 6.4) and some failure of heat exchanger tubes was reported. Seismic restraints to the heat exchangers and main stream lines had yielded in some cases, indicating that significant movement had occurred during the earthquake. At a point in one of the main steam lines lateral movement of the pipe by approximately half a diameter in either direction had occurred, damaging the side restraint steelwork and the thermal insulation (replacement steelwork is shown on Plate 6.5). The pipework remained undamaged.

Plate 6.5 : PG and E Replacement Steelwork Guide

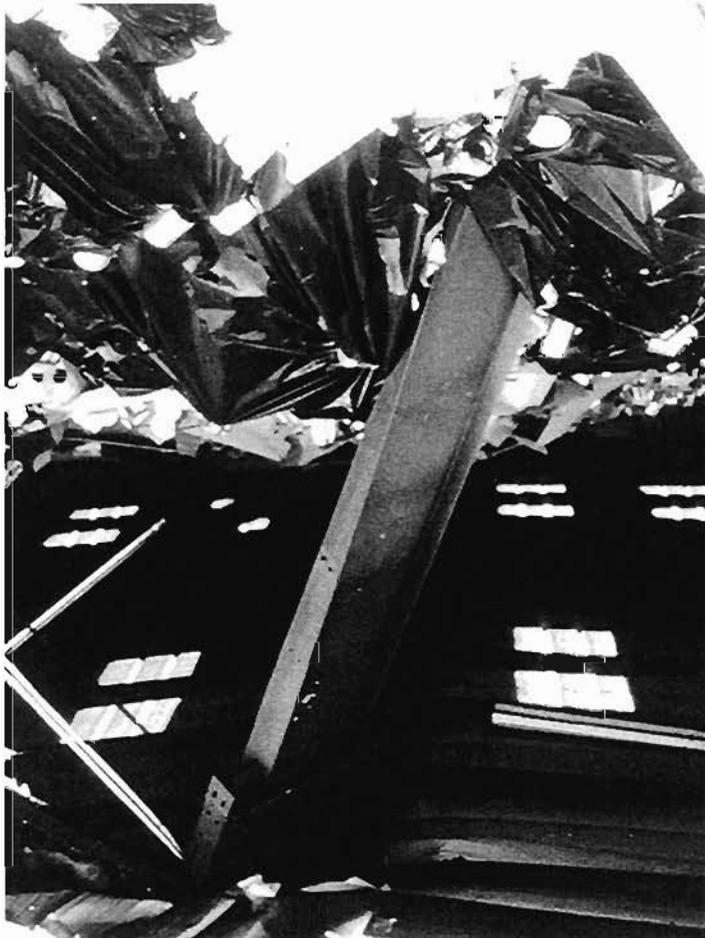
Plate 6.10 : Hollister - Twisted Column on Metalclad Warehouse

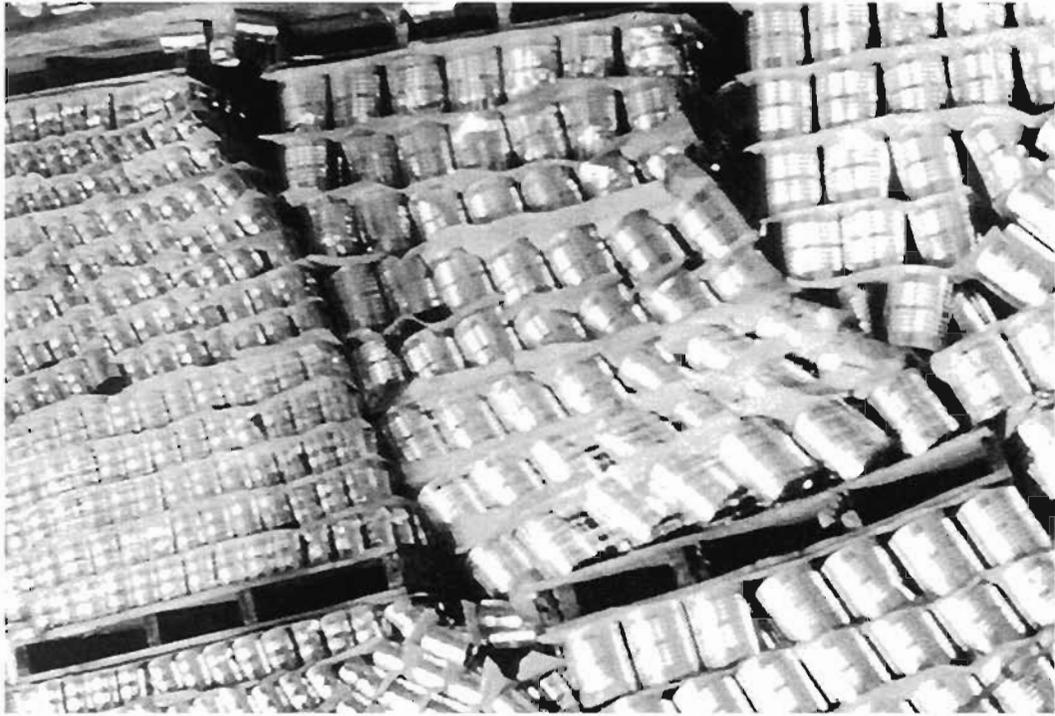
Plate 6.11 : Hollister - Small Tins (Shear/Crush)

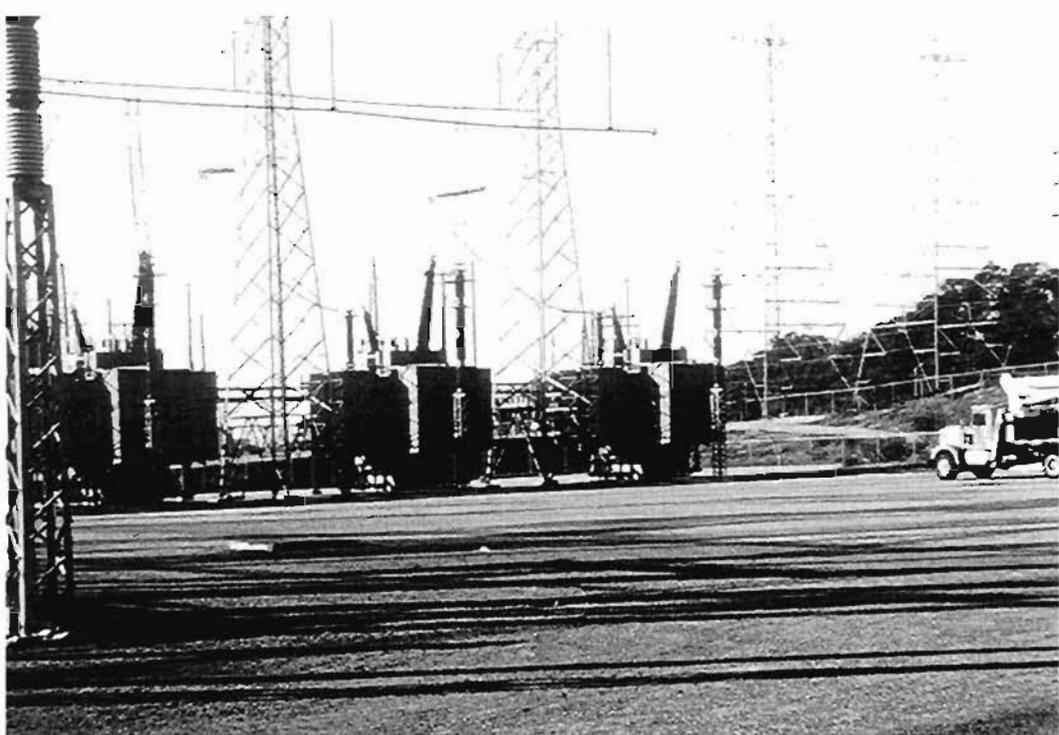
have performed satisfactorily. This was surprising as their large mass, small footprint and the lack of positive restraint due to their mounting on rails, made them vulnerable to damage (Plate 6.18).

Plate 6.18 : PG and E Transformers

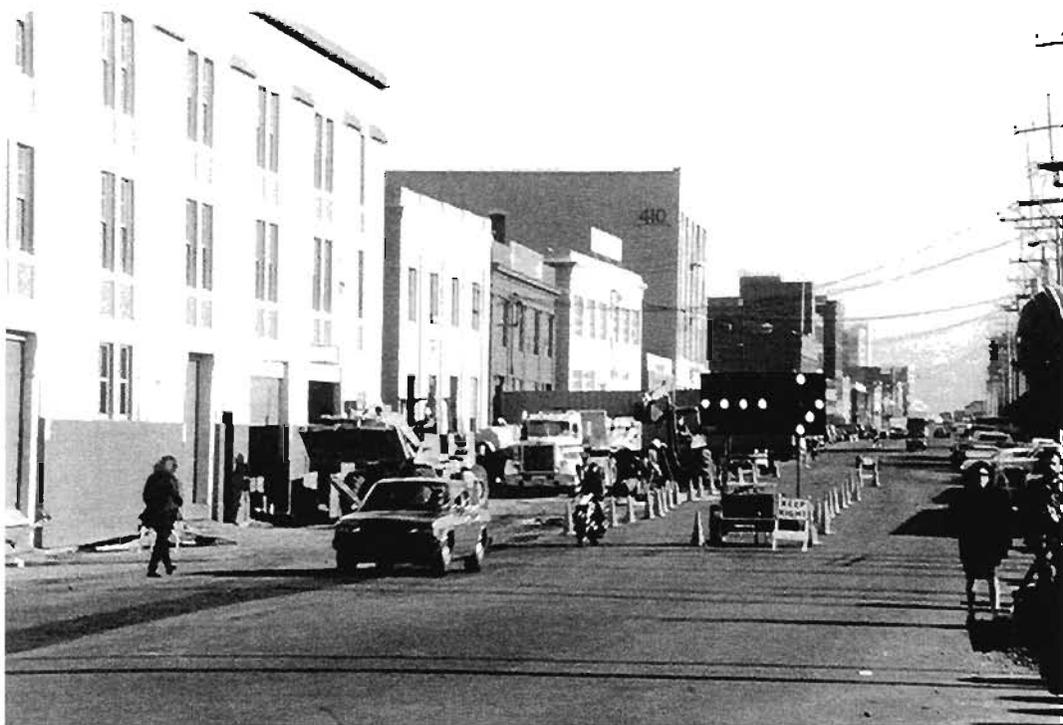
Plate 7.5 : Differential settlement south of Market Street

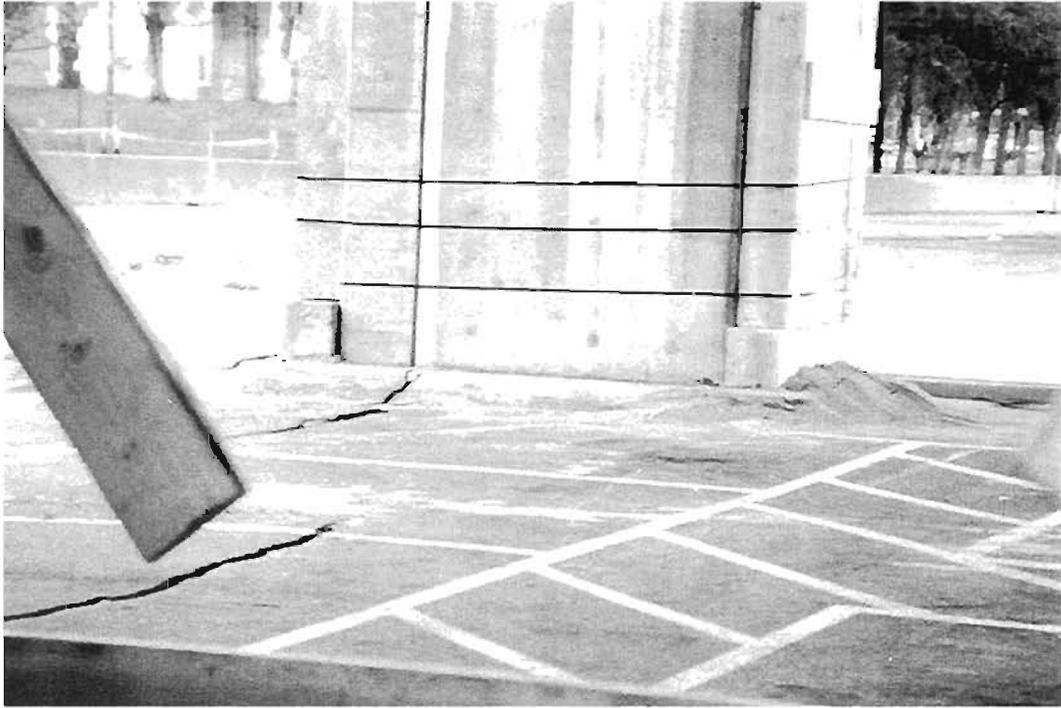
Plate 7.6 : Liquefaction around pile cap on the Embarcadero

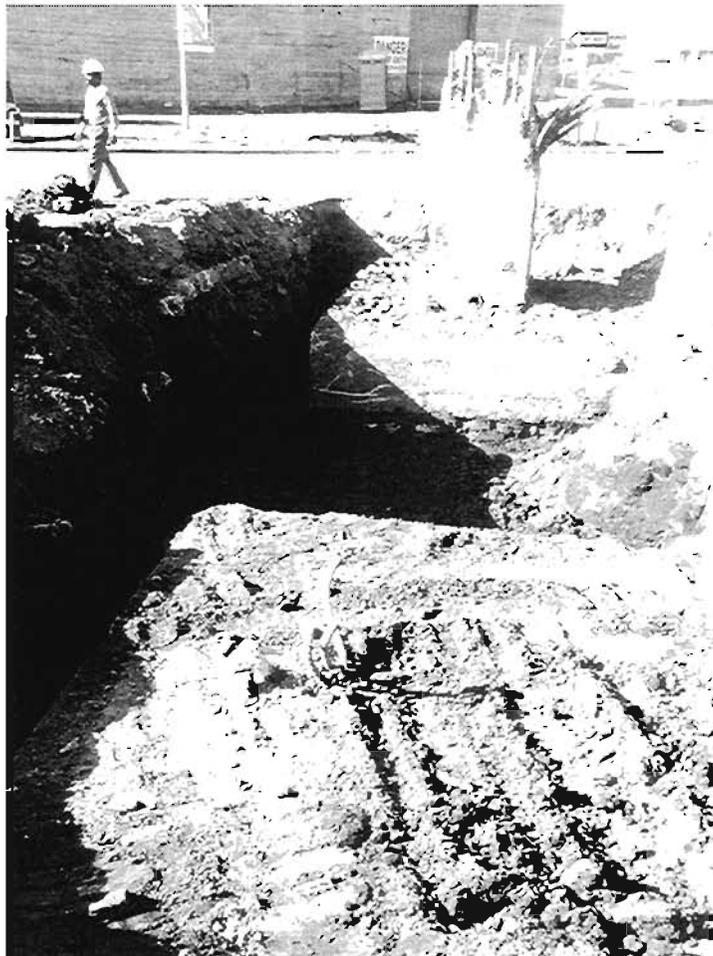
The freeway collapse was limited to the north-south section described above and which may be seen in Figure 7.1. The foundations of the piers are piled with a substantial pile cap at the foot of each pier. Detailed drawings of the foundations are not available, but a sketch indicating the pile cap and piles is shown in Figure 7.7. Plate 7.7 shows an excavated pile cap.

Plate 7.7 : Excavated pile cap on the Nimitz freeway
