THE LUZON, PHILIPPINES EARTHQUAKE OF 16 JULY 1990

A FIELD REPORT BY EEFIT

SUMMARY

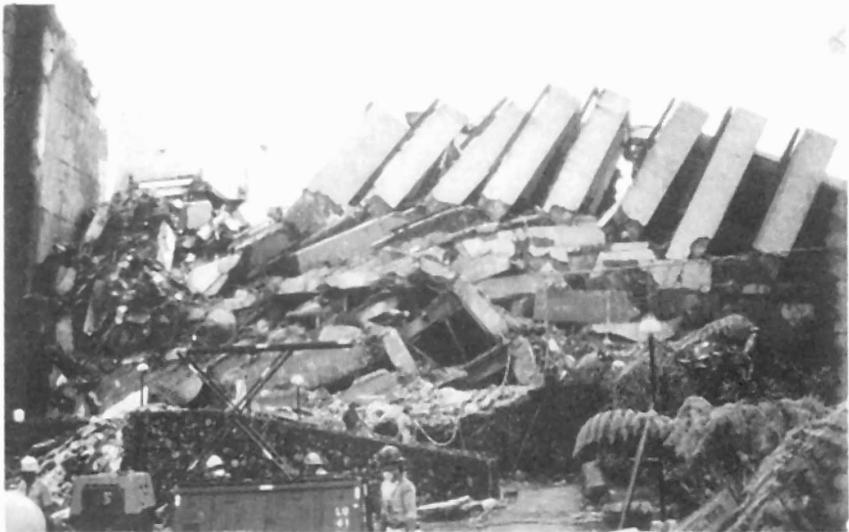
Figure 5.7

Hyatt Terraces Hotel,
Baguio: Aparthotel

The Aparthotel (Figure 5.7) is understood to have collapsed in the first shock to be felt in Baguio, falling onto the western side of the main Hotel. It is understood that the Aparthotel consisted of 4 rectangular blocks connected in plan and grouped around a core (Figure 5.4). The date of construction of the Aparthotel is not known; it is thought to have been built after the main hotel, which dates from 1975.

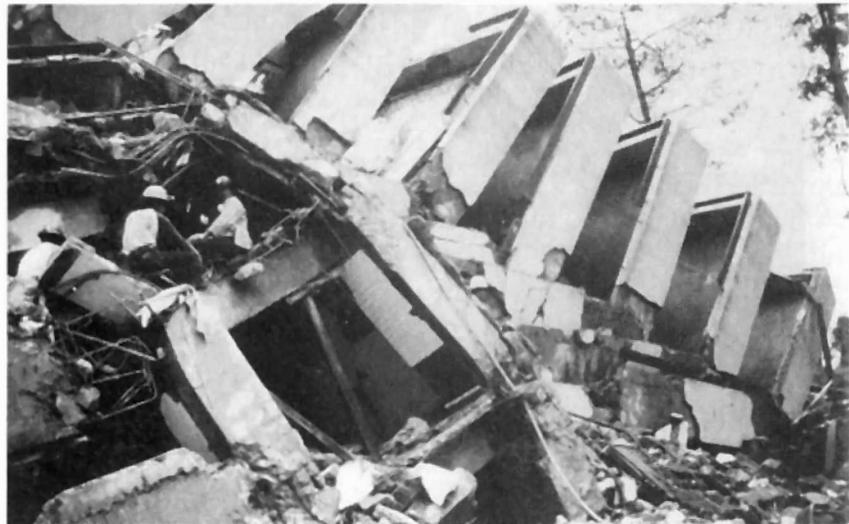
Miners digging for bodies
in Aparthotel

The close-up in Figure 5.8 shows local volunteer miners digging for bodies, more than two weeks after the earthquake. A man trapped in the collapsed building for 17 days after the earthquake was rescued alive on 2nd August, the day before EEFIT visited Baguio City. Figure 5.9 shows the Aparthotel from the south, with a failed shear wall. Failure in the columns on the side closest to the main hotel possibly initiated the collapse, but the exact cause of failure was uncertain. In Figure 5.9 reinforcement details in the Aparthotel can be seen. The concrete was apparently reasonable, with 40-50mm pebble aggregate. The main reinforcement consisted of 32mm deformed bars, some of which were rusty. There were 10mm diameter links (transverse reinforcement) at approximately 250mm centres, which had apparently failed to give sufficient confinement to prevent buckling of the longitudinal bars.

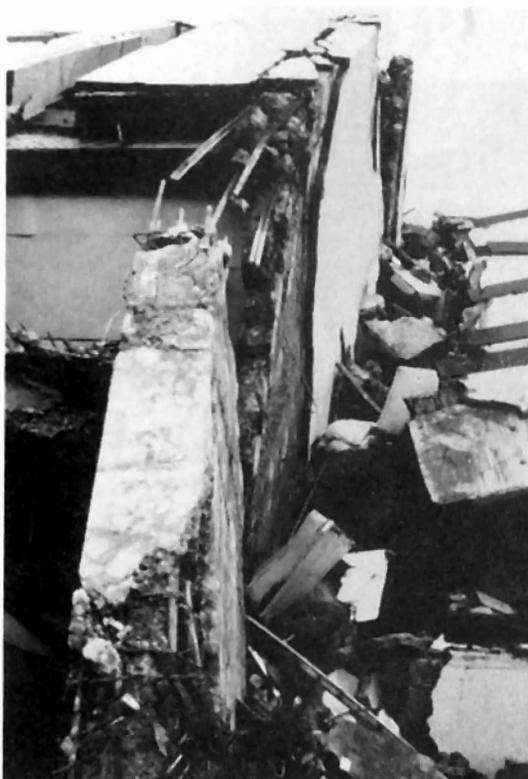
Figure 5.9

Hyatt Terraces Hotel,
Baguio: shear wall details
in Aparthotel

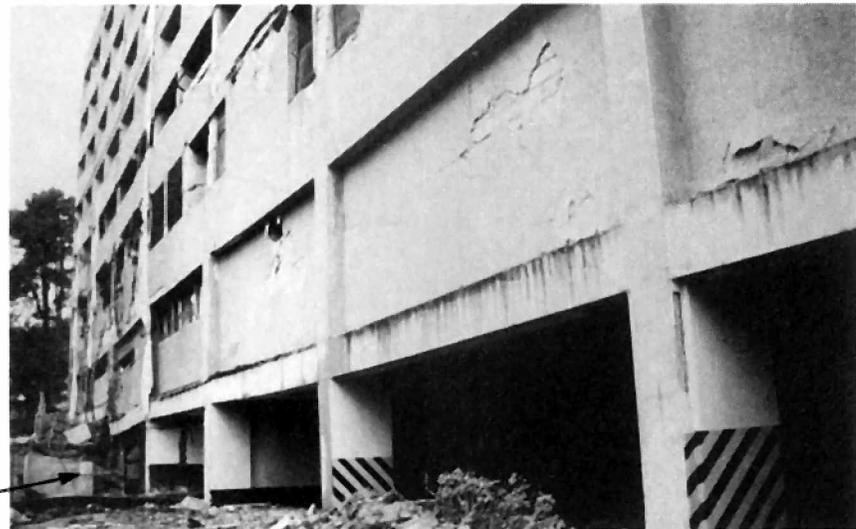
Figure 5.14

Car park under East
Wing, Hyatt Terraces
Main Hotel

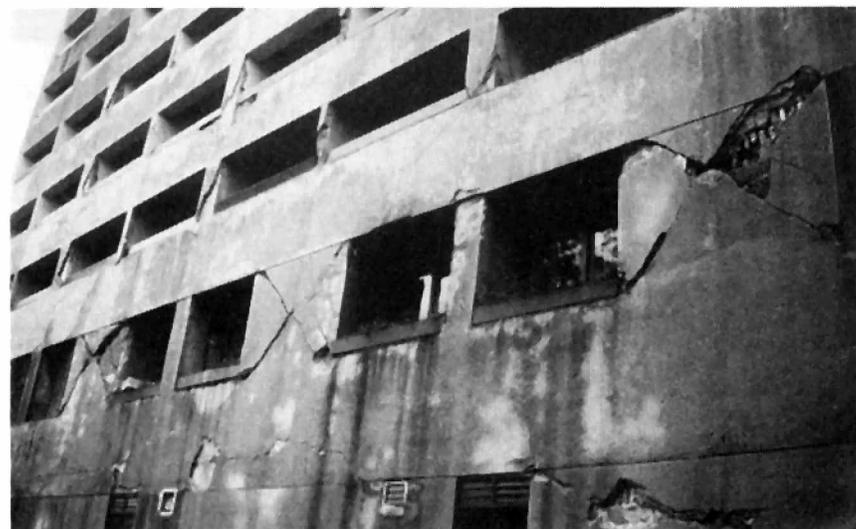
The side wall of the west wing, shown in Figure 5.15 had considerable damage to inadequately reinforced masonry infill, particularly at the second storey level. The major structural damage in the west wing wall resulted from impact of the aparthotel.

Side wall of West Wing
Hyatt Terraces
Main Hotel

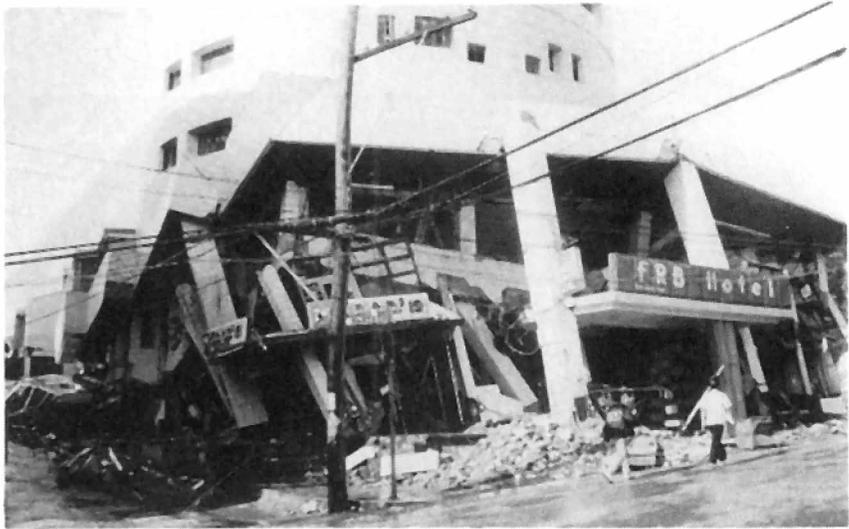
Figure 5.21

FRB Hotel, Baguio from
General Luna Avenue

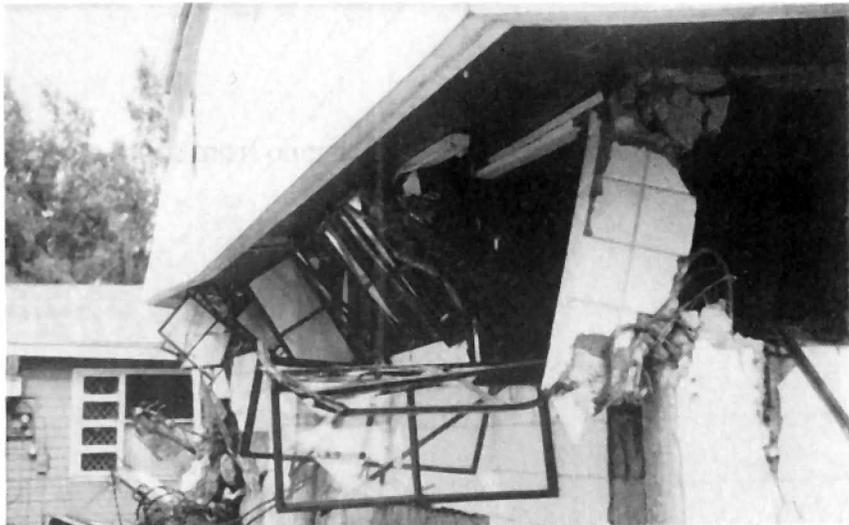
Figure 5.22

FRB Hotel, Baguio
showing soft storey
collapse

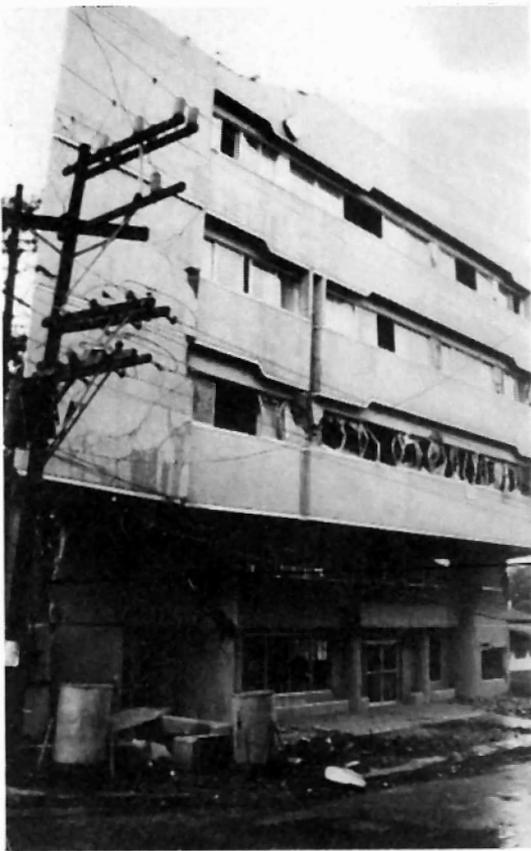
Figure 5.30
Building with
cantilevered front, Baguio

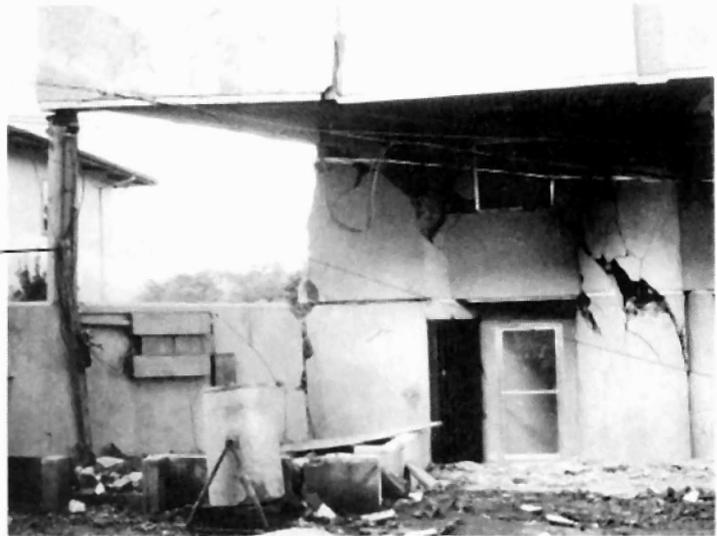
Figure 5.31
Detail of Figure 5.30

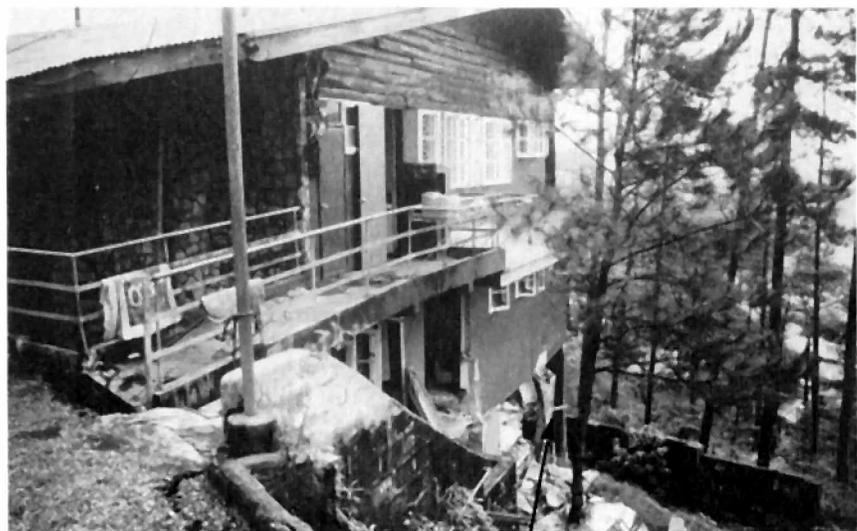
Figure 5.38

Unstable timber framed building below Hyatt Terraces Hotel, Baguio

Severe damage to supporting columns

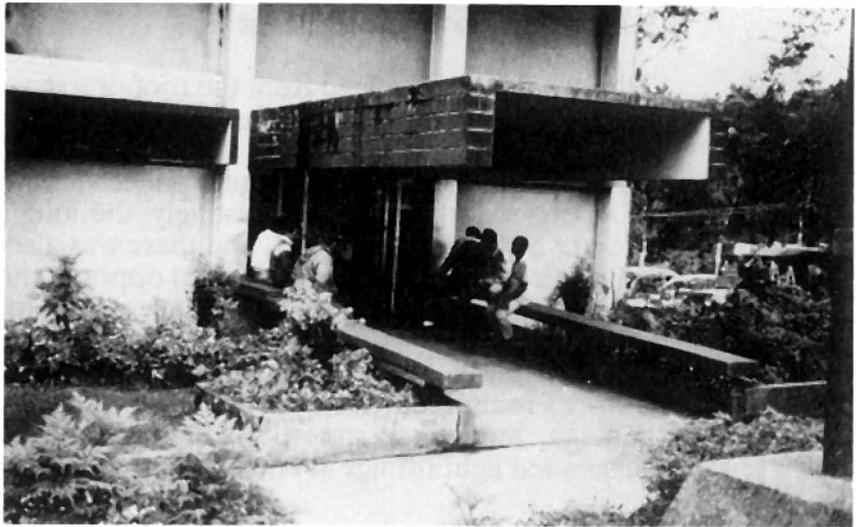
Figure 5.40

Baguio Police Station:
cantilevered entrance
canopy

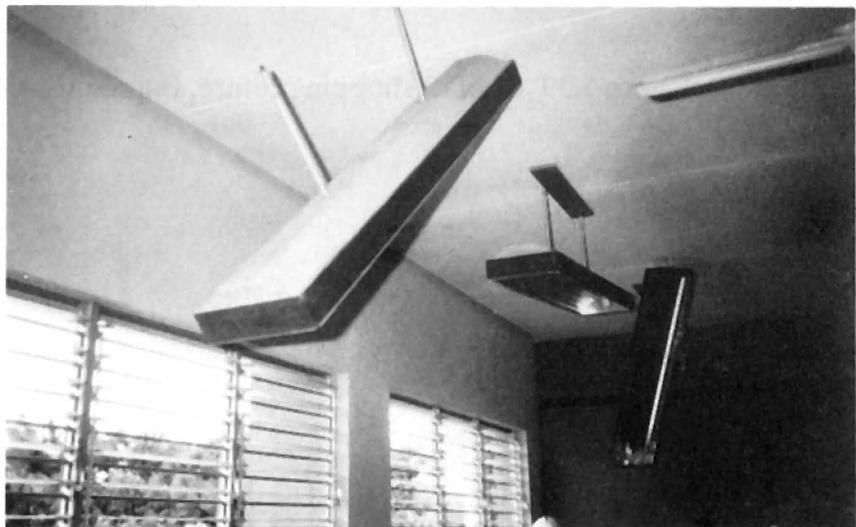
Figure 5.42

Interior of 5.41, showing
minor internal damage

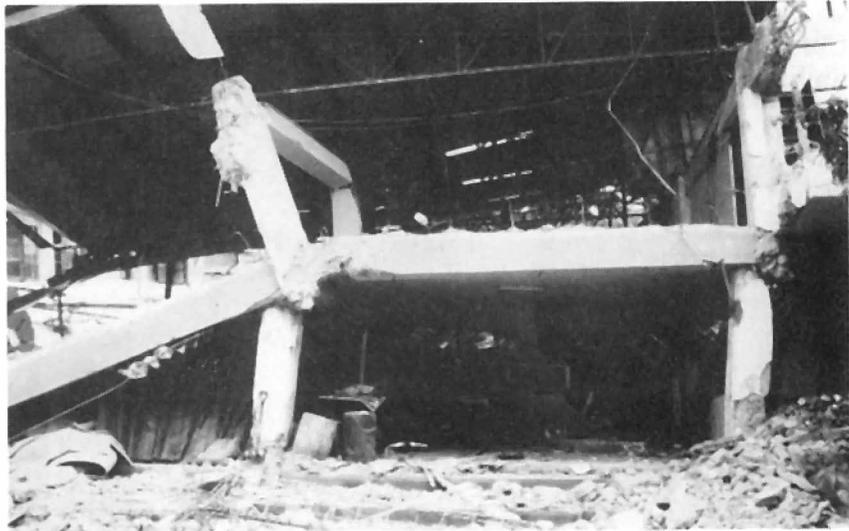
Figure 5.50

Agoo town centre:
collapse of 2 storey
r.c. frame building

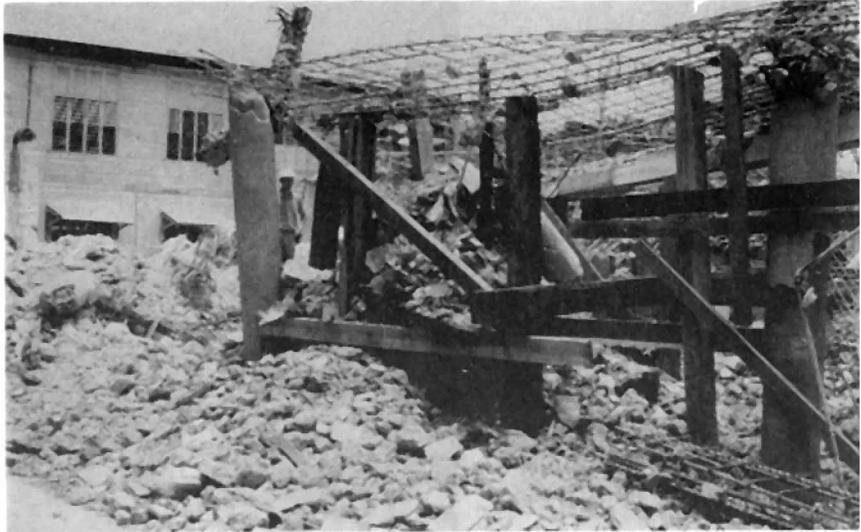
Figure 5.52

There was one catastrophic collapse in the town of a 6 storey reinforced concrete frame building. This was part of the Christian College of the Philippines. It is reported that the upper storeys were added after the original construction. When the EEFIT team examined the building, it had been partially demolished as part of the search and rescue operation (Figure 5.52). Surrounding concrete frame buildings of similar height which formed part of the College appeared completely undamaged. They also had provision made for extension (Figure 5.53). The library building of the Central Luzon State University was also reported to have suffered partial collapse (3).

Christian College of the
Philippines, Cabanatuan

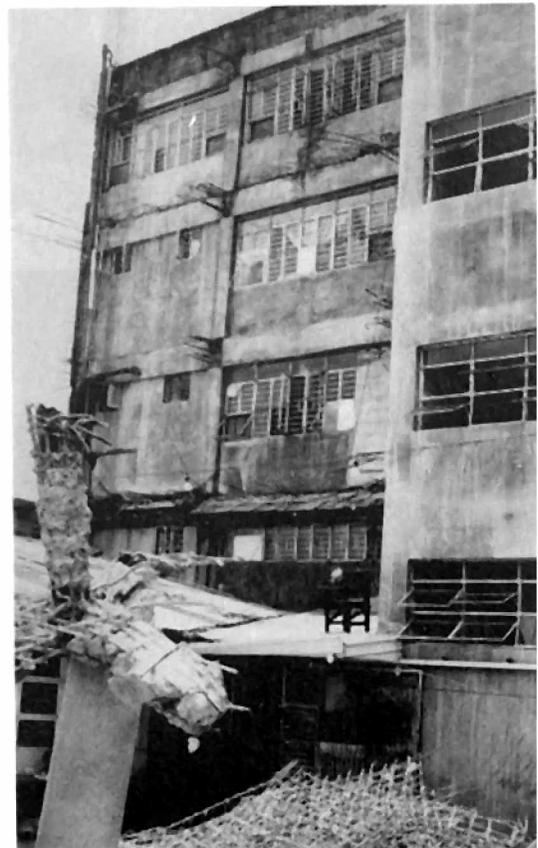
Figure 5.53

Christian College of the
Philippines, Cabanatuan:
provision for extension

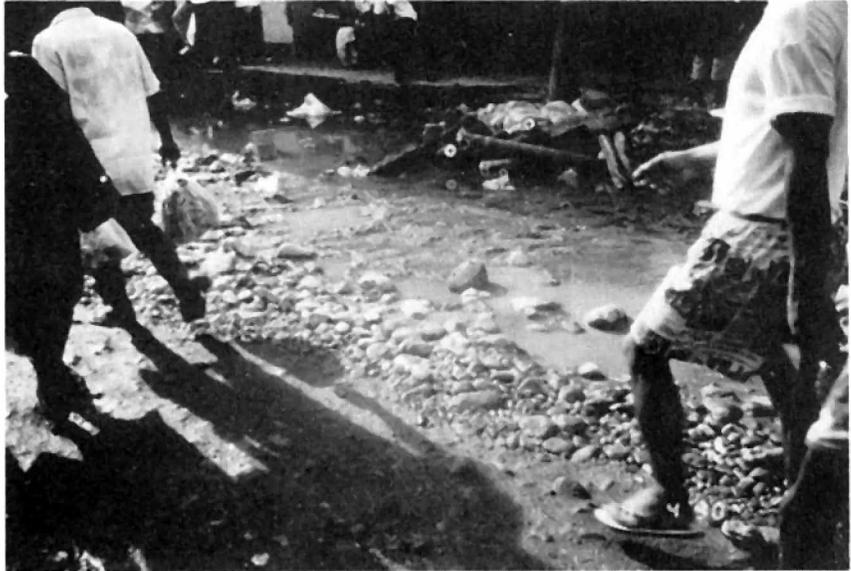
Figure 6.2

Evidence of liquefaction
on Dagupan main street

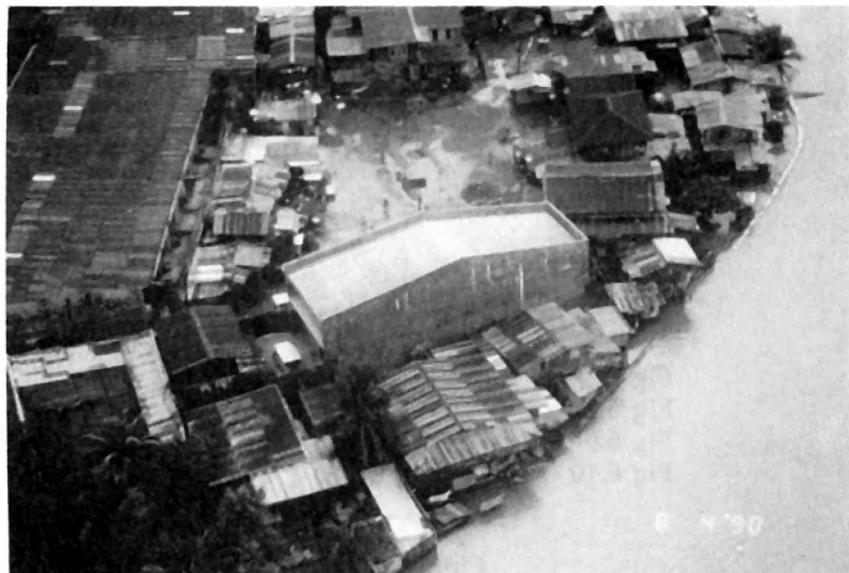
Figure 6.3

The 1990 earthquake caused liquefaction in many places along the Lingayen Gulf and the Central Plain and was particularly severe in Dagupan. As described below, many buildings were affected, but there was equally serious damage to the road network. The two major roads through the town were flooded and the road base had failed (Figure 6.2); many minor roads in the area between were also affected. In addition, the Magsaysay Bridge, one of two crossings of the Pantal River collapsed as described in section 6.3.3. Many areas were flooded, both along the river banks (see Figure 6.3) and elsewhere.

Flooding on the banks of
River Pantal, Dagupan.

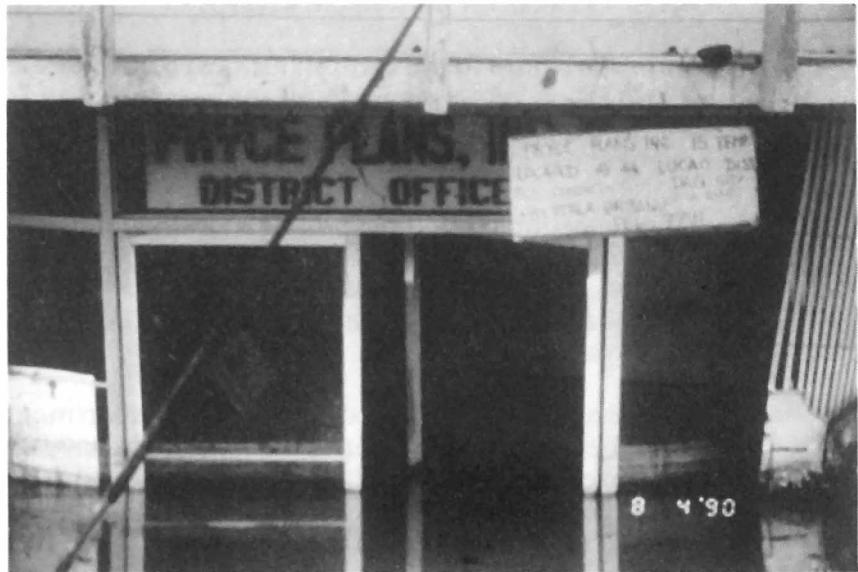
Figure 6.5

Many buildings in the central business district settled and tilted (some by up to 1.5m) following bearing failure (see Figures 6.4 and 6.5). The major commercial area along the two main streets of Perez and Angel Fernandez Boulevards was particularly affected.

Foundation failure of building in Dagupan

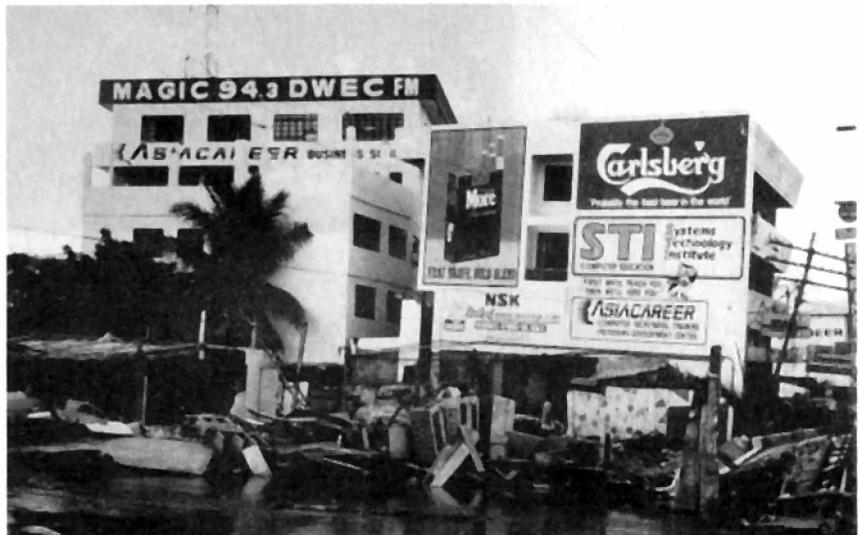
Figure 6.9

Two major buildings (Figure 6.9) which suffered severe settlement were located near the east bank of the Pantal River, immediately downstream of the failed Magsaysay Bridge (section 6.3.3). One building, the STI building, was 3 storeys tall; the other, the AsiaCareer building, was 5 storeys and had a light roof mounted radio mast. Both buildings were reinforced concrete frame structures and were reported to have strip foundations of unspecified depth.

STI and AsiaCareer buildings, Dagupan

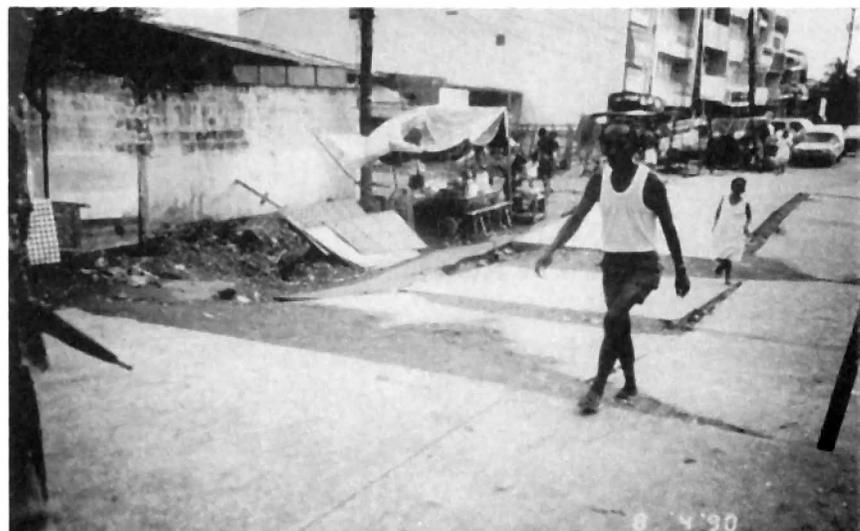
Figure 6.13

Road failure near STI building and Magsaysay Bridge, Dagupan.

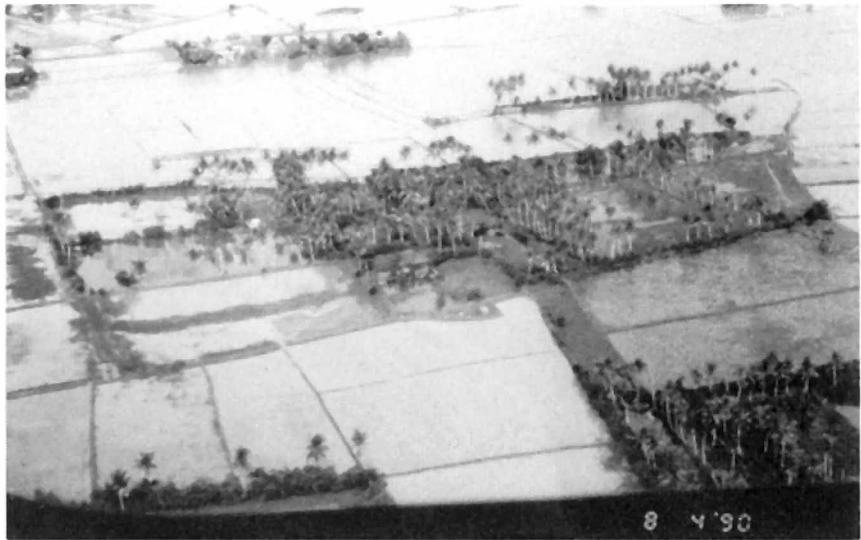
Figure 6.15

The 1990 earthquake caused large areas of the low lying coastal area around Agoo to liquefy and settle. Houses built along the coast, rice fields and milkfish ponds were flooded with sea water (Figure 6.15). Although as reported in section 5.2, there was no indication of liquefaction in Agoo, the banks of a river immediately to the north had moved (Figure 6.16), although the adjacent bridge was undamaged. A bridge about 2km north of Agoo had undergone a large foundation movement (Section 6.3.2).

Flooding of coastal areas near Agoo

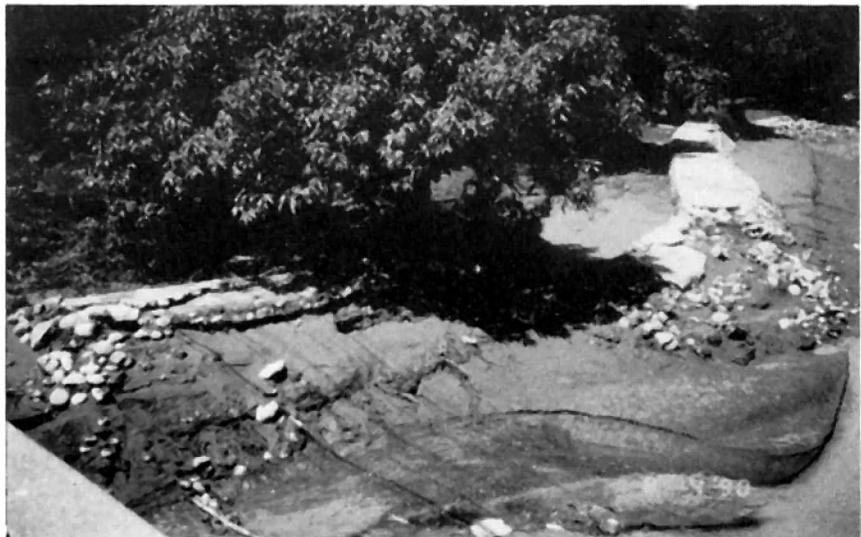
Figure 6.16

Spreading of river bank just outside Agoo

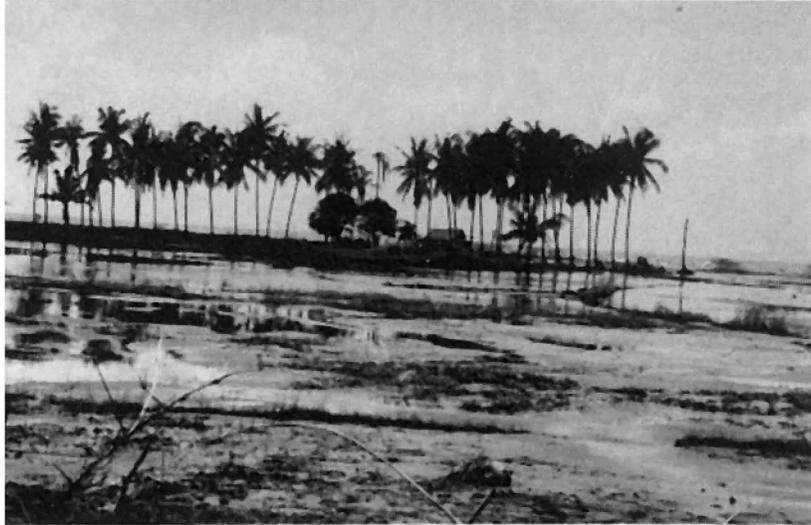
The village itself had been almost totally destroyed by the earthquake, with some thirty houses along the line of the palm trees in Figure 6.18 collapsing. Inland from the village, there were extensive signs of liquefaction, with many liquefaction blowholes (Figure 6.19) and ejected fine black sand. The villagers reported that water spurted from these blowholes to a height of about 1m high during the earthquake; the ejected water was said to be hot. The ground inland from the village had settled by at least 1m, allowing seawater to flood in and spoil paddy fields and fishfarms.

Figure 6.18 Remains of the village of Alaska

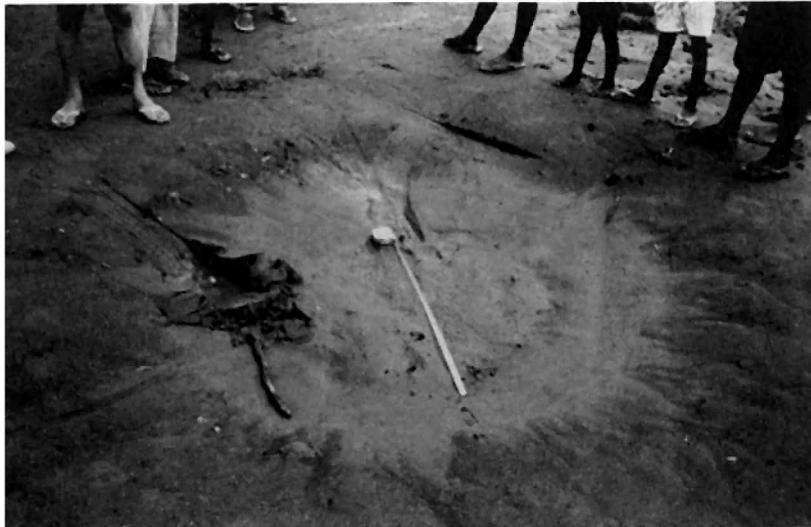
Figure 6.19 Liquefaction blowhole near Alaska

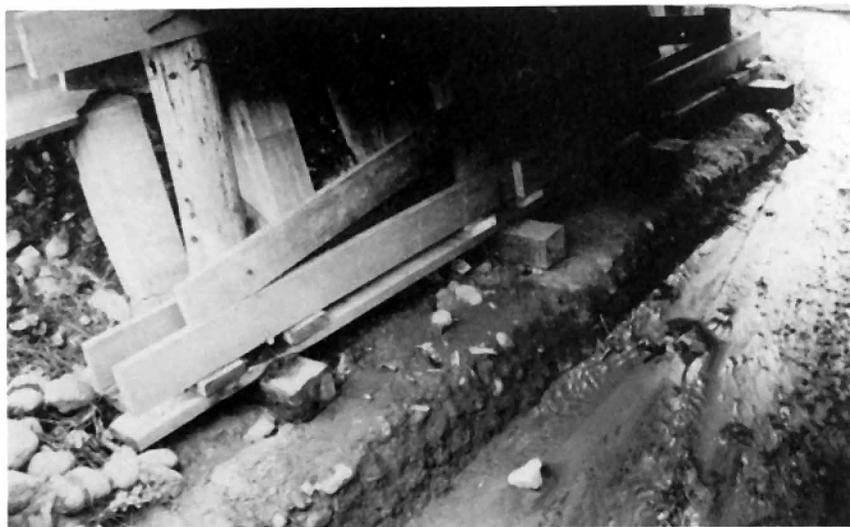
Figure 6.21

This concrete road bridge spanned a small river about 2 km north of Agoo and carried the main highway on the Agoo/San Fernando road. It had a single river span of about 7m and two short abutment spans. The bases of both piers, which were about 2m high, had moved in towards the centre of the river by about ½ metre (Figure 6.21). Temporary wooden shoring had been installed to support the deck and the bridge was open to traffic. It formed part of the only land link from Manila to Baguio open after the earthquake.

Bridge between Agoo
and San Fernando

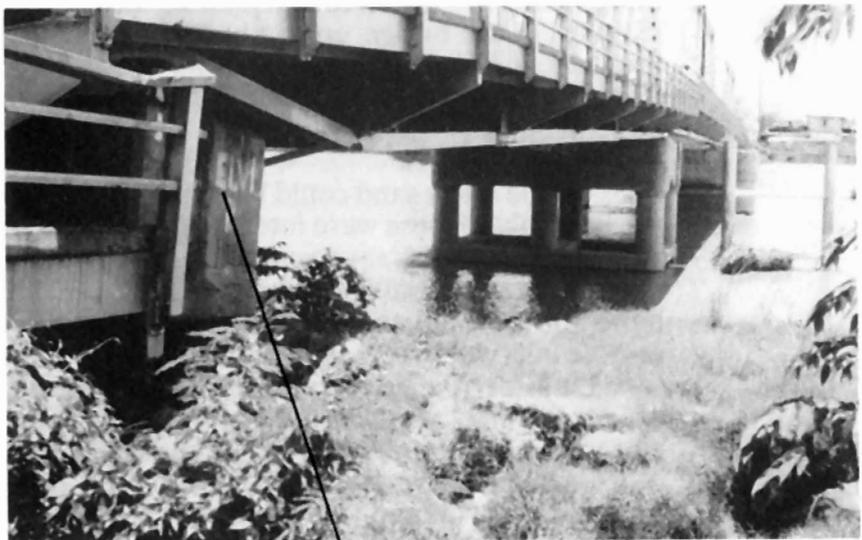
Figure 6.26

The main damage was caused by a substantial rotation of the main east abutment, which had moved about 1.5 metres toward the river, causing the short end span to come off its bearings (Figure 6.27). There was an associated minor slip of material around the east abutment (Figure 6.26) and fine black sand could be seen, evidence that liquefaction had taken place.

East abutment of Calvo Bridge, Bayambang

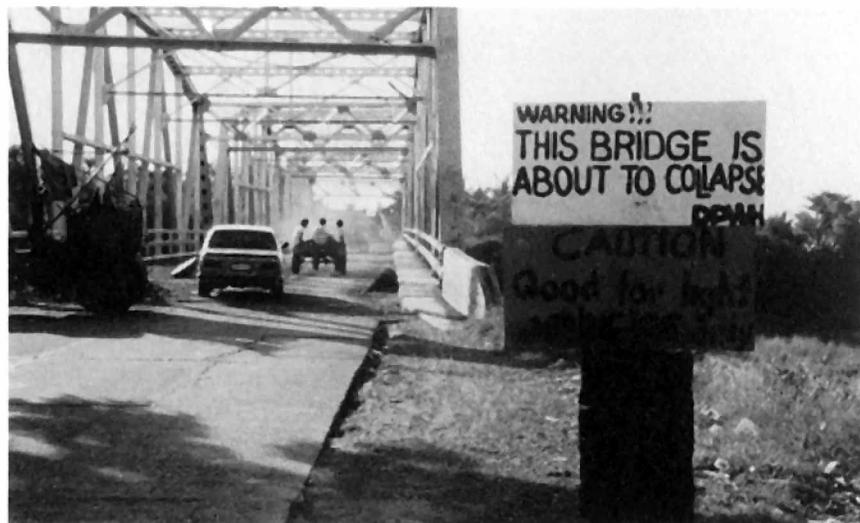
Two bridges on this road which had been damaged by the earthquake were crossed by the EEFIT team. One was north of Talevera and was of similar construction to the Calvo and Carmen bridges described above, with upstand steel girders supported by concrete piers and abutments. It had three spans of approximately 40m each. The southern river pier appeared to have rotated so that the top of the pier had moved about 200mm away from the centre of the river, causing both the decks it supported to come off their bearings. The river span was therefore left with only about 150mm bearing on the edge of the pier and seemed to be in some danger of collapse. The bridge was open to single line traffic and there was a suitable warning posted at either end of the bridge (Figure 6.32). Minor soil movements were observed on the south abutment slopes.

Figure 6.32
Warning notice on bridge near Talevera

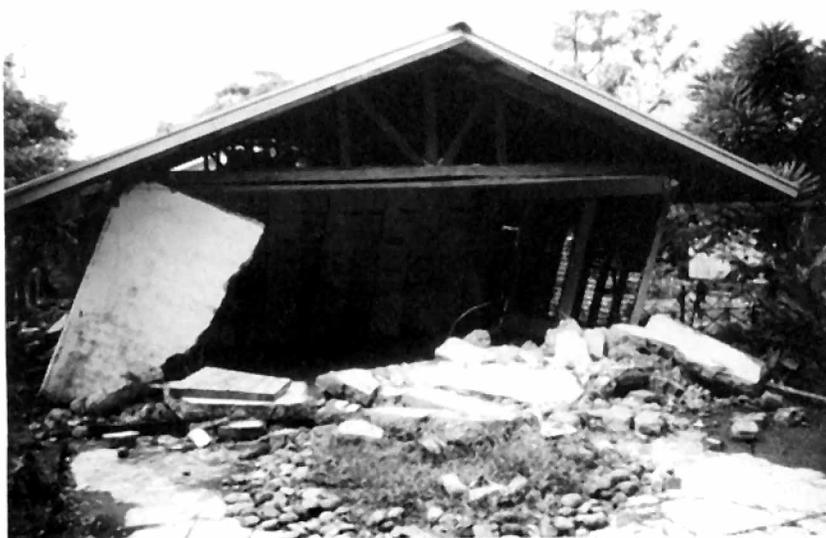
Figure 8.3

Damage to poorly attached blockwork walls at Rizal Central School.

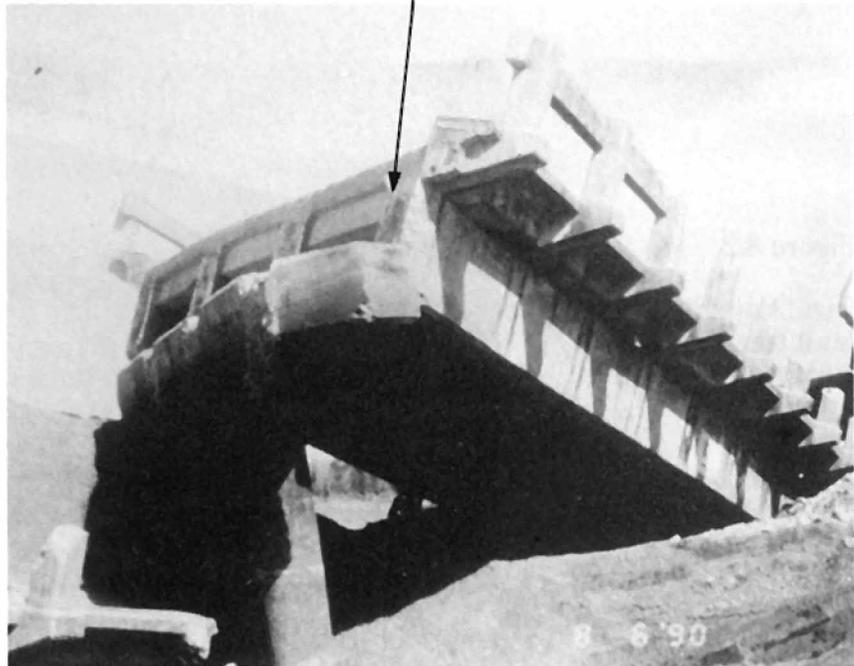
Figure 8.5

Detail of 8.4 showing
collapsed bridge

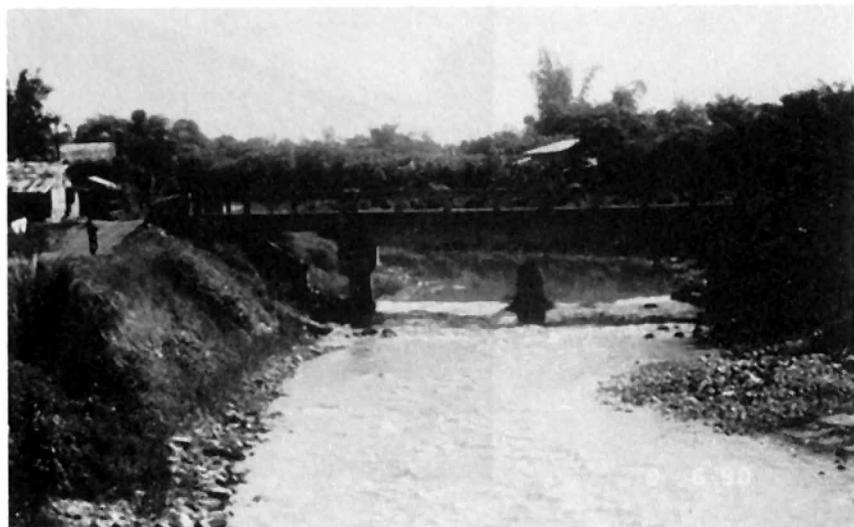
Figure 8.6

Undamaged concrete
bridge at Rizal

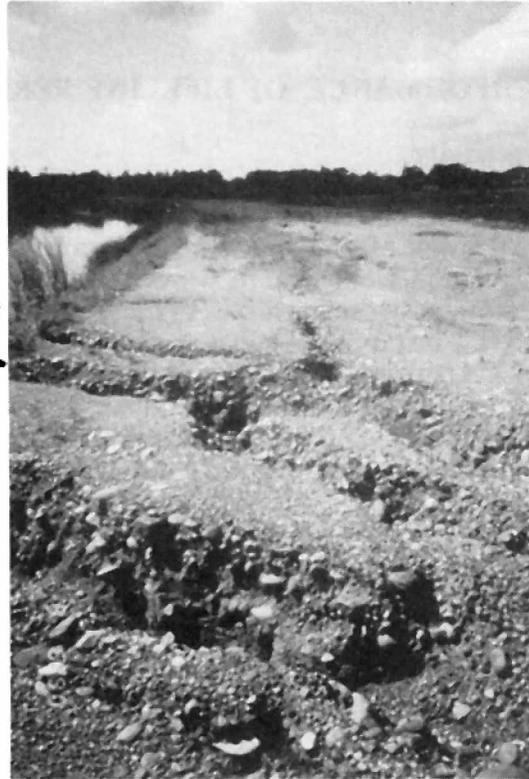
Figure 8.7

Levee near Figure 8.6
bisected by fault trace

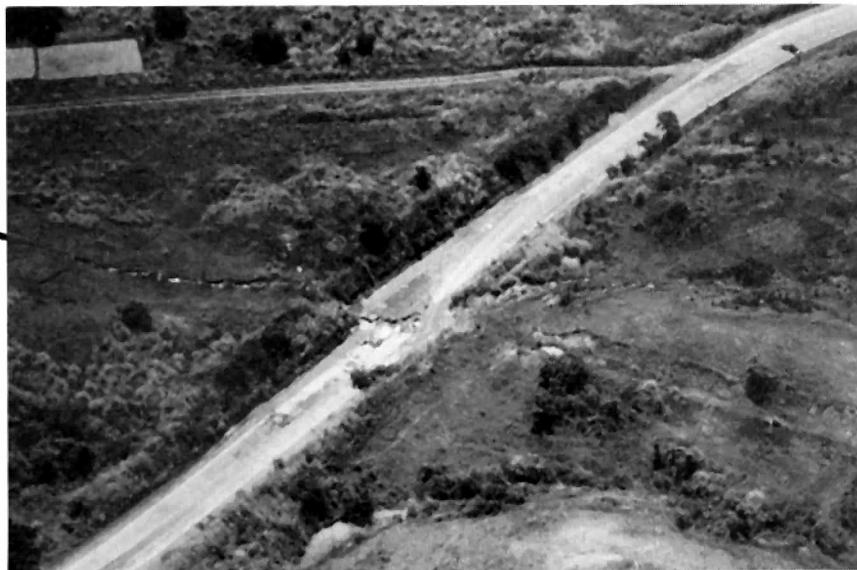
Fault movement in road
through Dalton Pass
