THE MEXICAN EARTHQUAKE OF 19TH SEPTEMBER 1985

A FIELD REPORT BY EEFIT

### Summary of EEFIT's conclusions

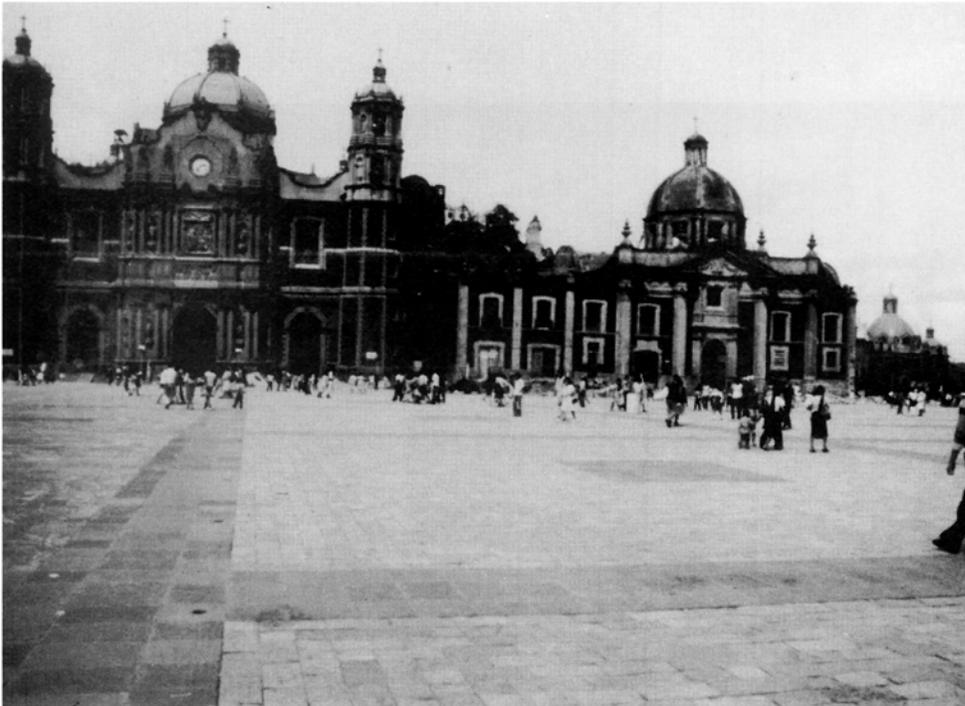
PLATE 3.3

Previous settlement at Guadalupe Cathedral

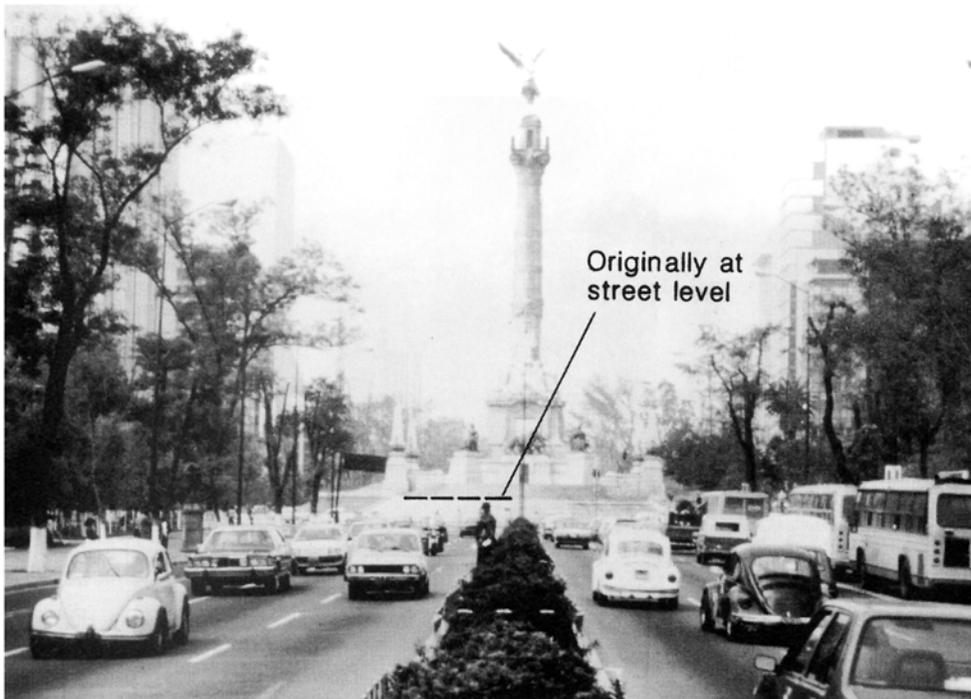
PLATE 3.4

Previous emergence at Independence Monument (Site 54)

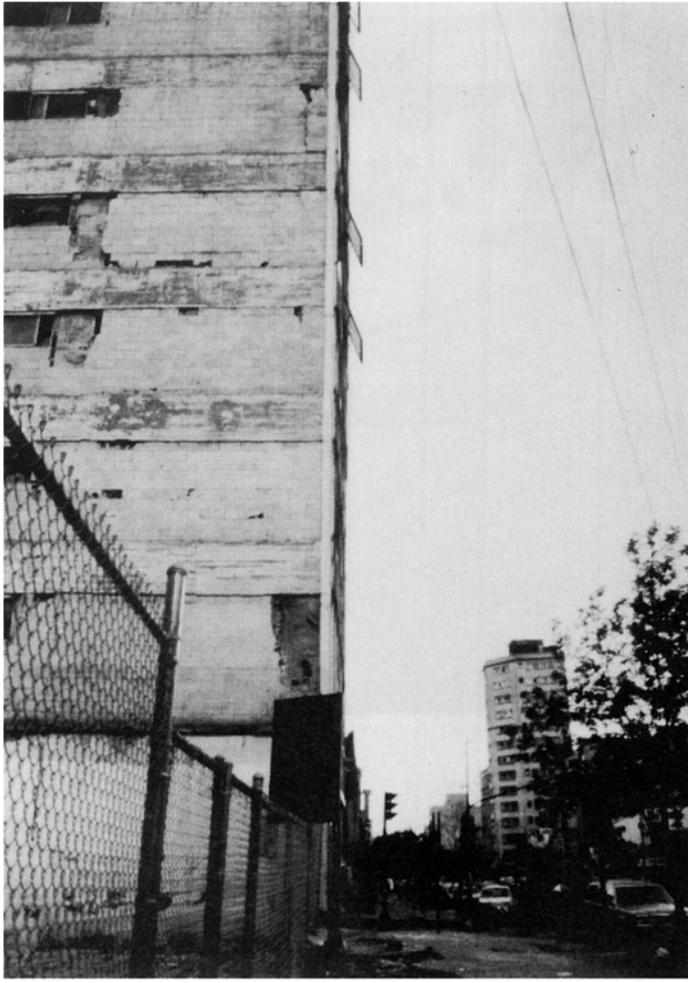
PLATE 3.7

Sloping Building (Site 29)

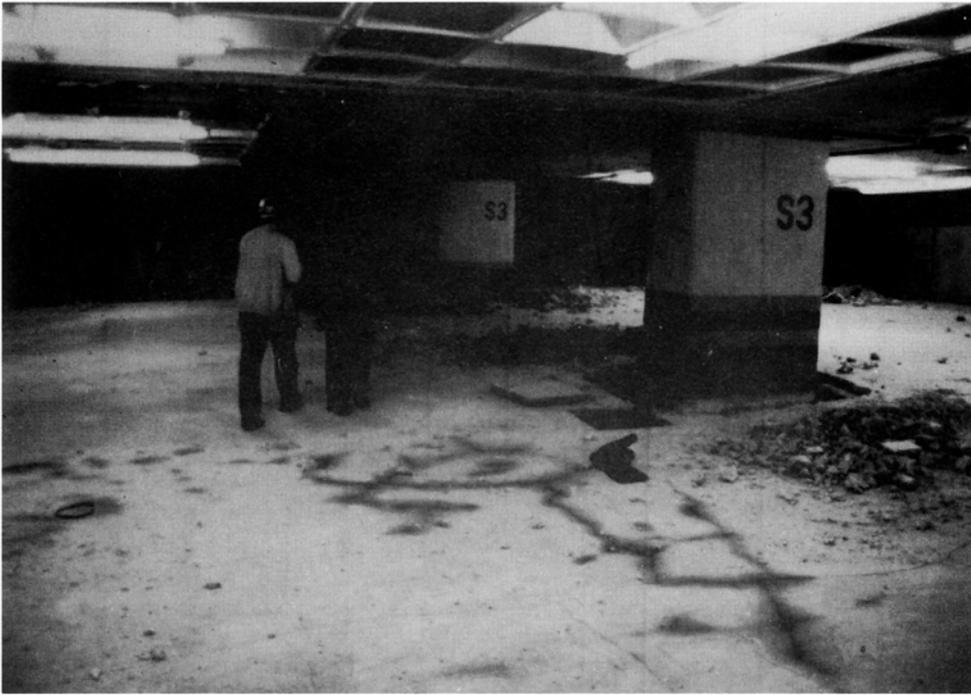
PLATE 3.11

Inside Social Security Building (Site 15)

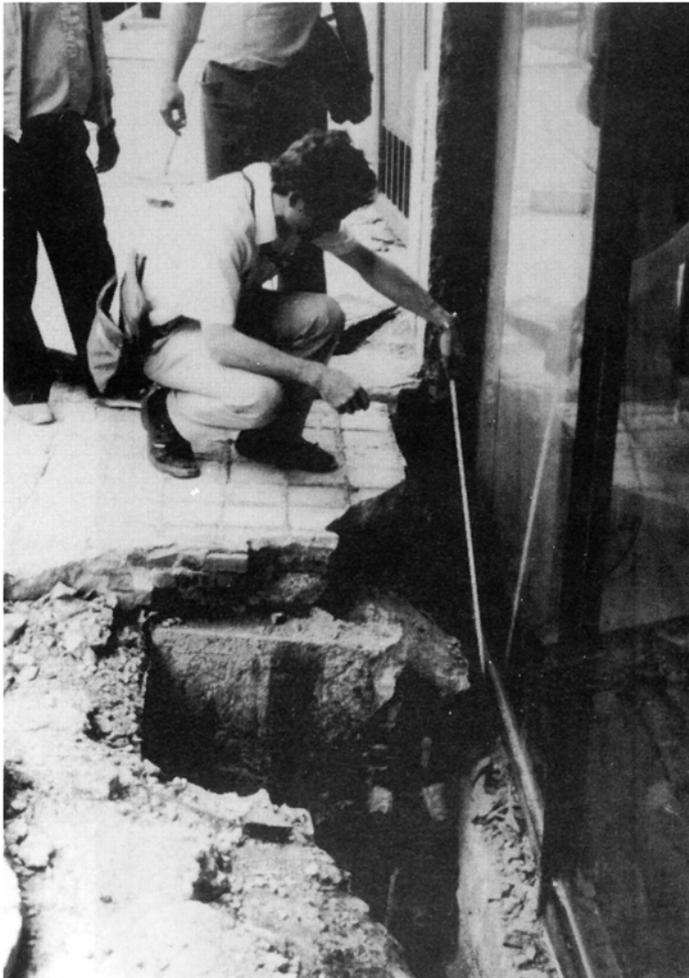
PLATE 3.12

Settled Building at Iztacalco (Site 87)

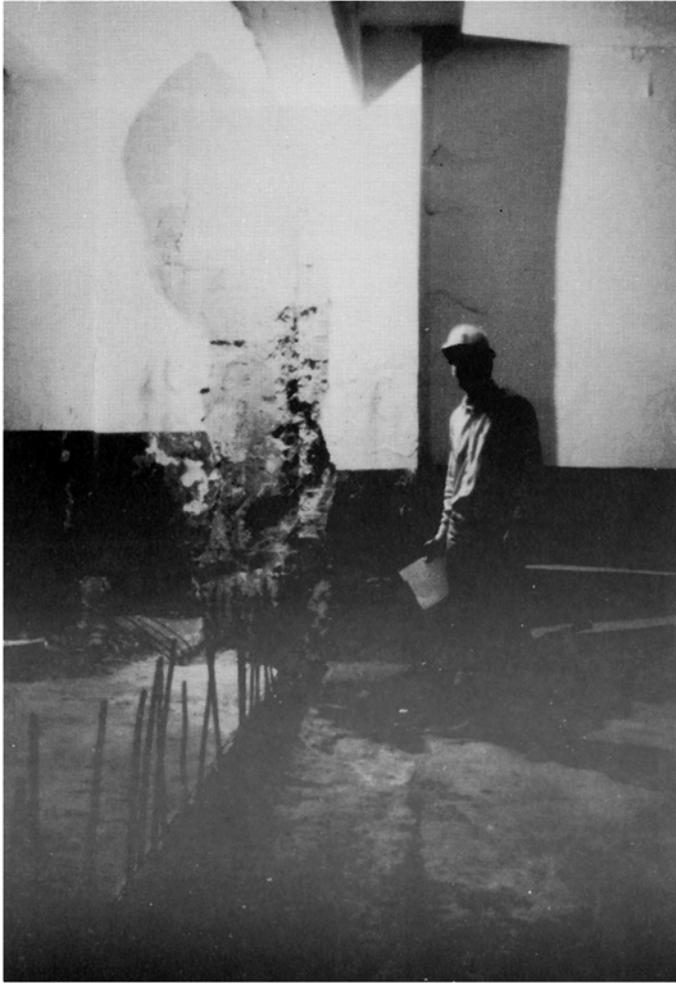
PLATE **3.13**

Ground slab joint at junction of eleven and four storey building

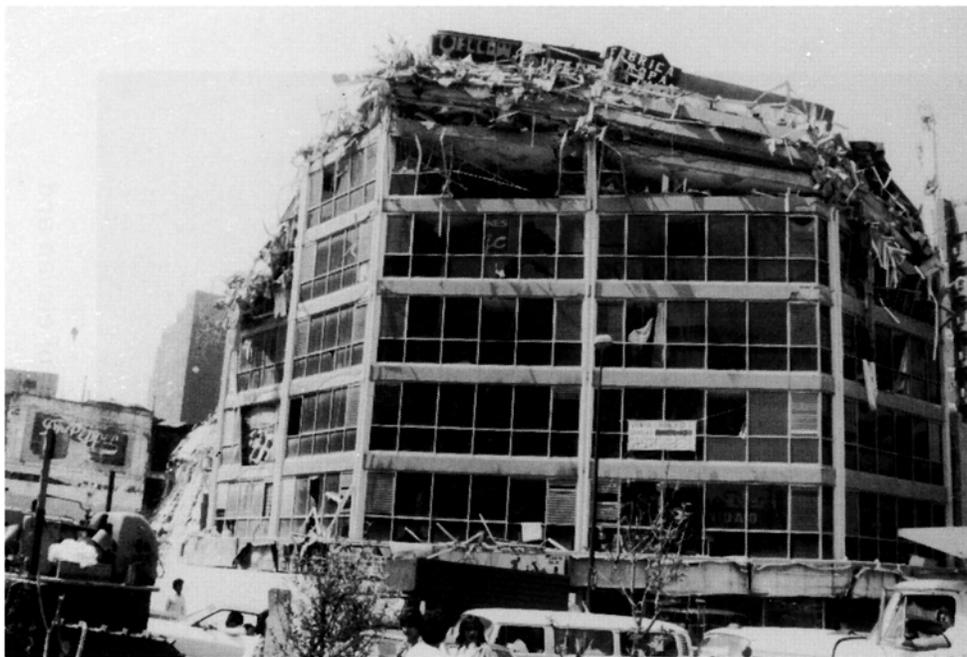
PLATE **3.16**

Top down collapse of newer building (Site 60)

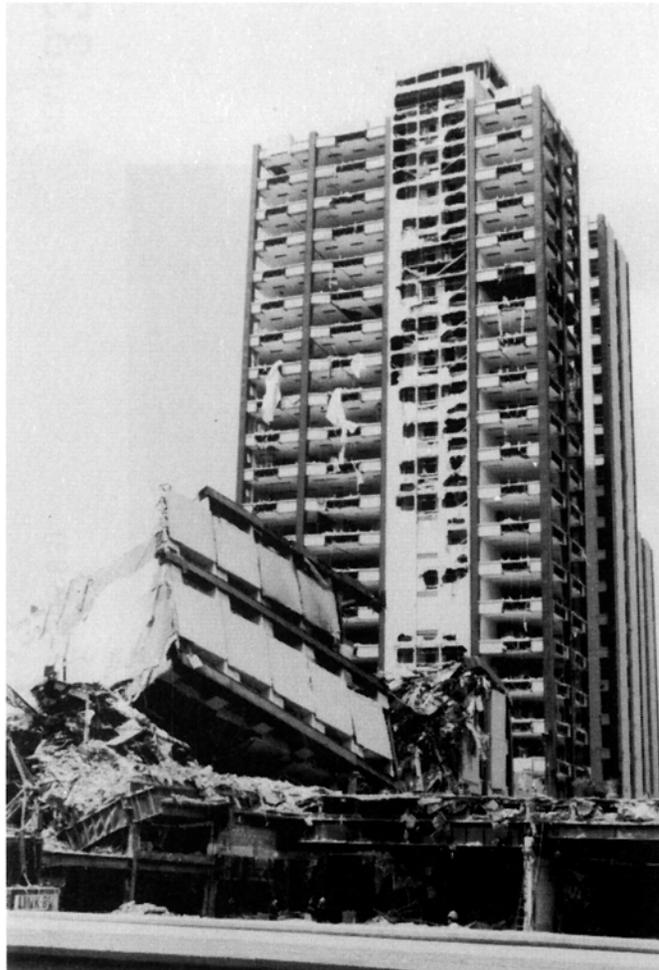
PLATE 3.32

Nuevo Leon - column failure in surviving section

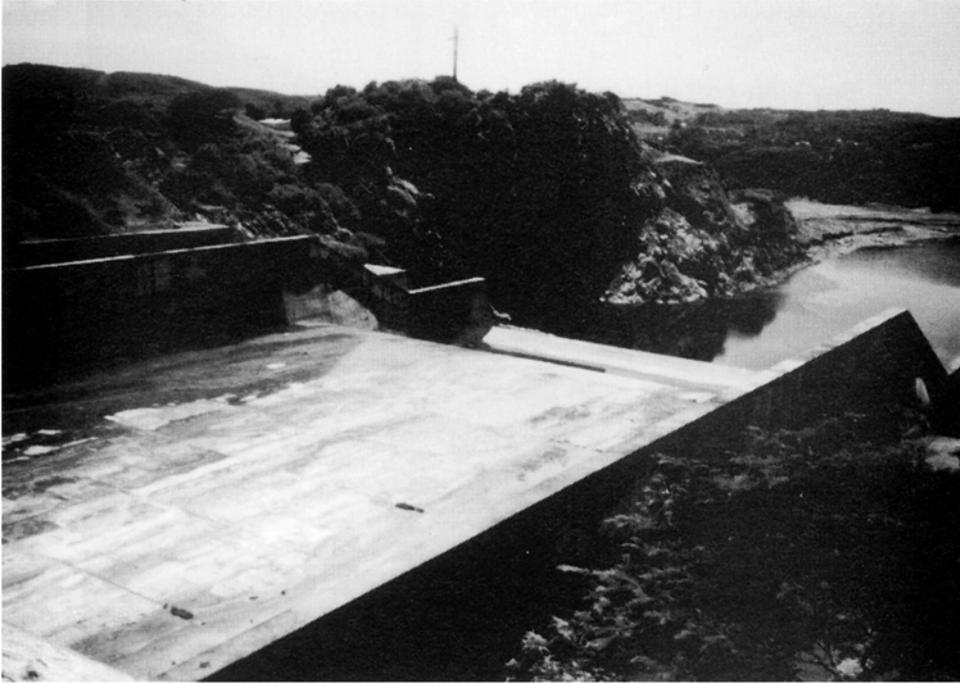
PLATE 4.7

Crest of Jose Maria Morelos Hydro-electric Dam showing longitudinal cracks

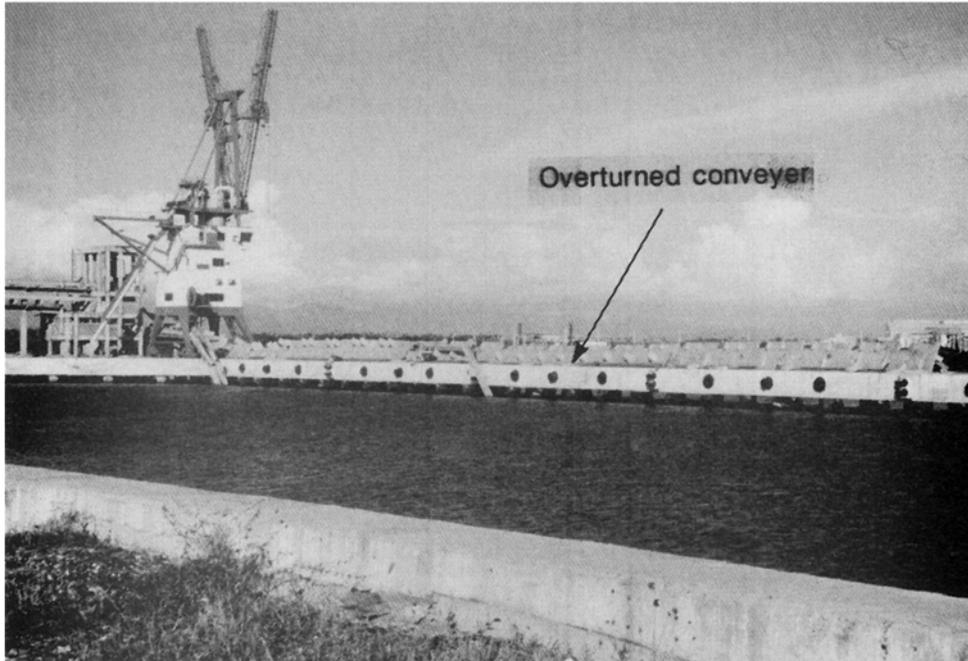
PLATE 4.14

Damage was observed to the silos shown in Plate 4.14 where the clear storey of the control structure on top of the silos had collapsed. The berthing facilities associated with this silo are shown in Plate 4.15 where damage to the pile heads was observed. The conveyor structure on the berth can also be seen to have collapsed.

Overturned conveyer

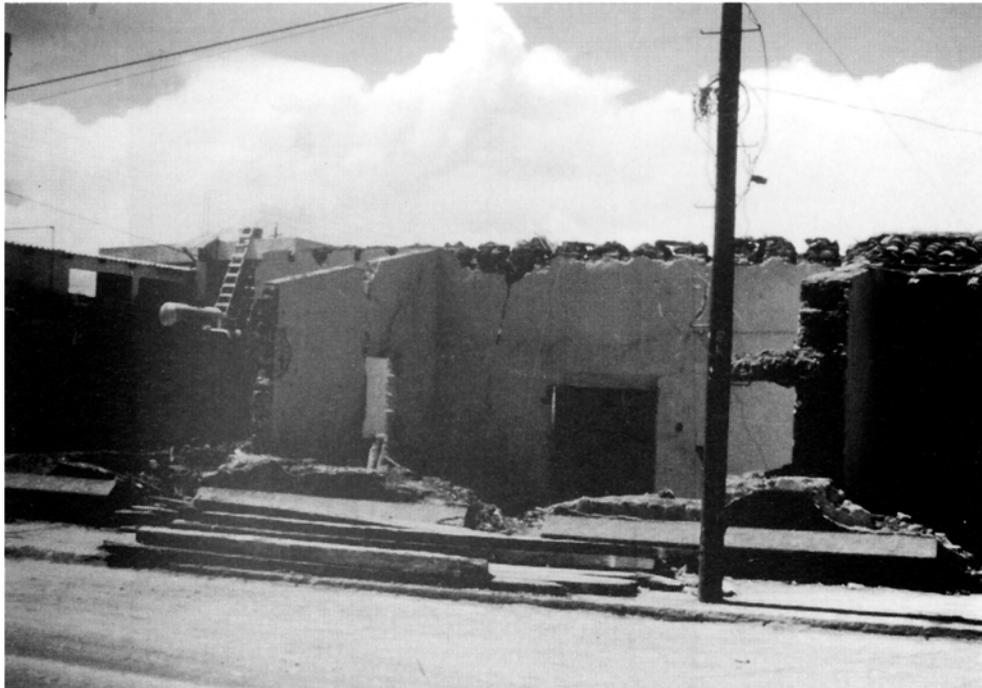
PLATE 4.18

General view of Ciudad Guzman (Site 5)

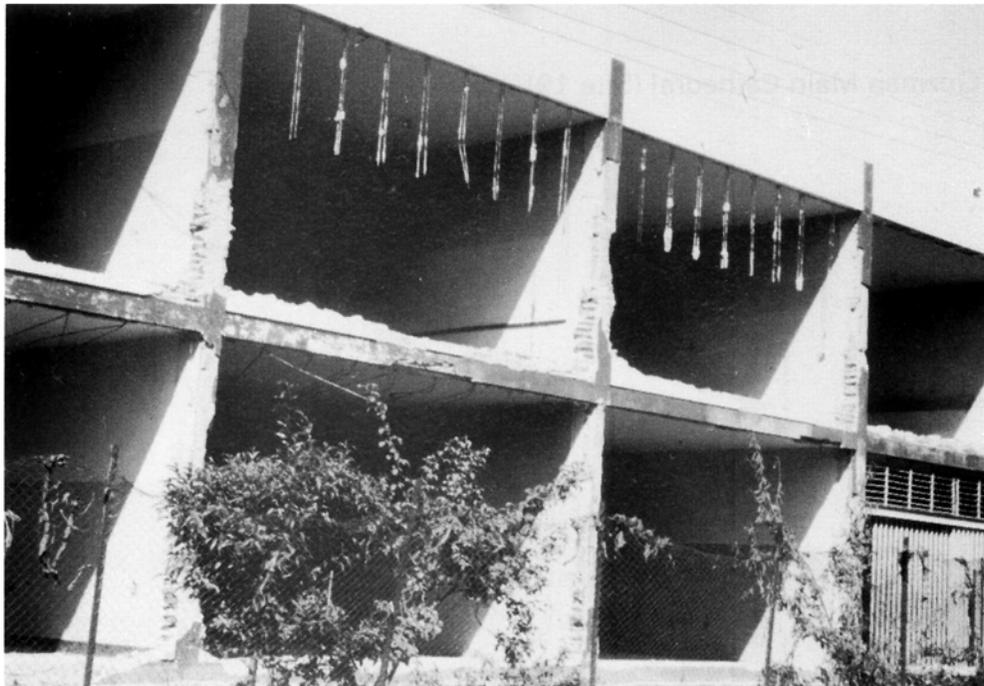
PLATE 4.25

A two storey school (J. Clemente Orosco) appeared to consist of a light r.c. frame with rigid brick infill panels. The structure appeared in no danger of collapse, but the infill panels in the long direction of the building (east-west) had all either totally fallen out during the earthquake or else had been so seriously damaged they had been completely removed (Plate 4.25). Evidence of reinforcing bars and restraining beams which connected the failed panels to the structure could be clearly seen.

J Clemente Orozco School (Site 17)

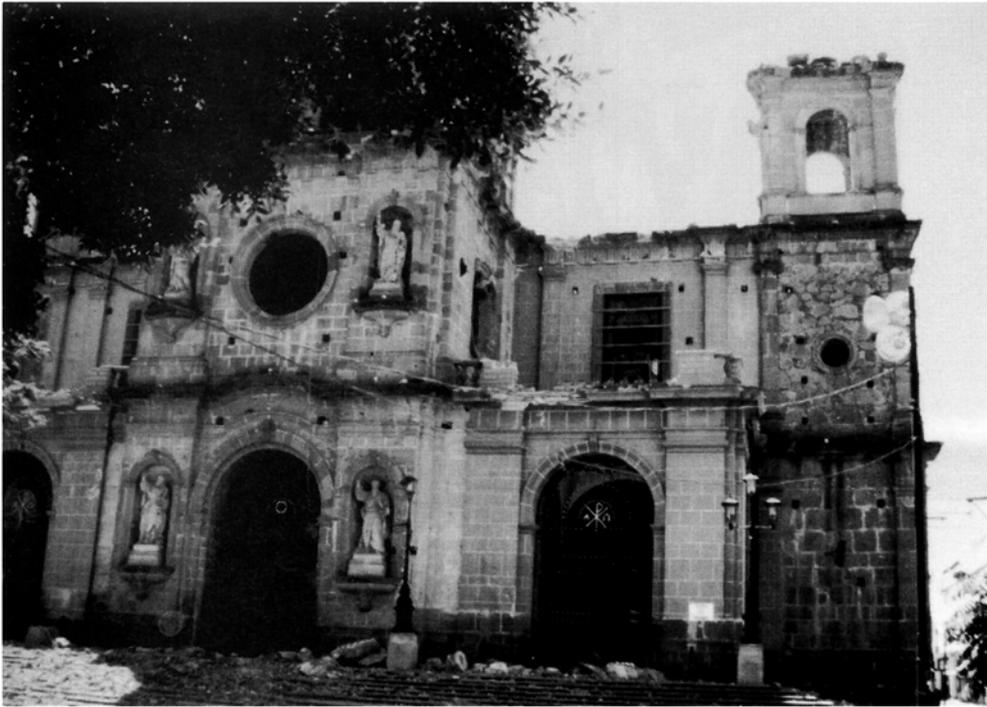
PLATE. 4.26

All five churches in Guzman were damaged to some extent. The most seriously affected ancient building was the main cathedral (Plate 4.26) which was closed to the public, and had suffered heavy loss of masonry, though no general collapse.

Ciudad Guzman Main Cathedral (Site 19)
