THE HYOGO-KEN NANBU (KOBE) EARTHQUAKE OF 17 JANUARY 1995

A FIELD REPORT BY EEFIT

EEFIT March 1997

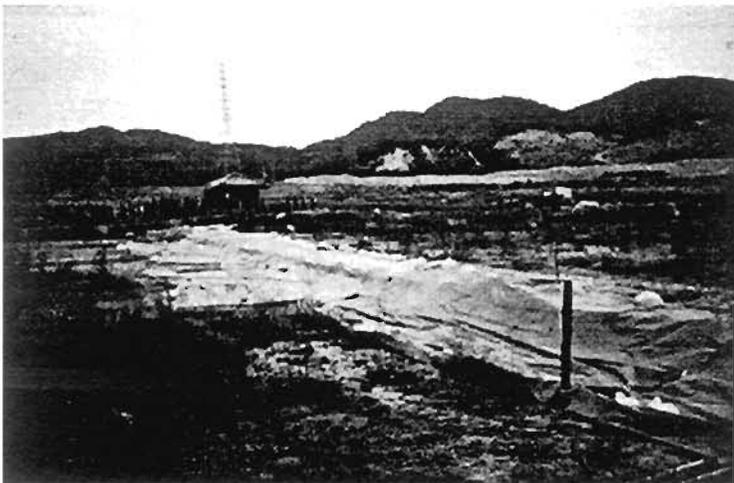
Plate 3.3: Surface rupture of the Nojima fault observed at Okura, Awaji Island
(The rupture is covered by plastic sheets)

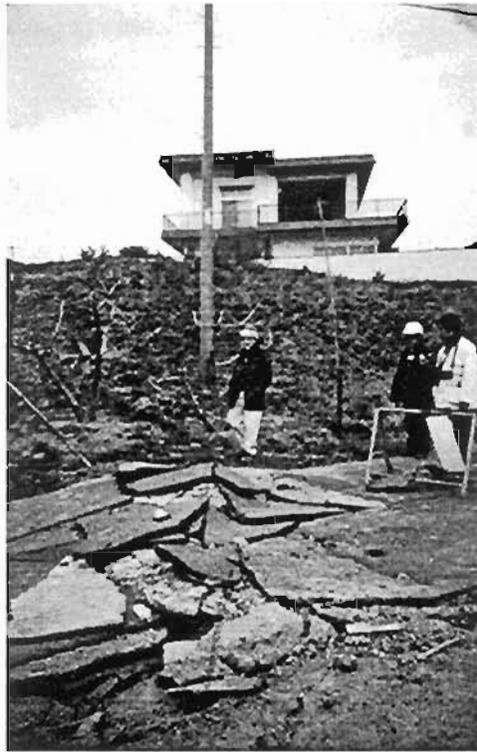
Plate 3.4: Pavement rupture due to the movement of the Nojima fault at Okura, Awaji Island

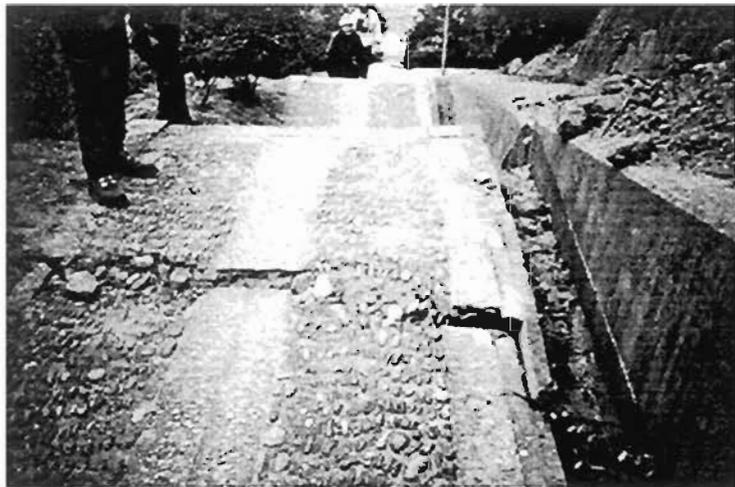
Plate 3.5: Surface rupture of the Nojima fault observed at Ezaki, Awaji Island

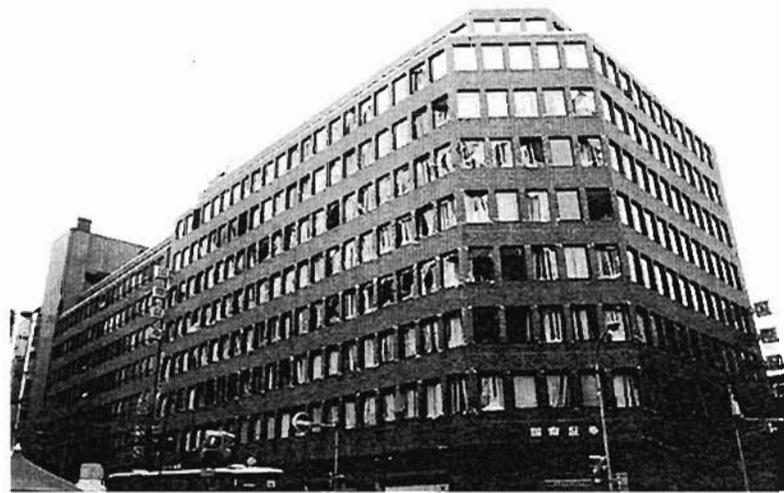
Plate 4.4: Distributed RC mullion damage due to minimal damage in corner mullions

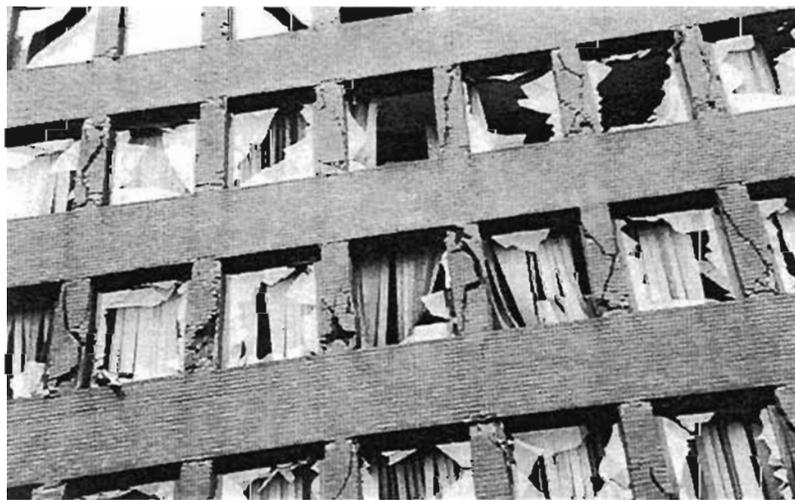
- (d) The effect of site period is considered in section 4.11.
- (e) Corner sites at road intersections are damage prone situations needing special design consideration. Large corner bevells constitute a severe plan irregularity, exacerbating the vulnerability of the situation (see Plates 4.5, 4.13 and 4.90 and Reference 4.29 for even more extreme examples).

Plate 4.5: Two RC buildings originally of same height, one with distributed damage and one with collapse in lowest storey

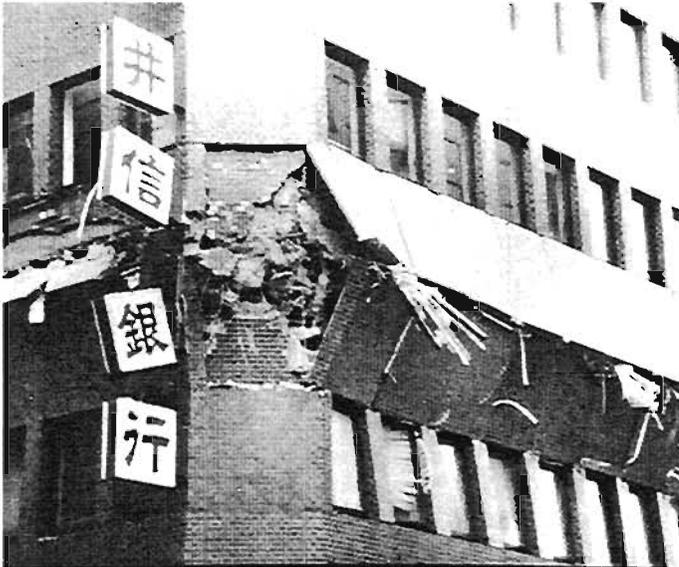
Plate 4.7: RC Building with collapse in 3rd storey

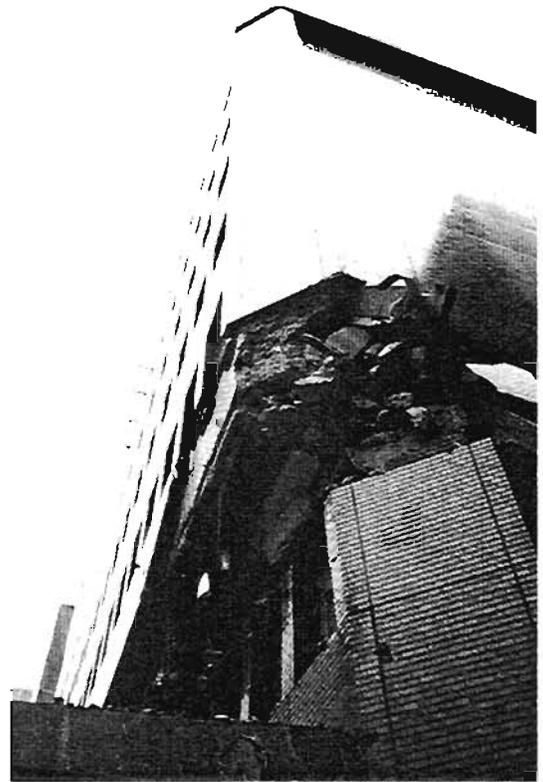
Plate 4.8: Bulging facade at corner where building dropped

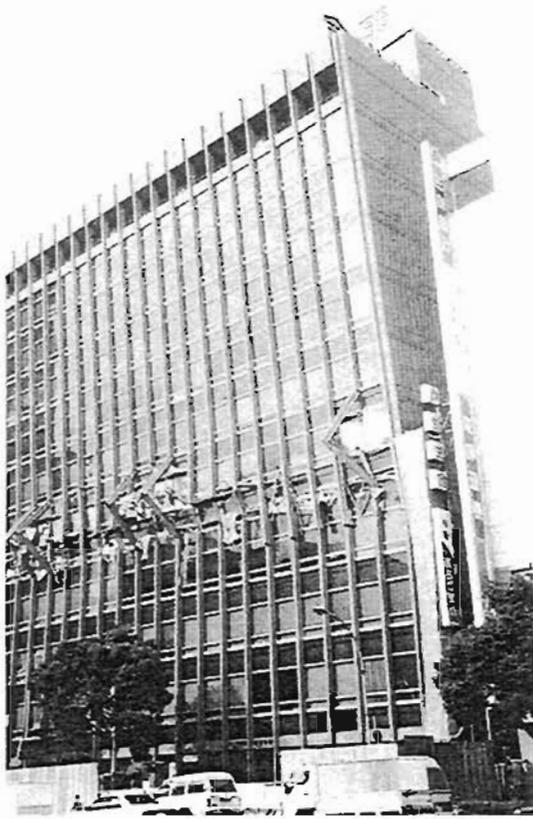
Plate 4.9: Streerwise displacement at adjacent corner

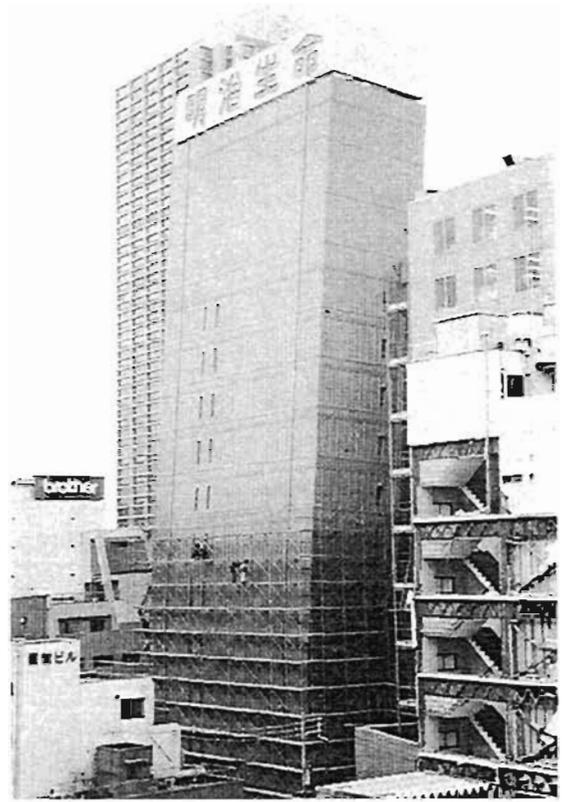
Plate 4.10: Streetwise tilt of 12 storey frame/shear wall structure

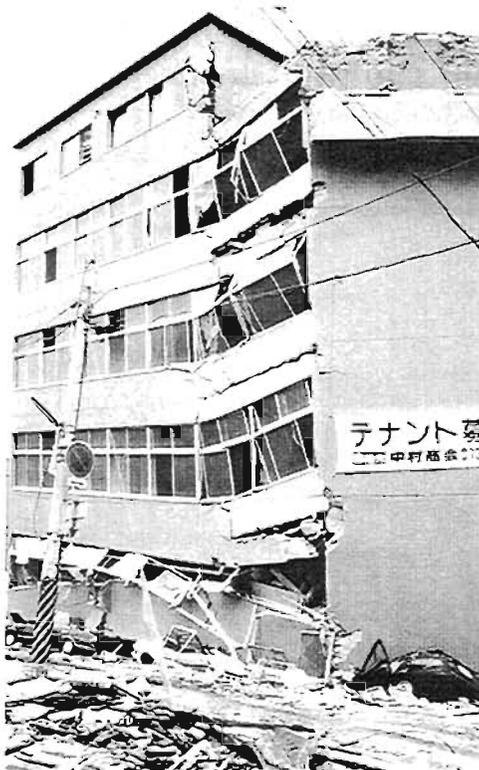
Plate 4.13: 2nd Storey collapse in 7 storey corner building

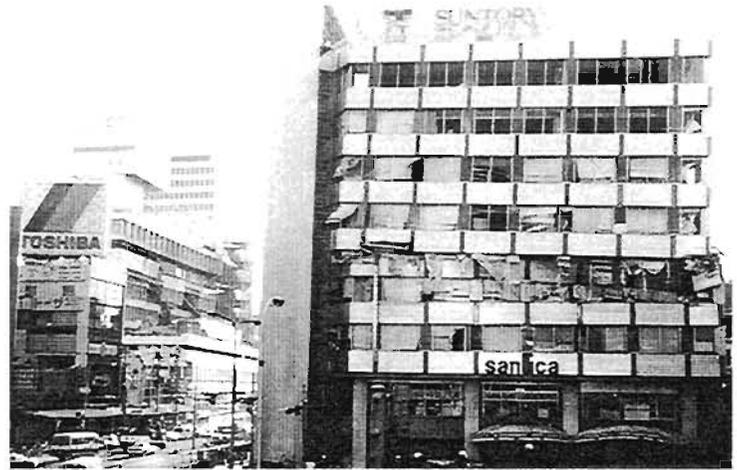
Plate 4.15: 2 Storey collapse in irregular building

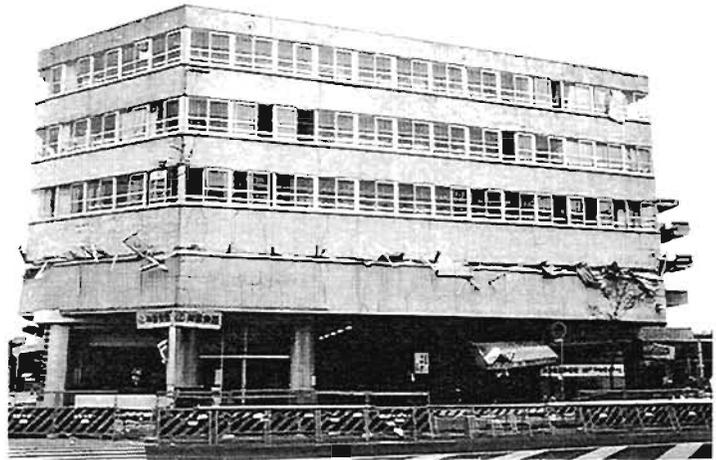
Plate 4.14: 4th and 5th Storey collapse in 9 storey building

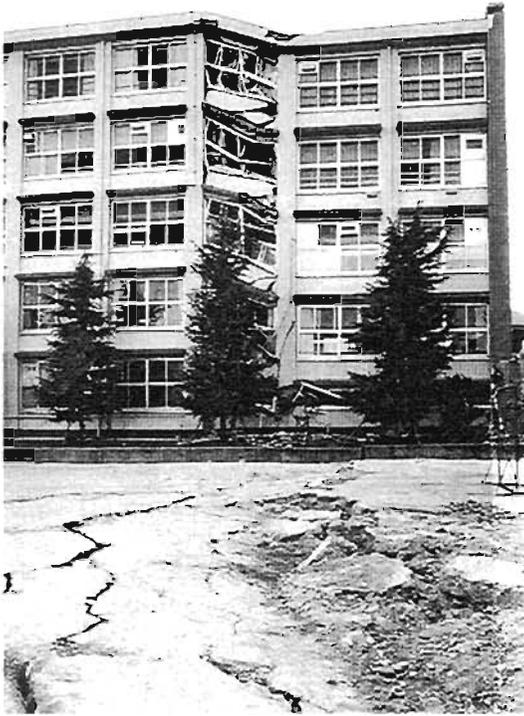
Plate 4.17: 2nd & 3rd Storey collapse in long building

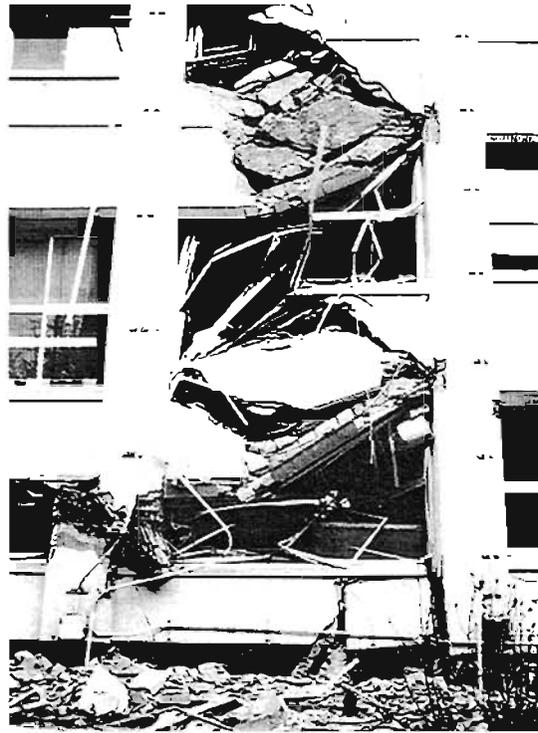
Plate 4.18: Partial storey collapse in 2nd storey

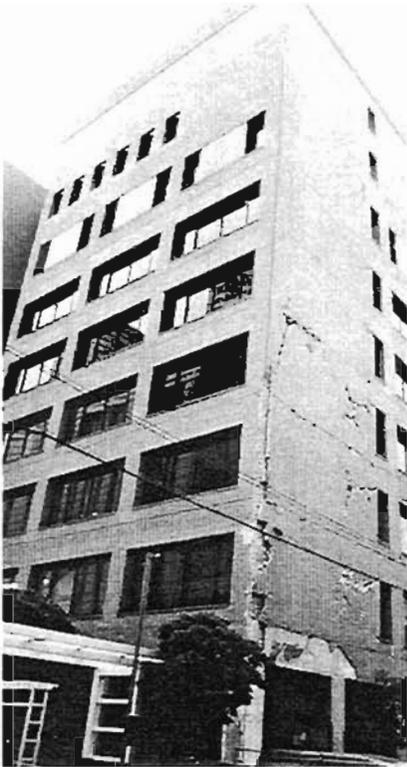
Plate 4.24:

2-way collapse following shear wall failure after buffeting and attributable to lack of longitudinal shear walls

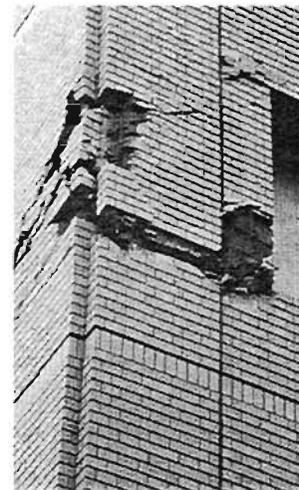
Plate 4.28: Flexural/shear failure in shear wall building

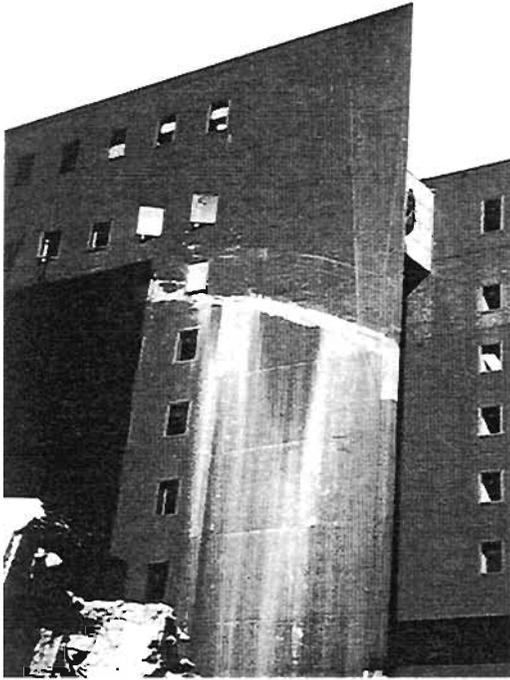
Buckled reinforcement

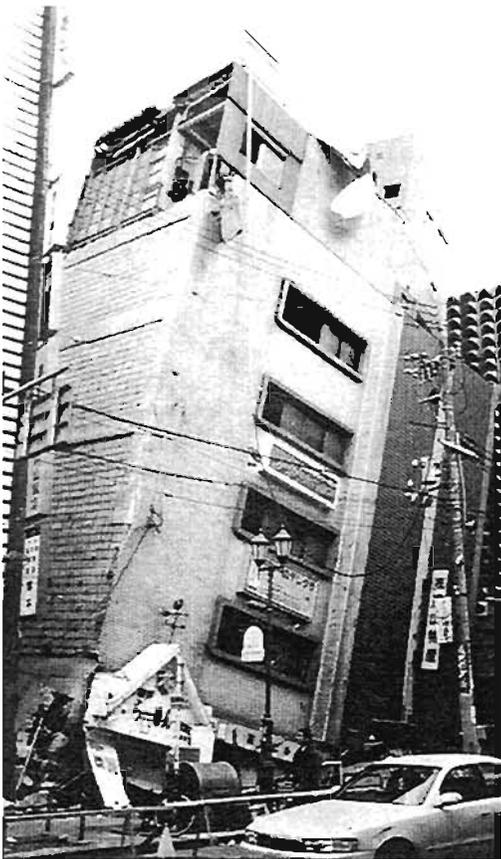
Plate 4.30: Distributed inelasticity in shear wall structure

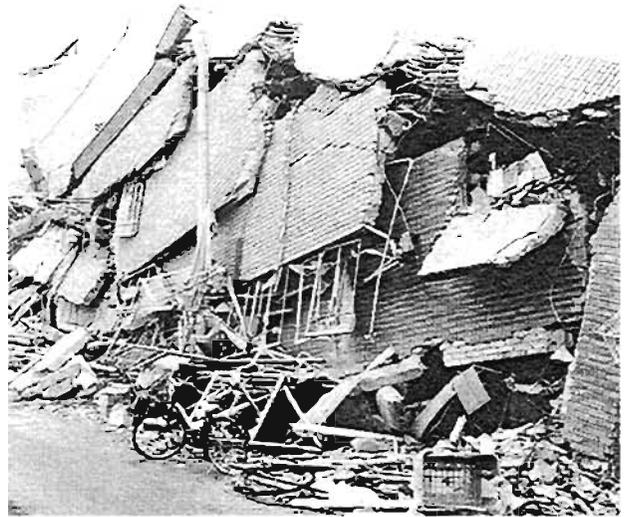
Plate 4.32: Shear wall compression failure with consequential shear fracture along vertical axis

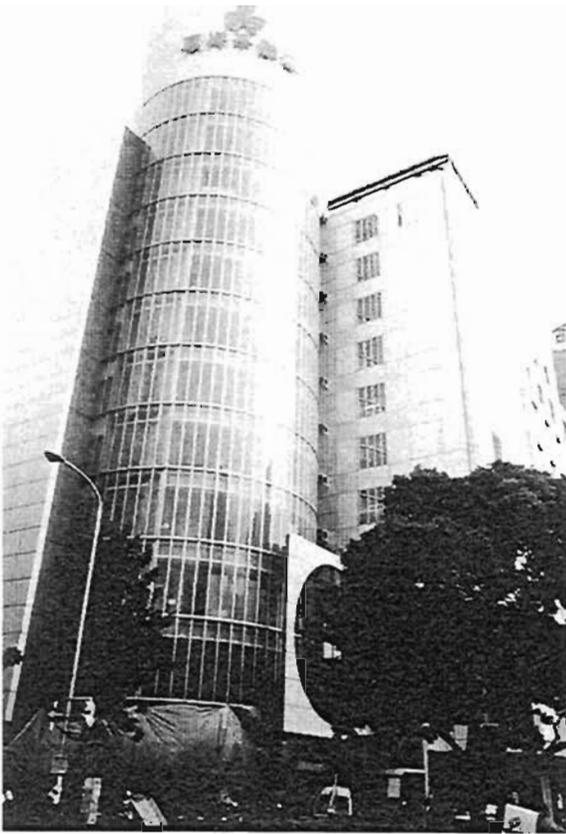
Plate 4.34: Collapsed building with separated shear walls

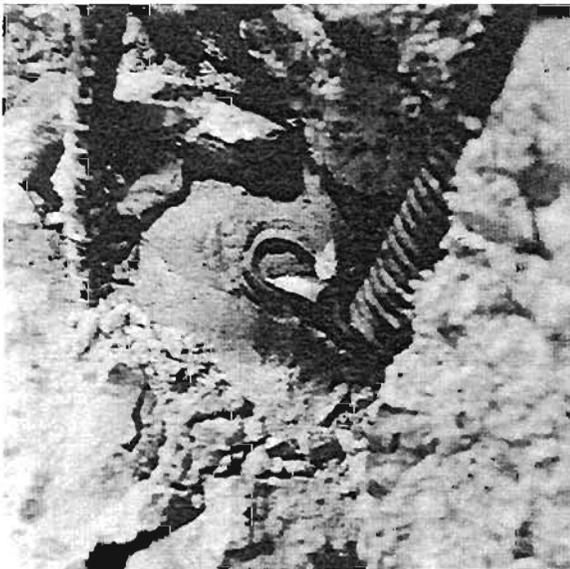
Plate 4.36: Damaged connection beams

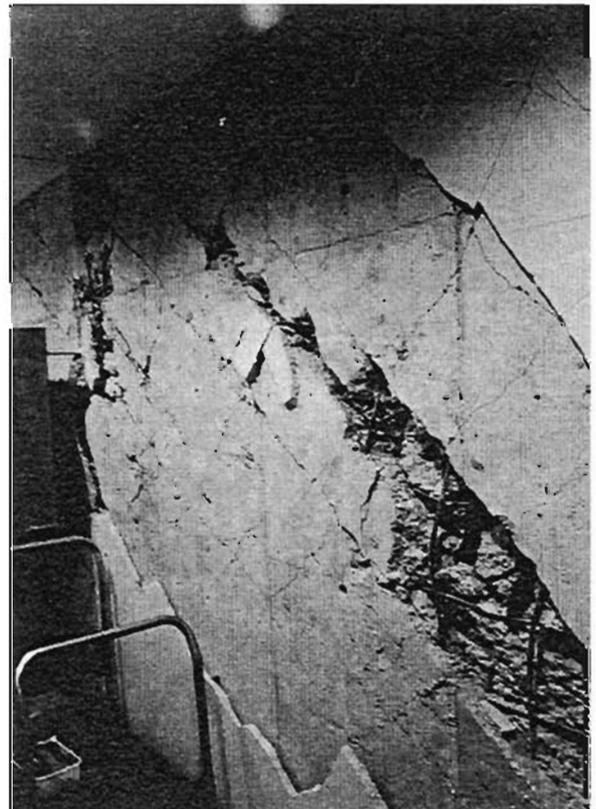
Plate 4.38: Live electrical duct in shear wall

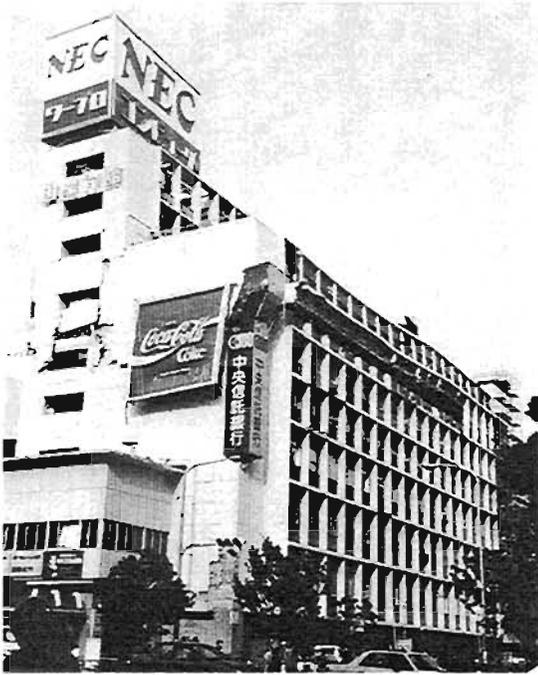
Plate 4.37: Shattered shear wall

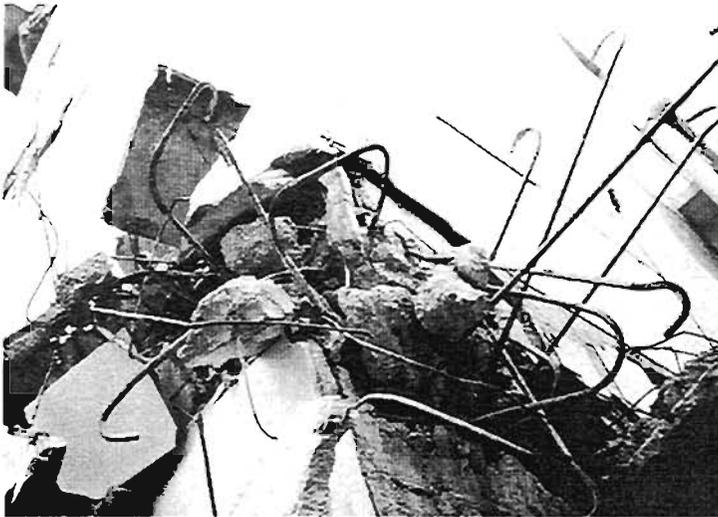
Plate 4.40: Damage at root of tower

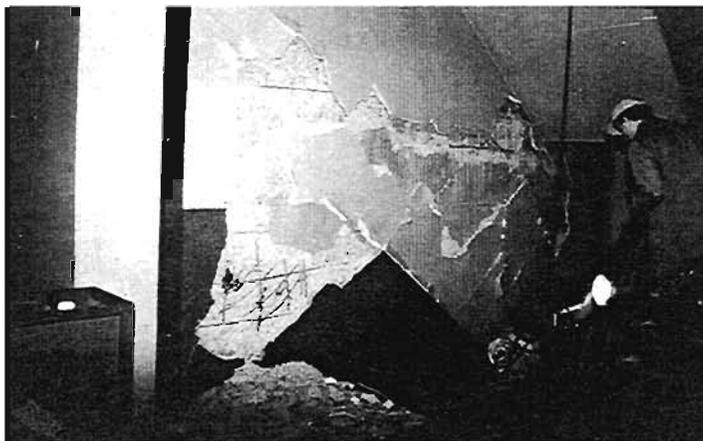
Plate 4.41: Disintegrated corner with reinforced fascia panels

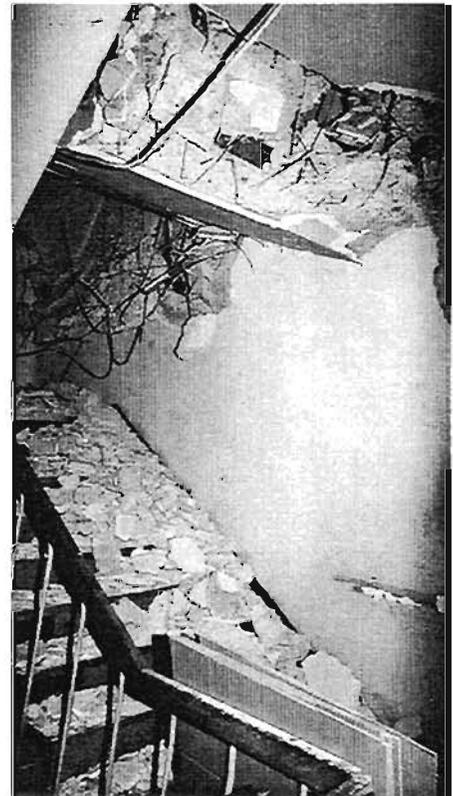
Plate 4.42: Hole in asymmetrically reinforced shear wall

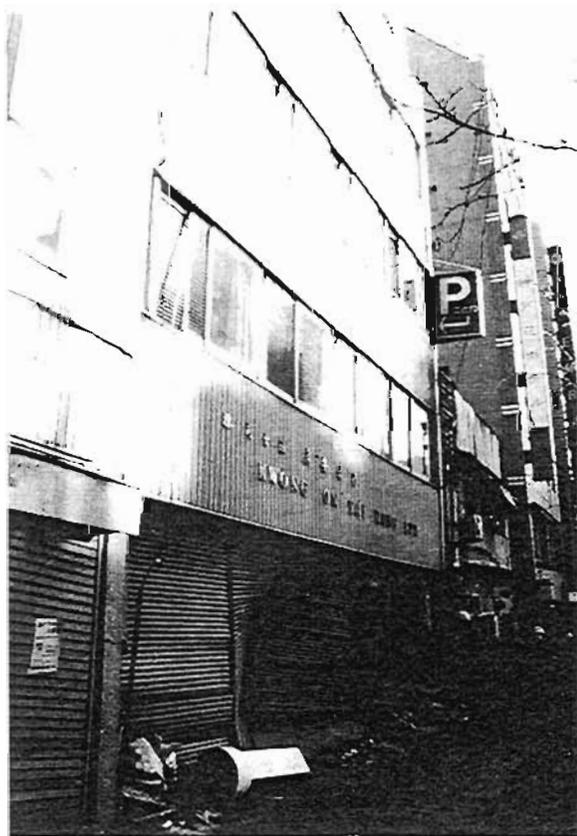
Plate 4.45: Corner joint damage in irregular building

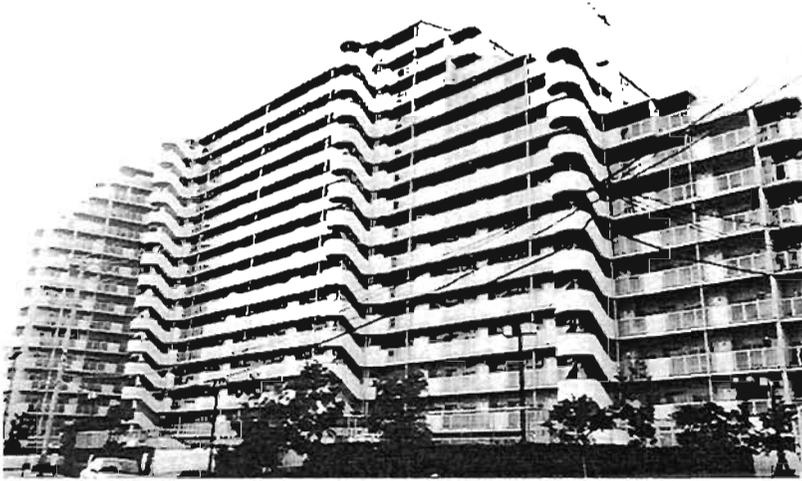
Plate 4.47: Failed off-centre central column

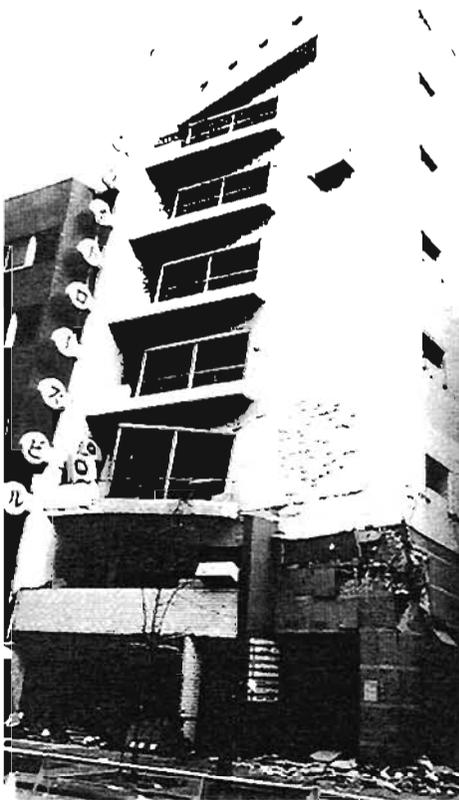
Damage between doors and windows

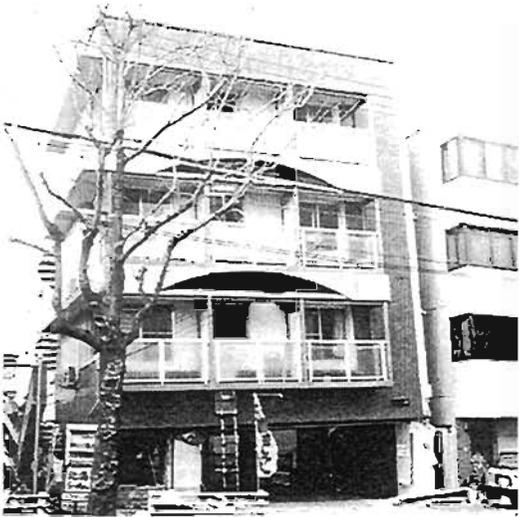
Plate 4.55: Spalling between staircase and stair well cross beam

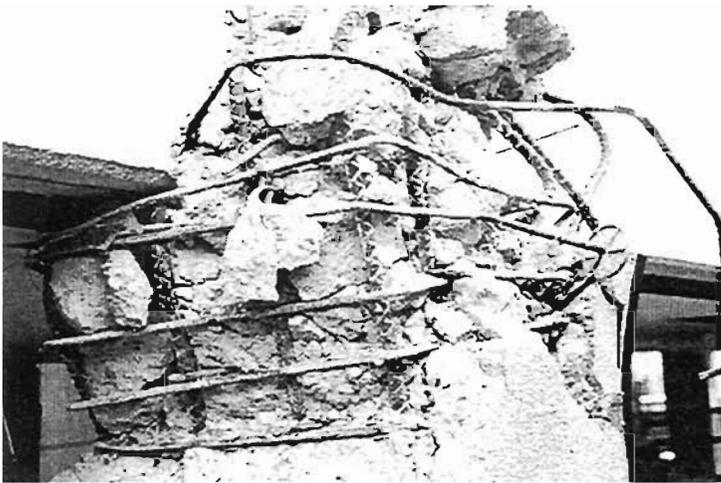
Plate 4.57: Anchorage of ramp to first floor

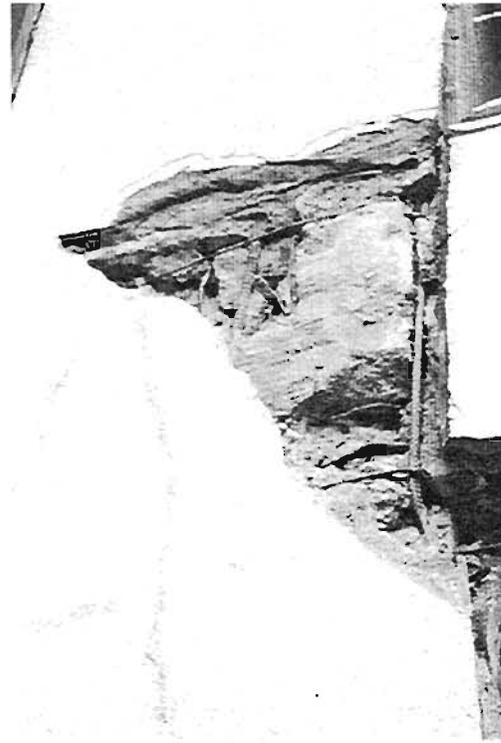
Plate 4.62

A joint in this building with an irregular frame had suffered classical shear failure and lateral distortion where the beam had punched into the column, buckling the longitudinal bars (plate 4.62). The long fracture zone at the top of the joint suggests the top beam bar, which was not visible, had pulled out.

Shear crack in first floor joint

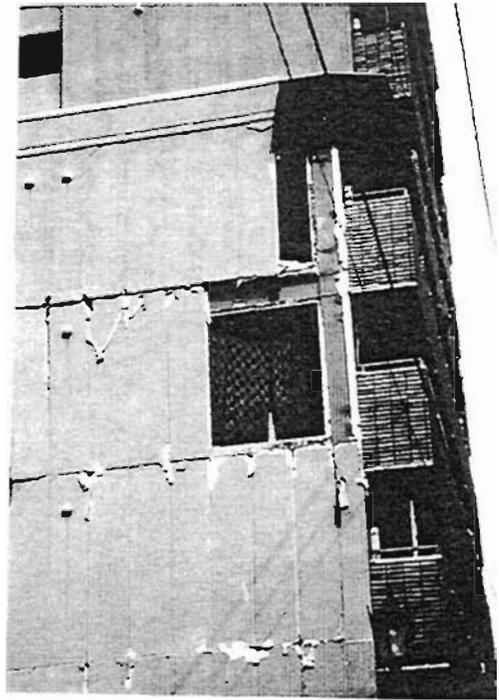
Plate 4.65:

Missing and damaged pre-cast cladding
on steel framed building

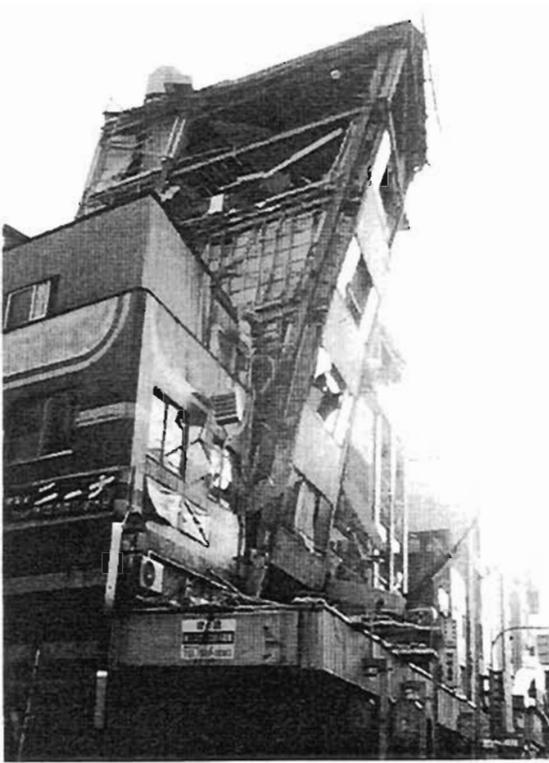
Plate 4.68: Sway after snapping of bracing flats in upper stories

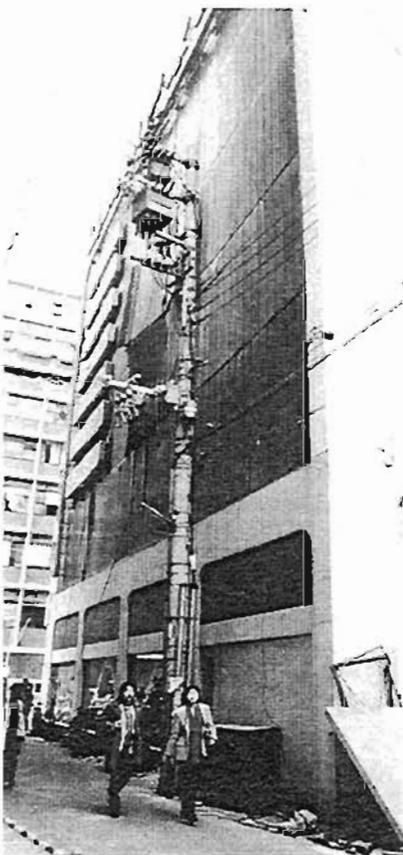
This building of narrow frontage compared to its depth behind the street, was unusual in that it lacked internal columns and moreover there were no columns on the front facade (plates 4.72 and 4.73). The back wall was of reinforced concrete construction with two vertical rows of small windows. On the sides were braced frames which appeared to comprise I-section columns (connected by bolted splice plates just above floor level), light lattice beams and bracing (either of rectangular sections or I section) with its minor axis perpendicular to the frame. A remarkable form of in-plane deformation had occurred, with in-plane buckling of the bracing taking place well away from the joints in the four storeys which had lost their cladding (plate 4.73). In the lowest of the storeys, where storey height was appreciably greater, the braces had failed at the central gusset. The opposite face had suffered little distortion, with only one cladding sheet badly damaged (plate 4.74). The building was well separated from its neighbour so buffeting had not occurred.

Plate 4.74: Damage to cladding on opposite face

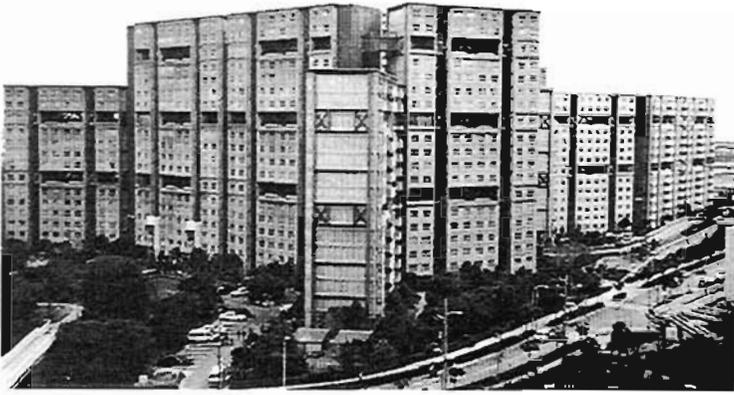
An old style building with deep beams and columns fabricated from I and T sections had failed at the beam to column welds (plate 4.75). There was no evidence of bracing.

Plate 4.75: Building with failed welds at beam/column connections

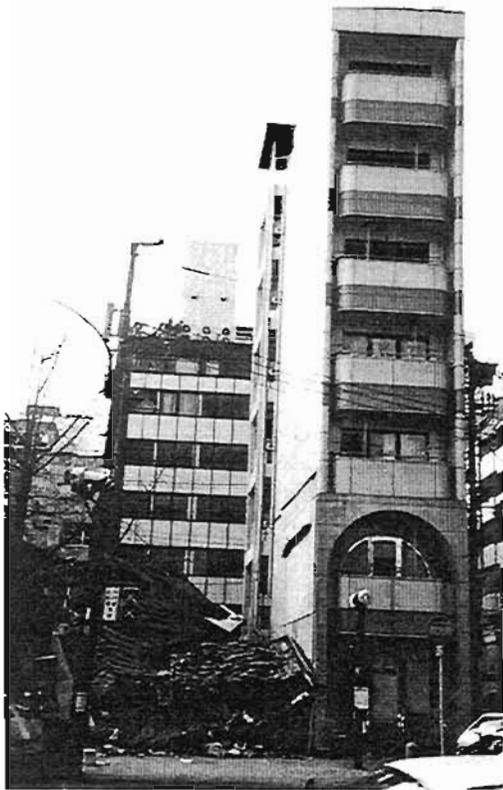
Around one building circumferential steps had occurred in the ground indicating general settlement of the surrounding ground relative to the building, which was undoubtedly piled (plate 4.80).

Plate 4.80: Settlement rings

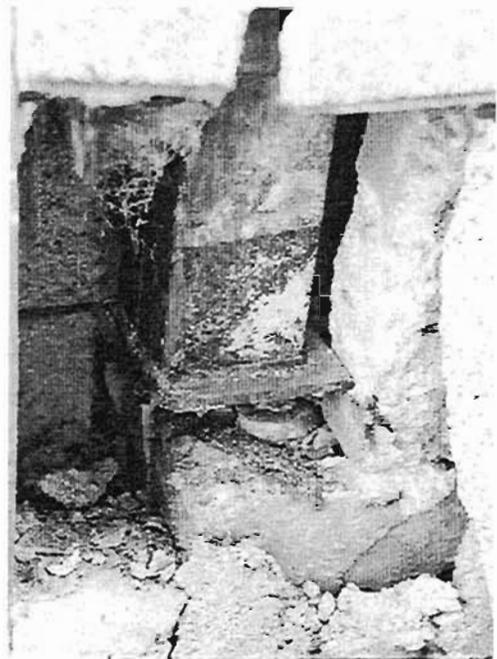
Plate 4.82: Disintegrated plinth of corner column

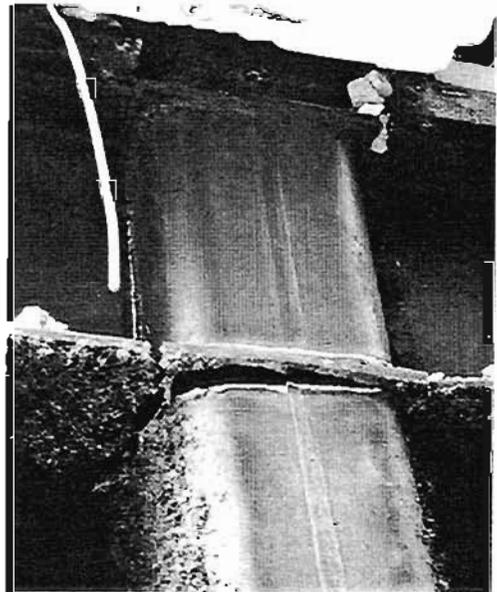
Plate 4.84: Failure at internal joint

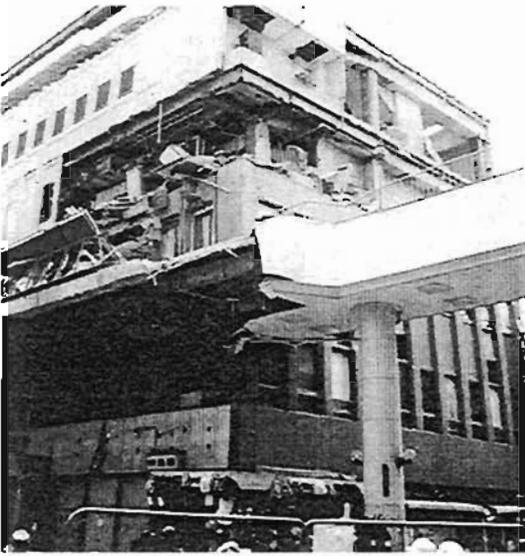
Plate 4.89: SRC building damaged by link bridge

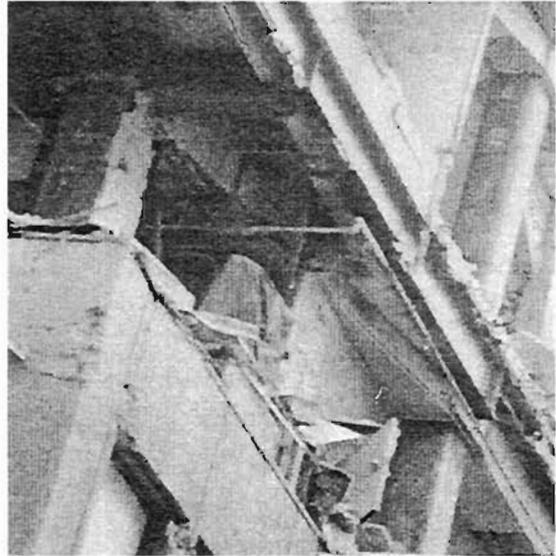
SRC/steel transition

Plate 4.90: Damaged irregular corner building of SRC/mixed construction

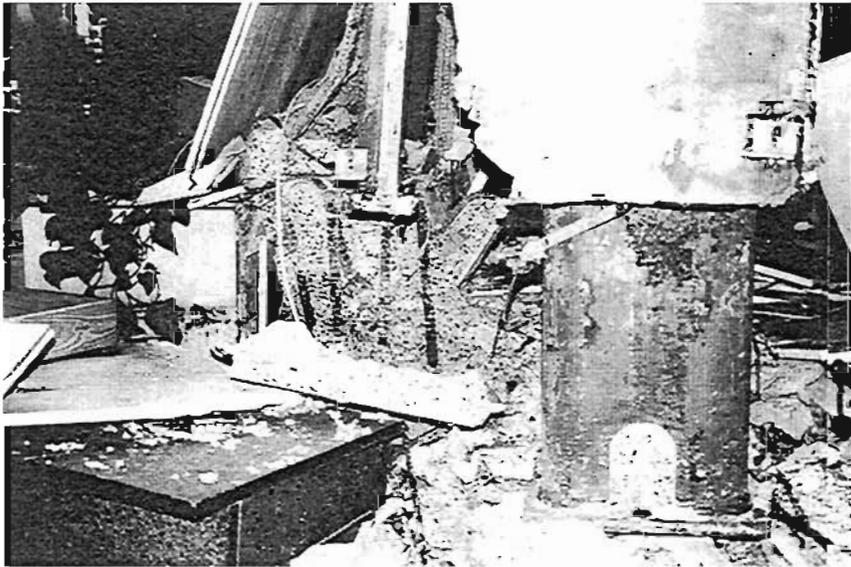
Plate 4.93: Column pulled out of plinth

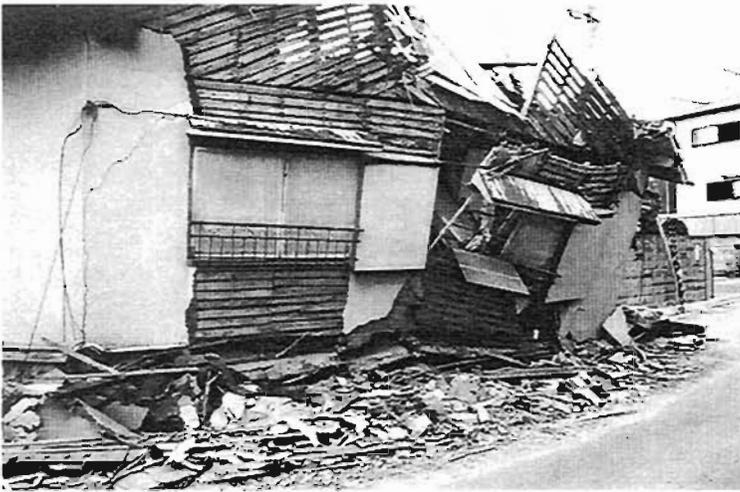
Plate 4.96: Collapsed timber-framed houses

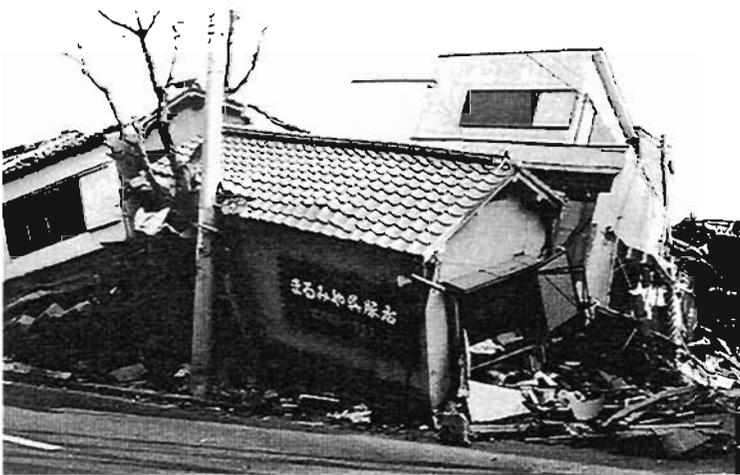
Plate 4.97: Collapsing house stabilised by pole

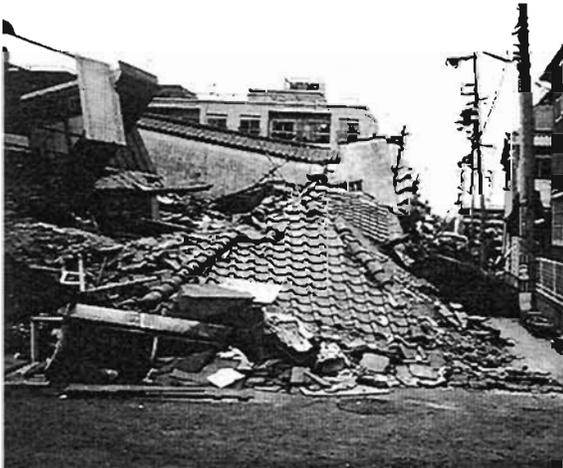
Plate 4.99: Collapse with roof intact

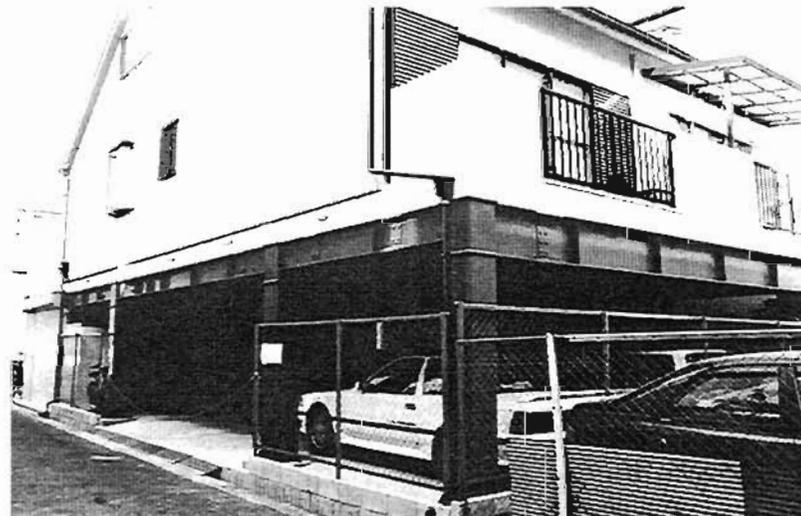
There was no damage whatsoever in this three storey domestic house with an open ground floor, forming a car park (plate 4.104). The structure at ground floor comprised a moment resisting frame of rectangular steel columns with a shallow stiffened girder supporting the upper floors.

Plate 4.104: House with ground floor moment resisting frame

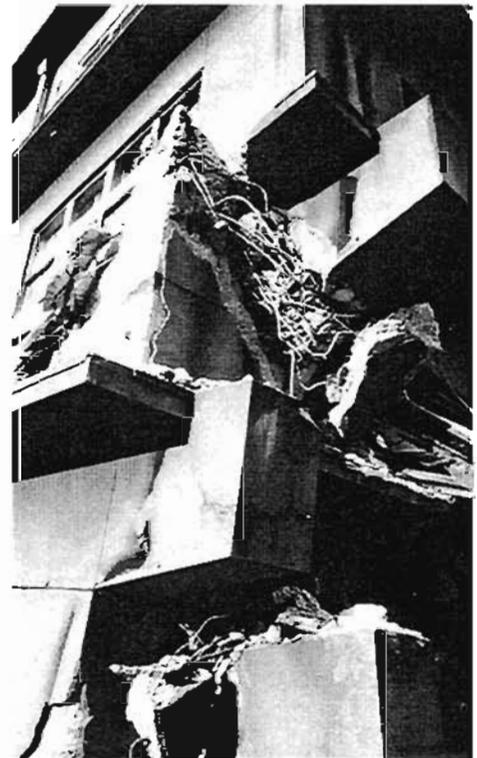
This four storey building with 3 storeys of offices above ground and one storey in a well, had suffered collapse of the second storey and partial collapse in lowest storey (plate 4.110). The collapse appeared to have been promoted by the hard point where a slab in front of the main entrance bridged the well.

Plate 4.110: Precast concrete building with partial collapse induced by link bridge

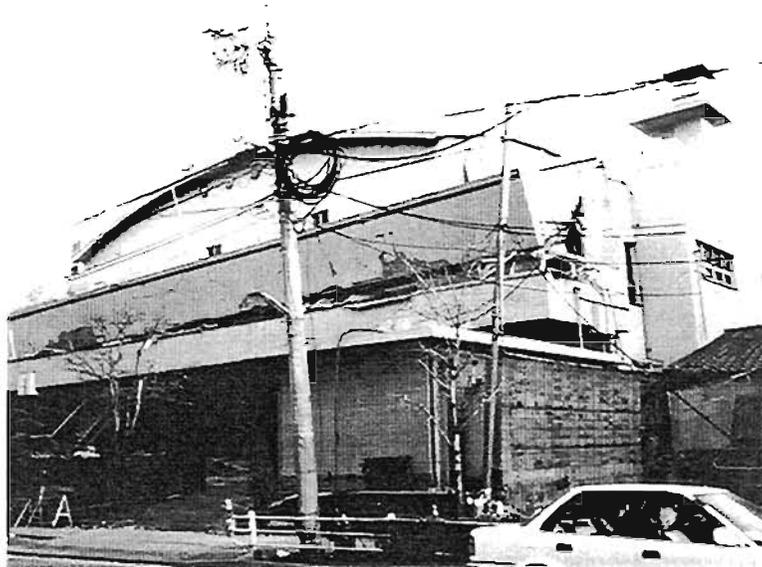
Details of precast monoliths

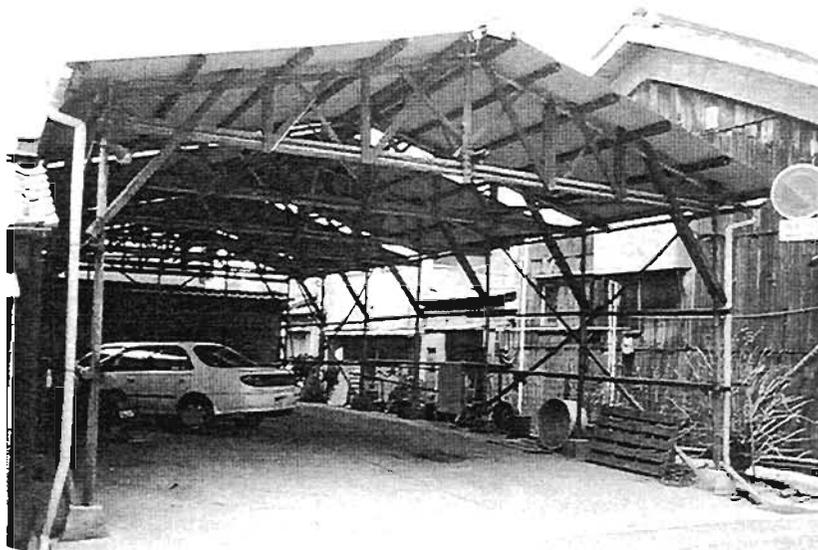
The middle of the long side of a steel portal shed near the coastal highway moved towards the sea, which could be attributed to inadequate foundations generally and the absence of mid side tie beams (plate 4.113).

Plate 4.113: Mid-side failure of long steel frame shed

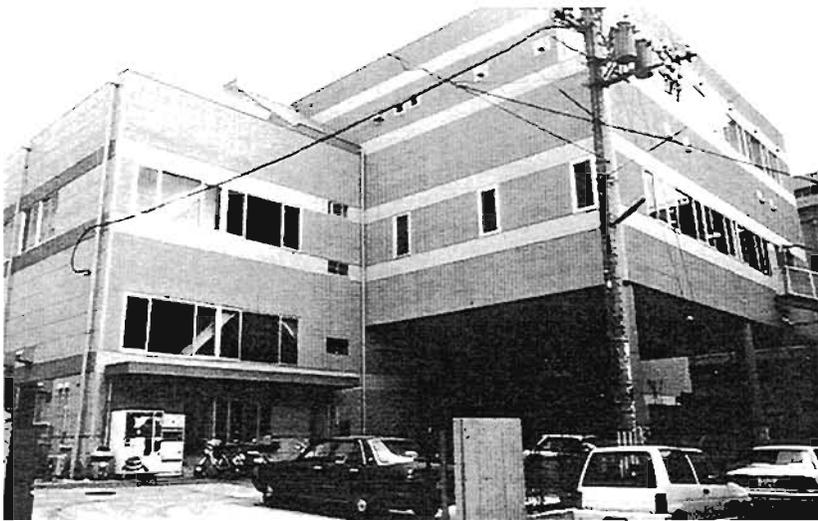
A large 3-storey warehouse in the port area with few windows but with large sliding doors at all levels, leading onto deep cantilevered balconies, had survived undamaged, but the ground in front had subsided (Plate 4.115).

Plate 4.115: Undamaged 3-storey warehouse in the port

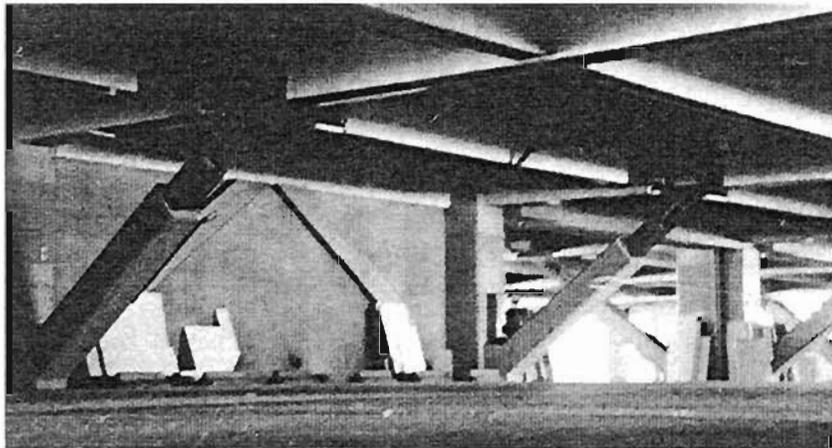
Plate 4.118: New large multi-storey car park near the ferry

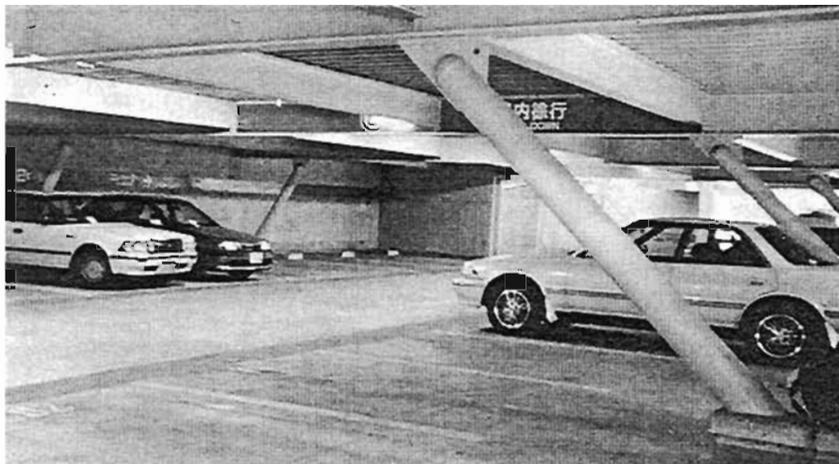
Plate 4.125: Damage to confined concrete at end

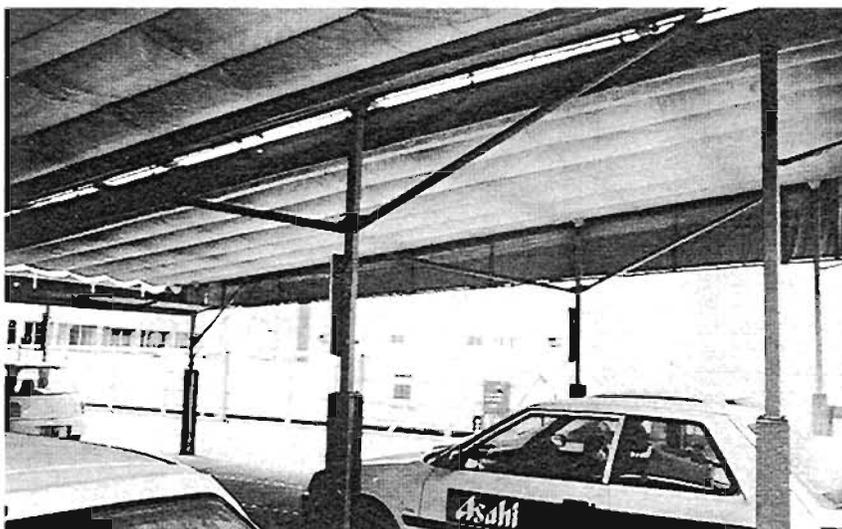
Plate 4.136: Column base/brace connection

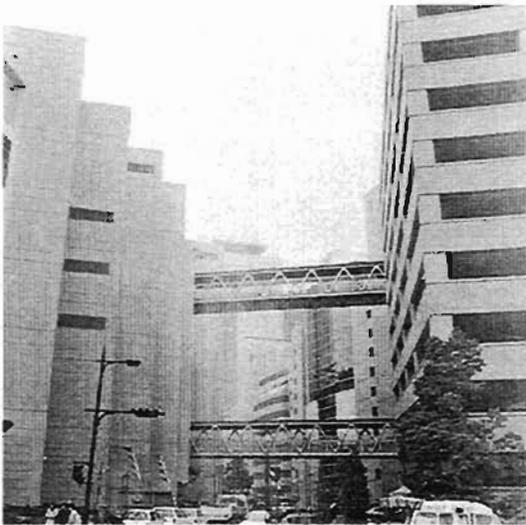
Plate 4.141: Underside of bridge

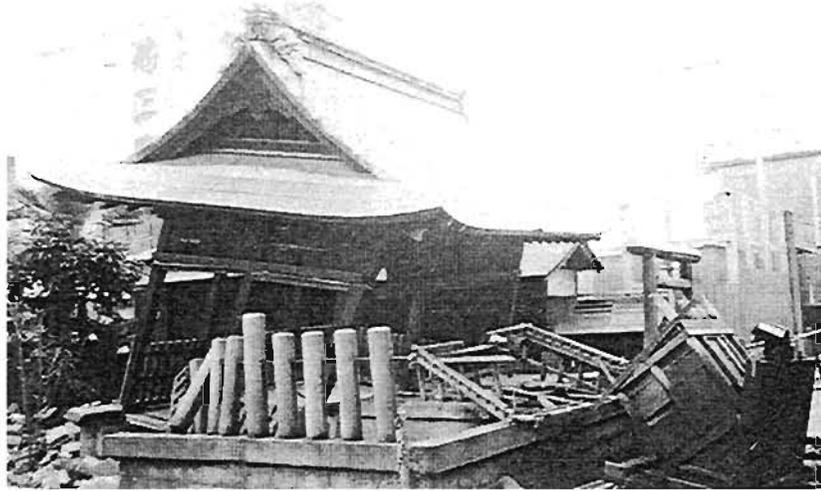
The few very old buildings affected by earthquake were temples and monuments. All examined had fared badly, suffering column collapse (plate 4.150) or severe racking (Plate 4.151). In cemeteries sculptures and headstones toppled (Plates 4.152 and 4.153).

Plate 4.150: Collapsed temple

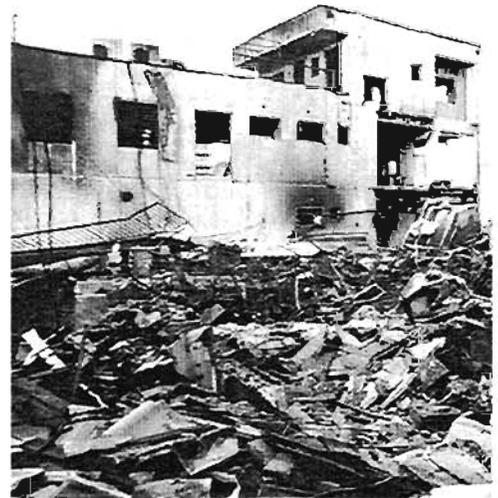
Land space in Kobe, as in all of Japan, is at a premium and hence the outskirts of Kobe are very densely populated with only very narrow streets or alleys in between buildings. The older buildings are wooden frame and in most areas there is a mix of light industrial and residential buildings (plates 4.164 and 4.165). Timber buildings are particularly vulnerable as most Japanese homes do not have central heating and rely on kerosene, gas or electric heaters for warmth. These heaters are easily toppled in earthquakes and readily start fires. The combination of a large potential source of combustible material and small scale industry with unprotected gas tanks and domestic users with heaters has always had the potential for disaster.

The commercial properties interdispersed between the timber houses were badly damaged by the flames (plates 4.164 and 4.165). The areas affected in total amounted to about 70% of that affected by the Great Fire of London.

Plate 4.164: Fire damaged commercial property in zone of collapsed housing

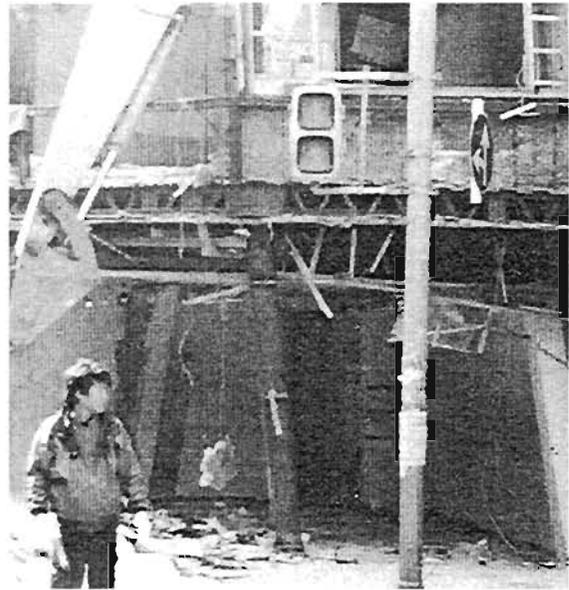
Close-up of racked ground floor storey
